**OPEN SPACE ADVISORY COMMITTEE  
STAFF REPORT**

**REQUEST:** **Discussion and Possible Action:** To recommend to the Board of Supervisors acceptance of the monitoring report for the Horsecreek Ranch Conservation Easement for 2013.

## **Carson City Open Space – Conservation Easement Monitoring**

**Date:** July 24, 2013

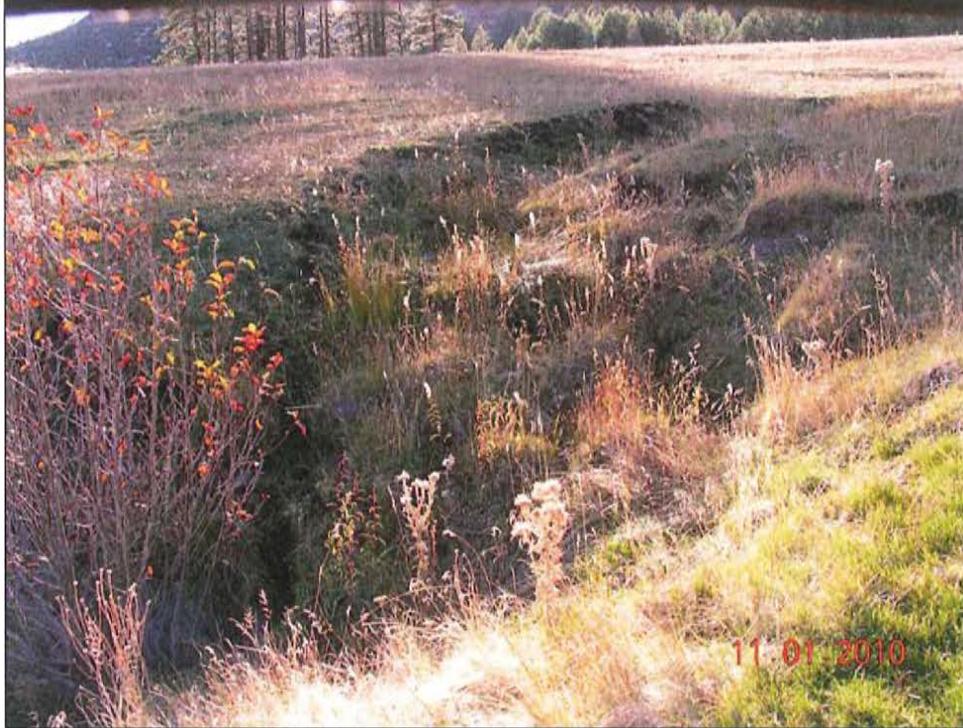
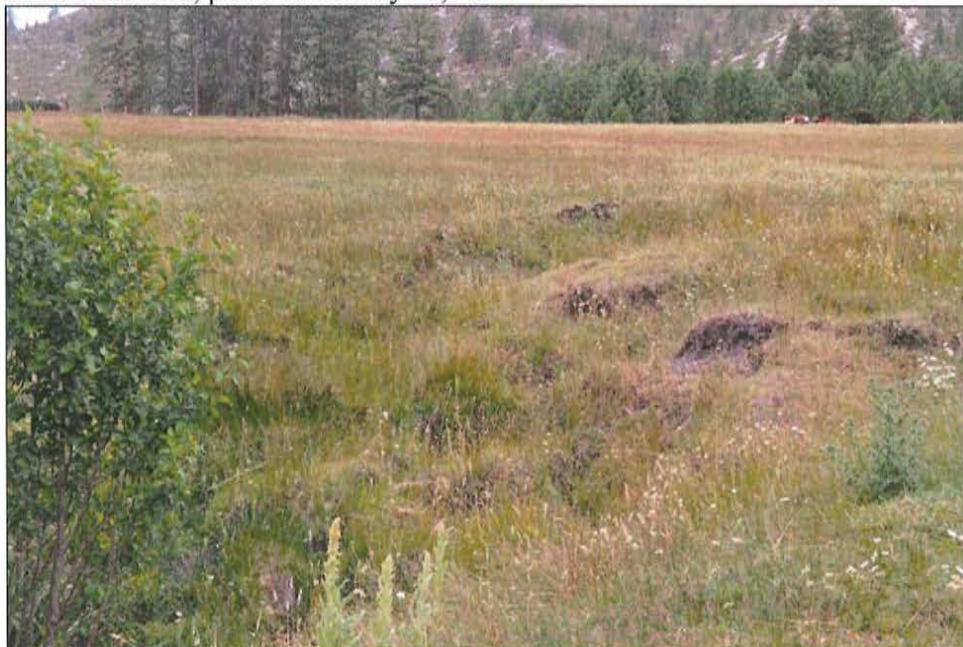
Photo Point: The photo of this drainage, located south of the cabins, has been included to document change and vegetation growth. N 39 07' 42.7" W 119 50' 10.2"

Near the southeast corner, one specific area is being monitored for landscape change. This low drainage area of the meadow appears to be vegetated and stable though a few isolated mounds or hummocks may be the result of cattle trampling. A qualitative assessment with the photo comparisons may be a little deceptive because the first photo was taken at the end of the growing season in November after grasses were grazed and/or died whereas the current photo was taken at the peak of the growing season in July when grasses are actively growing.

2010 Condition, photo taken November 1, 2010 (initial assessment – view west)

2013 Condition, photo taken July 23, 2013

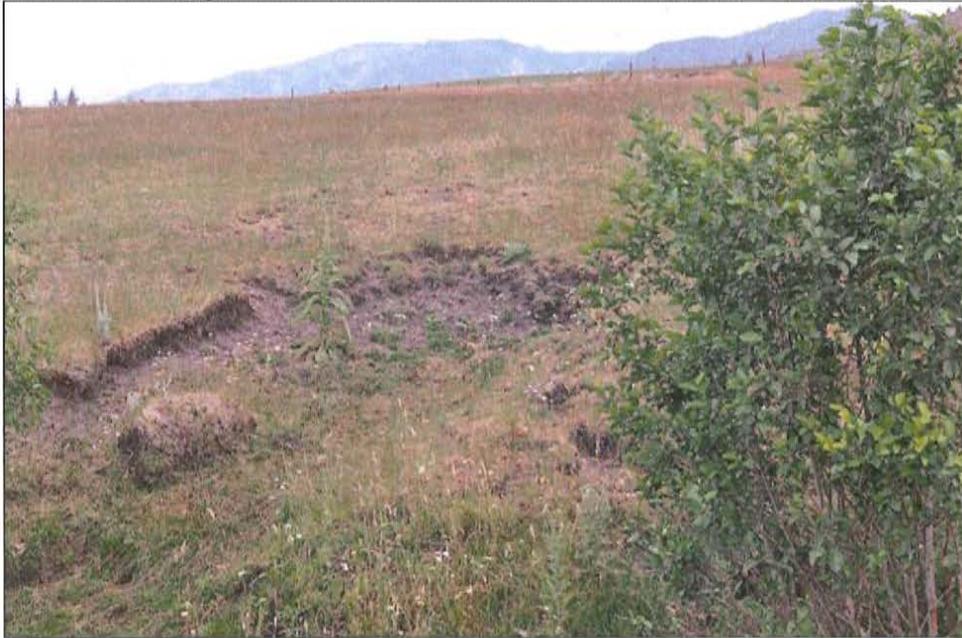
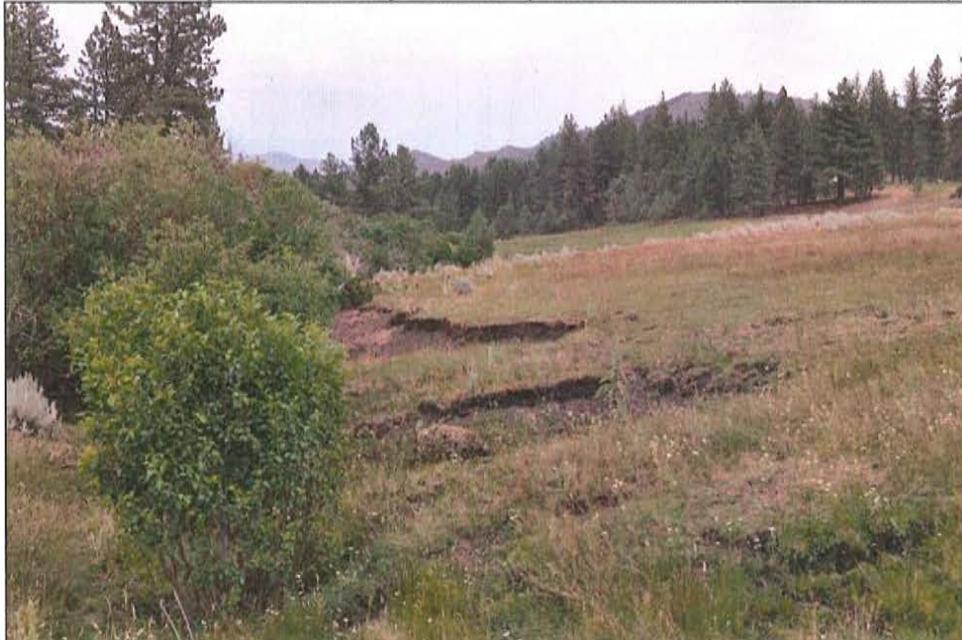
2013 Condition, photo taken July 23, 2013 (initial assessment – view south)

2013 Condition, photo taken July 23, 2013 (initial assessment – view southeast)

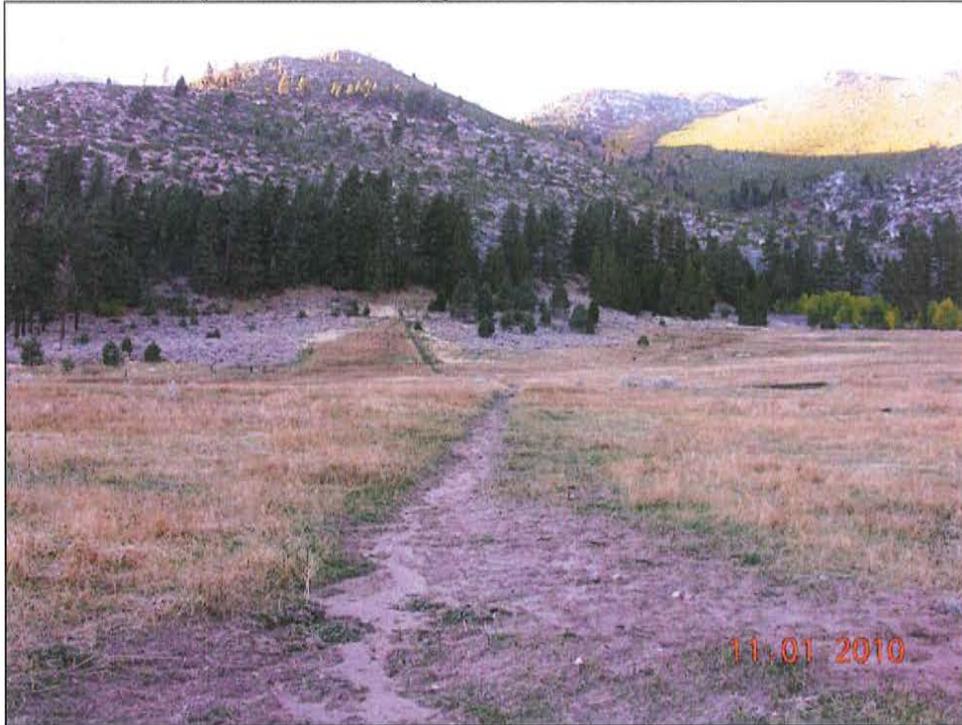
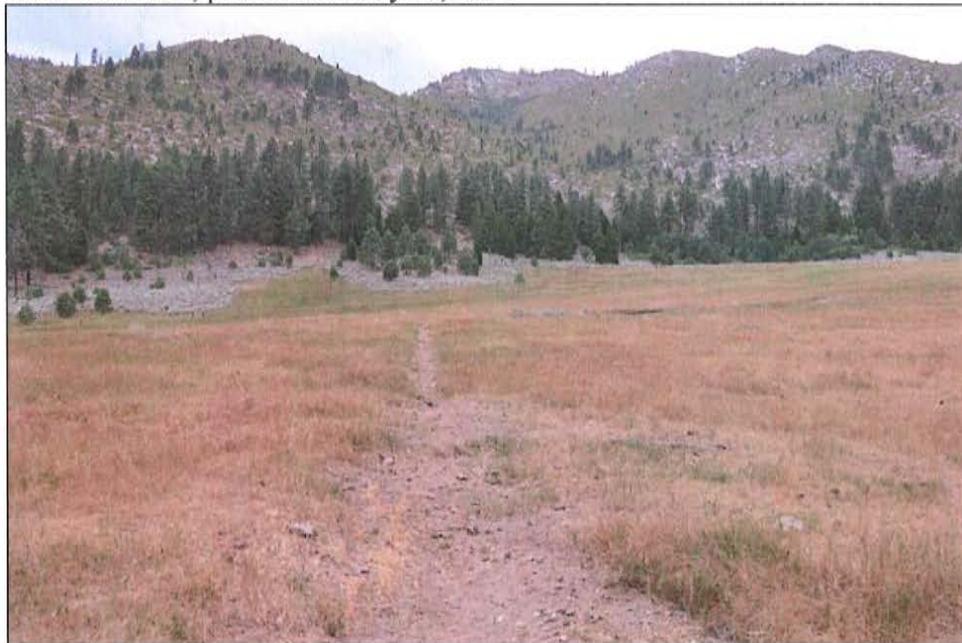
Photo Point: The photo of the pipeline excavation area has been included to document change and vegetation growth.

The linear excavation for the water pipeline to the cabins occurred prior to signing of the conservation easement in March 2009, but some of the impact remains visible. Natural revegetation seems to be occurring on the upper, wetter end of the excavated area. On the lower end closer to the cabins, however, the cattle seem to travel along the route and revegetation is not occurring. The disturbed area is minimal; therefore, at this time, no further action is recommended.

2010 Condition (initial assessment), photo taken November 1, 2010

2013 Condition, photo taken July 23, 2013

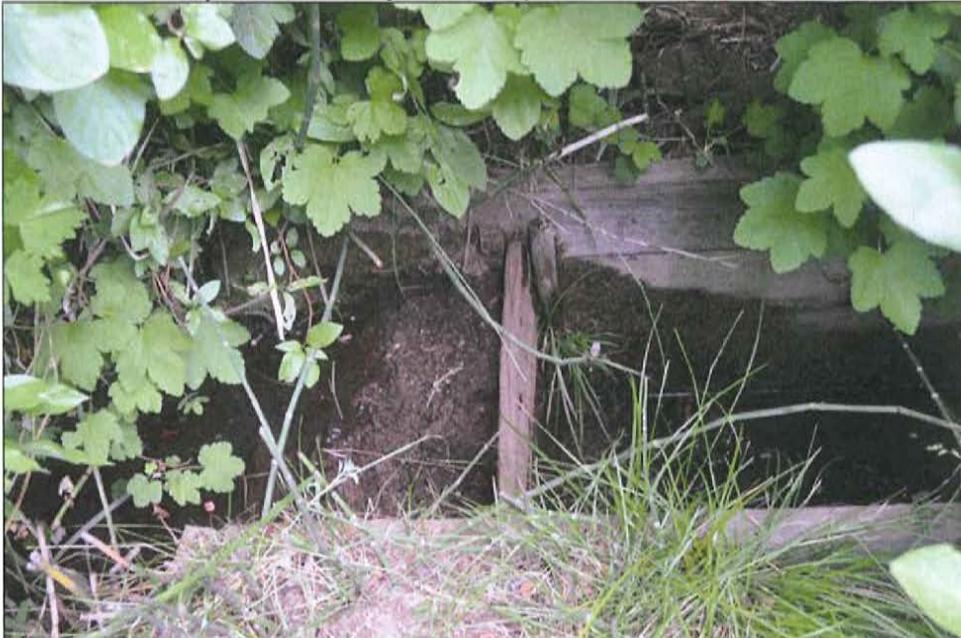
- Stewardship Account: There are no expenses to report. The account has a current balance of \$47,375.00.
- The irrigation ditch known as “Neal’s Flume” was dry during this field monitoring. Mr. Fagen informed staff that the adjacent landowners (Jeff Schulz and John Schulz) had cleaned the flume in April/May 2013 and typically water is sent to the top of the meadow in early spring for at least one good surface flood. It should be noted that the Baseline Condition Report also commented that the ditch is not used during the minimum flow periods of the north fork of Clear Creek due to significant conveyance losses on the ditch. An inspection of the upper reach revealed water flow in the north fork of Clear Creek; however, the water level seemed low and it was certainly lower than the accumulated sediment behind the control box for Neal’s Flume. While the upper meadow at Horsecreek Ranch was not currently receiving water from Neal’s Flume, two other springs were flowing and providing water to nearby areas. Overall, the meadow was fairly green and productive.

2013 Condition, photo taken July 23, 2013 (view of the control box for Neal’s Flume)

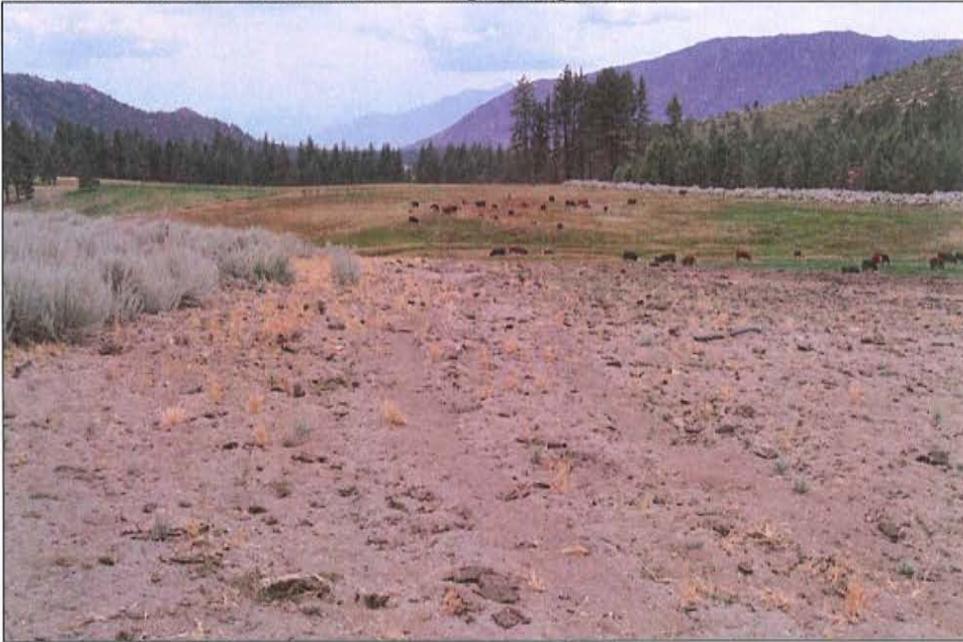
- The previous report recommended monitoring of the cattle loafing area located just outside the gated entrance to the cabins with the goal to limit further expansion. The below documentation provides photo points and respective measurements.

2013 Condition, photo taken July 23, 2013 (initial assessment – view south): The bare area measures 157' north to south along the sagebrush.

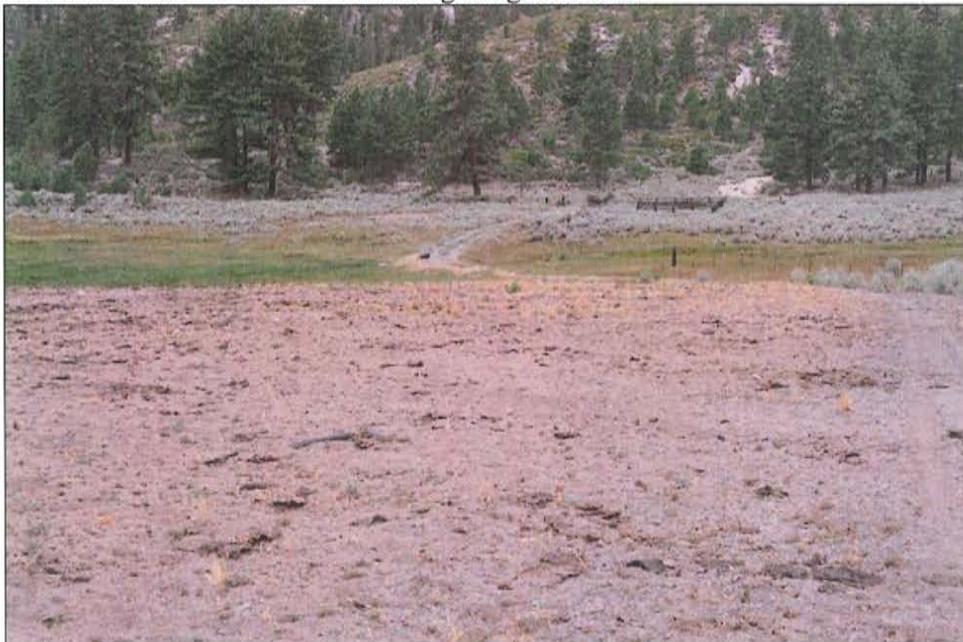
2013 Condition, photo taken July 23, 2013 (initial assessment – view west): The bare area measures 145' east to west along the gravel road.

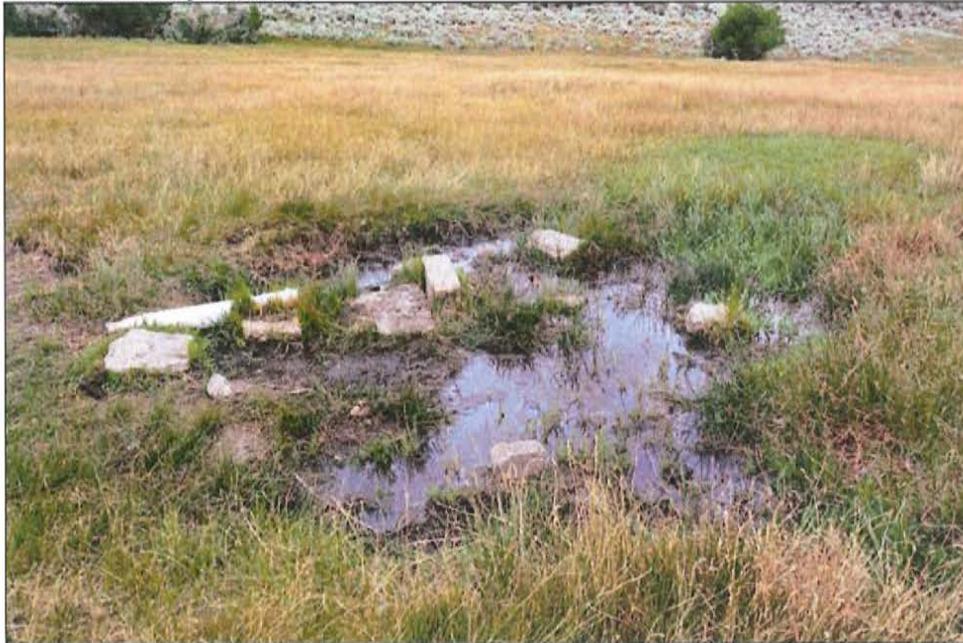
Photo taken July 23, 2013

- One vegetative response observed throughout the woody ecological sites of the property is the new growth and establishment of conifer seedlings including pine, fir, and cedar.
- One distribution box located approximately in the middle of the meadow is in complete disrepair. The water is ponding rather than spreading throughout the ditches. This replacement should occur prior to the next irrigation season.

- 1) Replacement of the concrete distribution box; and
- 2) Continued removal of bull thistle

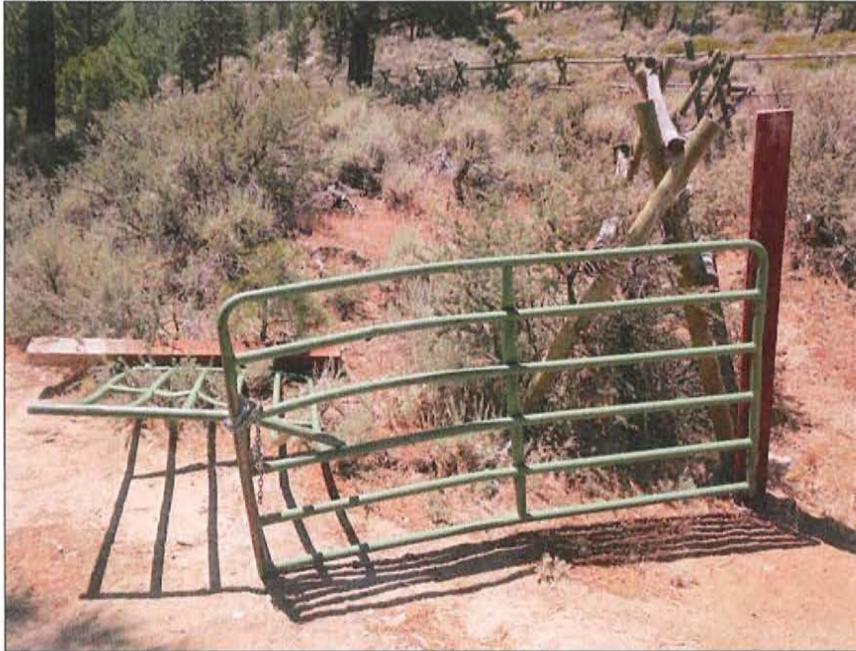
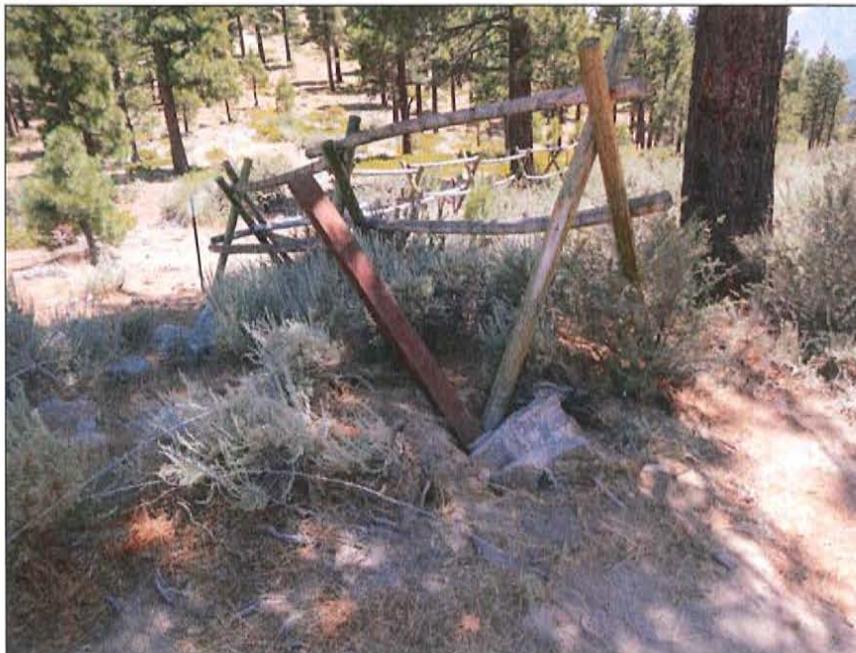
Photos taken July 18, 2013

- On July 18, 2013, Mr. Paul Schmidt, the volunteer ranger for the Open Space Program, reported significant damage to the entrance gate to Horsecreek Ranch. Staff responded and inspected the property for further vandalism. The two lower gates remained closed, the cabins were secure, and no other damage was evident. Mr. Fagen paid for repairs and requested additional patrol from Carson City.

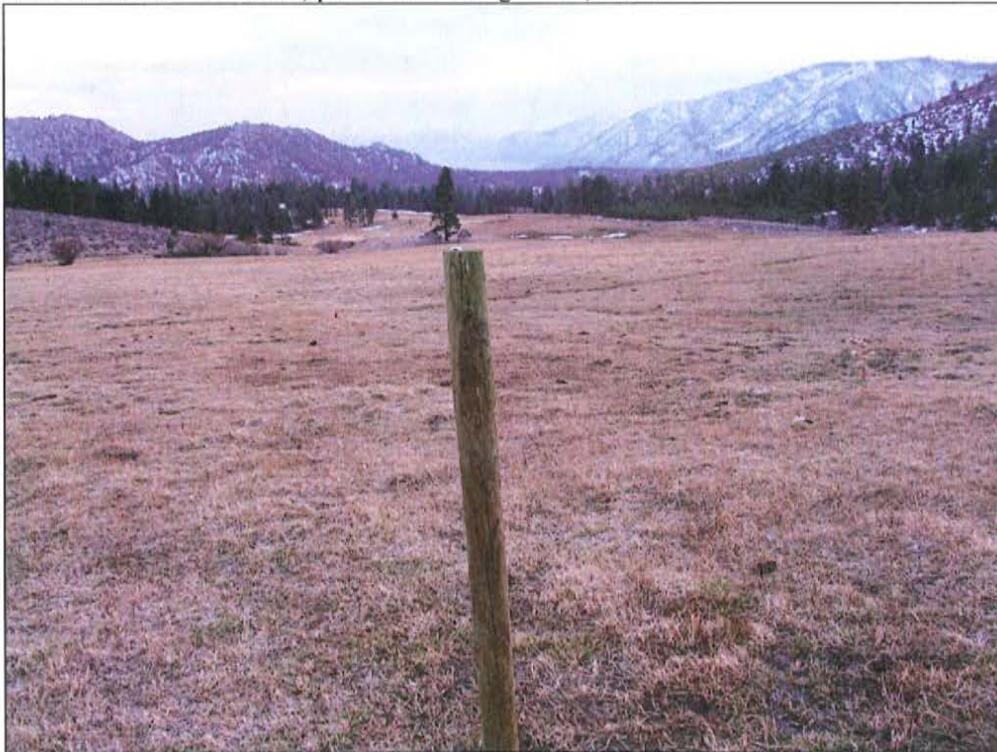
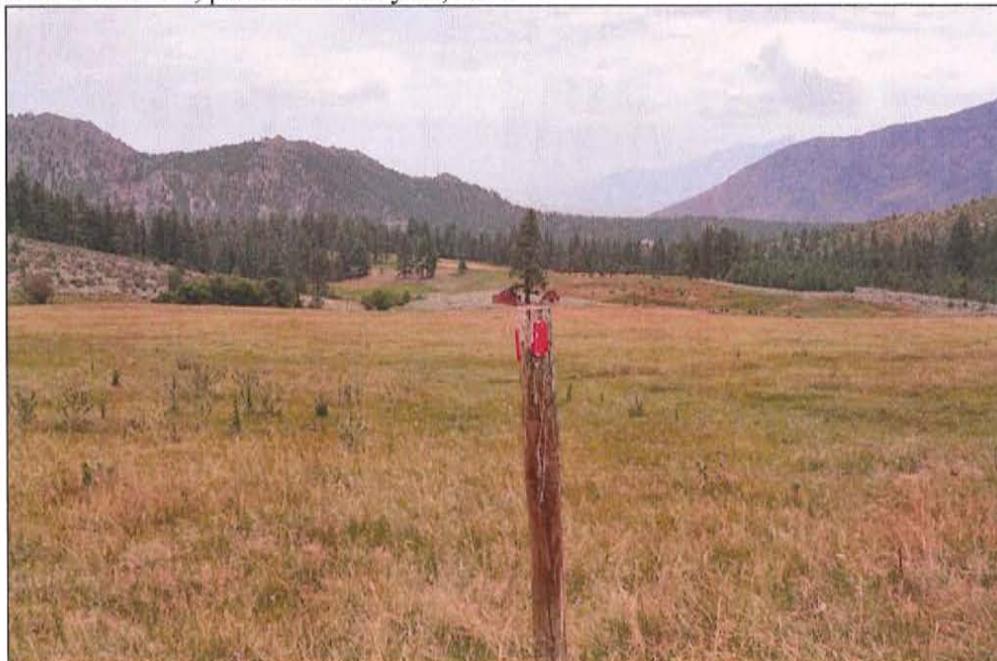
**Photo Point 9: A permanently marked 100' x 100' area to monitor pasture condition. This annual inventory will be used to monitor not only pasture condition but irrigation efficiency, vegetative response to drought and appropriate livestock utilization.**

- The Pasture Utilization and Condition Assessment was conducted by Ms. Bollinger, Natural Resource Specialist, and included a visual observation of the monitoring plot as described in the Baseline Condition Report. A diversity of pasture and wetland-type plants remains present with various utilization levels depending on species. The overall stubble height was 2-6” with an estimated utilization around 60%. Grazing was not occurring in this pasture at the time of monitoring. Generally, this level of grazing seems appropriate and assures sufficient ground cover prior to the winter snowfall.
