**OPEN SPACE ADVISORY COMMITTEE
STAFF REPORT**

REQUEST: **For Possible Action:** To approve the monitoring report for the Horsecreek Ranch Conservation Easement for 2014.

Carson City Open Space – Conservation Easement Monitoring

Date: November 5, 2014

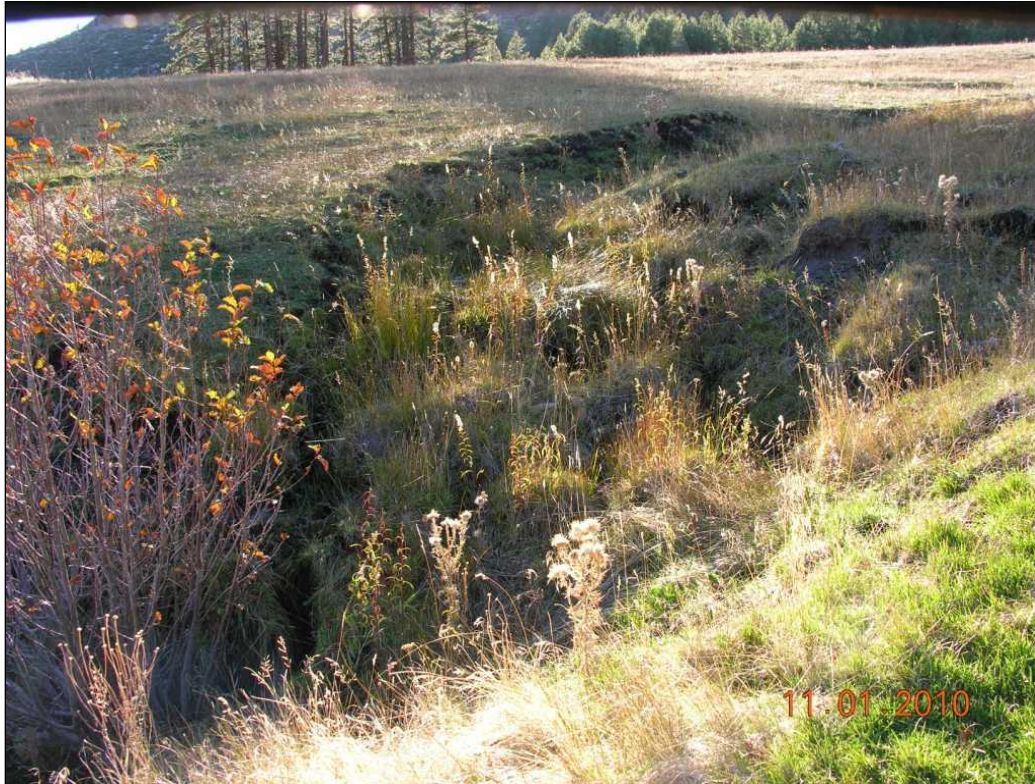
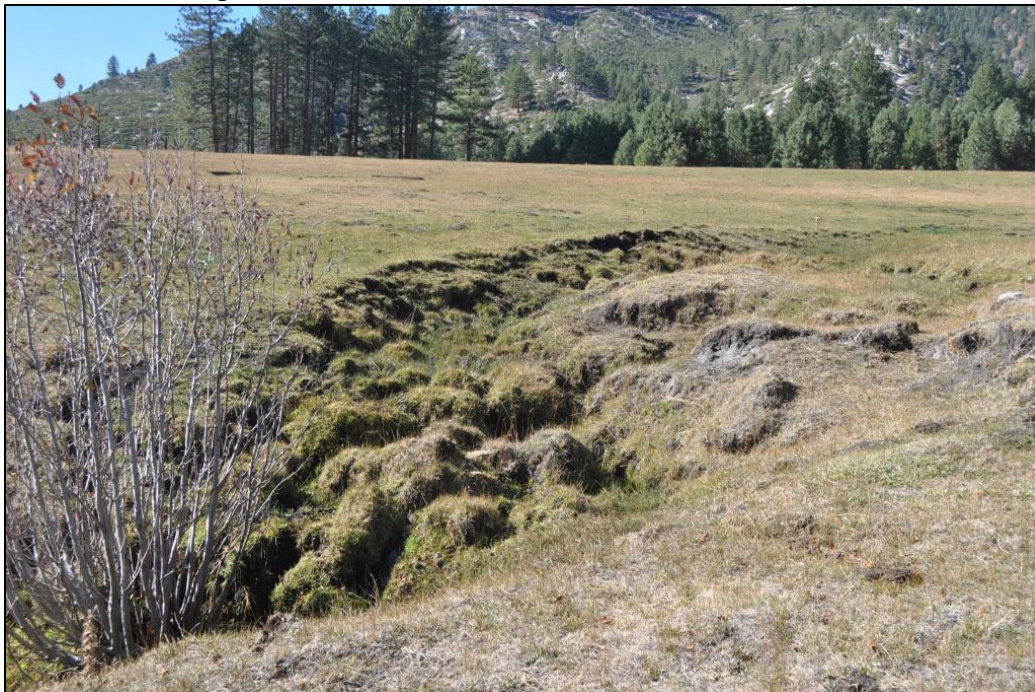
Photo Point: The photo of this drainage, located south of the cabins, has been included to document change and vegetation growth. N 39 07' 42.7" W 119 50' 10.2"

Near the southeast corner, one specific area is being monitored for landscape change. This low drainage area of the meadow appears to be vegetated and stable though a few isolated mounds or hummocks may be the result of cattle trampling. A qualitative assessment with the photo comparisons may be a little deceptive because of the time of year each photo was taken – either during the growing season or at the end of the season after grasses were grazed and/or died.

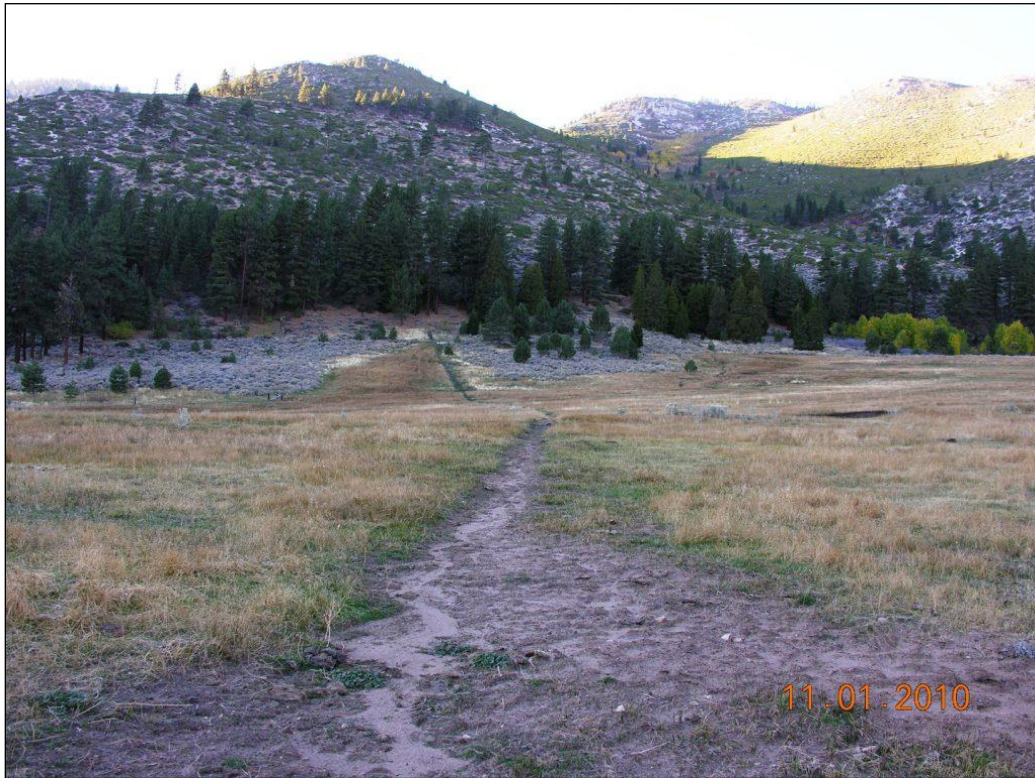
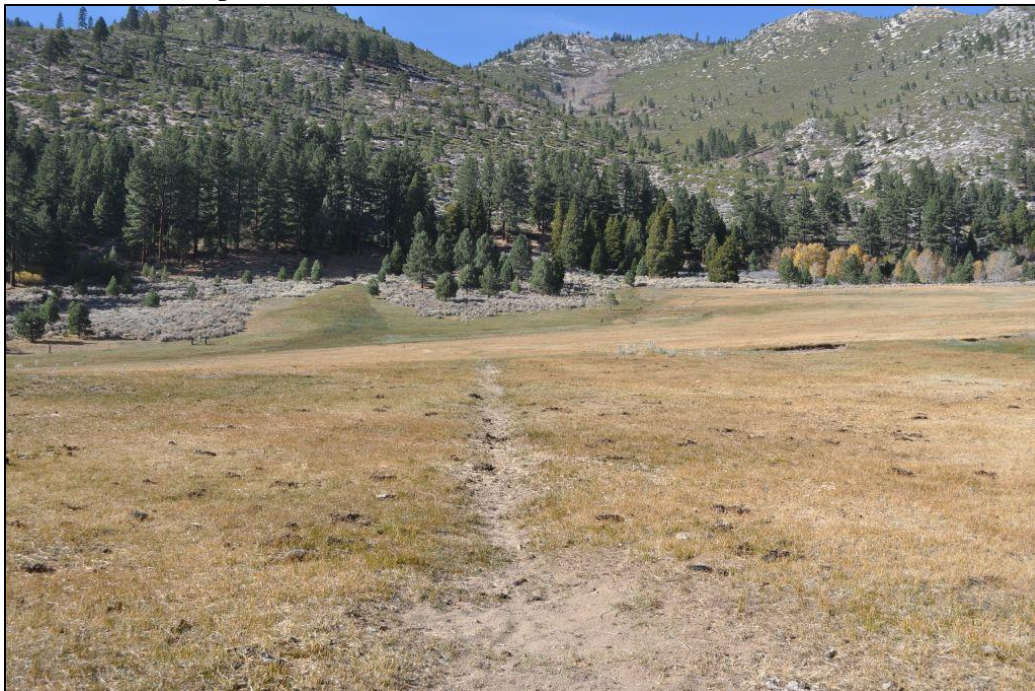
Photo Point: The photo of the pipeline excavation area has been included to document change and vegetation growth.

The linear excavation for the water pipeline to the cabins occurred prior to signing of the conservation easement in March 2009, but some of the impact remains visible. Natural revegetation seems to be occurring on the upper, wetter end of the excavated area. On the lower end closer to the cabins, however, the cattle seem to travel along the route and revegetation is not occurring. The disturbed area is minimal; therefore, at this time, no further action is recommended.

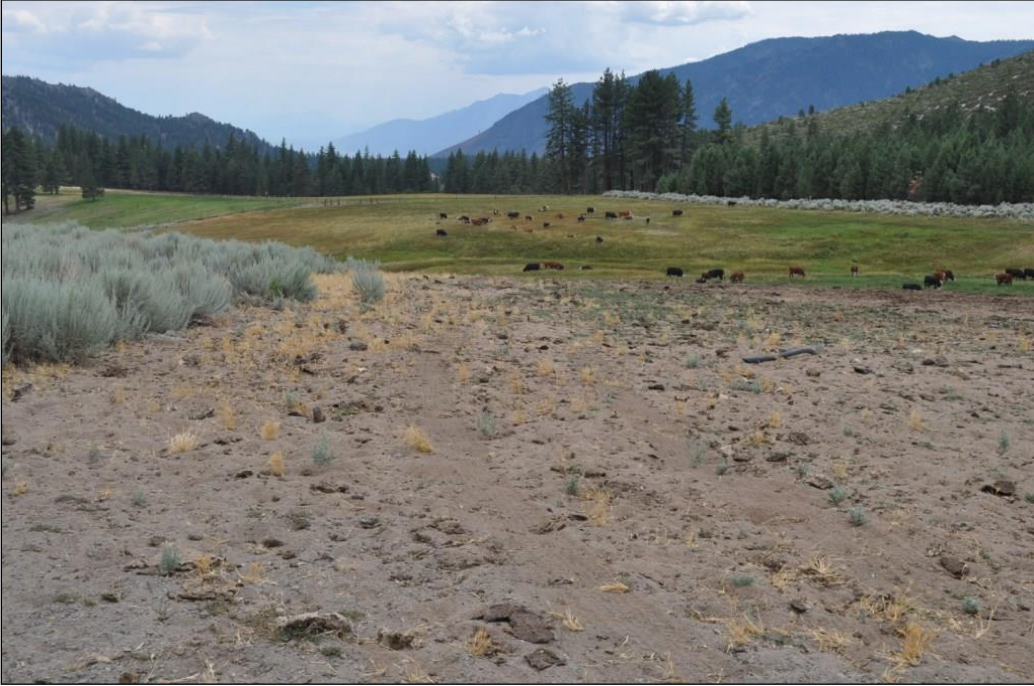
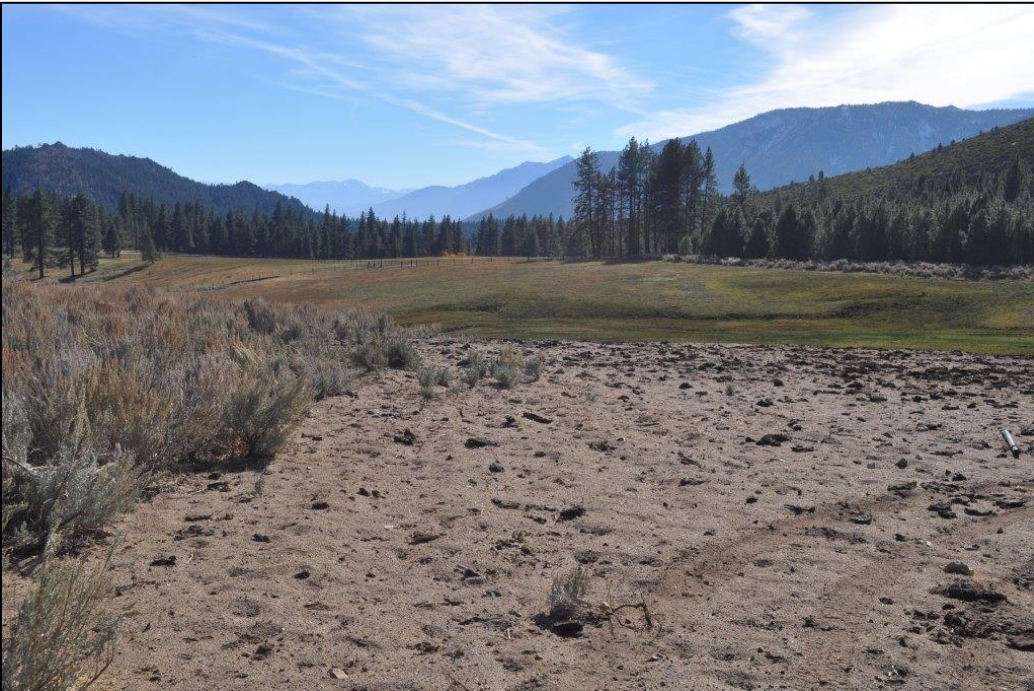
- The previous reports recommended monitoring of the cattle loafing area located just outside the gated entrance to the cabins with the goal to limit further expansion. The below documentation provides photo points and respective measurements.

2013 Condition, photo taken July 23, 2013 (initial assessment – view south): The bare area measures 157' north to south along the sagebrush.

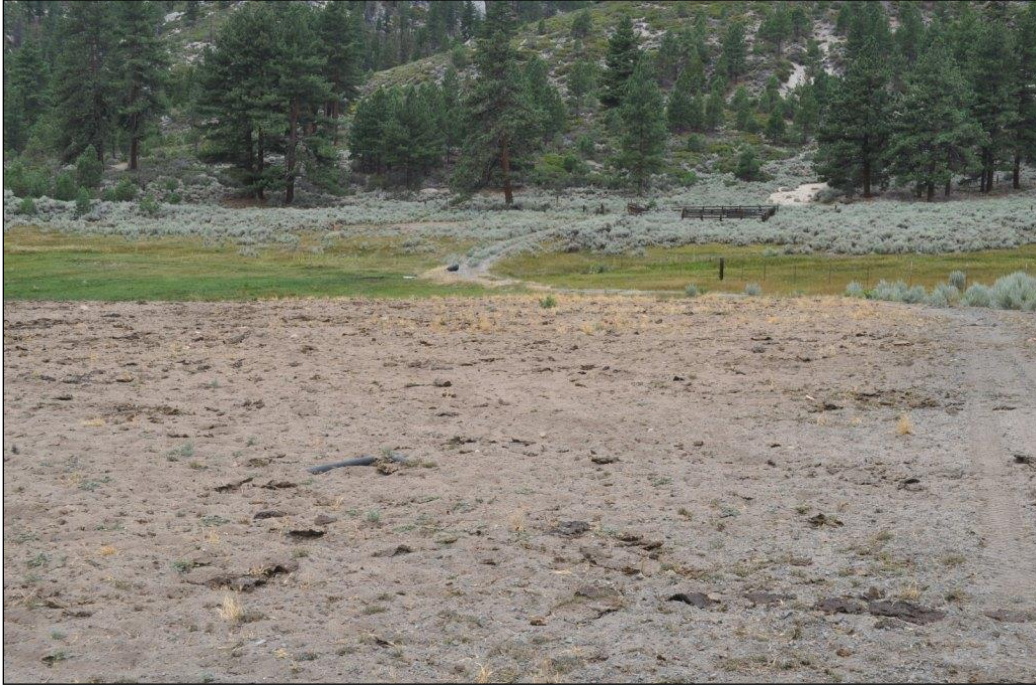
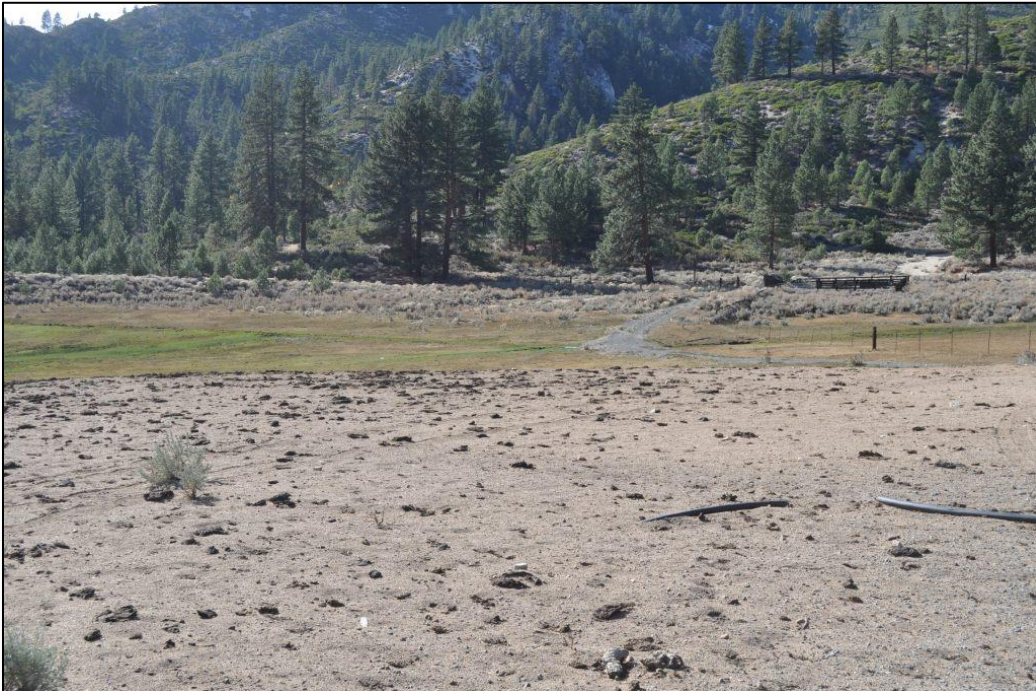
2013 Condition, photo taken July 23, 2013 (initial assessment – view west): The bare area measures 145' east to west along the gravel road.

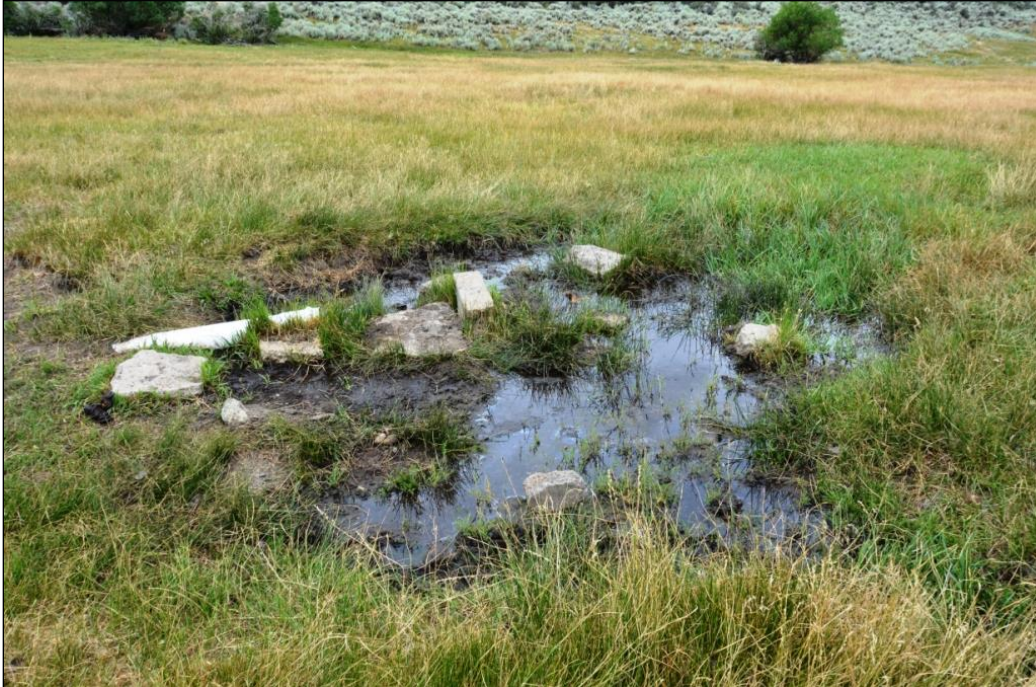
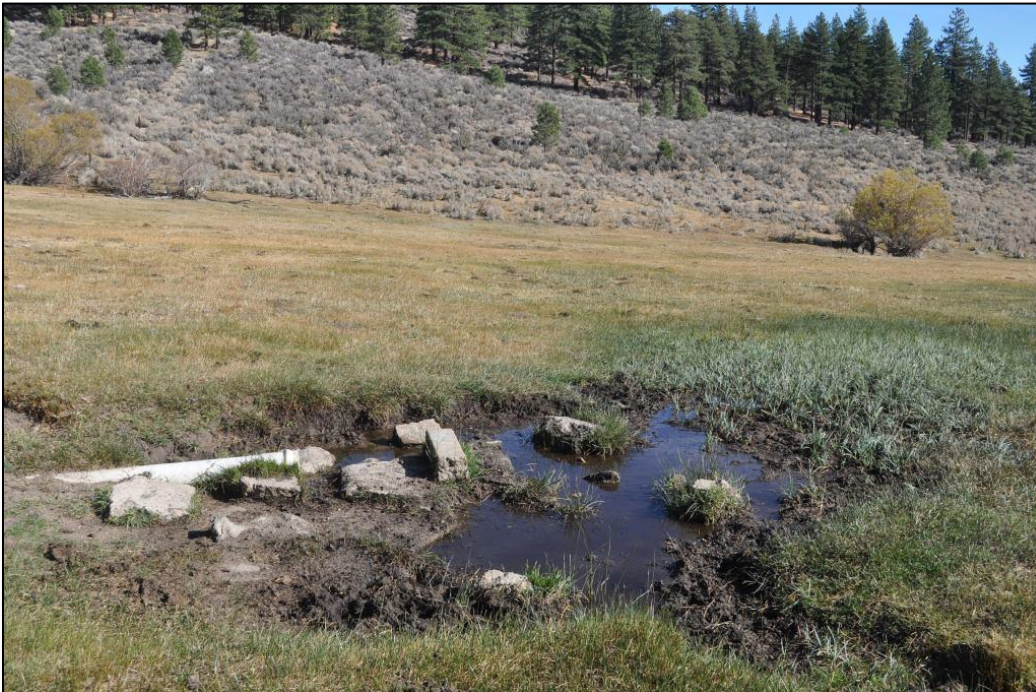
- One vegetative response observed throughout the woody ecological sites of the property is the new growth and establishment of conifer seedlings including pine, fir, and cedar.
- One distribution box located approximately in the middle of the meadow is in complete disrepair. The water is ponding rather than spreading throughout the ditches. This replacement should occur prior to the next irrigation season.

- 1) Replacement of the concrete distribution box; and
- 2) Continued removal of bull thistle

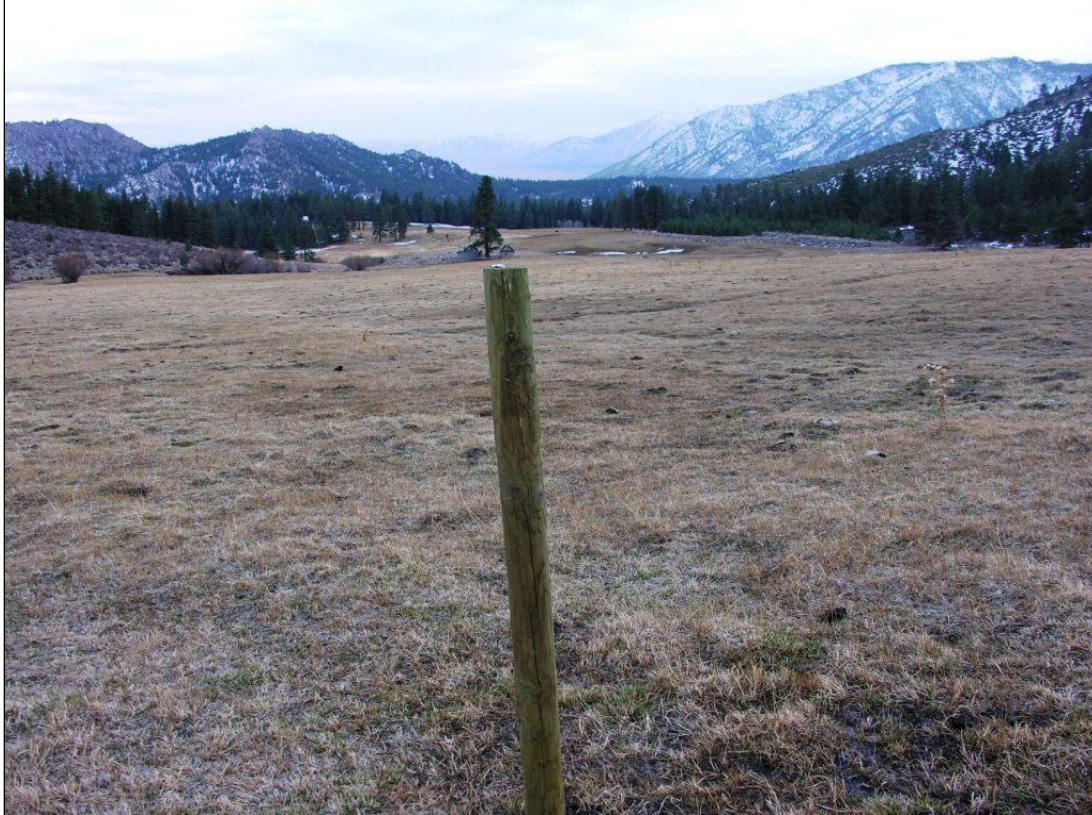
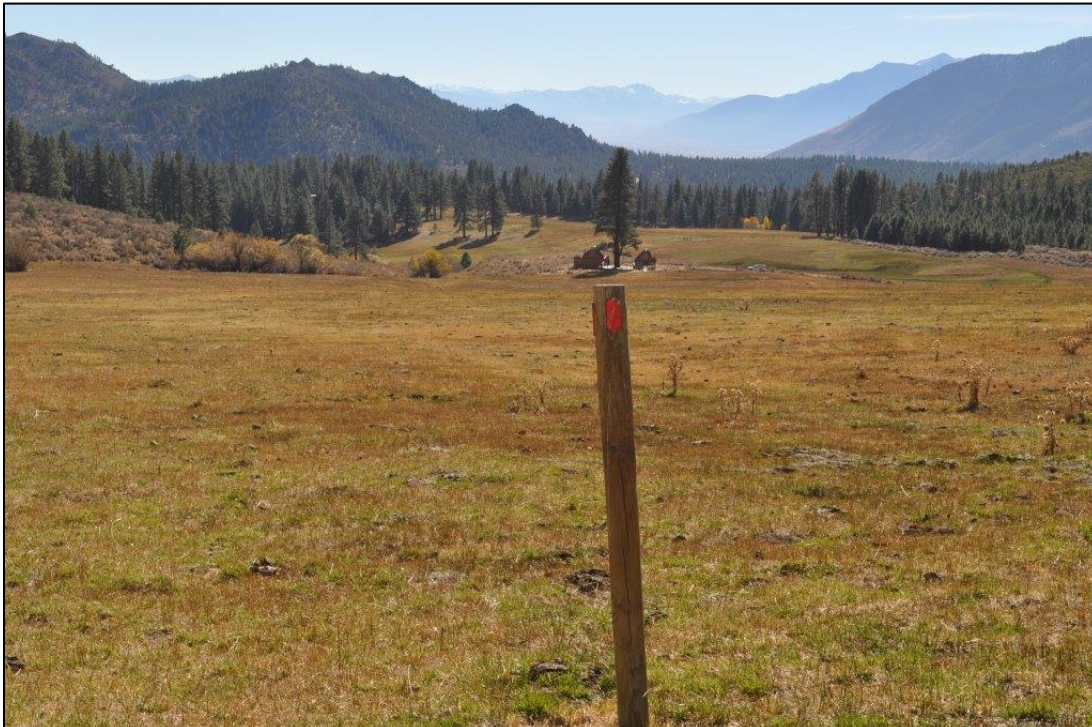
Photo Point 9: A permanently marked 100' x 100' area to monitor pasture condition. This annual inventory will be used to monitor not only pasture condition but irrigation efficiency, vegetative response to drought and appropriate livestock utilization.

- The Pasture Utilization and Condition Assessment was conducted by Ms. Bollinger, Open Space Administrator, and included a visual observation of the monitoring plot as described in the Baseline Condition Report. A diversity of pasture and wetland-type plants remains present with various utilization levels depending on species. The overall stubble height was 2-6” with an estimated utilization around 60%. Grazing was not occurring in this pasture at the time of monitoring. Generally, this level of grazing seems appropriate and assures sufficient ground cover prior to the winter snowfall.
