**OPEN SPACE ADVISORY COMMITTEE  
STAFF REPORT**

**REQUEST:** **For Possible Action:** To approve the monitoring report for the Horsecreek Ranch Conservation Easement for 2016.

## **Carson City Open Space – Conservation Easement Monitoring**

**Date:** June 20, 2016

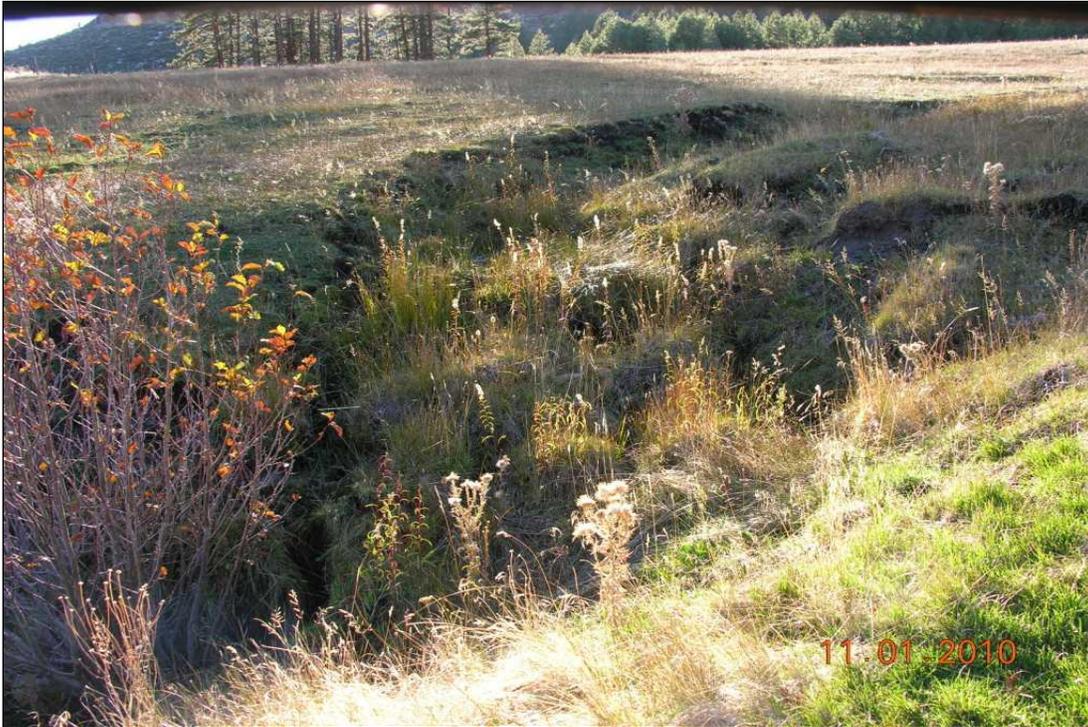
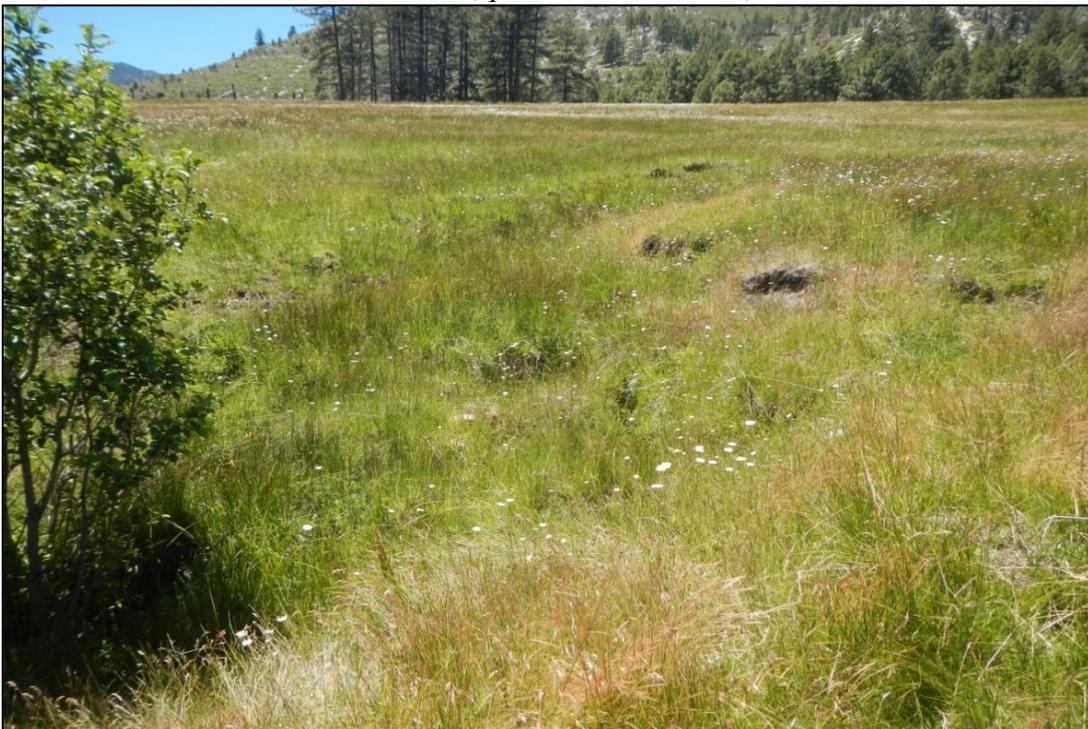
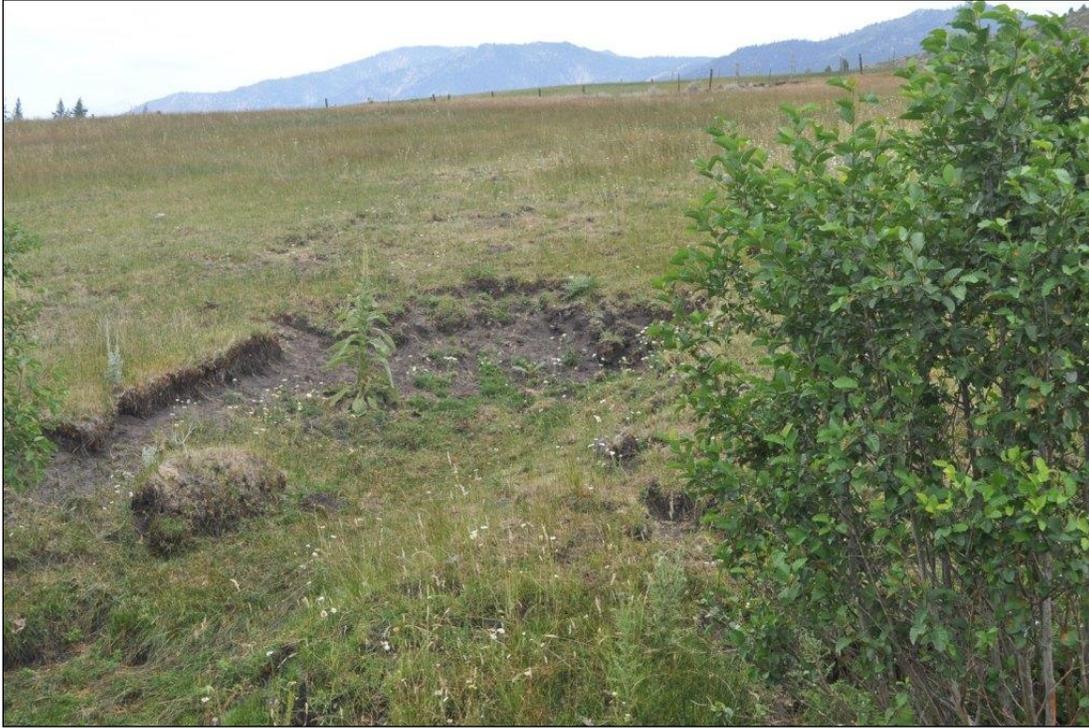
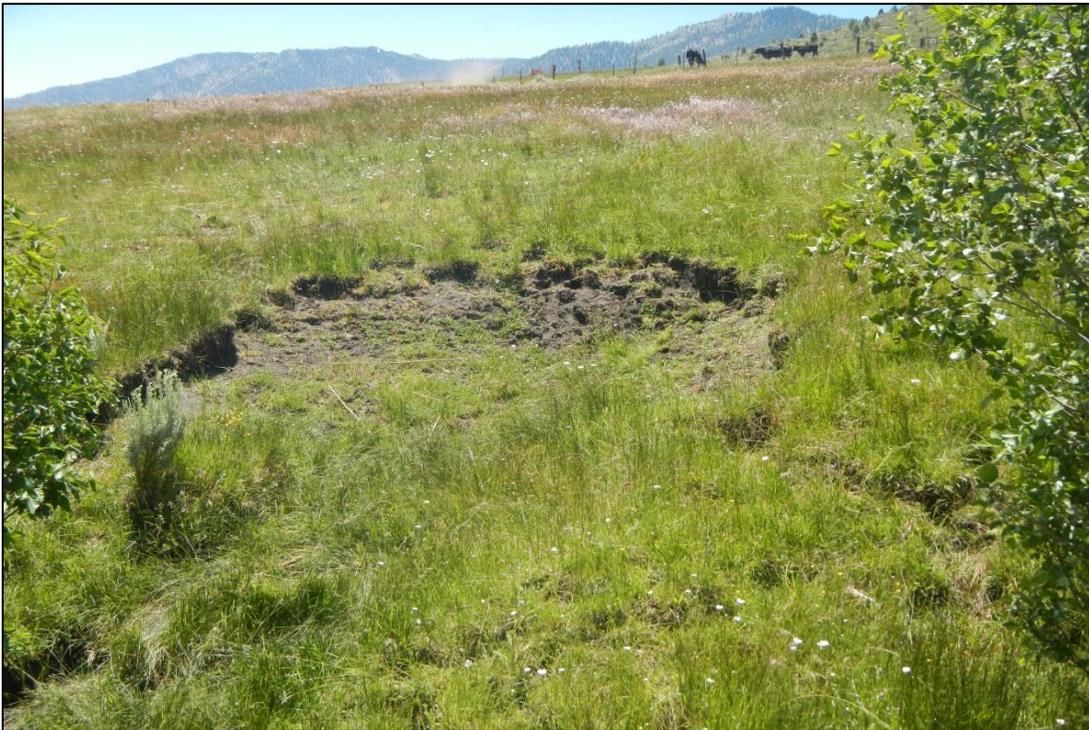
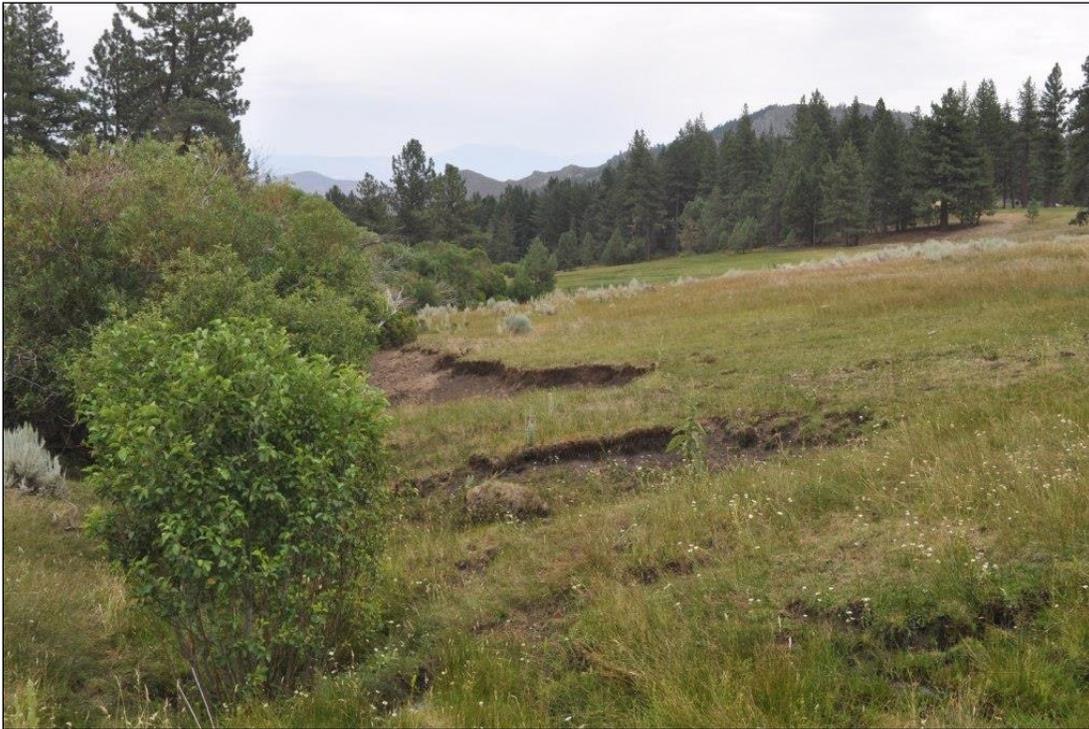
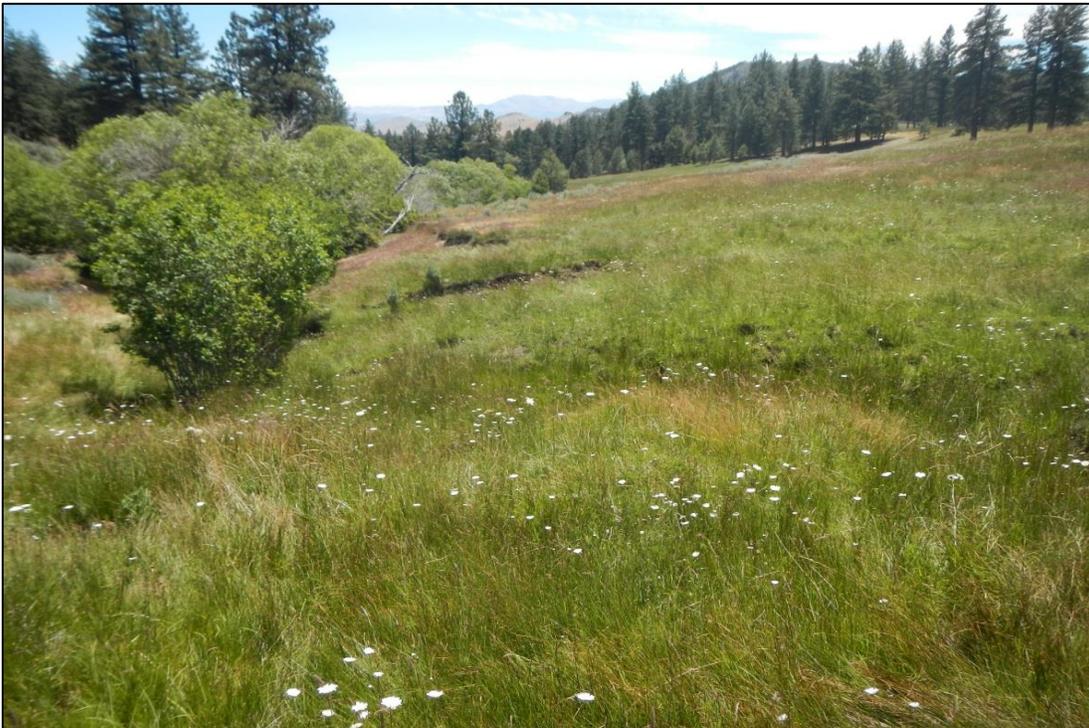
Photo Point: The photo of this drainage, located south of the cabins, has been included to document change and vegetation growth. N 39 07' 42.7" W 119 50' 10.2"

Near the southeast corner, one specific area is being monitored for landscape change. This low drainage area of the meadow appears to be vegetated and stable though a few isolated mounds or hummocks may be the result of cattle trampling. A qualitative assessment with the photo comparisons may be a little deceptive because of the time of year each photo was taken – either during the growing season or at the end of the season after grasses were grazed and/or died.

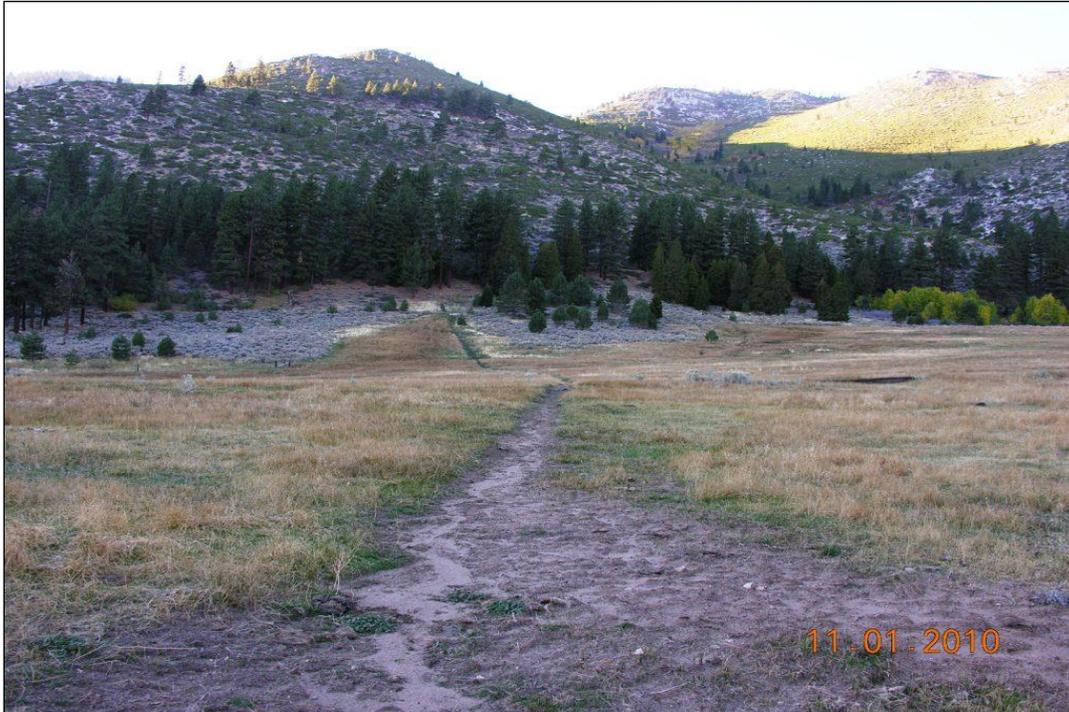
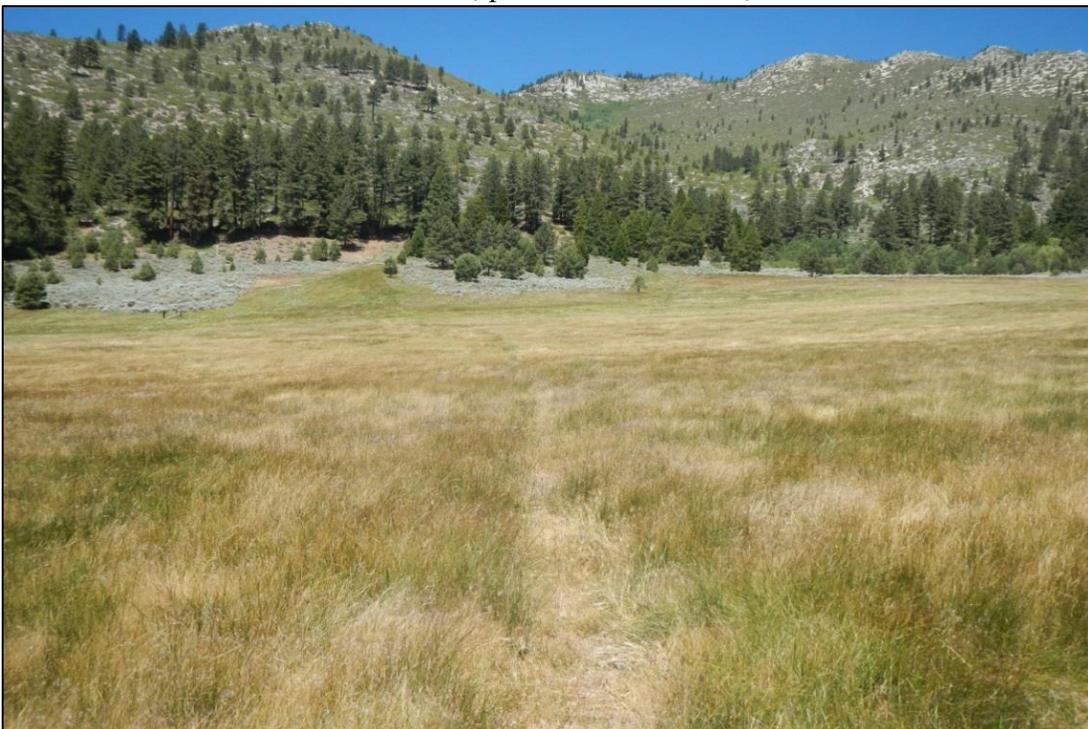
Photo Point: The photo of the pipeline excavation area has been included to document change and vegetation growth. (Photo facing northwest)

The linear excavation for the water pipeline to the cabins occurred prior to the signing of the conservation easement in March 2009. With that said, the visible impact has been monitored throughout the past few years. Natural revegetation seems to be occurring and the disturbed area is minimal. Staff is comfortable with removing any future discussion and monitoring on this photo point location.

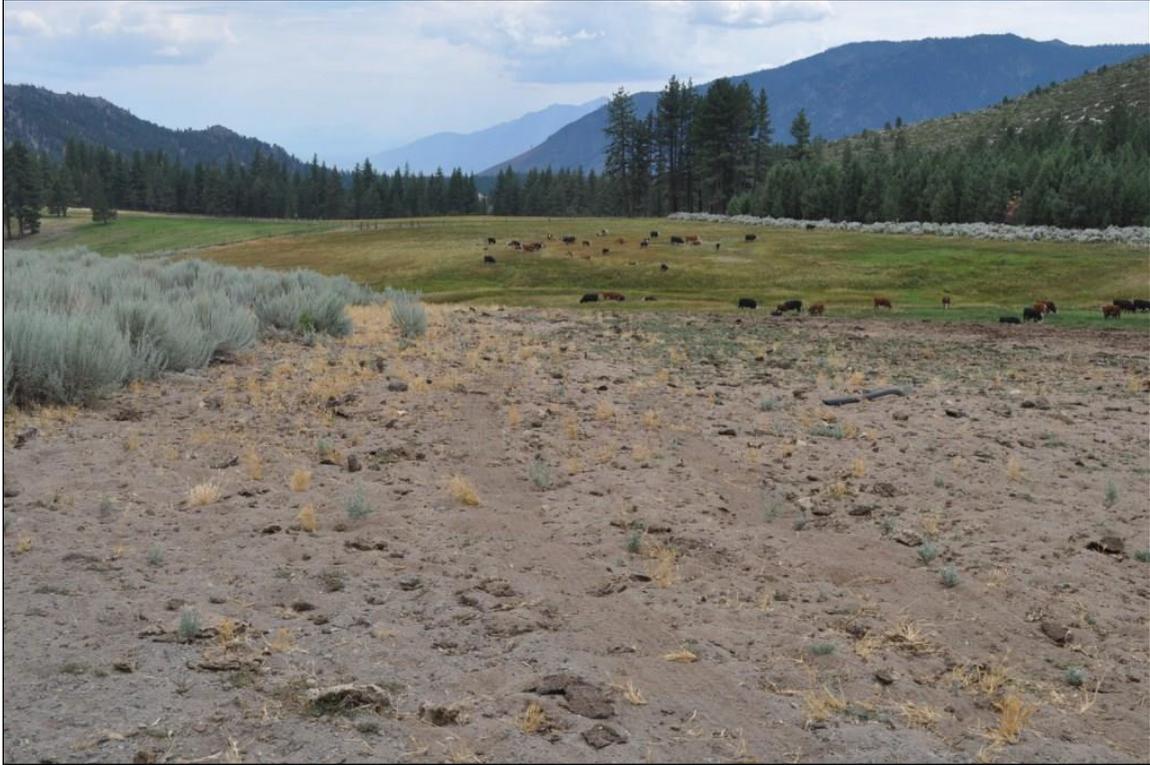
- The previous reports recommended the monitoring of the cattle loafing area located just outside the gated entrance to the cabins with the goal to limit further expansion. The following documentation provides photo points and respective measurements. The disturbed area consists primarily of cheatgrass and foxtail barley although sagebrush is starting to re-establish on the east edge of the disturbed area.

2013 Condition, photo taken July 23, 2013 (initial assessment – view south):  
The bare area measures 157' north to south along the sagebrush.

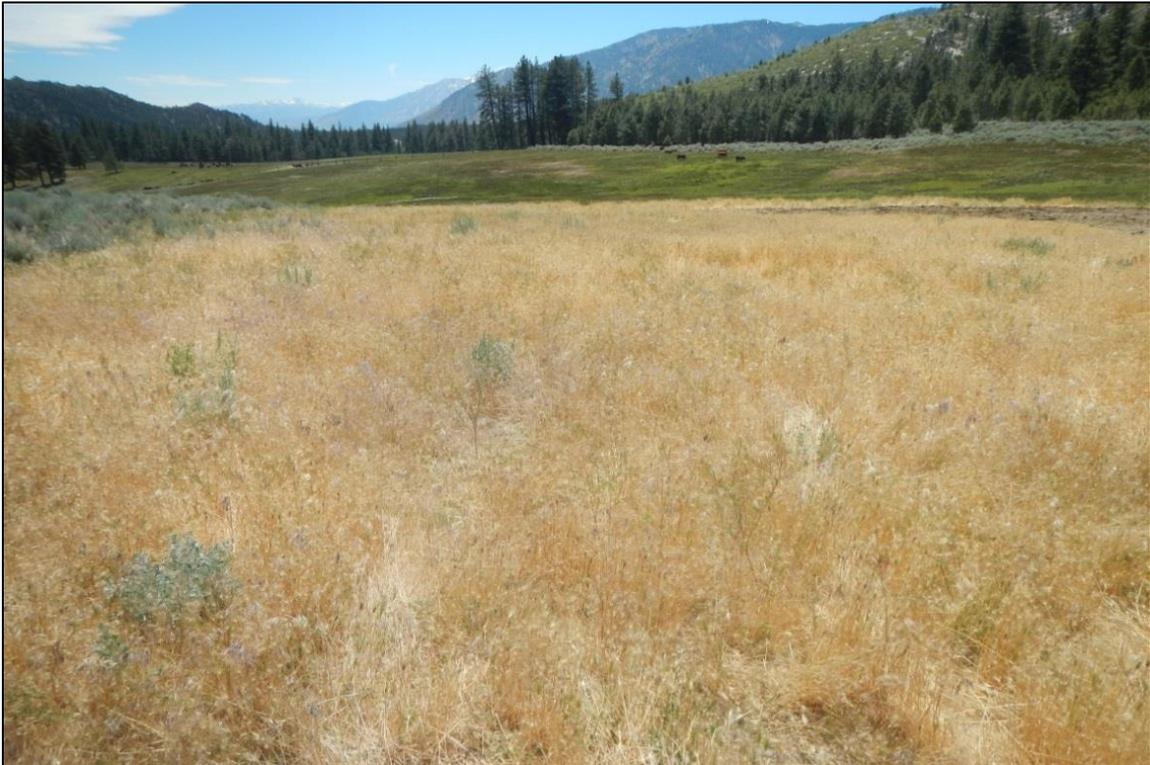
2016 Condition, photo taken June 20, 2016:  
The bare area measures 163' north to south along the sagebrush.

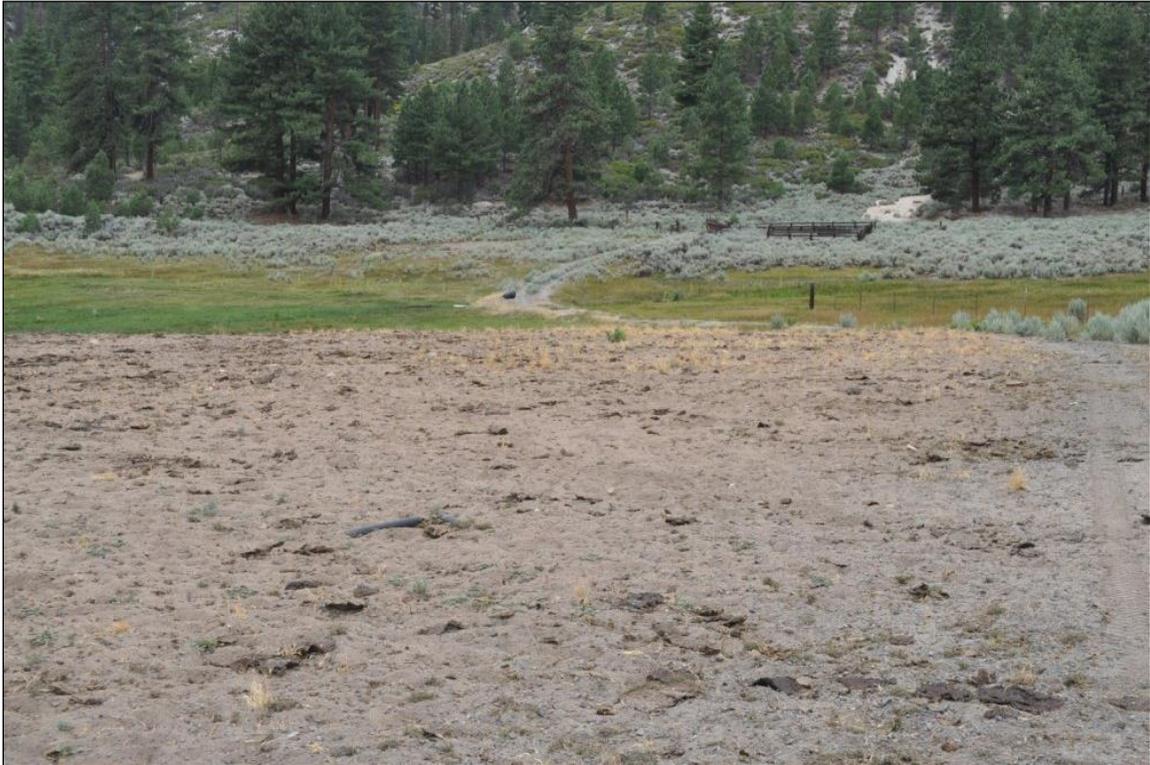
2013 Condition, photo taken July 23, 2013 (initial assessment – view west):  
The bare area measures 145' east to west along the gravel road.

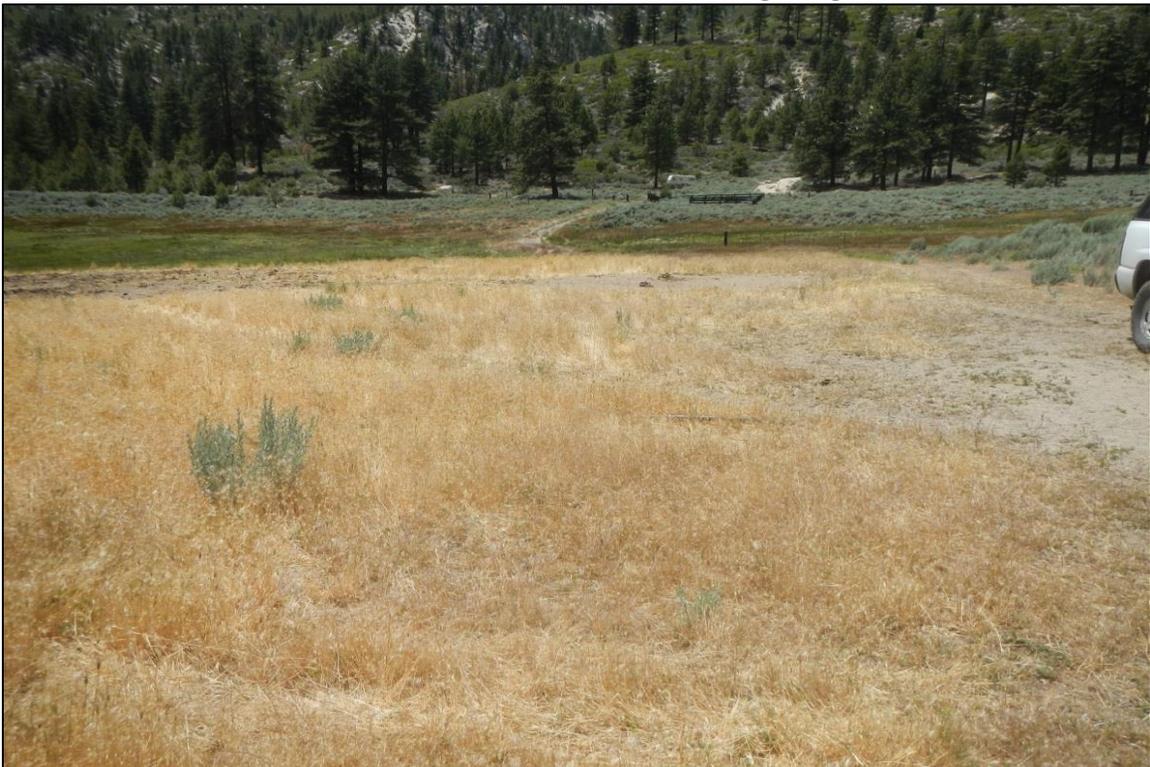
2016 Condition, photo taken June 20, 2016:  
The bare area measures 148' east to west along the gravel road.

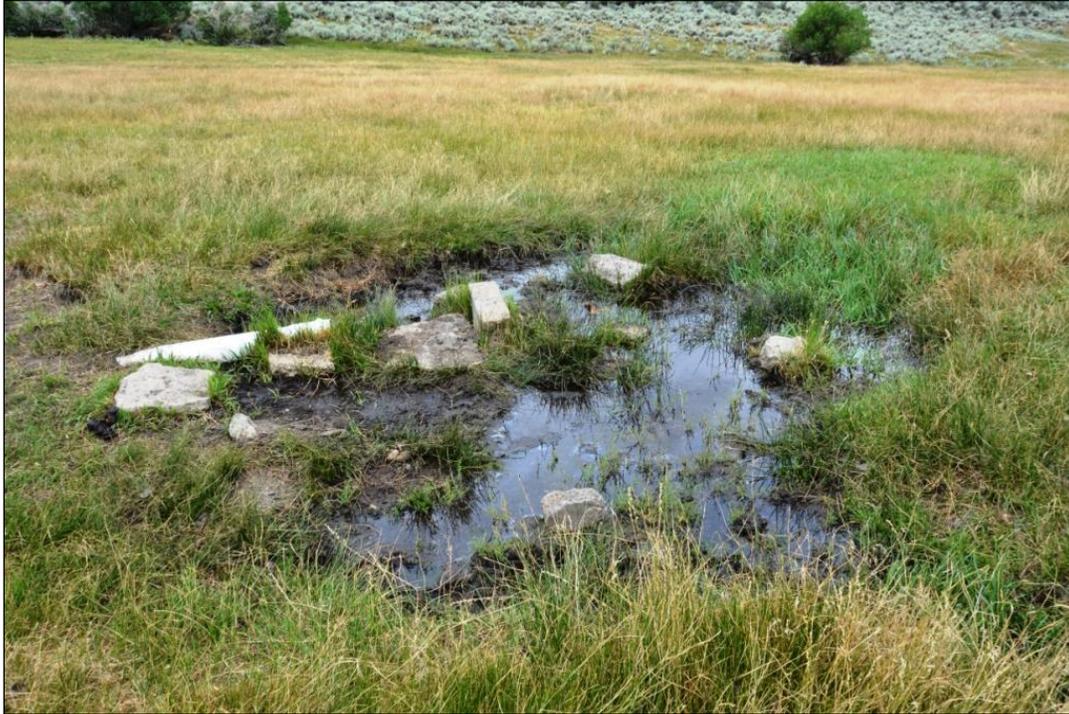
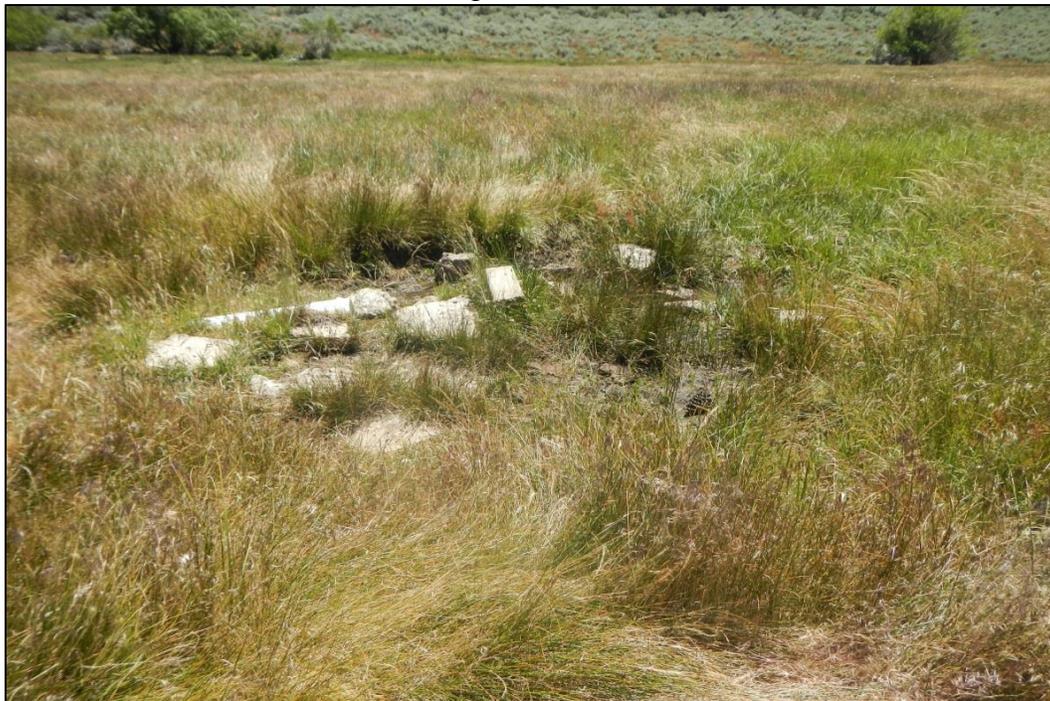
- One distribution box located approximately in the middle of the meadow is in complete disrepair. The water is ponding rather than spreading throughout the ditches. This box should be replaced prior to the next irrigation season.

- 1) Replacement of the concrete distribution box
- 2) Continued removal of bull thistle
