**OPEN SPACE ADVISORY COMMITTEE
STAFF REPORT**

REQUEST: **For Possible Action:** To approve the annual monitoring report for the Horse Creek Ranch conservation easement for 2017.

Carson City Open Space – Conservation Easement Monitoring

Date: September 26, 2017

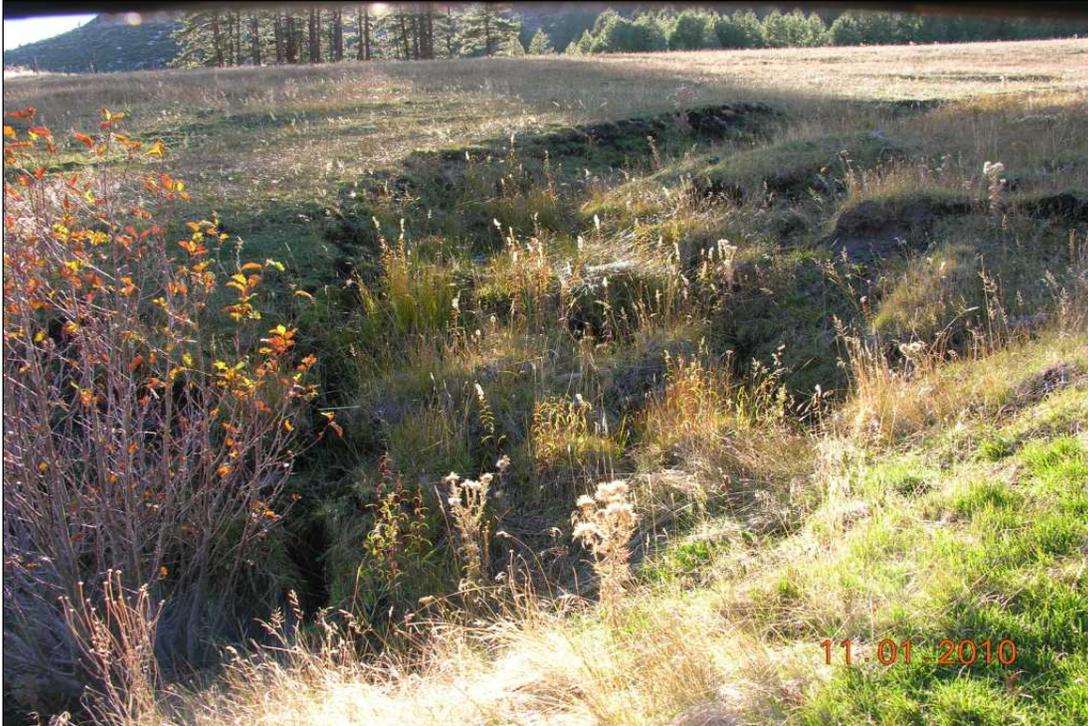
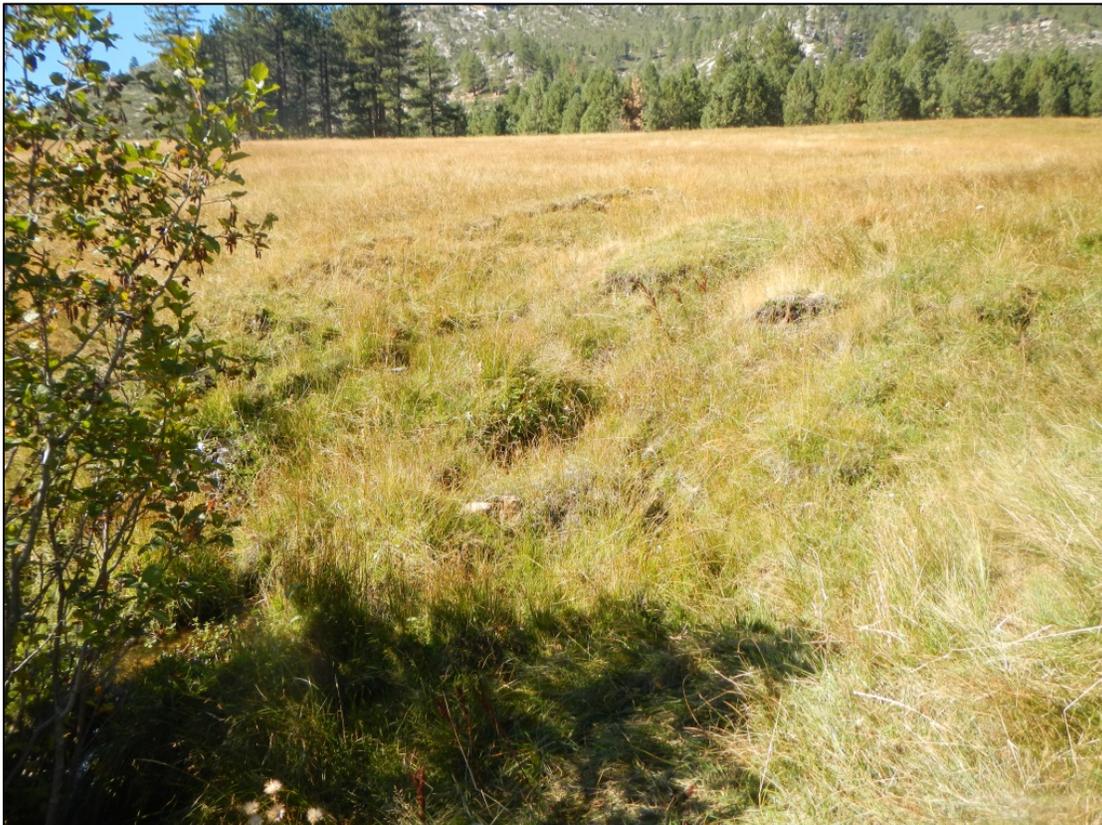
Near the southeast corner, one specific area is being monitored for landscape change. This low drainage area of the meadow appears to be vegetated and stable though a few isolated mounds or hummocks may be the result of cattle trampling. A qualitative assessment with the photo comparisons may be deceptive due to the time of year each photo was taken – either during the growing season or at the end of the season after grasses were grazed and/or senesced. Additionally, a new head cut was observed on the creek northeast of the cabins. This head cut is small in size currently (1 - 1.5 feet), but it should be monitored in future years to document change in size or location, as it could potentially migrate upstream.

Photo Point: The photo of this drainage, located south of the cabins, has been included to document change and vegetation growth. N 39 07' 42.7" W 119 50' 10.2"

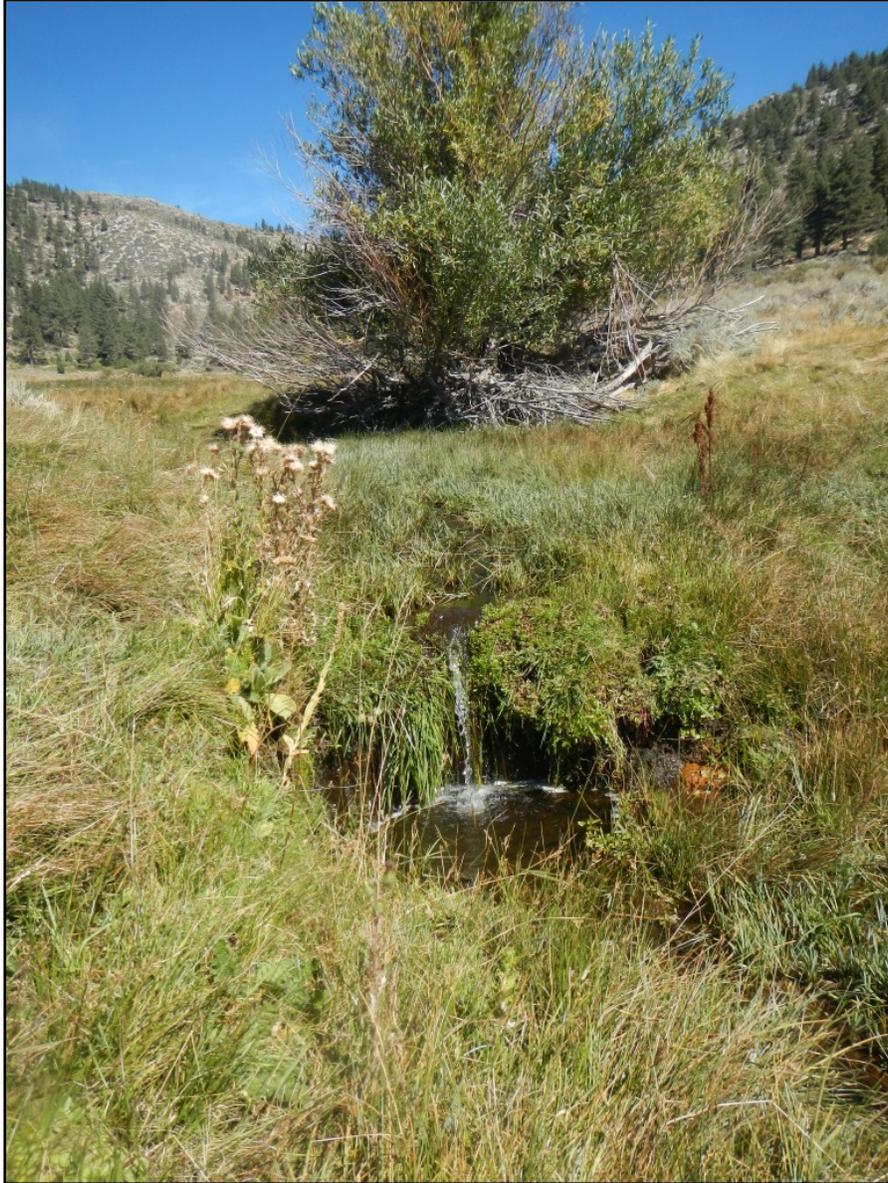
Photo Point: The photo of this head cut, located northeast of the cabins, has been included to document stream channel changes and erosion. N 39 07' 51.0" W 119 50' 11.4"

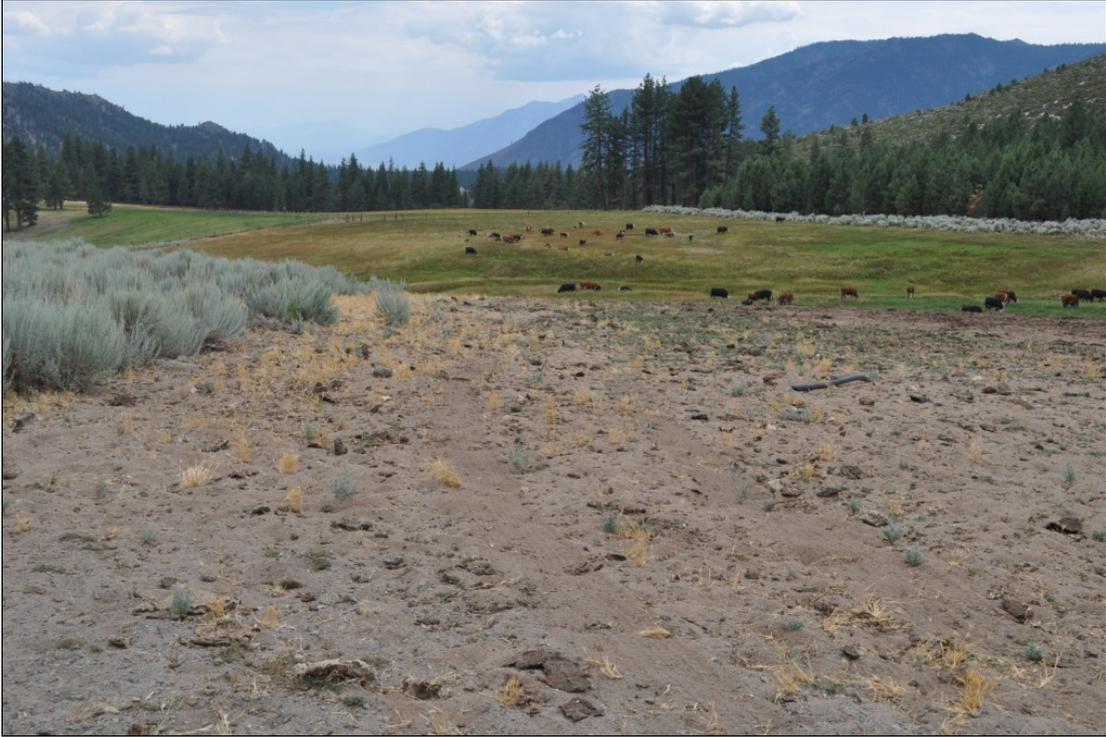
- The previous reports recommended the monitoring of the cattle loading area located just outside the gated entrance to the cabins with the goal to limit further expansion. The following documentation provides photo points and respective measurements. The disturbed area consists primarily of cheatgrass and foxtail barley although sagebrush is successfully re-establishing on the east edge of the disturbed area. It is important to note that depending on the timing of monitoring, cheatgrass abundance and cover varies indicating that cattle are likely grazing the cheatgrass.

2013 Condition, photo taken July 23, 2013 (initial assessment – view south):
The bare area measures 157' north to south along the sagebrush.

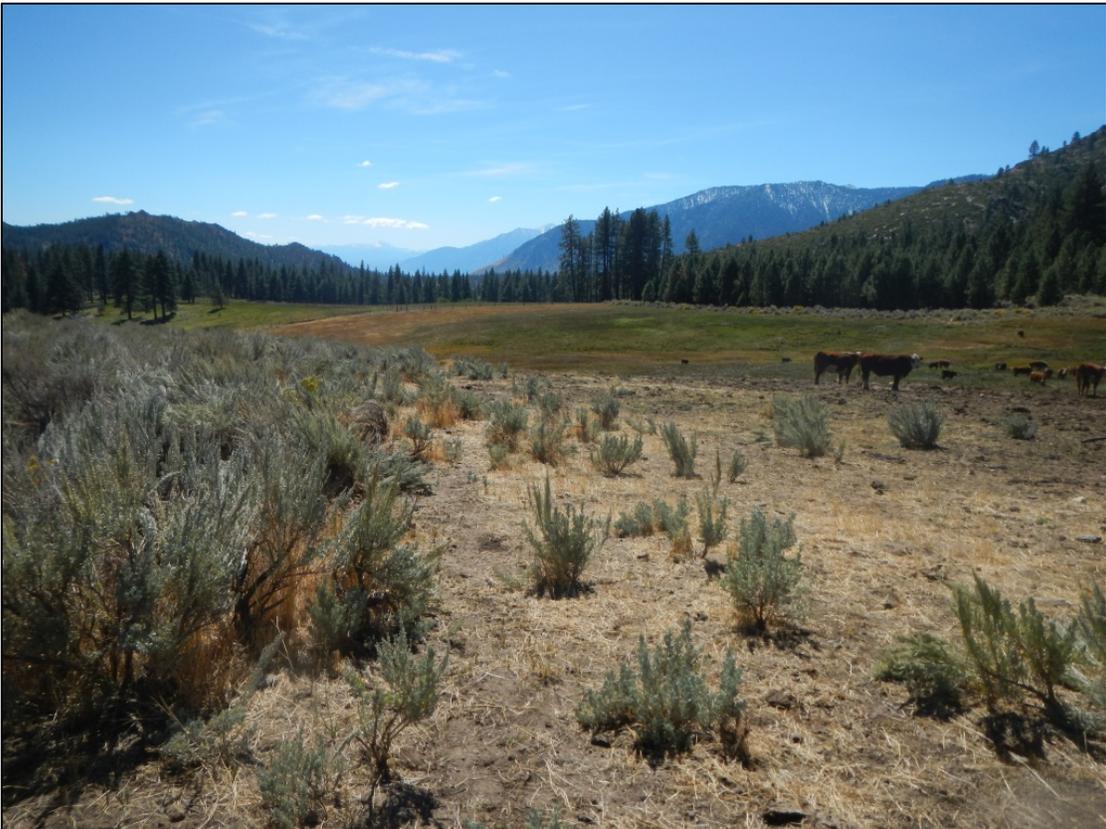
2017 Condition, photo taken September 26, 2017:
The bare area measures 150' north to south along the sagebrush.

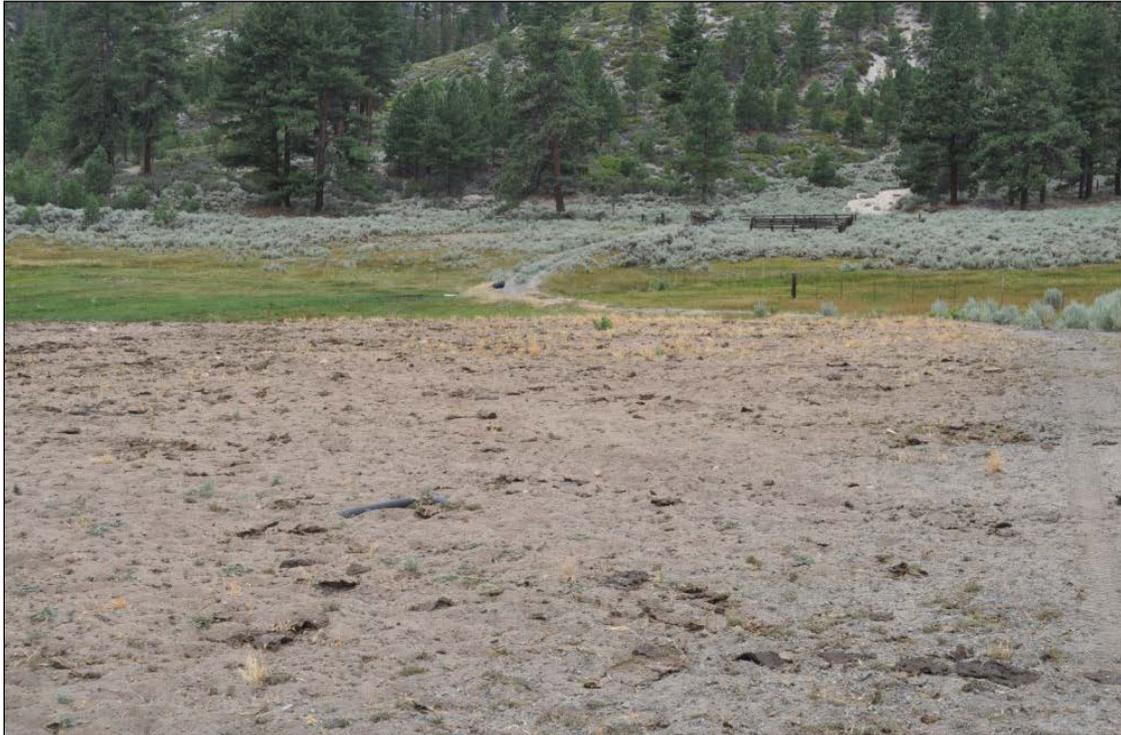
2013 Condition, photo taken July 23, 2013 (initial assessment – view west):
The bare area measures 145' east to west along the gravel road.

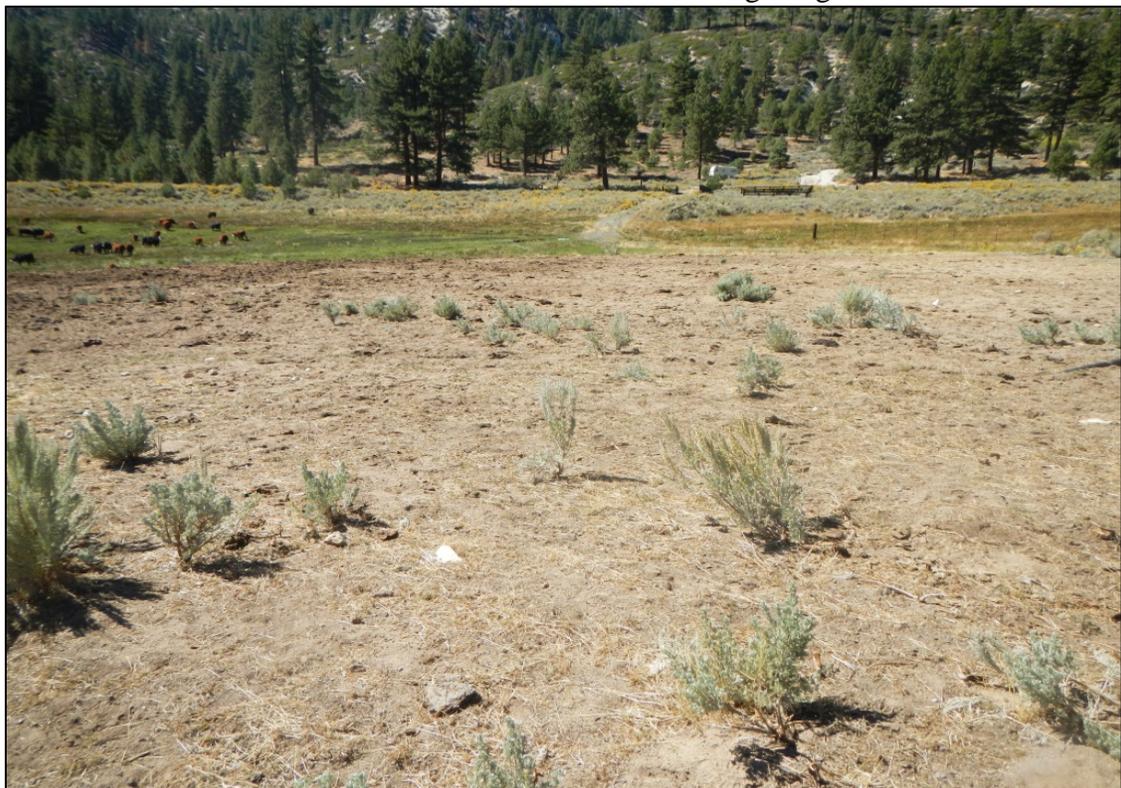
2017 Condition, photo taken September 26, 2017:
The bare area measures 147' east to west along the gravel road.

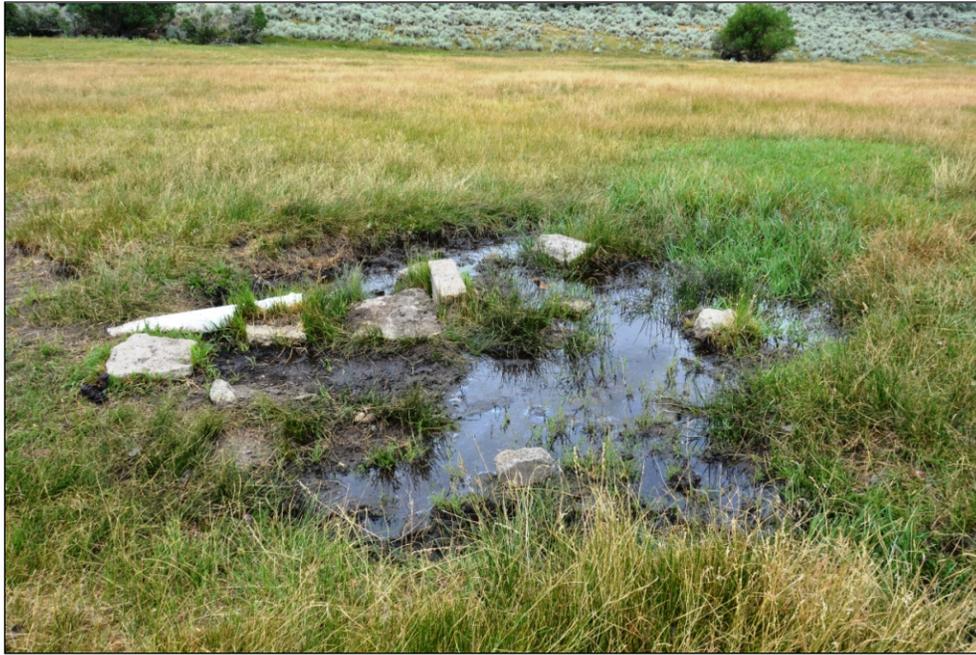
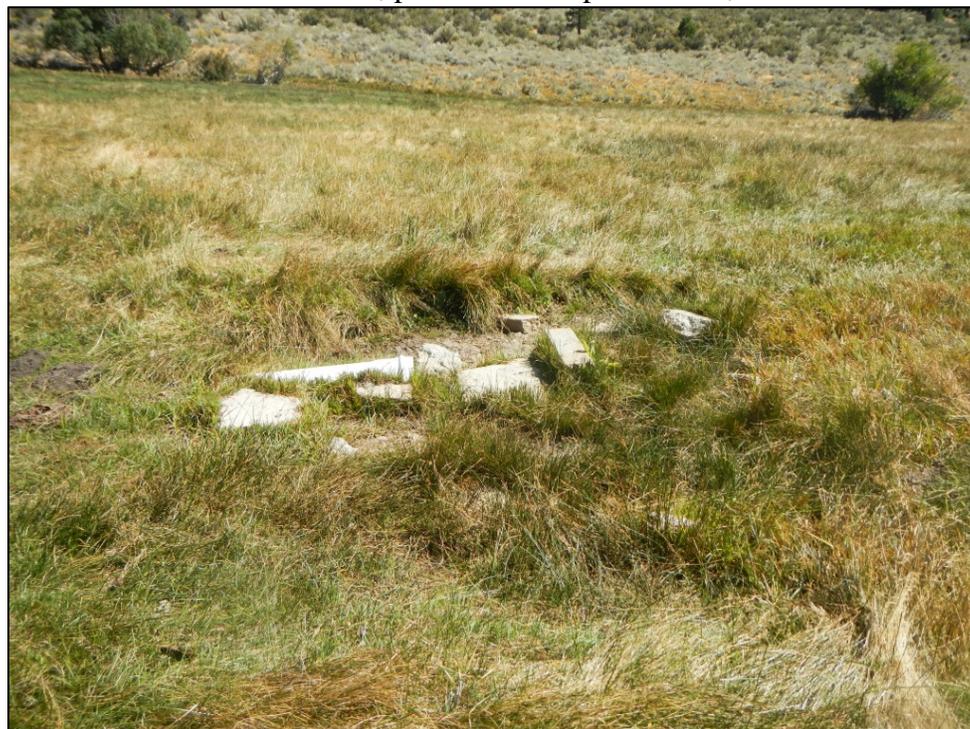
- One distribution box located approximately in the middle of the meadow is in complete disrepair. It was noted in the 2016 monitoring report that this box should be replaced prior to the next irrigation season, which has not yet been completed. In the future, the box will need to be replaced in order to regain functionality of this irrigation system.

- 1) Replacement of the concrete distribution box
- 2) Continued removal of bull thistle

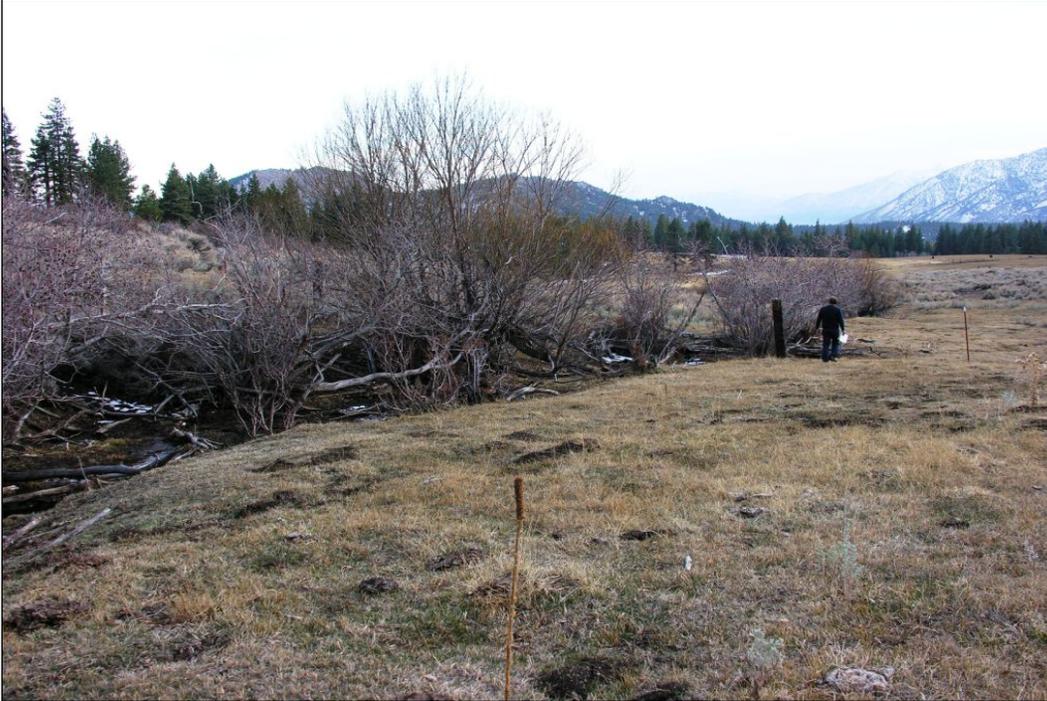
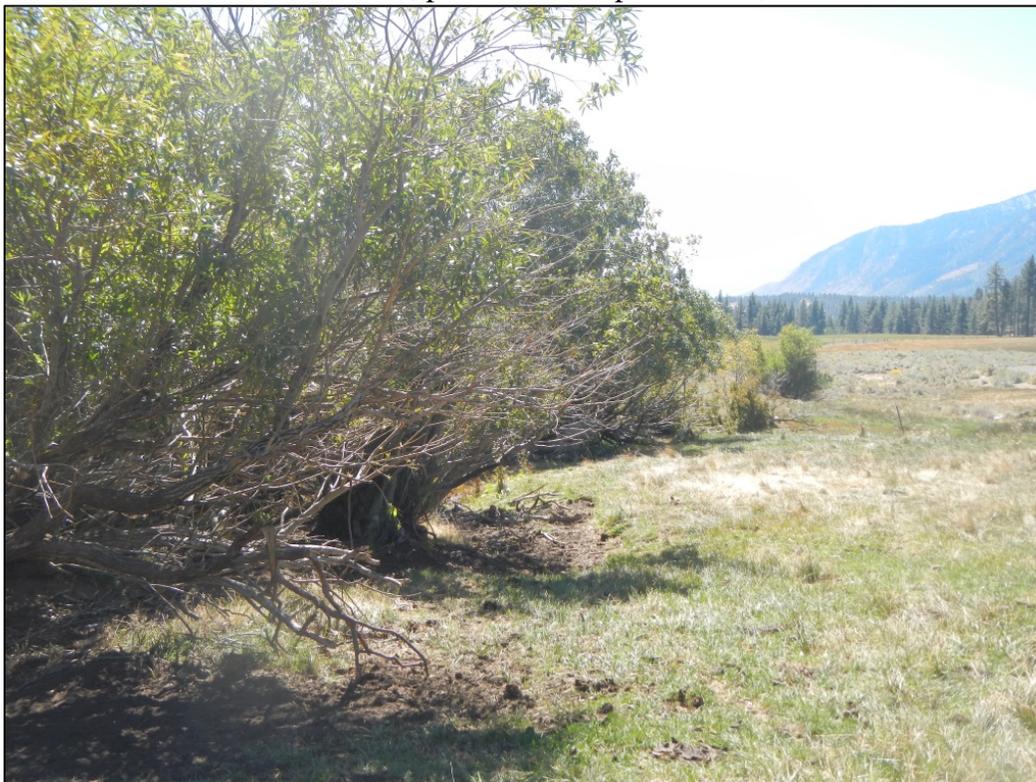
Photo Point 2 (view south): A photo point located in bottom of the active stable drainage channel to the southeast of the house to monitor side slope stability.

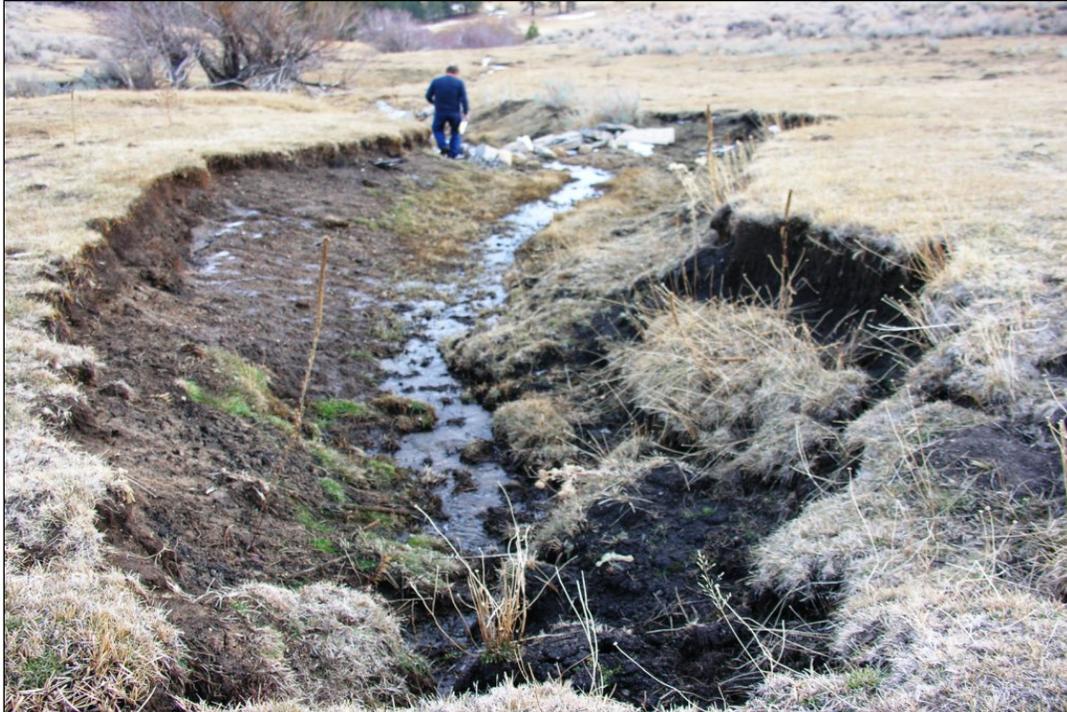
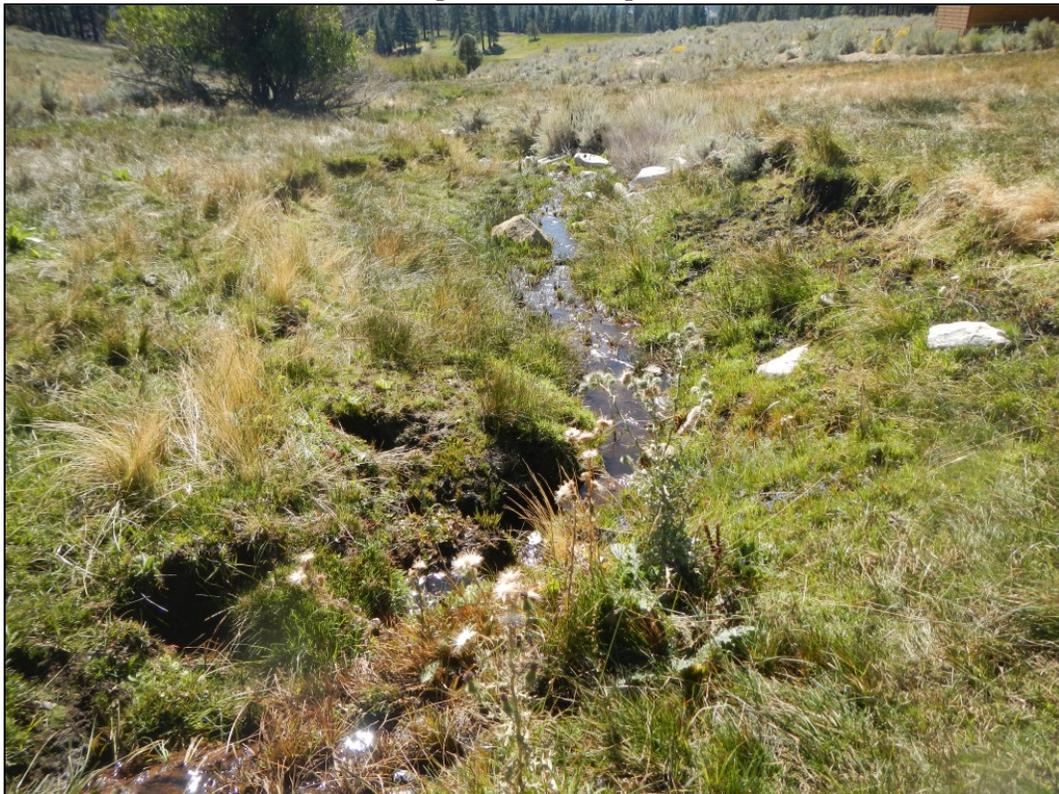
Photo Point 3 (view south): A photo point located immediately east of the house in the active channel where rip-rap has been placed for stabilization.

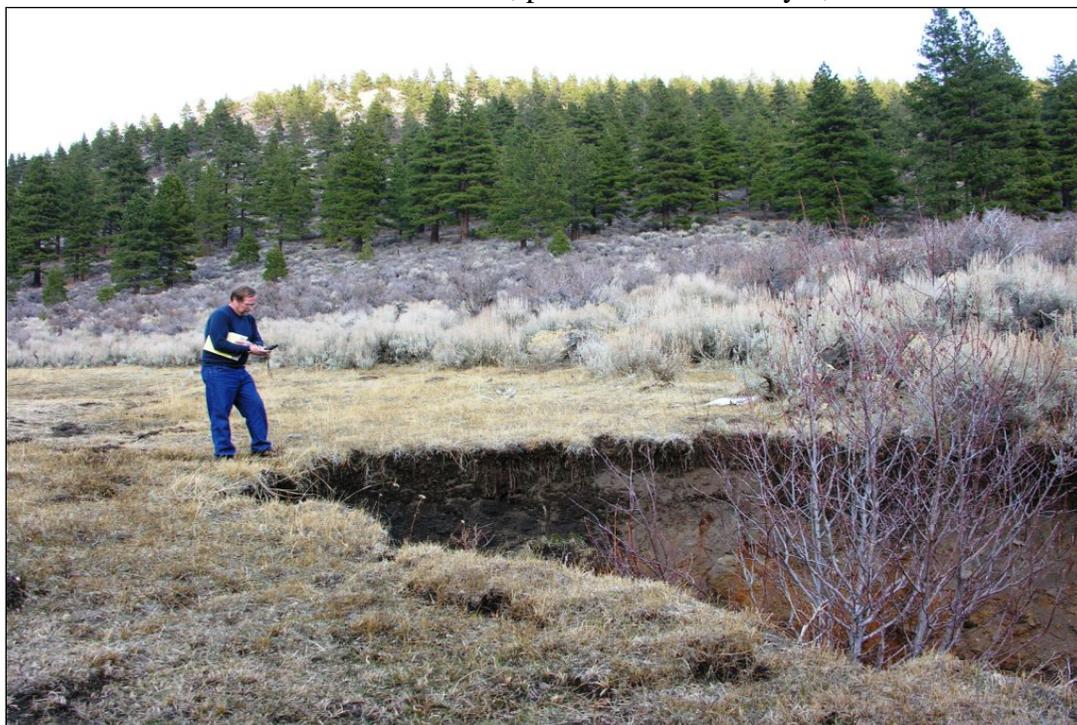
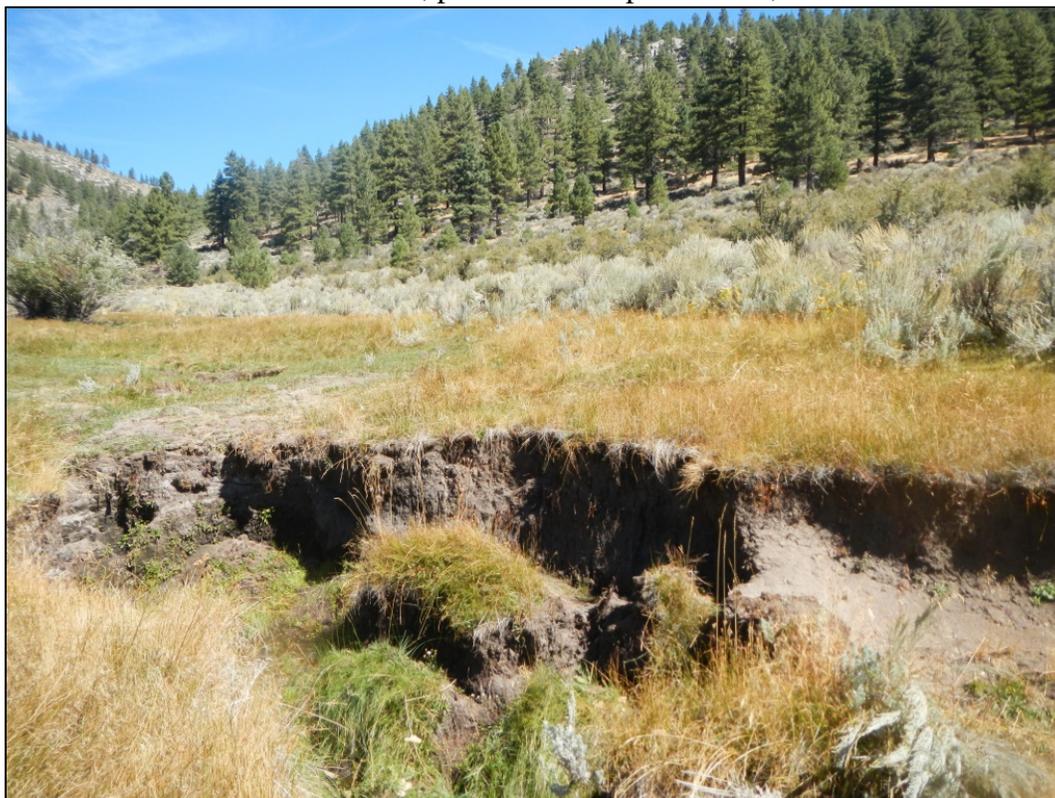
Photo Point 4A (view north): A photo point located at the most northern active headcut after required stabilization to monitor effectiveness.

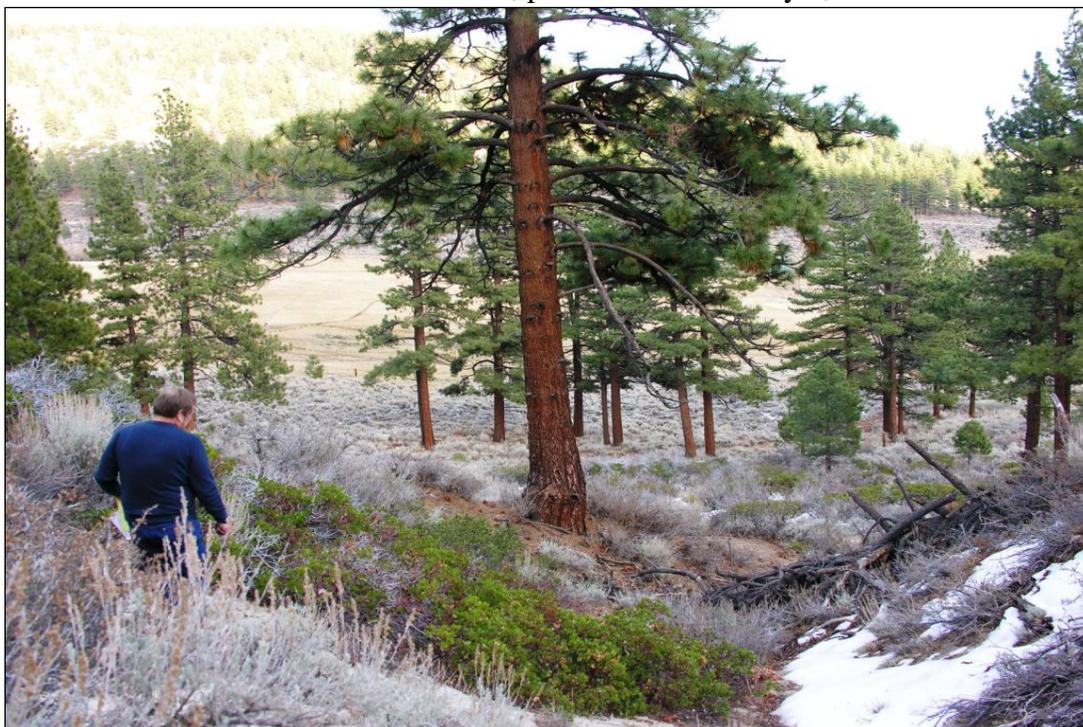
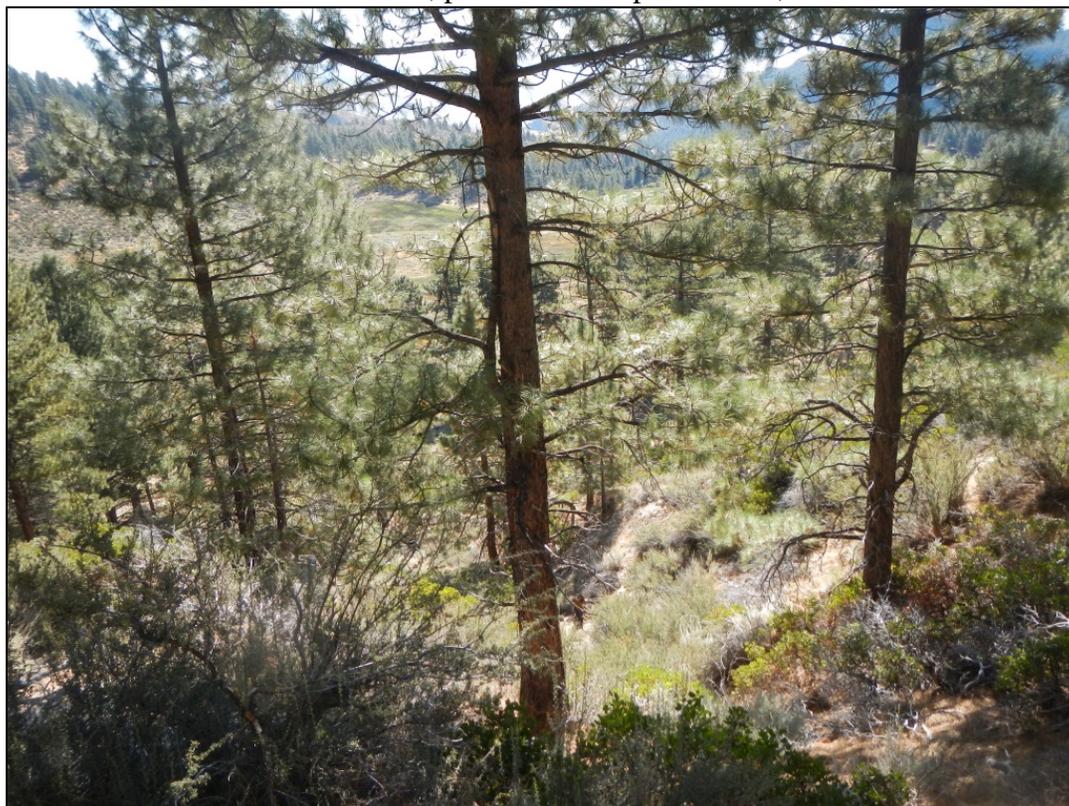
Photo Point 5 (view east): A photo point on the hillside conveyance ditch at a location where a previous washout has occurred to monitor ditch maintenance.
