**SUBJECT: HRC-2020-0027 For Possible Action: Discussion and possible action regarding the 2021 Historic Preservation Fund (HPF) grant.**

# RED RANCH COMPLEX PRESERVATION PLAN

## CONDITION ASSESSMENT

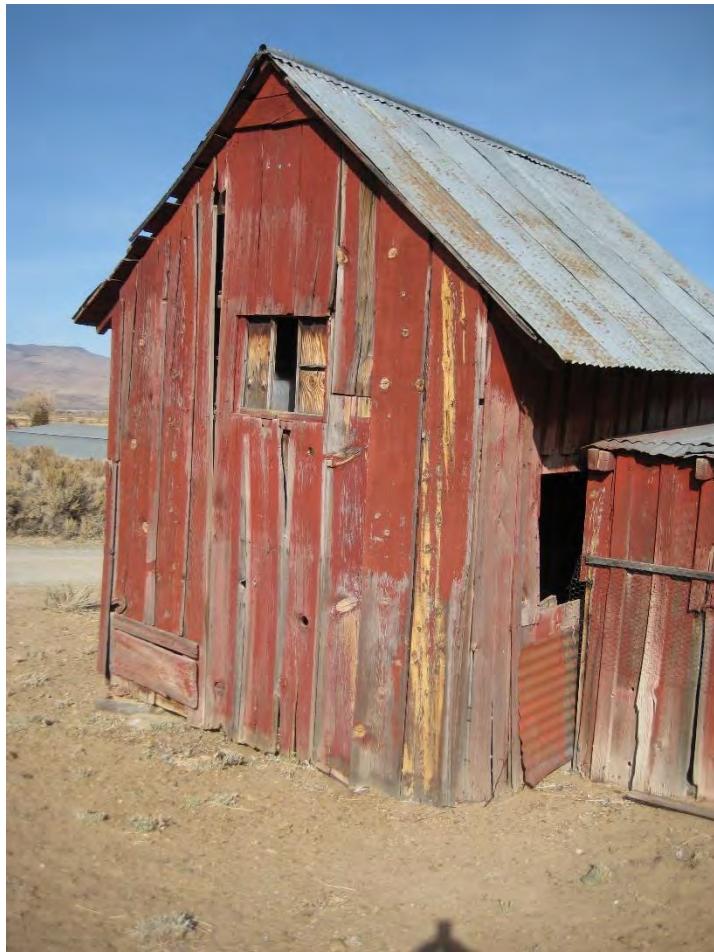
Chicken coop survives today in poor condition; it was moved by the BLM so structural condition in ca. 1990 would have been adequate to sustain move

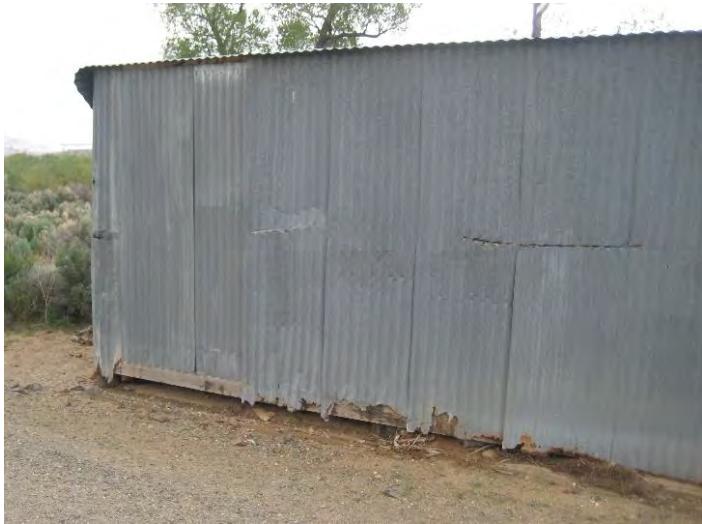
Corrosion occurs when metal sustains ongoing contact with water from snow, rain, and the ground

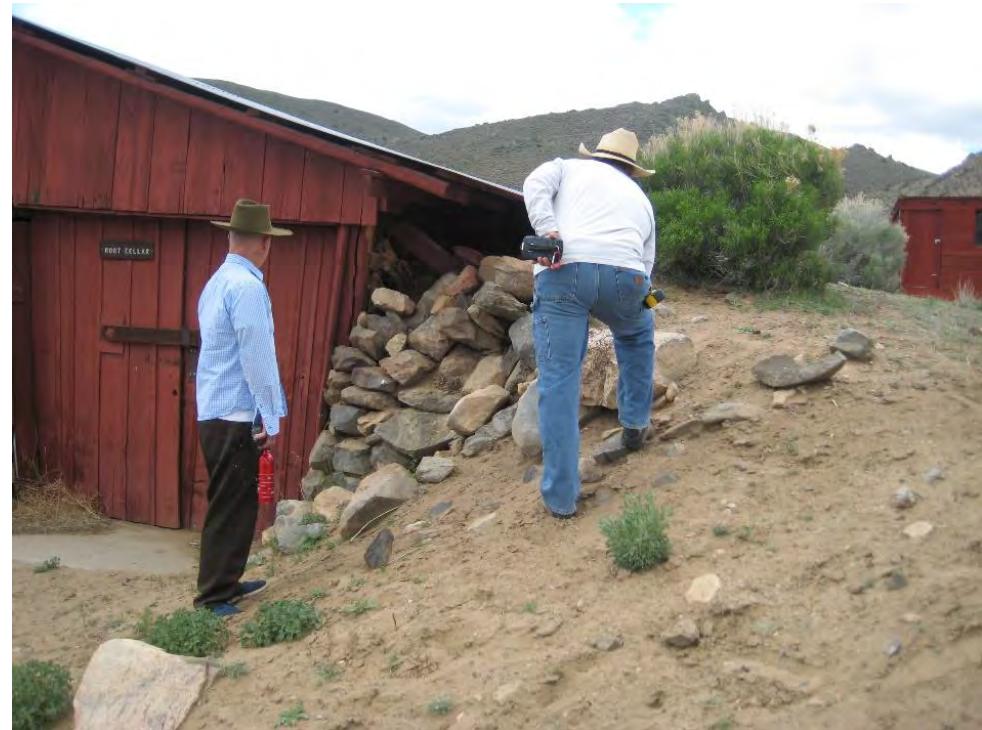
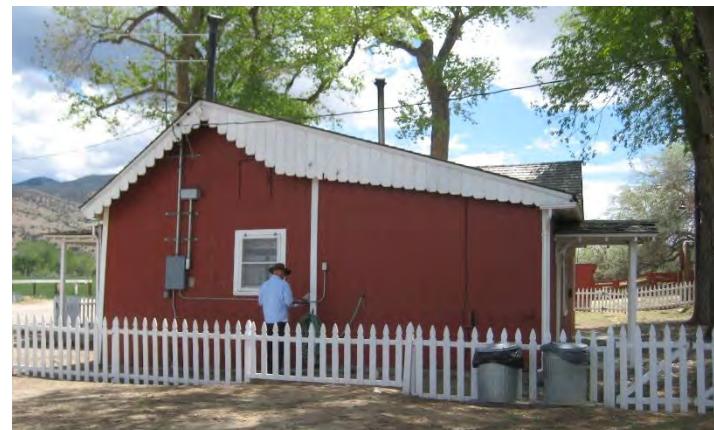
Top: Cellar concerns include standing water at entrance, wood roof framing in contact with ground; rock walls to be rebuilt for better drainage

- Regrade for positive slope away from foundations and divert water with channels/ French drains at building/structure perimeter
- Add shallow gutters to carry water to ditch
- Seal openings; stack rocks at foundation
- Direct storm water away from buildings

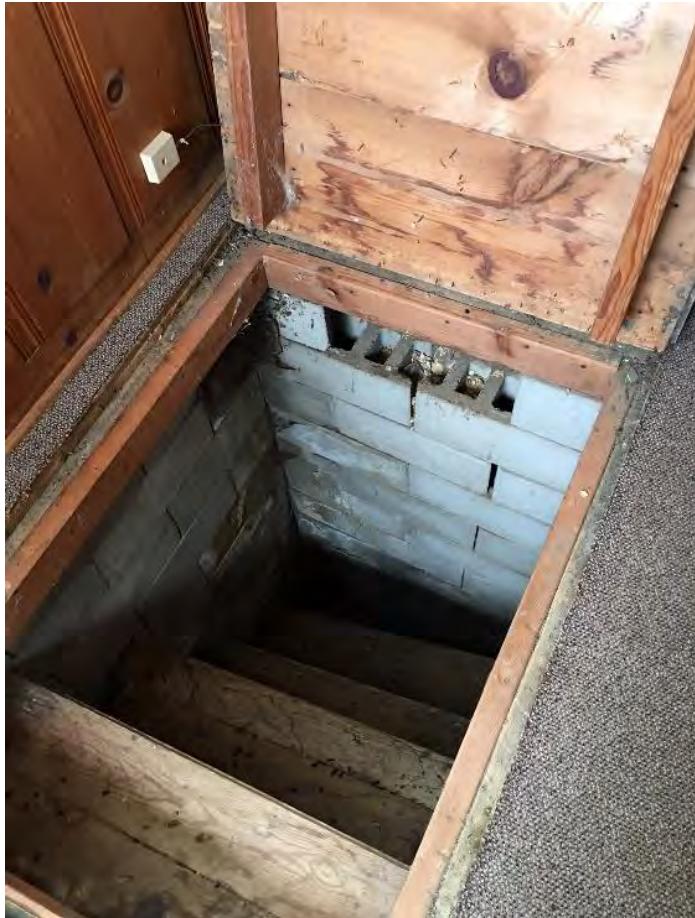
Floor hatch and staircase to cellar under the room in the hipped extension off façade of residence (possibly earlier open porch); note concrete block walls, no mortar visible in the open cells of the blocks suggesting an unreinforced masonry wall

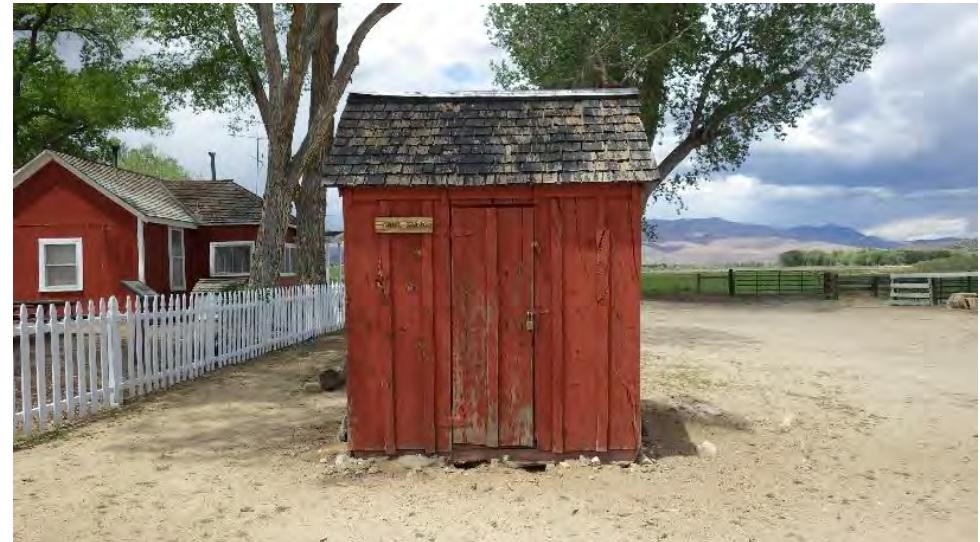
Tool Shed south elevation (top); west elevation (bottom)

The building is in fair condition, down from a rating of good in the 2004 Jones & Stokes Inventory. Routine maintenance is advised.

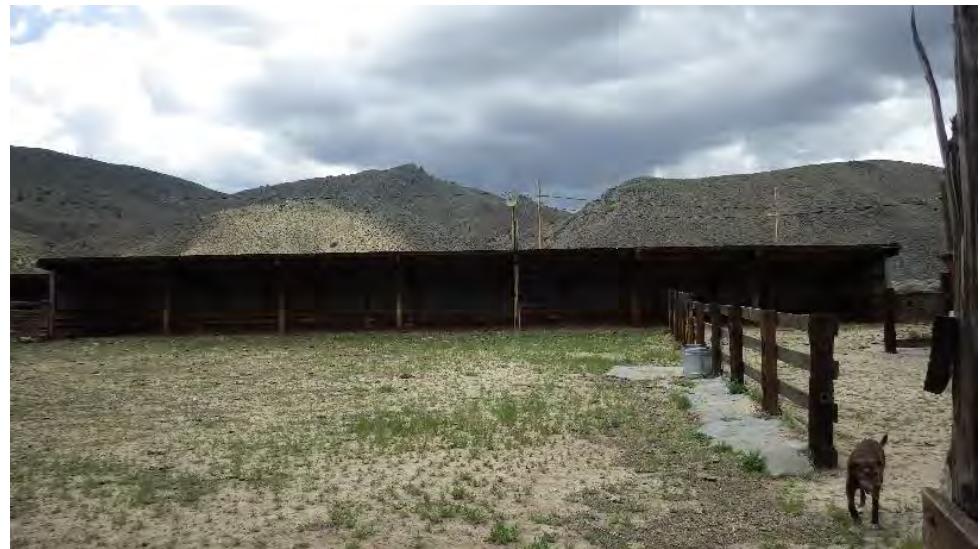
The building is in fair condition; continued maintenance efforts would include mitigating standing water along the bottom of the metal siding and deterring corrosion. Any future repair or replacement of materials will be accomplished with in-kind materials in order to maintain the essential appearance of the building, particularly the corrugated metal sheathing and the circular support posts (probably salvaged telephone poles) along its open facade. Because the shelter lacks a dry foundation, additional attention will likely be necessary to prevent rot at the bases of the supporting members.

Vet Shed, view to west (top); south wall with rust visible (bottom)

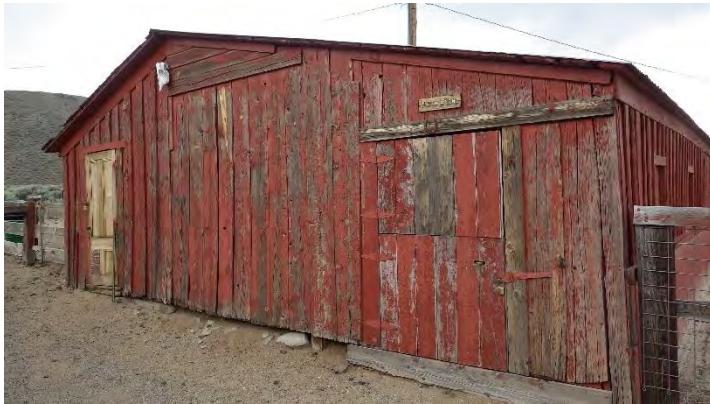
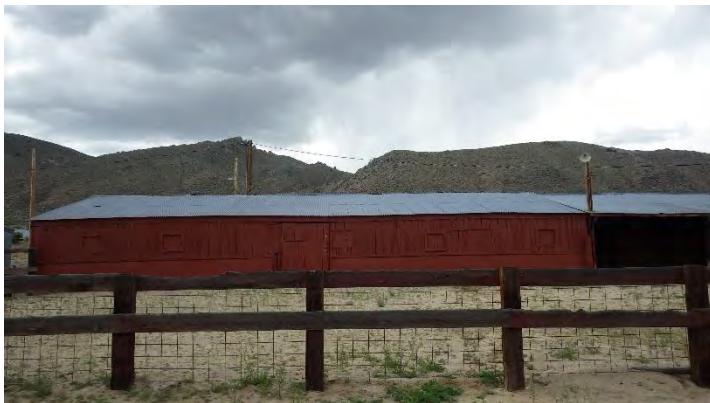
Top: Milk Barn/Tack Room façade, south elevation; note condition of paint and aprons

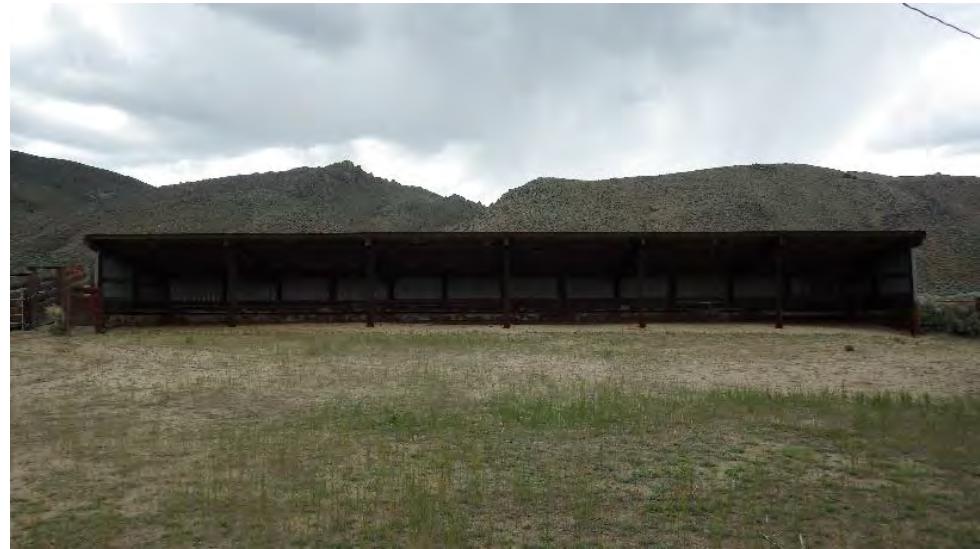
The shelter is in fair condition and its continued preservation requires minimal annual maintenance. Similar to other 3-sided animal shelters, the corrugated metal sheathing and round support posts along the open front are the defining characteristics of this simple structure. Because the shelter lacks a dry foundation, particular attention should be given to the bases of the supporting members in order to prevent deterioration from wood rot. Recommend addressing rust with appropriate inhibitor product.

Animal Shed, view to west (top); northwest corner of Bld. #9 (bottom)

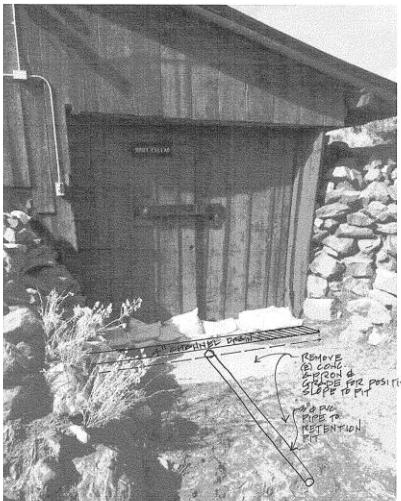
The building survives today in fair condition. The cellar has not been used for some time and has received only minimal maintenance and repair. Because of the external pressure on the buried walls, there is a possibility that the cellar is not structurally sound and will require future stabilization by installing interior braces on the upper walls; suggest study be undertaken before structural repairs. Wood roof framing members are making contact with the dirt; water observed to pool at the front entrance that is lower than road grade in front of the building. Details on mitigating moisture concerns are detailed on page 36. The building would also benefit from added ventilation.

# Drainage solutions proposed for the Root Cellar plans by Scott MacLellan, March 2019

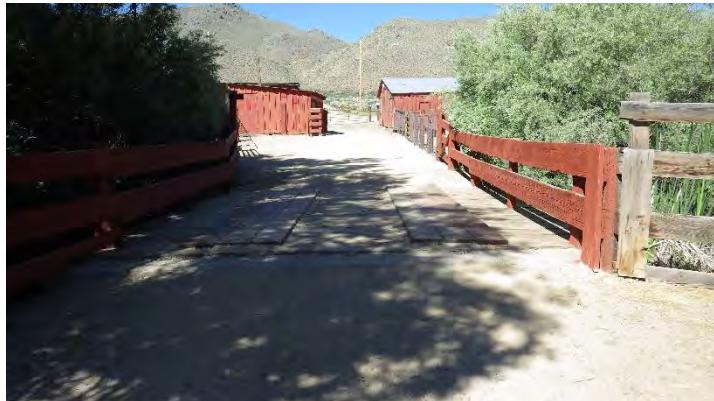
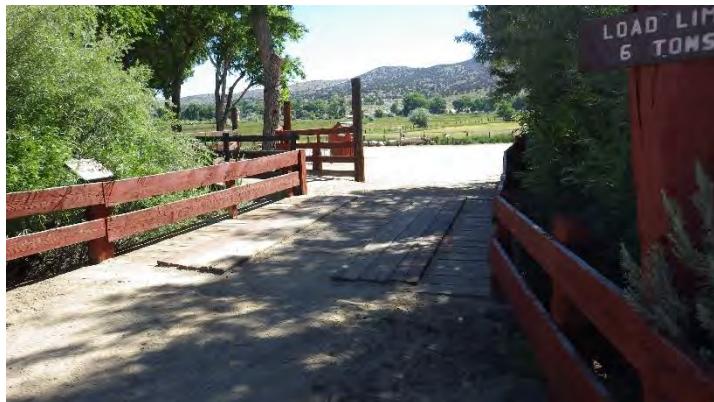
Top: Bridge, view west over Ditch

The Bridge is in fair condition; wood should be protected from contact with the earthen ditch berms. Bridge to be sealed and/or painted (Barn red) to prevent moisture damage and extend useful life of the wood as part of routine maintenance.

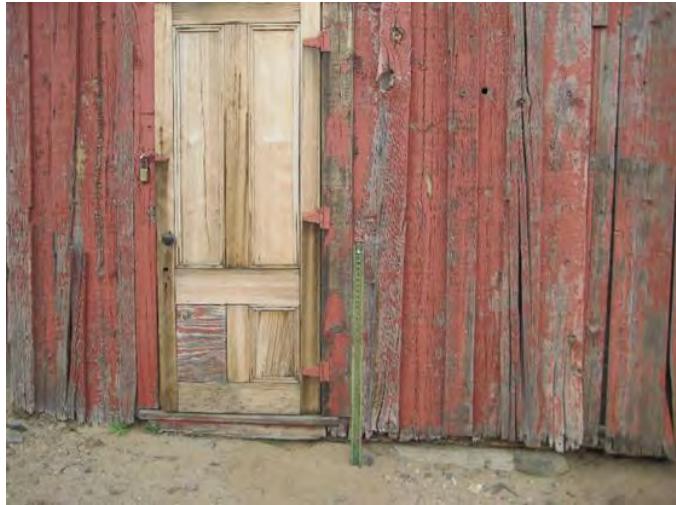
South elevation wall of the Milk Barn showing degradation of paint and severe weathering of wood boards and door.

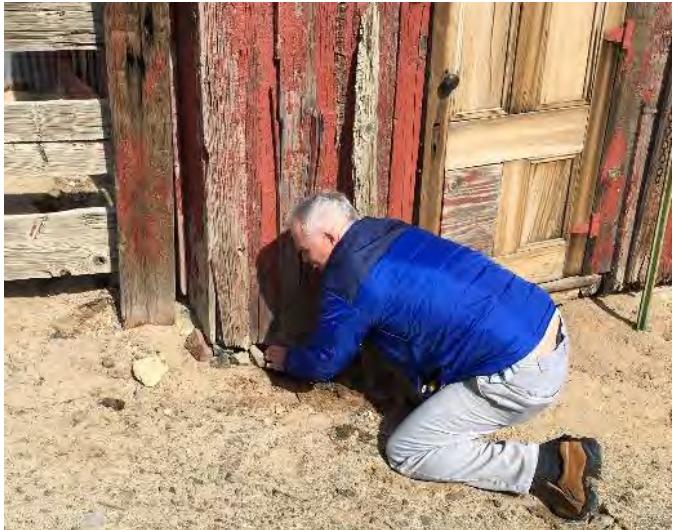
Scott pulling dirt away from wood and stacking rocks to protect and channel water away from corner of Milk Barn; problem area to be monitored.

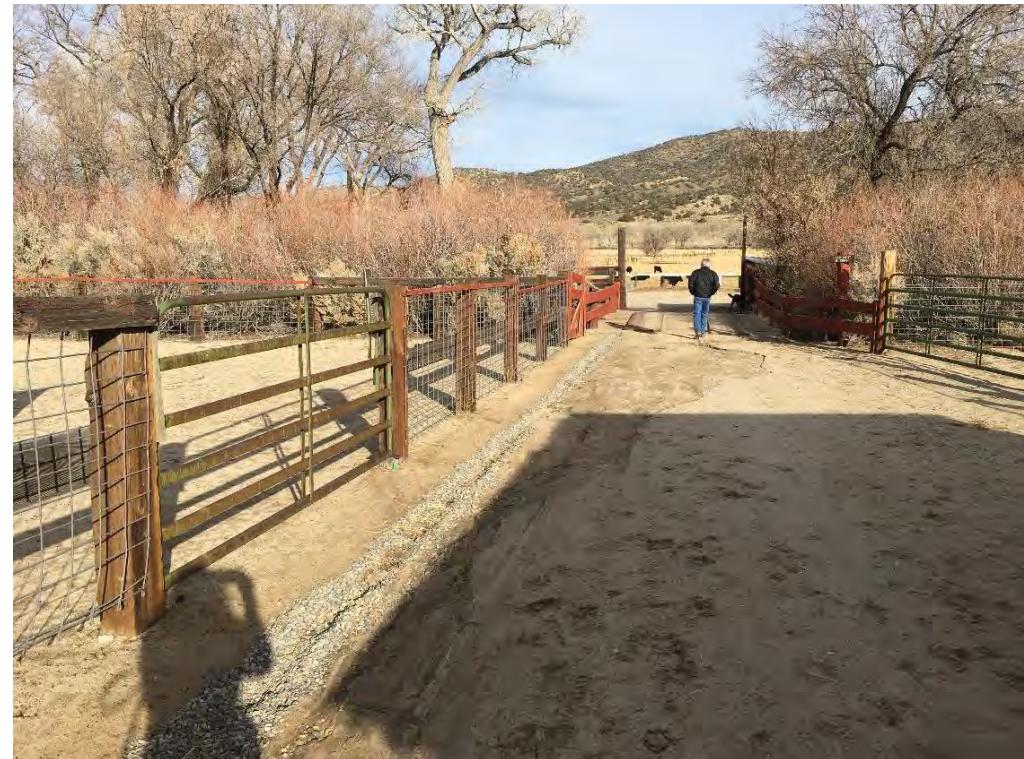
Photo of shallow drain installed to move water towards the Mexican Ditch and away from building foundations and the wood siding on the Milk Barn (December 2018)

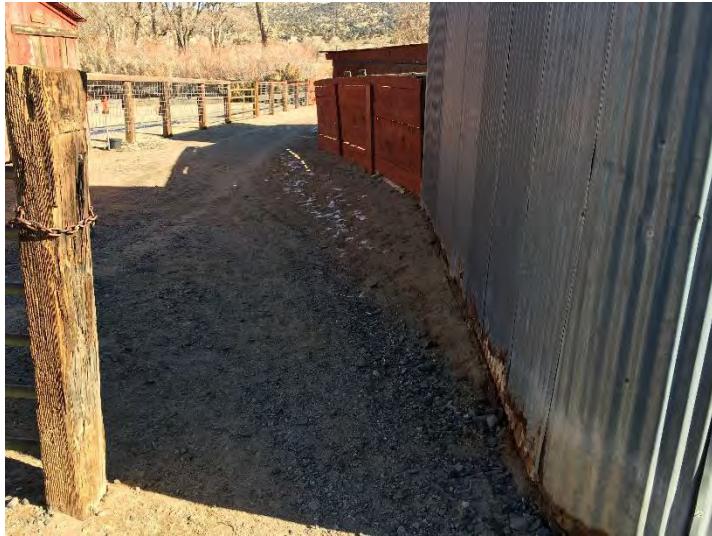
Top: Problem drainage at entry to ranch, metal in contact with earth

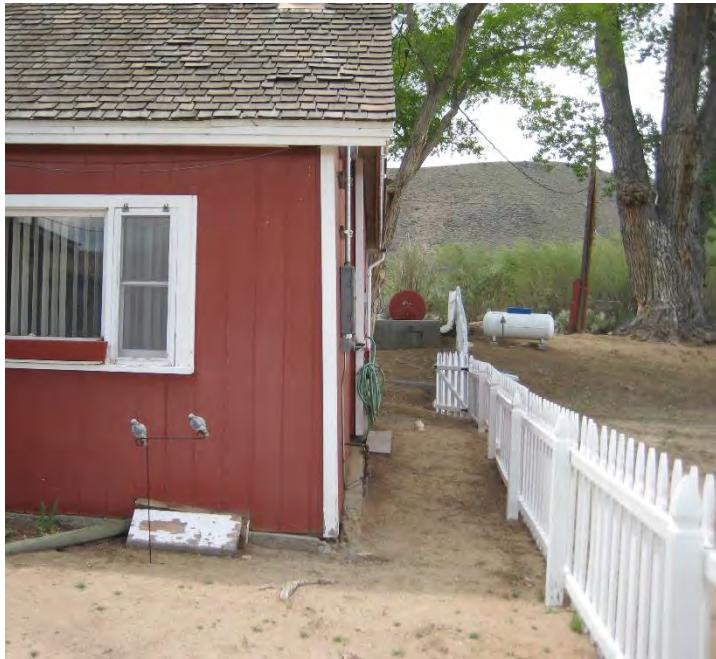
Northeast corner of the residence, view to the west towards the Mexican Ditch; slight inward bowing of north elevation wall of Ranch House is visible suggesting some possible structural concerns; advise a baseline structural assessment that would also include Root Cellar

A baseline structural assessment of the building was suggested by the Carson City Building Inspector while discussing the condition of the North elevation wall in 2018. The baseline report will provide data to be used to monitor the overall structural condition of building. For the next episode of replacement fencing, suggest removing pickets and returning the fence to wood and wire to more accurately reflect what was standing prior to 1963.

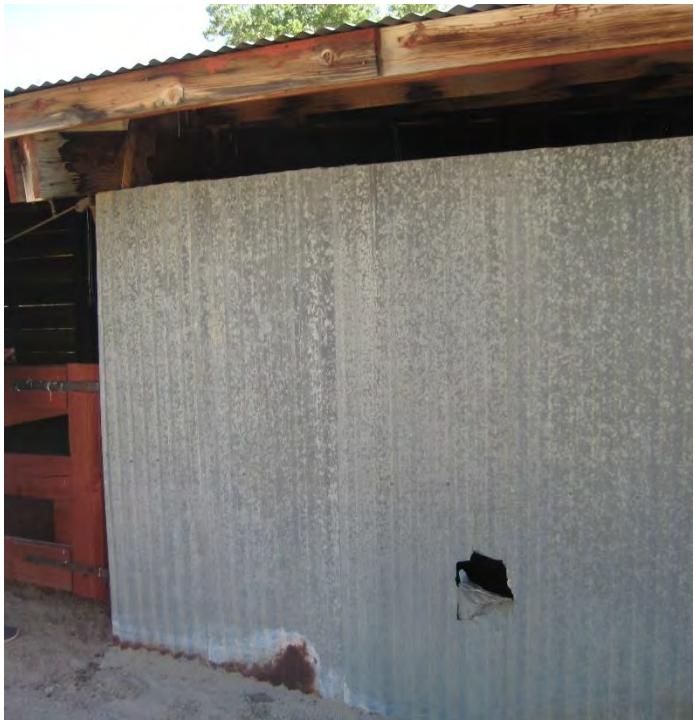
Rust/tears apparent on west wall of Building #8
