Neighborhood Improvement District (NID) Board Minutes

BOB BOLDRICK THEATER

ADA ASSESSMENT

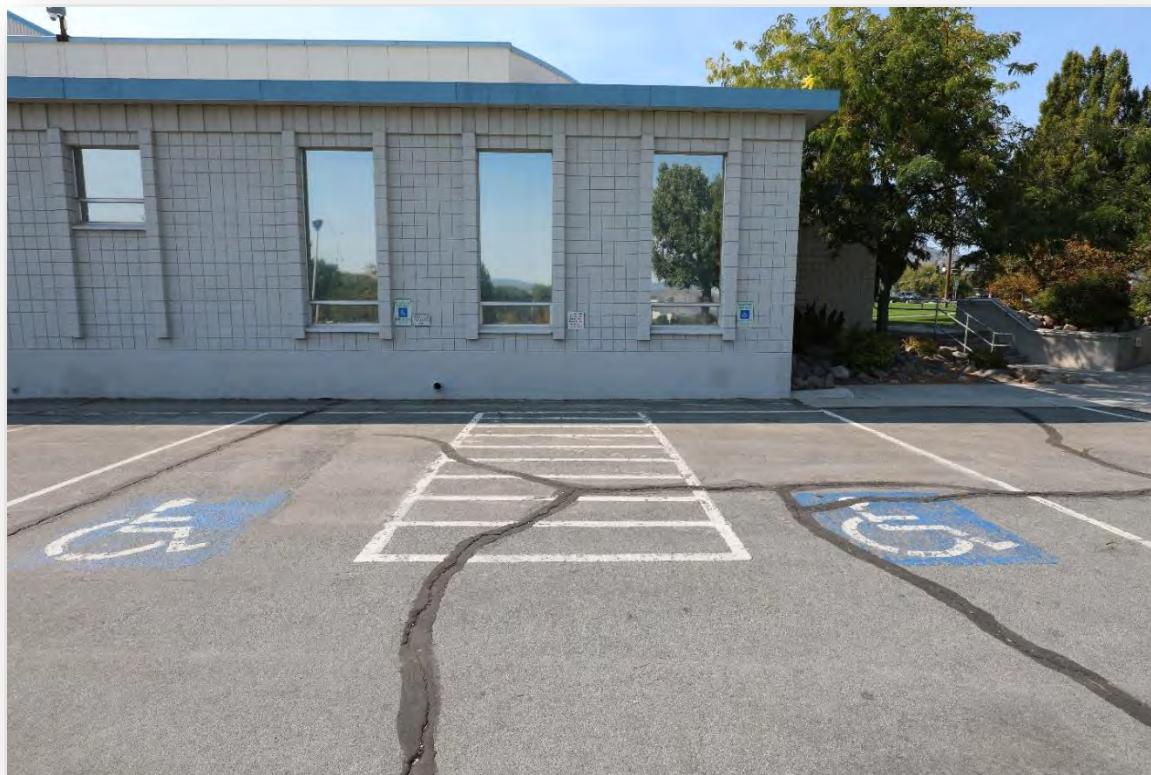
Photo 1 East parking lot looking west

As shown in the photo above, there are two accessible parking spaces that share a common access aisle facing west toward the building. The access aisle intersects the accessible route, tucked up against the building, which leads to the accessible building entrance.

- As part of routine maintenance (note deteriorating asphalt repairs), the pavement markings denoting “no parking zone” should be re-applied at a diagonal similar to access aisle striping on west parking lot
- Each van accessible parking space and intermediate access aisle should be 8' wide
- The signs should be replaced with new signs indicating van accessible parking with the bottom of signs at 60 inches above finish surface of parking lot
- Maintain (and stripe) a minimum 48" clear accessible route where the access aisle intersects the accessible route (against the building)

- Provide wheel stops (minimum six feet long) to prevent overhanging vehicles from encroaching into the accessible route or consider installing concrete filled metal pipe bollards with integrated pole and sign at each accessible parking space

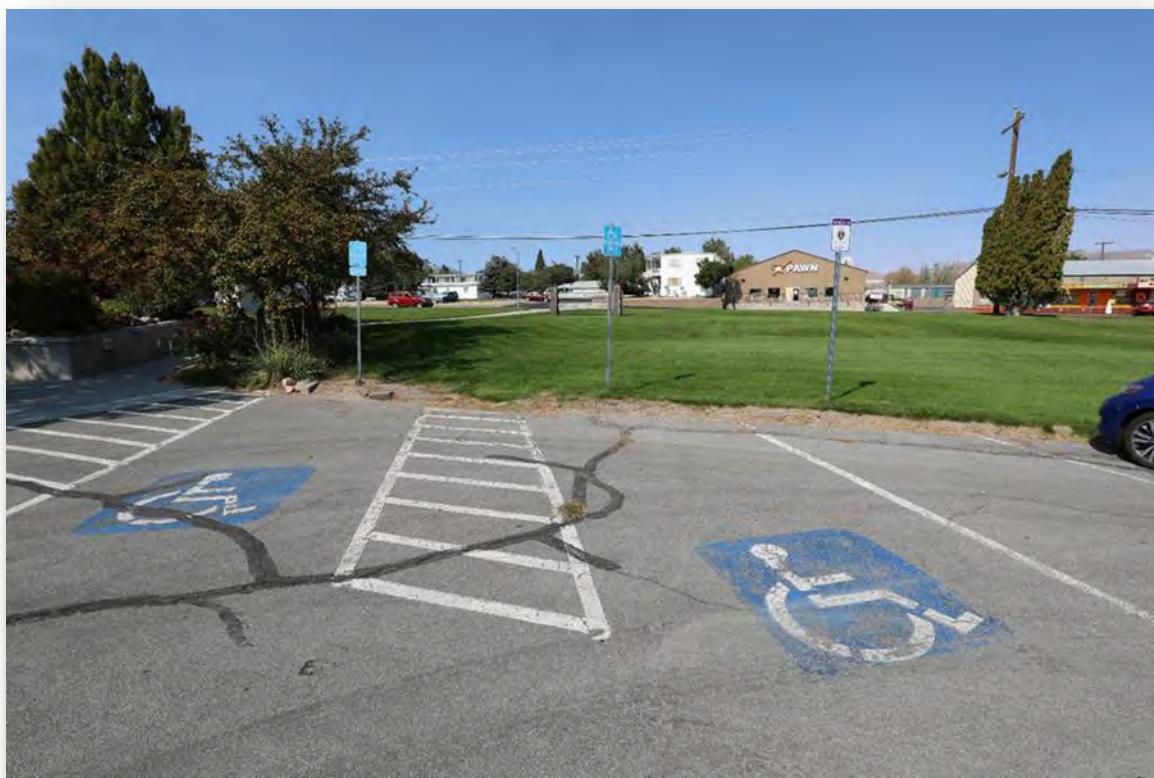
Photo 2 East parking lot looking north

As shown in the photo above, there are two angled van accessible parking spaces that share a common access aisle facing north toward the lawn area. Neither the stall width nor the access aisle width meet the standards. Note that there is no defined path from the access aisle leading to the accessible route and disabled users are forced to wheel or walk behind parking spaces and out into the vehicular way.

- As part of routine maintenance (note deteriorating asphalt repairs), the pavement markings denoting “no parking zone” should be re-applied at a diagonal similar to access aisle striping on west parking lot
- Signage should be consistent in messaging, style, color, etc., throughout the parking lots
- Provide wheel stops to prevent overhanging vehicles from encroaching into the accessible route

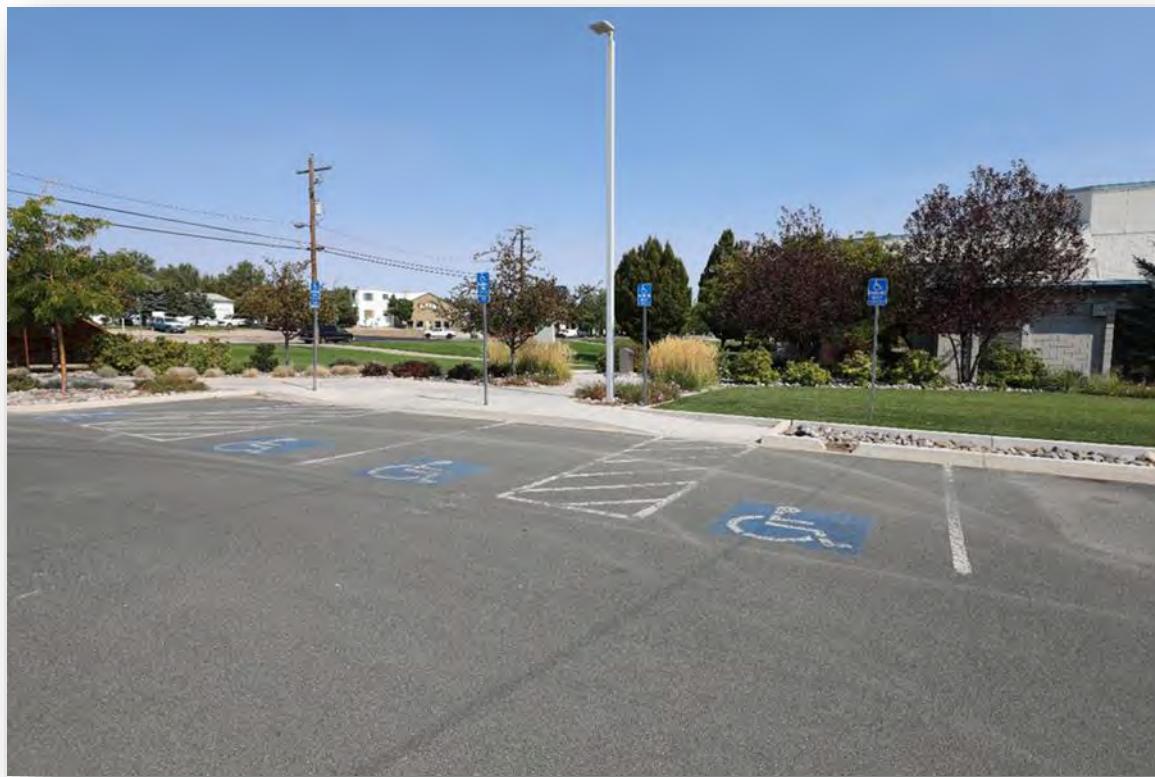
Photo 3 West parking lot looking east

There are two 8' wide van accessible parking spaces that share a common 8' wide access aisle and two 8' wide accessible parking spaces that share a common 5' wide access aisle facing east as indicated in the photo above.

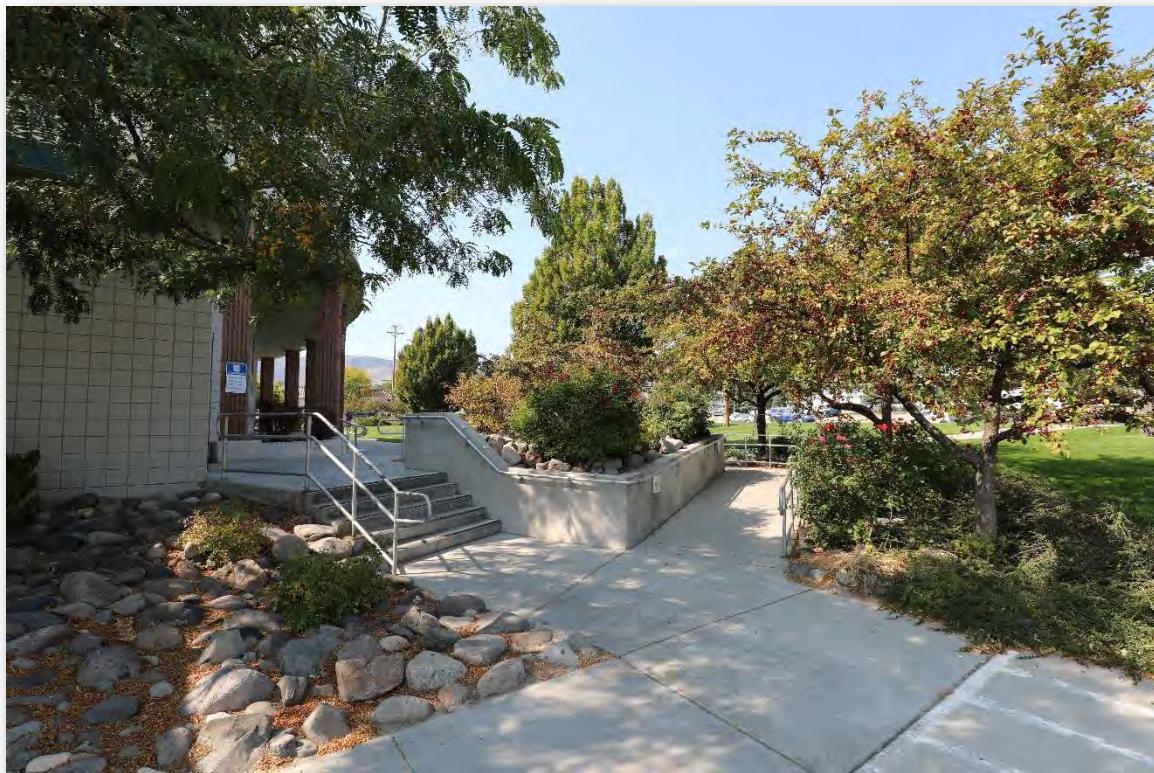
Photo 4 accessible route from east parking lot looking northwesterly

- The deteriorated electric vault lid disrupts accessible route and should be replaced or the vault relocated outside the accessible route
- The running slope in the direction of travel exceeds 5% leading to the east entry

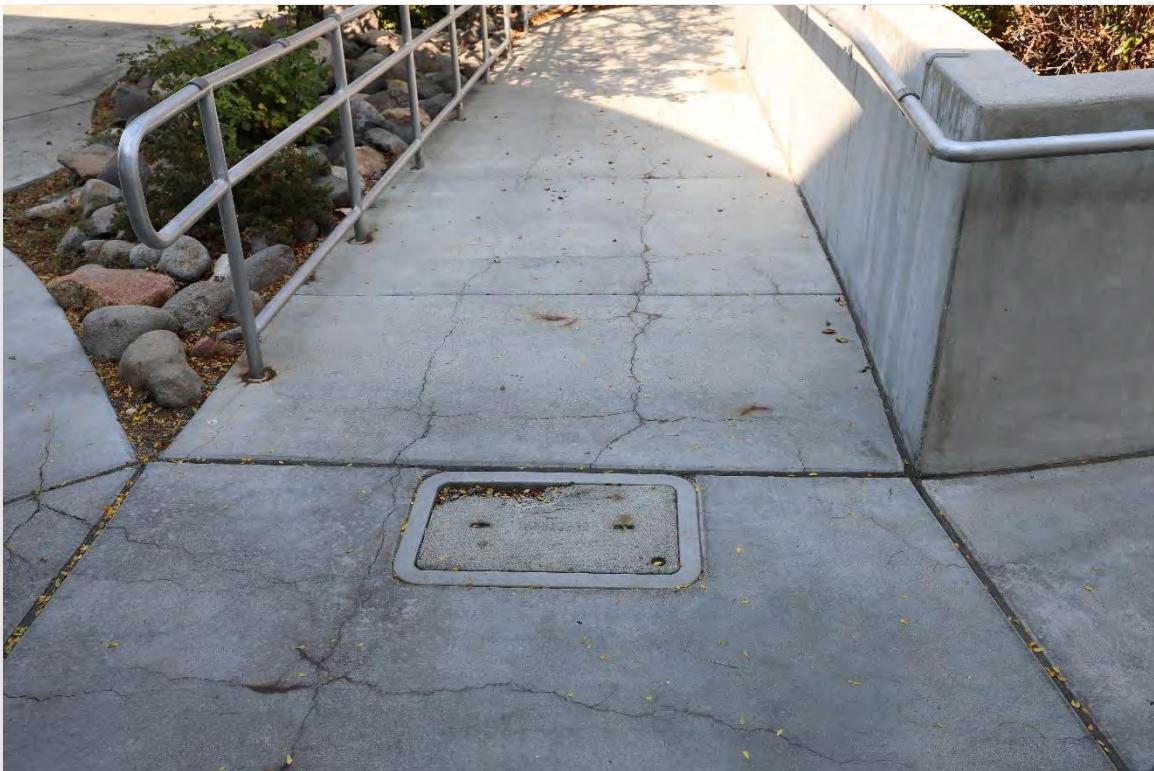
Photo 6 damaged vault lid in accessible route at east ramp looking north

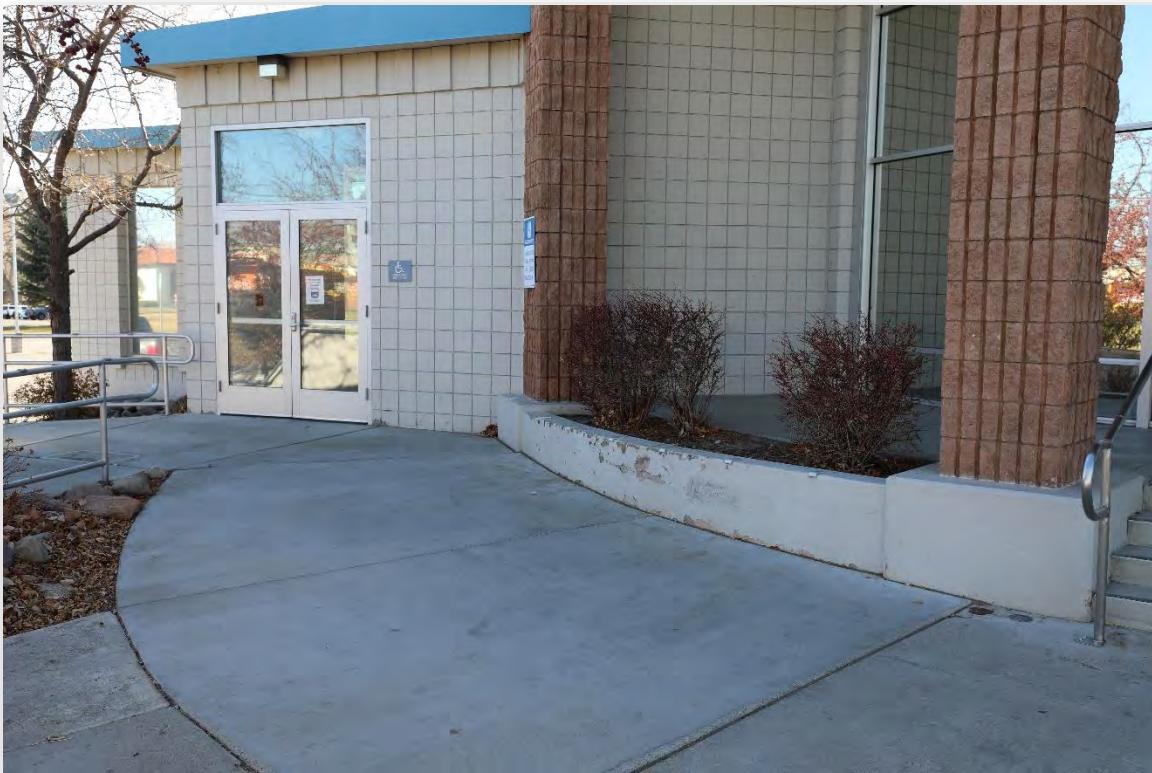
Photo 7 Running slope in direction of travel exceeds 5% and should be considered a ramp with level landings top and bottom and handrails on both sides

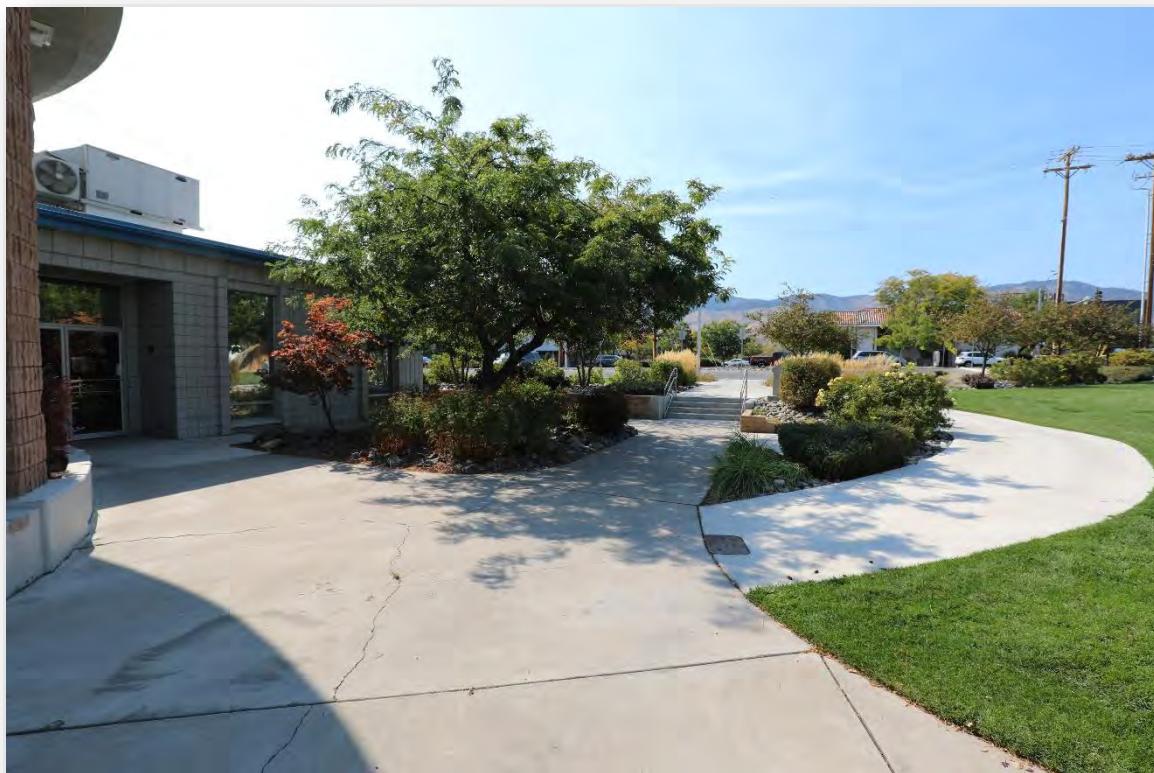
Photo 8 Accessible route from west parking lot to theater entrance

- The slope of the curved accessible route shown at right in the photo above exceeds 5% in the direction of travel – regrade or provide handrails both sides
- If possible, relocate the vault shown in the photo above out of the accessible path

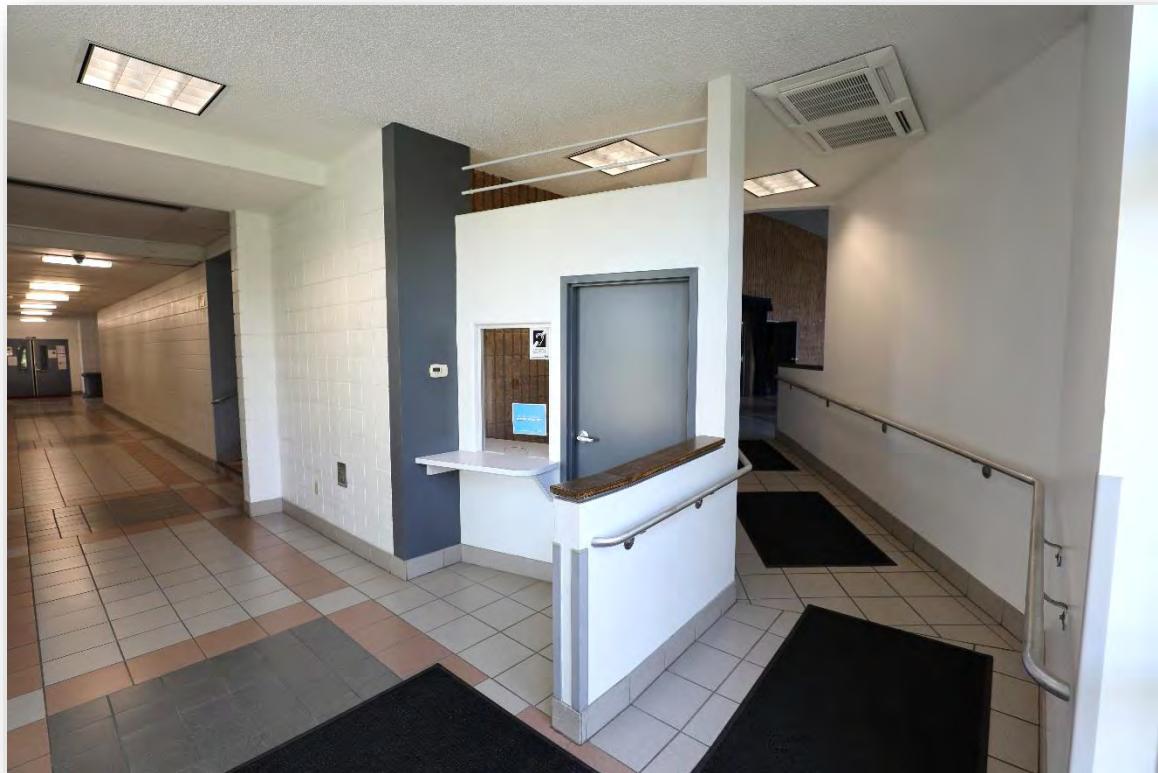
Photo 9 East Lobby at ticket office

- The ticket counter is 36 inches in width and measures 34 inches from the floor to the top of the counter, allowing a forward approach that meets the requirements of ANSI A117.1
- The ramp is approximately 58 inches in width, exceeding the minimum 36 inches requirements of ANSI A117.1. However, the ramp doglegs to the left as shown in the photo above and does not meet the requirement for a landing at any change of direction

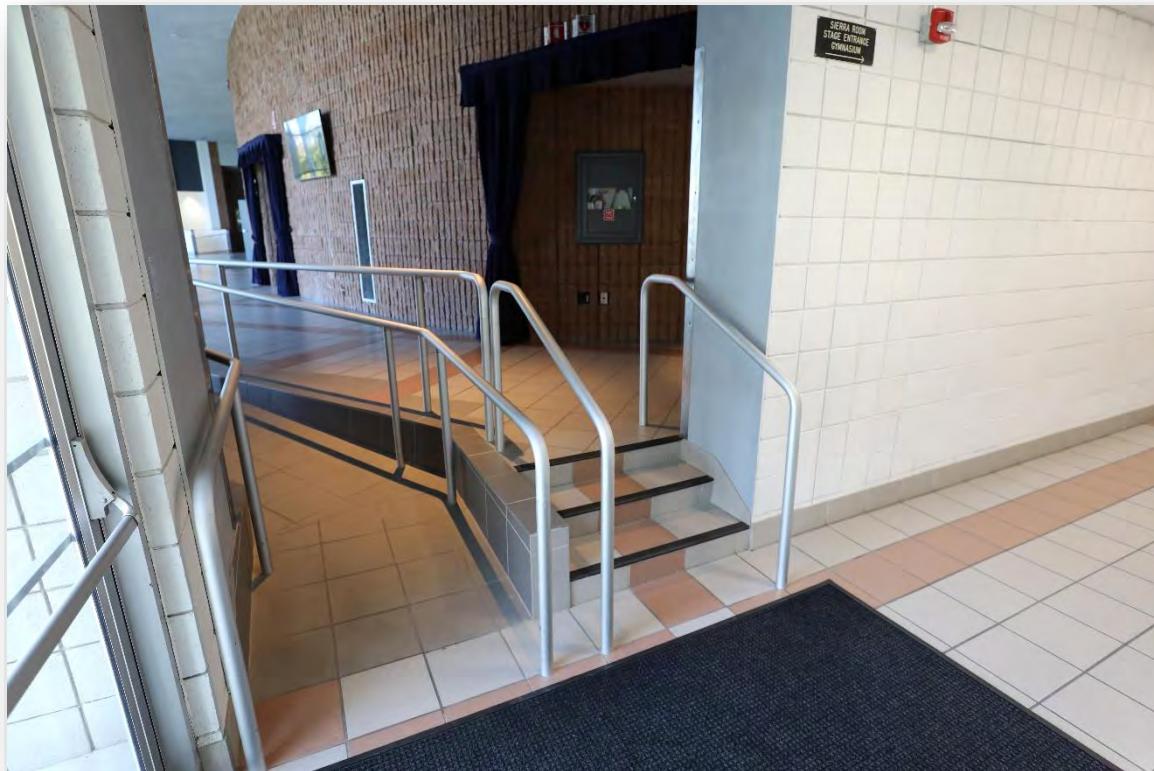
Photo 10 West lobby looking east

- The ramp is approximately 42 inches in width, exceeding the minimum 36 inches requirements of ANSI A117.1. However, the ramp doglegs to the left as shown in the photo above and does not meet the requirement for a landing at any change of direction
- The stairway is approximately 38 inches in width and doesn't meet the minimum 44 inch requirement in IBC Section 1011 or the minimum 48 inches for accessible means of egress per IBC Section 1009.3

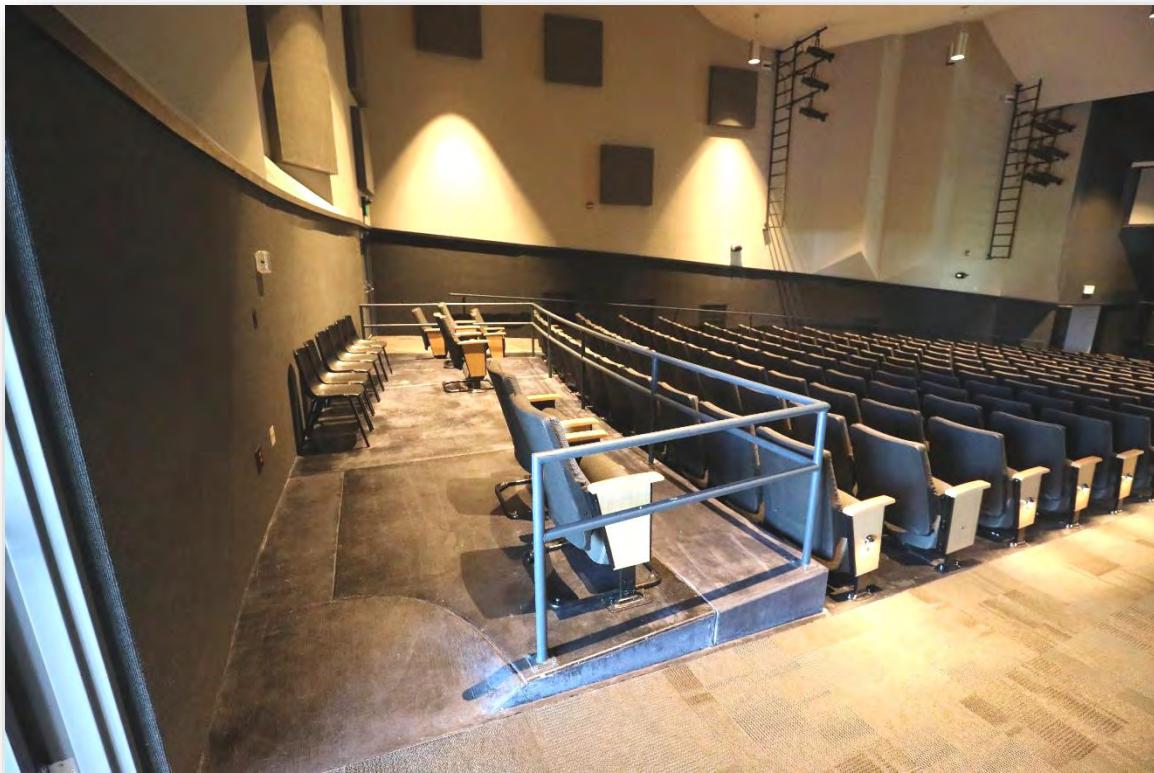
The upper ADA seating area is on a concrete platform and is accessed via a flared curb-ramp as shown in the photo below. There is no level landing at the doorway, nor adjacent to the platform, because the auditorium floor slope starts at the door threshold and drops down toward the stage. Consequently, the platform doesn't meet the accessibility requirements.

Photo 11 Upper ADA seating area looking toward east lobby – west lobby similar

- Demolition and new structural steel frame as required to cut in a new in-swinging door to access the platform from the main lobby as shown in Figure 4 below
- Extend platform as indicated, including handrails
- Eliminate non-compliant existing curb-ramp at platform with new level concrete section and extend handrails to back wall
- Relocate fire extinguisher and cabinet
- Relocate existing electrical outlets

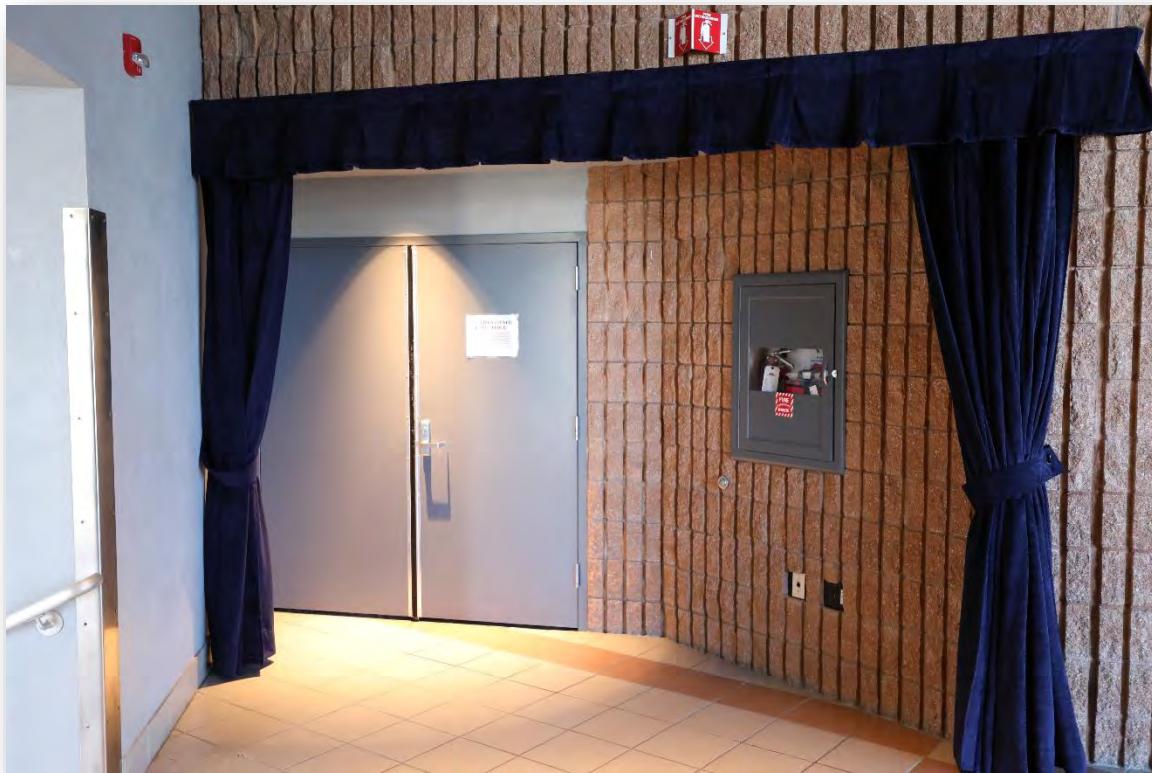
Photo 12 Possible door location to upper ADA seating area – note the recessed fire extinguisher cabinet and electrical outlets that will have to be relocated

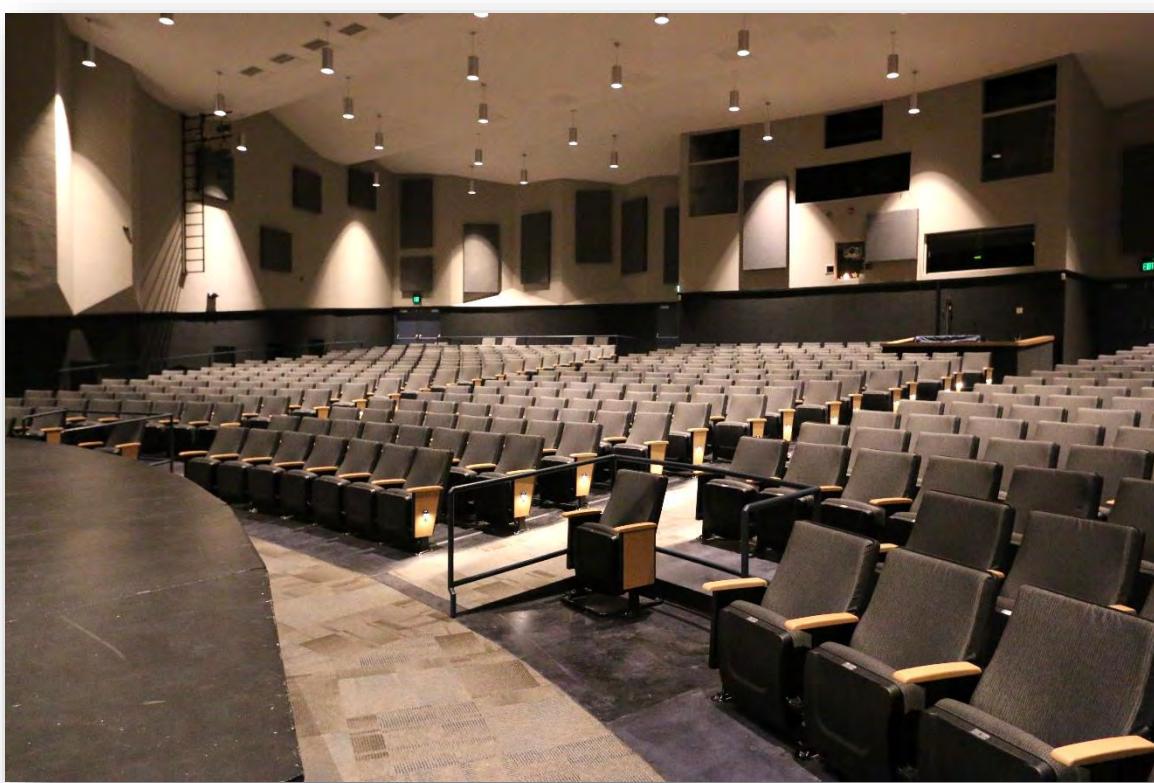
During a previous renovation, a portion of the existing sloping concrete floor was removed and a level concrete platform was poured to form the lower ADA seating area – one each on the east and west sides of the theater as shown in the photo below and on Figure 6.

- The slope of the auditorium floor is too steep for wheelchairs to safely navigate and the only other access to the lower level is via stairs flanking both sides of the theater
- Without an accessible route and accessible means of egress, the lower ADA seating areas cannot be used and the theater doesn't meet the minimum wheelchair space locations

Photo 13 Lower ADA seating area

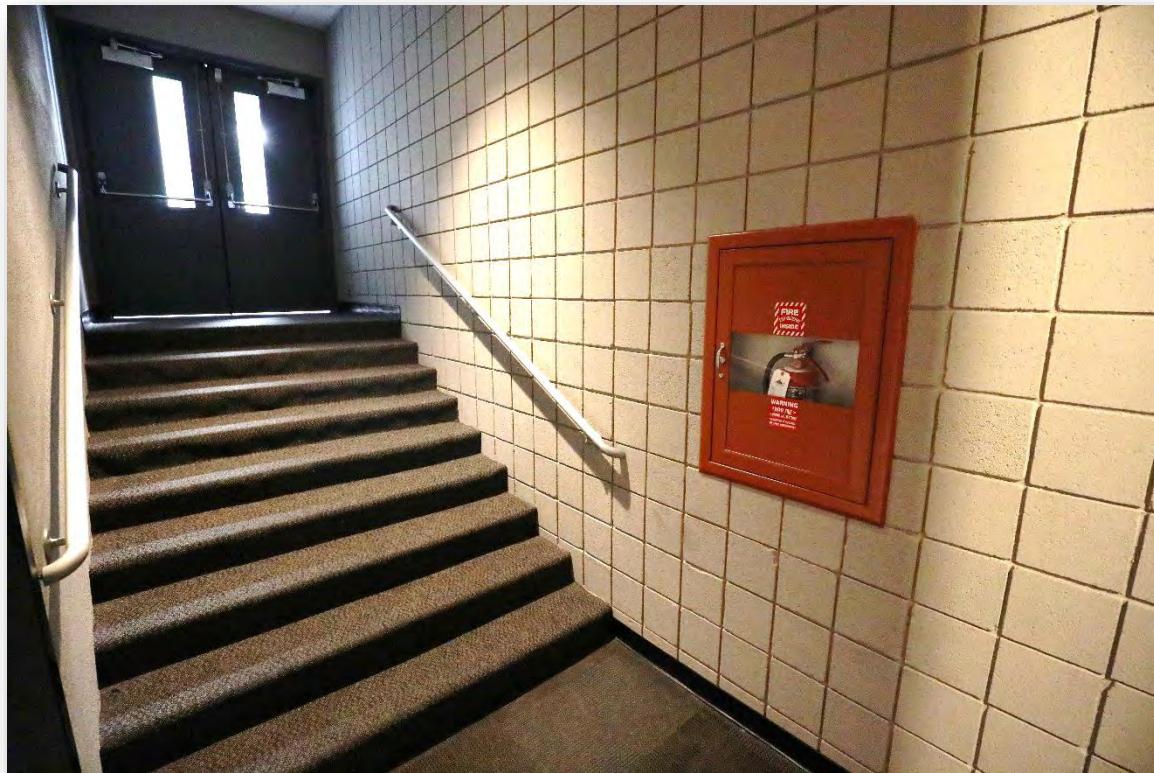
Photo 14 East stairway (west similar) leading up to east corridor from lower auditorium

- An incline platform lift such as an example shown in Figure 5 below will fit easily within the existing stairway, requiring little modification other than attaching the extruded aluminum guide and support rails directly to the existing CMU wall
- The lift, when folded against the wall, may block access to the existing fire extinguisher which is located in a recessed fire extinguisher cabinet as shown in the photo below, requiring relocation of the fire extinguisher

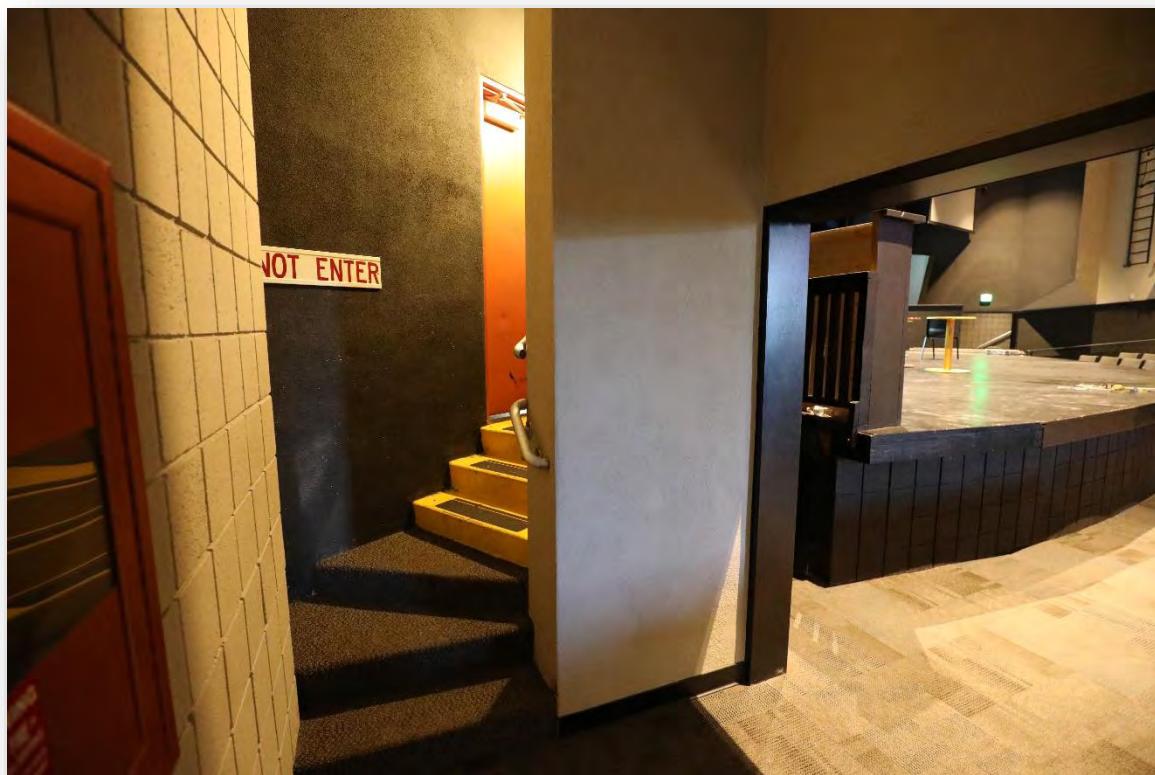
Photo 15 View looking south to stage access on east side of auditorium

As indicated in the photo above, the stage is accessed via a set of stairs leading up from the auditorium on the east and west sides. The steps leading down to the orchestra pit to the left of the stage in the photo above (and typical stage right and stage left) are hidden under the pit cover sometimes used to extend the stage during some performances.

- Infill orchestra pit flush with stage and install vertical platform lift to provide access to stage from seating area as shown in Figure 7
