**STAFF REPORT FOR THE HISTORIC RESOURCES COMMISSION MEETING  
OF SEPTEMBER 08, 2011**

**FILE NO: HRC-11-045**

**REQUEST:** To allow installation and replacement of windows on property zoned Residential Office.

**LOCATION/APN:** 403 N. Division Street / 003-226-04

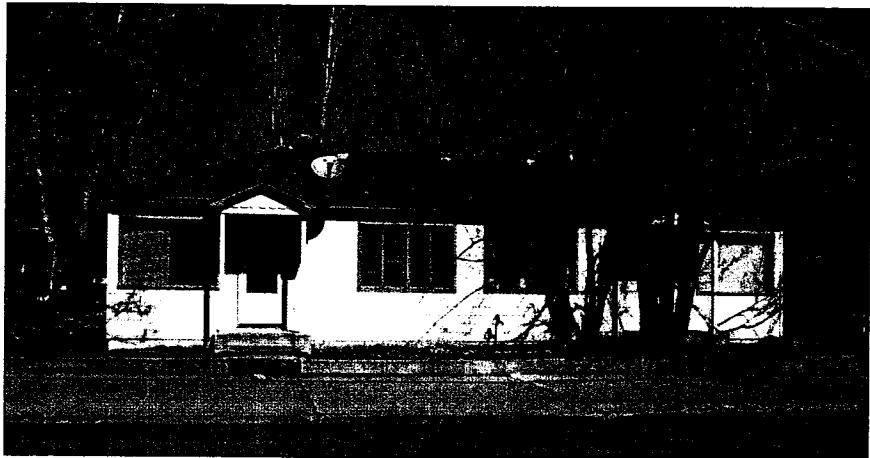
There are two duplexes on this parcel arranged in an "L" configuration. The southerly building is addressed as 310 and 314 W. Telegraph Street and the west-facing building is addressed as 403 and 405 N. Division Street. They are identical buildings. Both have hip roofs and narrow, enclosed eaves. They have v-groove, shiplap siding, a concrete foundation, and a composition shingle roof. They are vernacular buildings, constructed in 1943 (*Assessor data*).

Each unit has a centrally-placed entry accessed via two concrete steps. Over the entry stoop is an enclosed gable roof with vertical board detailing, supported by simple wood posts. The entry door is paneled. To one side of the door is a large, horizontally-oriented, single-light window. To the other is a paired, double-casement window with wood frames. This configuration is typical for each unit. The wood casement windows with narrow surrounds are typical of those found throughout the building. Each unit has an interior chimney. The buildings are in good condition and have excellent integrity.

Front (south) façade, southerly unit

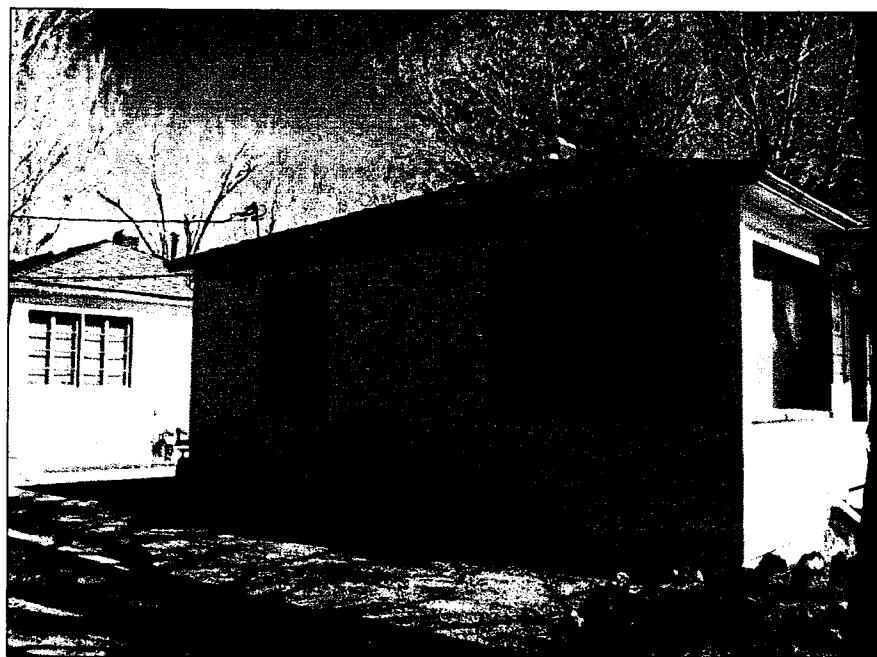
Staff conducted a site visit on July 01, 2011, currently all work has stopped on site awaiting HRC review of the window replacements that have taken place so far. From what staff can determine, regarding the southern duplex unit, on the southern façade one casement window has been replaced with a vinyl slider and on the western façade the southwestern casement window has been replaced with a slider also. On the northern duplex unit on the southern façade the applicant has replaced the two southern casement windows with a vinyl slider and a picture vinyl window. On the western façade the applicant has replaced a casement with a vinyl slider.

Side (west) façade, southerly unit

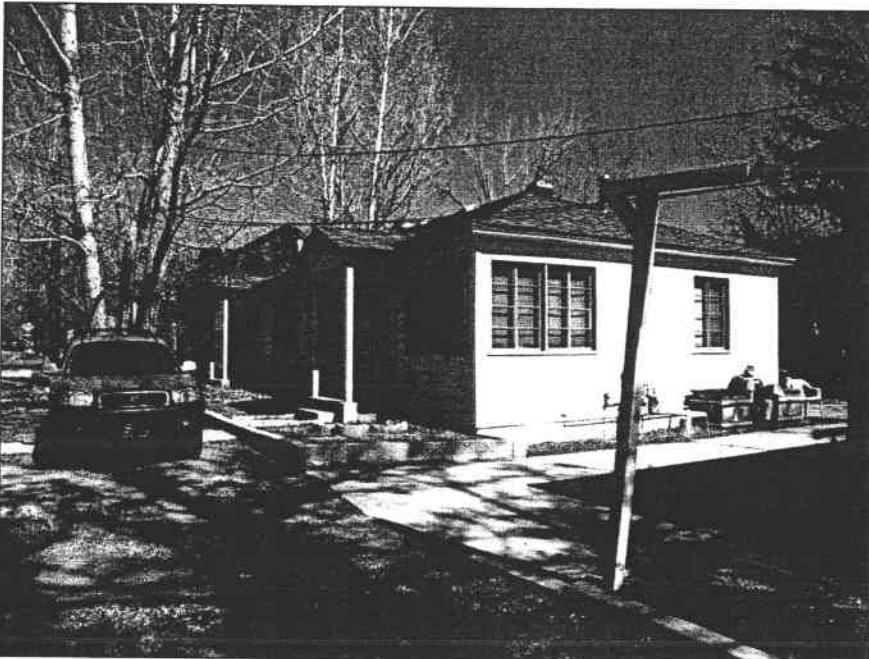
Front (west) and side (south) façades, northerly unit
