OPEN SPACE ADVISORY COMMITTEE STAFF REPORT

Ash Canyon Erosion Control Plan

November 2013

RCI Resource Concepts, Inc.
340 N. Minnesota Street
Carson City, NV 89703-4152
Resource Concepts Inc

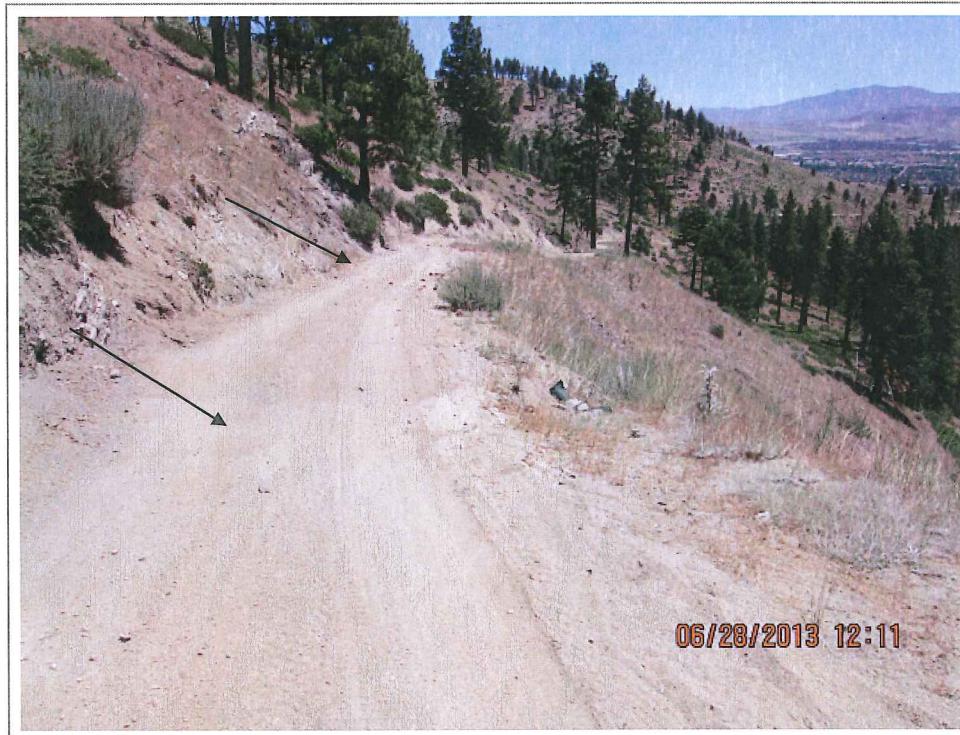
Photo 1. Rolling dips are noted by arrows near MP 2.2.

A series of rolling dips and water bars direct stormwater flow off of the driving surface along the length of the road as illustrated in Photo 1.

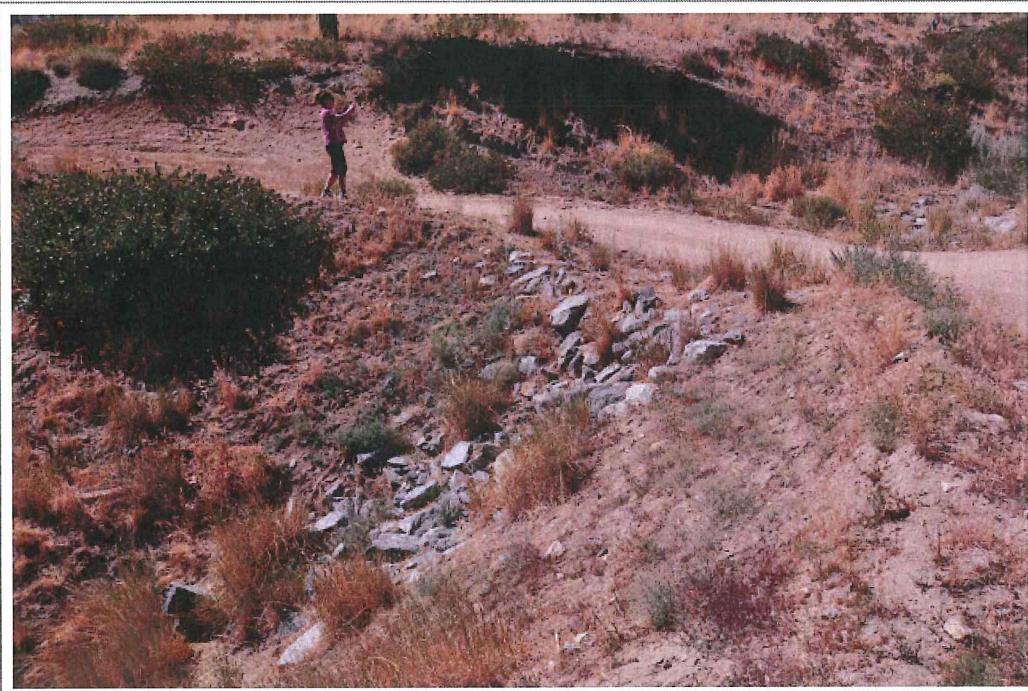
Photo 2. View of rock lined drainage near MP 1.2.

Water is conveyed from the rolling dips off of the edge of the roadway. In some places, the water is conveyed into BMPs consisting of either rock-lined drainages, or galvanized steel chutes as illustrated in Photos 2 and 3.

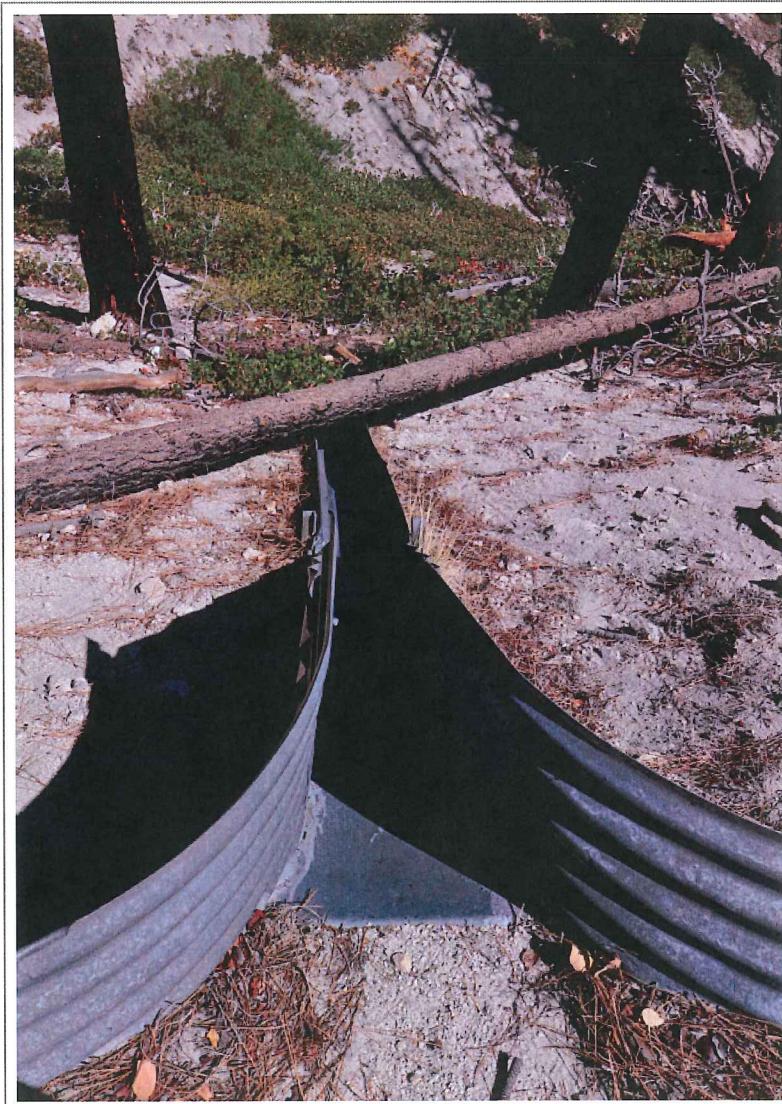
Photo 3. View down galvanized steel chute near MP 3.4.

Galvanized steel chutes are in place in some areas where road shoulders are extremely steep and stormwater is concentrated down highly erodible, unvegetated soils. The chutes appear to be accomplishing their intended purpose of conveying stormwater away from the driving surface in a manner that does not result in down slope rilling and erosion.

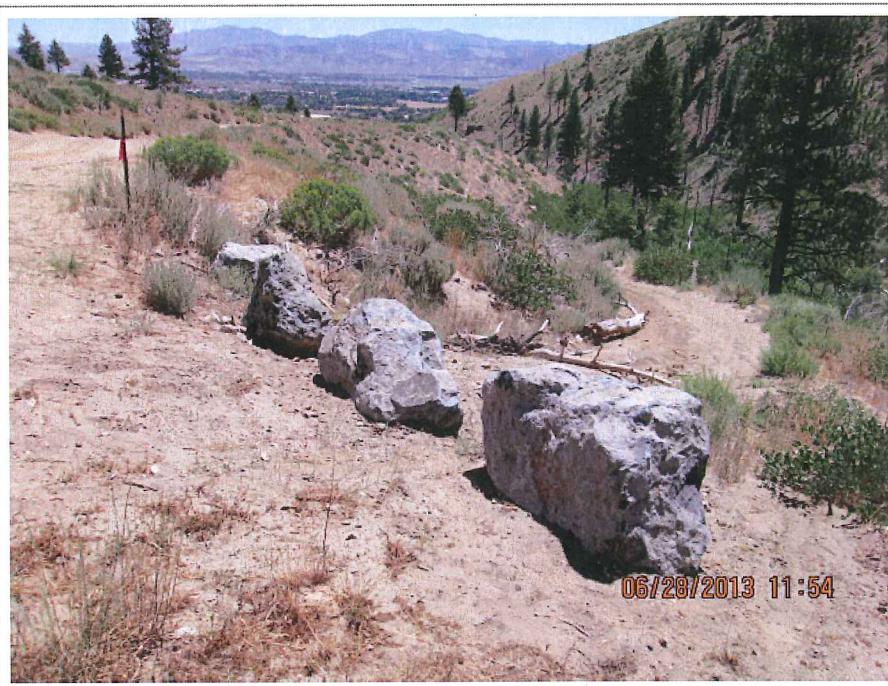
Photo 4. NDOW Road closure with boulders near MP 1.1.

Access has been limited to several auxiliary dirt roads originating from the main Ash Canyon Road. This has been accomplished through a series of signs and / or placement of large obstructions (dirt berms, boulders and/or logs) as illustrated by Photo 4 and 5.

The placement of natural obstructions such as rocks and logs has proven effective in Ash Canyon at eliminating travel across closed or unauthorized roads and trails. The most effective means of blocking roads and trails permanently is to key in rocks and boulders so they cannot be pushed or pulled out of the way as illustrated in Photos 4 and 5. Landing #4 is currently in need of such barriers as illustrated by Photo 7.

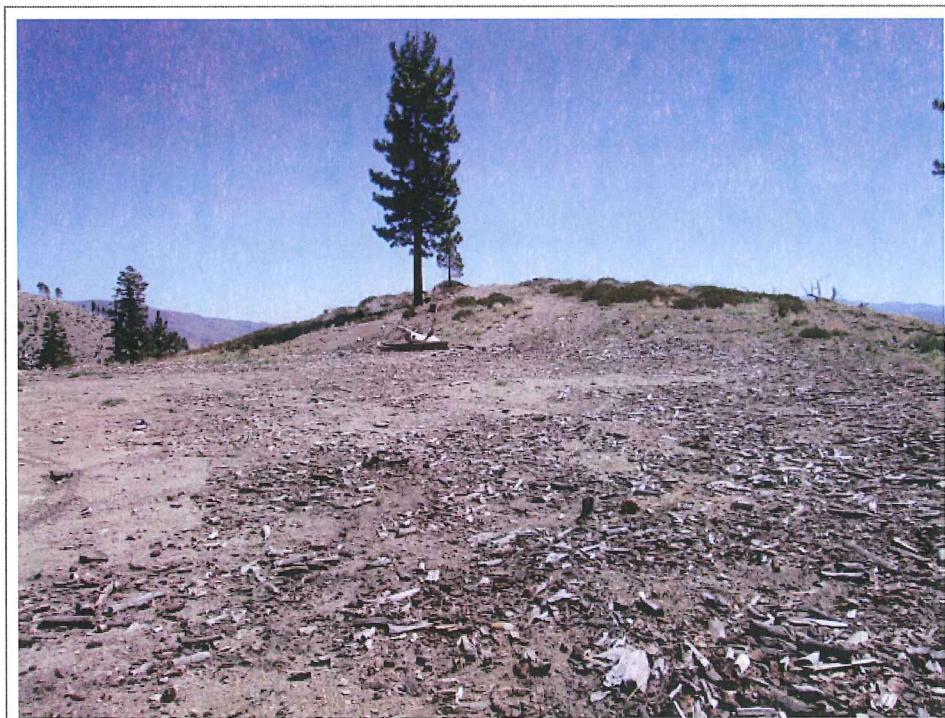
Photo 6. Parking area at Landing #4 with wood chips.

Several parking and pullout areas are located along the length of the road. These have been placed primarily to take advantage of natural wide spots or old helicopter landings. Some of the landings have been covered with wood chips in the past in an effort to prevent erosion across the otherwise unimproved DG surfaces.

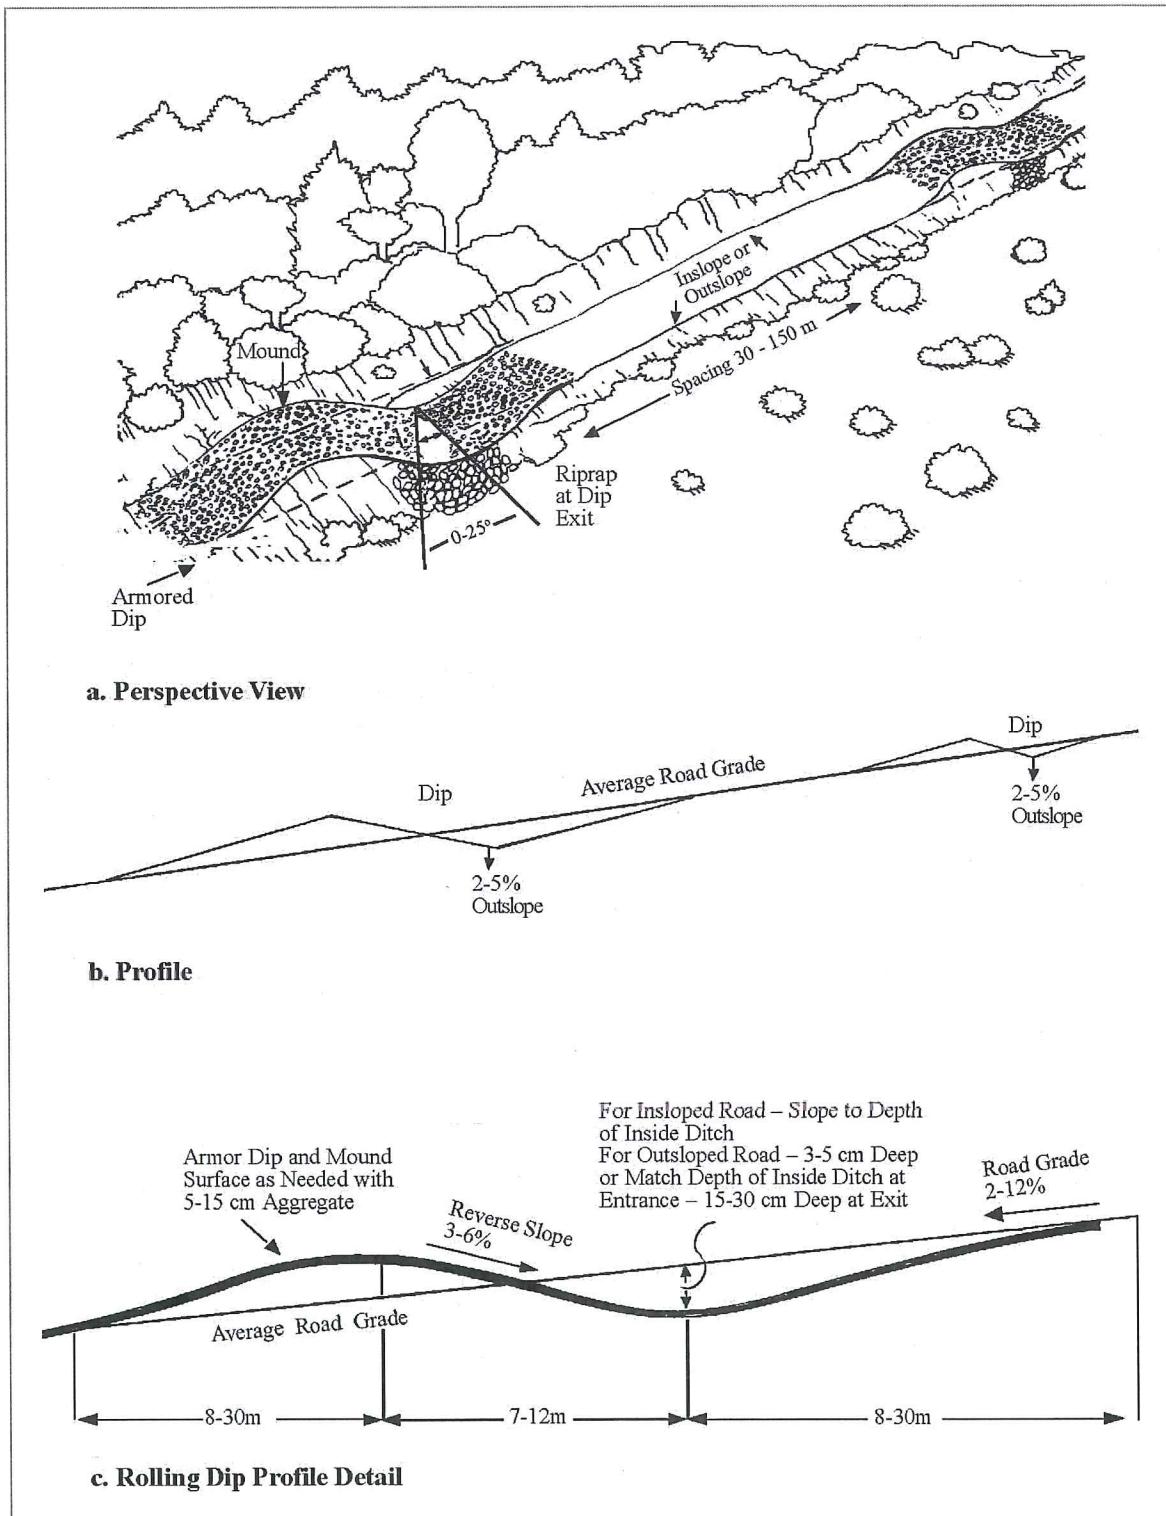
Figure 1. Rolling Dip Detail

Rolling dips should be designed and maintained with the dimensions and parameters shown in the following figure (Kelly and Sherar, 2003)

- In areas where monitoring reveals chronic issues with rilling and erosion, culvert and/or drain outlets and drain ditches will be rock armored with riprap placed over geotextile.
- Rolling dips that are subject to chronic erosion or damage will be surfaced with rock aggregate as noted in the above figure (Kelly and Sherar, 2003).

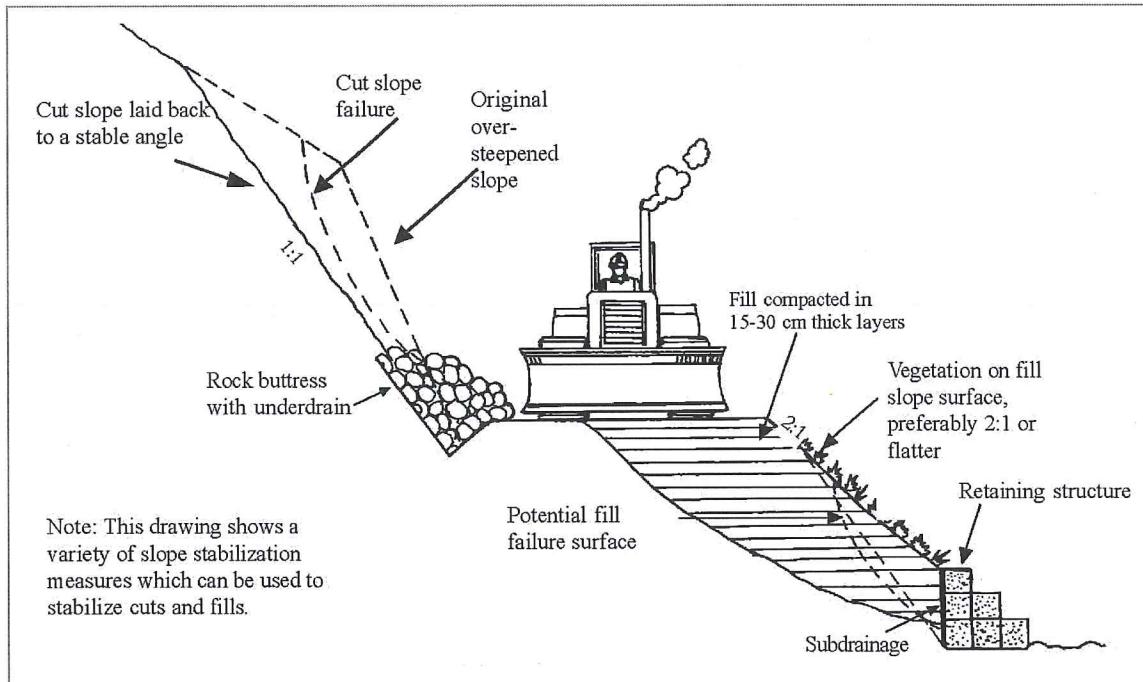
Figure 2. Slope Stabilization Detail with Rock Buttress

An improvement option is to key in boulders at the toe of the slope and construct a rock buttress, as shown in the below figure. This may not be feasible for all cut slopes depending on the depth to bedrock and width of the driving surface (Kelly and Sherar, 2003). Figure 2 illustrates this method.

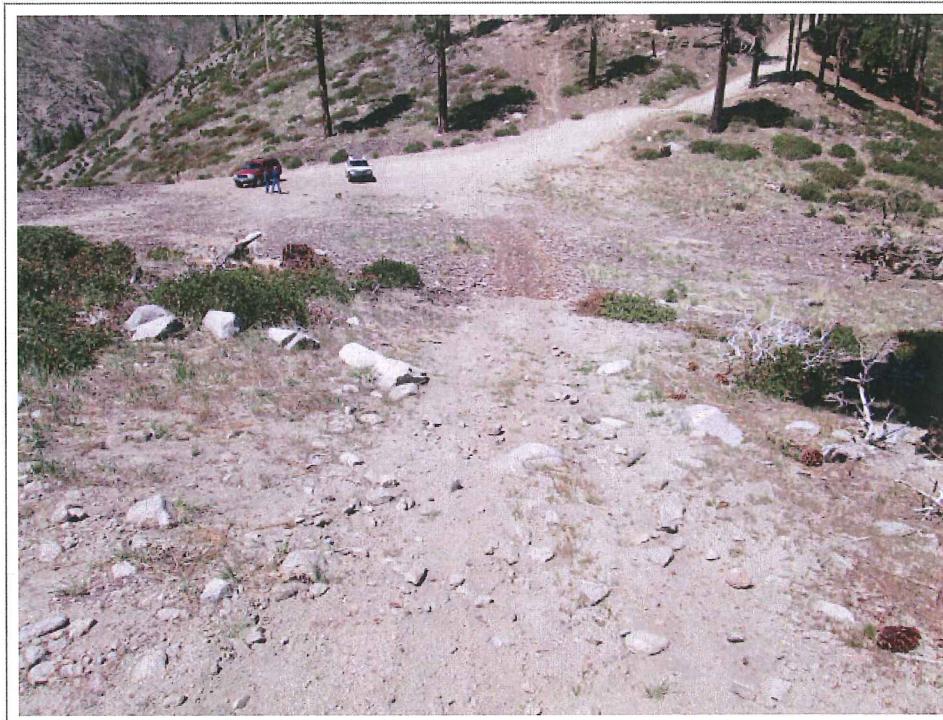
Photo 7: View from hill above parking area at Landing #4. Note OHV use in foreground. Vehicle barriers and signage should be installed to inform the users that this area is restricted to foot traffic only.
