City of Carson City Agenda Report

Subject Title: For Possible Action: Discussion and possible action to convey to the 2015 Legislature the Board's support of Bill Draft Request (BDR) No. 625, a request for a bill to develop enabling legislation for the development and preservation of the decommissioned Nevada State Prison. This item will include presentation of the final report to the Legislature entitled *Preservation, Use and Development of the Nevada State Prison, September 2014* by Carson City members of the Nevada State Prison Steering Committee. (Susan Dorr Pansky)

Preservation, Development and Use of the Nevada State Prison

Preservation, Development and Use of the Nevada State Prison
Recommendations to: 78th Session - Nevada State Legislature – 2015
Prepared by: Nevada State Prison Steering Committee
September, 2014
Page ii

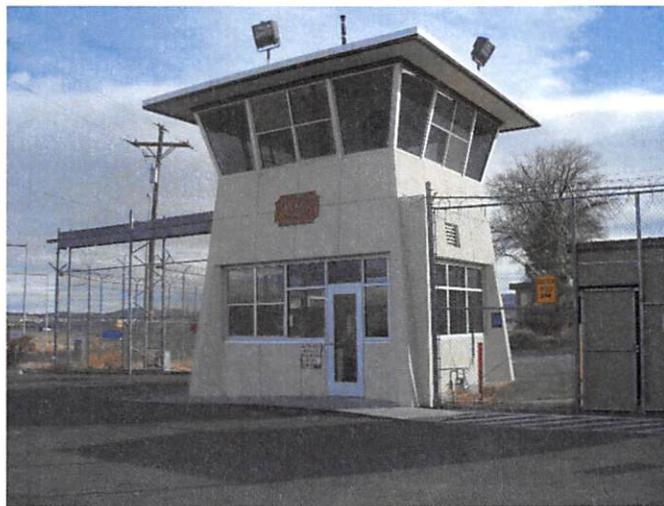
- The Main Gate / Tower 1 is located on the west side of the prison and next to a vehicle gate.
- This building is in generally fair shape.
- The building is a painted precast concrete structure that has two levels.
- It has approximately 450 square feet of space and was constructed in 1963.
- The lower level served as the visitor's check in and entry point into the prison.
- The upper level is the guard tower.

- The interior wall, floor and ceiling finishes are in poor condition.
- The interior finishes are faded and damaged to a point where the concrete walls and floors are showing wear and deterioration.

- The building's sanitary wastewater system is showing signs of deterioration.
- The drains operate slowly.
- Deposits within the pipes will cause them to be restricted, which will slow the flow of water.

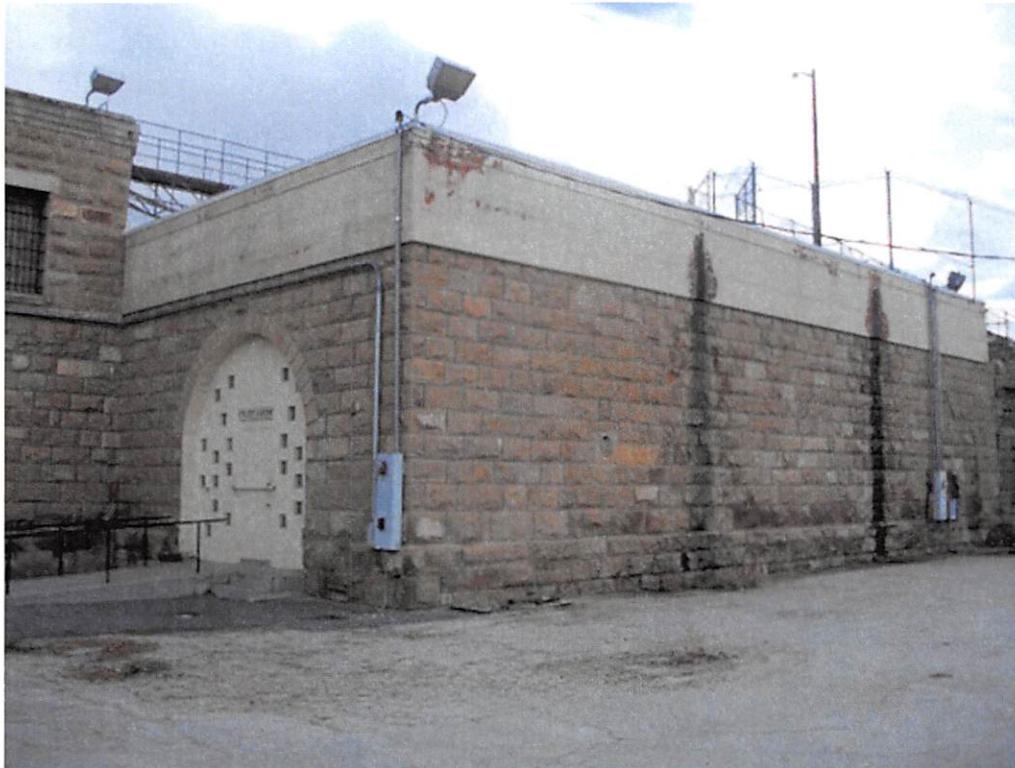
- The Courthouse is a stone masonry structure with a single-ply roof membrane.
- This building is attached to the Administration / Cell Block building and is one of the oldest structures on site.
- It was originally constructed in the 1927-28, as a sally port for major vehicle access to the old prison yard.
- It was covered with a roof in the 1960's as a construction project by the Synanon Foundation to provide 1,475 square feet of interior space.
- It then served as a chapel and offices for caseworkers.
- The facility was remodeled for court proceedings.
- The building is in fair shape

- The Courthouse is constructed of sandstone masonry walls on the exterior and wood framed interior walls and roof.
- The structure requires seismic strengthening to meet current life safety codes.
- This 1927-28 portion of the structure should be retrofitted to meet today's seismic standards.
- This project would cost approximately \$75,000.
- It is recommended that the building be painted in the next 3-5 years.

- The interior finishes are in fair condition.

- It is recommended that the interior walls be painted at least once in the next two to three years.
- The interior floor covering is mostly carpet and is showing signs of extreme wear.

- Several areas are worn out and tears are evident throughout the carpeted areas causing a tripping hazard.
- This flooring should be replaced with carpet tile to allow for future replacement of only those sections of carpet that are worn or damaged without the need to remove the entire carpeted area.

- This replacement would cost approximately \$15,000.
- The building has a suspended acoustical tile ceiling system.
- The T-bar framing is bent and rusted in many areas and a number of the ceiling tiles are damaged and stained.

- The replacement of this ceiling system would be nice but not immediately necessary at this time, regardless of its use.
- The estimate for this ceiling replacement is \$15,000.

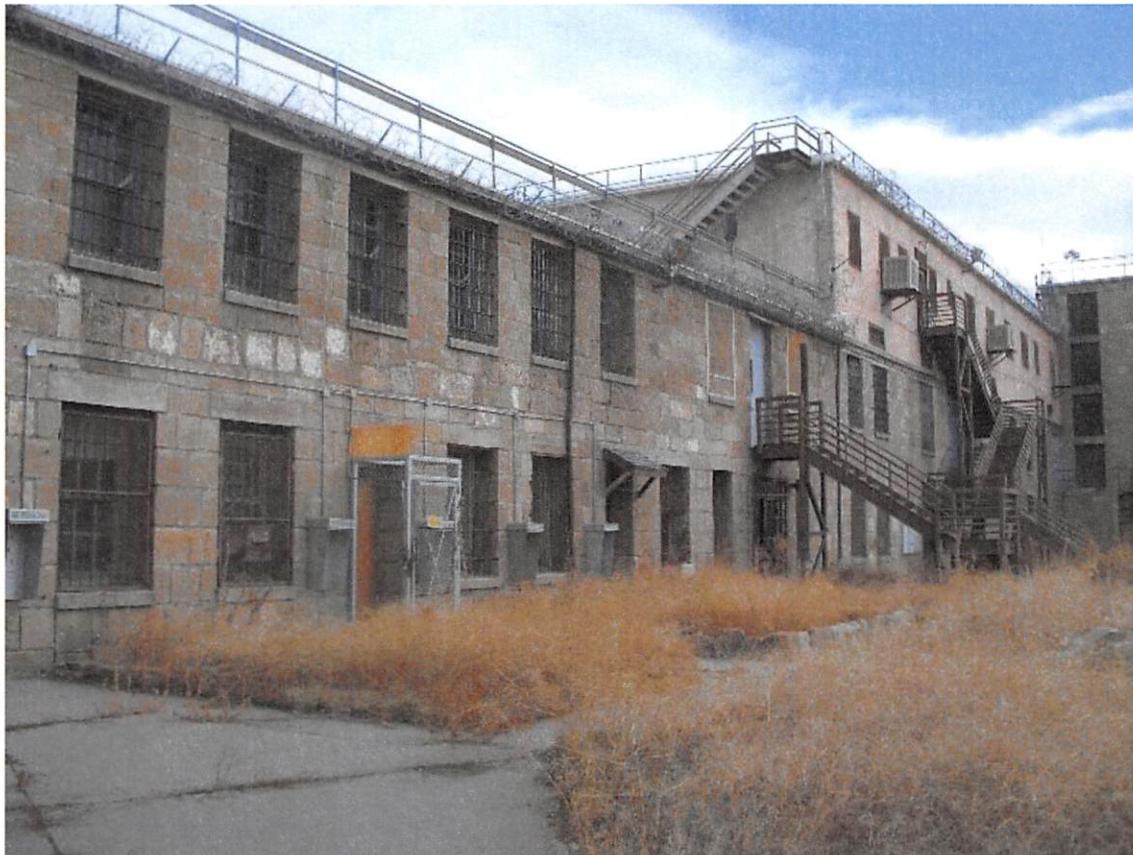
North Wing (Hospital Wing)

- The northern wing of the structure housed a complex assortment of functions.
- There is an access to a cellar area, called "Sagebrush", after the inmate newspaper that was once published by them.
- Today it simply provides access to some utilities.
- The first floor of the wing contained large, open, shop areas.
- These spaces are dim and worn, but could be remodeled for office or file space on an easily accessible ground level through doors that are outside the secure area of the structure.

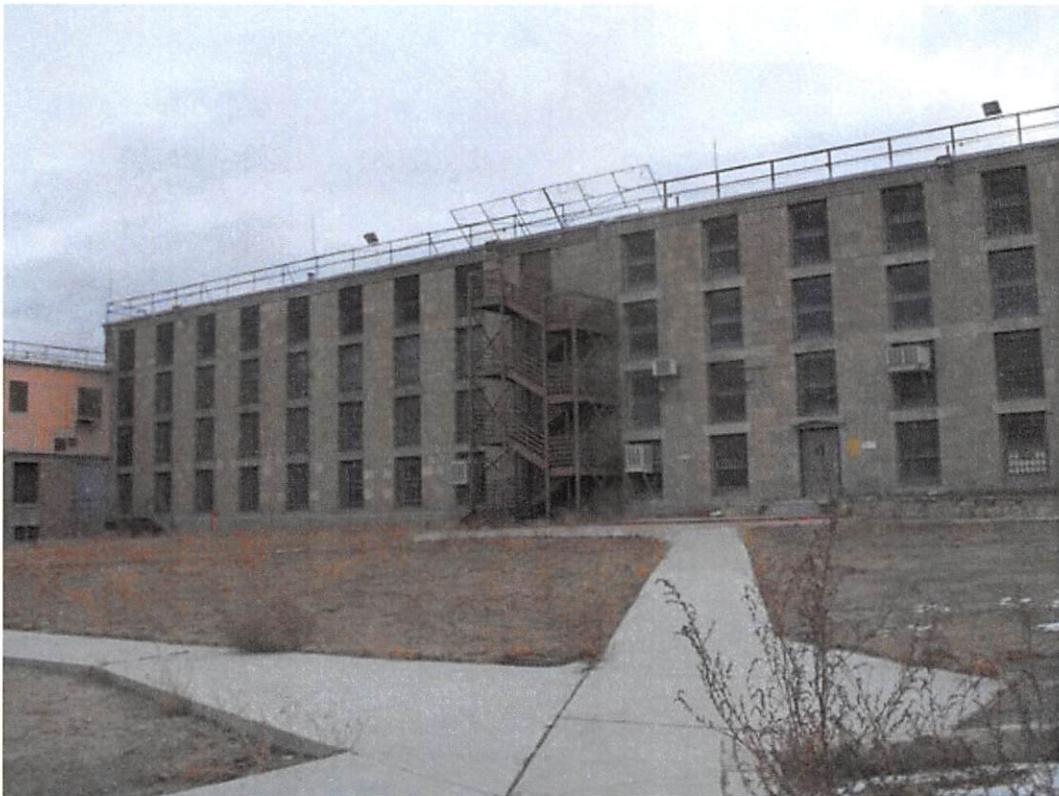
East Wing (Cell Blocks A & B)

- Easily hold 300 inmates
- A & B 4 stories
- A constructed in 1920-25
- B constructed in 1947-50
- Retrofit of bar – gates – hardware with construction of B block
- Interior cell configuration
- Cells inside
- Staff corridors outside next to windows
- Accessed by stairs only on north end of wing

- The first three floors of the cellblocks are the preferred route for a proposed museum.
- The remaining floors could be used for State or commercial document storage, considering there is no fire sprinkler system in any of the cells.
- Their cell configuration allows for easy compartmentalization and securing of items.
- They could also be used for commodity or bulk storage.
- They can be used for agency general and incident training.
- They can be used for TV or movie production.

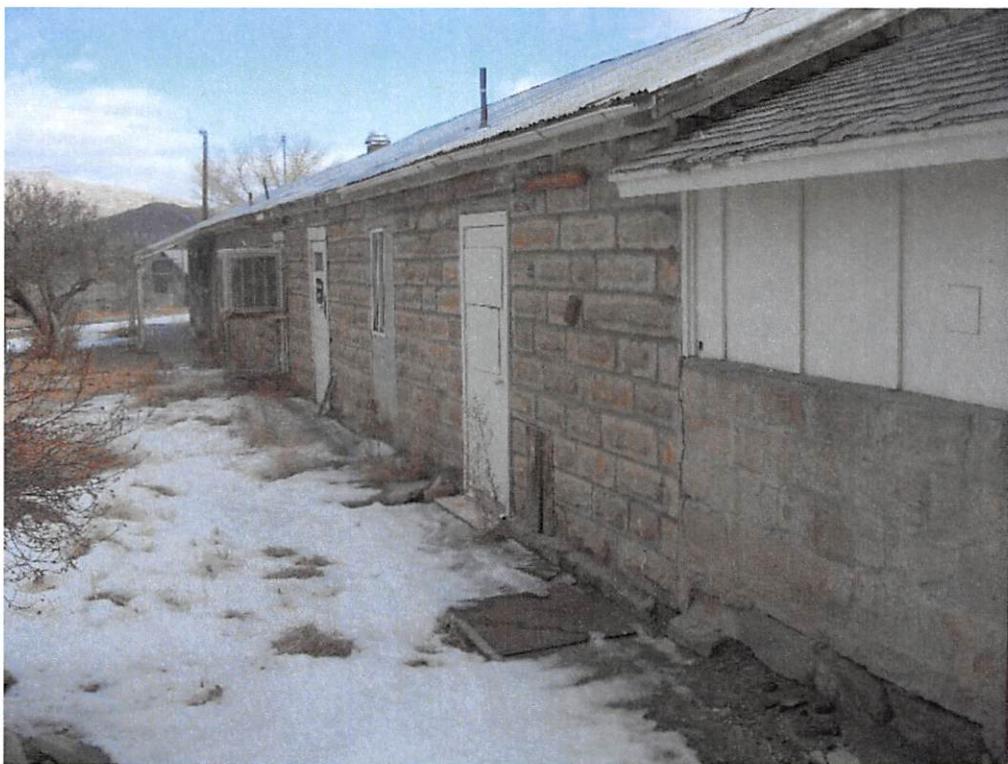
- The Storage and Maintenance Office is a stone masonry and wood framed structure on a concrete slab-on-grade.
- The building has low hazard storage adjacent to the welding shop.
- The roofing is corrugated metal.
- The building contains small office areas, storage areas, a welding area and restrooms in roughly 3 separate spaces and three different occupancies.
- Some portions of this structure are over 50 years old.
- 2,190 sf.
- Constructed in 1952
- The structure is in fair shape.

- The facility is not ADA compliant and does not have a fire protection system.
- No proposed use in this plan
- It is appropriate to retain it for its appearance and perhaps make it suitable for non-critical storage,

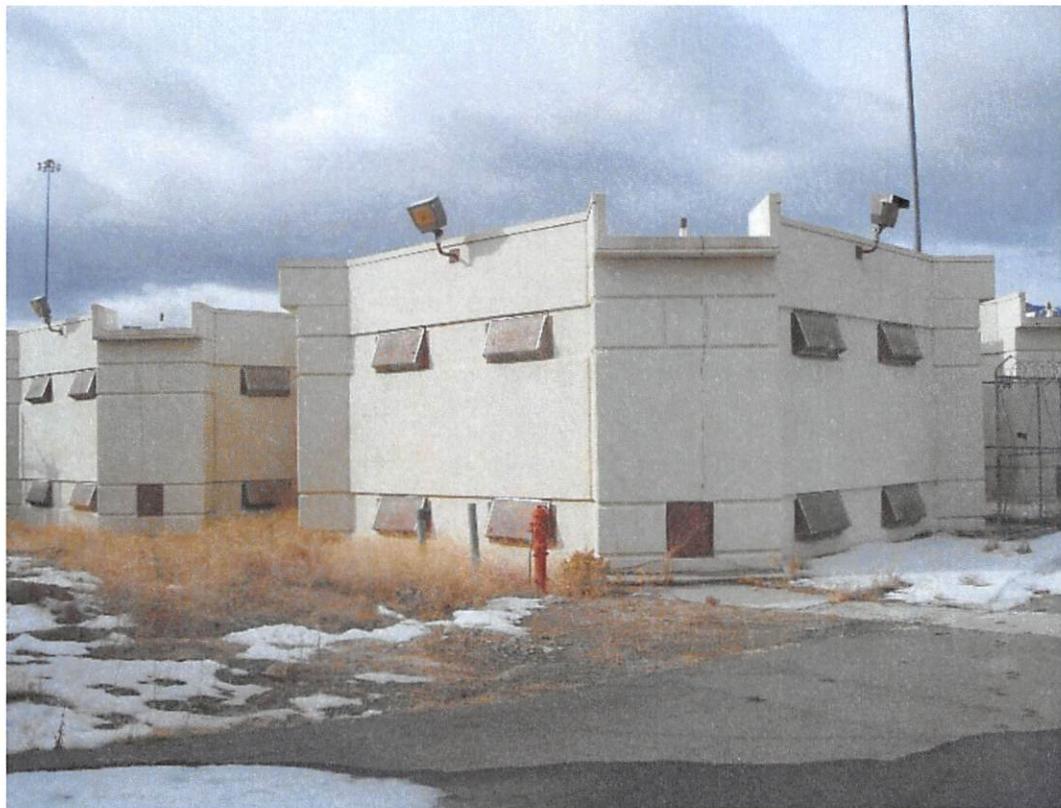
Units 6-7-8-9-10-11

- These housing units are known as the "Hill Units" and are painted precast concrete structures with single-ply membrane roofs
- Each contain 48 cells for 98 inmates, showers and a central control room all on two levels.
- The units are in fair shape.
- Each unit has 7,801 sf of space and were constructed in 1981.

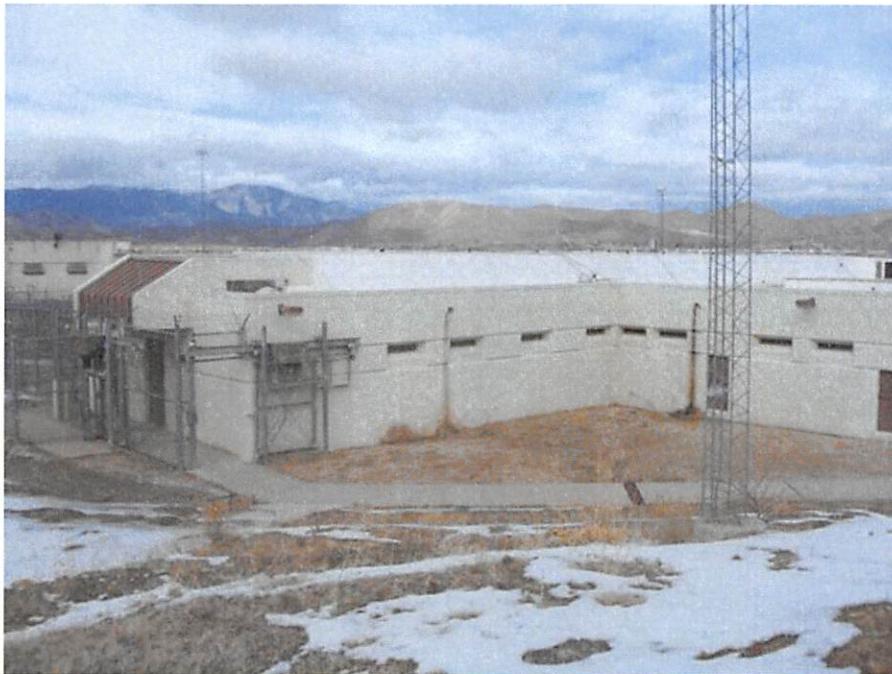
Housing Unit 12

- Housing Unit 12, also known as a "Hill Unit" is a painted precast concrete structure with a single-ply membrane roof.
- It contains 40 cells, showers, visitor's area, a public restroom, mechanical rooms and a central control room.
- The building is considered a "lock-down" unit.
- Each unit has 7,931 sf of space and were constructed in 1982.

- The building has fire sprinklers
- The fire alarm system is original to the building and is due for an upgrade if it were to be occupied.
- Again, this would depend on its new use.
- The interior finishes are in fair condition. It is recommended that the interior walls be painted at least once in the next four to six years.

- It has an HVAC system which provides heating and cooling which is original to the building.
- The HVAC system consists of a boiler, air handler and a condenser.
- It is original equipment and should be scheduled for replacement in the next two to four years to mitigate possible emergency funding due to failure.

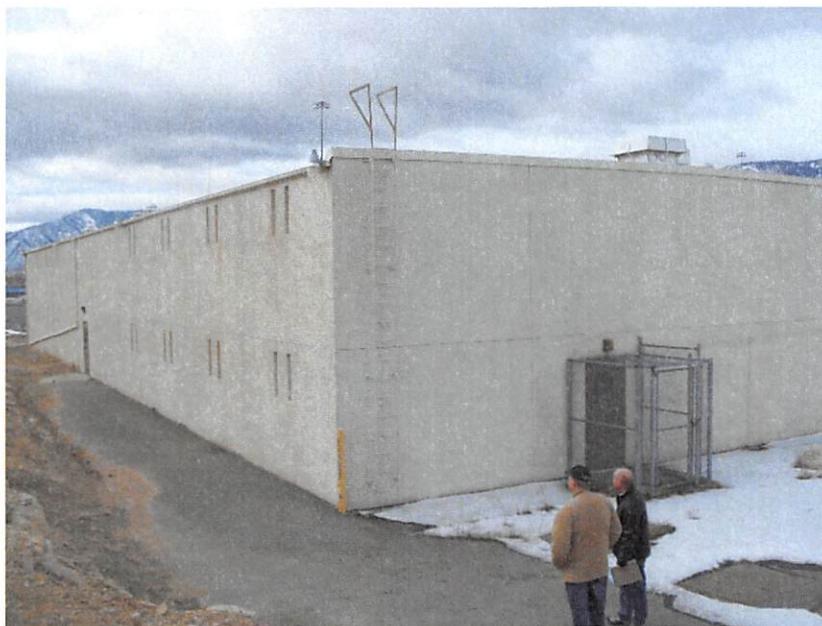
Housing Unit 13

- Housing Unit 13, also known as a "Hill Unit" is a precast concrete structure covered with painted stucco and a single-ply membrane roof.
- It contains cells, showers and a central control room all on two levels.
- This housing unit is a "lockdown" unit for the prison.
- The structure is in fair shape.
- The unit has 11,888 sf of space and was constructed in 1988.

- The interior finishes are in fair to poor condition.
- It is recommended that the interior walls be painted in the next two to four years.
- There are fire sprinklers in the unit.

- The building has roof mounted packaged HVAC systems which are original equipment and in need of replacement.

- It is important to maintain the finish, weather resistance and appearance of the building.
- It is recommended that the building be painted in the next 5-7 years

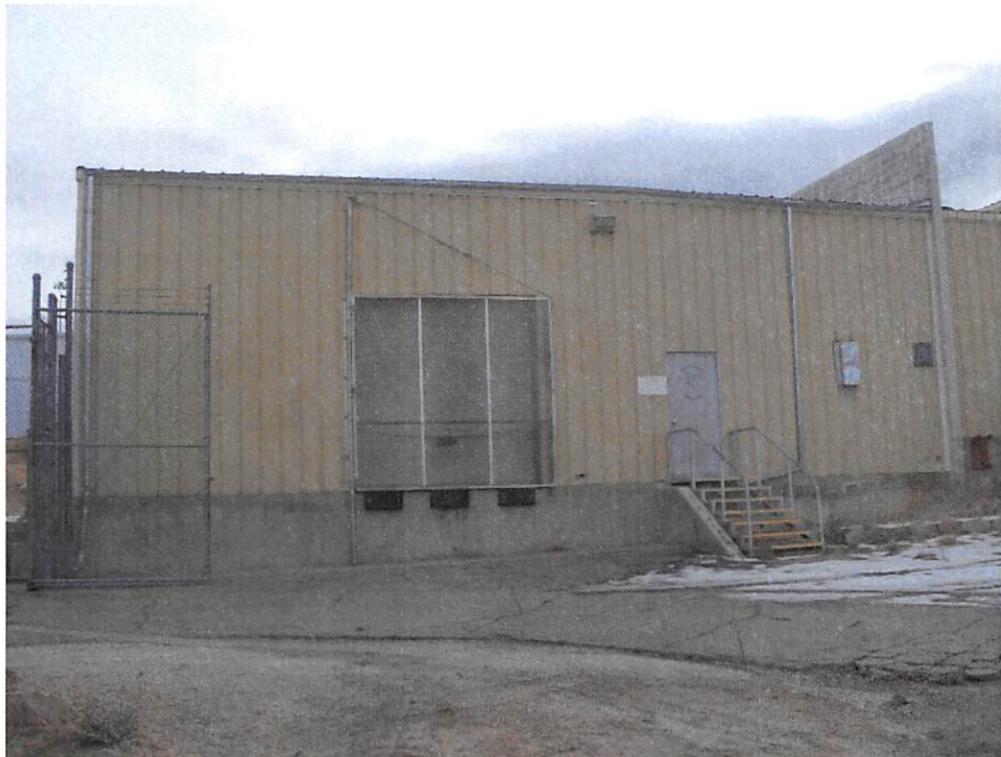
Bookbindary

- The Book Bindery is an engineered, insulated, structural steel building with metal siding and roof.
- There is a mezzanine used for storage and printing accessed by a metal stairway.
- It has 4,137 sf of space, and was constructed in 1976.

- The standing seam metal roof on this building was in poor condition at the time of the survey and had active leaks.
- It is recommended that this building be re-roofed in the next one to two years with a new single-ply roofing system to be installed over the existing metal roofing system.

- The interior finishes are in fair condition.
- It is recommended that the interior walls be painted at least once in the next two to four years.
- The exit signs in this building are older types or painted on the walls.
- Illuminated exit signs shall be marked per 2003 IBC Section 1011.1.
- Replacement would provide self-illuminating or LED models with internal battery backups along all of the required exit pathways.
- This building is equipped with an automatic fire detection and alarm system that no longer complies with current requirements.
- An upper level storage mezzanine has been constructed inside of the Bindery Building.

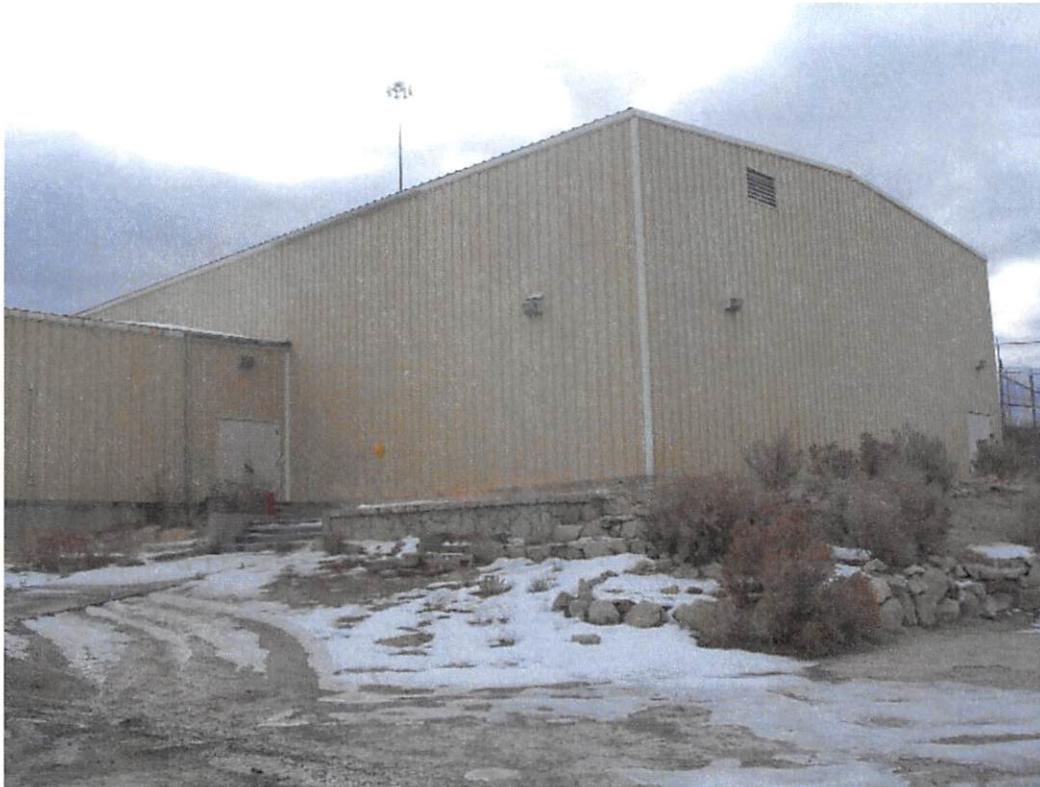
- The Gymnasium is an insulated engineered steel structure with metal siding and roof.
- The building was used to allow inmates to play basketball, table tennis and lift weights.
- It has restrooms with showers, a couple of offices and storage areas and a large activity area with a concrete floor.
- The building has 7,980 sf of space and was constructed in 1976.

- At the time of the 2009 survey, staff reported that there are leaks in the metal roofing system.
- The standing seam metal roof on this building was in poor condition at the time of the survey and had active leaks.
- It is recommended that the exterior of the building be repaired and painted in the next 5-7 years.

- The existing concrete exterior stairs at the entry are lacking handrails as required in the 2006 IBC Chapter 10, Section 1012.
- The interior finishes are in fair condition. It is recommended that the interior walls be painted at least once in the next two to four years.
- The flooring system in the weight and shower area needs to be resealed.
- A significant amount of foot traffic has gone through this building and is showing signs of wear from constant use and abuse.

- The exit signs in this building are older types or are missing.

- This building is equipped with an automatic fire detection and alarm system, but the system is old, does not meet current code requirements and is missing in some locations.
- This building does not have an automatic fire suppression system. It should be retrofitted with fire sprinklers during the next remodel or addition.
- This project would provide funding for the installation of fire sprinklers including backflow prevention devices.

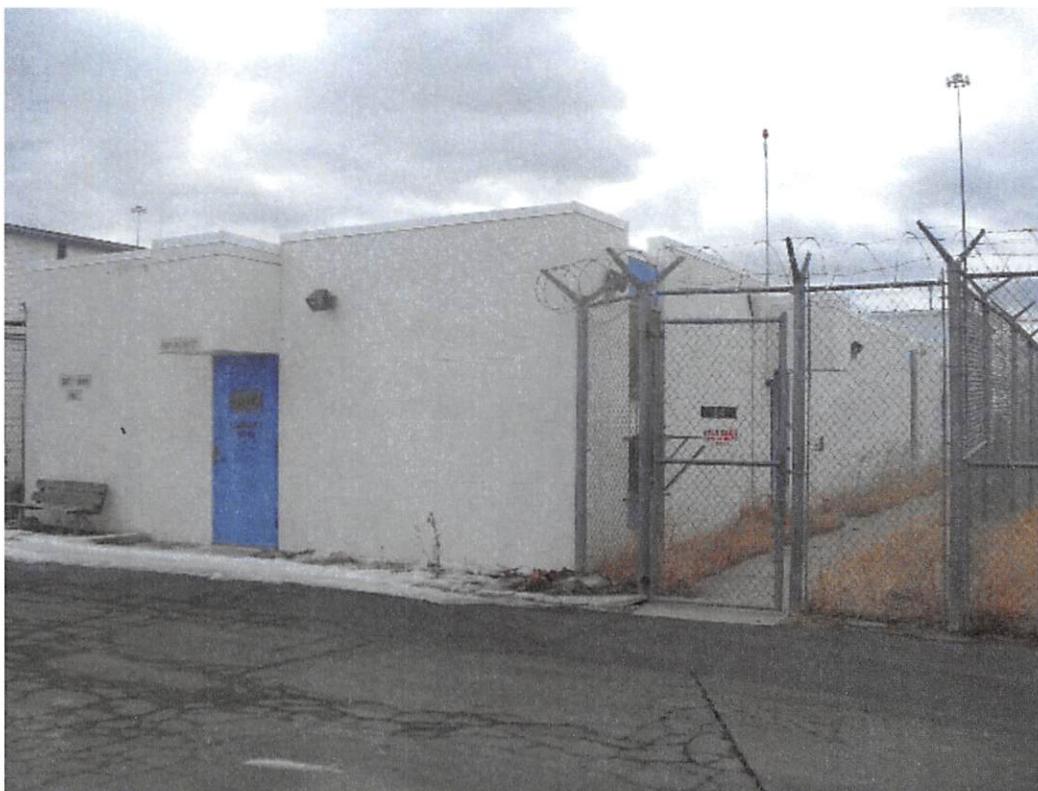
Chapel/6-Post

- The Chapel/Six Post is a concrete masonry unit (CMU) structure with a single-ply membrane roof and a concrete slab- on-grade foundation.
- The building contains the chapel, office area, restroom and Six Post.
- Gross Area (square feet): Year Constructed:
- It has 2,968 sf of space and was constructed in 1981.

- The interior finishes are in fair condition.
- The floor coverings in this building are in generally poor condition and have reached the end of their serviceable life.
- It was reported that in some areas of the buildings asbestos was present.
- The exit signs in this building are older types or painted on the walls. Illuminated exit signs shall be marked per 2006 IBC Section 1011.1.
- It is recommended that the interior walls be painted at least once in the next two to four years.

- The Chapel / Six Post currently has only ducted heat and evaporative cooling which is in need of replacement.

- It is recommended that the building be painted in the next 5-7 years

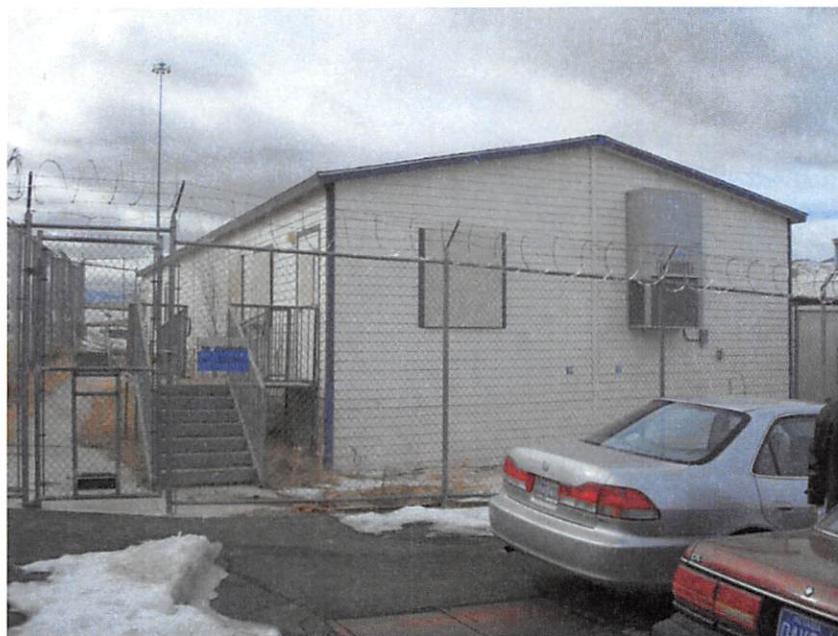
- The Modular Education Building is a manufactured or modular style structure with painted Masonite siding, asphalt composition roof on an 8 point foundation.
- The facility contains two large classroom areas and restrooms.
- The current occupancy or use is for educational purposes and is classified as a B occupancy per the 2003 IBC.
- Constructed in 2002, 1680 sf.

- The building is in good shape.
- It is recommended that the building be painted in the next 5-7 years

- The interior finishes are in fair condition.
- The emergency egress lighting is insufficient and the exit signs do not meet current standards.

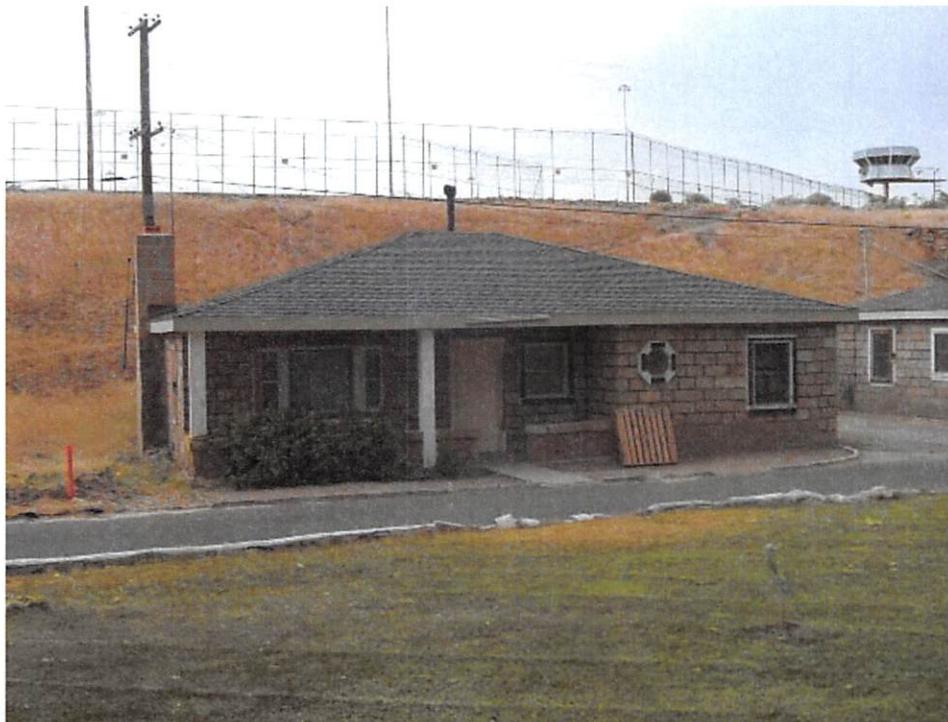
Cottage 1-6

- The cottages are located along the entrance road to Warm Springs Correctional Center east of NSP.
- They were constructed in 1957, using stone quarried from the prison.
- They were used to house prison staff until the mid-1970s.
- Since that time they have been variously used as storage and offices and female inmate housing.
- Cottage 1 is currently used for file storage by WSCC.
- They have 850 to 1,000 square feet of space and they were constructed in 1957.

- The interiors of the cottages are worn and configured as residences.
- The floor tiles contain asbestos and have reached the end of their useful life.
- When cabinets or files are moved around, asbestos fiber becomes air-borne, this is harmful to anyone inside the building. They might require some remodeling depending on the approved use.
- They require interior maintenance and painting.

- To continue the use of the structures it would be reasonable to replace the heater and evaporative cooler.

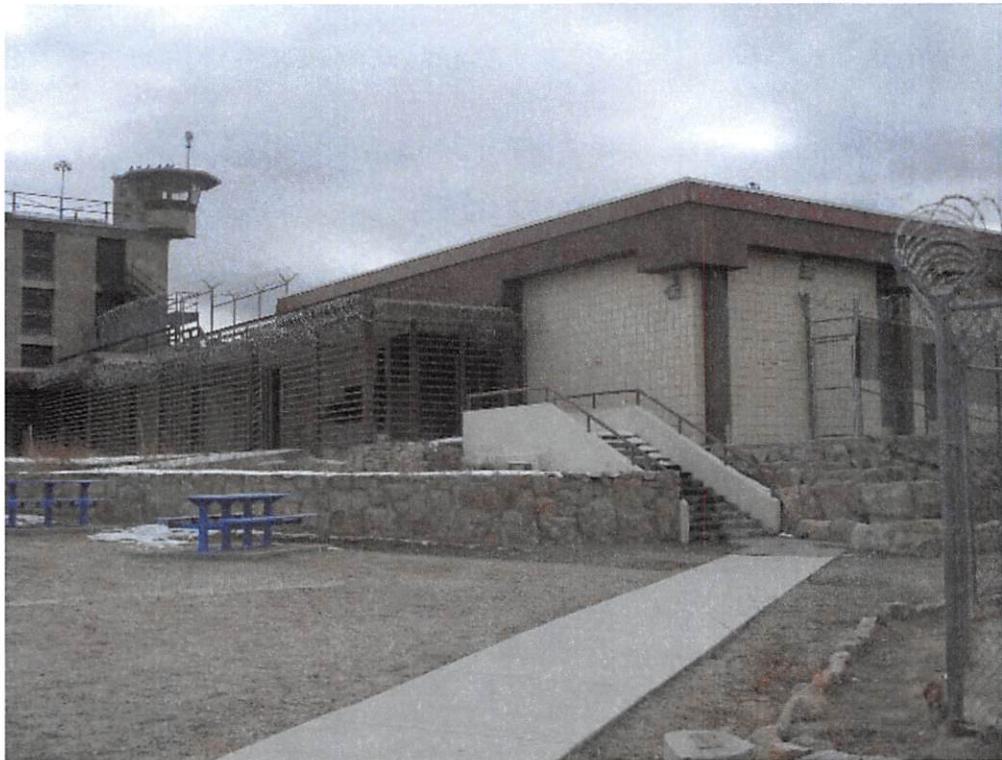
Culinary/Dining Hall

- The Culinary / Dining Hall is a concrete masonry unit structure with a single-ply membrane roof.
- The building contains the food preparation, storage and dining services for the prison.
- The Culinary encloses the South side of the old prison yard,
- Dining room is filled with substantial table/seat systems that are bolted to the floor, consistent with current correctional practice.
- It is guarded by two interior gun posts.
- Gross Area (square feet): Year Constructed:
- The Culinary has 11,334 sf of space and was constructed in 1966.

- The roof on this building was in fair condition at the time of the survey.
- The current roofing system was installed in 1999.
- It is recommended that this building be re-roofed in the next five years.
- The existing exterior doors to the Culinary / Dining Hall are original to the building.
- They are showing signs of wear and deterioration from constant use and inmate abuse.
- Security concern but not a problem for any new use.
- It is recommended that the building be painted in the next 2-3 years.

- The interior finishes are in fair condition.
- It is recommended that the interior walls be painted at least once in the next two to four years.

- The painted floor in the dining area needs to be repaired and resealed if it were to continue in daily, intense use.
- The painted concrete floor in the kitchen is worn and damaged.
- The dishwashing room is severely damaged and deteriorating from moisture and water overspray. The floor in the food preparation area is an epoxy flooring system, painted concrete in the dining room and concrete in the storage areas.
- The exit signs in this building are older types or painted on the walls. Illuminated exit signs shall be marked per 2006 IBC Section 1011.1

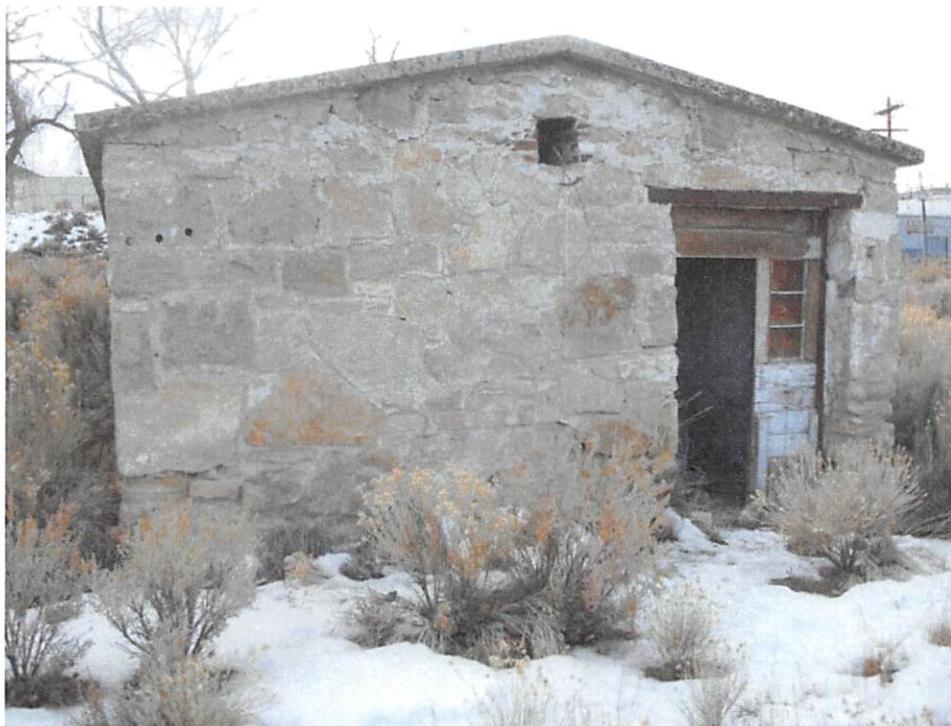
Old Butcher Shop

- The Old Butcher's Shop is a stone masonry structure with a concrete roof.
- It is located north of the main prison, outside the secure perimeter.
- It has 300 sf of space and was constructed in 1868.
- The Old Butchers Shop has code and safety issues including but not limited to rodent infestation, missing windows and doors, and possible structural deficiencies.
- Also, the building is located outside of the secure area of the prison and could be accessed by the public.

- A proposed use is not presented at this time. Recommend securing the structure and future historical interpretation.

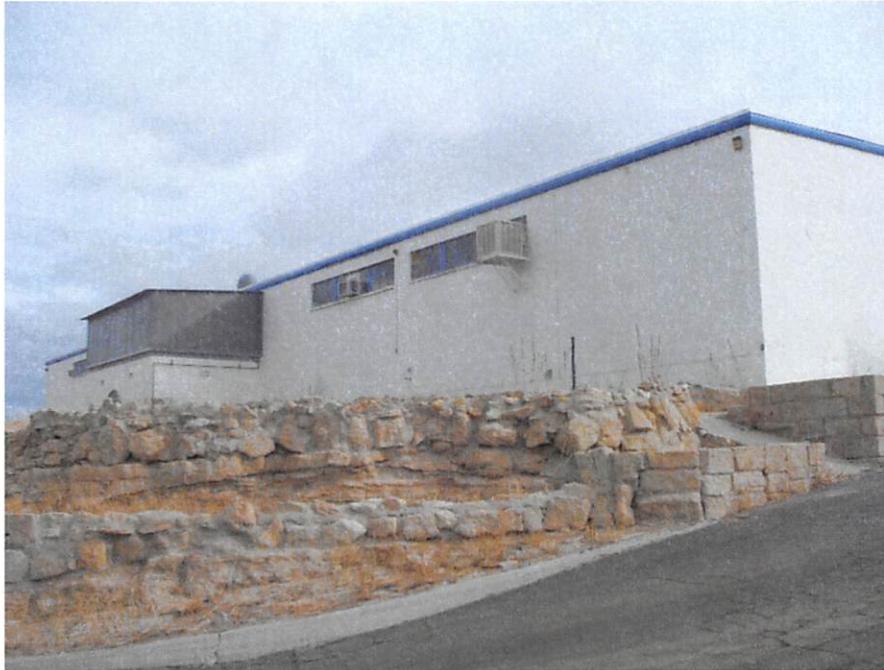
License Plate Factory

- The Industrial/License Plate Factory is a concrete masonry unit constructed building with a single-ply roof on a concrete slab-on-grade foundation.
- It has 7,462 sf of space and was constructed in 1959.
- This facility contains all of the equipment and materials used in the making of the State's license plates.
- Appropriations have been made for the construction of a new license plant at NNCC.
- Would make this substantial building available for multiple uses.

- The windows are single pane, open inward which protrudes into the isles and are original to the building.
- Some of the units have several cracks, seals are broken, are difficult to operate and they have reached the end of their useful life.

- The interior finishes are in fair condition.
- The exit signs in this building are older types or painted on the walls. Illuminated exit signs shall be marked per 2006 IBC Section 1011.1.

- This building is lacking a fire detection and alarm system.
- It is recommended that a fire detection and alarm system be installed depending on the identified use.

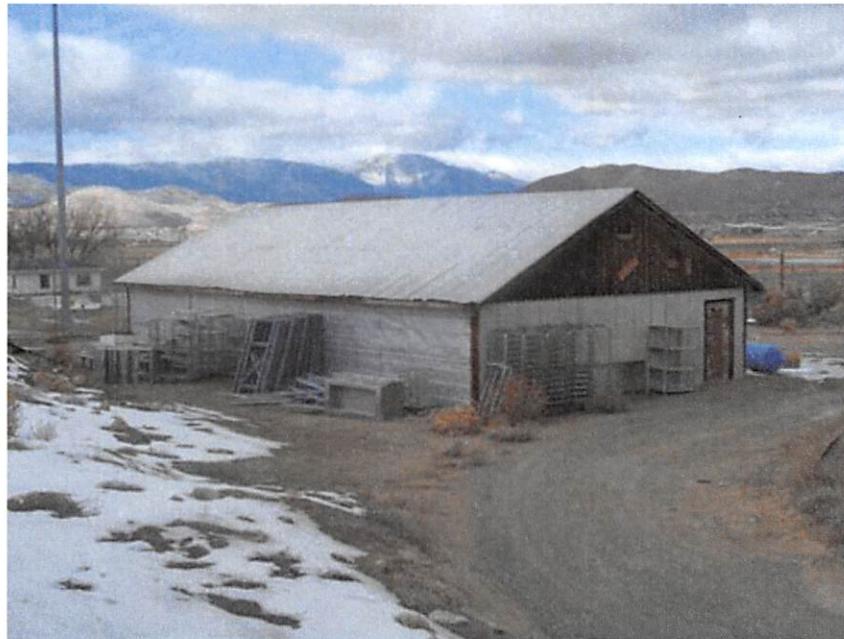
- The Maintenance Warehouse 2 is a wood framed structure with metal siding and roof.
- It is located on the north side of the prison outside the fence.
- This structure is no longer in use.
- 1,288 sf.
- Constructed in 1950.

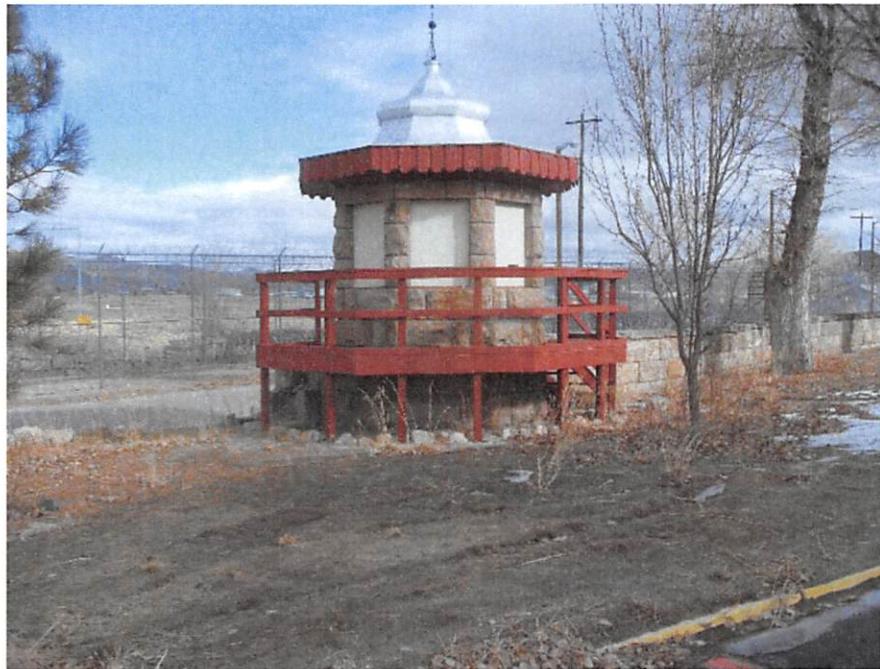
Old Fifth Street Tower

- The Old 5th Street Tower is a stone masonry building with a sloped roof.
- 100 sf
- Constructed in 1868, improved 1911-25
- There is a small copula on the top of the roof.
- The structure was formally a guard tower located along 5th street which was realigned years ago further north of the prison site.
- Examination of historic photos indicate that the structure was originally 2 stories tall.
- There is a wood walkway around the building accessed by wood stairs.

- The interior finishes are in fair to poor condition.

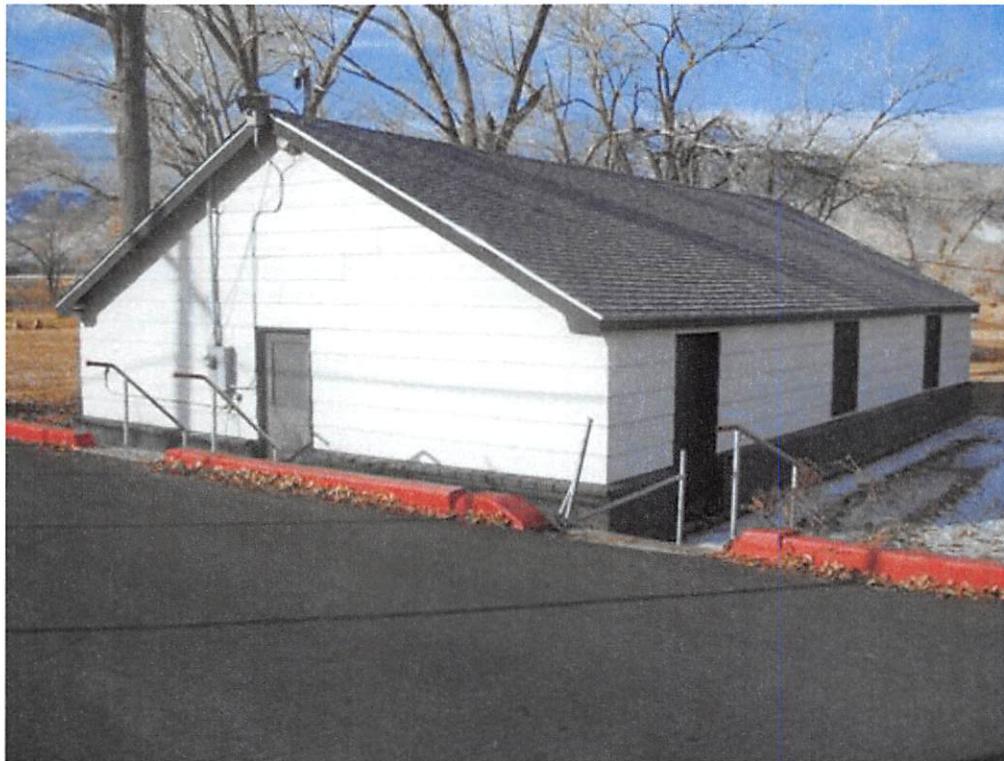
- The Property Warehouse 1 / Old Armory is a concrete masonry unit (CMU) and wood framed structure.
- The facility was formerly the warehouse and armory storage for the prison and is now abandoned.
- It was constructed in 1950, and has 1,800 sf of space.

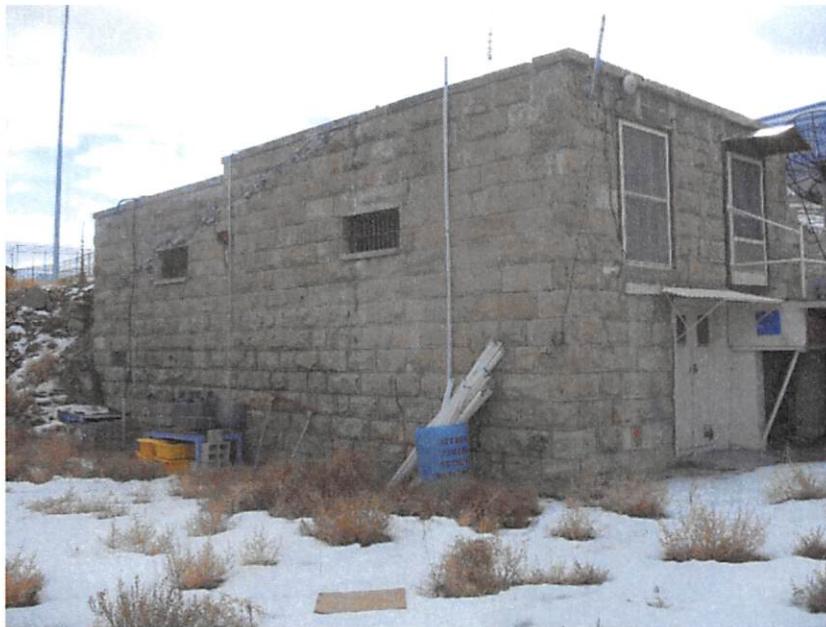
- The Old Electric Shop is a two level, uninsulated Sandstone masonry building with a cast in place concrete roof.
- It has 1,930 sf of space and was constructed in pre 1942.
- The building is currently used as the electrician's office, shop and storage.

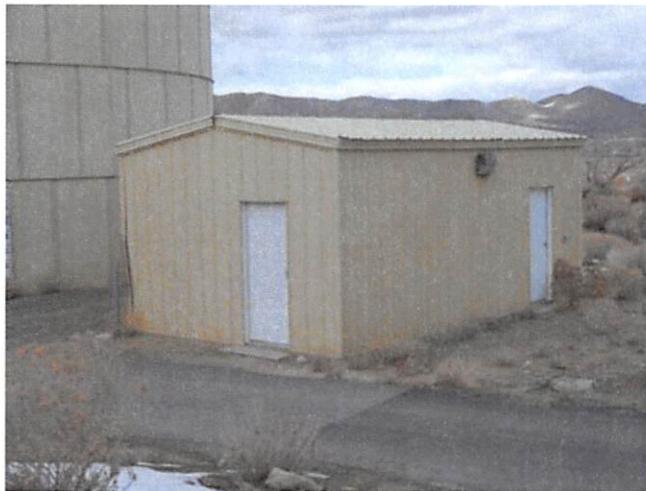
- The Pump House is an engineered metal building that contains the domestic water service and back flow prevention device.
- It is located next to the now abandoned water tank along the northeast side of the prison site, outside the fence.
- The prison is now on city water and the water pumping equipment has been removed.
- 380 sf, constructed in 1988.

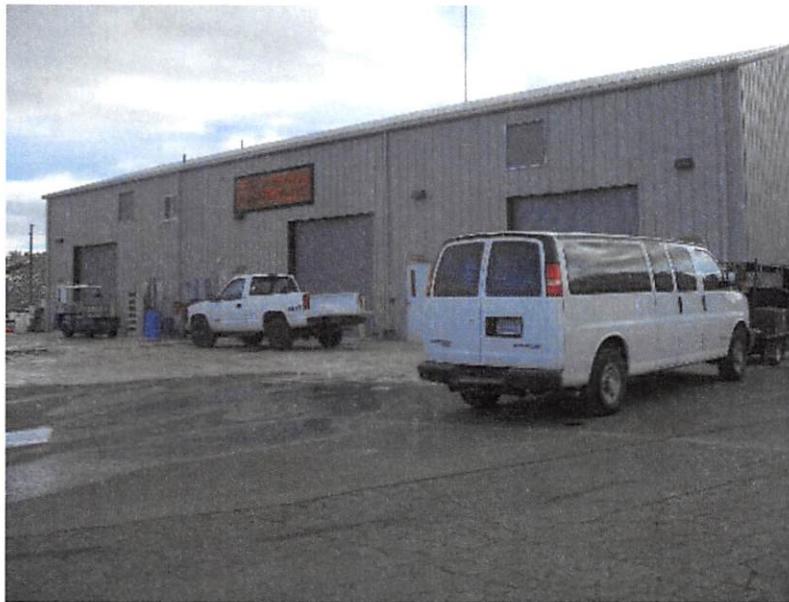
- The Maintenance Shop is an engineered steel building with metal siding and roof on a concrete slab-on-grade foundation.
- It is divided up into three bays, a Carpenter Shop, Plumbing / HVAC Shop and Auto shop.
- The Plumbing / HVAC Shop bay contains a mezzanine level with offices for maintenance staff.
- The building has 4,000 sf of space and was constructed in 2002.

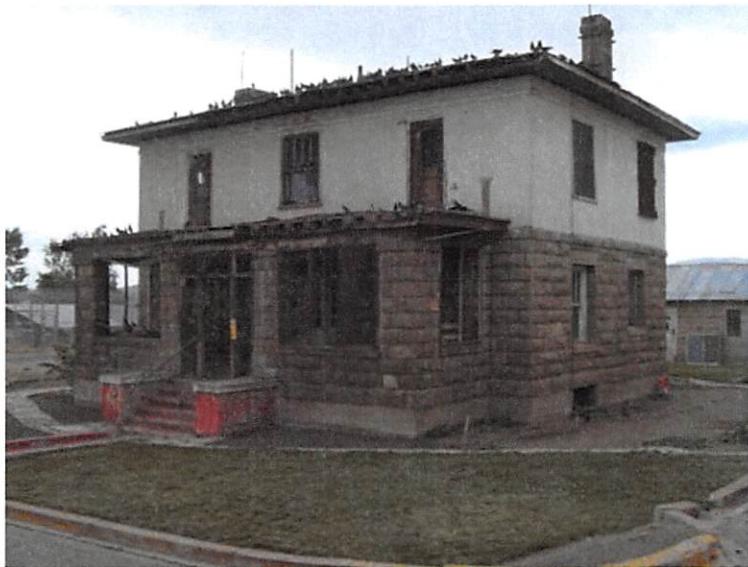
- The Old Warden's House is a stone masonry and wood framed structure with a wood shingle roof.
- It is located on the north side of the prison outside of the main prison yard.
- The house has 2,880 sf of space.
- The SPWB say that it was constructed in the 1920s.

- Pest control;
- Removal of accumulated waste;
- Windows and doors to be secured with louvers to permit ventilation of the structure.
- This house should eventually be restored because of its historic nature and correctional context.
- We believe that the structure should be maintained until that restoration can be financed and accomplished and integrated into the proposed museum.

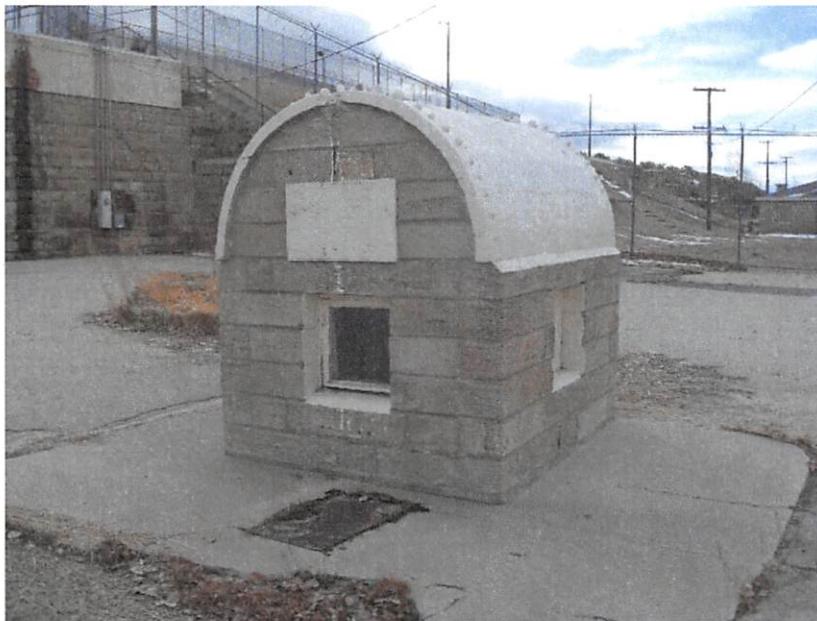
- The Old Pump House is an old sandstone masonry building with an arched concrete roof.
- It used to serve as the pump house for the prison's old water system and is no longer in use.
- 64 sf of space and is one of the oldest, if not the oldest structure on the site.
