Geotechnical Investigation

## Single Family Townhomes -

004-021-13

Carson City, Nevada

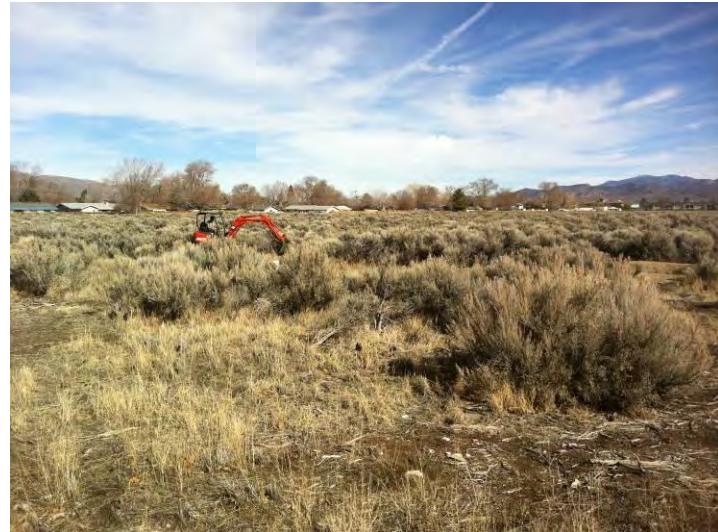
Site Conditions

The project site consists of undeveloped land crisscrossed by several undeveloped roads (dirt tracks). Along the western border of the site is a raised roadbed constructed with an estimated 2 to 3 feet of fill.

The existing dirt tracks exhibit large depressions and promote ponding of water, such that most were impassable during site exploration. Bicycle (BMX style) riders and dirt bike riders have constructed several jump tracks throughout the area and use the area extensively for recreation.

The site has also been subject to uncontrolled dumping. Minor piles of landscaping and concrete debris are present in addition to other piles of garbage that include mattresses and televisions. Much of this material is located adjacent to the perimeter paths on the western and northern sides of the parcel. This trash and debris material is estimated to be less than 50 cubic yards.

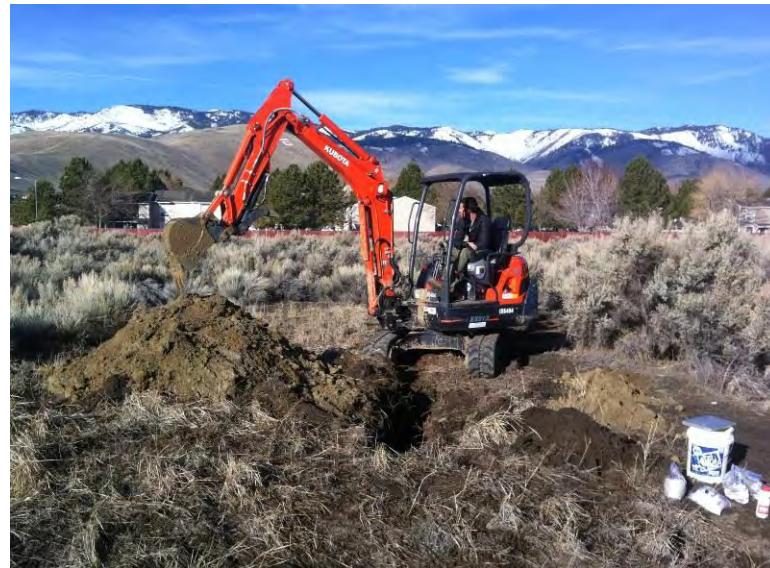
Test Pit Exploration

The proposed townhome site was explored on February 15, 2016, by excavating 11 test pits using a rubber-tracked Kubota® KX 91-3 mini-excavator. Locations of the test pits are shown on Plate 1. The maximum depth of exploration was 10 feet below the existing ground surface. Bulk samples for index testing were collected from the trench wall sides at specific depths in each soil horizon. Pocket penetrometer testing was performed in exposed, fine-grained soil strata to assess in-place, unconfined compressive strength for evaluating trench stability. The depth to groundwater was measured at the time of exploration. The test pits were backfilled immediately after exploration. Backfill was loosely placed and the area re-graded to the extent possible with equipment on hand.

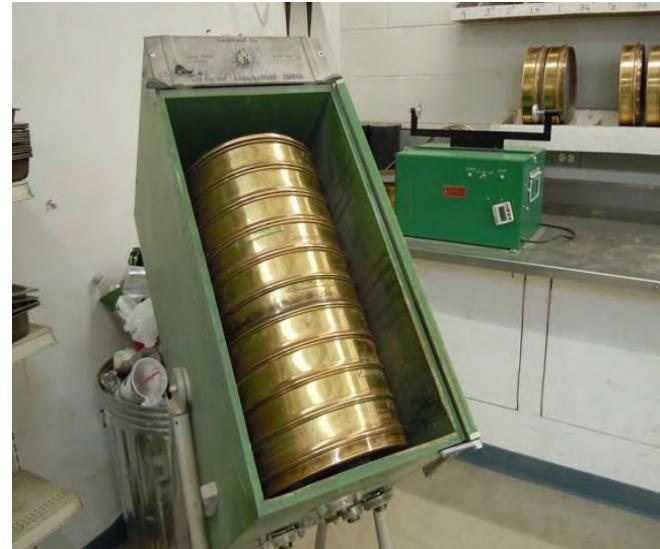
Grain Size Analysis

Samples of each significant soil type were analyzed to determine their in-situ moisture content (ASTM D 2216), grain size distribution (ASTM D 422), and plasticity index (ASTM D 4318). The results of these tests are shown on Plate 4 (Index Test Results). Test results were used to classify the soils according to ASTM D 2487 and to verify field logs, which were then updated as appropriate. Classification in this manner provides an indication of the soil's mechanical properties and can be correlated with published charts (Bowles, 1996; Naval Facilities Engineering Command [NAVFAC], 1986a and b) to evaluate bearing capacity, lateral earth pressures, and settlement potential.

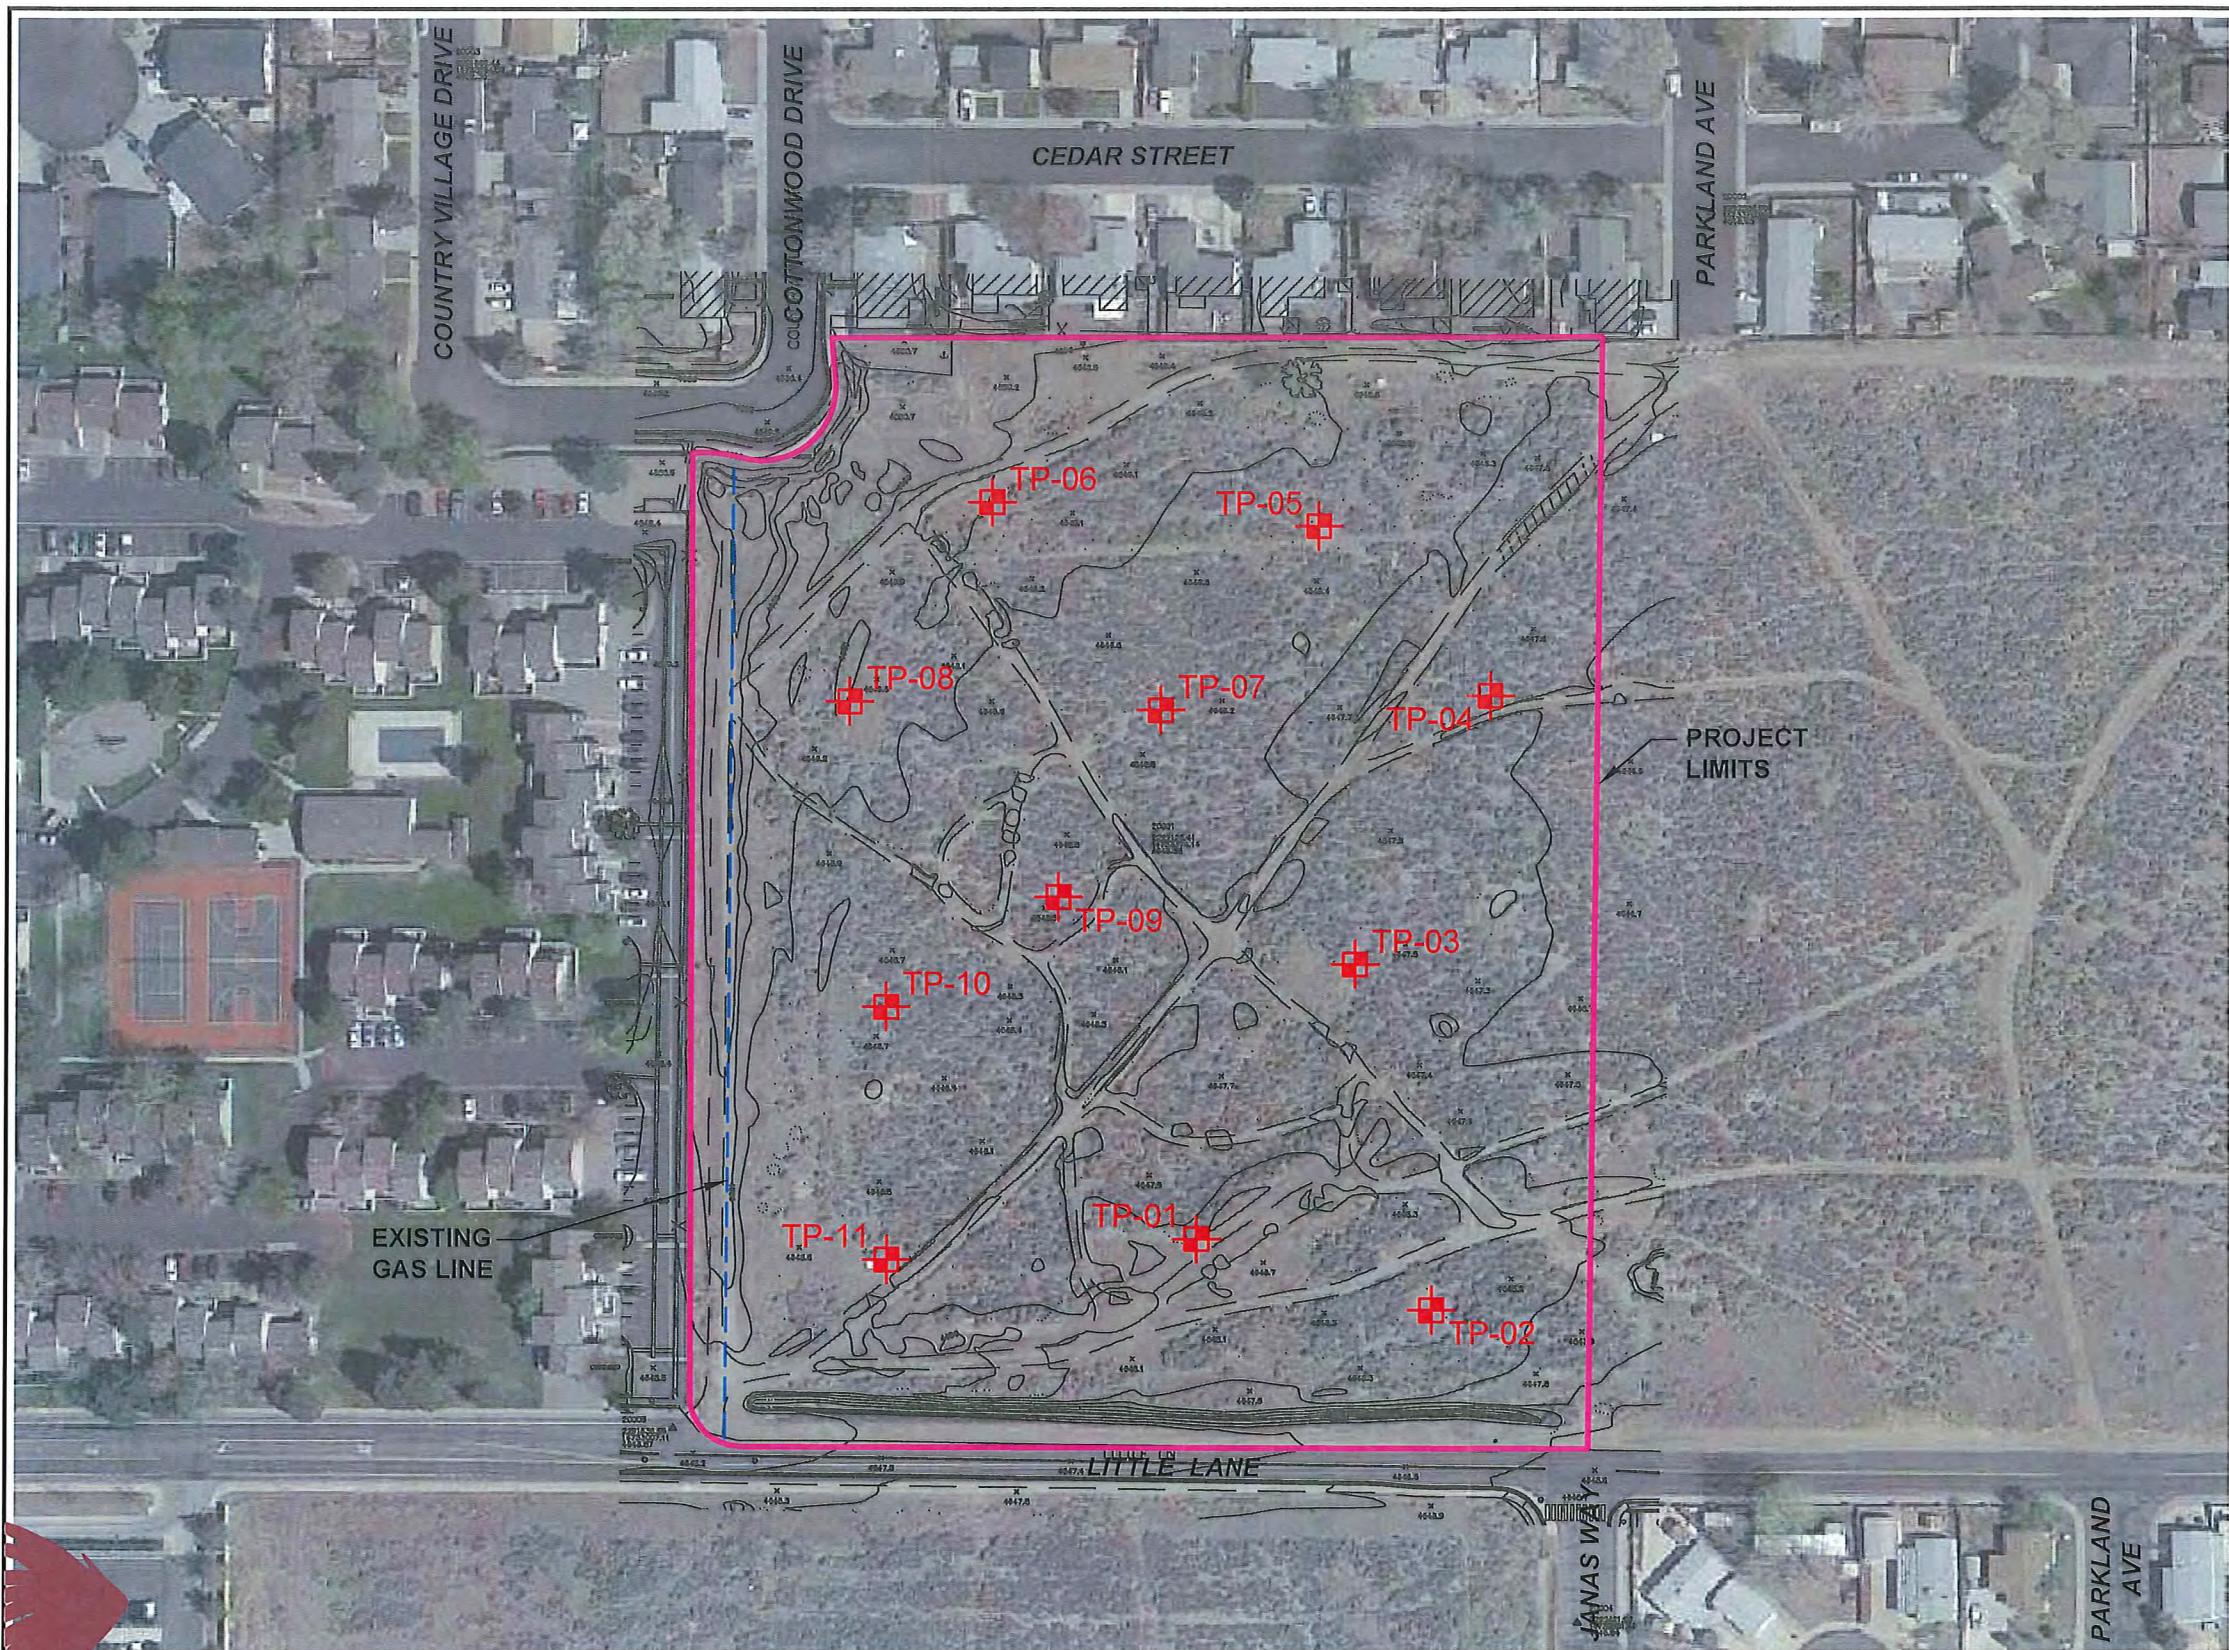
SCALE: 1"=120'  
(APPROXIMATE)

The area covered by this report is shown on Plate 1 (Plot Plan). Our investigation included field exploration, laboratory testing, and engineering analysis to determine the physical and mechanical properties of the various on-site materials. Results of our field exploration and testing programs are included in this report and form the basis for all conclusions and recommendations.

This report has been prepared in accordance with generally accepted geotechnical practices. The analyses and recommendations submitted are based on field exploration performed at the locations shown on Plate 1. This report does not reflect soils variations that may become evident during the construction period, at which time re-evaluation of the recommendations may be necessary. We recommend our firm be retained to perform construction observation in all phases of the project related to geotechnical factors to ensure compliance with our recommendations.

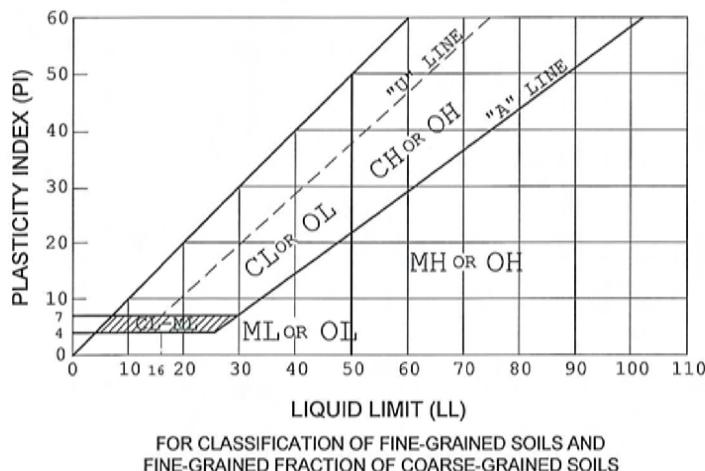
## PLASTICITY CHART

NOTE: DUAL SYMBOLS ARE USED TO INDICATE BORDERLINE SOIL CLASSIFICATIONS.

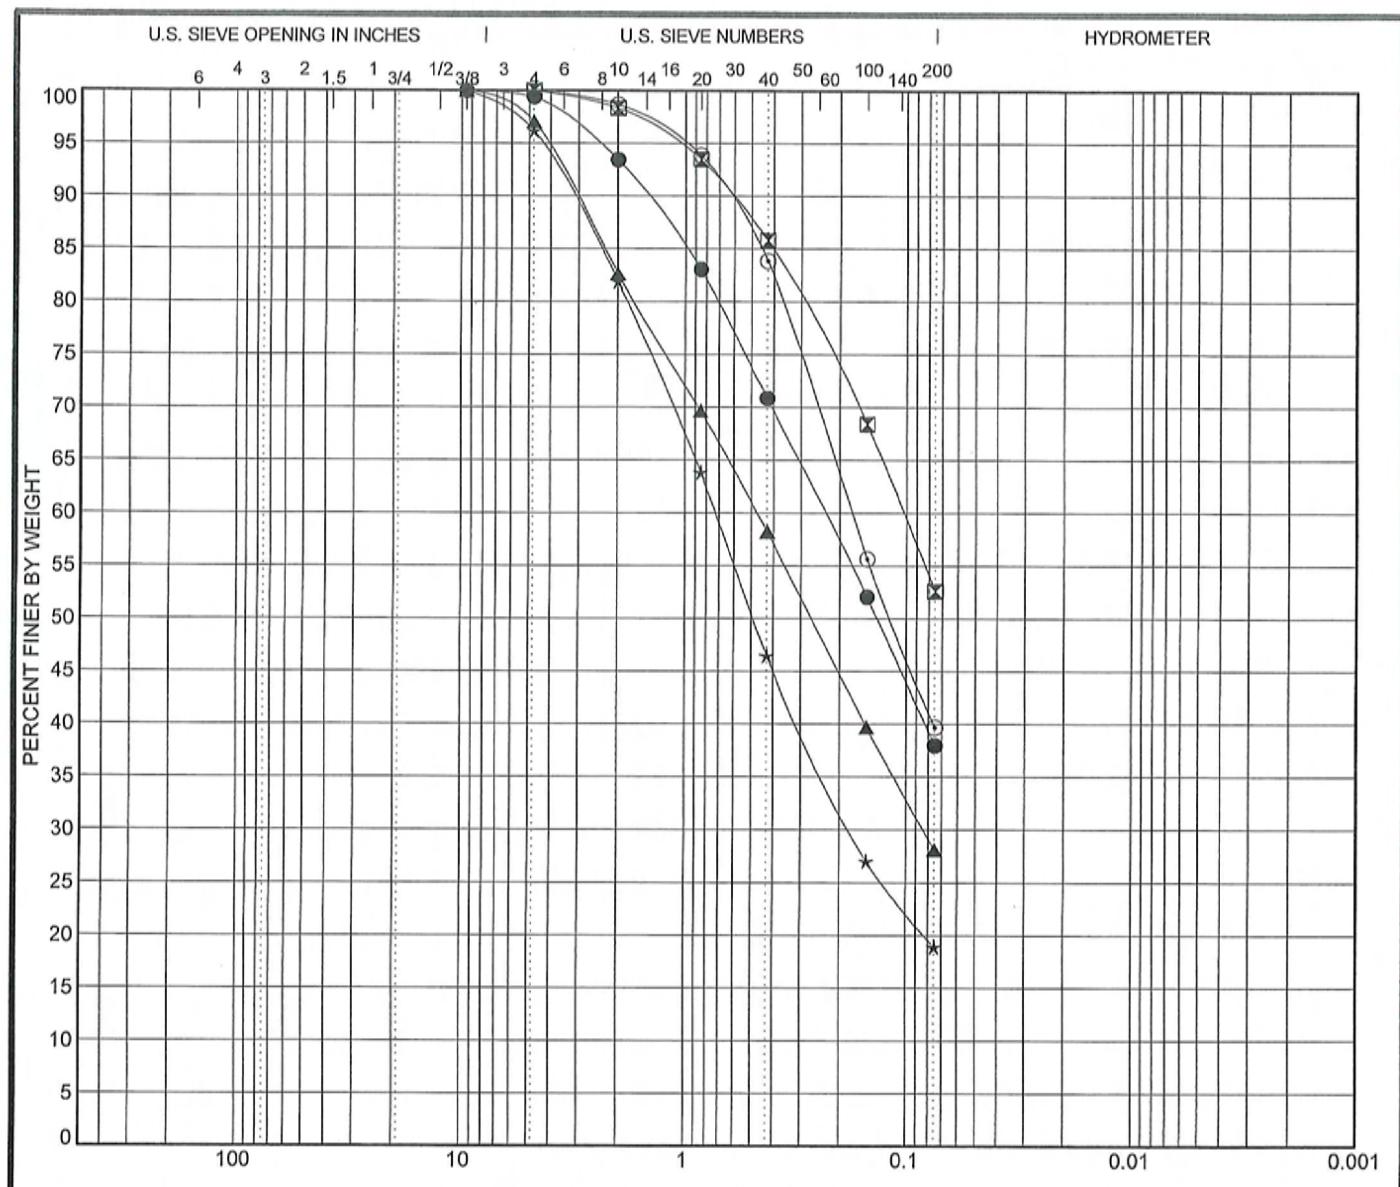
GRAIN SIZE DISTRIBUTION				
Project: Single Family Townhomes APN 004-021-13				
Location: Carson City, NV				
Project Number: 1487-05-1				Plate: 4a

COBBLES	GRAVEL		SAND			SILT OR CLAY		
	coarse	fine	coarse	medium	fine

Specimen Identification	USCS Classification						LL	PL	PI	Cc	Cu
● TP-01 3.0'	CLAYEY SAND (SC)						32	22	10		
☒ TP-02 0.0'	SANDY SILT (ML)						NP	NP	NP		
▲ TP-04 1.5'	CLAYEY SAND (SC)						30	18	12		
★ TP-05 2.0'	SILTY, CLAYEY SAND (SC-SM)						26	20	6		
○ TP-06 0.0'	CLAYEY SAND (SC)						27	18	9

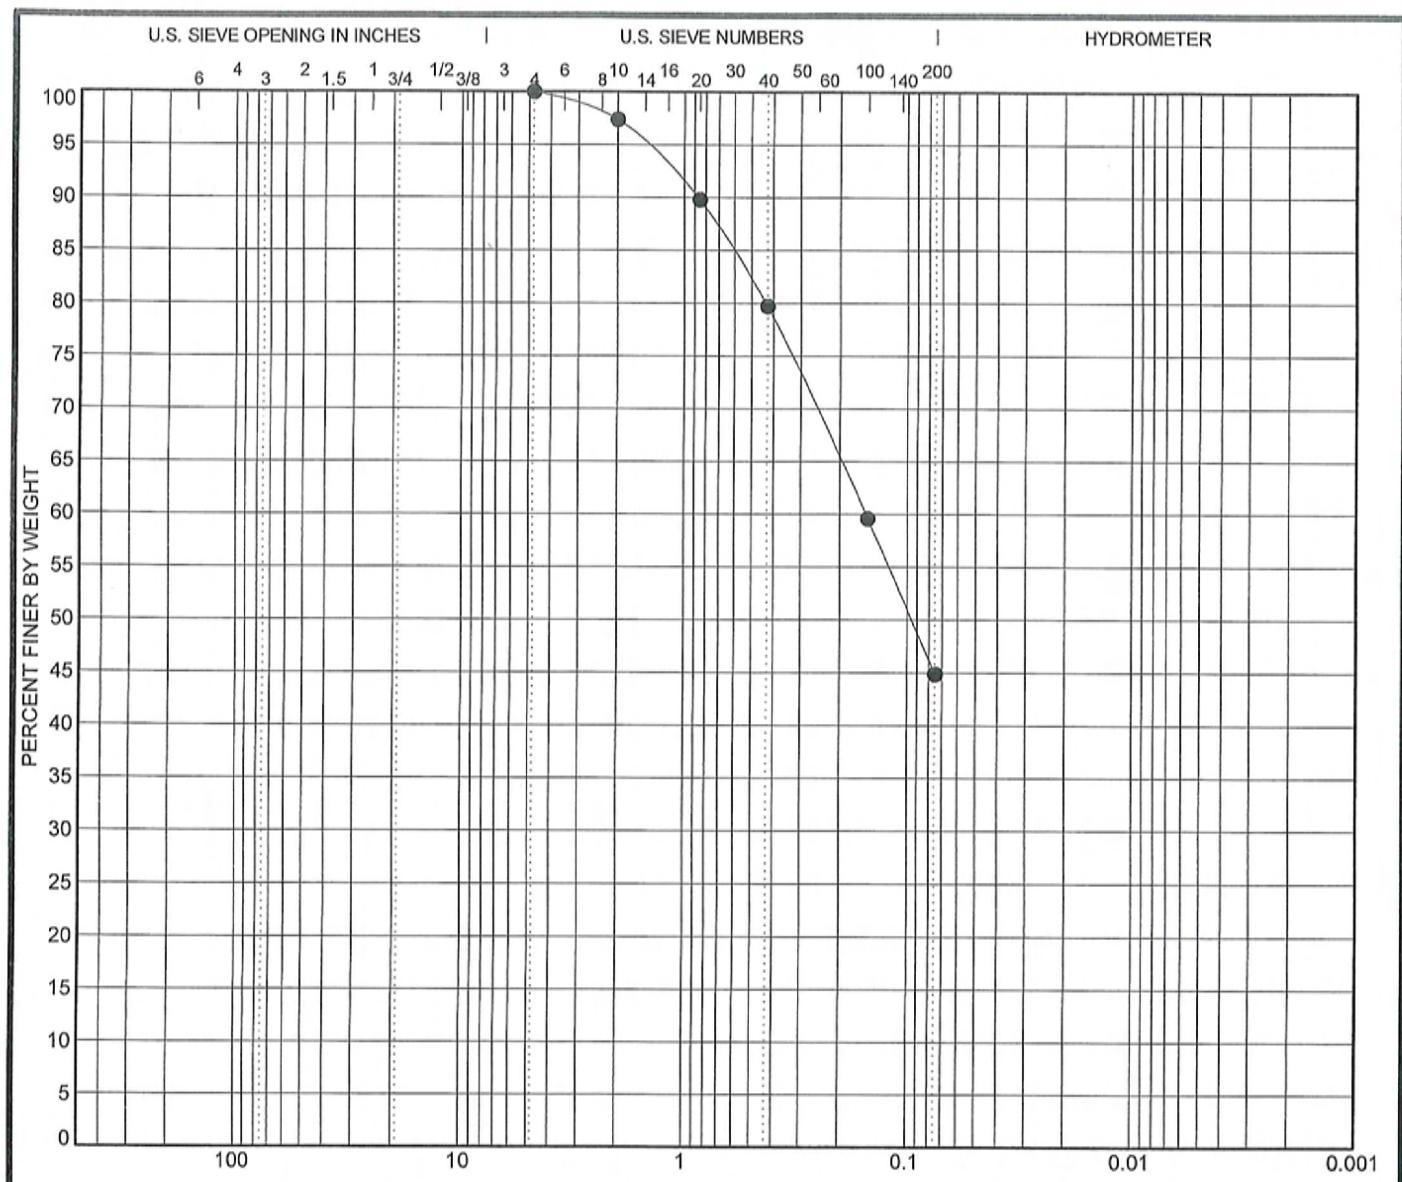
<p>Black Eagle Consulting, Inc. 1345 Capital Blvd., Suite A Reno, Nevada 89502-7140 Telephone: (775) 359-6600 Fax: (775) 359-7766</p>	GRAIN SIZE DISTRIBUTION											
	Project: Single Family Townhomes APN 004-021-13	Location: Carson City, NV	Project Number: 1487-05-1	Plate: 4b

COBBLES	GRAVEL		SAND			SILT OR CLAY		
	coarse	fine	coarse	medium	fine

Specimen Identification	USCS Classification							LL	PL	PI	Cc	Cu
● TP-10 1.0'	CLAYEY SAND (SC)							30	18	12		
Specimen Identification	D100	D60	D30	D10	MC %	%Gravel	%Sand	%Silt	%Clay			
● TP-10 1.0'	4.75	0.153			15.9	0.0	55.1		44.9
