Historic Resource Commission of September 13, 2018

SUBJECT: **HRC-18-114** – To consider potential modifications to Section 5.16 of the Development Standards regarding guidelines for windows in the Historic District.

Building Exterior **Windows**

THE SECRETARY
OF THE INTERIOR'S
**STANDARDS FOR
THE TREATMENT
OF HISTORIC
PROPERTIES**

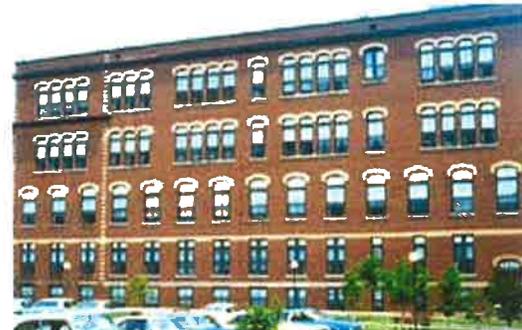
Distinctive window design on 19th century building.

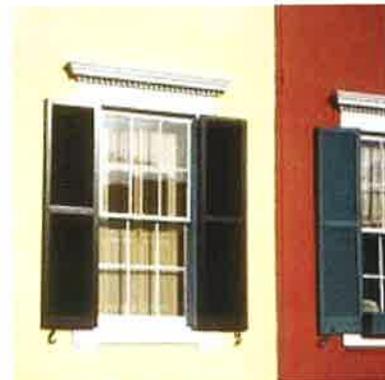
Delicate muntins and multi-pane sash on early 19th c. row houses.

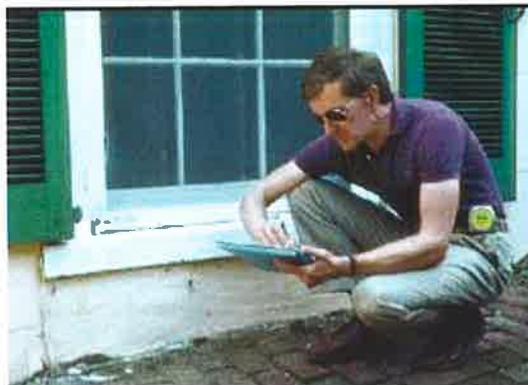
Window condition assessment preceding repair work.

Conducting an indepth survey of the conditions of existing windows early in rehabilitation planning so that repair and upgrading methods and possible replacement options can be fully explored.

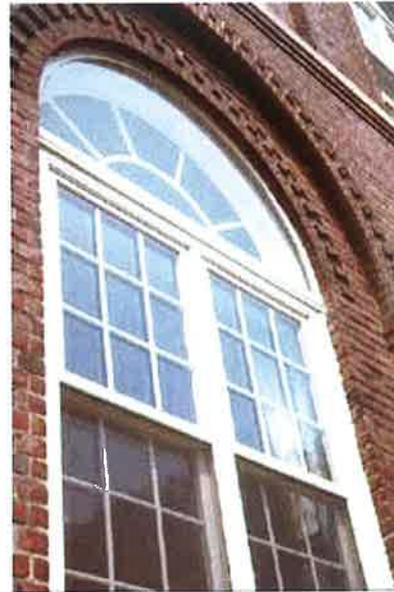
Newly painted double-hung wood windows.

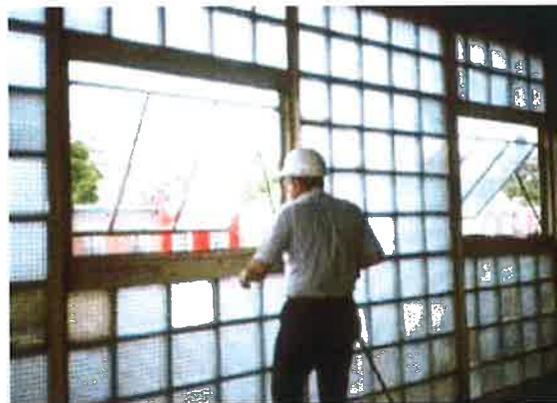
Preparing historic steel windows for repairs and re-finishing.

Repairing window frames and sash by patching, splicing, consolidating or otherwise reinforcing.

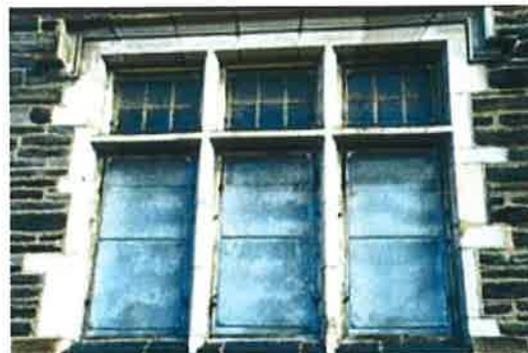
Deteriorated lower window sash shown prior to its replacement in kind.

Replacing in kind an entire window that is too deteriorated to repair using the same sash and pane configuration and other design details. If using the same kind of material is not technically or economically feasible when replacing windows deteriorated beyond repair, then a compatible substitute material may be considered.

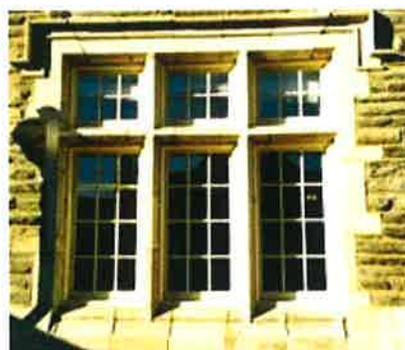
Lower window sash replaced, based on physical documentation.

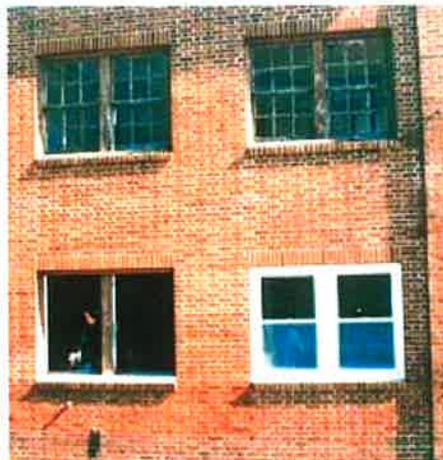
Incompatible new window (lower right), resulting in loss of the building's historic character.

Installing new windows, including frames, sash, and muntin configuration that are incompatible with the building's historic appearance or obscure, damage, or destroy character-defining features.

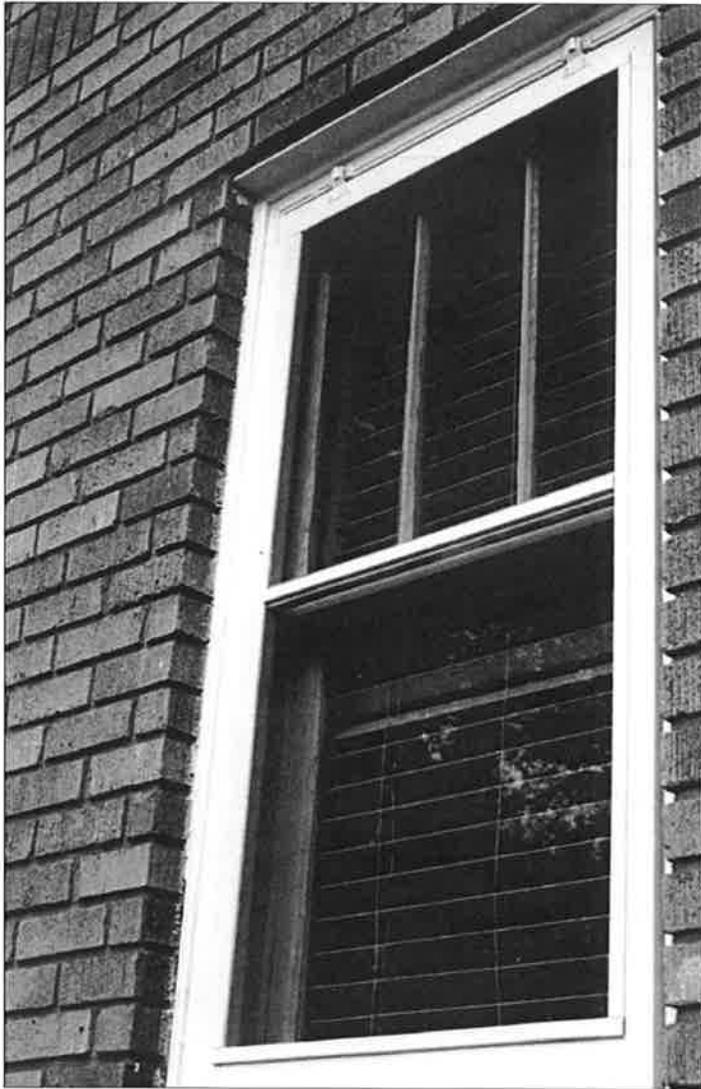
[10] Historic exterior storm windows preserve and help to insulate wood windows.

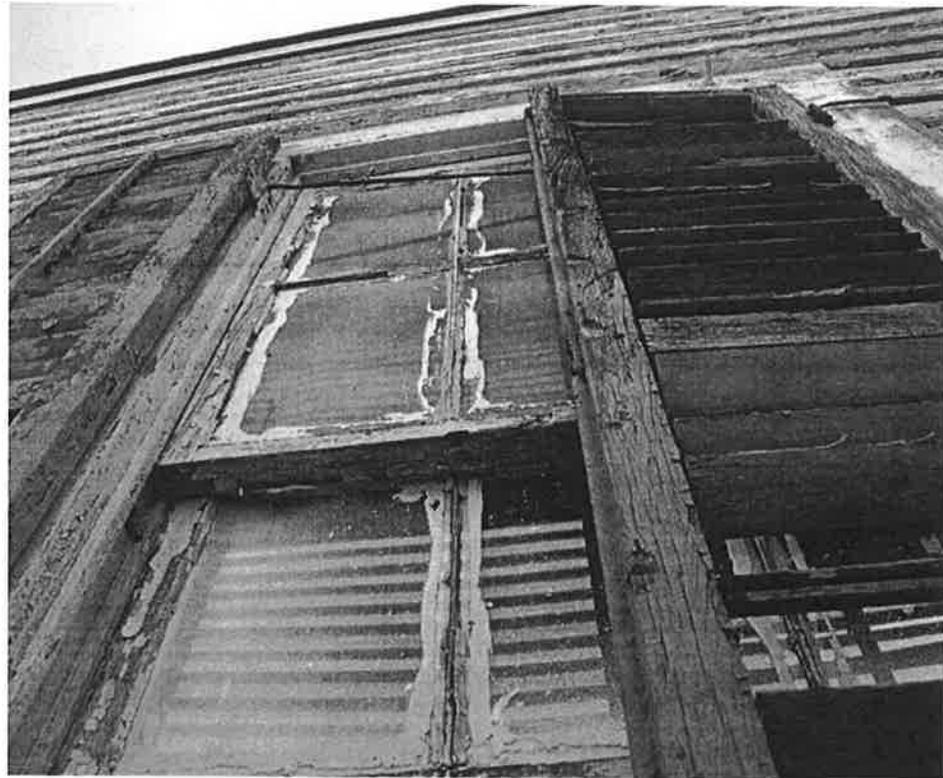
[11] Old and brittle glazing putty should be removed carefully before reputtying to keep window glazing weathertight.

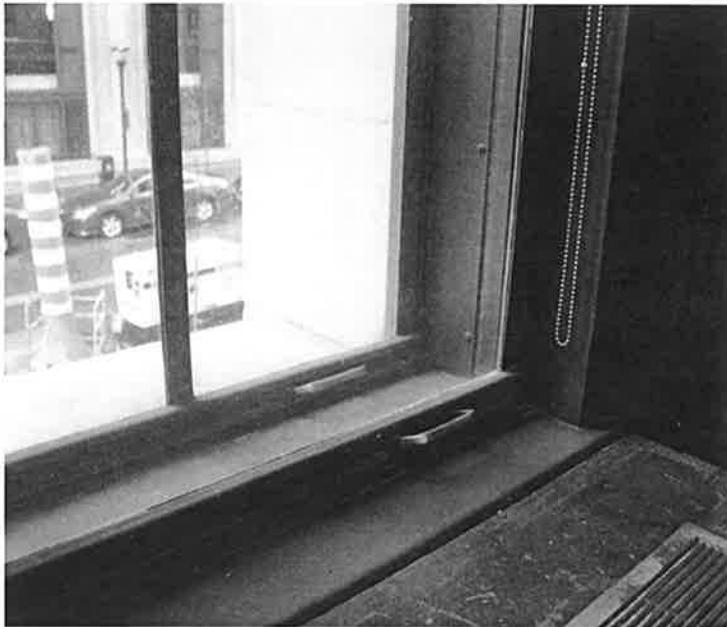
[18] The historic metal storm windows in this 1920s office building were retained and repaired during the rehabilitation project.

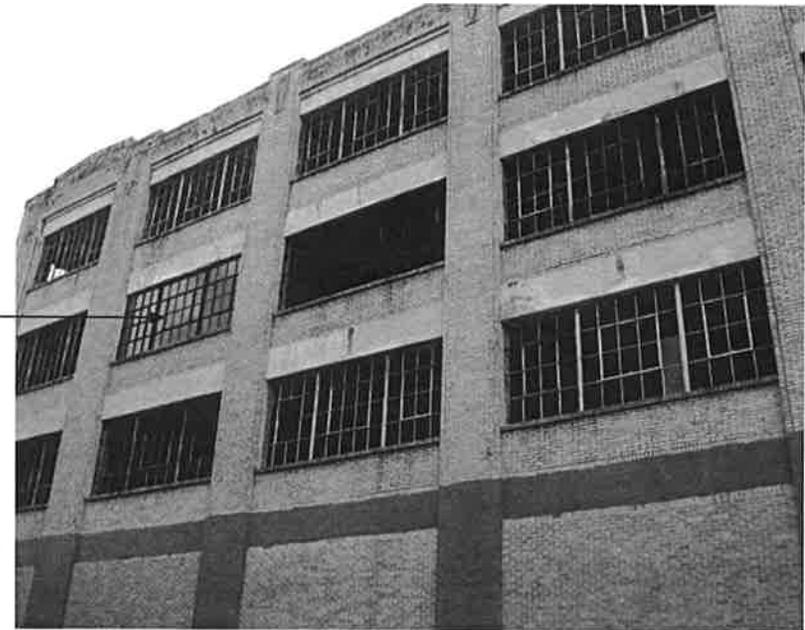
[19] Installing a mockup of a proposed replacement window can be helpful to evaluate how well the new windows will match the historic windows that are missing or too deteriorated to repair.

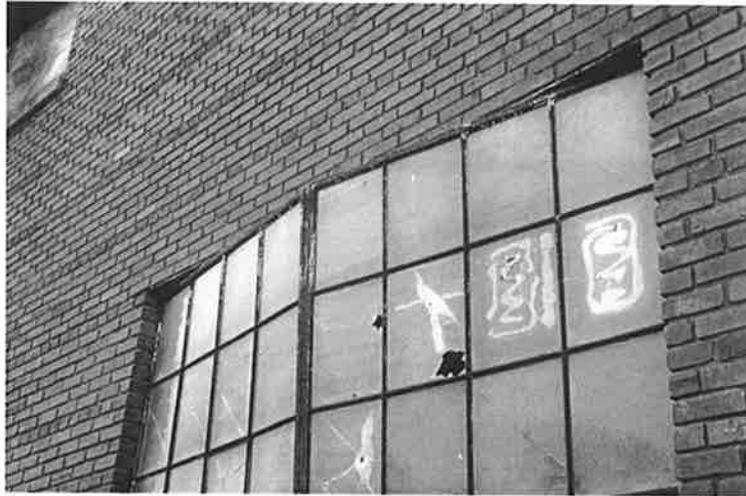
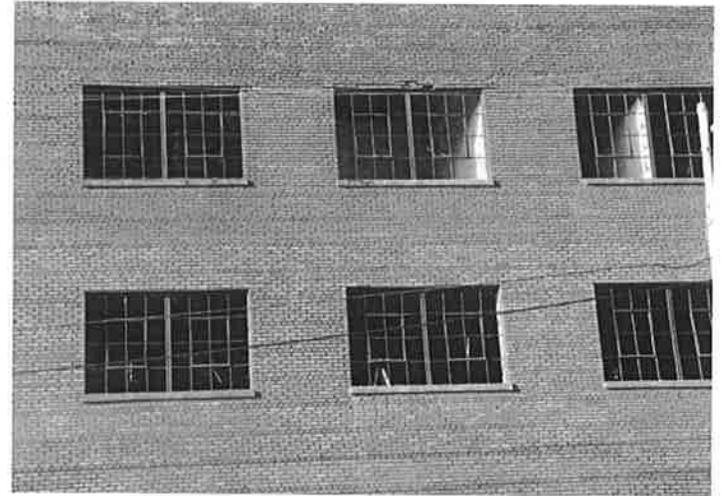
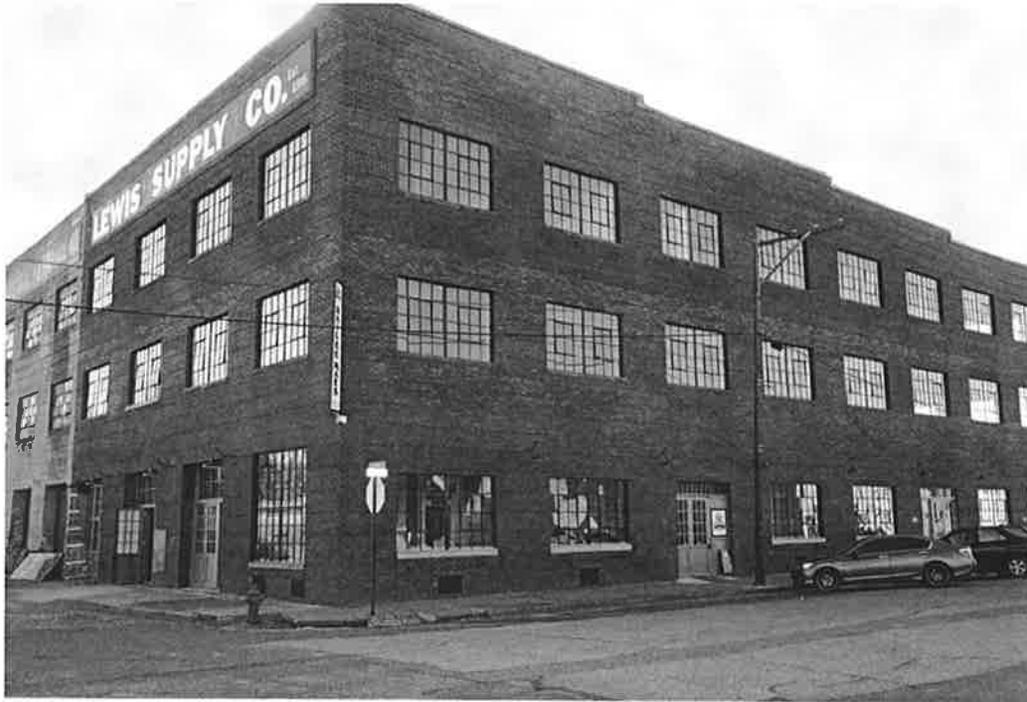
[20 a-d] The original steel windows in this industrial building were successfully repaired as part of the rehabilitation project (left).

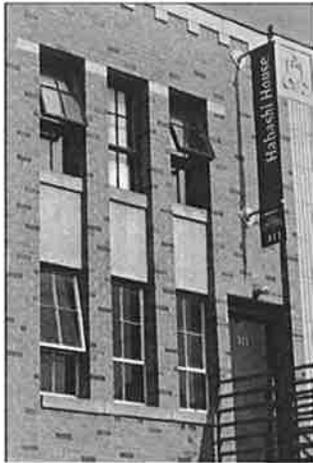
[21] The windows on the lower floor, which were too deteriorated to repair, were replaced with new steel windows matching the upper-floor historic windows that were retained.

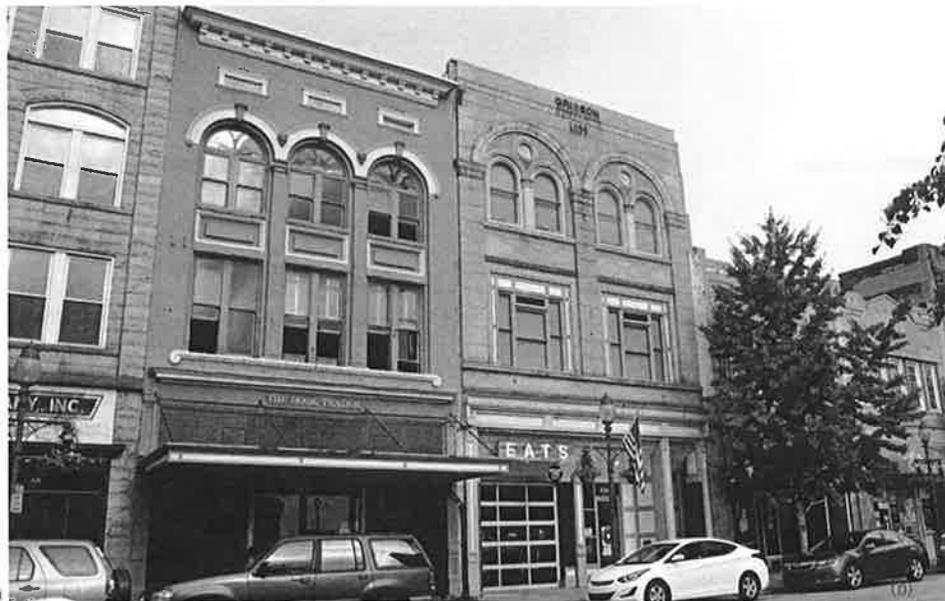
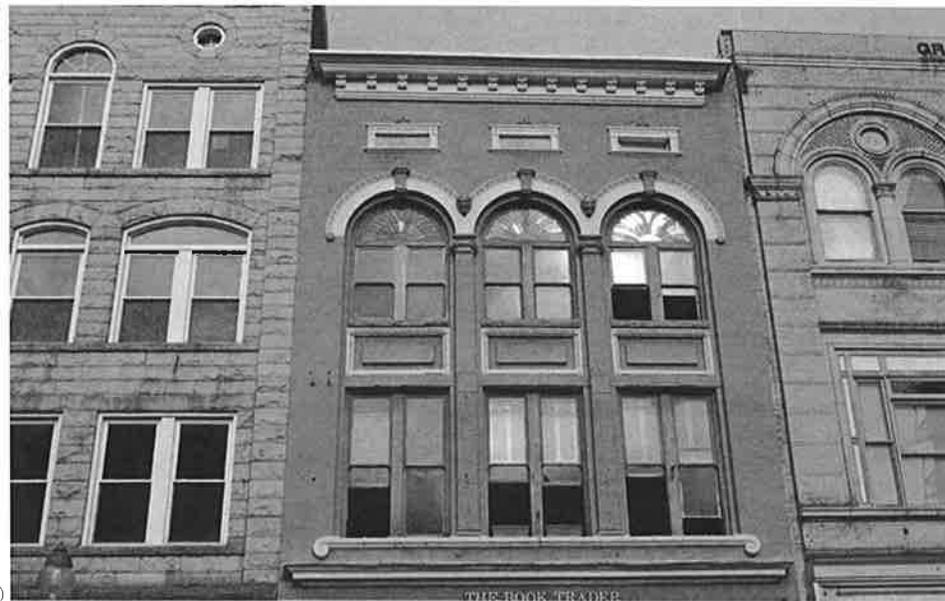
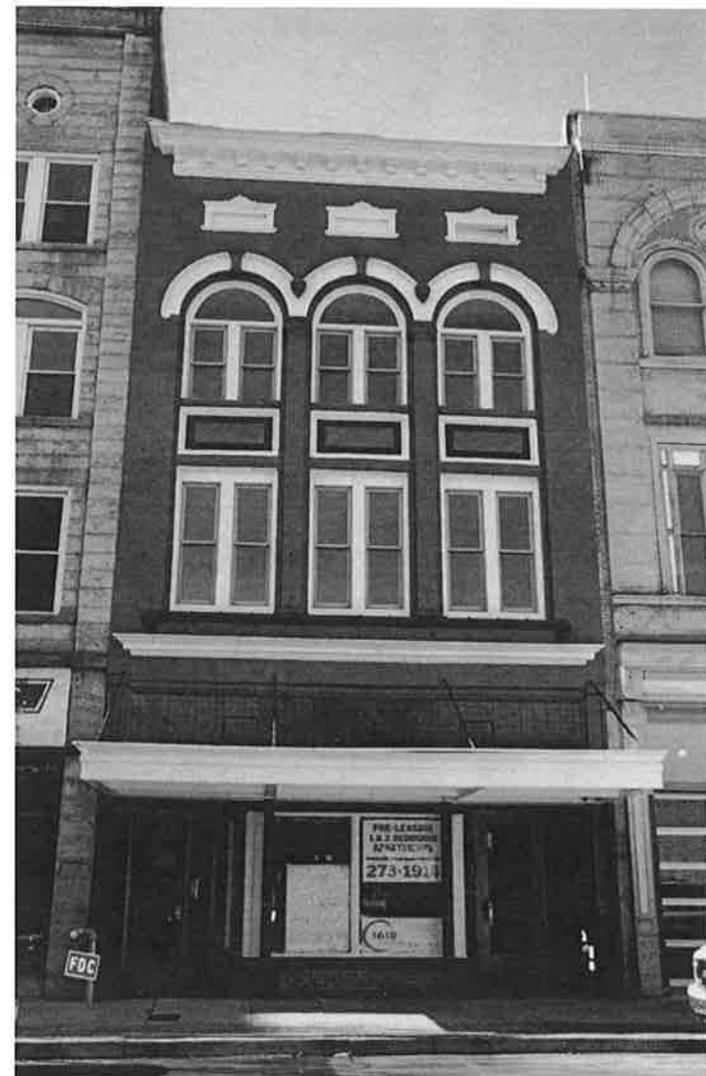
[22] **Not Recommended:** (a-b) The original wood windows in this late-19th-century building, which were highly decorative, could likely have been repaired and retained. (c) Instead, they were replaced with new windows that do not match the detailing of the historic windows and, therefore, do not meet the Standards (above).

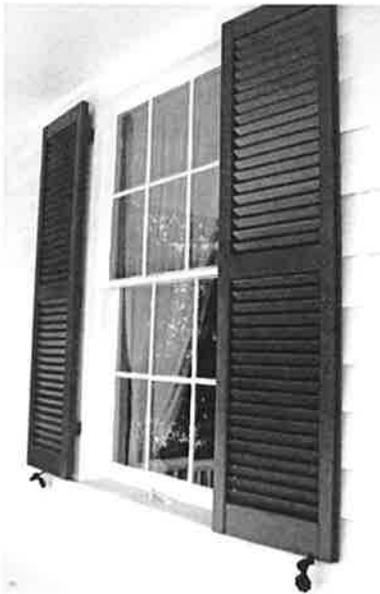
[9] Historic window and shutter hardware such as that shown here should be retained and repaired in a restoration project.
