Range Evaluation Report

Project #: NV20190103

Subject: Carson City, Nevada Range

**Project #: NV20190103
Carson City Nevada Range**

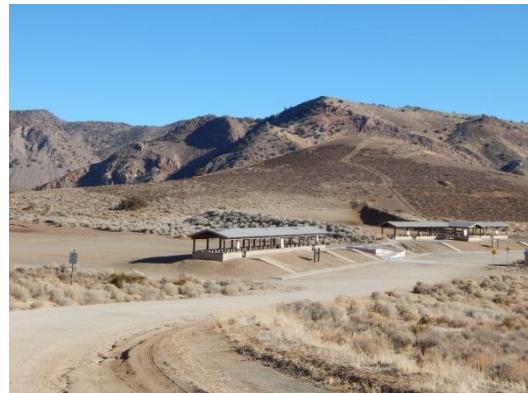
Figure 1

The range is a city park shooting facility located in a mostly rural brushy terrain area zoned "Public Community Use". (See fig. 1) The range property is under the control of the Carson City Parks and Recreation Department but the range is operated by the non-profit Carson Rifle and Pistol Club through a land use agreement. Reasonable accommodations for the safety of both those using the range and the general public are achieved by considering the entire context in which this particular facility is operated. The type of shooting conducted, the rules and controls that are practiced, the overall design of the range, and the surrounding environment must be considered.

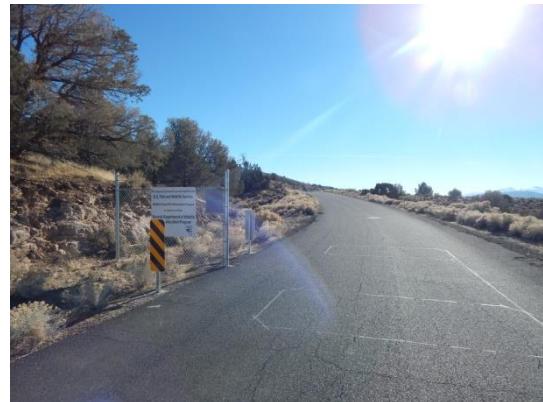
Figure 2

Range access is controlled by the locked gate and limited to the posted hours of operation. The road access to the facility is adequate and leads directly to the ranges. (See fig. 2)

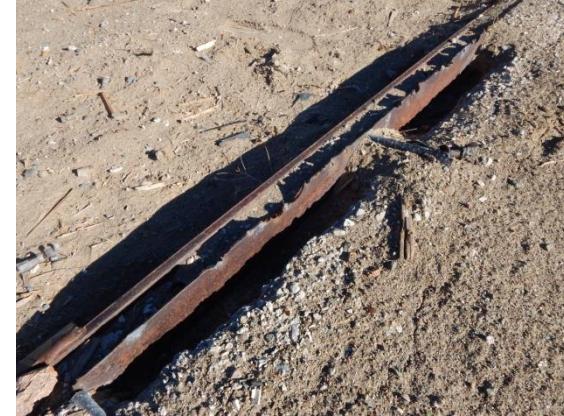
Figure 3

The intermediate target line positions are in need of repair. The concrete foundations are shot to the point that exposed rebar is found along the entire length. There are sections of old steel train rails that are shot to pieces. (See fig. 3)

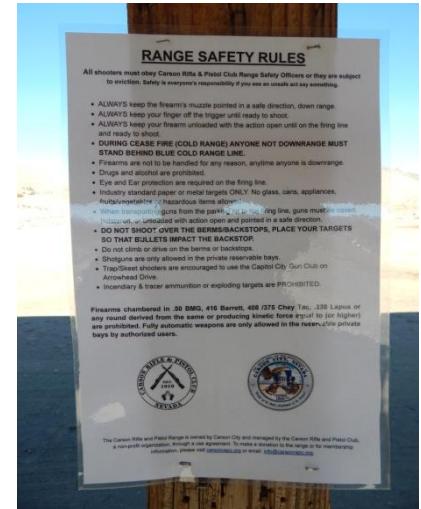
Figure 4

The range firearm safety rules and other safety signs are not adequate for the number of shooting positions in this bay. (See fig. 4) The firing line under the covered positions is adequately marked. The firing line for the 20 uncovered positions is not adequately defined.

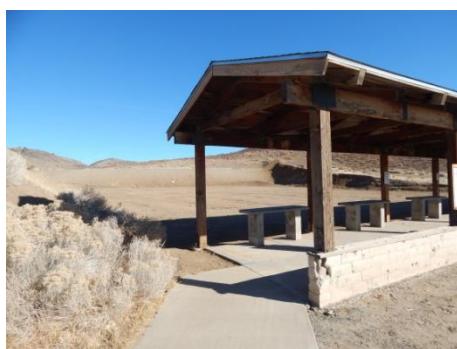
Figure 6

Side berms fail to meet the minimum suggested height published in the NRARSB and are too low to expect total projectile containment. They also taper from a high point at the backstop intersection back towards the firing line. (See fig. 6)

5. The Side Berm height should be increased to the suggested height of at least 8 feet with a minimum of 4 feet width/depth at the highest part **ON ALL BAYS**. See the NRARSB for backstop design considerations. All berms and backstops would benefit from additional grooming and maintenance as is recommended by the NRARSB.

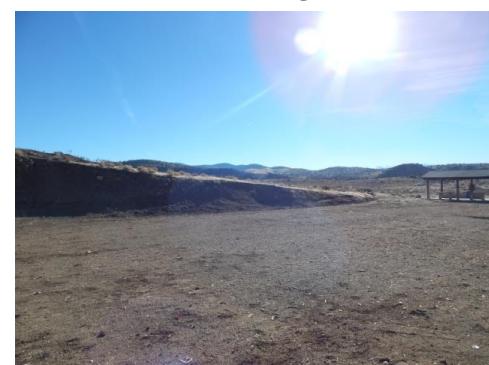
Figure 5

The 50 yard rifle bay backstop does not meet the minimum suggested height published in the NRARSB and is too low to expect total projectile containment. The high point of the backstop is approximately 12 feet. (See fig. 5)

3. The backstop height should be increased to the suggested height of at least 20 feet with a minimum of 4 feet width/depth at the highest part **ON ALL BAYS**. See the NRARSB for backstop design considerations. All berms and backstops would benefit from additional grooming and maintenance as is recommended by the NRARSB.

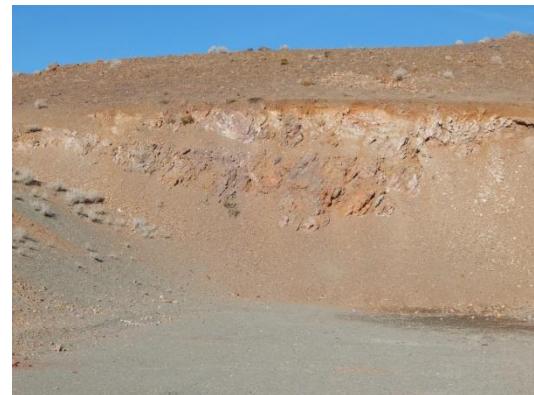
Figure 8

The 50 yard bay has a backstop and side berms that fail to meet the minimum suggested heights published in the NRARSB and are too low to expect total projectile contain-

ment. The backstop in this bay is positioned directly in front of a ragged rock outcropping. (See fig. 8)

The rocky surface directly behind the backstop in this bay is a dangerous situation as projectiles hitting this hard irregular rocky area have a higher potential to ricochet than to remain captured.

4. The rocky outcropping behind the backstop in Shooting Bay 2 needs to be addressed. There are many ways to neutralize this rocky area. Removing the rock surface or covering the area with dirt, rubber, or wood may all be appropriate solutions.

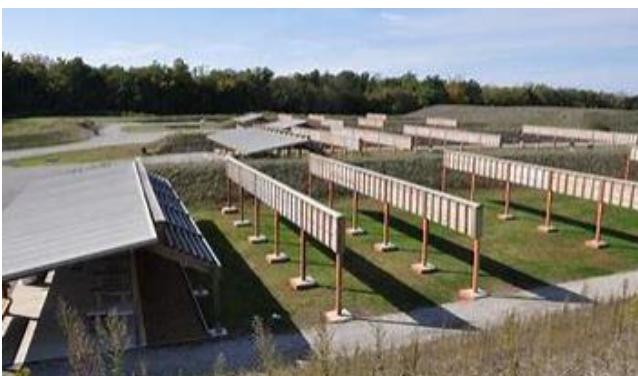
Figure 9

Examples of possible baffle solutions can be found figures 9 and 10. A properly engineered overhead downrange baffle system is the only way to guarantee projectile containment.

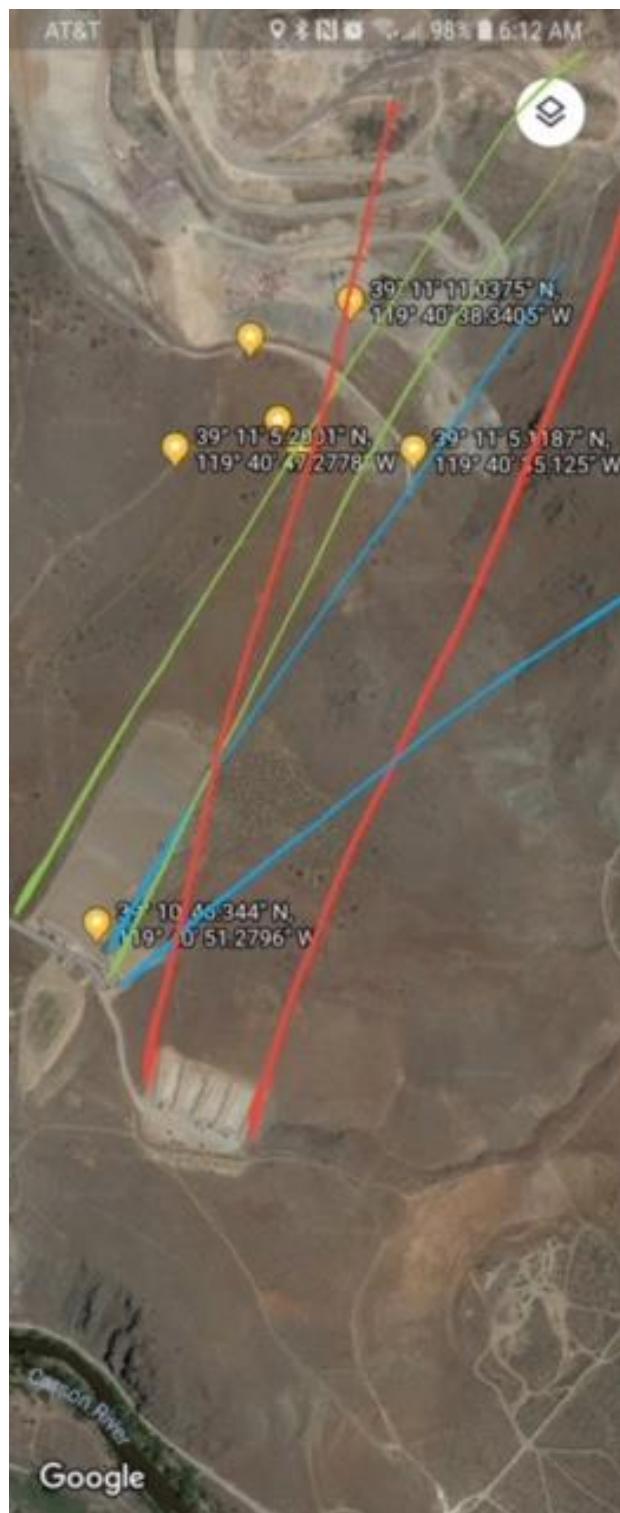
Prior to my inspection, club members accompanied by City Public Works staff collected numerous bullets from the referenced landfill area during shooting activity at the range on November 18, 2018. The club members had established communications with the RSO at the firing line who confirmed the shooting locations and direction of the ongoing shooting activity. In talking with the club members and the City staff it is clear that they are certain the projectiles heard "whizzing" overhead originated from the range. They also indicated that the rounds heard were more than likely ricocheted as they did not hear the "crack" normally associated with a rifle round as it passes overhead. See Appendix A for an aerial view of the group's findings.
