STAFF REPORT

Agenda Title: For Possible Action: To approve the annual monitoring report for the Horse Creek Ranch Conservation Easement for 2018.

Carson City Open Space – Conservation Easement Monitoring

Baseline Report Repeat Photo Documentation

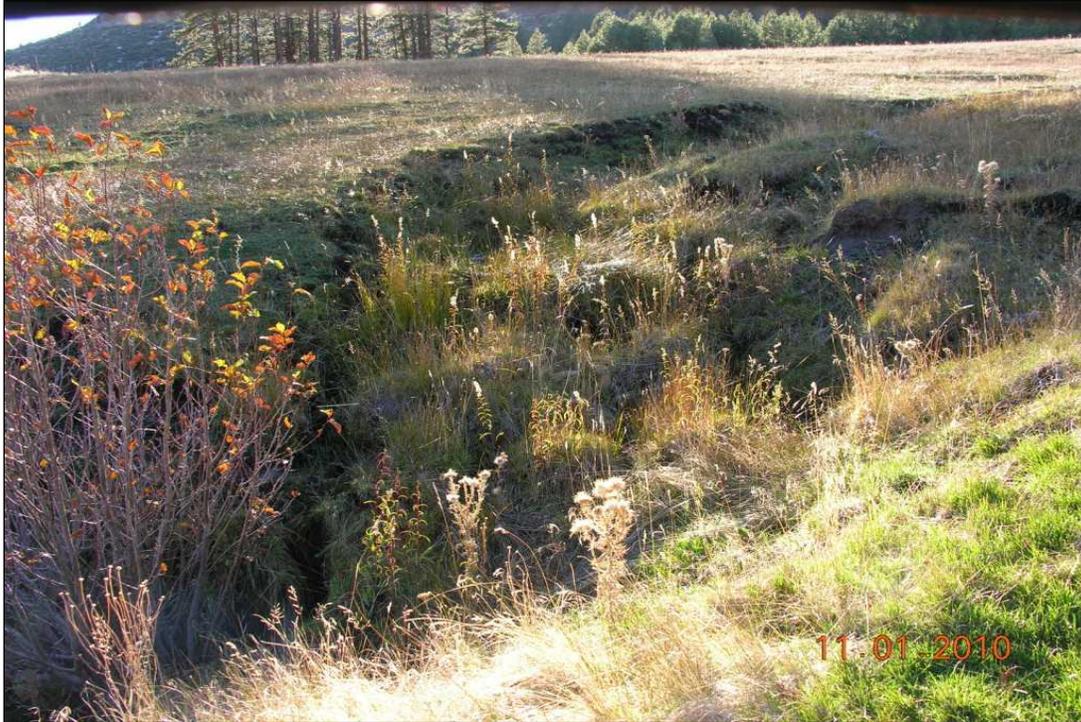
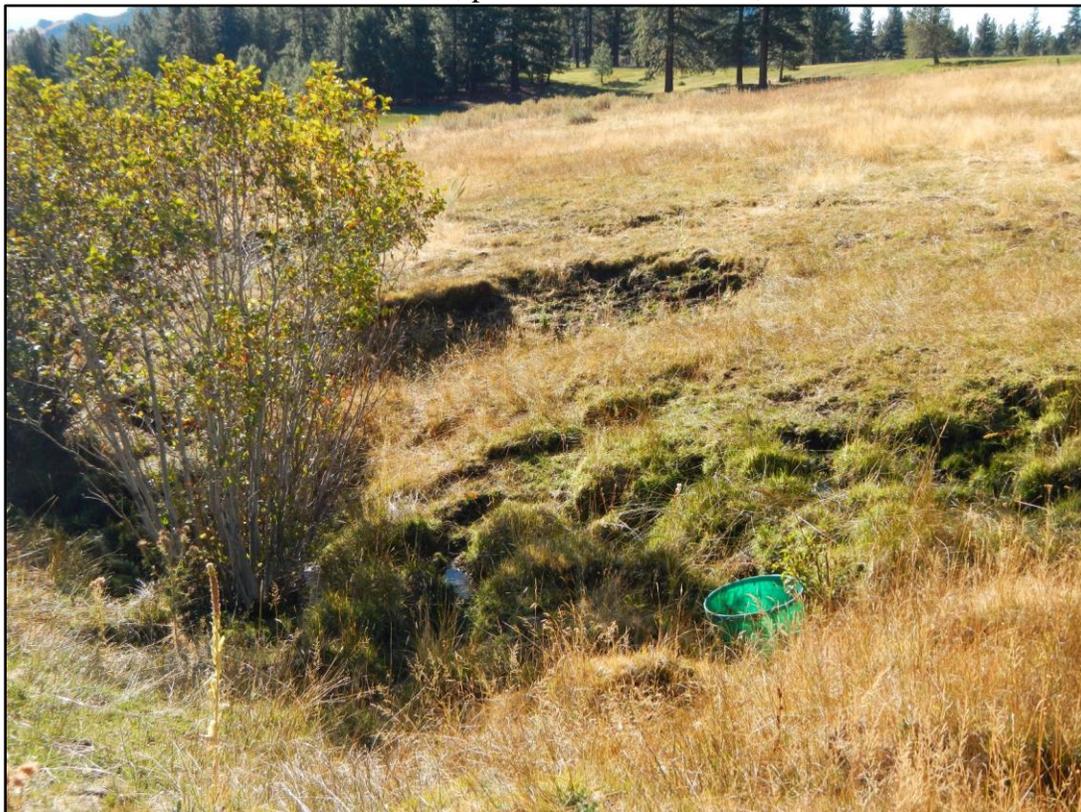
Photo Point: The photo of this drainage, located south of the cabins, has been included to document change and vegetation growth. N 39 07' 42.7" W 119 50' 10.2"

Near the southeast corner, one specific area is being monitored for landscape change. This low drainage area of the meadow appears to be vegetated and stable though a few isolated mounds or hummocks may be the result of cattle trampling. A qualitative assessment with the photo comparisons may be deceptive due to the time of year each photo was taken – either during the growing season or at the end of the season after grasses were grazed and/or senesced. Additionally, the new head cut observed in 2017 on the creek northeast of the cabins was monitored, and remains relatively the same size (1 - 1.5 feet) as observed last year, but it should be monitored in future years to document change in size or location, as it could increase in size or potentially migrate upstream. In conjunction with the USDA EQIP grant funding that has been awarded to repair irrigation structures and efficiency, Mr. Fagen has also applied for additional USDA EQIP grants to fund the design and repair plan for the existing headcuts. If awarded, this funding will be utilized in 2020-2021.

2010 Condition, photo taken November 1, 2010 (initial assessment – view west)

2018 Condition, photo taken October 8, 2018

- 1) Continue to work with the NRCS and USDA EQIP grant to identify and complete repairs for the flood irrigation system to be implemented in 2019-2020.
- 2) Continue to work with the NRCS and USDA EQIP grant to identify a mitigation strategy and repair plan for existing headcuts to be implemented 2020-2021.
- 3) Continued removal of bull thistle.

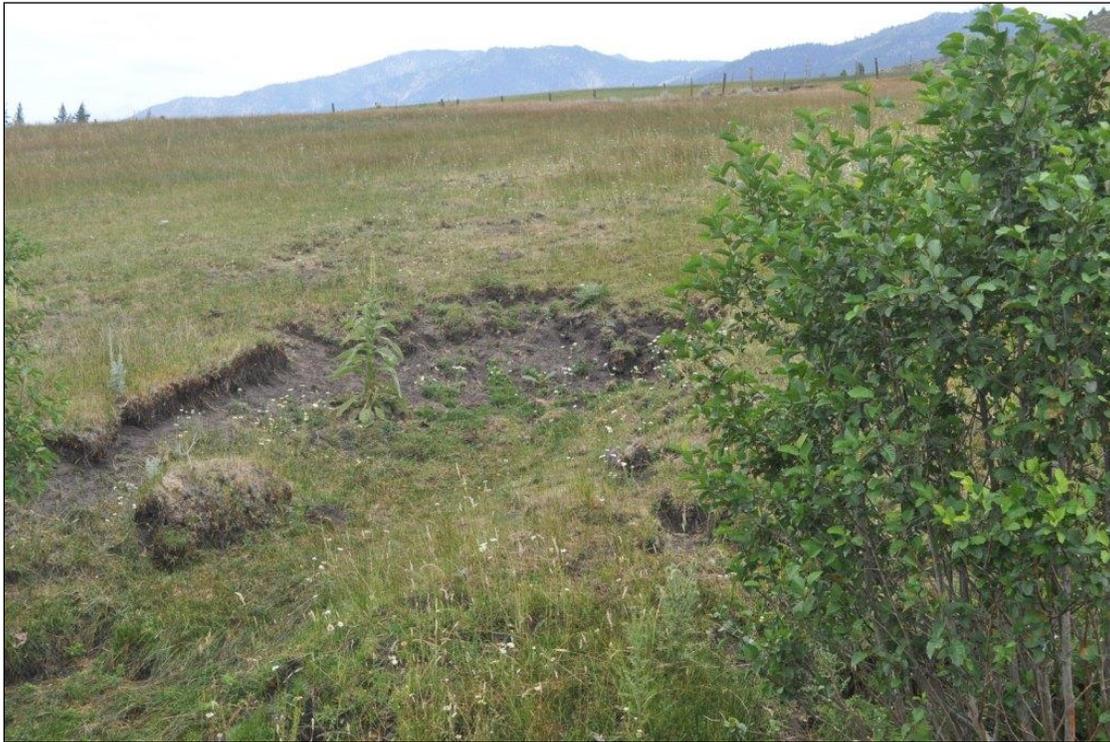
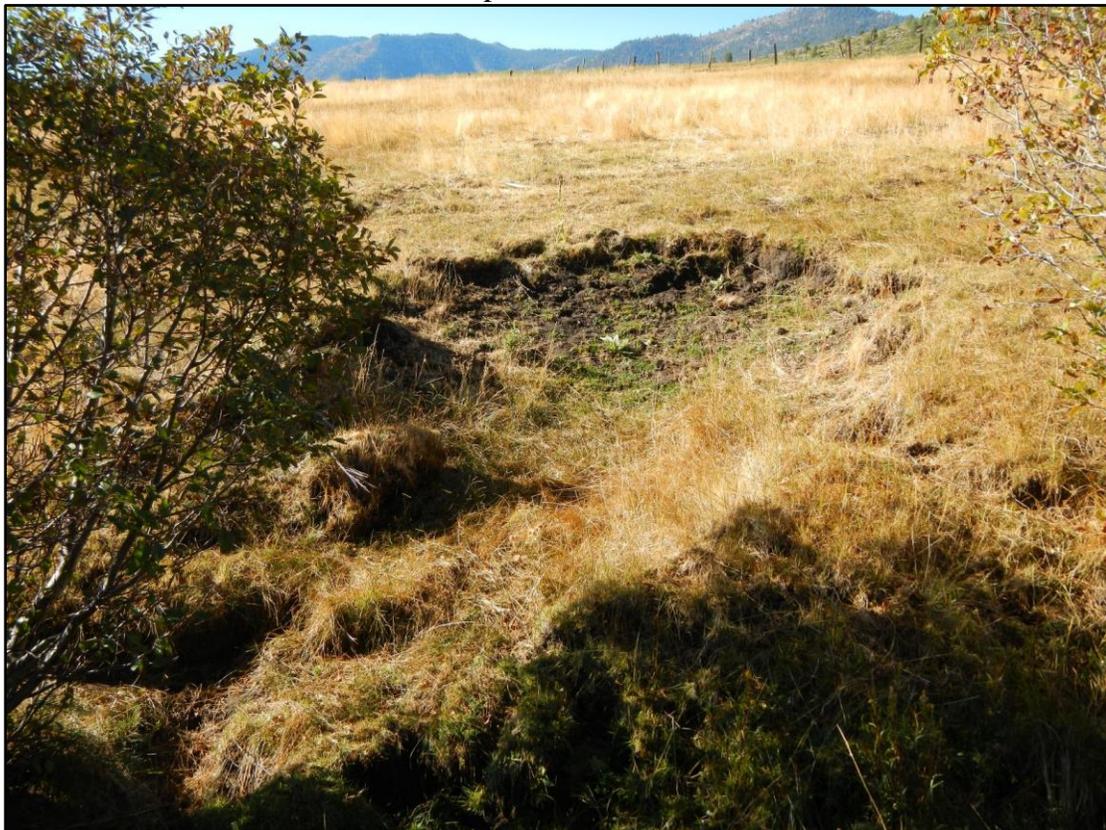
2013 Condition, photo taken July 23, 2013 (initial assessment – view south)

2018 Condition, photo taken October 8, 2018

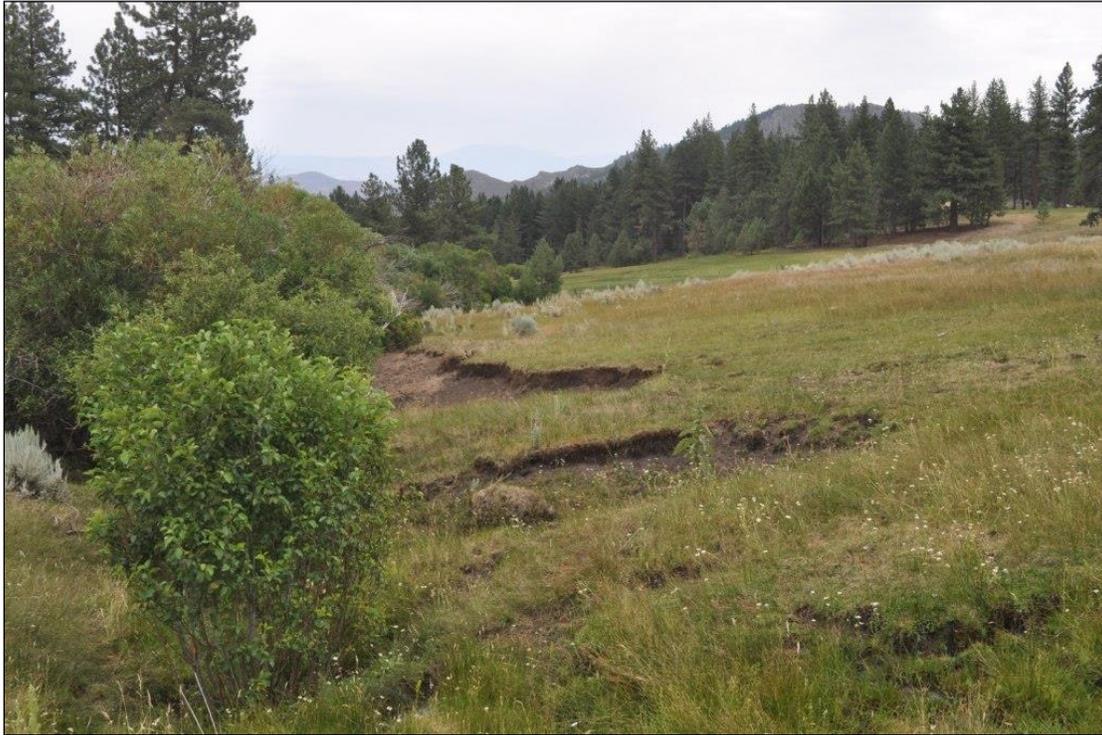
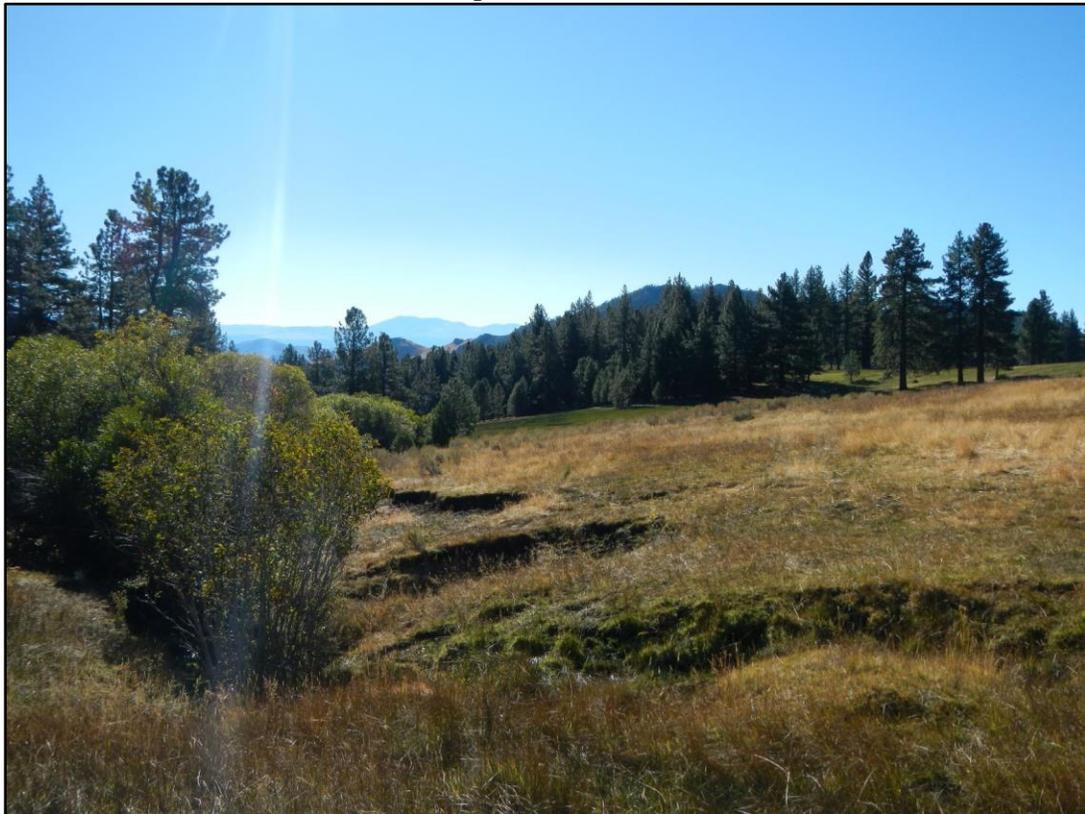
2013 Condition, photo taken July 23, 2013 (initial assessment – view south)

2018 Condition, photo taken October 8, 2018

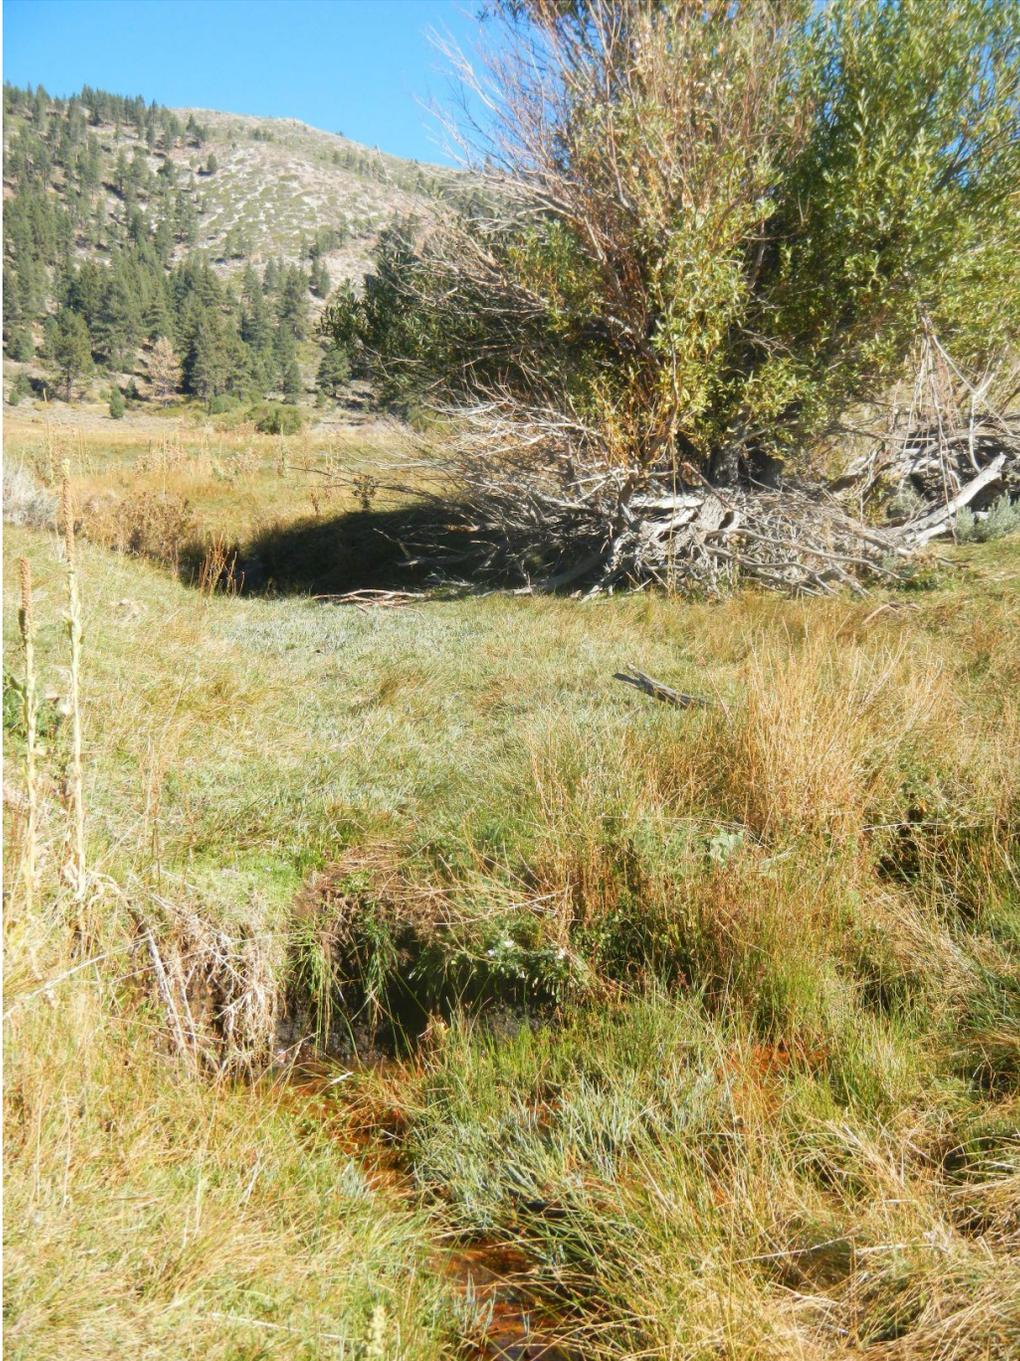
Photo Point: The photo of this head cut, located northeast of the cabins, has been included to document stream channel changes and erosion. N 39 07' 51.0" W 119 50' 11.4"

2018 Condition, photo taken October 8, 2018 (view north)

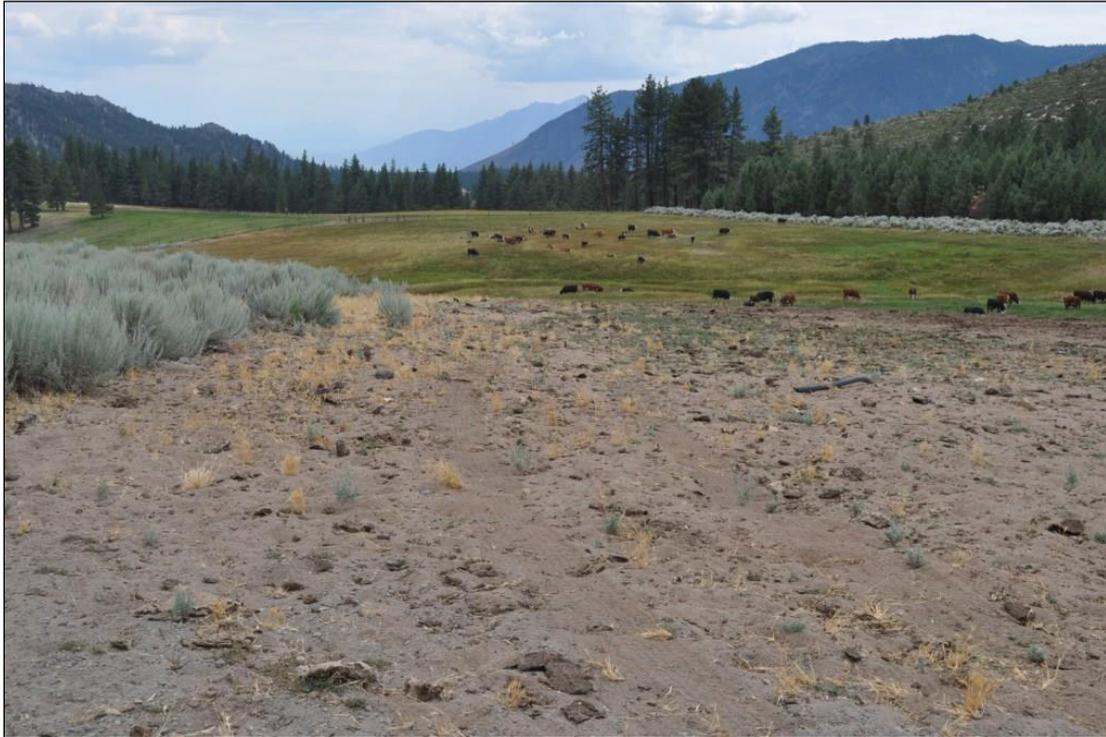
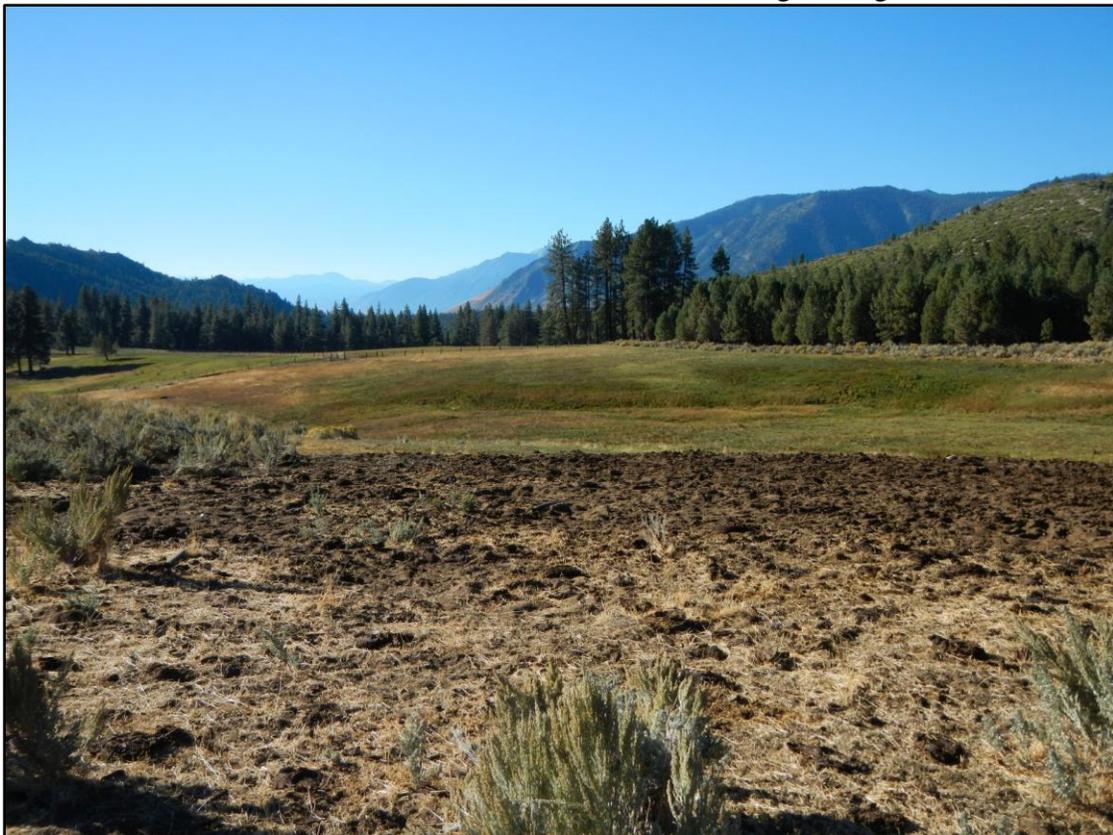
- The previous reports recommended the monitoring of the cattle loading area located just outside the gated entrance to the cabins with the goal to limit further expansion. The following documentation provides photo points and respective measurements. The disturbed area consists primarily of cheatgrass and foxtail barley although sagebrush is successfully re-establishing on both the north and east edge of the disturbed area. The disturbed area has shown a reduction in size over the last two monitoring cycles. Lastly, it is important to note that depending on the timing of monitoring, cheatgrass abundance and cover varies indicating that cattle are likely grazing the cheatgrass.

2013 Condition, photo taken July 23, 2013 (initial assessment – view south):
The bare area measures 157' north to south along the sagebrush.

2018 Condition, photo taken October 8, 2018:
The bare area measures 153.6' north to south along the sagebrush.

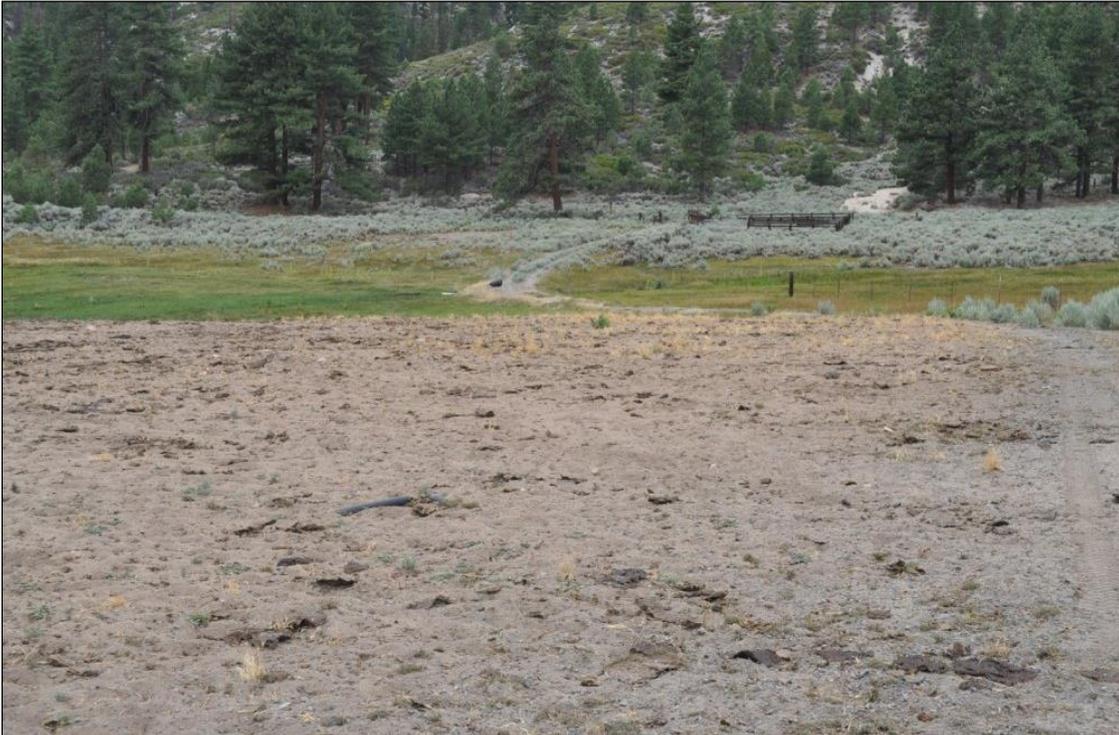
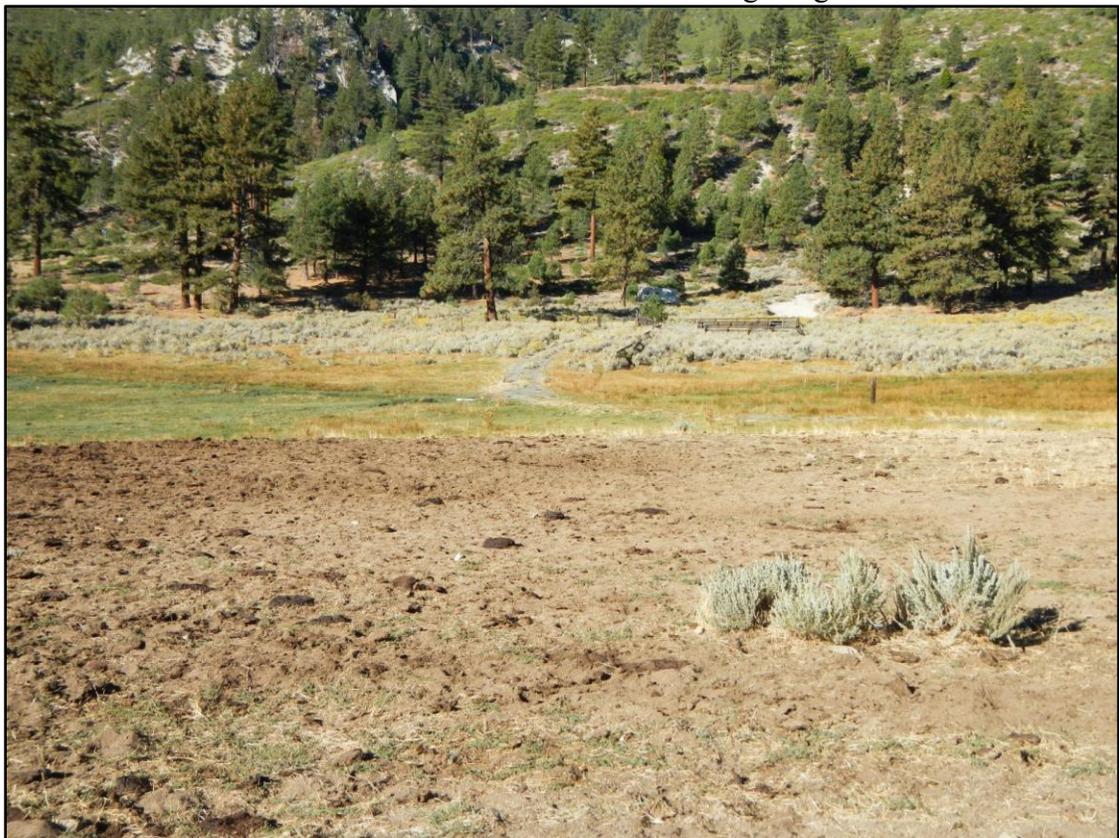
2013 Condition, photo taken July 23, 2013 (initial assessment – view west):
The bare area measures 145' east to west along the gravel road.

2018 Condition, photo taken October 8, 2018:
The bare area measures 137' east to west along the gravel road.

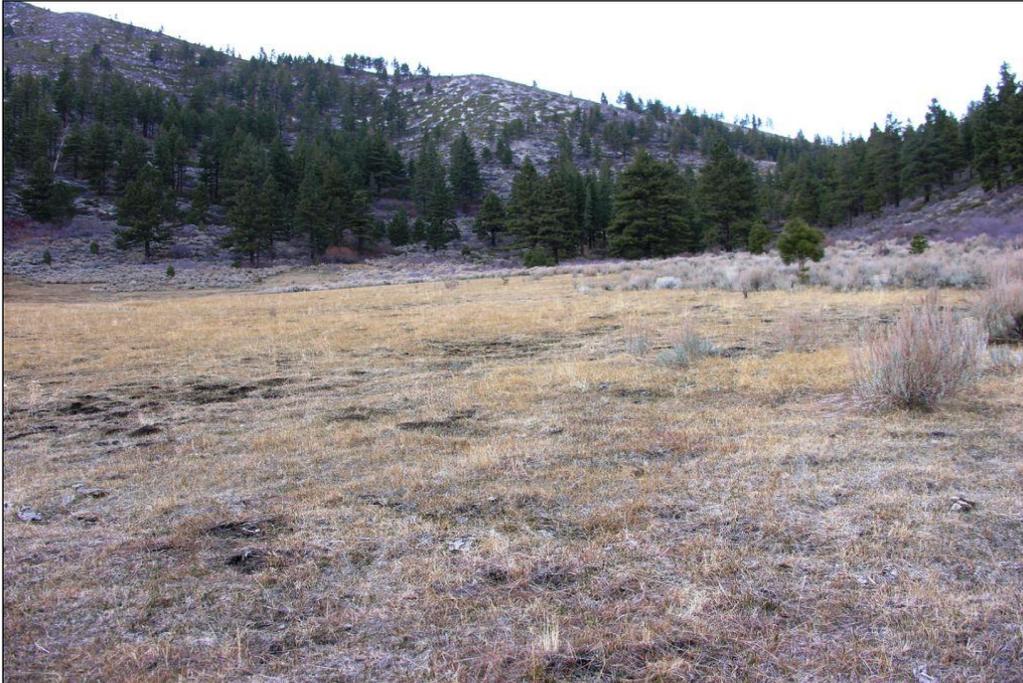
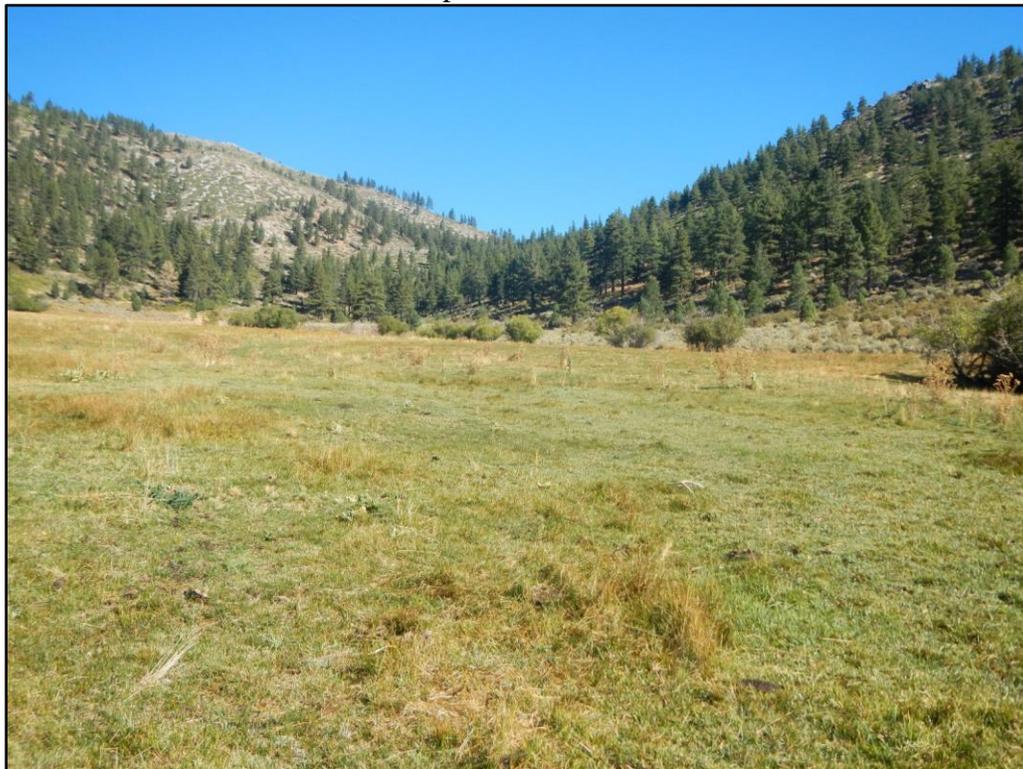
Photo Point 1A (view northeast): A photo point located at the edge of the shrub dominated granitic fan and the irrigated meadow. This would be used to monitor shrub invasion into the meadow area indicating irrigation problems.

2009 Baseline Condition, photo taken February 4, 2009:
(GPS coordinate: N39° 08' 02.3" W119° 50' 11.8")

2018 Condition, photo taken October 8, 2018

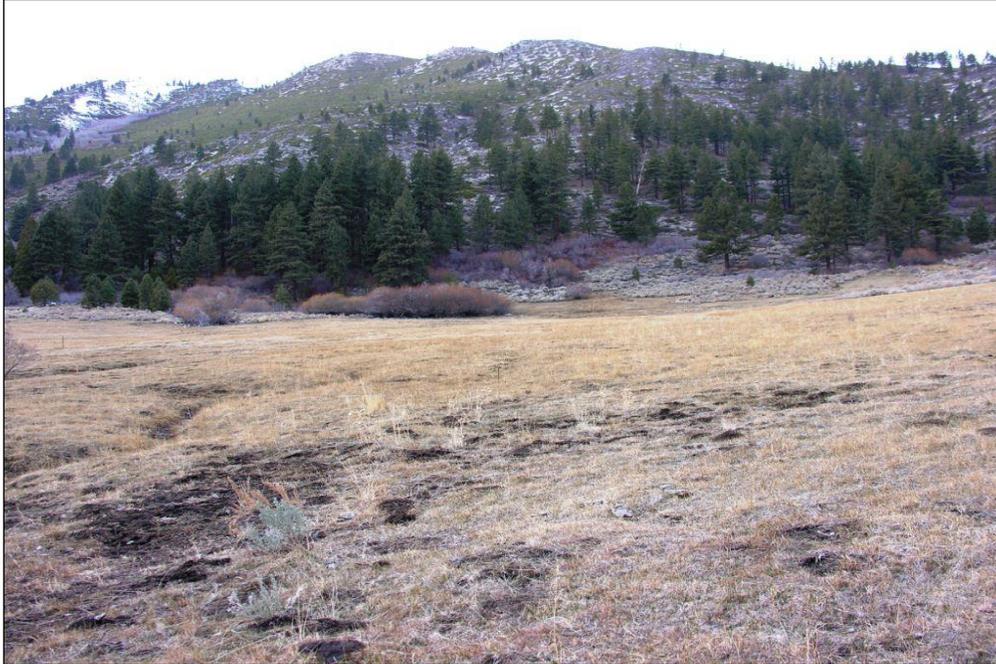
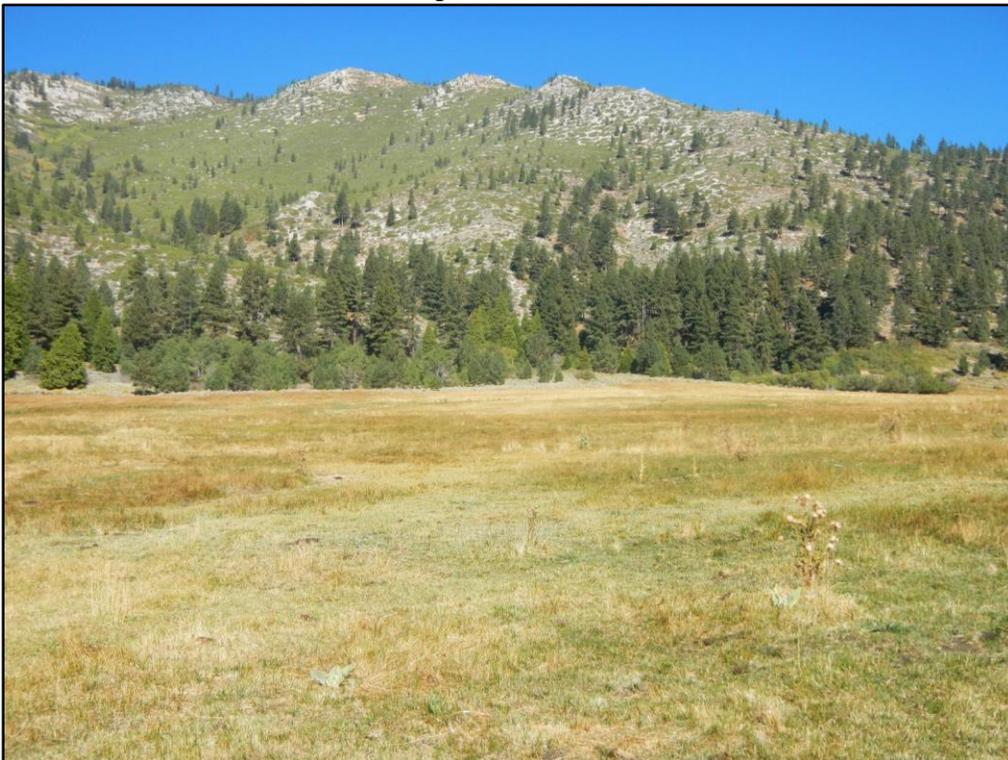
Photo Point 1B (view northwest): A photo point located at the edge of the shrub dominated granitic fan and the irrigated meadow. This would be used to monitor shrub invasion into the meadow area indicating irrigation problems.

2009 Baseline Condition, photo taken February 4, 2009:
(Photo possibly taken from the upper meadow, near the new GPS coordinate for Photo Point 2 updated in 2010: N39 07' 54.9" W119 50' 11.3")

2018 Condition, photo taken October 8, 2018

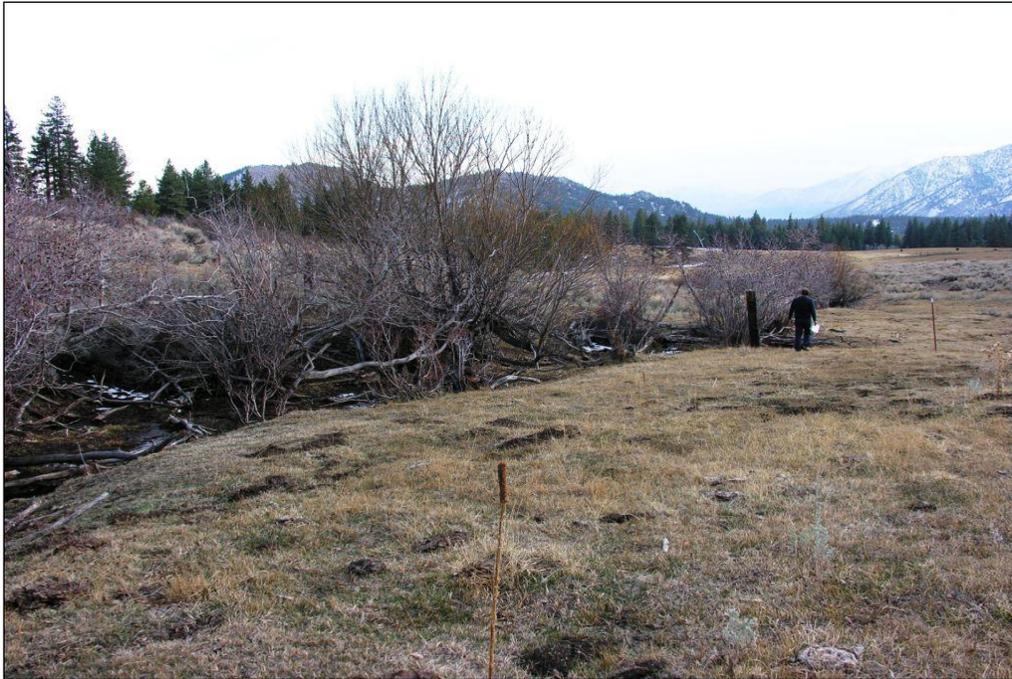
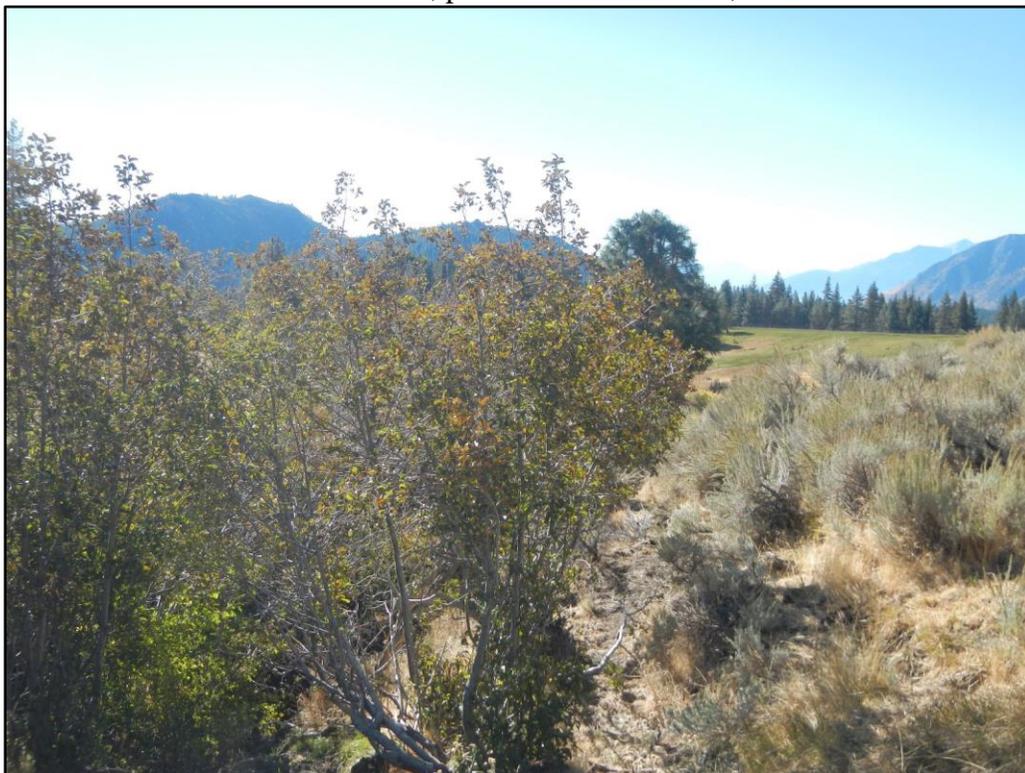
Photo Point 2 (view south): A photo point located in bottom of the active stable drainage channel to the southeast of the house to monitor side slope stability.

2009 Baseline Condition, photo taken February 4, 2009:
(GPS coordinate updated in 2010: N39 07' 54.9" W119 50' 11.3")

2018 Condition, photo taken October 8, 2018

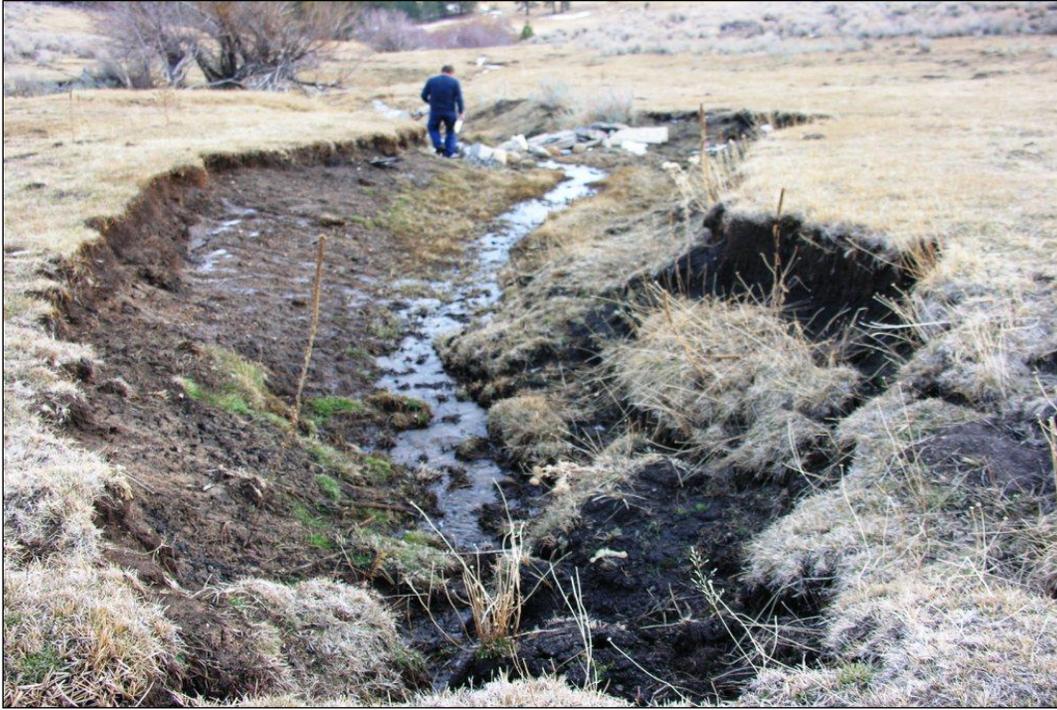
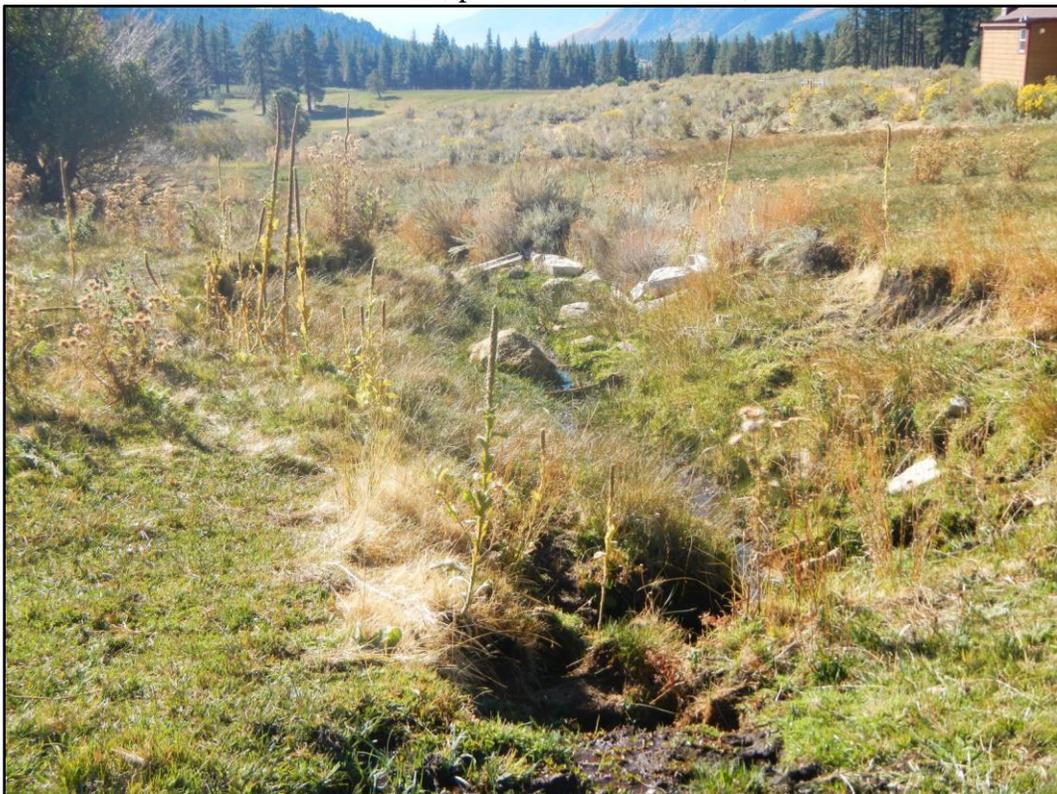
Photo Point 3 (view south): A photo point located immediately east of the house in the active channel where rip-rap has been placed for stabilization.

2009 Baseline Condition, photo taken February 4, 2009

2018 Condition, photo taken October 8, 2018

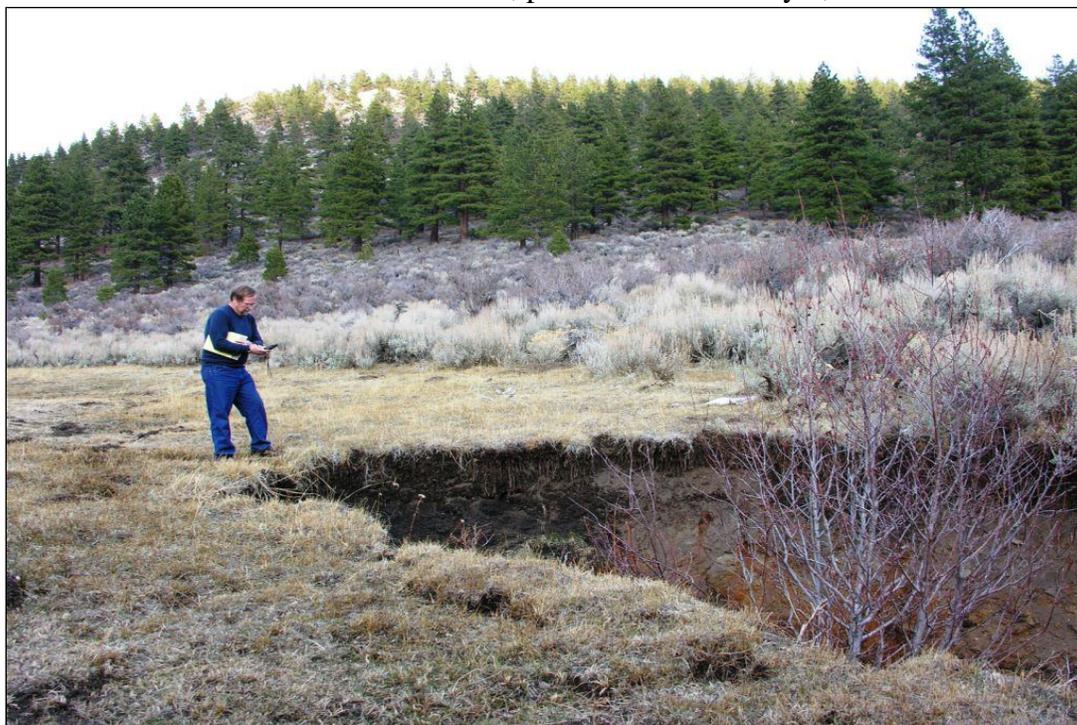
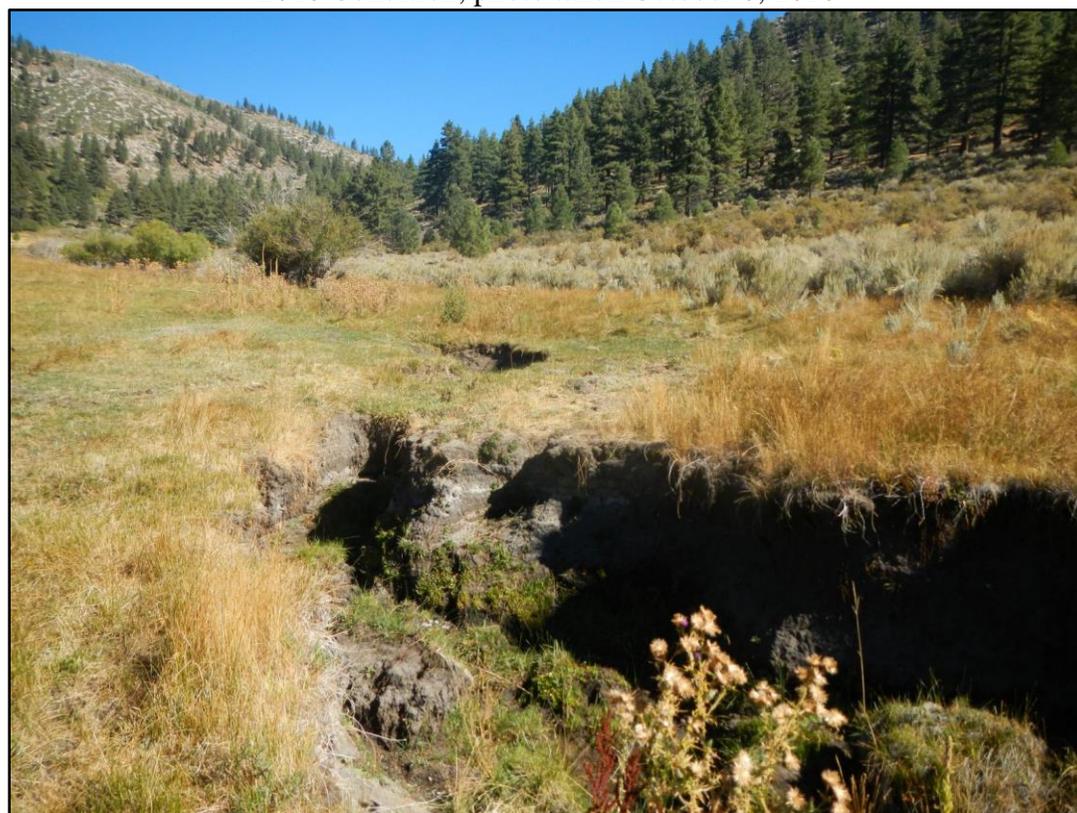
Photo Point 4A (view north): A photo point located at the most northern active headcut after required stabilization to monitor effectiveness.

2009 Baseline Condition, photo taken February 4, 2009

2018 Condition, photo taken October 8, 2018

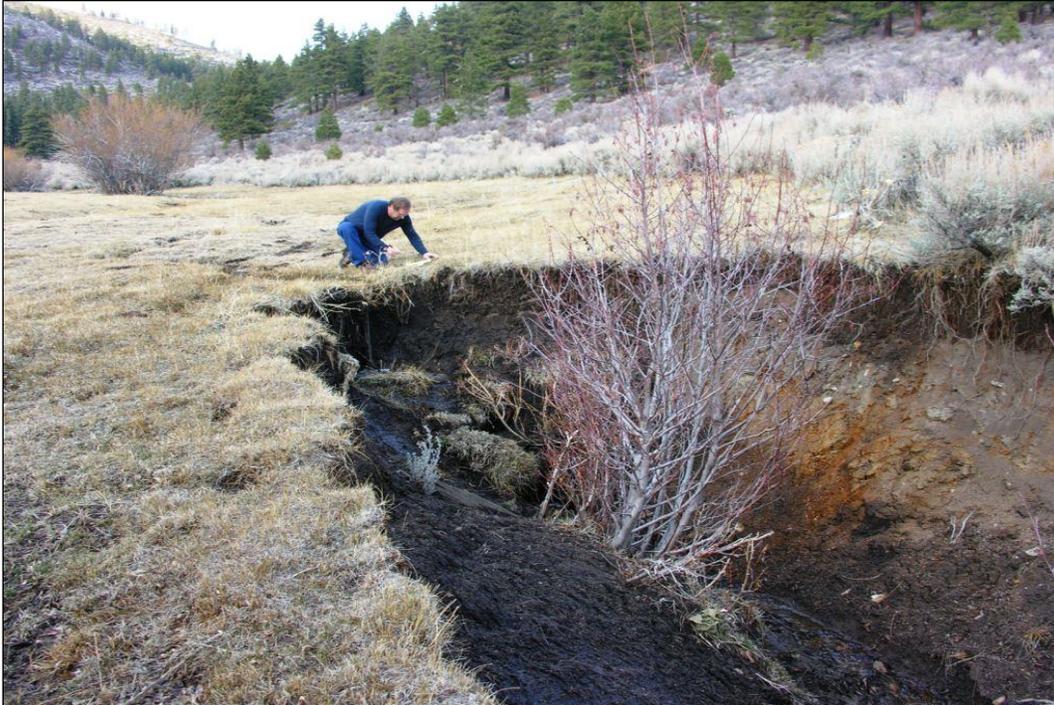
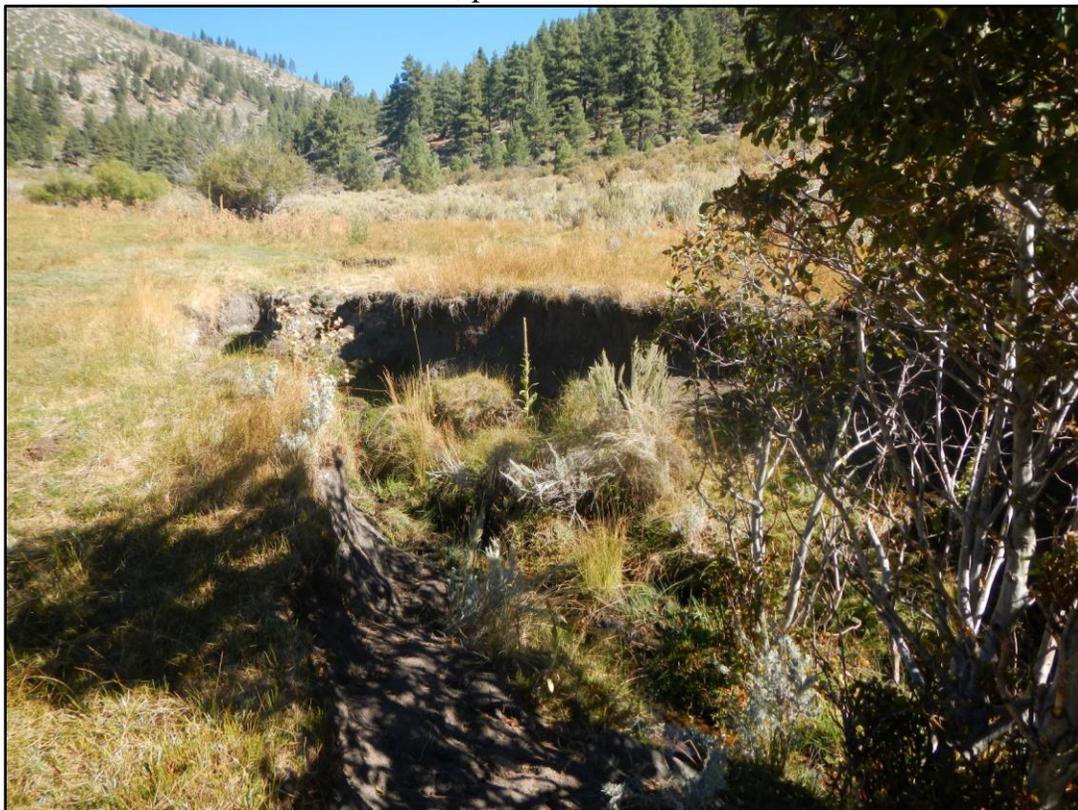
Photo Point 4B (detail): A photo point located at the most northern active headcut after required stabilization to monitor effectiveness.

2009 Baseline Condition, photo taken February 4, 2009

2018 Condition, photo taken October 8, 2018

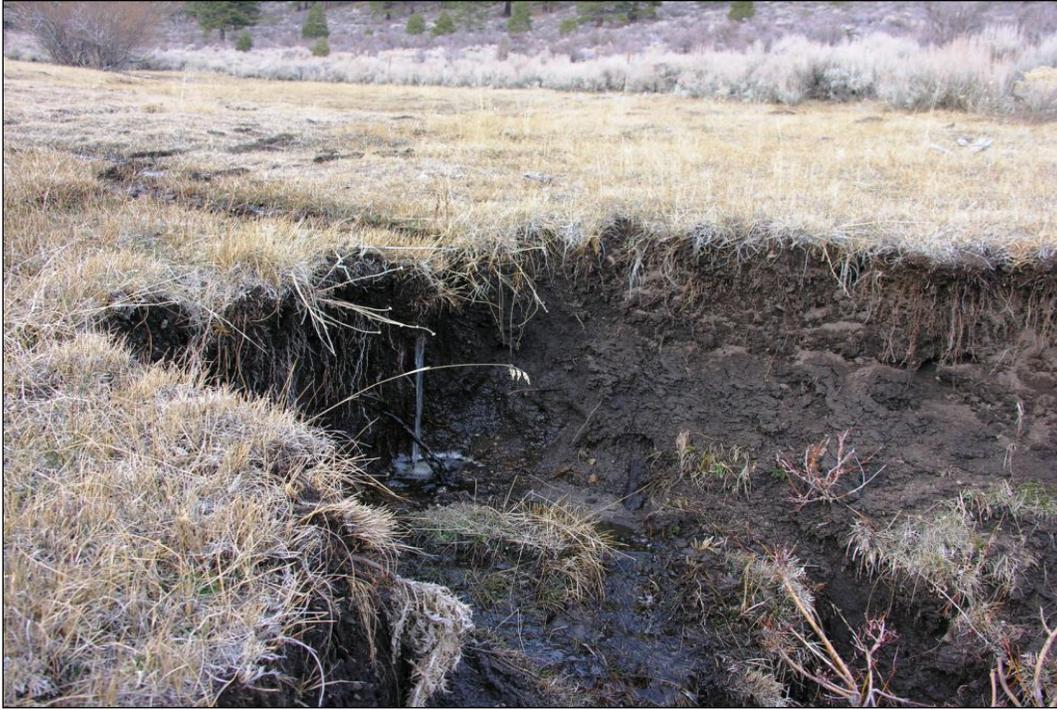
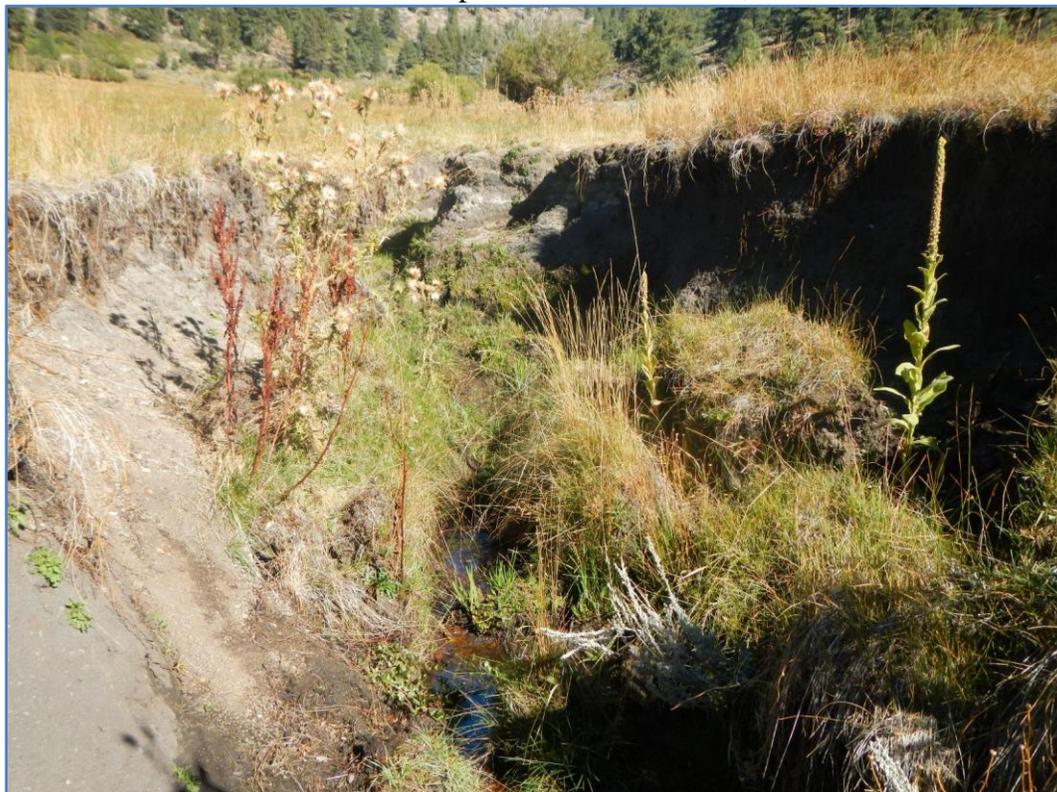
Photo Point 4C (detail): A photo point located at the most northern active headcut after required stabilization to monitor effectiveness.

2009 Baseline Condition, photo taken February 4, 2009

2018 Condition, photo taken October 8, 2018
