STAFF REPORT

Agenda Title: For Possible Action: To approve the annual monitoring report for the Horse Creek Ranch Conservation Easement for 2018.

Carson City Open Space – Conservation Easement Monitoring

Baseline Report Repeat Photo Documentation

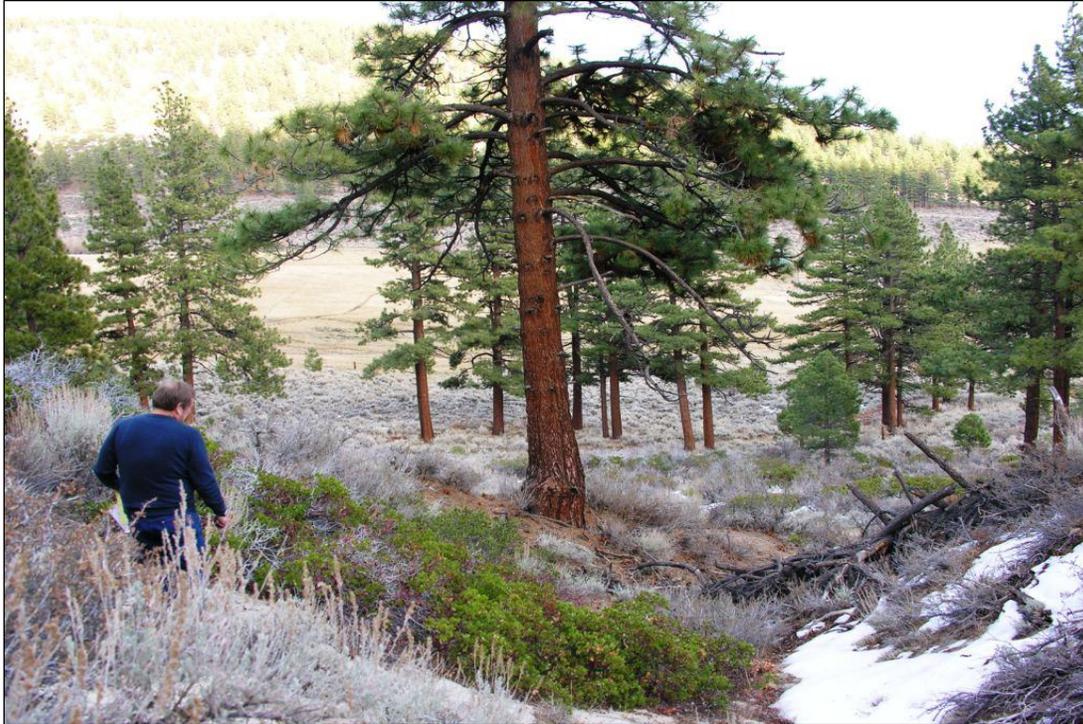
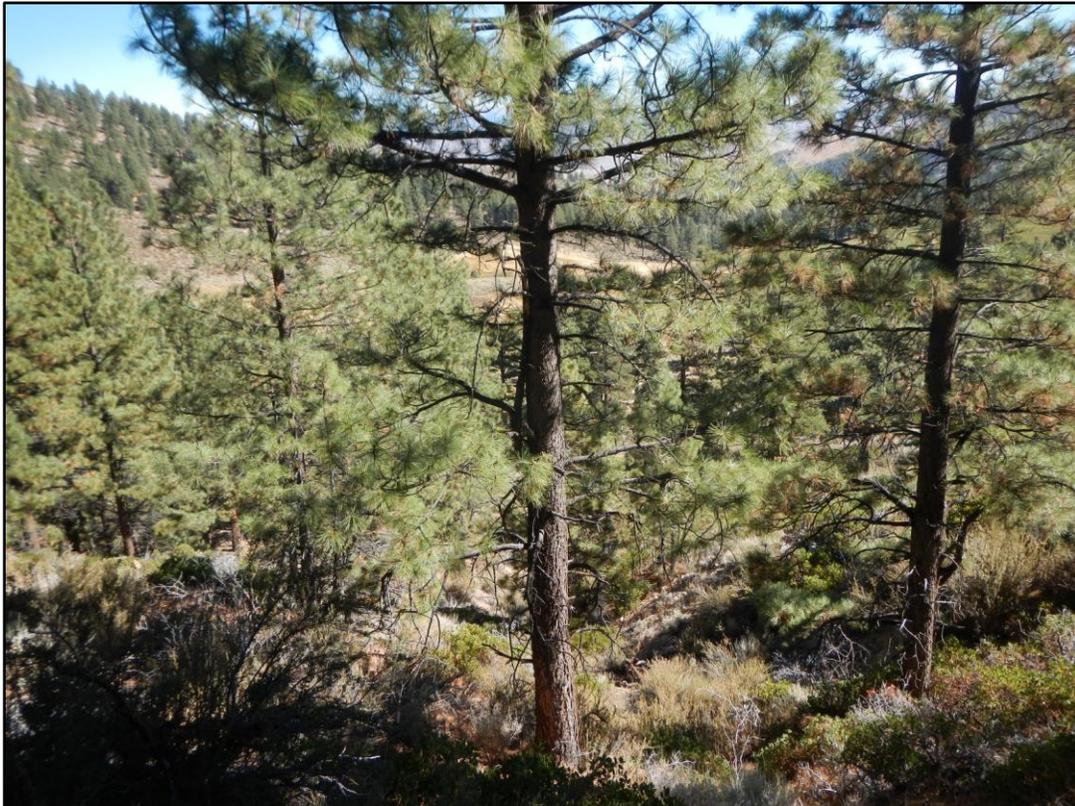
Photo Point 5 (view east): A photo point on the hillside conveyance ditch at a location where a previous washout has occurred to monitor ditch maintenance.

2009 Baseline Condition, photo taken February 4, 2009

2018 Condition, photo taken October 8, 2018

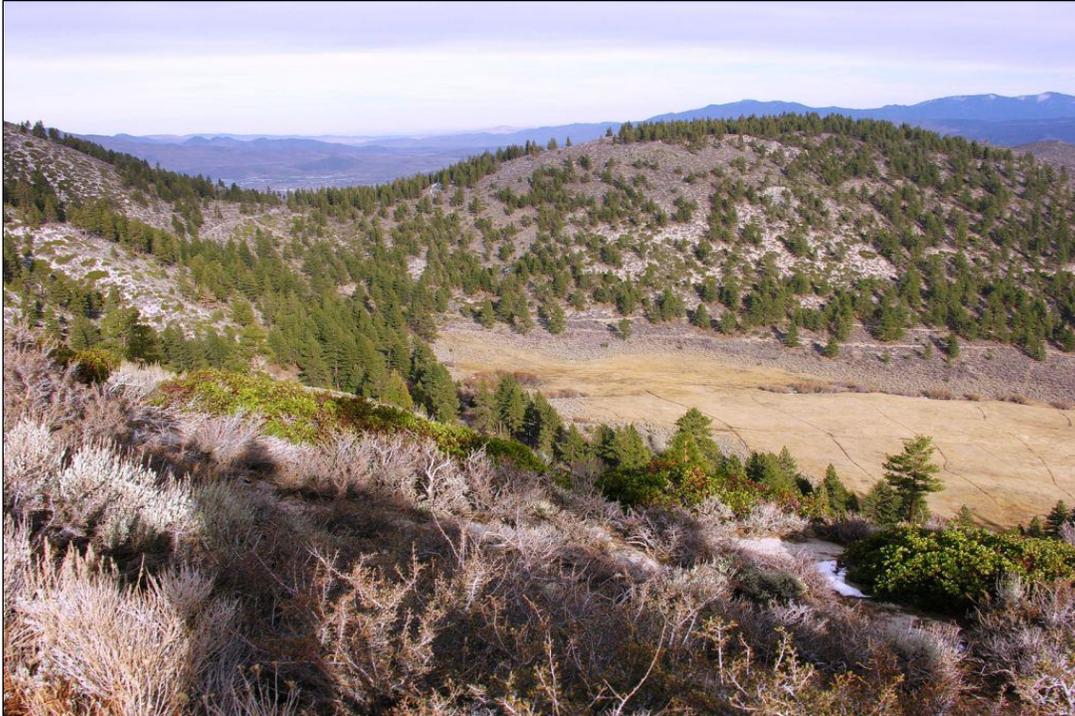
2009 Baseline Condition, photo taken February 4, 2009

Photo Point 6A (view north): A photo point from the Kings Canyon Road that would provide panoramic views of the ranch from a west to east perspective.

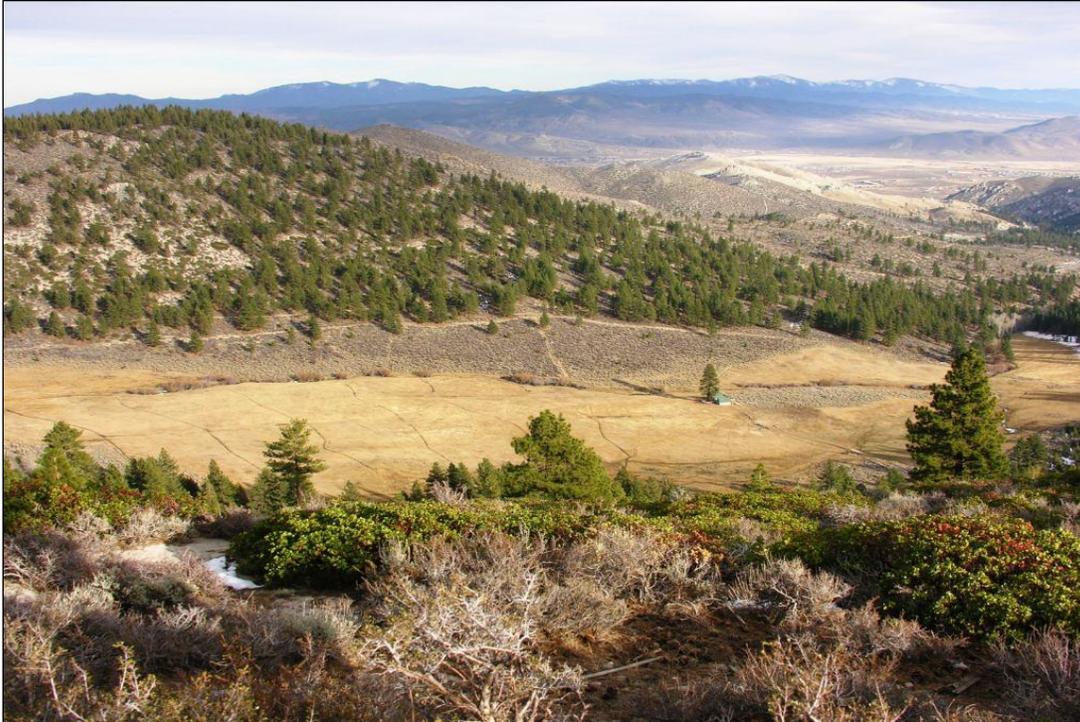
2009 Baseline Condition, photo taken February 4, 2009

Photo Point 6B (view center): A photo point from the Kings Canyon Road that would provide panoramic views of the ranch from a west to east perspective.

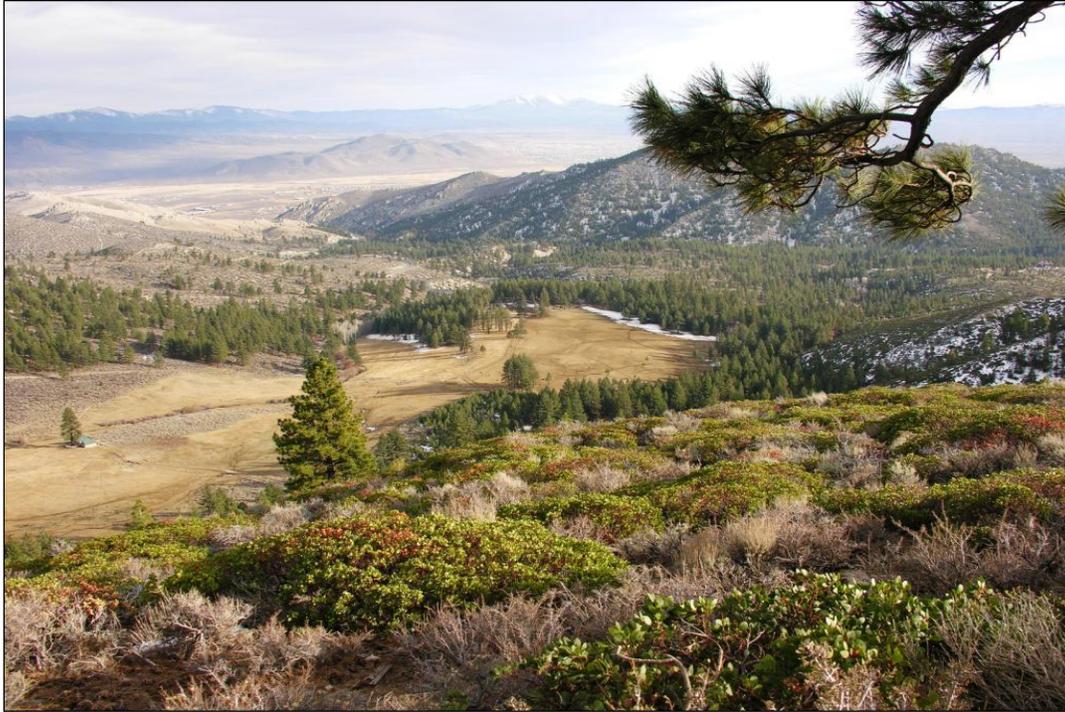
2009 Baseline Condition, photo taken February 4, 2009

Photo Point 6C (view south): A photo point from the Kings Canyon Road that would provide panoramic views of the ranch from a west to east perspective.

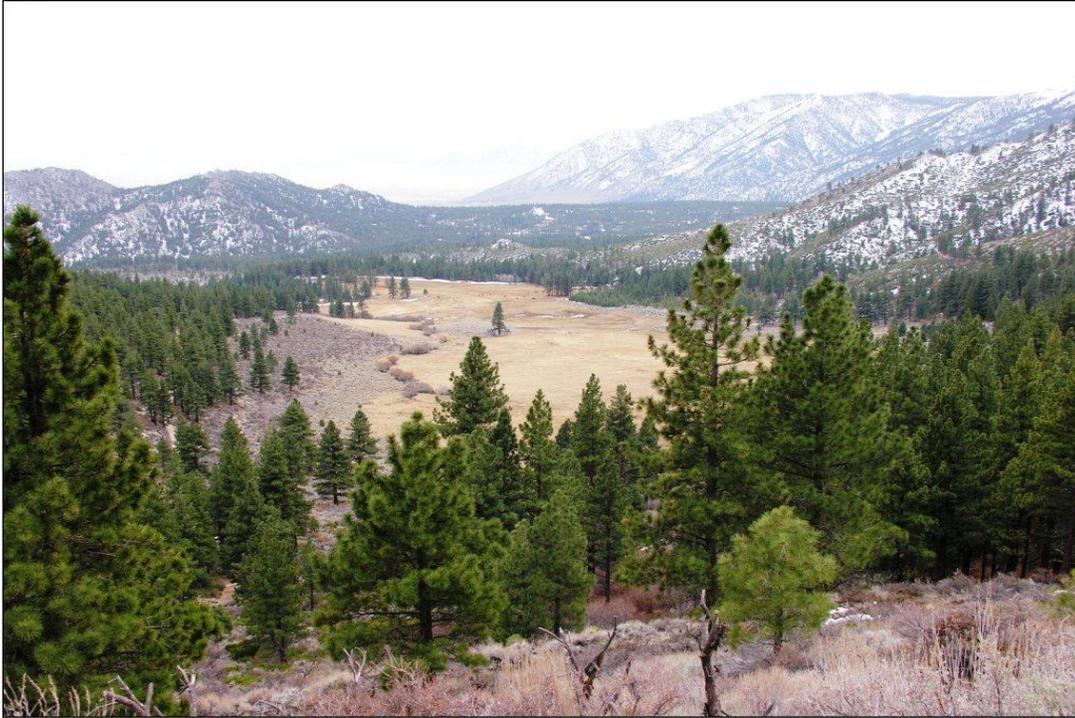
2009 Baseline Condition, photo taken February 4, 2009

Photo Point 7B (view south): A photo point from Kings Canyon Road that would provide panoramic views of the ranch from a north to south perspective.

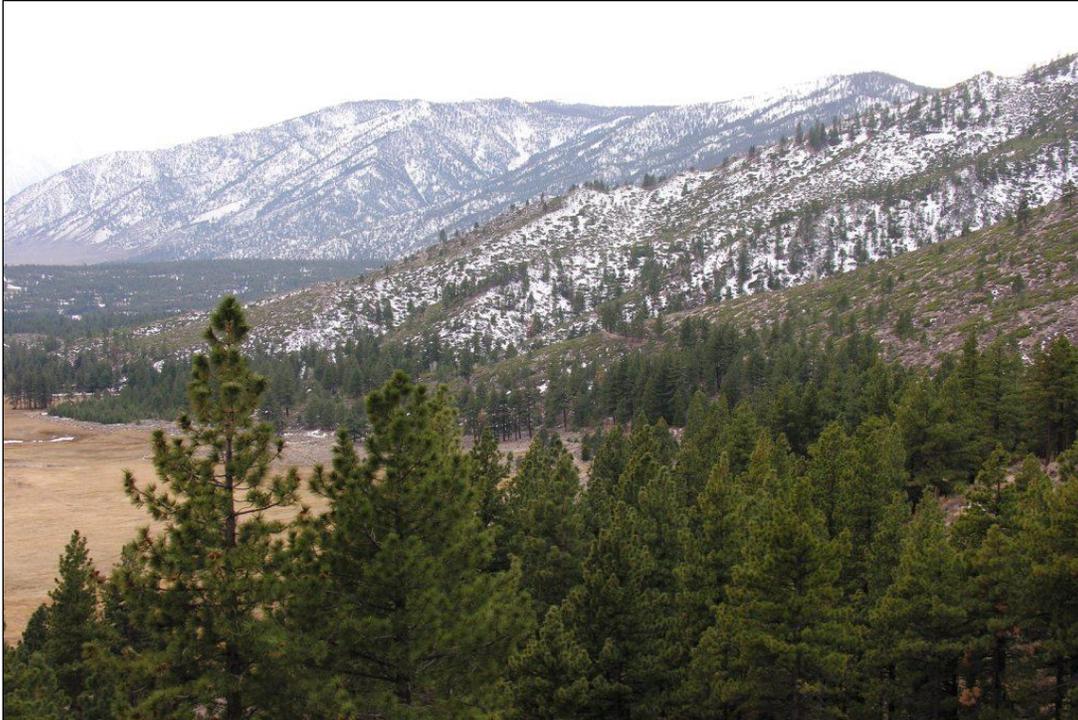
2009 Baseline Condition, photo taken February 4, 2009

Photo Point 7C (view southwest): A photo point from Kings Canyon Road that would provide panoramic views of the ranch from a north to south perspective.

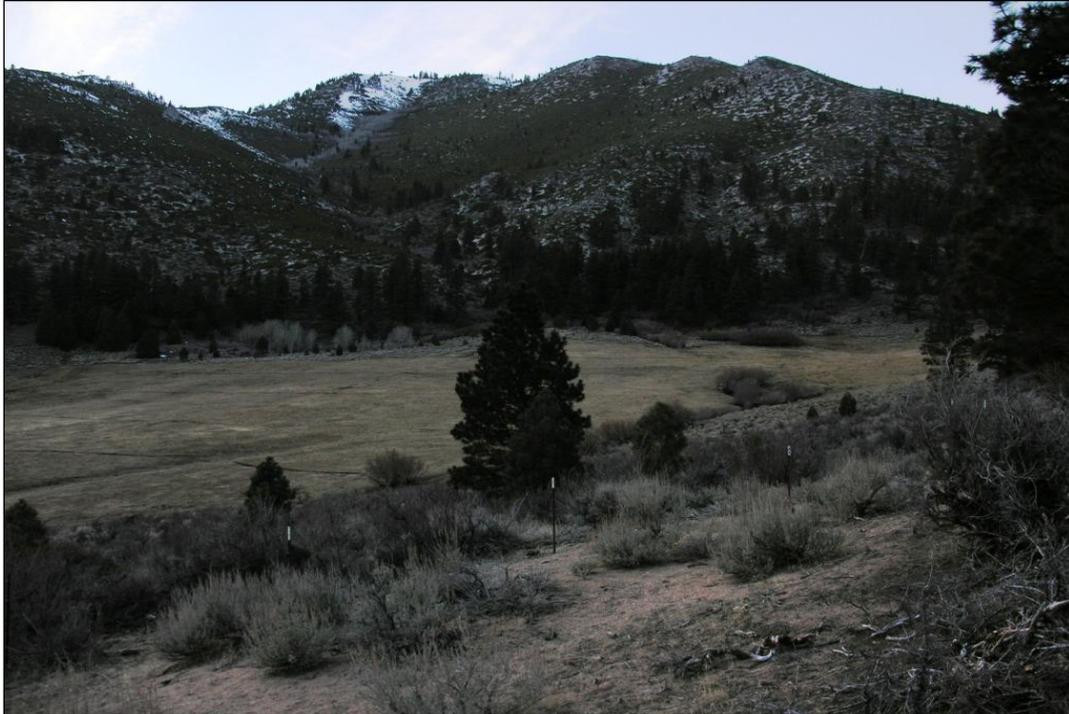
2009 Baseline Condition, photo taken February 4, 2009

Photo Point 8A (view northwest): A photo point overlooking the meadow from the east to the west located next to the property corner along the new road.

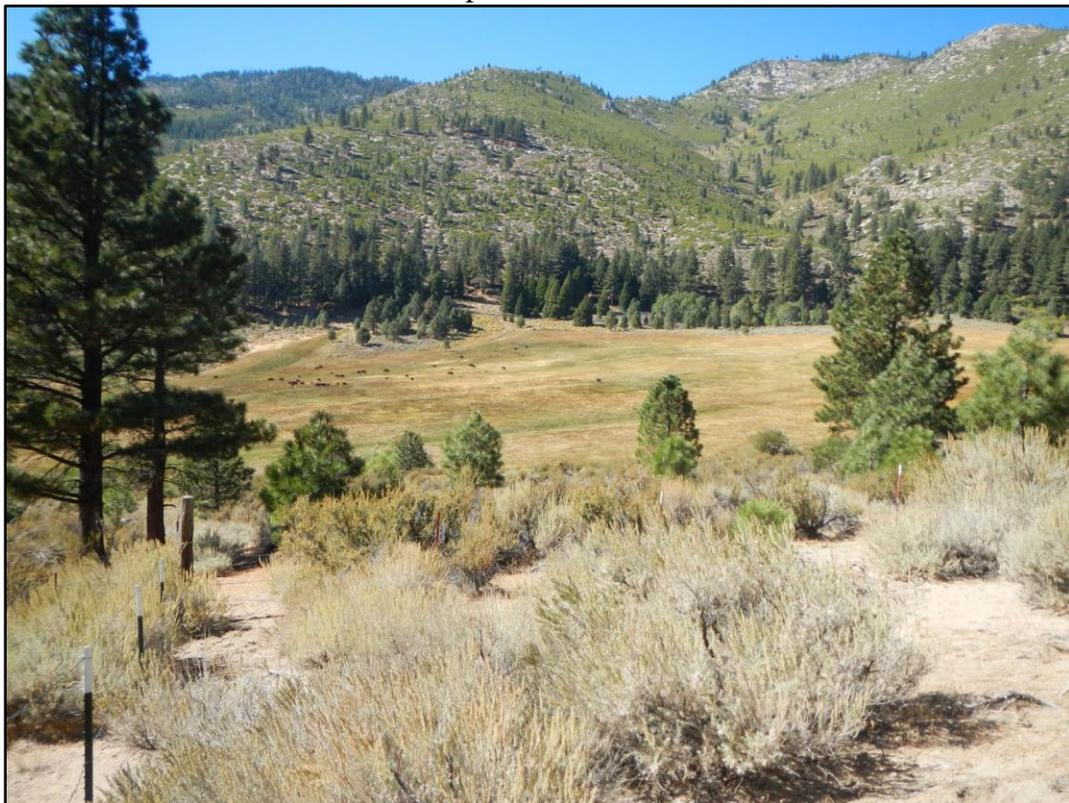
2018 Condition, photo taken October 8, 2018

Photo Point 8B (view west): A photo point overlooking the meadow from the east to the west located next to the property corner along the new road.

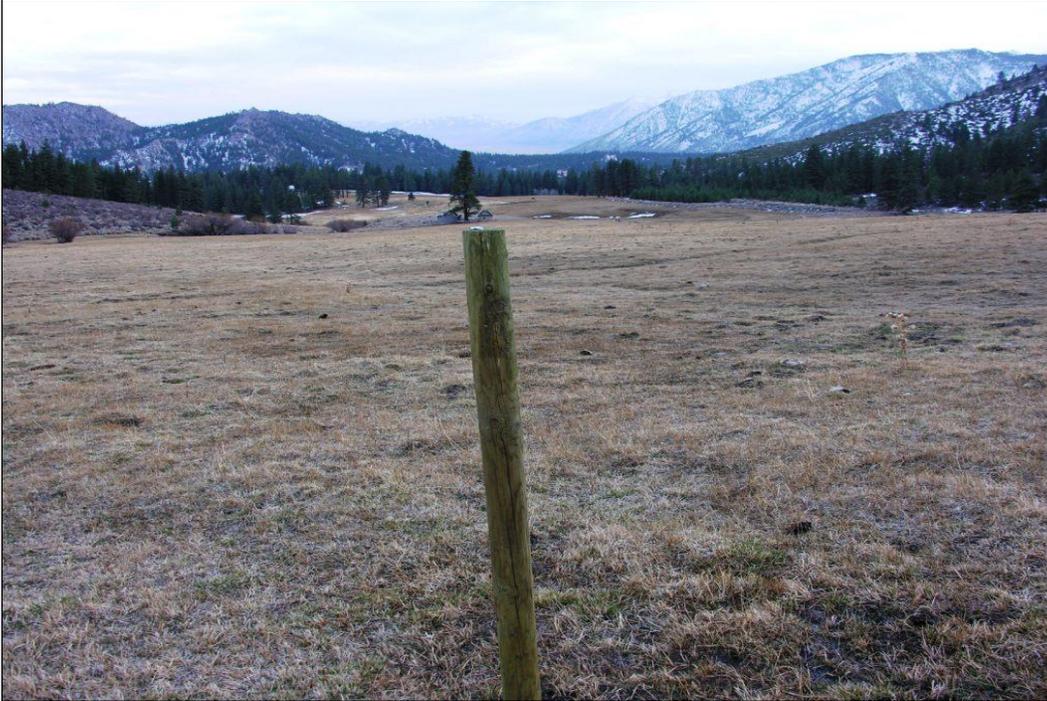
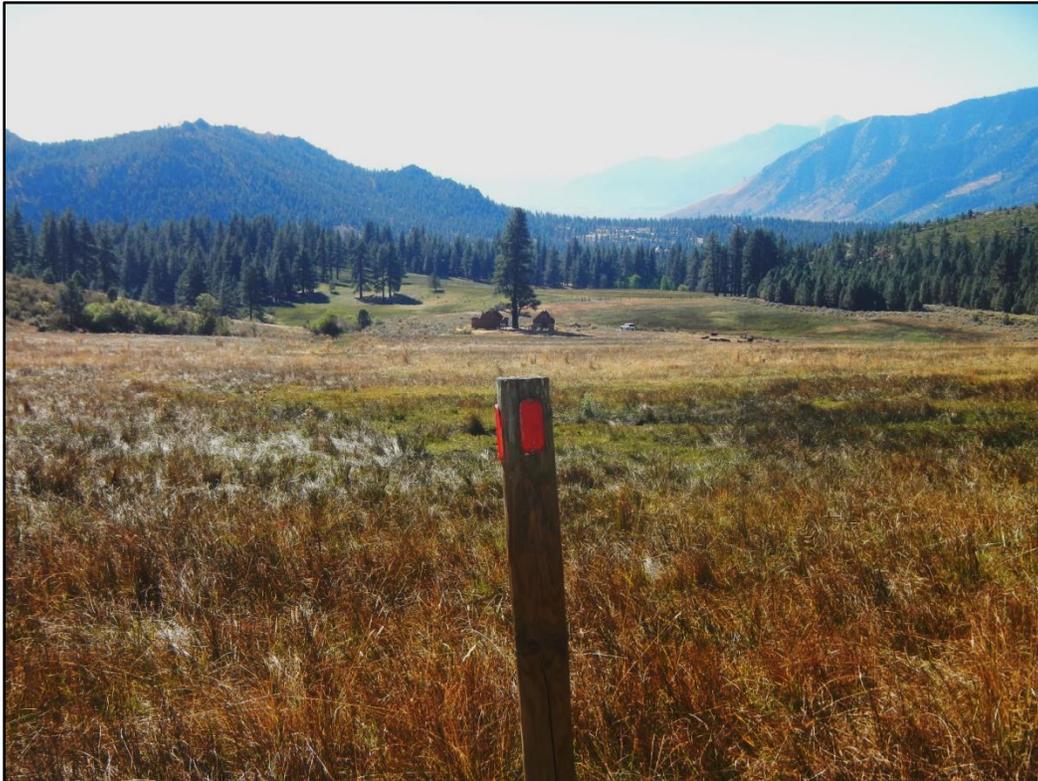
respectively. This Pasture Utilization and Condition Assessment included a visual observation of the monitoring plot as described in the Baseline Condition Report. A diversity of pasture, wetland-associated (*Juncus*), and invasive grasses (cheatgrass) exhibited various utilization levels depending on species. It should be noted that cover of invasive grasses (cheatgrass) has reduced. Overall, grazing appeared negligible and an average stubble height of 3 – 4” was recorded.

Photo Point 9: A permanently marked 100' x 100' area to monitor pasture condition. This annual inventory will be used to monitor not only pasture condition but irrigation efficiency, vegetative response to drought and appropriate livestock utilization.

2009 Baseline Condition, photo taken February 4, 2009

2018 Condition, photo taken October 8, 2018
