# STAFF REPORT

**Agenda Title:** For Possible Action: Discussion and possible action regarding the annual monitoring report for the Horse Creek Ranch Conservation Easement for 2019.

## **Carson City Open Space – Conservation Easement Monitoring**

**Date:** September 12, 2019

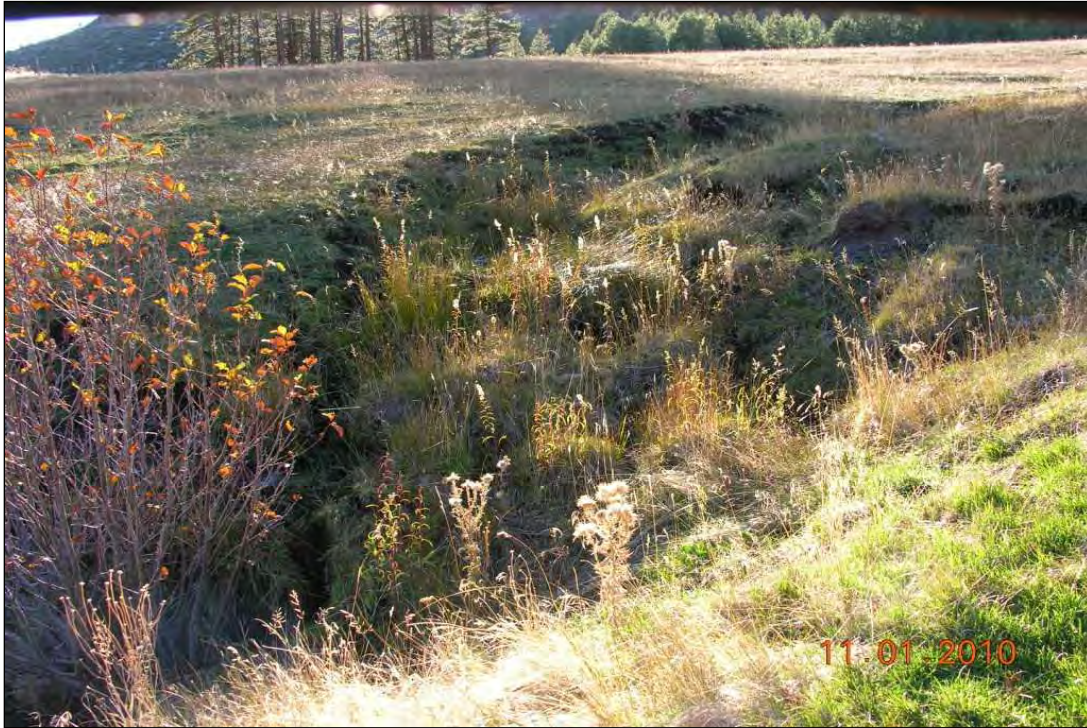
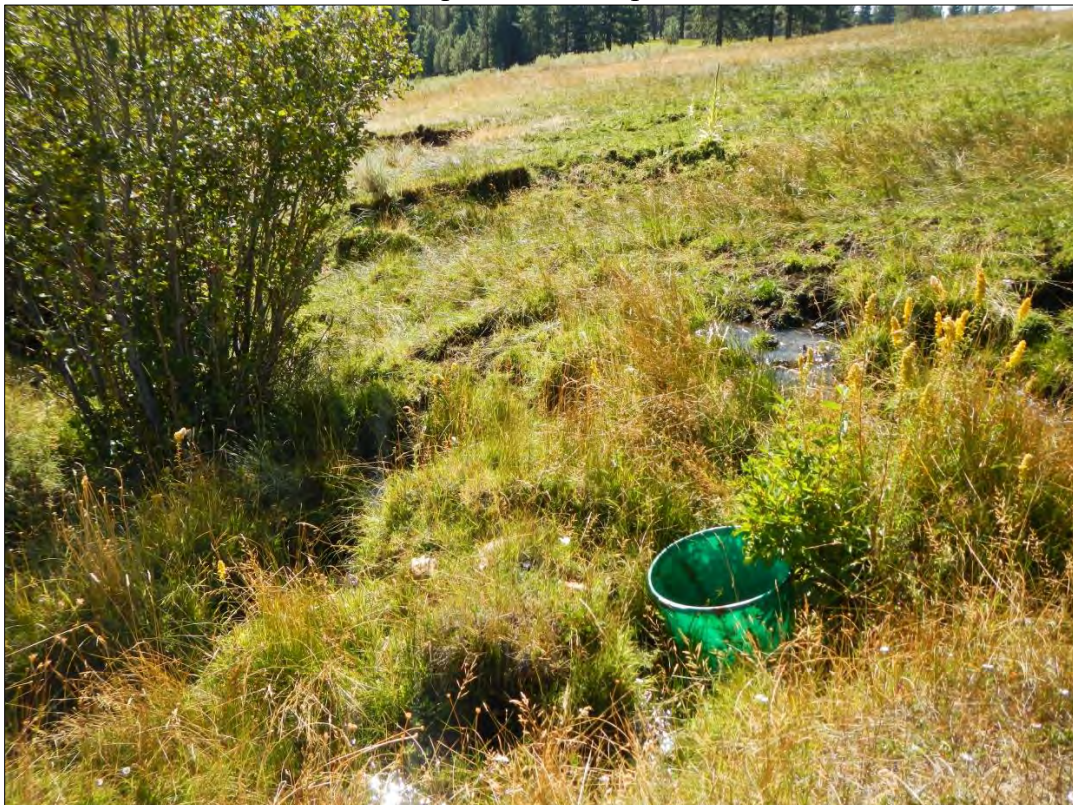
Near the southeast corner, one specific area is being monitored for landscape change. This low drainage area of the meadow appears to be vegetated and stable though a few isolated mounds or hummocks may be the result of cattle trampling. A qualitative assessment with the photo comparisons may be deceptive due to the time of year each photo was taken – either during the growing season or at the end of the season after grasses were grazed and/or senesced. However, monitoring completed in 2019 illustrates that the erosion is recovering naturally. Additionally, the new headcut observed in 2017 on the creek northeast of the cabins was attempted to be monitored, but after thorough searching could not be identified on the landscape. This site and associated reach of creek should be monitored in future years to confirm successful revegetation of the headcut, or to document change in size or location, as it could have migrated upstream. In conjunction with the USDA EQIP grant funding that was awarded to repair irrigation structures and efficiency, Mr. Fagen also applied for additional USDA EQIP grants to fund the design and repair plan for the existing headcuts.

Photo Point: The photo of this drainage, located south of the cabins, has been included to document change and vegetation growth. N 39 07' 42.7" W 119 50' 10.2"

2010 Condition, photo taken November 1, 2010 (initial assessment – view west)

2019 Condition, photo taken September 12, 2019

Unfortunately, due to access challenges and a lack of available contractors willing to complete the work, Mr. Fagen had to withdraw his application. In the future, a conservation organization such as the Great Basin Institute or Nevada Division of Forestry could be contracted to complete the work through non mechanized means. This would mitigate the challenge of getting large pieces of mechanized equipment to the site to complete this project. However, a repair design still needs to be completed.

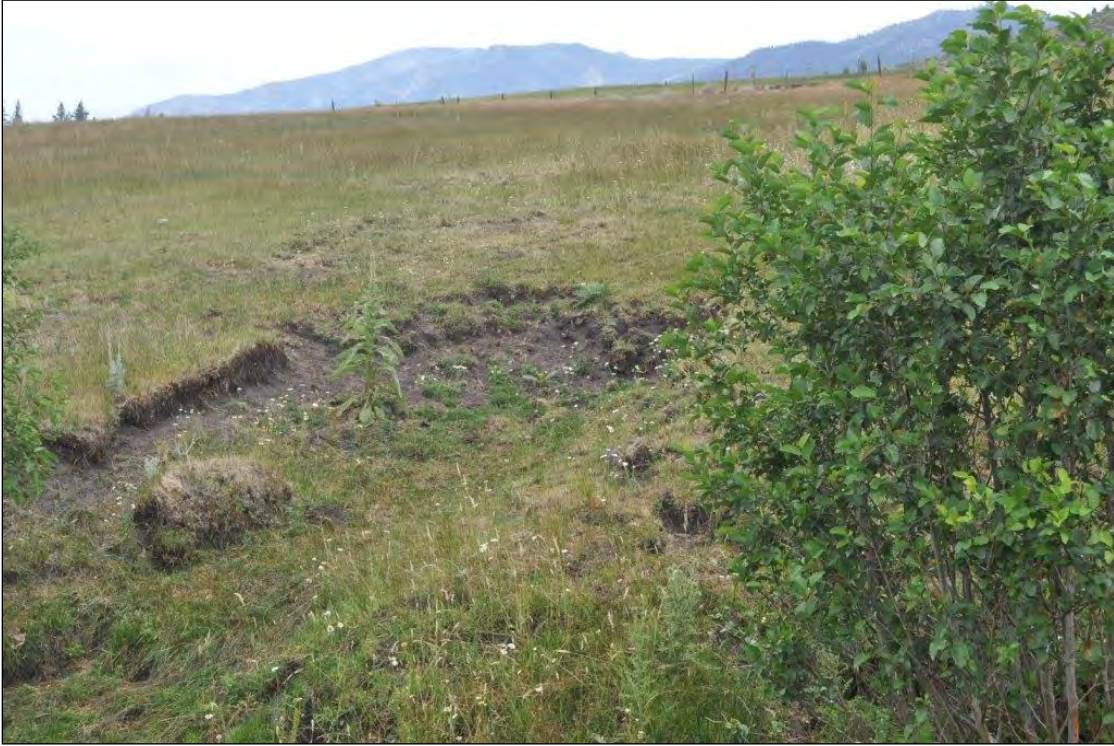
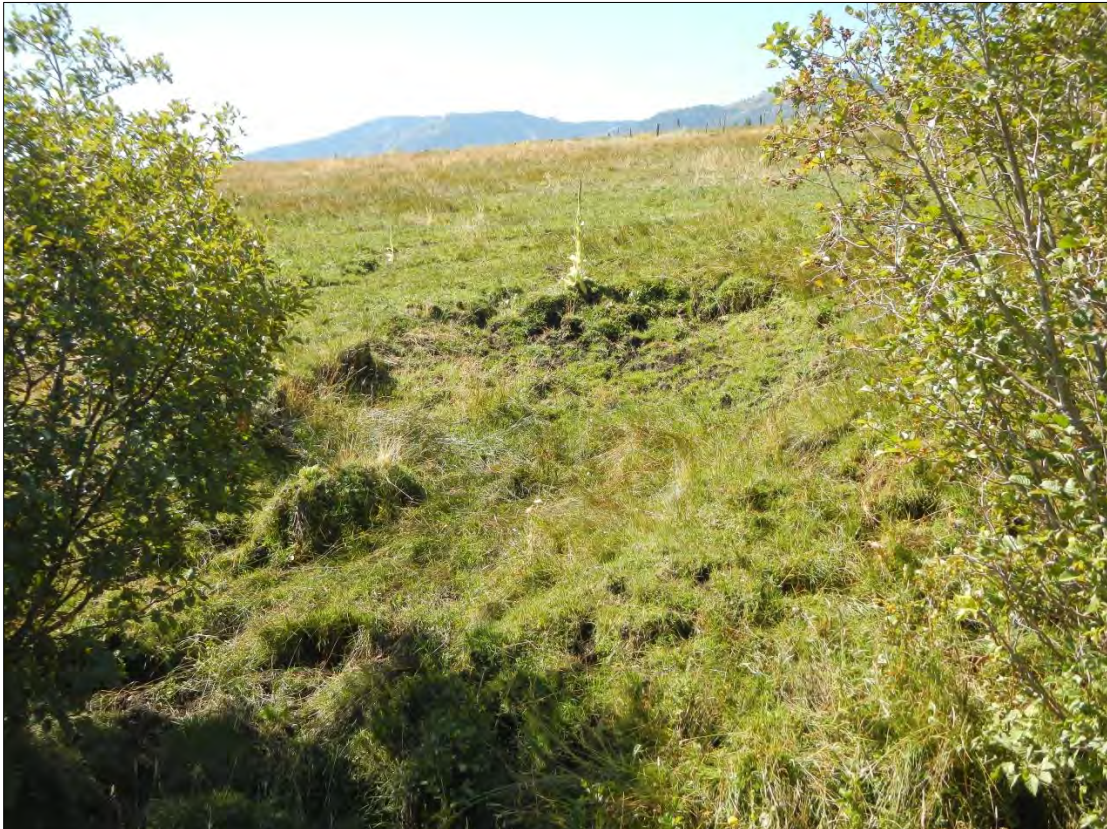
2013 Condition, photo taken July 23, 2013 (initial assessment – view south)

2019 Condition, photo taken September 12, 2019

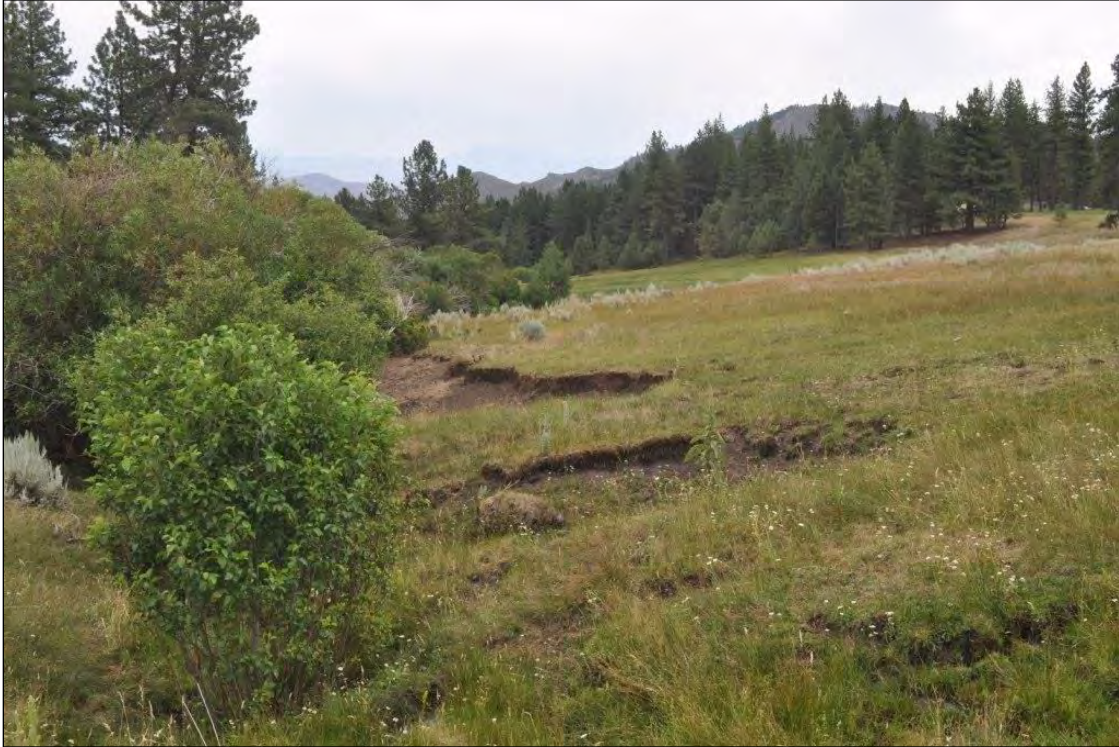
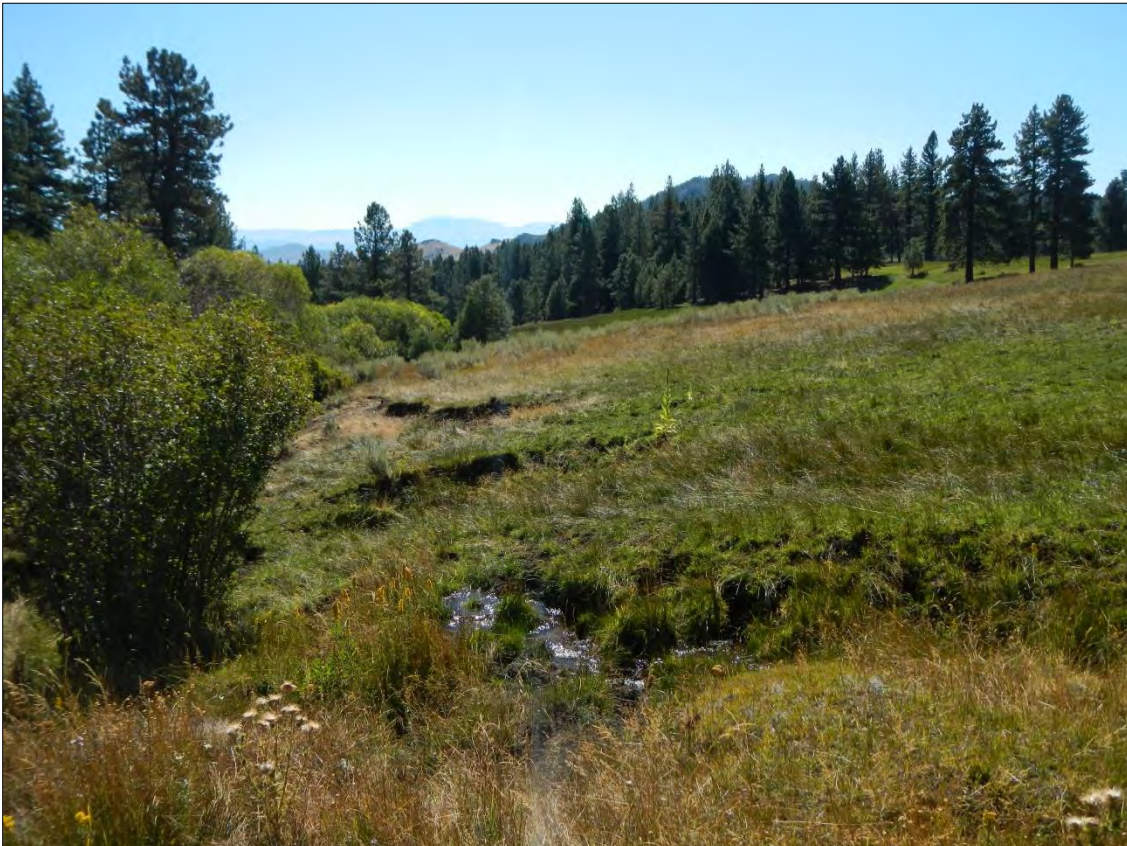
2013 Condition, photo taken July 23, 2013 (initial assessment – view south)

2019 Condition, photo taken September 12, 2019

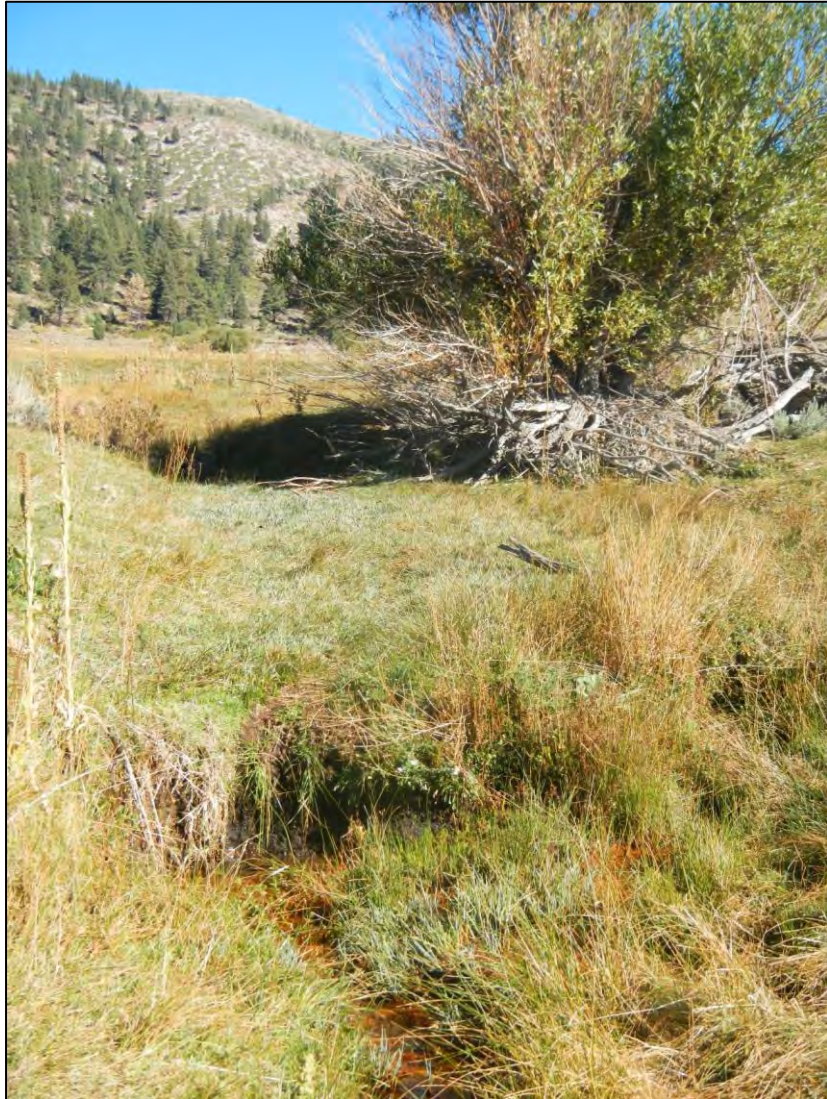
Photo Point: The photo of this headcut, located northeast of the cabins, has been included to document stream channel changes and erosion. N 39 07' 51.0" W 119 50' 11.4"

2018 Condition, photo taken October 8, 2018 (view north)

After completing a thorough survey of the site and associated creek, staff could not see the headcut on the landscape. This feature appears to have healed and revegetated beyond identification of the conditions shown above. Monitoring of this feature will continue in 2020, but if it cannot be identified at that time the photo point will be removed from the monitoring report.

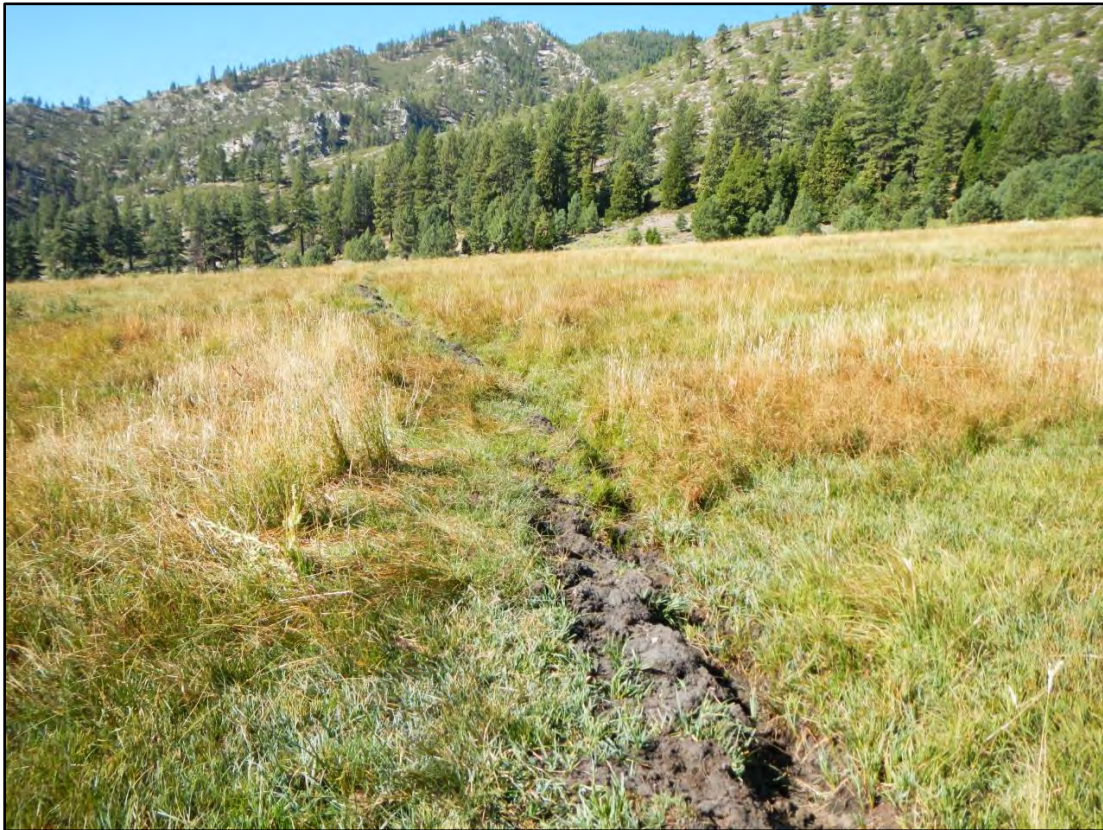
Photo Point: The photo of this newly constructed lateral irrigation ditch, located in the upper meadow has been included to document site improvements. Additionally, bull thistle was already observed colonizing the banks of the new ditch, so these areas will need to be monitored and focused on in future volunteer thistle dig events. N 39° 7' 58.1196"W 119° 50' 14.0172"

2019 Condition, photo taken September 12, 2019 (view west)

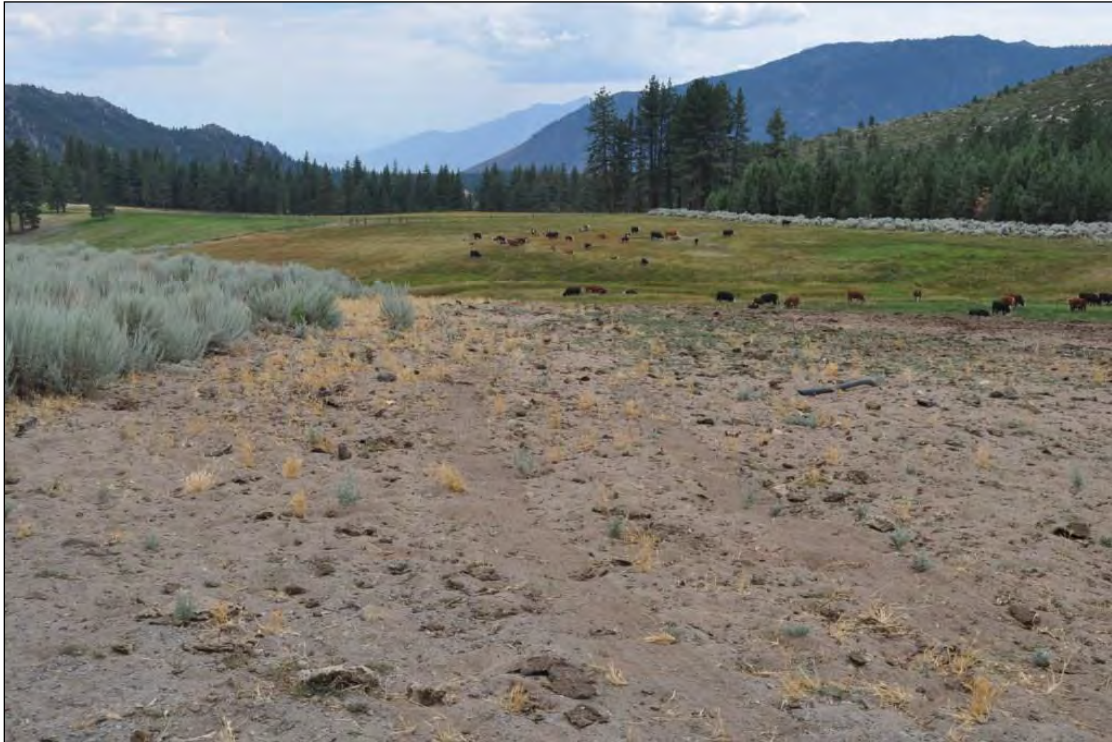
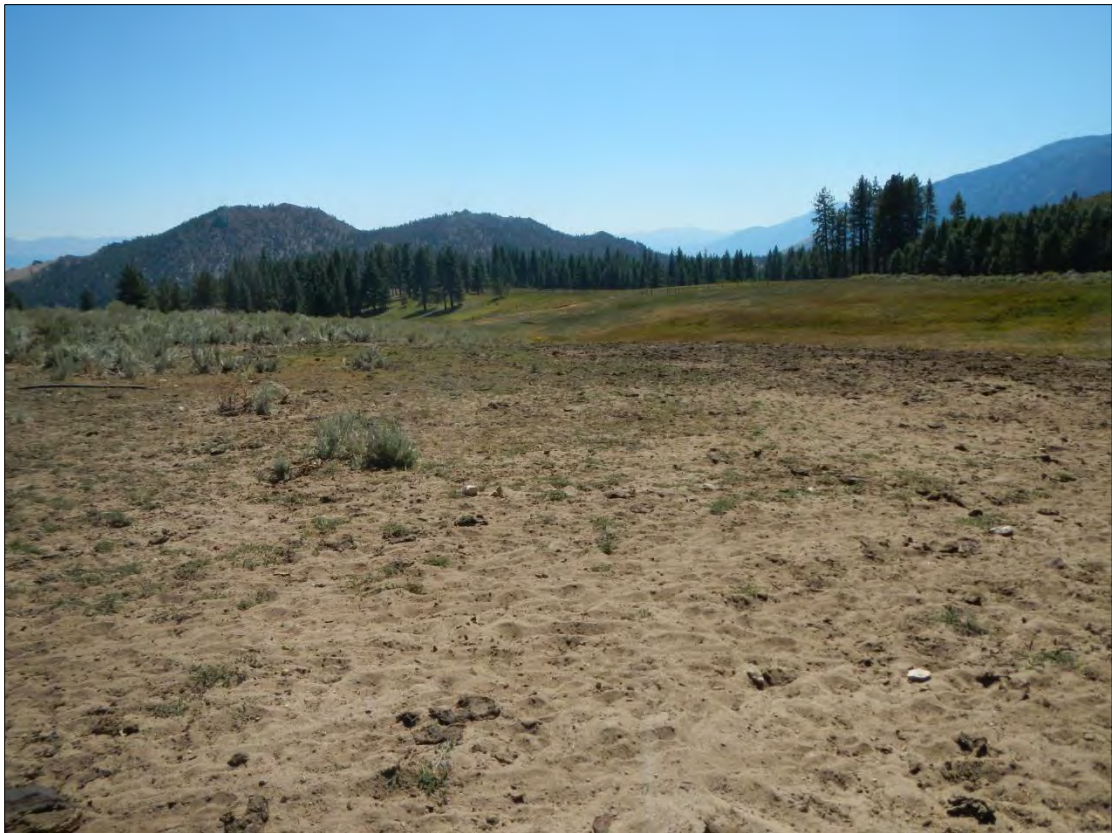
- The previous reports recommended the monitoring of the cattle loading area located just outside the gated entrance to the cabins with the goal to limit further expansion. The following documentation provides photo points and respective measurements. The disturbed area consists primarily of cheatgrass and foxtail barley although sagebrush is successfully re-establishing on both the north and east edge of the disturbed area. The disturbed area has shown an overall reduction in size over the last two monitoring cycles, however this particular monitoring period revealed that the extent of the loafing area north-south has increased by 4 feet, while the extent east-west has been reduced by 37 feet since 2013. Lastly, it is important to note that depending on the timing of monitoring, cheatgrass abundance and cover varies indicating that cattle are likely grazing the cheatgrass.

2013 Condition, photo taken July 23, 2013 (initial assessment – view south):  
The bare area measures 157' north to south along the sagebrush.

2019 Condition, photo taken September 12, 2019:  
The bare area measures 161' north to south along the sagebrush.

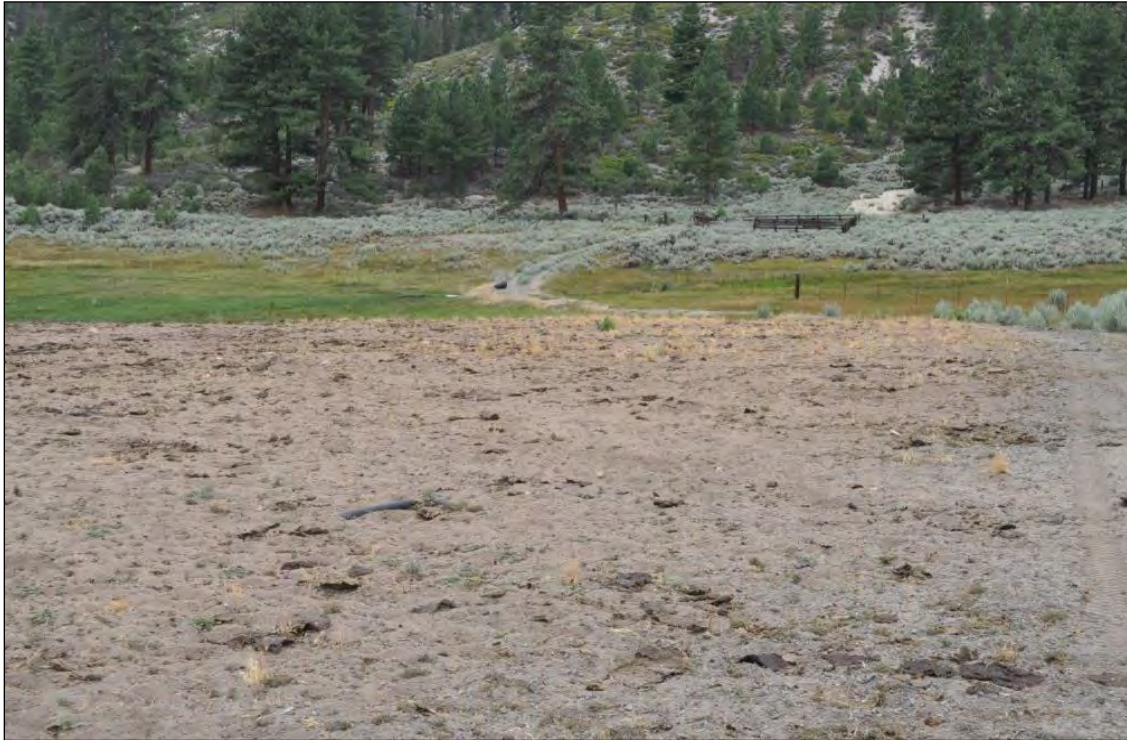
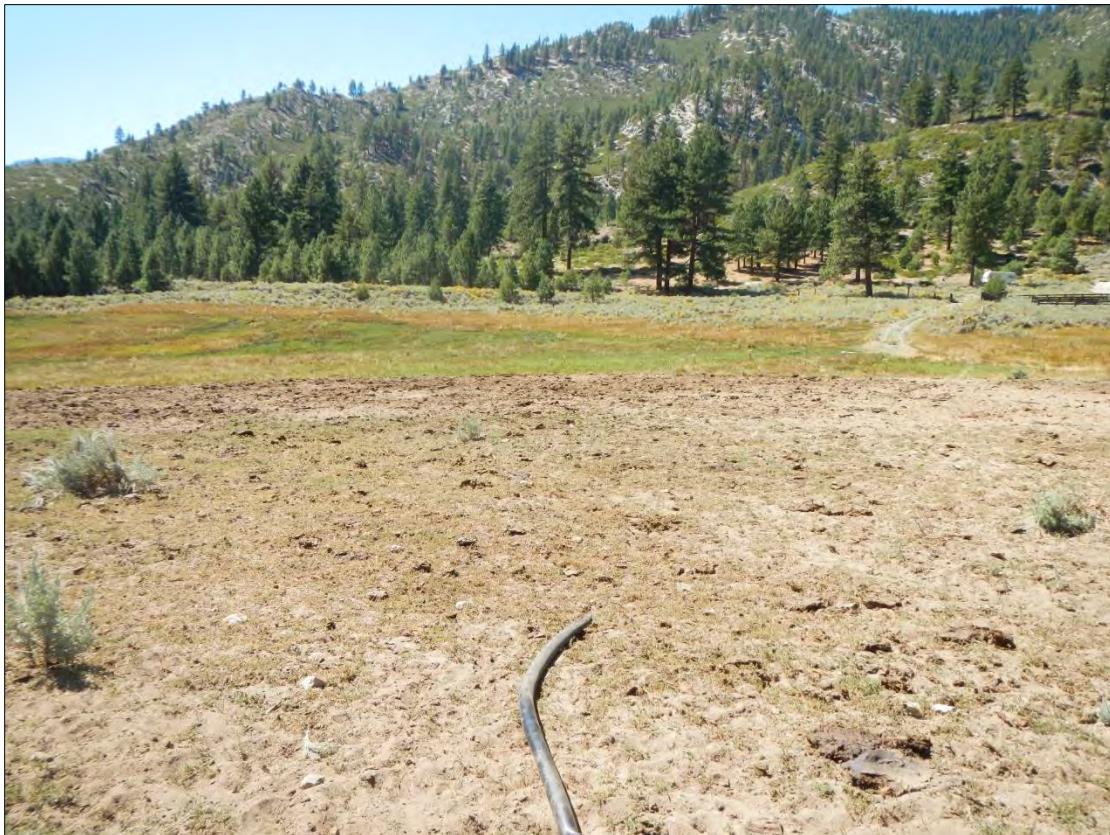
2013 Condition, photo taken July 23, 2013 (initial assessment – view west):  
The bare area measures 145' east to west along the gravel road.

2019 Condition, photo taken September 12, 2019:  
The bare area measures 108' east to west along the gravel road.

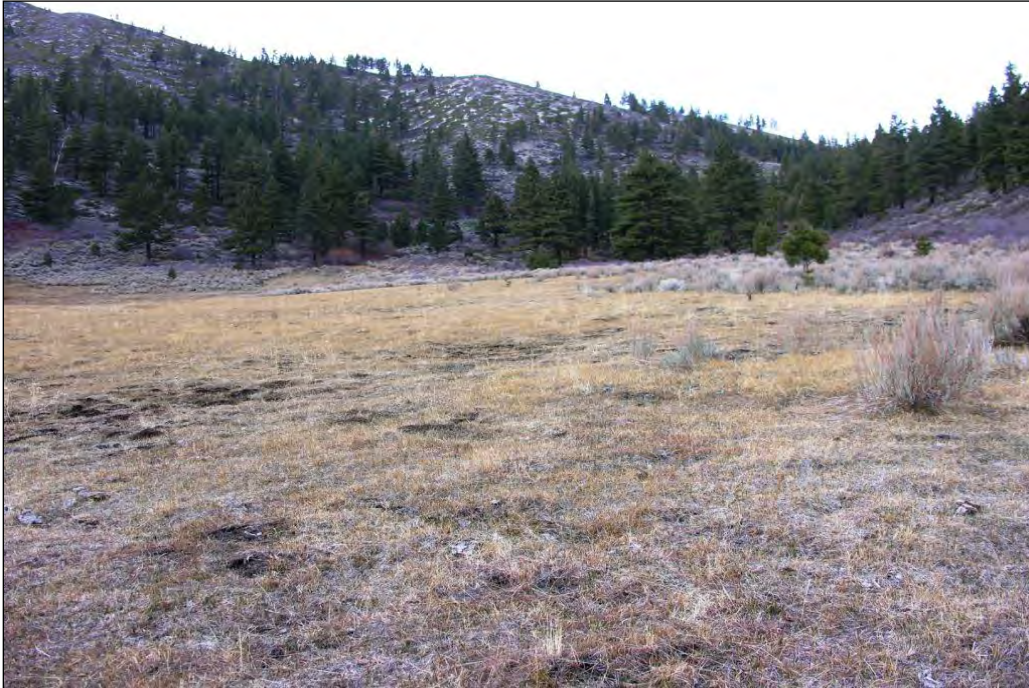
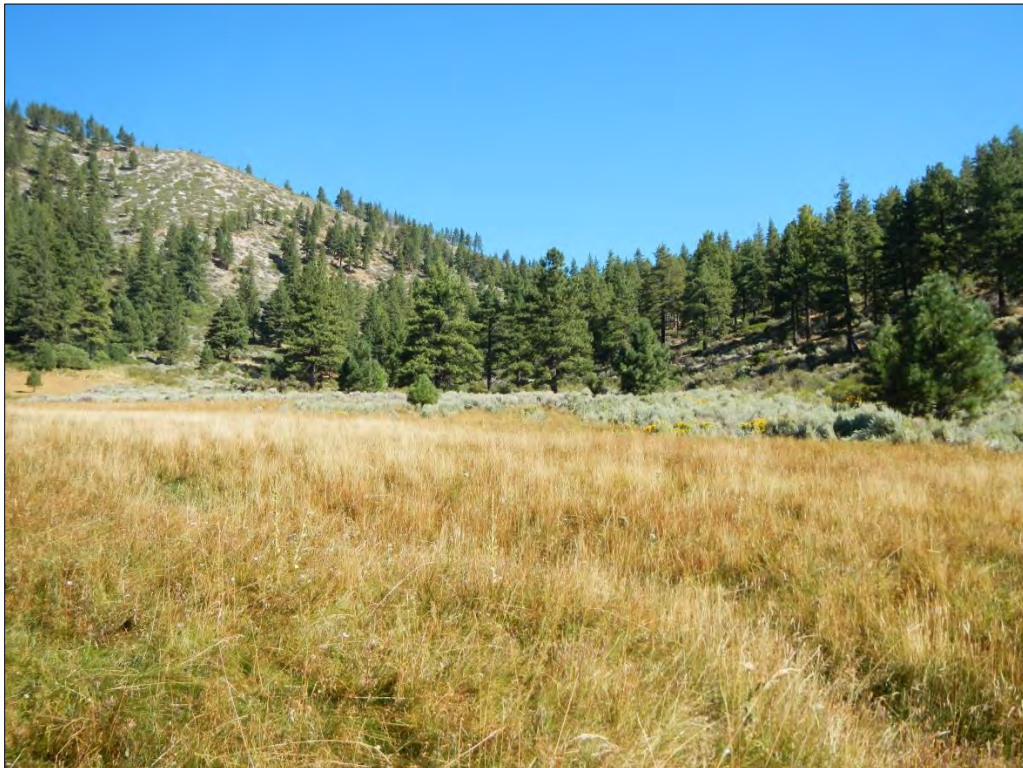
**Photo Point 1A (view northeast): A photo point located at the edge of the shrub dominated granitic fan and the irrigated meadow. This would be used to monitor shrub invasion into the meadow area indicating irrigation problems.**

2009 Baseline Condition, photo taken February 4, 2009:  
(GPS coordinate: N39° 08' 02.3" W119° 50' 11.8")

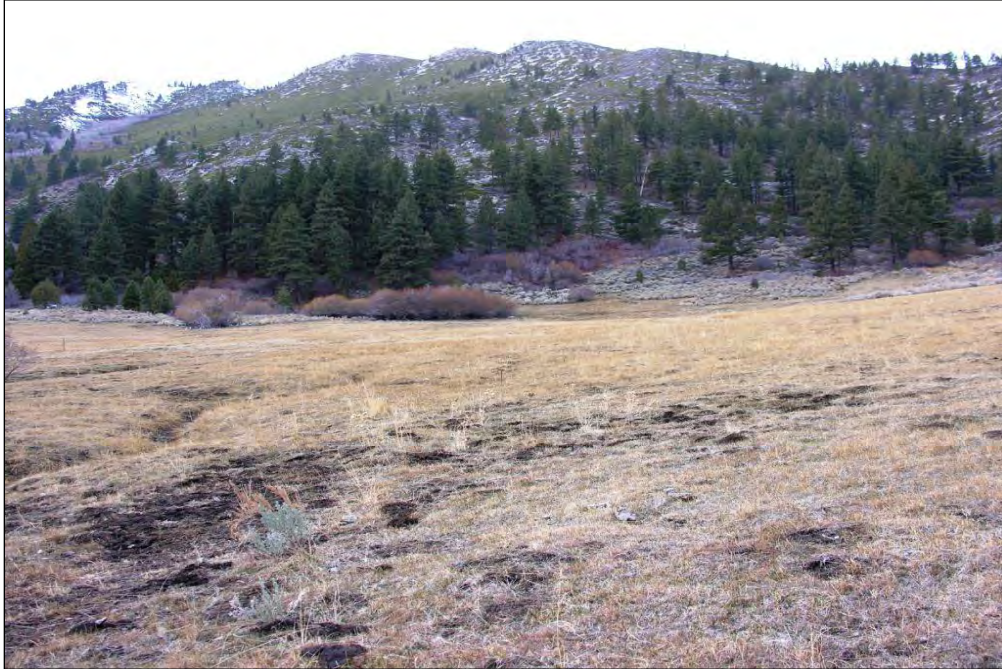
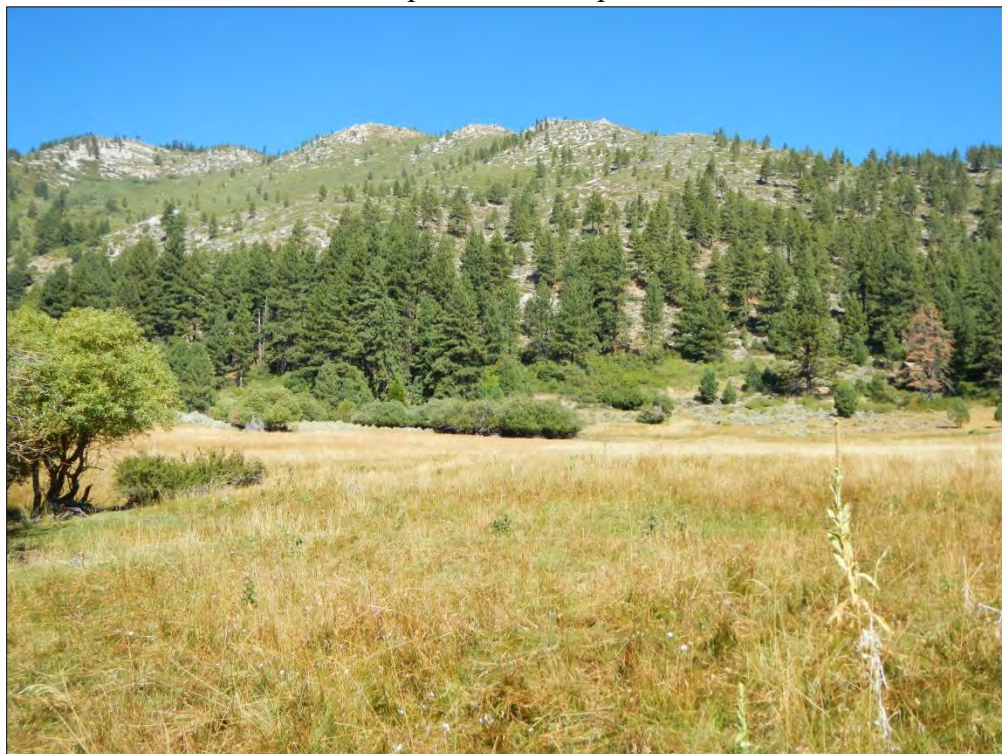
**Photo Point 1B (view northwest): A photo point located at the edge of the shrub dominated granitic fan and the irrigated meadow. This would be used to monitor shrub invasion into the meadow area indicating irrigation problems.**

2009 Baseline Condition, photo taken February 4, 2009:  
(Photo possibly taken from the upper meadow, near the new GPS coordinate for  
Photo Point 2 updated in 2010: N39 07' 54.9" W119 50' 11.3")

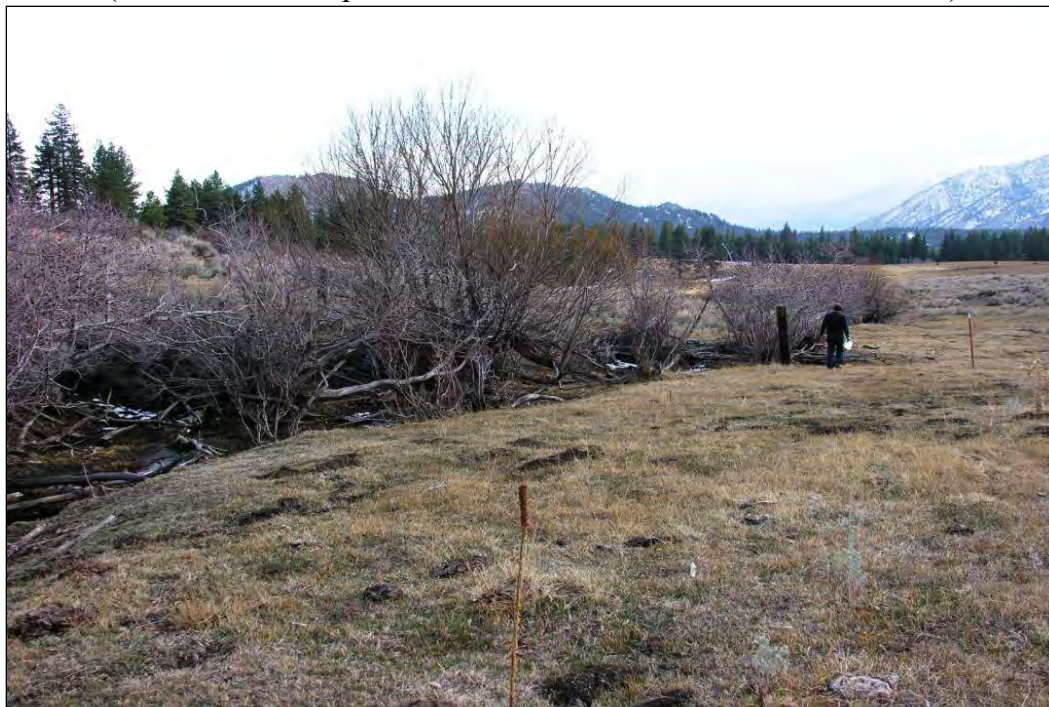
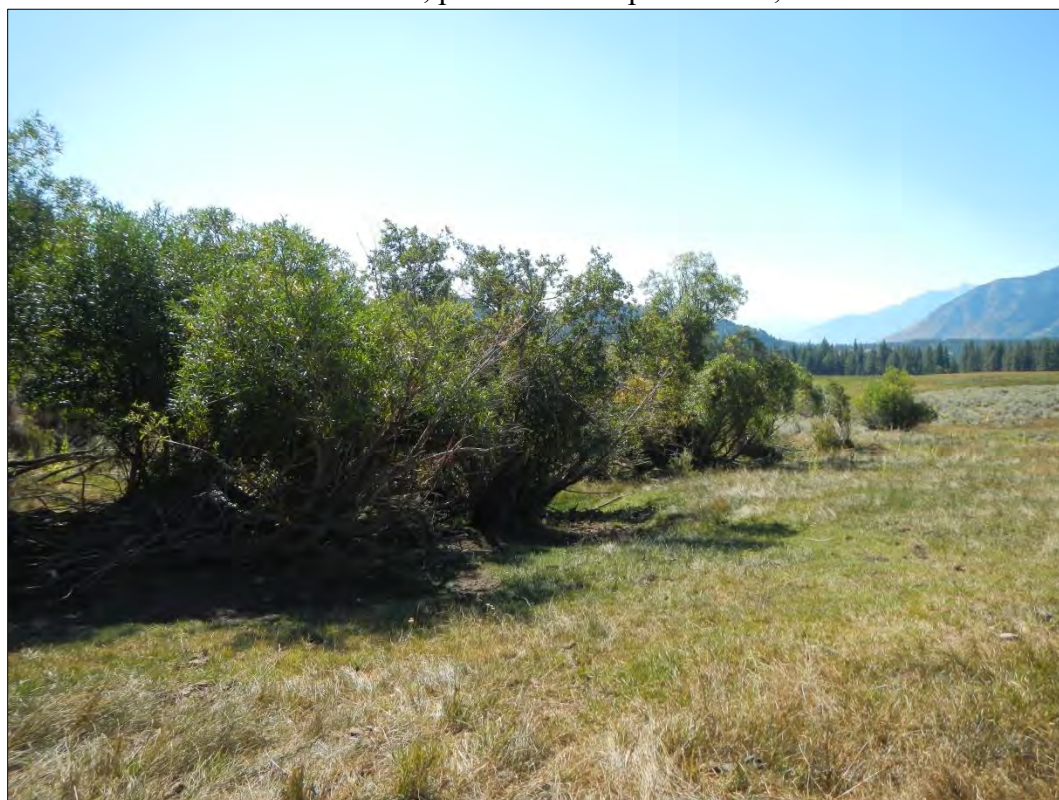
**Photo Point 2 (view south): A photo point located in bottom of the active stable drainage channel to the southeast of the house to monitor side slope stability.**

2009 Baseline Condition, photo taken February 4, 2009:  
(GPS coordinate updated in 2010: N39 07' 54.9" W119 50' 11.3")

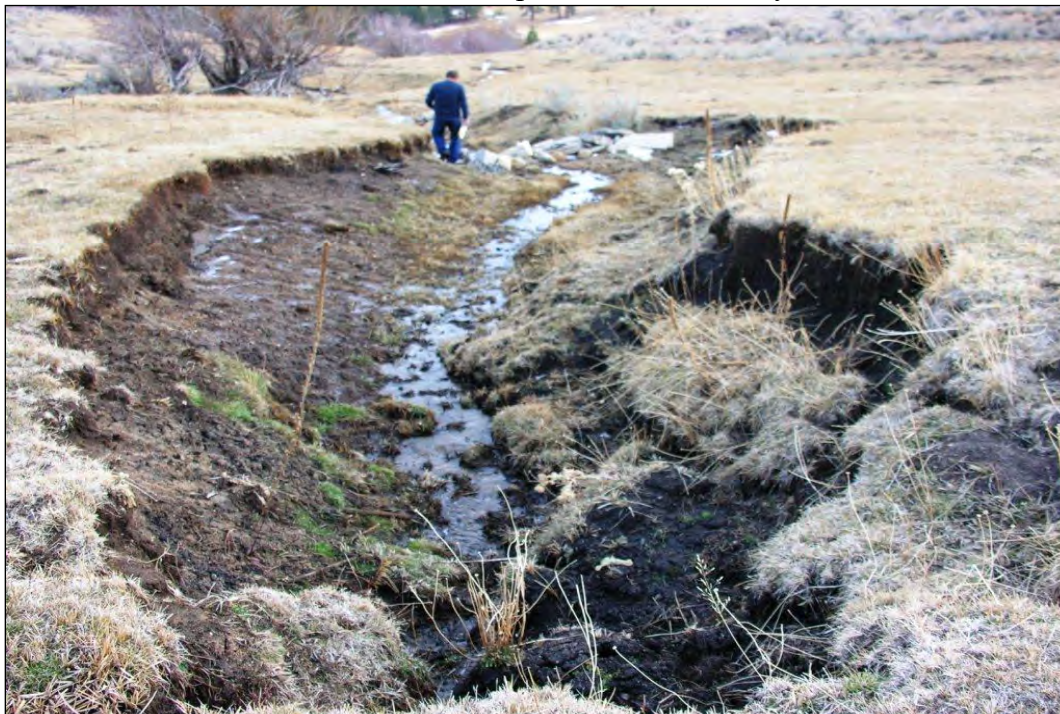
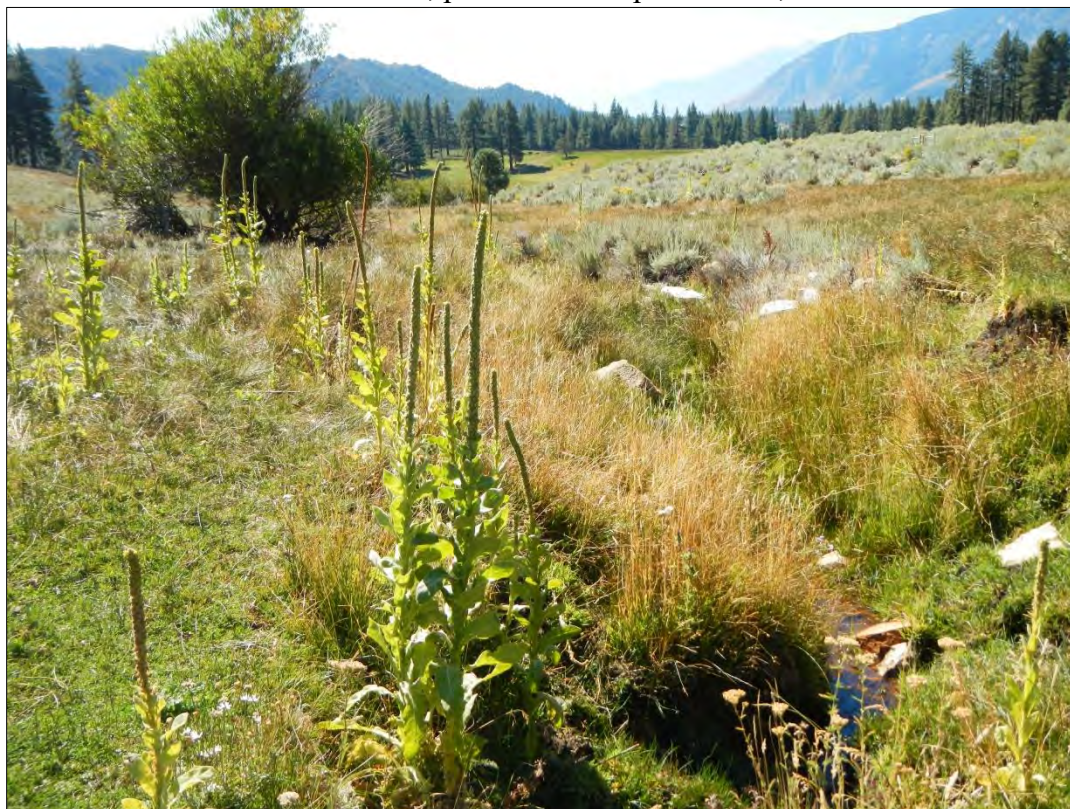
**Photo Point 3 (view south): A photo point located immediately east of the house in the active channel where rip-rap has been placed for stabilization.**

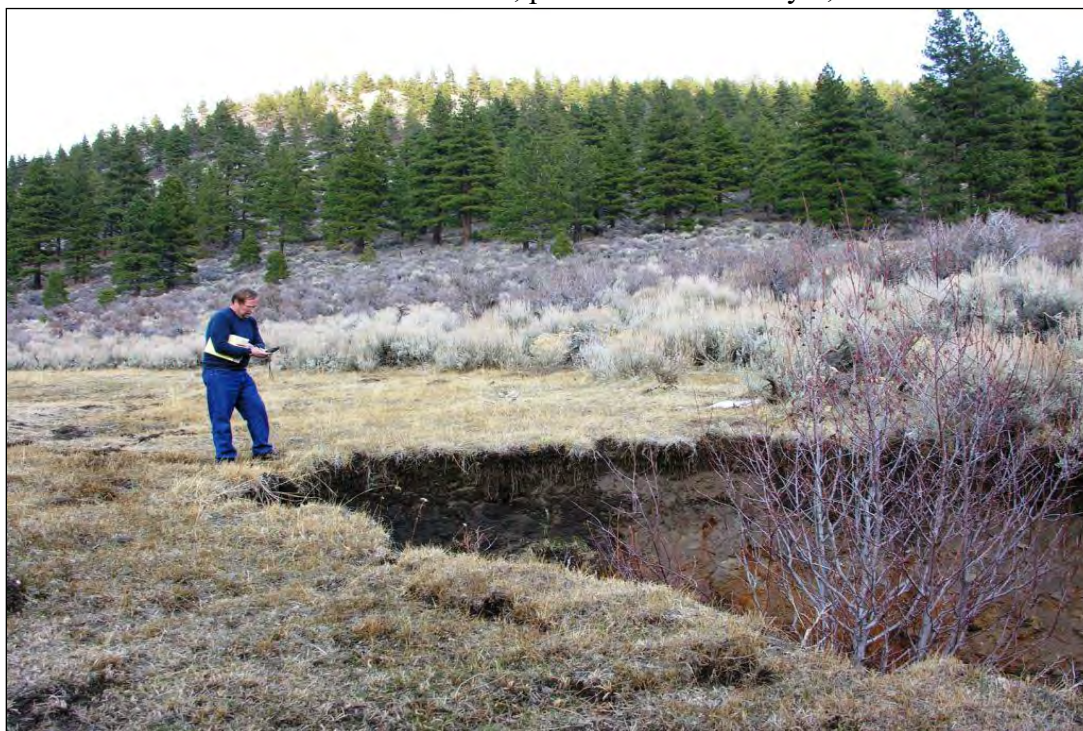
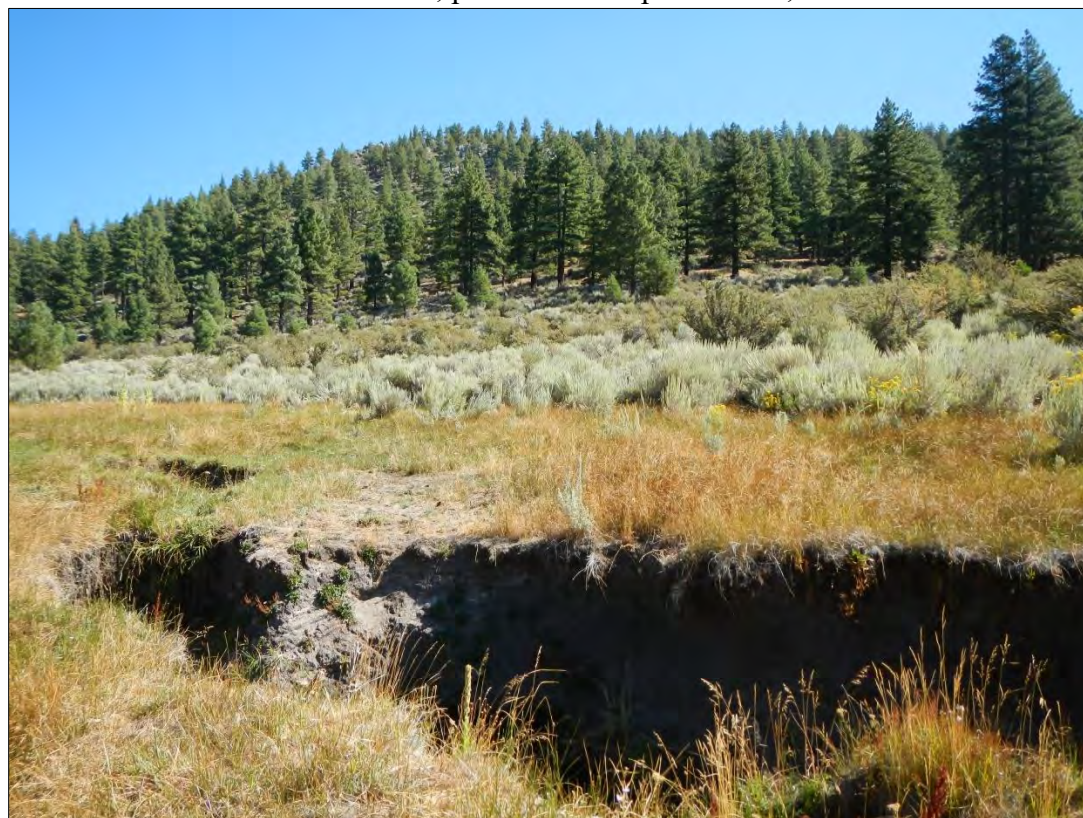
**Photo Point 4A (view north): A photo point located at the most northern active headcut after required stabilization to monitor effectiveness.**

- 1) Continue to work to identify a mitigation strategy and repair plan for existing headcuts to be implemented 2020-2021.
- 2) Continued removal of bull thistle.

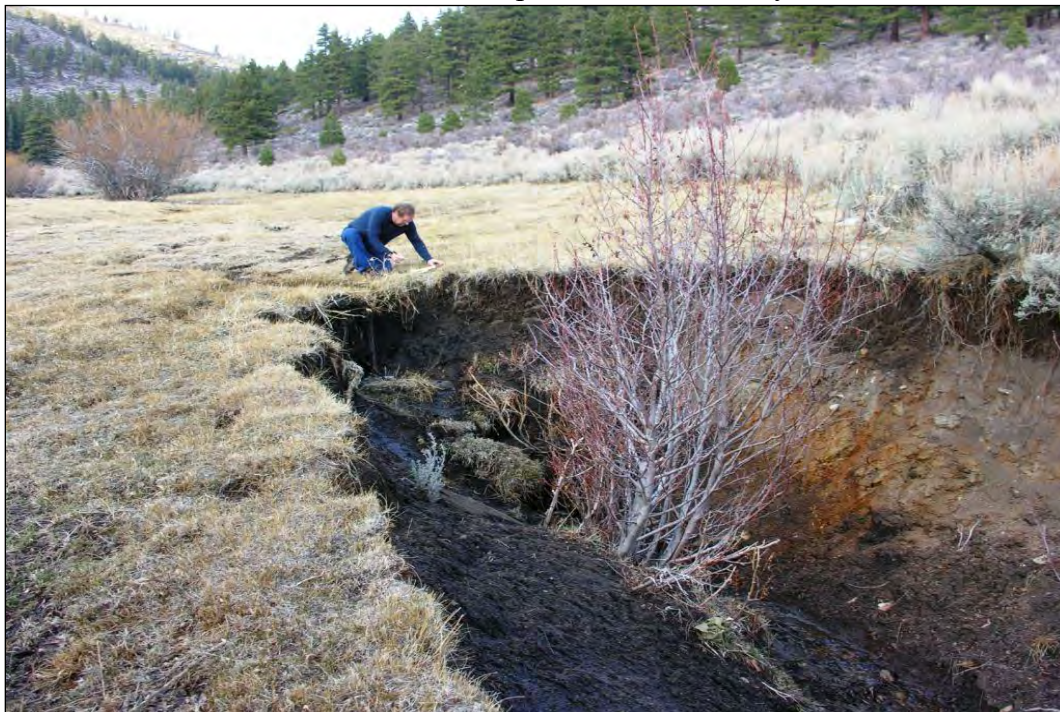
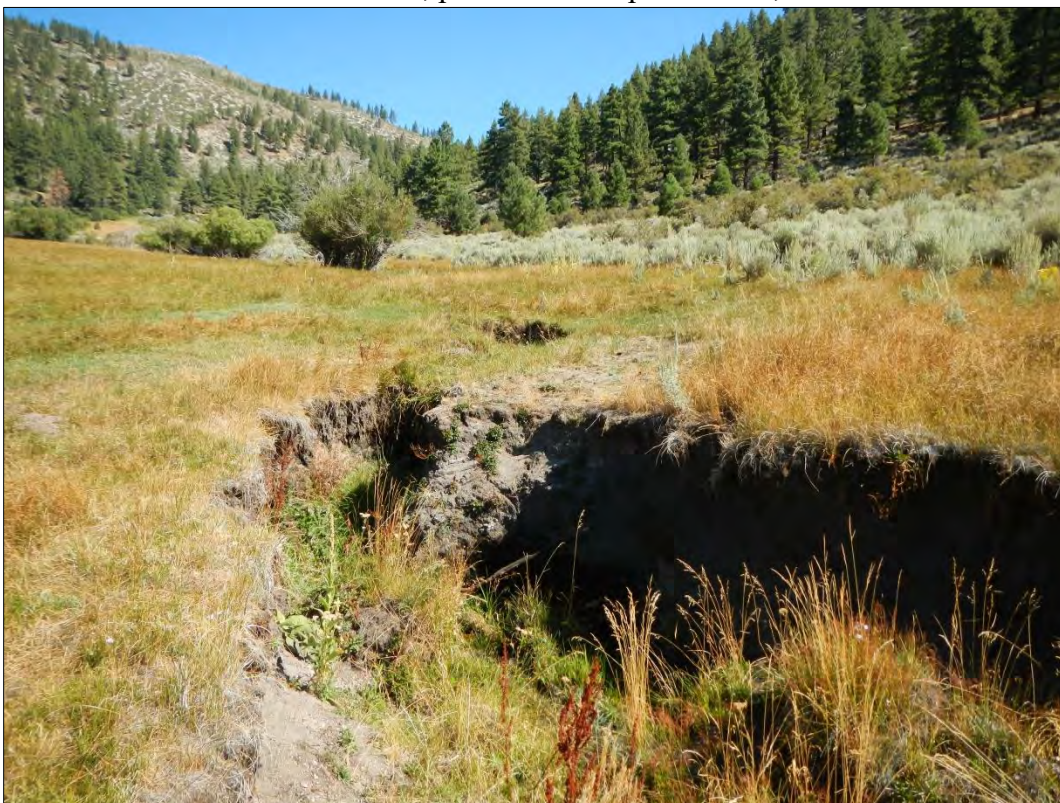
**Photo Point 4B (detail): A photo point located at the most northern active headcut after required stabilization to monitor effectiveness.**
