# STAFF REPORT

**Agenda Title:** For Possible Action: Discussion and possible action regarding the annual monitoring report for the Horse Creek Ranch Conservation Easement for 2019.

## **Carson City Open Space – Conservation Easement Monitoring**

**Date:** September 12, 2019

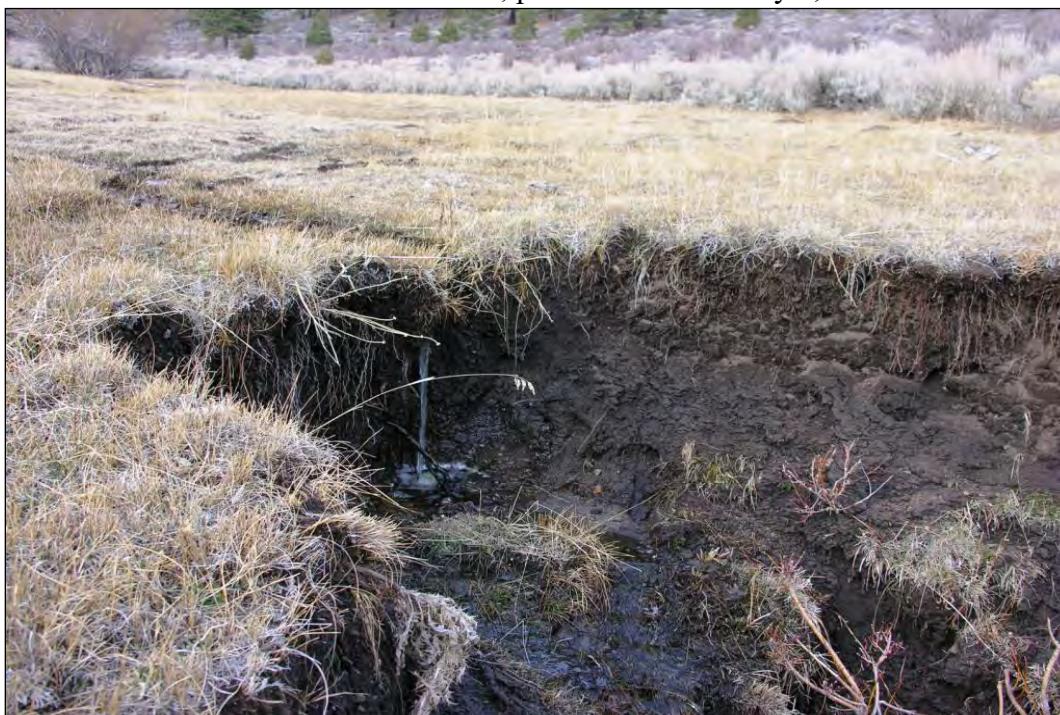
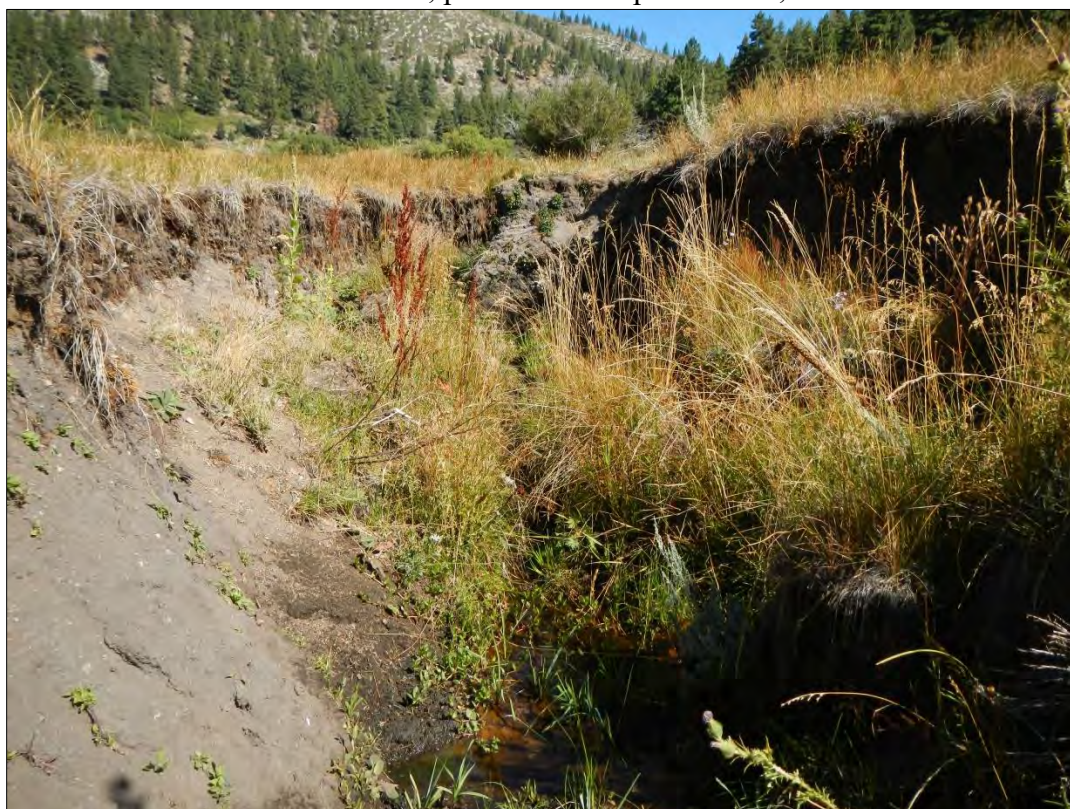
**Photo Point 4C (detail): A photo point located at the most northern active headcut after required stabilization to monitor effectiveness.**

- 1) Continue to work to identify a mitigation strategy and repair plan for existing headcuts to be implemented 2020-2021.
- 2) Continued removal of bull thistle.

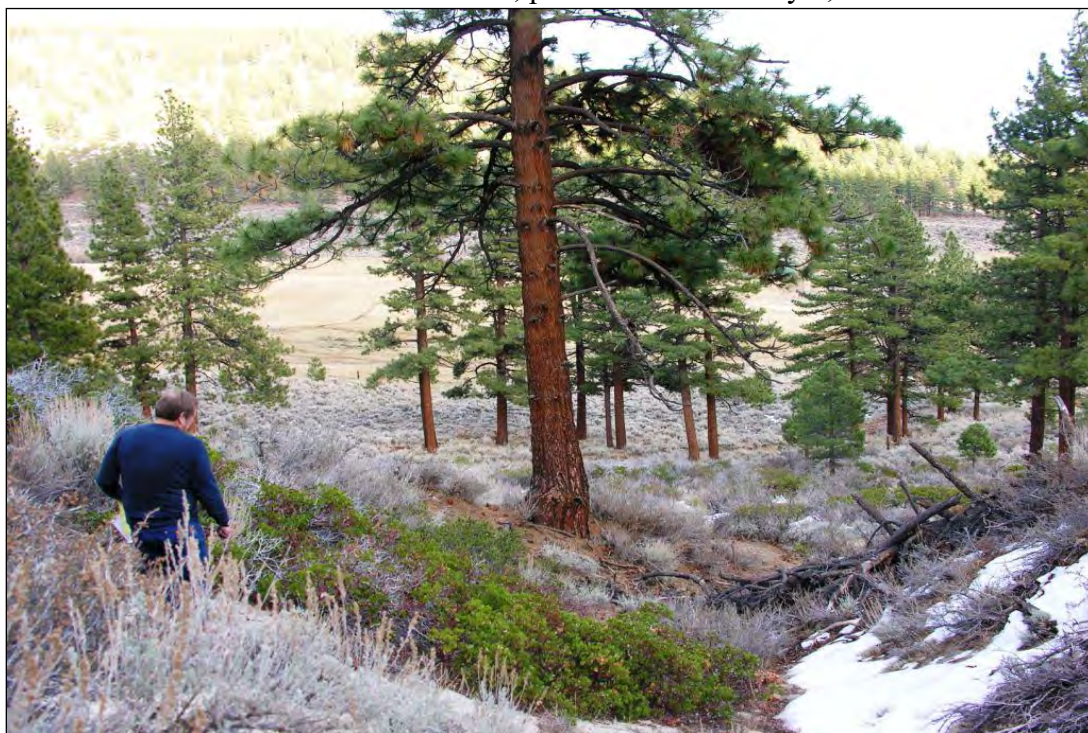
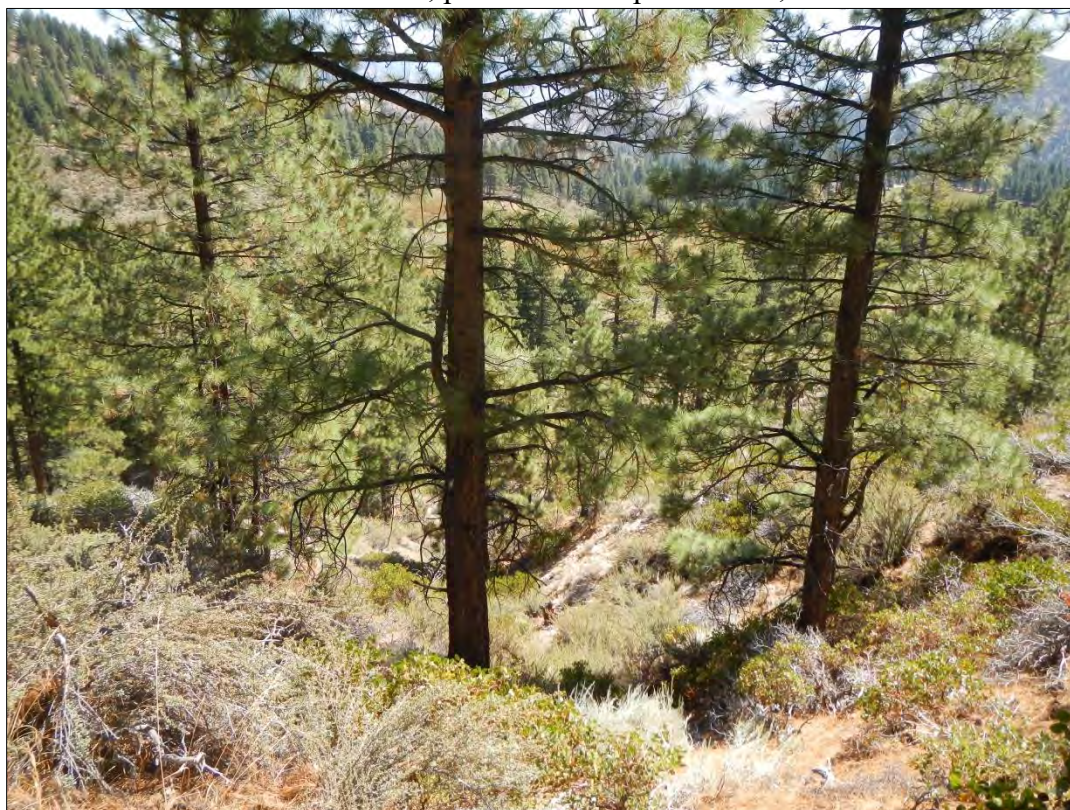
**Photo Point 5 (view east): A photo point on the hillside conveyance ditch at a location where a previous washout has occurred to monitor ditch maintenance.**

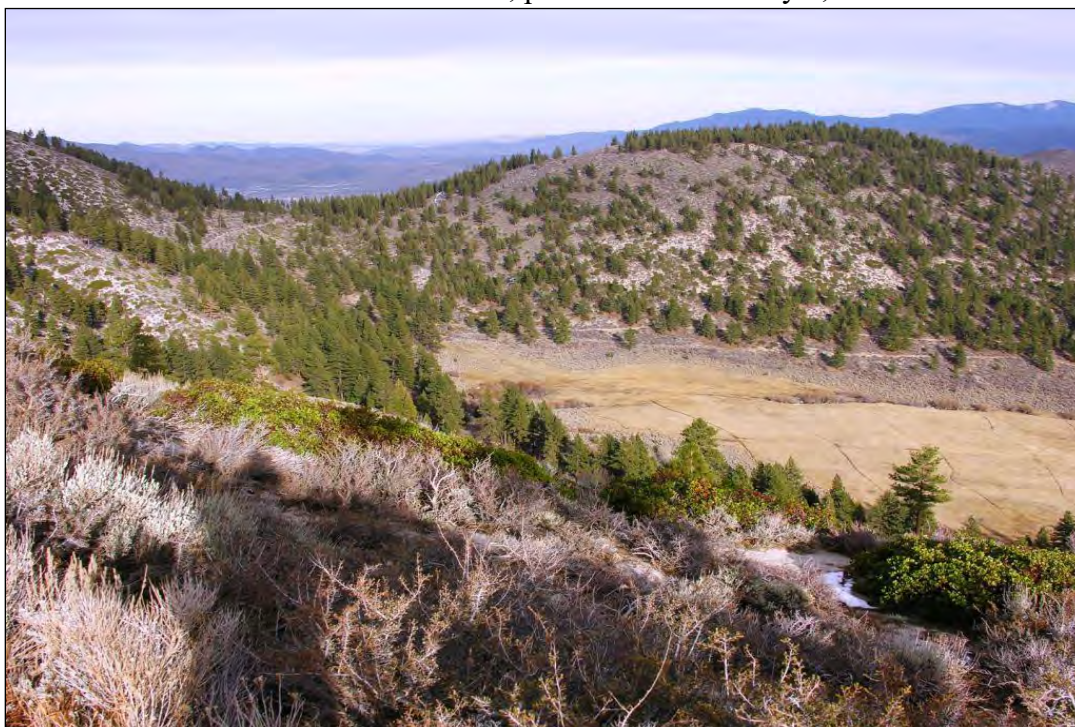
2009 Baseline Condition, photo taken February 4, 2009

**Photo Point 6A (view north): A photo point from the Kings Canyon Road that would provide panoramic views of the ranch from a west to east perspective.**

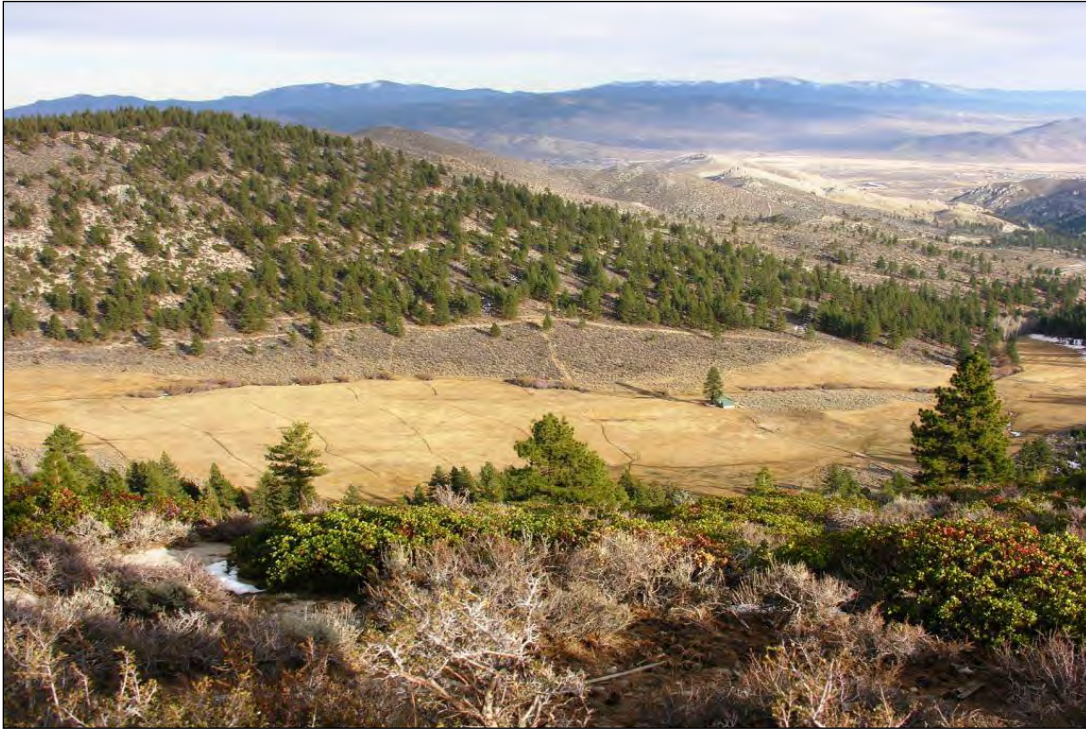
2009 Baseline Condition, photo taken February 4, 2009

**Photo Point 6B (view center): A photo point from the Kings Canyon Road that would provide panoramic views of the ranch from a west to east perspective.**

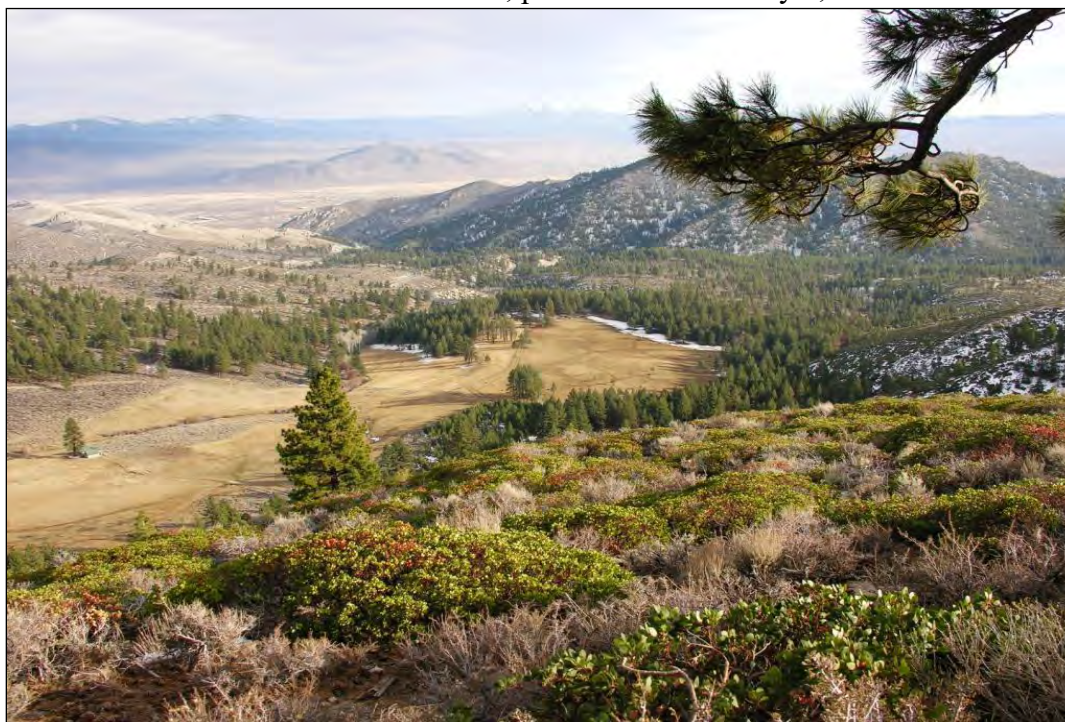
2009 Baseline Condition, photo taken February 4, 2009

**Photo Point 6C (view south): A photo point from the Kings Canyon Road that would provide panoramic views of the ranch from a west to east perspective.**

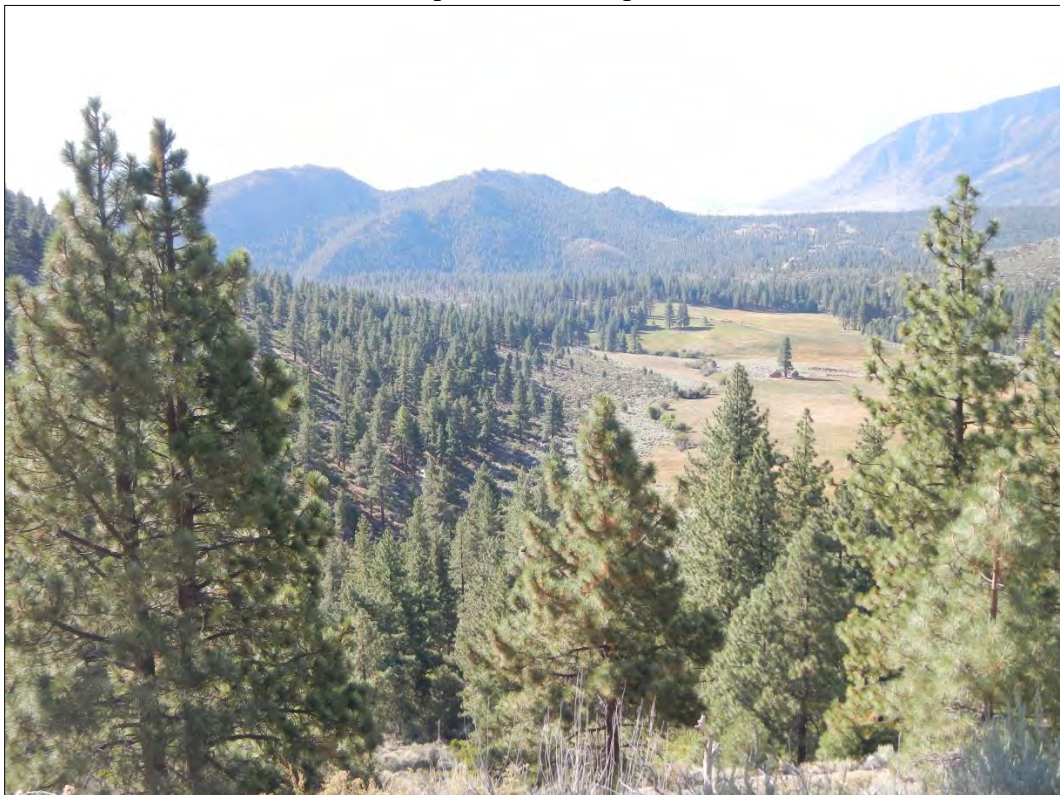
2019 Condition, photo taken September 12, 2019

**Photo Point 7A (view southeast): A photo point from Kings Canyon Road that would provide panoramic views of the ranch from a north to south perspective.**

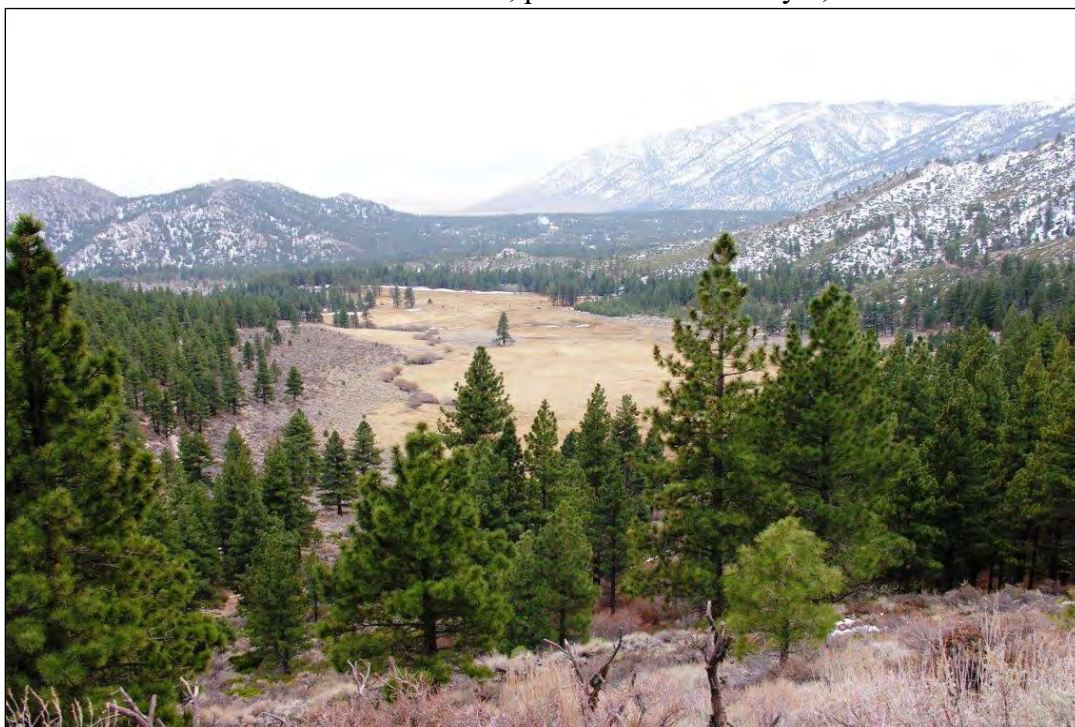
2009 Baseline Condition, photo taken February 4, 2009

**Photo Point 7B (view south): A photo point from Kings Canyon Road that would provide panoramic views of the ranch from a north to south perspective.**

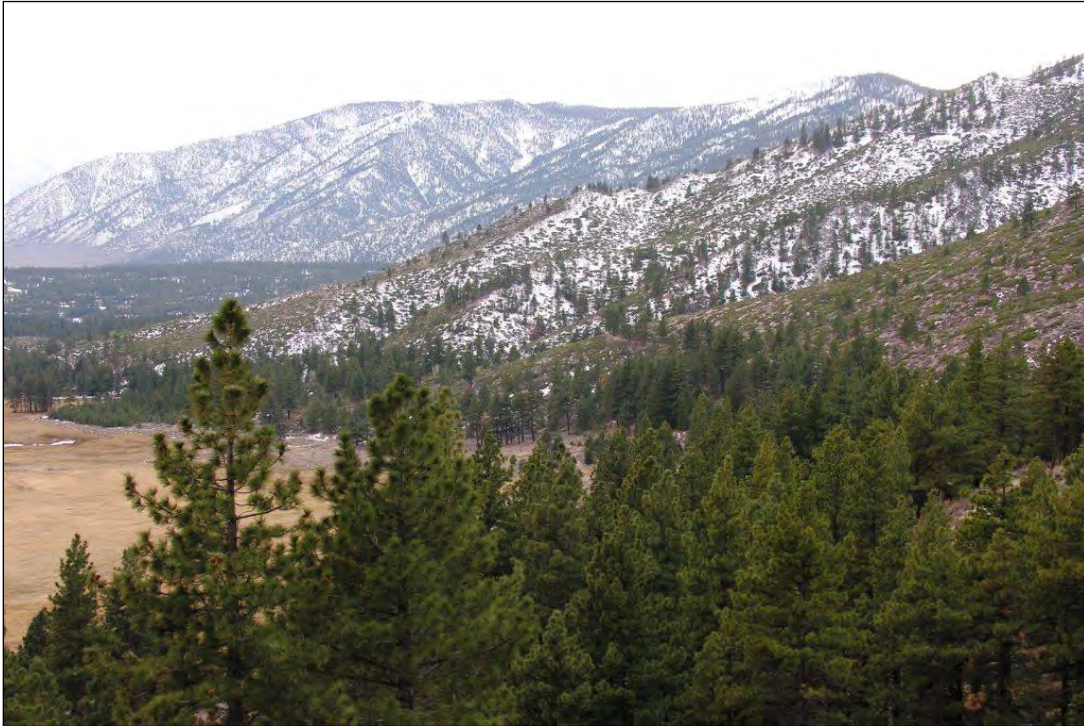
2009 Baseline Condition, photo taken February 4, 2009

**Photo Point 7C (view southwest): A photo point from Kings Canyon Road that would provide panoramic views of the ranch from a north to south perspective.**

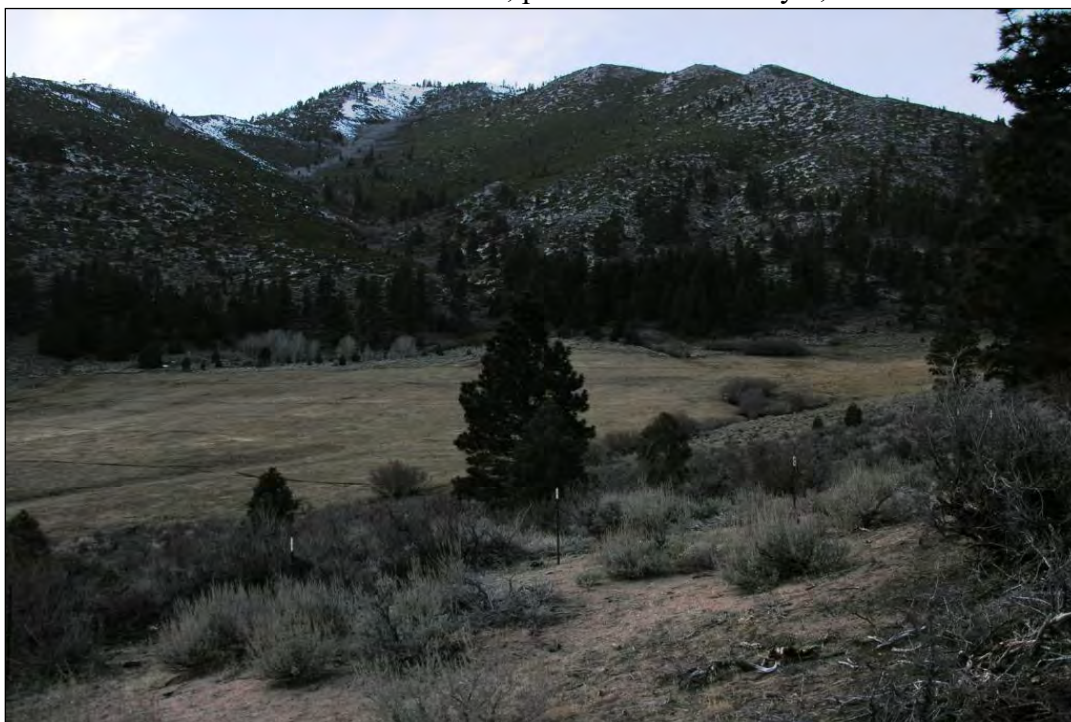
2009 Baseline Condition, photo taken February 4, 2009

**Photo Point 8A (view northwest): A photo point overlooking the meadow from the east to the west located next to the property corner along the new road.**

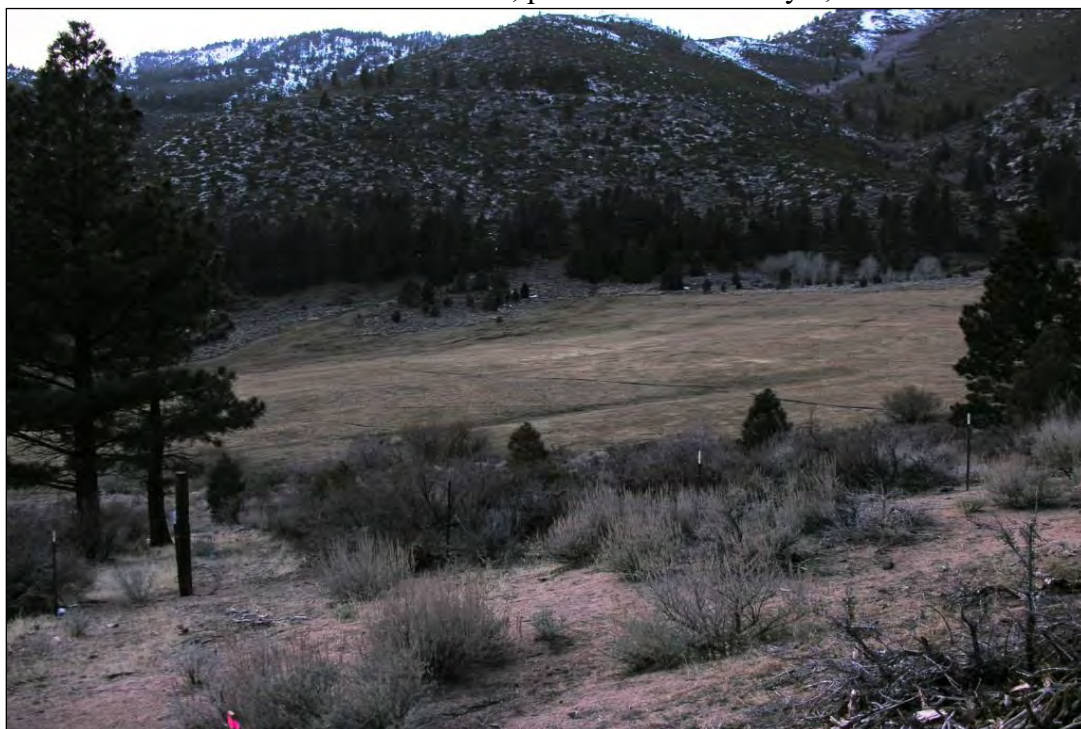
2009 Baseline Condition, photo taken February 4, 2009

**Photo Point 8B (view west): A photo point overlooking the meadow from the east to the west located next to the property corner along the new road.**

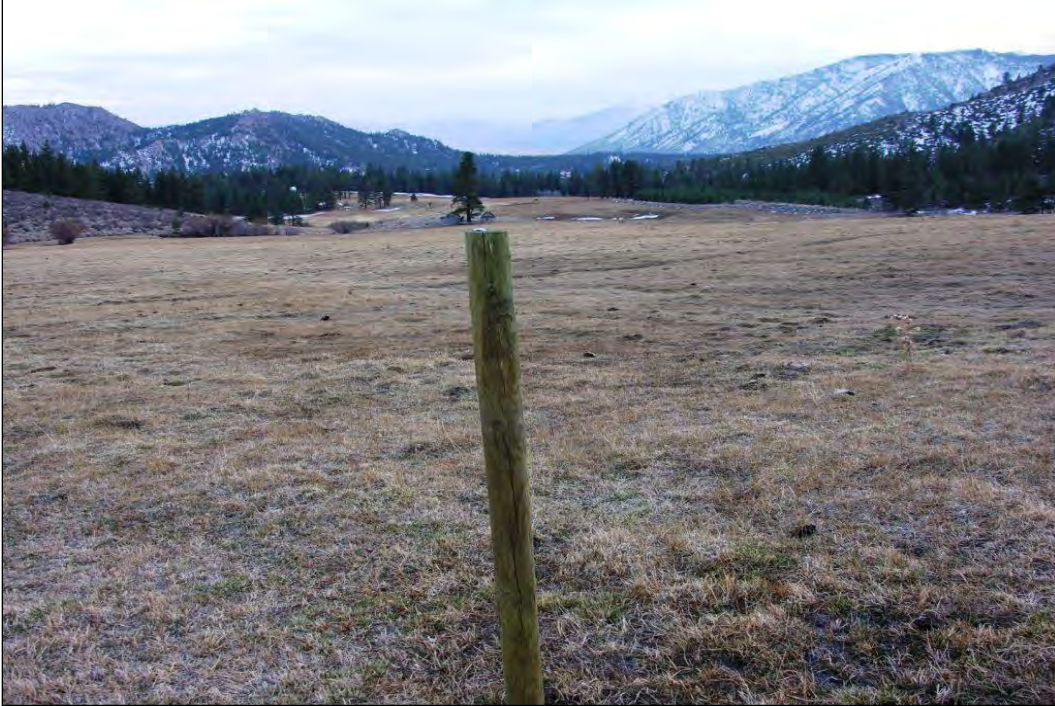
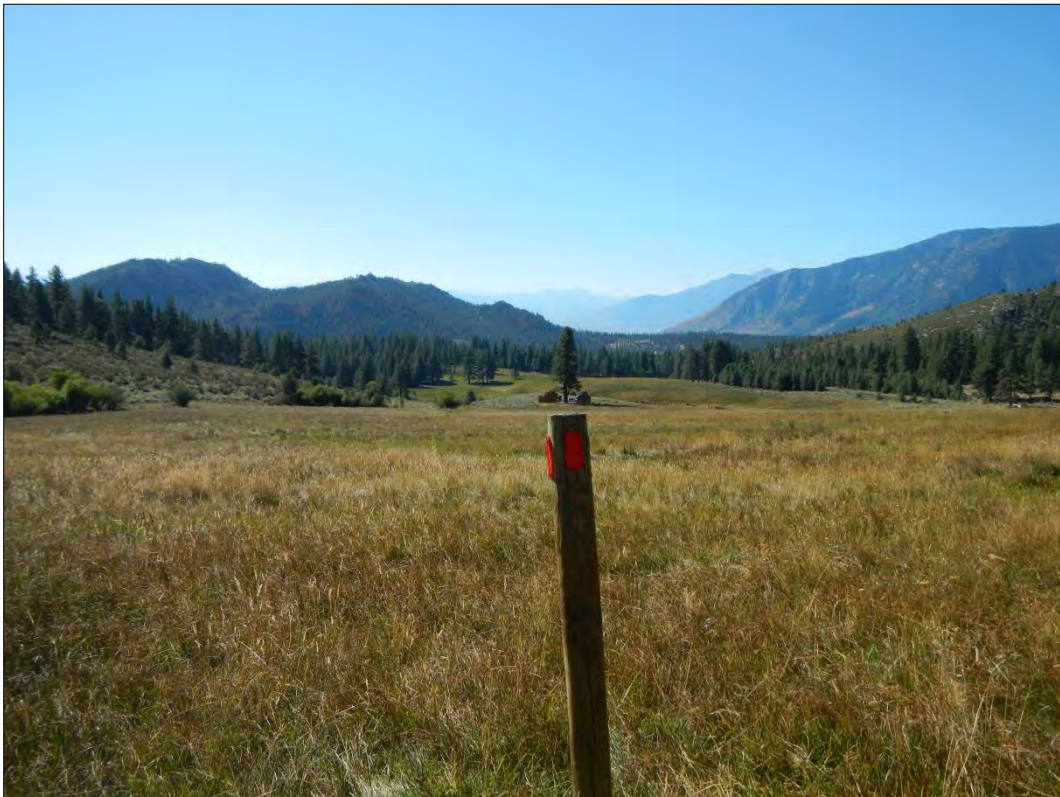
**Photo Point 9: A permanently marked 100' x 100' area to monitor pasture condition. This annual inventory will be used to monitor not only pasture condition but irrigation efficiency, vegetative response to drought and appropriate livestock utilization.**
