# Historic Building Inspection Checklist

## Silver Saddle Ranch

# RED RANCH COMPLEX PRESERVATION PLAN

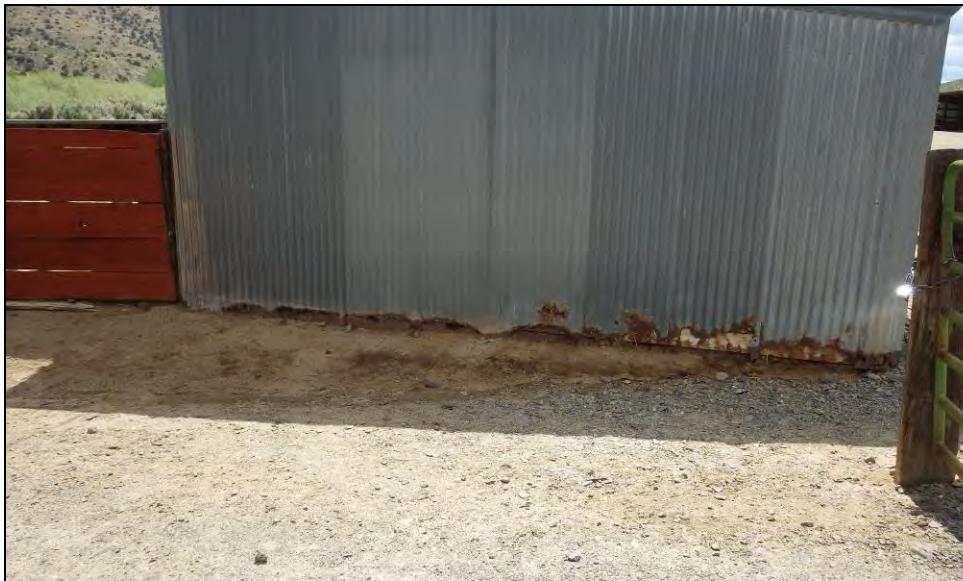
Yes	No	Problem	Comment
		Walls plumb and structurally sound?	
		Door and window frames square?	
		Signs of dry-rot or water damage?	
		Signs of termite infestation?	
		Missing, loose or damaged siding?	Corrugated metal sheets are deteriorated where in contact with earth on S. Side
		Paint peeling, blistering, powdered or chalky?	
		Other:

Caption: Feature 6, North elevation; detail of damaged corrugated metal sheeting  
View to: S Photo file name: 1666

Comments & Photo Reference Nos. The building is in fair condition; continued maintenance efforts would include mitigating standing water along the bottom of the metal siding and deterring corrosion. Any future repair or replacement of materials will be accomplished with in-kind materials in order to maintain the essential appearance of the building, particularly the corrugated metal sheathing and the circular support posts (probably salvaged telephone poles) along its open facade. Because the shelter lacks a dry foundation, additional attention will likely be necessary to prevent rot at the bases of the supporting members.

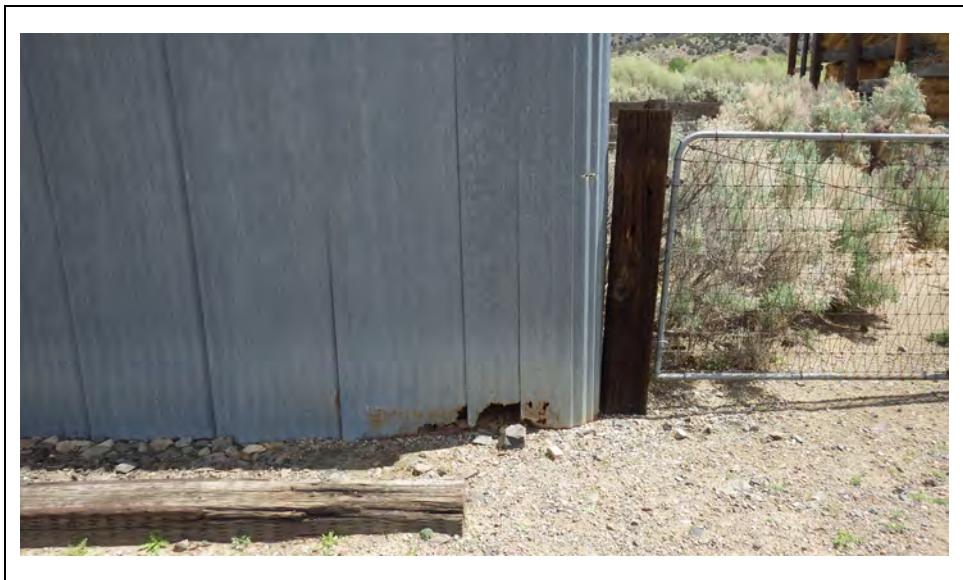
Yes	No	Problem	Comment
		Bows or bridges apparent when sighting along walls?	
		Settling caused by partial foundation or no foundation?	
		Signs of dry-rot, insect infestation, or water damage (wood)?	Water damage on posts
		Is drainage lacking or inadequate?	
		Other

Caption: Feature 6, Southwest corner; detail of damaged corrugated metal sheeting  
View to: E Photo file name: 1662  
Photographer: M. Drews Date: 5/16/2018

Comments: Foundation is earthen. Drainage to be addressed at the south elevation. Because the shelter lacks a dry foundation, additional attention will likely be necessary to prevent rot at the bases of the supporting members.

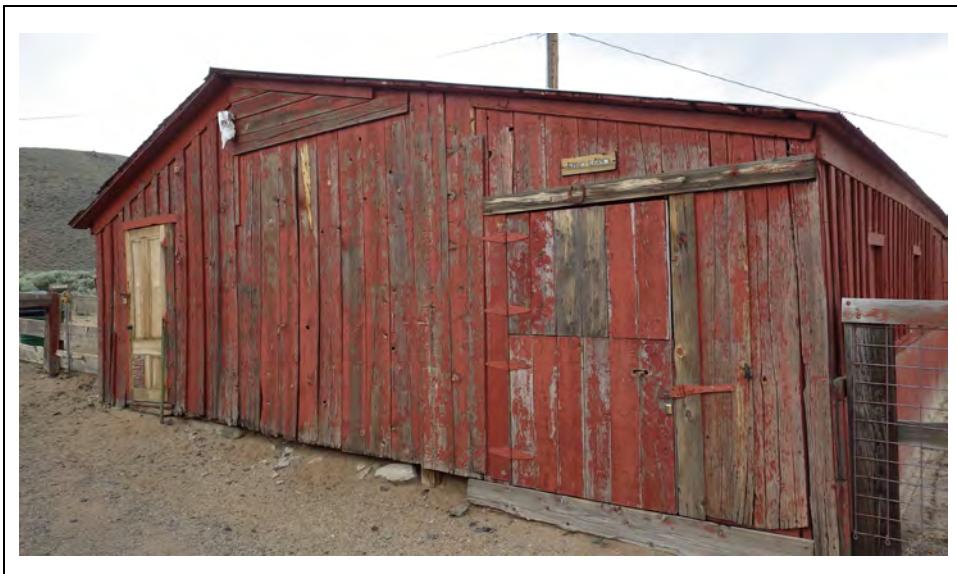
Yes	No	Problem	Comment
		Walls plumb and structurally sound?	
		Door and window frames square?	
		Signs of dry-rot or water damage?	
		Signs of termite infestation?	
		Missing, loose or damaged siding?	Board and Batten in need of repair
		Paint peeling, blistering, powdered or chalky?	S. elevation needs painting
		Other:

Yes	No	Problem	Comment
		Sills / frames square, intact?	
		Signs of dry-rot or water damage?	
		Peeled or old paint?	Paint and repair needed on 4-panel door in s. elevation.
		Weather-stripping needed, or does old weather-stripping need replaced?	
		Broken or deteriorated latches, hinges, or other hardware?	
		Other

Yes	No	Problem	Comment
		Cracked or crumbling concrete?	
		Bows or bridges apparent when sighting along walls?	
		Settling caused by partial foundation or no foundation?	
		Signs of dry-rot , insect infestation, or water damage (wood)?	Water damage on wood sills in S. elevation.
		Is drainage lacking or inadequate?	
		Other

Caption: Feature 7, South elevation View to: N Photo file name: 1700  
Photographer: M. Drews Date: 5/16/2018

Comments & Photo Reference Nos. Current maintenance recommendations include addressing drainage concerns on south elevation; recoating wood boards; repairing 4-panel door and painting; and installing new aprons along south wall.

Comments: The building has "barn type" doors that are in good condition. Four panel door in S. Elevation needs repair and painting.

Comments: Foundation is earthen with concrete footings. Drainage to be addressed at the south elevation. Because the building lacks a dry foundation, additional attention will likely be necessary to prevent rot at the bases of the supporting members. New Floor Sills needed along S. Wall.

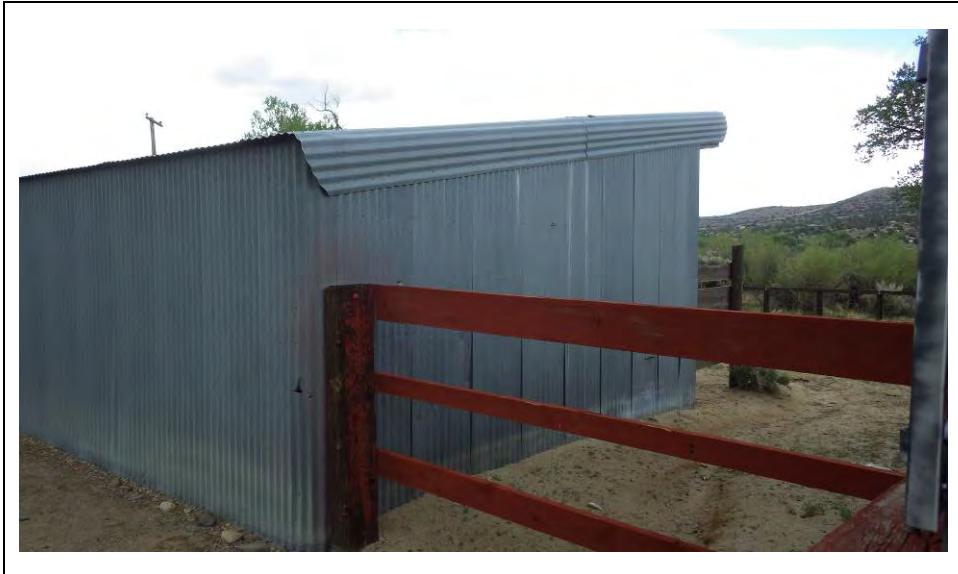
Yes	No	Problem	Comment
		Walls plumb and structurally sound?	
		Signs of dry-rot or water damage?	Damage to metal sheeting
		Signs of termite infestation?	
		Missing, loose or damaged siding?	Rust Inhibitor needed
		Paint peeling, blistering, powdered or chalky?	
		Other:

Caption: Feature 9 Animal Shed, South Elevation

Comments & Photo Reference Nos. The shelter is in fair condition and its continued preservation requires minimal annual maintenance. Similar to other 3-sided animal shelters, the corrugated metal sheathing and round support posts along the open front are the defining characteristics of this simple structure. Because the shelter lacks a dry foundation, particular attention should be given to the bases of the supporting members in order to prevent deterioration from wood rot. Recommend addressing rust with appropriate inhibitor product.

Comments: Foundation is earthen. Drainage to be addressed at the north elevation. Because the building lacks a dry foundation, additional attention will likely be necessary to prevent rot at the bases of the supporting members.

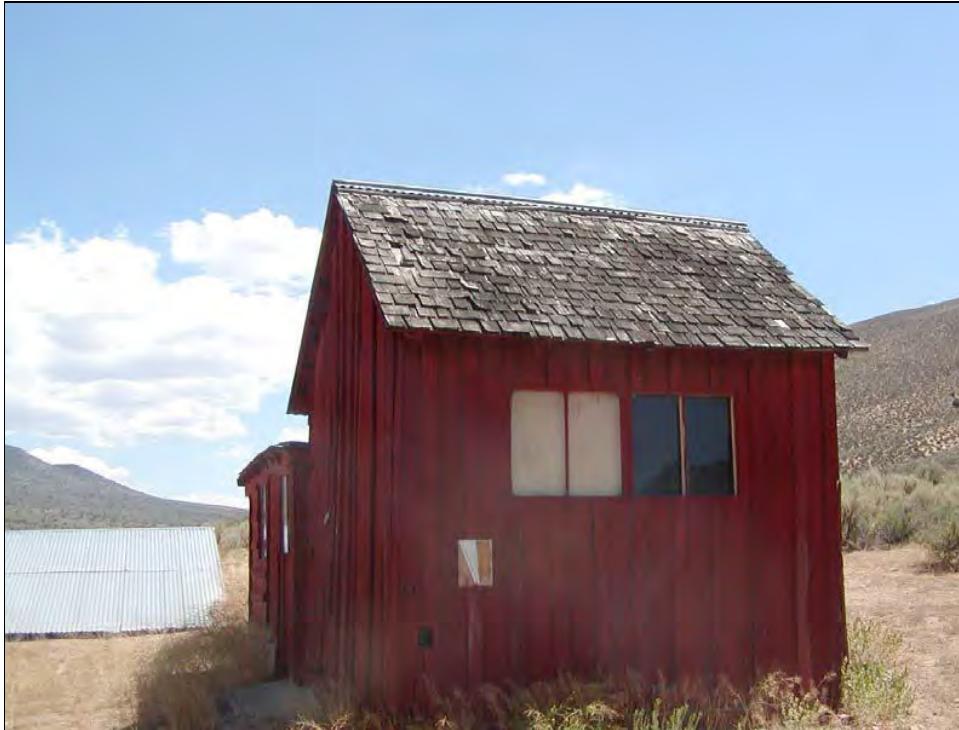
Comments: Some curling of tin, north side all wood shingle. Few missing, thin

Caption: North and east elevation, shingle roof

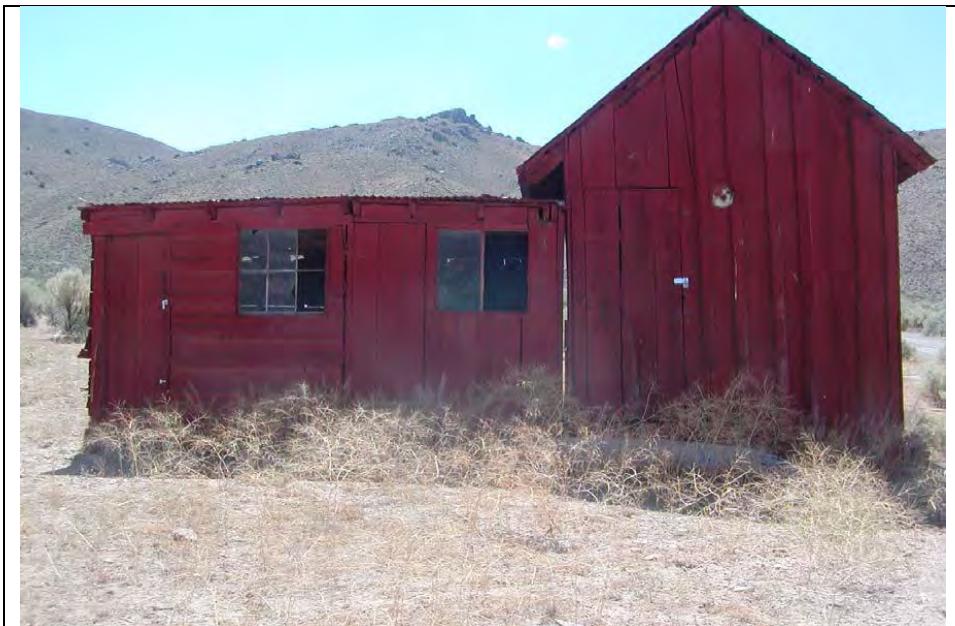
Comments: Windows on east elevation have broken panes, muntins intact.

Caption: East Elevation  
Photographer: M. Drews
