# STAFF REPORT

**Agenda Title:** For Possible Action: Discussion and possible action regarding a recommendation to the Board of Supervisors on the Fiscal Year 2021-2022 Capital Improvement Program budget request and priorities for the Parks, Recreation and Open Space Department. ([jbudge@carson.org](mailto:jbudge@carson.org))

Facility Condition Assessment

For  
Carson City  
Aquatic Facility - Main Building  
841 N Roop St  
Carson City,  
NV 89701

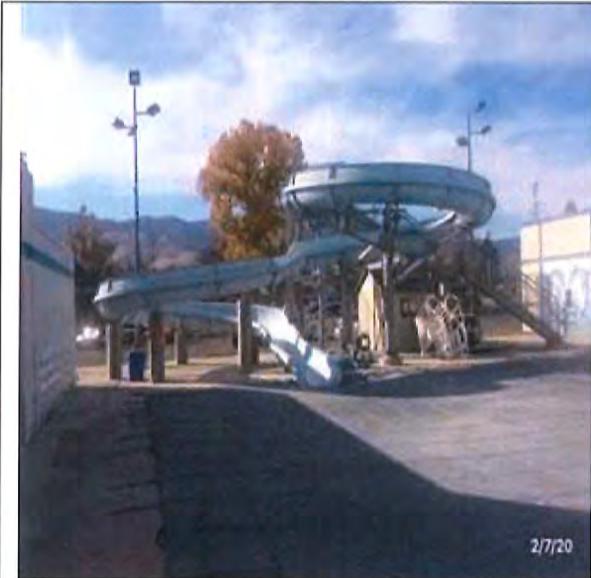
View of Exterior Stairs(s) - Steel Construction  
(Slide)

- ⊕ B Shell: Replace Exterior Stairs(s) - Steel Construction (Slide) at an estimated cost of \$26,163 in year 2020
- ⊕ B Shell: Replace Double Aluminum Glazed Doors at an estimated cost of \$17,756 in year 2021

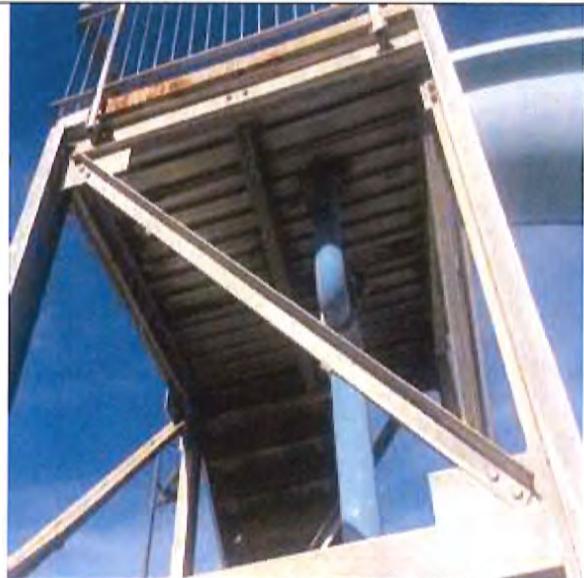
B1015 Exterior Stairs and Fire Escapes :-  
View of Exterior Stairs(s) - Steel Construction  
(Slide)

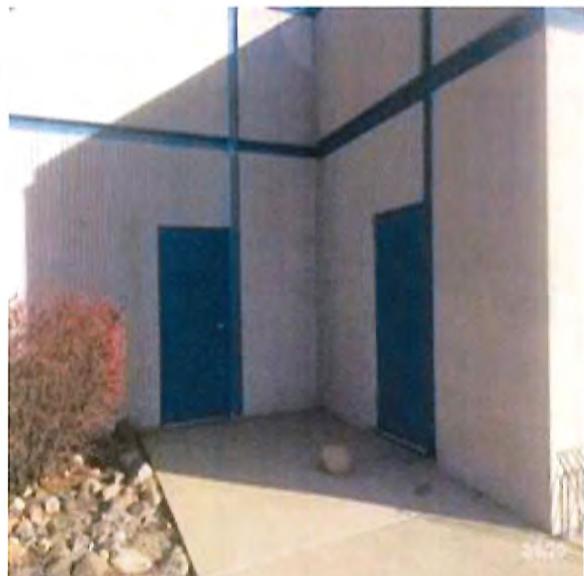
It should also be noted, there was multiple signs of minor cracking to the exterior stucco walls. An allowance to repaint the exterior walls and repair any cracking to the stucco has been included within the capital expenditure. The cracking should be monitored under operations and maintenance and if the cracking deteriorates further a structural engineering assessment should be carried out.

View of Stucco over CMU Walls

- ⊕ B Shell: Replace Aluminum Window Units - Fixed or Single Hung at an estimated cost of \$300,831 in year 2021
- ⊕ B Shell: Allowance to Repaint Exterior Wall Surfaces and Repair Stucco at an estimated cost of \$50,000 in year 2022

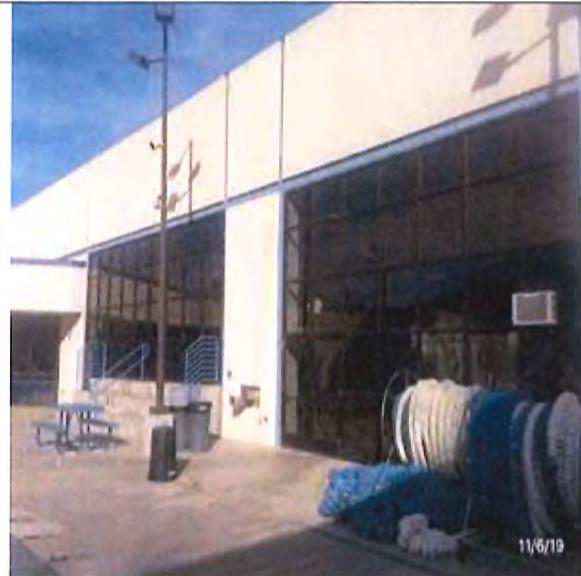
View of Aluminum Window Units - Fixed or Single Hung

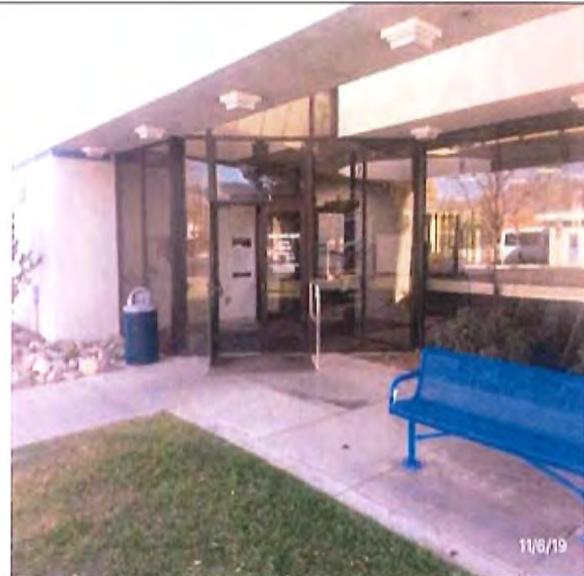
B2031 Glazed Doors & Entrances :-  
View of Double Aluminum Glazed Doors

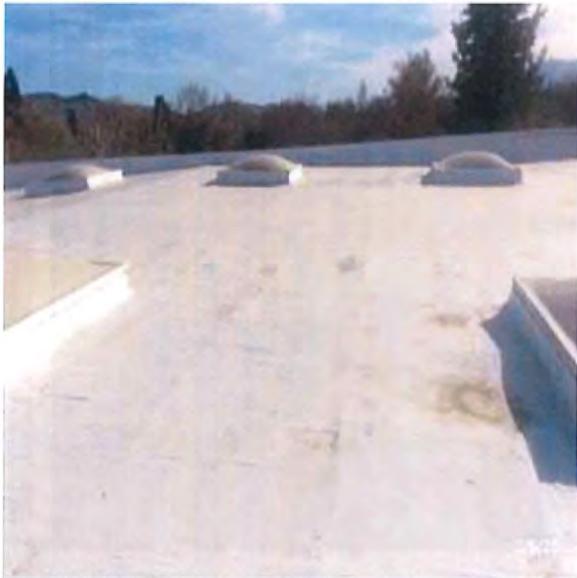
A liquid membrane was applied to the upper roof circa 2013, with the roof membrane reapplied under warranty in 2016. The roof membrane is reported to have a fifteen-year warranty from the date of installation and therefore any roof issues during this time should be repaired by the roof contractor. It is recommended that the original roof covering is fully replaced when the warranty ends, as re-coating the roof with a liquid

View of Single-ply Roof Membrane incl. Insulation  
(Upper)

- ⊕ B Shell: Replace Single-ply Roof Membrane incl. Insulation (Upper) at an estimated cost of \$498,327 in year 2028
- ⊕ B Shell: Replace Single HM Doors at an estimated cost of \$6,760 in year 2029

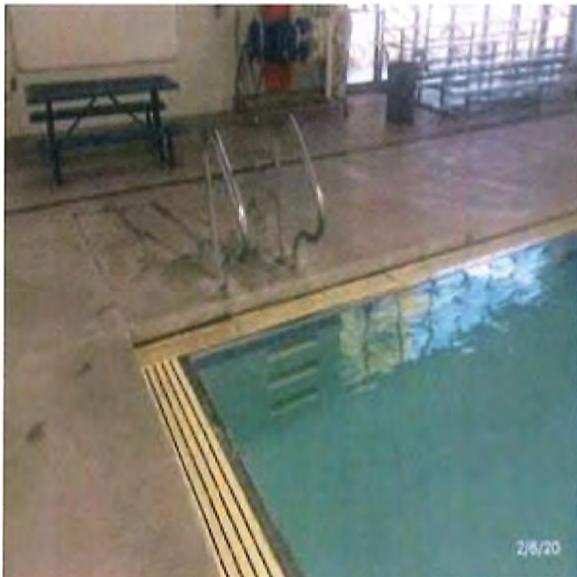
C2014 Stair Handrails and Balustrades :-  
View of Pool Handrails - Steel Construction

- ⊕ C Interiors: Replace Pool Handrails - Steel Construction at an estimated cost of \$42,061 in year 2025
- ⊕ C Interiors: Replace Floor Paint - Non Slip at an estimated cost of \$145,211 in year 2028

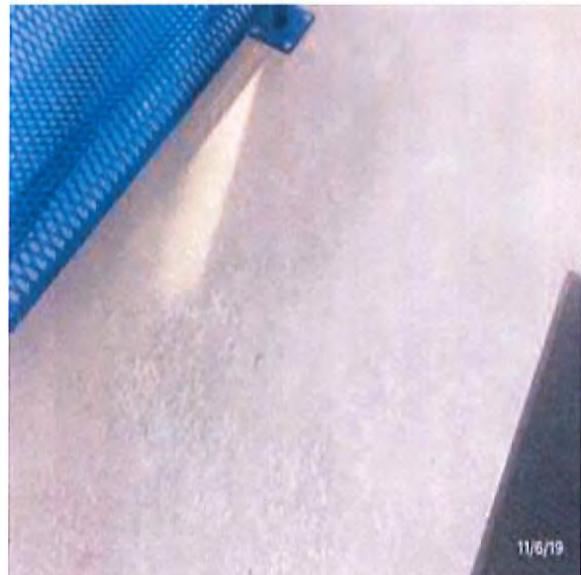
View of Floor Paint - Non Slip

- ⊕ C Interiors: Replace Interior Single Aluminum Glazed Door(s) at an estimated cost of \$5,047 in year 2021
- ⊕ C Interiors: Replace Floor Paint - Non Slip at an estimated cost of \$145,211 in year 2023

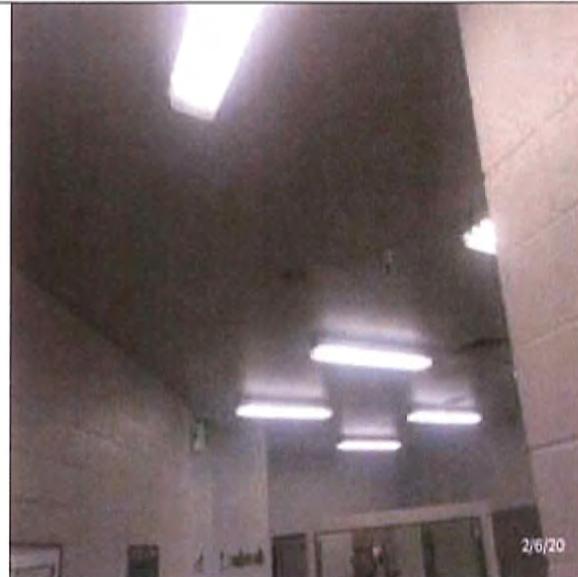
It should be further noted; a small section of the gypsum wall board ceiling was damaged to the staff room. This should be repaired/replaced under general operations and maintenance.

View of Gypsum Wall Board Ceilings

- ⊕ C Interiors: Replace Painted Finish - Standard at an estimated cost of \$240,500 in year 2028
- ⊕ C Interiors: Replace Gypsum Wall Board Ceilings at an estimated cost of \$38,077 in year 2029

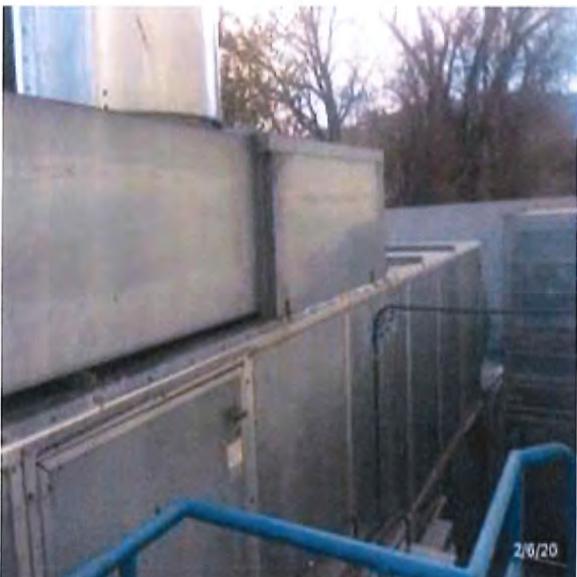
View of Make-up Air Unit - MAU-2

- ⊕ D Services: Replace Make-up Air Unit - MAU-1 at an estimated cost of \$52,670 in year 2024
- ⊕ D Services: Replace Make-up Air Unit - MAU-2 at an estimated cost of \$52,670 in year 2024

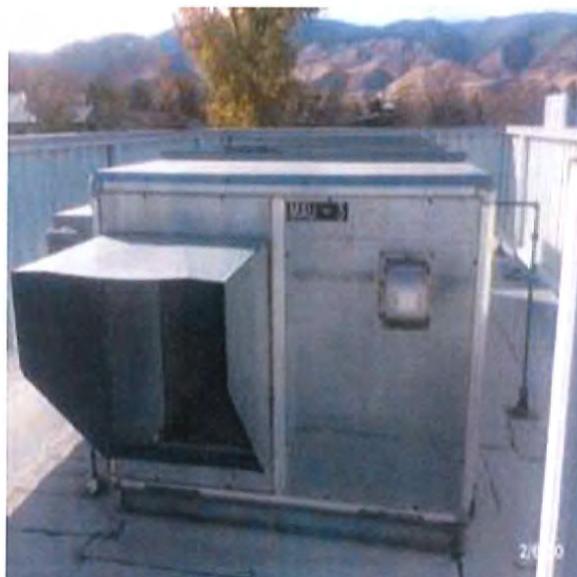
D3041 Air Distribution Systems :-  
View of Make-up Air Unit - MAU-3

- ⊕ D Services: Replace Fire Alarm System - High Density at an estimated cost of \$413,766 in year 2024
- ⊕ D Services: Replace Make-up Air Unit - MAU-3 at an estimated cost of \$10,534 in year 2024

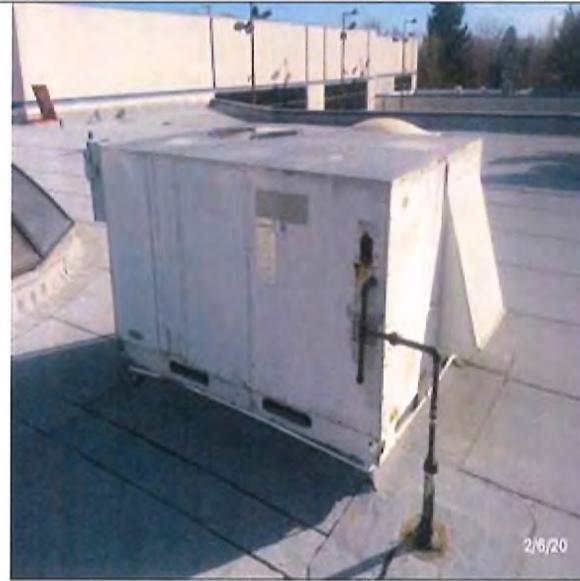
D3052 Package Units :-  
View of Packaged Rooftop A/C With Heat, Under 20  
Tons

- ⊕ D Services: Replace Packaged Rooftop A/C With Heat, Under 20 Tons at an estimated cost of \$15,773 in year 2020
- ⊕ D Services: Replace Wall Mounted Standard Drinking Fountain (Dual/Bi-Level) at an estimated cost of \$12,679 in year 2021

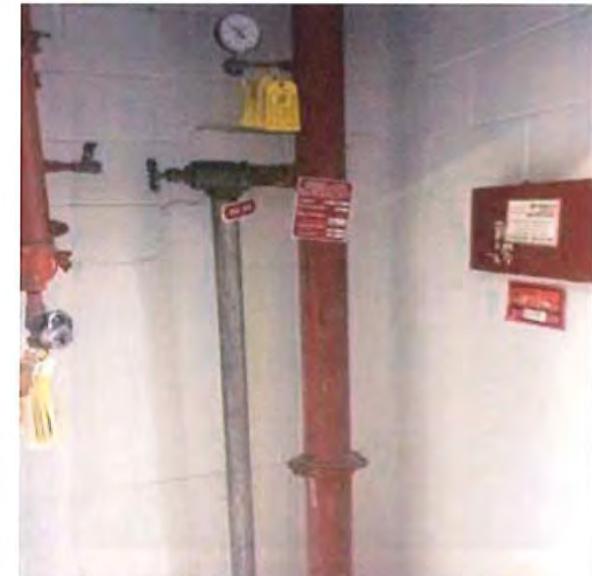
D4011 Sprinkler Water Supply :-  
View of Wet-Pipe Sprinkler System

- D Services: Replace Wet-Pipe Sprinkler System at an estimated cost of \$300,591 in year 2025
- D Services: Replace Shower Mixing Valve(s) at an estimated cost of \$18,314 in year 2028
- D Services: Replace Wiring Systems (Inc. Receptacles & Switches) at an estimated cost of \$356,726 in year 2028
- E Equipment & Furnishing: Replace Metal Lockers at an estimated cost of \$10,063 in year 2021
- E Equipment & Furnishing: Replace Floor Mounted Base Cabinet(s) - Standard at an estimated cost of \$30,015 in year 2023
- E Equipment & Furnishing: Replace Counter Top - Laminated at an estimated cost of \$8,112 in year 2023
