STAFF REPORT

Agenda Title: For Possible Action: Discussion and possible action regarding the annual monitoring report for the Horsecreek Ranch Conservation Easement for 2020.

ATTACHMENT 1 – 2020 Horsecreek Ranch Conservation Easement Monitoring Report

Carson City Open Space – Conservation Easement Monitoring
--

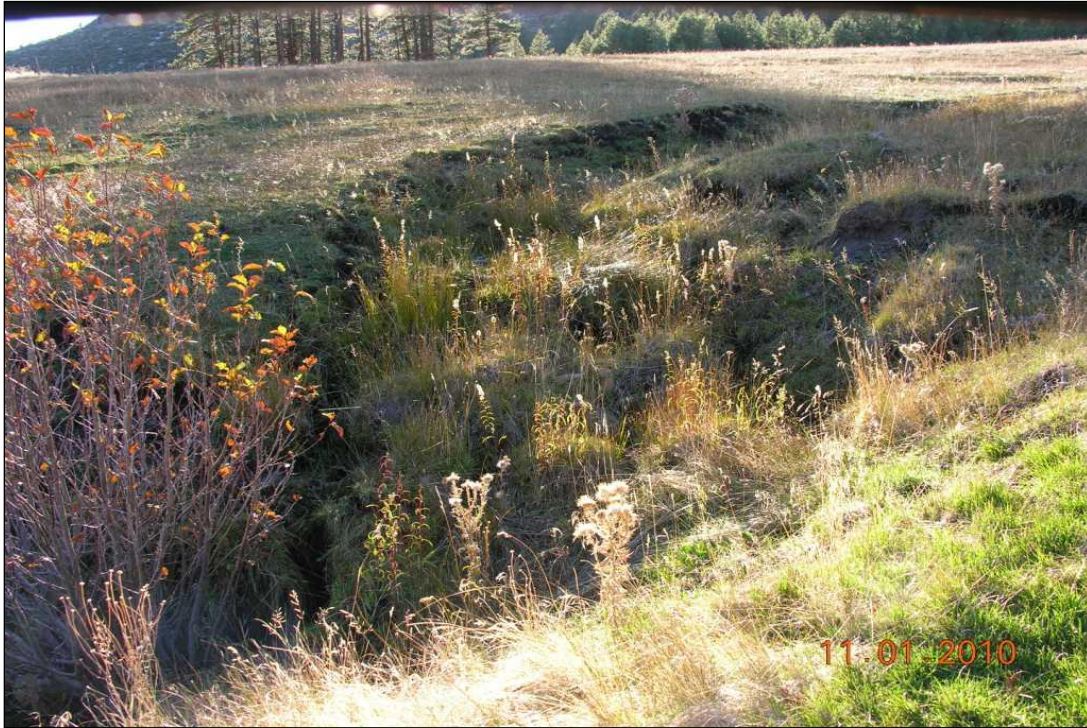
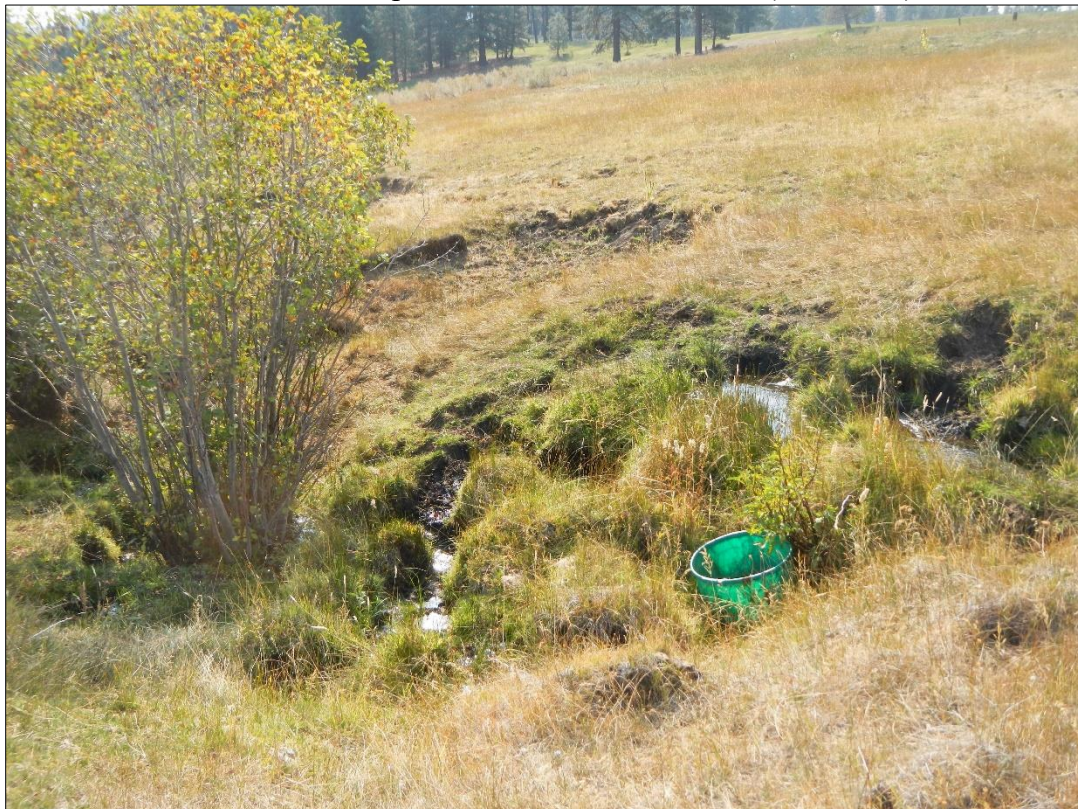
Photo Point: The photo of this drainage, located south of the cabins, has been included to document change and vegetation growth. N 39 07' 42.7" W 119 50' 10.2"

Near the southeast corner, one specific area is being monitored for landscape change. This low drainage area of the meadow appears to be vegetated and stable though a few isolated mounds or hummocks may be the result of cattle trampling. A qualitative assessment with the photo comparisons may be deceptive due to the time of year each photo was taken – either during the growing season or at the end of the season after grasses were grazed and/or senesced. However, monitoring completed in 2020 illustrates that the erosion is recovering naturally. Additionally, the new headcut observed in 2017 on the creek northeast of the cabins was monitored in 2020 and appears to be revegetating naturally as well. This site and associated reach of creek should continue to be monitored in future years to confirm successful revegetation of the headcut, or to document change in size or location, as it could migrate upstream. The previous owner of the property, Mr. Fagen had previously applied for USDA EQIP grants to fund the design and repair plan for the existing headcuts on the property. Access challenges and a lack of available contractors willing to complete the work prevented successful funding awards for this project. In the future, a conservation organization such as the Great Basin Institute or Nevada Division of Forestry could be contracted to complete the work through non-mechanized means, which would mitigate the access and contractor availability challenges. However, a repair design still needs to be completed.

2010 Condition, photo taken November 1, 2010 (initial assessment – view west)

2020 Condition, photo taken October 9, 2020 (view west)

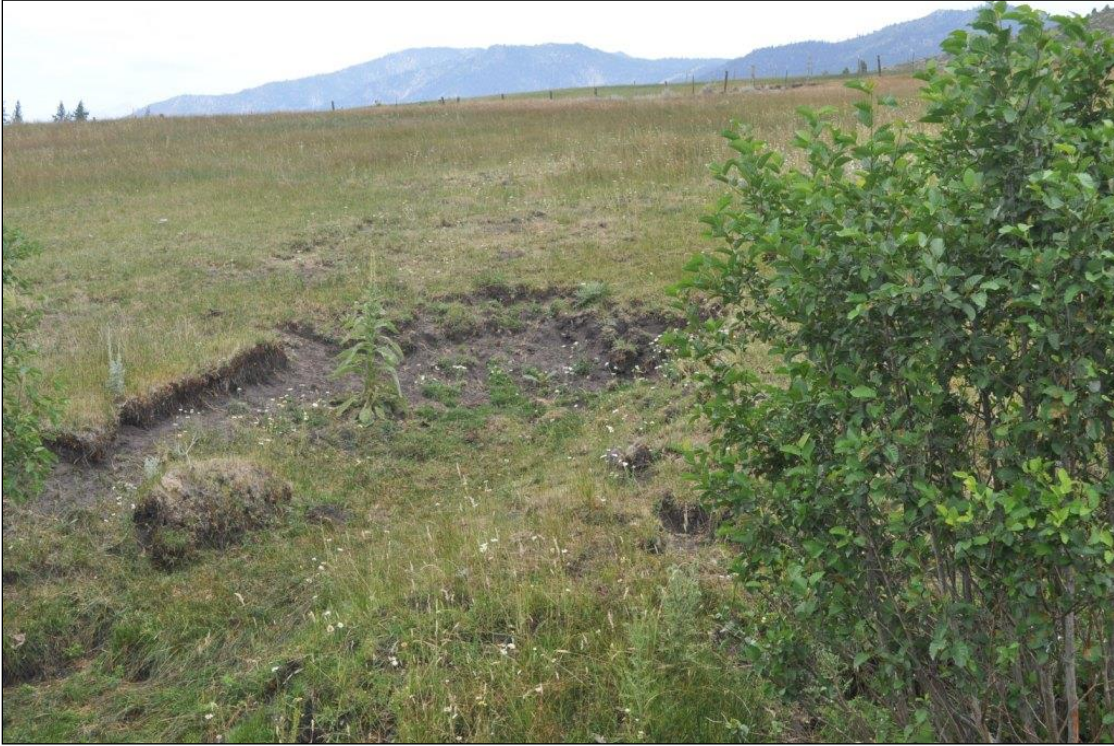
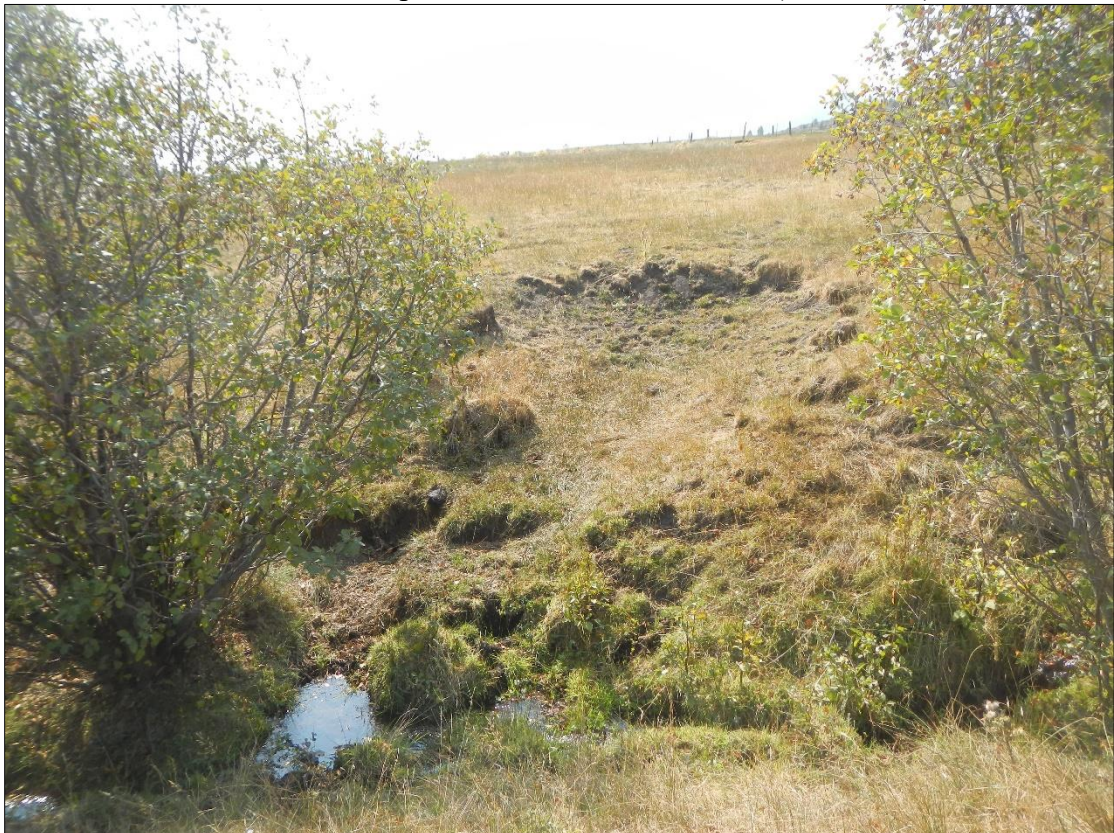
2013 Condition, photo taken July 23, 2013 (initial assessment – view south)

2020 Condition, photo taken October 9, 2020 (view south)

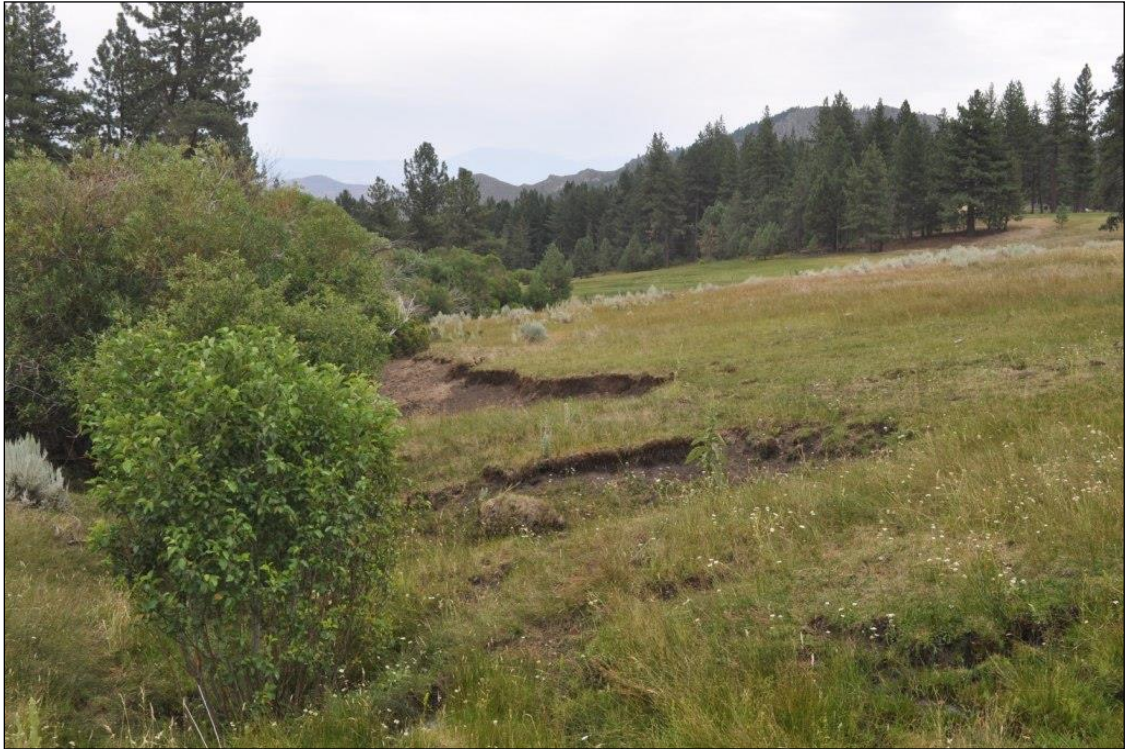
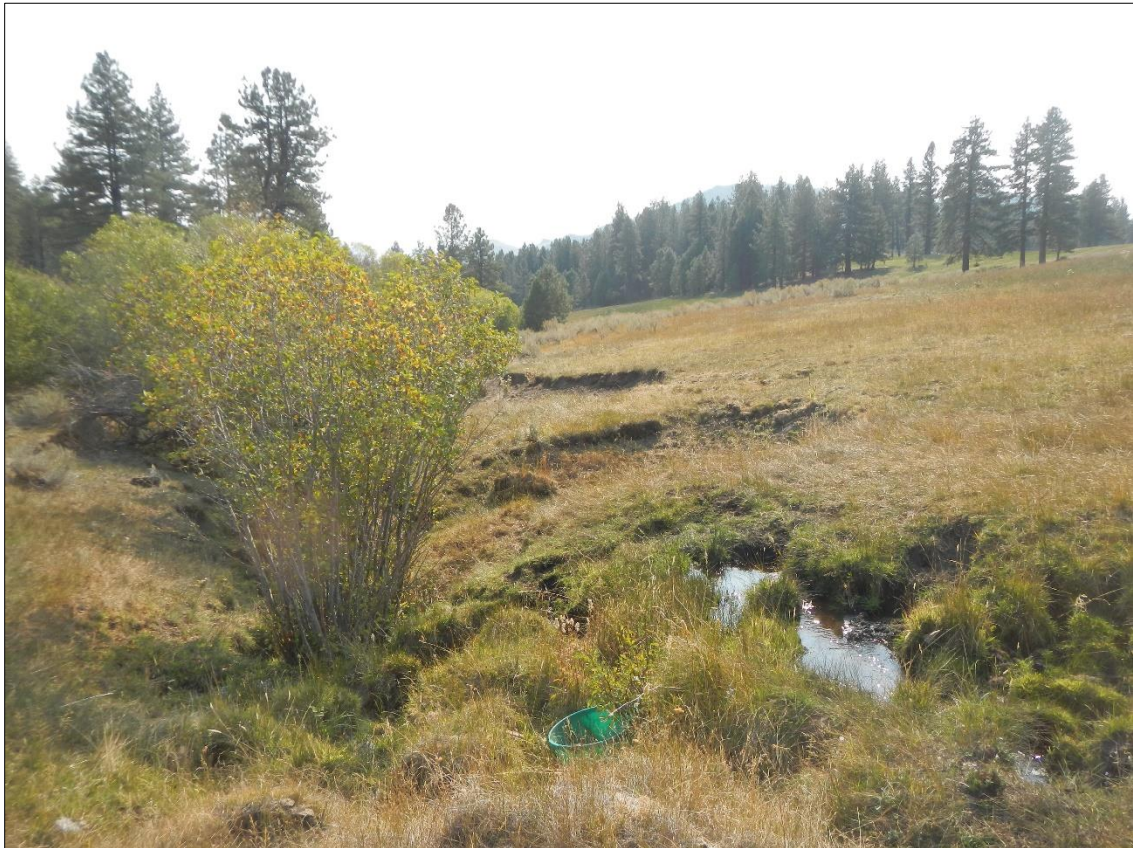
2013 Condition, photo taken July 23, 2013 (initial assessment – view south)

2020 Condition, photo taken October 9, 2020 (view south)

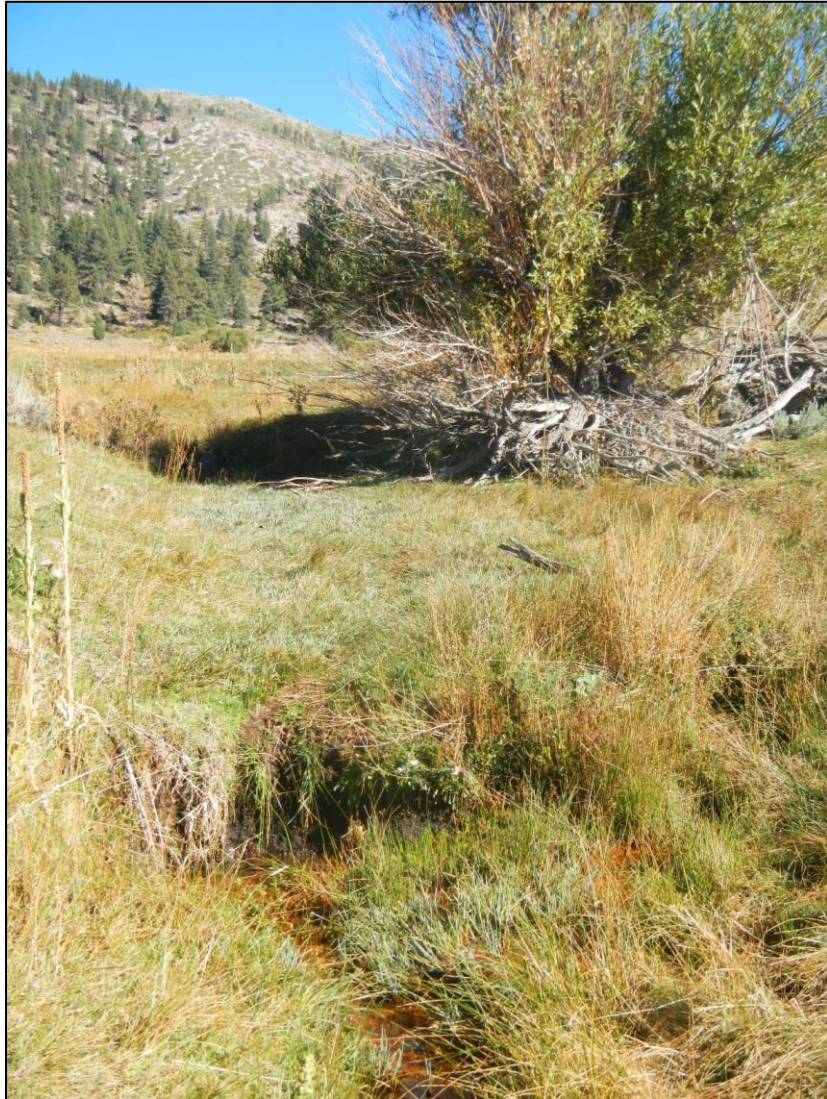
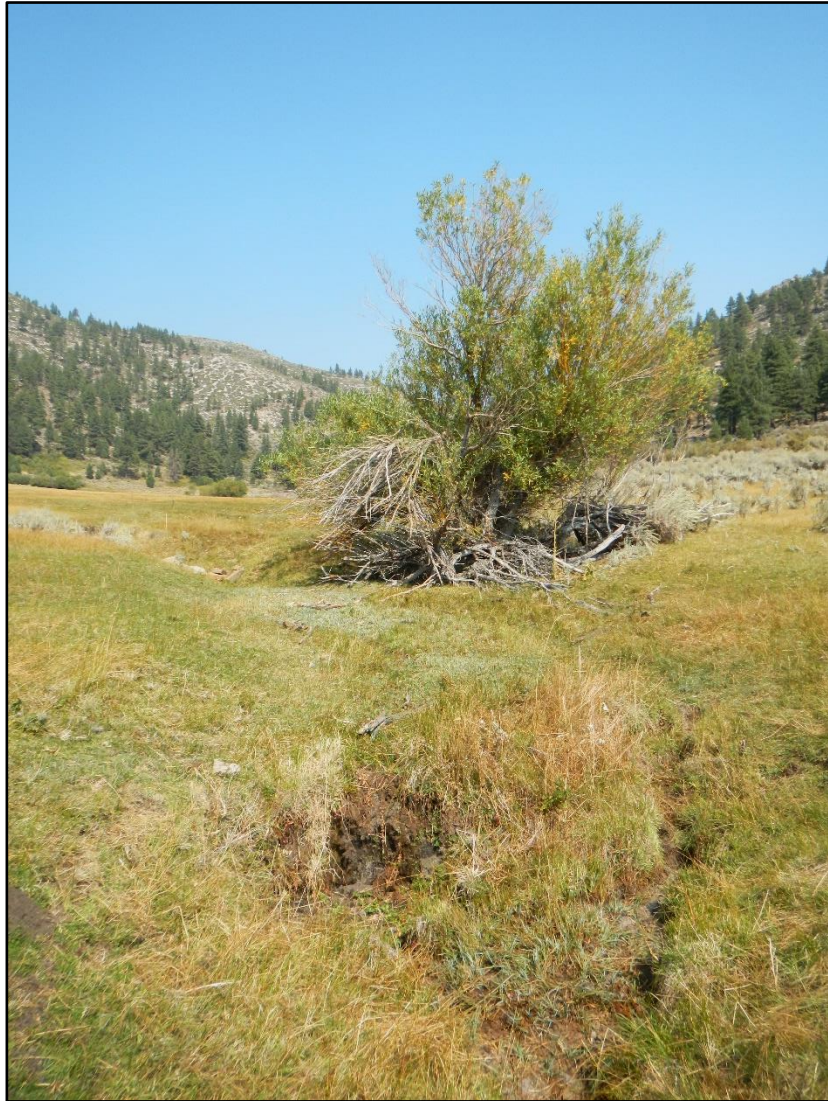
Photo Point: The photo of this headcut, located northeast of the cabins, has been included to document stream channel changes and erosion. N 39 07' 51.0" W 119 50' 11.4"

2018 Condition, photo taken October 8, 2018 (view north)

2020 Condition, site visit October 9, 2020 (view north)

- 1) Prepare building plans and submit to Carson City Open Space staff for review and approval by the Open Space Advisory Committee, and subsequently the Carson City Planning Department.
- 2) Continue to work to identify a mitigation strategy and repair plan for existing headcuts to be implemented 2022.
- 3) Continued removal of bull thistle.

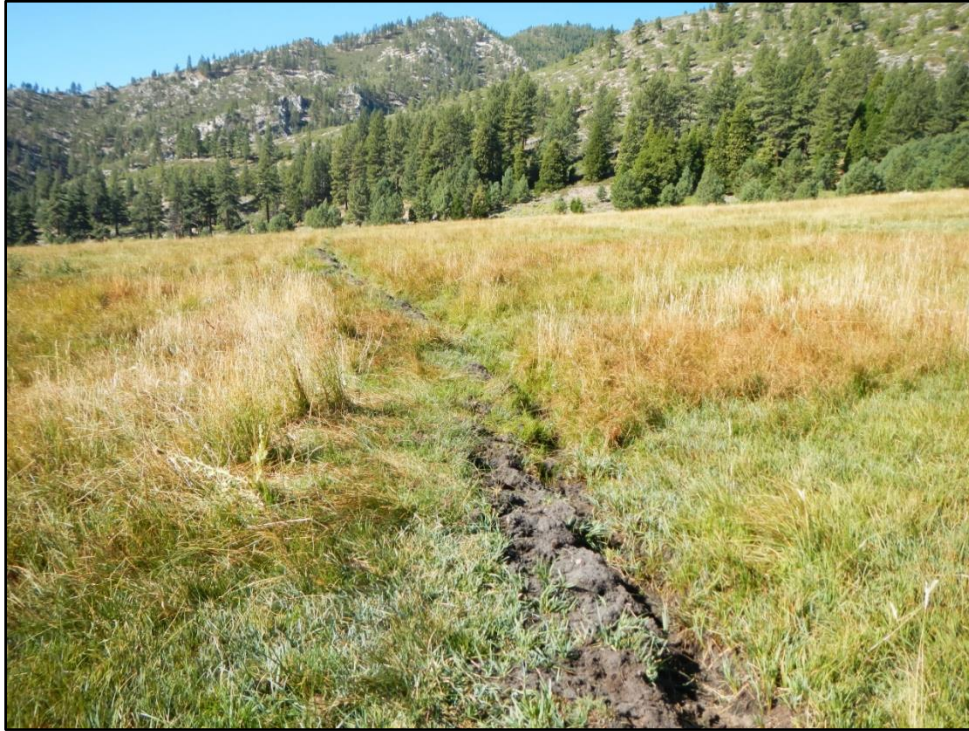
Photo Point: The photo of this lateral irrigation ditch, located in the upper meadow, has been included to document site improvements. N 39° 7' 58.1196"W 119° 50' 14.0172"

2019 Condition, photo taken September 12, 2019 (view west)

2020 Condition, photo taken October 9, 2020 (view west)

- The irrigation ditch known as “Neal’s Flume” was flowing during this field monitoring visit and appeared to be providing adequate flow to the upper meadow at Horsecreek Ranch; lateral ditches in the meadow were also flowing. While the lower portion of the Flume was maintained in spring 2018, upper portions of the Flume remain overgrown. This upper portion of the Flume will be monitored in the future and will be cleared if the vegetation begins to impact water flow and delivery.

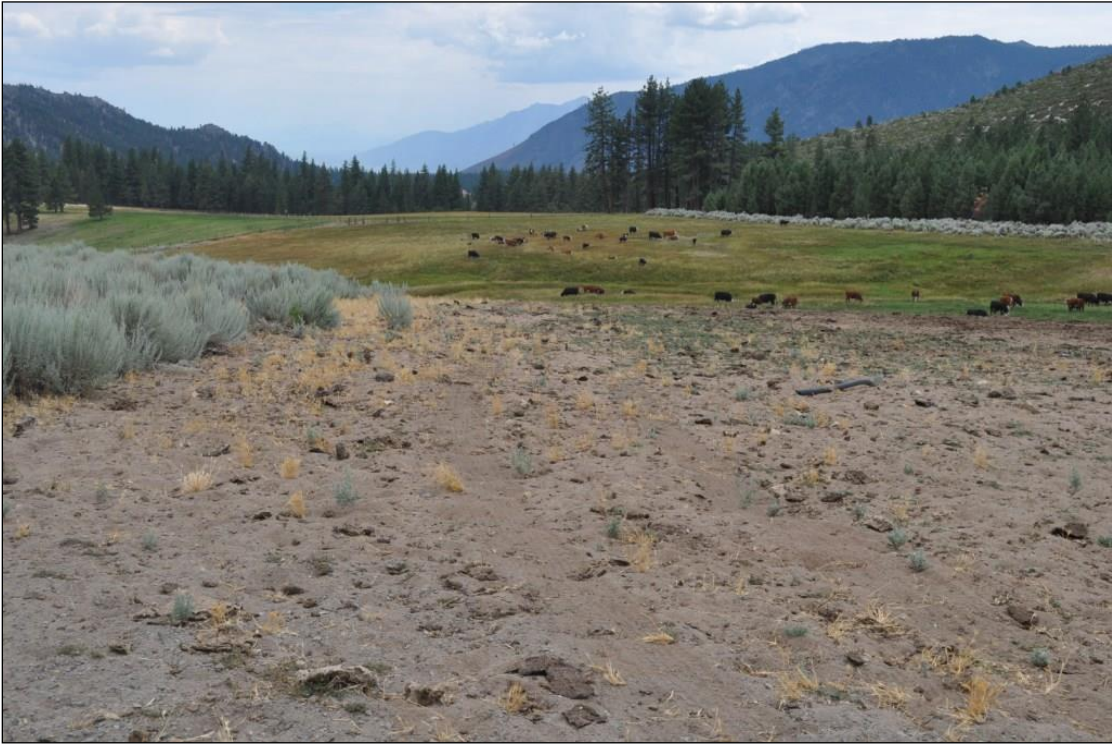
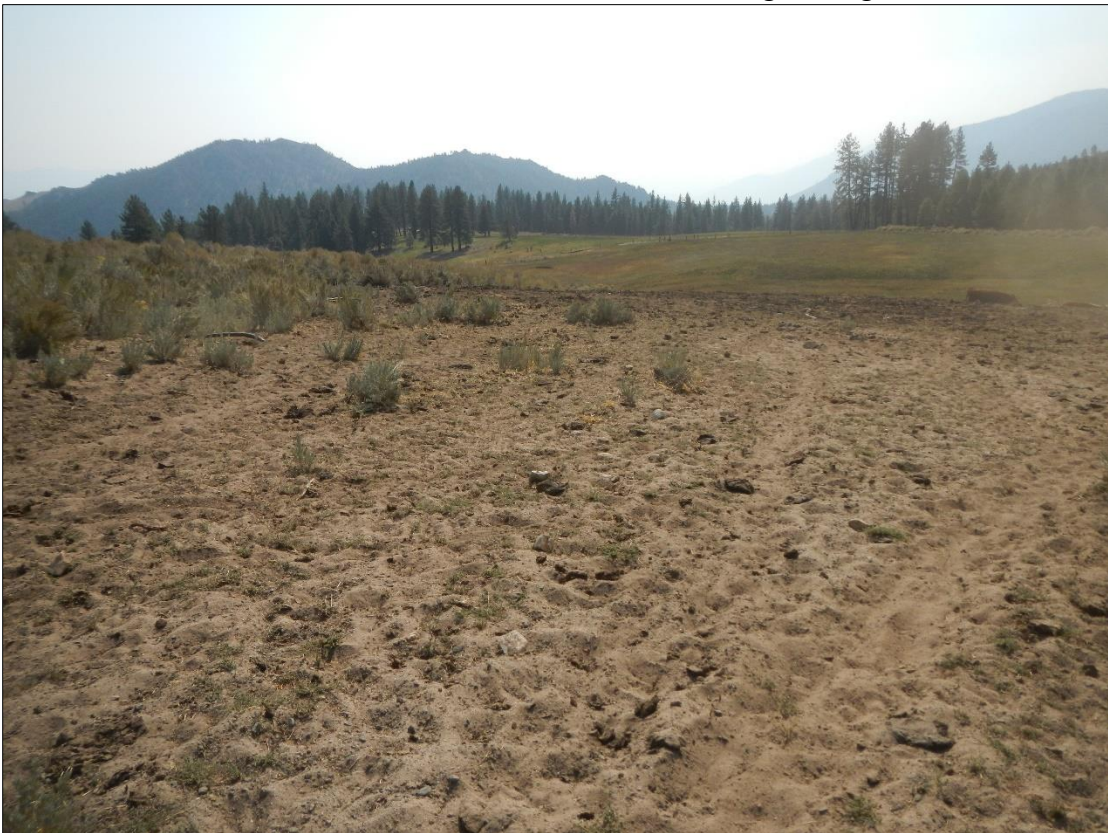
- The previous reports recommended the monitoring of the cattle loafing area located just outside the gated entrance to the cabins with the goal to limit further expansion. The following documentation provides photo points and respective measurements. The disturbed area consists primarily of cheatgrass and foxtail barley although sagebrush is successfully re-establishing on both the north and east edge of the disturbed area. The disturbed area has shown an overall reduction in size over the last two monitoring cycles, however this monitoring period revealed that the extent of the loafing area north-south has decreased by 21 feet, while the extent east-west has increased by 3 feet since 2019. Lastly, it is important to note that depending on the timing of monitoring, cheatgrass abundance and cover varies indicating that cattle are likely grazing the cheatgrass.

2013 Condition, photo taken July 23, 2013 (initial assessment – view south):
The bare area measures 157' north to south along the sagebrush.

2020 Condition, photo taken October 9, 2020:
The bare area measures 140' north to south along the sagebrush.

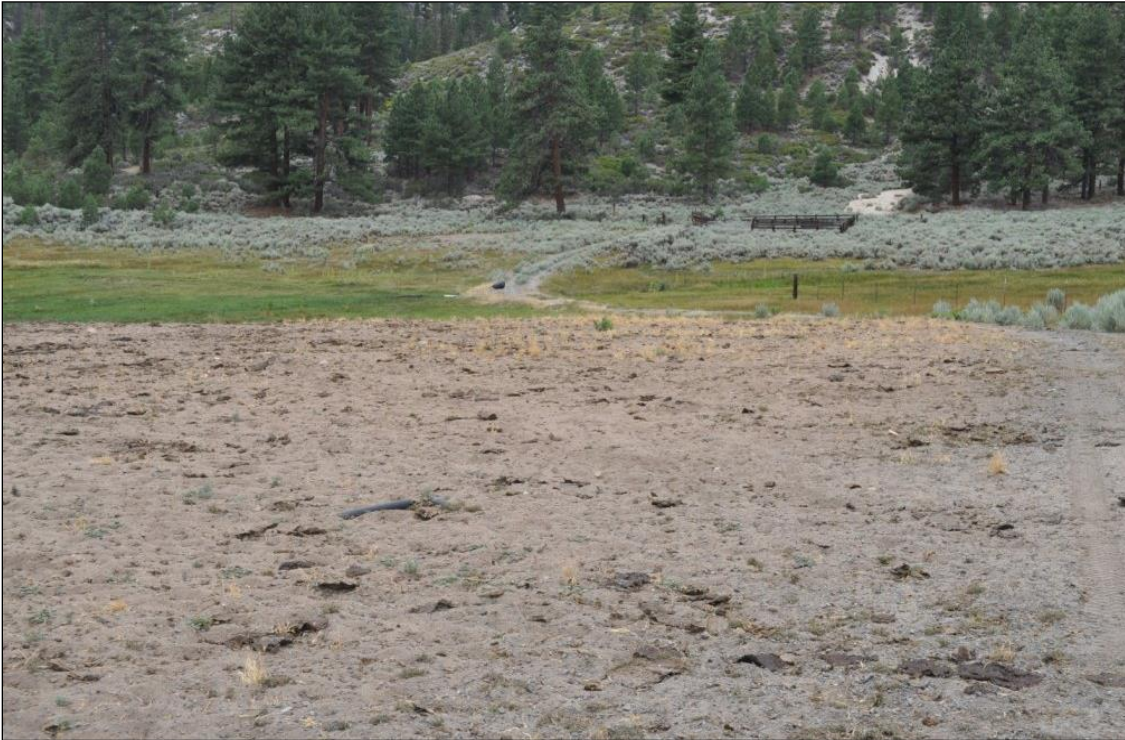
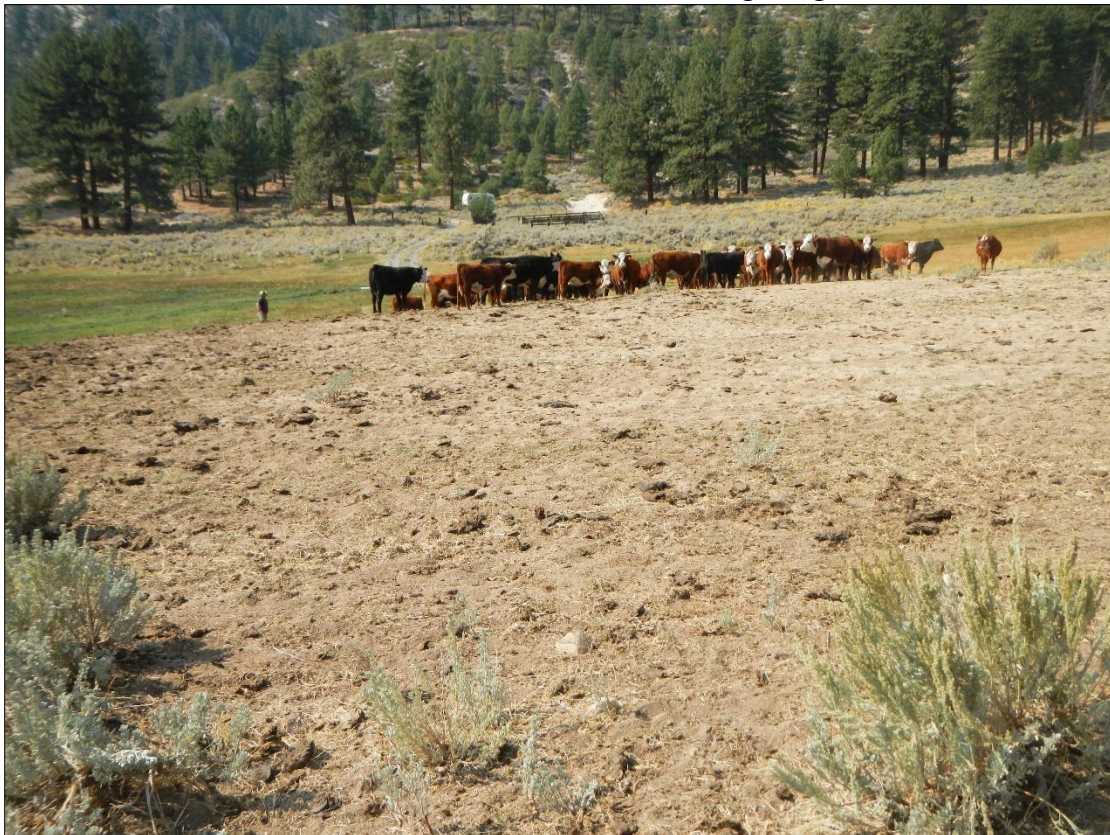
2013 Condition, photo taken July 23, 2013 (initial assessment – view west):
The bare area measures 145' east to west along the gravel road.

2020 Condition, photo taken October 9, 2020:
The bare area measures 111' east to west along the gravel road.

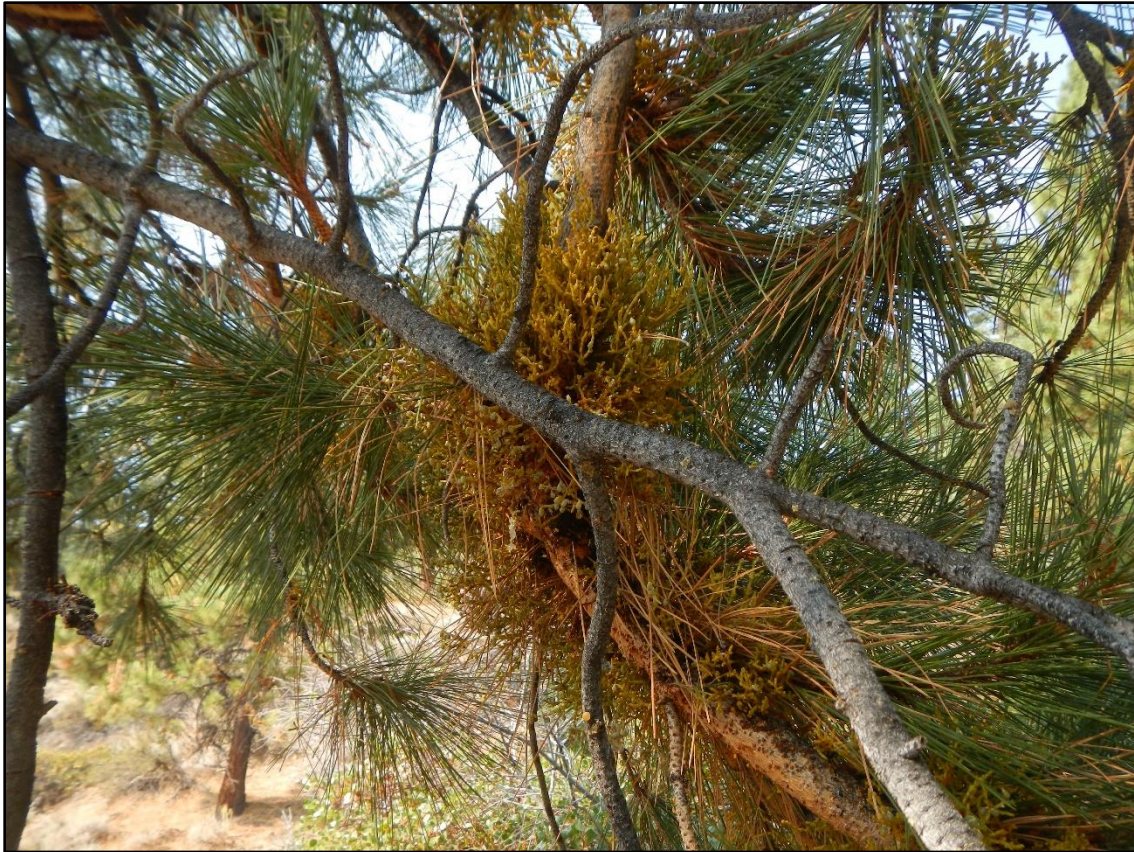
Photo Point: The photo of western dwarf mistletoe, growing in a Jeffrey pine tree in a stand west of the cabins has been included to monitor the presence and spread of western dwarf mistletoe infestations on the property.

2020 Condition, photo taken October 9, 2020

- Western dwarf mistletoe, *Arceuthobium spp.* has been observed growing in the Jeffrey pine tree stand located west of the cabins. Western dwarf mistletoe is a parasitic plant and impacts growth rate and seed production and can ultimately lead to tree mortality. Infestations of Western dwarf mistletoe should be continually monitored annually, and removal of infected trees may need to be coordinated in conjunction with Nevada Division of Forestry (NDF).
- Mr. Cosker has inquired with Nevada Division of Forestry staff regarding the Forest Stewardship Program to fund selective thinning of tree stands on the property. Implementation of this program is pending funding release and availability of NDF field staff for site visit.

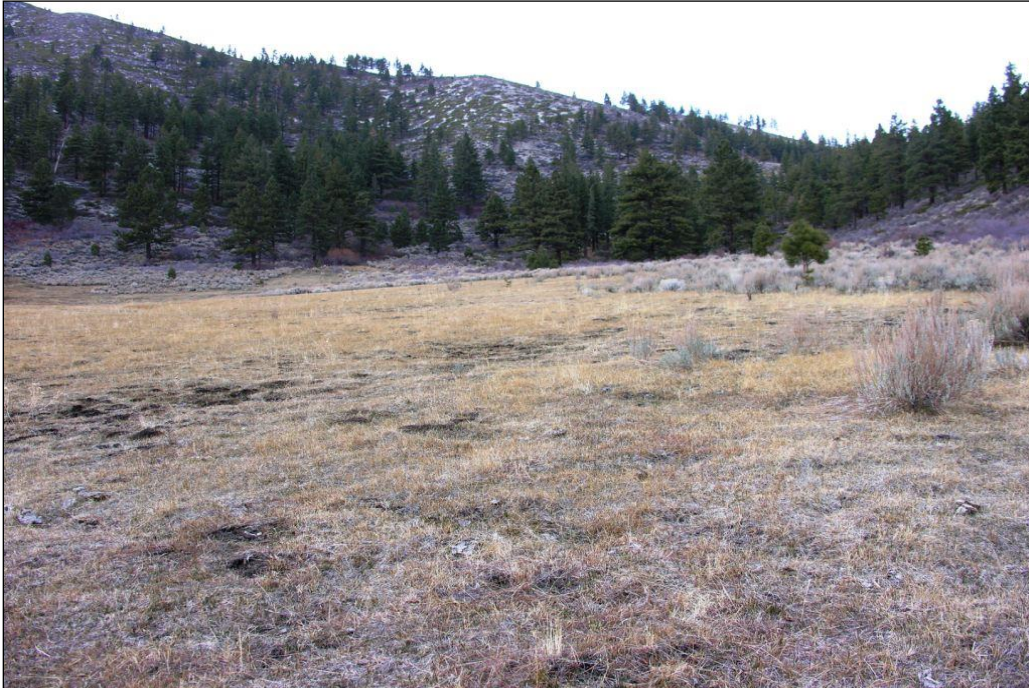
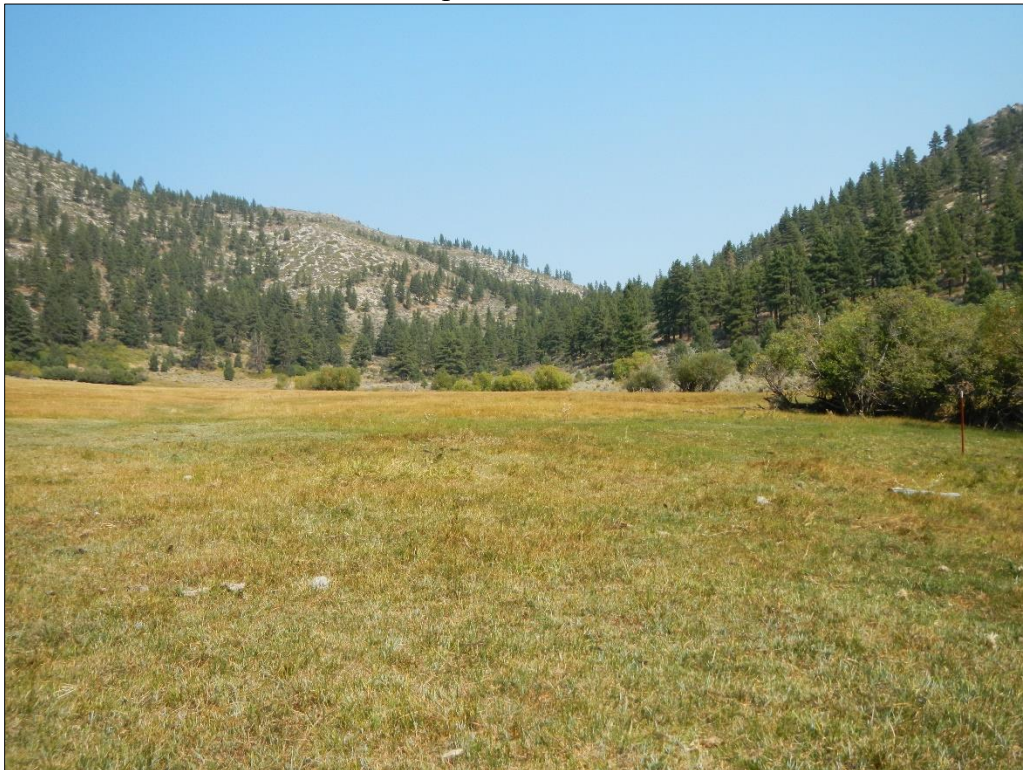
Photo Point 1A (view northeast): A photo point located at the edge of the shrub dominated granitic fan and the irrigated meadow. This would be used to monitor shrub invasion into the meadow area indicating irrigation problems.

2009 Baseline Condition, photo taken February 4, 2009:
(GPS coordinate: N39° 08' 02.3" W119° 50' 11.8")

2020 Condition, photo taken October 9, 2020

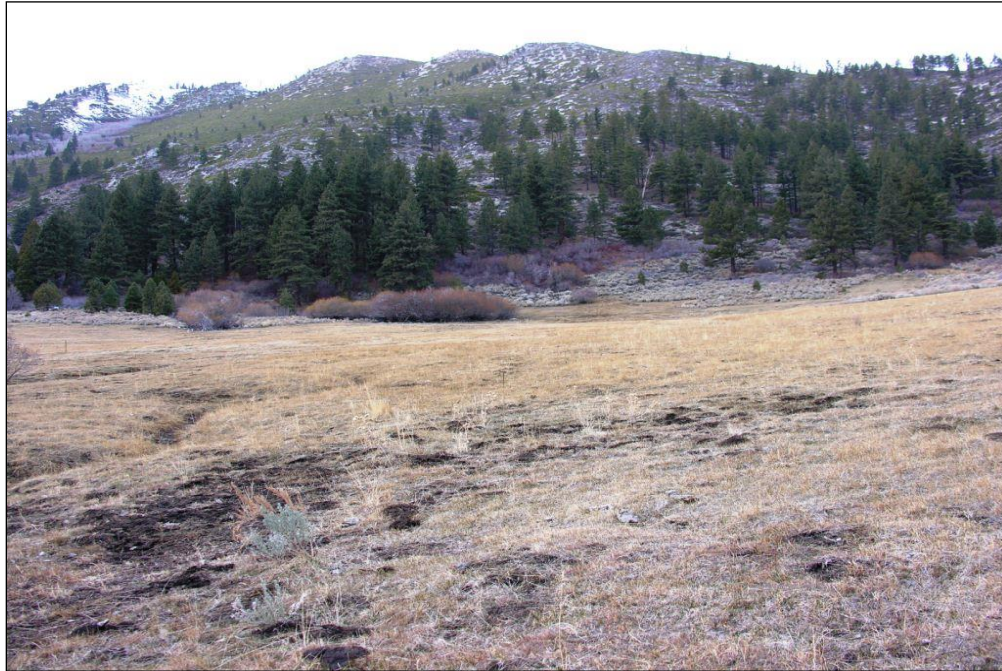
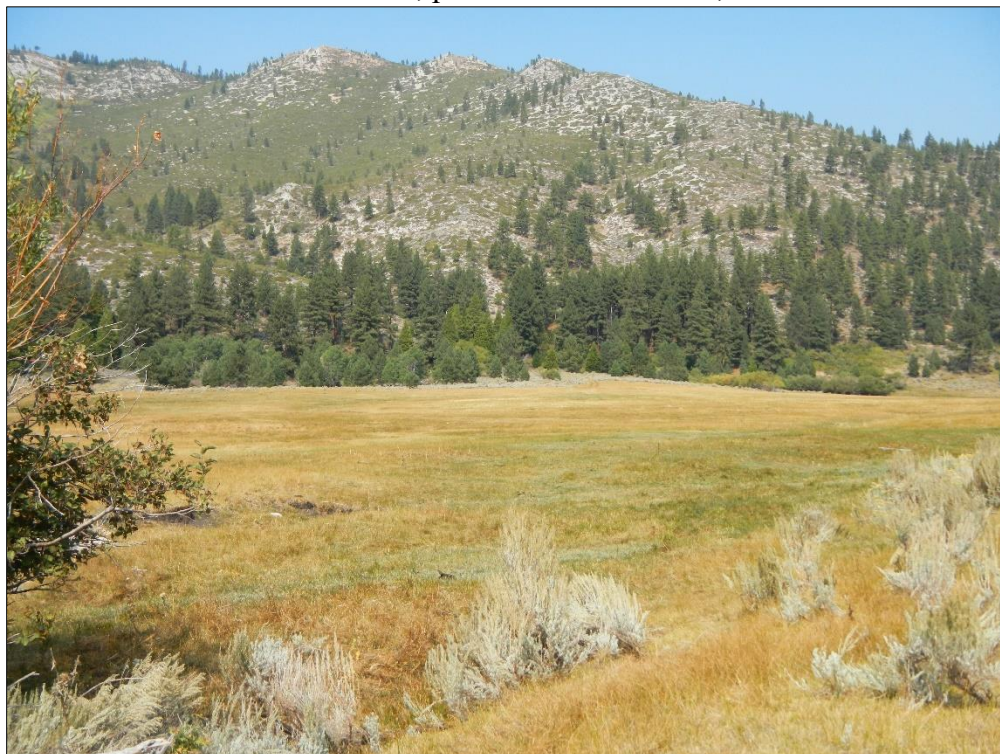
Photo Point 1B (view northwest): A photo point located at the edge of the shrub dominated granitic fan and the irrigated meadow. This would be used to monitor shrub invasion into the meadow area indicating irrigation problems.

2009 Baseline Condition, photo taken February 4, 2009:
(Photo possibly taken from the upper meadow, near the new GPS coordinate for Photo Point 2 updated in 2010: N39 07' 54.9" W119 50' 11.3")

2020 Condition, photo taken October 9, 2020

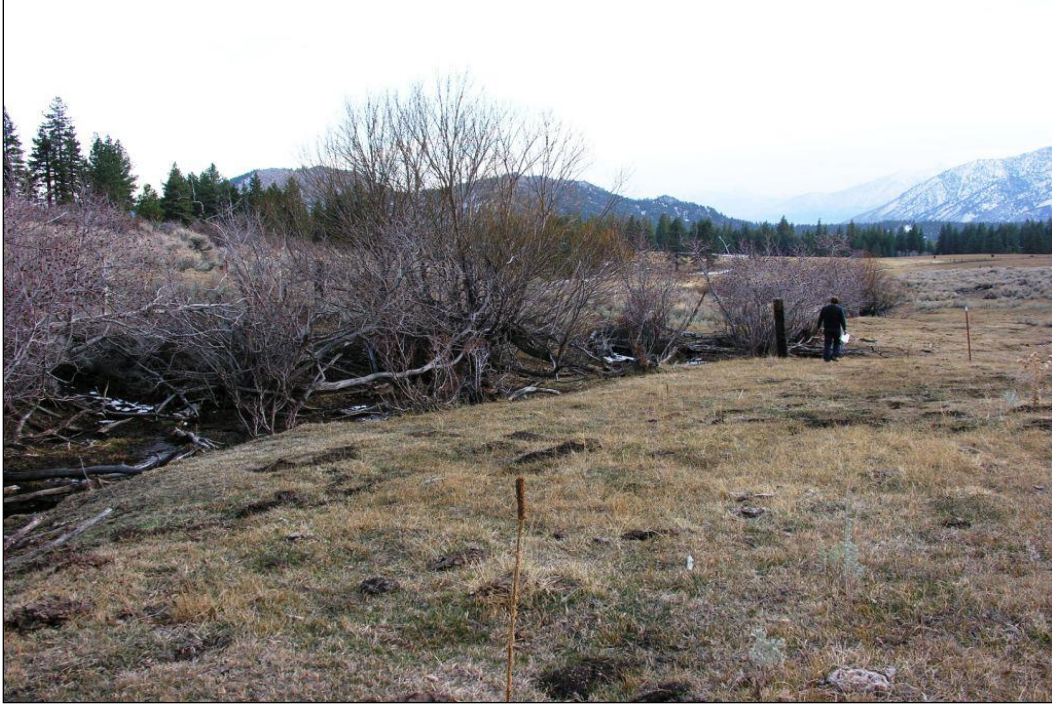
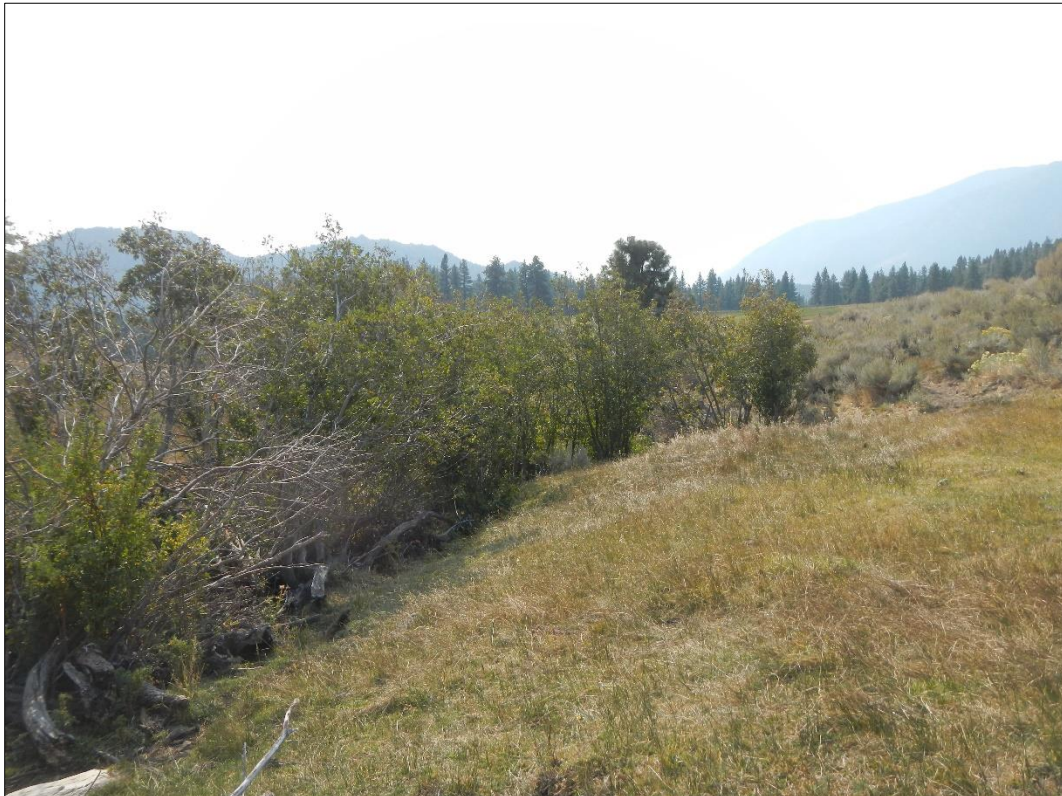
Photo Point 2 (view south): A photo point located in bottom of the active stable drainage channel to the southeast of the house to monitor side slope stability.

2009 Baseline Condition, photo taken February 4, 2009:
(GPS coordinate updated in 2010: N39 07' 54.9" W119 50' 11.3")

2020 Condition, photo taken October 9, 2020

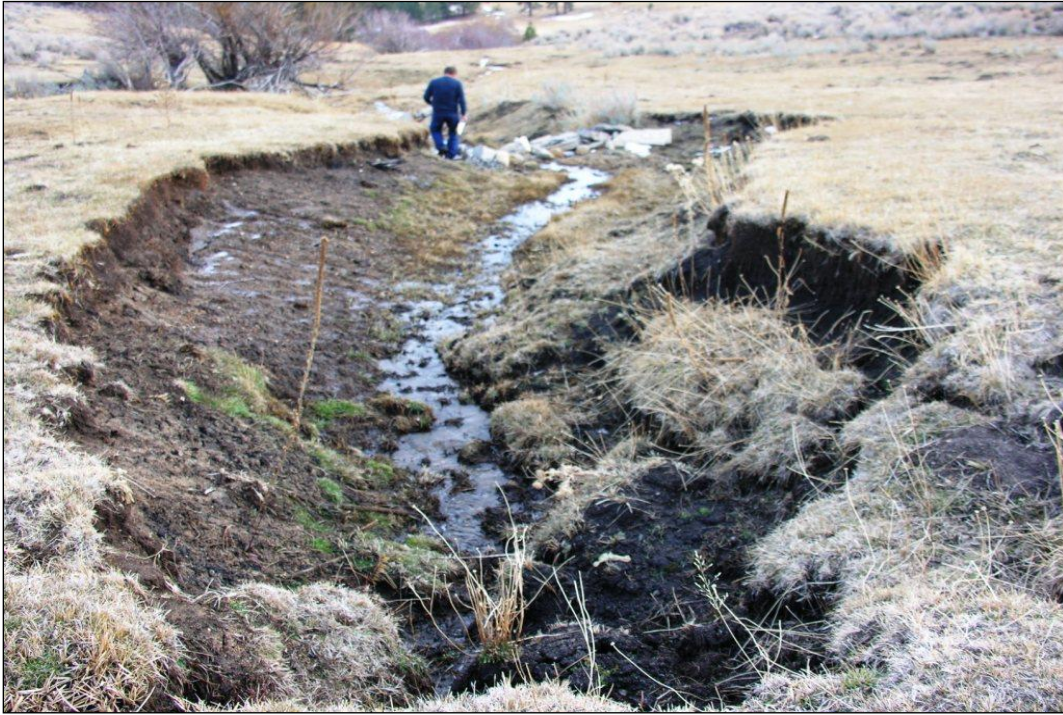
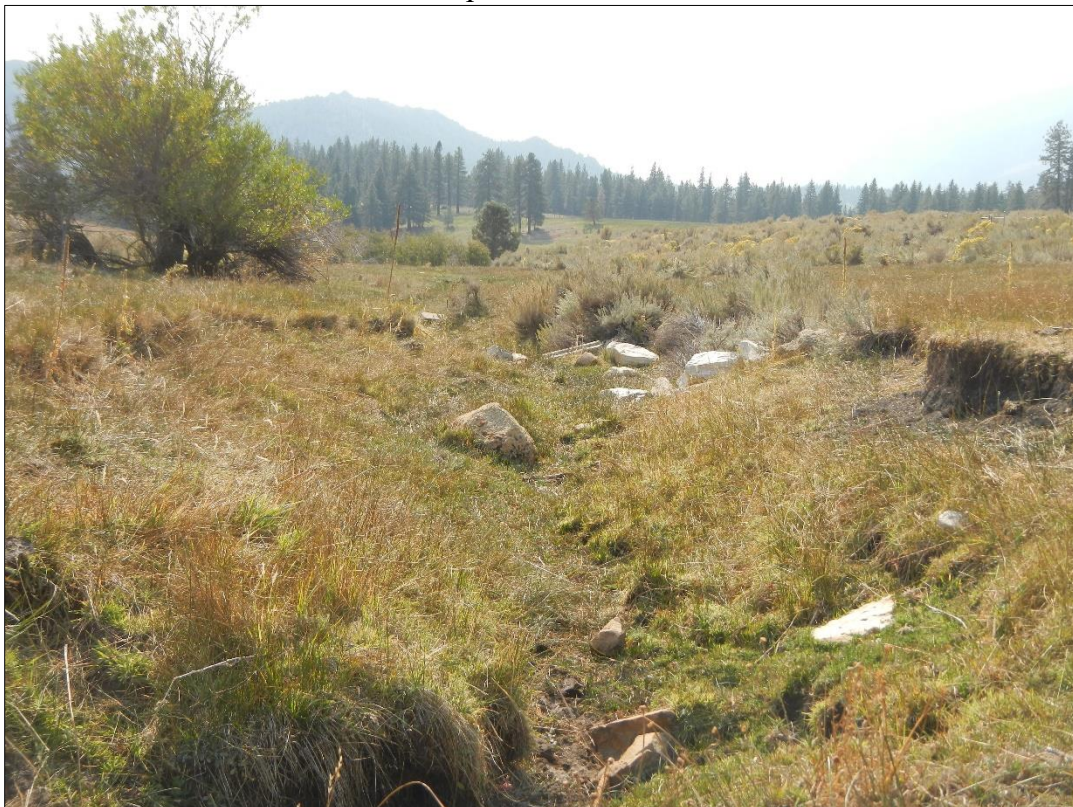
Photo Point 3 (view south): A photo point located immediately east of the house in the active channel where rip-rap has been placed for stabilization.

2009 Baseline Condition, photo taken February 4, 2009

2020 Condition, photo taken October 9, 2020

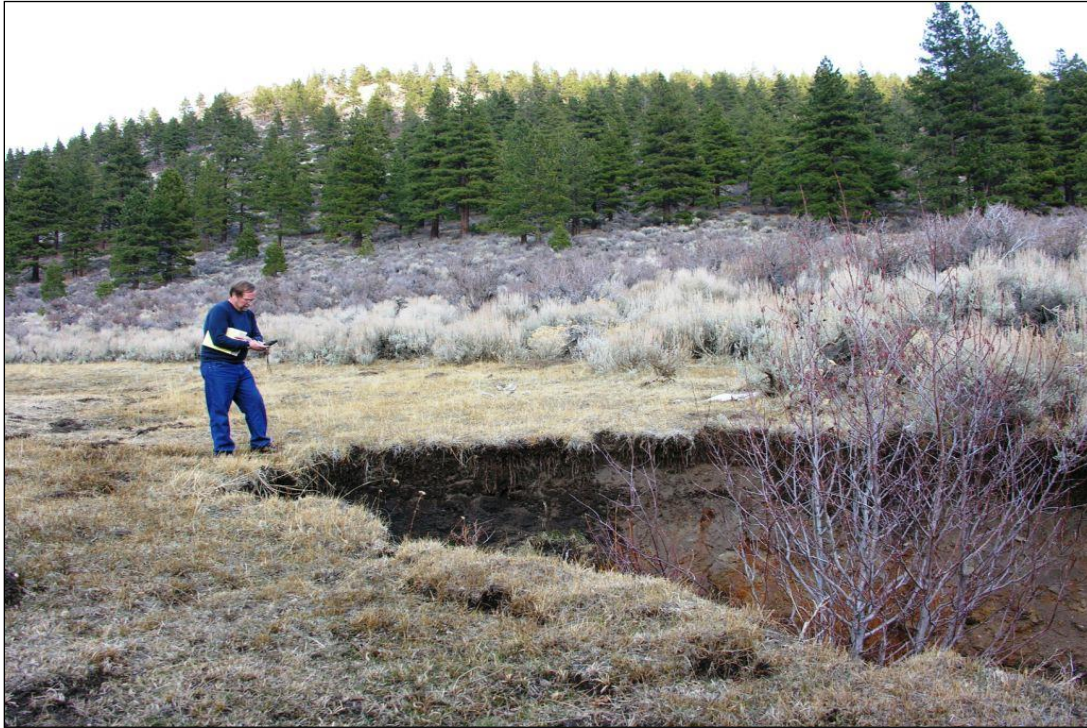
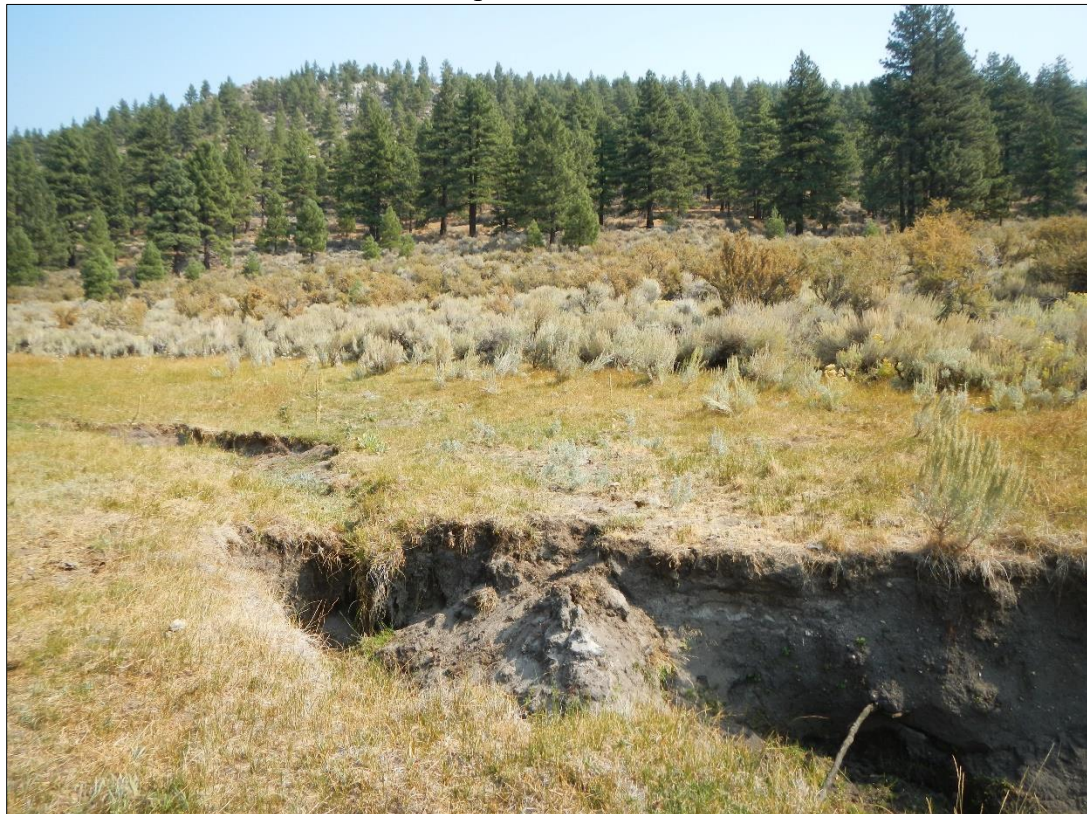
Photo Point 4A (view north): A photo point located at the most northern active headcut after required stabilization to monitor effectiveness.

2009 Baseline Condition, photo taken February 4, 2009

2020 Condition, photo taken October 9, 2020
