STAFF REPORT

Agenda Title: For Possible Action: Discussion and possible action regarding the annual monitoring report for the Horsecreek Ranch Conservation Easement for 2020.

ATTACHMENT 1 – 2020 Horsecreek Ranch Conservation Easement Monitoring Report

Carson City Open Space – Conservation Easement Monitoring
--

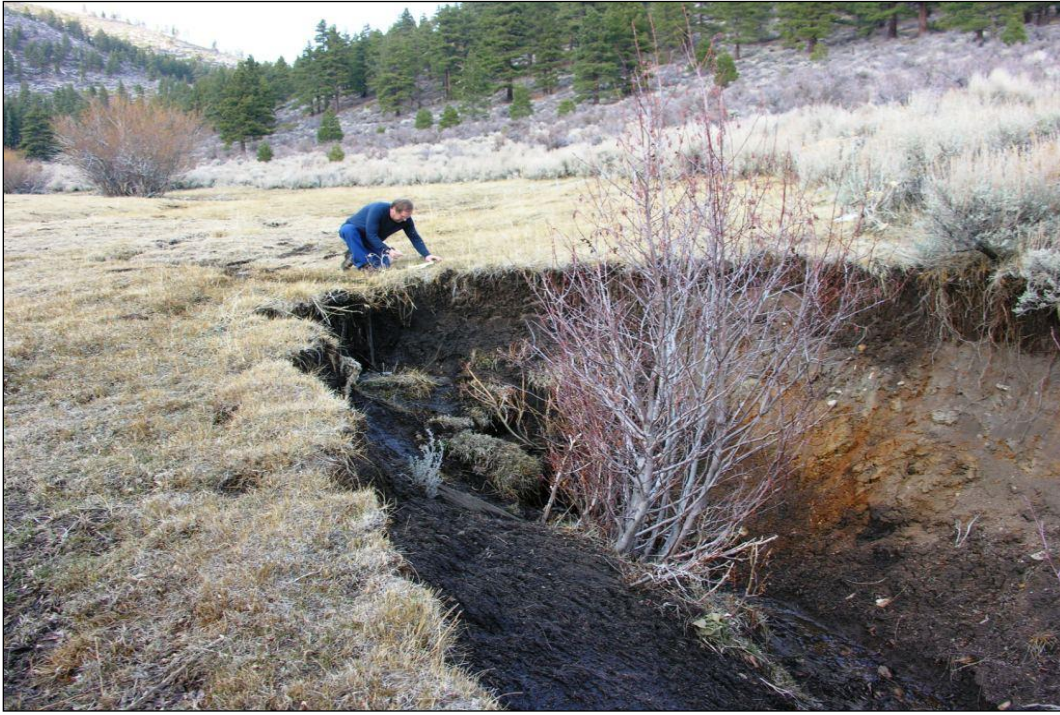
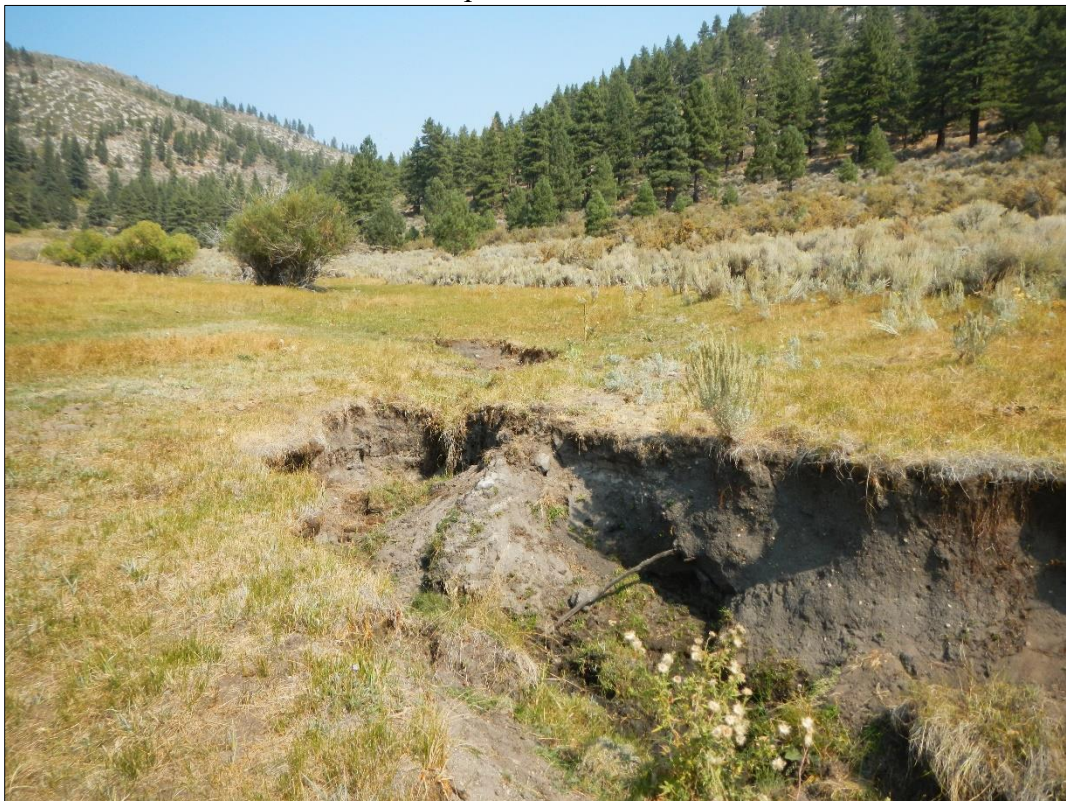
Photo Point 4B (detail): A photo point located at the most northern active headcut after required stabilization to monitor effectiveness.

2009 Baseline Condition, photo taken February 4, 2009

2020 Condition, photo taken October 9, 2020

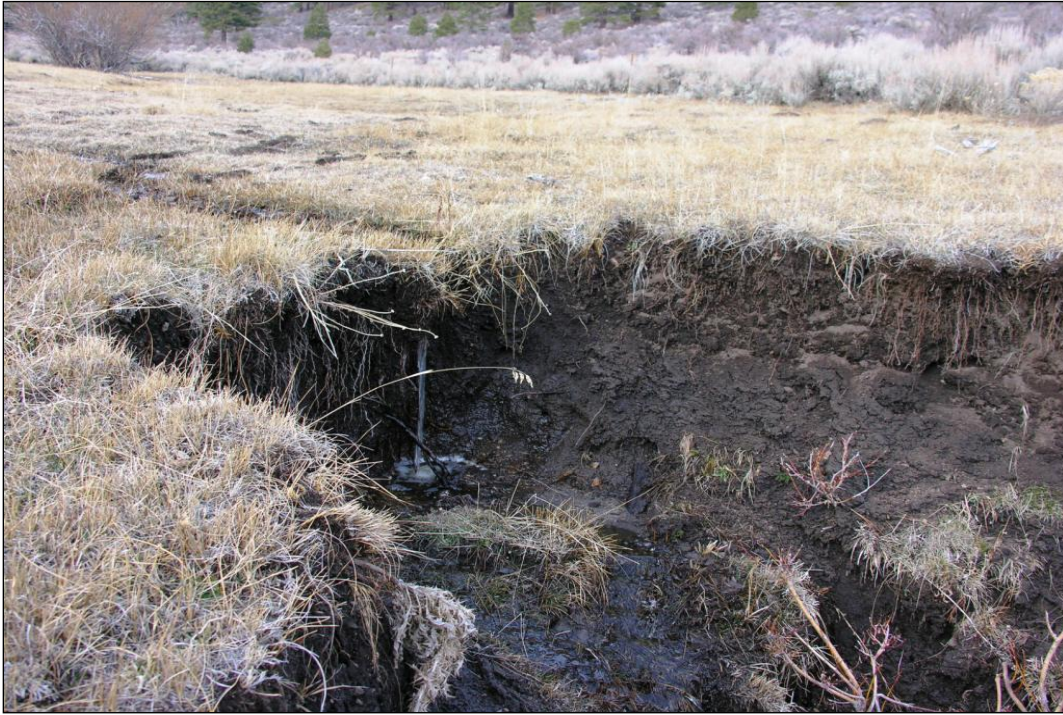
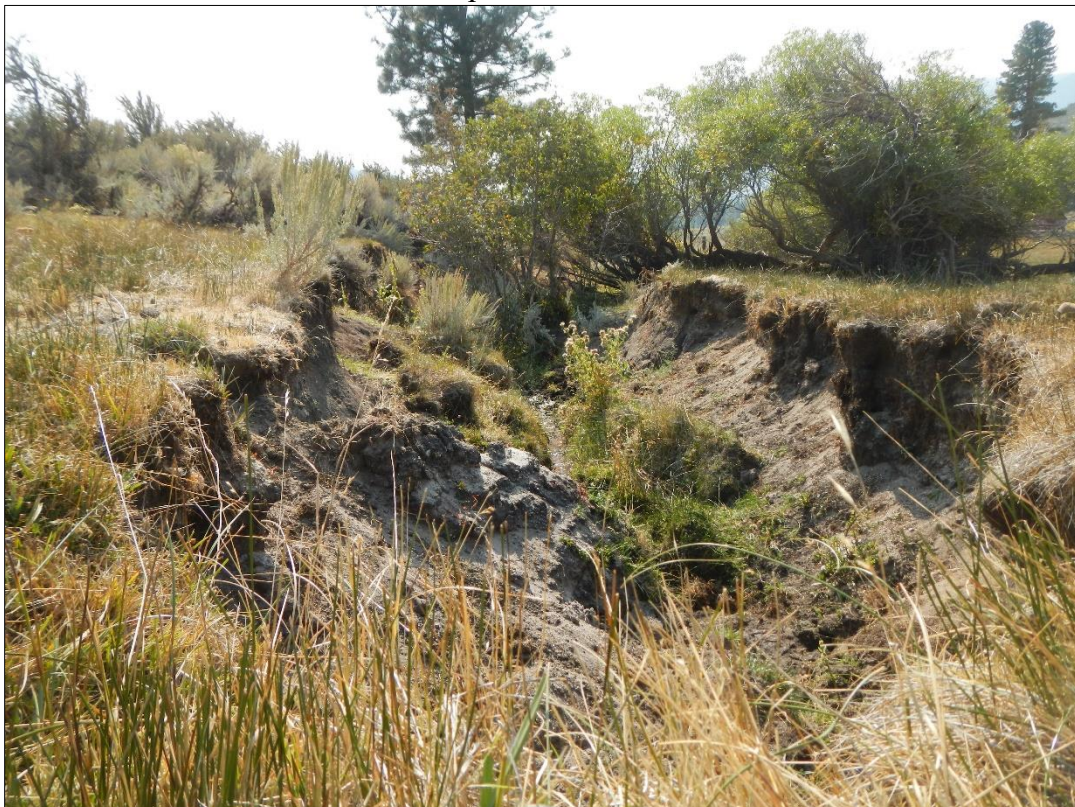
Photo Point 4C (detail): A photo point located at the most northern active headcut after required stabilization to monitor effectiveness.

2009 Baseline Condition, photo taken February 4, 2009

2020 Condition, photo taken October 9, 2020

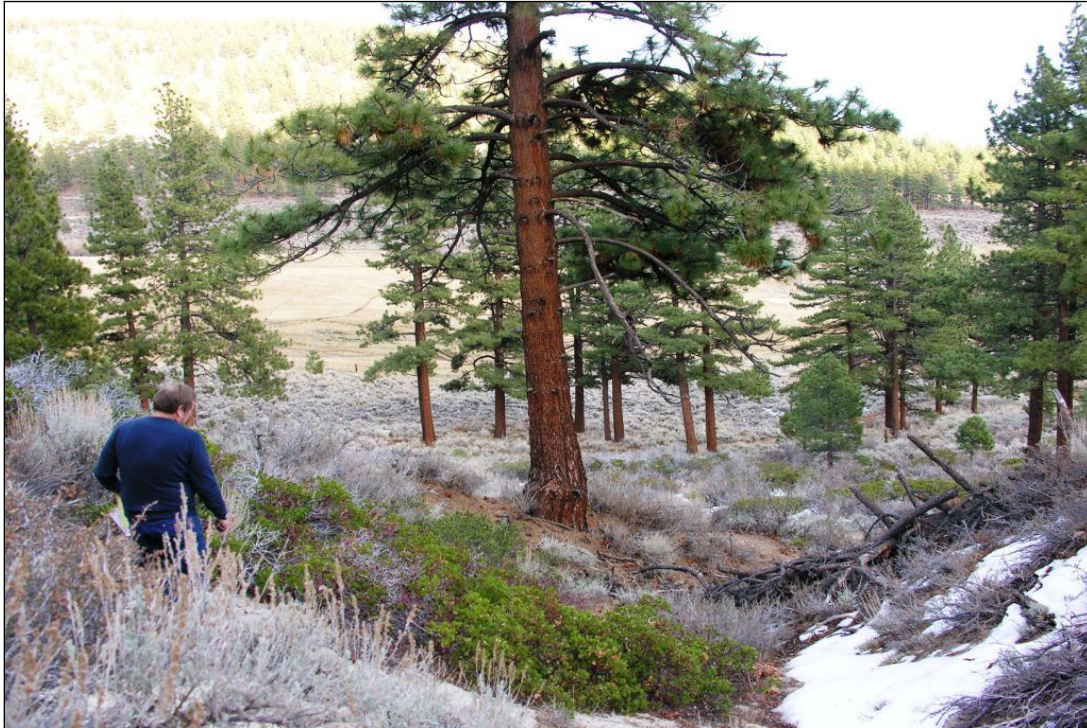
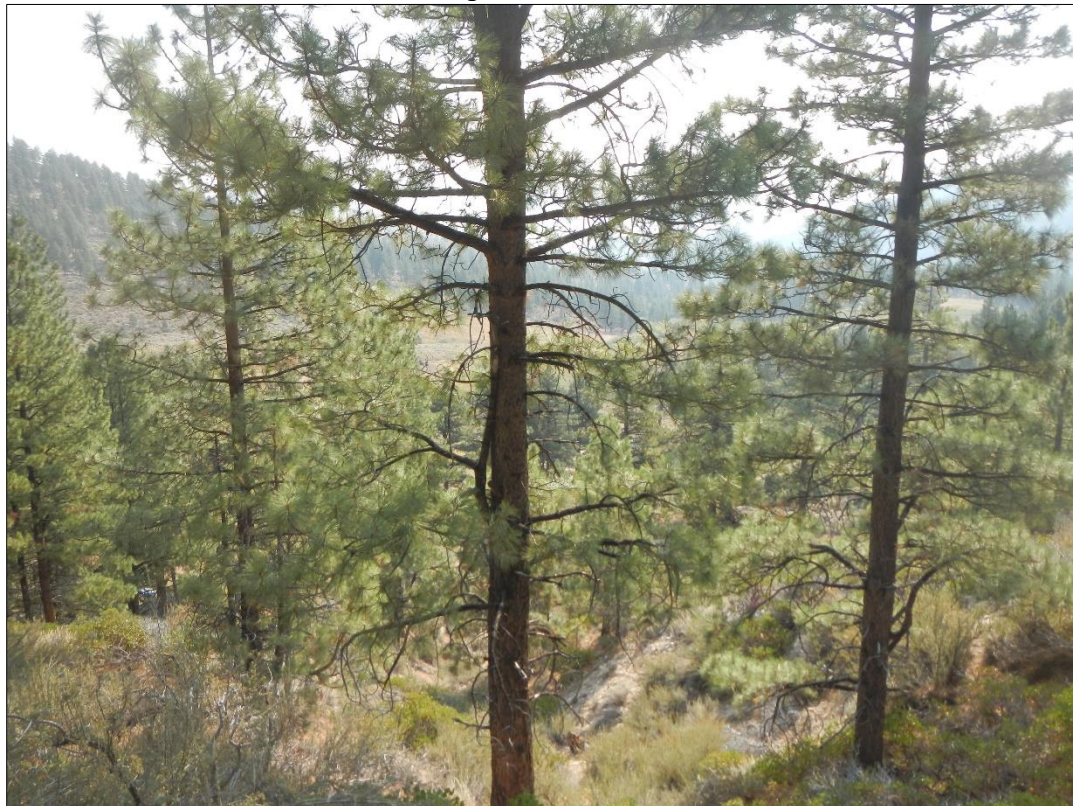
Photo Point 5 (view east): A photo point on the hillside conveyance ditch at a location where a previous washout has occurred to monitor ditch maintenance.

2009 Baseline Condition, photo taken February 4, 2009

2020 Condition, photo taken October 9, 2020

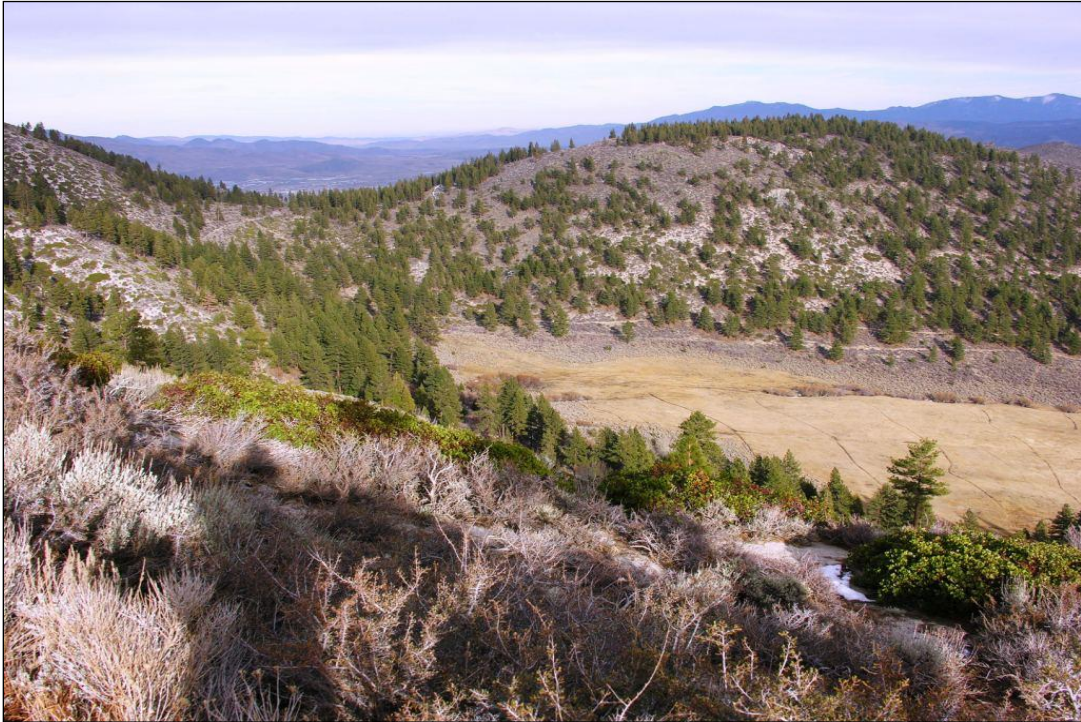
2009 Baseline Condition, photo taken February 4, 2009

Photo Point 6A (view north): A photo point from the Kings Canyon Road that would provide panoramic views of the ranch from a west to east perspective.

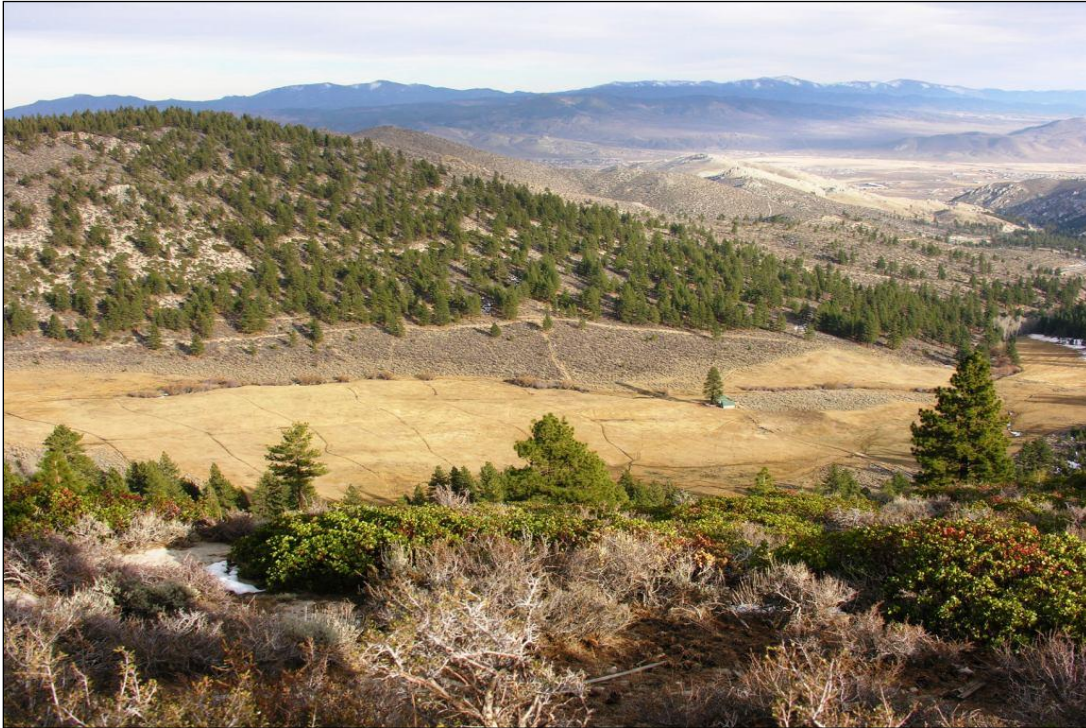
2009 Baseline Condition, photo taken February 4, 2009

Photo Point 6B (view center): A photo point from the Kings Canyon Road that would provide panoramic views of the ranch from a west to east perspective.

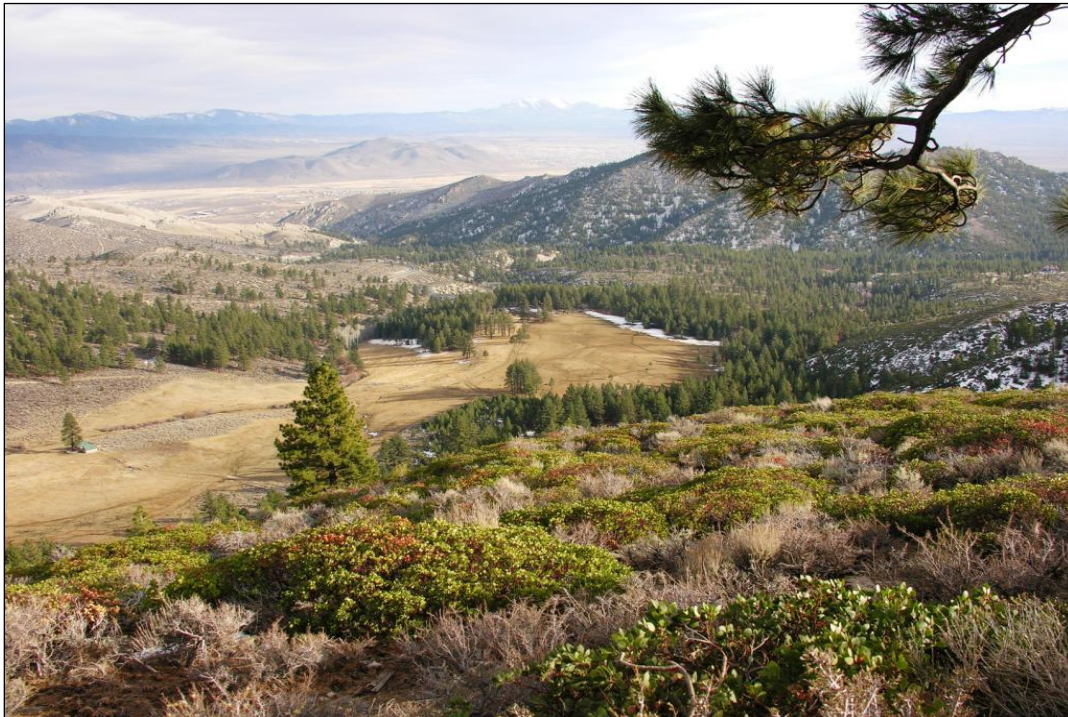
2009 Baseline Condition, photo taken February 4, 2009

Photo Point 6C (view south): A photo point from the Kings Canyon Road that would provide panoramic views of the ranch from a west to east perspective.

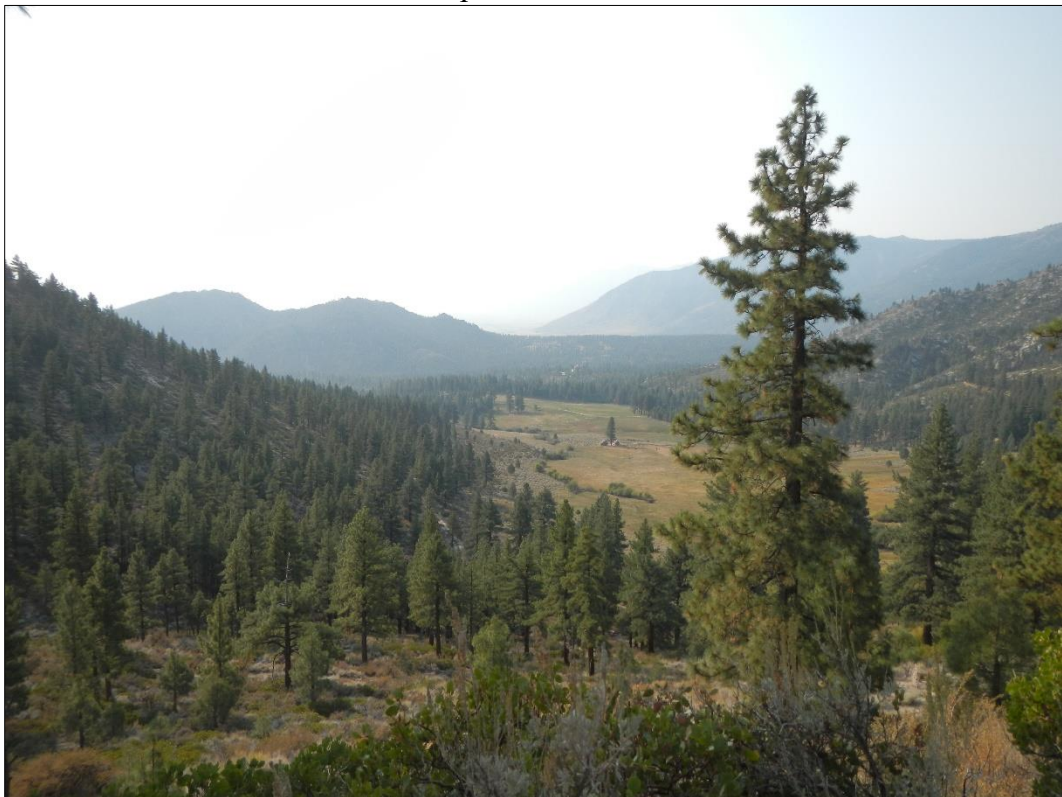
2020 Condition, photo taken October 9, 2020

Photo Point 7A (view southeast): A photo point from Kings Canyon Road that would provide panoramic views of the ranch from a north to south perspective.

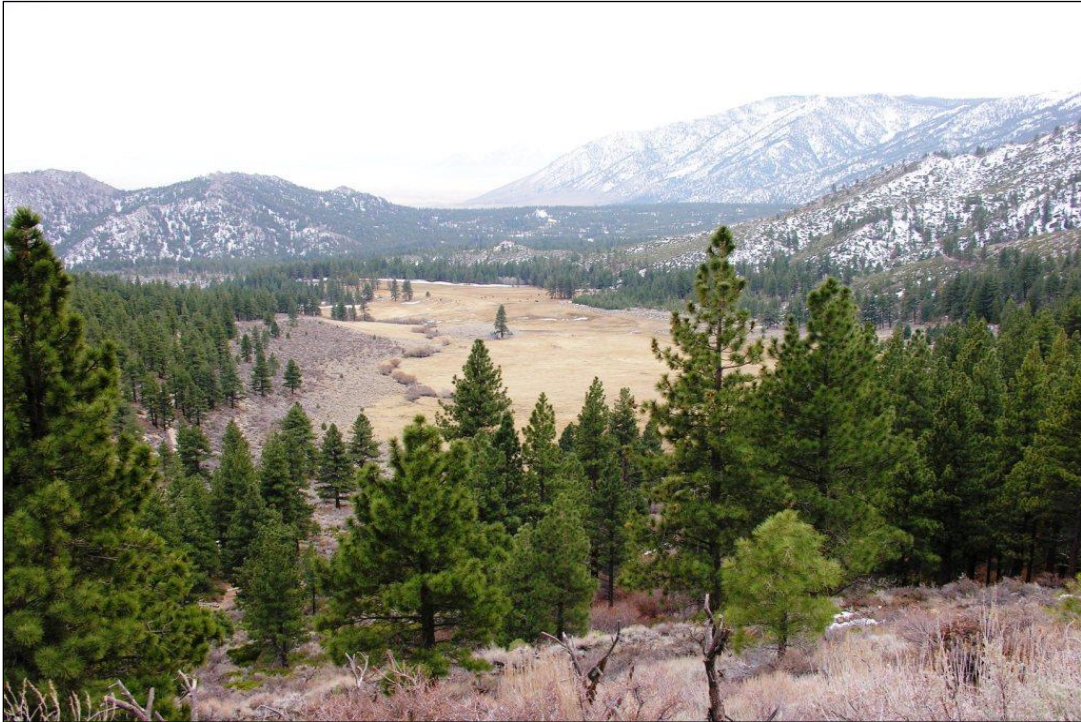
2009 Baseline Condition, photo taken February 4, 2009

Photo Point 7B (view south): A photo point from Kings Canyon Road that would provide panoramic views of the ranch from a north to south perspective.

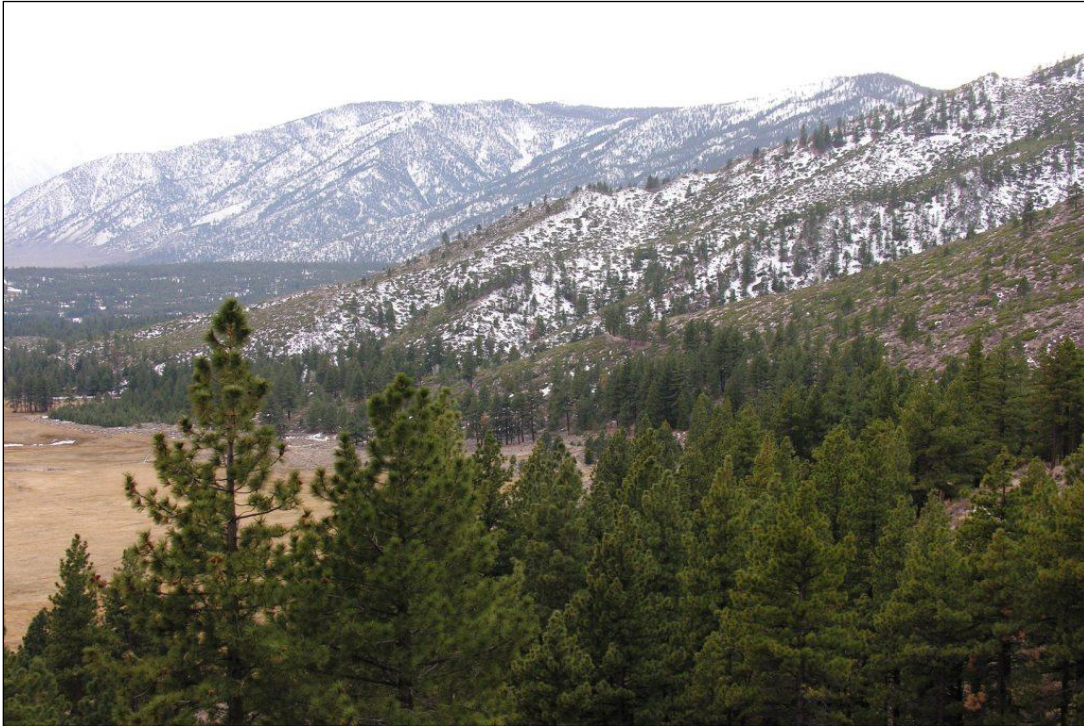
2009 Baseline Condition, photo taken February 4, 2009

Photo Point 7C (view southwest): A photo point from Kings Canyon Road that would provide panoramic views of the ranch from a north to south perspective.

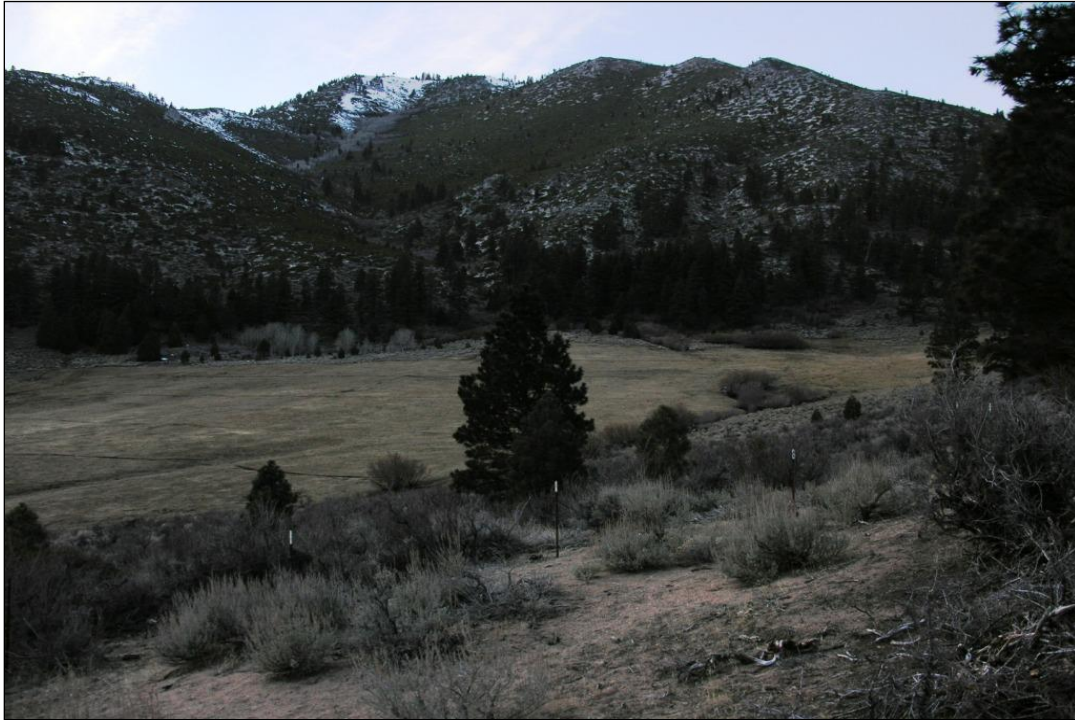
2009 Baseline Condition, photo taken February 4, 2009

Photo Point 8A (view northwest): A photo point overlooking the meadow from the east to the west located next to the property corner along the new road.

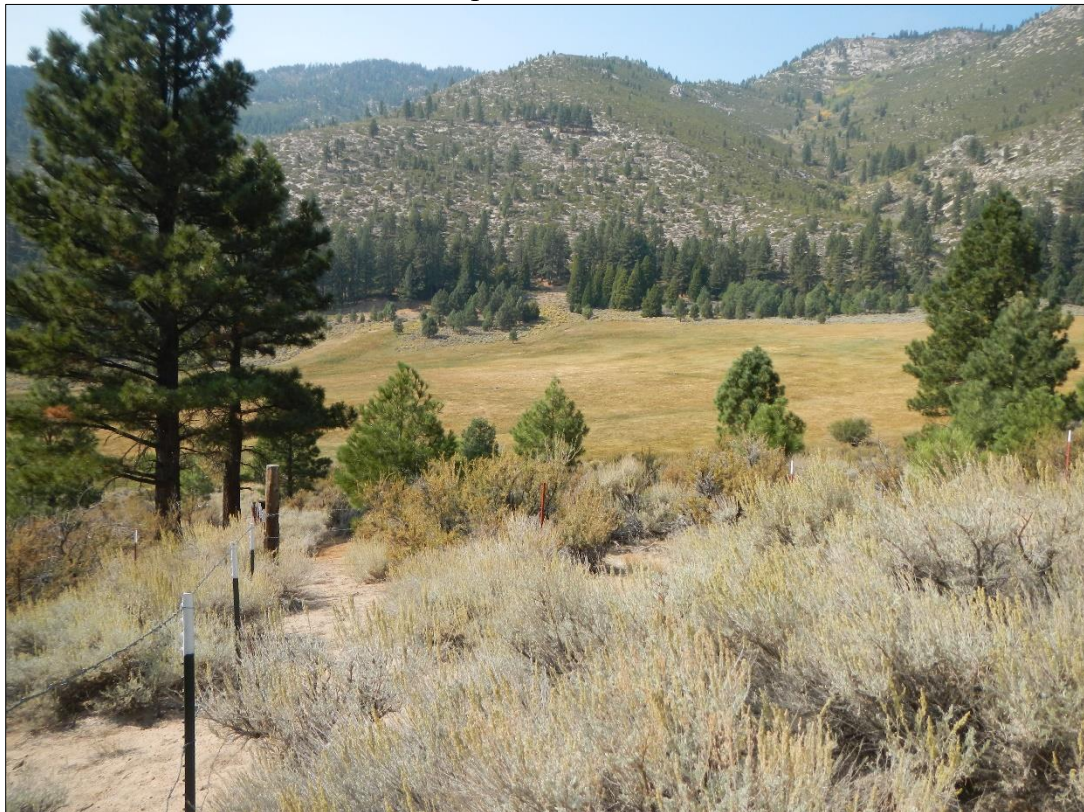
2020 Condition, photo taken October 9, 2020

Photo Point 8B (view west): A photo point overlooking the meadow from the east to the west located next to the property corner along the new road.

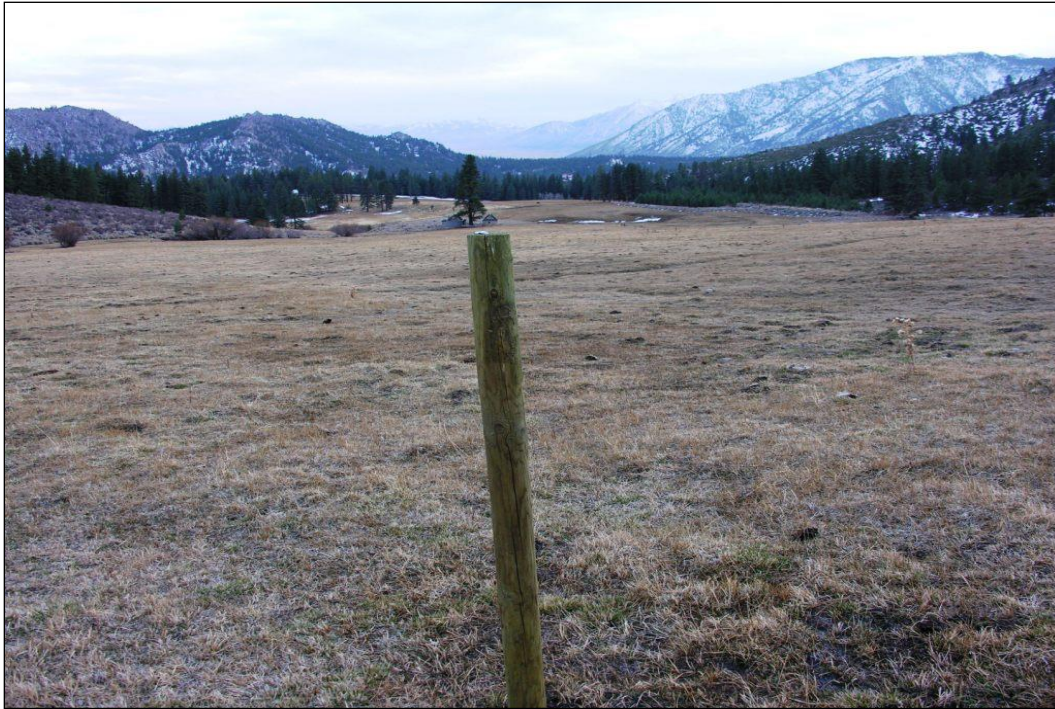
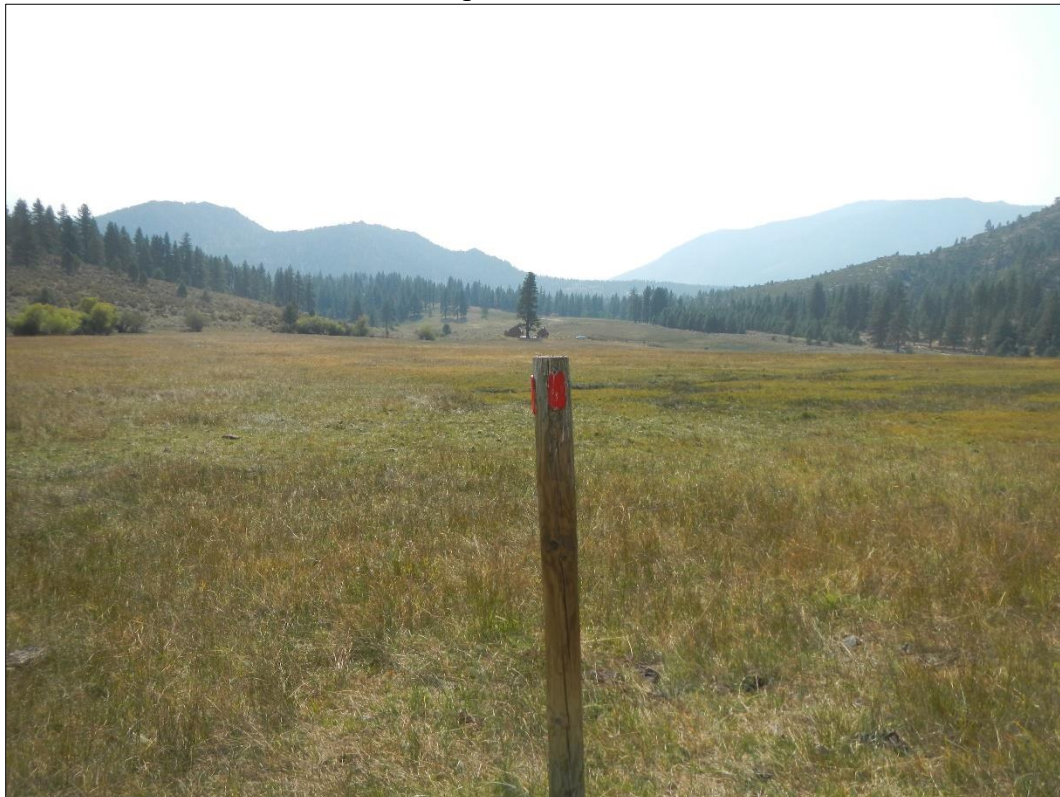
- The Pasture Utilization and Condition Assessment was conducted by Carson City staff and included a visual observation of the monitoring plot as described in the Baseline Condition Report. A diversity of pasture, wetland associated (*Juncus*), and invasive grasses (cheatgrass) exhibited various utilization levels depending on species. It should be noted that cover of invasive grasses (cheatgrass) has reduced. Overall, grazing at this location appeared negligible and an average stubble height of 3 – 4” was recorded.

Photo Point 9: A permanently marked 100' x 100' area to monitor pasture condition. This annual inventory will be used to monitor not only pasture condition but irrigation efficiency, vegetative response to drought and appropriate livestock utilization.

2009 Baseline Condition, photo taken February 4, 2009

2020 Condition, photo taken October 9, 2020
