STAFF REPORT

Agenda Title: For Discussion Only: Review and discussion of the Prison Hill OHV Area Monitoring Report, and updates on the Prison Hill OHV Area. (*Georgia Vasey and Gregg Berggren*)

Carson City Open Space – Conservation Easement Monitoring

Prison Hill OHV Area – Monitoring Report

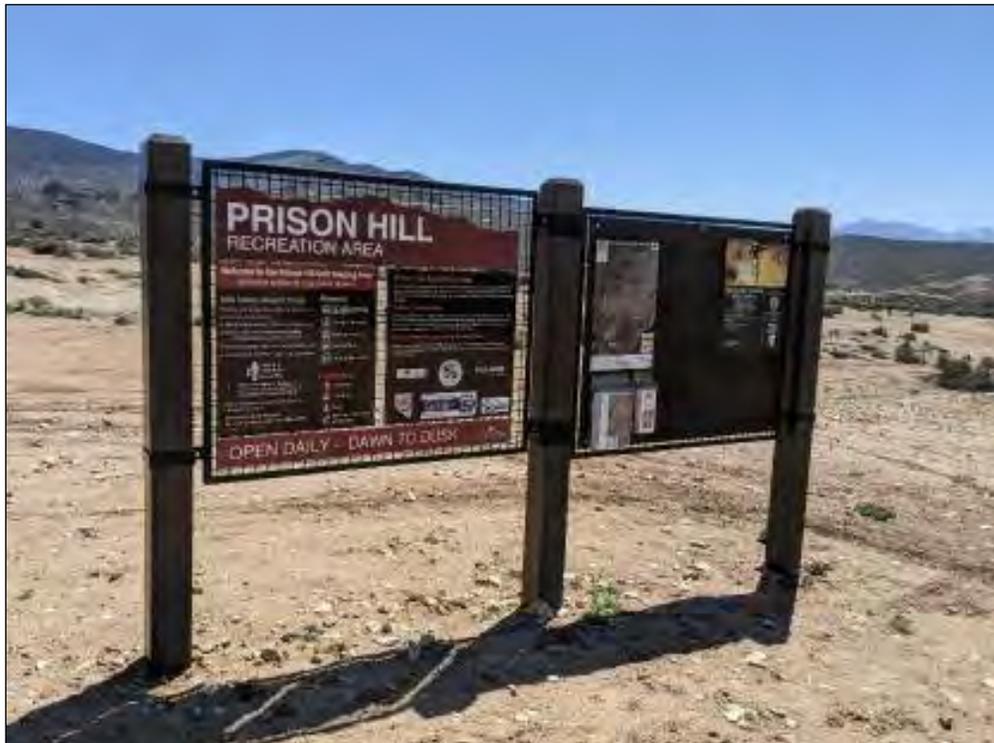
(2A) Photo Point: The photo of the new kiosk at the staging area showing rules and regulation information, as well as a map.

2021 Condition, photo taken June 23, 2021

- (A) In the fall of 2019, an informational kiosk was installed near the entrance to the staging area. As of the summer of 2021, the kiosk now includes a map, rules and regulation information, and site updates.

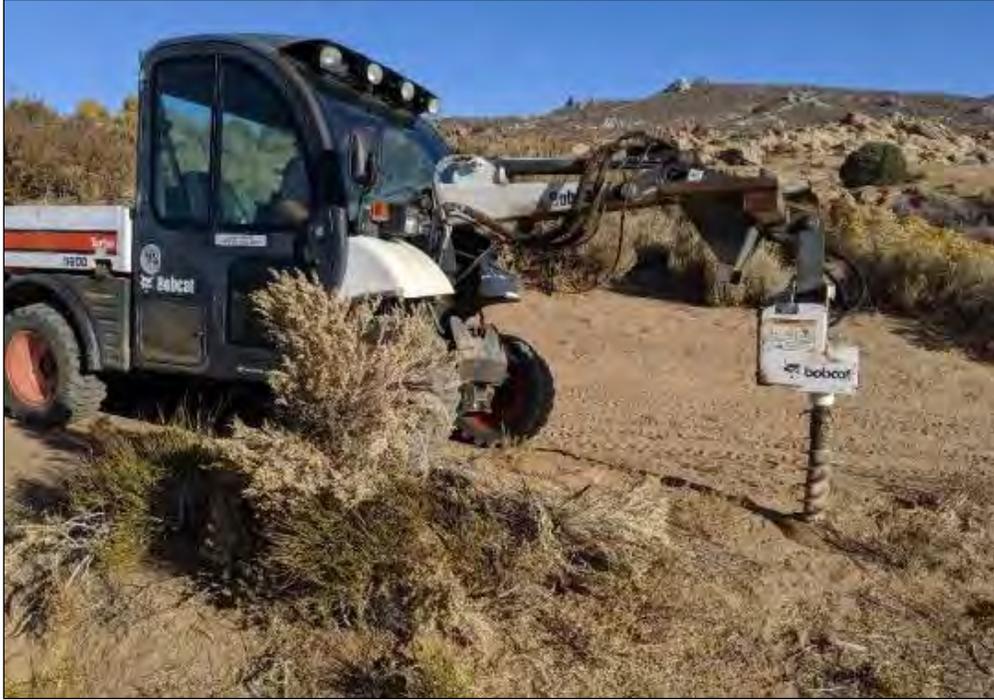
(2B-1) Photo Point: The photo shows Jared using the tool cat to auger holes for new signage.

2019 Condition, photo taken November 29, 2019

- (B) Signage was installed beginning in 2019, with 63 different locations that year alone. One of the first objectives were to sign the open and closed areas. Route signs and safety signs were also installed across the PHRA. Open Space Maintenance Coordinator, Jared Whitaker, has operated a tool cat to auger sign holes. Trails Coordinator, Gregg Berggren, continues to add and remove signs as needed.

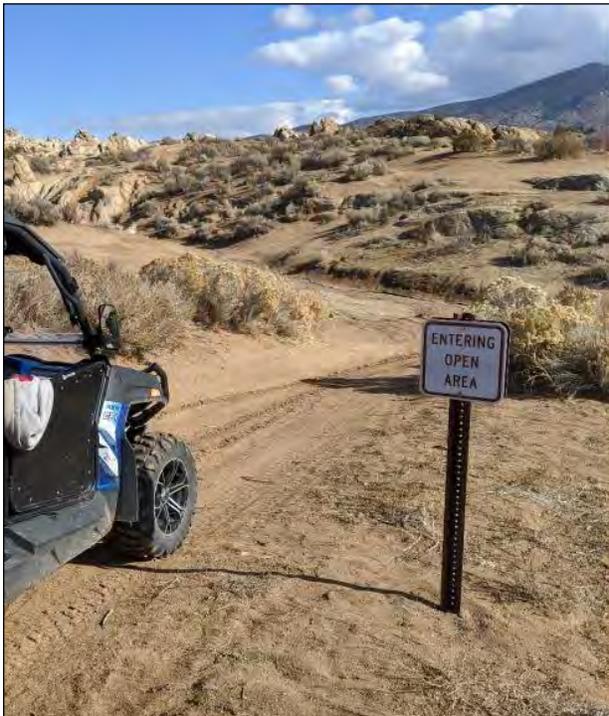
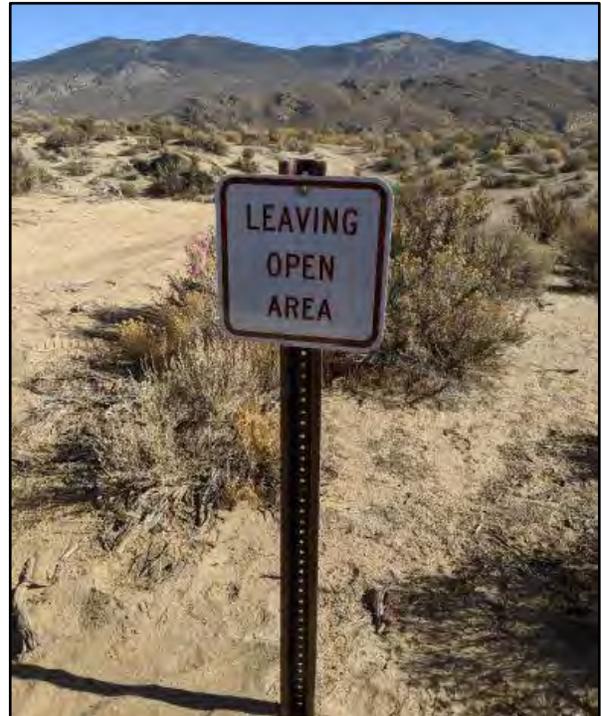
(2B-2) Photo Point: The photo shows example Open Area/Leaving Open Area signage that clearly demarcates permitted OHV-use areas.

2019 Condition, photo taken November 29, 2019

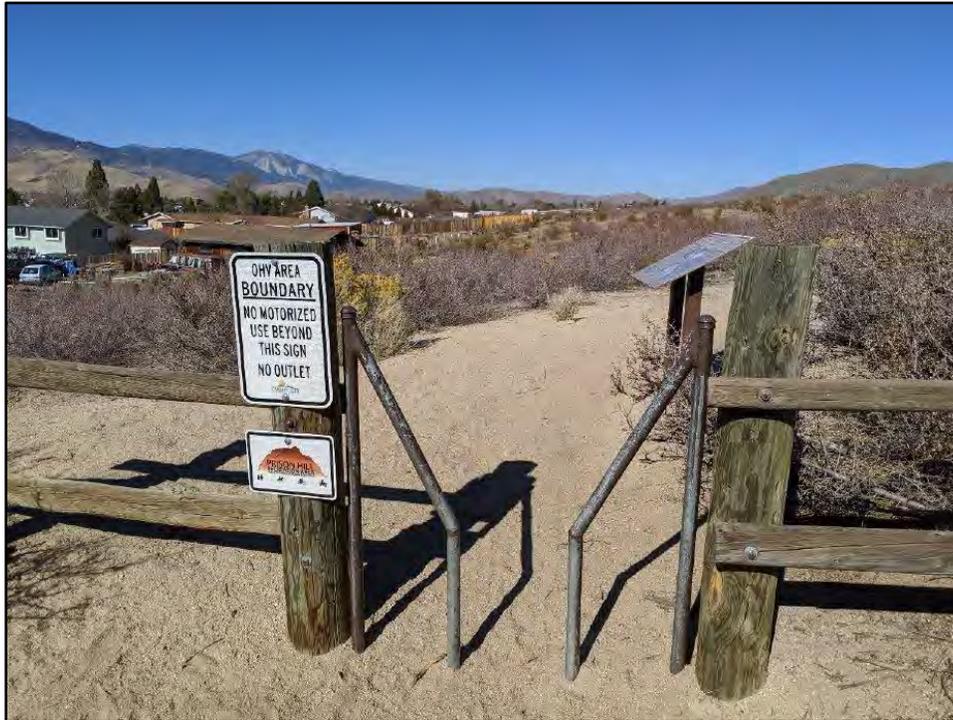
(2B-3) Photo Point: The photo shows the improved recreation area boundary signage.

2019 Condition, photo taken November 29, 2019

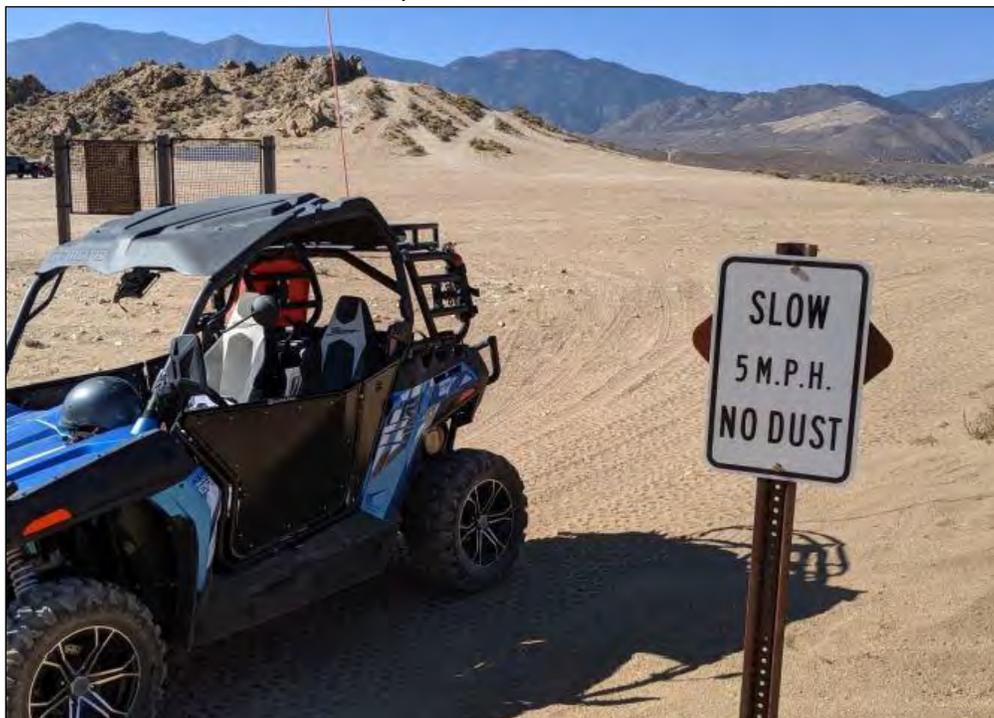
(2B-4) Photo Point: The photo of this safety sign is located near the staging area to inform riders to slow down to a safe speed near the Tot Lot and Beginner Area.

2019 Condition, photo taken November 29, 2019

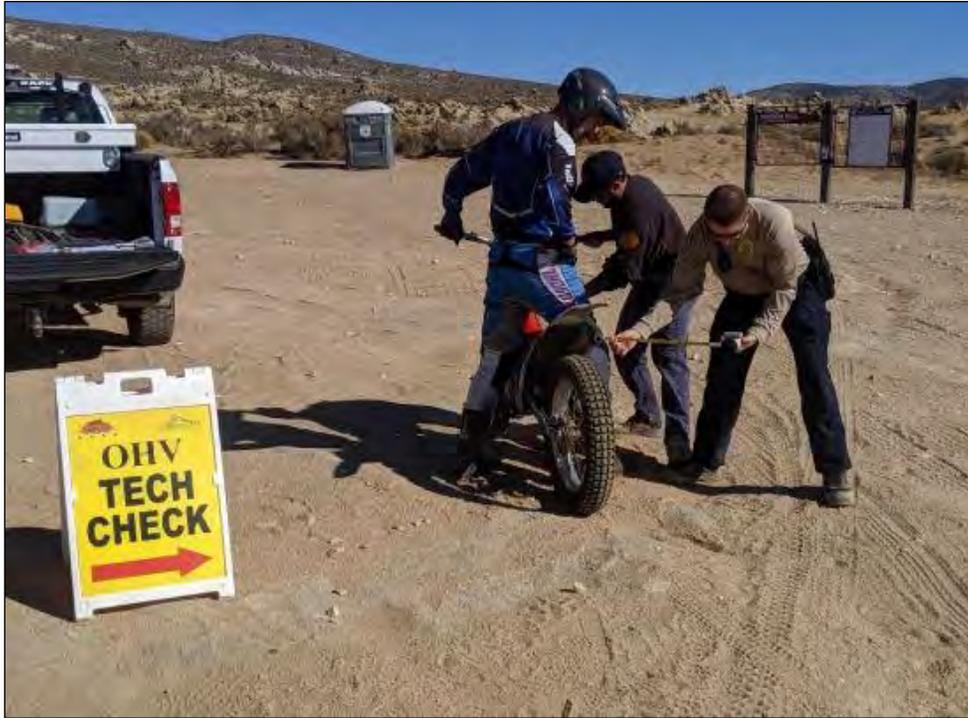
(2C-1) Photo Point: The photo shows an OHV tech check with Senior Park Ranger, John Costello.

2019 Condition, photo taken November 29, 2019

- (C) Education on tech checks began in the fall of 2019, conducted at the staging area. Park Rangers learned how to check for spark arrestors, check sound level, and check for Nevada OHV registration. Vehicles that passed inspection obtained an official Prison Hill Tech Check, Riding Right decal. Additionally, since November of 2019, a campaign called “Don’t Crush the Brush” has begun to educate riders on knowing where to ride, as well as the rules of PHRA to hopefully prevent further soil loss and damaged vegetation.

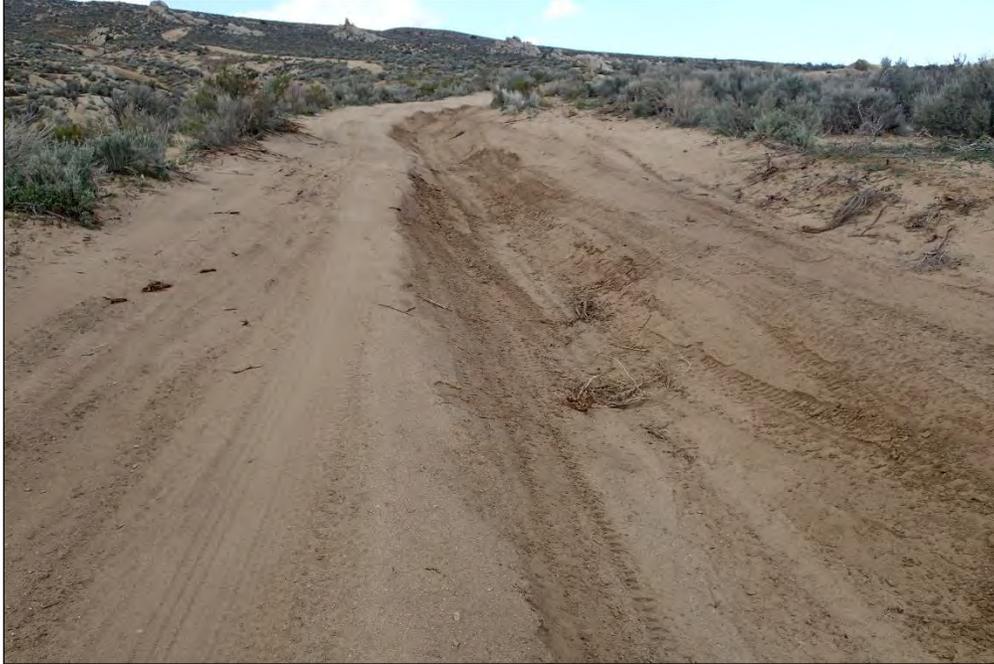
(3A-1) Photo Point: The photo shows the former eroded road before it was decommissioned in 2019. It is mid-slope on Center Road, located off Cable Road near Death Walls Wheeler Trail (Photo Point #14, GPS location: 39.109900, -119.730203).

2017 Condition, photo taken April 12, 2017 (view north)

- (A) In fall of 2019, erosion control improvements were implemented on Center Road to mid-slope where it intercepted with other east-west contour routes (see Category 4: Erosion and Soil Degradation). Following road improvements, Center Road heading towards Golden Eagle Rock above mid-slope was decommissioned for 100 feet (photo monitoring point #14). The new improvements included installing rip rap, vertical mulch, and new signage. To our current knowledge, OHV-use on the road has ceased.

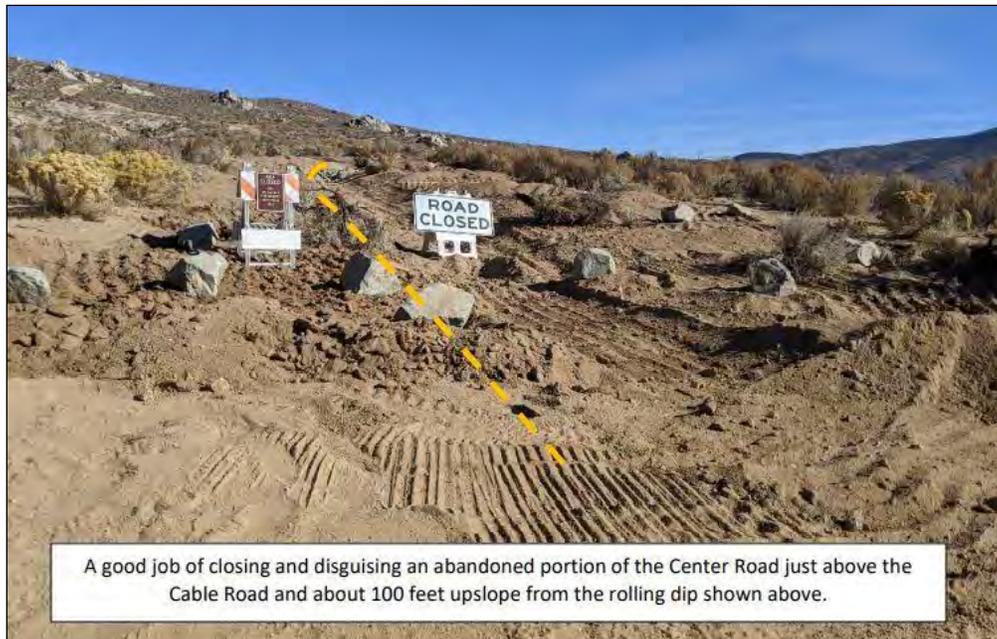
(3A-2) Photo Point: The photo shows the initial construction zone when decommissioning the road in 2019 (Photo Point #14, GPS location: 39.109900, -119.730203).

2019 Condition, photo taken November 29, 2019 (view north)

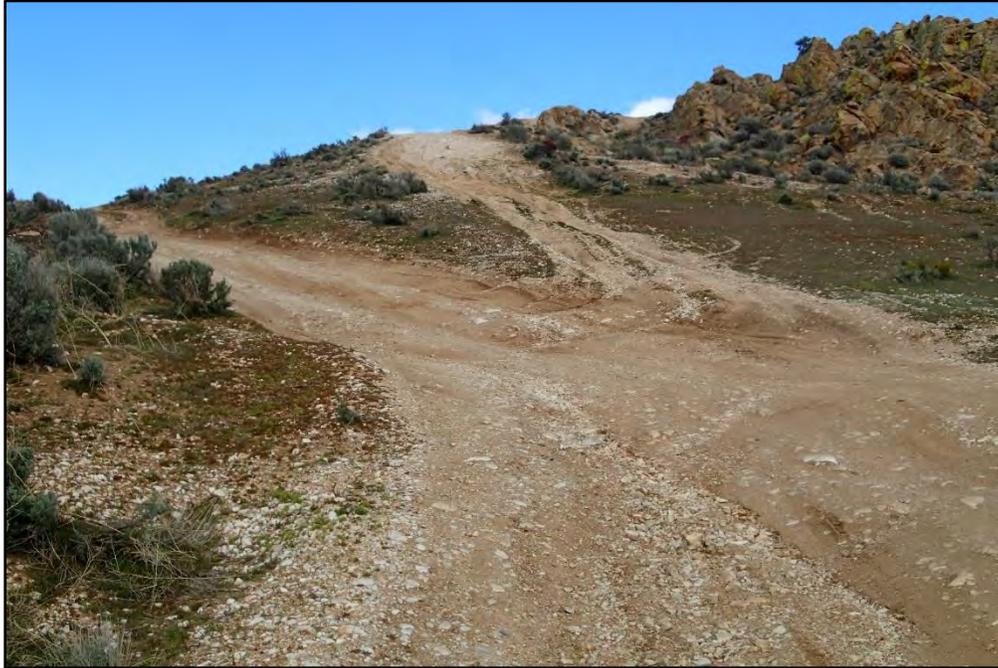
(3B-1) Photo Point: This photo shows the initial conditions of the former access point from the west at Golden Eagle Lane (Photo Point #13, GPS coordinates: 39.104735, -119.735214).

2017 Condition, photo taken April 12, 2017 (view east)

- (B) There were two access roads into the staging area: one on the east side of the rocky mound by Golden Eagle Lane and one to the west side of the rocky mound. The eastern access was reconstructed in October of 2019 as the official entrance to the staging area. The western access (photo-monitoring point #13) was decommissioned in November of 2019, as it had steeper grades, more erosion, unsafe sight distances, and went directly into the children training facilities. The area was rehabilitated with new drainage, reseeded with an approved seed mix, and closed off both at the bottom and top portions of the former road using jackrail fencing. As of 2021, vegetation appears to be growing back.

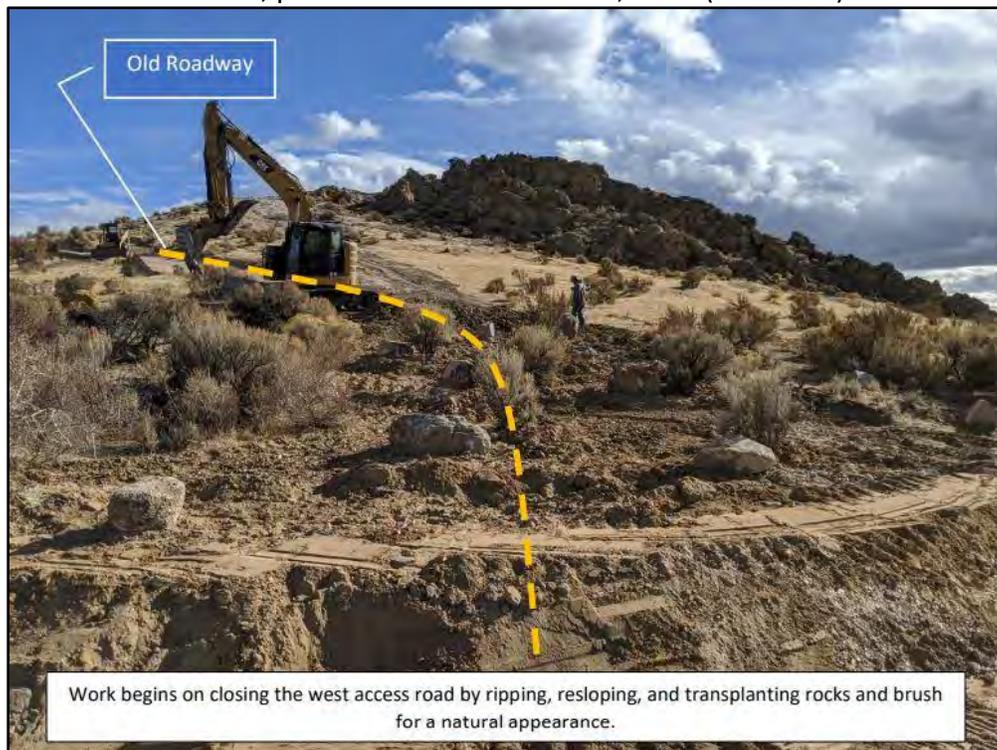
(3B-2) Photo Point: This photo shows construction in progress during fall of 2019 to decommission the former western access from Golden Eagle Lane (Photo Point #13).

2019 Condition, photo taken November 29, 2019 (view east)

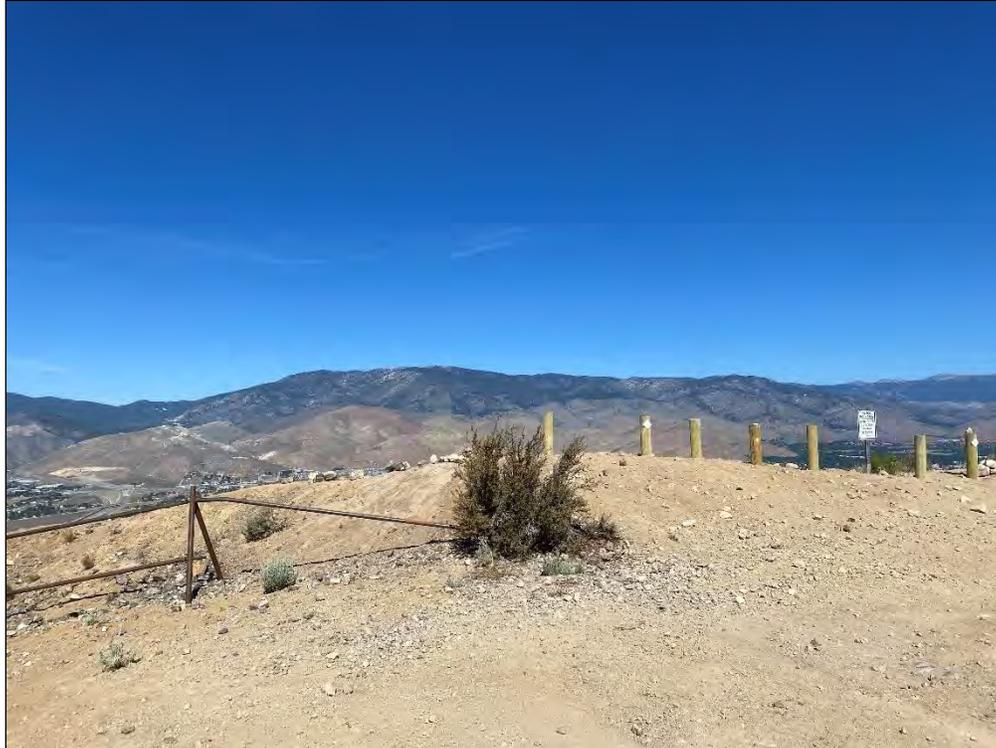
(3C) Photo Point: The photo of this road closure is located at the Prison Hill Summit (Photo Point #9, GPS location: 39.108428, -119.716747).

2021 Condition, photo taken June 17, 2021 (initial assessment – view west)

- (C) In 2021, the Prison Hill Summit access to the west (photo-monitoring point #9) was officially blocked off for future OHV use. A berm was constructed, in which pressure treated posts were installed for fencing. Additional jackrail fencing now outlines the perimeter, and signage announces that it is a closed area.

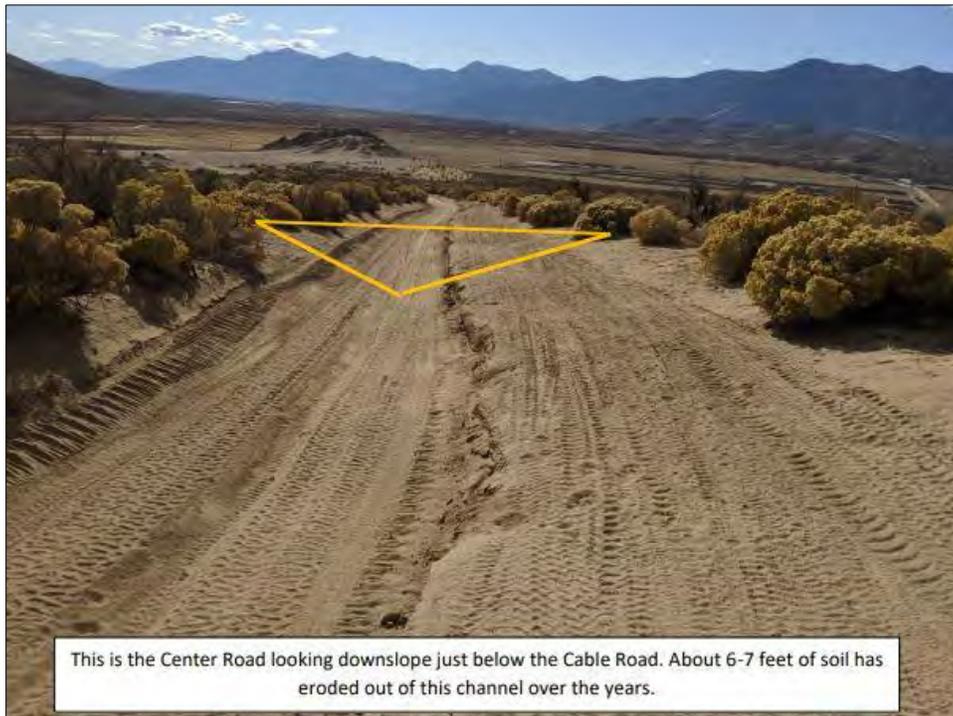
Prior to construction in the fall of 2019, the main road up to Golden Eagle Rock called 'Center Road' had major erosion issues that would move large quantities of sand into the staging area during storm events. A drivable route up the slope was identified, and then the over-width of the road which had eroded away was ripped up and filled with drainage structures. Thereafter, it was seeded with an approved native-seed mix.

Photo Point: The photo shows conditions of erosion prior to construction in October of 2019. There was about 6 to 7 feet of soil that eroded out of this channel over the years.

2019 Condition, photo taken October 28, 2019 (view south)

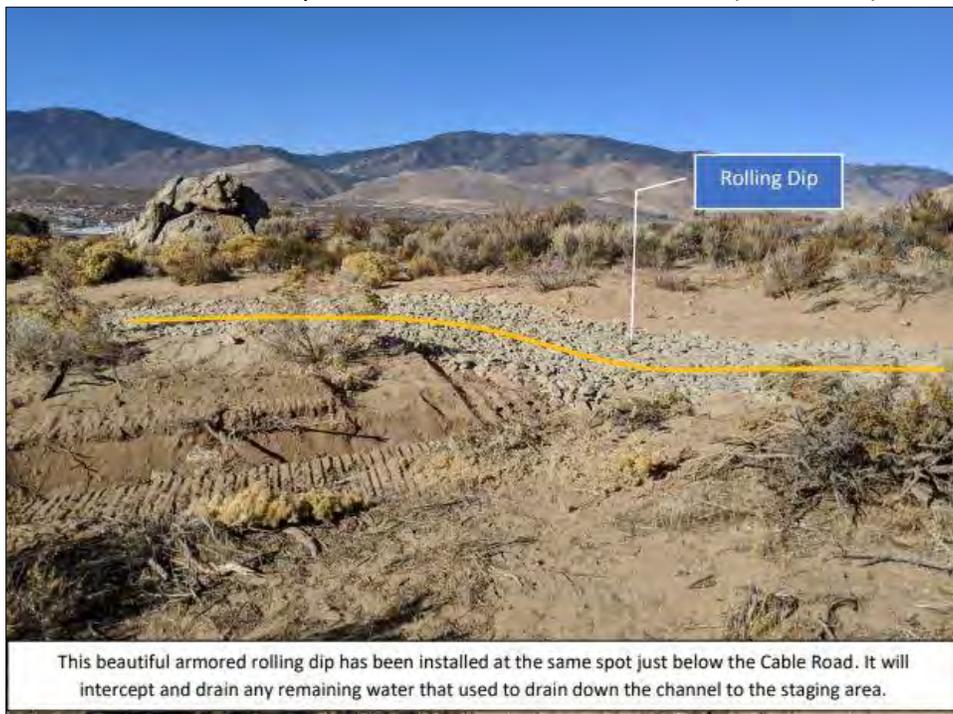
Photo Point: The photo shows the rolling dip with drainage rocks and reseeded areas to fill the formerly eroded 'Center Road' up to mid-slope (below Photo Point #14).

2019 Condition, photo taken November 29, 2019 (view west)

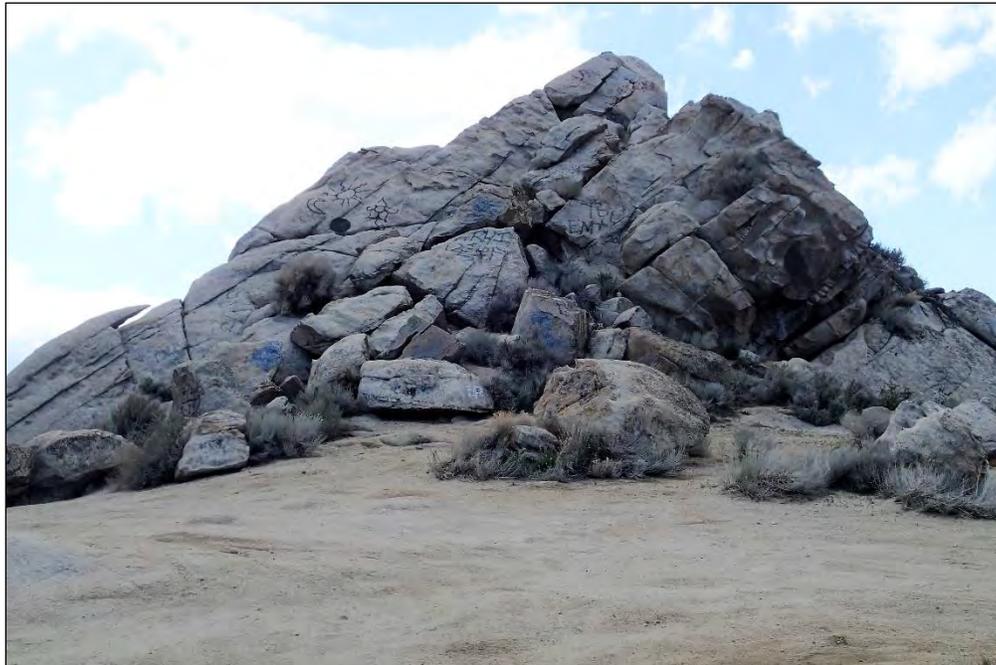
Photo Point: The photo shows graffiti at Golden Eagle Rock in 2017 after being graffitied (Photo Point #8A, GPS location: 39.118457, -119.728973).

2017 Condition, photo taken April 12, 2017 (view west)

In the past, Golden Eagle Rock was repeatedly vandalized with graffiti (Photo-monitoring Point #8A). In response, the Open Space Division responded by painting over the graffiti with natural toned spray-paint starting in 2018. Since establishing more of an active management presence, graffiti at this location has subsided (GPS coordinates: 39.118457, -119.728973).

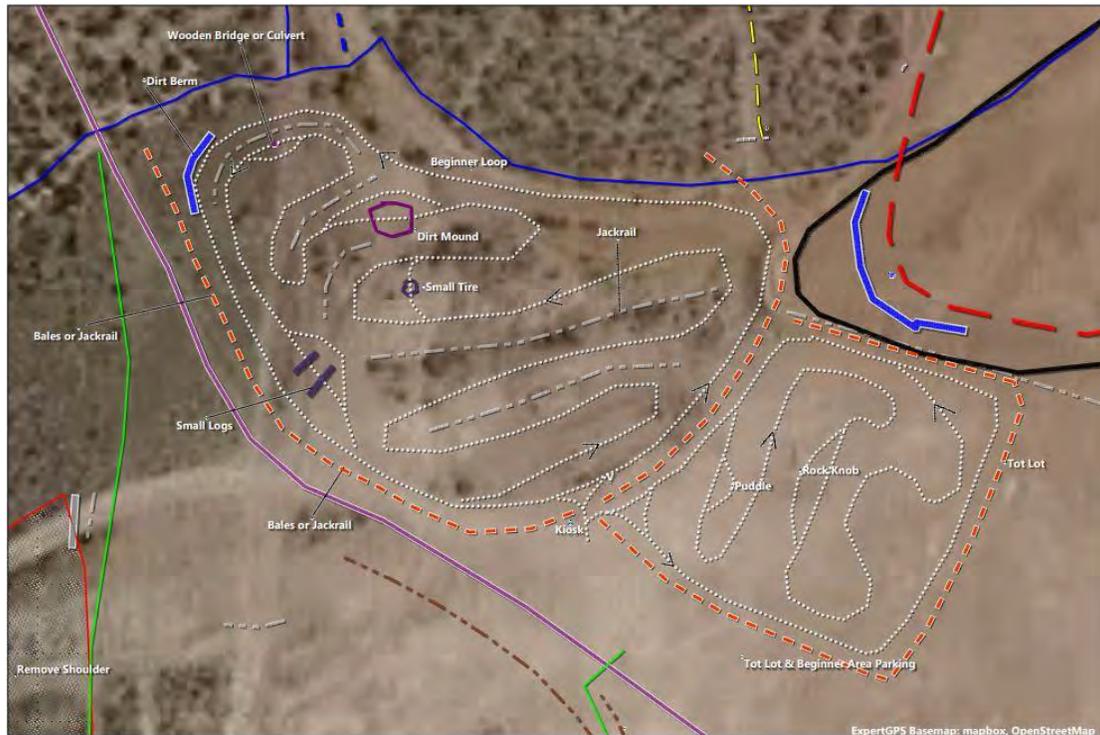
(8A-1) Photo Point: The photo shows the 2021 construction plans for the family friendly OHV areas.

starting in 2020. The Tot Lot is now surrounded by jackrail fencing, and some benches have been installed into the jackrail for families to comfortably watch their children. The perimeter for the Beginner Area is also defined by jackrail. There are two loops: the perimeter loop and the serpentine loop. Lastly, an ADA portable toilet has been placed in the staging area close to the Tot Lot for visitor use.

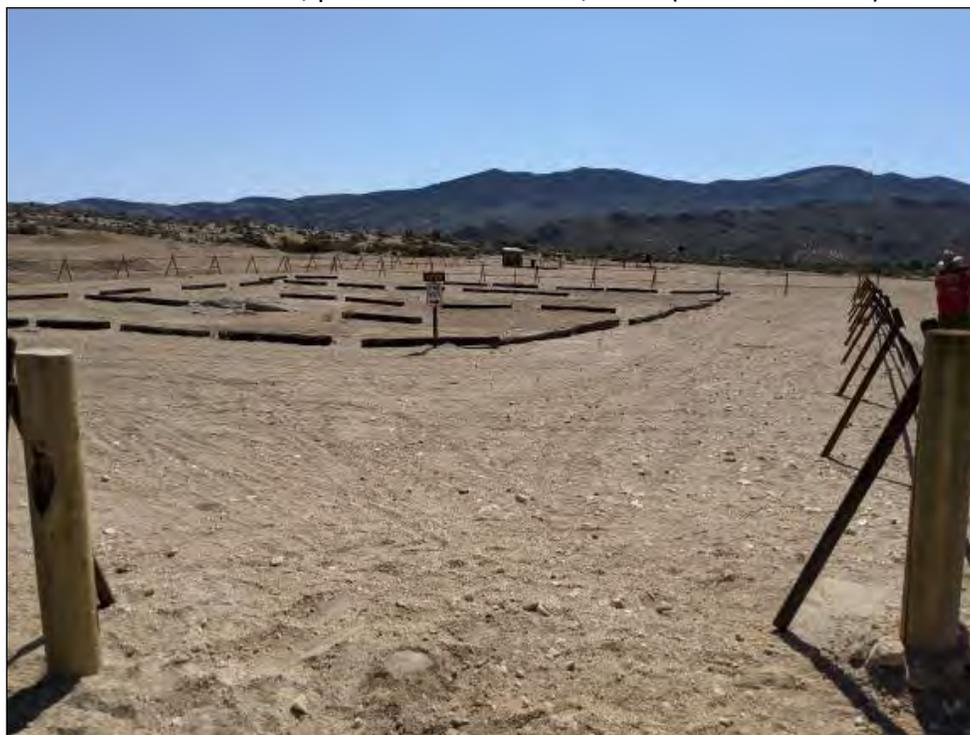
(8A-2) Photo Point: The photo shows the improvements at the Tot Lot in the staging area. 2021 Condition, photo taken June 23, 2021 (view northeast)

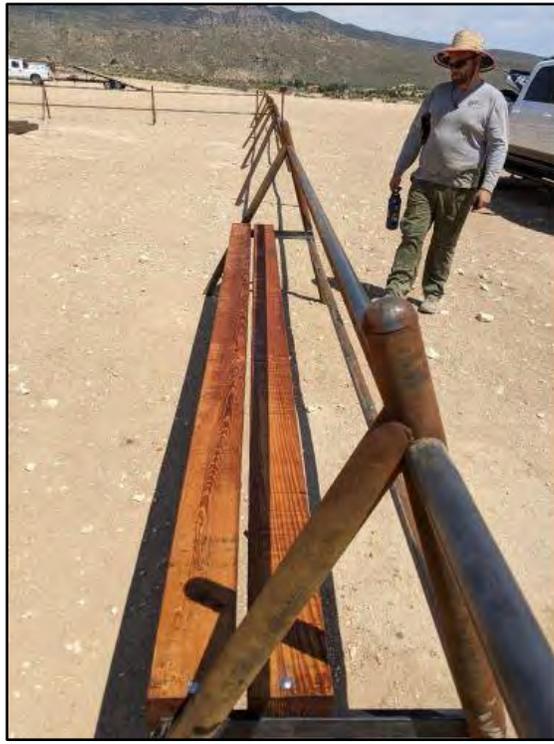
(8A-3) Photo Point: The photo shows the new benches installed into the jackrail fencing at the Tot Lot.

2021 Condition, photo taken June 23, 2021 (view east)

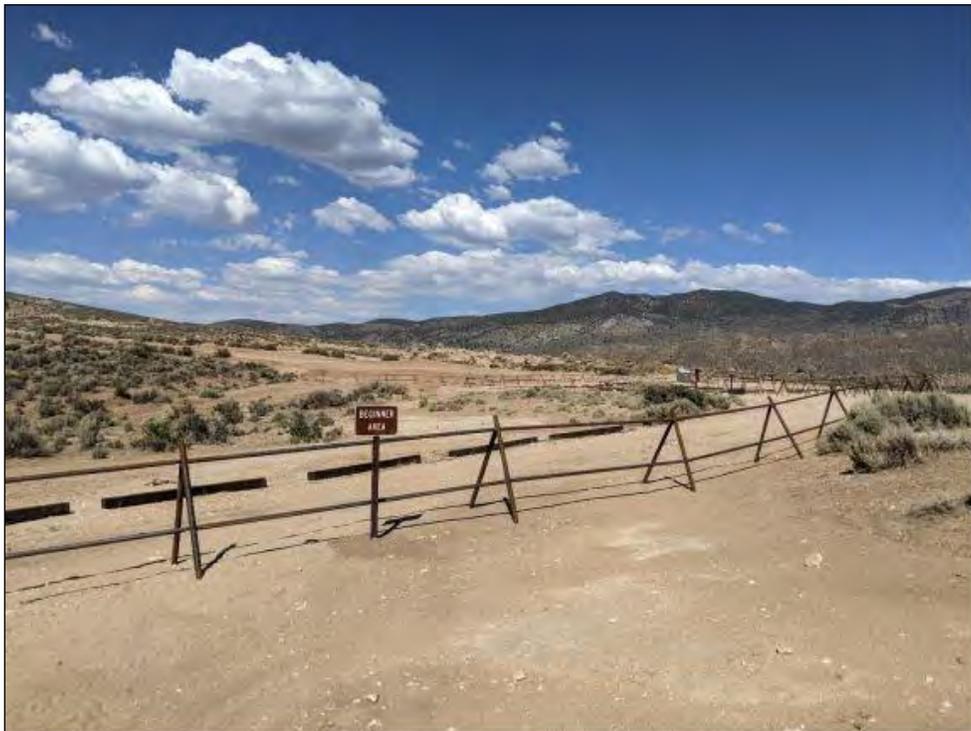
(8A-4) Photo Point: The photo shows the jackrail fencing surrounding the perimeter of the Beginner Area.

2021 Condition, photo taken June 23, 2021 (view northeast)

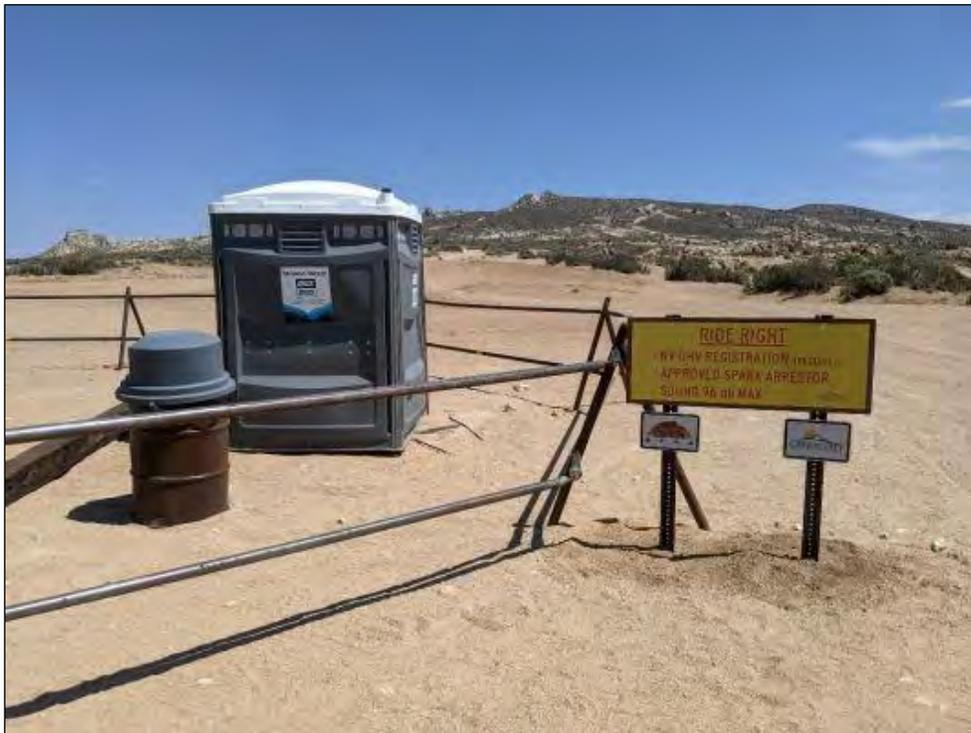
(8A-5) Photo Point: The photo shows the improved location of the ADA portable toilet.

2021 Condition, photo taken June 23, 2021 (view north)

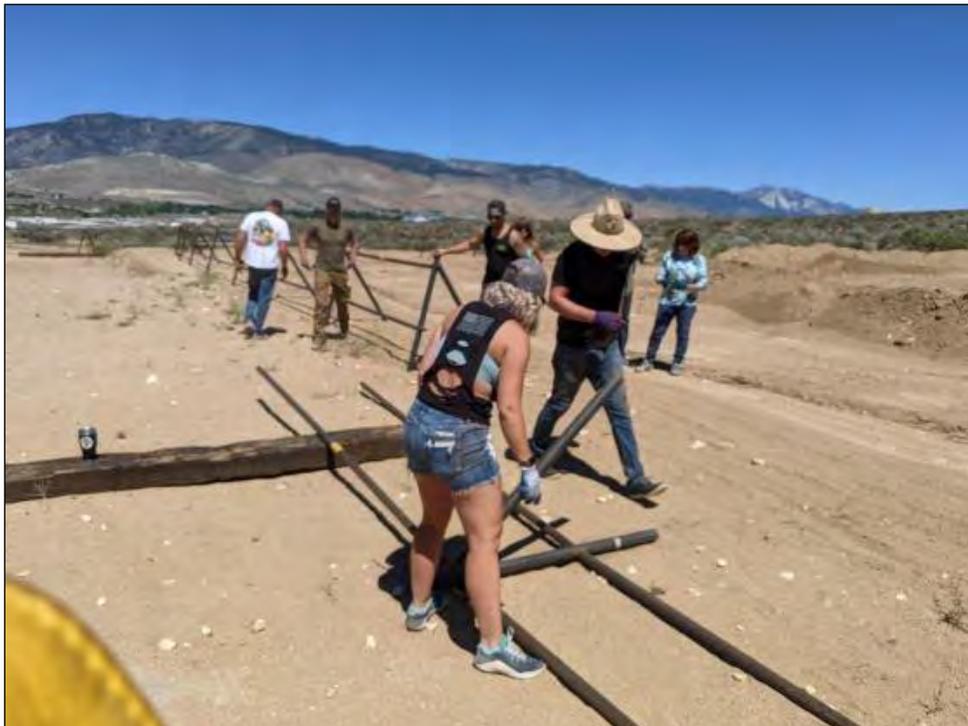
(8B-3) Photo Point: The photo shows volunteers installing jackrail fencing around the Tot Lot.

2021 Condition, photo taken June 12, 2021 (view west)

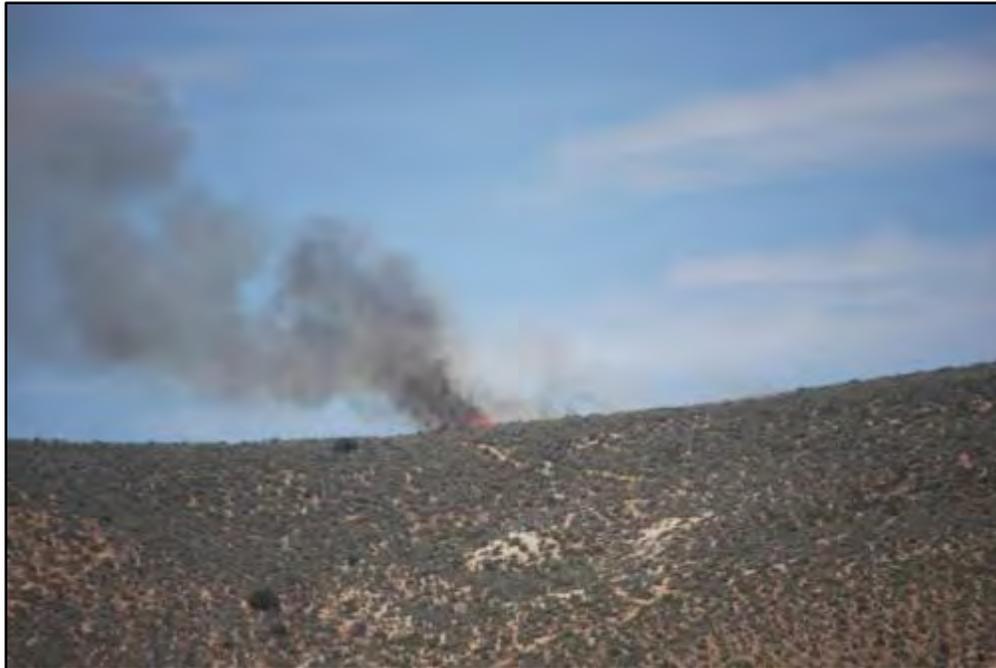
Photo Point: The photo is of the 2019 brush fire at Prison Hill. Baseline photo monitoring point #16 has been added this year to track changes over time in the recently burned area.

2019 Condition, photo taken June 6, 2019 (view north)

On June 6, 2019 a brush fire started at the south end of Prison Hill. Within two hours, the fire was put out by multiple fire crews, although it burned approximately 1 acre. Recently on June 6, 2021, another fire started close to the staging area, but was quickly suppressed. On June 21, 2021, Carson City announced that it will be closing PHRA during red flag warning days (e.g. winds greater than 15 mph, relative humidity less than or equal to 25%, and a temperature greater than 75 degrees).

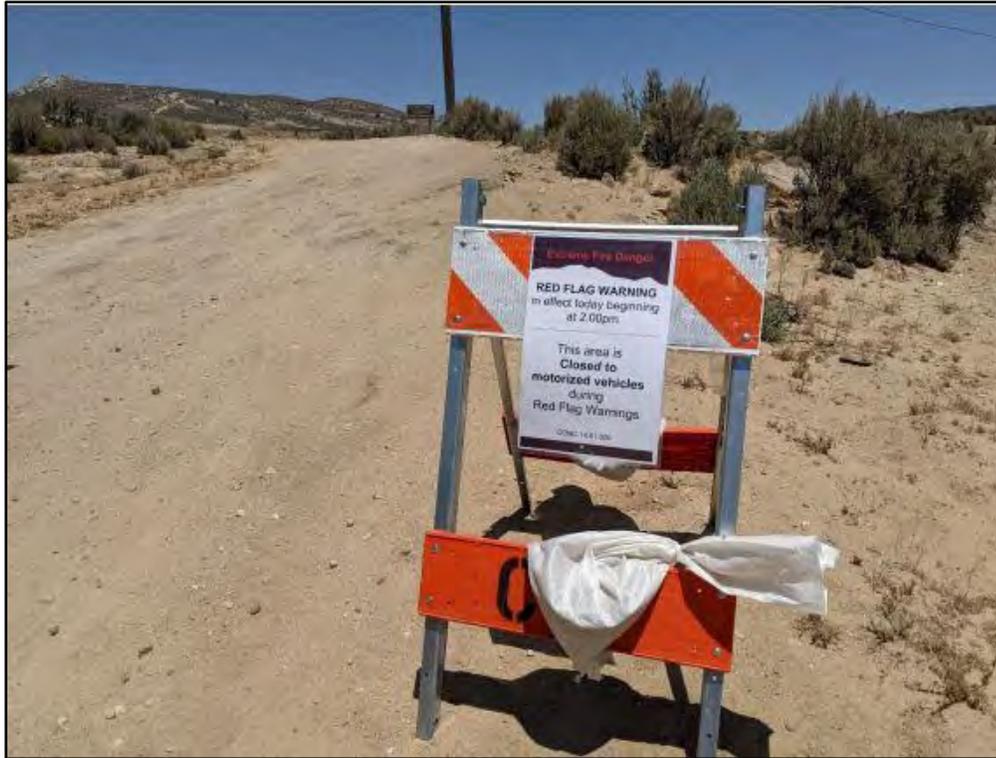
Photo Point: The photo shows the temporary signage put out on red flag closure days.

2021 Condition, photo taken June 23, 2020 (view looking north from entrance)

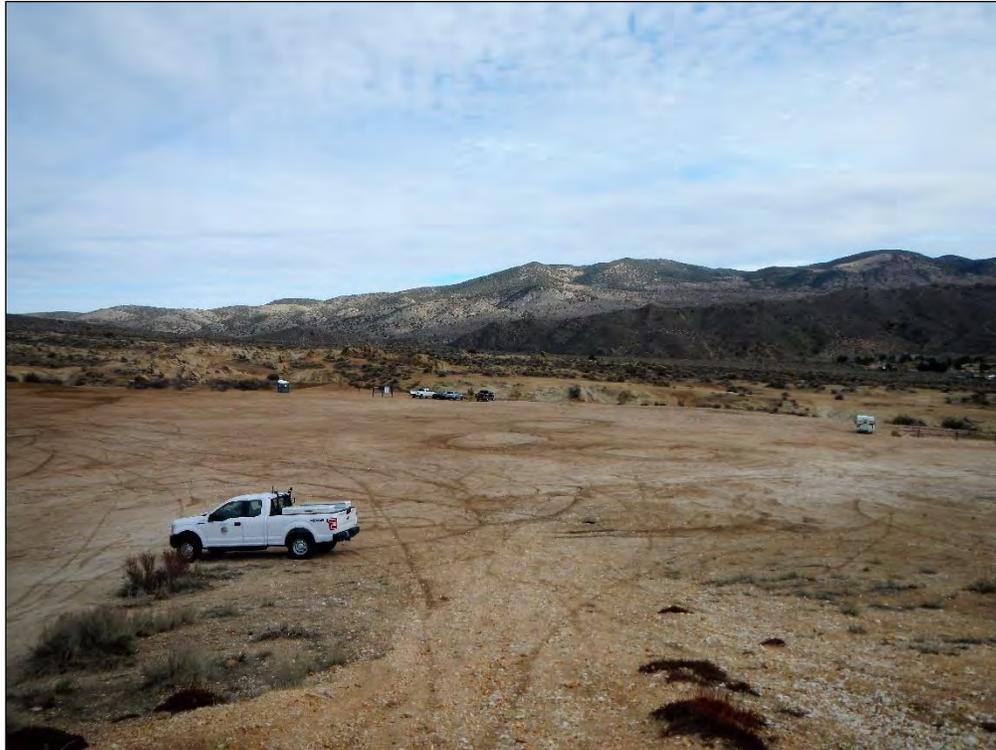
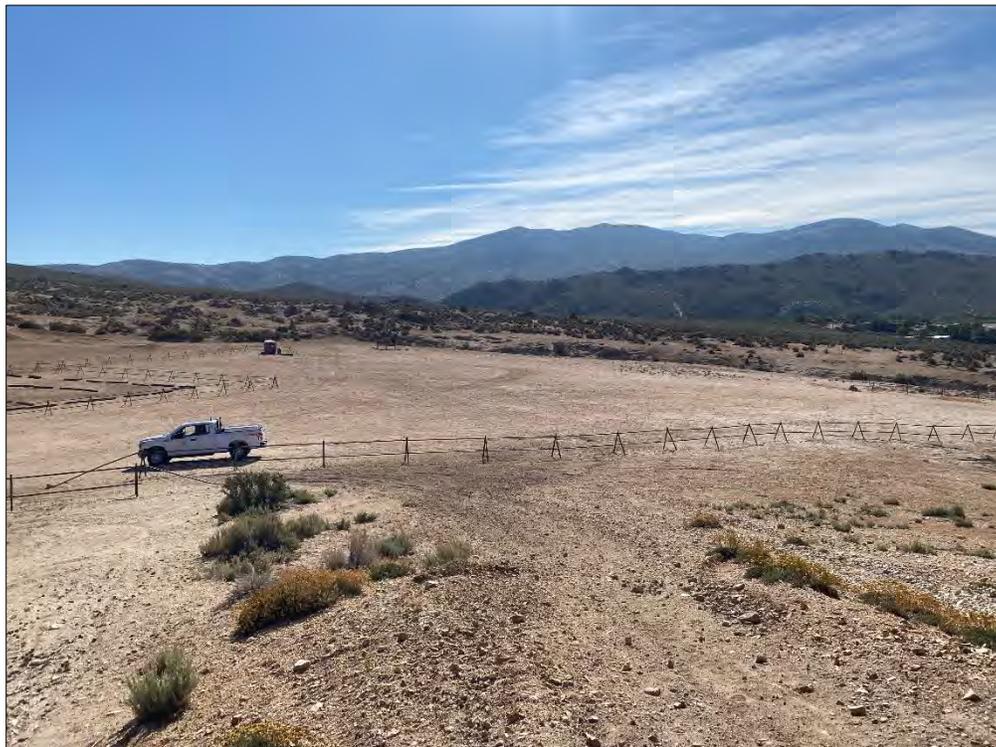
2020 Baseline Condition, photo taken January 24, 2020:

(GPS coordinates: 39.104745, -119.733277)

2021 Condition, photo taken June 17, 2021

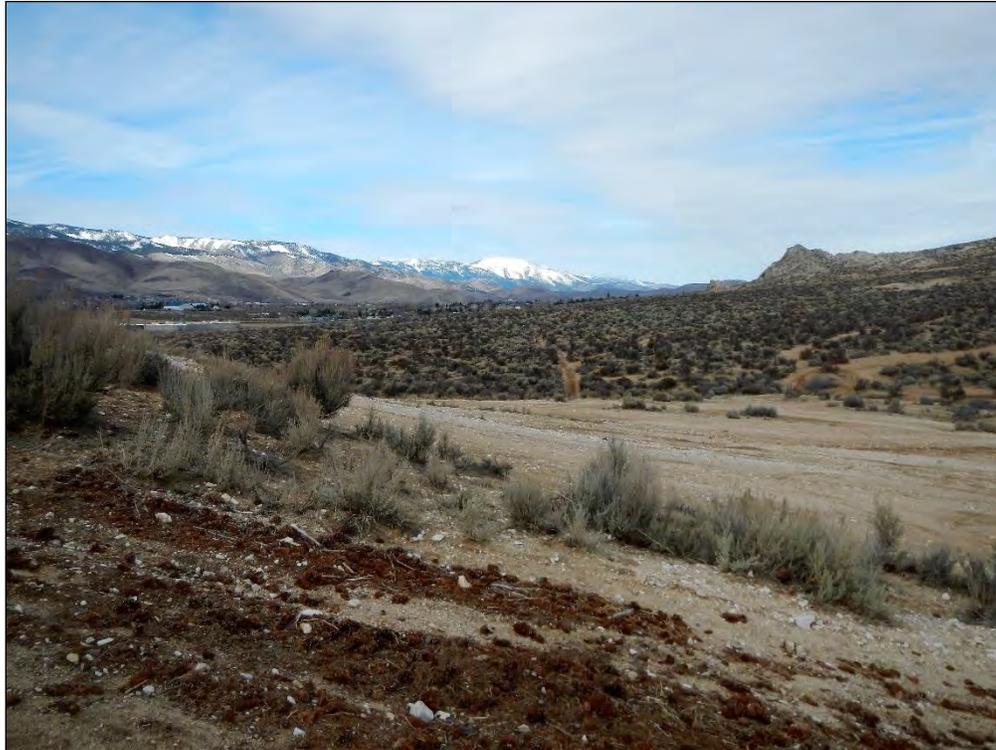
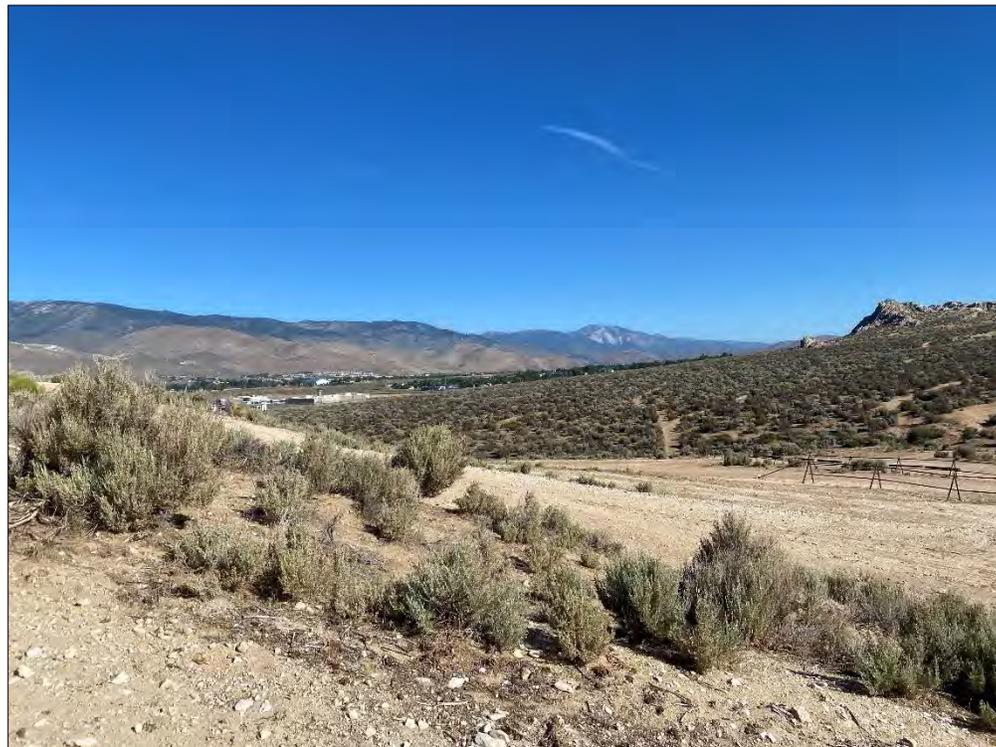
Photo Point 1B (view northwest): A photo point located at the boundary of the staging area.

2020 Baseline Condition, photo taken January 24, 2020:
(GPS coordinates: 39.104745, -119.733277)

2021 Condition, photo taken June 17, 2021

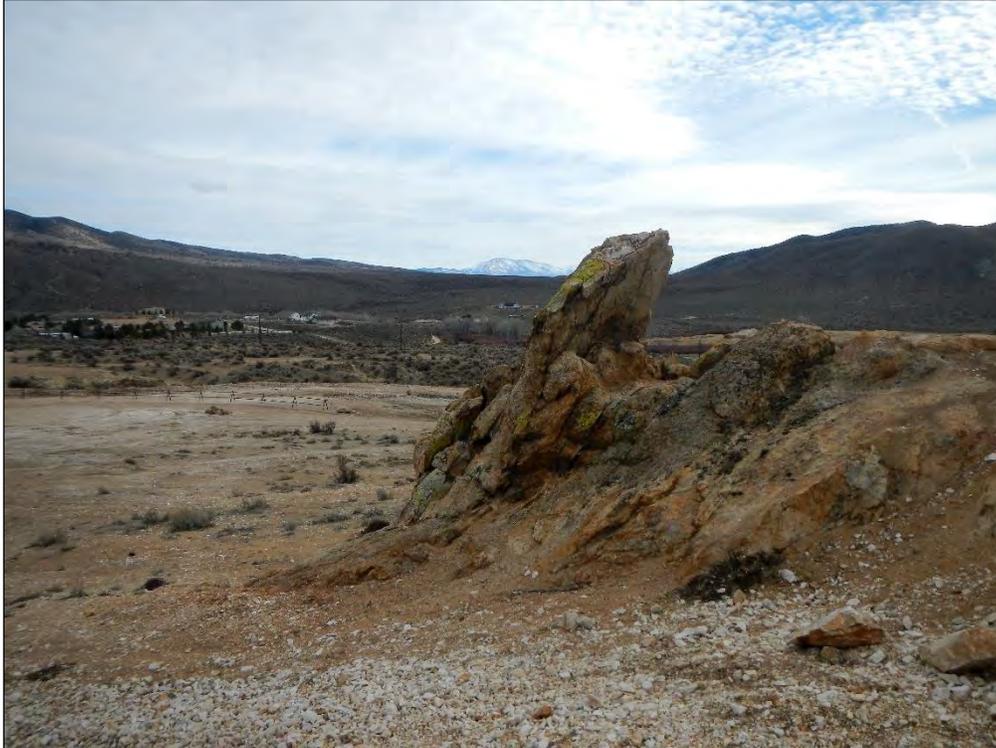
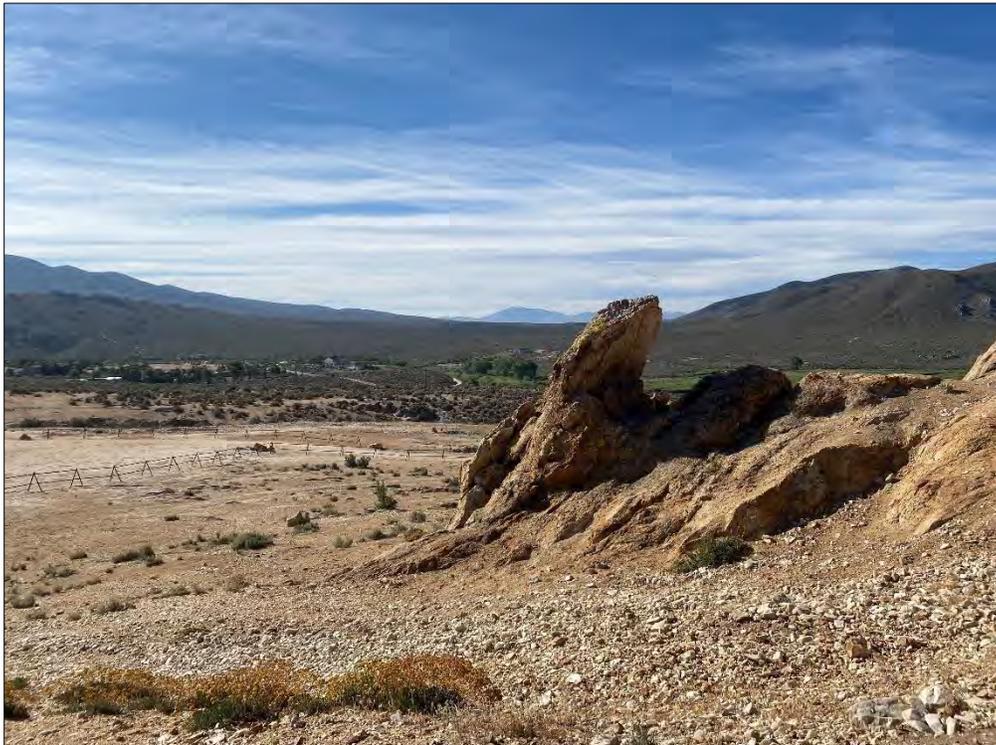
Photo Point 1C (view southeast): A photo point located at the boundary of the staging area.

2020 Baseline Condition, photo taken January 24, 2020:
(GPS coordinates: 39.104745, -119.733277)

2021 Condition, photo taken June 17, 2021
