STAFF REPORT

Agenda Title: For Discussion Only: Review and discussion of the Prison Hill OHV Area Monitoring Report, and updates on the Prison Hill OHV Area. (*Georgia Vasey and Gregg Berggren*)

Carson City Open Space – Conservation Easement Monitoring

Prison Hill OHV Area – Monitoring Report

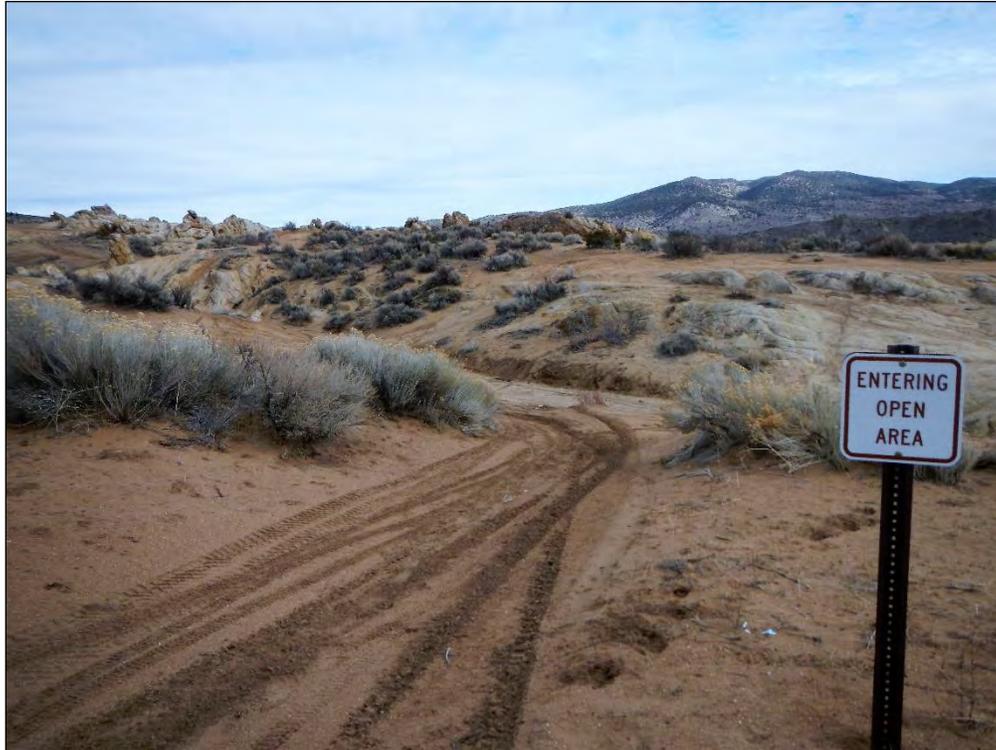
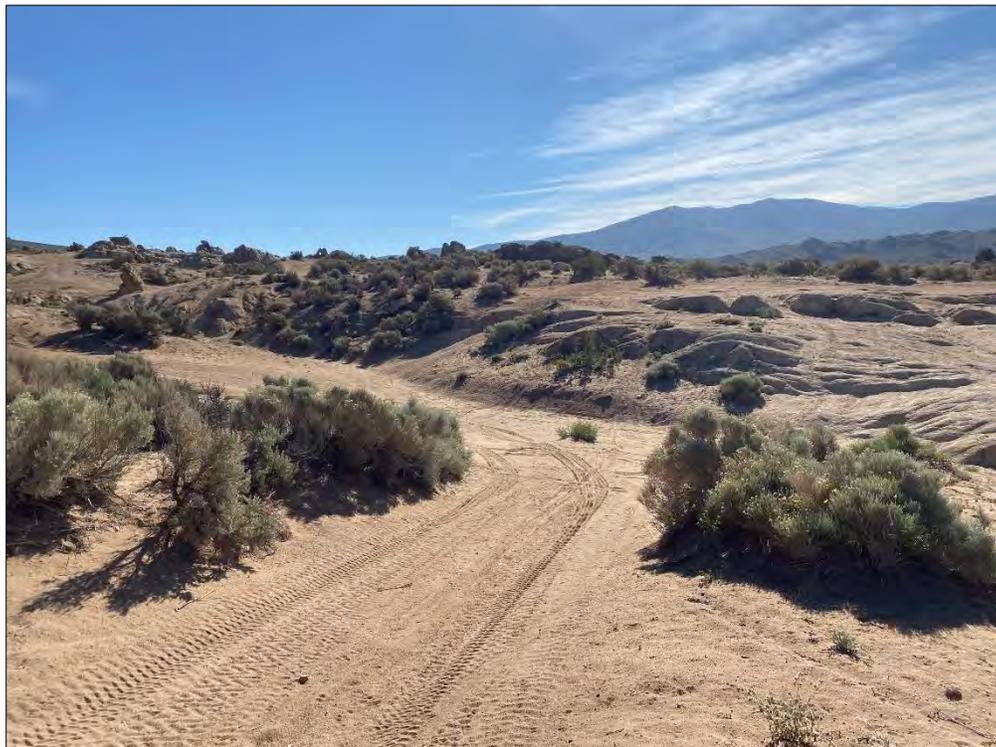
Photo Point 2 (view east): A photo point located in the open area east of the staging area.

2020 Baseline Condition, photo taken January 24, 2020:
(GPS coordinates: 39.105205, -119.731003)

2021 Condition, photo taken June 17, 2021

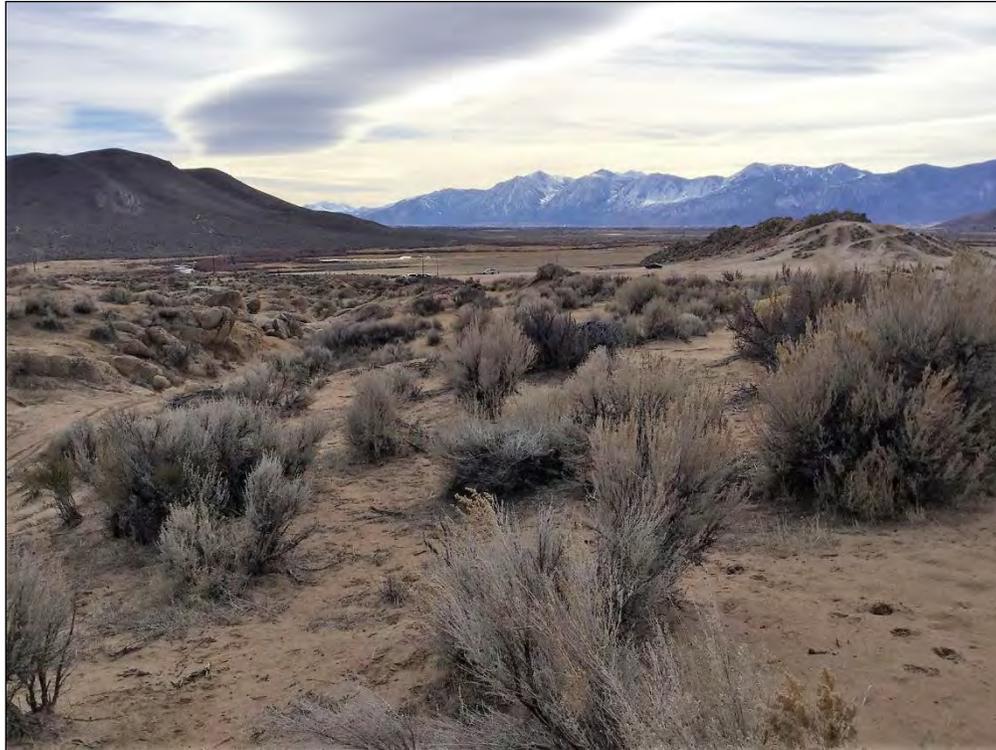
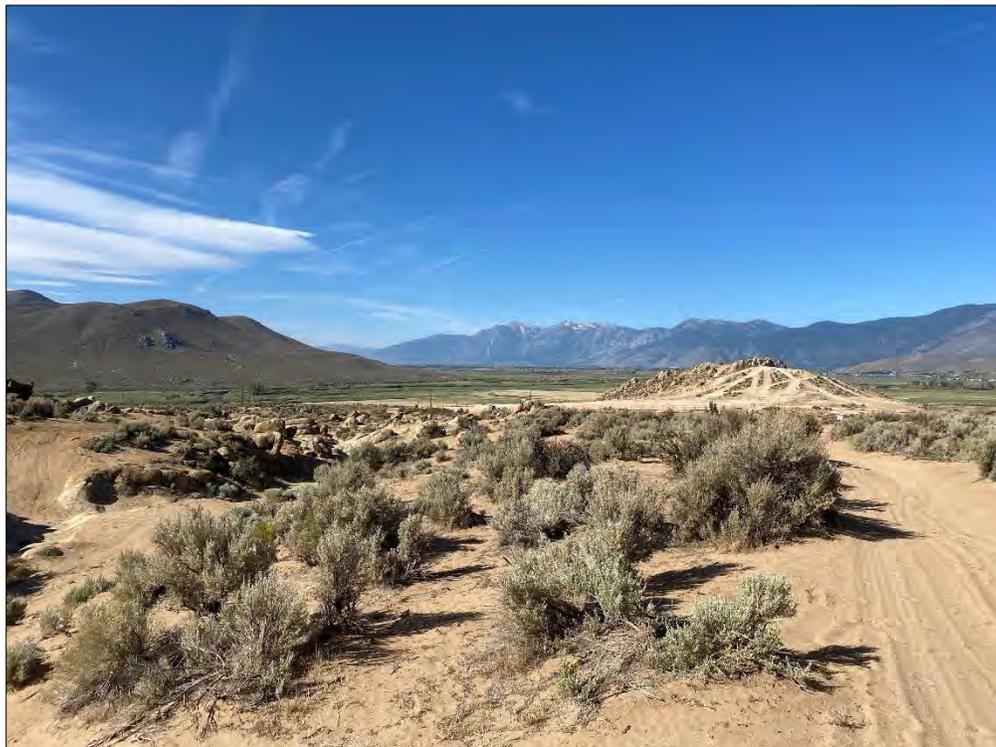
Photo Point 3 (view southwest): A photo point located north of the staging area on the east side of the road.

2020 Baseline Condition, photo taken January 24, 2020:
(GPS coordinates: 39.107231, -119.730827)

2021 Condition, photo taken June 17, 2021

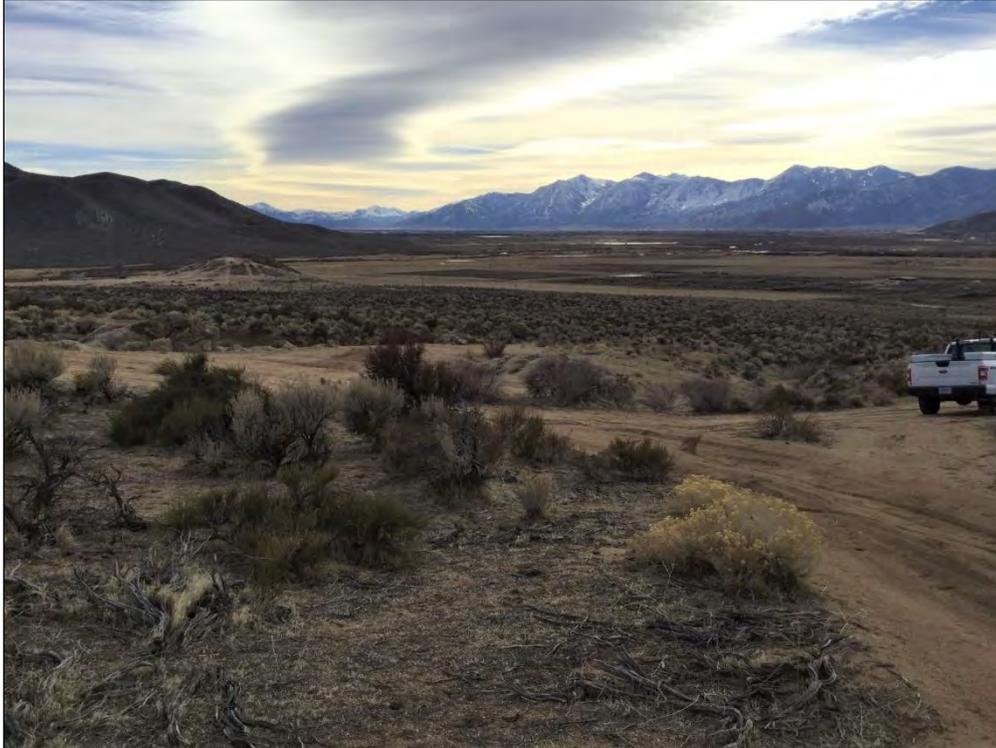
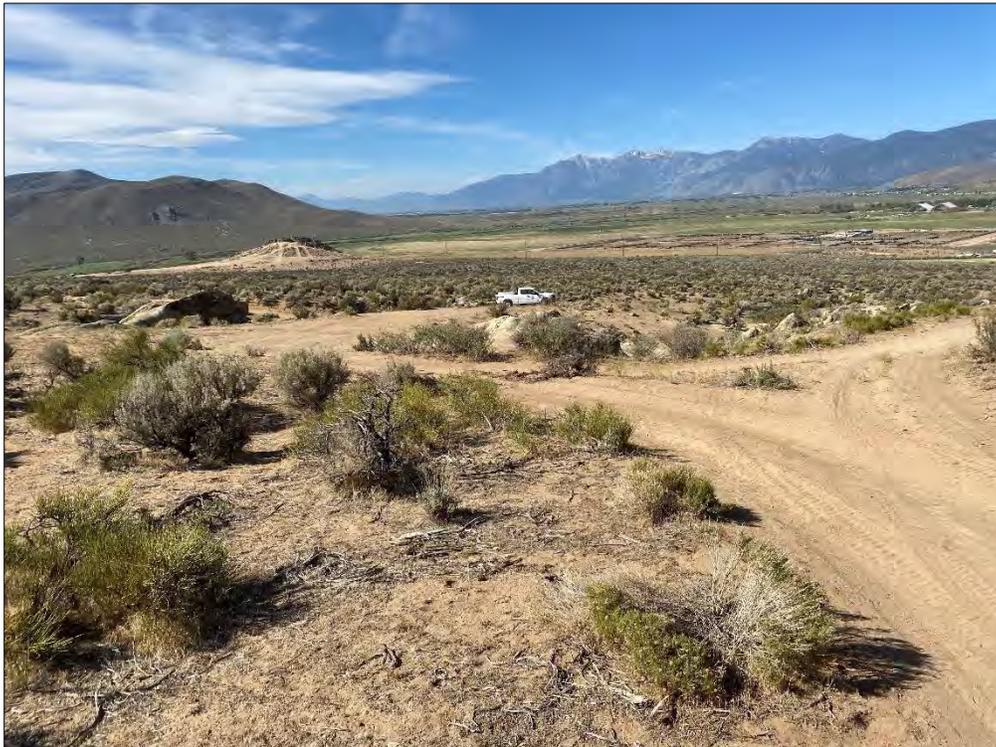
Photo Point 4 (view south): A photo point located west of Gunslinger Wheeler Trail.

2020 Baseline Condition, photo taken January 24, 2020:
(GPS coordinates: 39.111562, -119.733702)

2021 Condition, photo taken June 17, 2021

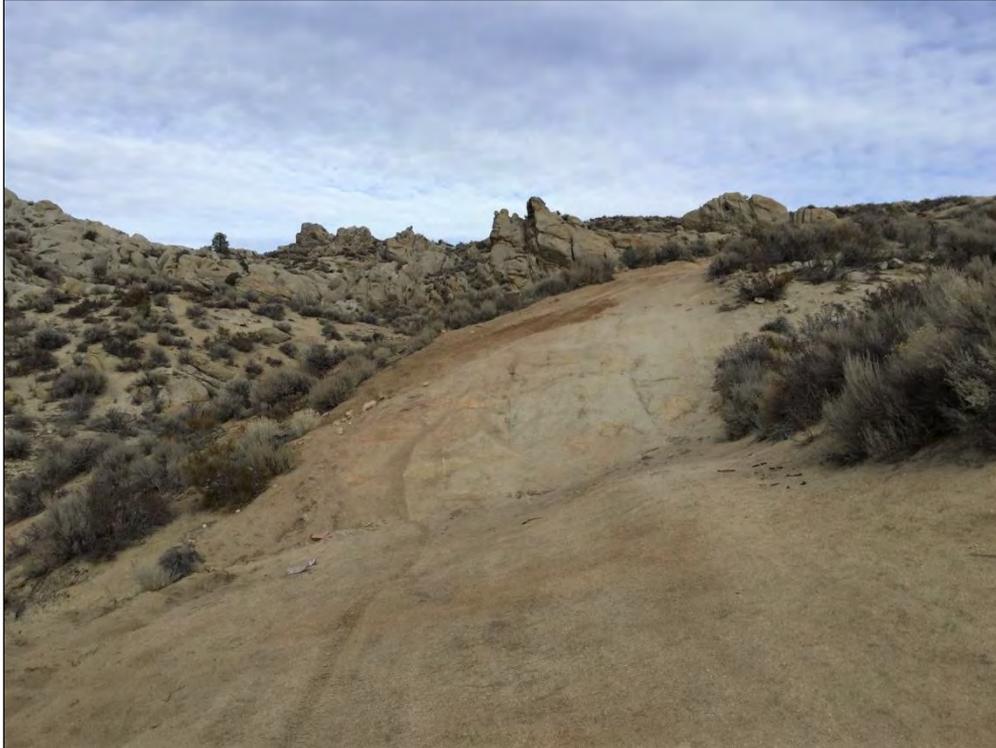
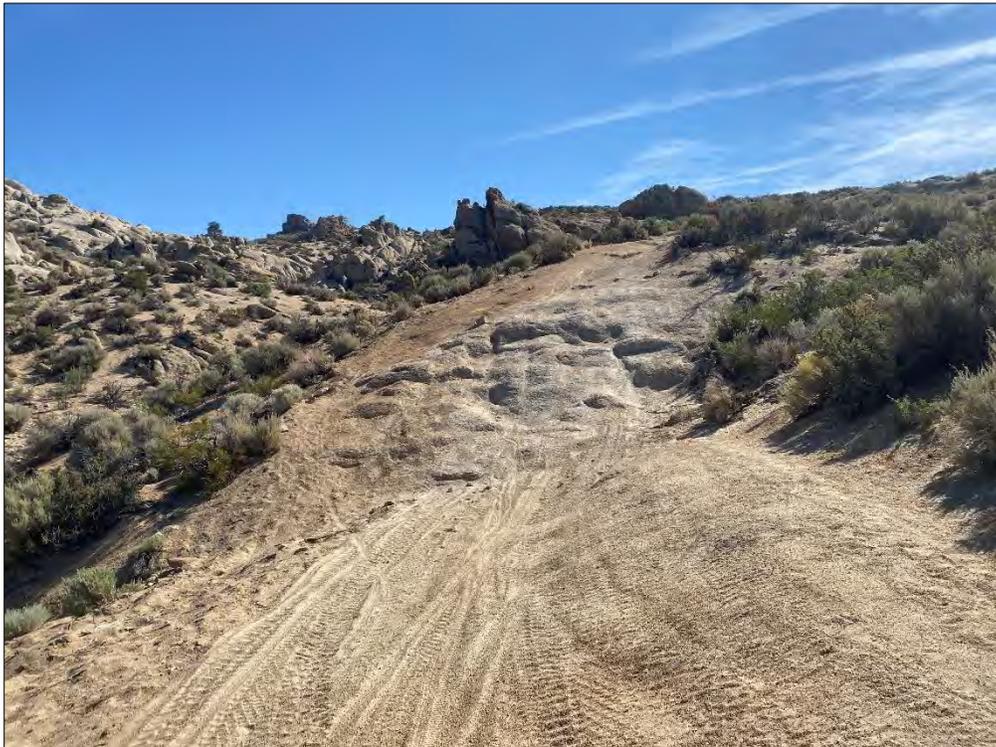
Photo Point 5A (view north): A photo point located at Rubber Side Up Wheeler Trail.

2020 Baseline Condition, photo taken January 24, 2020:
(GPS coordinates: 39.113363, -119.735607)

2021 Condition, photo taken June 17, 2021

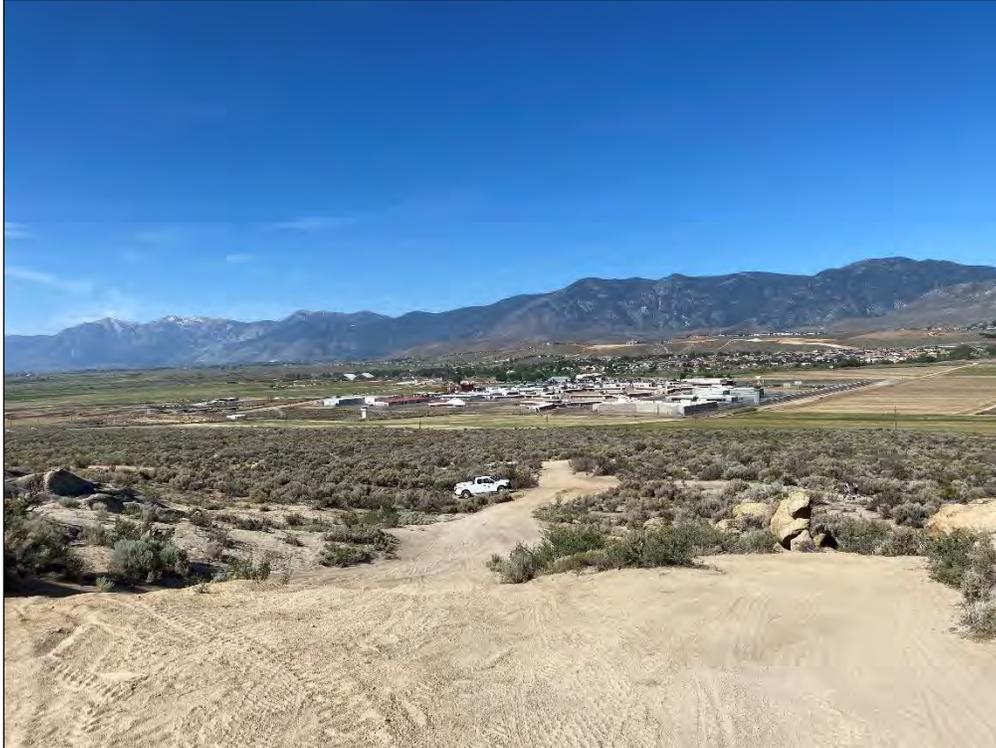
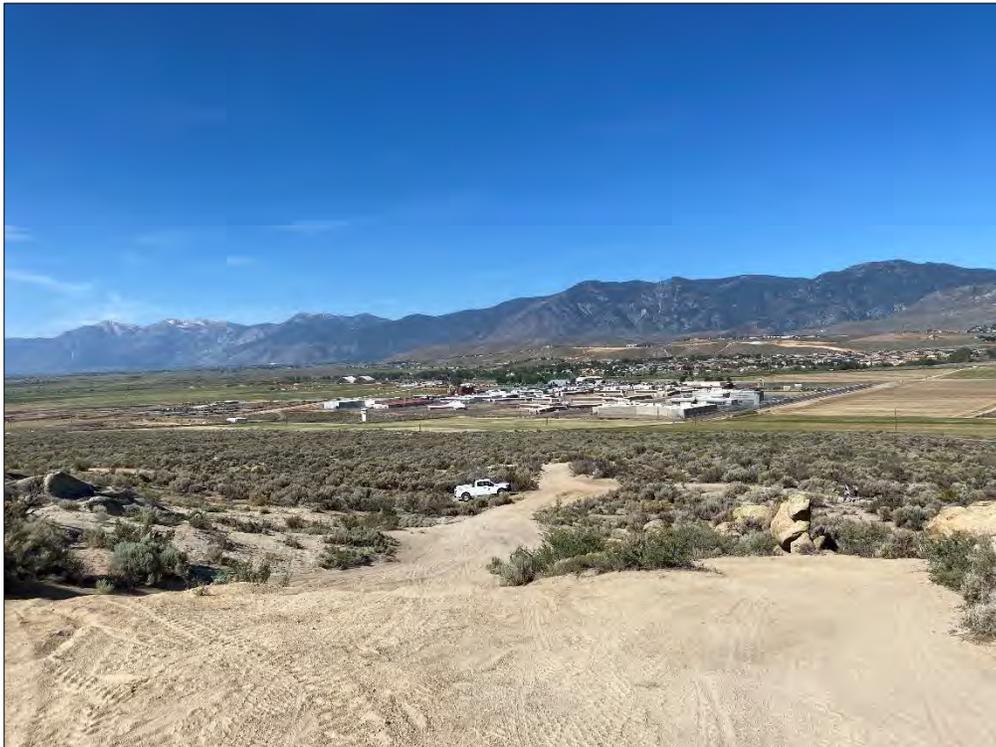
Photo Point 5B (view southwest): A photo point located at Rubber Side Up Wheeler Trail facing the prison.

2020 Baseline Condition, photo taken January 24, 2020:
(GPS coordinates: 39.113363, -119.735607)

2021 Condition, photo taken June 21, 2021

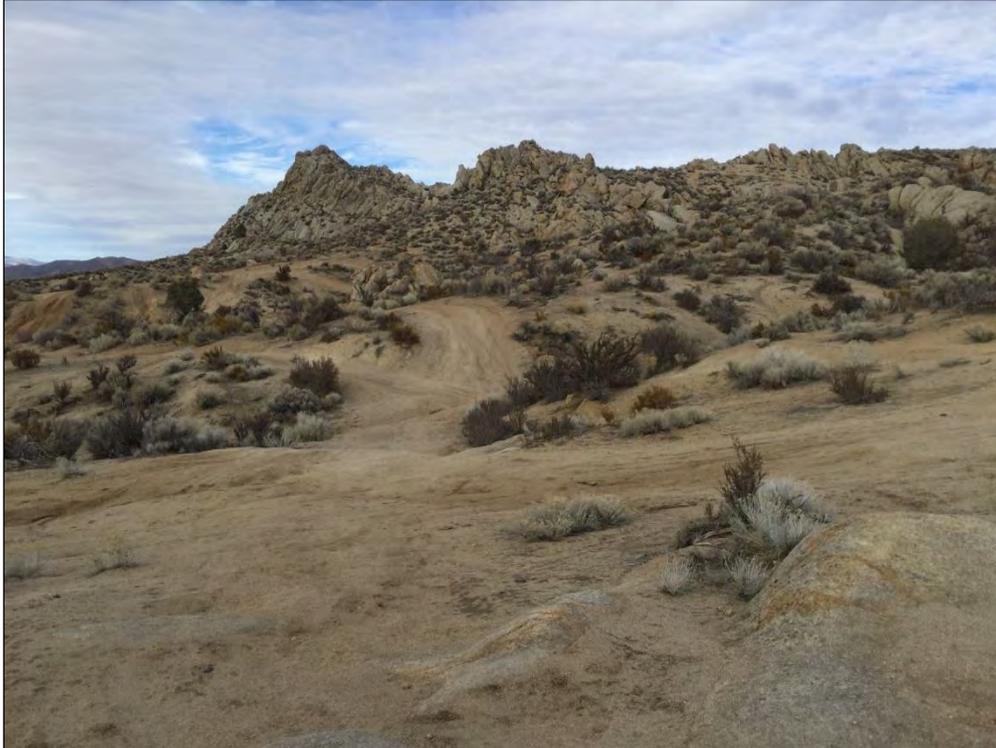
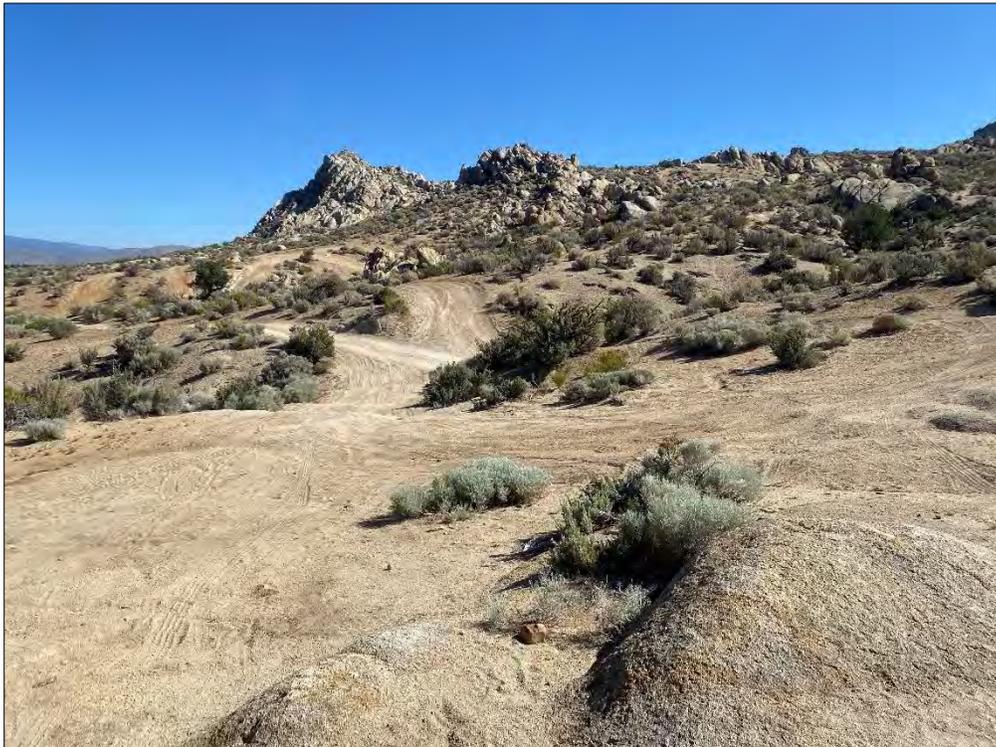
Photo Point 6 (view north): A photo point located at Rhino Rock.

2020 Baseline Condition, photo taken January 24, 2020:
(GPS coordinates: 39.111322, -119.735470)

2021 Condition, photo taken June 21, 2021

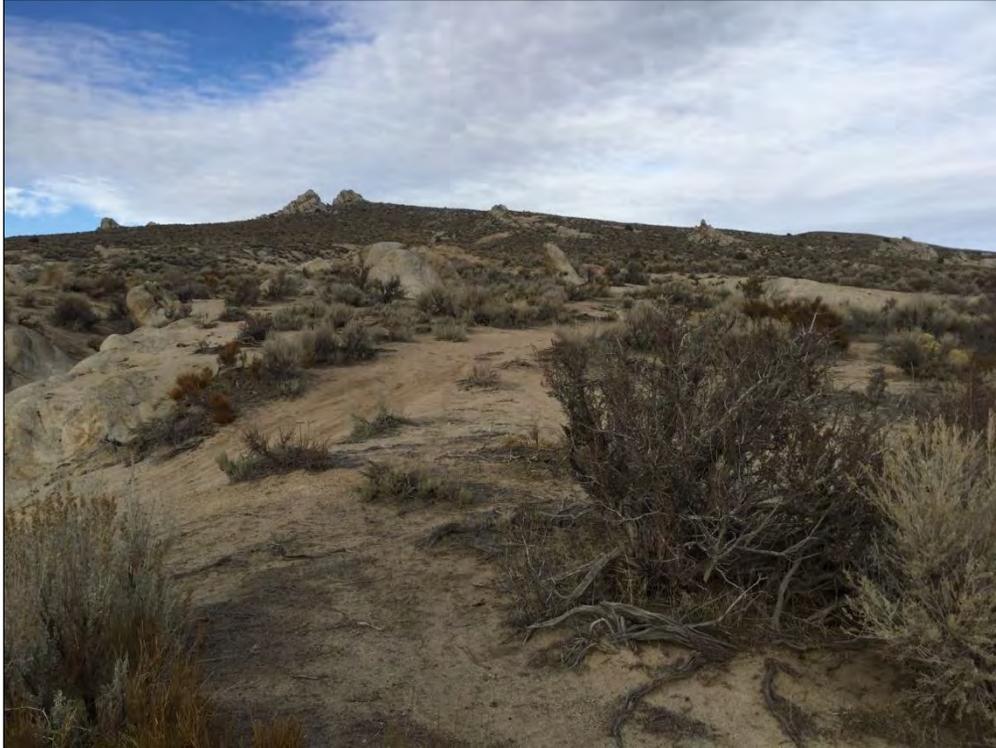
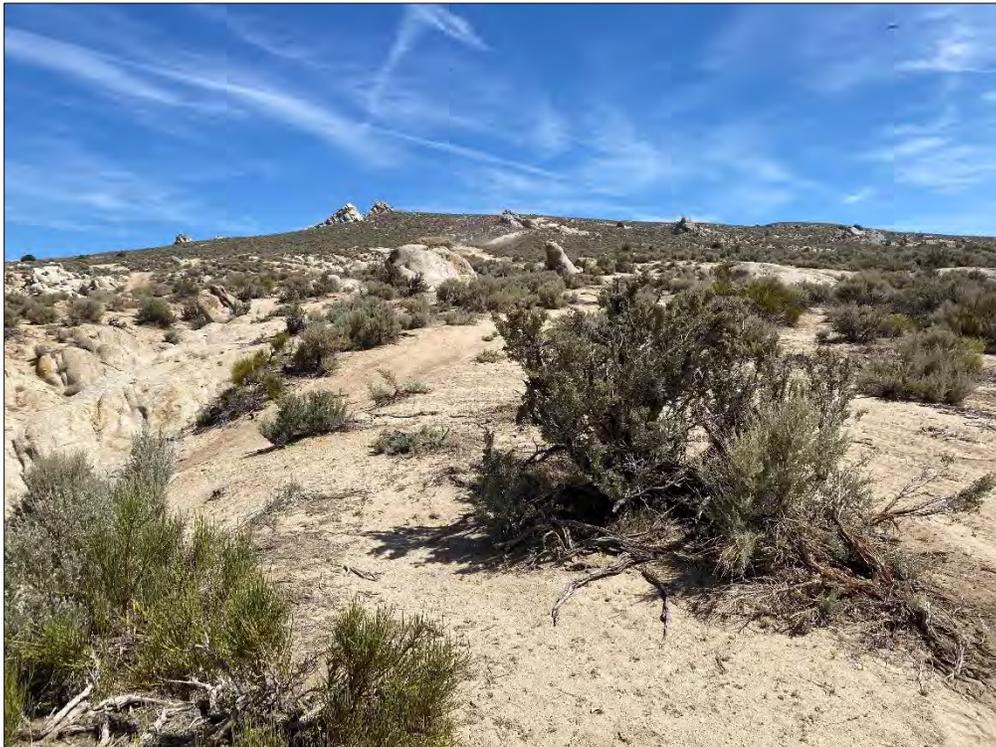
Photo Point 7A (view north): A photo point located at the entry way to the open area north of Cable Road.

2020 Baseline Condition, photo taken January 24, 2020:
(GPS coordinates: 39.110377, -119.728973)

2021 Condition, photo taken June 21, 2021

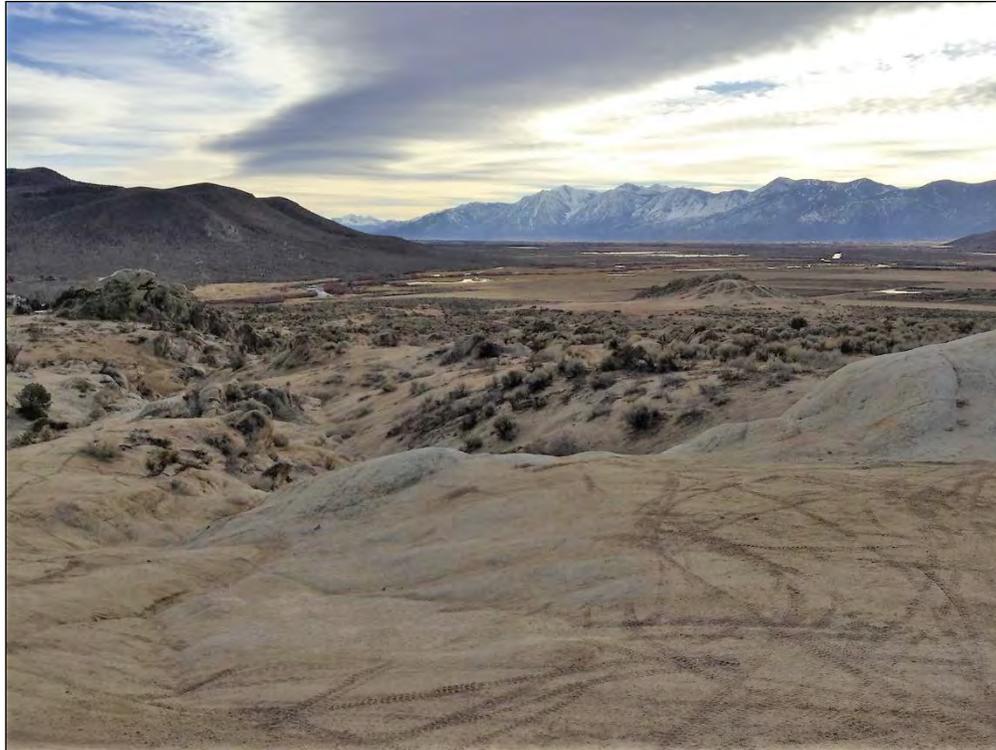
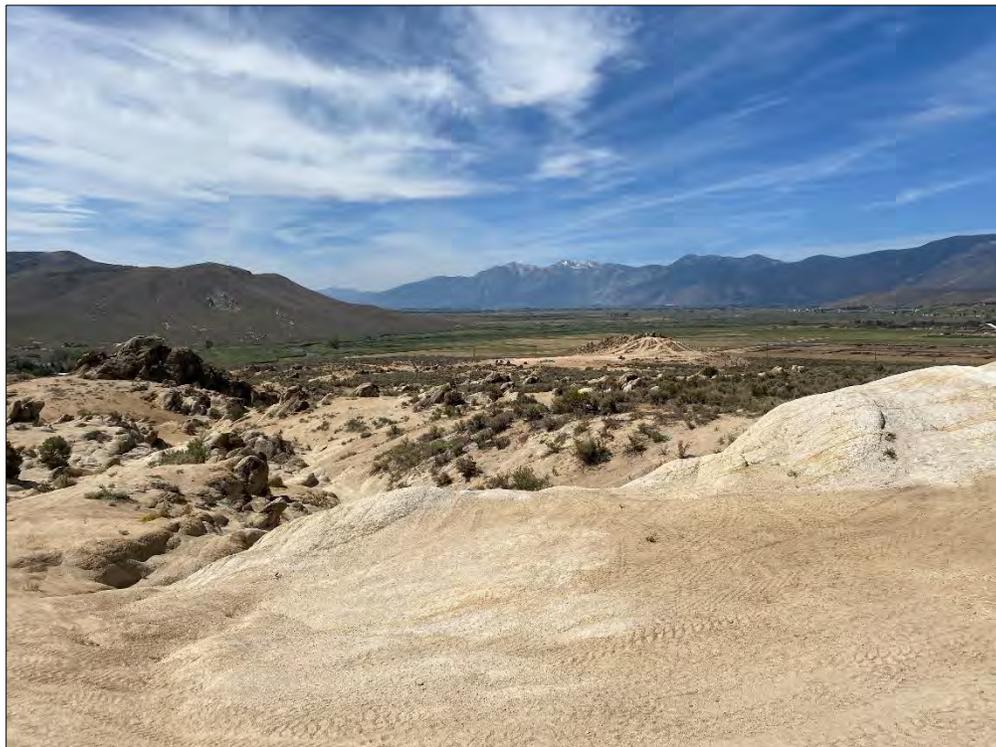
Photo Point 7B (view south): A photo point located at the entry way to the open area north of Cable Road.

2020 Baseline Condition, photo taken January 24, 2020:
(GPS coordinates: 39.110377, -119.728973)

2021 Condition, photo taken June 21, 2021

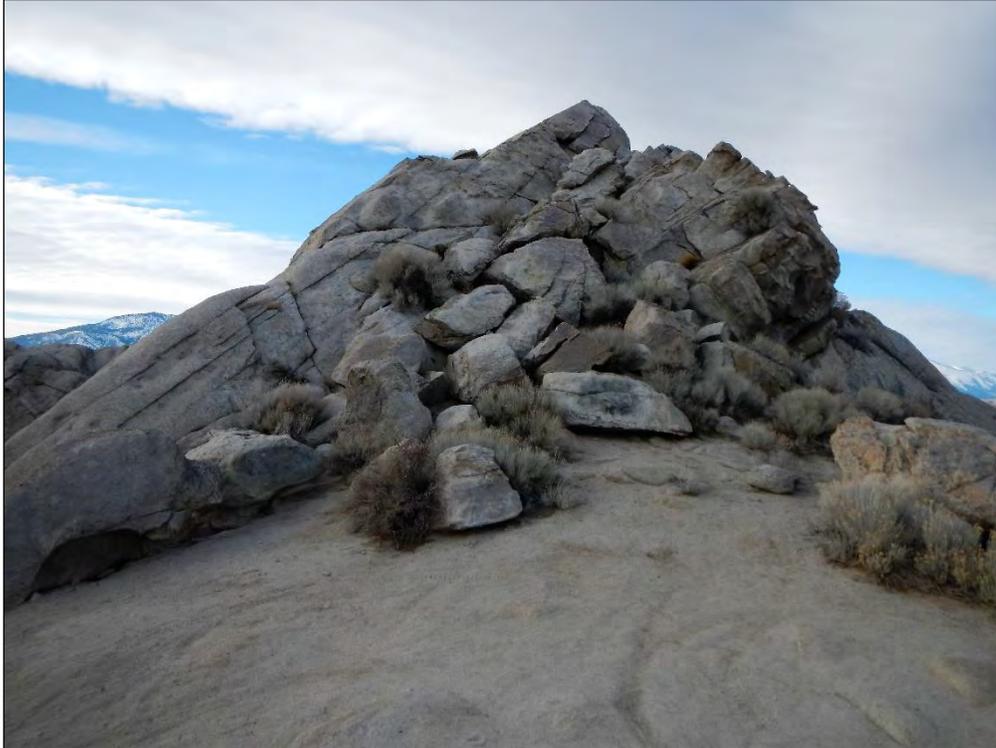
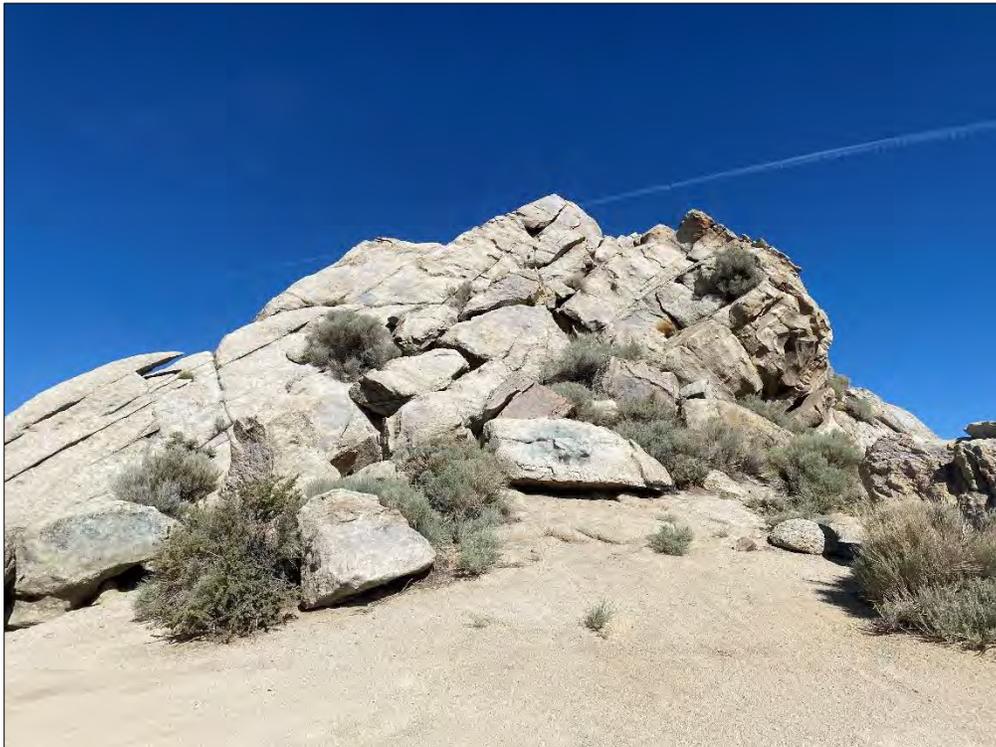
Photo Point 8A (view west): A photo point located at Golden Eagle Rock.

2020 Baseline Condition, photo taken January 24, 2020:
(GPS coordinates: 39.118457, -119.728973)

2021 Condition, photo taken June 21, 2021

In the past, Golden Eagle Rock was repeatedly vandalized with graffiti (Photo-monitoring Point #8A). In response, the Open Space Division responded by painting over the graffiti with natural toned spray-paint starting in 2018. Since establishing more of an active management presence, graffiti at this location has subsided (GPS coordinates: 39.118457, -119.728973).

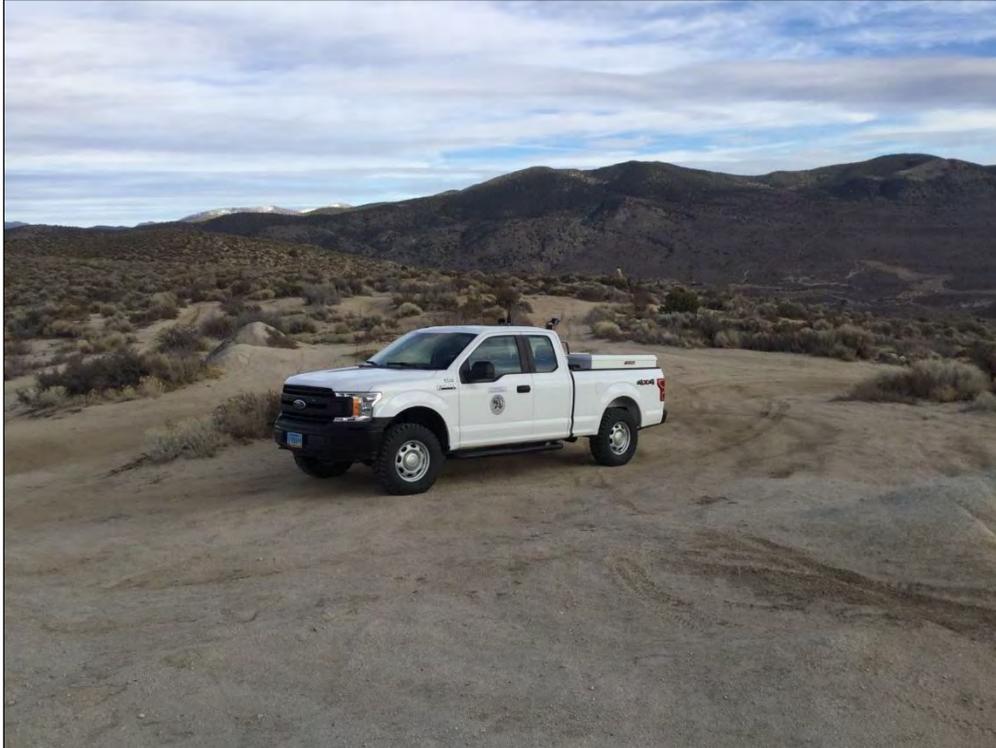
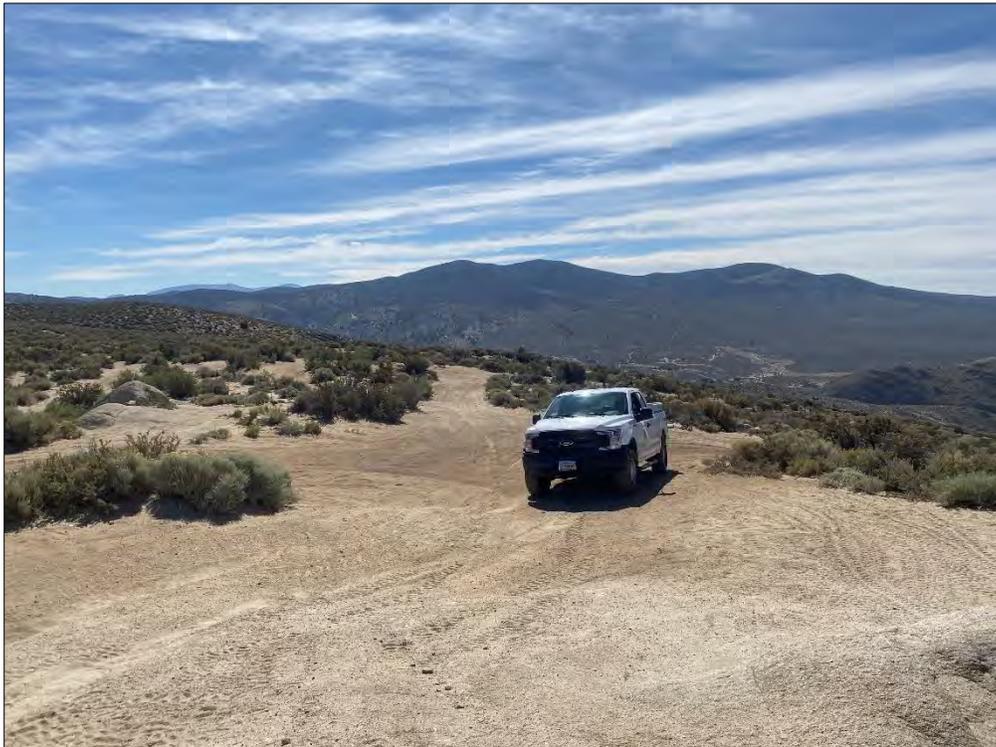
Photo Point 8B (view east): A photo point located at Golden Eagle Rock.

2020 Baseline Condition, photo taken January 24, 2020:
(GPS coordinates: 39.118457, -119.728973)

2021 Condition, photo taken June 21, 2021

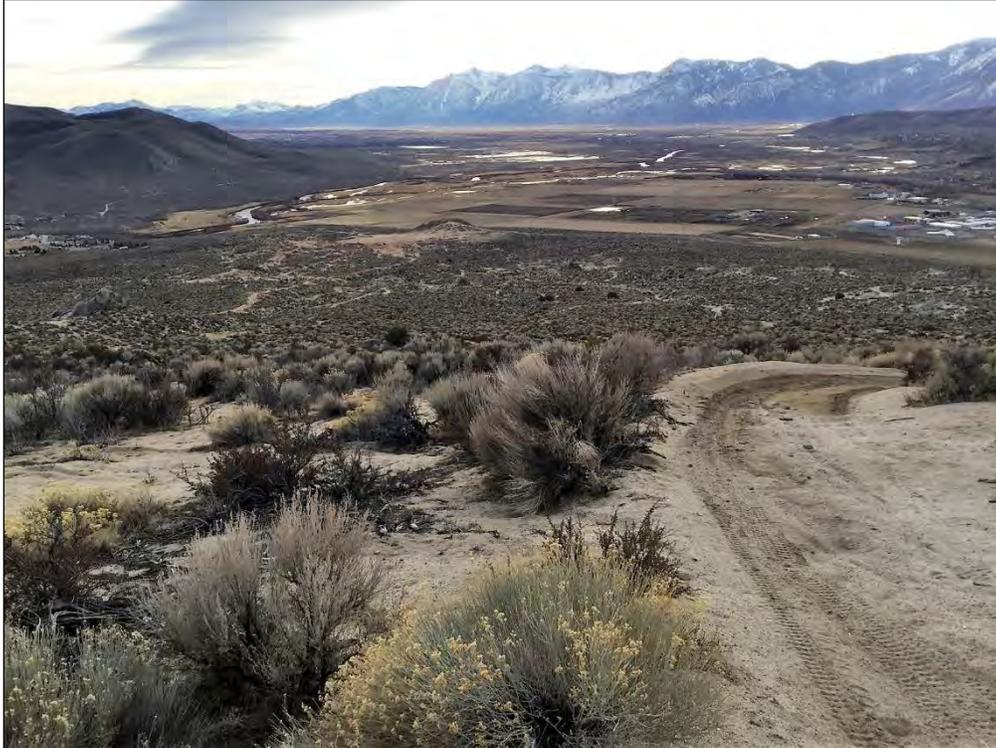
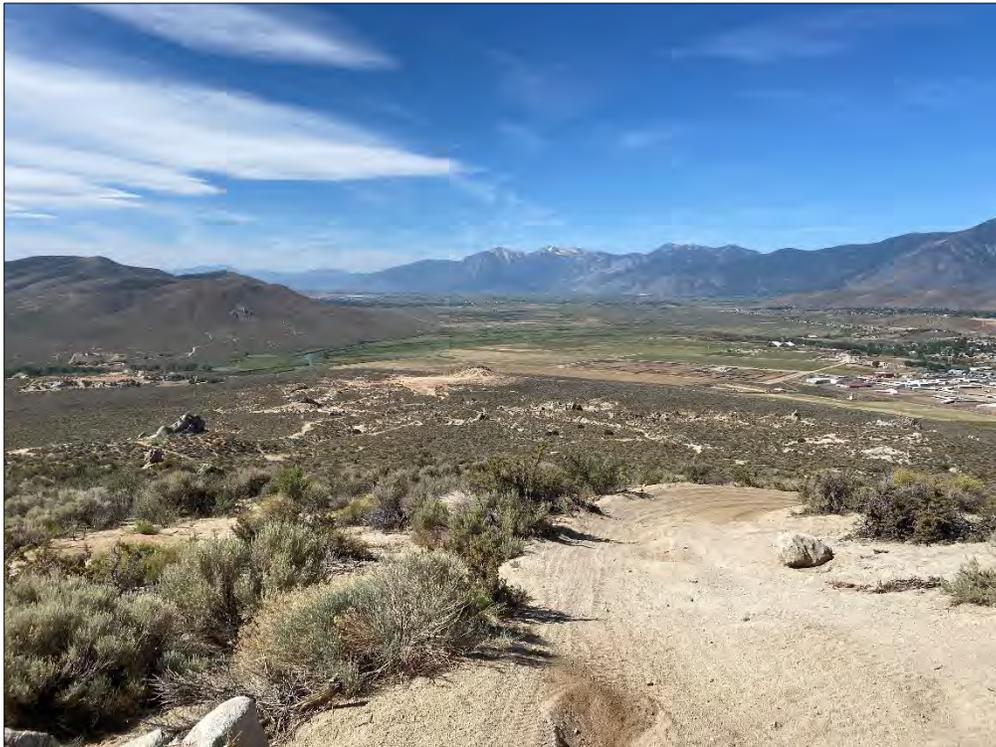
Photo Point 8C (view south): A photo point located at Golden Eagle Rock.

2020 Baseline Condition, photo taken January 24, 2020:
(GPS coordinates: 39.118457, -119.728973)

2021 Condition, photo taken June 21, 2021

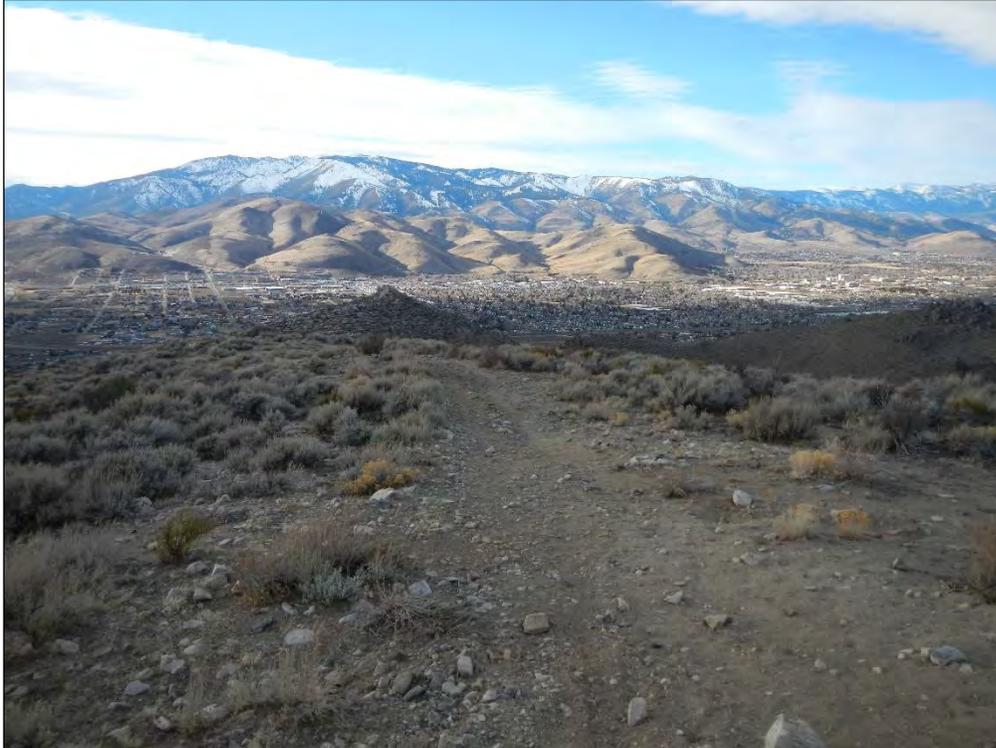
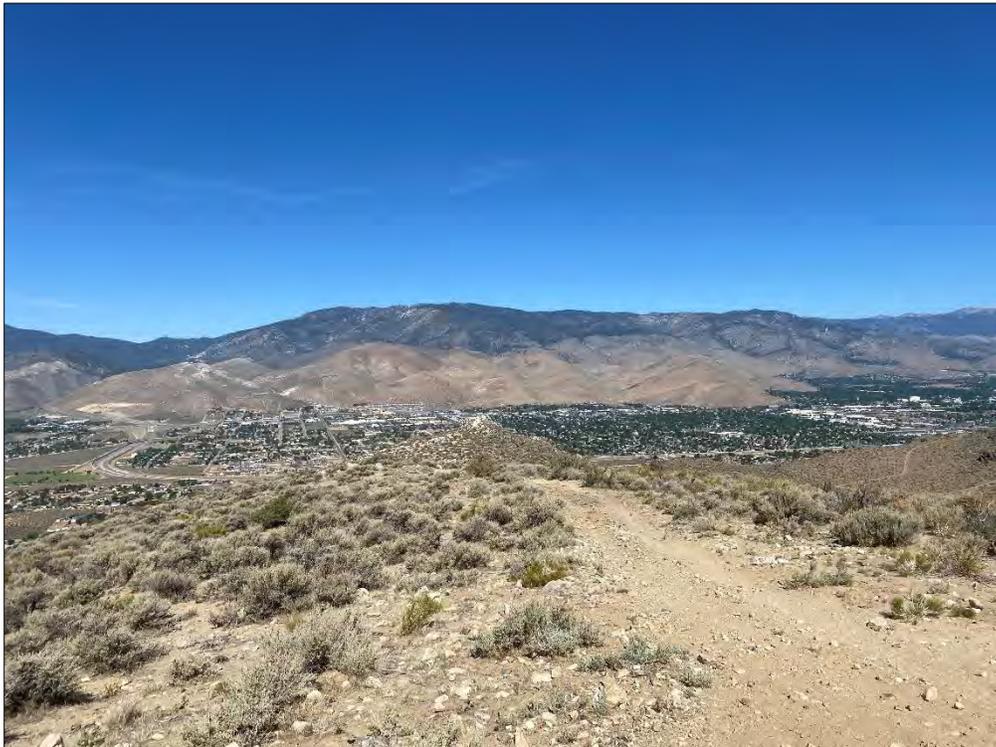
Photo Point 9A (view west): A photo point located at the Prison Hill Summit.

2020 Baseline Condition, photo taken January 24, 2020:
(GPS coordinates: 39.126752, -119.722705)

2021 Condition, photo taken June 21, 2021

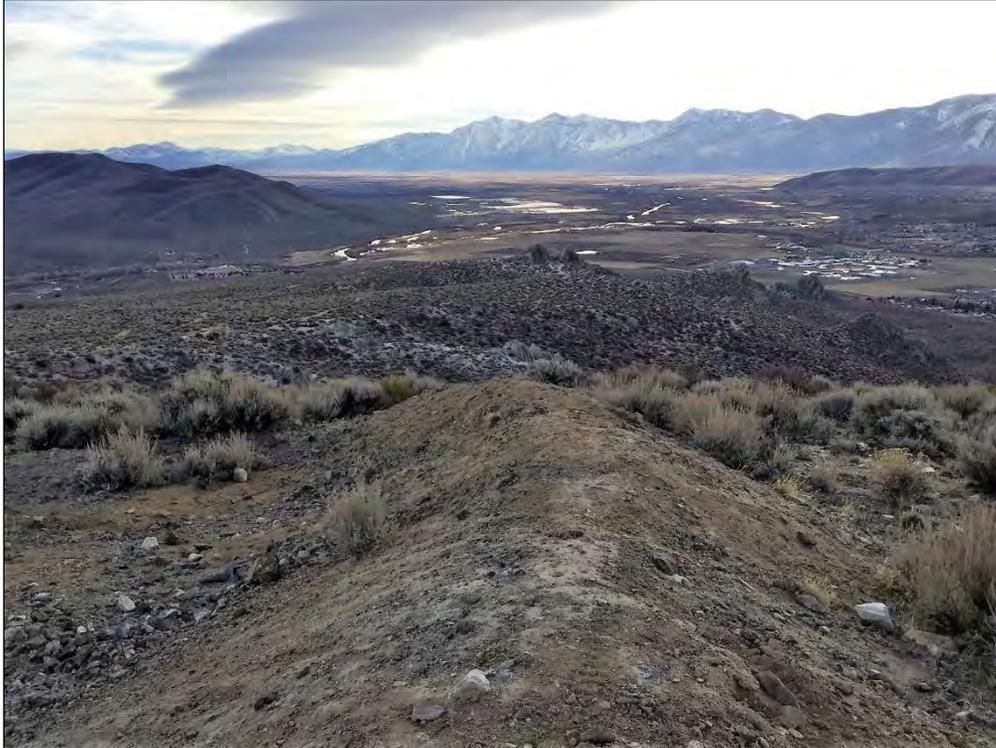
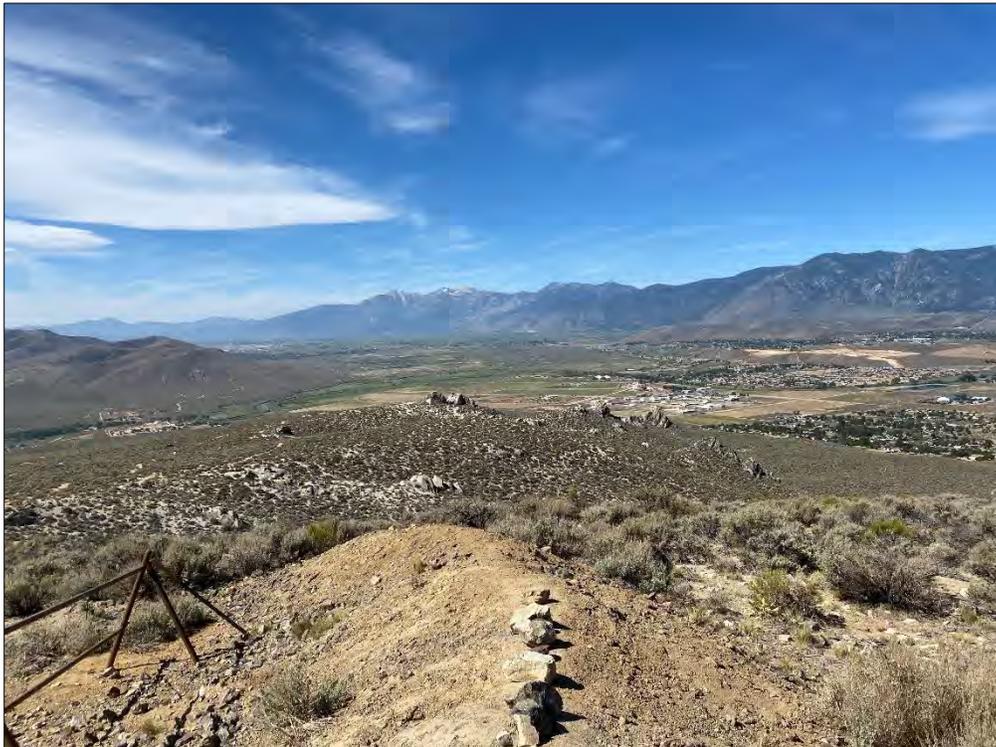
Photo Point 9B (view south): A photo point located at the Prison Hill Summit.

2020 Baseline Condition, photo taken January 24, 2020:
(GPS coordinates: 39.126752, -119.722705)

2021 Condition, photo taken June 21, 2021

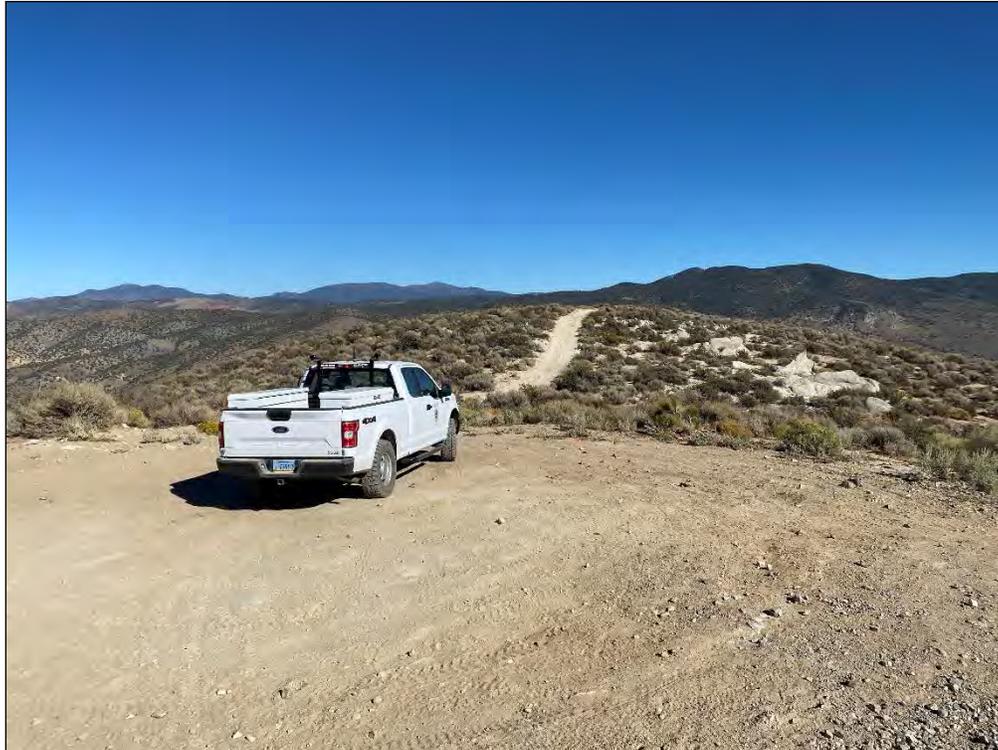
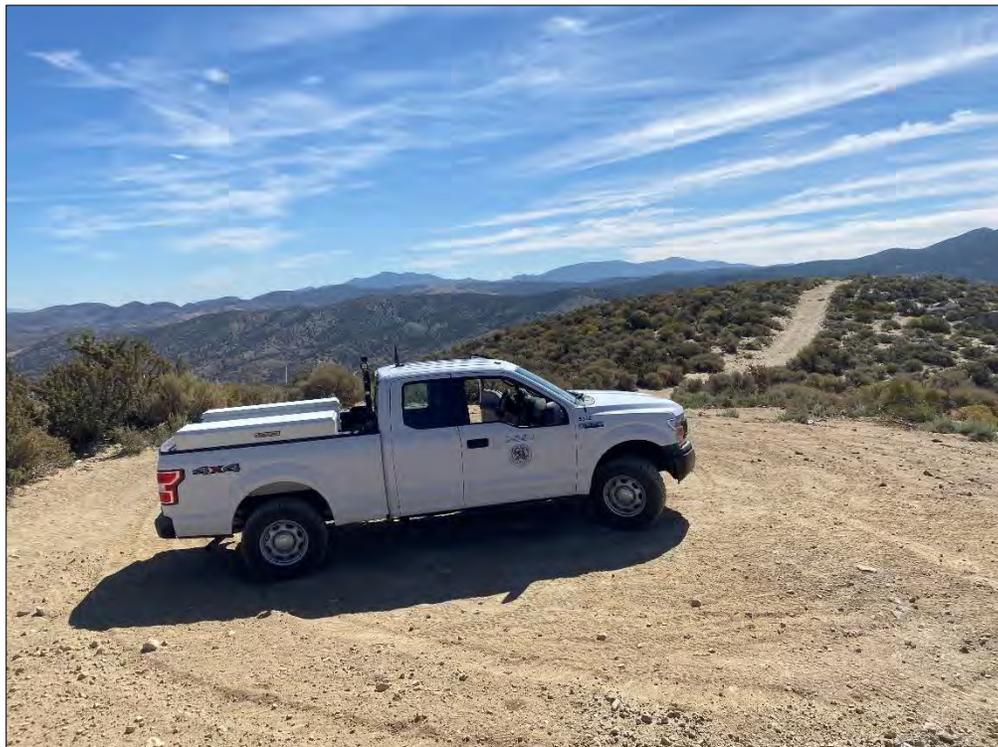
Photo Point 9C (view east): A photo point located at the Prison Hill Summit.

2020 Baseline Condition, photo taken January 24, 2020:
(GPS coordinates: 39.126752, -119.722705)

2021 Condition, photo taken June 21, 2021
