STAFF REPORT

Agenda Title: For Discussion Only: Review and discussion of the Prison Hill OHV Area Monitoring Report, and updates on the Prison Hill OHV Area. (*Georgia Vasey and Gregg Berggren*)

Carson City Open Space – Conservation Easement Monitoring

Prison Hill OHV Area – Monitoring Report

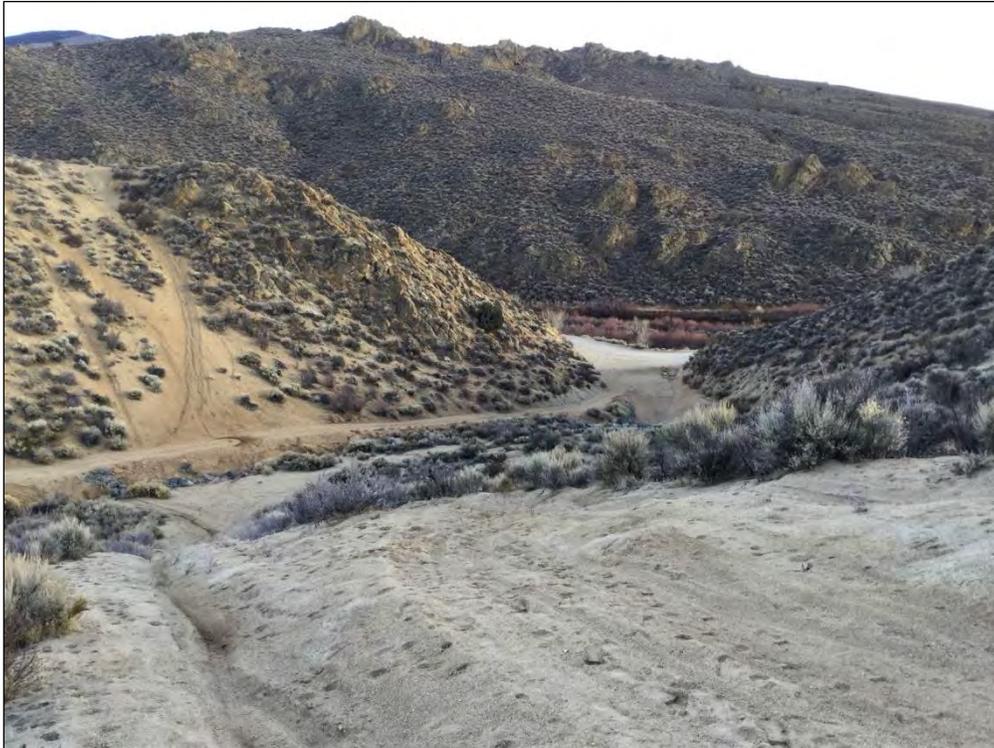
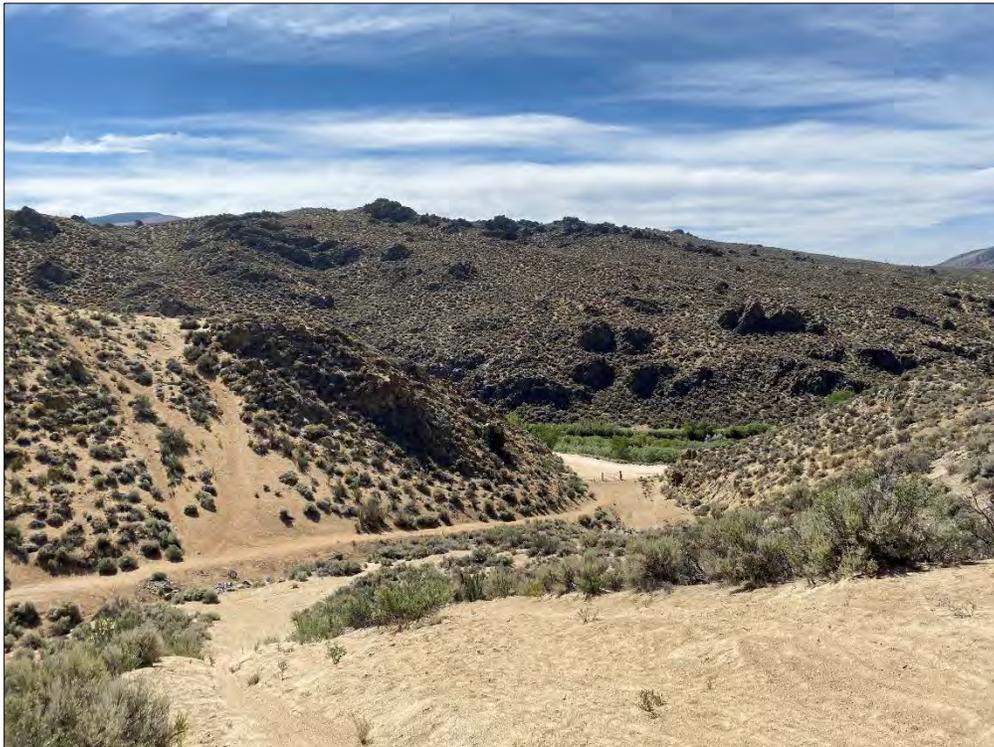
Photo Point 10A (view east): A photo point located above Golden Eagle Open Space and the erosion control project.

2020 Baseline Condition, photo taken January 24, 2020:
(GPS coordinates: 39.108428, -119.716747)

2021 Condition, photo taken June 21, 2021

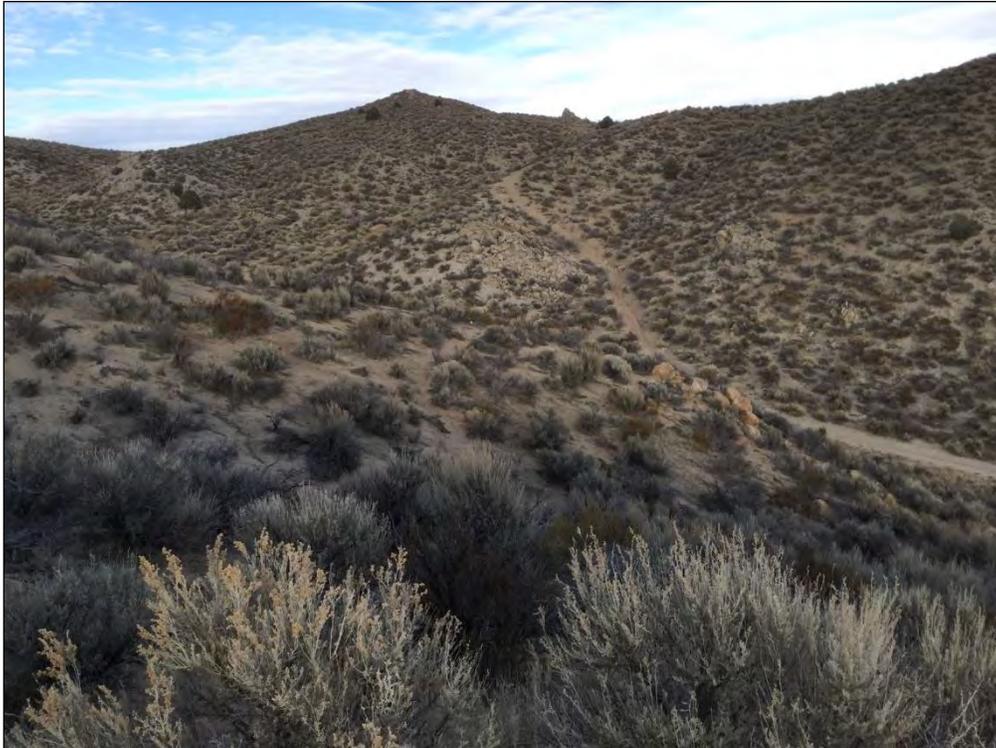
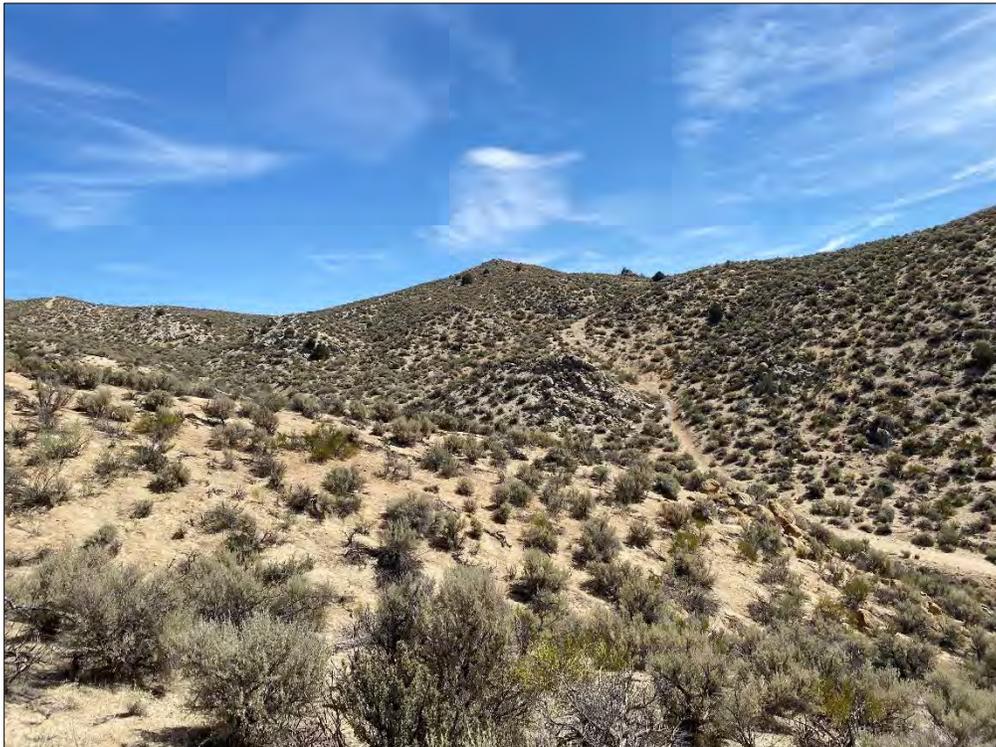
Photo Point 10B (view north): A photo point located above Golden Eagle Open Space and the erosion control project.

2020 Baseline Condition, photo taken January 24, 2020:
(GPS coordinates: 39.108428, -119.716747)

2021 Condition, photo taken June 21, 2021

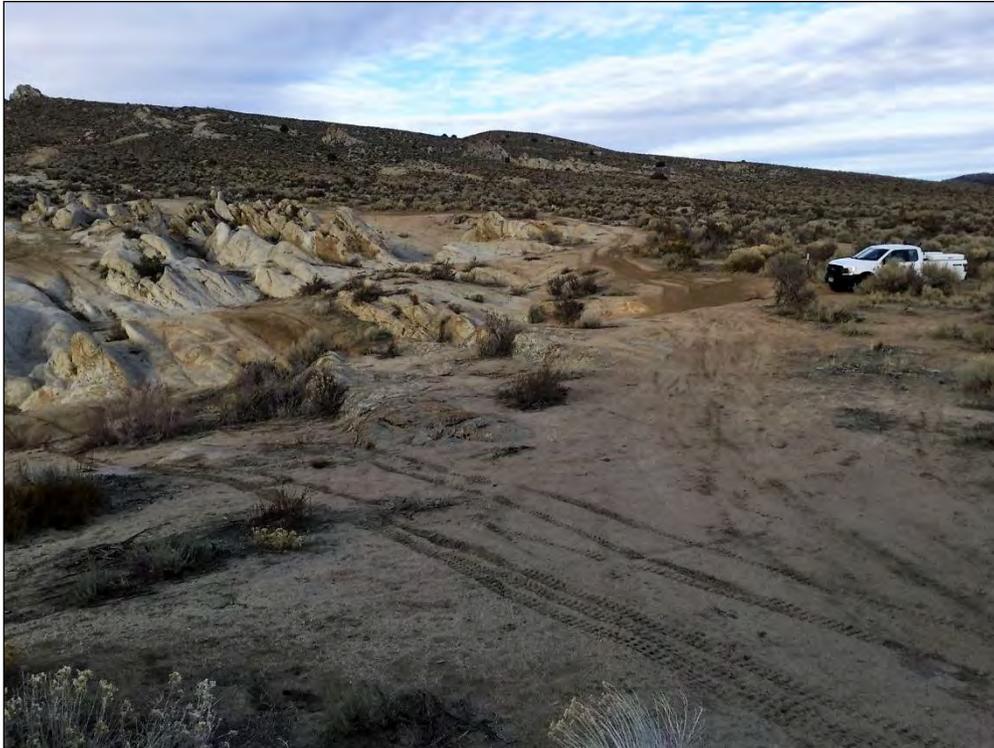
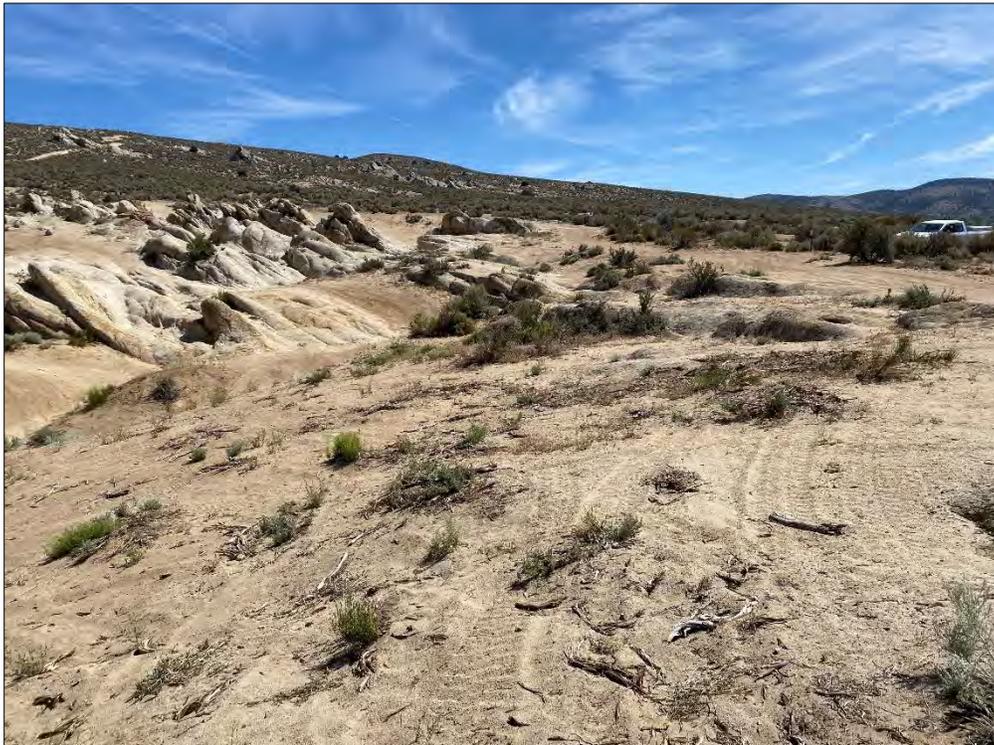
Photo Point 11A (view north): A photo point located in the largest open area, just south of Cable Road.

2020 Baseline Condition, photo taken January 24, 2020:
(GPS coordinates: 39.109063, -119.728908)

2021 Condition, photo taken June 21, 2021

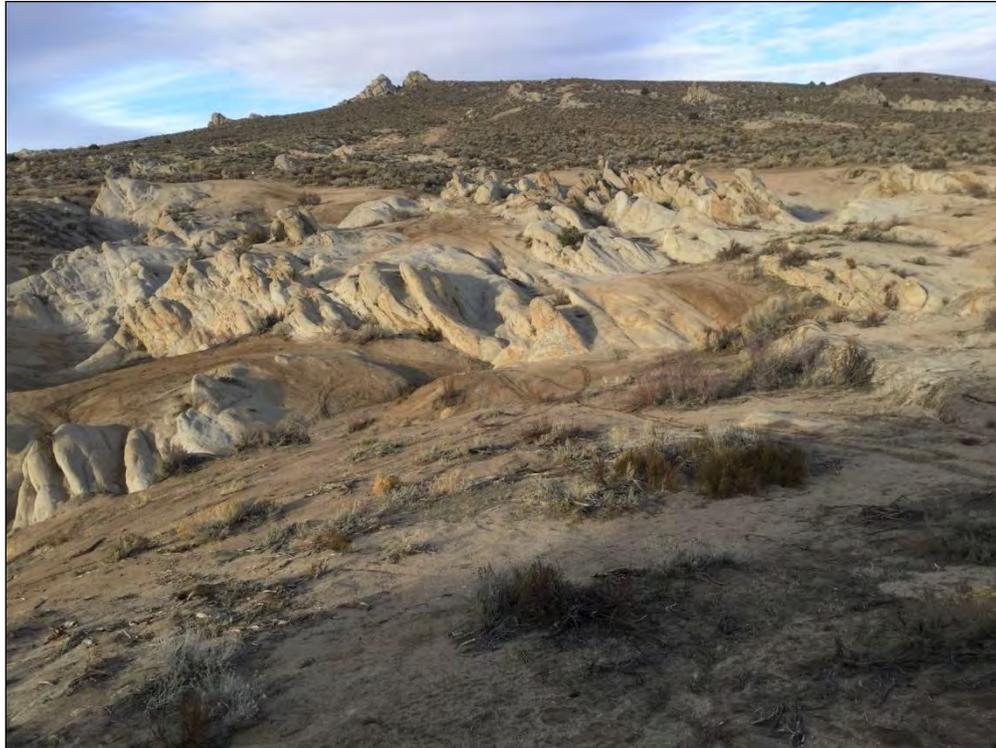
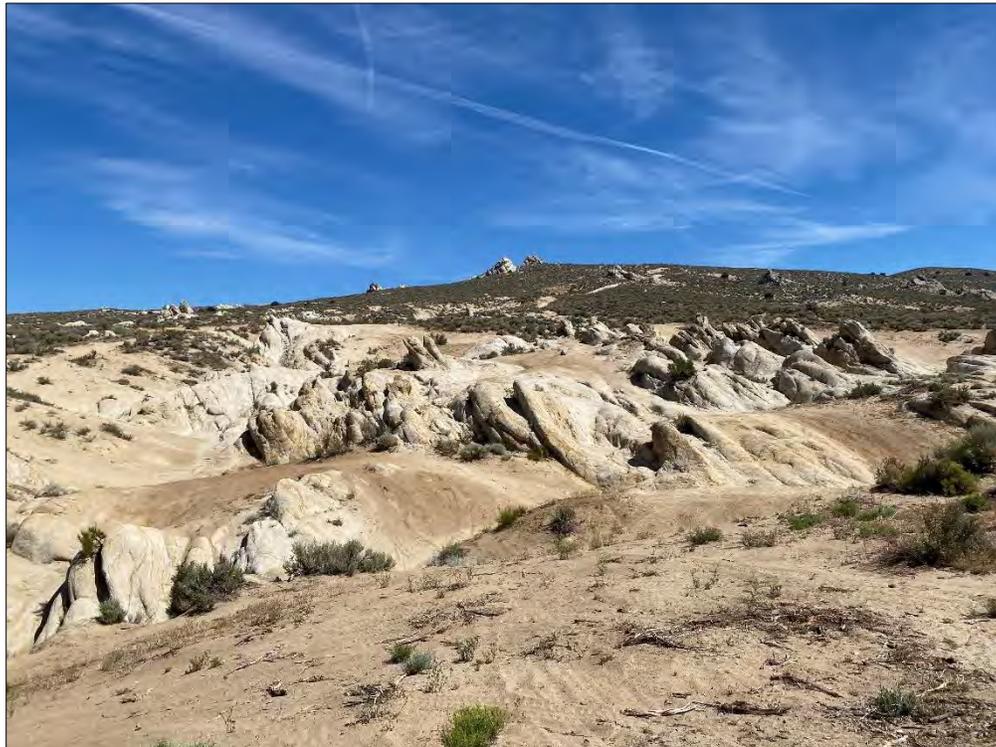
Photo Point 11B (view northwest): A photo point located in the largest open area, just south of Cable Road.

2020 Baseline Condition, photo taken January 24, 2020:
(GPS coordinates: 39.109063, -119.728908)

2021 Condition, photo taken June 21, 2021

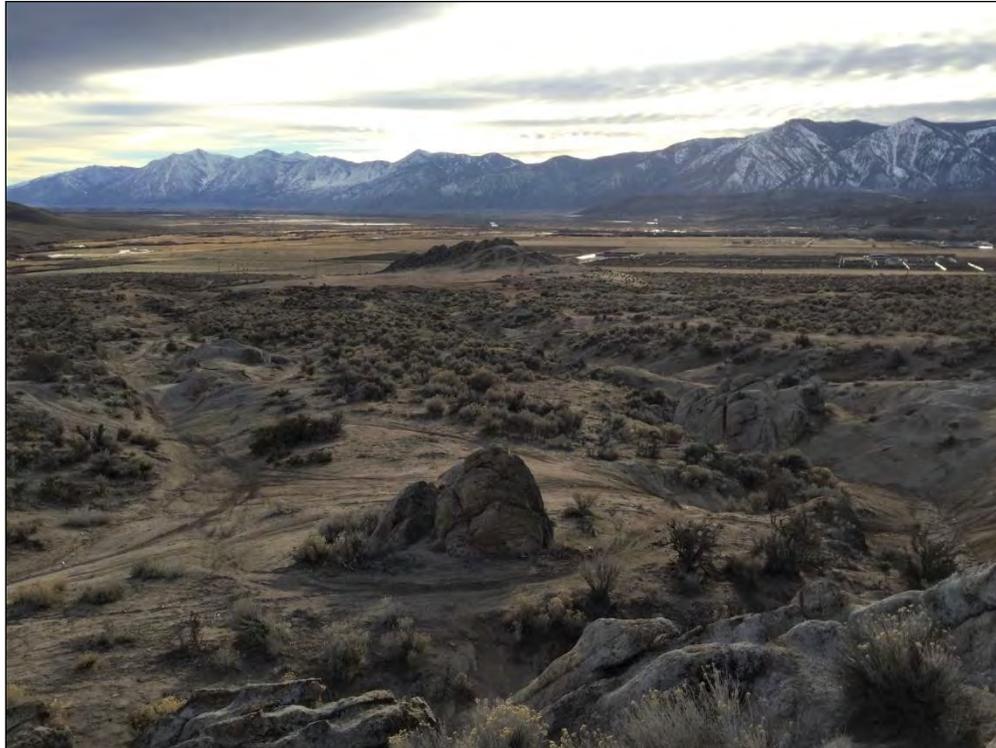
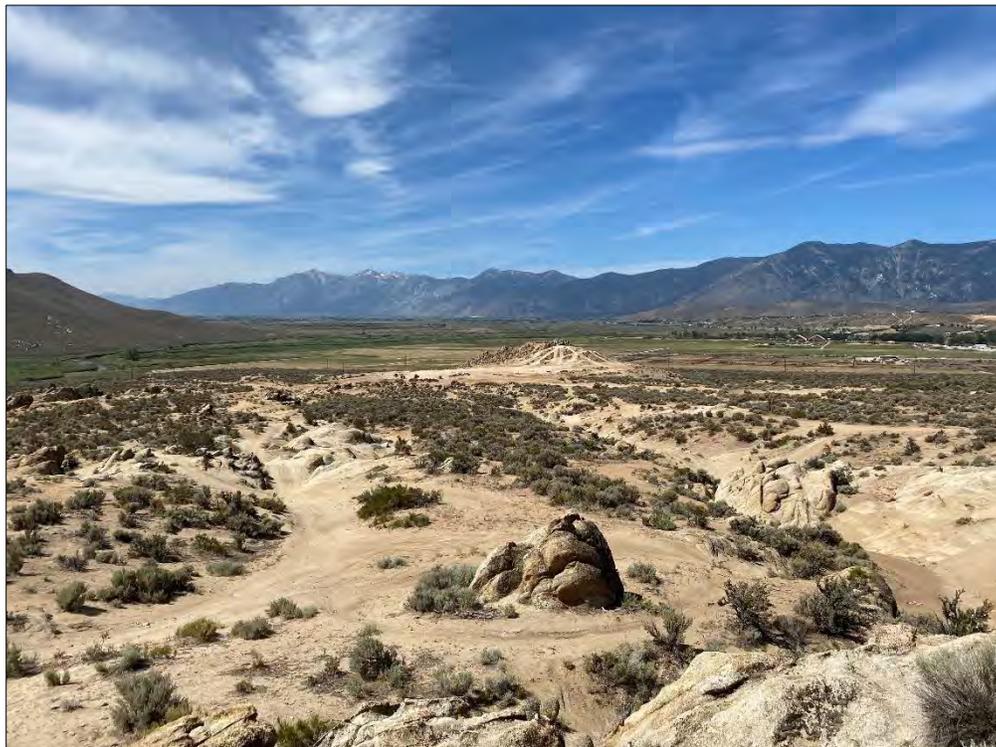
Photo Point 11C (view southwest): A photo point located in the largest open area, just south of Cable Road. Walk up to the lookout rock to frame photo correctly.

2020 Baseline Condition, photo taken January 24, 2020:

2021 Condition, photo taken June 21, 2021

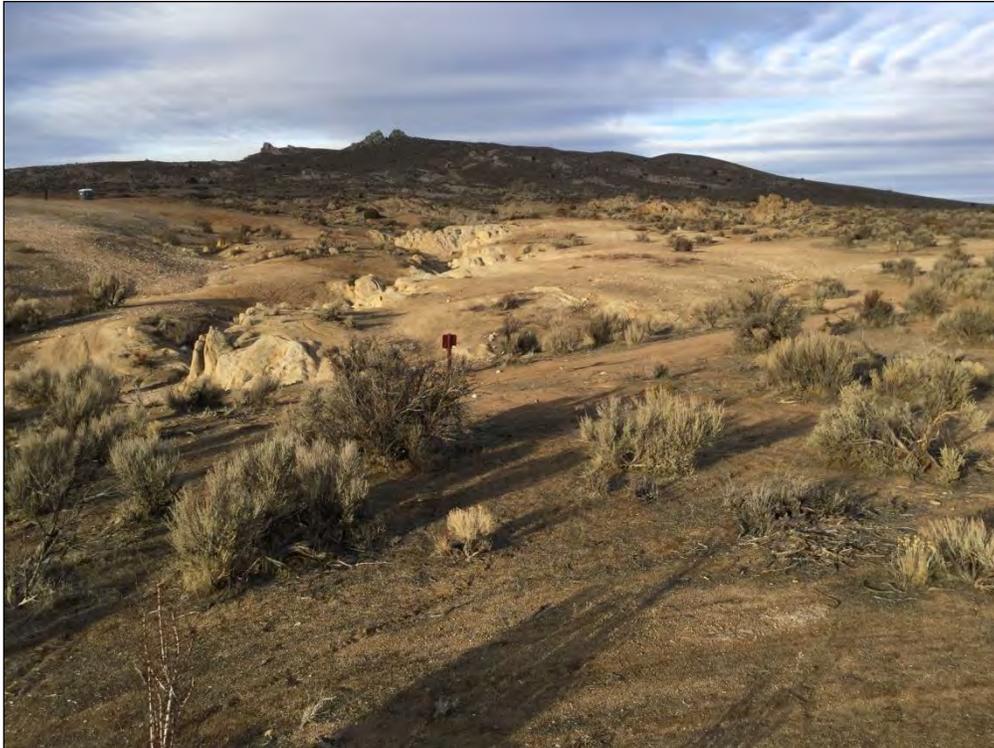
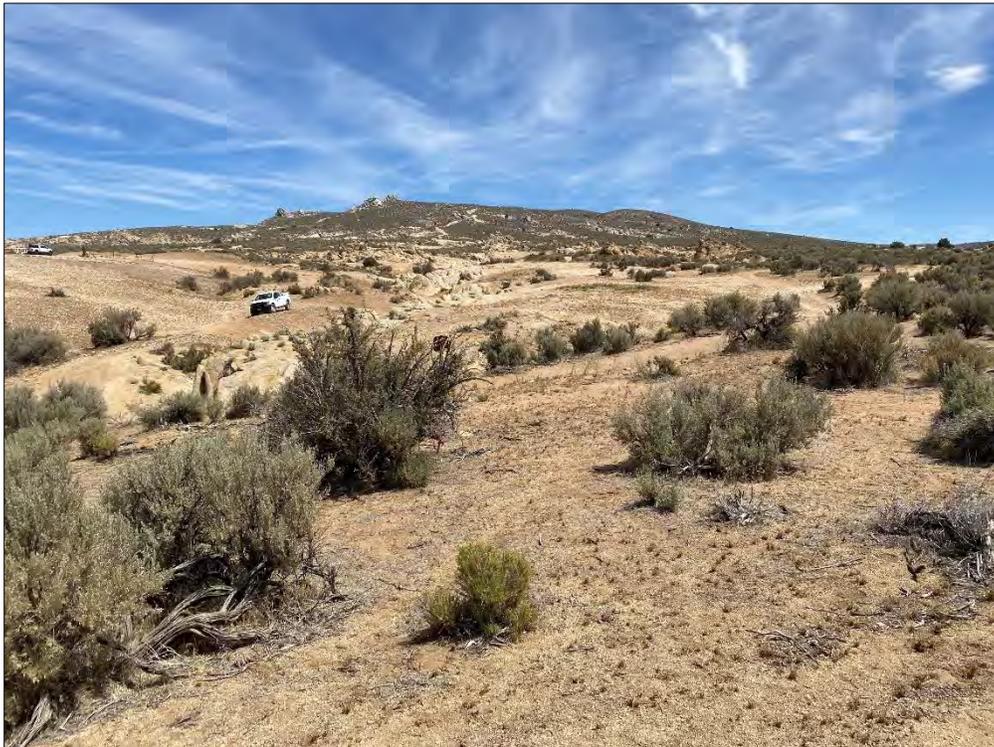
Photo Point 12A (view east): A photo point located south of the largest open area on the east side of the drainage.

2020 Baseline Condition, photo taken January 24, 2020:
(GPS coordinates: 39.103478, -119.731260)

2021 Condition, photo taken June 21, 2021

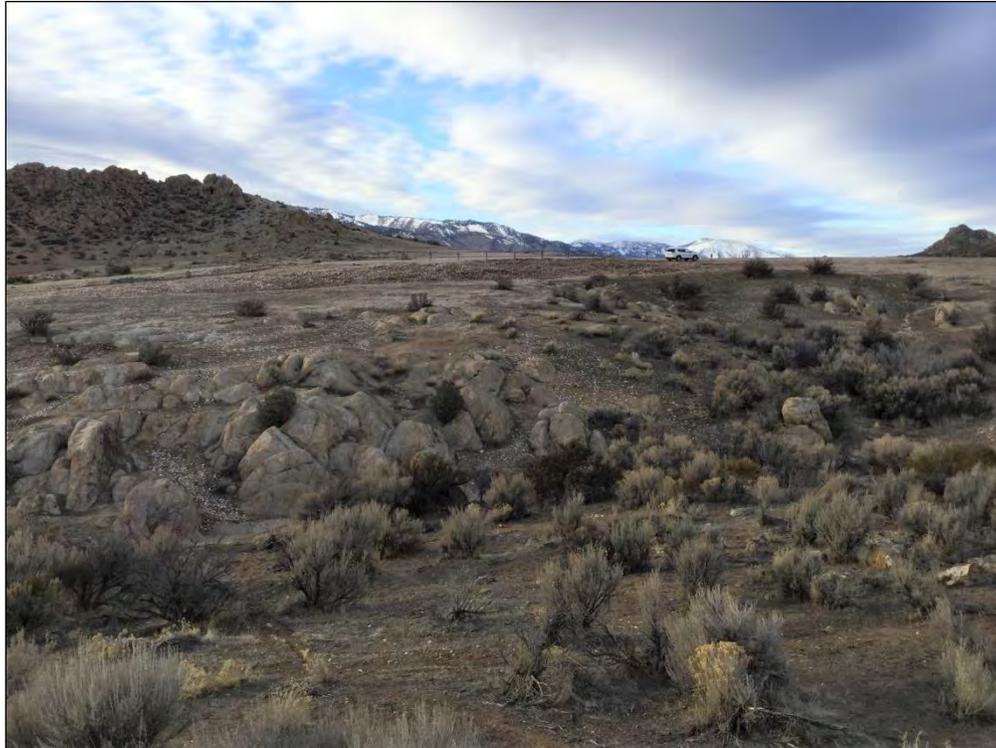
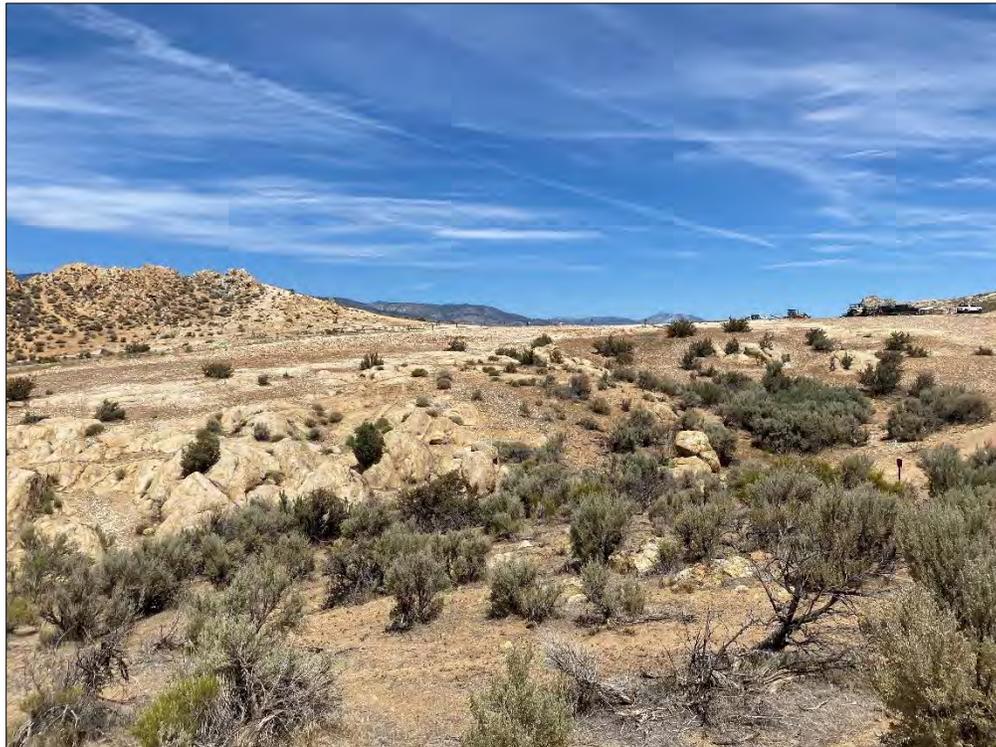
Photo Point 12B (view northwest): A photo point located south of the largest open area on the east side of the drainage.

2020 Baseline Condition, photo taken January 24, 2020:
(GPS coordinates: 39.103478, -119.731260)

2021 Condition, photo taken June 21, 2021

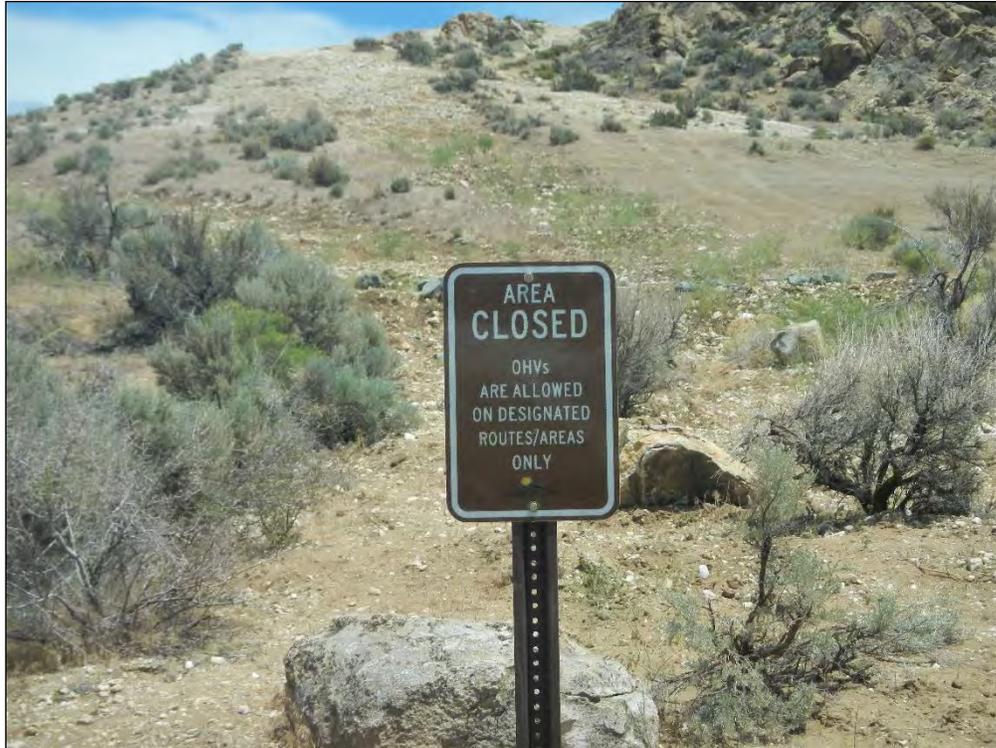
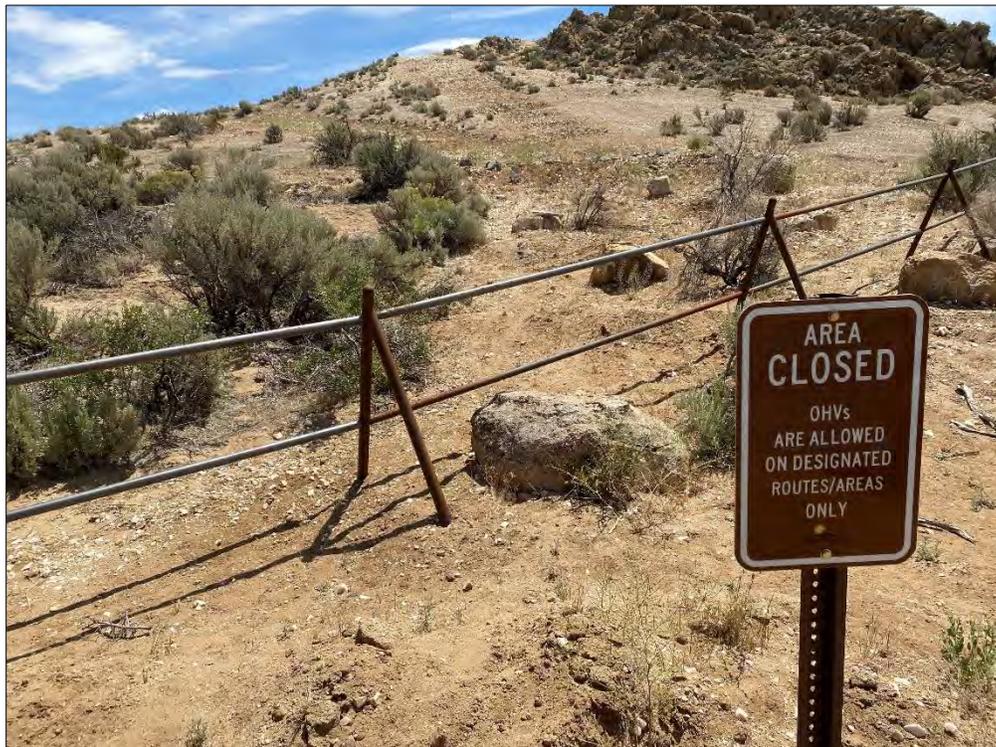
Photo Point 13 (view east): A photo point located at the closed-off western access point adjacent to Golden Eagle Lane.

2020 Baseline Condition, photo taken January 24, 2020:
(GPS coordinates: 39.104735, -119.735214)

2021 Condition, photo taken June 21, 2021

(3B-1) Photo Point: This photo shows the initial conditions of the former access point from the west at Golden Eagle Lane (Photo Point #13, GPS coordinates: 39.104735, -119.735214).

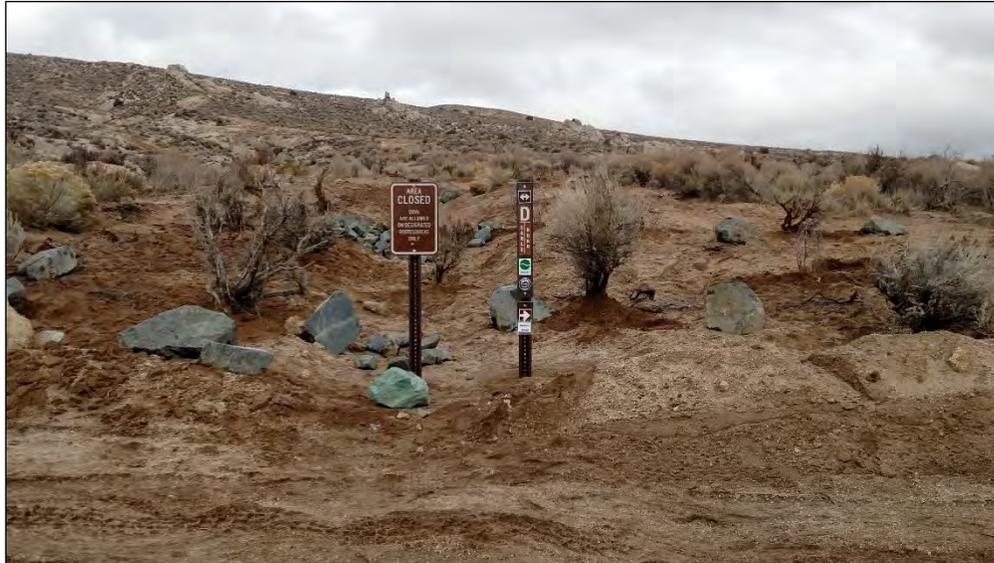
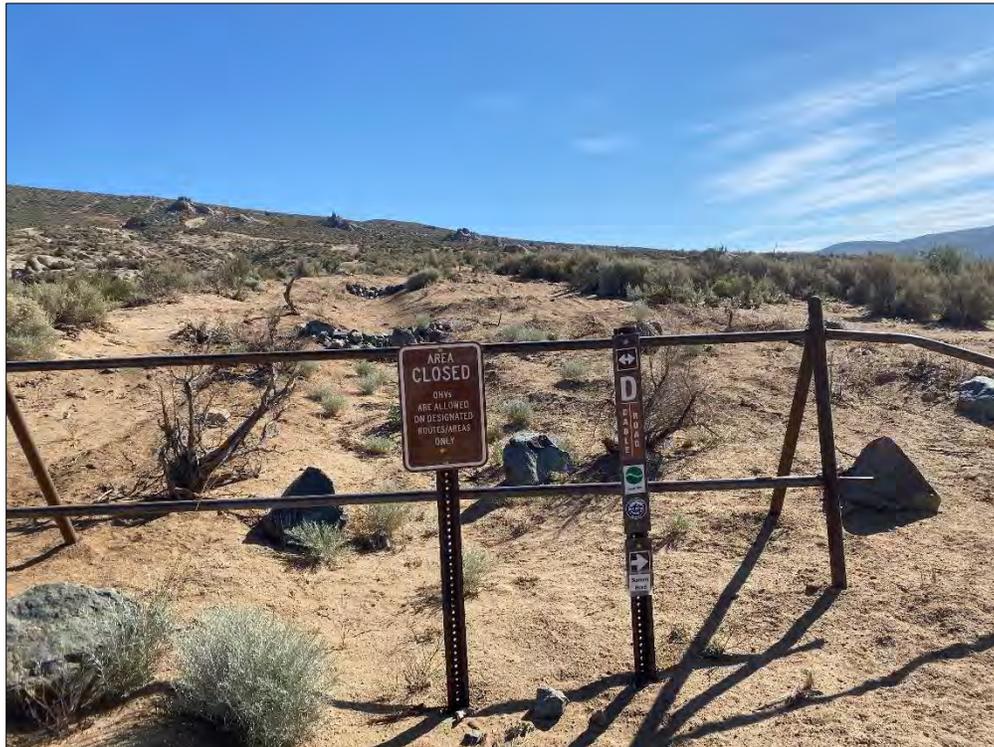
Photo Point 14 (view north): A photo point located at the closed section of the main road, north of Cable Road.

2020 Baseline Condition, photo taken January 24, 2020:
(GPS coordinates: 39.109900, -119.730203)

2021 Condition, photo taken June 21, 2021

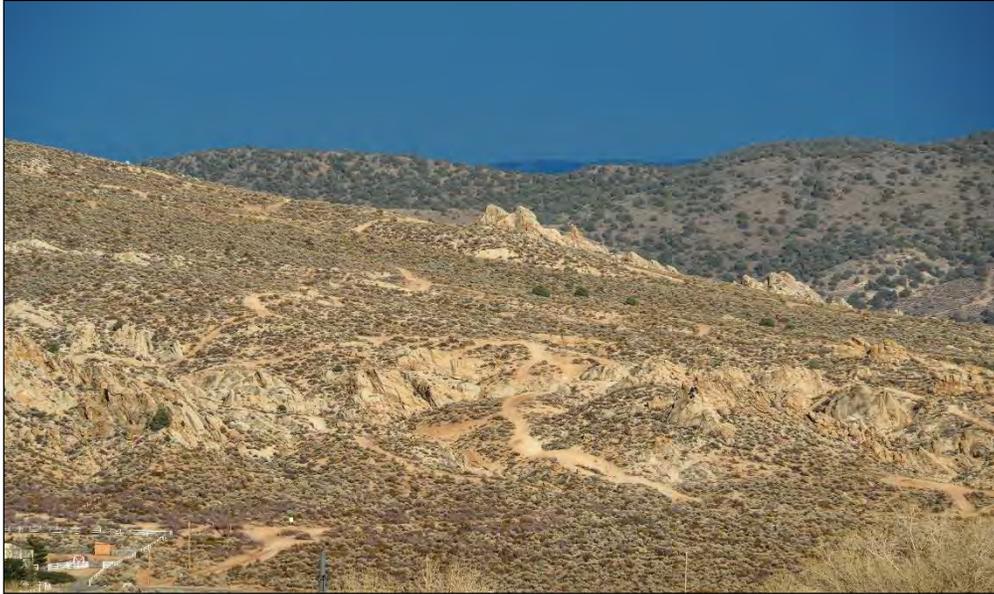
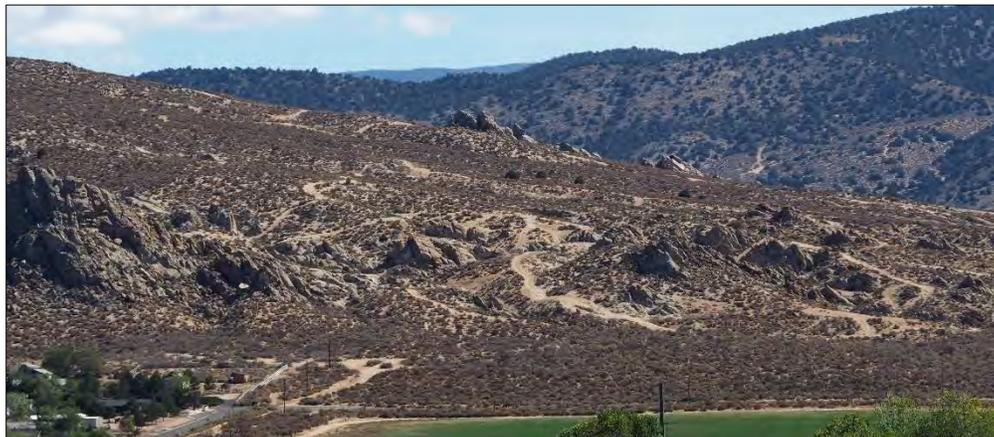
Photo Point 15A (view east): A photo point located off Topsy Lane above Center Drive to capture the full extent of the West Basin.

2020 Baseline Condition, photo taken February 1, 2020:
(GPS coordinates: 39.110186, -119.762719)

2021 Condition, photo taken September 19, 2021

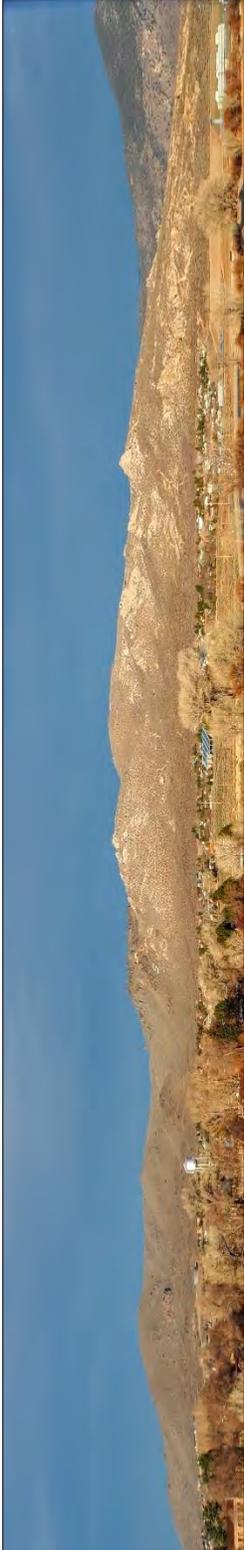
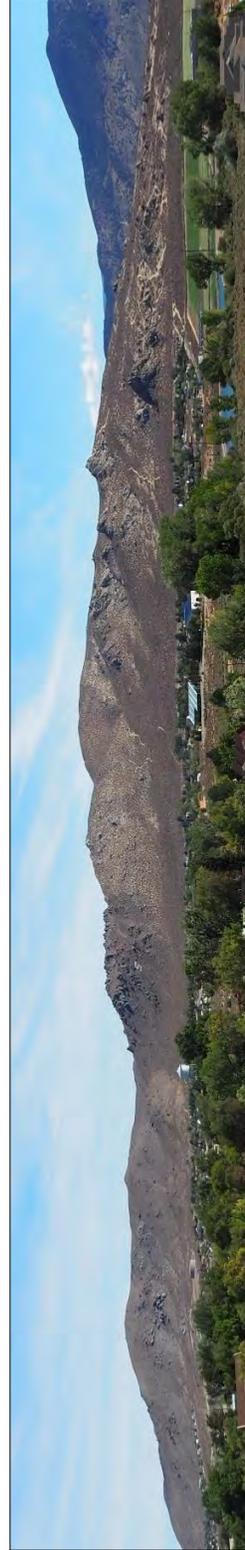
Photo Point 15B (view east): A photo point located off Topsy Lane above Center Drive that shows the entire west side of Prison Hill (panoramic).

2020 Baseline Condition, photo taken February 1, 2020:
(GPS coordinates: 39.110186, -119.762719)

2021 Condition, photo taken September 19, 2021

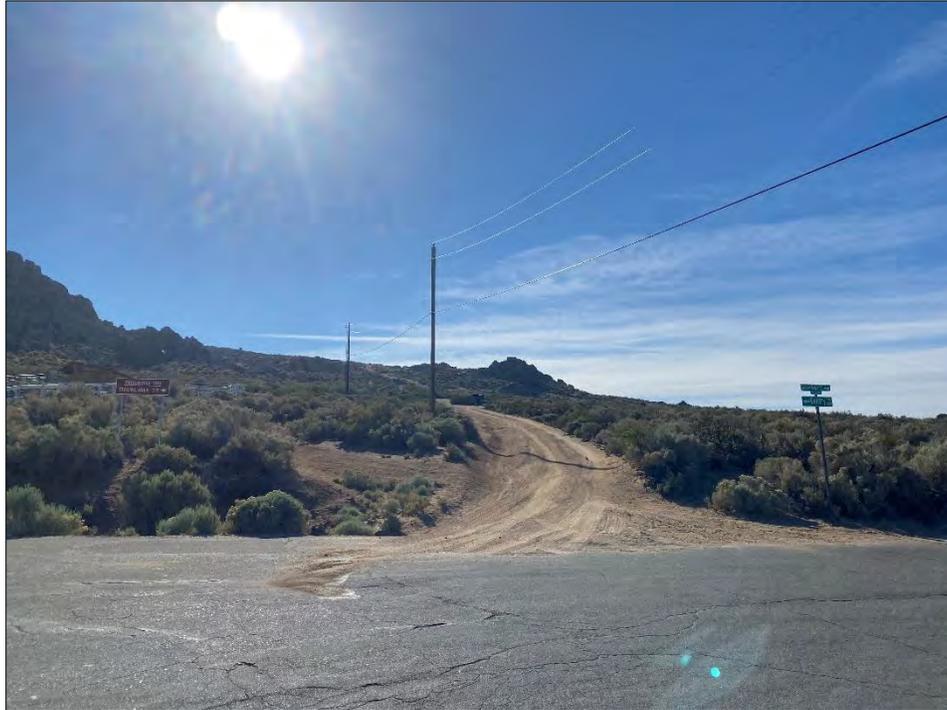
Photo Point 16 (view east): A photo point located at the Snyder Entrance taken from the mailboxes.

2021 Baseline Condition, photo taken June 17, 2021: (GPS coordinates: 39.114, -119.739)

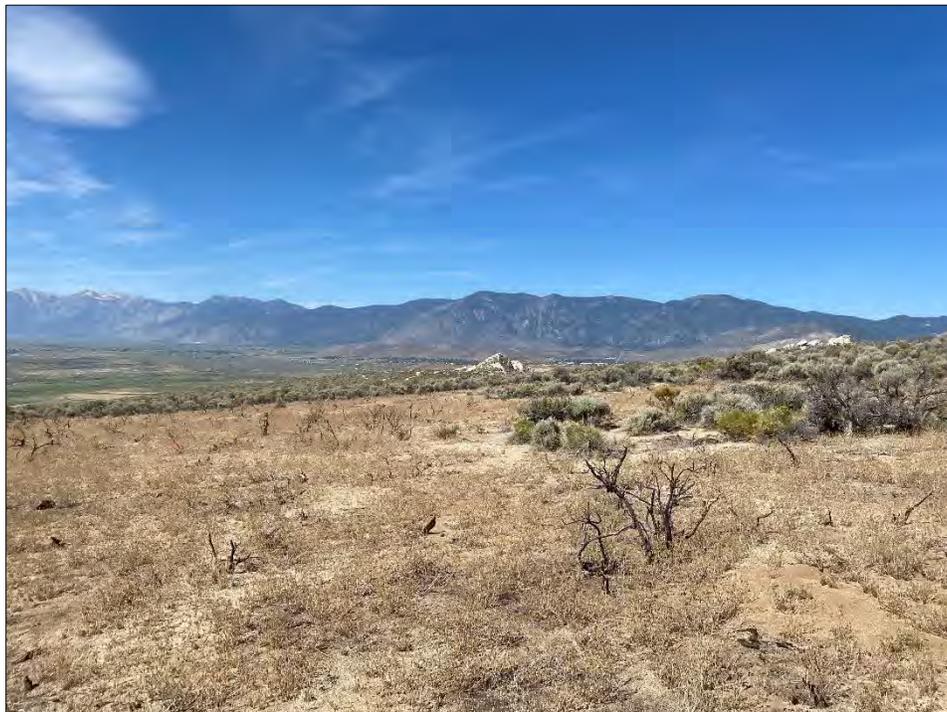
Photo Point 17 (view southwest): A photo point located at the new fire scar on Prison Hill.

2021 Baseline Condition, photo taken June 17, 2021: (GPS coordinates: 39.122, -119.721)

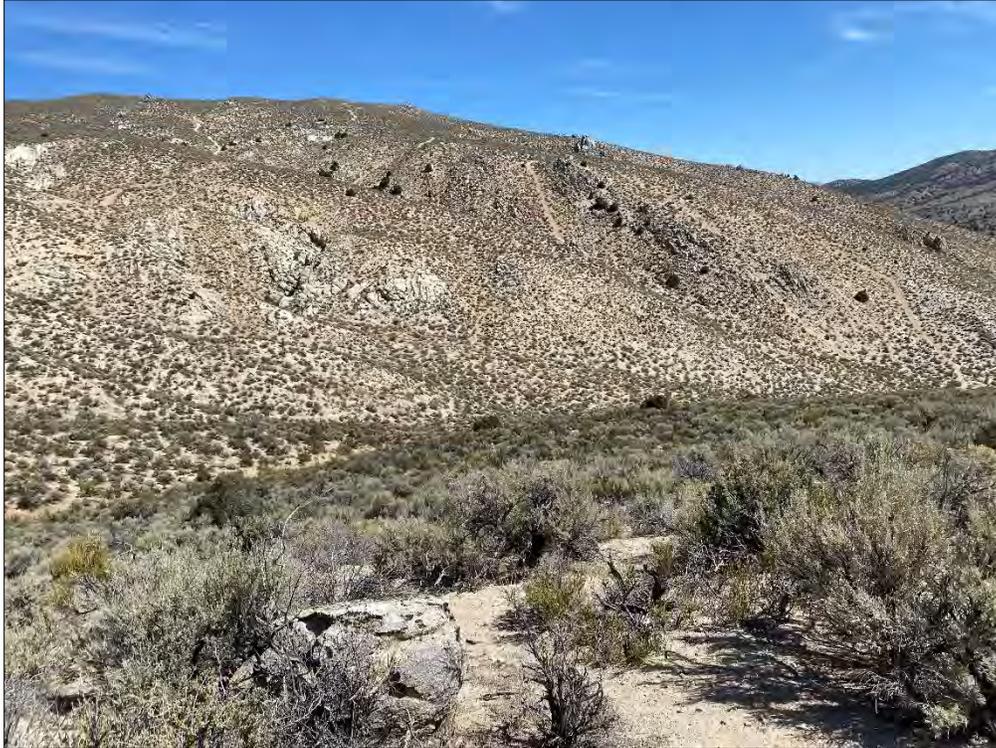
Photo Point 18 (view northwest): A photo point located near the viewpoint overlooking decommissioned trails in the Golden Eagle Open Space.

2021 Baseline Condition, photo taken June 17, 2021:

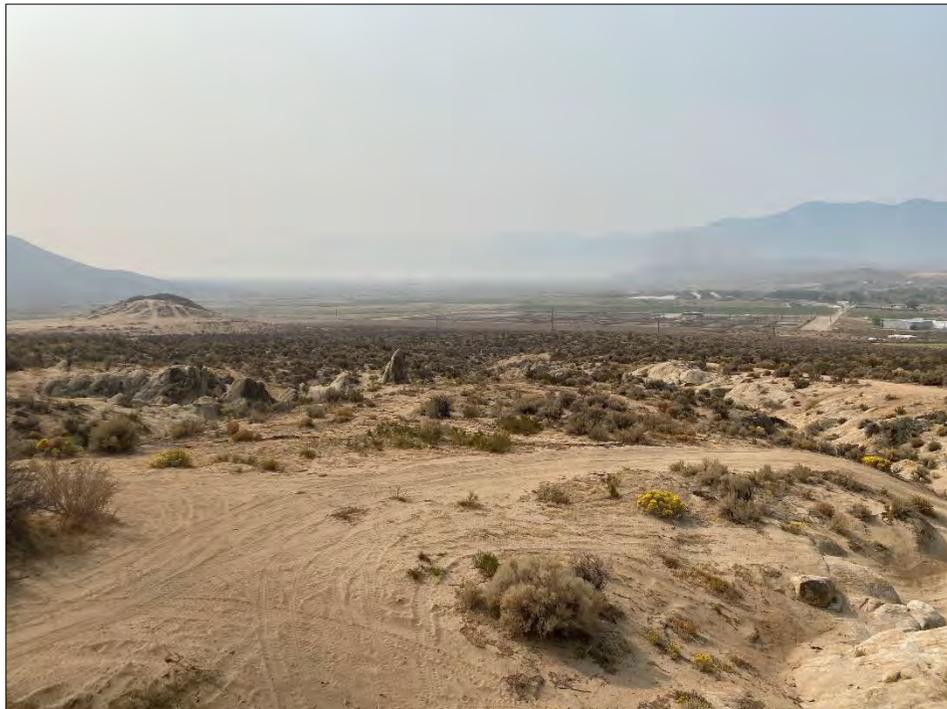
Photo Point 19 (view south): A photo point looking over Headlight Area Open Space.

2021 Baseline Condition, photo taken October 4, 2021: (GPS coordinates: 39.1102, -119.7322)

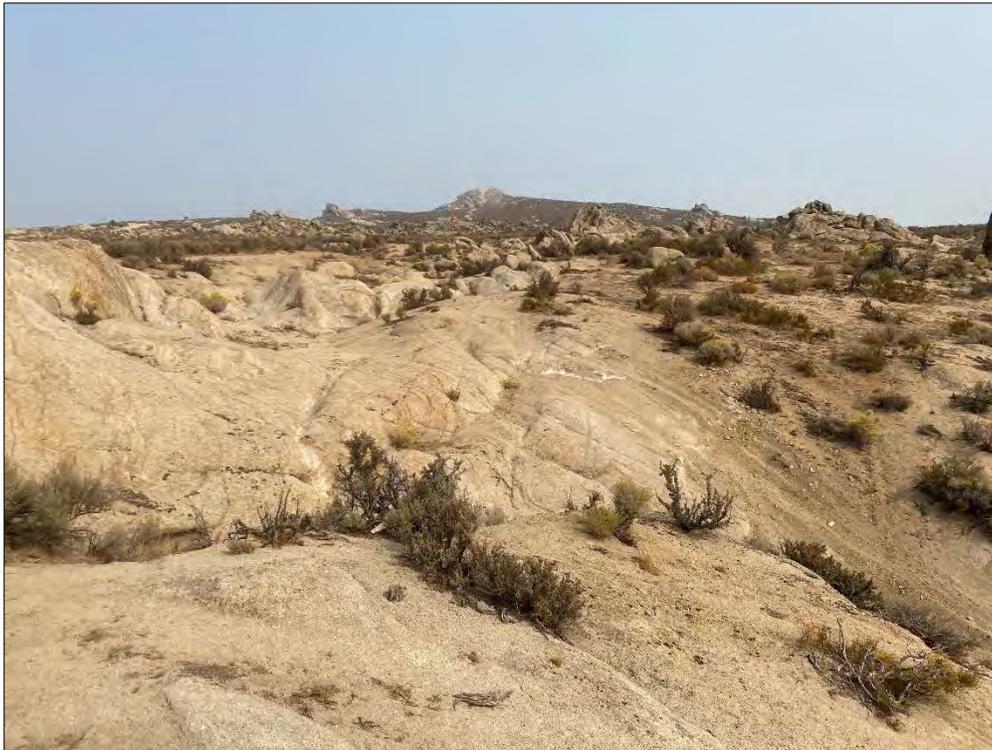
Photo Point 20A (view northwest): A photo point marking the end of the Headlight Open Space.

2021 Baseline Condition, photo taken October 4, 2021: (GPS coordinates: 39.10925, -119.7337)

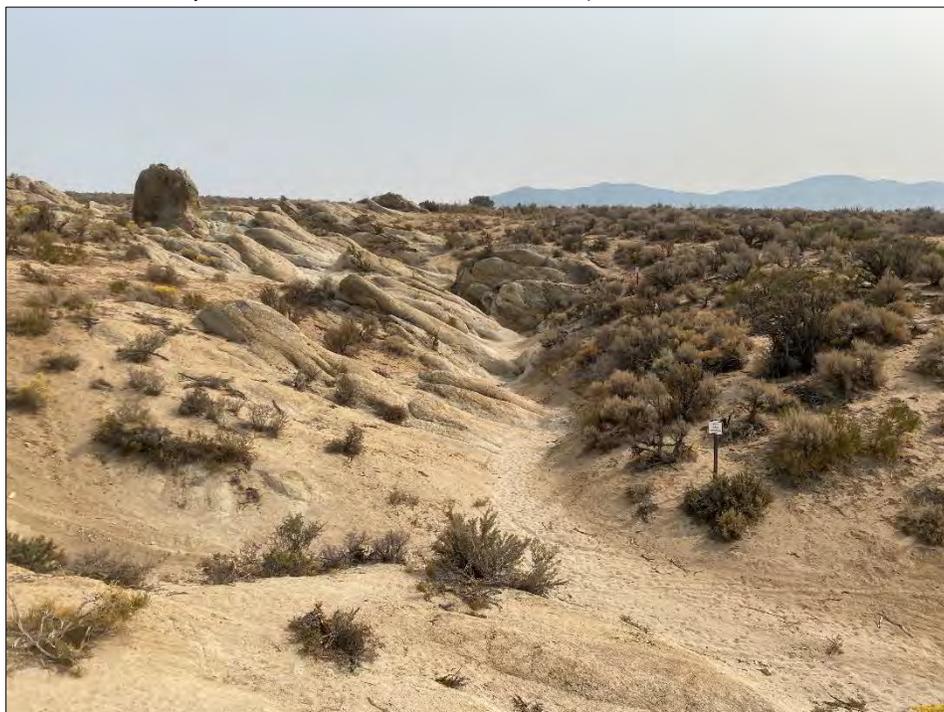
Photo Point 20B (view northeast). A photo point marking the end of the Headlight Open Space.

2021 Baseline Condition, photo taken October 4, 2021: (GPS coordinates: 39.10925, -119.7337)
