**STAFF REPORT FOR THE HISTORIC RESOURCES COMMISSION MEETING OF  
May 12, 2022**

**FILE NO: HRC-2022-0203**

**AGENDA TITLE:** Discussion and possible action regarding a request to remove five brick and mortar chimneys on property zoned Residential Office (“RO”) located at 212 N. Division Street, APN 003-202-04. (Heather Ferris, [hferris@carson.org](mailto:hferris@carson.org))

# Structural Evaluation Report

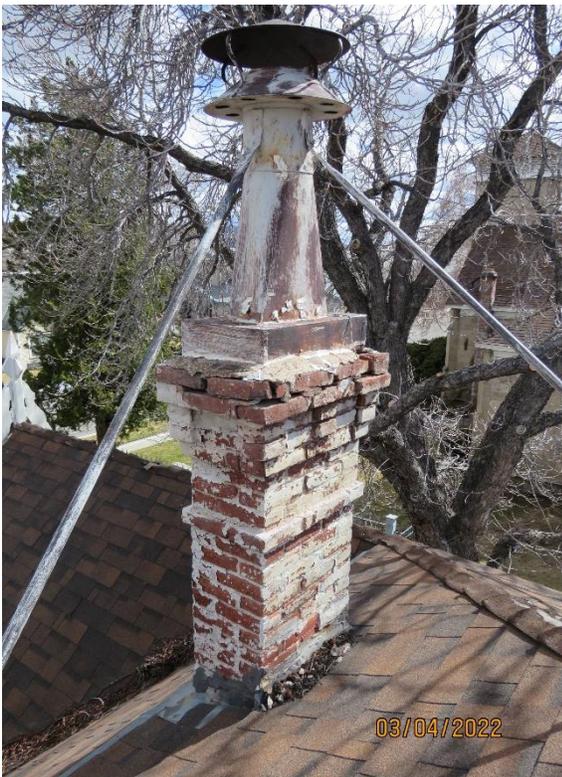
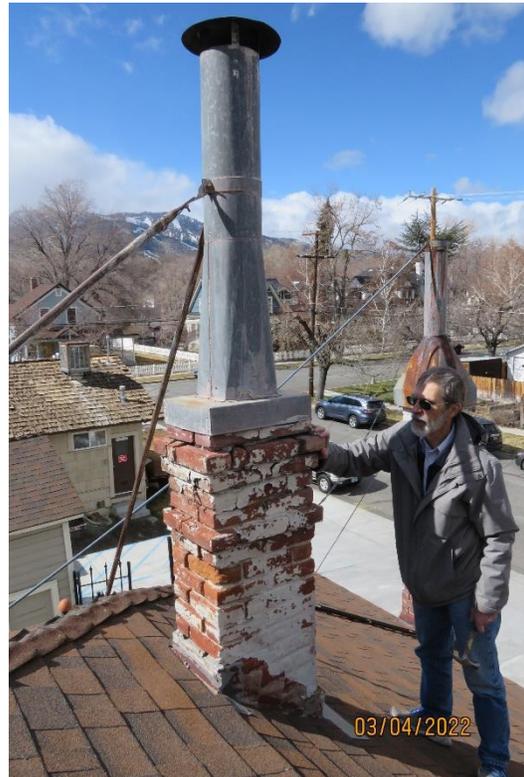
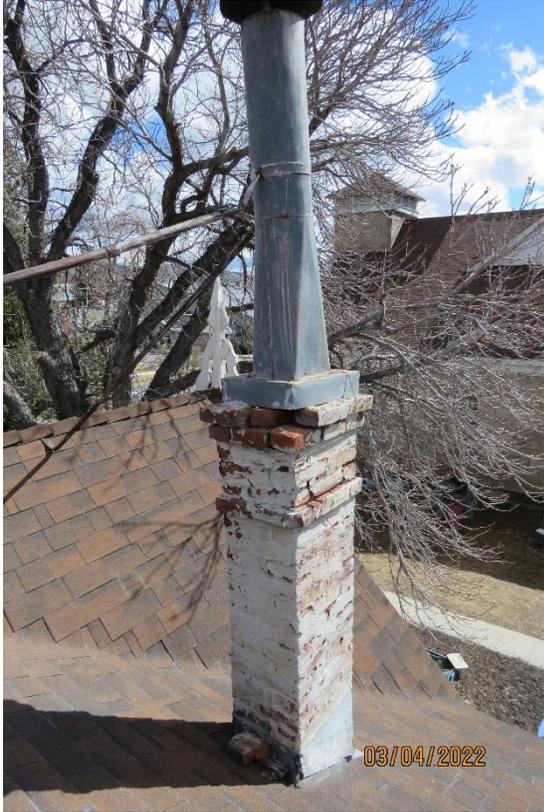
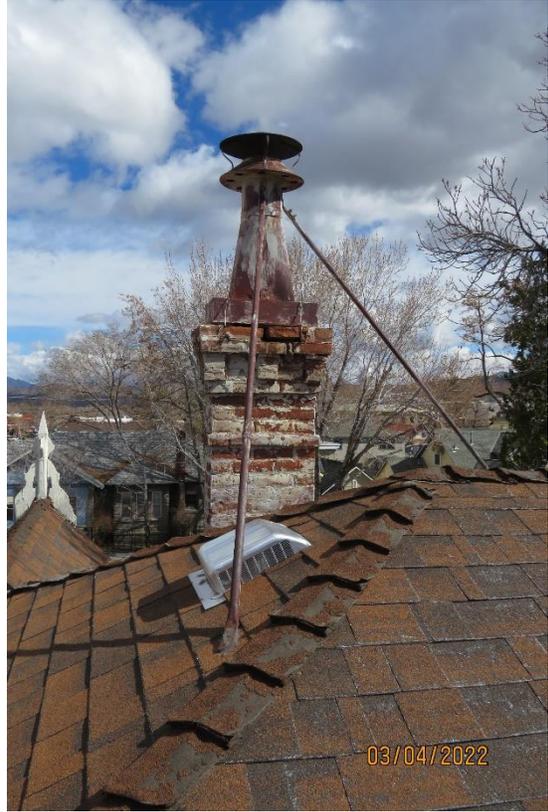
The project is the removal of five brick and mortar chimneys on a house built in 1874. Four of the chimneys are entirely on the top of the building and one chimney is on the north side of the building and extending well above the roof. The chimneys have deteriorated bricks and mortar. The side chimney is leaning northward away from the building. A Structural Evaluation Report for the leaning chimney is attached. Also attached are photographs of all the chimneys. Plans are underway to have the building roof repaired at the same time as the removal of chimneys.

Photos of Chimney on north side of building

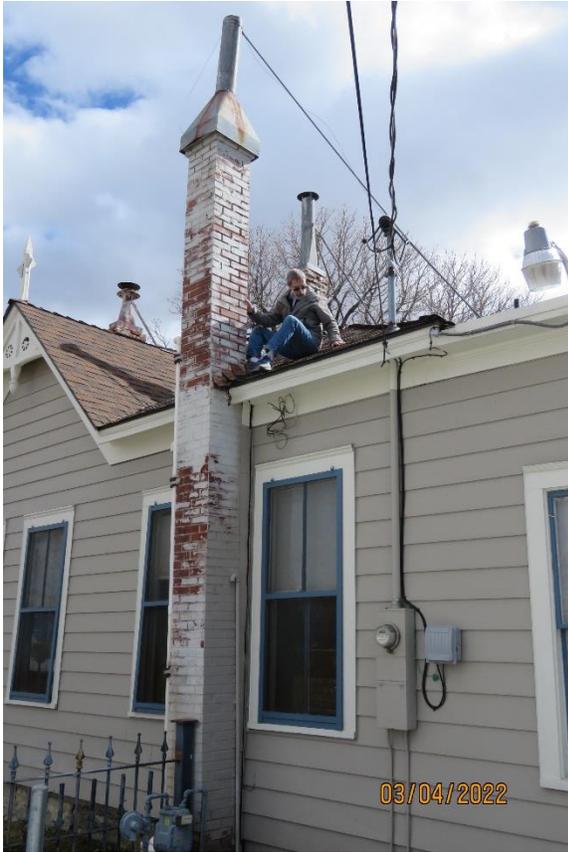
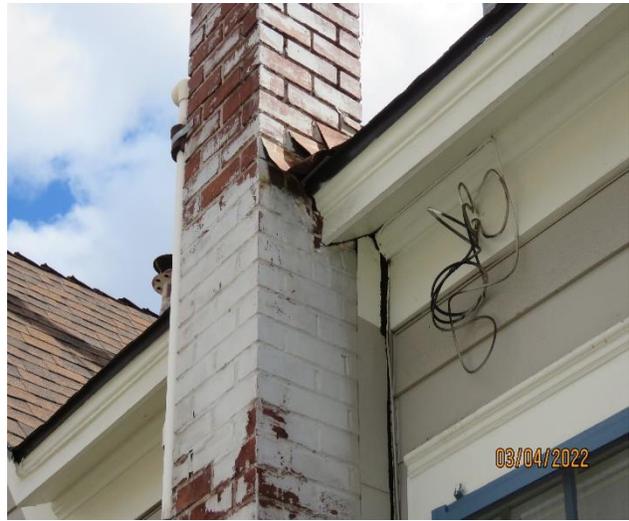
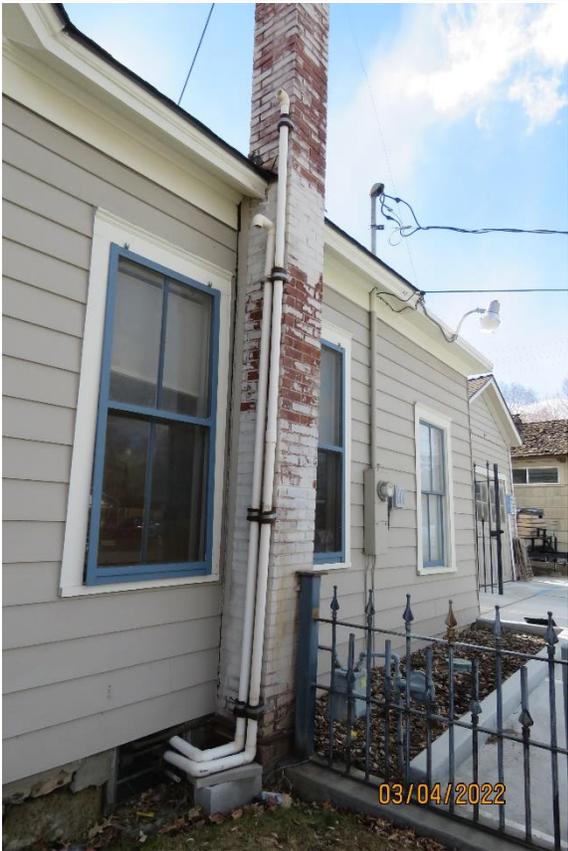
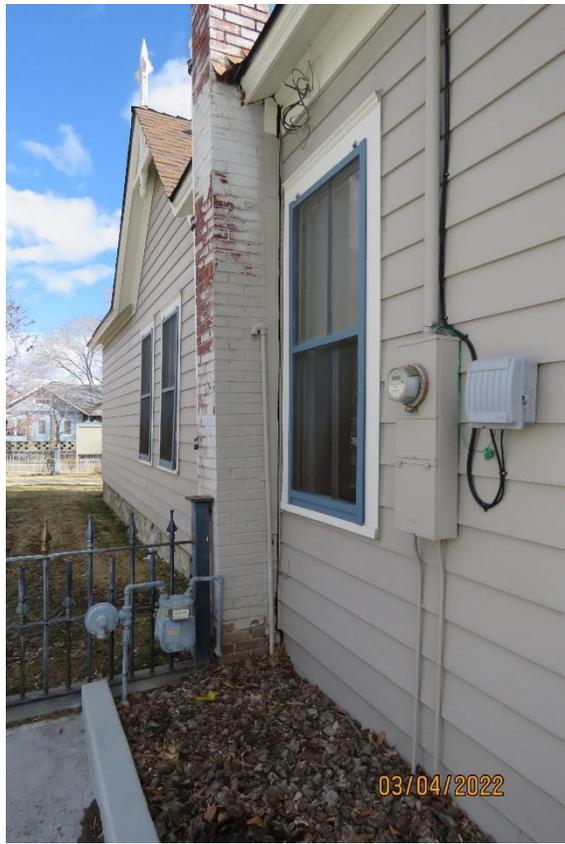
What House Would Look Like Without Chimneys  
(Edited Photographs)

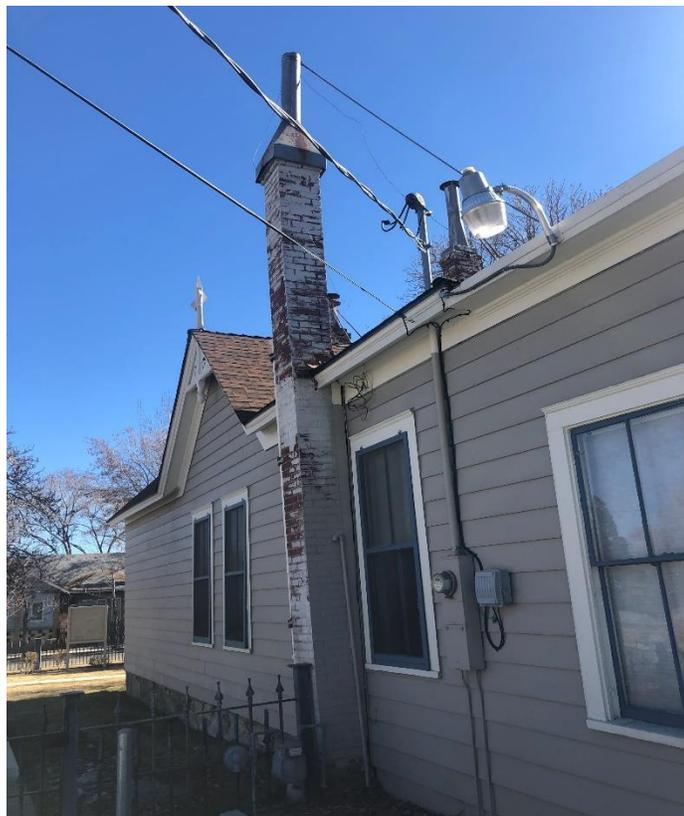
The chimney appears to be constructed of un-reinforced brick masonry that is very weathered with visible loss of mortar joint material and even some section loss to the clay brick. The chimney appears to be founded on a footing or foundation (not observable) that is either next to or integral with the building foundation. The chimney appears to be leaning northward away from the wall of the building at approximately 1” in every 4’ to 6’ of height. This lean appears to be consistent from near the ground level up to the eave line, where then it appears to slightly straighten (See Photo 1).

**Photo 1. West side of chimney showing lean. Note gap at wall.**

**Statement of Opinion.** It is my professional opinion that the chimney is currently in a compromised state of structural integrity and stability. Given that the steel cap support rods appear not to be providing any significant lateral support, the chimney may not be able to withstand the lateral forces imposed by a seismic event. Should such an event occur during the day, when the building is occupied, it may further pose a risk to life should sections fall on those leaving the site on the sidewalk near the chimney. Therefore, the chimney should be evaluated for removal or reinforcement.

During my two site visits, there was some discussion and review with Mr. Rob Lauder that a possible re-roofing activity may occur soon. This would be the perfect time to either remove the chimney entirely (which might be difficult given the historic nature of the building) or reinforce it with structural steel members which could be positively fastened to the building roof and wall. The chimney is a key architectural feature of the building (as are several other brick chimneys on the roof), hence there may be some merit it is reinforcing rather than removing.

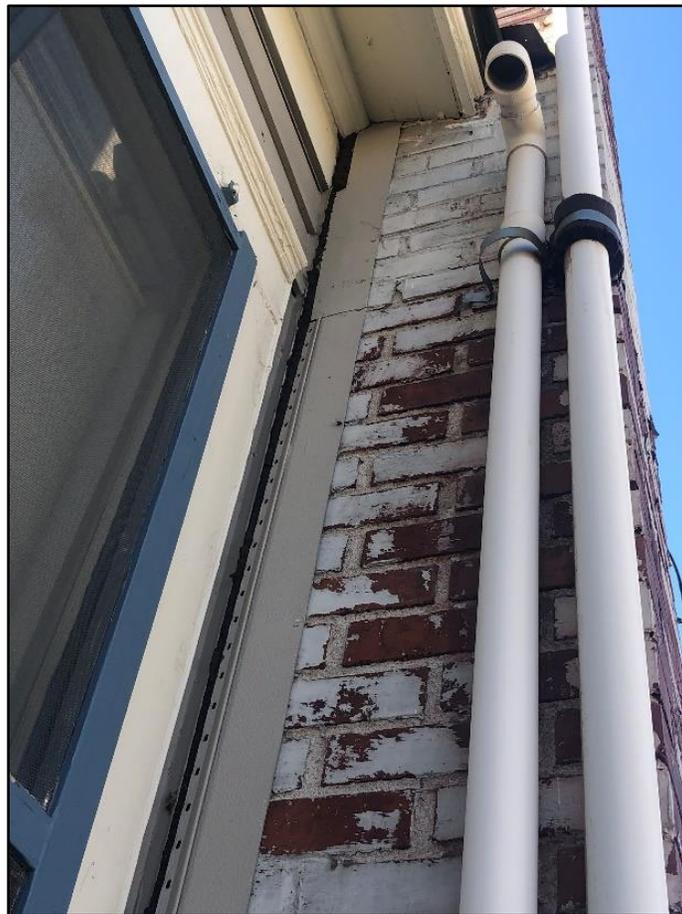
There is little to no evidence as to whether the chimney has been in the current condition for some time, or if it is more recent. There is, however, evidence of flashing and painting of the wall and flashing to cover the gap between the wall and the chimney. The owner may have historical records which might shed some light on the timing of the gap/lean (See Photos 2 & 3). These items point to maintenance activities, in the past, to seal the gap between the chimney and the wall. The vent or flue pipes that are shown in Photo 2 are for a modern gas-fired forced-air HVAC unit in the basement. It does not appear that the chimney is being used as a flue.

Photo 2. East Side showing flashing and gap at under eave wall.

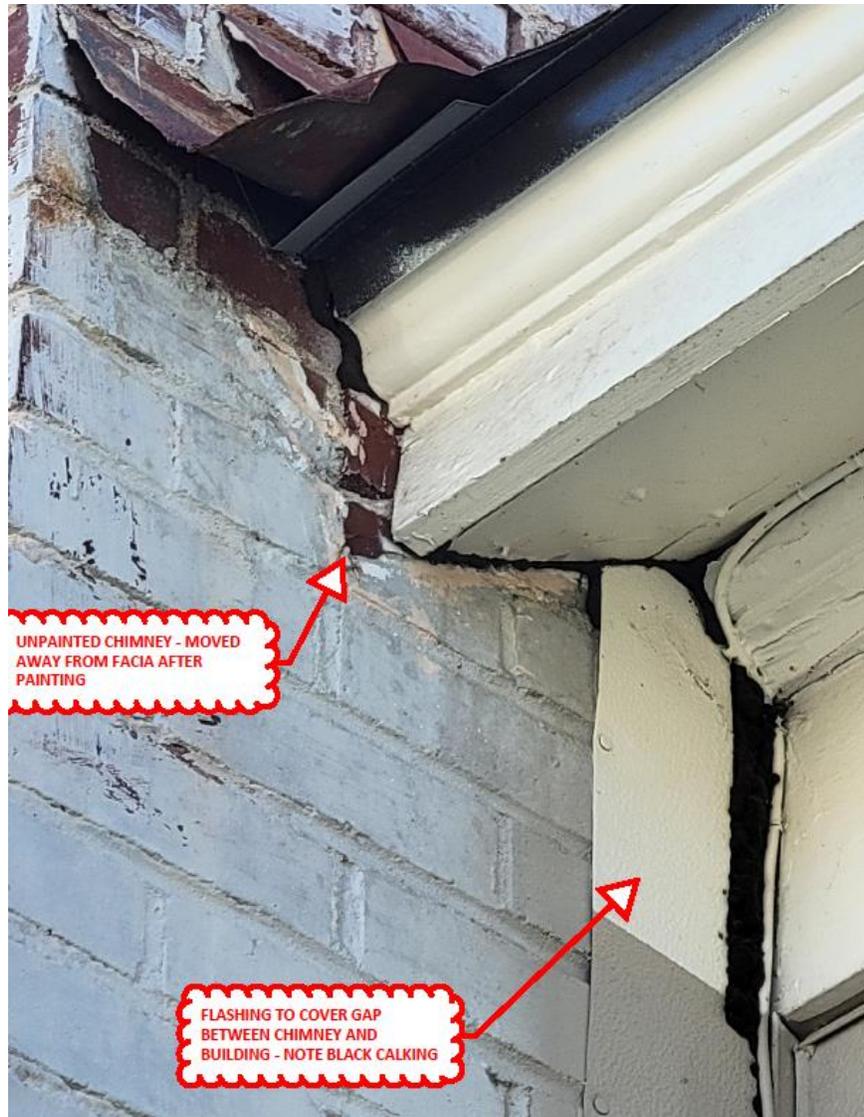
Photo 3. West Side showing paint and flashing at under eave wall.

It is my opinion that the chimney was constructed true and plumb, but has, at some point over time, leaned away from the wall due to forces of wind and/ or even seismic lateral loads. From the flashing and caulking, it appears that the owner has attempted to seal the gap during maintenance and painting activities.
