**GEOTECHNICAL INVESTIGATION
REPORT**

THE VINTAGE AT KING'S CANYON

Carson City, Nevada

LUMOS and ASSOCIATES, INC.

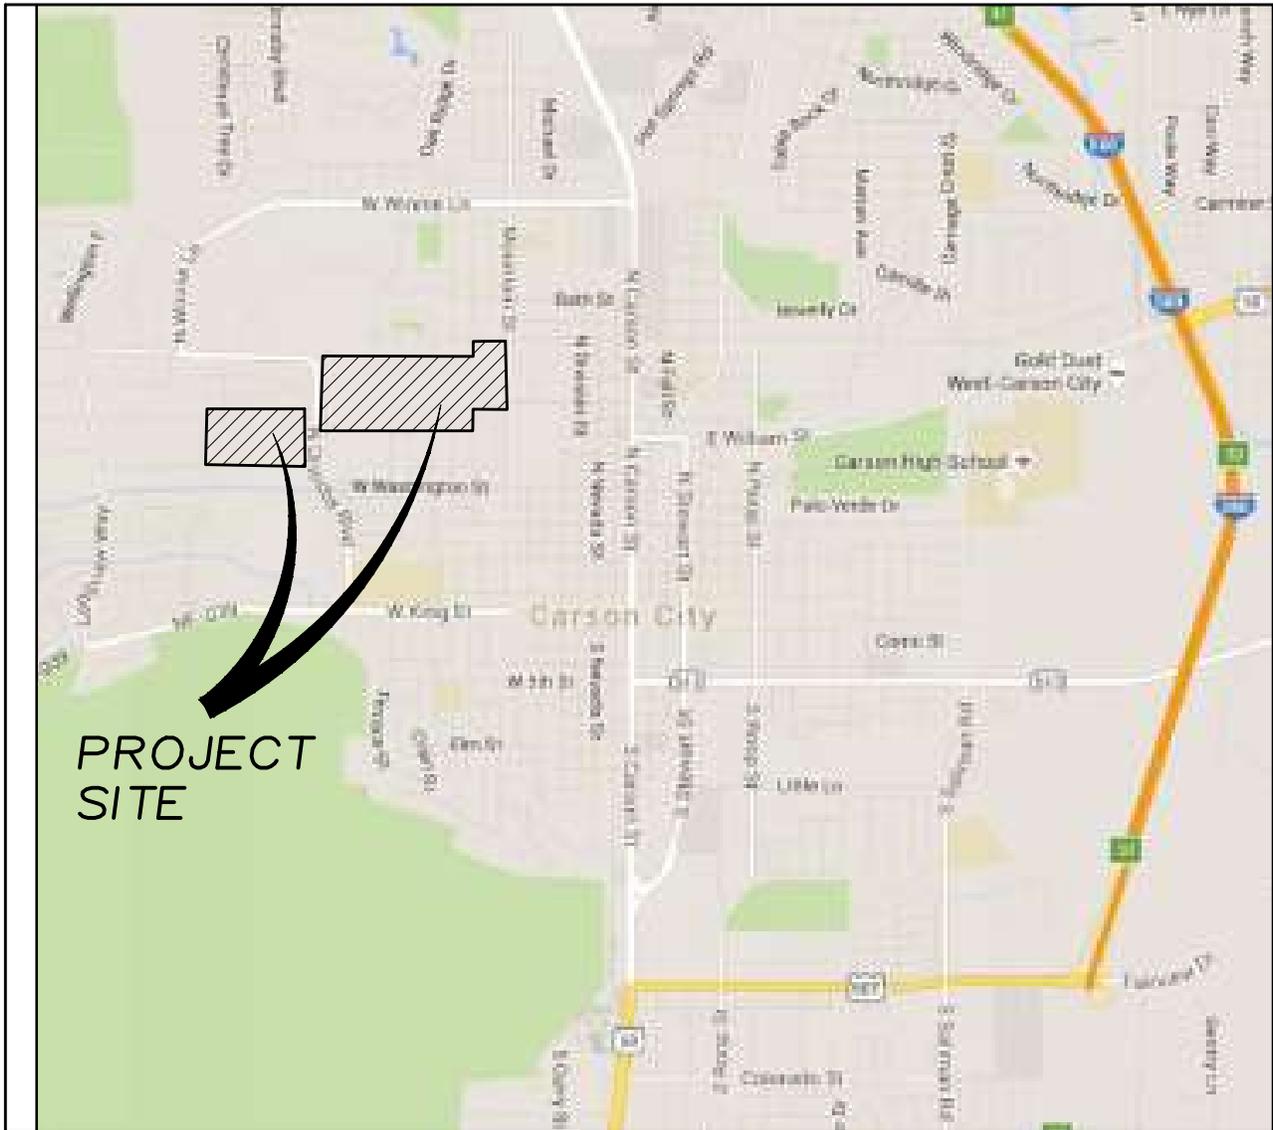
Date: May 2016
Scale: N.T.S.
Job No: 8947.000
PLATE 1

**PROJECT
SITE**

Submitted herewith are the results of Lumos and Associates, Inc. (Lumos) geotechnical investigation for the proposed Vintage at King's Canyon project to be located in Carson City, Nevada. North Ormsby Boulevard bisects the site. The western portion of the site (approximately 25 acres in size) is located in the northwest quarter of section 18, township 15 north, range 20 east and is bounded by residential developments to the north and west, agricultural fields to the south, and North Ormsby Boulevard to the east. The eastern portion of the site (approximately 50 acres in size) is located in the north half of section 18 and the south half of section 7, township 15 north, range 20 east and is partially bounded by residential developments and agricultural fields to the north and south, is bounded on the west by North Ormsby Boulevard, and is bounded on the east by Mountain Street (refer to Plate 1).

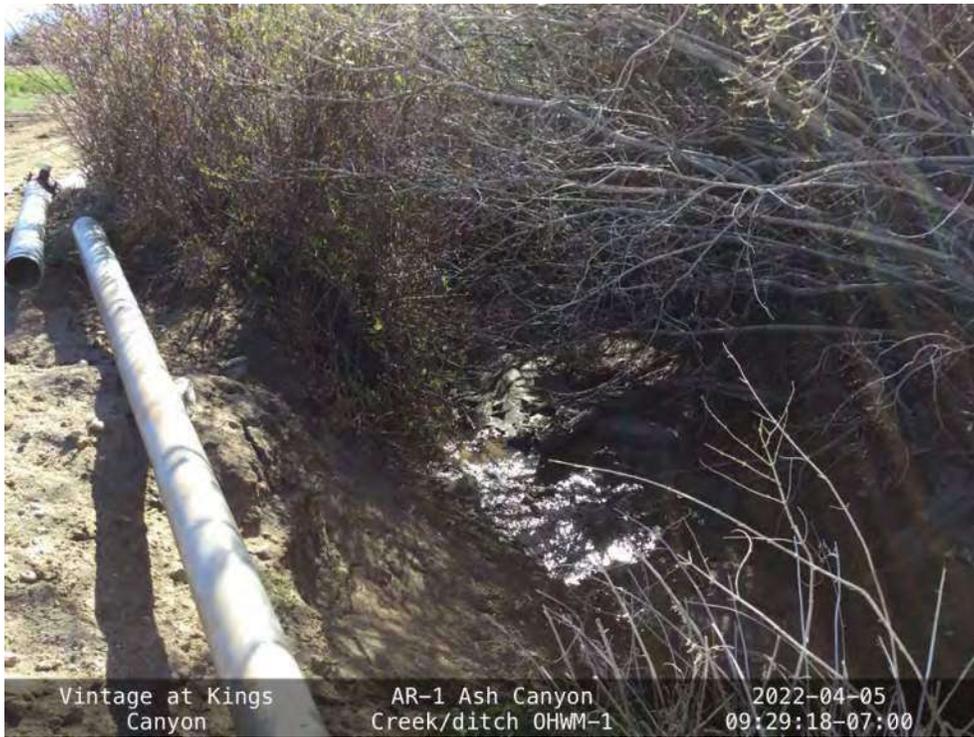
Photo 5. OHWM-1: picture showing approximately 2-4 inches of water in Ash Canyon Creek (AR-1). Exposed/partially excavated left bank with disconnected irrigation line. View looking southeast.

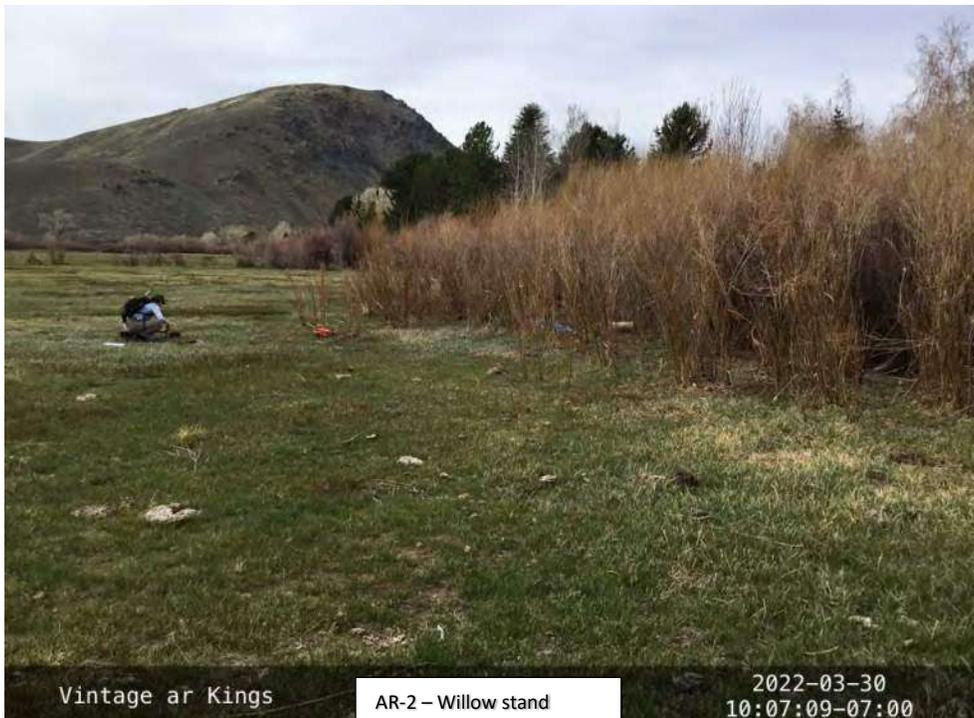
Photo 6. AR-2: Irrigation ditch running along the western boundary of Survey Area, flows south to north then terminates at northwest corner. Water from AR-2 flood irrigates pasture visible in picture. View looking south.

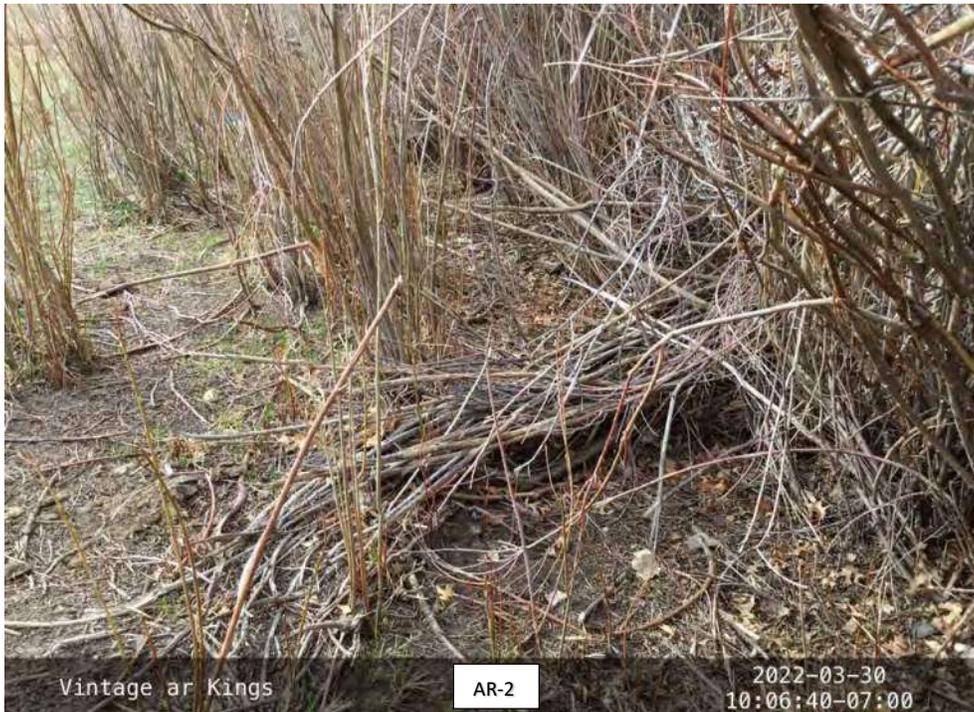
Photo 7. OHWM-2: AR-2 irrigation ditch at western boundary of Survey Area. Thick willow obscuring view of channel. Average channel width approximately 5 feet. View looking southwest.

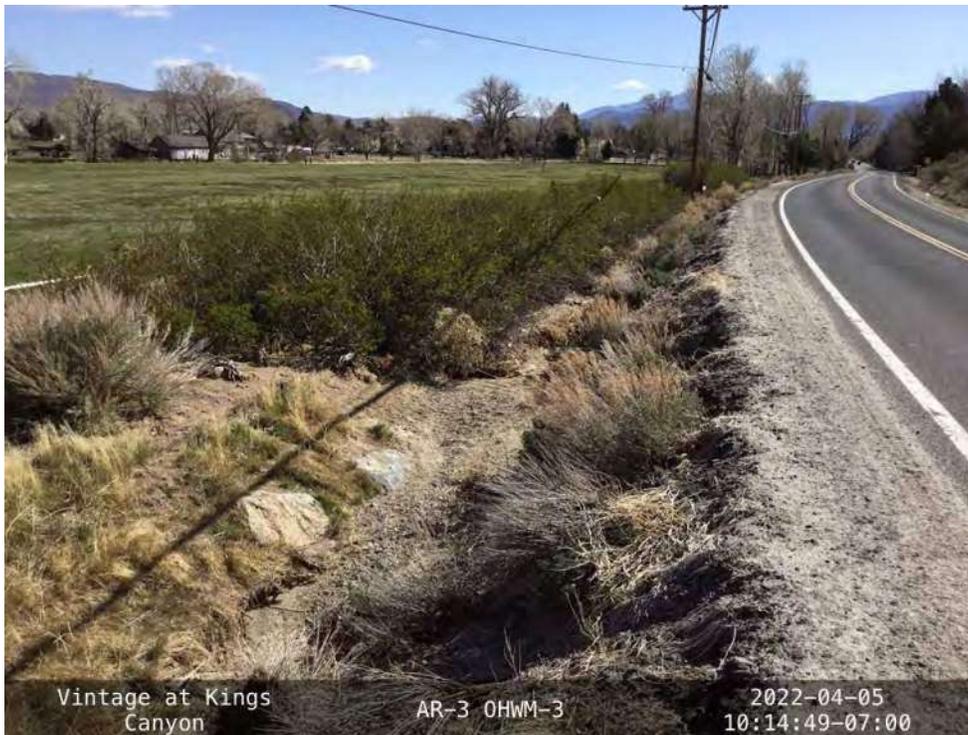
Photo 8. OHWM-3: AR-3 excavated roadside ditch capturing storm water from road. When present, water flow from west to east into storm drain at southeast corner of Survey Area. View looking east.

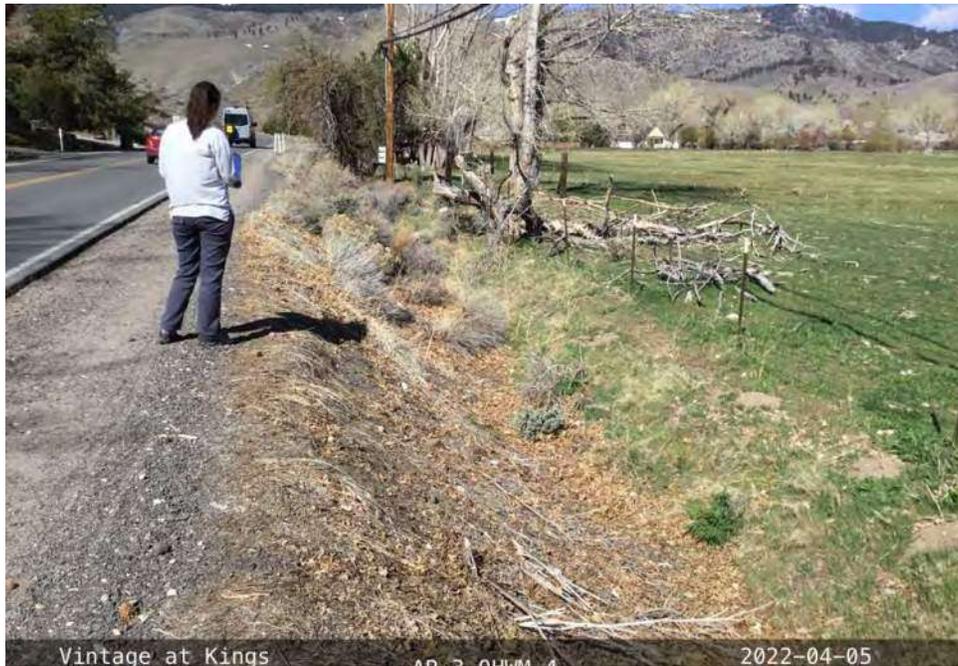
Photo 9. OHWM-4: AR-3 excavated roadside ditch at eastern end when some overland flow from irrigated pasture may intermittently be entering ditch. View looking west.

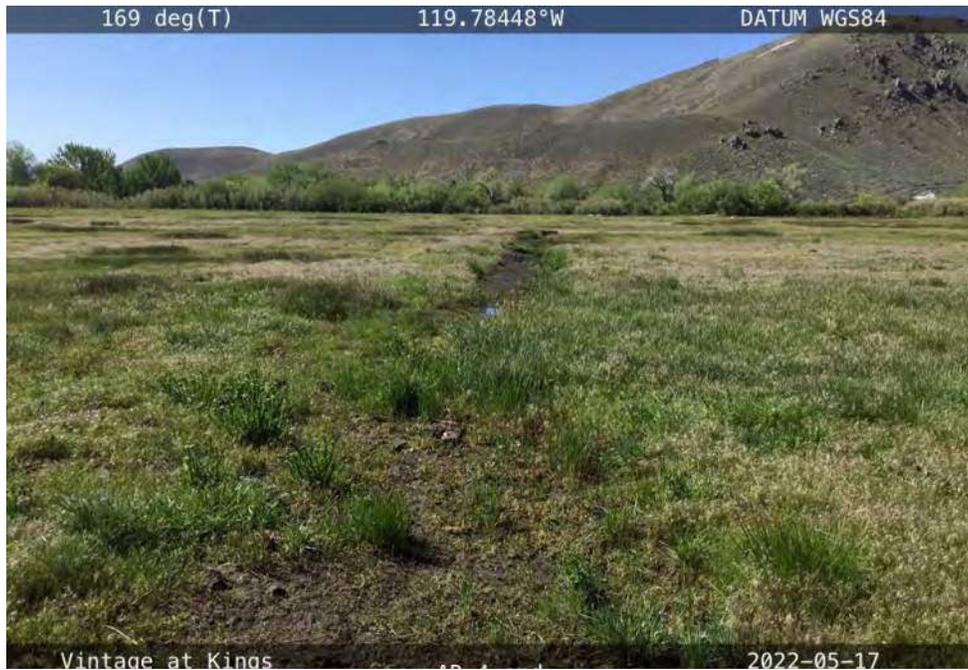
Photo 11. AR-4b: Older excavated irrigation ditch no longer conveying water, only capturing sheet flow from northwestern half of pasture when irrigated. View looking south.

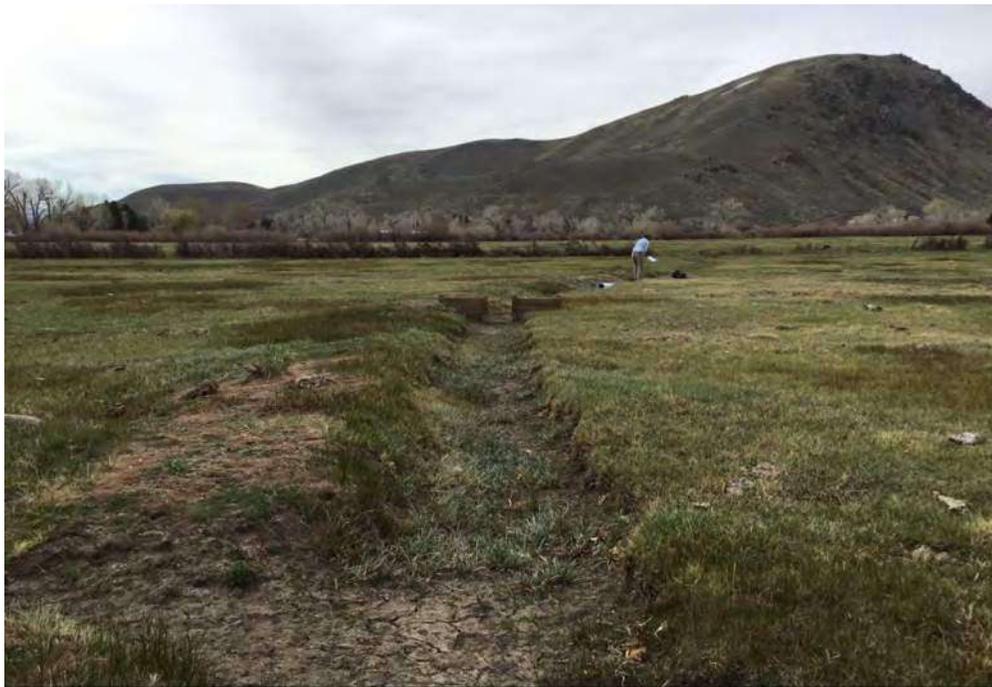
Photo 12. AR-4a: Southern end of AR-4 excavated irrigation ditch. Old irrigation ditch capturing sheet flow across pasture. Small weir visible in picture no longer operating. View looking south.
