STAFF REPORT

Agenda Title: For Discussion Only: Review and discussion of the Prison Hill OHV Area Monitoring Report, and updates on the Prison Hill OHV Area. (*Lyndsey Boyer and Gregg Berggren*)

Carson City Open Space – Conservation Easement Monitoring

Prison Hill OHV Area – Monitoring Report

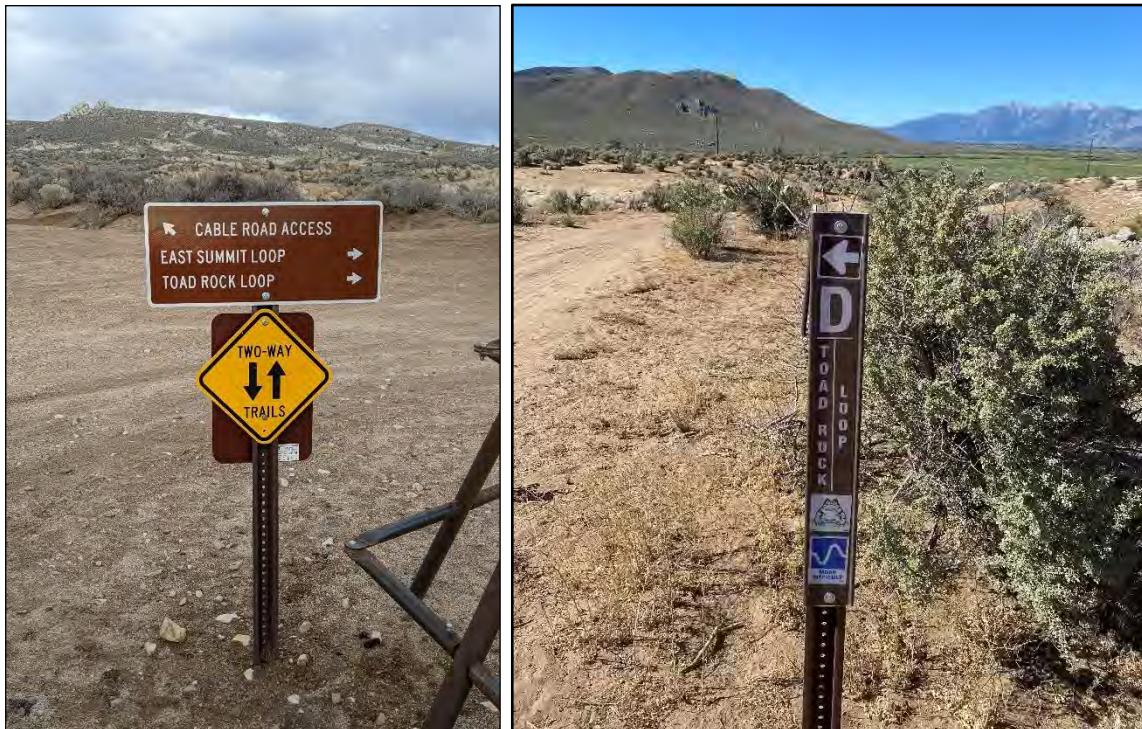
(A) Several new wayfinding signs have been installed, particularly at trail junctions with Toad Rock Loop, East Summit Loop, and West Summit Loop by Trails Coordinator, Gregg Berggren, and Nevada Off-Highway Vehicle Commission interns.

(2A) Photo Point: The photo of the new wayfinding signage at trail junctions.

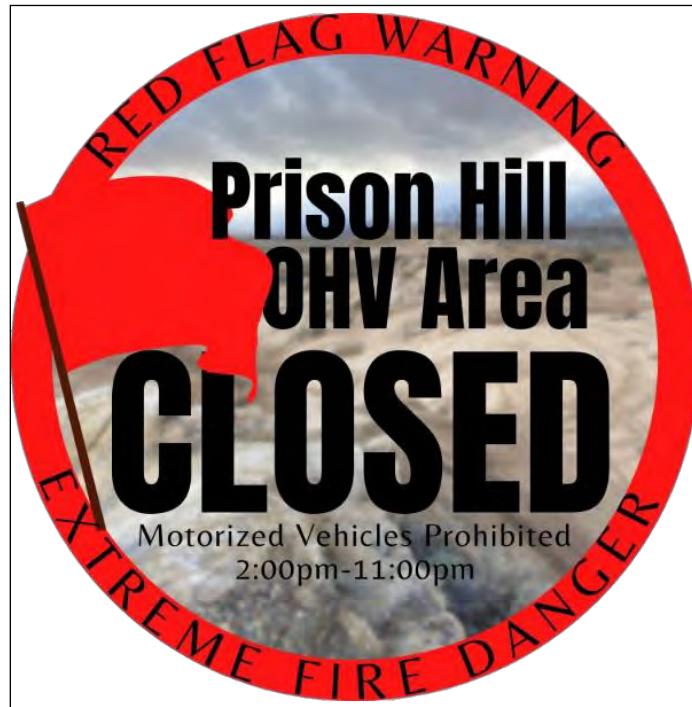
(2B) Photo Point: The photo shows the new flyer for red flag warning days.

(B) Since June of 2021, Carson City has closed the OHV area at PHRA during red flag warning days (e.g. winds greater than 15 mph, relative humidity less than or equal to 25%, and temperature greater than 75 degrees). Park Ranger, Tyler Kerver, designed a new flyer that is posted to the website to notify visitors.

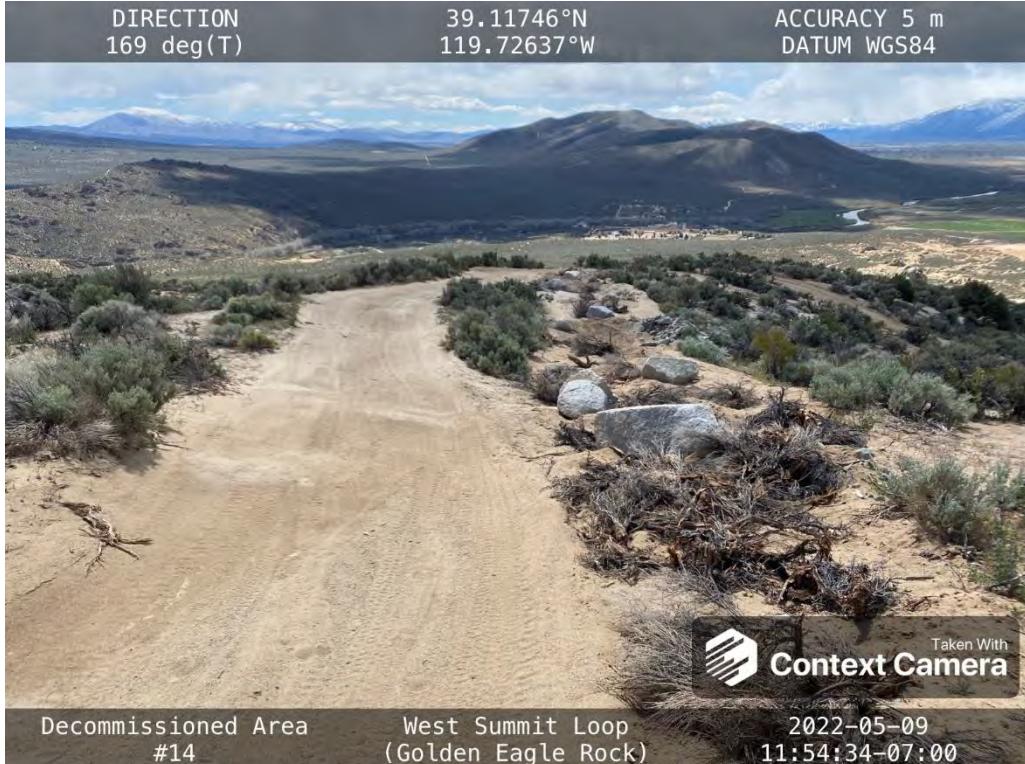
2022 Condition, Post-Construction

(3A) Photo Point: The photo shows former erosion on West Summit Loop near Golden Eagle Rock that was decommissioned to prevent further erosion and make the road narrower.

- (A) West Summit Loop – closure/rehabilitation, route reconstruction, and new route construction to create a continuous and sustainable trail.
- (B) Mailbox Canyon and Once is Enough – closure/rehabilitation of certain specific locations to support sustainability.
- (C) Gunslinger and Death Walls – filter installation in challenging wheeler routes.
- (D) Toad Rock Loop – route reconstruction, new route construction, and some closure/rehabilitation to create a new continuous and sustainable loop trail.

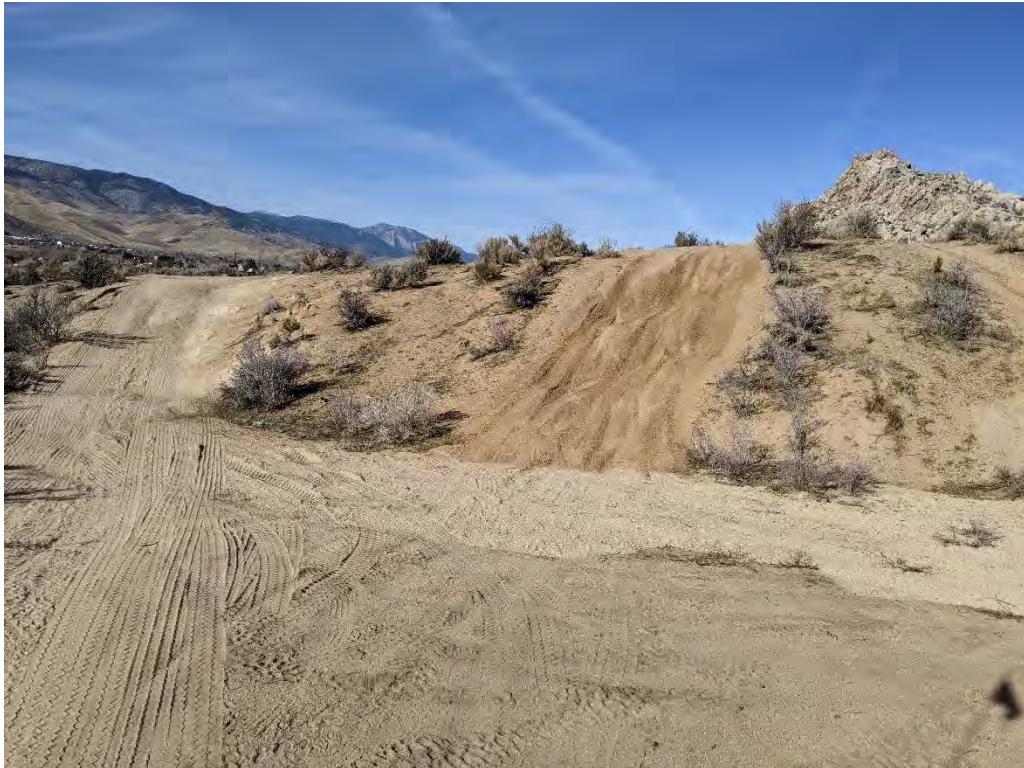
(3B-1) Photo Point: The photo shows the decommission and rehabilitation of spur roads at Mailbox Canyon (View West).

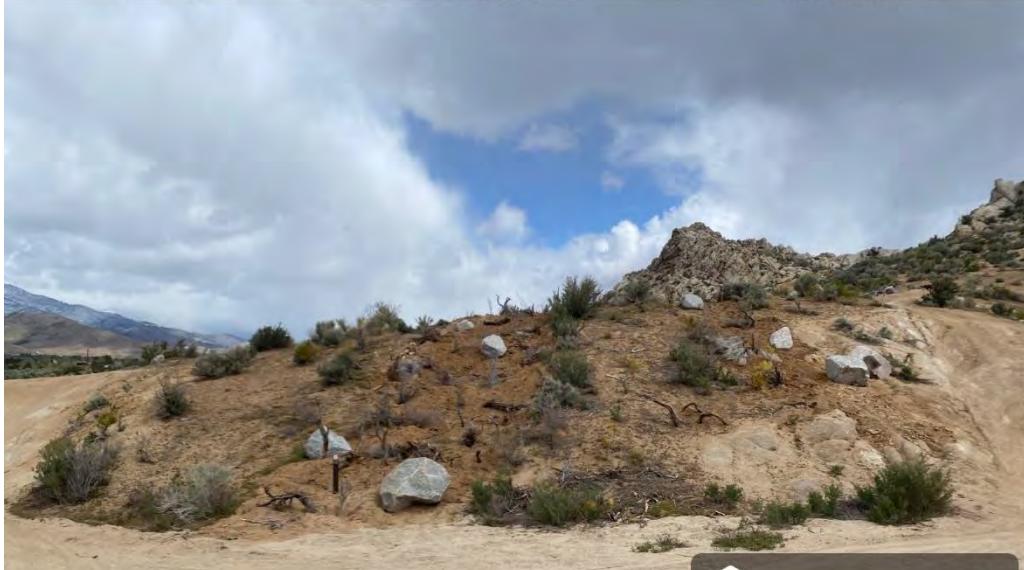
2022 Condition, Post-Construction

Decommissioned Area
#9

Mailbox Canyon (West)

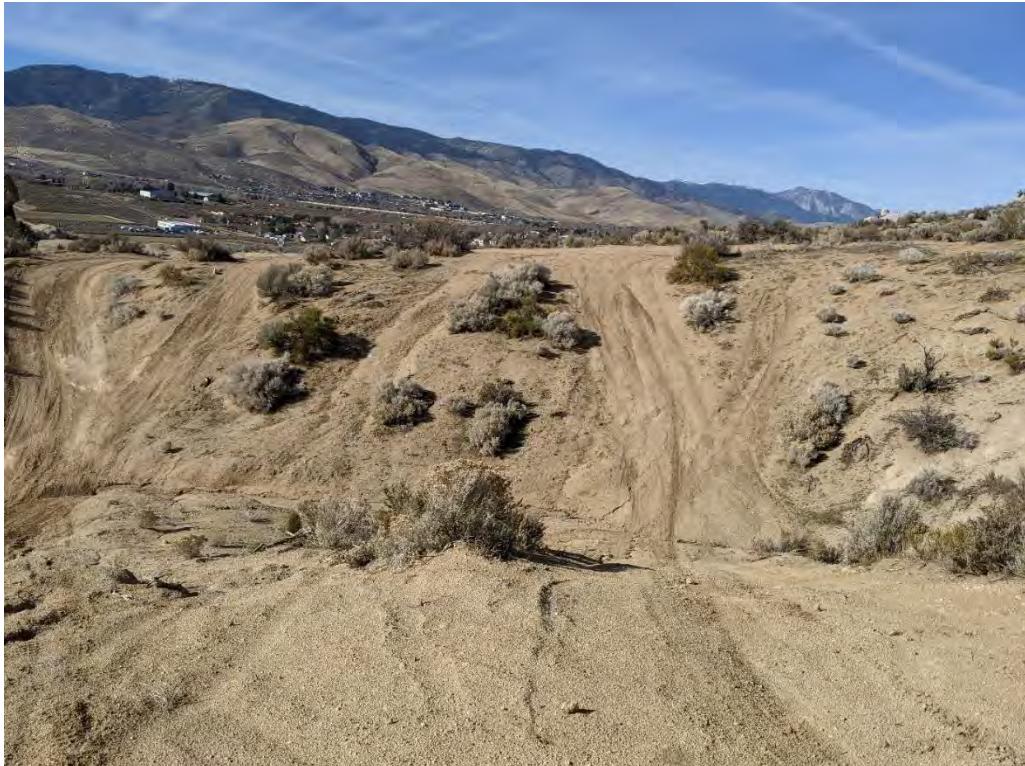
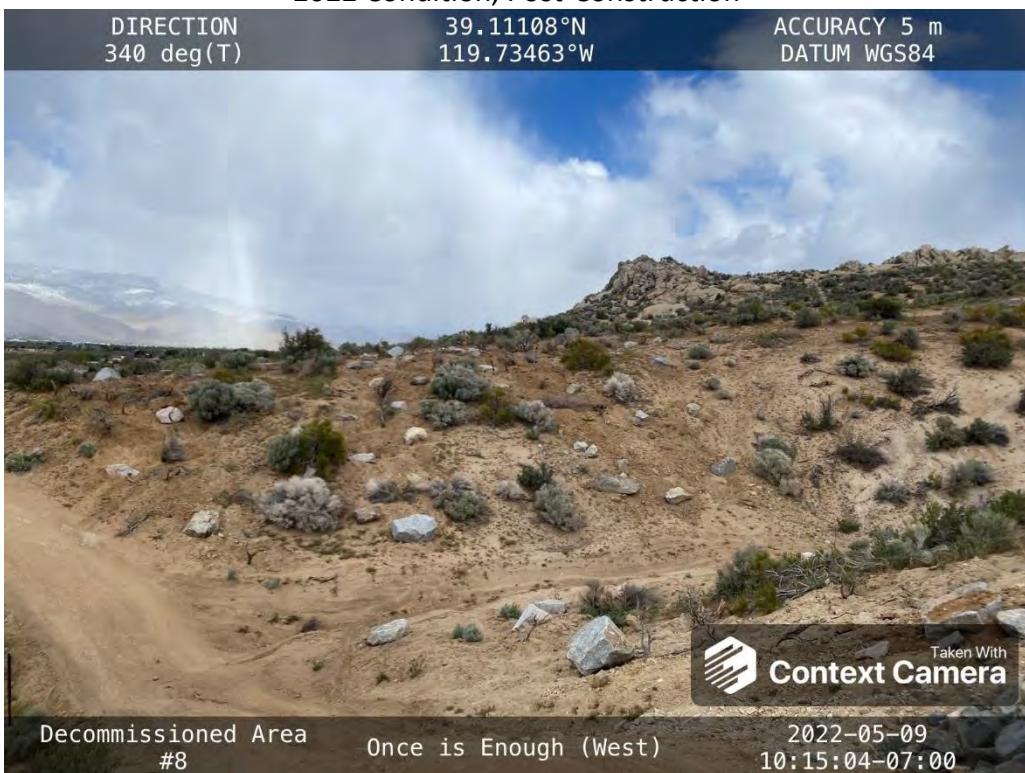
(3B-2) Photo Point: The photo shows decommissioned and rehabilitated spur roads at Once is Enough (View West).

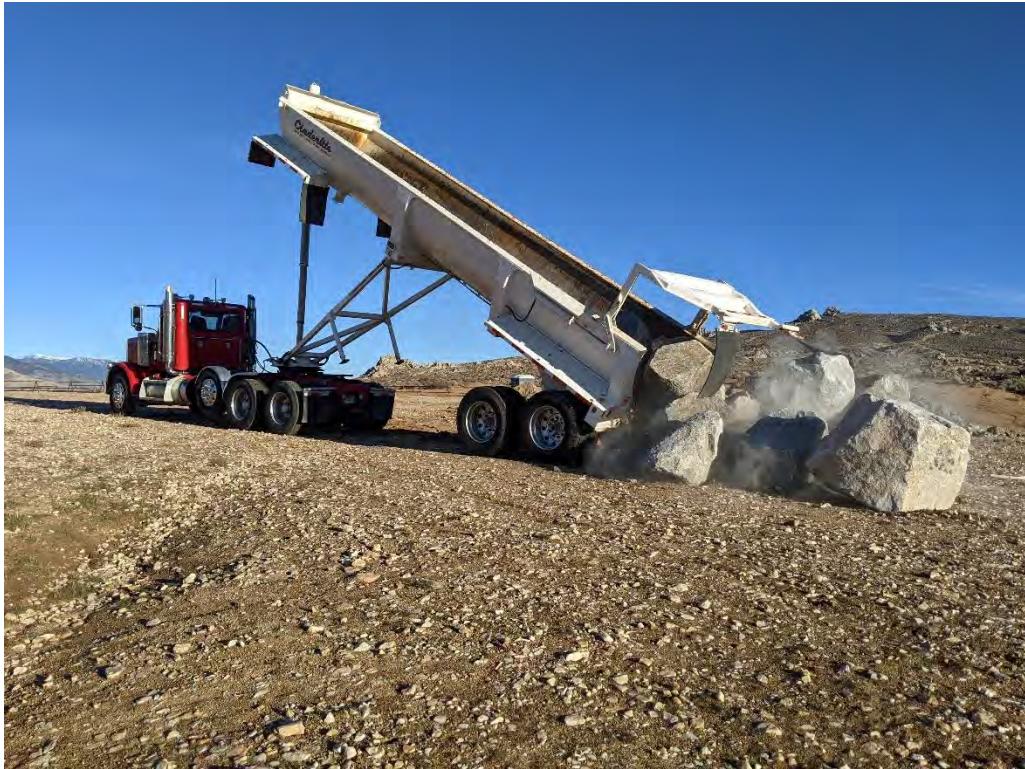
(3C-1) Photo Point: The photos show necessary materials and equipment for construction of filters in November, 2021.

November 12, 2021 -- Rocks being delivered to Staging Area

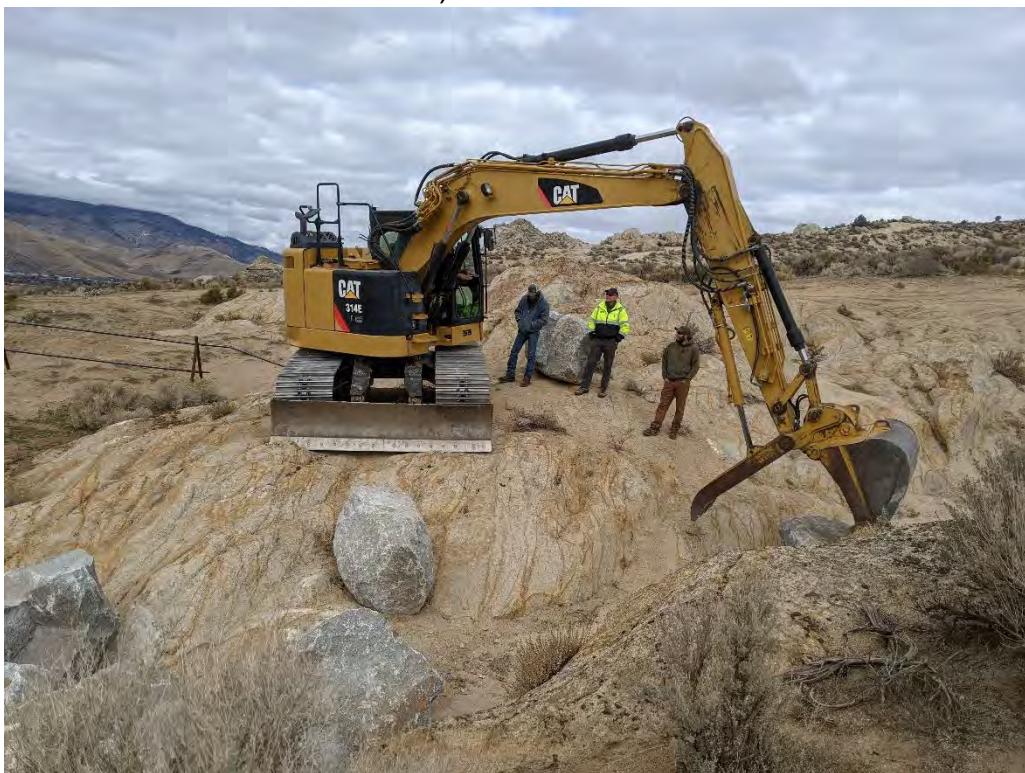
November 20, 2021 – Filter Installation

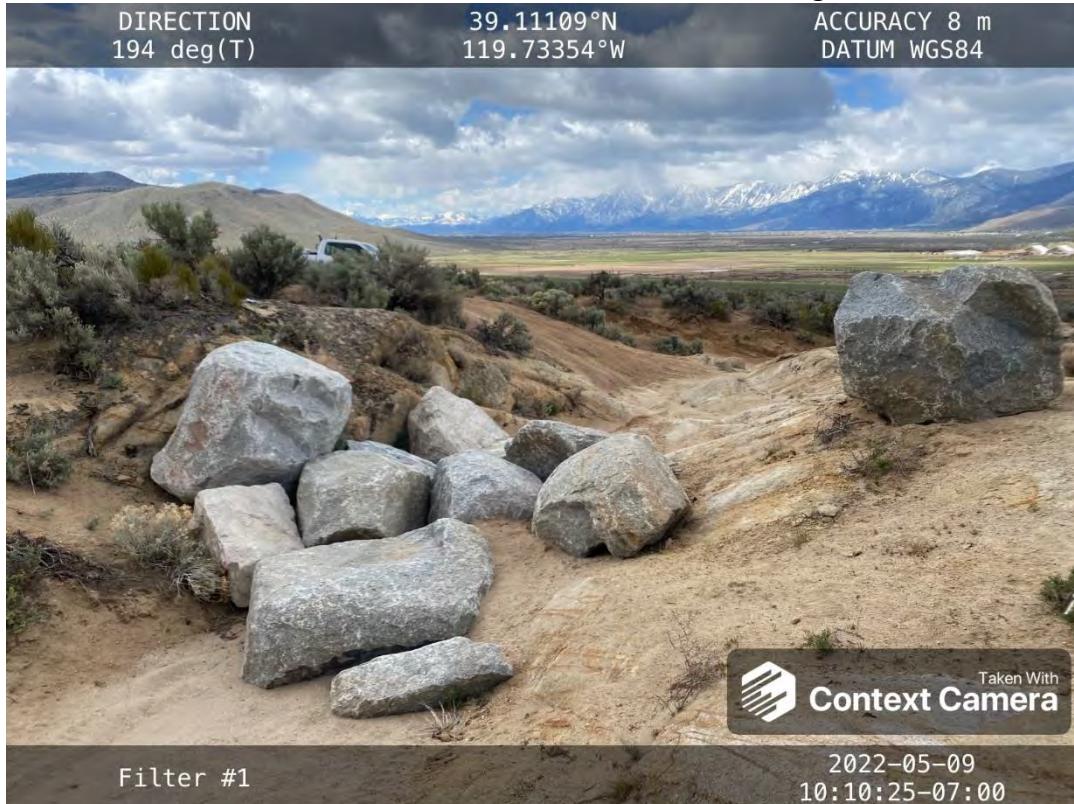
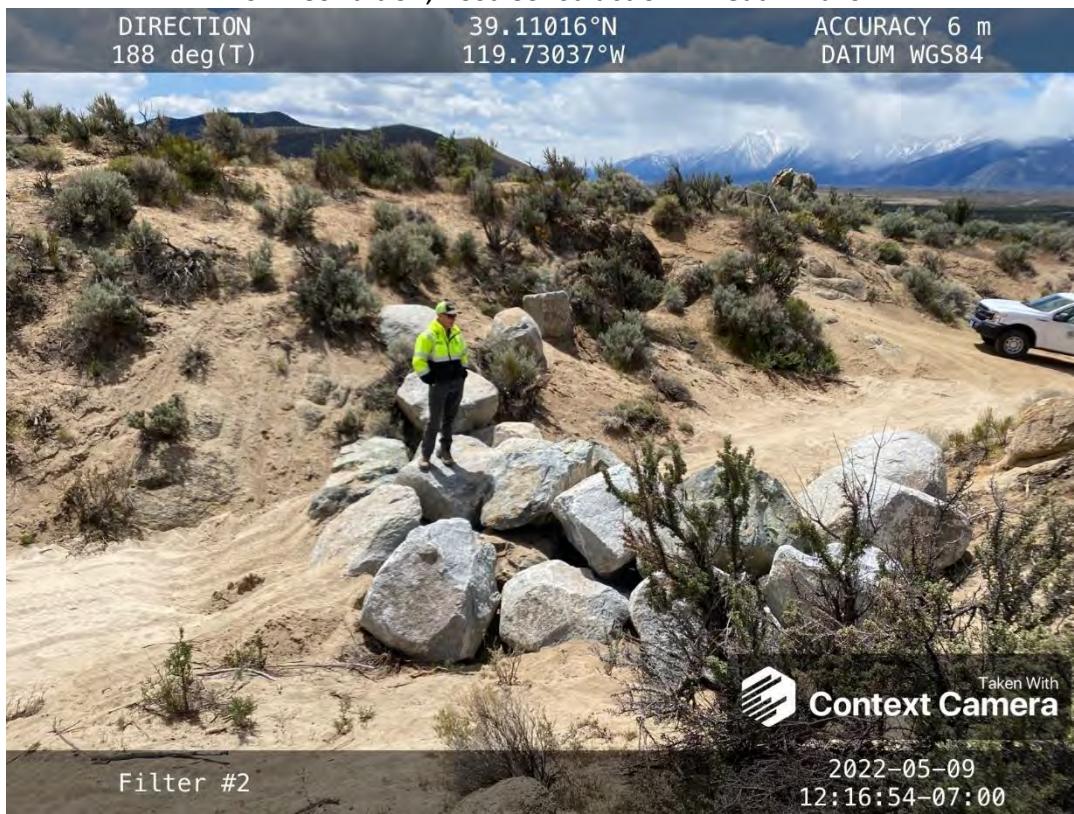
(3C-2) Photo Point: The photos show the two completed filters post-construction in 2022.

2022 Condition, Post-Construction – Gunslinger

2022 Condition, Post-Construction – Death Walls

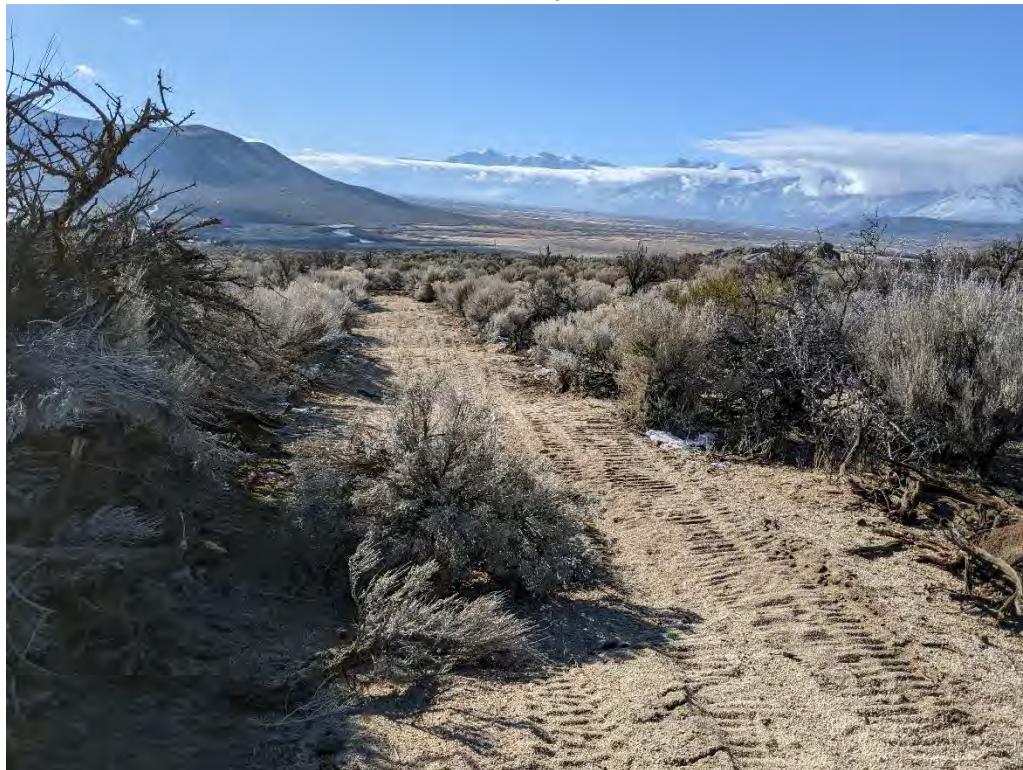
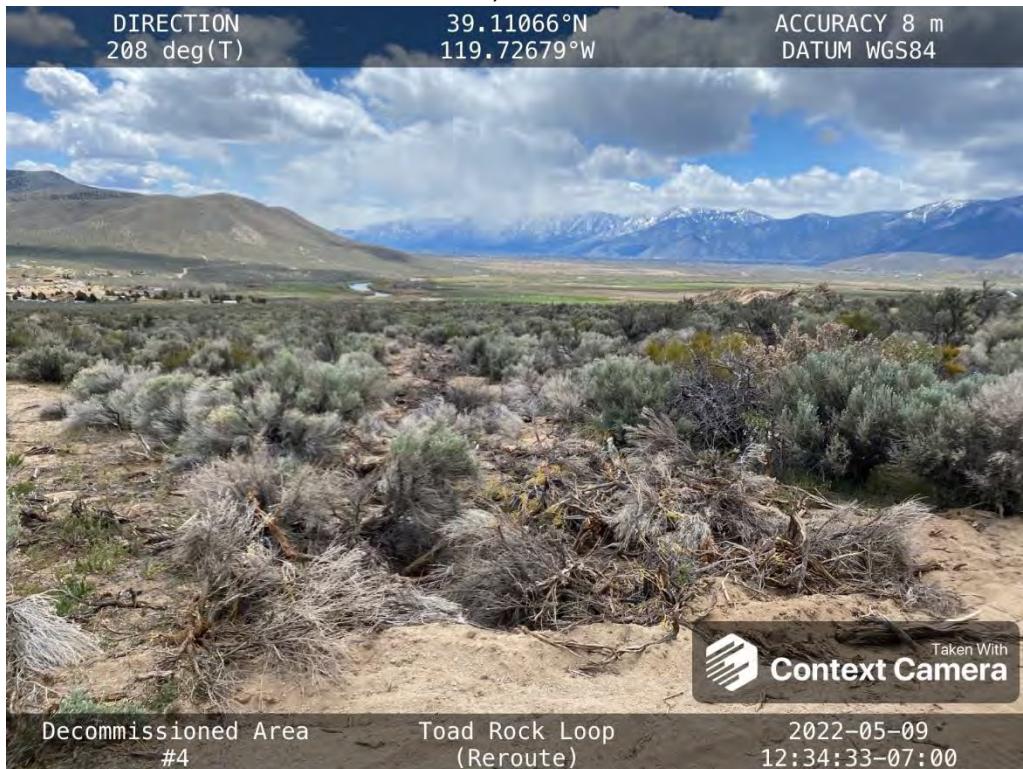
(3D-1) Photo Point: The photo shows a decommissioned fall-line road to reroute Toad Rock Loop (View South).

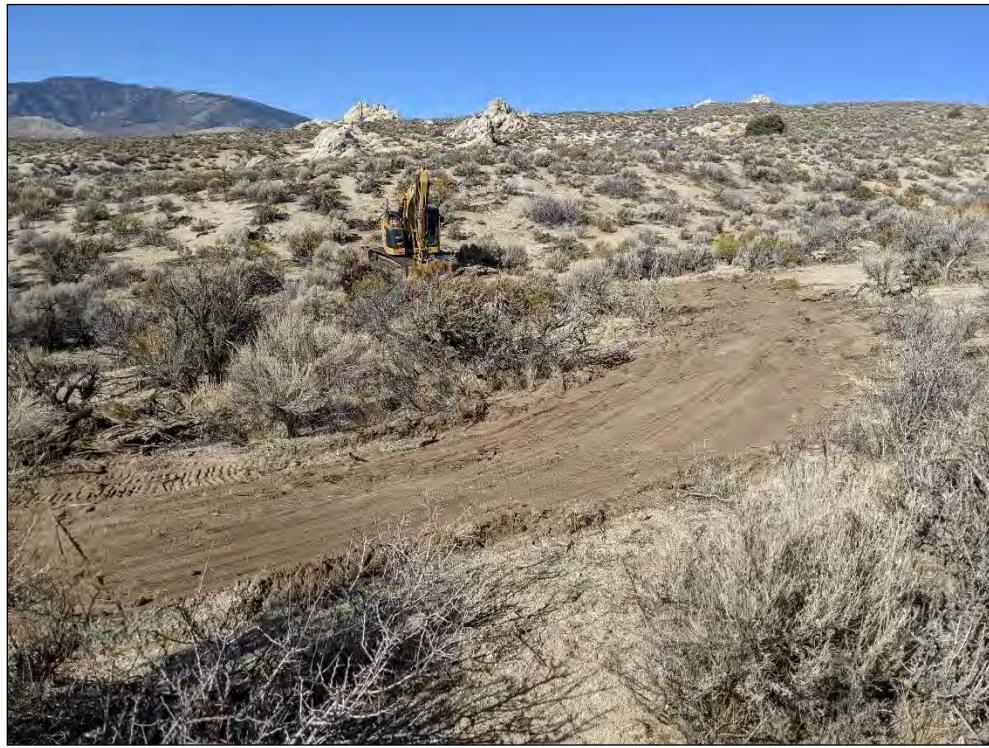
(3D-2) Photo Point: The photo shows the construction of a new segment of route for Toad Rock Loop, making the road more sinuous.

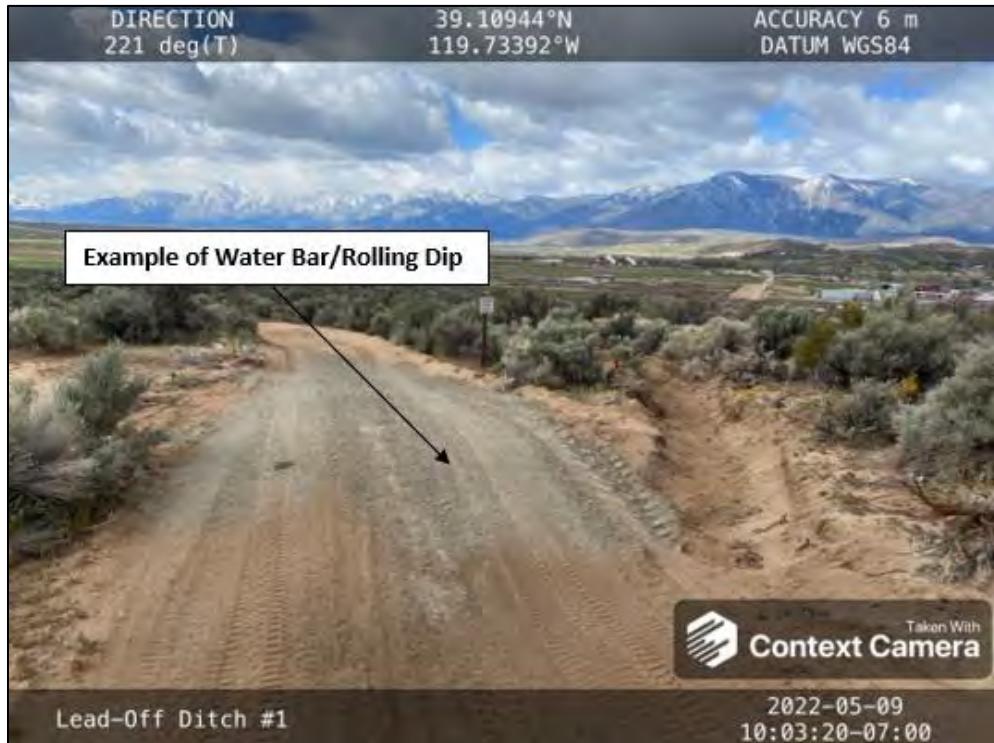
(3E) Photo Point: The photo shows an example of constructed lead off ditches and rolling dips using finer rock “reject” material to manage high flows during precipitation events.

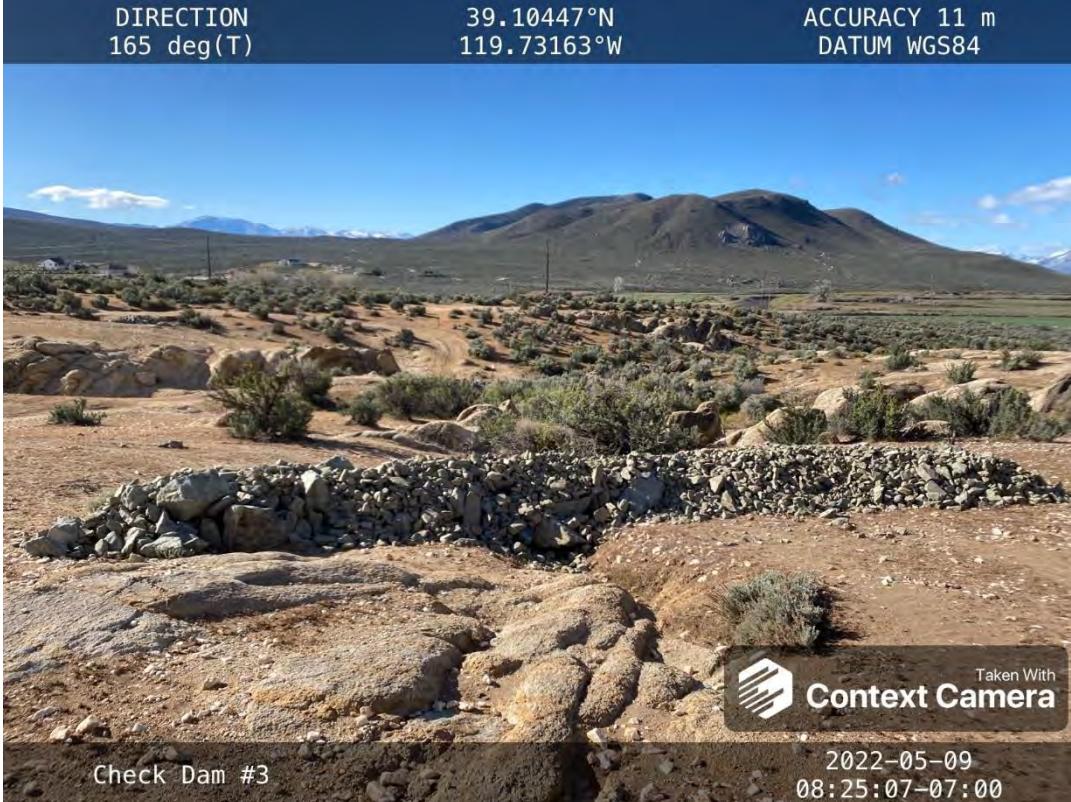
- (E) Lead-Off Ditch and Rolling Dip – example to show constructed lead-off ditches and rolling dips.
- (F) Check Dams – using Class 300 and Class 900 rock, check dams were built to slow flow in drainages and at trail intersections.

(3F) Photo Point: The photos show examples of two out of the 50 check dams installed.

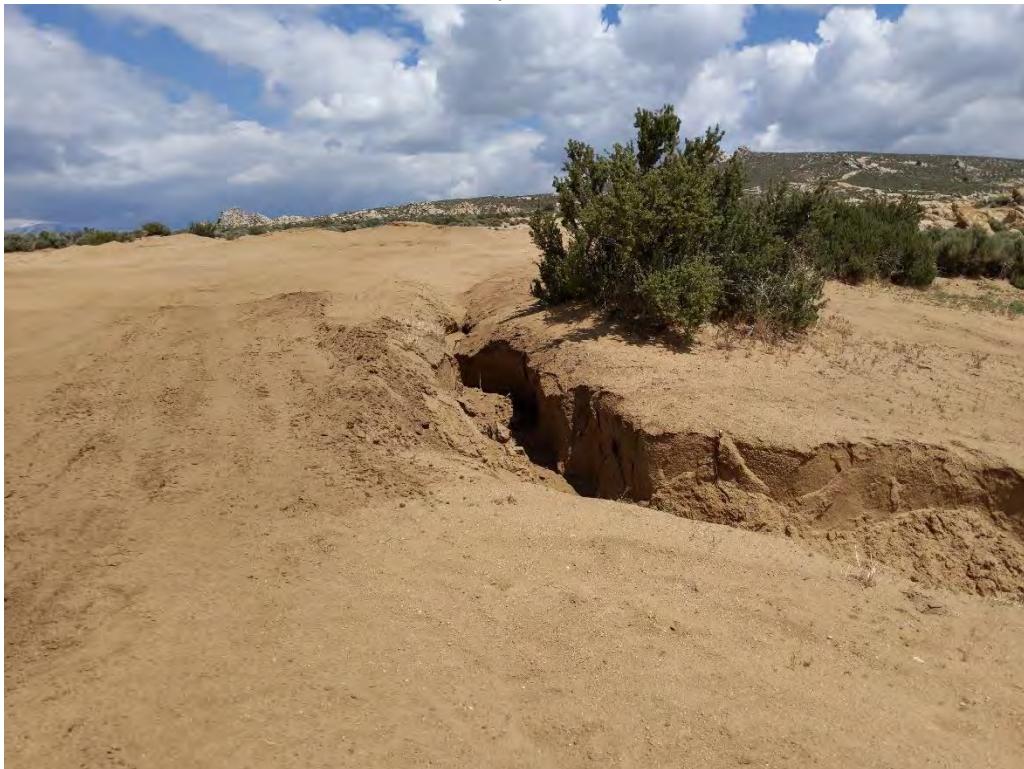
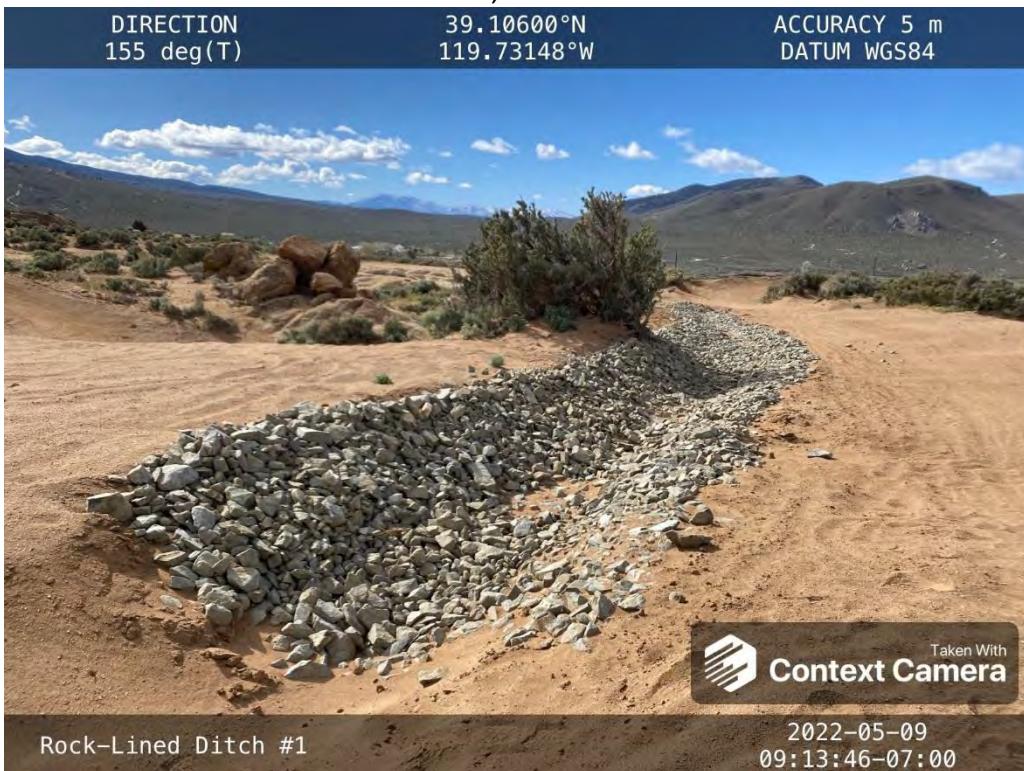
(4A) Photo Point: Photo of gully at the base of Center Road (near the Staging Area) that was lined with rocks to prevent future erosion.

Major gullies that were formed during storm events were regraded and lined with permeable rock to prevent erosion from occurring in future large rainfall events. In addition, fifty check dams were installed in various drainages to slow sediment runoff. Lastly, the berms that were built up and compacted with sand in the motocross (MX) sand-track area act as natural earthen containment basins to catch water and sand during winter weather.

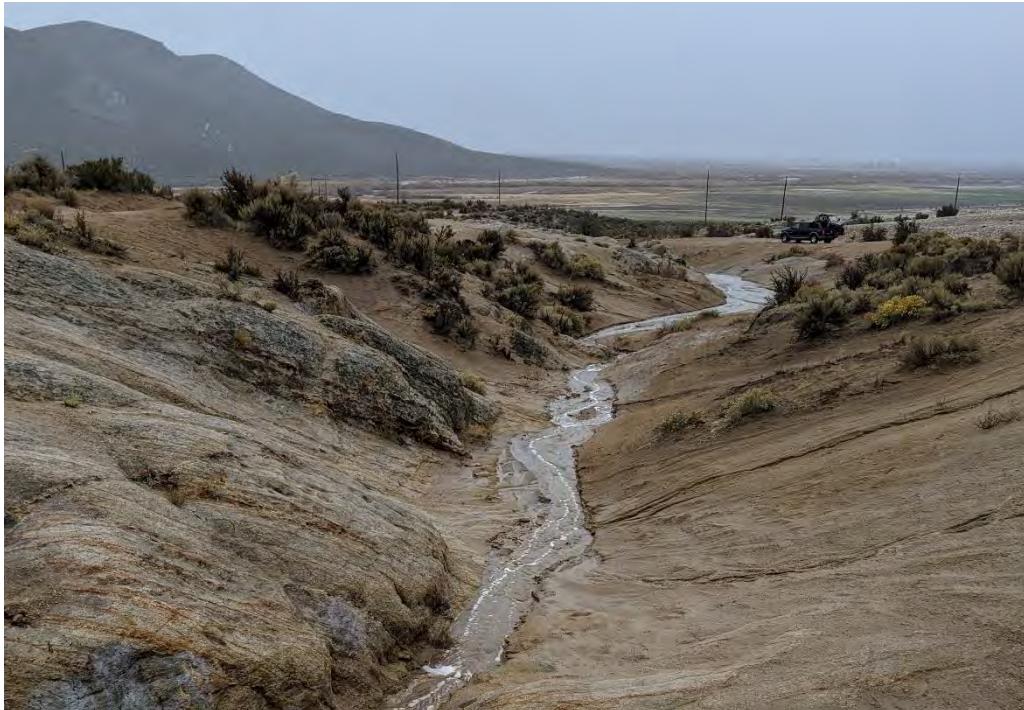
(4B) Photo Point: Photo of erosion and sediment runoff during a 2021 storm event that will be slowed in future weather with the installation of check dams.

2021 Condition, Pre-Construction – Winter storm runoff

2022 Condition, Post-Construction – New check dam to slow flows

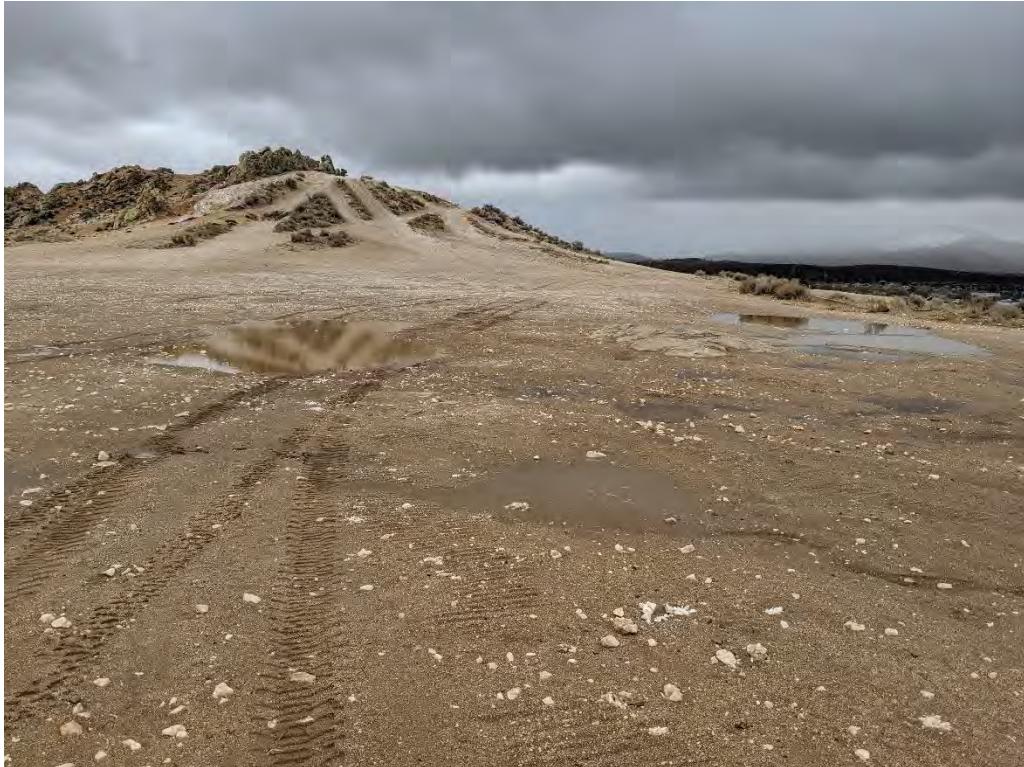
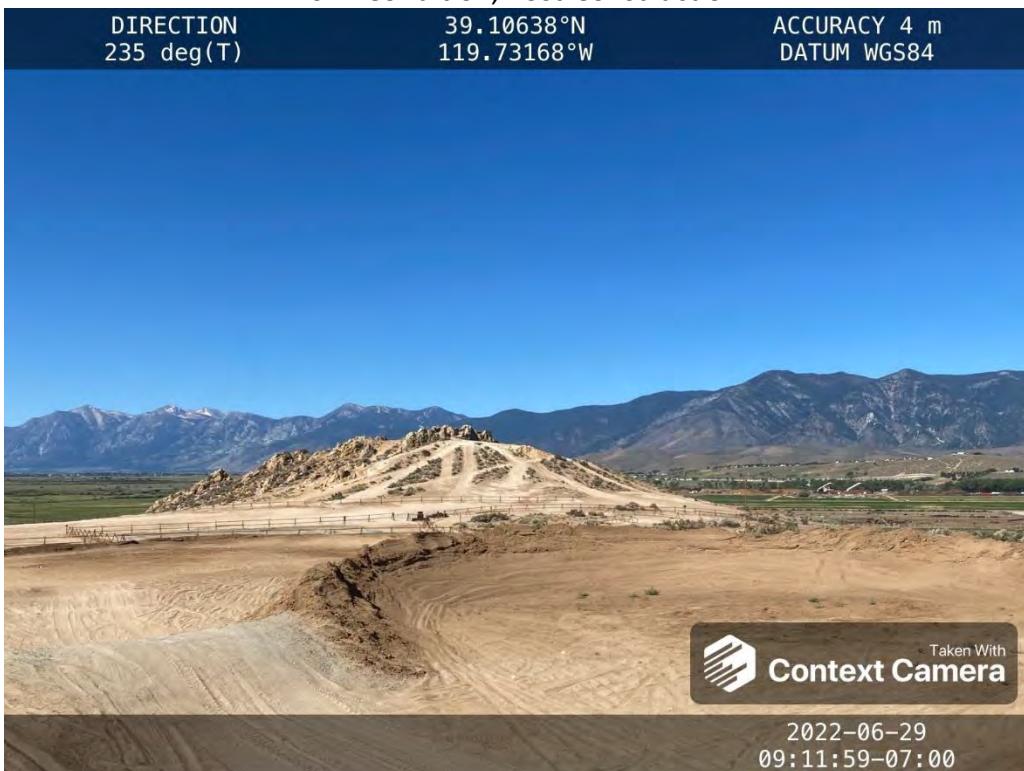
(4C) Photo Point: Photo of the motocross (MX) sand-track area just uphill of the Staging Area that has improved bank turns which created earthen containment basins to further catch erosional sedimentation into the Tot Lot, Beginner Area, and Staging Area.

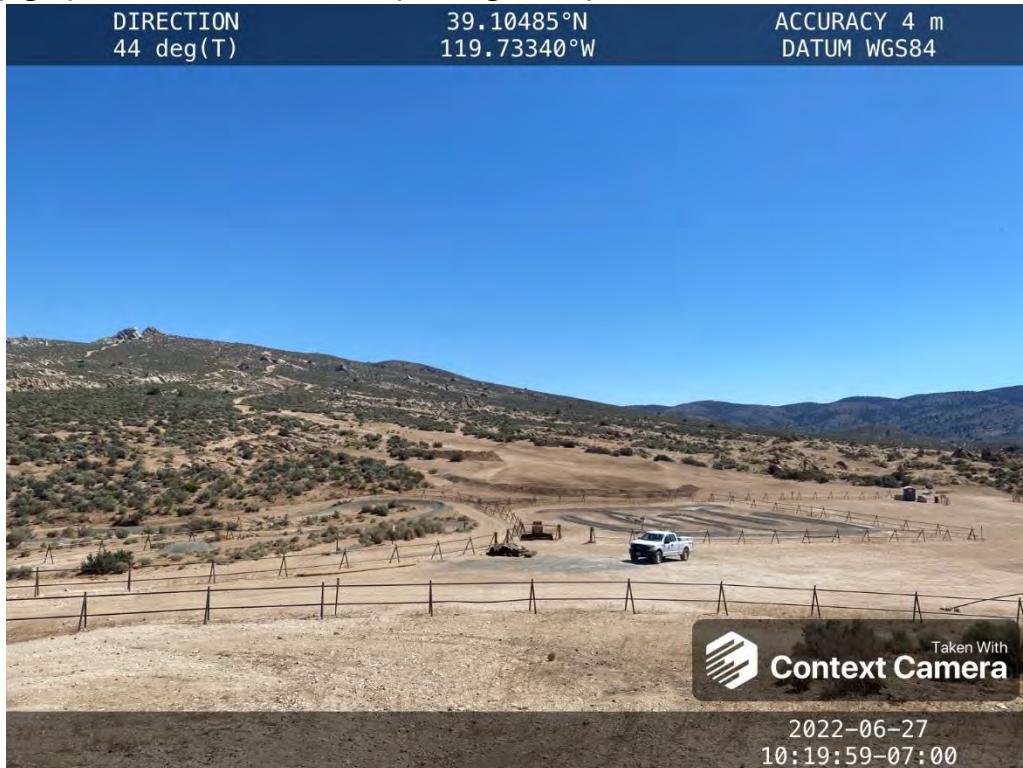
(8A-1) Photo Point: The photo shows the finished construction of the Beginner Area (left) and Tot Lot (right) shown from a distance (looking North).

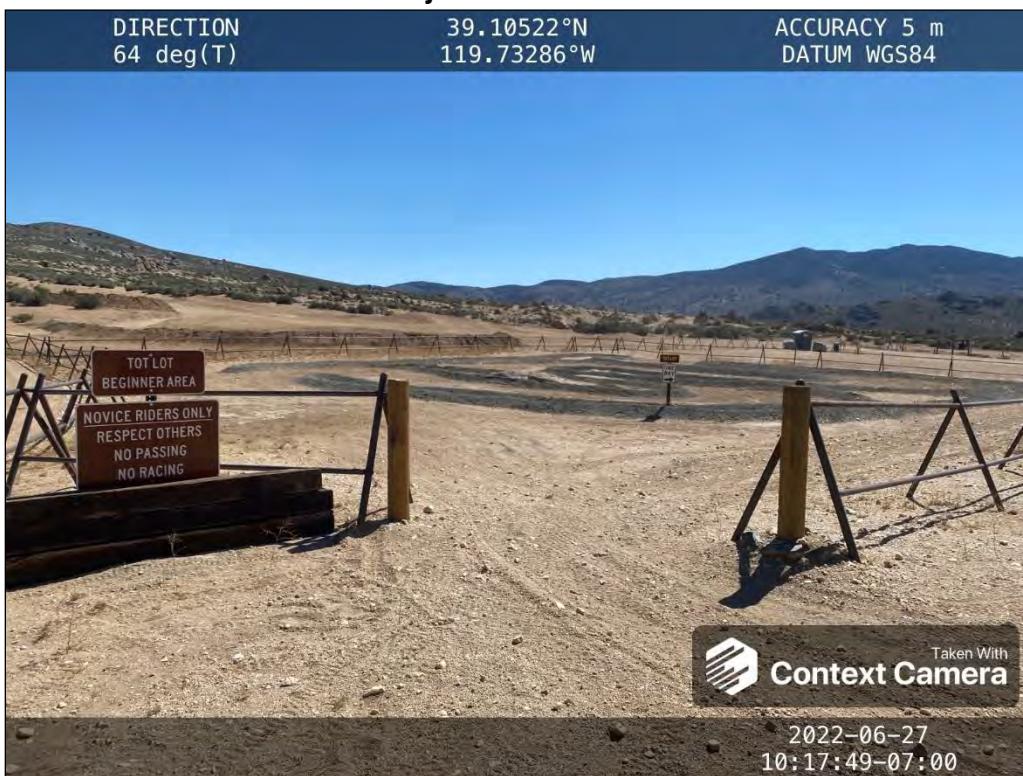
(8A-2) Photo Point: The photo shows a close-up view of the Tot Lot, with improved signage and reinforced tracks with finer rock “reject” material.

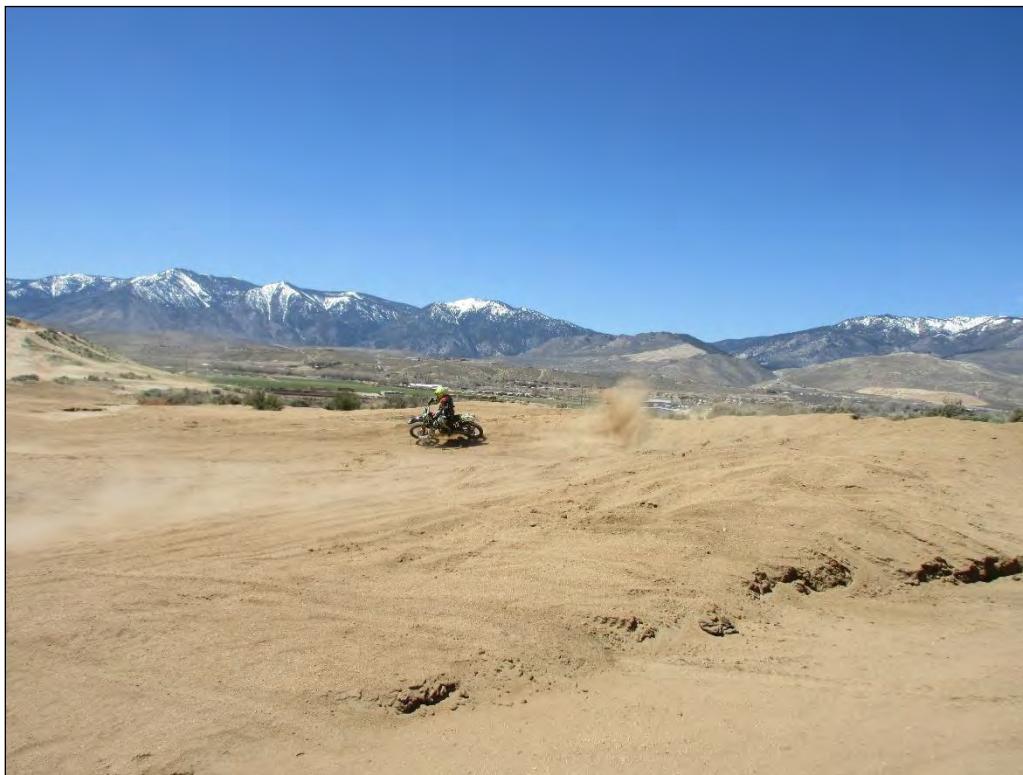
(8B-1) Photo Point: The photo shows motorcyclists using the berms when they were initially constructed in 2021.

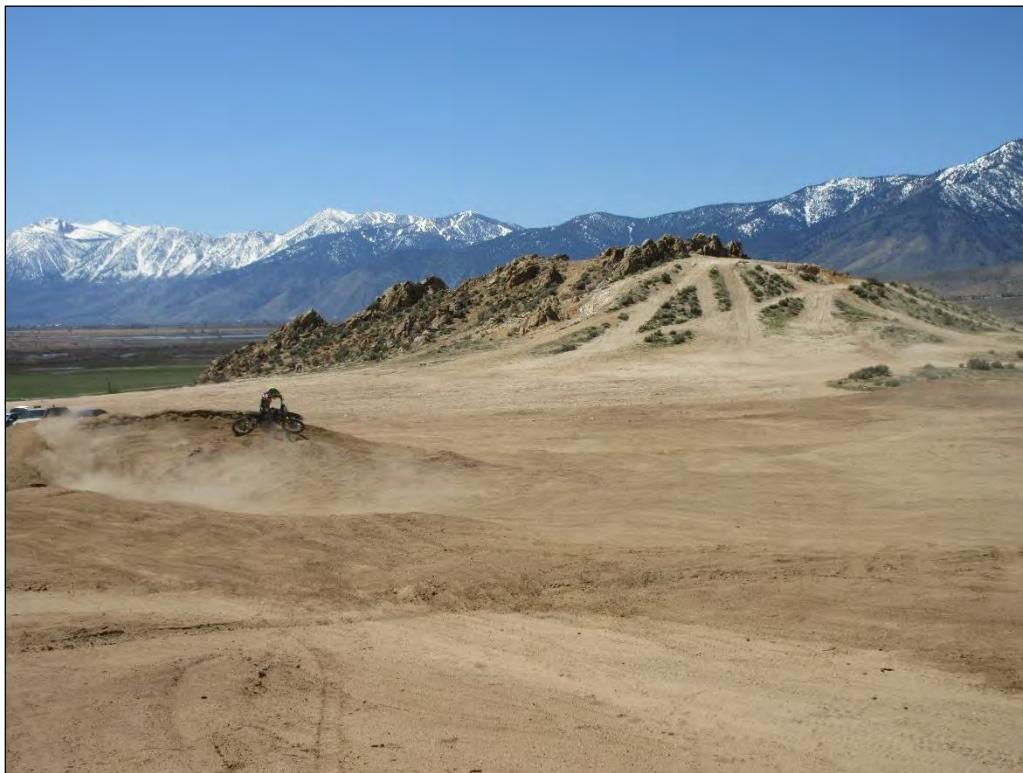
(8B-2) Photo Point: Another berm now exists to the right of the motorcyclist pictured, which enjoy riding the high turns.

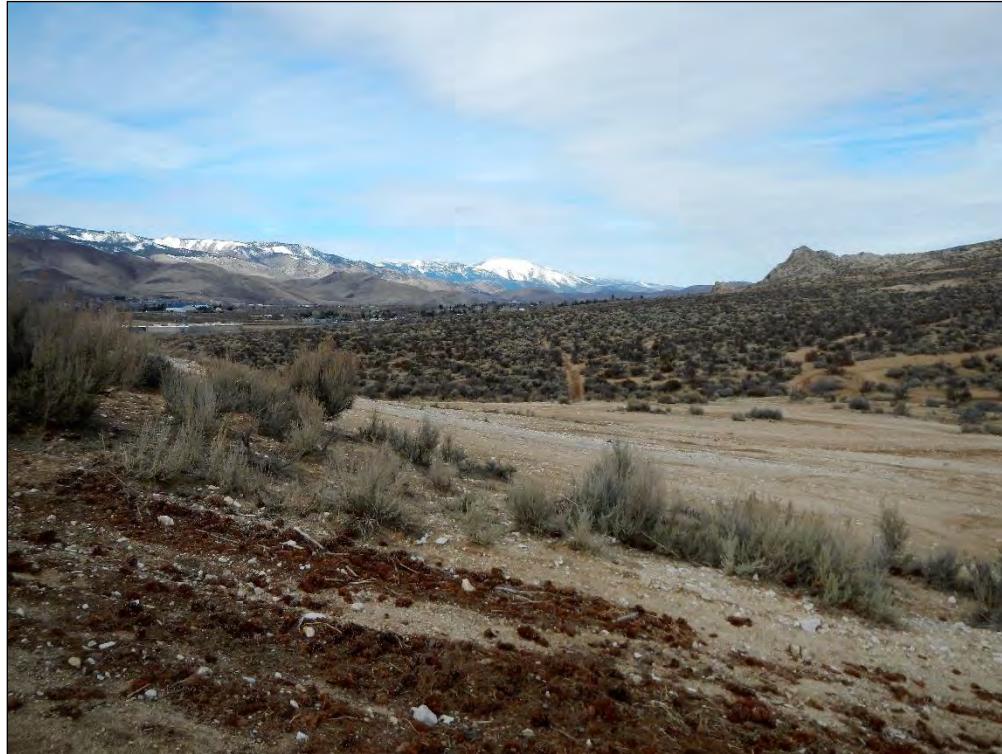
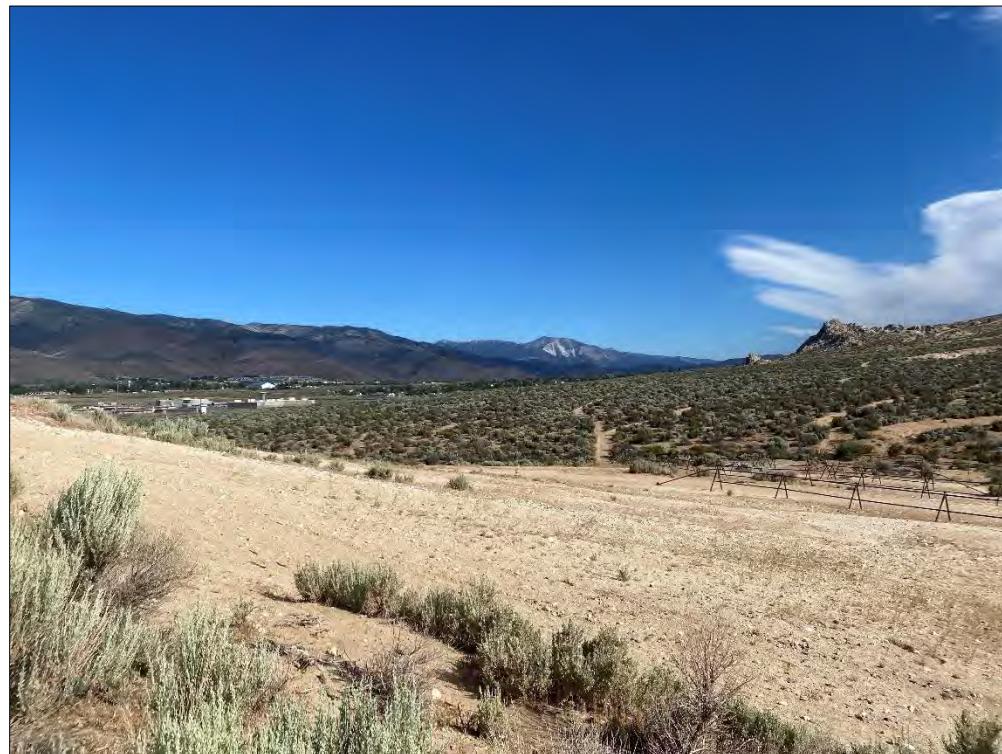
Photo Point 1B (view northwest): A photo point located at the boundary of the staging area.

2020 Baseline Condition, photo taken January 24, 2020:
(GPS coordinates: 39.104745, -119.733277)

2022 Condition, photo taken June 17, 2022
