STAFF REPORT

Agenda Title: For Discussion Only: Review and discussion of the Prison Hill OHV Area Monitoring Report, and updates on the Prison Hill OHV Area. (*Lyndsey Boyer and Gregg Berggren*)

Carson City Open Space – Conservation Easement Monitoring

Prison Hill OHV Area – Monitoring Report

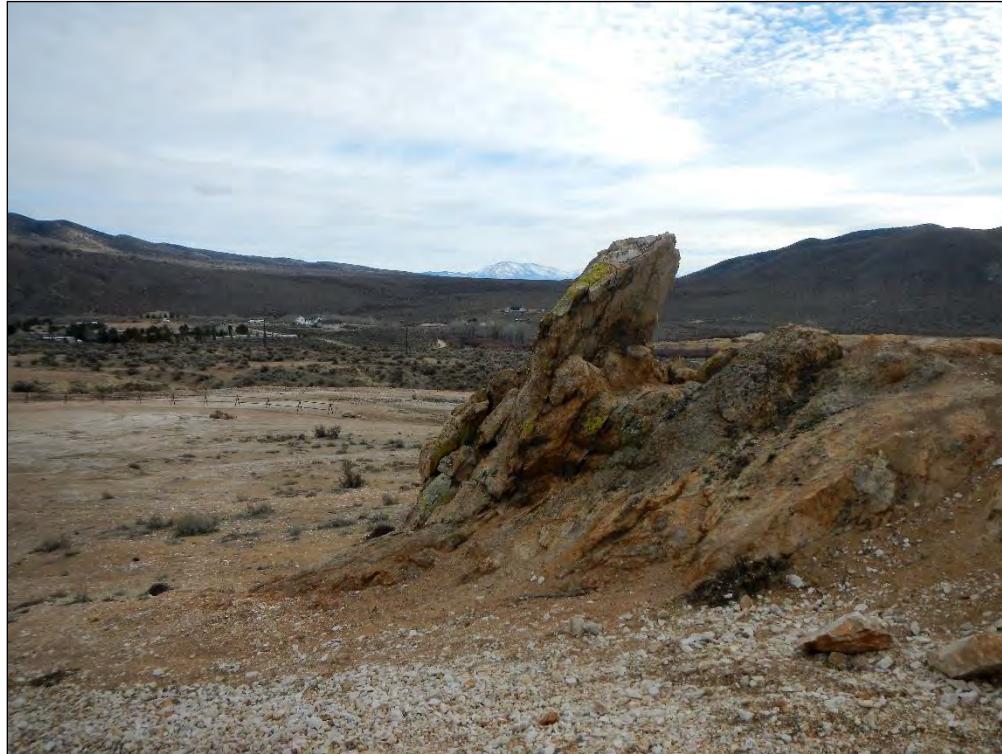
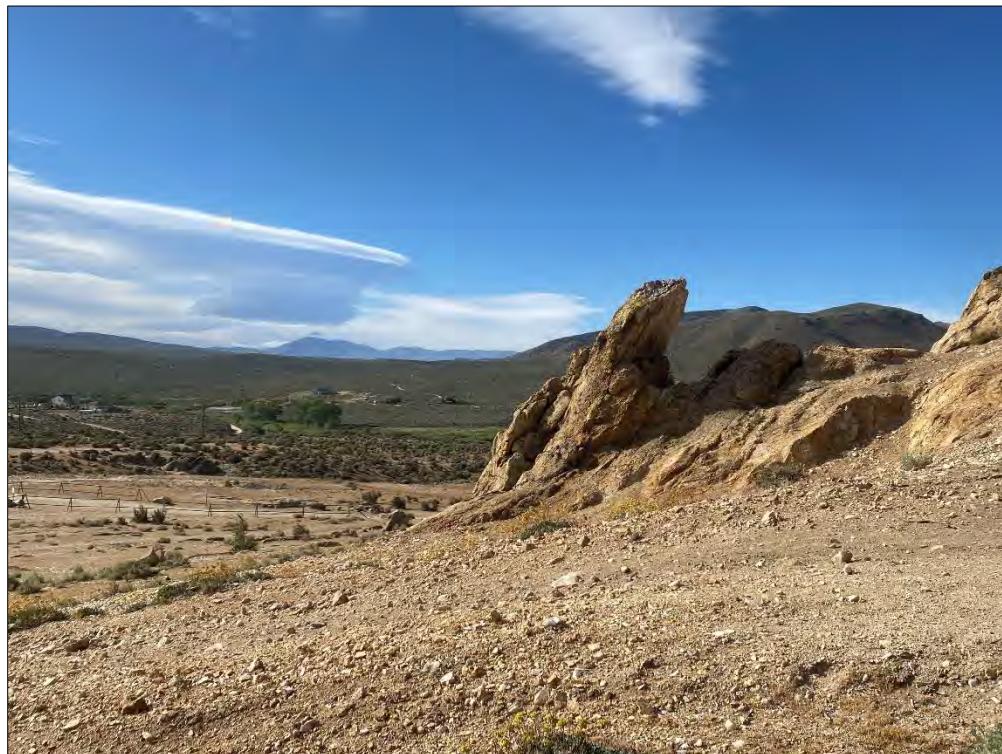
Photo Point 1C (view southeast): A photo point located at the boundary of the staging area.

2020 Baseline Condition, photo taken January 24, 2020:
(GPS coordinates: 39.104745, -119.733277)

2022 Condition, photo taken June 17, 2022

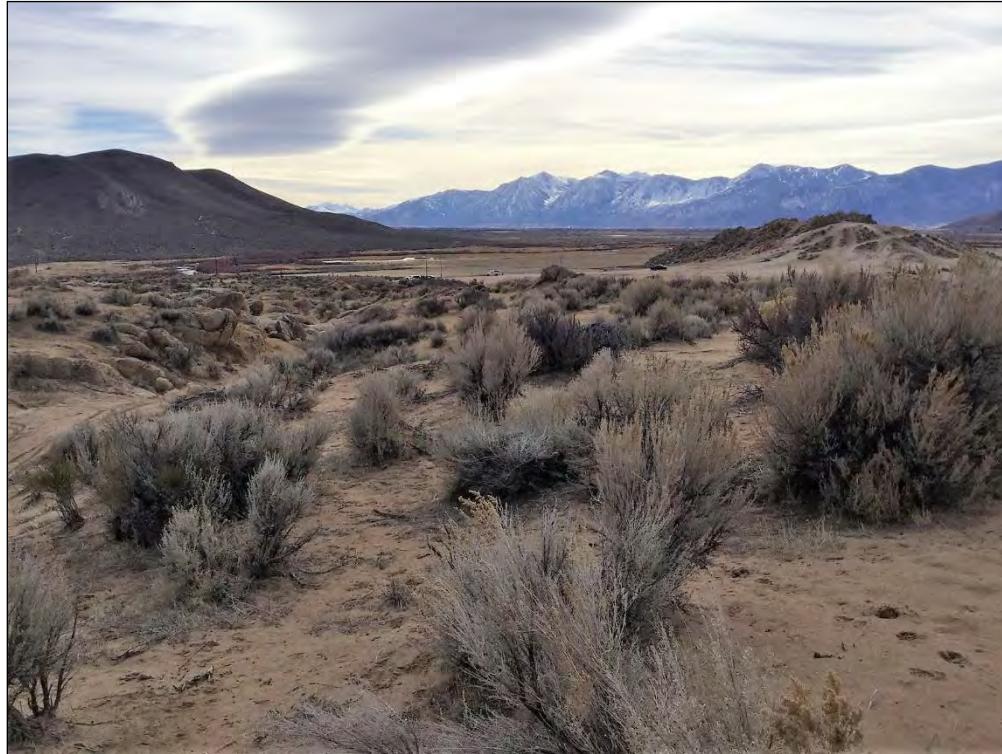
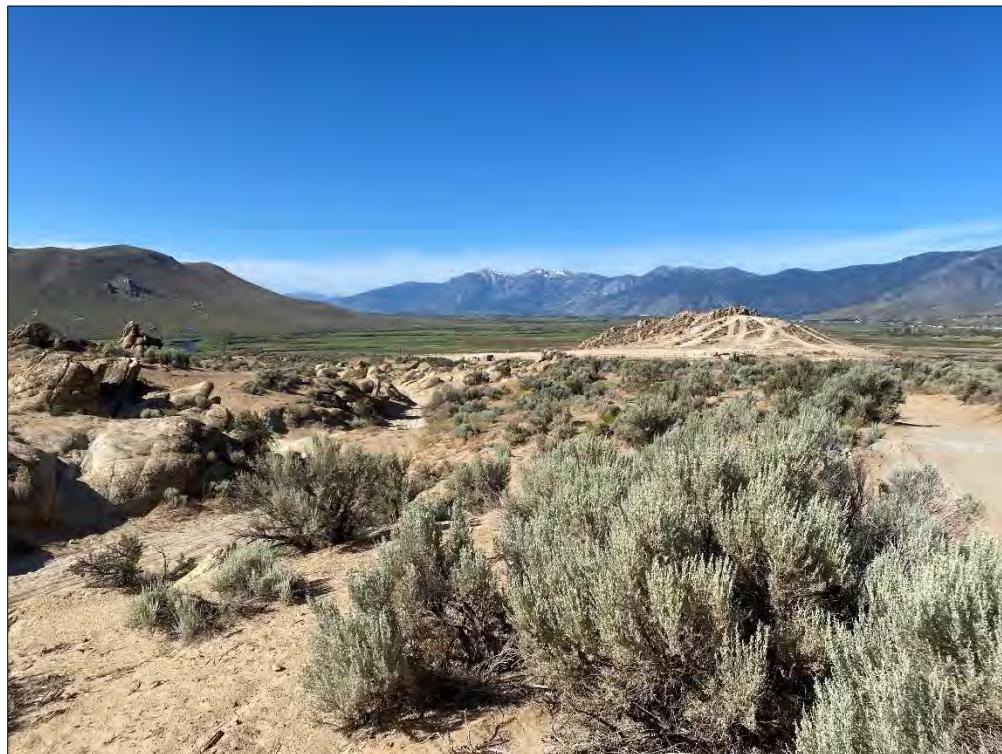
Photo Point 3 (view southwest): A photo point located north of the staging area on the east side of the road.

2020 Baseline Condition, photo taken January 24, 2020:
(GPS coordinates: 39.107231, -119.730827)

2022 Condition, photo taken June 17, 2022

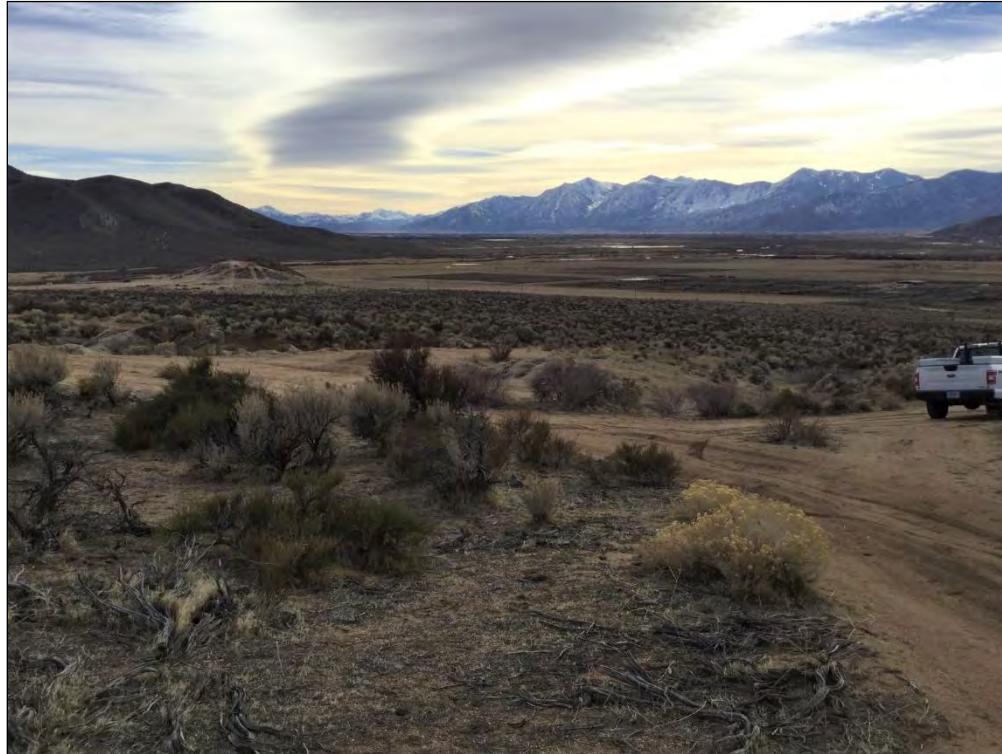
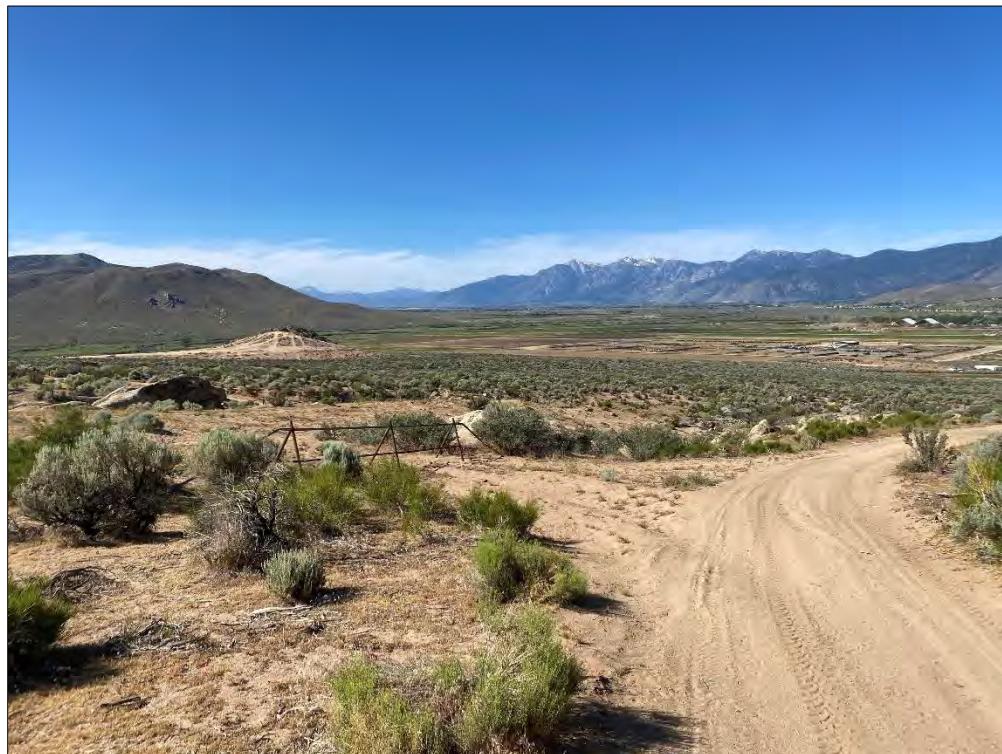
Photo Point 4 (view south): A photo point located west of Gunslinger Wheeler Trail.

2020 Baseline Condition, photo taken January 24, 2020:
(GPS coordinates: 39.111562, -119.733702)

2022 Condition, photo taken June 17, 2022

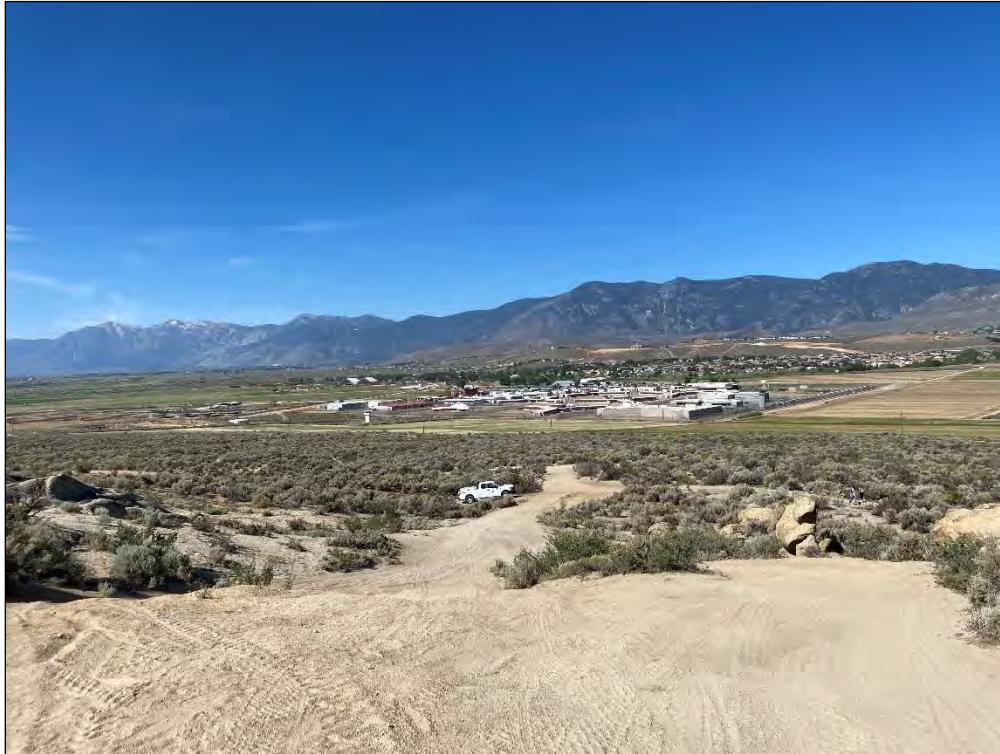
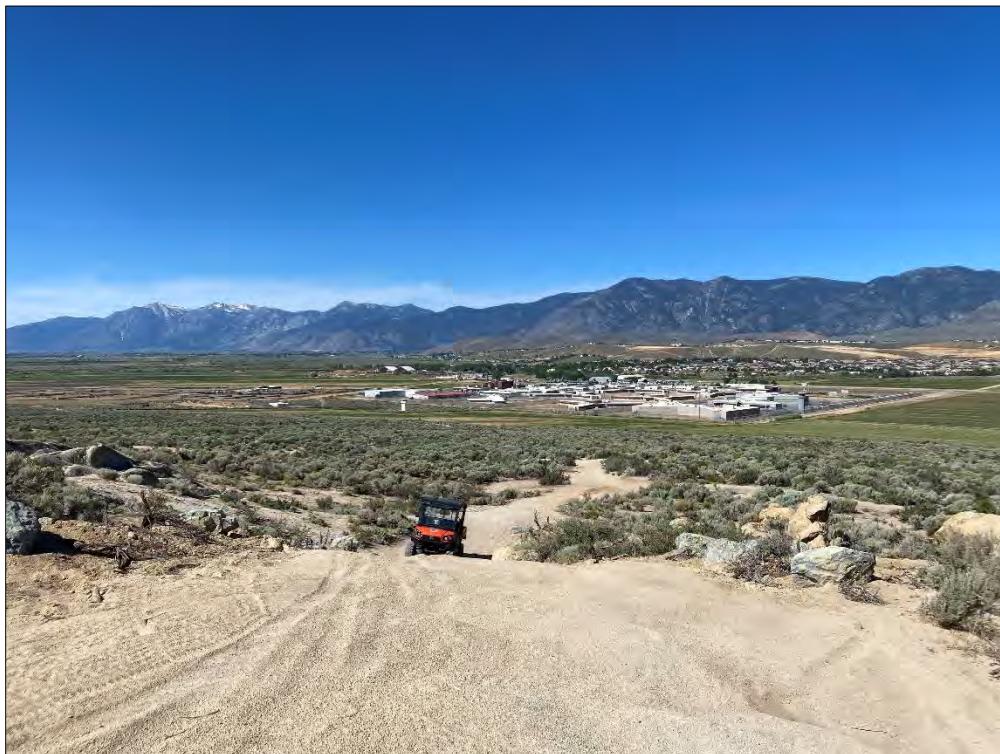
Photo Point 5B (view southwest): A photo point located at Rubber Side Up Wheeler Trail facing the prison.

2020 Baseline Condition, photo taken January 24, 2020:
(GPS coordinates: 39.113363, -119.735607)

2021 Condition, photo taken June 21, 2021

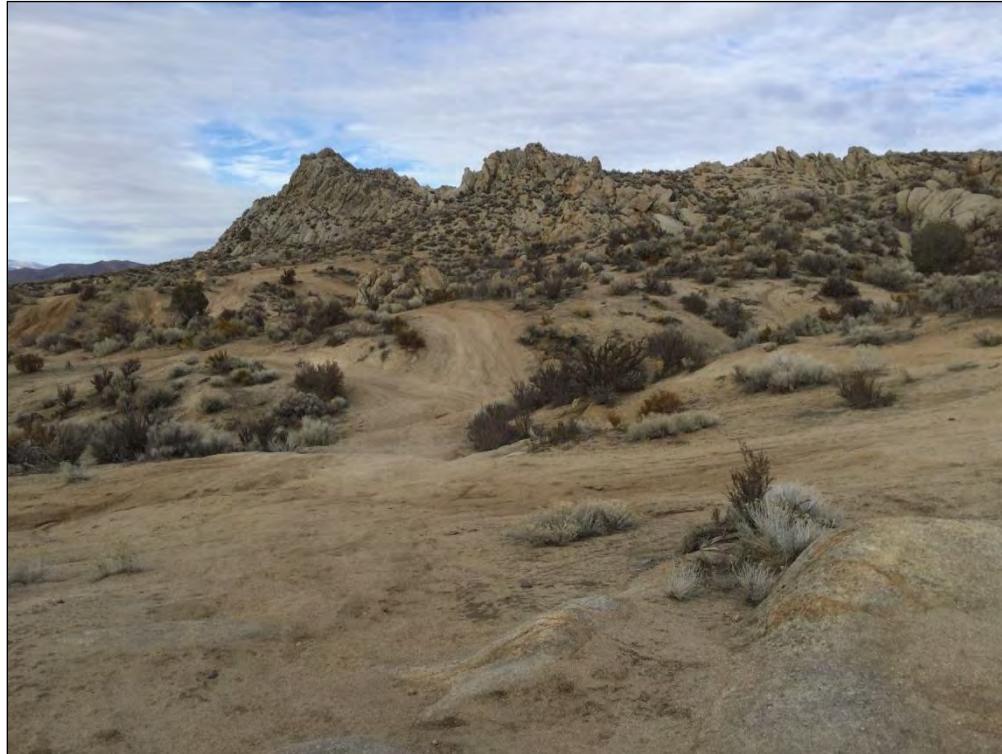
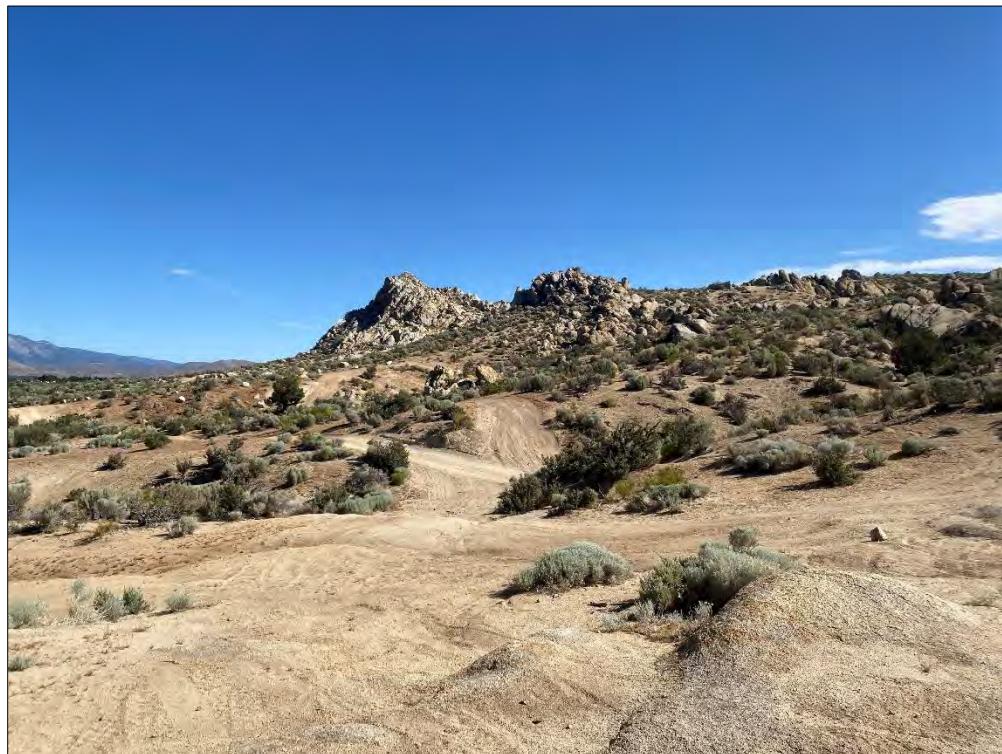
Photo Point 6 (view north): A photo point located at Rhino Rock.

2020 Baseline Condition, photo taken January 24, 2020:
(GPS coordinates: 39.111322, -119.735470)

2022 Condition, photo taken June 17, 2022

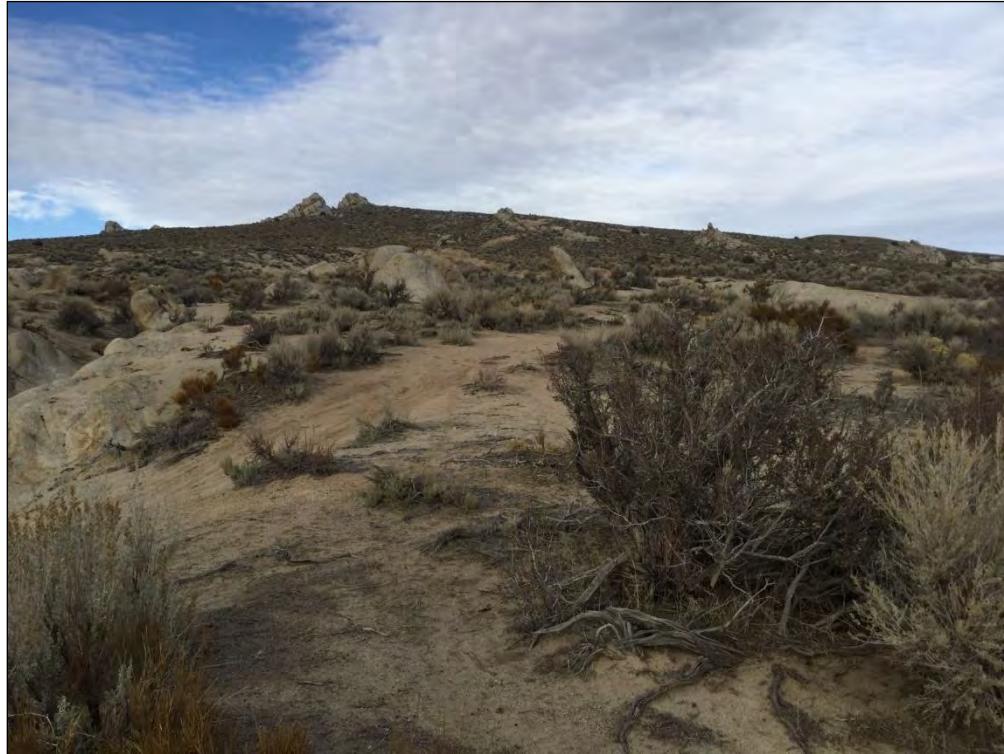
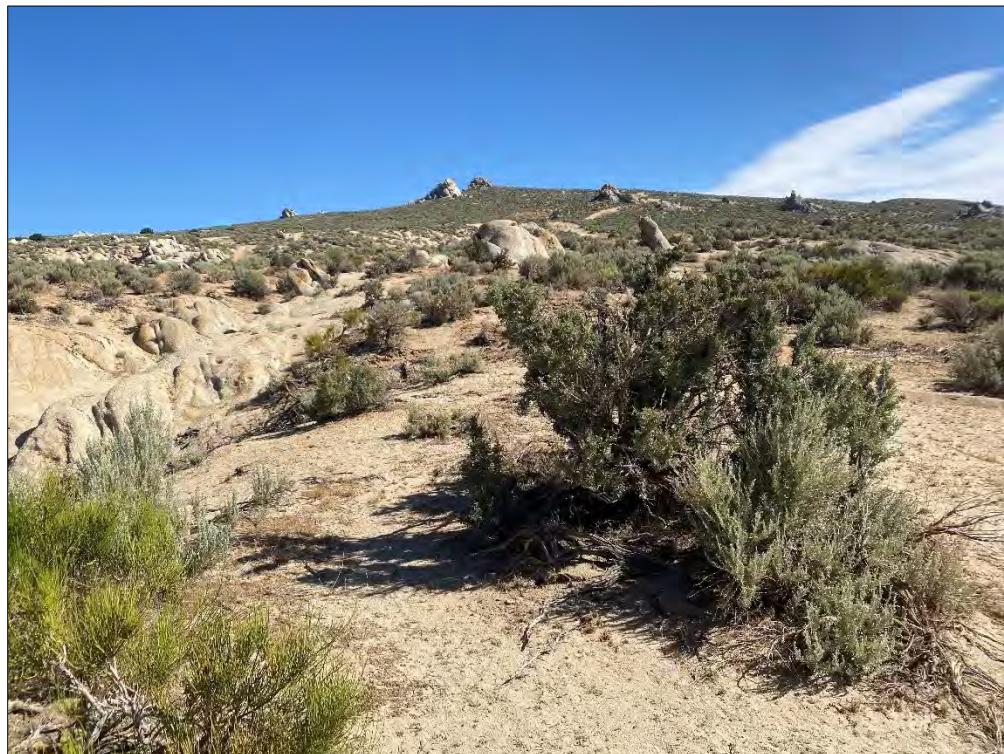
Photo Point 7A (view north): A photo point located at the entry way to the open area north of Cable Road.

2020 Baseline Condition, photo taken January 24, 2020:
(GPS coordinates: 39.110377, -119.728973)

2022 Condition, photo taken June 17, 2022

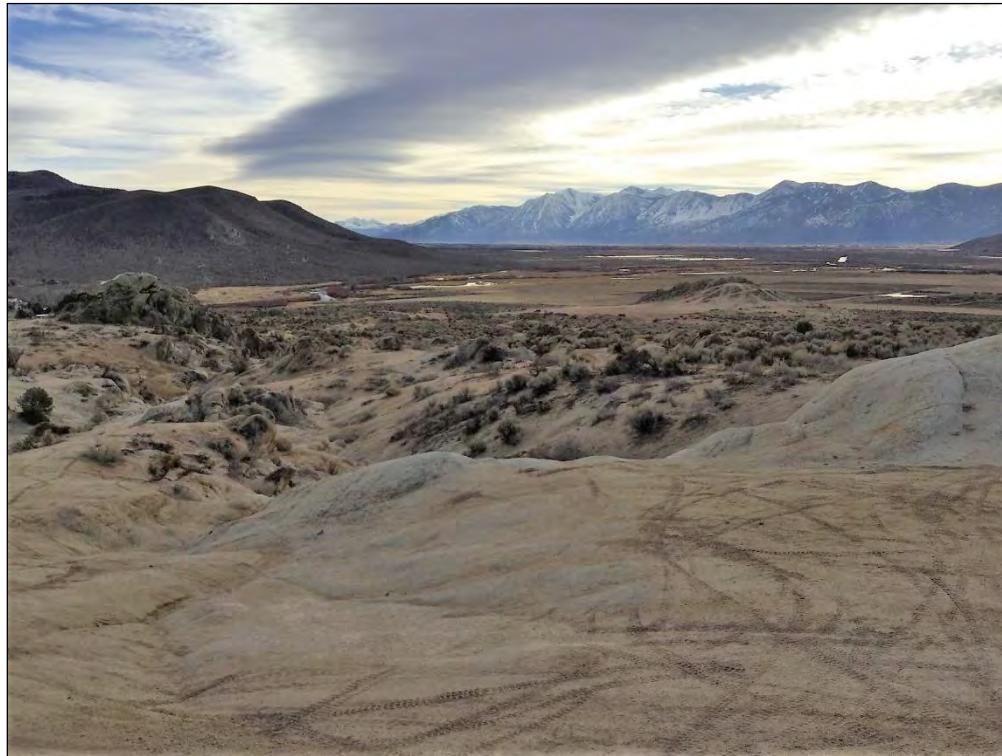
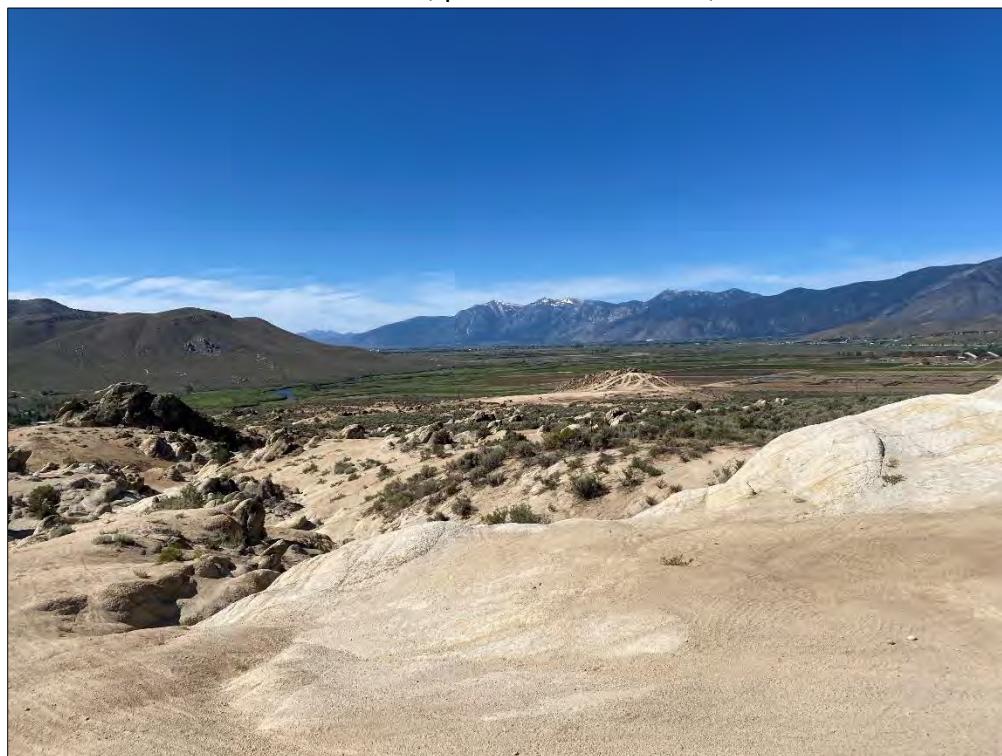
Photo Point 7B (view south): A photo point located at the entry way to the open area north of Cable Road.

2020 Baseline Condition, photo taken January 24, 2020:
(GPS coordinates: 39.110377, -119.728973)

2022 Condition, photo taken June 17, 2022

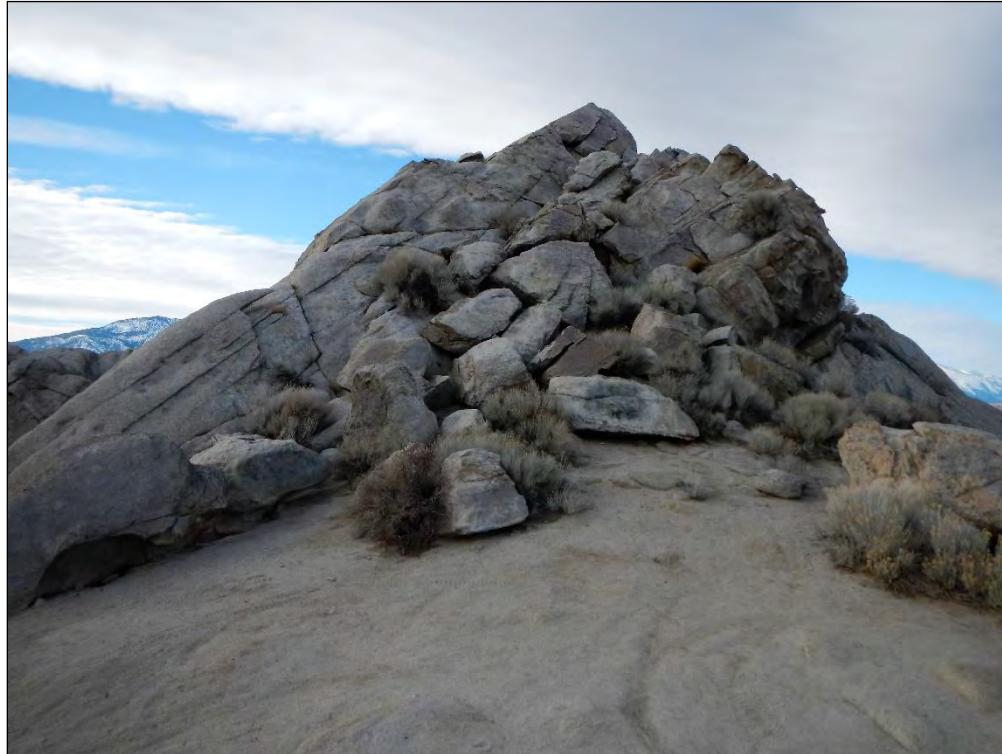
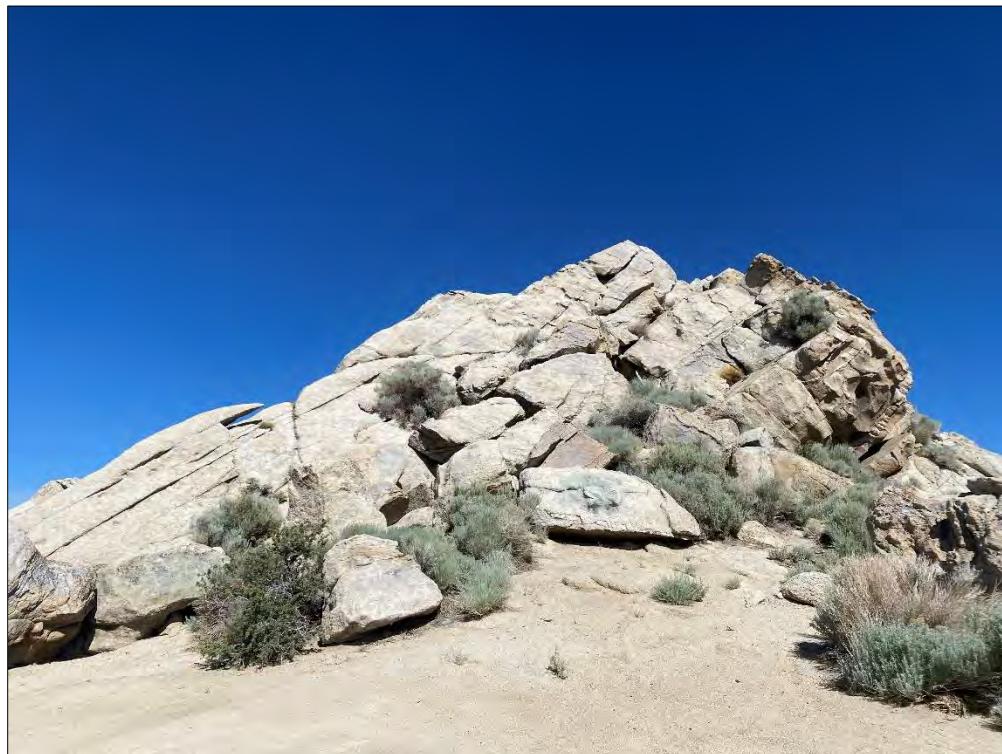
Photo Point 8A (view west): A photo point located at Golden Eagle Rock.

2020 Baseline Condition, photo taken January 24, 2020:
(GPS coordinates: 39.118457, -119.728973)

2022 Condition, photo taken June 17, 2022

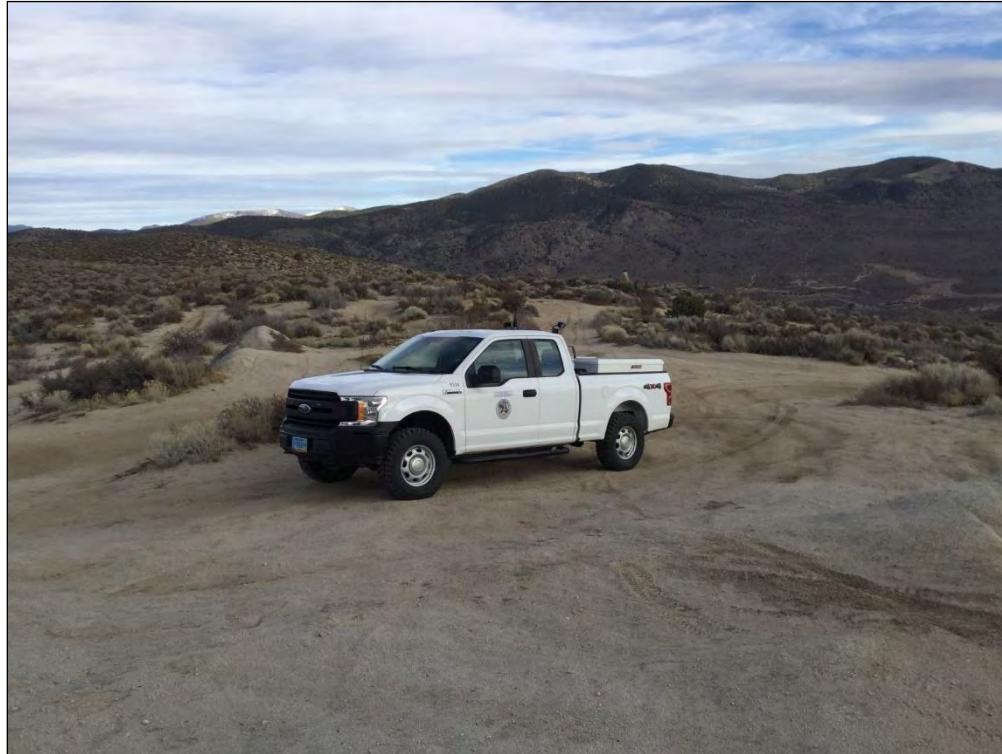
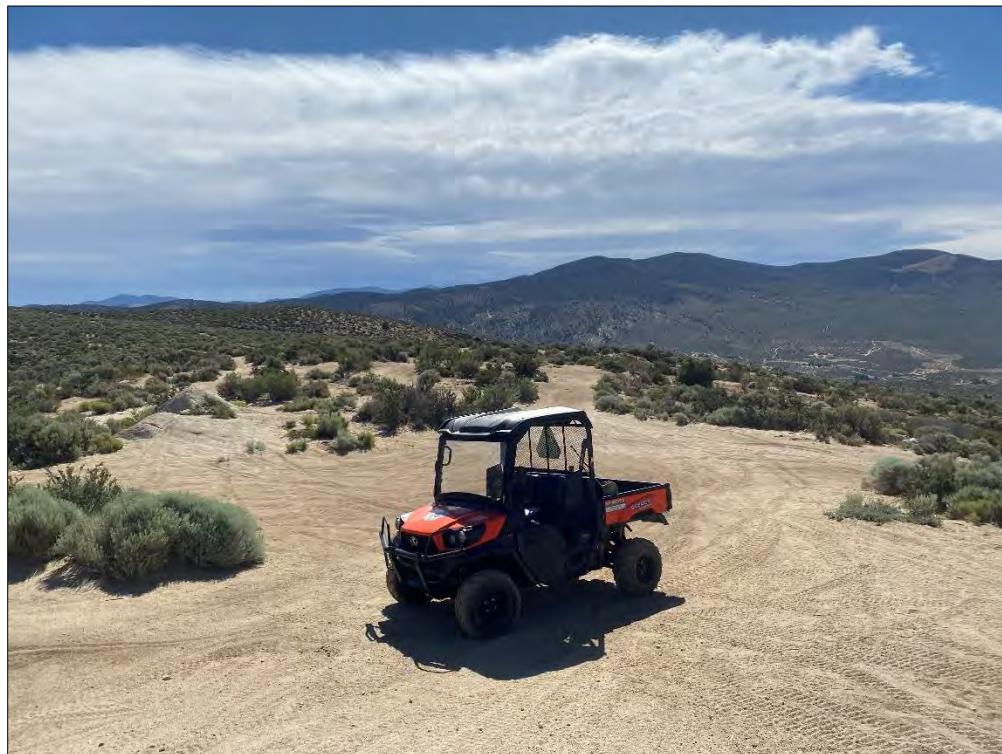
Photo Point 8B (view east): A photo point located at Golden Eagle Rock.

2020 Baseline Condition, photo taken January 24, 2020:
(GPS coordinates: 39.118457, -119.728973)

2022 Condition, photo taken June 17, 2022

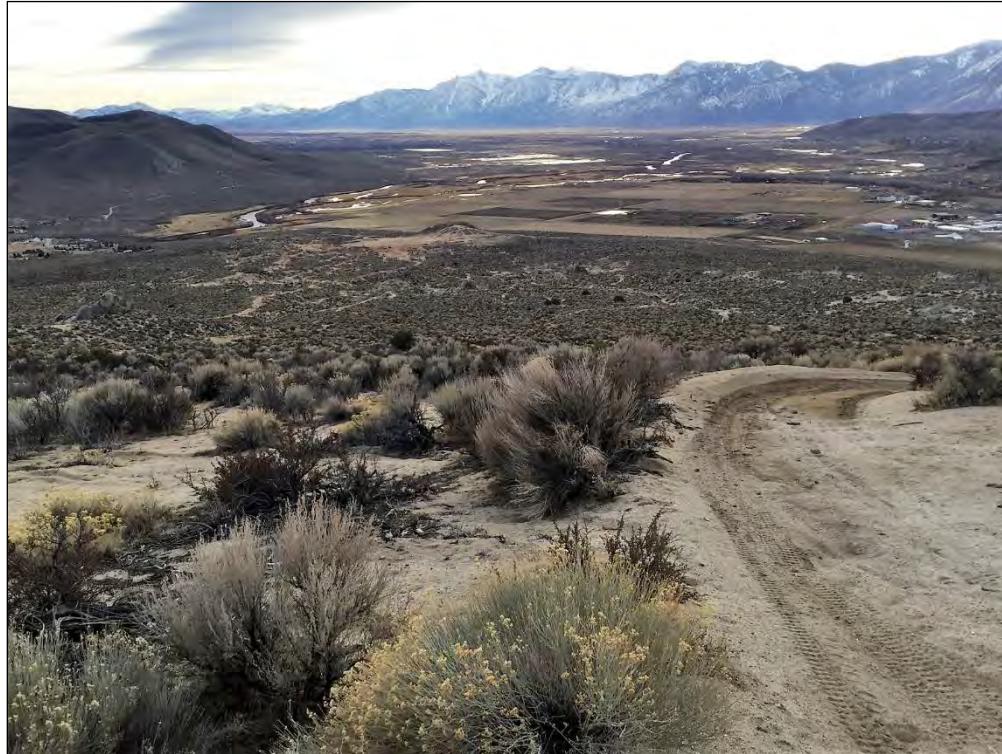
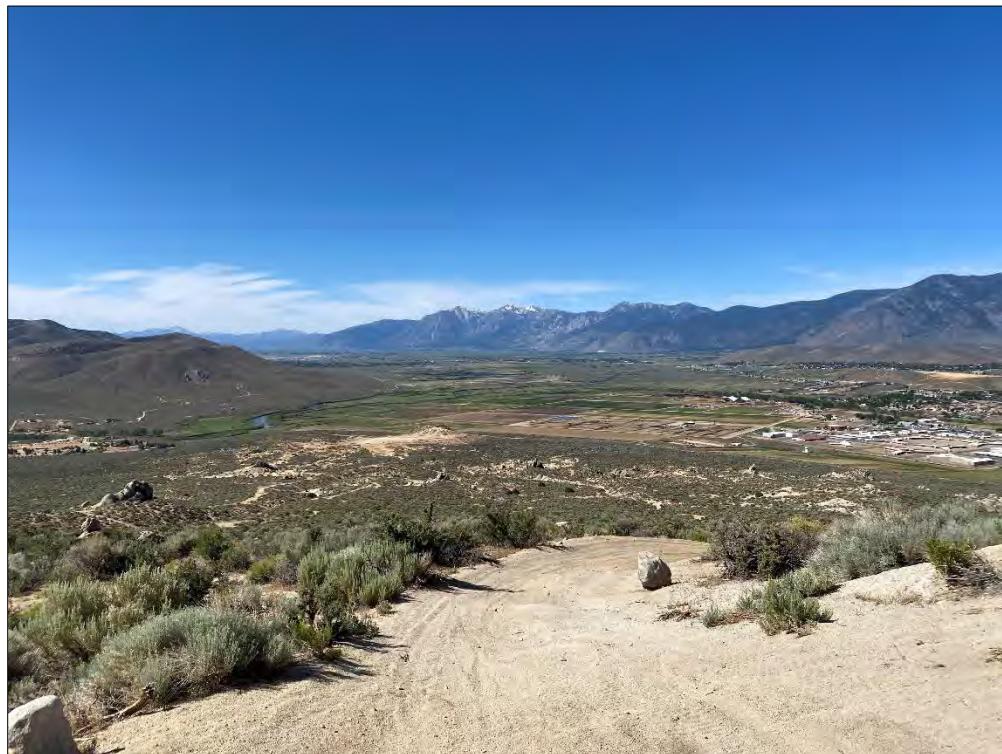
Photo Point 8C (view south): A photo point located at Golden Eagle Rock.

2020 Baseline Condition, photo taken January 24, 2020:
(GPS coordinates: 39.118457, -119.728973)

2022 Condition, photo taken June 17, 2022

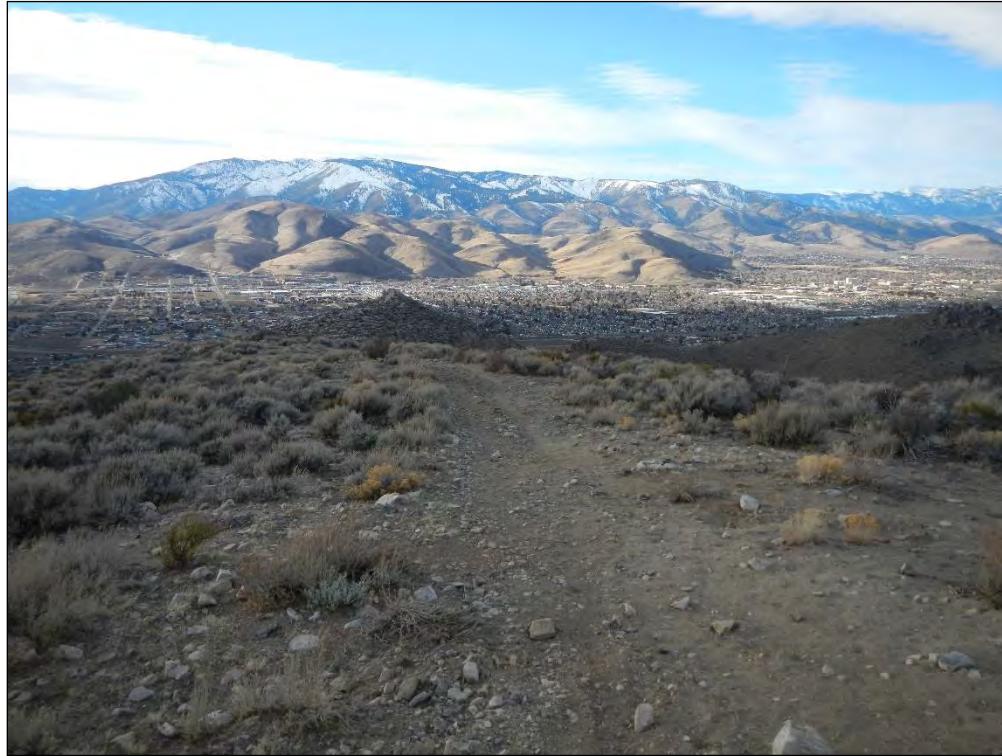
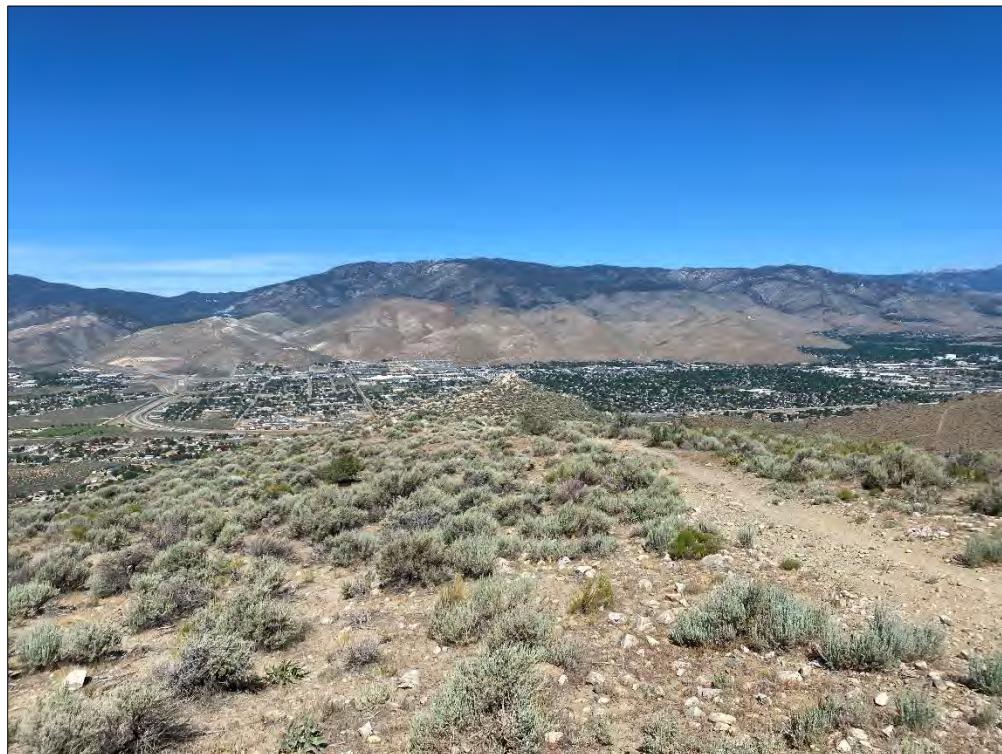
Photo Point 9A (view west): A photo point located at the Prison Hill Summit.

2020 Baseline Condition, photo taken January 24, 2020:
(GPS coordinates: 39.126752, -119.722705)

2022 Condition, photo taken June 17, 2022

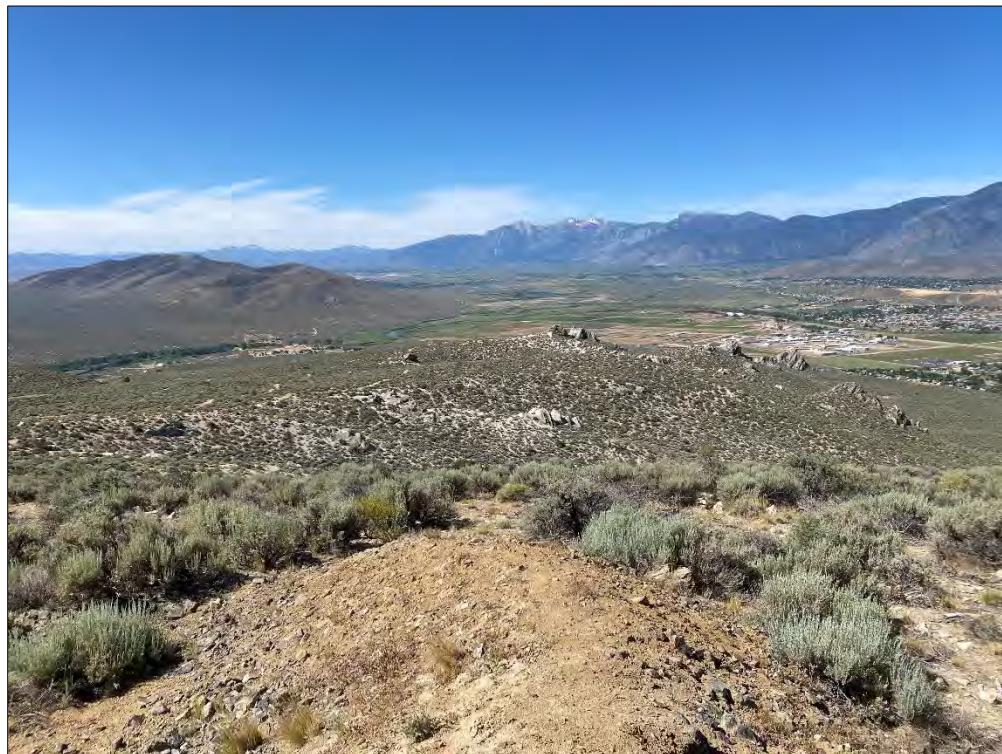
Photo Point 9B (view south): A photo point located at the Prison Hill Summit.

2022 Condition, photo taken June 17, 2022

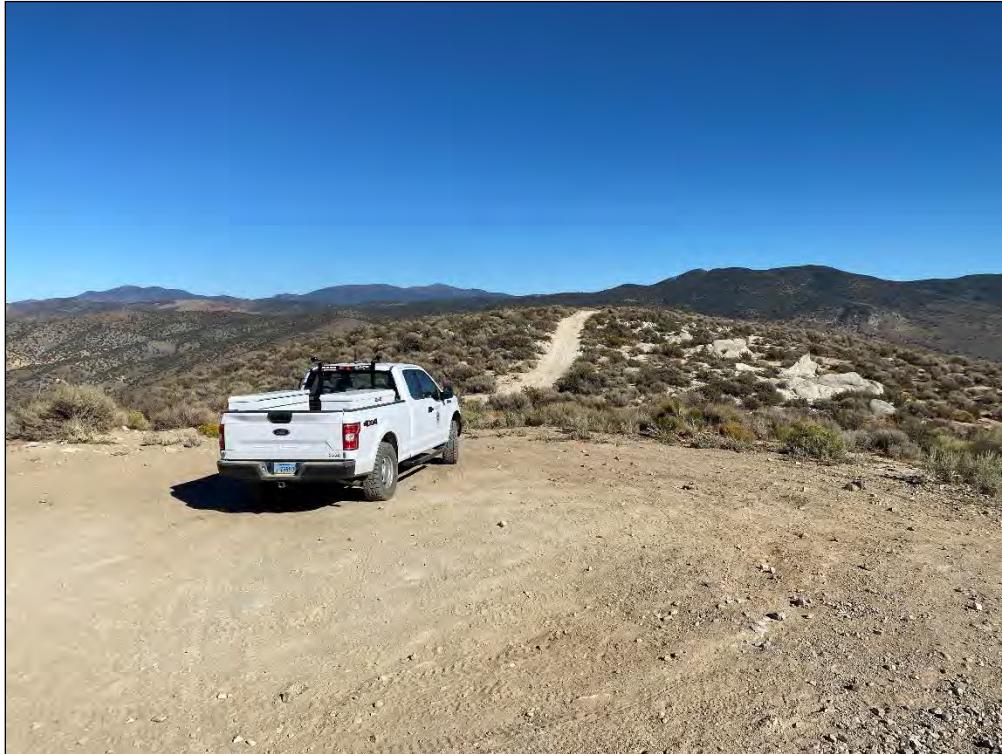
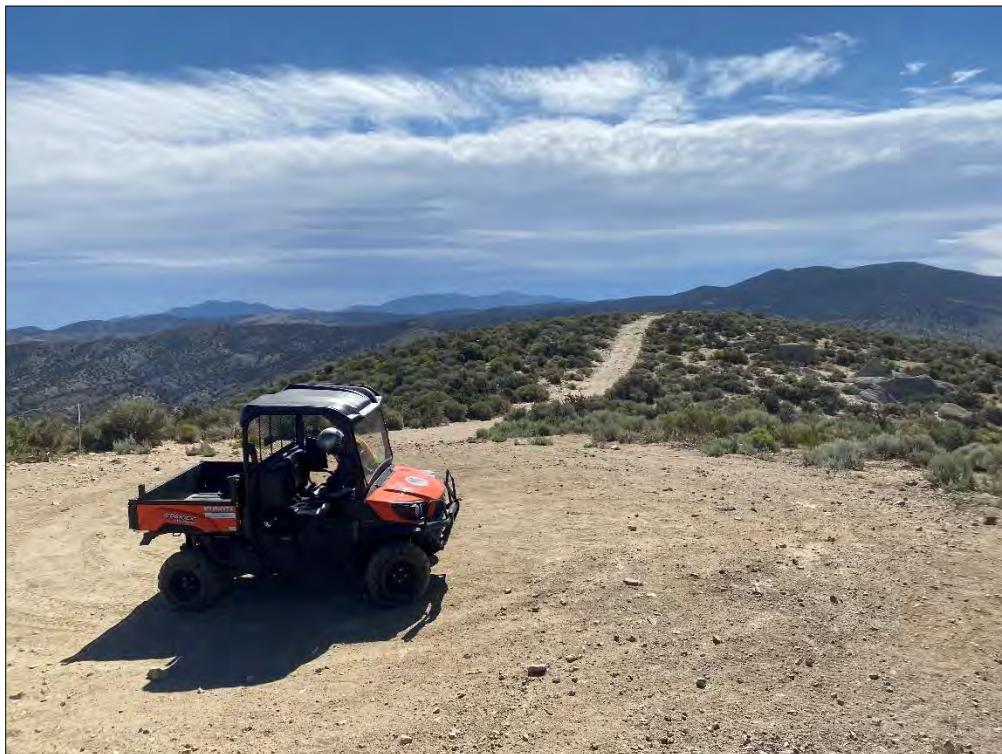
Photo Point 9C (view east): A photo point located at the Prison Hill Summit.

2020 Baseline Condition, photo taken January 24, 2020:

2022 Condition, photo taken June 17, 2022

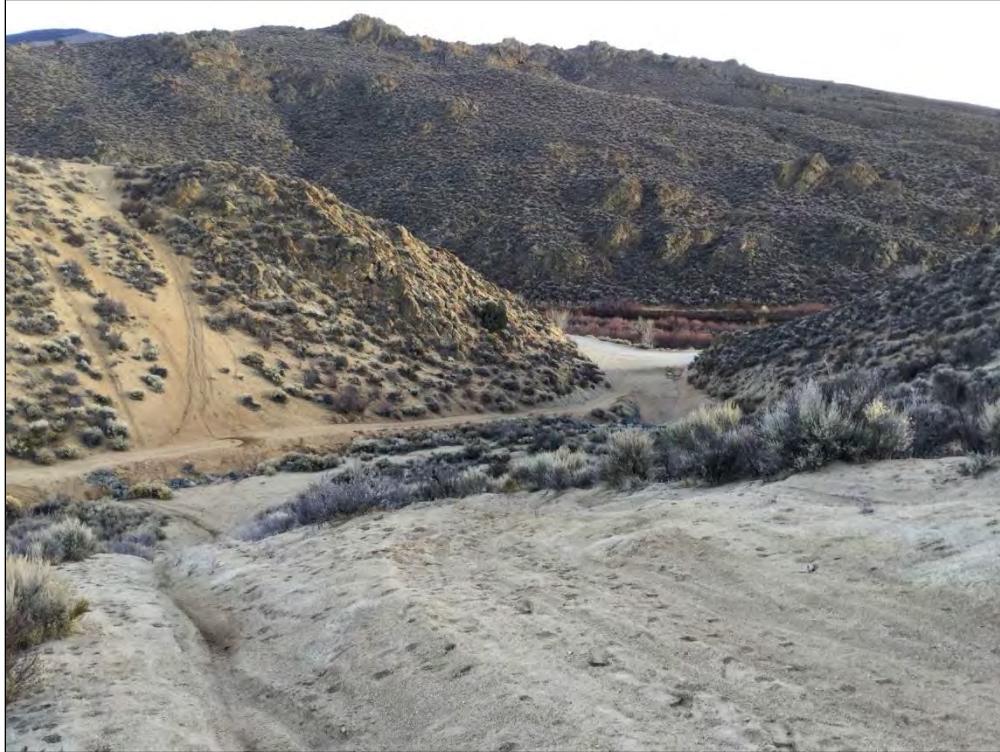
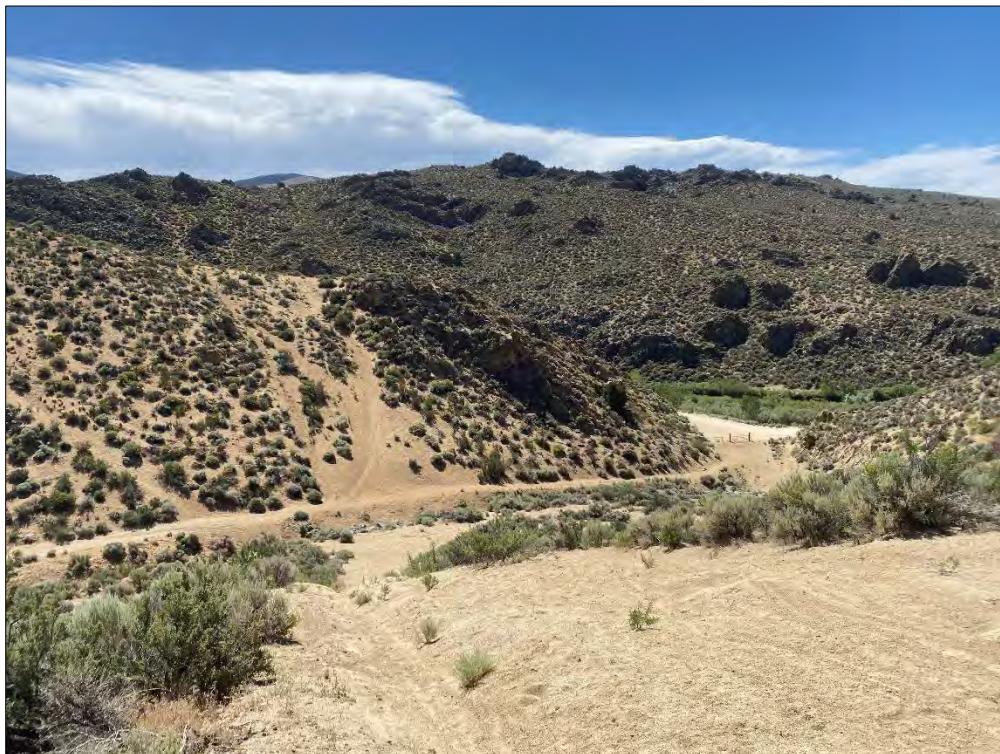
Photo Point 10A (view east): A photo point located above Golden Eagle Open Space and the erosion control project.

2020 Baseline Condition, photo taken January 24, 2020:
(GPS coordinates: 39.108428, -119.716747)

2022 Condition, photo taken June 17, 2022

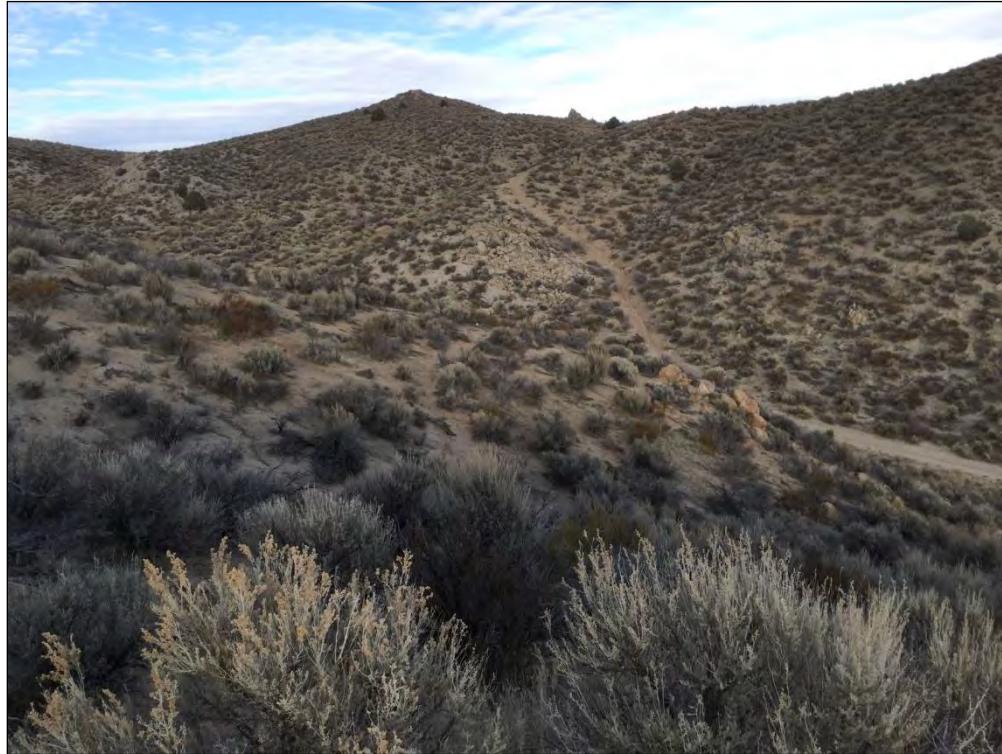
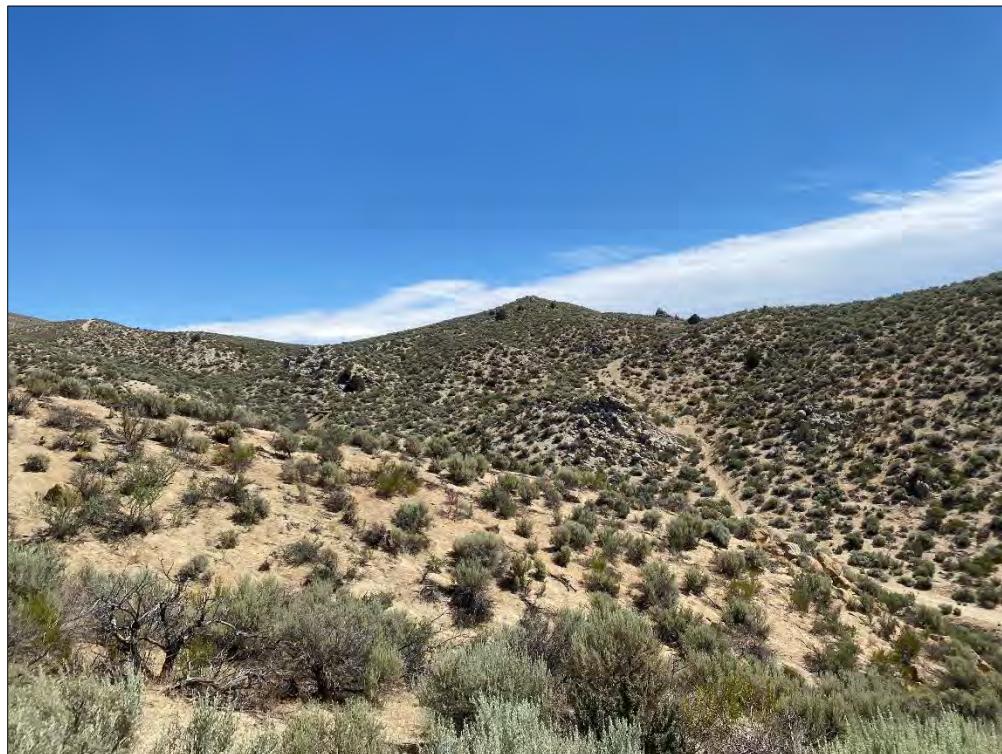
Photo Point 10B (view north): A photo point located above Golden Eagle Open Space and the erosion control project.

2020 Baseline Condition, photo taken January 24, 2020:
(GPS coordinates: 39.108428, -119.716747)

2022 Condition, photo taken June 17, 2022
