STAFF REPORT

Agenda Title: For Discussion Only: Review and discussion of the Prison Hill OHV Area Monitoring Report, and updates on the Prison Hill OHV Area. (*Lyndsey Boyer and Gregg Berggren*)

Carson City Open Space – Conservation Easement Monitoring

Prison Hill OHV Area – Monitoring Report

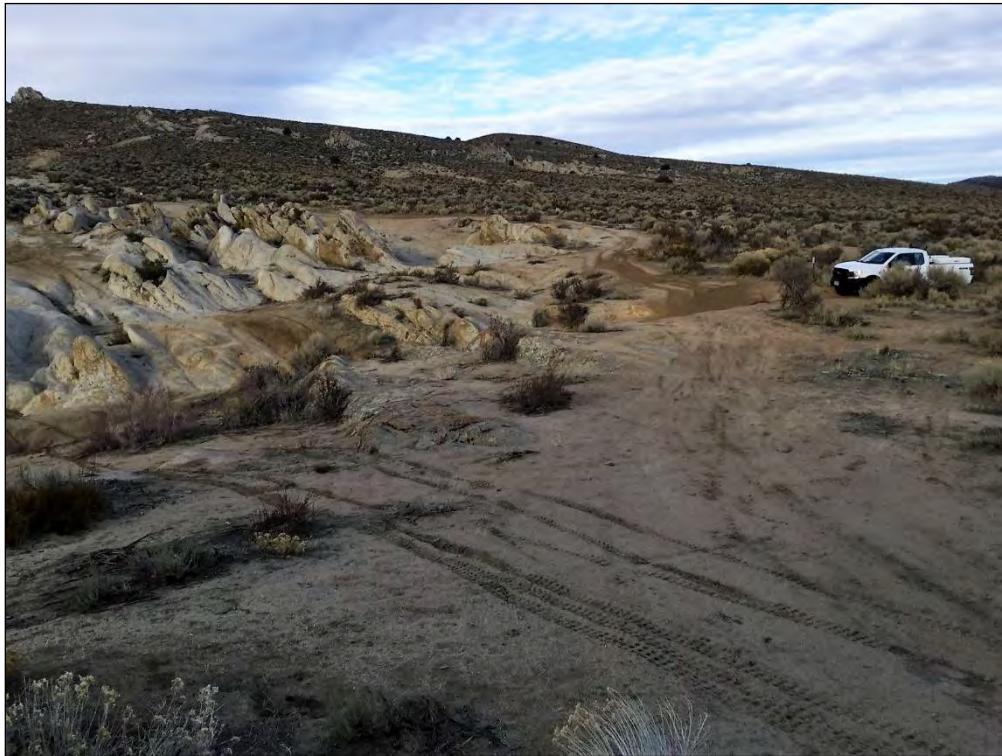
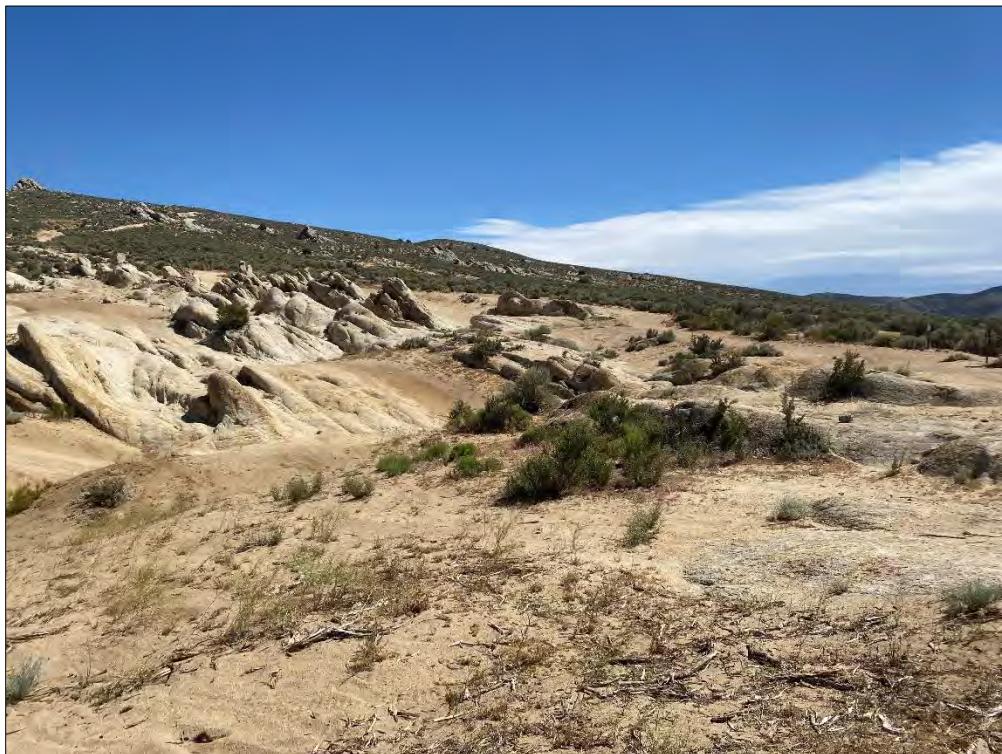
Photo Point 11A (view north): A photo point located in the largest open area, just south of Cable Road.

2020 Baseline Condition, photo taken January 24, 2020:

2022 Condition, photo taken June 17, 2022

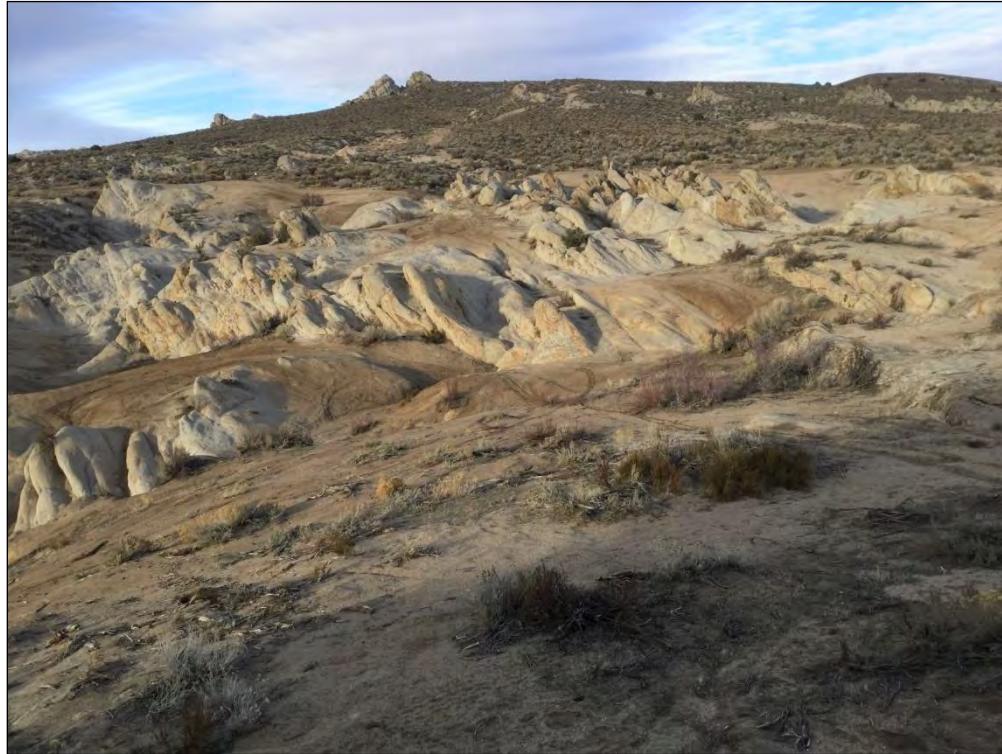
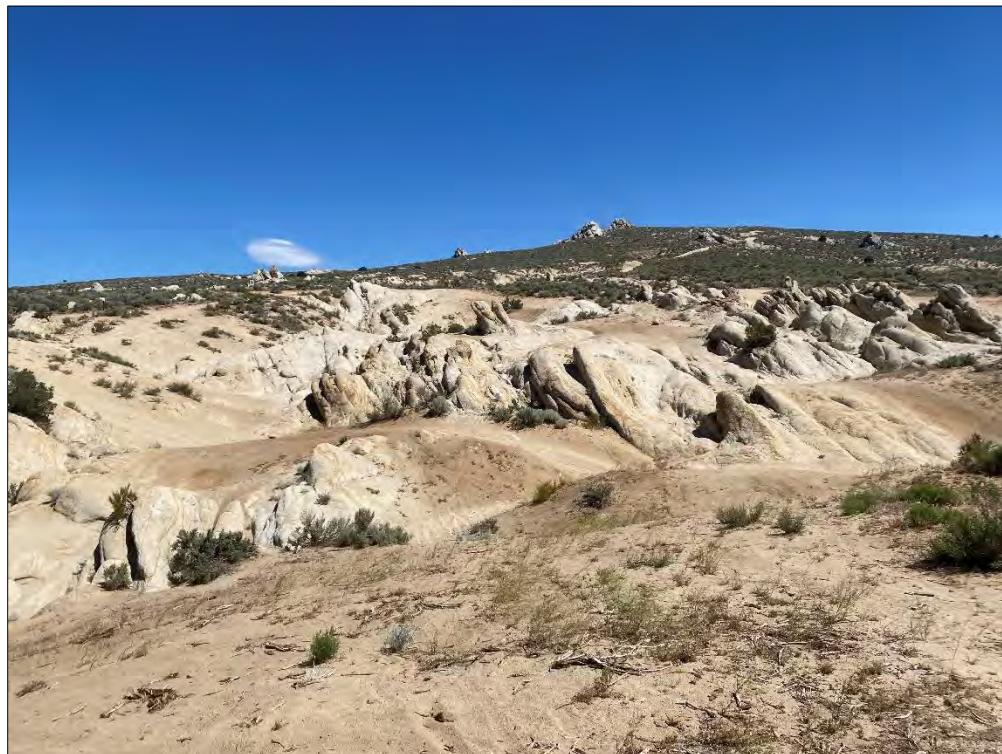
Photo Point 11B (view northwest): A photo point located in the largest open area, just south of Cable Road.

2020 Baseline Condition, photo taken January 24, 2020:
(GPS coordinates: 39.109063, -119.728908)

2022 Condition, photo taken June 17, 2022

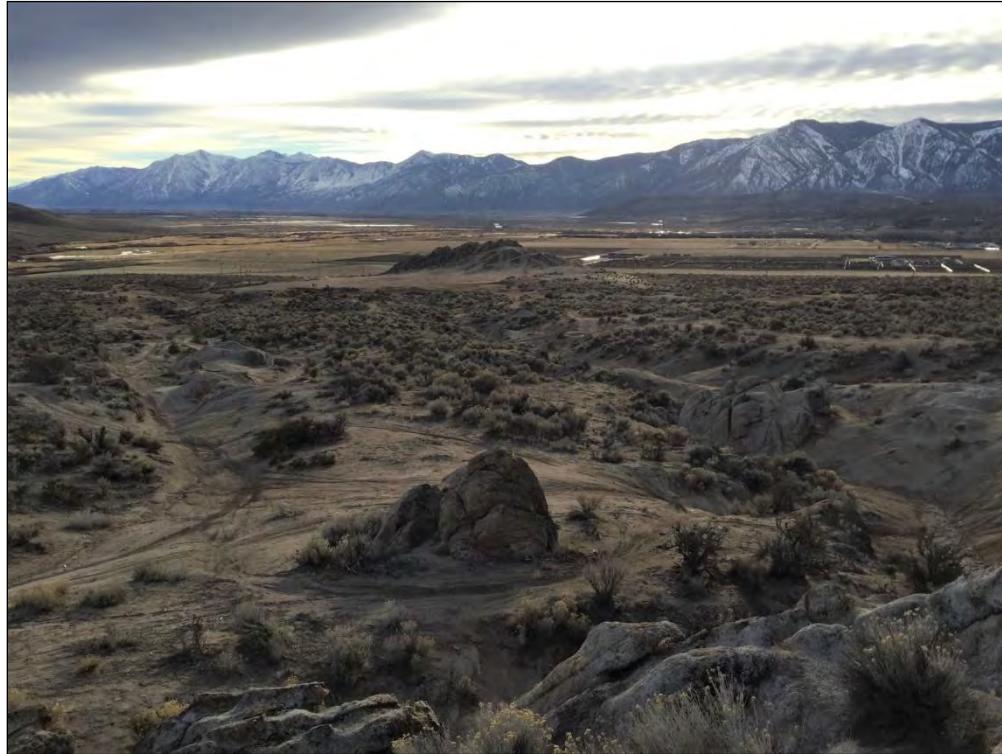
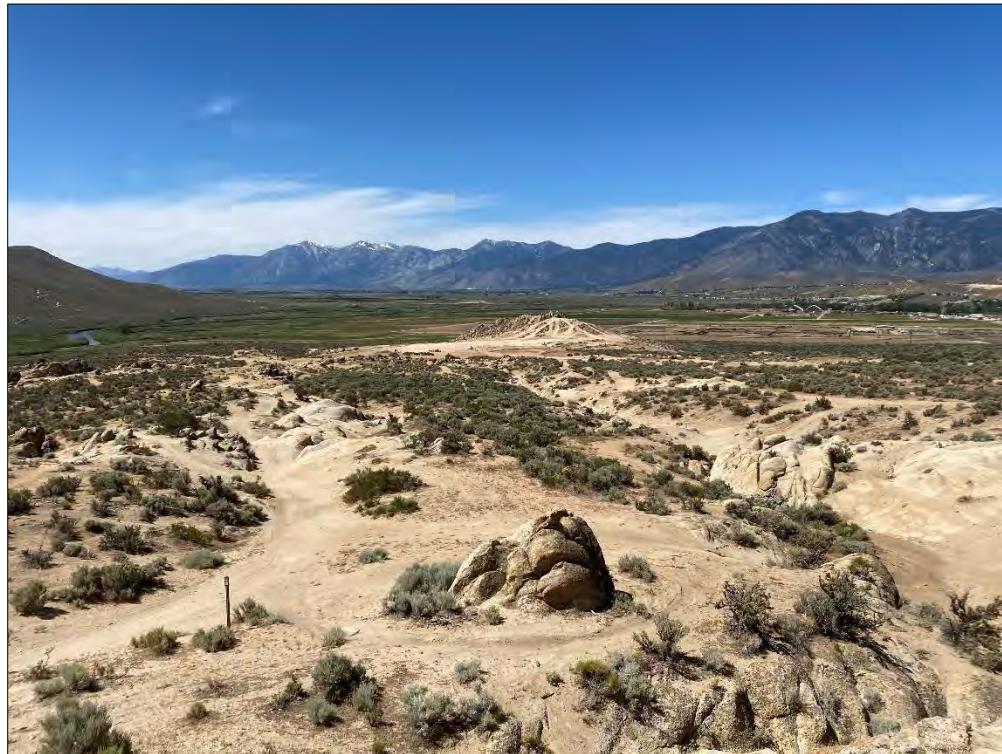
Photo Point 11C (view southwest): A photo point located in the largest open area, just south of Cable Road. Walk up to the lookout rock to frame photo correctly.

2020 Baseline Condition, photo taken January 24, 2020:
(GPS coordinates: 39.109063, -119.728908)

2022 Condition, photo taken June 17, 2022

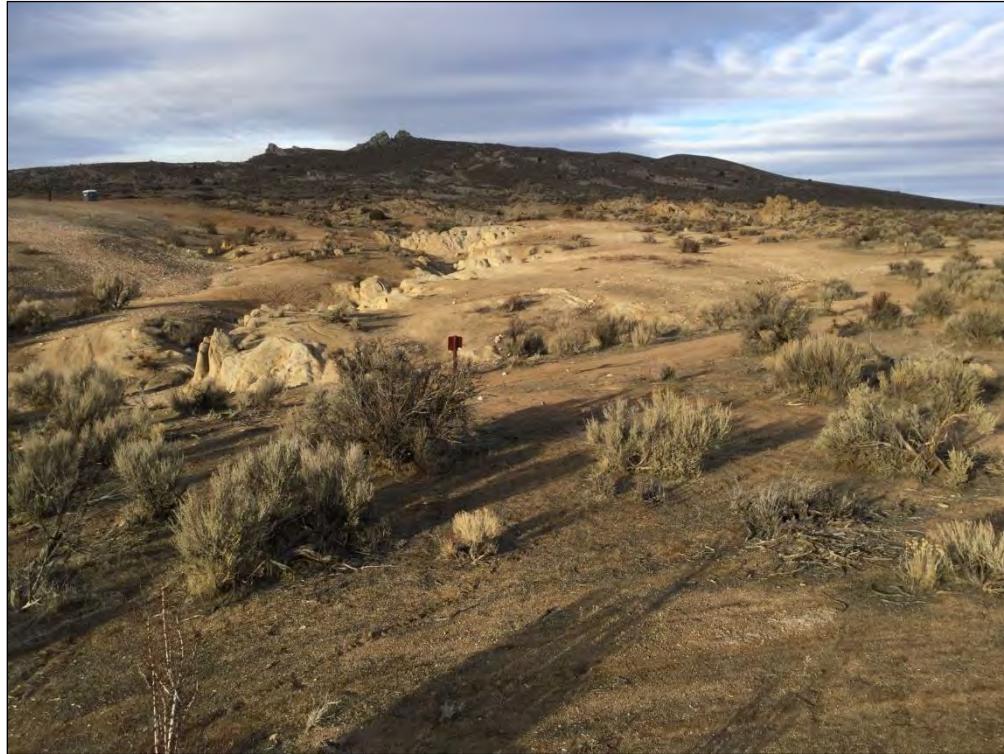
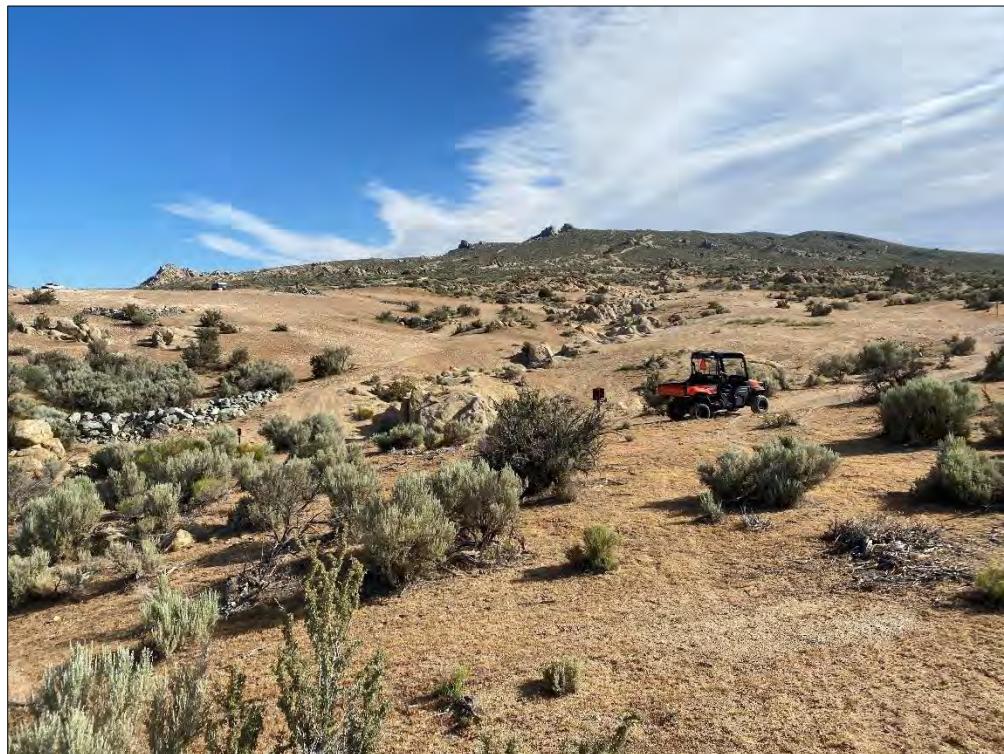
Photo Point 12A (view east): A photo point located south of the largest open area on the east side of the drainage.

2020 Baseline Condition, photo taken January 24, 2020:
(GPS coordinates: 39.103478, -119.731260)

2022 Condition, photo taken June 17, 2022

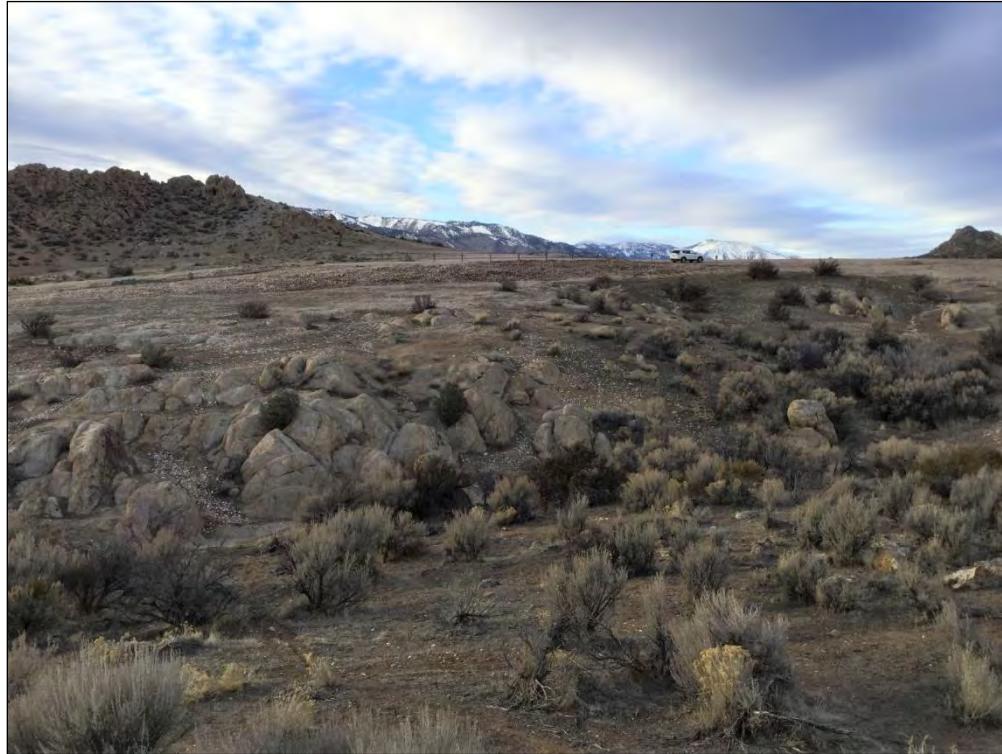
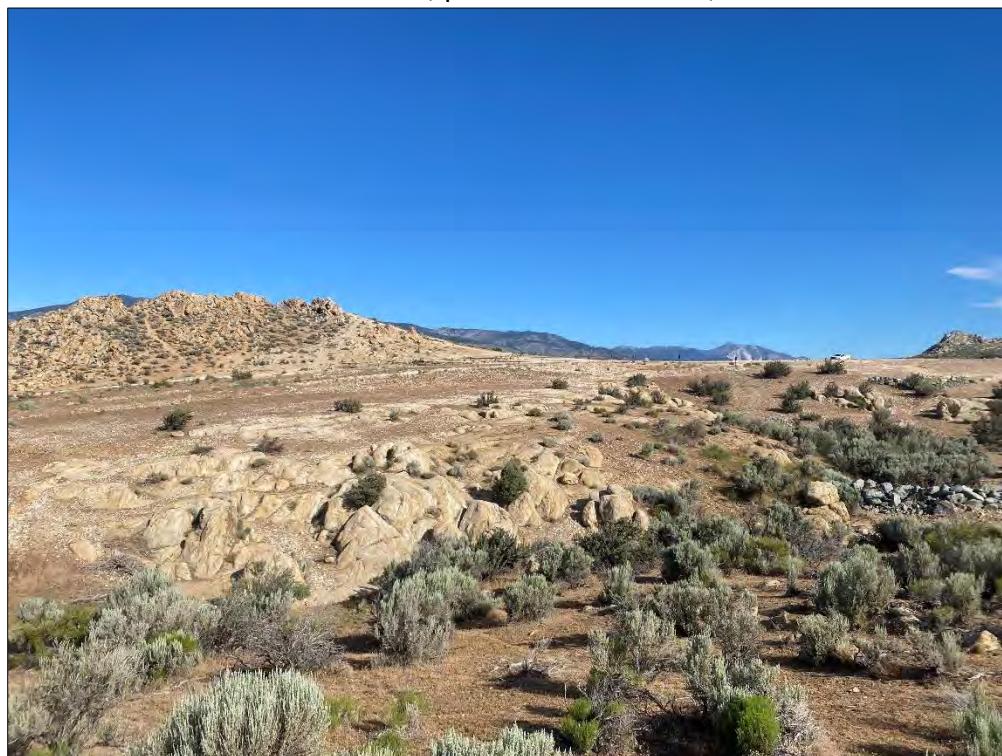
Photo Point 12B (view northwest): A photo point located south of the largest open area on the east side of the drainage.

2020 Baseline Condition, photo taken January 24, 2020:
(GPS coordinates: 39.103478, -119.731260)

2022 Condition, photo taken June 17, 2022

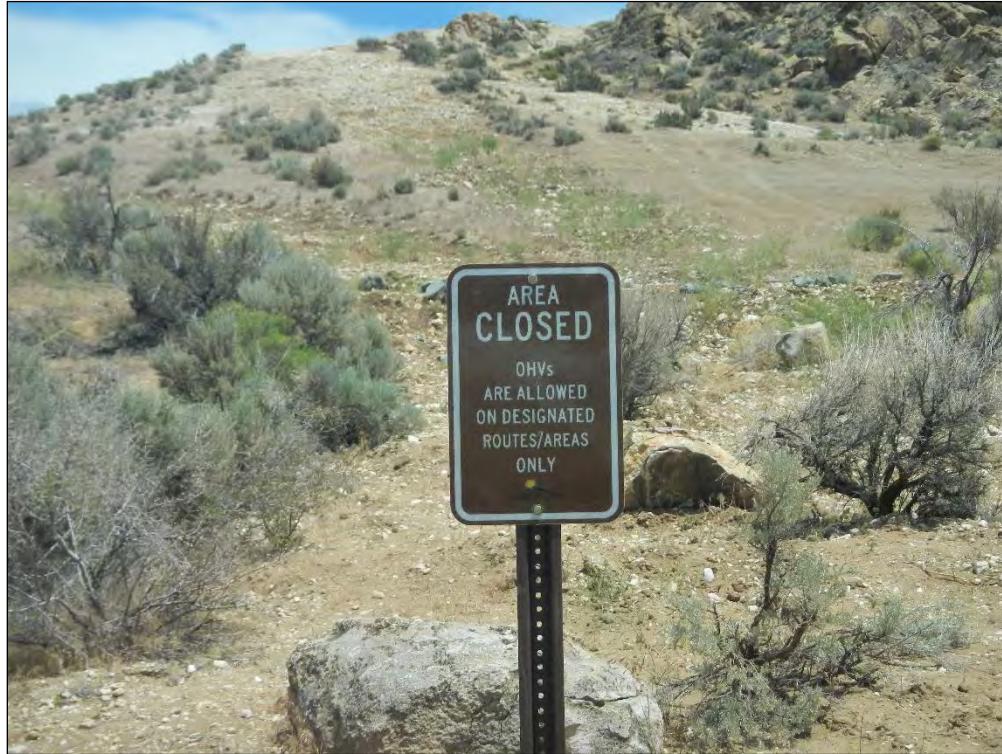
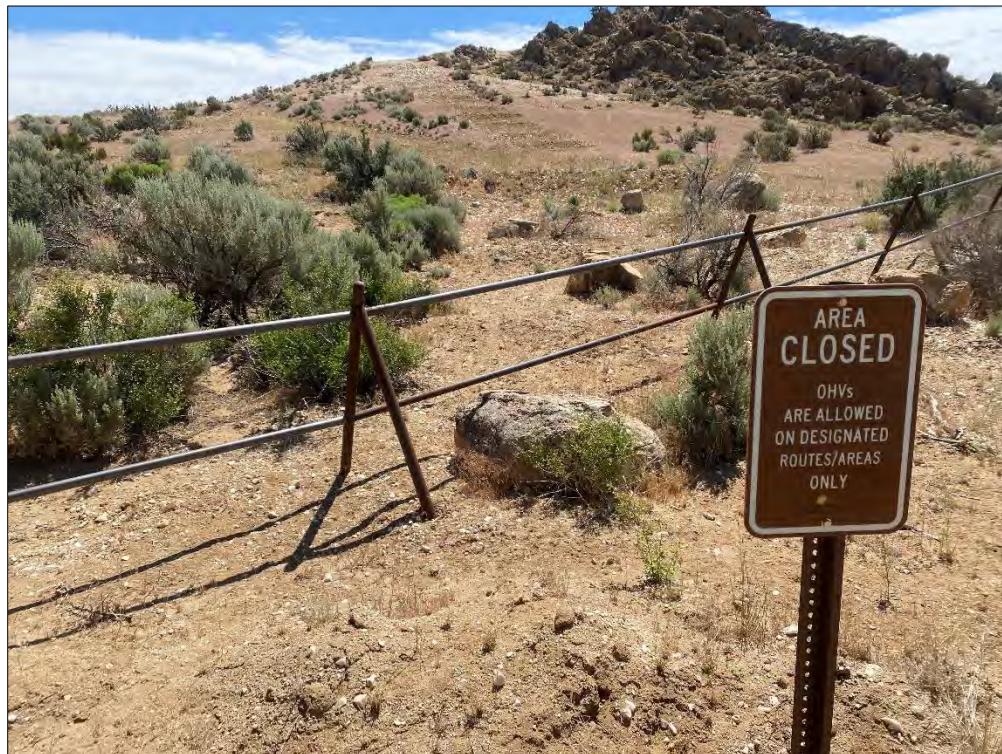
Photo Point 13 (view east): A photo point located at the closed-off western access point adjacent to Golden Eagle Lane.

2020 Baseline Condition, photo taken January 24, 2020:

2022 Condition, photo taken June 17, 2022

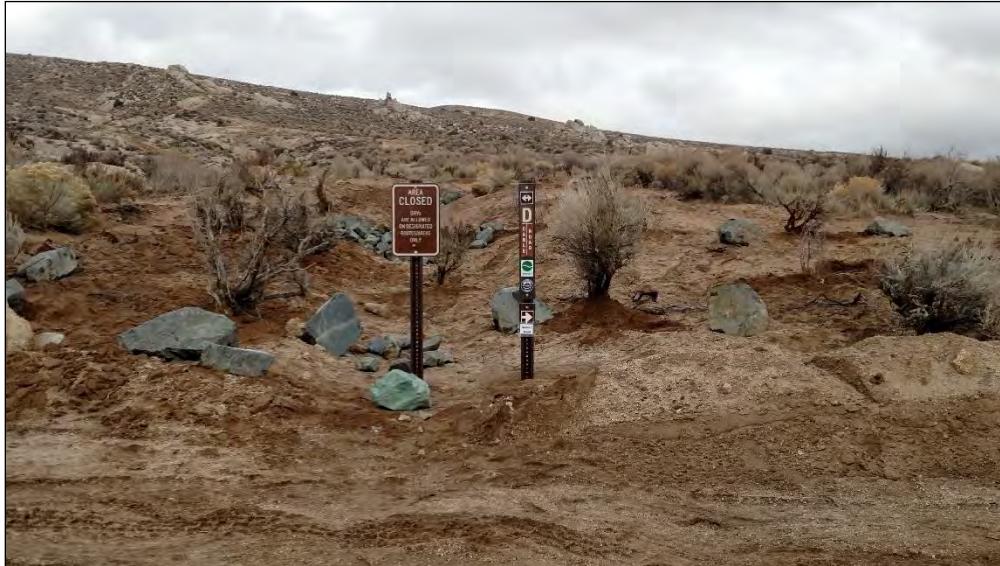
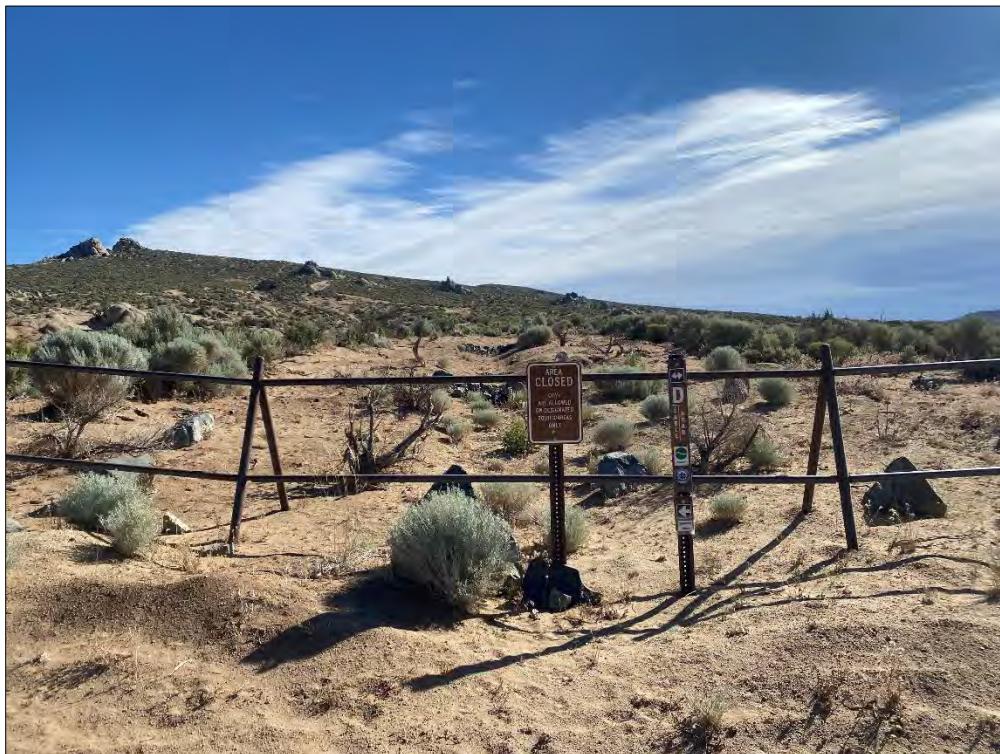
Photo Point 14 (view north): A photo point located at the closed section of the main road, north of Cable Road.

2020 Baseline Condition, photo taken January 24, 2020:
(GPS coordinates: 39.109900, -119.730203)

2022 Condition, photo taken June 17, 2022

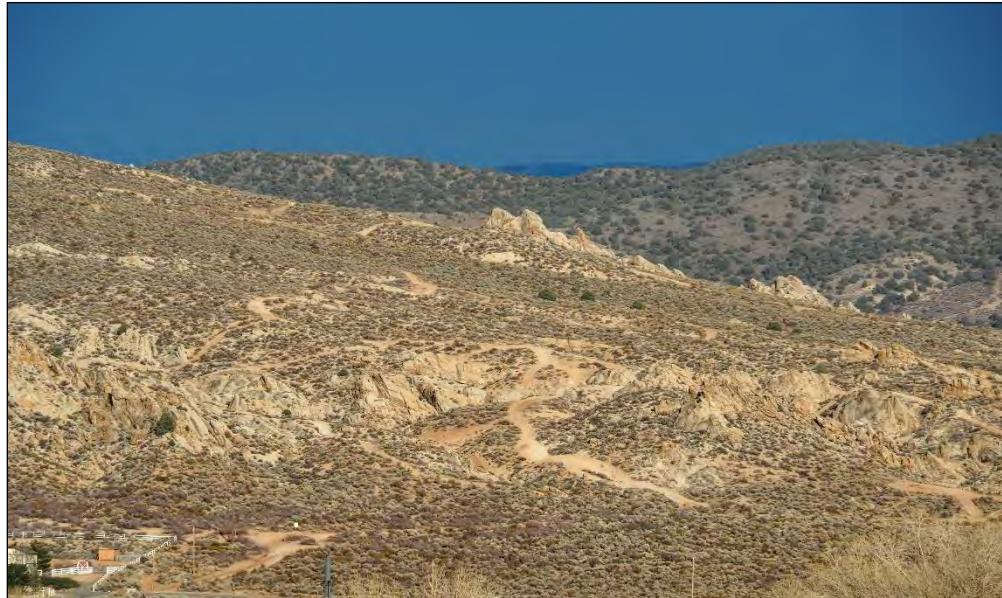
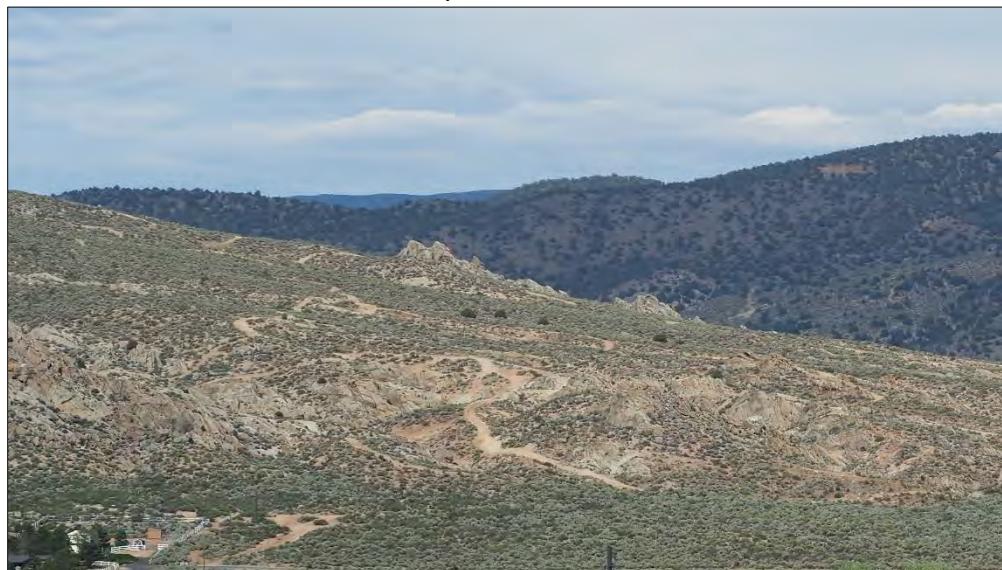
Photo Point 15A (view east): A photo point located off Topsy Lane above Center Drive to capture the full extent of the West Basin.

2020 Baseline Condition, photo taken February 1, 2020:
(GPS coordinates: 39.110186, -119.762719)

2022 Condition, photo taken June 22, 2022

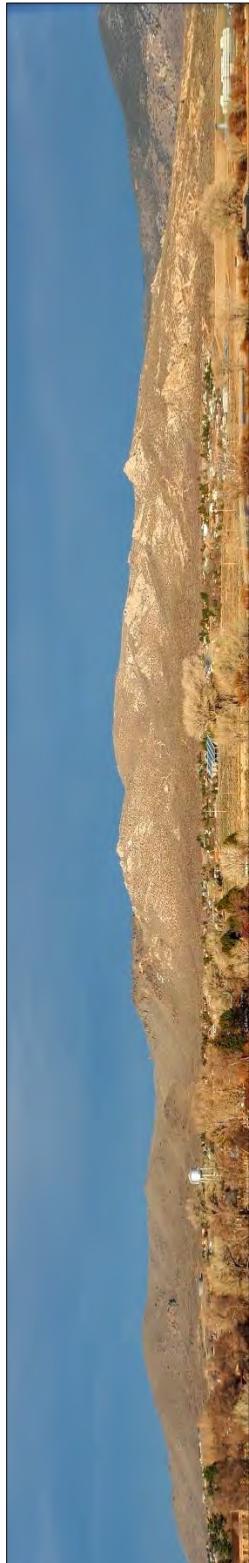
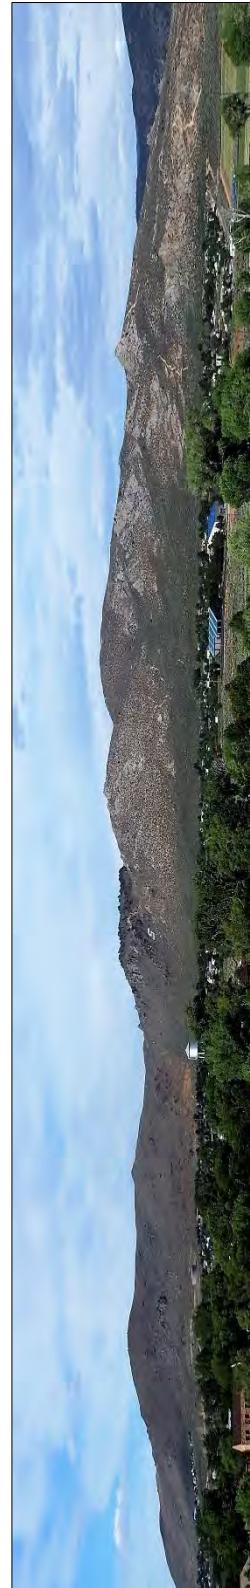
Photo Point 15B (view east): A photo point located off Topsy Lane above Center Drive that shows the entire west side of Prison Hill (panoramic).

2020 Baseline Condition, photo taken February 1, 2020:
(GPS coordinates: 39.110186, -119.762719)

2022 Condition, photo taken June 22, 2022

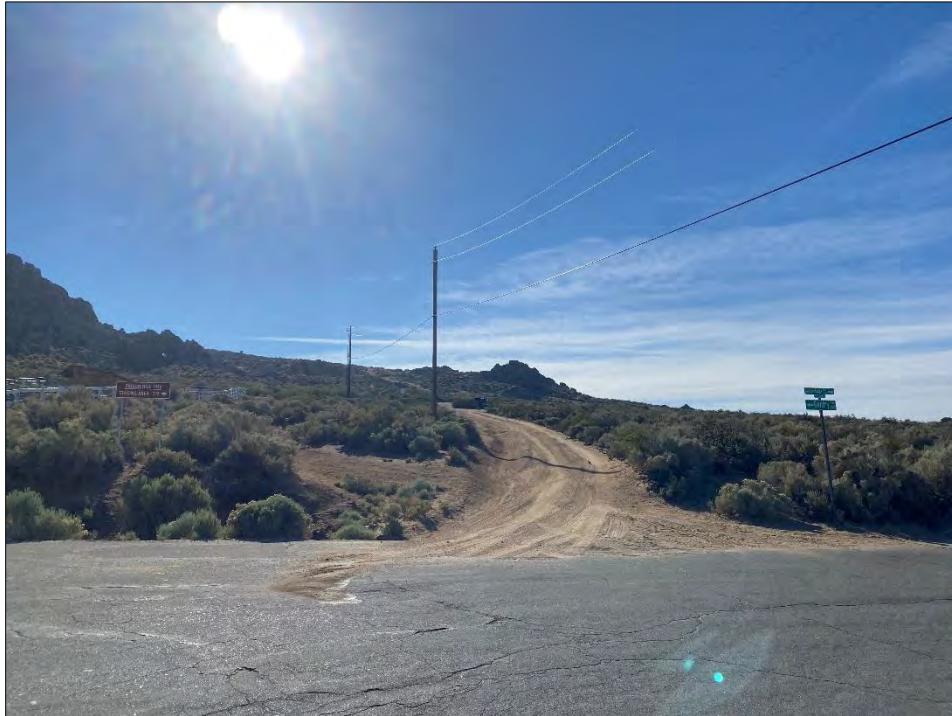
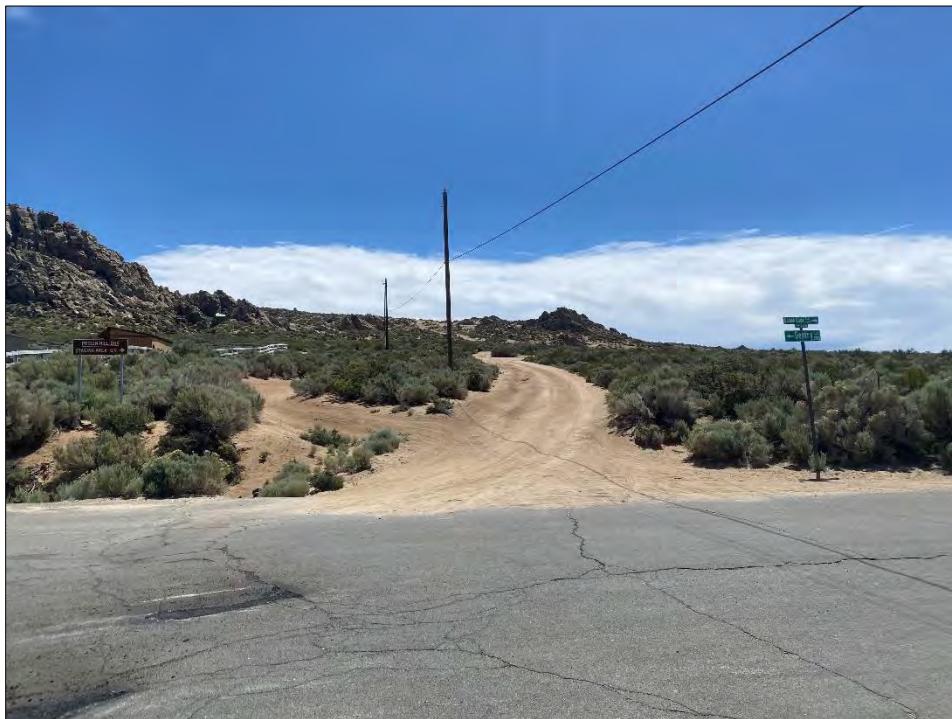
Photo Point 16 (view east): A photo point located at the Snyder Entrance taken from the mailboxes.

2021 Baseline Condition, photo taken June 17, 2021:
(GPS coordinates: 39.114, -119.739)

2022 Condition, photo taken June 17, 2022

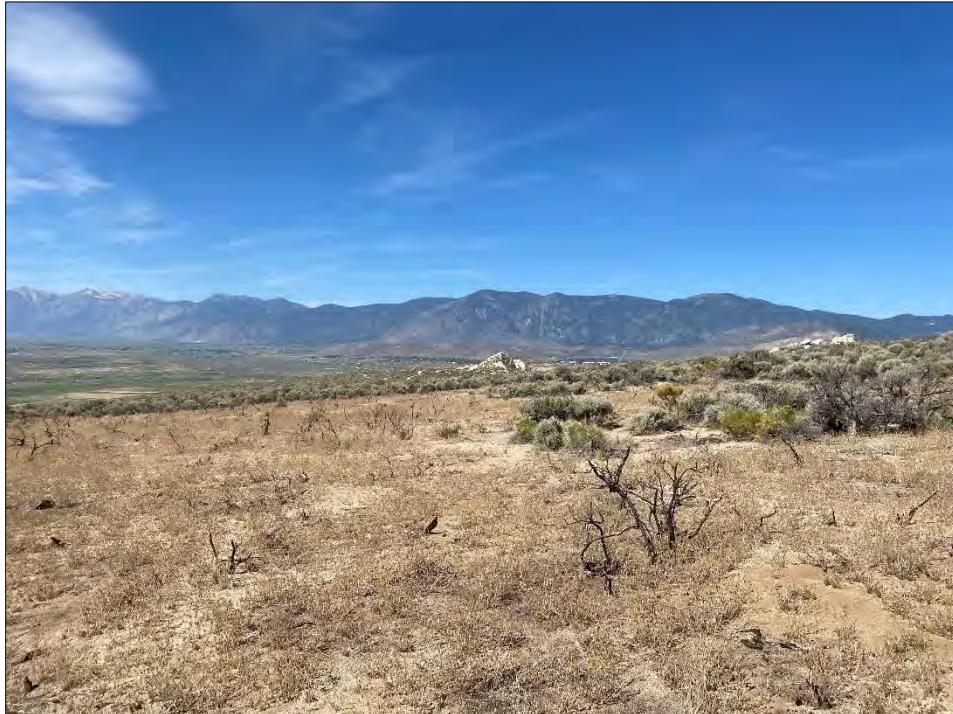
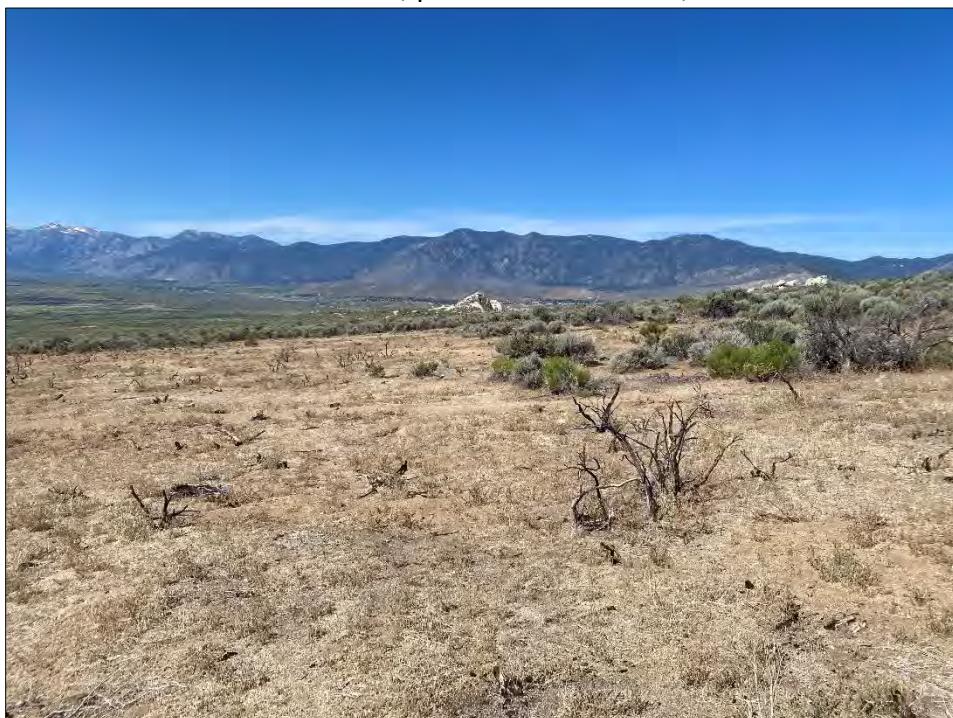
Photo Point 17 (view southwest): A photo point located at the new fire scar on Prison Hill.

2021 Baseline Condition, photo taken June 17, 2021:
(GPS coordinates: 39.122, -119.721)

2022 Condition, photo taken June 17, 2022

While a fire broke out on the north section of Prison Hill on July 2, 2021, burning 171 acres, the fire did not affect the OHV Area. Over the last year on red flag warning days (e.g. winds greater than 15 mph, relative humidity less than or equal to 25%, and temperatures greater than 75°F), PHRA OHV Area has been closed to prevent potential wildfire incidences.

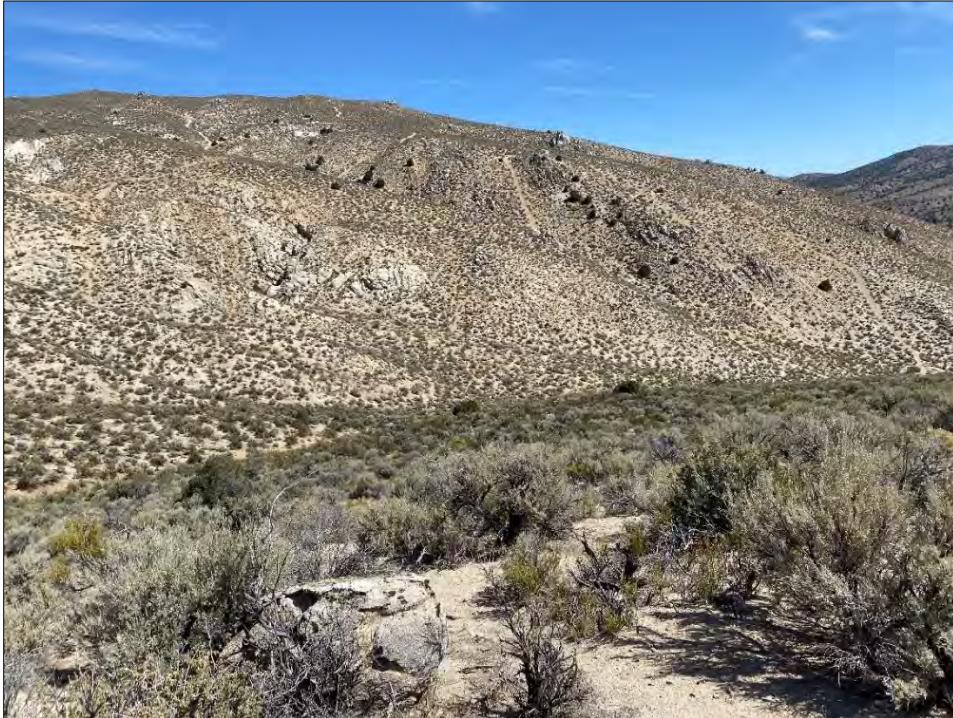
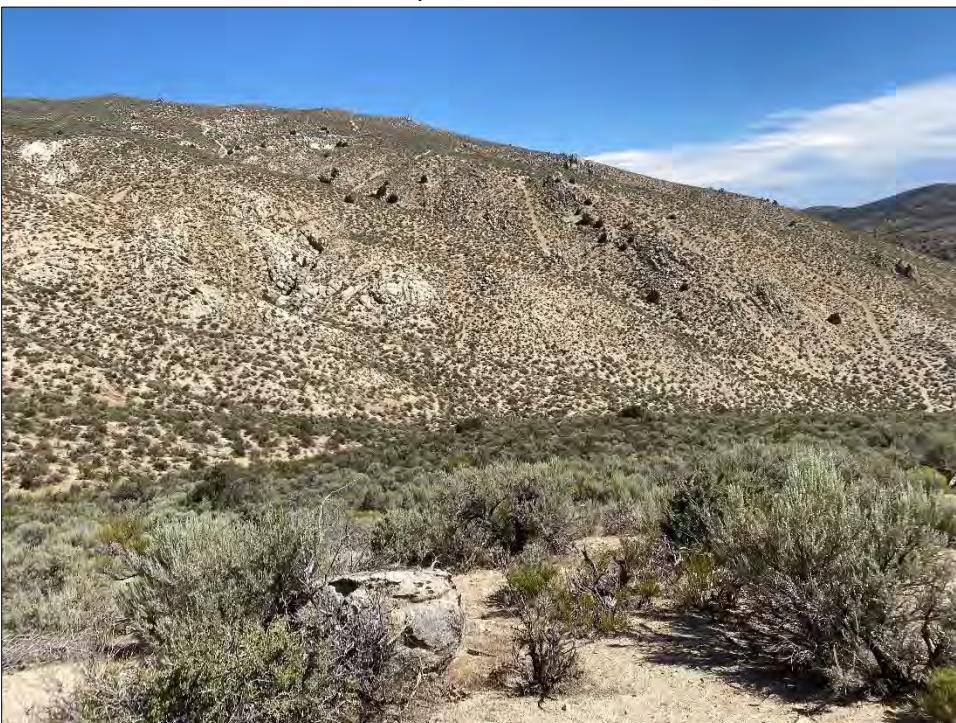
Photo Point 18 (view northwest): A photo point located near the viewpoint overlooking decommissioned trails in the Golden Eagle Open Space.

2021 Baseline Condition, photo taken June 17, 2021:
(GPS coordinates: 39.115, -119.714)

2022 Condition, photo taken June 17, 2022

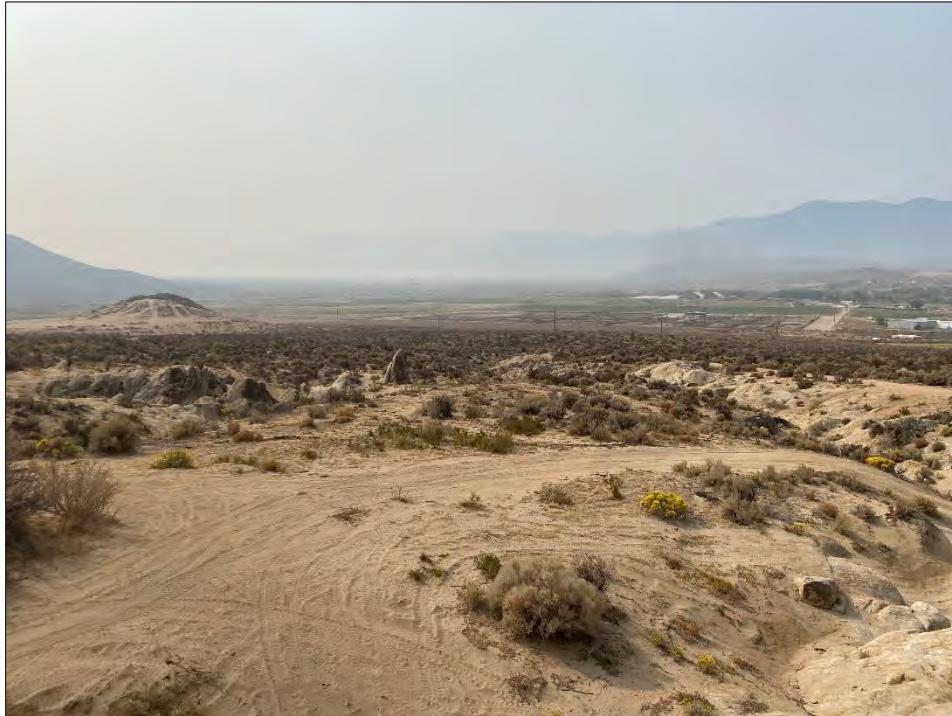
Photo Point 19 (view south): A photo point looking over Headlight Area Open Space.

2021 Baseline Condition, photo taken October 4, 2021:

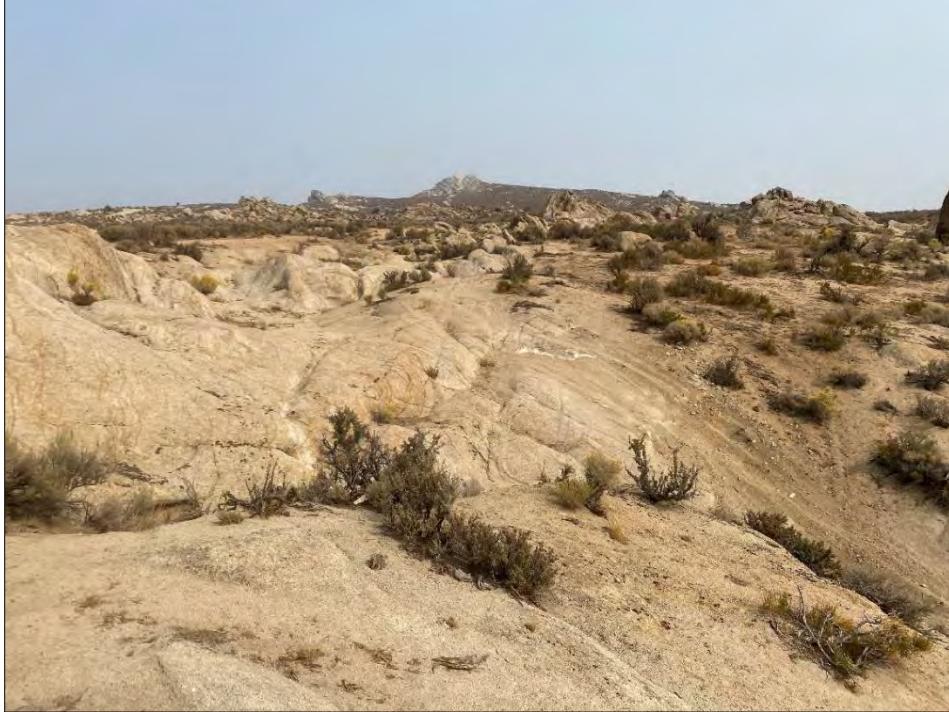
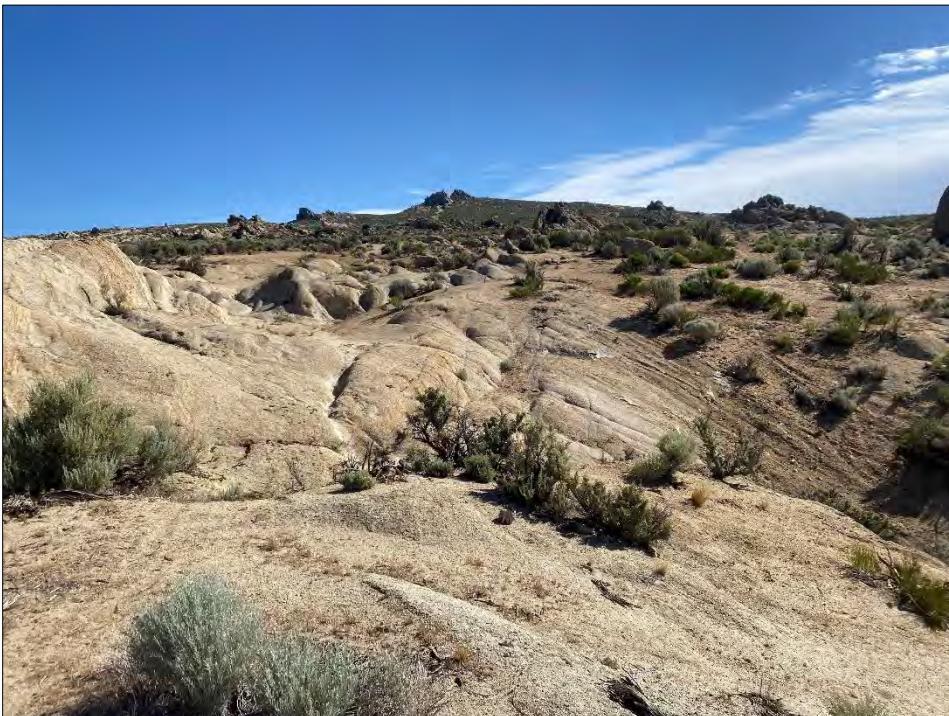
Photo Point 20A (view northwest): A photo point marking the end of the Headlight Open Space.

2021 Baseline Condition, photo taken October 4, 2021:
(GPS coordinates: 39.10925, -119.7337)

2022 Condition, photo taken June 17, 2022

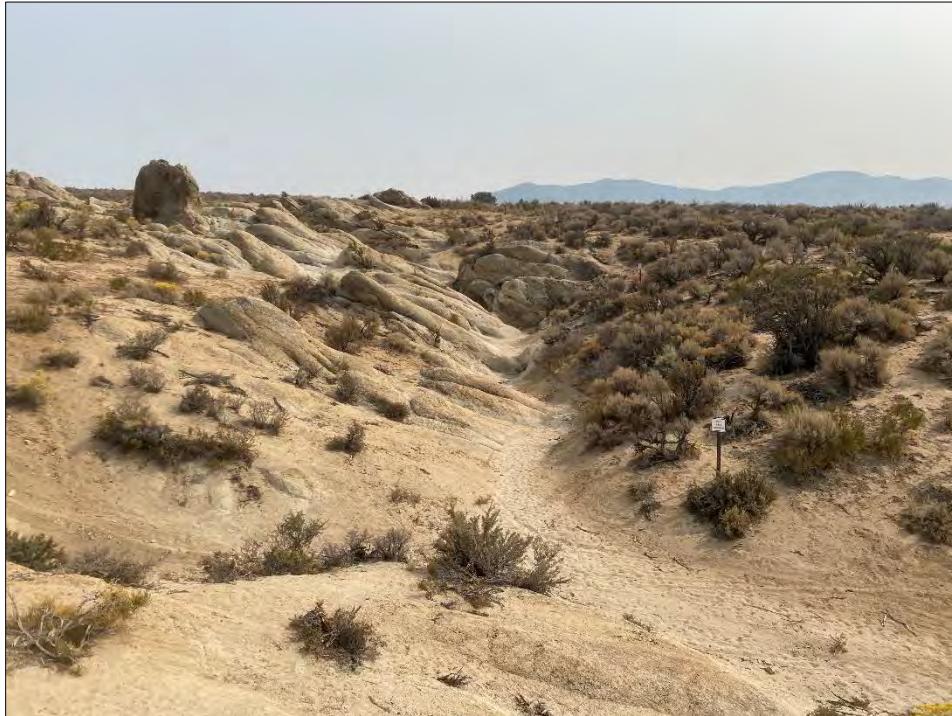
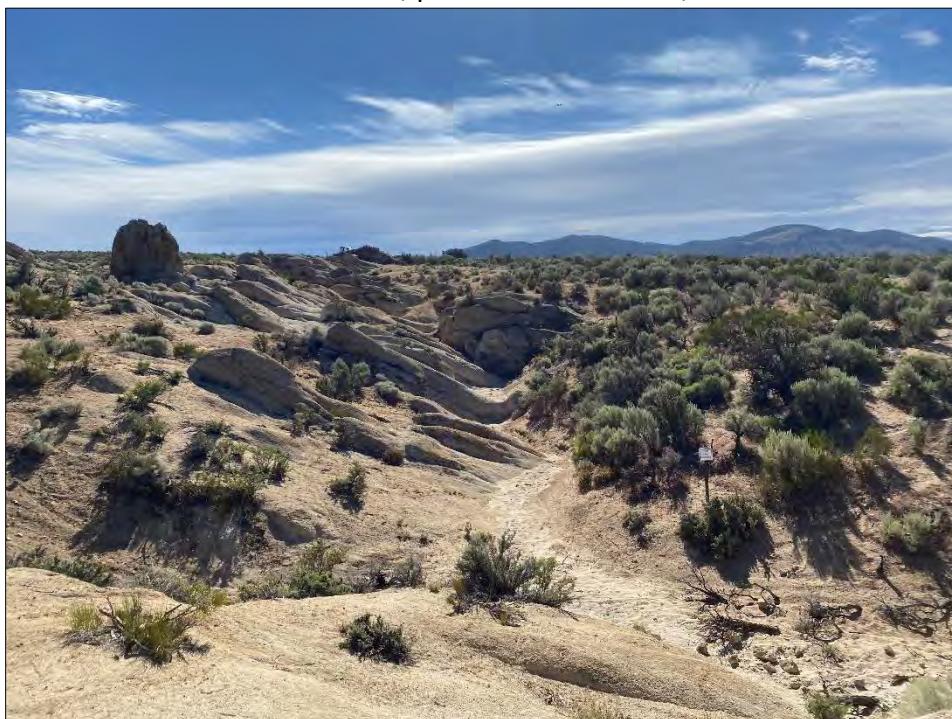
Photo Point 20B (view northeast). A photo point marking the end of the Headlight Open Space.

2021 Baseline Condition, photo taken October 4, 2021:
(GPS coordinates: 39.10925, -119.7337)

2022 Condition, photo taken June 17, 2022
