STAFF REPORT

Agenda Title: For Discussion Only: Review and discussion of the Prison Hill OHV Area Monitoring Report, and updates on the Prison Hill OHV Area. (*Lyndsey Boyer and Gregg Berggren*)

Carson City Open Space – Conservation Easement Monitoring

Prison Hill OHV Area – Monitoring Report

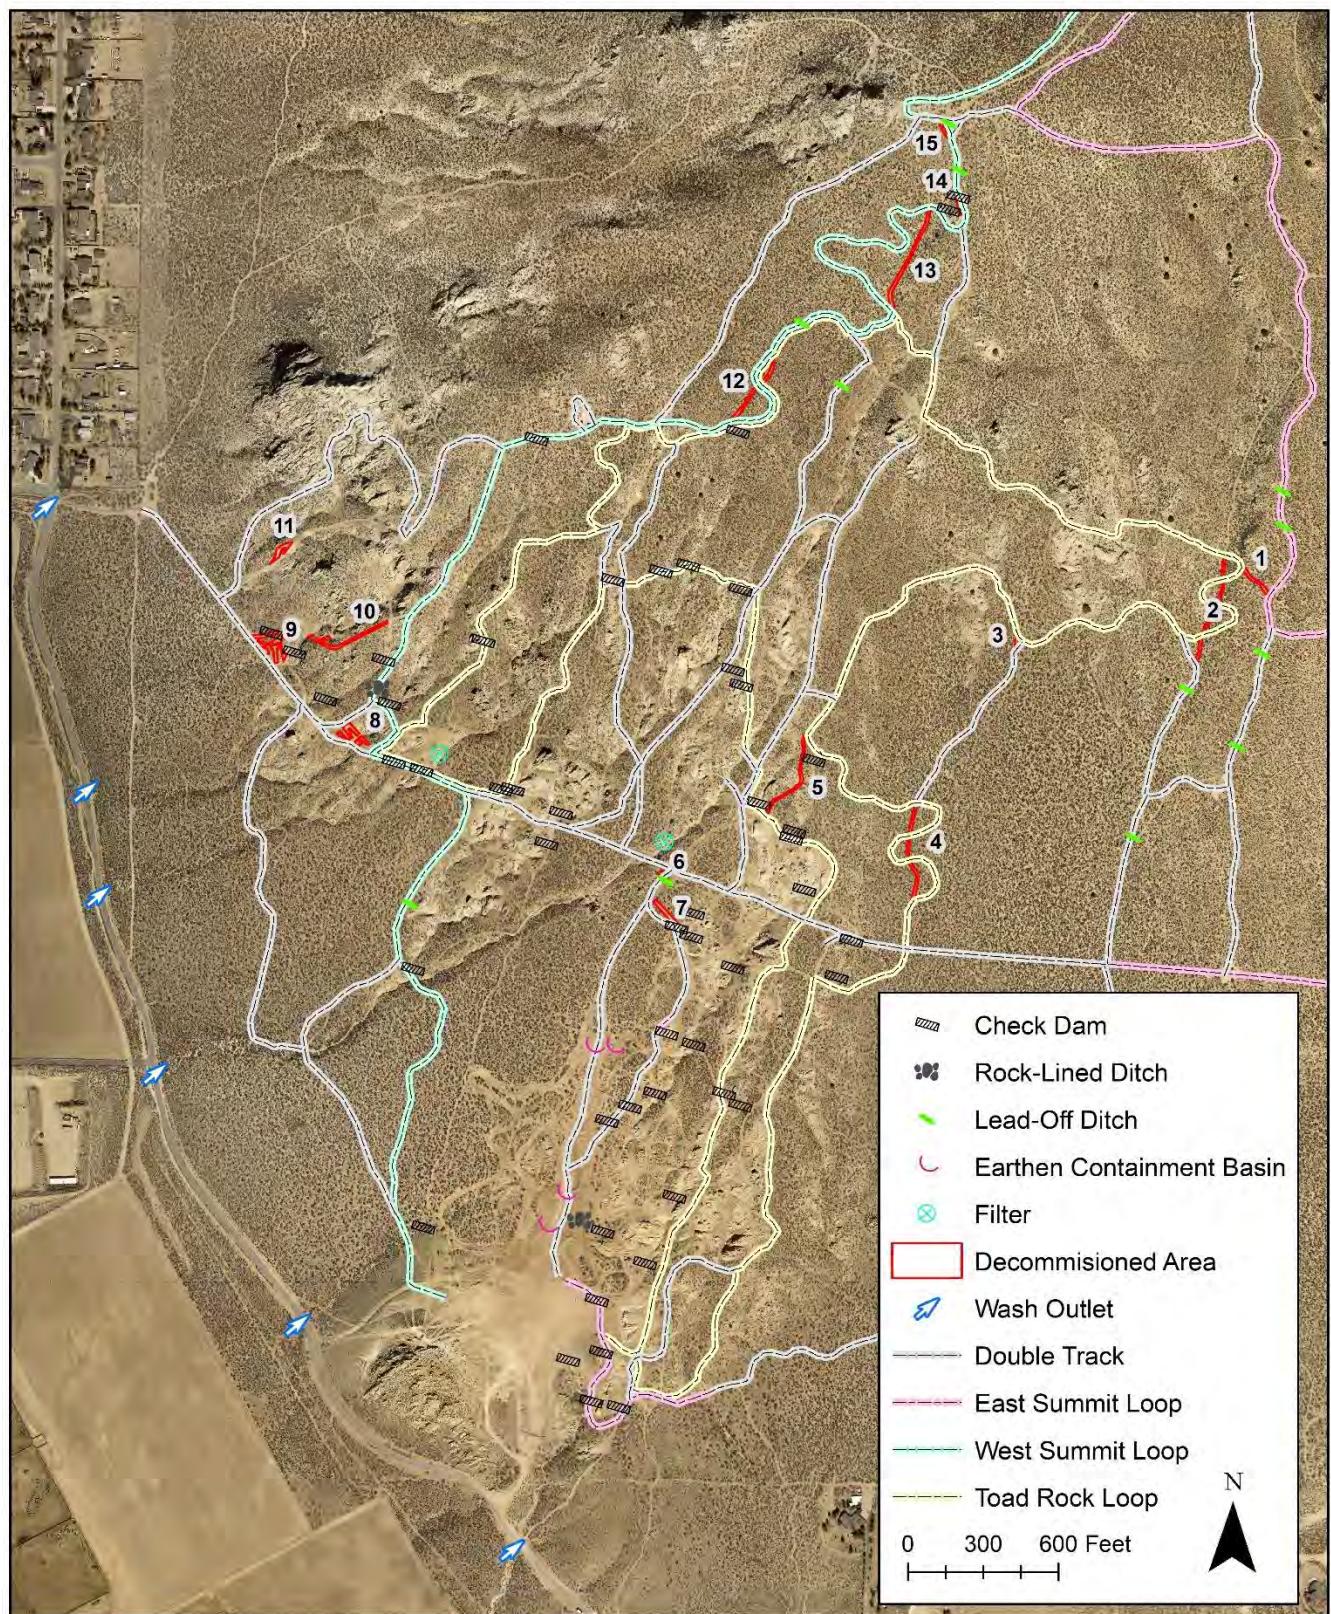
Figure 2.

2021/2022 As-Built Map

Carson City contracted Horizon Construction, Inc. for the Prison Hill OHV Improvement and Stabilization Project from November, 2021 to April, 2022 (Appendix, Figure 2). In total, 15 areas were decommissioned, which included ripping and scarifying, broadcast seeding, and installing vertical mulch. In addition, 50 check dams, two rock-lined ditches, 12 lead-off ditches, four earthen containment basins, and multiple water bars (i.e. rolling dips) were constructed at regular intervals throughout the site to reduce the velocity and volume of potential erosion. Lastly, two filters were installed in challenging wheeler routes (Gunslinger and Death Walls) to prevent novice riders from entering with underequipped vehicles.
