STAFF REPORT

Agenda Title: For Possible Action: Discussion and possible action regarding the annual monitoring report for the Horsecreek Ranch Conservation Easement for 2022. (Lyndsey Boyer, lboyer@carson.org)

Exhibit A: 2022 Horsecreek Ranch Conservation Easement Monitoring Report

Carson City Open Space – Conservation Easement Monitoring

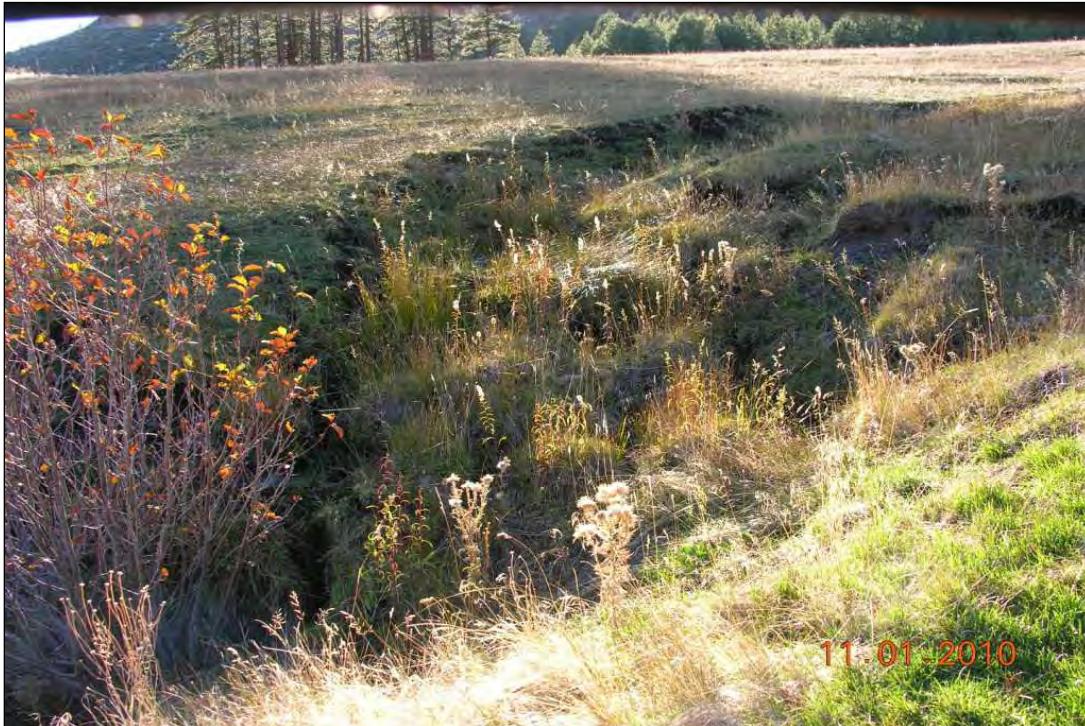
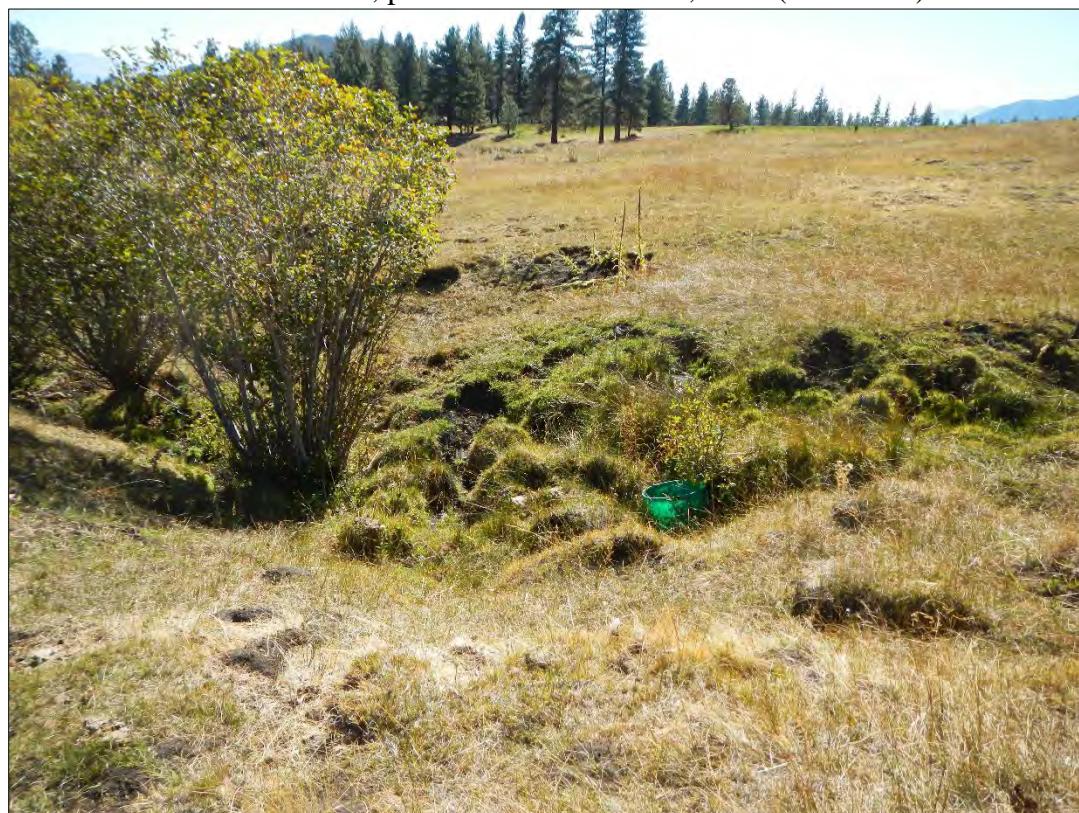
Photo Point: The photo of this drainage, located south of the cabins, has been included to document change and vegetation growth. N 39 07' 42.7" W 119 50' 10.2"

Near the southeast corner, one specific area is being monitored for landscape change. This low drainage area of the meadow appears to be vegetated and stable, though a few isolated mounds or hummocks may be the result of cattle trampling. A qualitative assessment with the photo comparisons may be deceptive due to the time of year each photo was taken – either during the growing season or at the end of the season after grasses were grazed and/or senesced. Monitoring completed in 2022 illustrates that the area is susceptible to seasonal changes based on precipitation, but overall the hummocks appear to be stable and not increasing in size or scale. Additionally, the new headcut observed in 2017 on the creek northeast of the cabins was monitored in 2022 and appears to be revegetating naturally, although certain pockets showed signs of scouring with new soil exposed. This site and associated reach of creek should continue to be monitored in future years to confirm successful revegetation of the headcut, or to document change in size or location, as it could migrate upstream. The previous owner of the property, Mr. Fagen had previously applied for USDA EQIP grants to fund the design and repair plan for the existing headcuts on the property. Access challenges and a lack of available contractors willing to complete the work prevented successful funding awards for this project. In the future, a conservation organization such as the Great Basin Institute or Nevada Division of Forestry could be contracted to complete the work through non-mechanized means, which would mitigate the access and contractor availability challenges. We advise mitigation to be explored and hope a repair design is revisited.

2010 Condition, photo taken November 1, 2010 (initial assessment – view west)

2022 Condition, photo taken October 14, 2022 (view west)

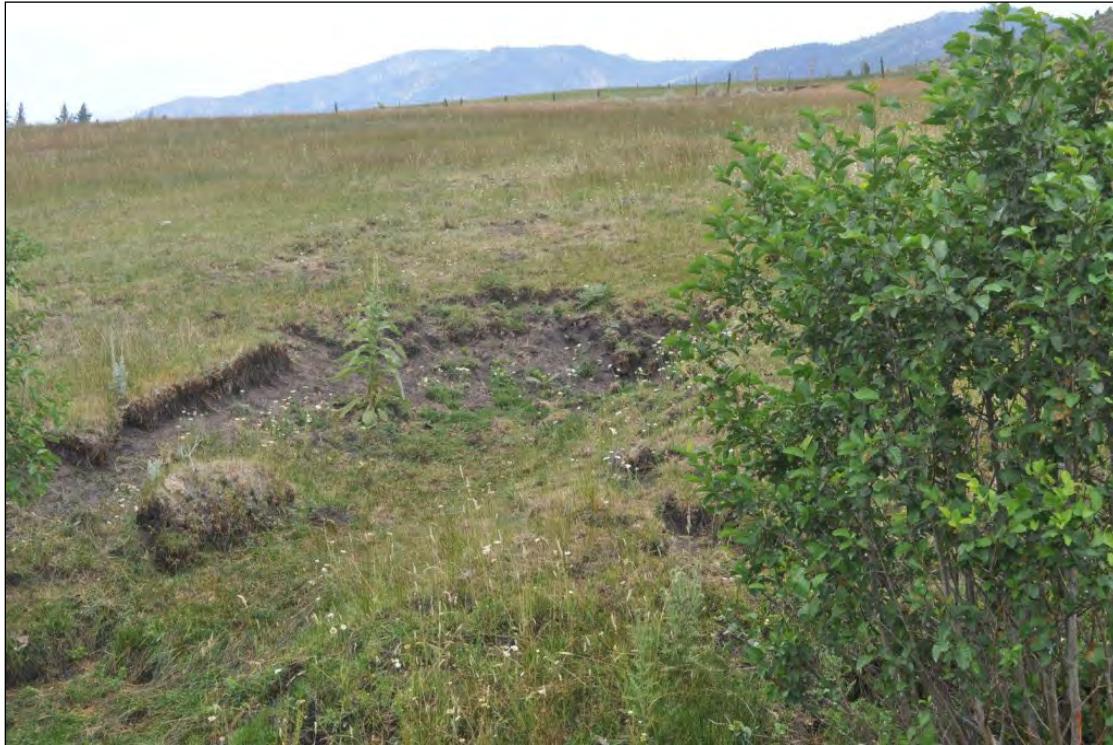
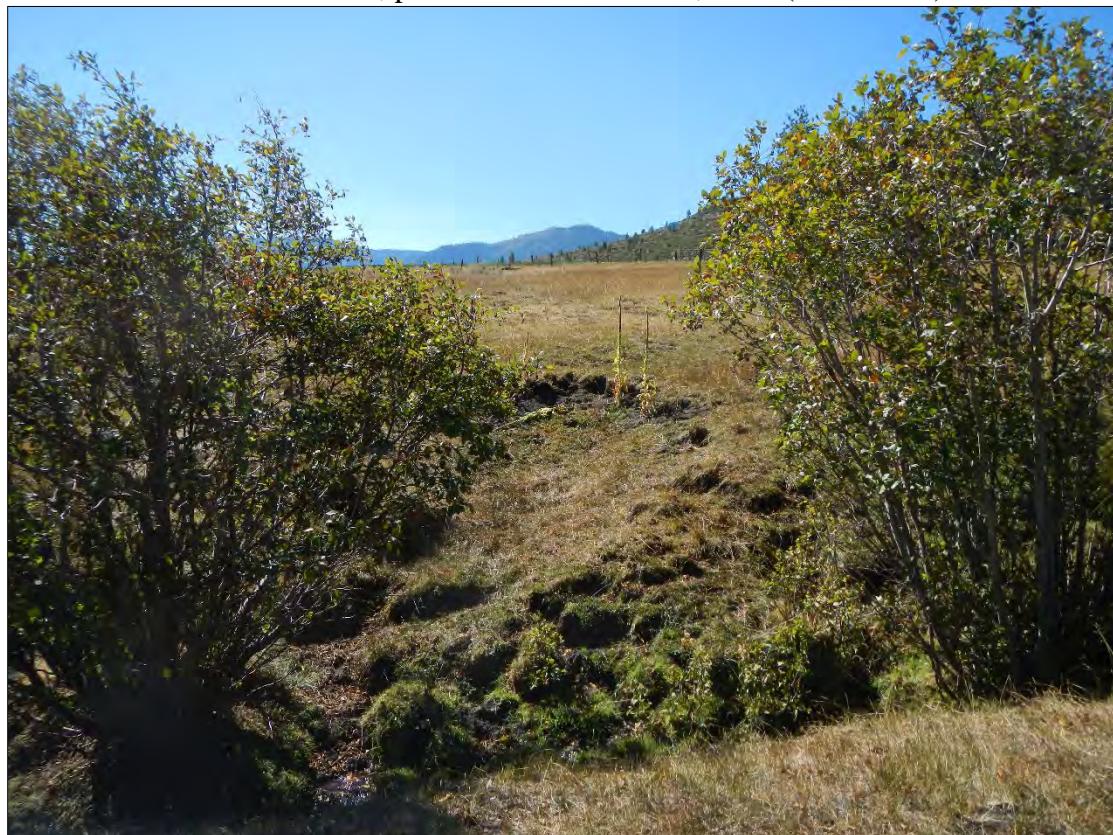
2013 Condition, photo taken July 23, 2013 (initial assessment – view south)

2022 Condition, photo taken October 14, 2022 (view south)

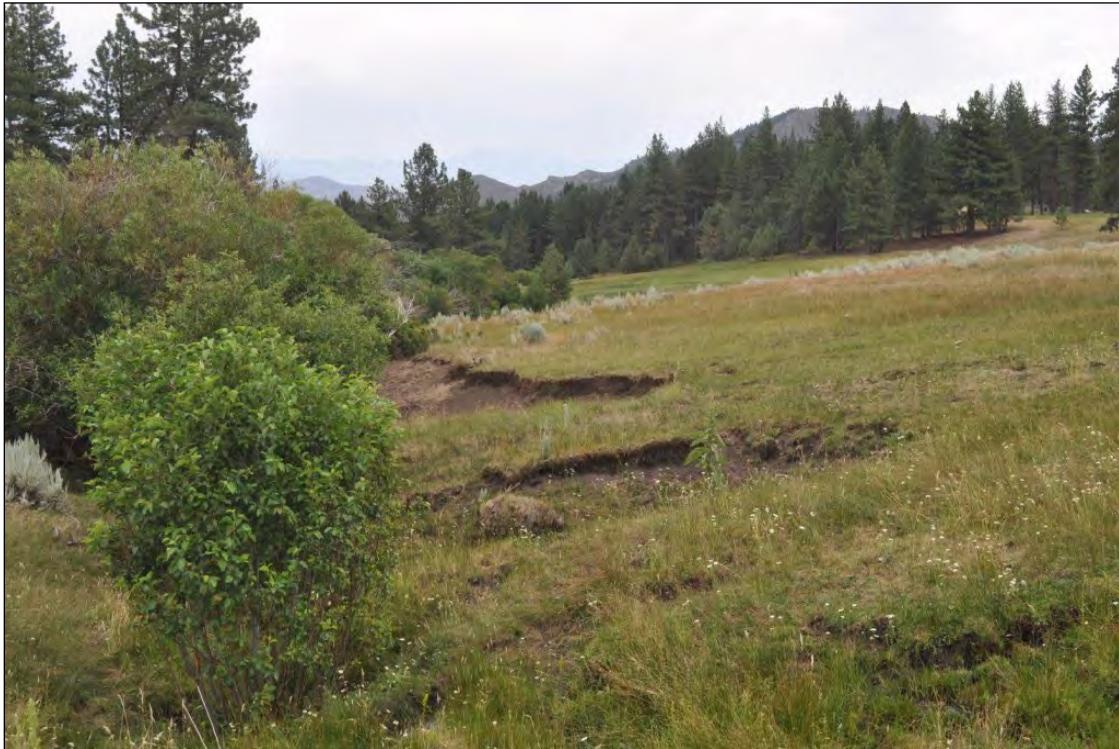
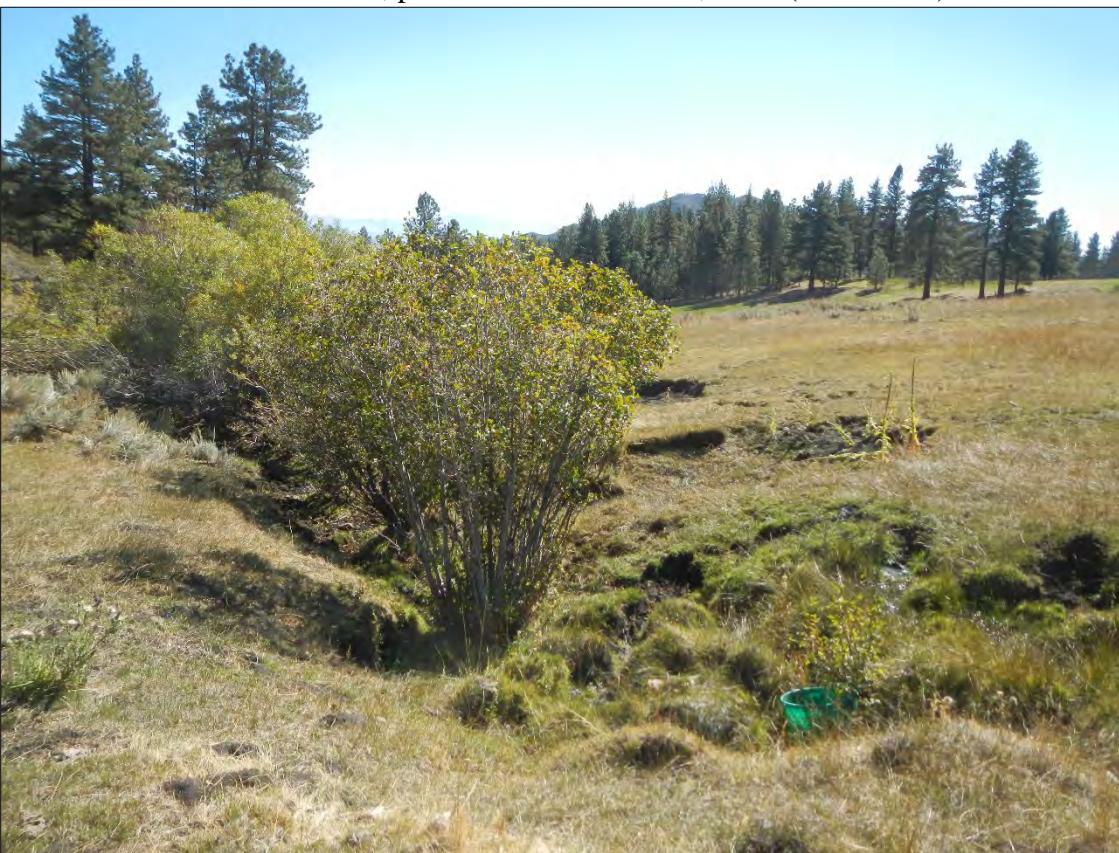
2013 Condition, photo taken July 23, 2013 (initial assessment – view south)

2022 Condition, photo taken October 14, 2022 (view south)

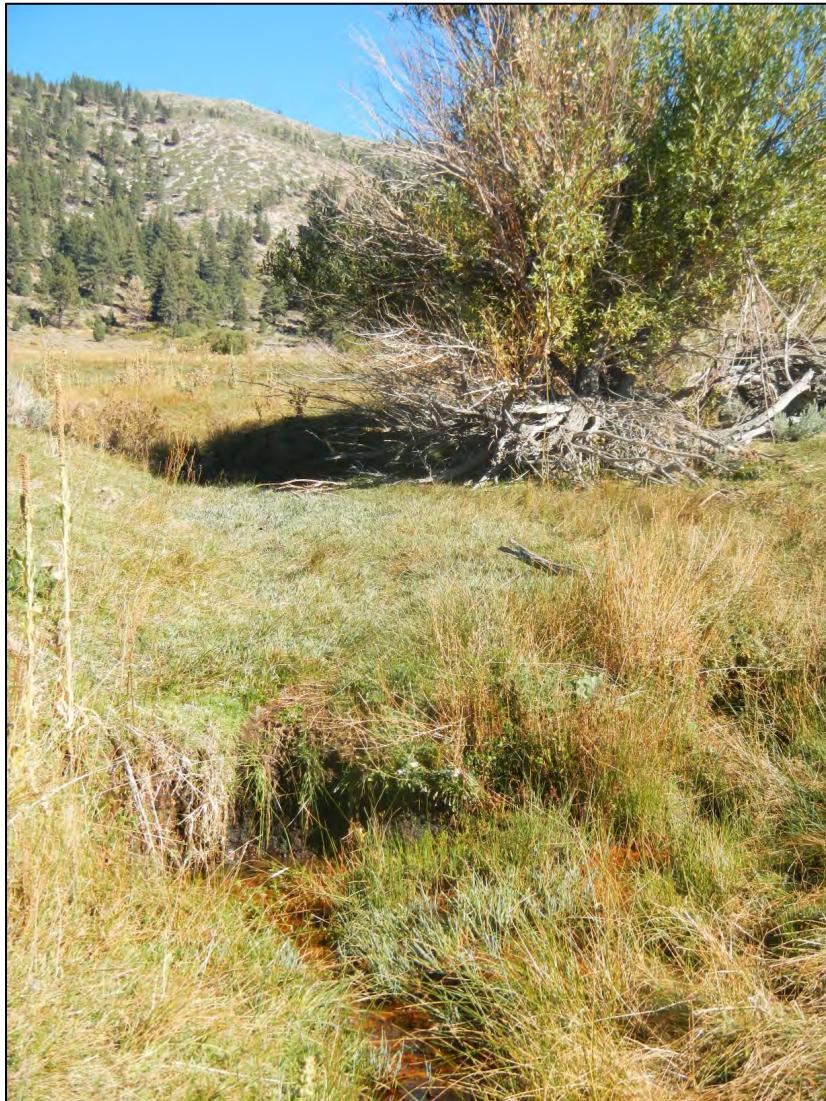
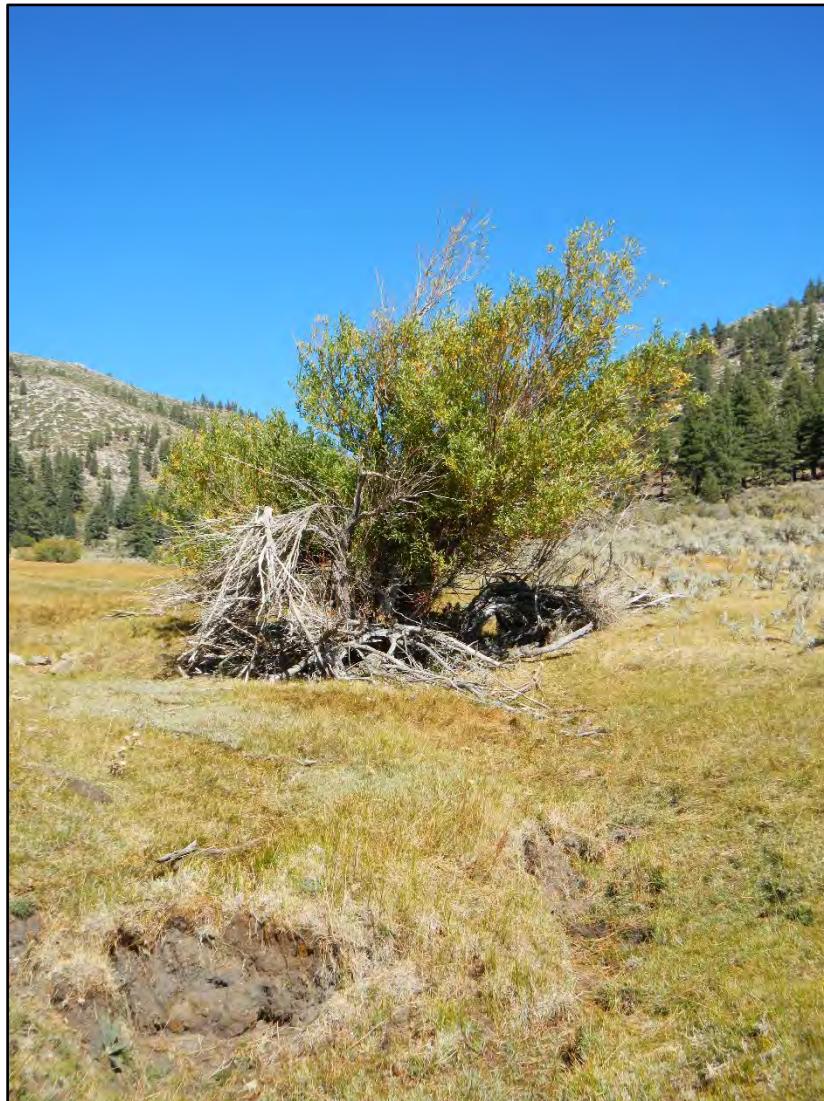
Photo Point: The photo of this headcut, located northeast of the cabins, has been included to document stream channel changes and erosion. N 39 07' 51.0" W 119 50' 11.4"

2018 Condition, photo taken October 8, 2018 (view north)

2022 Condition, photo taken October 14, 2022 (view north)

- 1) Continue to work to identify a mitigation strategy and repair plan for existing headcuts to be implemented in 2023.
- 2) Continued removal of bull thistle and potential forest thinning if possible.
- 3) Gate improvements at Kings Canyon Rd. The gate appears to be rotted and needs maintenance.

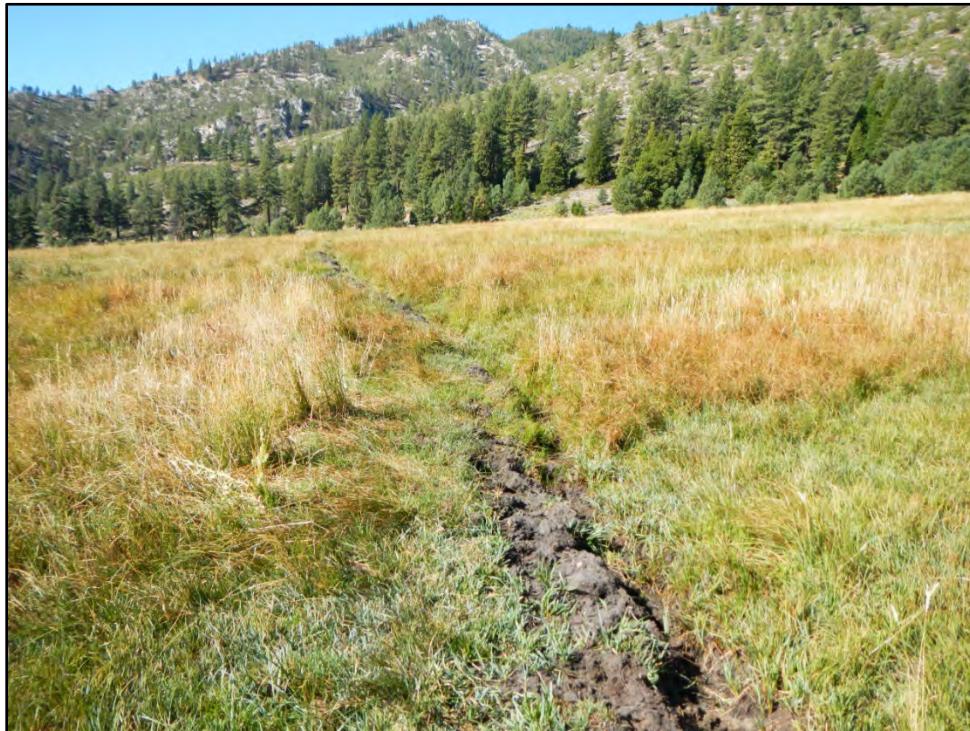
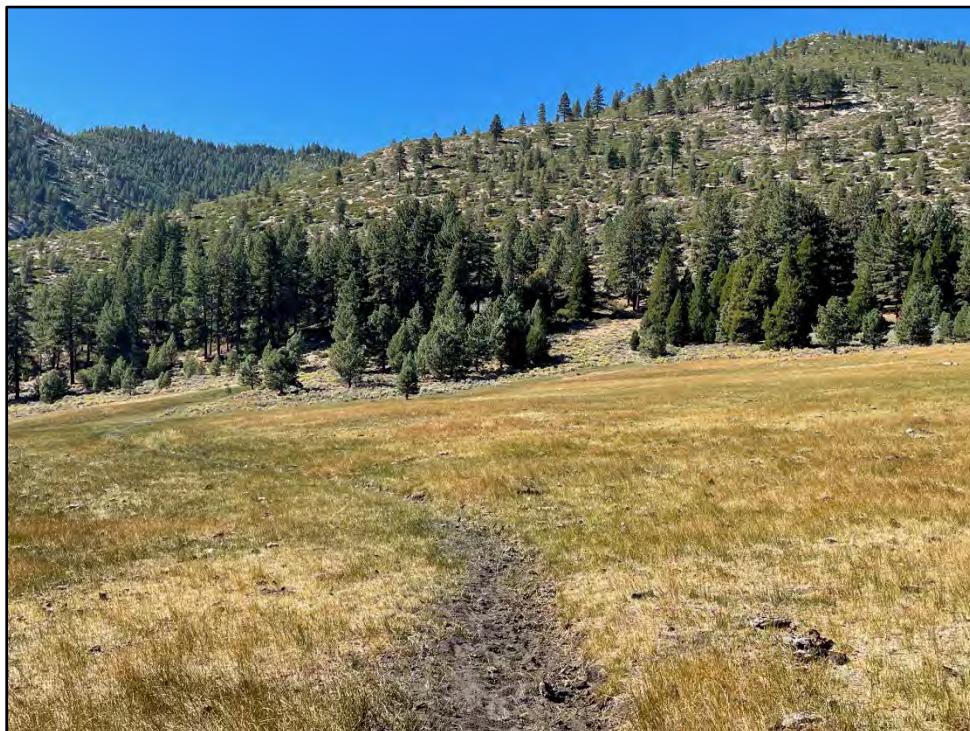
Photo Point: The photo of this lateral irrigation ditch, located in the upper meadow, has been included to document site improvements. N 39° 7' 58.1196"W 119° 50' 14.0172"

2019 Condition, photo taken September 12, 2019 (view west)

2022 Condition, photo taken October 14, 2022 (view west)

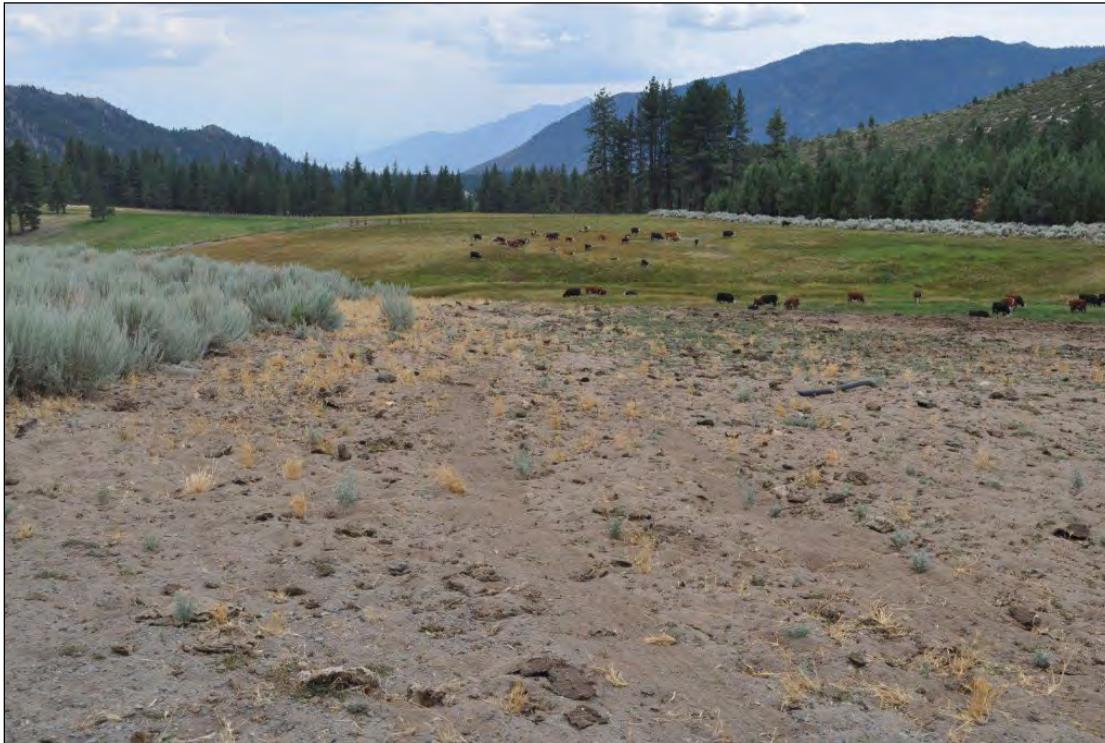
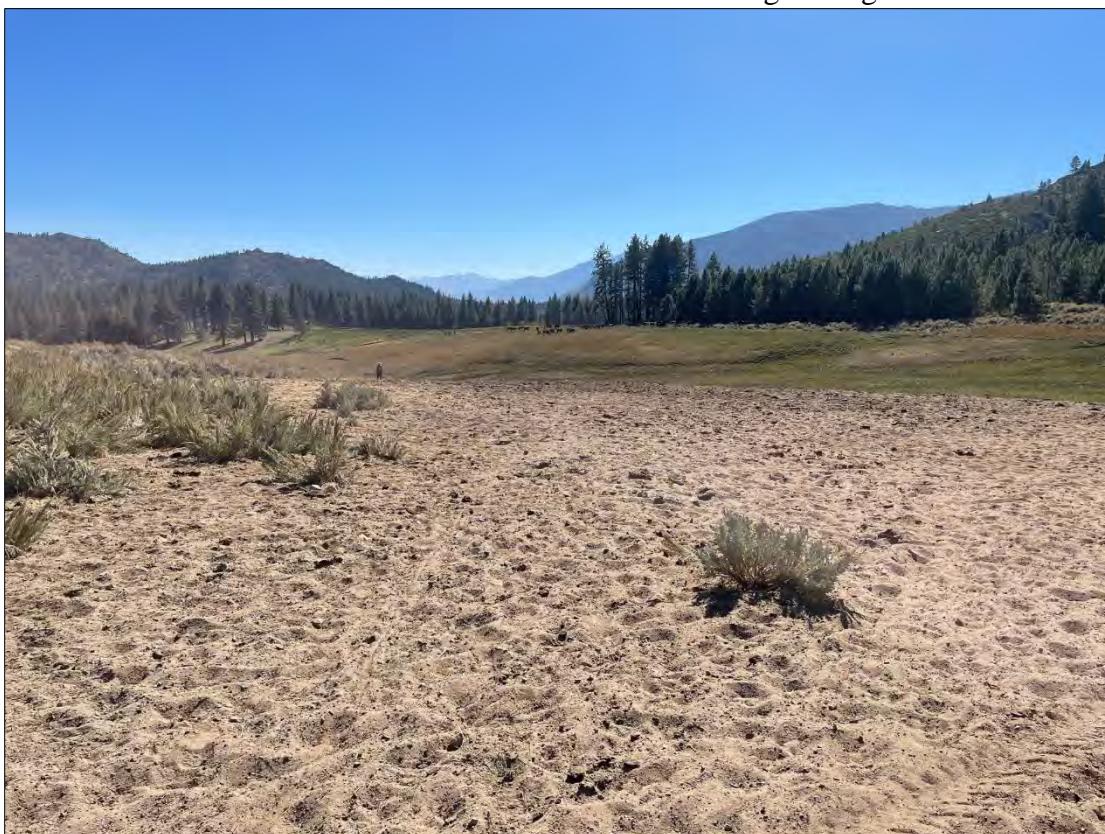
- The previous reports recommended the monitoring of the cattle loafing area located just outside the gated entrance to the cabins with the goal to limit further expansion. The following documentation provides photo points and respective measurements. The disturbed area consists primarily of cheatgrass and foxtail barley although sagebrush is successfully re-establishing on both the north and east edge of the disturbed area. The disturbed area has shown an overall increase in size over the last two monitoring cycles, and this monitoring period showed that the extent of the loafing area north-south has increased by 26 feet, while the extent east-west has decreased by 5 feet since 2020. Lastly, it is important to note that depending on the timing of monitoring, cheatgrass abundance and cover varies indicating that cattle are likely grazing the cheatgrass. Cows were not present for this field visit.

2013 Condition, photo taken July 23, 2013 (initial assessment – view south):
The bare area measures 157' north to south along the sagebrush.

2022 Condition, photo taken October 14, 2022:
The bare area measures 156' north to south along the sagebrush.

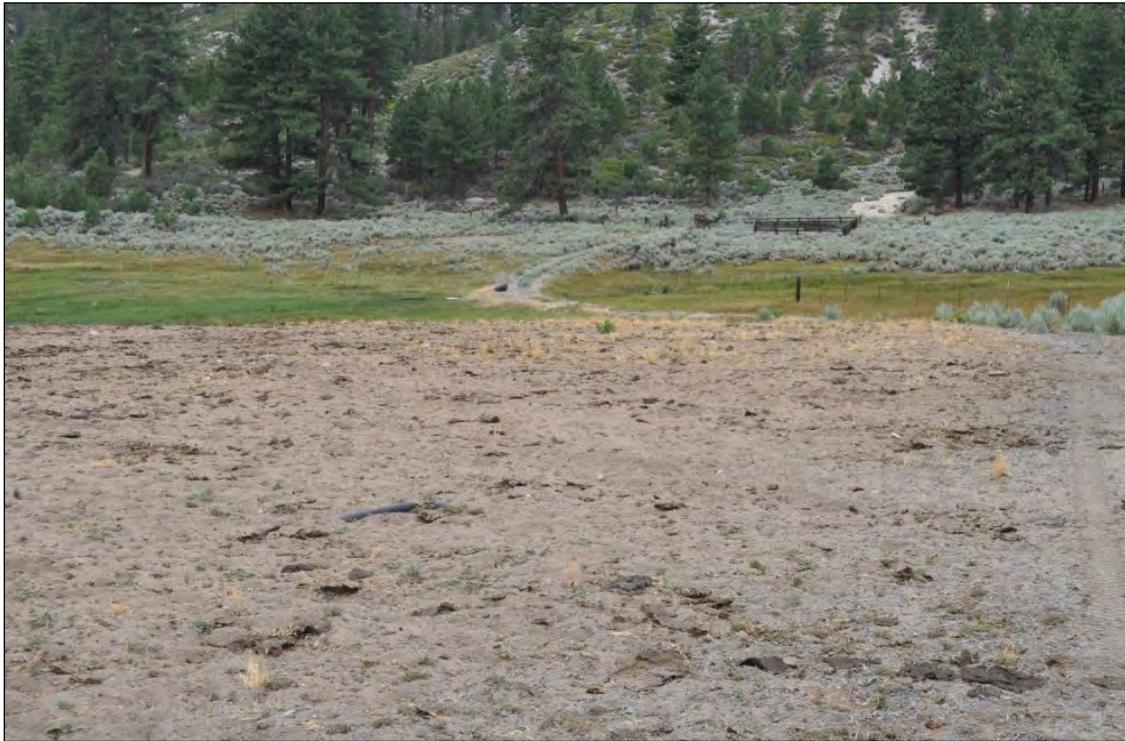
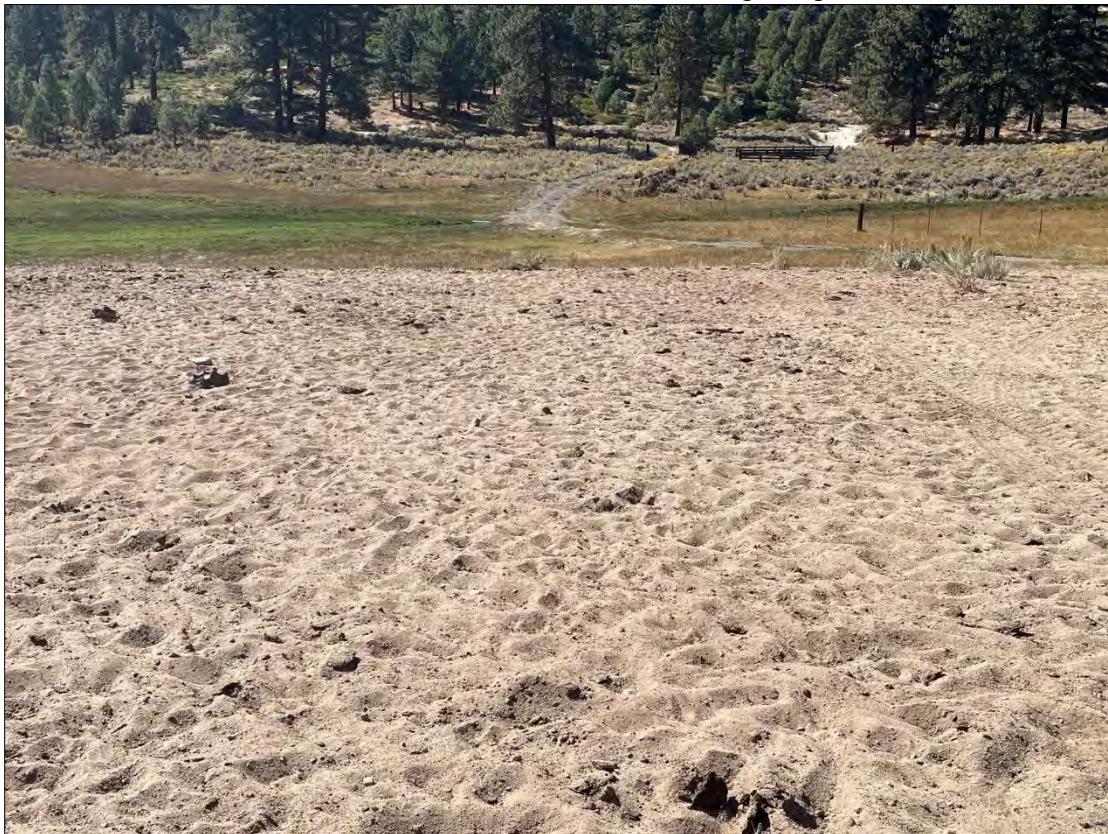
2013 Condition, photo taken July 23, 2013 (initial assessment – view west):
The bare area measures 145' east to west along the gravel road.

2022 Condition, photo taken October 14, 2022:
The bare area measures 106' east to west along the gravel road.

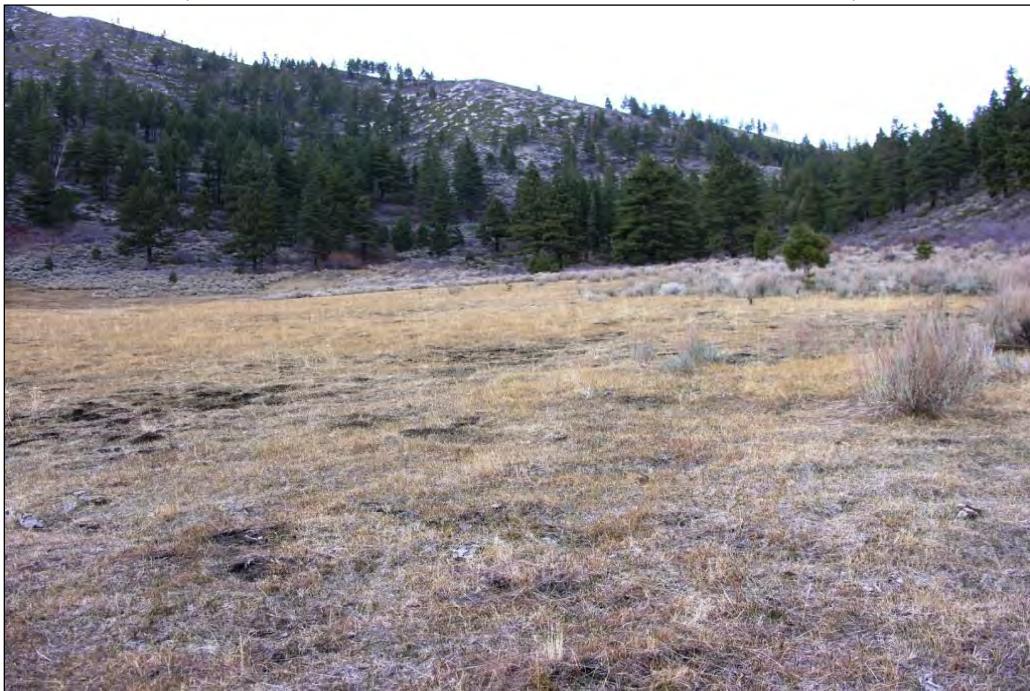
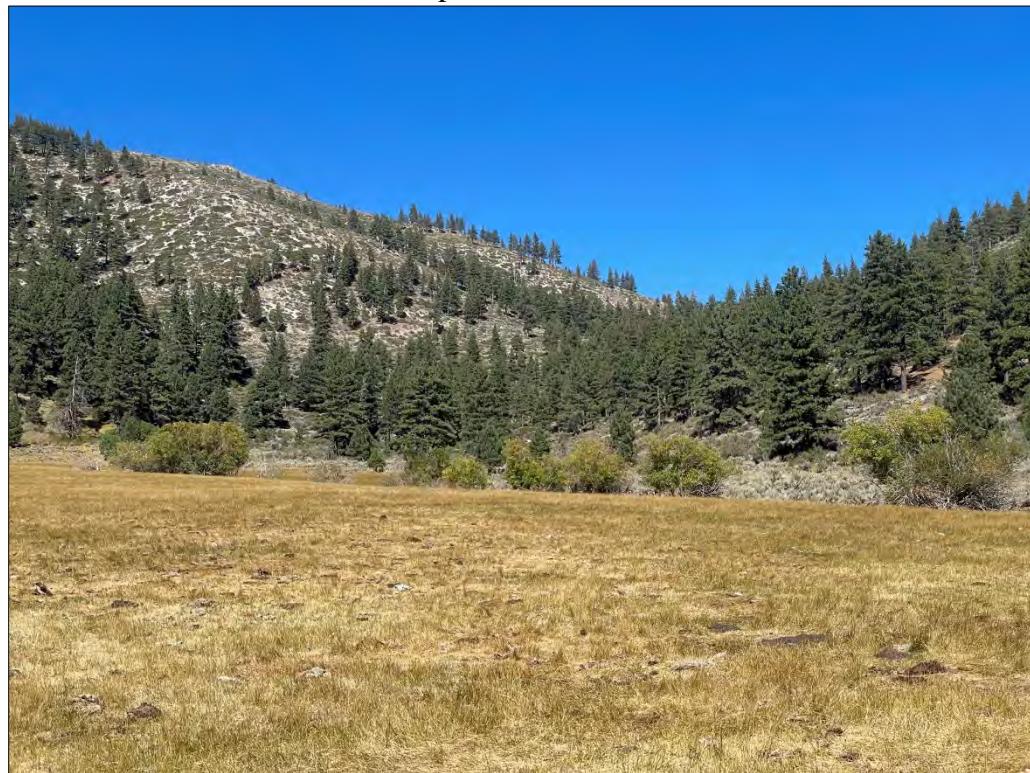
Photo Point 1A (view northeast): A photo point located at the edge of the shrub dominated granitic fan and the irrigated meadow. This would be used to monitor shrub invasion into the meadow area indicating irrigation problems.

2009 Baseline Condition, photo taken February 4, 2009:
(GPS coordinate: N39° 07' 54.912" W119° 50' 11.4")

2022 Condition, photo taken October 14, 2022

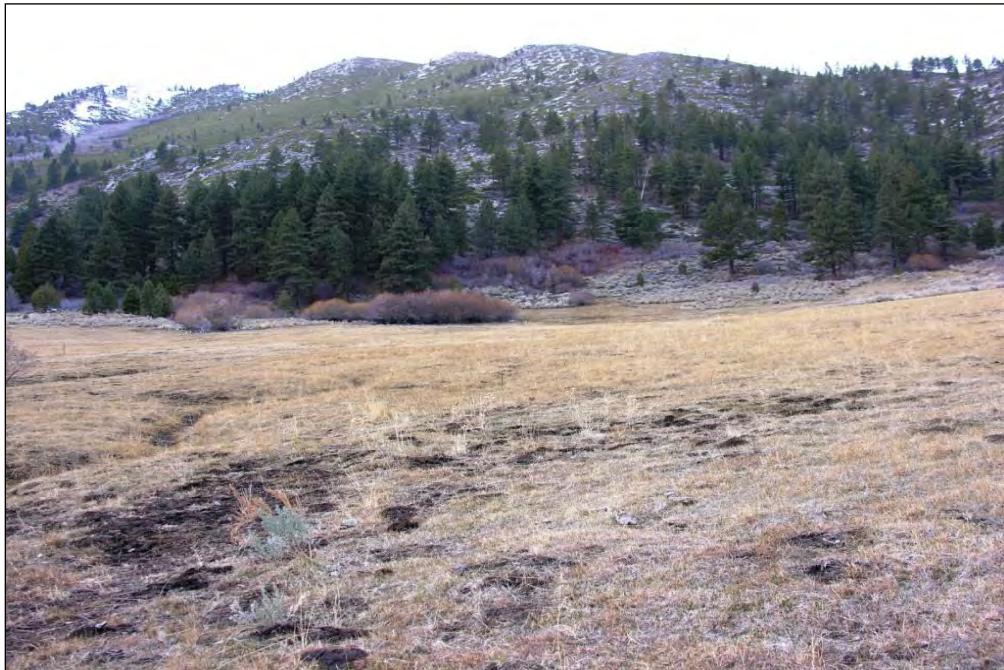
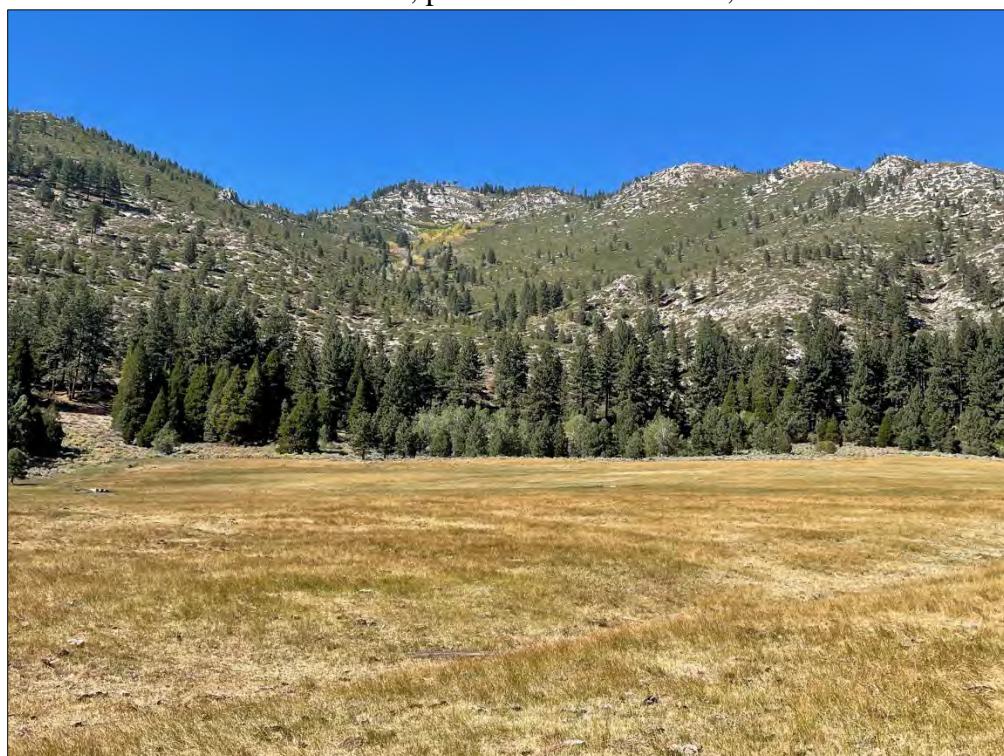
Photo Point 1B (view northwest): A photo point located at the edge of the shrub dominated granitic fan and the irrigated meadow. This would be used to monitor shrub invasion into the meadow area indicating irrigation problems. Note: This photo point is adjacent to the new headcut.

2009 Baseline Condition, photo taken February 4, 2009:
(GPS coordinate, different the PP#1A: N39° 07' 51.384" W119° 50' 11.04")

2022 Condition, photo taken October 14, 2022

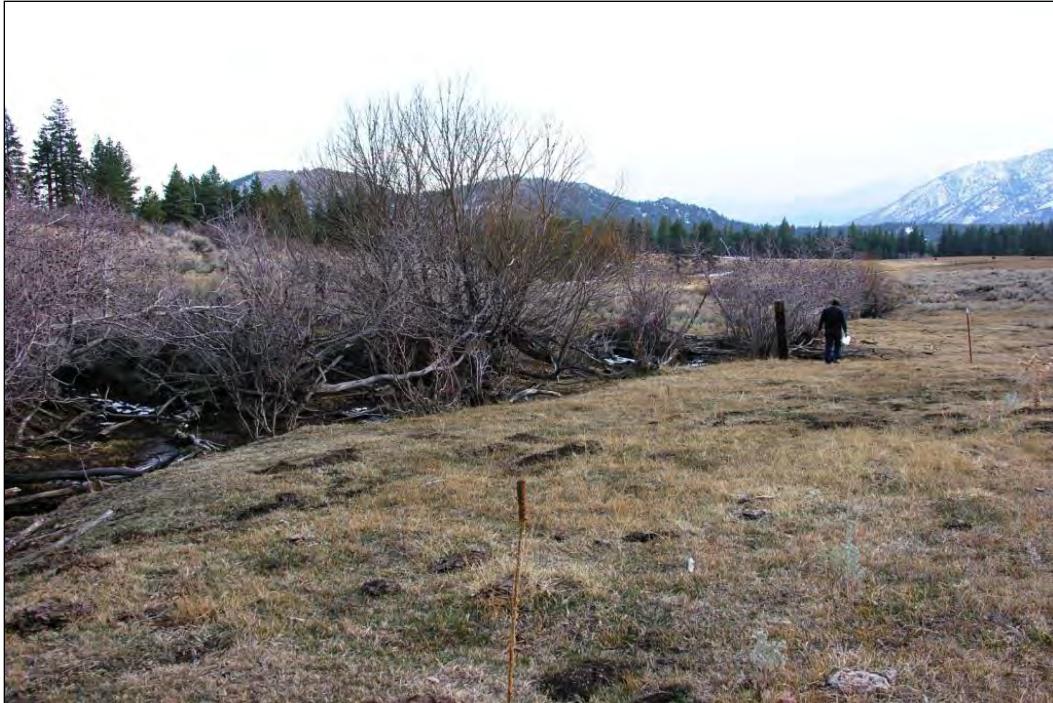
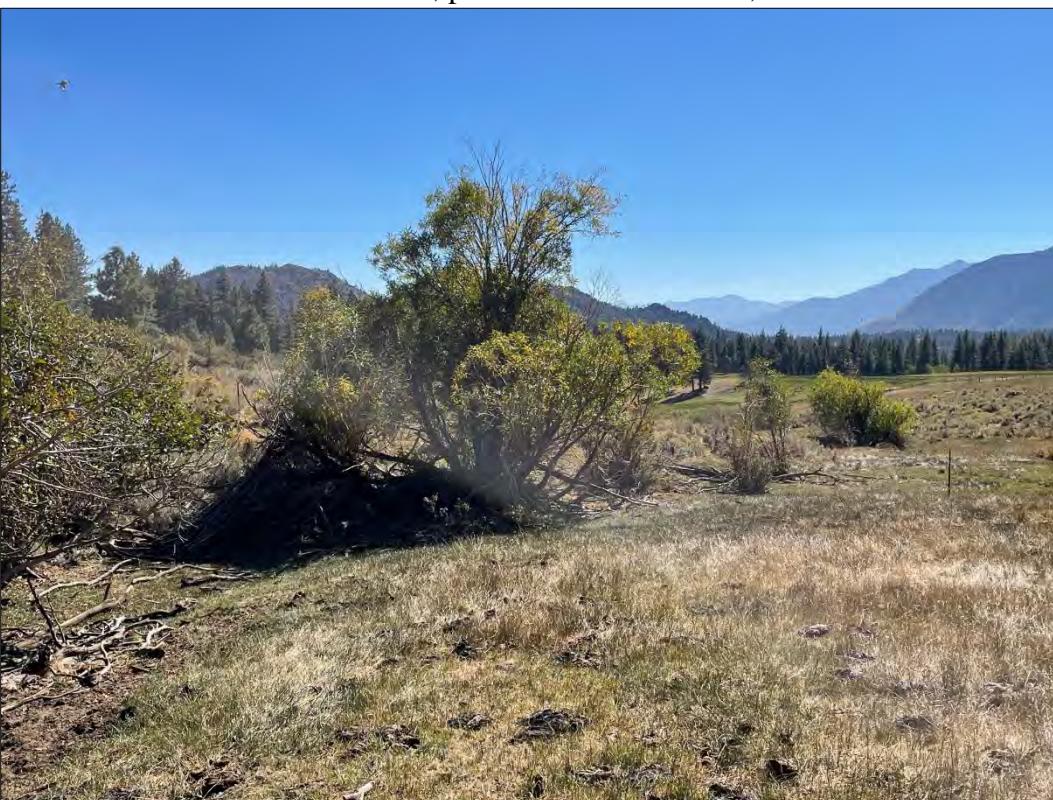
Photo Point 2 (view south): A photo point located in bottom of the active stable drainage channel to the southeast of the house to monitor side slope stability.

2009 Baseline Condition, photo taken February 4, 2009:
(GPS coordinate updated in 2010: N39 07' 54.9" W119 50' 11.3")

2022 Condition, photo taken October 14, 2022

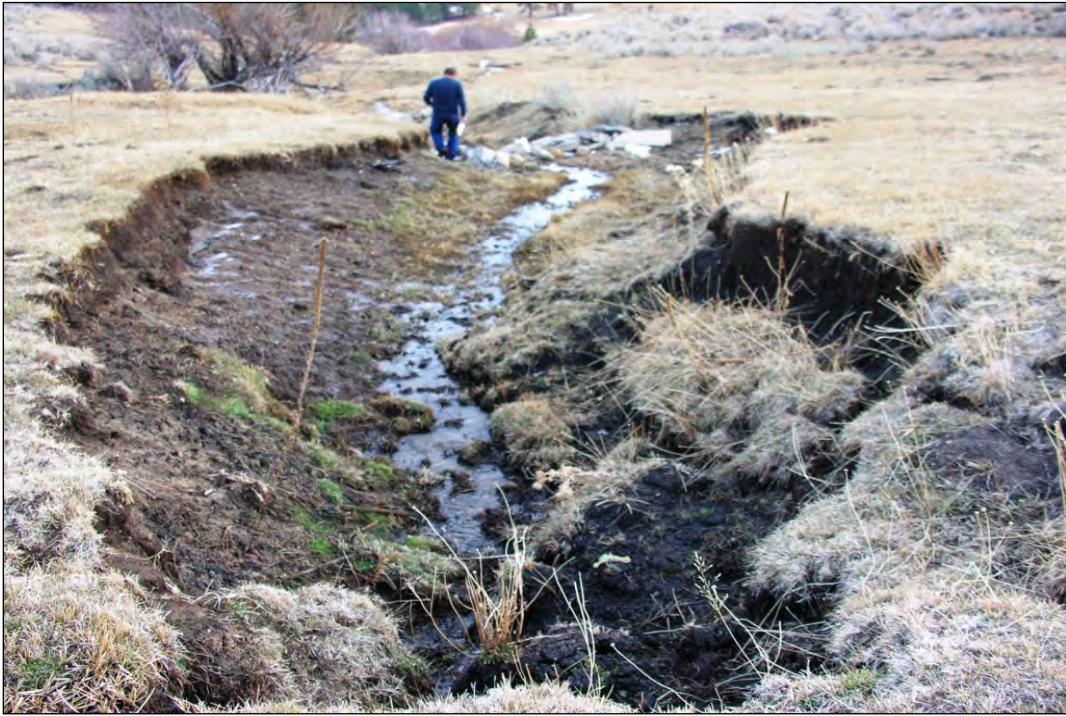
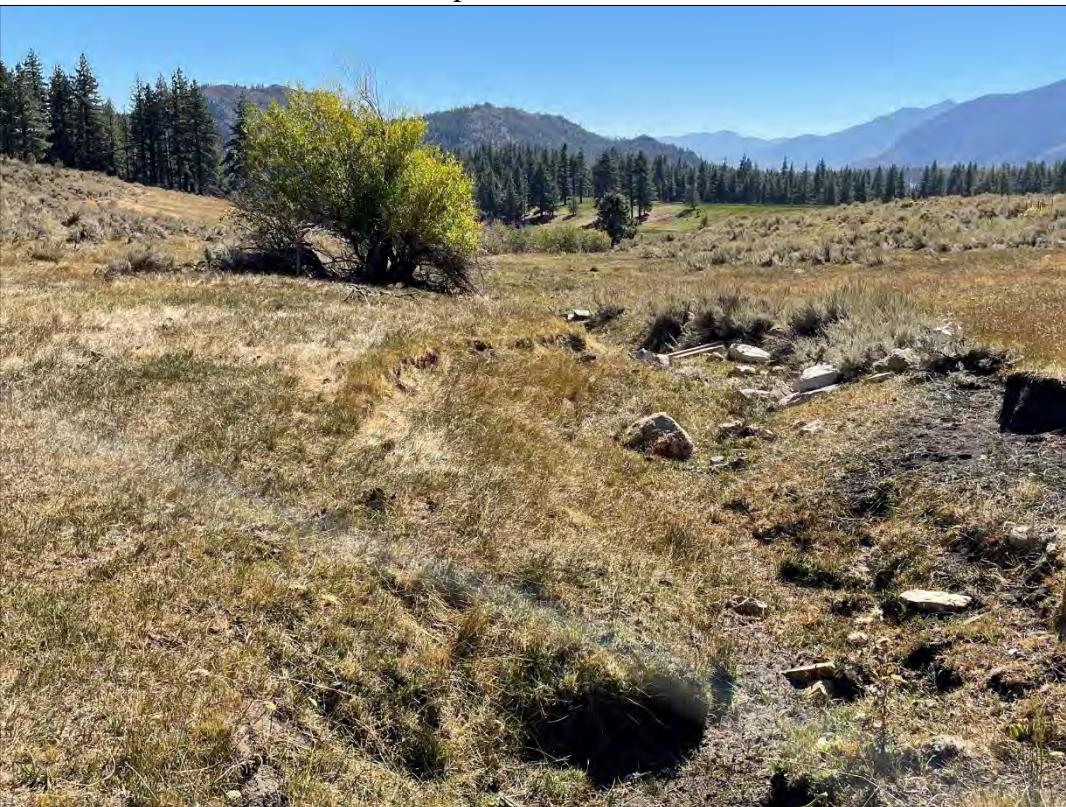
Photo Point 3 (view south): A photo point located immediately east of the house in the active channel where rip-rap has been placed for stabilization.

2009 Baseline Condition, photo taken February 4, 2009

2022 Condition, photo taken October 14, 2022

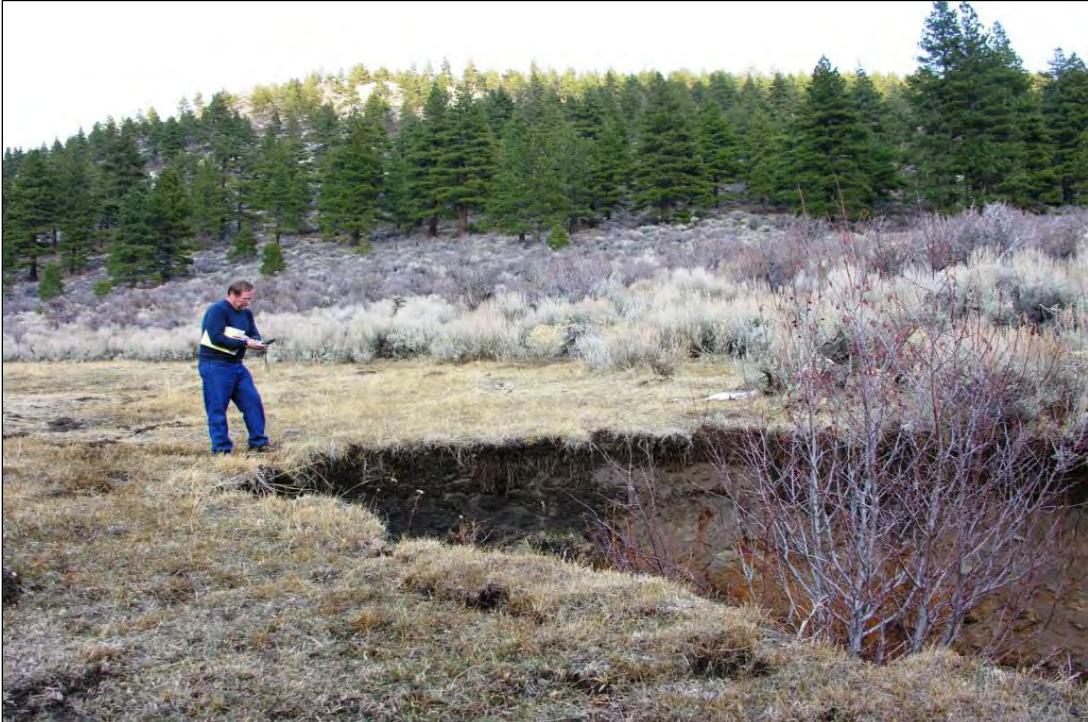
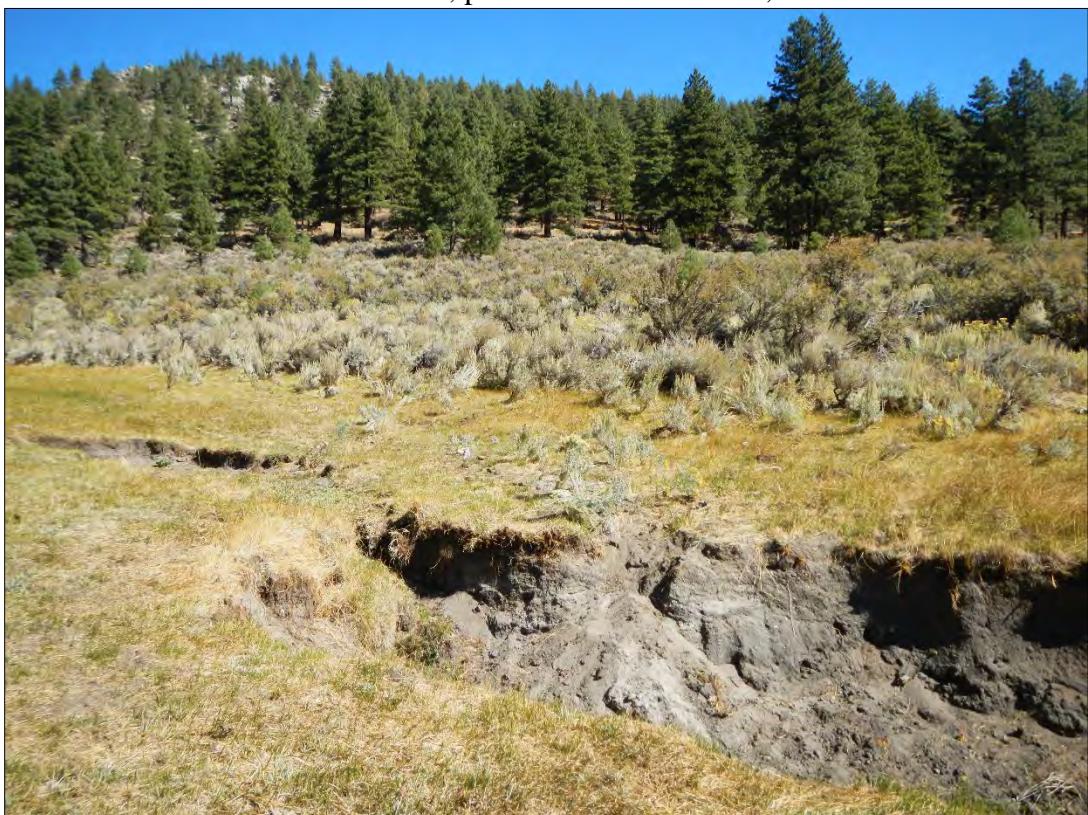
Photo Point 4A (view north): A photo point located at the most northern active headcut after required stabilization to monitor effectiveness.

2009 Baseline Condition, photo taken February 4, 2009

2022 Condition, photo taken October 14, 2022
