STAFF REPORT

Agenda Title: For Possible Action: Discussion and possible action regarding the annual monitoring report for the Horsecreek Ranch Conservation Easement for 2022. (Lyndsey Boyer, lboyer@carson.org)

Exhibit A: 2022 Horsecreek Ranch Conservation Easement Monitoring Report

Carson City Open Space – Conservation Easement Monitoring

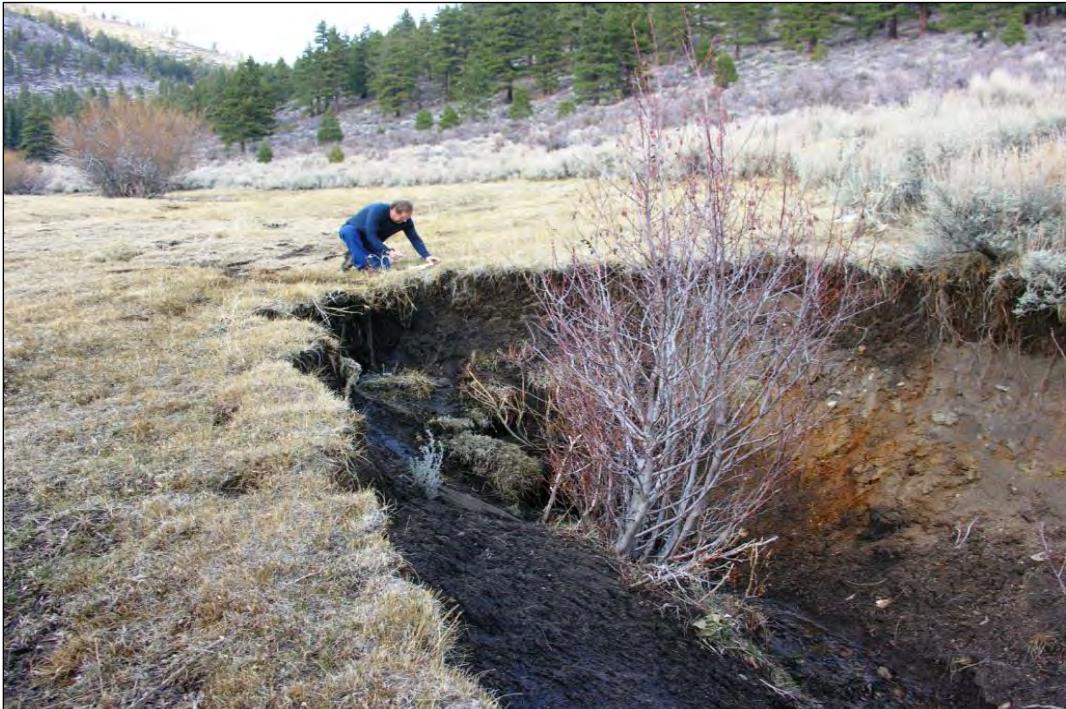
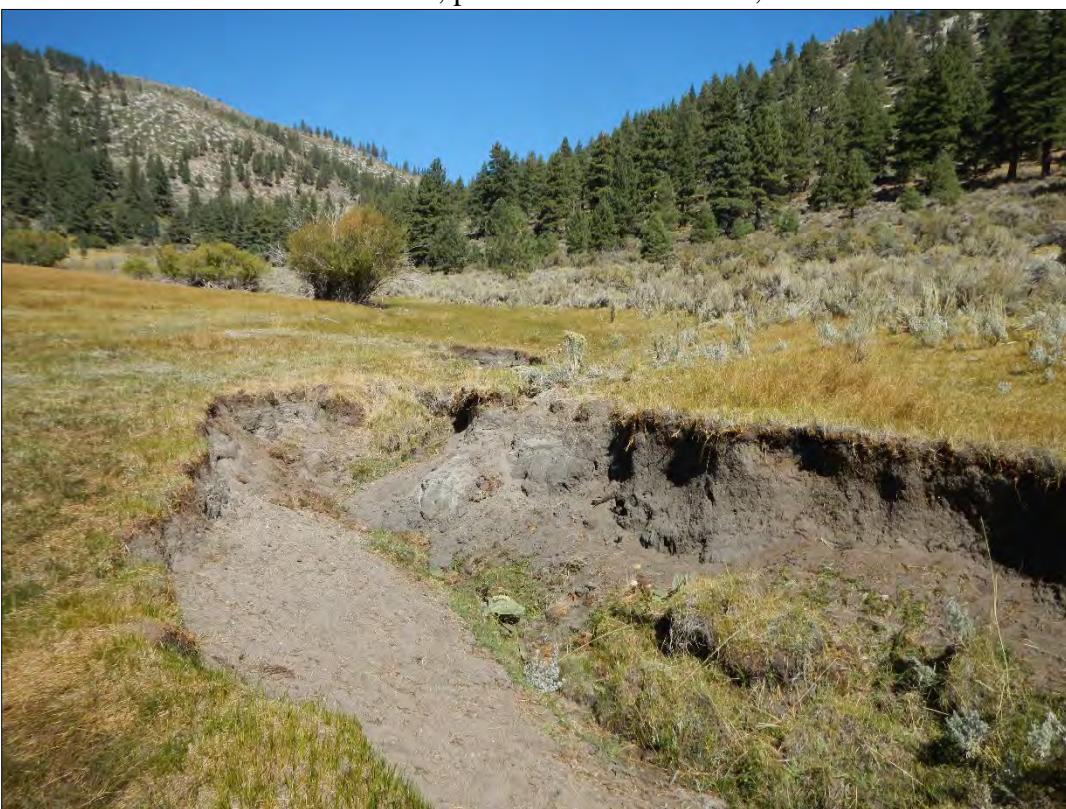
Photo Point 4B (detail): A photo point located at the most northern active headcut after required stabilization to monitor effectiveness.

2009 Baseline Condition, photo taken February 4, 2009

2022 Condition, photo taken October 14, 2022

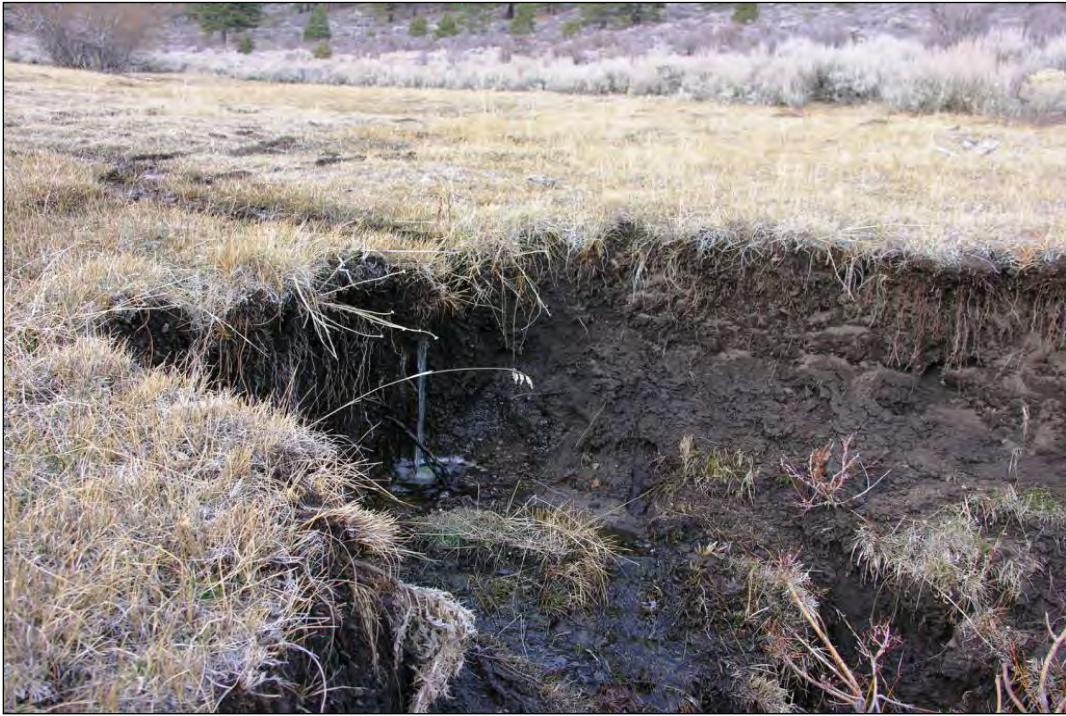
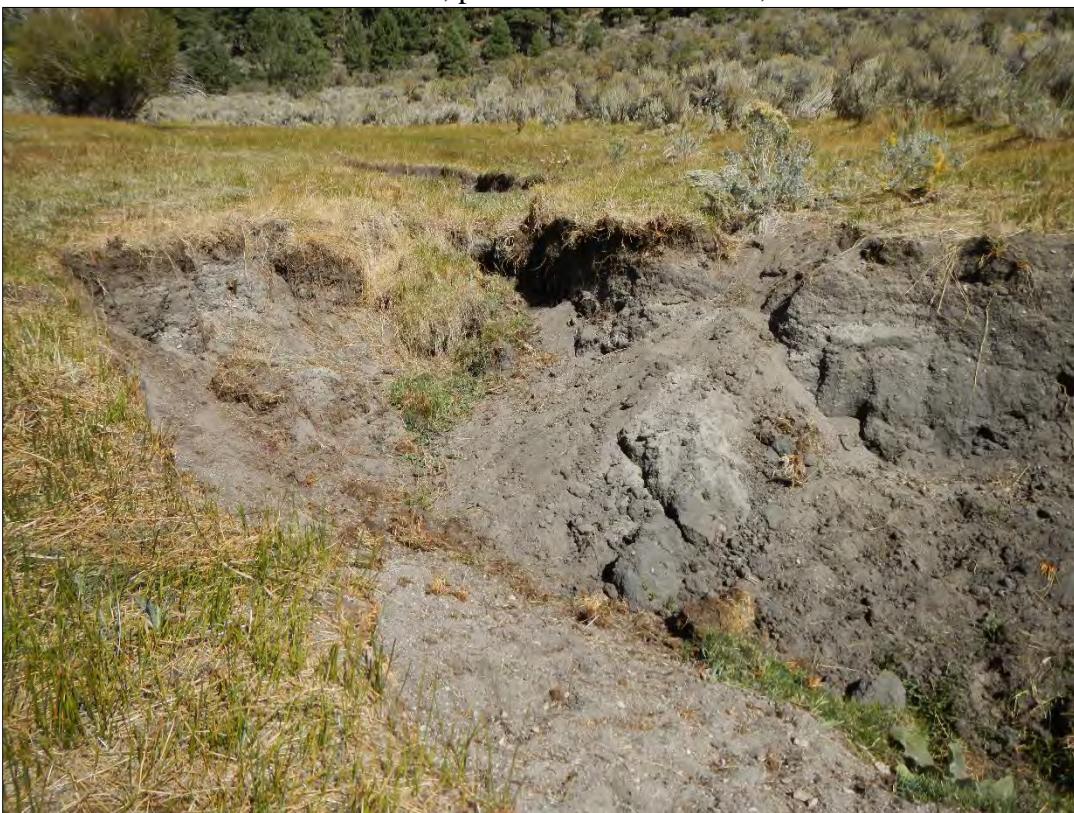
Photo Point 4C (detail): A photo point located at the most northern active headcut after required stabilization to monitor effectiveness.

2009 Baseline Condition, photo taken February 4, 2009

2022 Condition, photo taken October 14, 2022

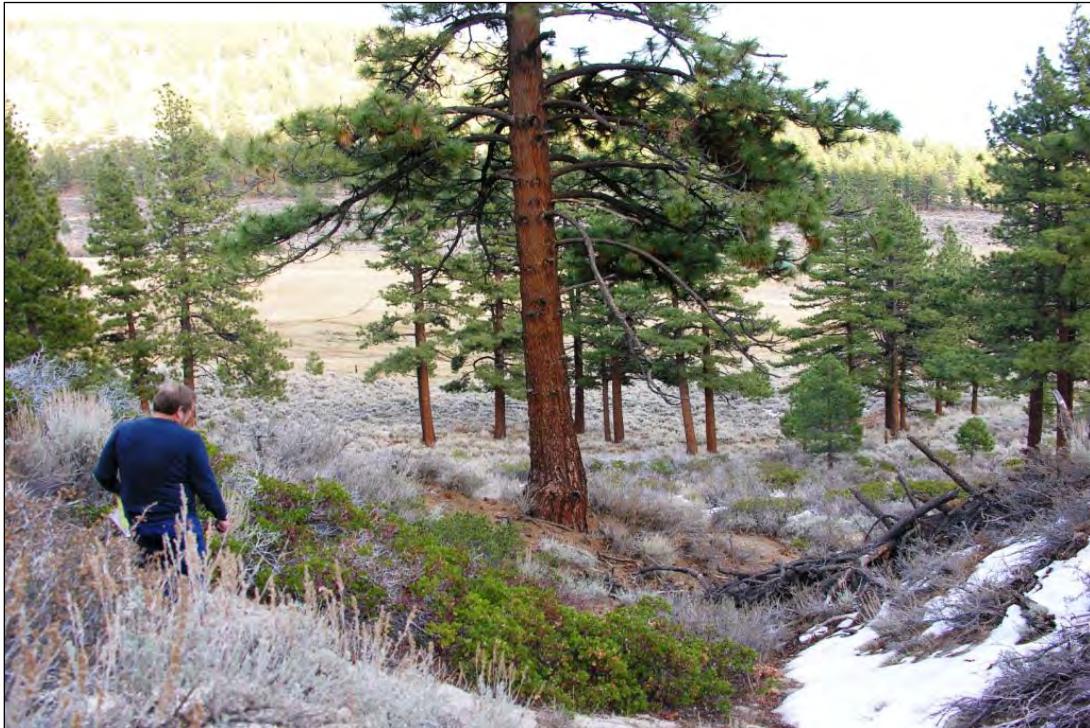
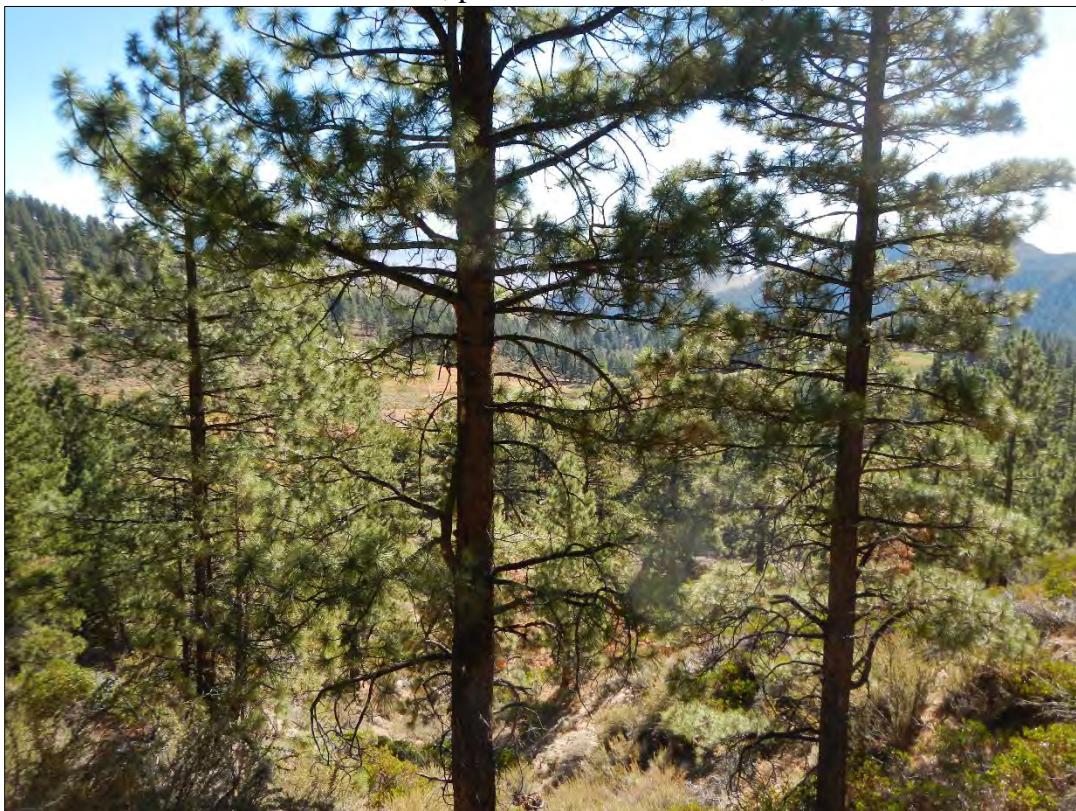
Photo Point 5 (view east): A photo point on the hillside conveyance ditch at a location where a previous washout has occurred to monitor ditch maintenance.

2009 Baseline Condition, photo taken February 4, 2009

2022 Condition, photo taken October 14, 2022

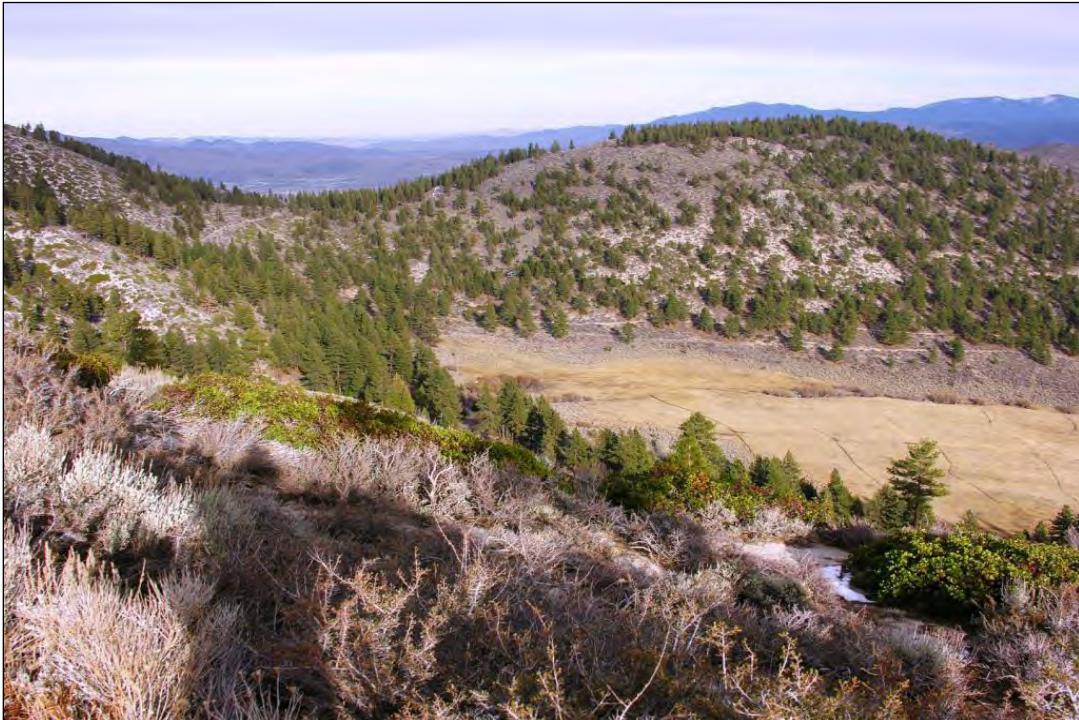
Photo Point 6A (view north): A photo point from the Kings Canyon Road that would provide panoramic views of the ranch from a west to east perspective.

2009 Baseline Condition, photo taken February 4, 2009

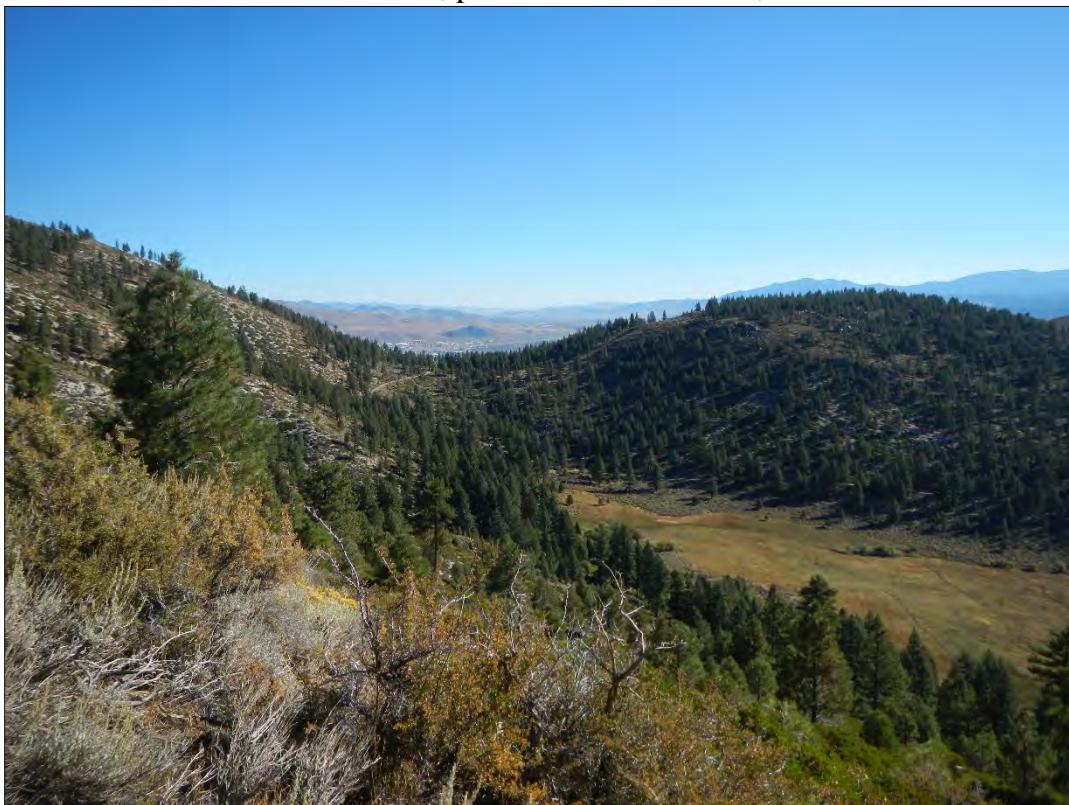
2022 Condition, photo taken October 14, 2022

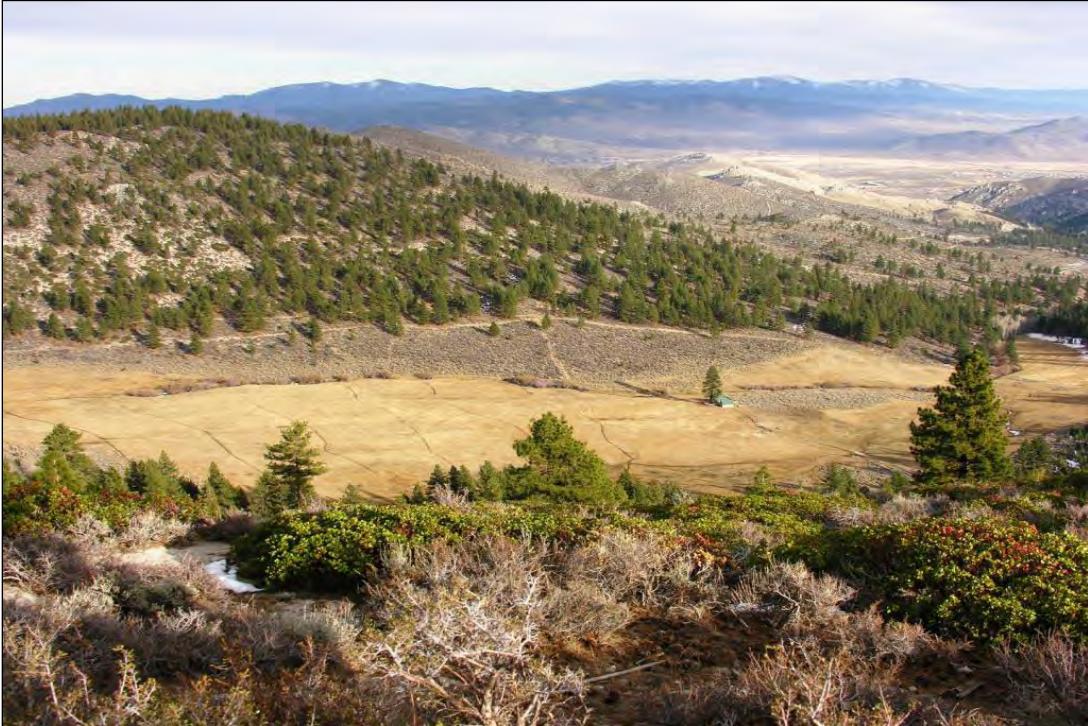
Photo Point 6B (view center): A photo point from the Kings Canyon Road that would provide panoramic views of the ranch from a west to east perspective.

2009 Baseline Condition, photo taken February 4, 2009

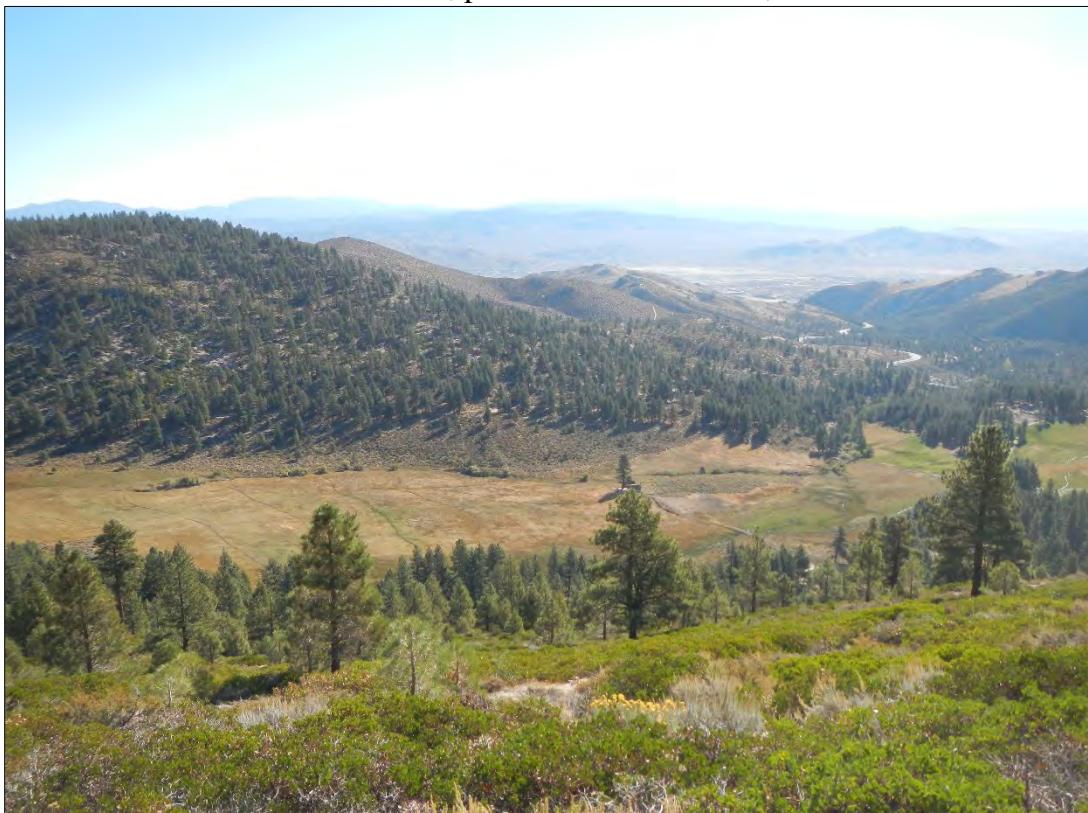
2022 Condition, photo taken October 14, 2022

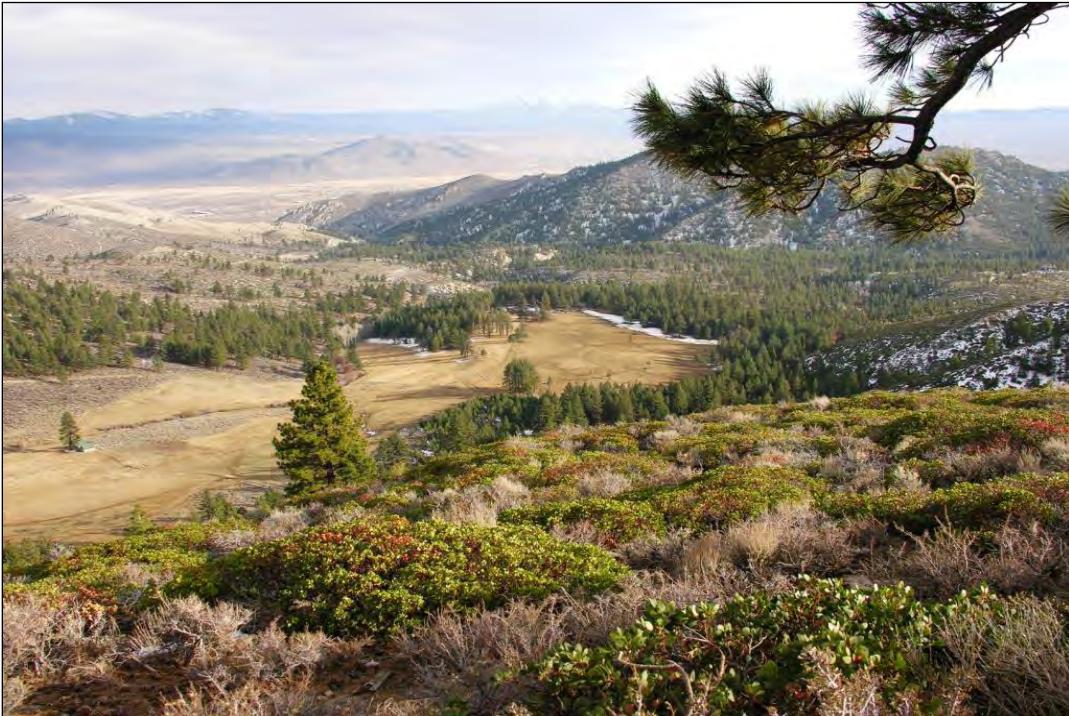
Photo Point 6C (view south): A photo point from the Kings Canyon Road that would provide panoramic views of the ranch from a west to east perspective.

2009 Baseline Condition, photo taken February 4, 2009

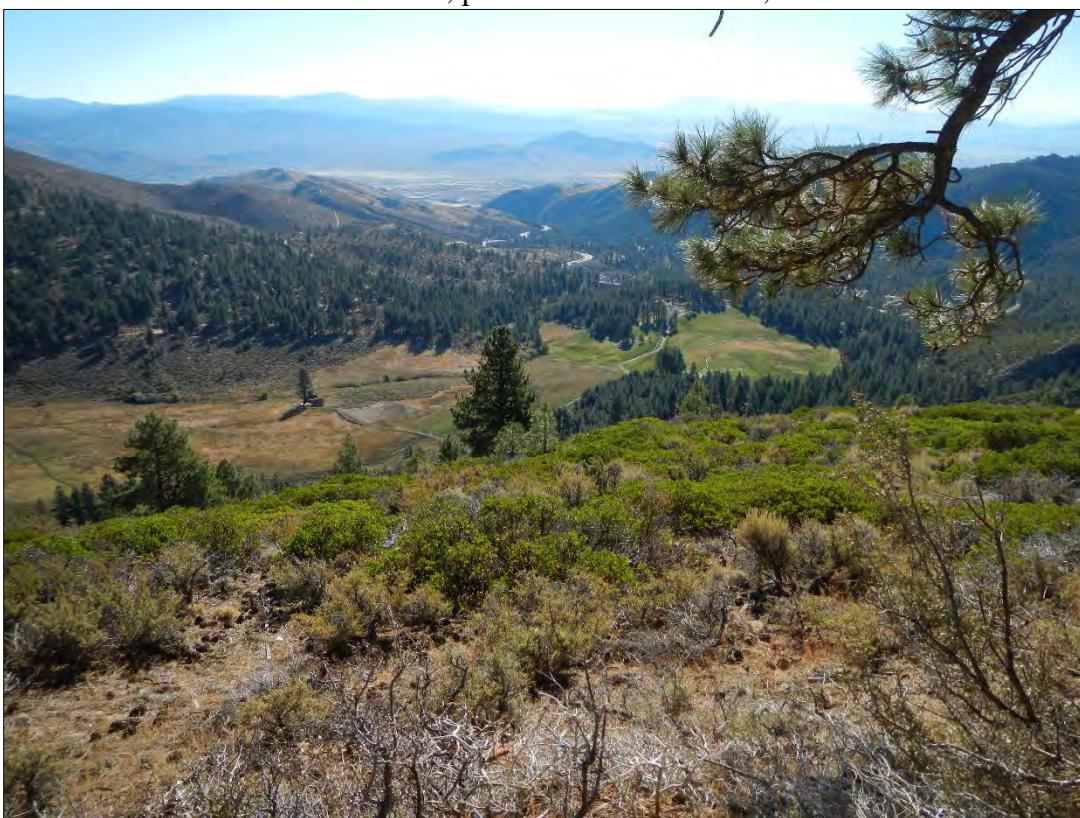
2022 Condition, photo taken October 14, 2022

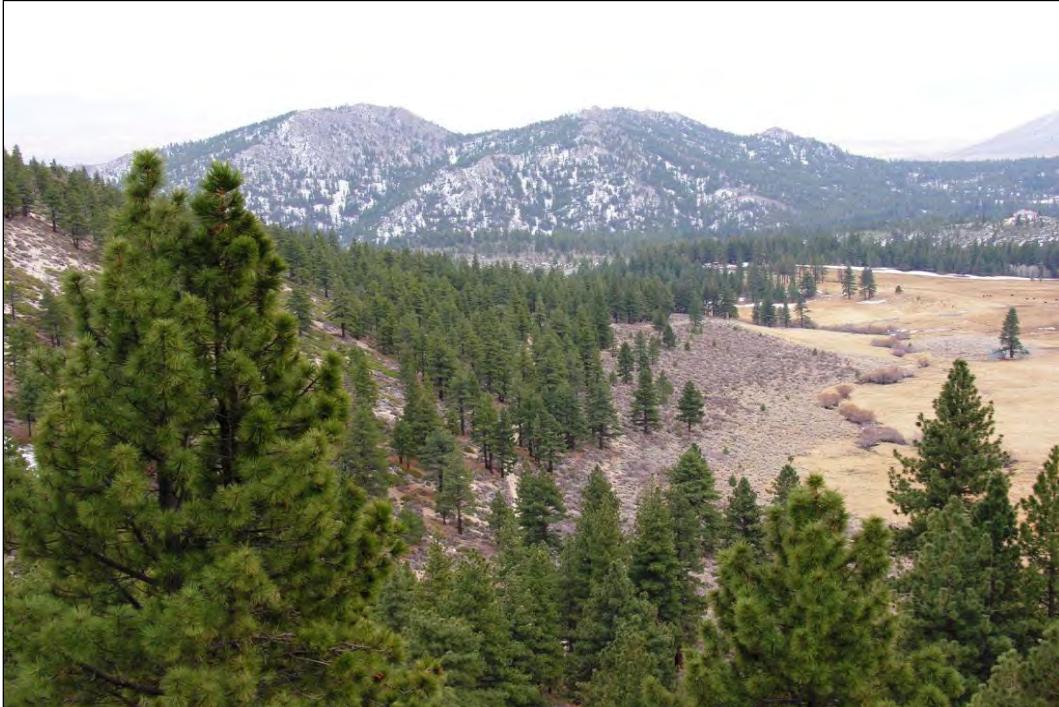
Photo Point 7A (view southeast): A photo point from Kings Canyon Road that would provide panoramic views of the ranch from a north to south perspective.

2009 Baseline Condition, photo taken February 4, 2009

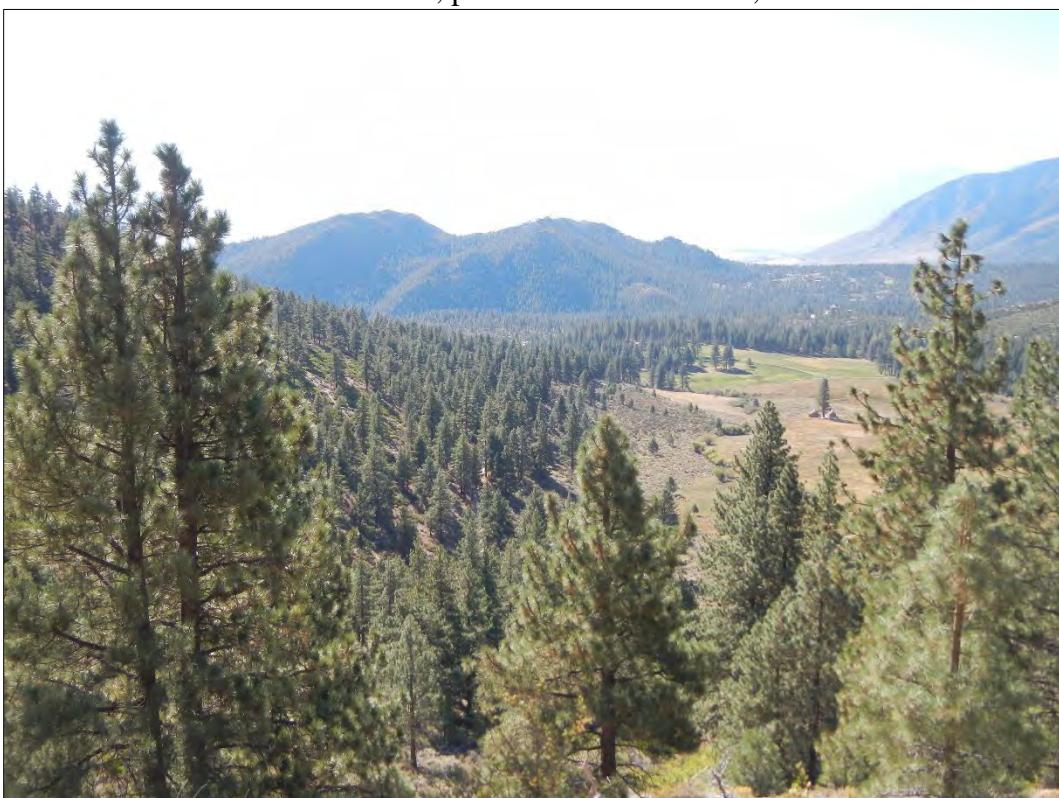
2022 Condition, photo taken October 14, 2022

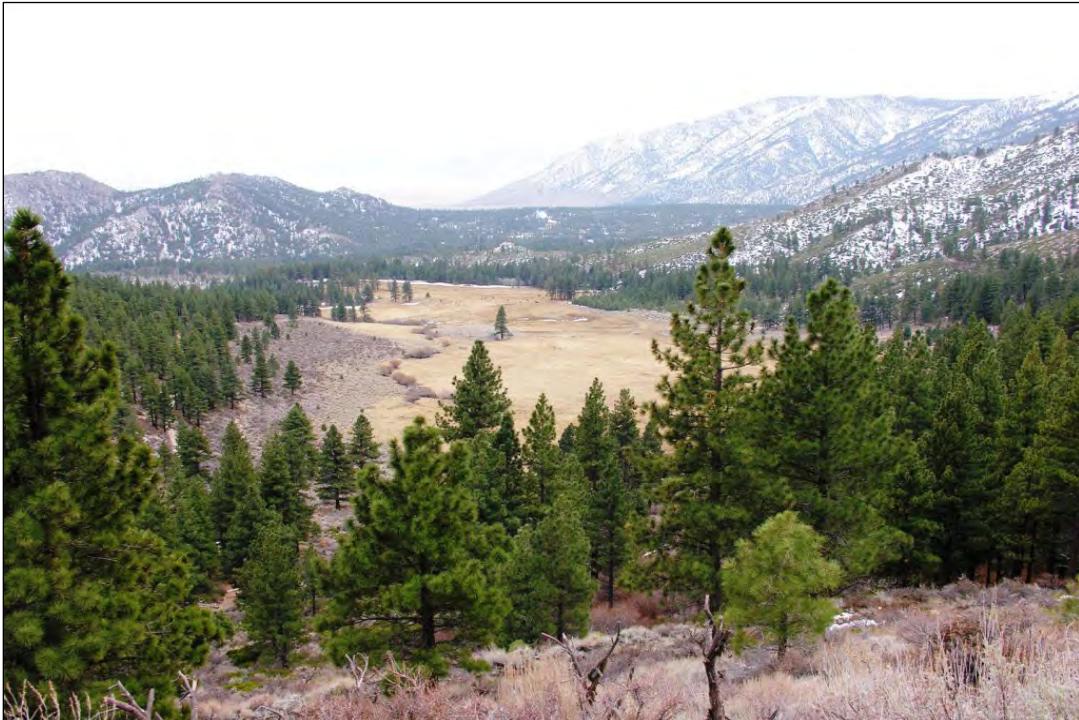
Photo Point 7B (view south): A photo point from Kings Canyon Road that would provide panoramic views of the ranch from a north to south perspective.

2009 Baseline Condition, photo taken February 4, 2009

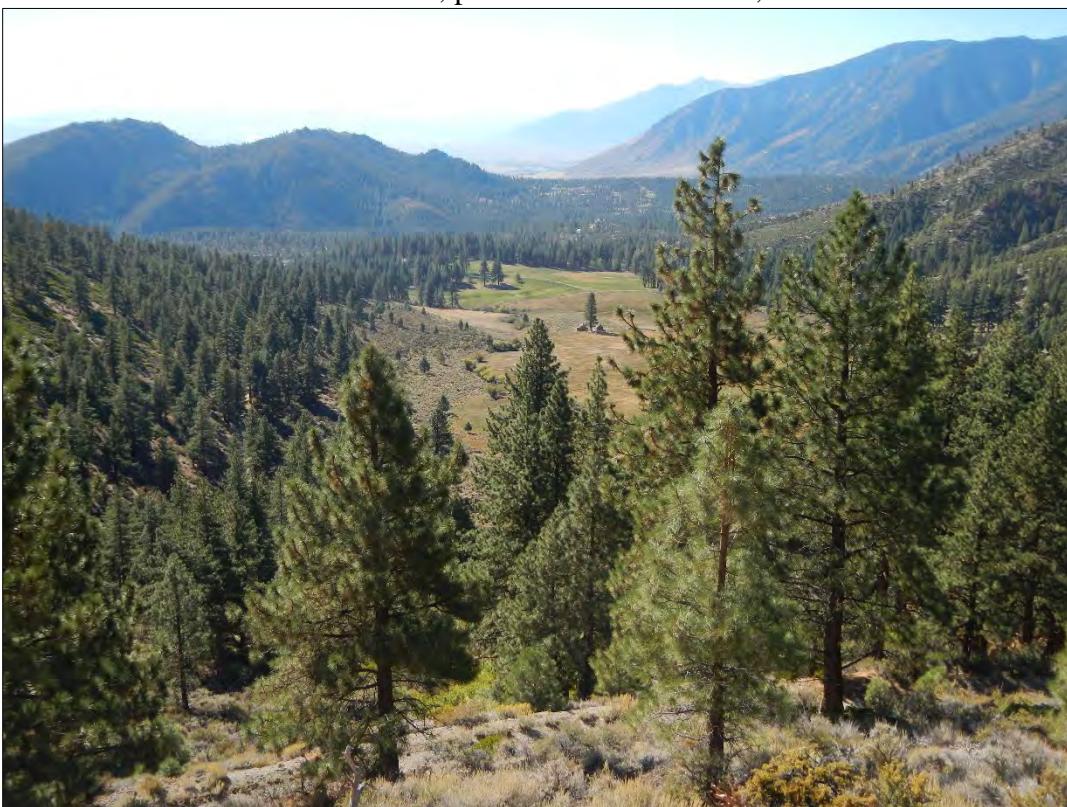
2022 Condition, photo taken October 14, 2022

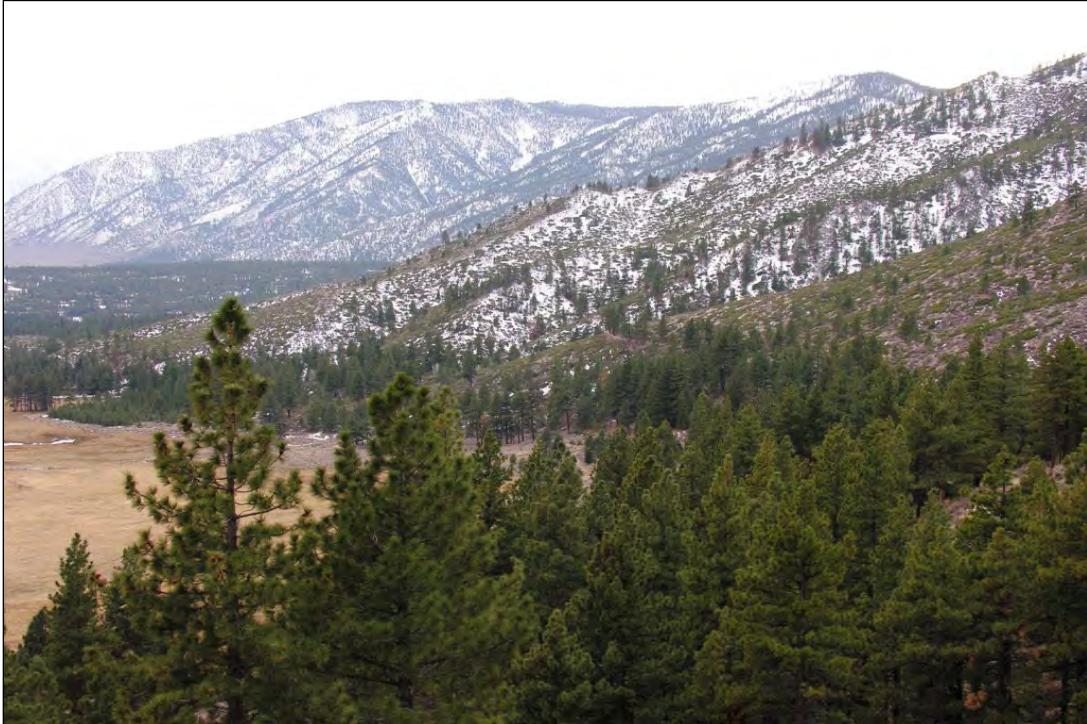
Photo Point 7C (view southwest): A photo point from Kings Canyon Road that would provide panoramic views of the ranch from a north to south perspective.

2009 Baseline Condition, photo taken February 4, 2009

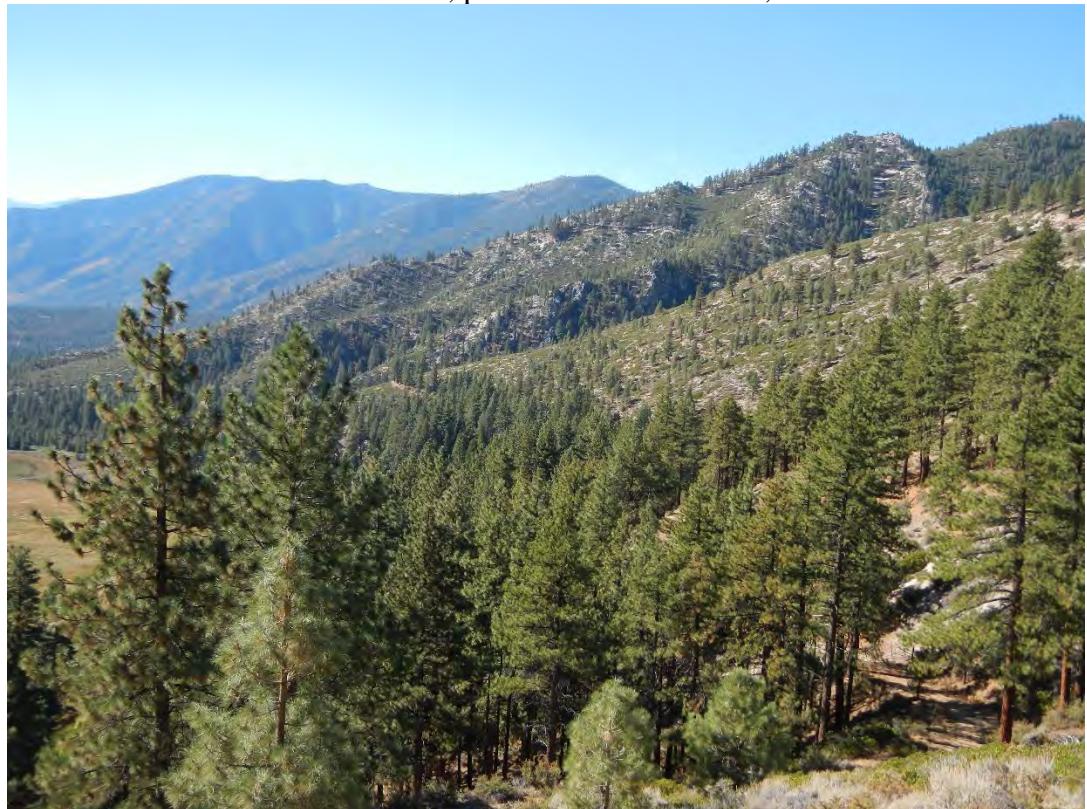
2022 Condition, photo taken October 14, 2022

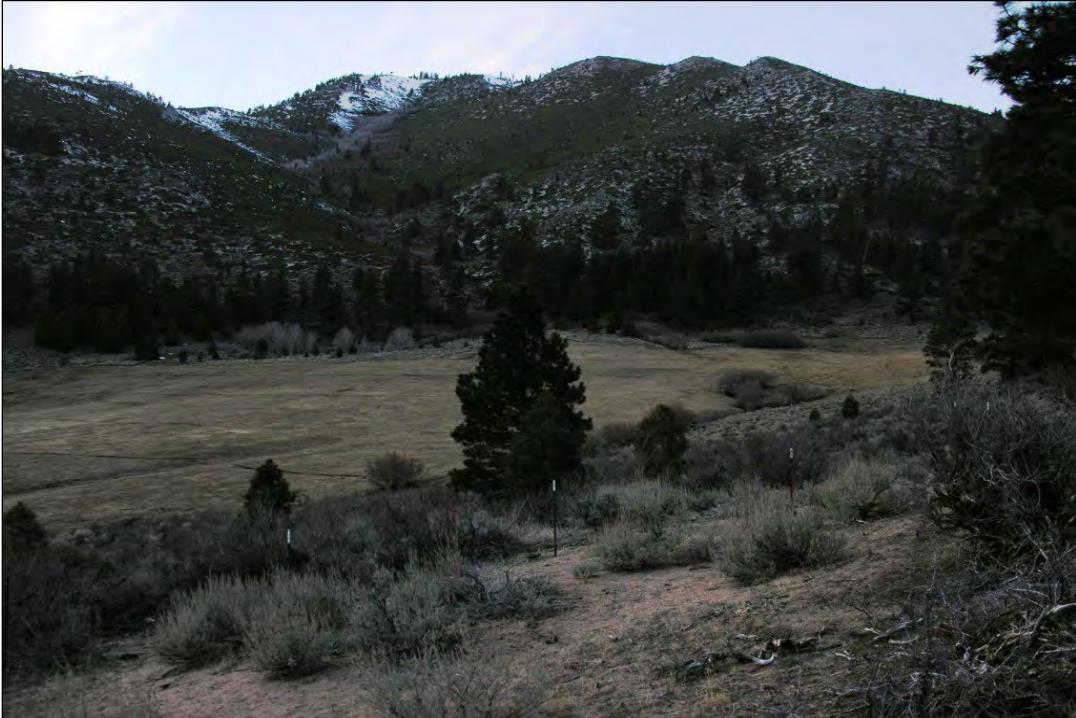
Photo Point 8A (view northwest): A photo point overlooking the meadow from the east to the west located next to the property corner along the new road.

2009 Baseline Condition, photo taken February 4, 2009

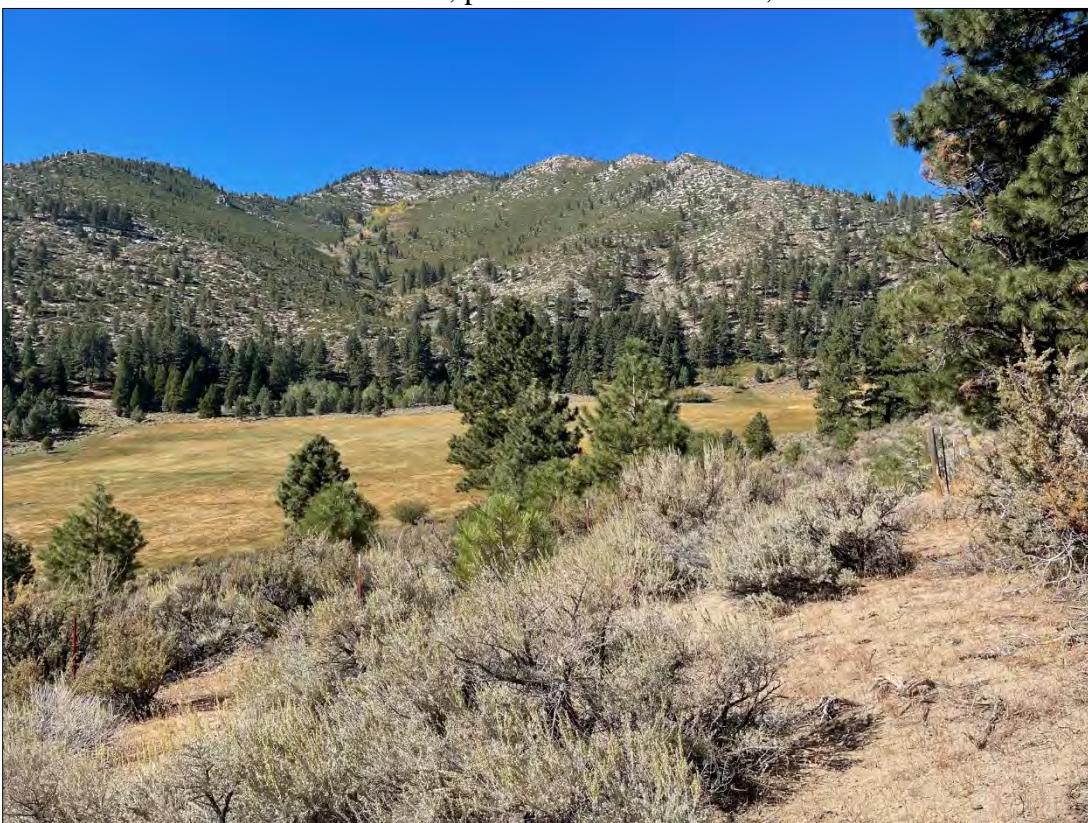
2022 Condition, photo taken October 14, 2022

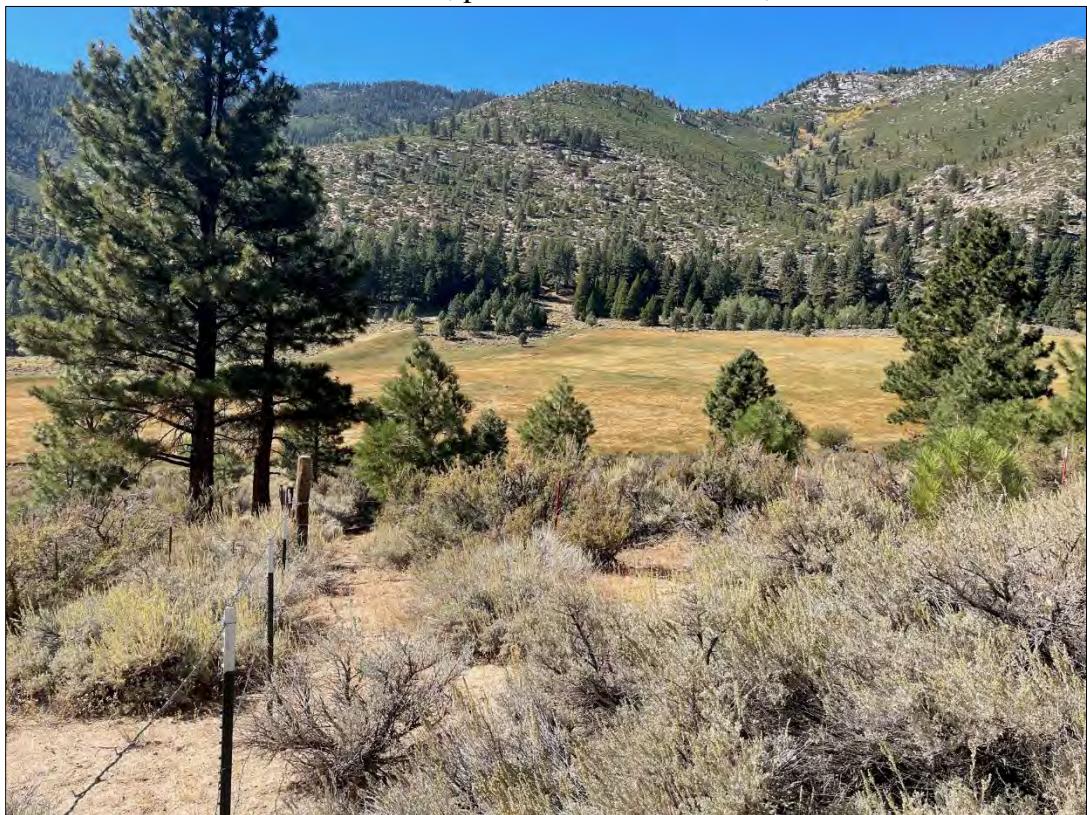
Photo Point 8B (view west): A photo point overlooking the meadow from the east to the west located next to the property corner along the new road.

2022 Condition, photo taken October 14, 2022

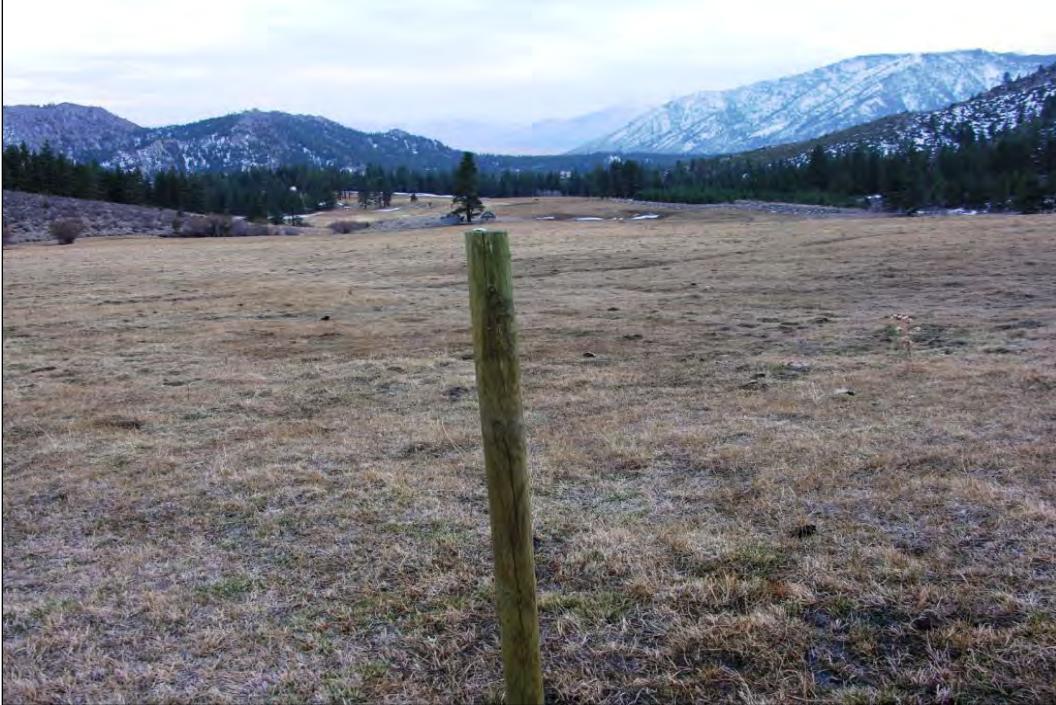
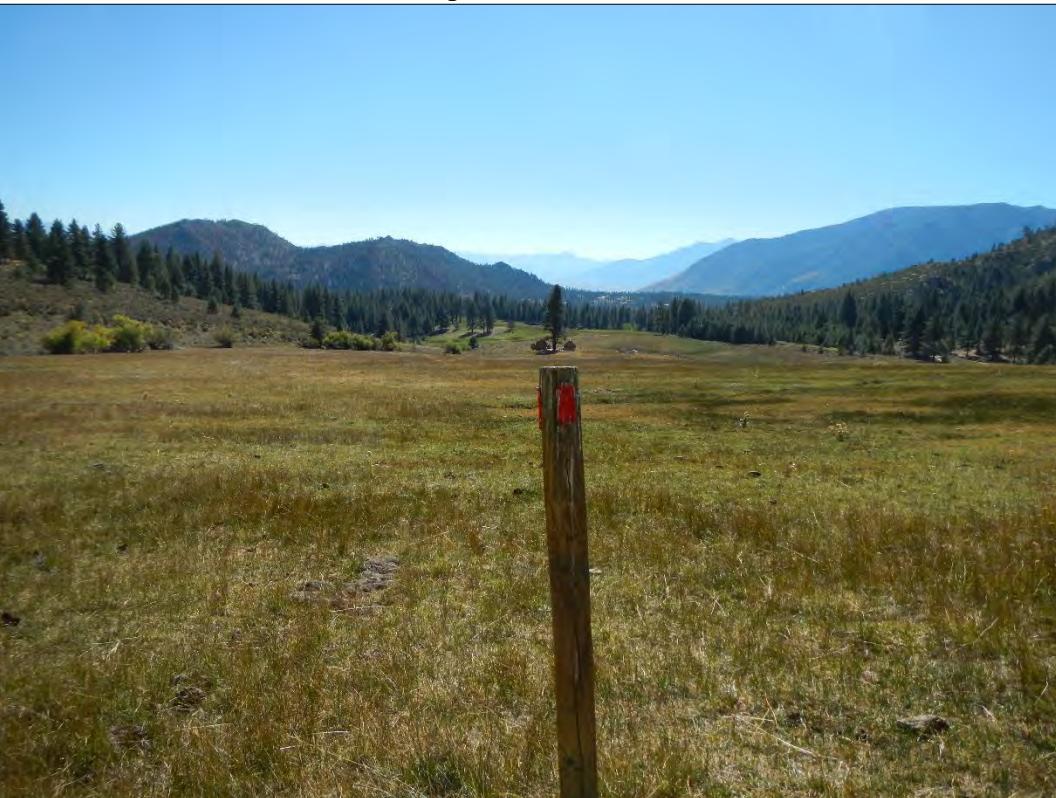
- The Pasture Utilization and Condition Assessment was conducted by Carson City staff and included a visual observation of the monitoring plot as described in the Baseline Condition Report (Photo Point 9). A diversity of pasture, wetland associated (*Juncus*), and invasive grasses (cheatgrass) exhibited various utilization levels depending on species. It should be noted that cover of invasive grasses (cheatgrass) has reduced. Overall, grazing at this location appeared patchy and an average stubble height of 4" was recorded indicating limited grazing at this location.

Photo Point 9: A permanently marked 100' x 100' area to monitor pasture condition. This annual inventory will be used to monitor not only pasture condition but irrigation efficiency, vegetative response to drought and appropriate livestock utilization.

2009 Baseline Condition, photo taken February 4, 2009

2022 Condition, photo taken October 14, 2022
