Appendix D

Future Year LOS Calculations

This conceptual drainage report identifies the existing and conceptually proposed site conditions, and the potential drainage improvements for the approximately 29.7-acre parcel (APN 009-012-21) located in South ½ of Section 7, North ½ of Section 18, Township 15N, Range 20E. The existing parcel is proposed to be developed as a single family subdivision development, consisting of 61-units, 3.8-acres of open space, and associated on-site civil and drainage infrastructures. Connections to Manhattan Drive and W. Washington Street, along with half street improvements to N. Ormsby Boulevard along the frontage are proposed. This study has been conducted in accordance with Division 14 of the Carson City Municipal Code.

The purpose of this Memo is to present the preliminary results and mitigation associated with the hydraulic analysis of Ash Canyon Creek in support of the FEMA Conditional Letter of Map Revision (CLOMR) to be submitted in association of the proposed Andersen Ranch West development. The proposed development is located within a Zone AE flood zone without a regulatory floodway, which includes Base Flood Elevations (BFEs) that have been

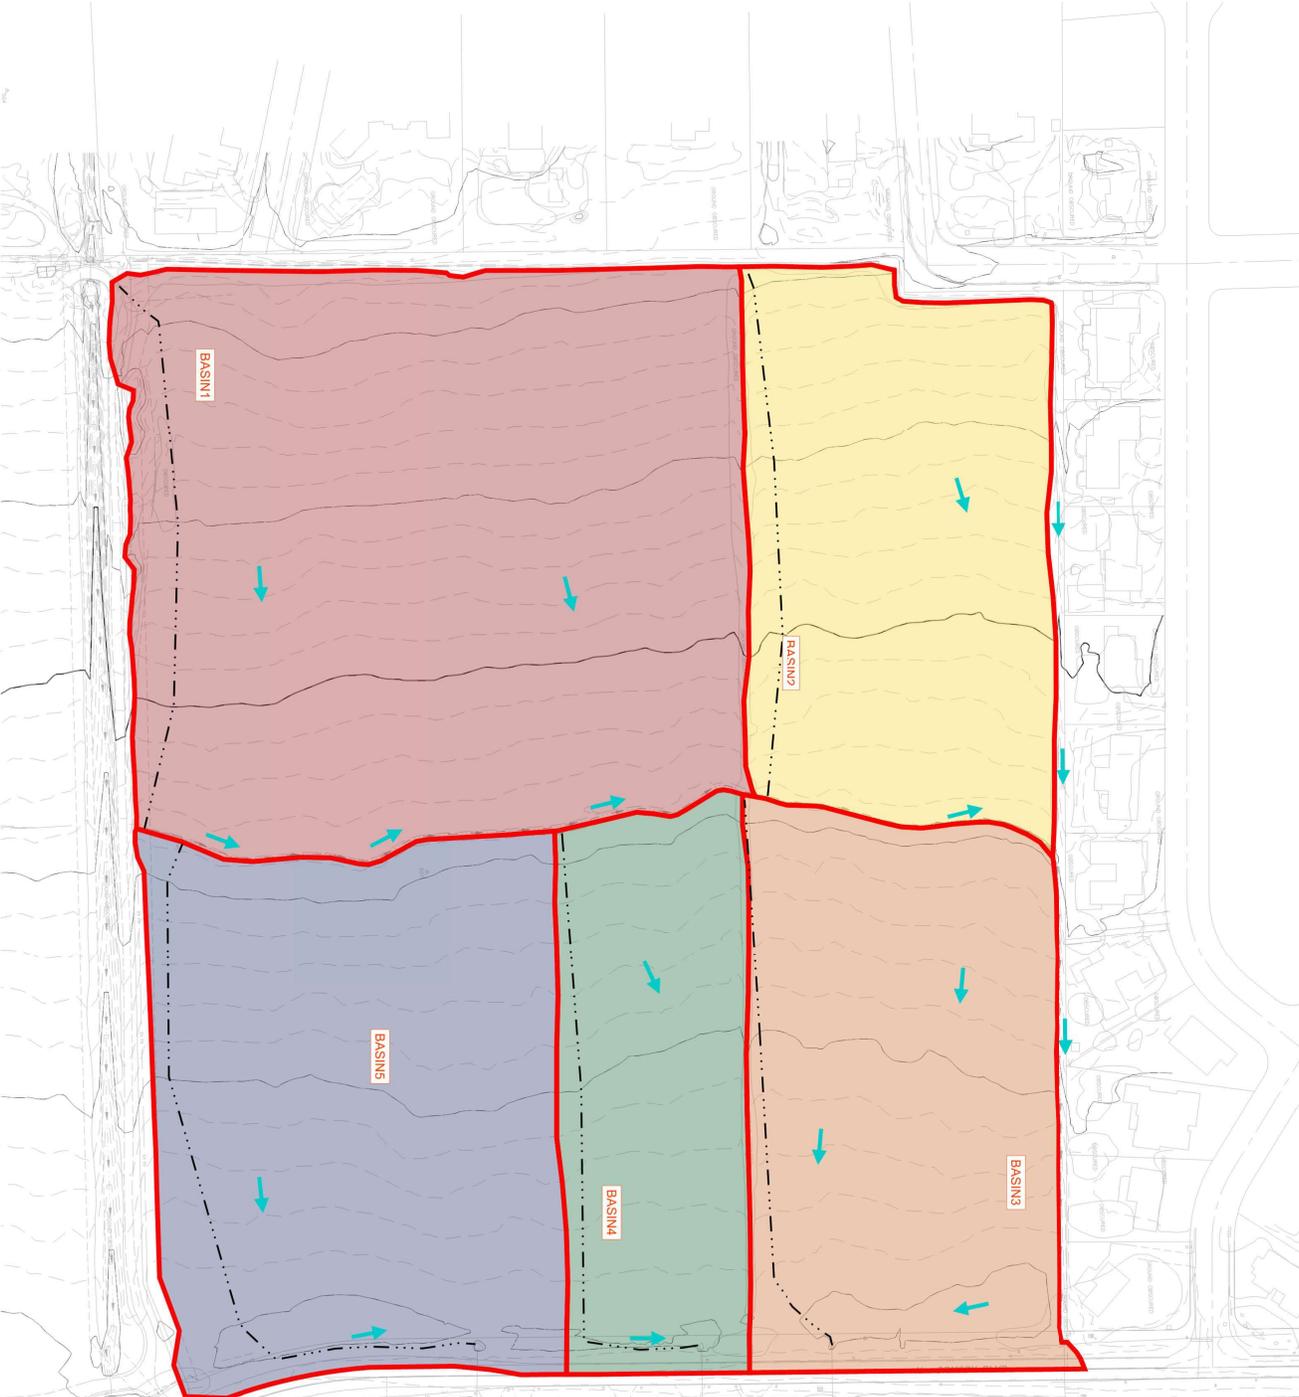
APPENDIX A – DRAINAGE EXHIBIT

BASIN 1-2
(EX. SWALE)

BASIN 3
(ON-SITE FLOWS
(ON DITCH))

For the purposes of the conceptual study, the project site is analyzed using a single drainage basin with an approximate area of 30.3-acres used to determine the peak runoff for the existing and proposed site conditions. Offsite flows within Ash Canyon Creek have been analyzed and detailed by House Moran, a copy of this report has been included Appendix D of this report. Existing conditions were analyzed using a single open space basin.

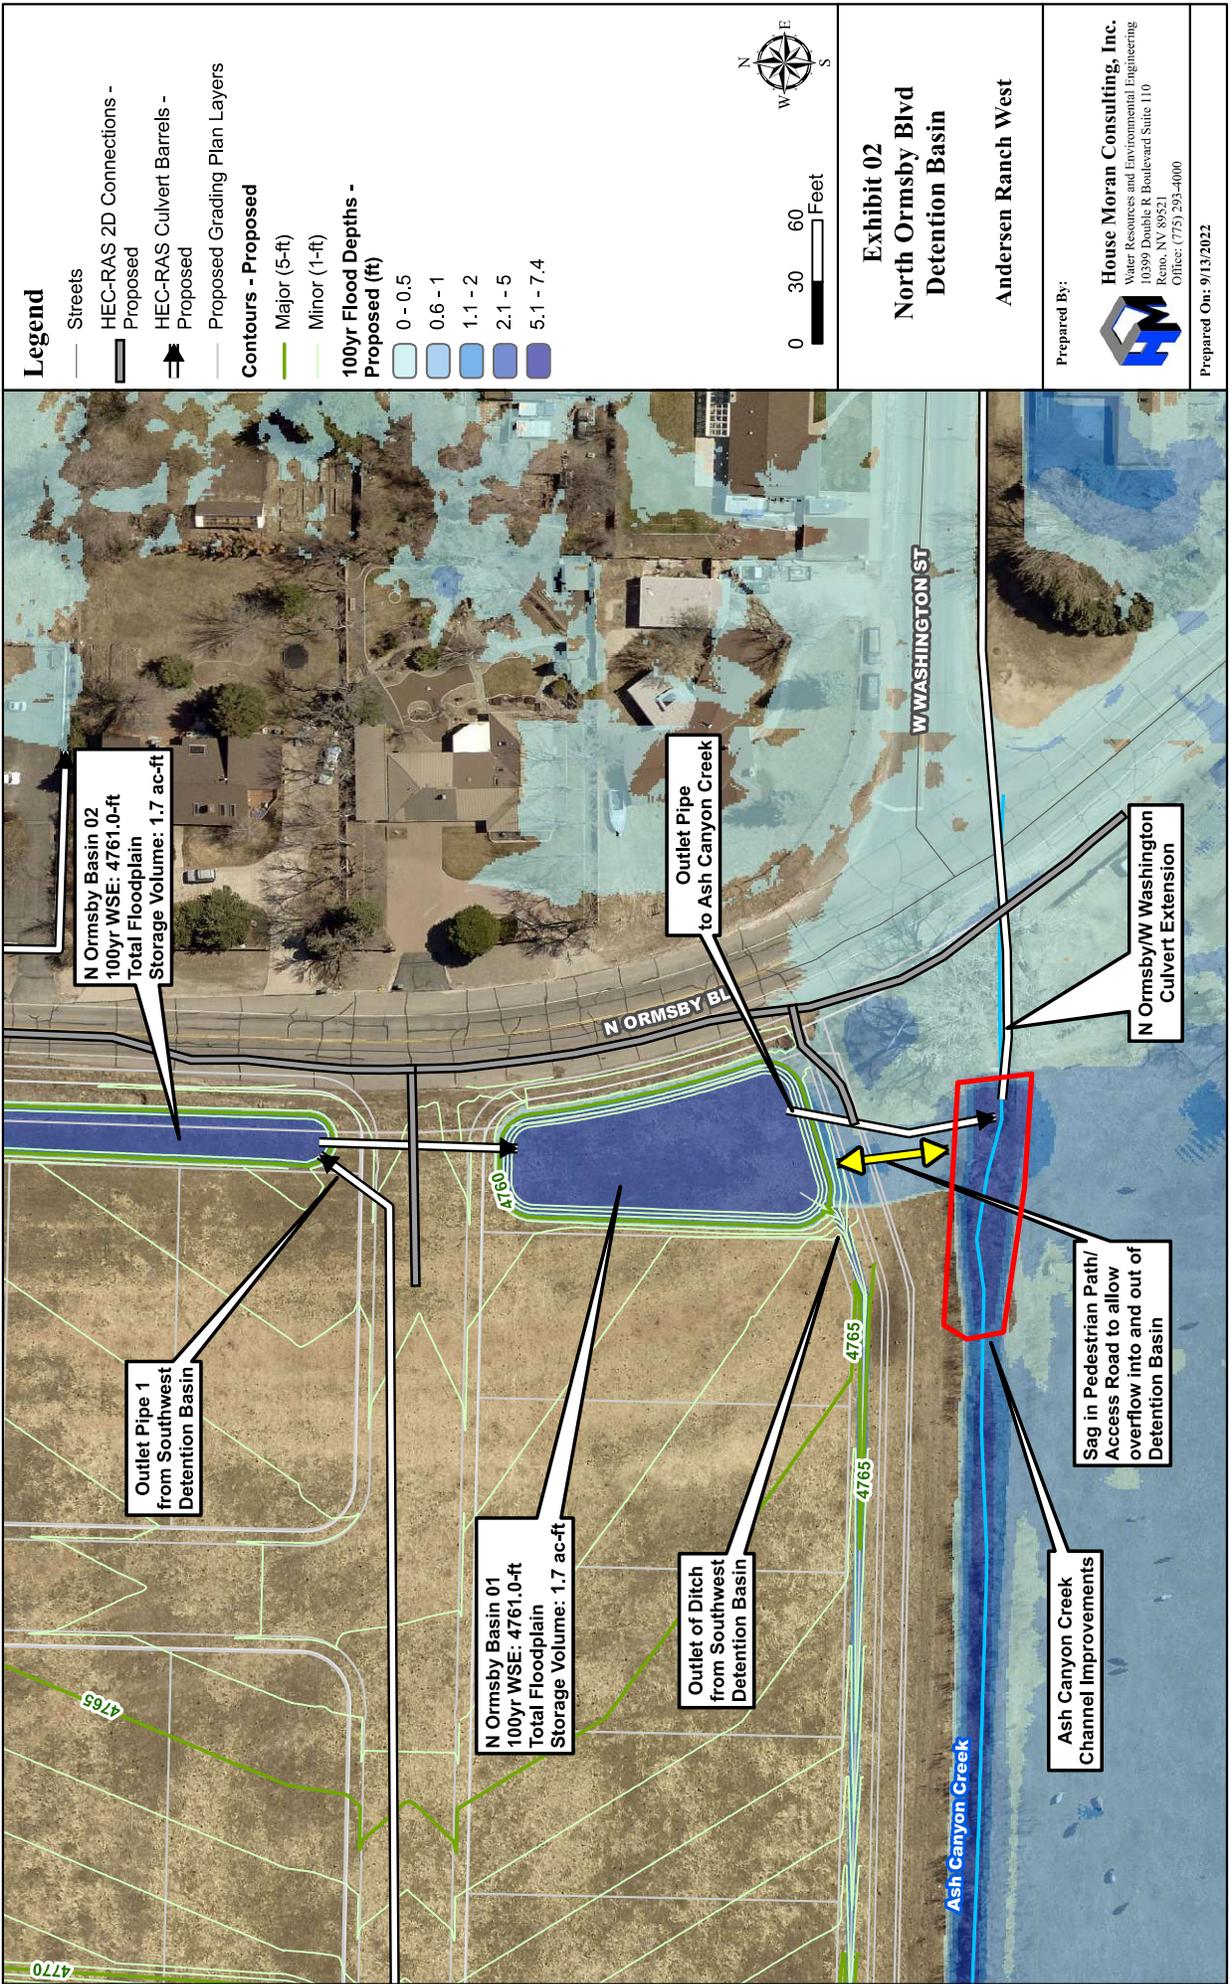
The details of North Ormsby detention basin system and the North Ormsby/West Washington culvert extension are illustrated on Exhibit 2 included in the attachments. As stated in the approach description, the purpose of basin system is to maintain floodplain storage similar to existing conditions. Table 2 below contains the floodplain storage volume calculated in existing and proposed conditions at Water Surface Elevation (WSE) 4761-ft.

The North Ormsby/West Washington culvert will be extended approximately 80 feet upstream and replace the existing culvert under the small dirt road. Approximately 100 feet of the Ash Canyon Creek channel will be improved upstream of the extended culvert to lower the channel and improve the transition into the entrance of the extended culvert.

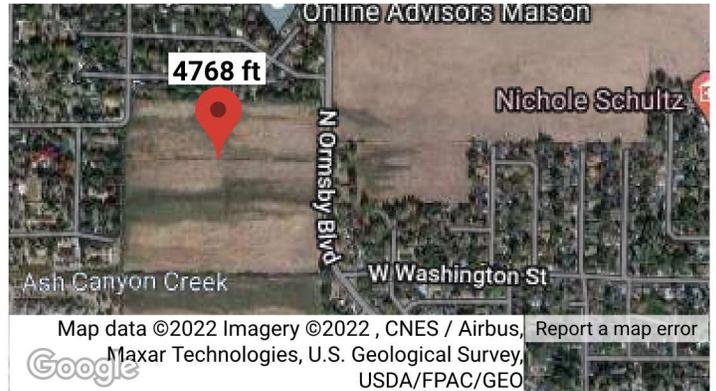
Coordinates: 39.170525, -119.784665
Elevation: 4768 ft
Timestamp: 2022-07-05T15:15:46.882Z
Hazard Type: Seismic
Reference Document: ASCE7-16
Risk Category: II
Site Class: D-default

Carson City has adopted the 2018 building code. Therefore, the seismic parameters provided in the original report need to be updated to the following (refer to Plate 2):

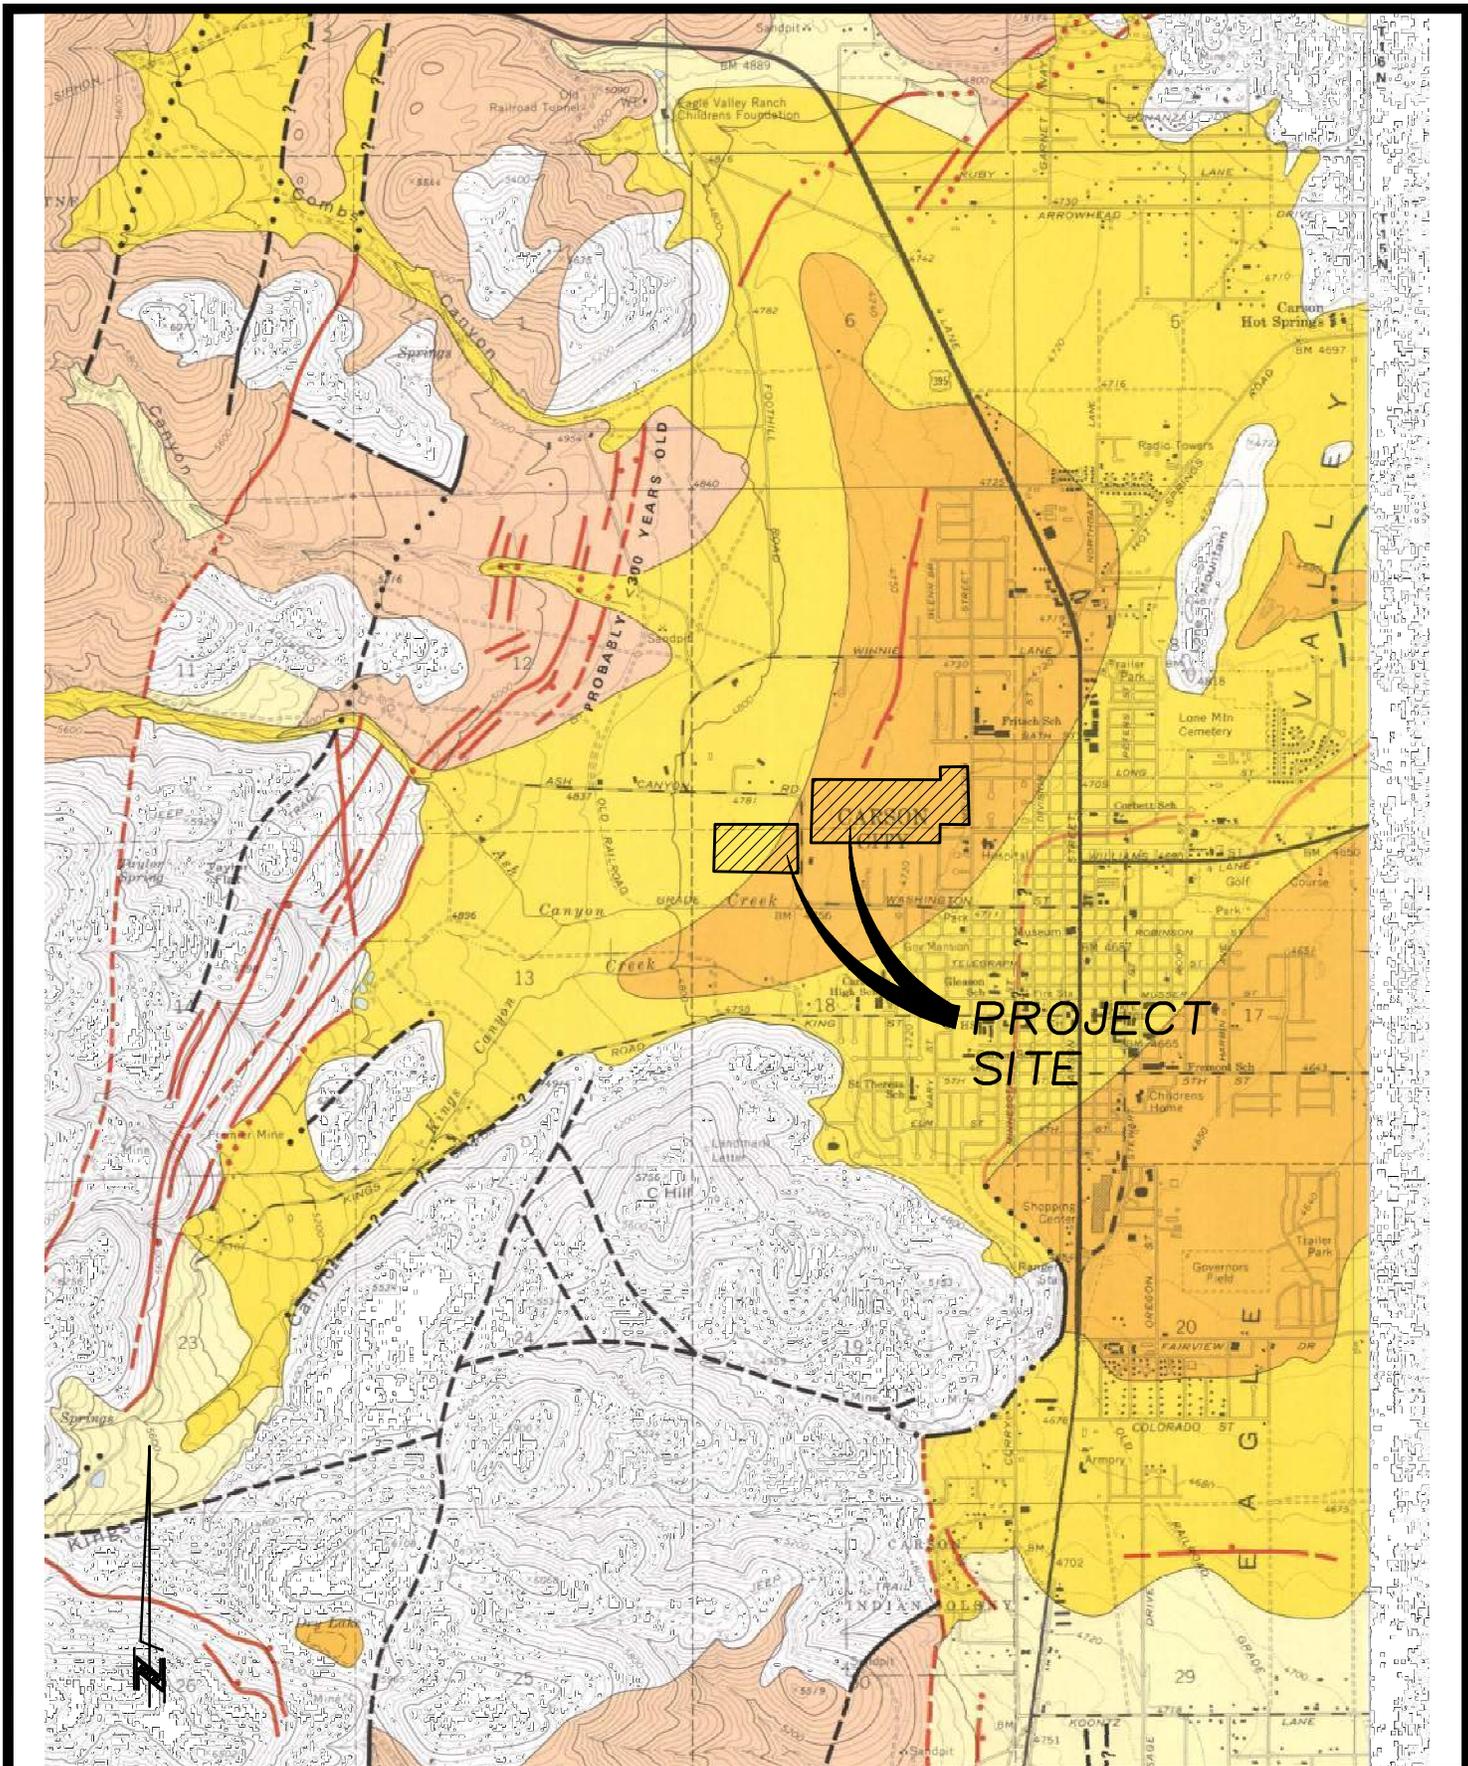
FAULT MAP

According to the Carson City Quadrangle Earthquake Hazards Map by Trexler and Bell (1979) a north/south trending fault is approximately 500-1000 feet north of the site (Plate 5). The fault is mapped as a Holocene, which is <12,000 years old, which is considered potentially active. However, no active Holocene (<12,000 years) age faulting is known to cross the site, nor has any direct evidence of on-site faulting been observed in the field during the current investigation.

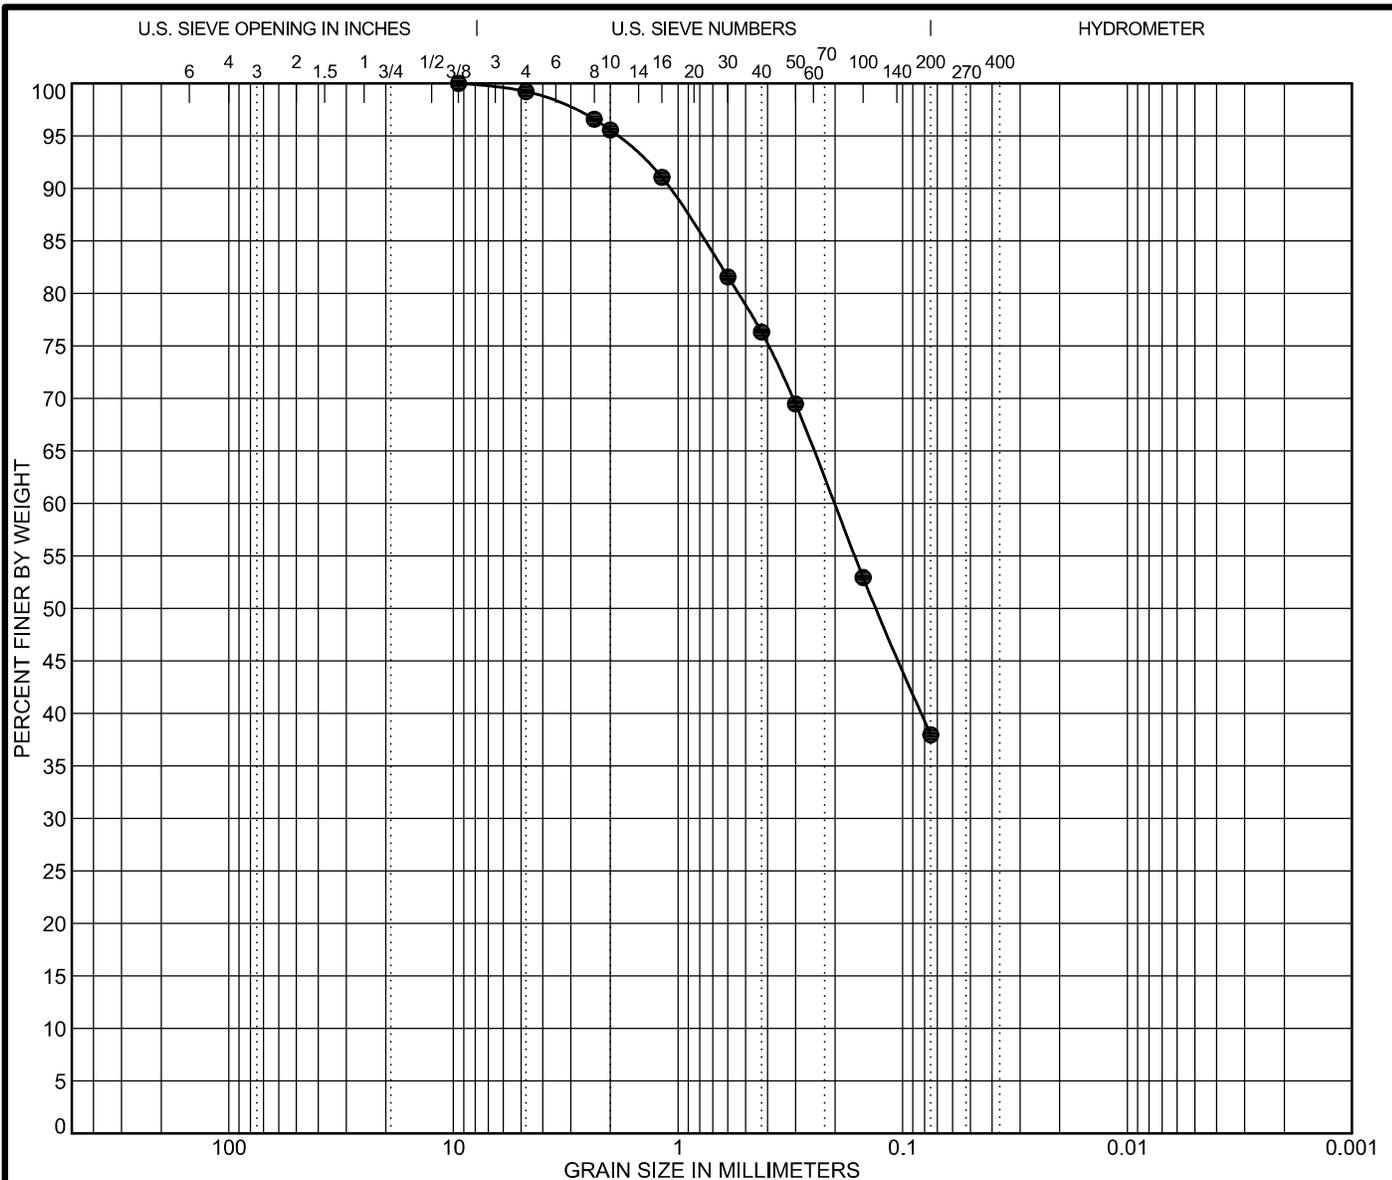
B-1.1

Specimen Identification	Date: 5-6-2016					LL	PL	PI	Cc	Cu
B-01	Classification					36	23	13		
Depth: 0	Clayey SAND (SC)									
Sample Location	Comb. Samp. B-1, 2, 3, & 5 from 0'-3'									
USCS	SC									
AASHTO										
Specimen Identification	D100	D60	D30	D10	%Gravel	%Sand	%Silt	%Clay		
B-01	9.5	0.202			0.8	61.3	38.0			
Depth: 0										
Natural Moisture	6.7 %		S.E.		Absorption %					
R-Value	43		Durability Index		Soundness					
Percentage of Wear (500 rev)	%		Specific Gravity		Direct Shear		35

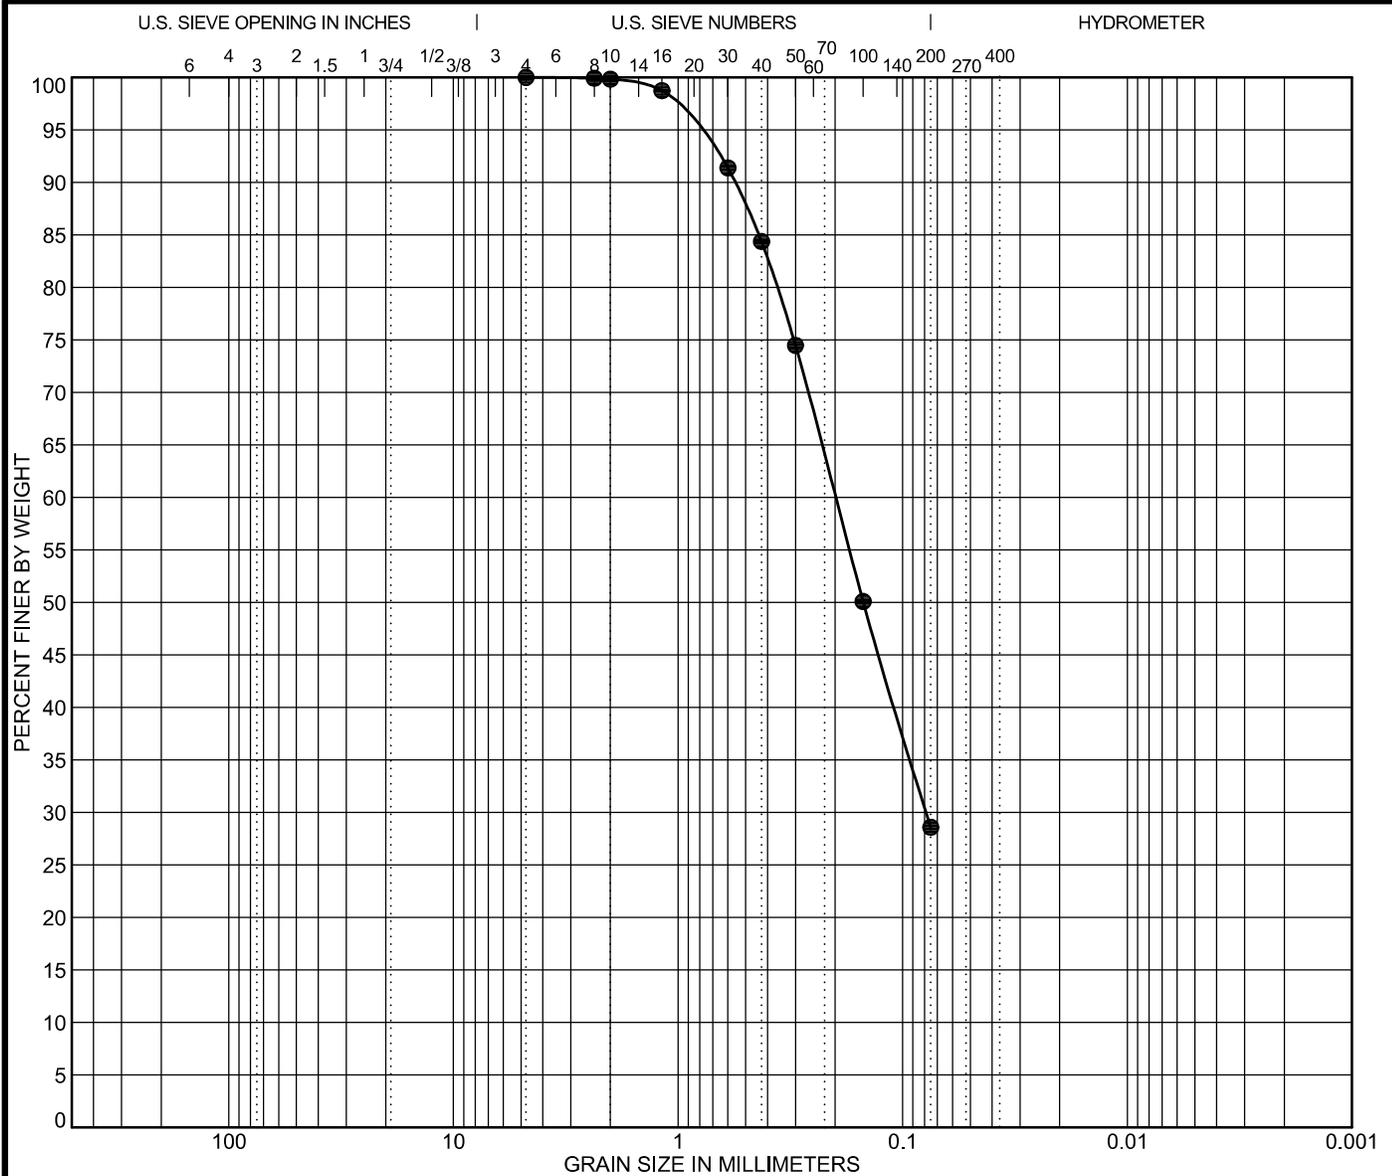
PLATE
B-1.2

Specimen Identification		Date: 5-2-2016				LL	PL	PI	Cc	Cu
●	B-01	Classification				34	16	18		
	Depth: 5	Clayey SAND (SC)								
	Sample Location	Boring 1 from 5' - 6.5'								
	USCS	SC								
	AASHTO									
Specimen Identification		D100	D60	D30	D10	%Gravel	%Sand	%Silt	%Clay	
●	B-01	4.75	0.199	0.079		0.0	71.4	28.6		
	Depth: 5									
	Natural Moisture	14.1 %		S.E.		Absorption %				
	R-Value			Durability Index		Soundness				
	Percentage of Wear (500 rev)	%		Specific Gravity		Direct Shear

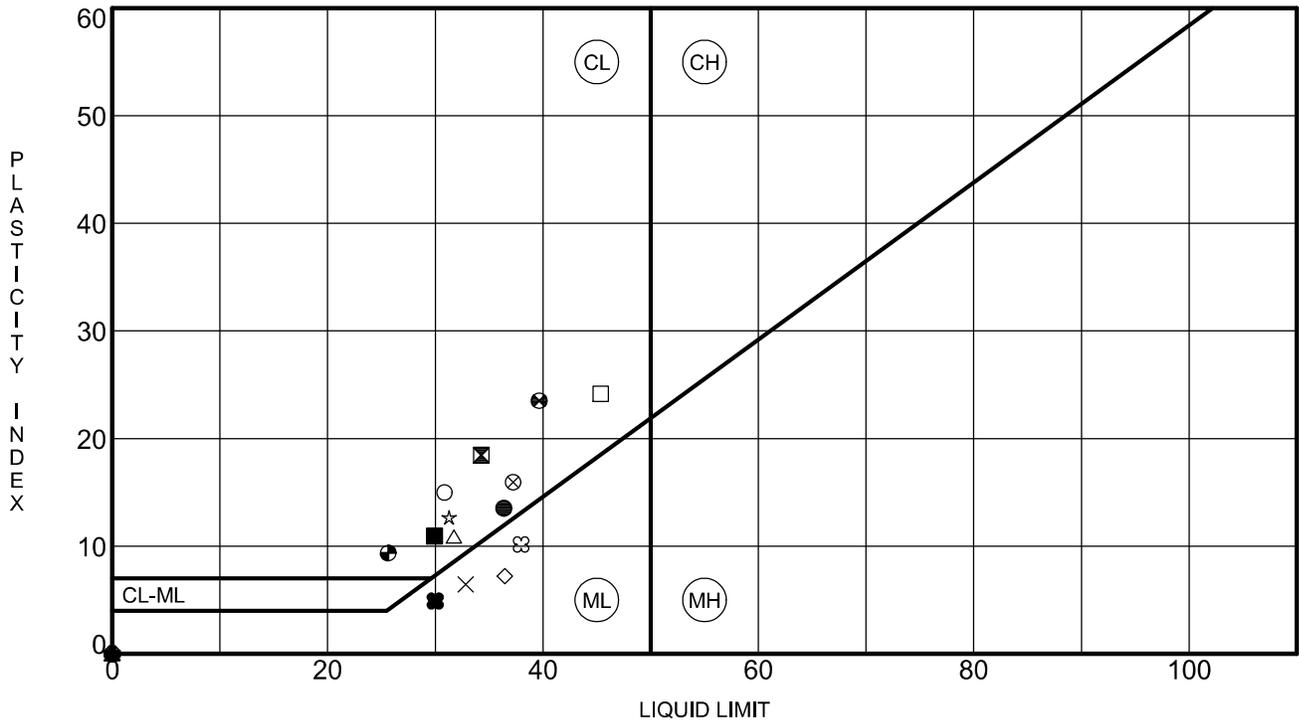
Specimen Identification	LL	PL	PI	Fines	Classification	
● B-01	0.0	36	23	13	38	Clayey SAND (SC)
⊠ B-01	5.0	34	16	18	29	Clayey SAND (SC)
▲ B-01	21.0	NP	NP	NP	17	Silty SAND (SM)
★ B-02	5.0	NP	NP	NP	15	Silty SAND (SM)
⊙ B-03	30.0	NP	NP	NP	12	Poorly Graded SAND w/Silt (SP-SM)
⊕ B-04	10.0	NP	NP	NP	30	Silty SAND (SM)
○ B-04	16.0	31	16	15	46	Clayey SAND (SC)
△ B-05	3.0	32	21	11	34	Clayey SAND (SC)
⊗ B-06	20.0	37	21	16	81	Lean CLAY with Sand (CL)
⊕ B-07	11.0	NP	NP	NP	11	Poorly Graded SAND w/Silt (SP-SM)
□ B-08	5.5	45	21	24	50	Clayey SAND (SC)
⊗ B-09	0.0	40	16	24	48	Clayey SAND (SC)
⊕ B-10	8.5	26	16	10	44	Clayey SAND (SC)
★ B-11	6.0	31	19	12	50	Clayey SAND (SC)
⊗ B-12	8.0	38	28	10	69	Sandy SILT (ML)
■ B-13	5.5	30	19	11	38	Clayey SAND (SC)
◆ B-14	30.0	NP	NP	NP	40	Silty SAND (SM)
◇ B-15	3.0	36	29	7	61	Sandy SILT (ML)
× B-16	0.0	33	26	7	36	Silty SAND (SM)
⊗ B-17	3.0	30	25	5	45	Silty SAND (SM)

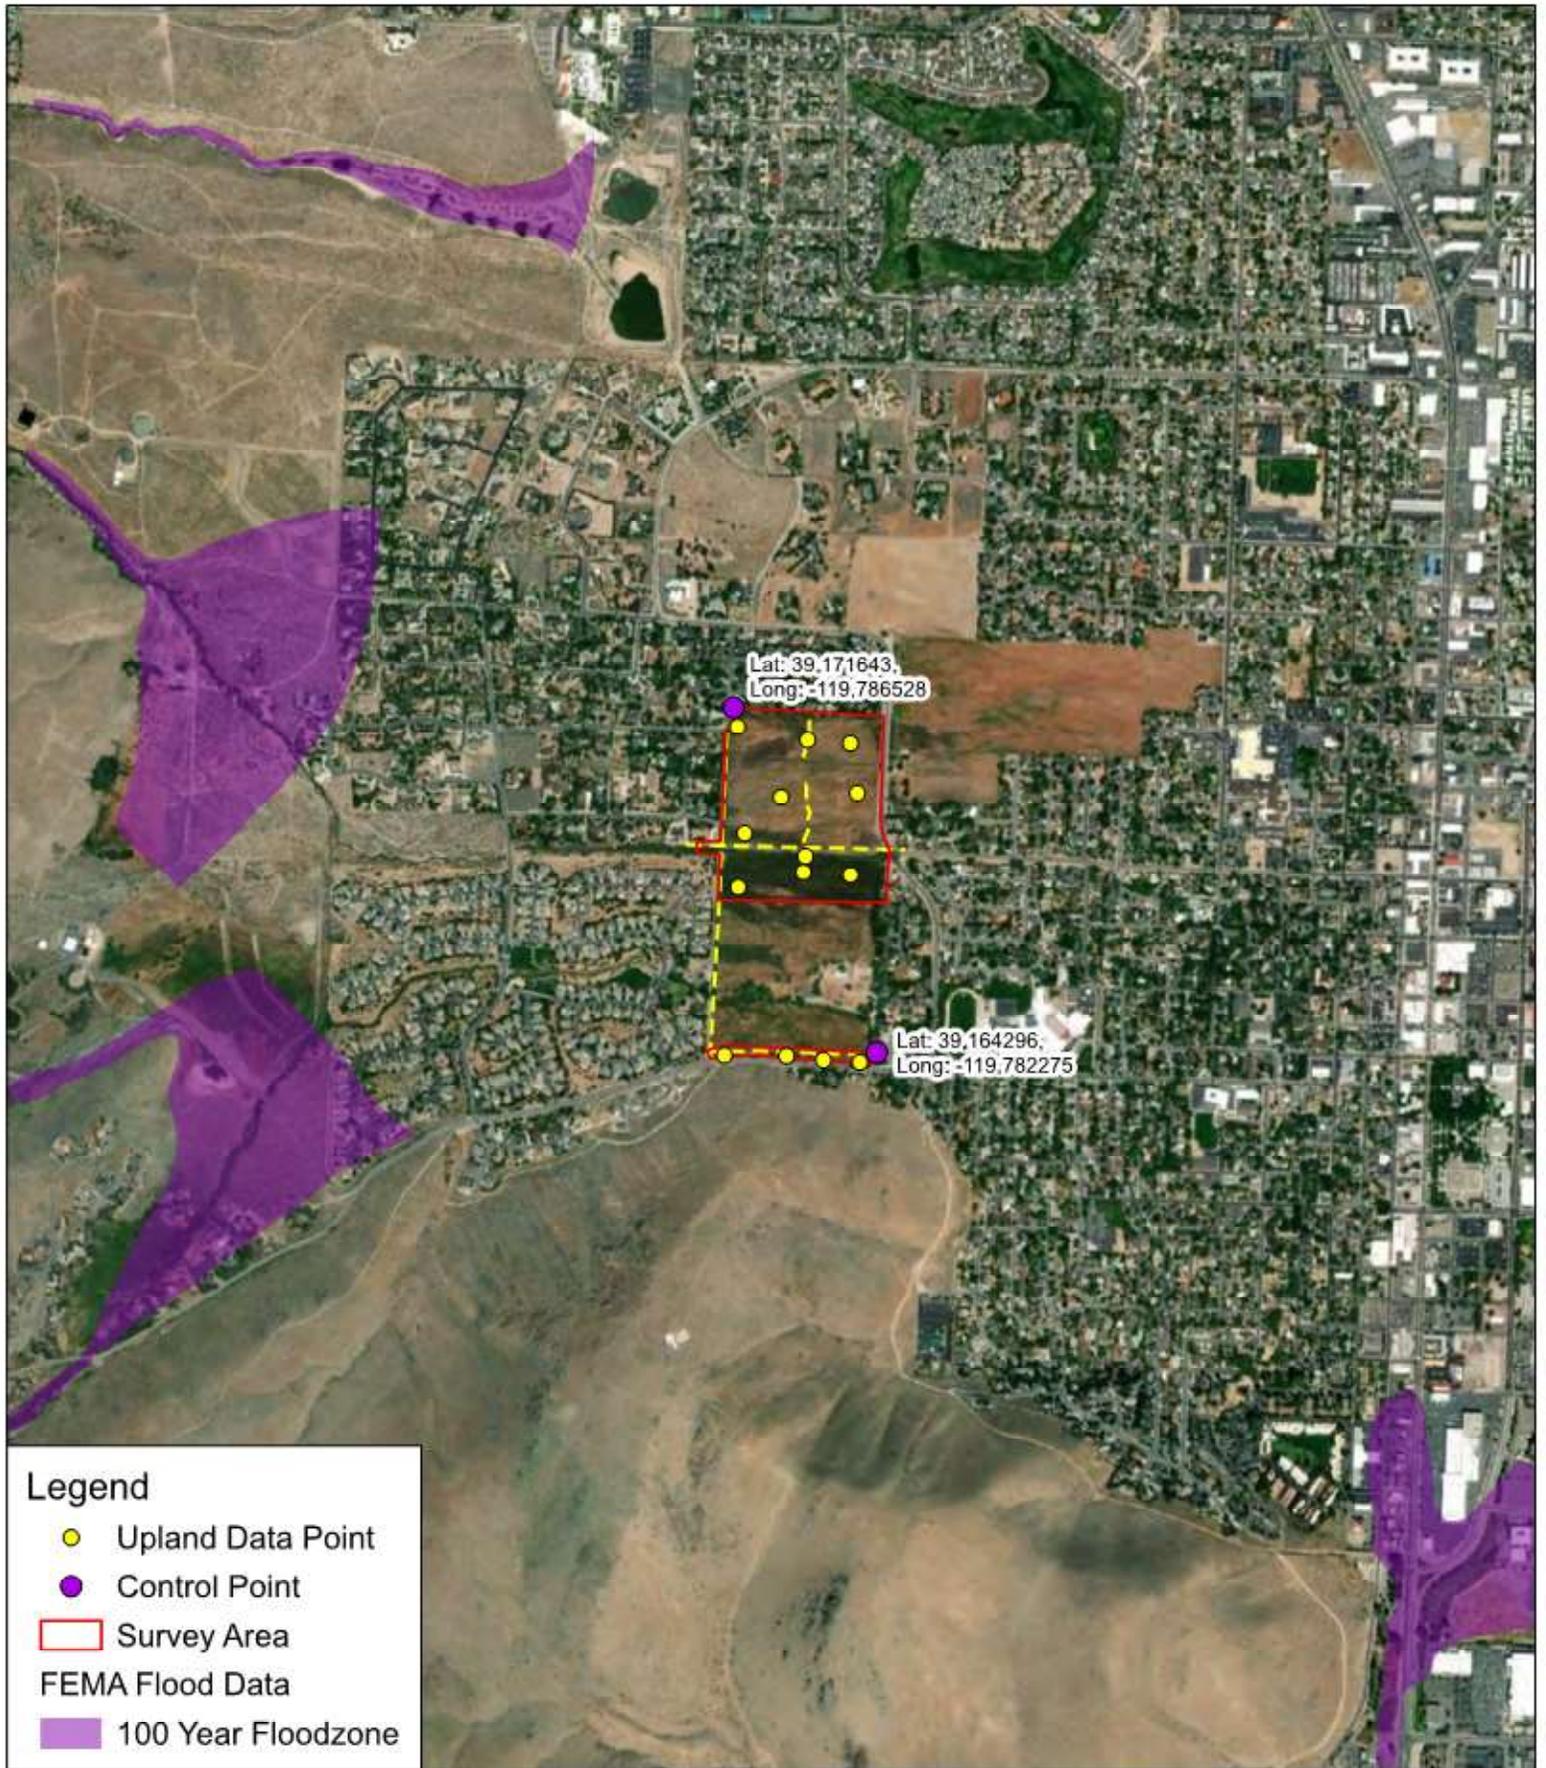
Figure 4
 Andersen Ranch
 FEMA Floodplain

Project: Vintage at Kings Canyon
 County: Carson City, Nevada
 Surveyors: JoAnne Michael, Erin Smith
 Date: Mar 30 & Apr 4, 2022
 Data Source: FEMA Flood Map, 2021

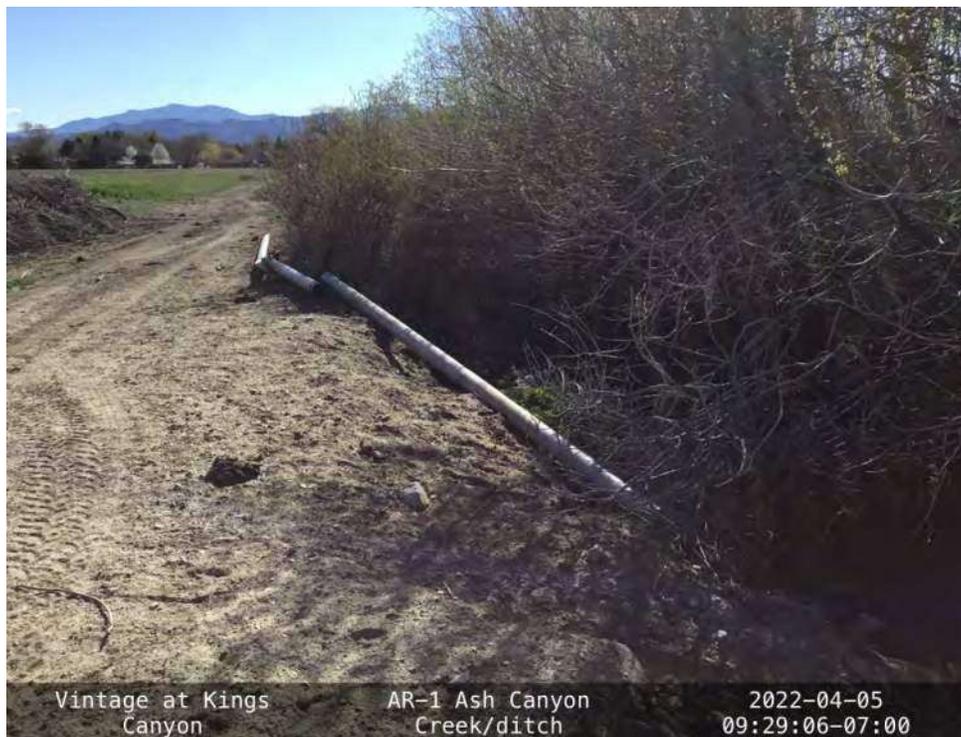
Photo 4. Overview of Ash Canyon Creek (AR-1). View looking east on north bank.

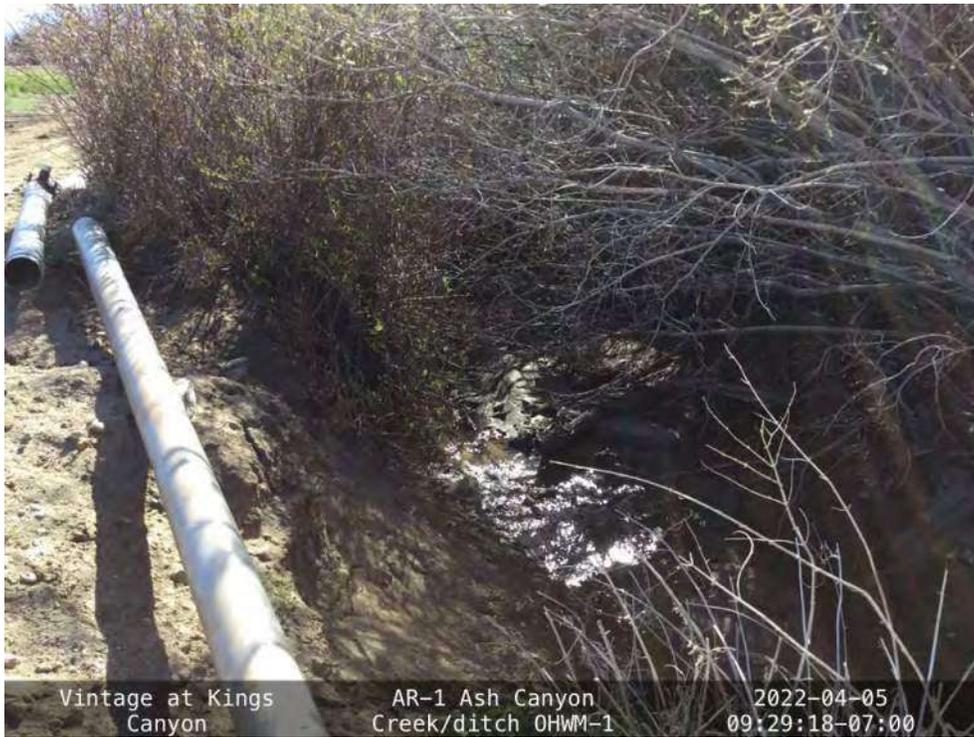
Photo 5. OHWM-1: picture showing approximately 2-4 inches of water in Ash Canyon Creek (AR-1). Exposed/partially excavated left bank with disconnected irrigation line. View looking southeast.

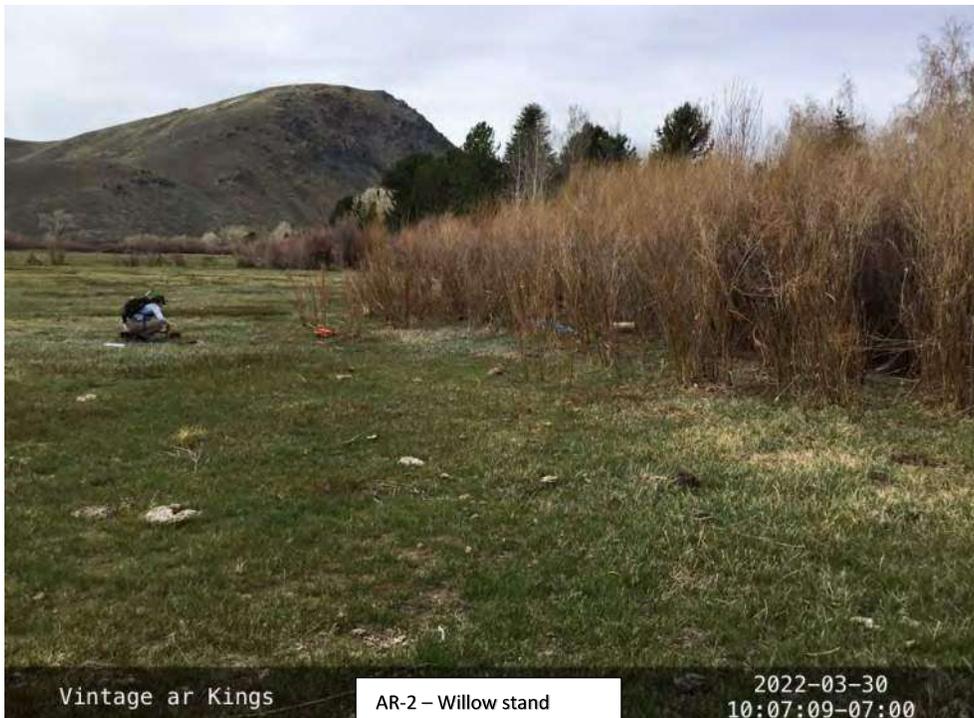
Photo 6. AR-2: Irrigation ditch running along the western boundary of Survey Area, flows south to north then terminates at northwest corner. Water from AR-2 flood irrigates pasture visible in picture. View looking south.

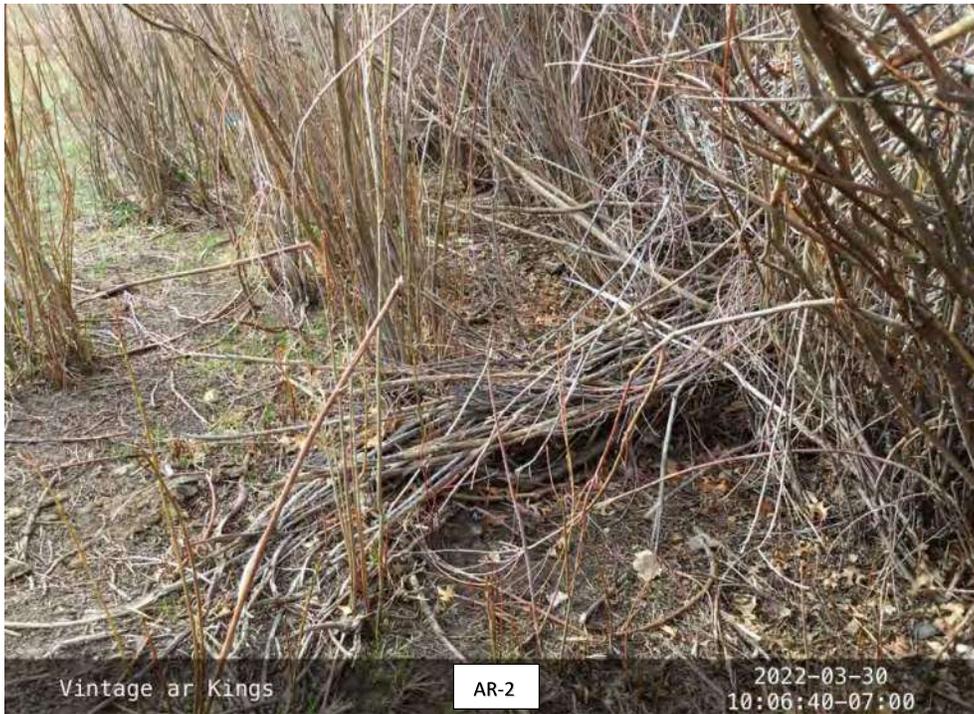
Photo 7. OHWM-2: AR-2 irrigation ditch at western boundary of Survey Area. Thick willow obscuring view of channel. Average channel width approximately 5 feet. View looking southwest.

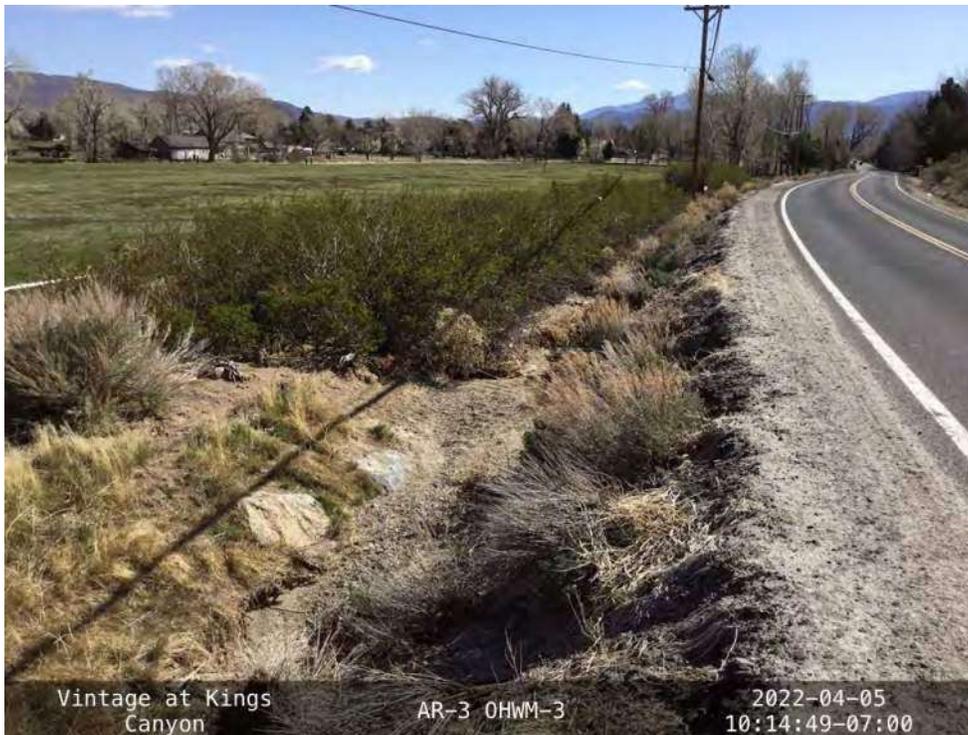
Photo 8. OHWM-3: AR-3 excavated roadside ditch capturing storm water from road. When present, water flow from west to east into storm drain at southeast corner of Survey Area. View looking east.

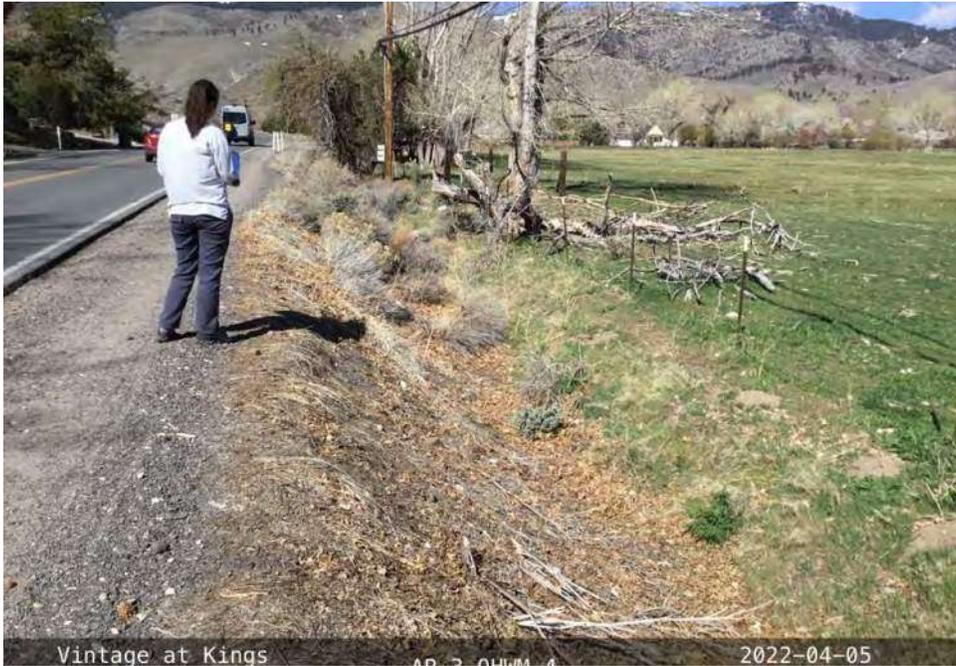
Photo 9. OHWM-4: AR-3 excavated roadside ditch at eastern end when some overland flow from irrigated pasture may intermittently be entering ditch. View looking west.

The on-site length of AR-3 is 1,350 feet (0.03 acres), with an average width of one foot at the OHWM. The OHWM was identified in the field by a lack of vegetation, change in substrate, and a scour line. AR-3 is described in OHWM-3 and OHWM-4 located in Attachment F and shown in photos 8 through 10 in Attachment C.

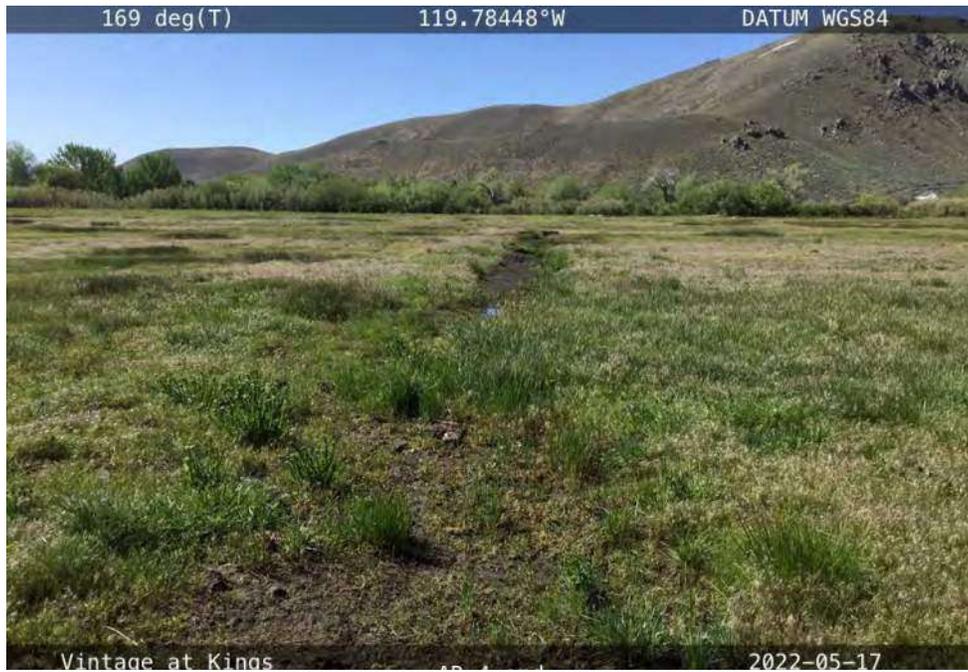
Photo 11. AR-4b: Older excavated irrigation ditch no longer conveying water, only capturing sheet flow from northwestern half of pasture when irrigated. View looking south.

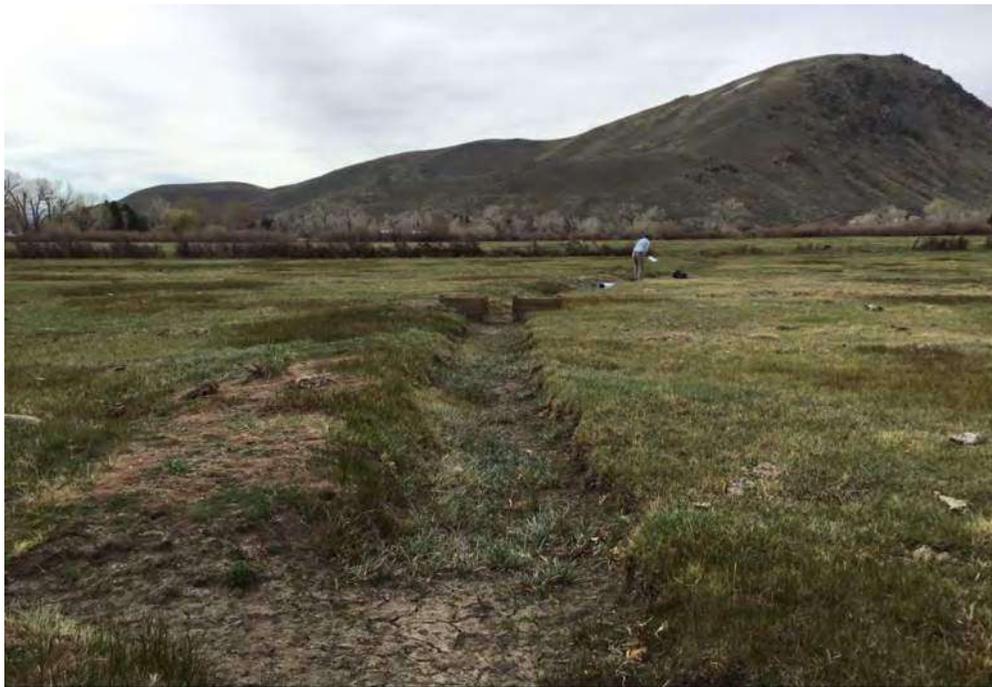
Photo 12. AR-4a: Southern end of AR-4 excavated irrigation ditch. Old irrigation ditch capturing sheet flow across pasture. Small weir visible in picture no longer operating. View looking south.

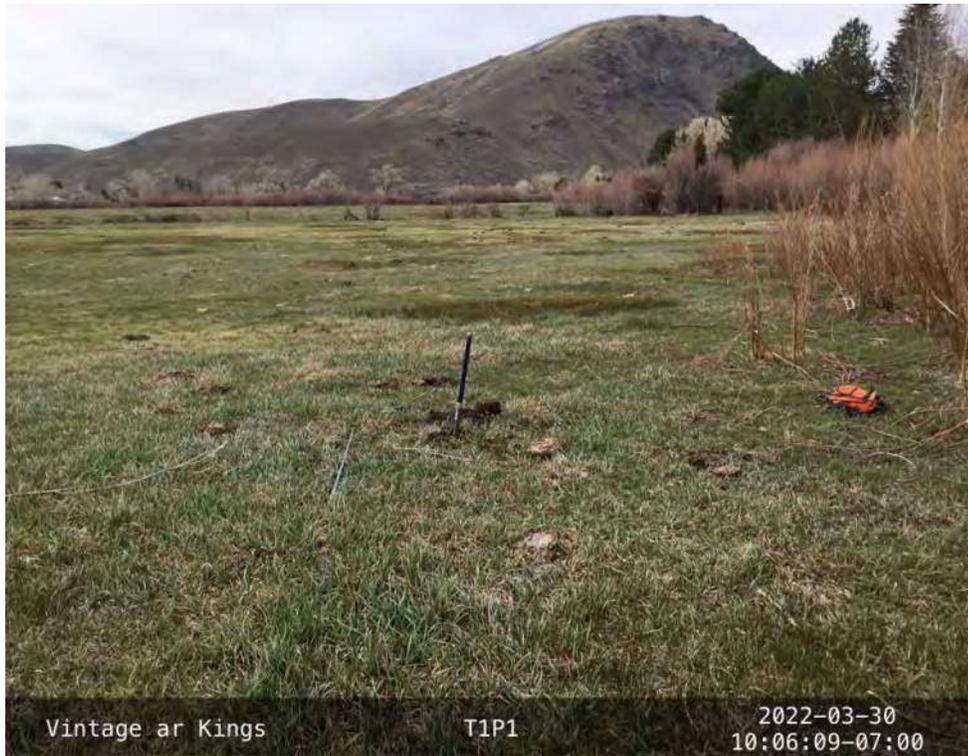
Photo 13. T1-P1: Data point taken at western boundary of Survey Area adjacent to willow stand surrounding AR-2 irrigation ditch. Vegetation was dominated by an unknown sedge species (*Carex* sp., OBL-FAC) and Narrow-leaf willow (*Salix exigua*, FACW). View looking south.

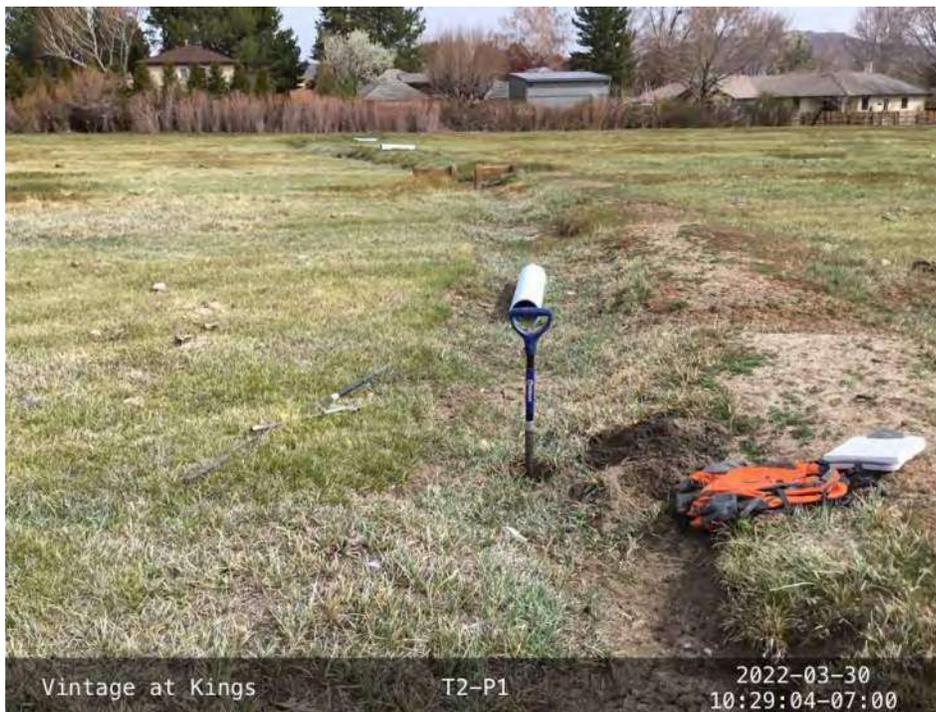
Photo 14. OHWM- 5: T2-P1 collected just north of OHWM-5 in swale area. Vegetation dominated by an unknown sedge species (*Carex* sp., OBL-FAC). View looking north.
