Appendix D

Future Year LOS Calculations

This conceptual drainage report identifies the existing and conceptually proposed site conditions, and the potential drainage improvements for the approximately 29.7-acre parcel (APN 009-012-21) located in South ½ of Section 7, North ½ of Section 18, Township 15N, Range 20E. The existing parcel is proposed to be developed as a single family subdivision development, consisting of 61-units, 3.8-acres of open space, and associated on-site civil and drainage infrastructures. Connections to Manhattan Drive and W. Washington Street, along with half street improvements to N. Ormsby Boulevard along the frontage are proposed. This study has been conducted in accordance with Division 14 of the Carson City Municipal Code.

The purpose of this Memo is to present the preliminary results and mitigation associated with the hydraulic analysis of Ash Canyon Creek in support of the FEMA Conditional Letter of Map Revision (CLOMR) to be submitted in association of the proposed Andersen Ranch West development. The proposed development is located within a Zone AE flood zone without a regulatory floodway, which includes Base Flood Elevations (BFEs) that have been

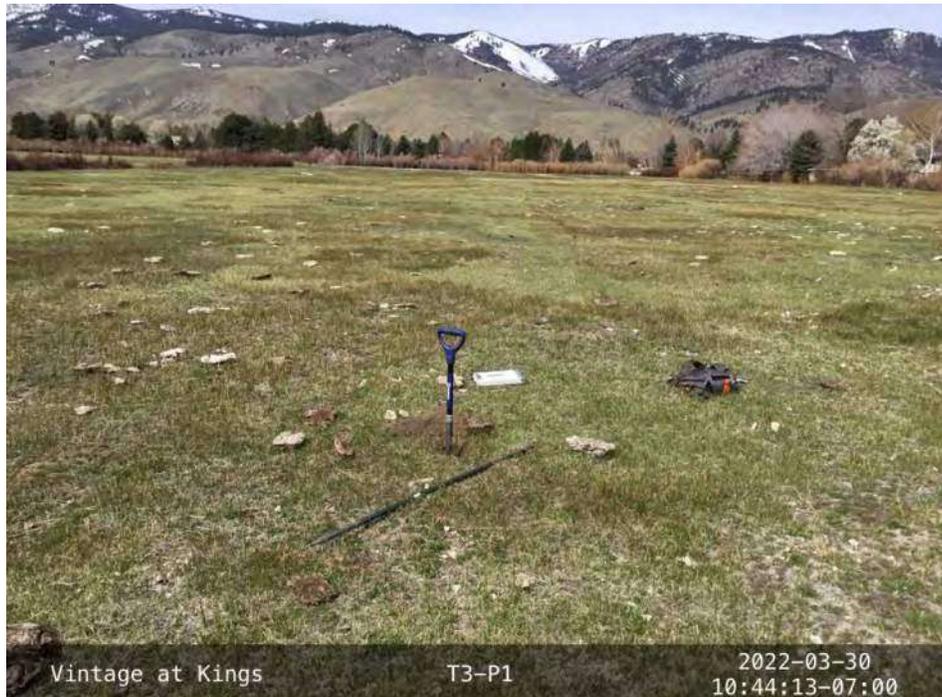
Photo 15. T3-P1: Data point taken in northeast upland portion of Survey Area. Vegetation was dominated by Cheatgrass (*Bromus tectorum*, UPL), Western tansymustard (*Descurainia pinnata*, UPL), and Common stork's-bill (*Erodium cicutarium*, UPL). View looking west.

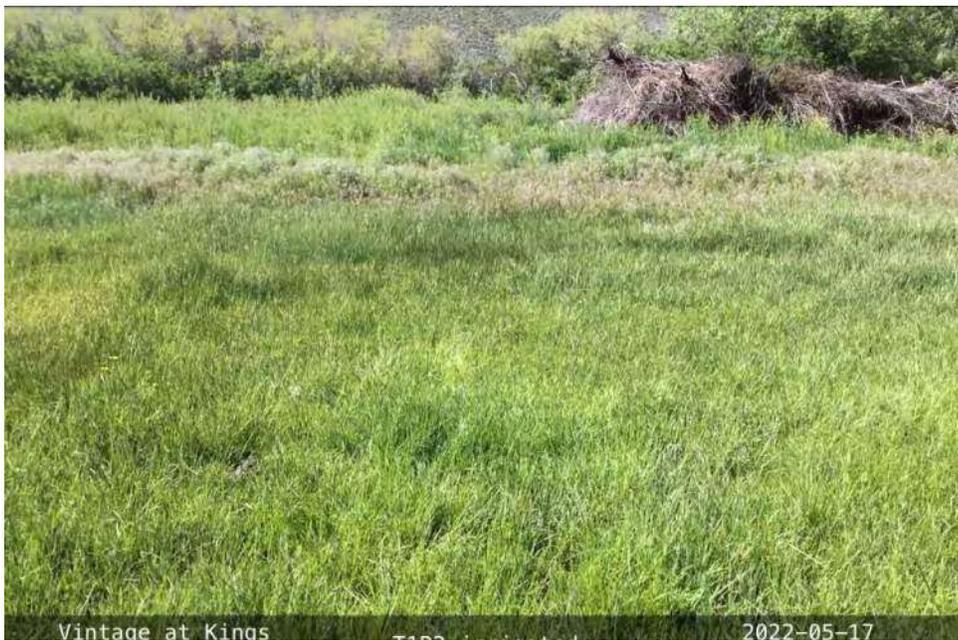
Photo 16. T1-P2: Data point taken at low point in western boundary of Survey Area adjacent to AR-1. Photo collected later (5/17/2022), showing more growth. Vegetation dominated by Kentucky bluegrass (*Poa pratensis*, FAC), Graceful cinquefoil (*Potentilla gracilis*, FAC), and Douglas' sedge (*Carex douglasii*, FAC). No hydric soils of wetland hydrology in the absence of irrigation.

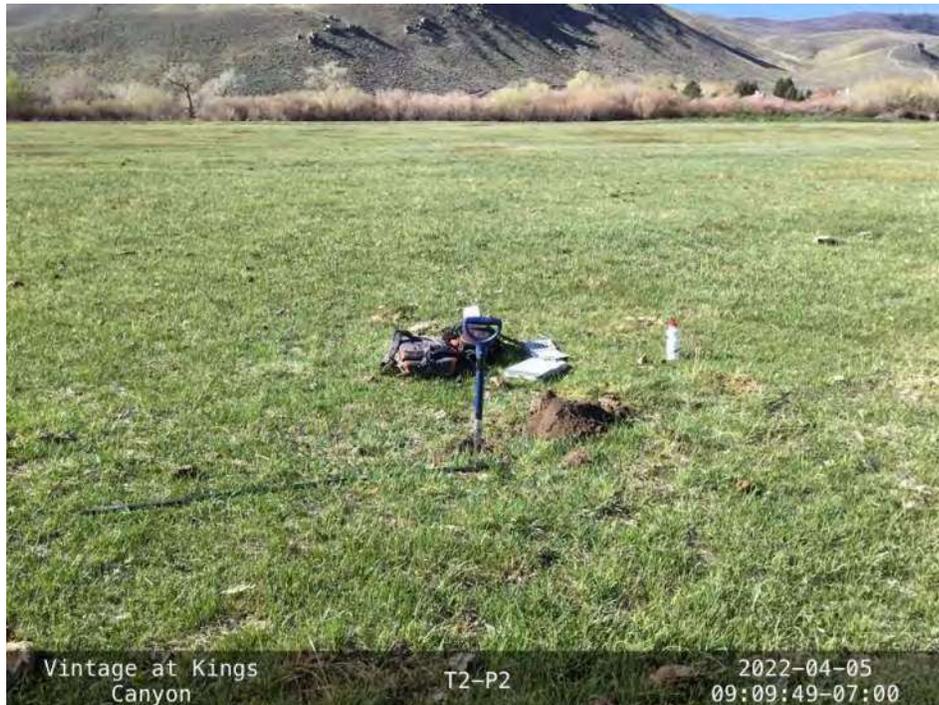
Photo 17. T2-P2: Data point taken in irrigated pasture (typical) north of AR-1 and west of AR-4a. Vegetation was dominated by White Clover (*Trifolium repens*, FACU), Baltic rush (*Juncus balticus*, FACW), and an unknown sedge (*Carex* sp., OBL-FAC). No hydric soils of wetland hydrology in the absence of irrigation.

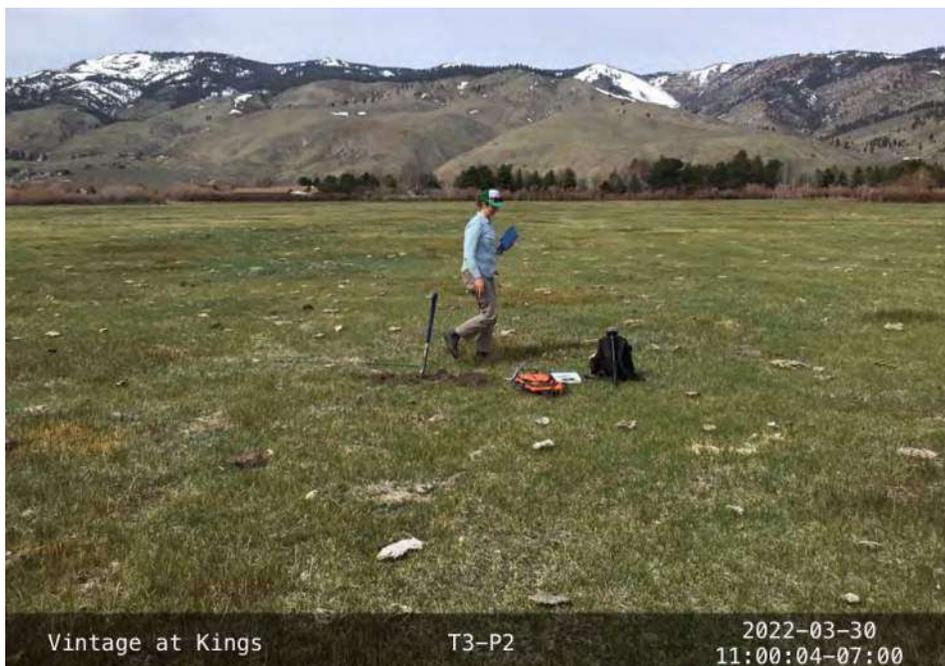
Photo 18. T3-P2: Data point taken in east end of irrigated pasture north of Ash Canyon Creek (AR-2). Vegetation was dominated by an unknown sedge (*Carex* sp., OBL-FAC), Douglas' sedge (*Carex douglasii*, FAC), and Common stork's-bill (*Erodium cicutarium*, UPL).

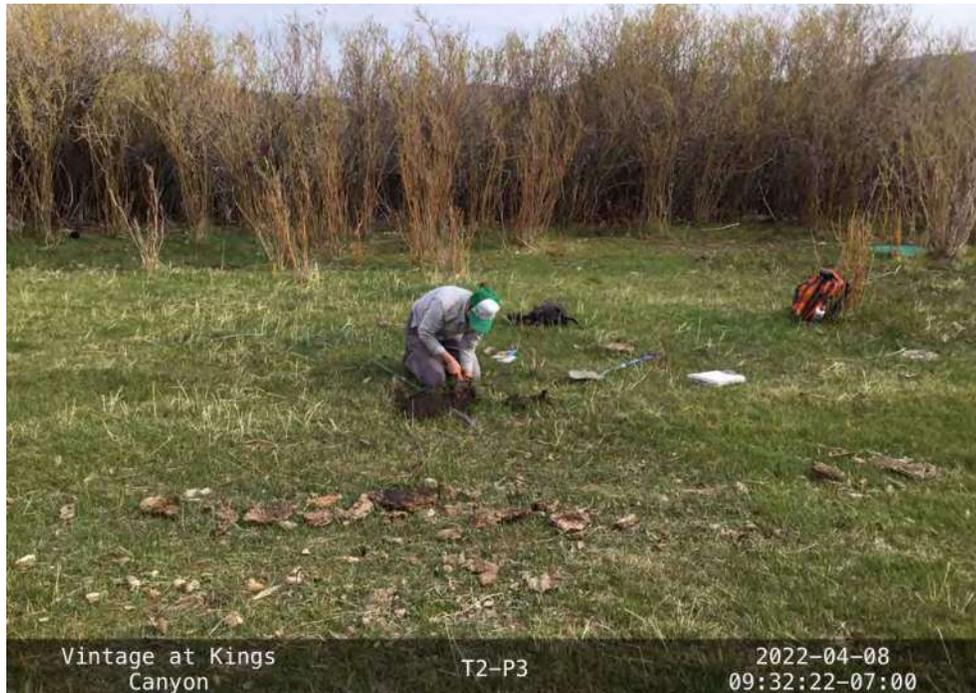
Photo 19. T2-P3: Data point taken in low spot adjacent to Ash Canyon Creek (AR-1). Vegetation dominated by Kentucky bluegrass (*Poa pratensis*, FAC), Douglas' sedge (*Carex douglasii*, FAC), and Baltic rush (*Juncus balticus*, FACW). No hydric soils of wetland hydrology in the absence of irrigation.

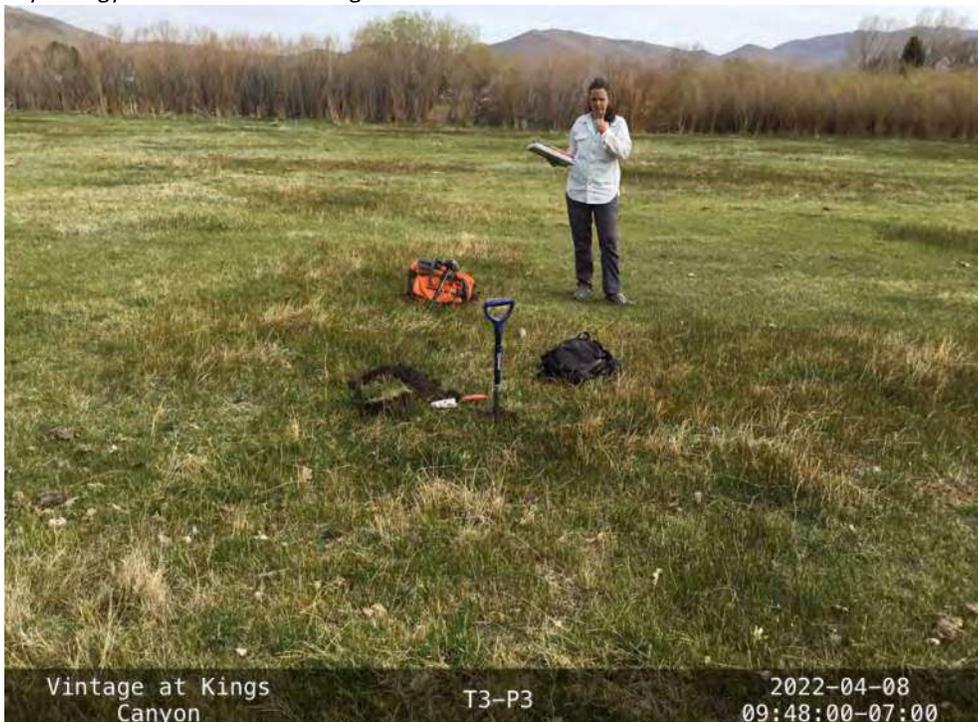
Photo 20. T3-P3: Data point taken in low spot within irrigated pasture. Vegetation dominated by Douglas' sedge (*Carex douglasii*, FAC) and Baltic rush (*Juncus balticus*, FACW). No hydric soils of wetland hydrology in the absence of irrigation.

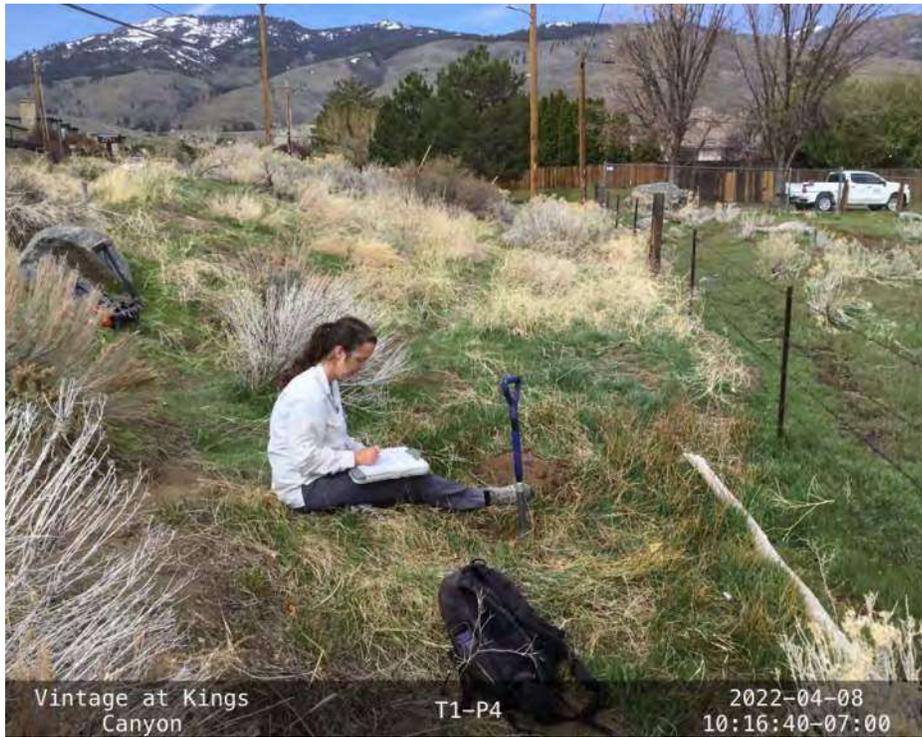
Photo 21. T1-P4: Data point taken in upland irrigated pasture. Vegetation is dominated by Big sagebrush (*Artemesia tridentata*, UPL), Cheatgrass (*Bromus tectorum*, UPL), and Fiddleneck (*Amsinckia tessellata*, UPL). View looking west.

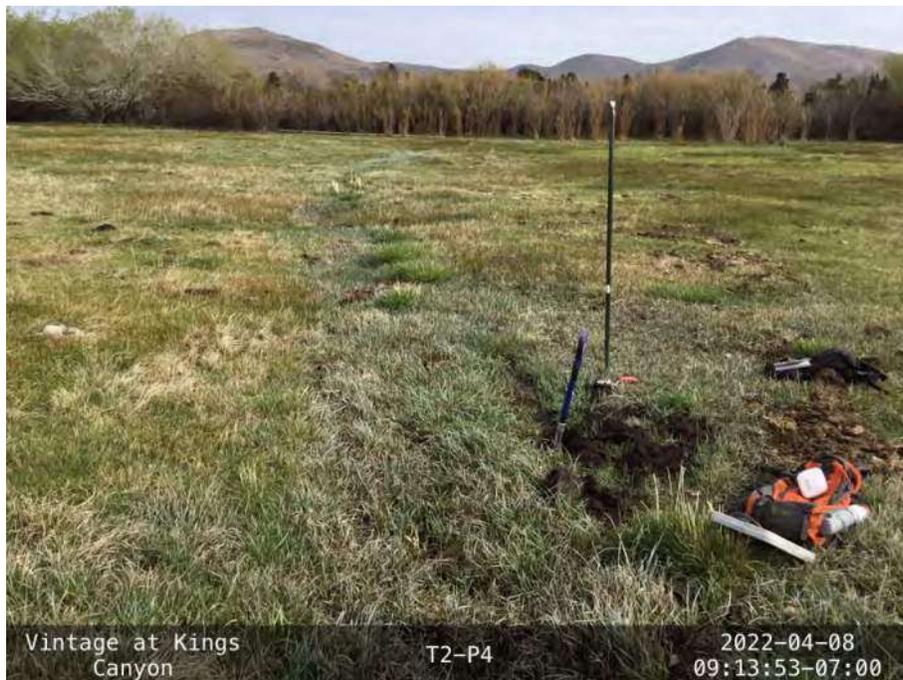
Photo 22. T2-P4: Data point taken within low point of pasture, likely a remnant of an irrigation ditch. Vegetation dominated by Kentucky blue grass (*Poa pratensis*, FAC), Douglas' sedge (*Carex douglasii*, FAC), and an unknown sedge species (*Carex* sp., OBL-FAC).

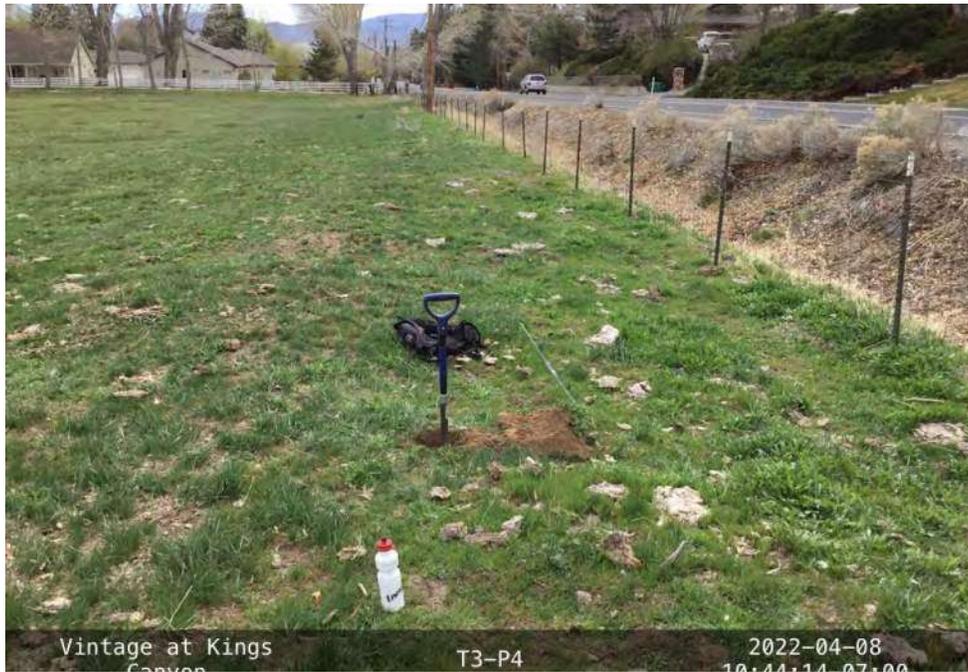
Photo 23. T3-P4: Data point taken on a slight rise in southern part of pasture. Vegetation is dominated by Kentucky Bluegrass (*Poa pratensis*, FAC) and Douglas' sedge (*Carex douglasii*, FAC).

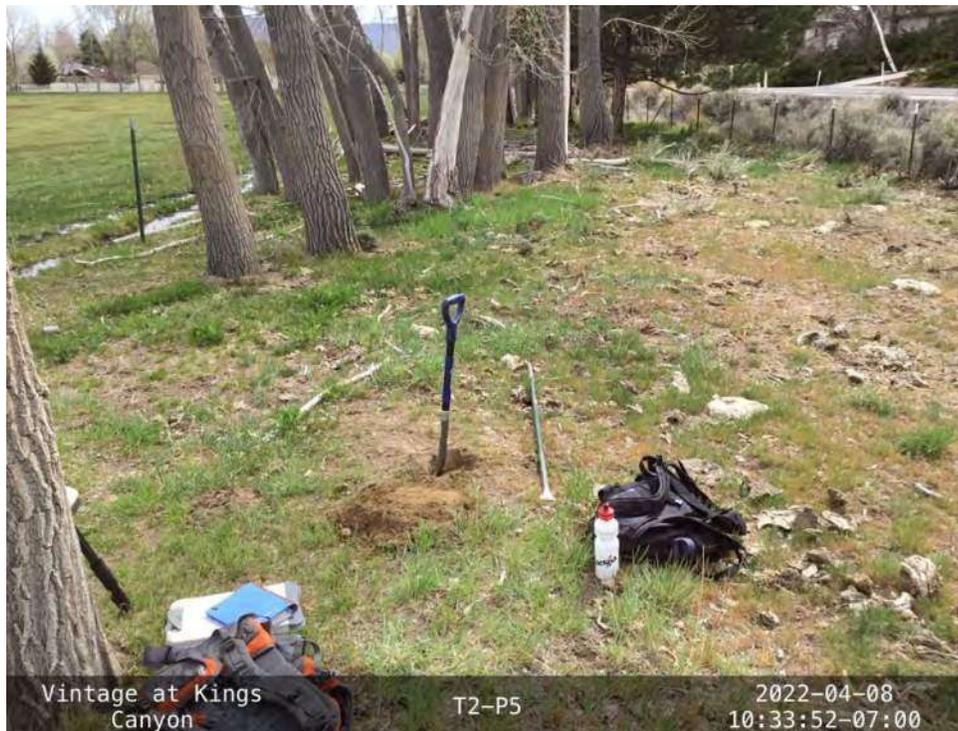
Photo 24. T2-P5: Data point collected in upland at southern end of Survey Area. Vegetation is dominated by Fremont Cottonwood (*Populus fremontii*, UPL), Big Sagebrush (*Artemisia tridentata*, UPL), Kentucky blue grass (*Poa pratensis*, FAC), and Common Stork's-bill (*Erodium cicutarium*, UPL).
