**GEOTECHNICAL EVALUATION  
CARSON CITY FIRE STATION  
CARSON CITY, NEVADA**

**PROJECT NO. R20215895E1  
March 14, 2022**

**RE: Geotechnical Evaluation  
Carson City Fire Station  
Butti Way  
Carson City, Nevada**

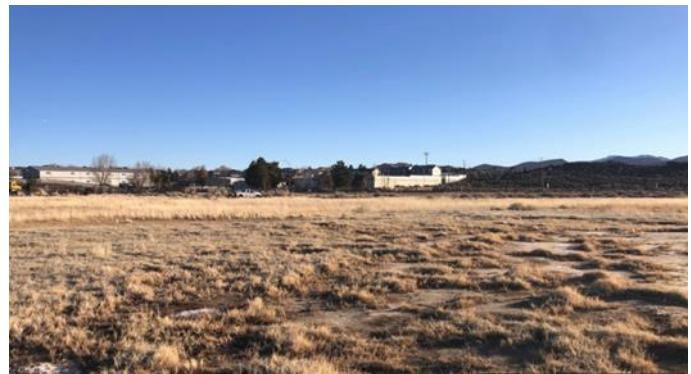
**Figure 1.3 Project Site**

The project site consists of approximately 4.5-acres of vacant land. The project site is currently vacant and undeveloped, consisting of small native brushes. The site is bordered by a vacant property to the South, Fairview Drive to the east, Butti Way to the north, and the Carson City Public Works building to the west.

The borrow site consists of undeveloped small to large desert brush located on uneven terrain. The site is bordered to the west by Airport Road, by the Public Works buildings to the north, by an irrigation ditch/sewage disposal facility to the south and by undeveloped land to the east.

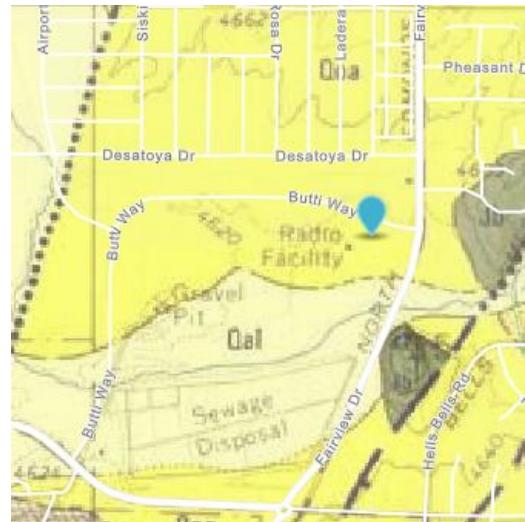
**Figure 2.1 Geological Map**

The project site is located on the referenced, Geologic Map of the New Empire Quadrangle, (Bingler, E.C., 1977) within an area mapped as Older Alluvial Plain Deposits (Qoa) described as greyish orange to dark yellow-brown small gravel to muddy sand, pebble gravel and minor well sorted cobbles and gravel with angular to subangular clasts.

The borrow site is located within an area mapped as Alluvial-Plain Deposits (Qal) described as unbedded to

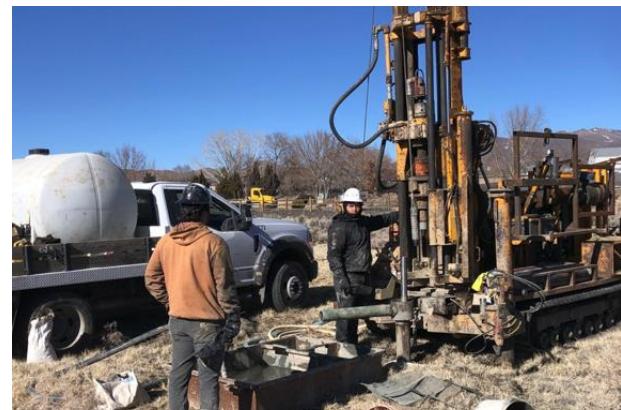
**Figure 2.5 On-site Drilling**

GES evaluated the subsurface conditions within the vicinity of the borrow site, by excavating three test pits (TP-1 through TP-3) on February 15, 2022. Test Pit TP-1 was excavated to a total depth of 11-feet below existing surface, Test Pit TP-2 was excavated to a total depth of 10.5-feet below existing surface, and Test Pit TP-3 was excavated to a total depth of 13-feet below existing surface. The total depth excavated was approximately 34.5-feet. Figure No. A-2b, in Appendix A of this report, shows the approximate test pit locations within the borrow area. The test pit location coordinates (datum NAD 1983 HARN) were recorded by GES staff using a handheld GPS unit

and approximate surface elevation estimated from Google Earth. Coordinates and elevations are provided on the exploration logs included in Appendix A.

GES evaluated the subsurface conditions within the project site, by drilling 4 borings (B-1 through B-4) on January 19, 2022, and February 1, 2022. Boring B-1 was drilled to a total depth of 5-feet below existing surface, boring B-2 was drilled to 36-feet below existing surface, boring B-3 was drilled to a total depth of 51.5-feet below existing surface, and boring B-4 was drilled 25-feet below the existing surface. The total depth drilled was approximately 117.5 lineal feet. Figure A-2a, in Appendix A of this report, shows the approximate drilling locations within the project area. The boring location coordinates (datum NAD 1983 HARN) were recorded by GES staff using a handheld GPS unit and approximate surface elevation estimated from Google Earth. Coordinates and elevations are provided on the exploration logs included in Appendix A.

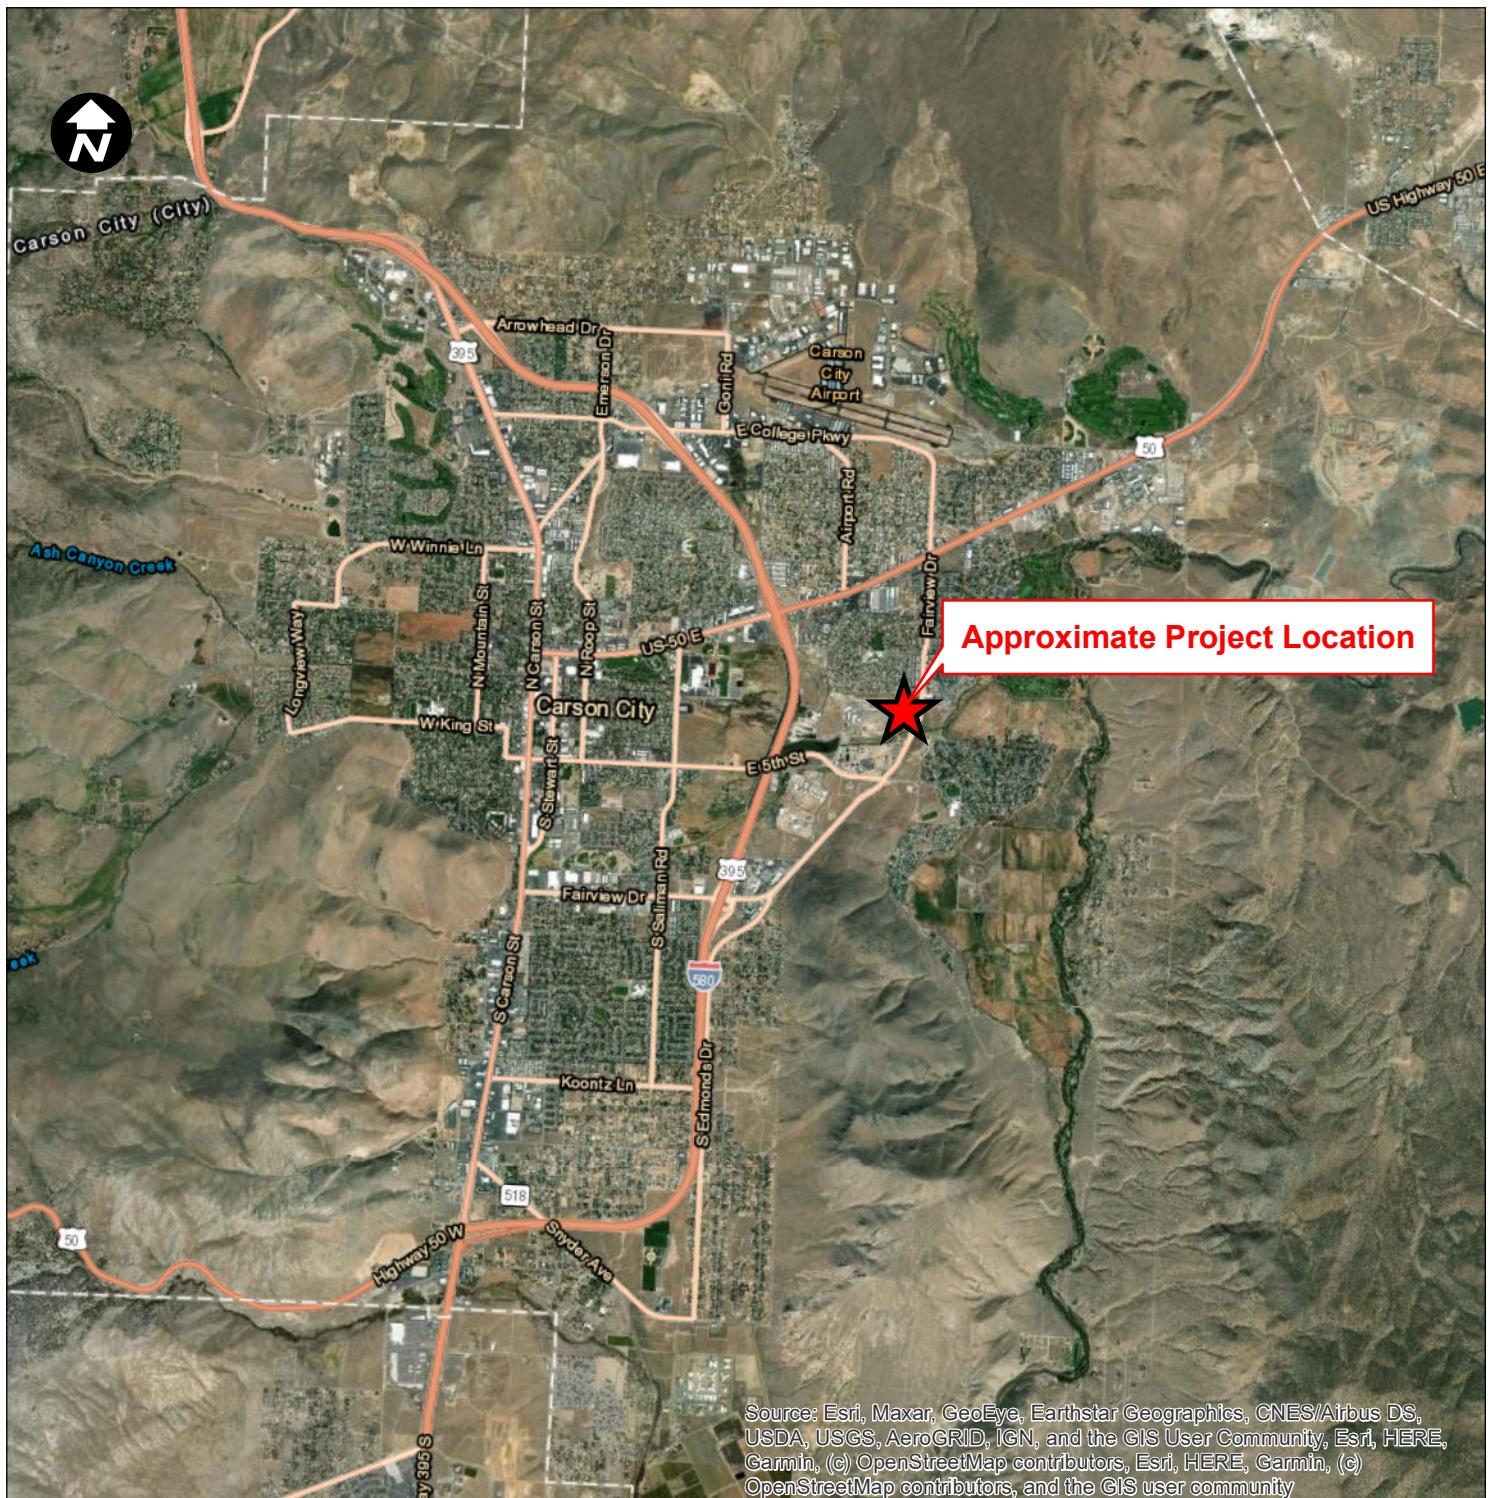
Drawn By: JJB	Date Drawn: 2/2/2022
Project No. R20215895E1	Figure No. A-2a

**EXPLORATION LOCATION MAP  
CARSON CITY FIRE STATION  
SW CORNER OF BUTTI WAY AND FAIRWAY DRIVE  
CARSON CITY, NEVADA**

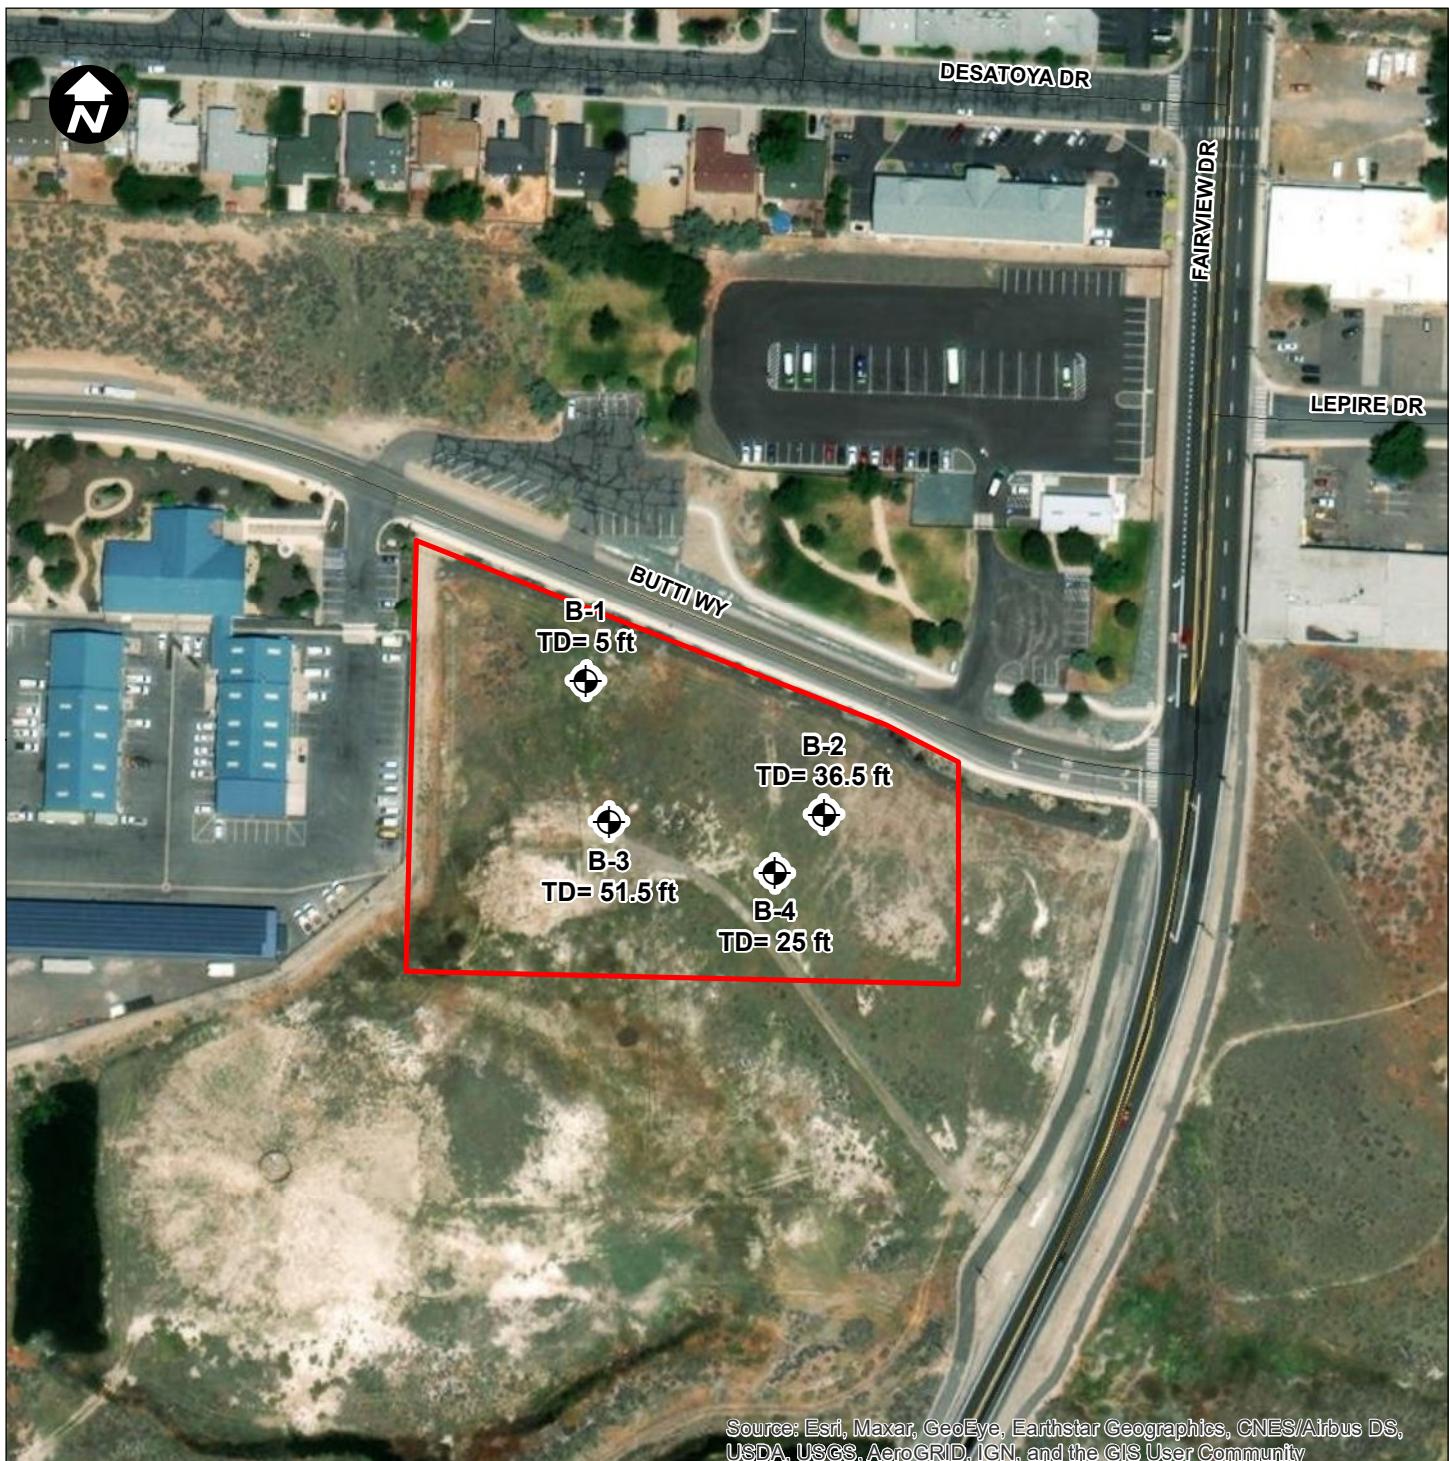
- B-1 Approximate Boring Location
- Approximate Site Boundary

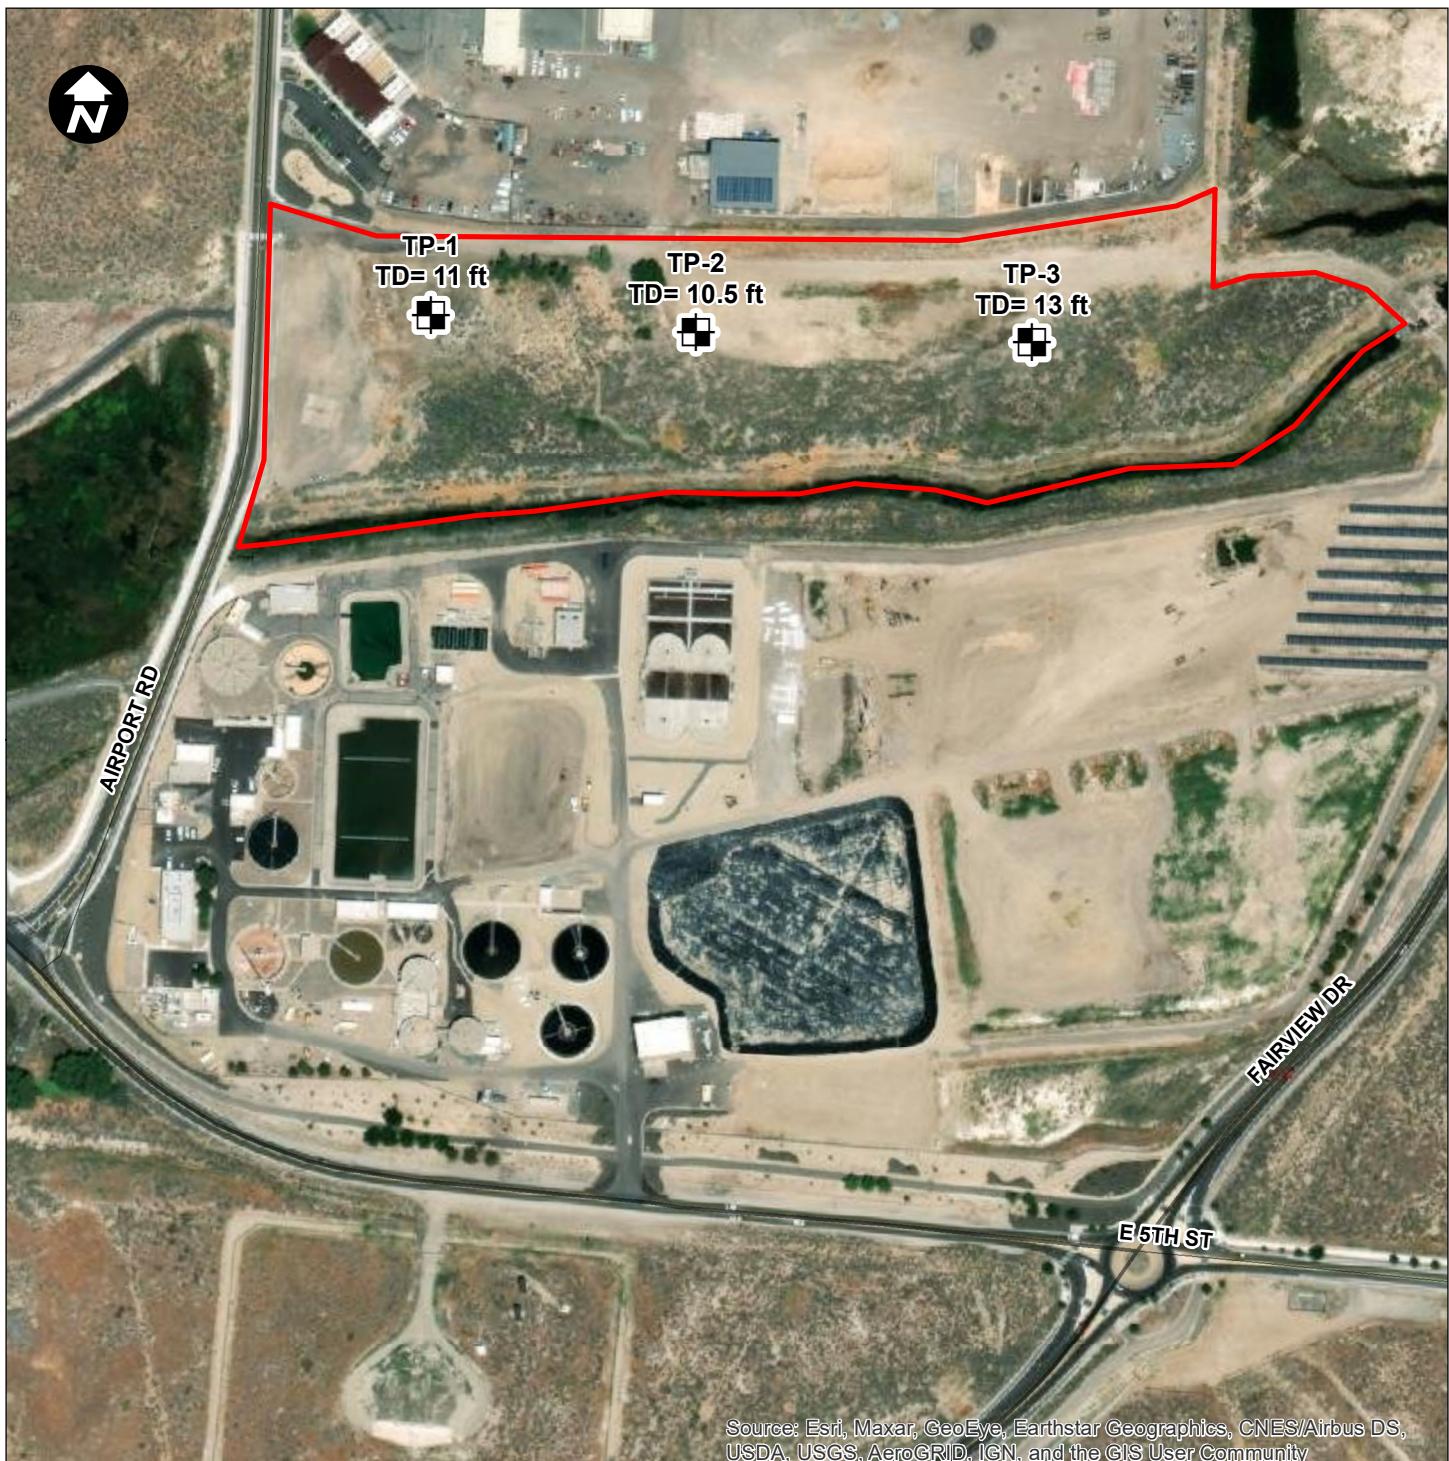
- TP-1      Approximate Test Pit Location
- Minor Collector
- Minor Arterial
- Approximate Site Boundary
