Pavement Data Collection and Pavement Management System Update

Carson City, Nevada

MARCH 2025

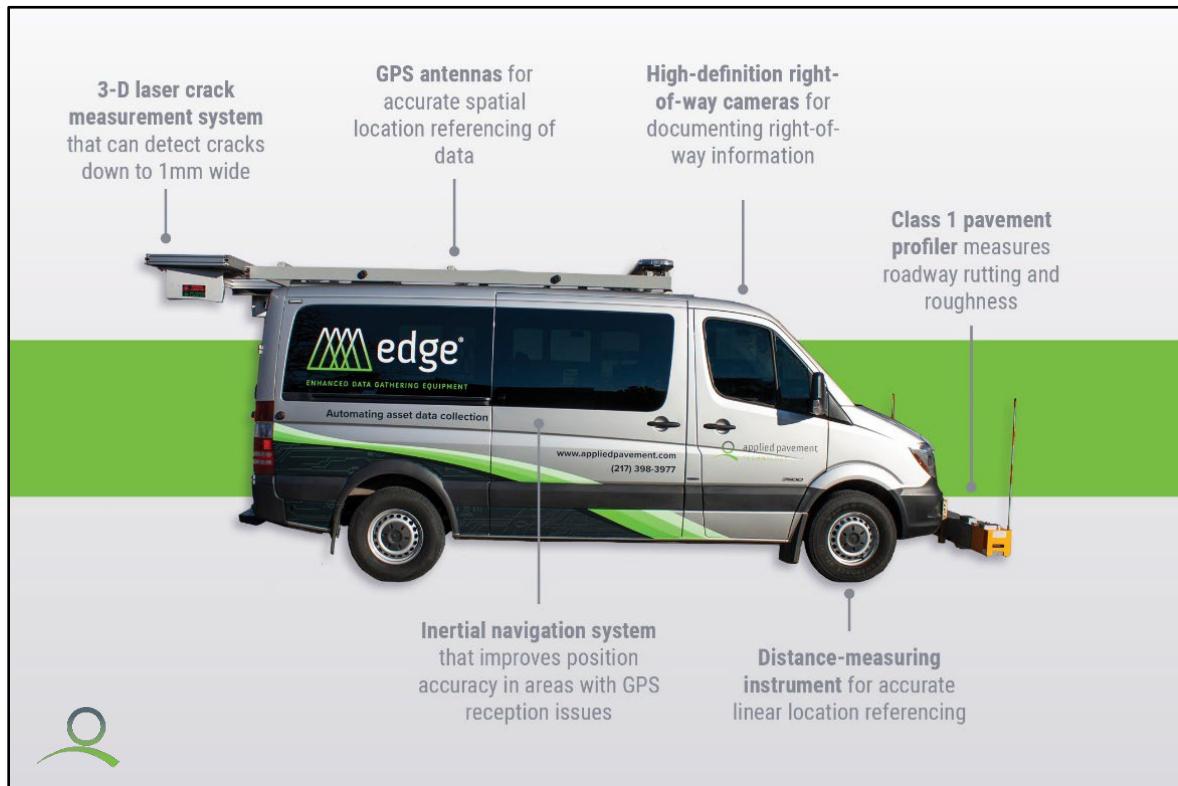
Figure 1. APTech's EDGE data collection vehicle.

Between October and November 2024, APTech used its Enhanced Data Gathering Equipment (EDGE – shown in Figure 1) for automated data collection. The EDGE collected downward imagery using a Laser Crack Measurement System (LCMS), road surface profile data (longitudinal and transverse), and four right-of-way (ROW) camera views (forward, forward-left, forward-right, and rearward). All collected information was georeferenced using an onboard GPS antenna. On two- or three-lane local roadways (including roads with one lane each direction and a center turning lane), data were collected on one lane in one direction. On four- and two-lane regional roadways, data were collected on one lane in each direction.

APTech used its EDGE automated data collection van to collect pavement condition data. As previously noted, the EDGE is equipped with ROW cameras, a Distance Measuring Instrument, GPS receivers, a five-laser road surface profiler bar, and a 3-D LCMS for comprehensive collection of georeferenced distress data. The EDGE collected condition data for roadway pavement sections in a single pass moving at posted roadway speeds without the need for traffic control.

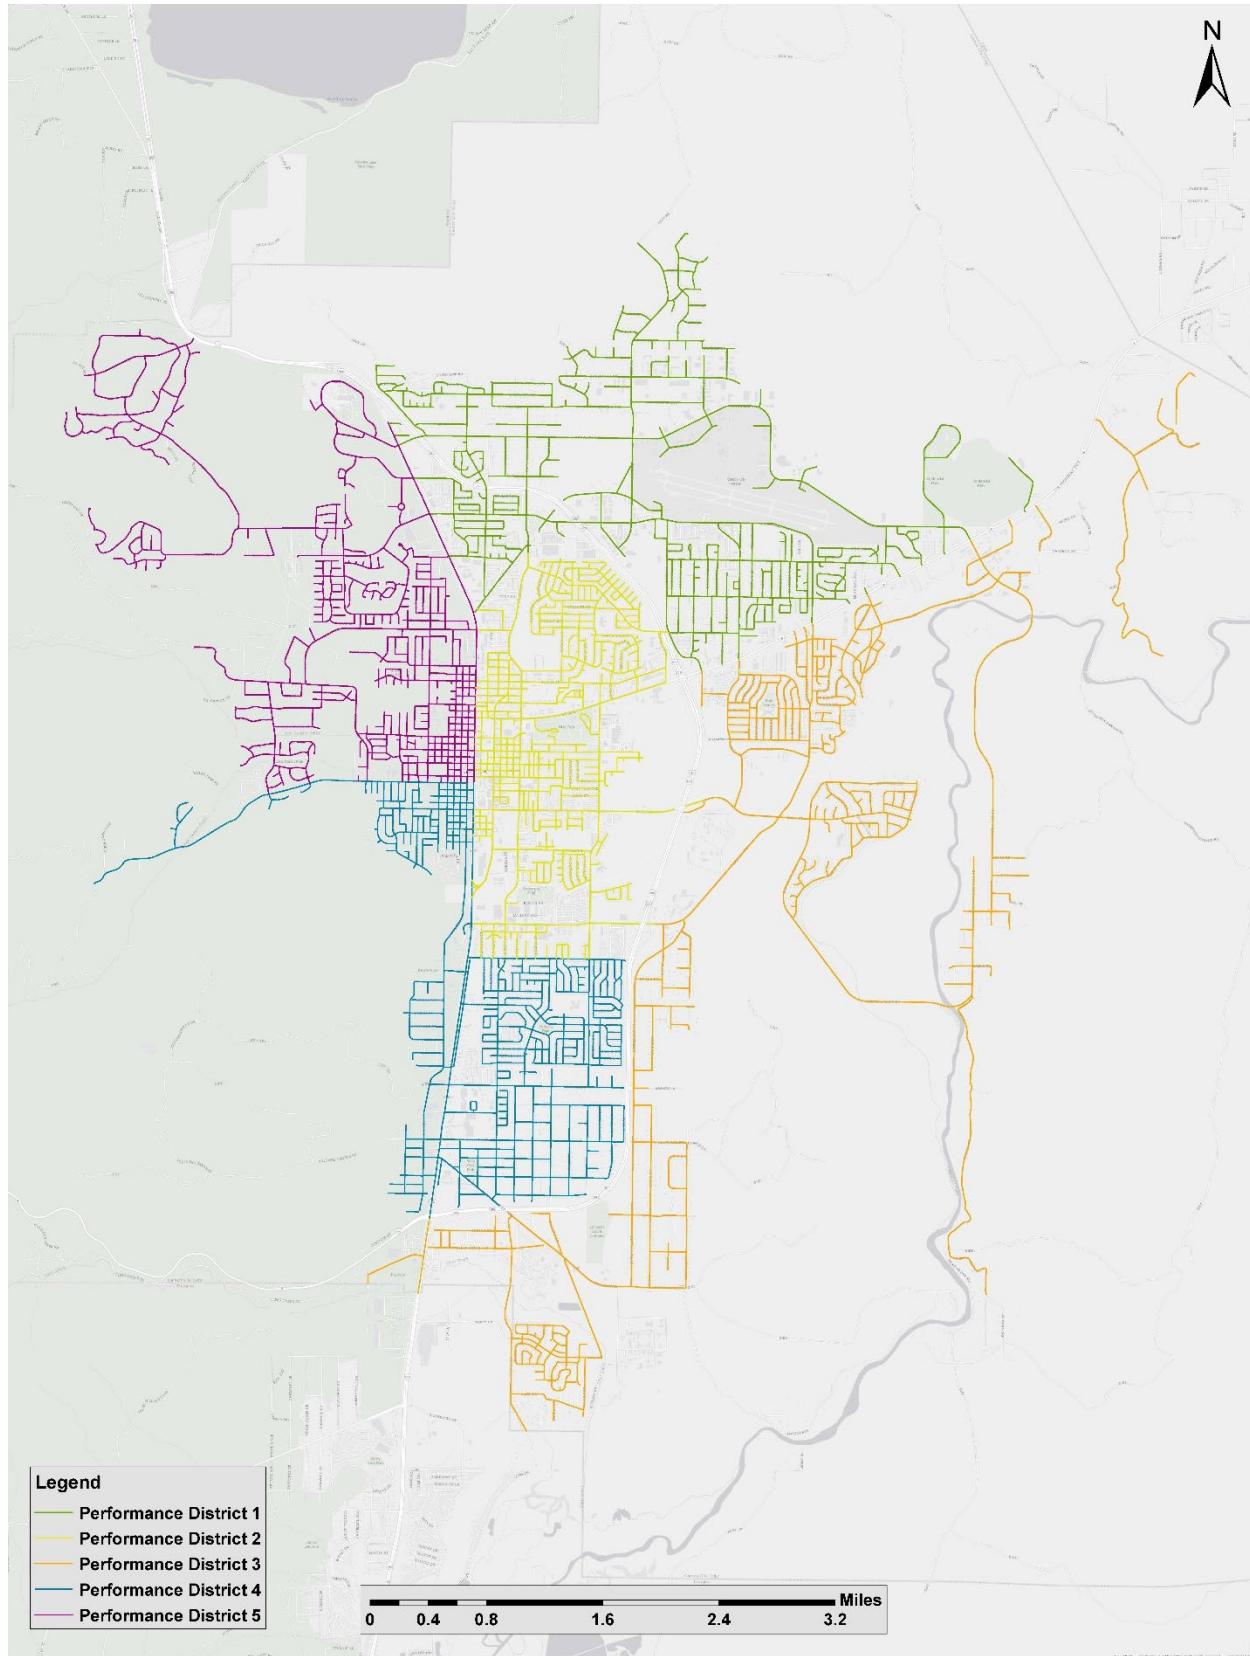
Figure 2. Carson City maintained roads by Performance District.

Per the PAVER database, the network consists of 274 centerline miles (paved with asphalt concrete) of streets sectioned into 3,035 sections that fall under one of three functional classifications and one of five Pavement Performance Districts (see figures 2 and 3). Tables 1 and 2 summarize surface area, centerline mileage, functional classification, Pavement Performance District, and number of sections for CCPW's roadway pavement network. The network is predominantly comprised of local roads.

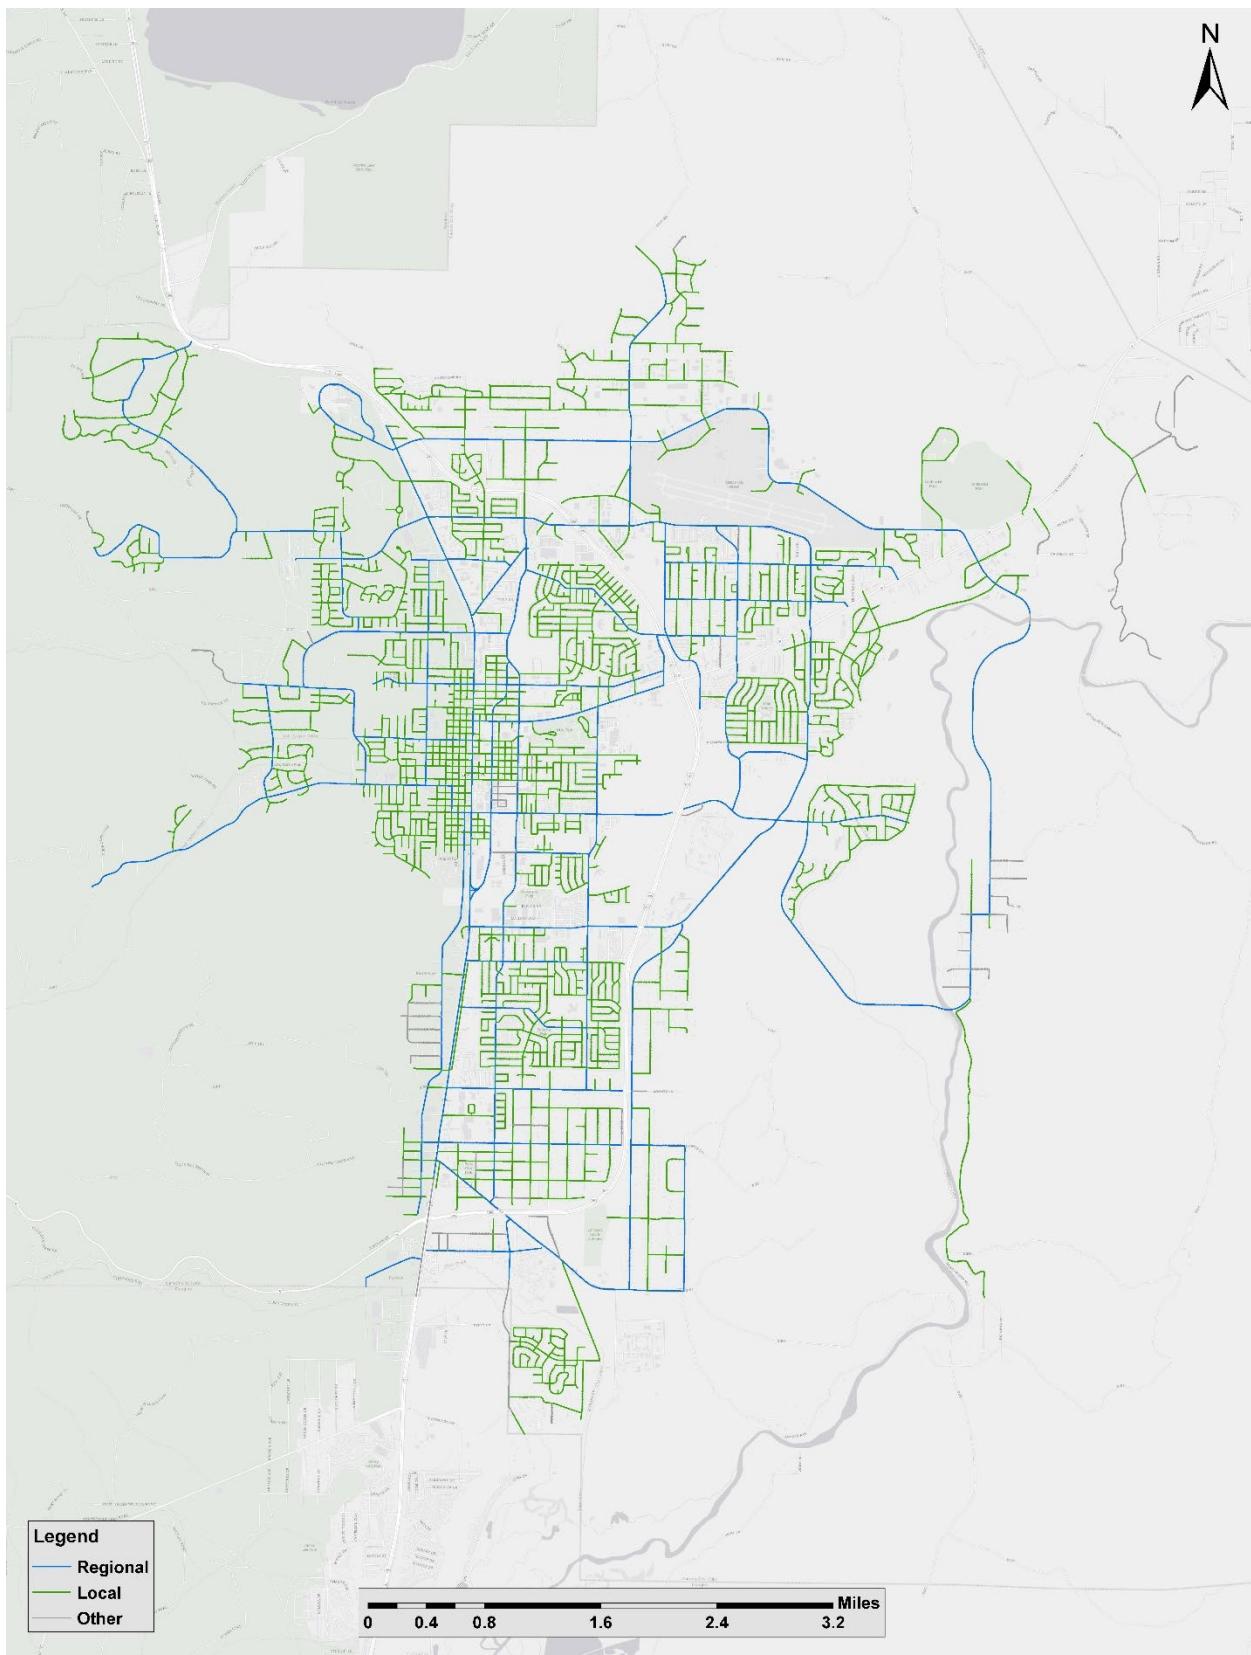
Figure 3. Carson City maintained roads by city classification.

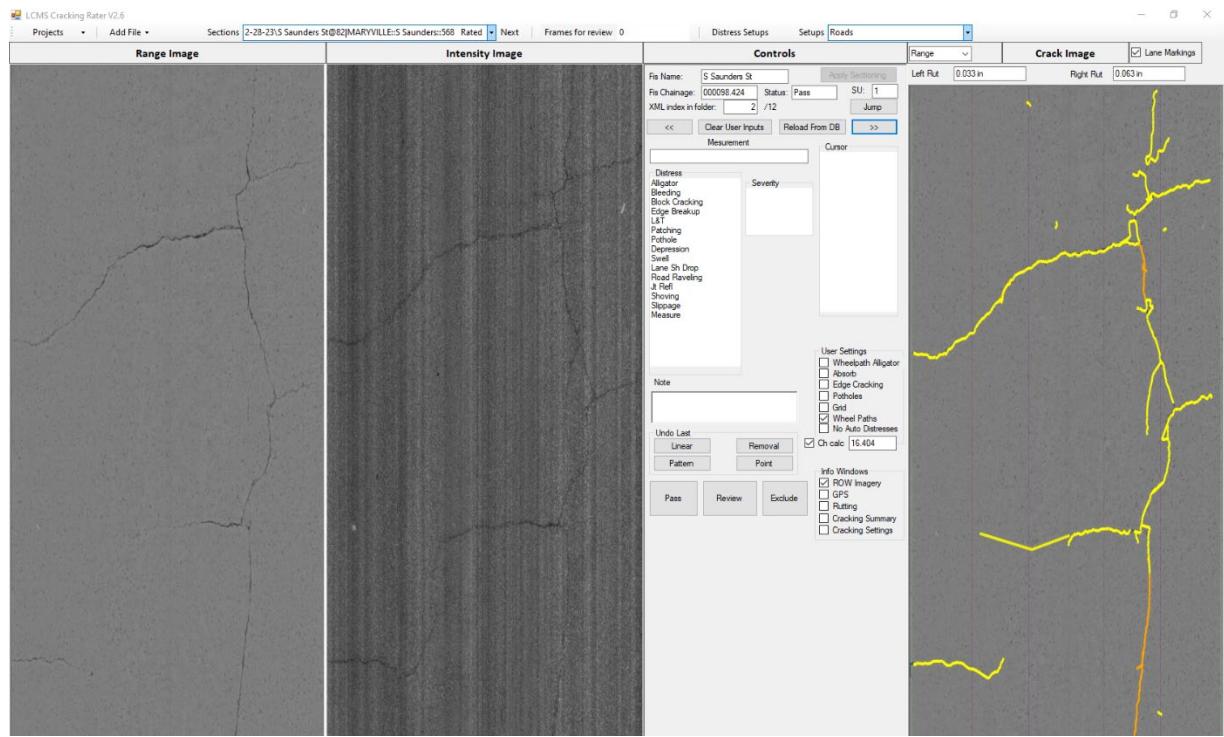
Figure 4 is a view of the computer system used for pavement distress rating. The two images on the left show cracking as noted on the range and intensity images from the LCMS. The yellow lines on the right side are the computer system identification of the pavement cracking.

Figure 4. Digital images used for pavement distress rating.

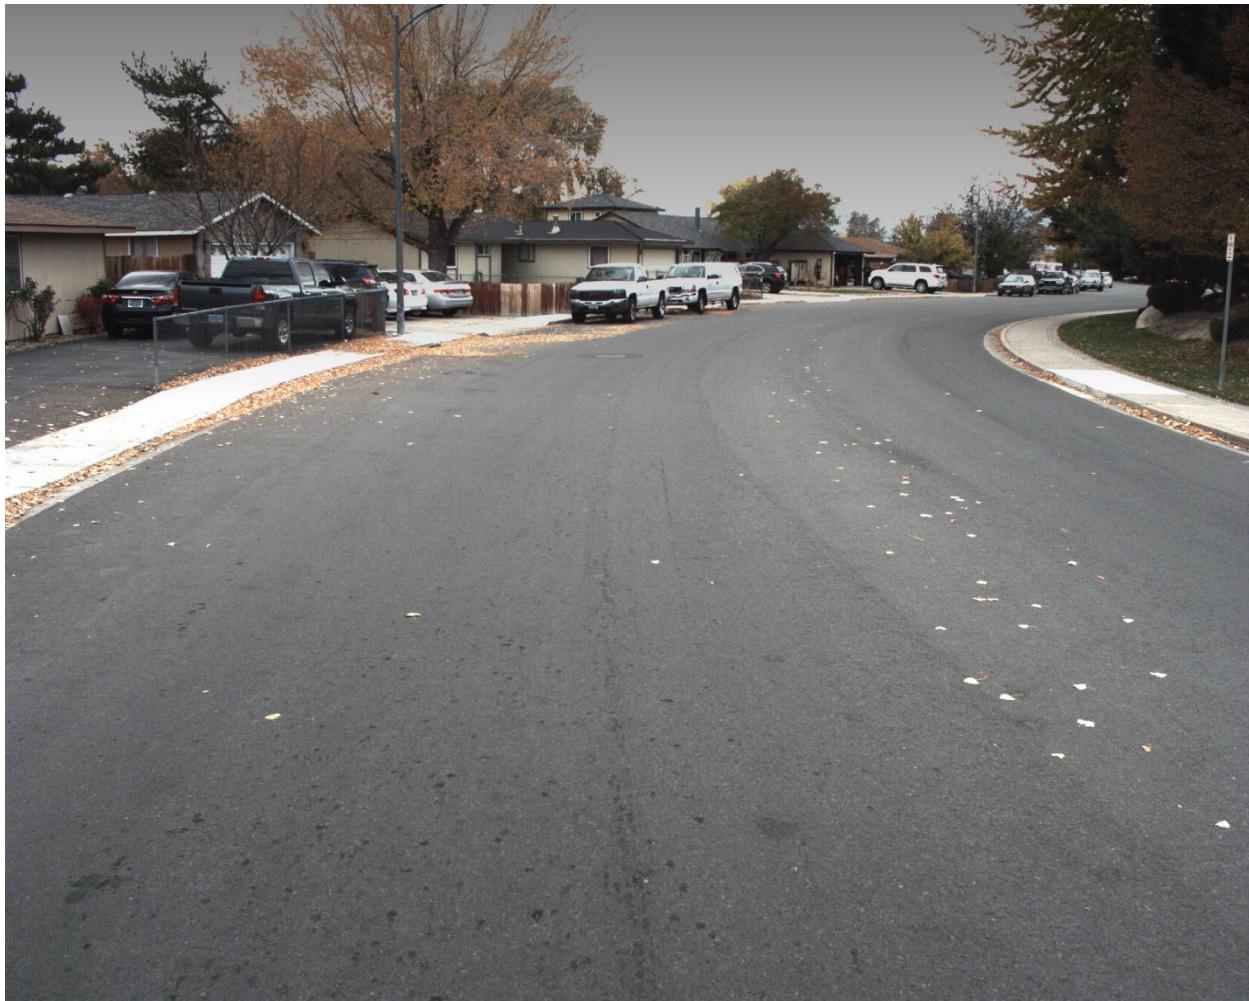
Figure 5 was taken on Airport Road. This road section has no visible distress (13 percent of the roads in Carson City are in the *Good* condition category).

Figure 5. Pavement in *Good* condition category (PCI 100–86).

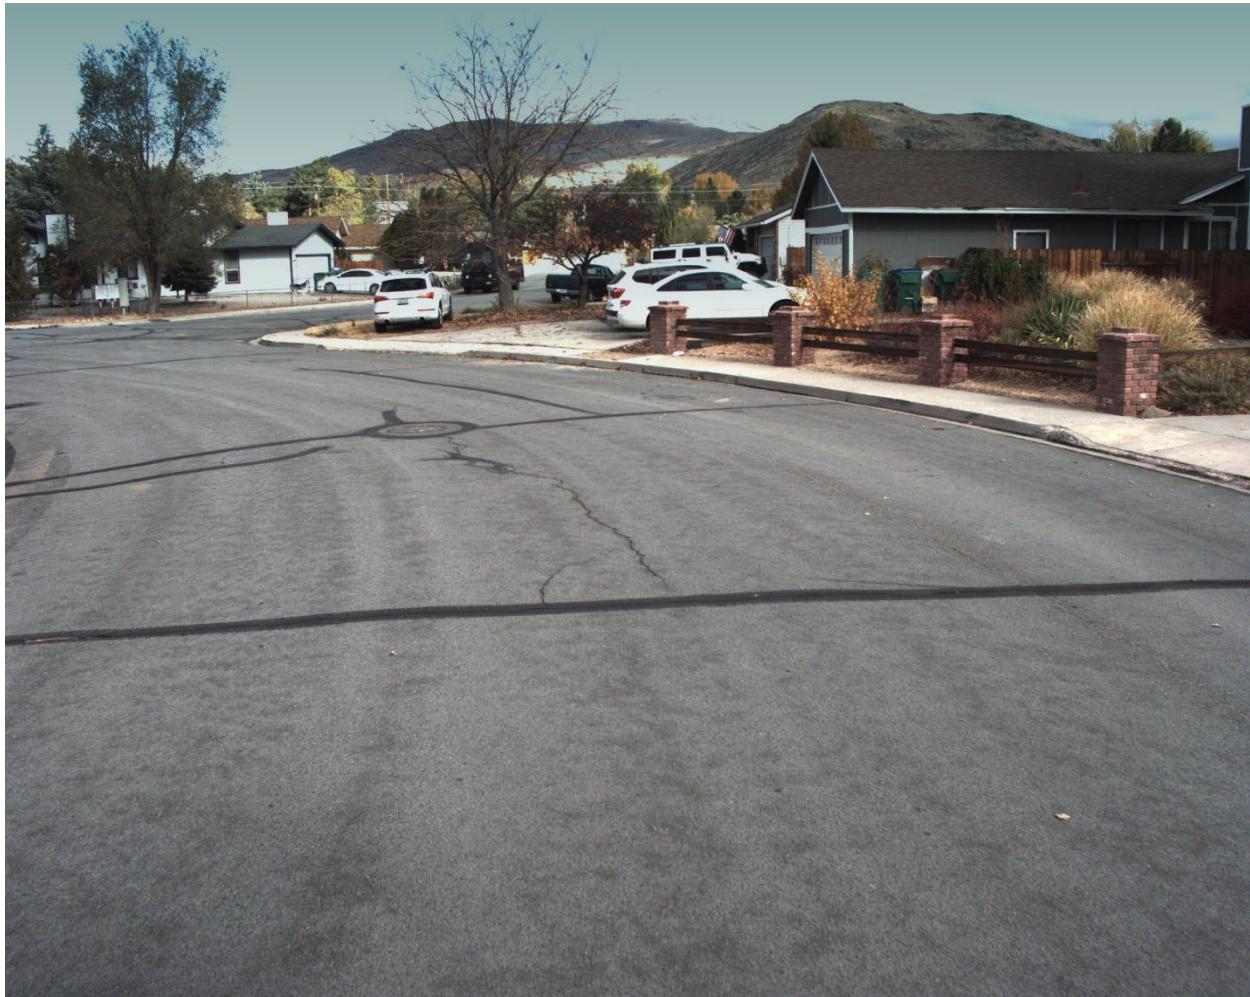
Figure 6 is a photograph taken on Ballarat Drive. This road shows low- and medium-severity longitudinal and transverse cracking (20 percent of the roads in Carson City are in the *Satisfactory* condition category).

Figure 6. Pavement in *Satisfactory* condition category (PCI 85–71).

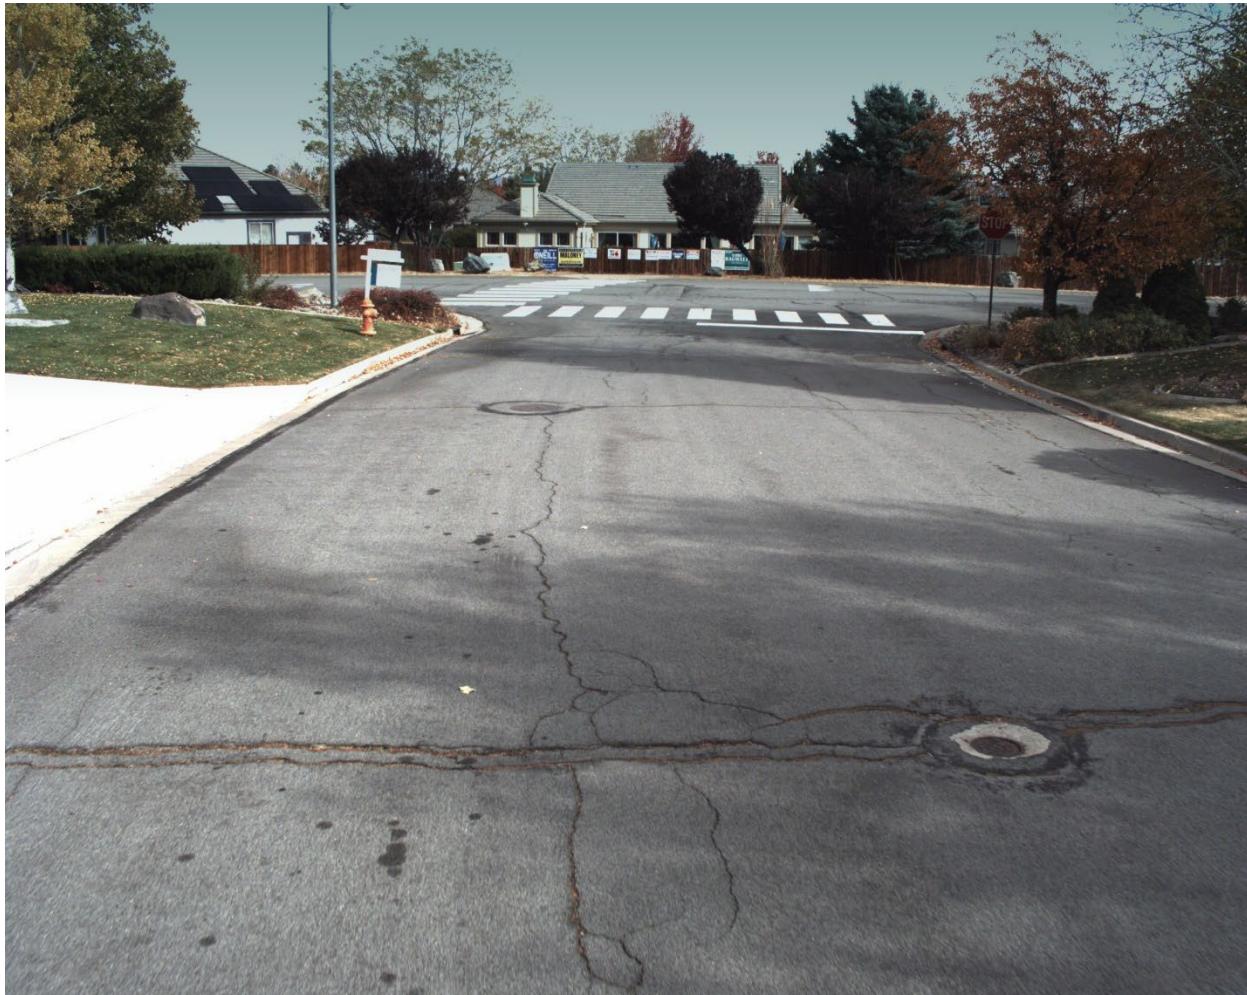
Figure 7 was taken on Bedford Way. This pavement shows a combination of medium-severity transverse cracking and low-severity alligator cracking (24 percent of the roads in Carson City fall in the *Fair* condition category).

Figure 7. Pavement in *Fair* condition category (PCI 70–56).

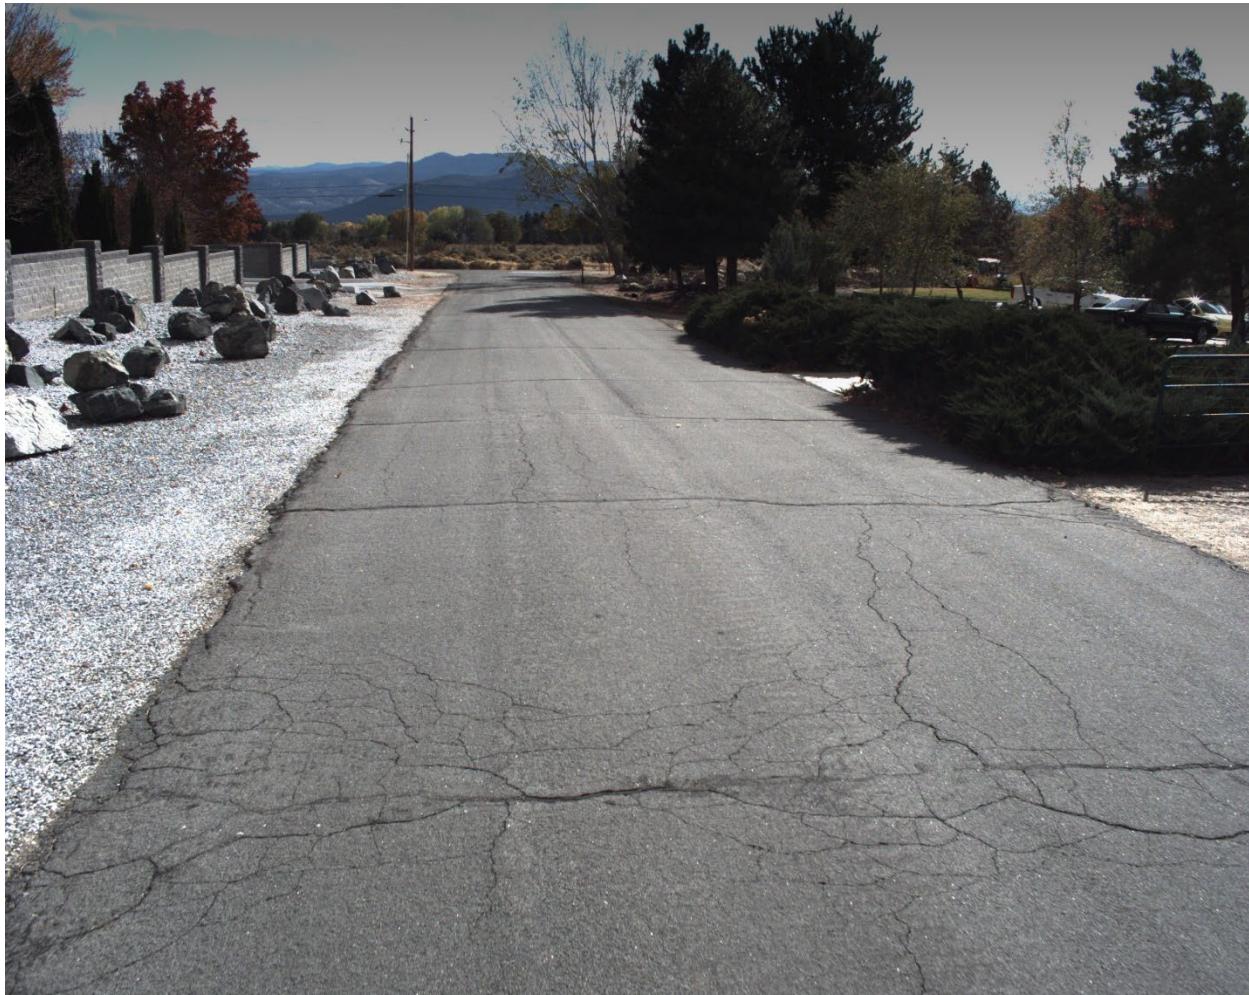
Figure 8 shows a photo on Alfred Way. This section shows a combination of low- and medium-severity longitudinal cracking and medium-severity alligator cracking (19 percent of the roads in Carson City are in the *Poor* condition category).

Figure 8. Pavement in *Poor* condition category (PCI 55–41).

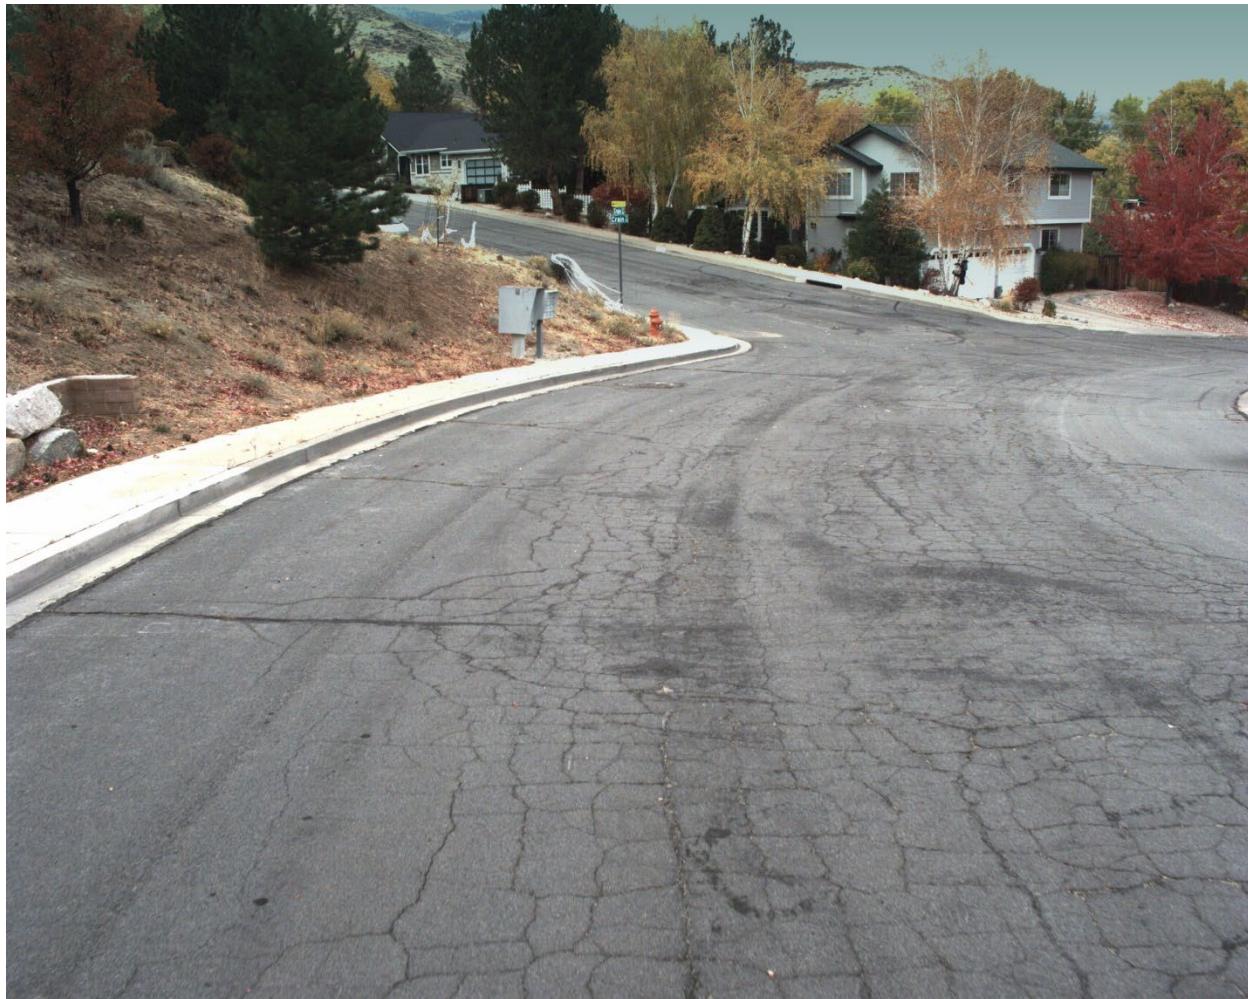
Figure 9 shows the condition of Crain Street. This section shows a combination of low- and medium-severity longitudinal and transverse cracking and a considerable amount of medium-severity alligator cracking with low-severity rutting (18 percent of the roads in Carson City fall in the *Very Poor* condition category).

Figure 9. Pavement in *Very Poor* condition category (PCI 40–26).

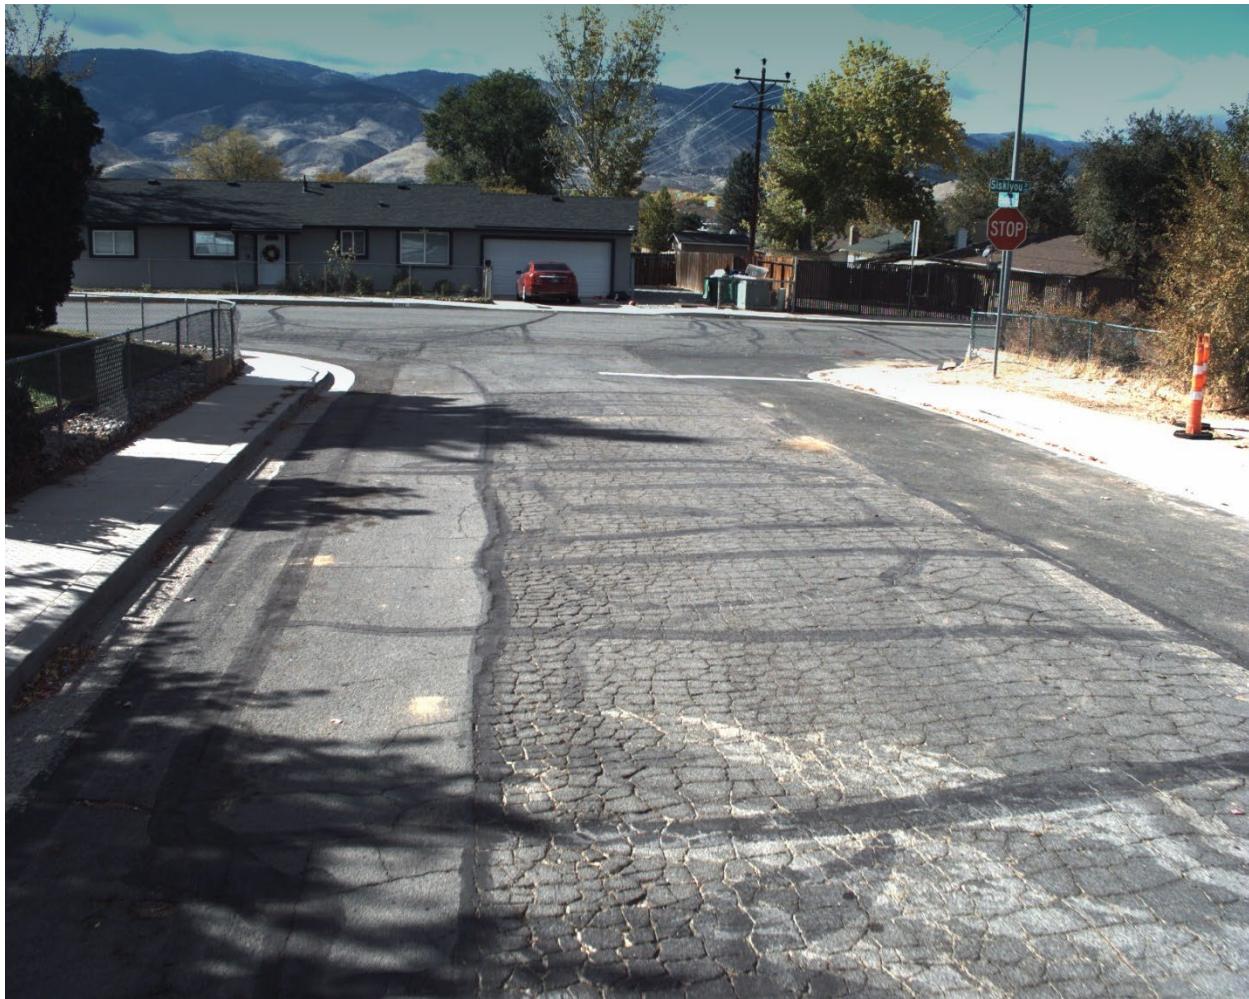
Figure 10 shows an overview photo on Stanton Drive. This section shows a combination of low- and medium-severity longitudinal and transverse cracking along with considerable amounts of medium- and high-severity alligator cracking with low- and medium-severity rutting (5 percent of the roads in Carson City are in the *Serious* condition category).

Figure 10. Pavement in *Serious* condition category (PCI 25–11).

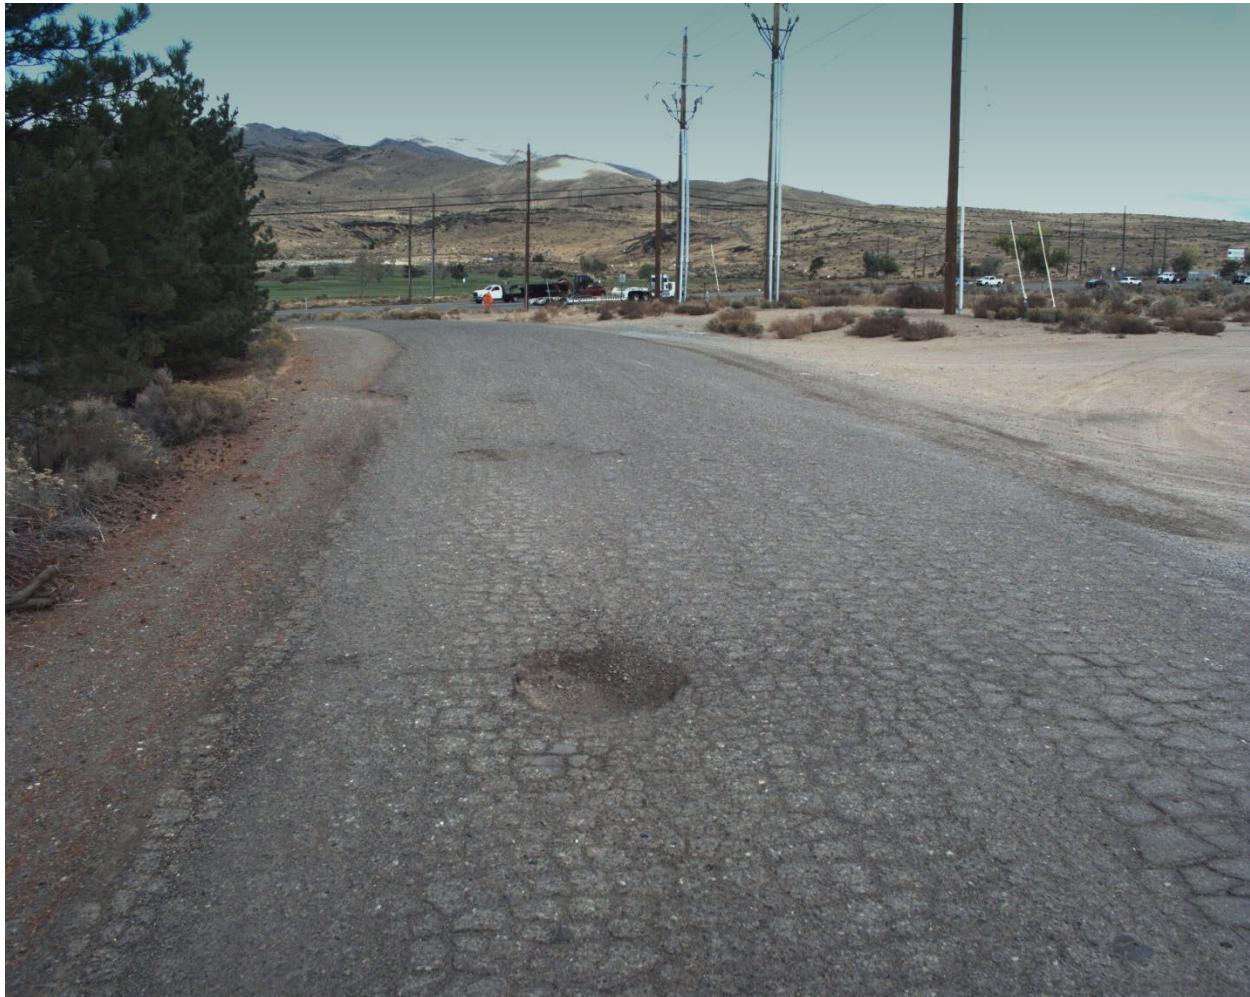
Figure 11 presents a photograph on Asphalt Drive and shows a combination of medium- and high-severity alligator cracking and potholes (less than 1% of the roads in Carson City fall in the *Failed* condition category).

Figure 11. Pavement in *Failed* condition category (PCI 10–0).

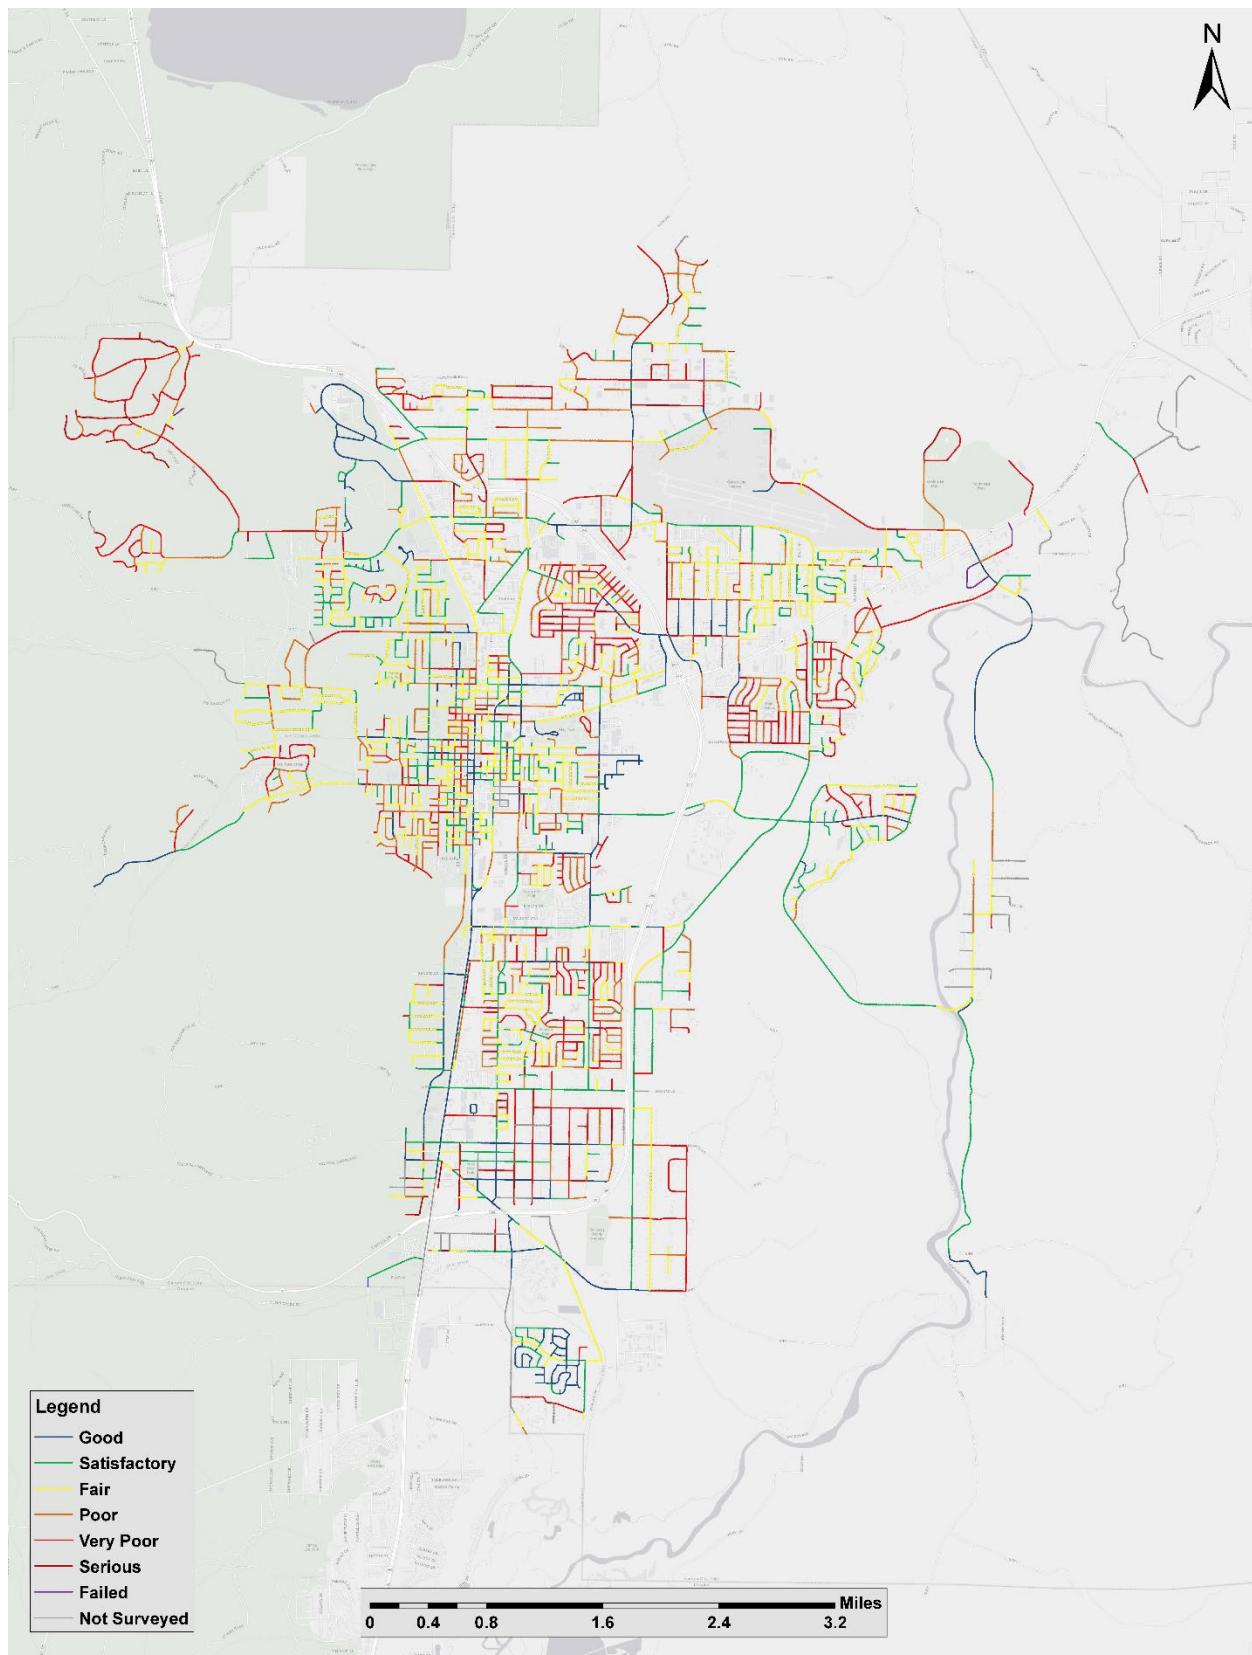
The 2024 area-weighted PCI for the CCPW network is 60. This value indicates the network is in *Fair* condition overall. A map of the City network showing the PCI for each segment is shown in Figure 12. Tables 4 and 5 provide a breakdown of the area-weighted PCIs by functional classification and jurisdiction. These findings show that regional roads have the highest area-weighted PCI of 69 (*Fair*), while local roads are in worse condition with an area-weighted PCI of 55 (*Poor*). Note that these are average values, and there is a distribution of condition levels within the network.

Figure 12. Carson City map showing color-coded PCIs.

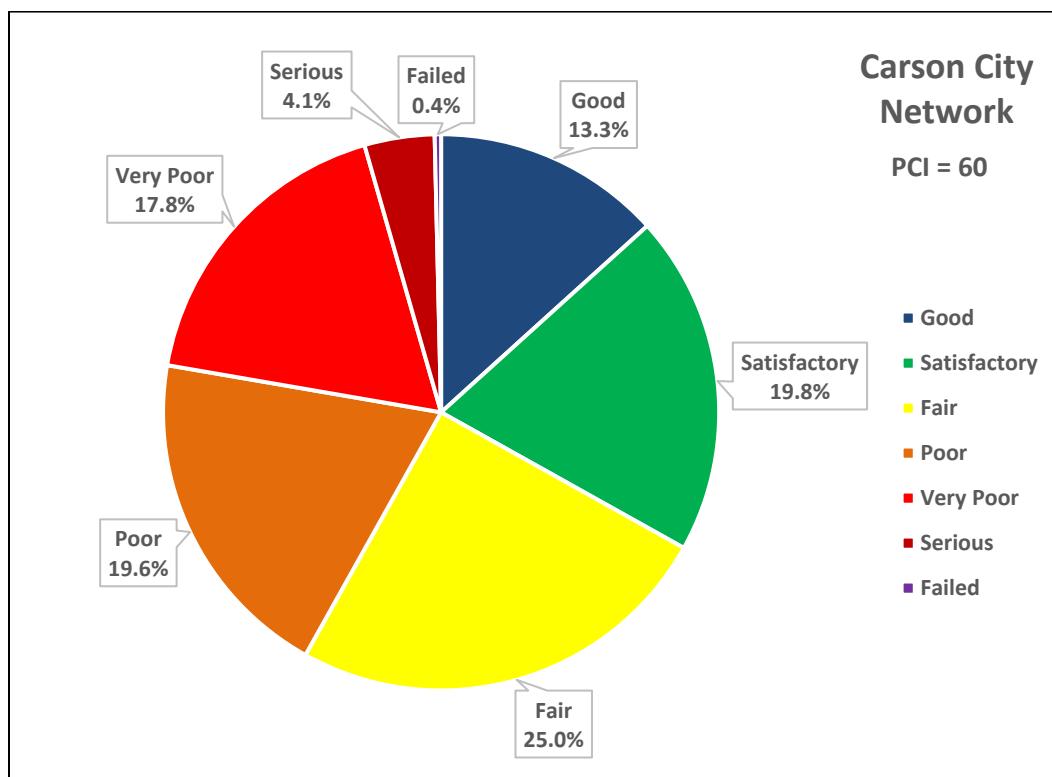
Figure 13 displays the distribution of pavement area by condition category. Approximately 33 percent of the roadway network area is in *Good* to *Satisfactory* condition with PCIs greater than 70. Roadways in *Good* or *Satisfactory* condition are typically excellent candidates for pavement preservation treatments. Strategically timed pavement preservation treatments may extend the life of these roadways in a cost-effective manner, delaying the need for more costly treatments.

Approximately 45 percent of the roadways in the City are in *Fair* or *Poor* condition with PCIs between 40 and 70. Based on the City's standard practice, roadways in these condition categories will likely require some form of rehabilitation work or pavement preservation work to restore or prolong performance. The remaining 22 percent of the City's roadways are in *Very Poor*, *Serious*, or *Failed* condition. Roadways in these conditions are generally candidates for more costly reconstruction or major rehabilitation.

Figure 13. Distribution of network pavement area by condition category.

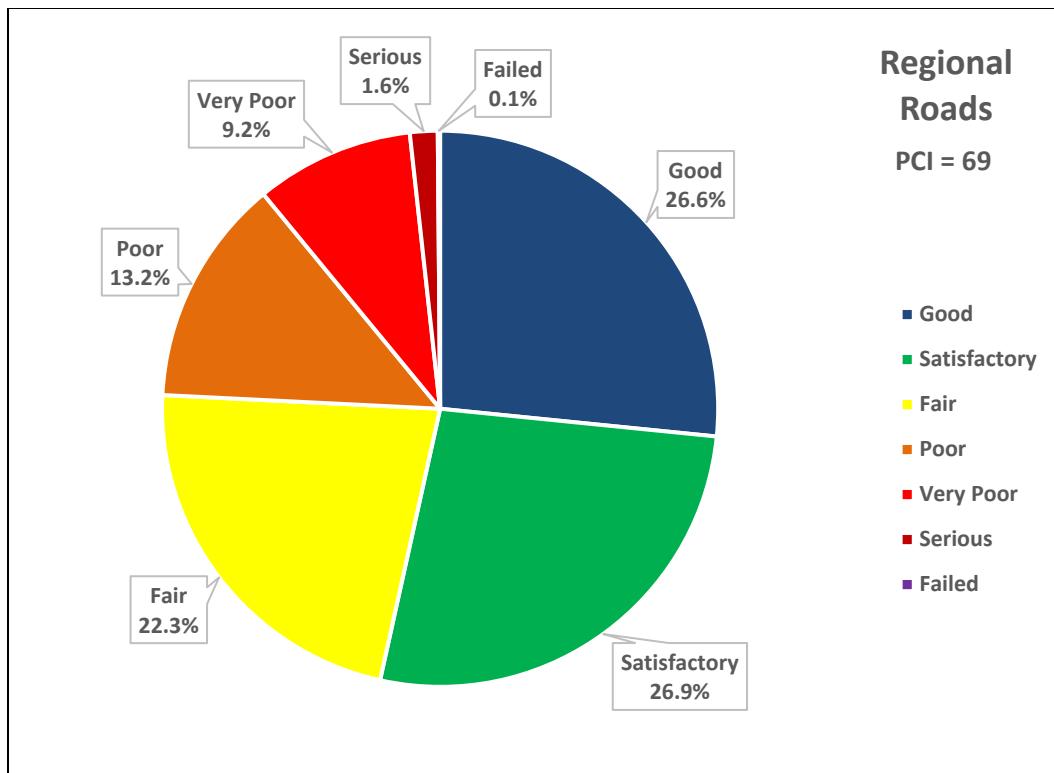
Figures 14 and 15 display the distribution of pavement area by condition category for each City classification. Approximately 53 percent of the regional roads are in *Good* or *Satisfactory* condition, while only 22 percent of the local roads are in *Good* or *Satisfactory* condition.

Figure 14. Distribution of pavement area by condition category for regional roadways.

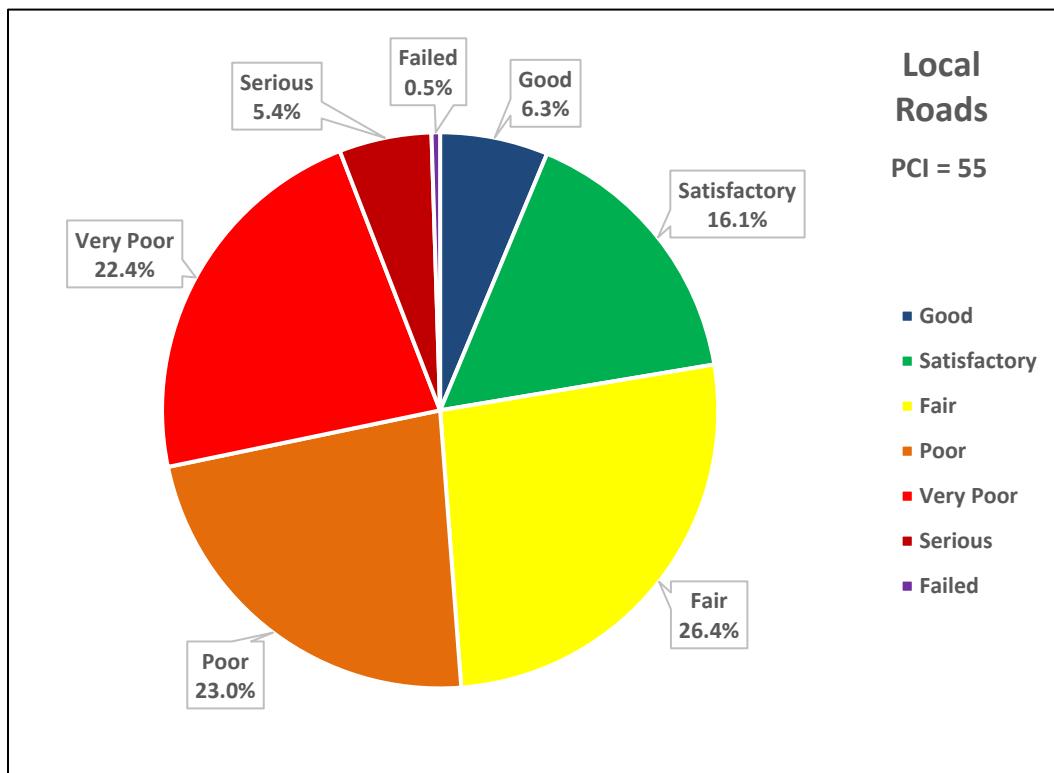
Figure 15. Distribution of pavement area by condition category for local roadways.
