**OPEN SPACE ADVISORY COMMITTEE
STAFF REPORT**

REQUEST: **For Possible Action:** To approve the monitoring report for the Horsecreek Ranch Conservation Easement for 2014.

Carson City Open Space – Conservation Easement Monitoring

Date: November 5, 2014

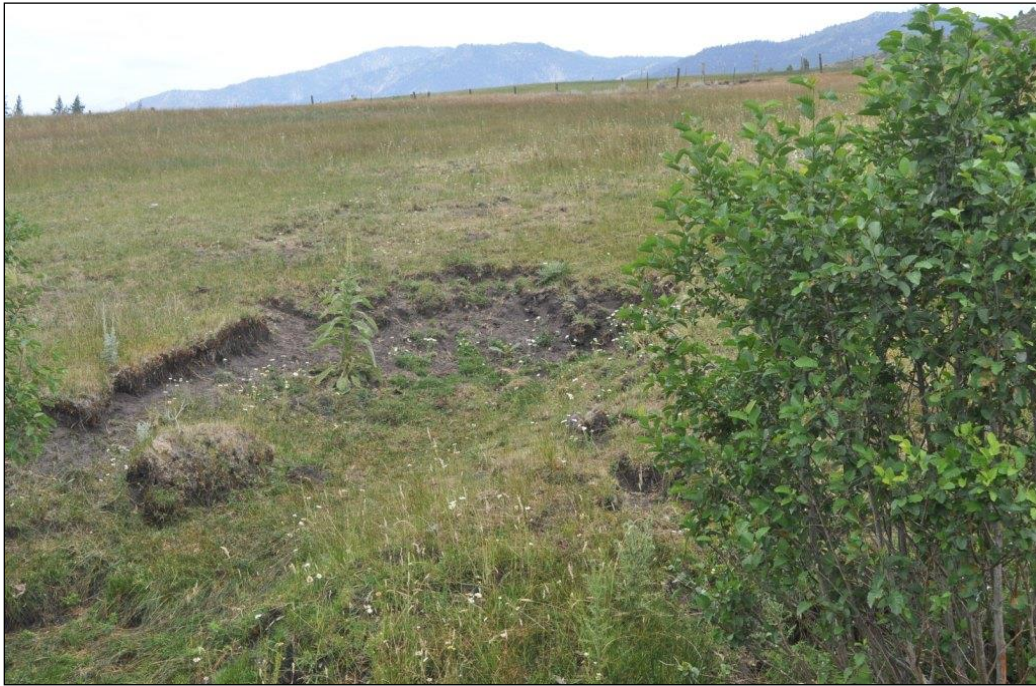
2013 Condition, photo taken July 23, 2013 (initial assessment – view south)

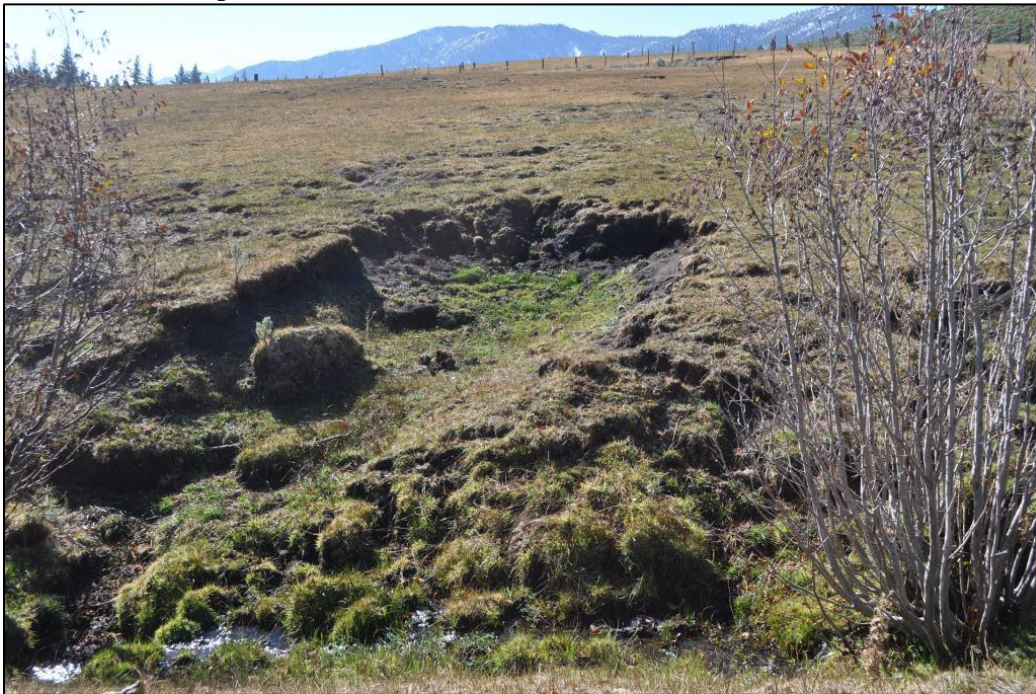
2014 Condition, photo taken November 5, 2014

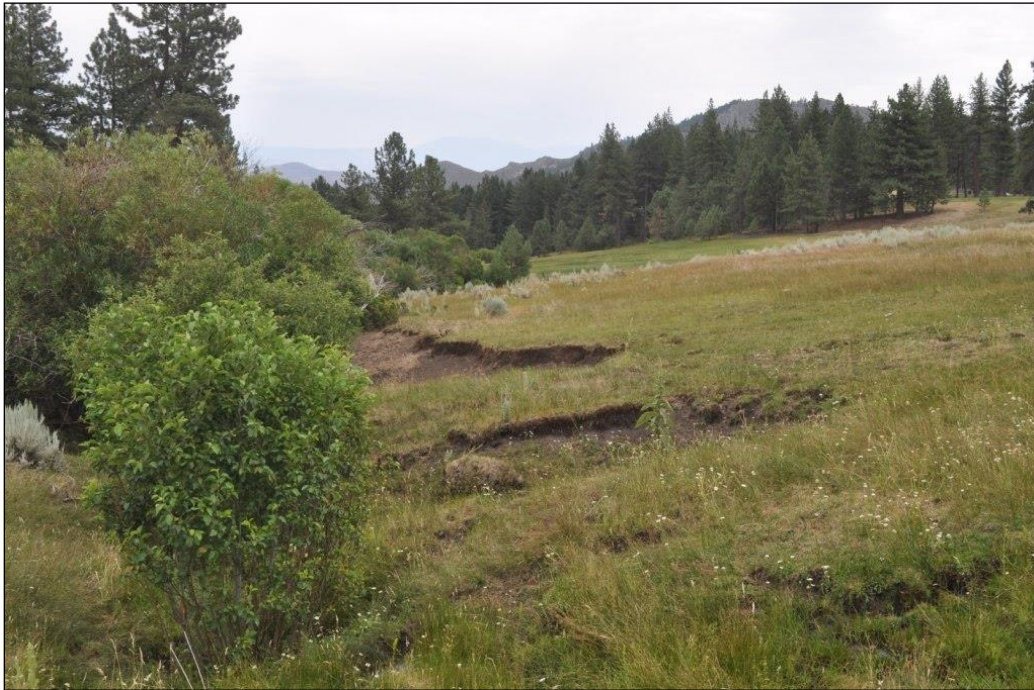
2013 Condition, photo taken July 23, 2013 (initial assessment – view south)

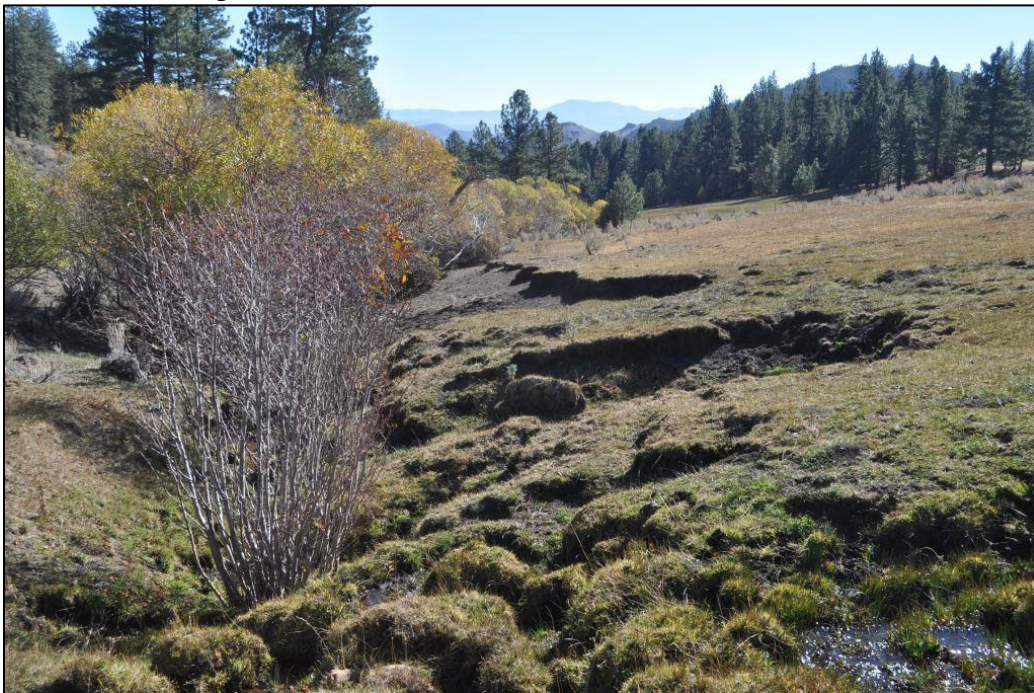
2014 Condition, photo taken November 5, 2014

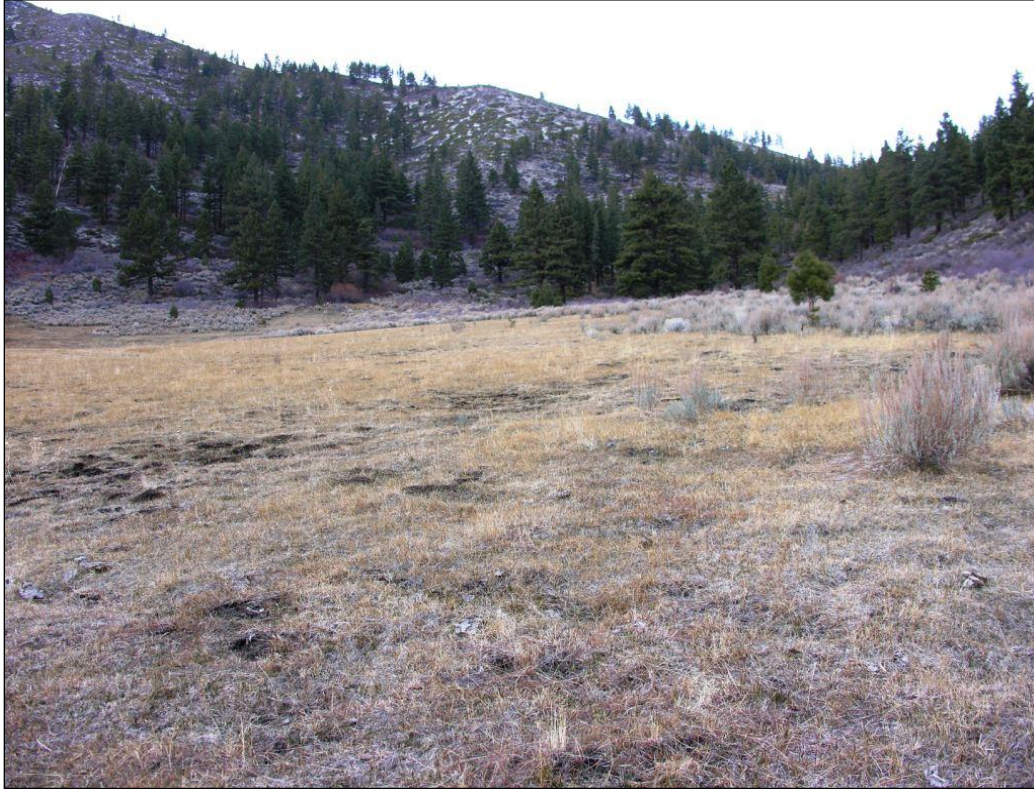
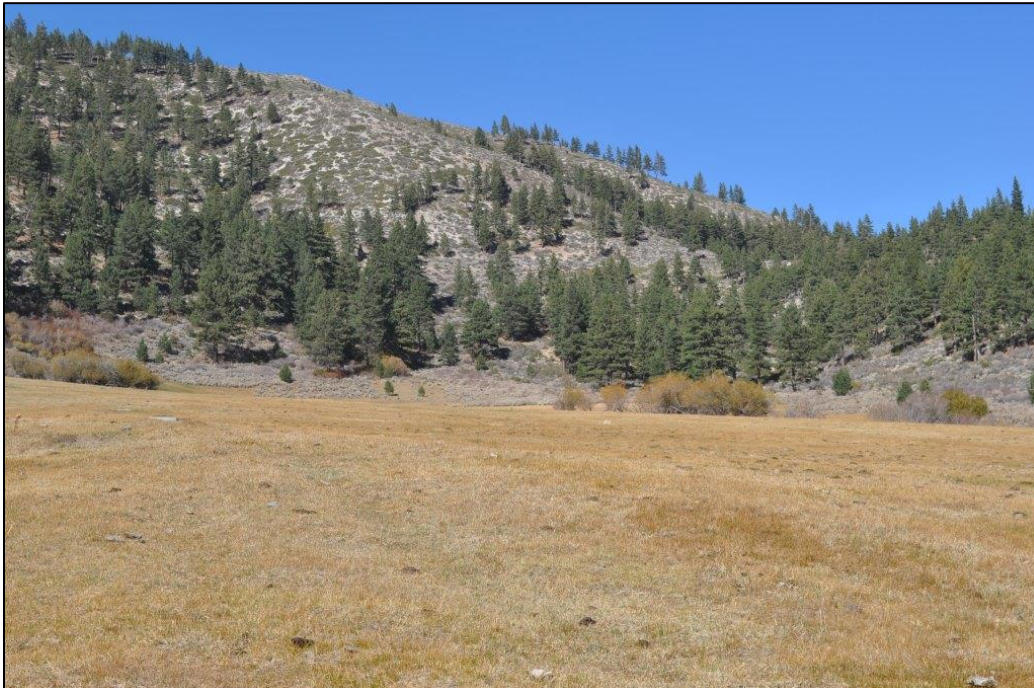
Photo Point 1A (view northeast): A photo point located at the edge of the shrub dominated granitic fan and the irrigated meadow. This would be used to monitor shrub invasion into the meadow area indicating irrigation problems.

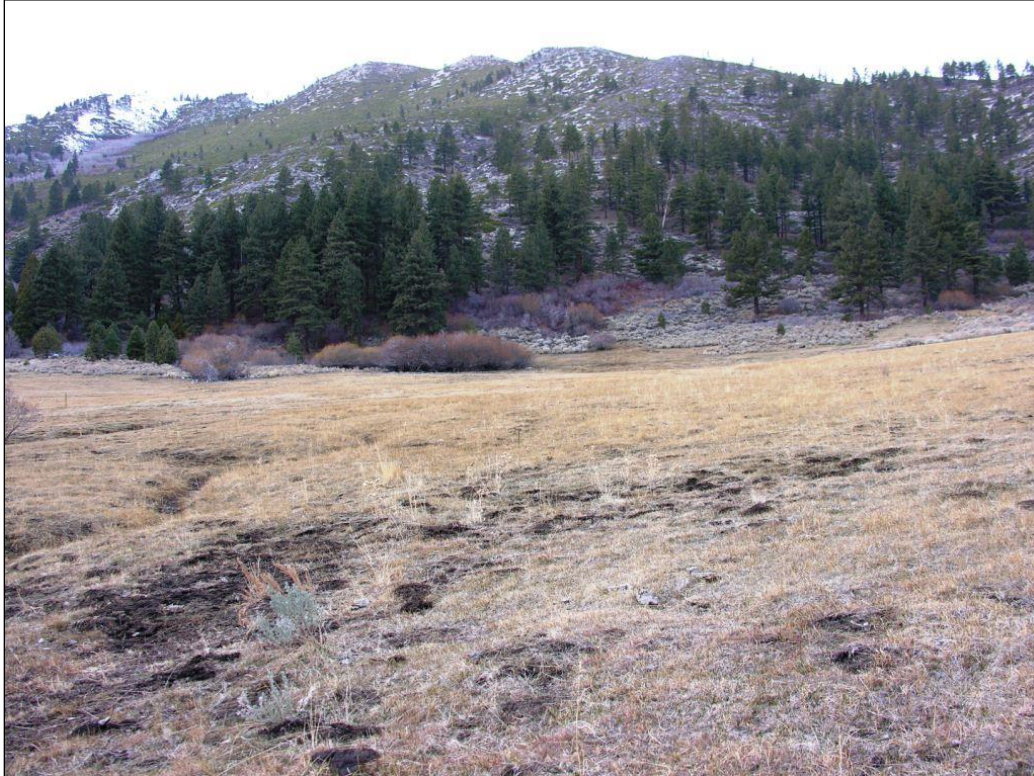
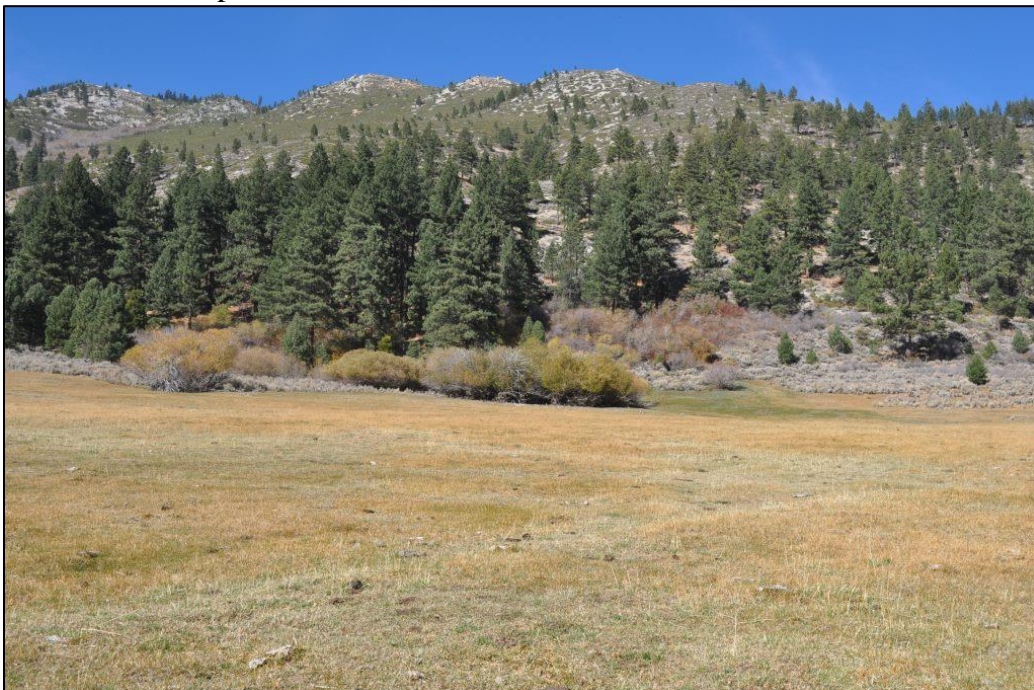
Photo Point 1B (view northwest): A photo point located at the edge of the shrub dominated granitic fan and the irrigated meadow. This would be used to monitor shrub invasion into the meadow area indicating irrigation problems.

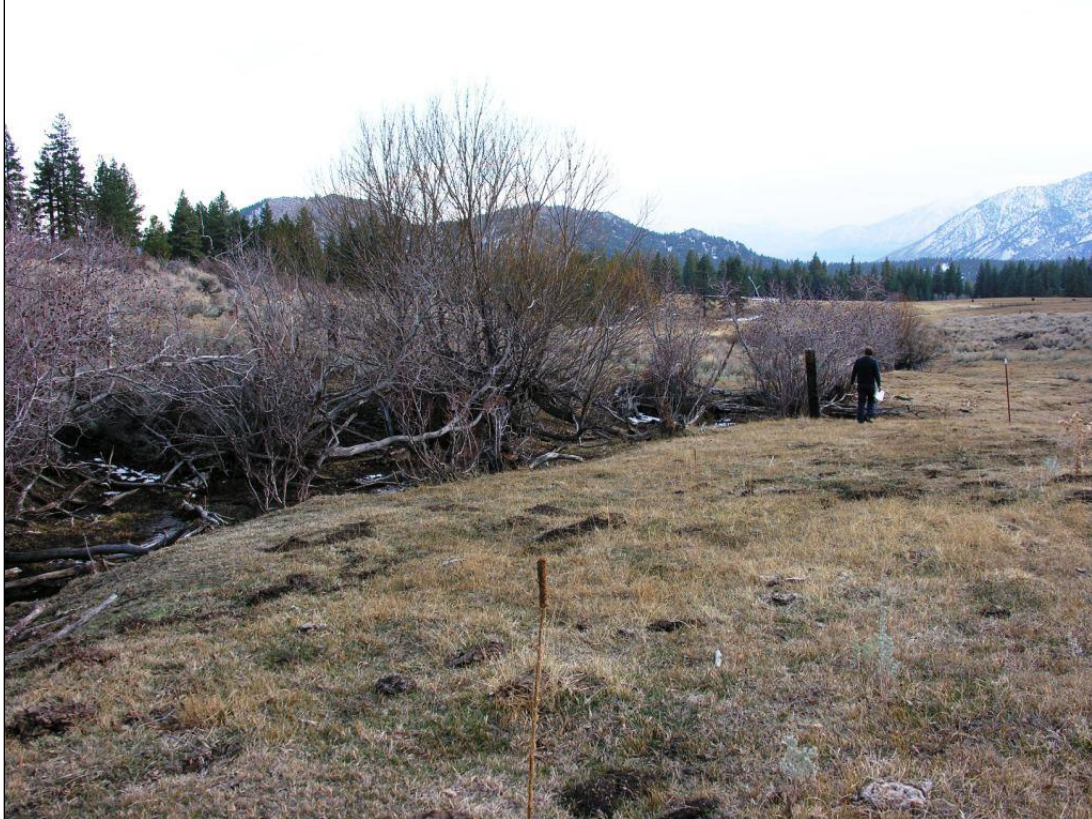
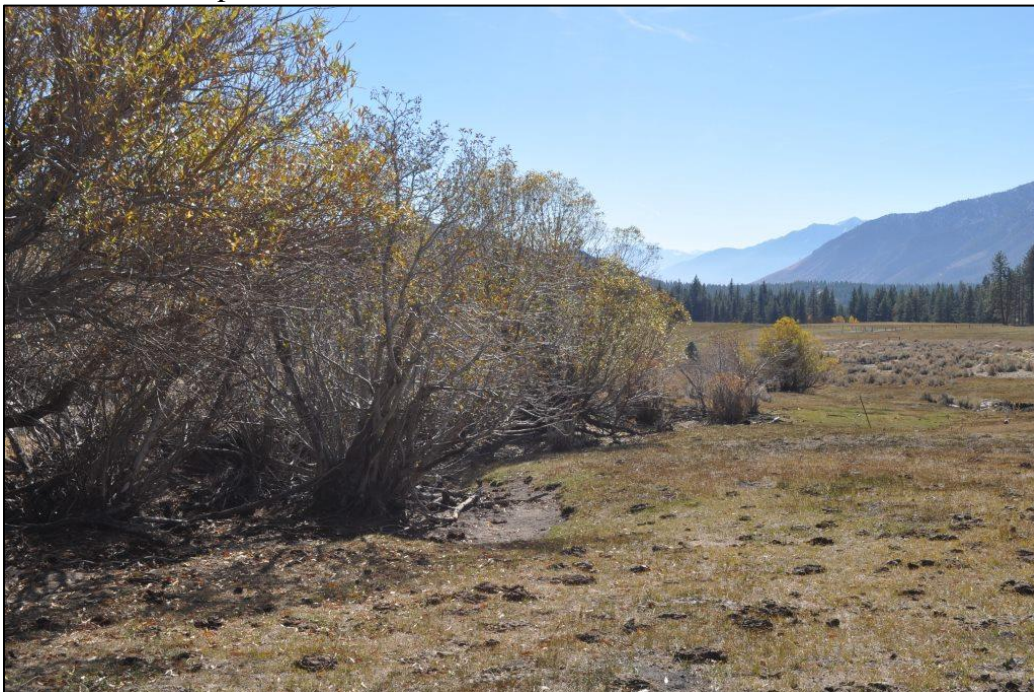
Photo Point 2 (view south): A photo point located in bottom of the active stable drainage channel to the southeast of the house to monitor side slope stability.

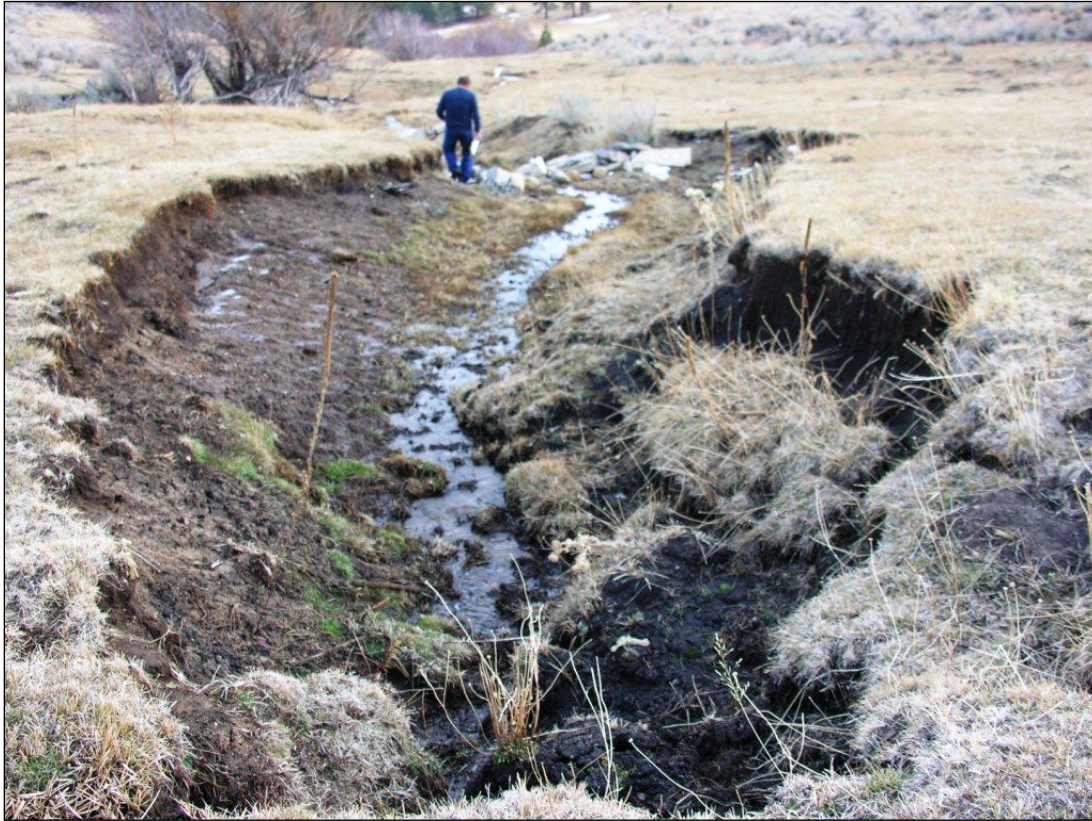
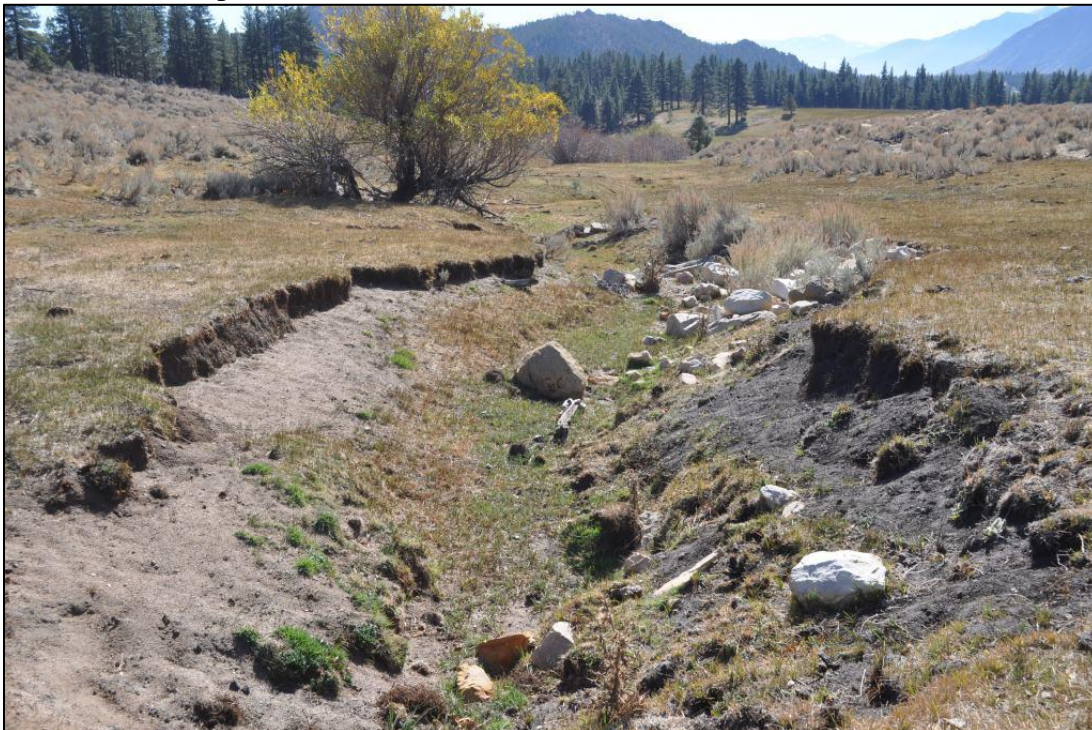
Photo Point 3 (view south): A photo point located immediately east of the house in the active channel where rip-rap has been placed for stabilization.

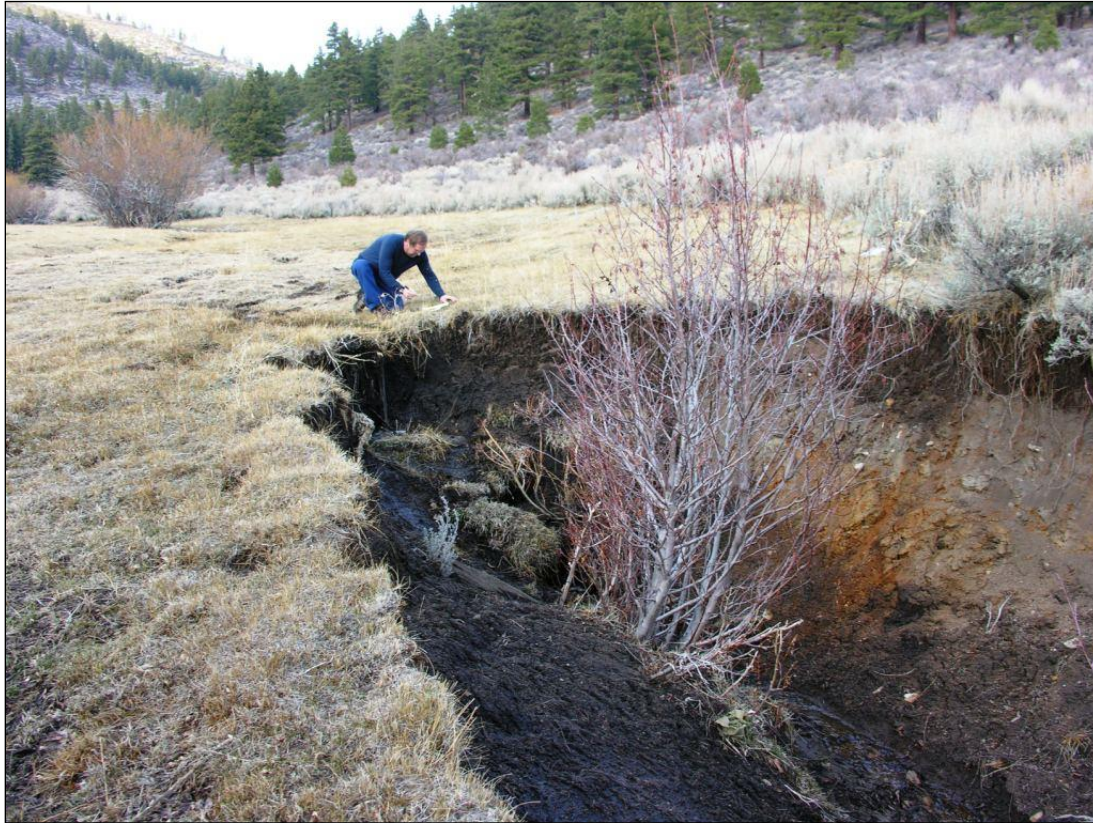
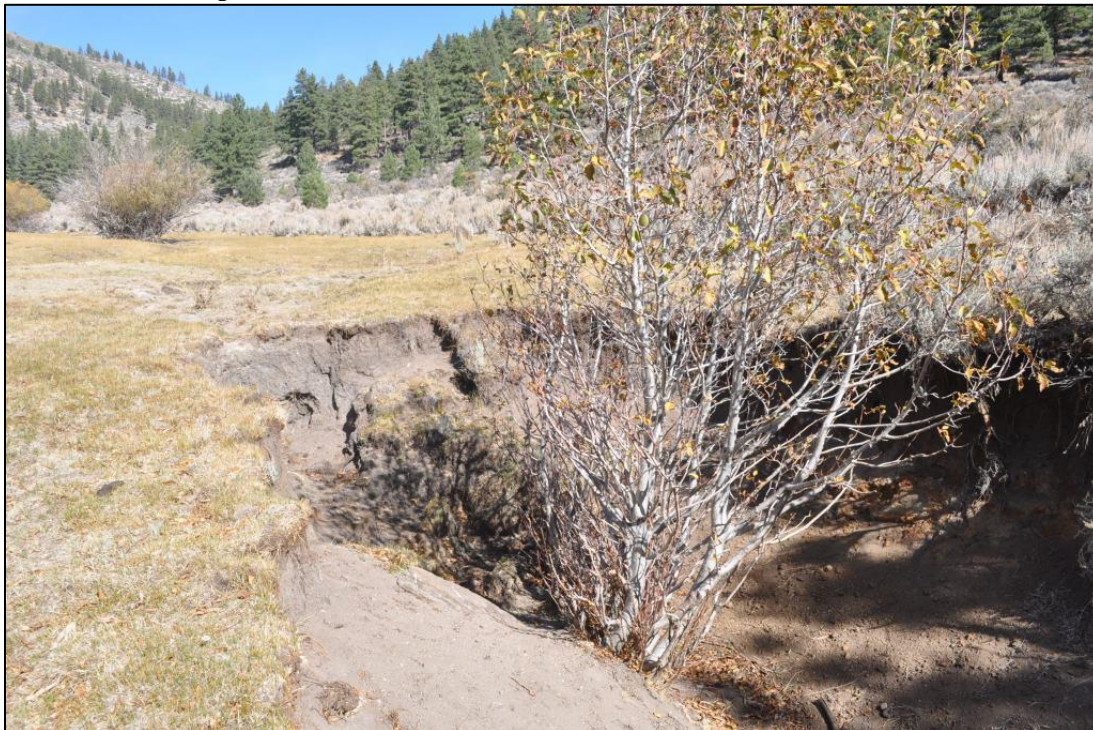
Photo Point 4B (detail): A photo point located at the most northern active headcut after required stabilization to monitor effectiveness.

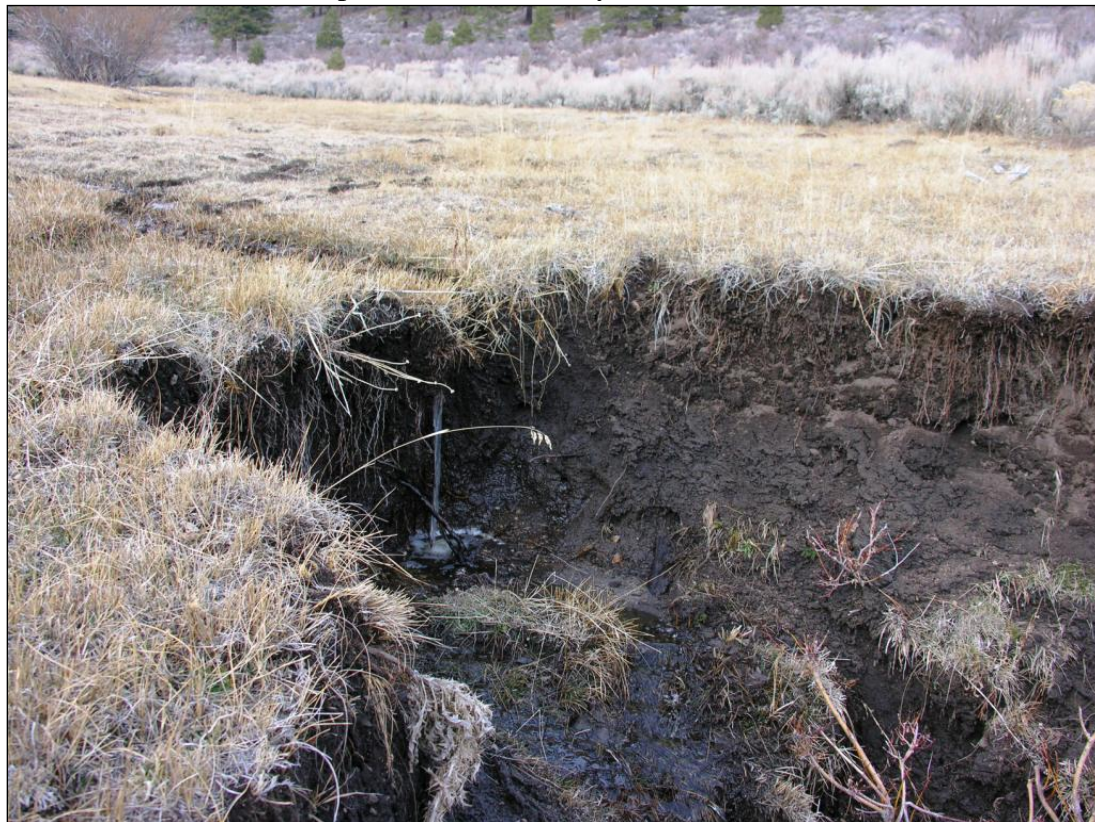
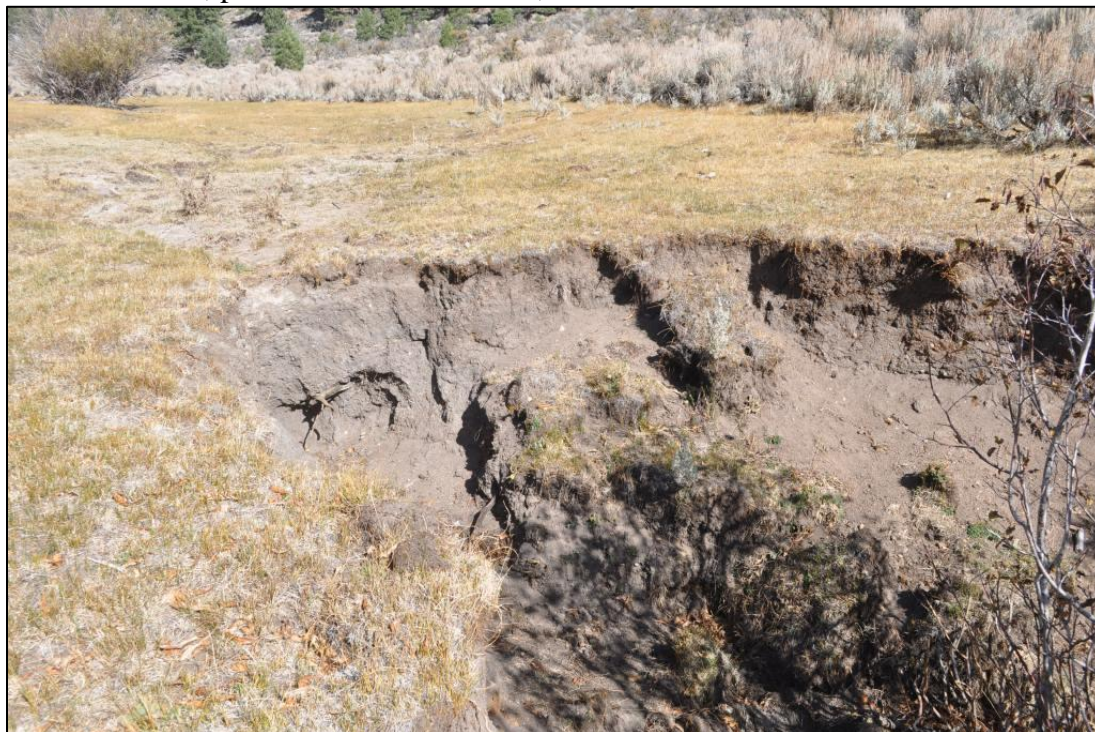
Photo Point 4C (detail): A photo point located at the most northern active headcut after required stabilization to monitor effectiveness.

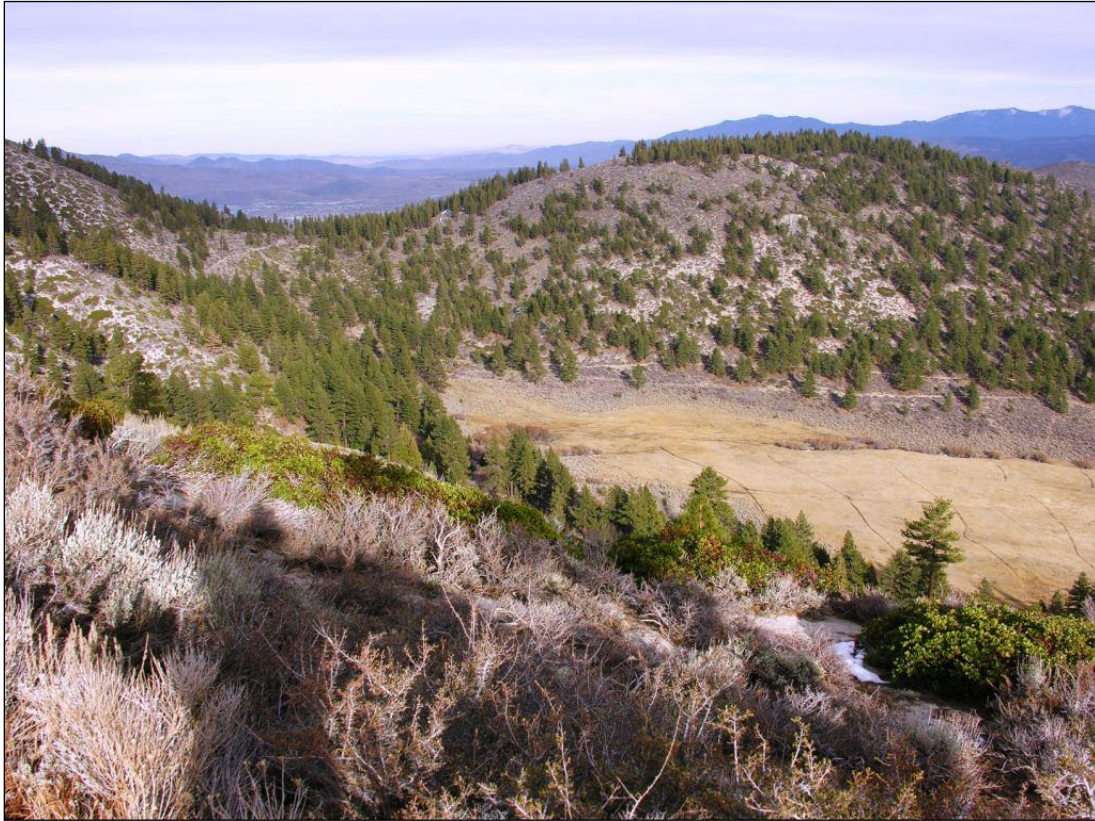
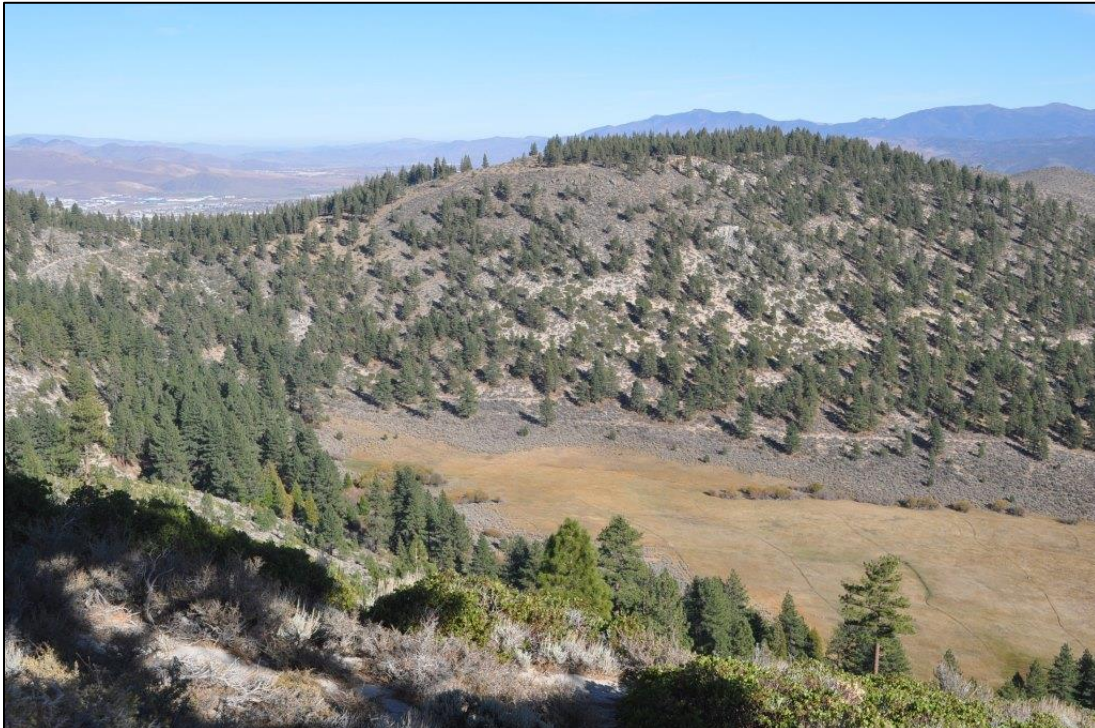
Photo Point 6A (view north): A photo point from the Kings Canyon Road that would provide panoramic views of the ranch from a west to east perspective.

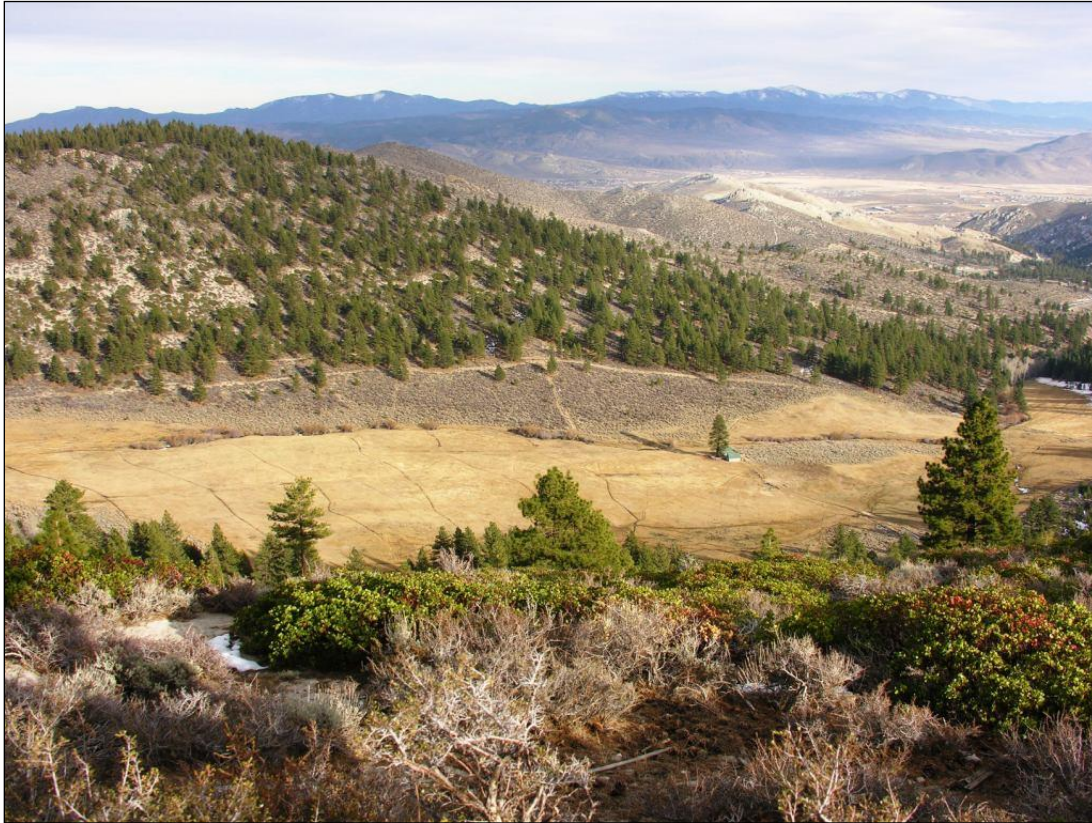
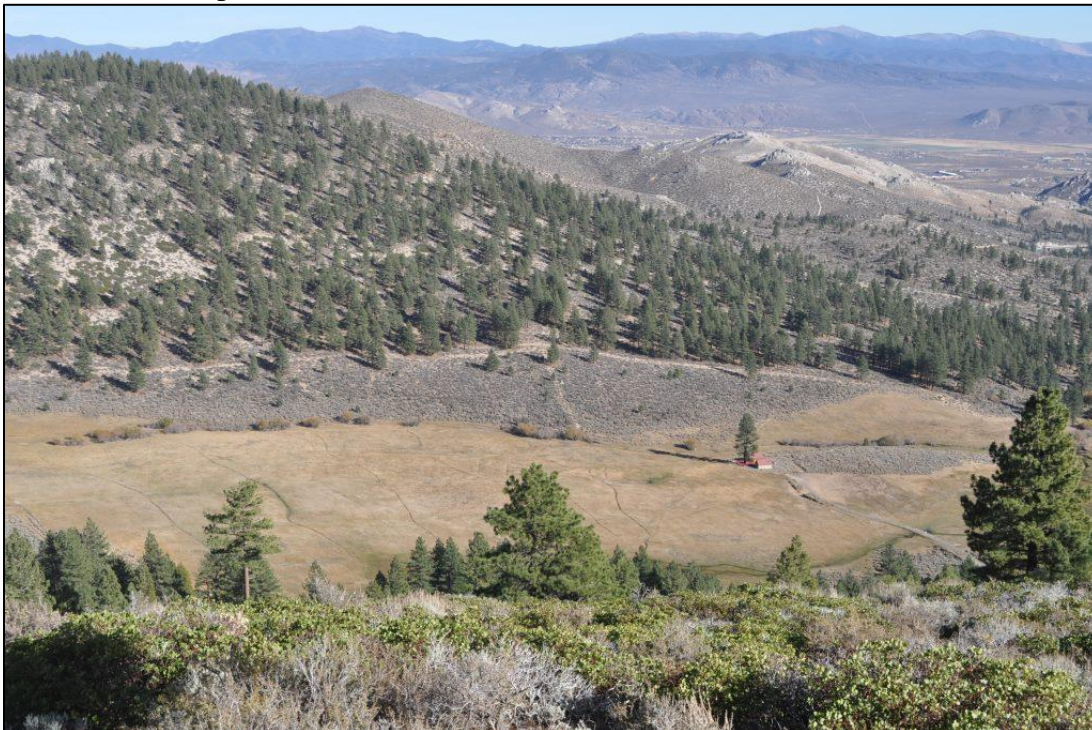
Photo Point 6B (view center): A photo point from the Kings Canyon Road that would provide panoramic views of the ranch from a west to east perspective.

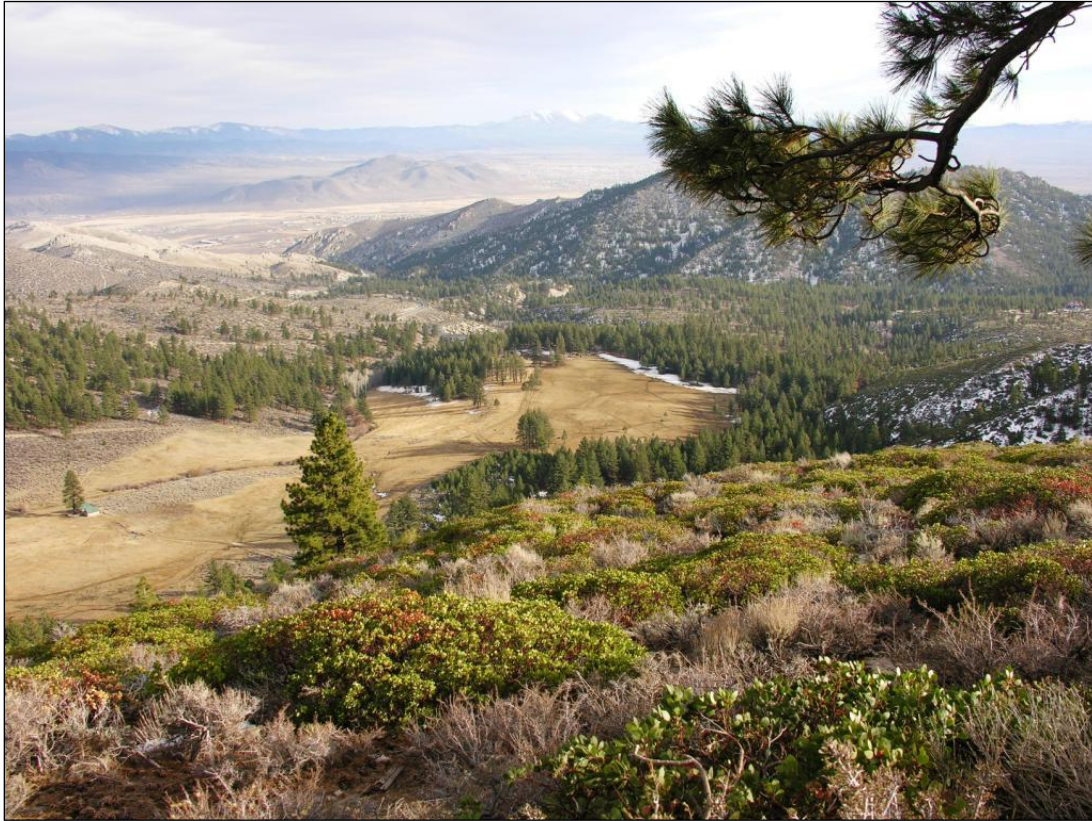
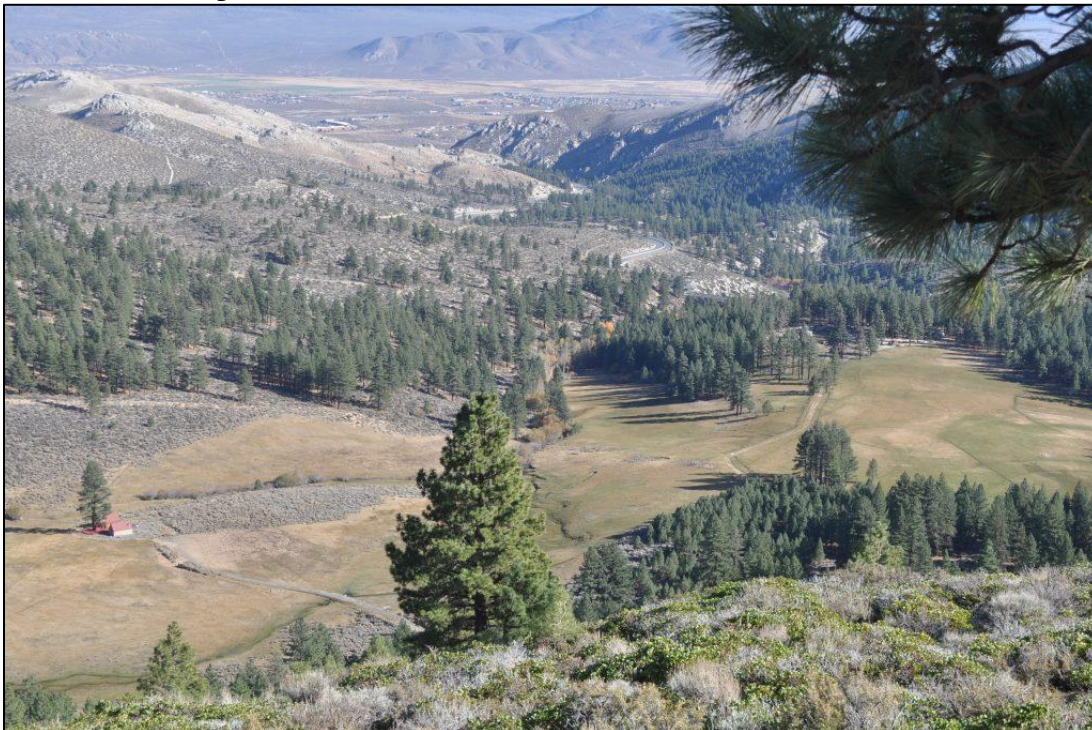
Photo Point 6C (view south): A photo point from the Kings Canyon Road that would provide panoramic views of the ranch from a west to east perspective.

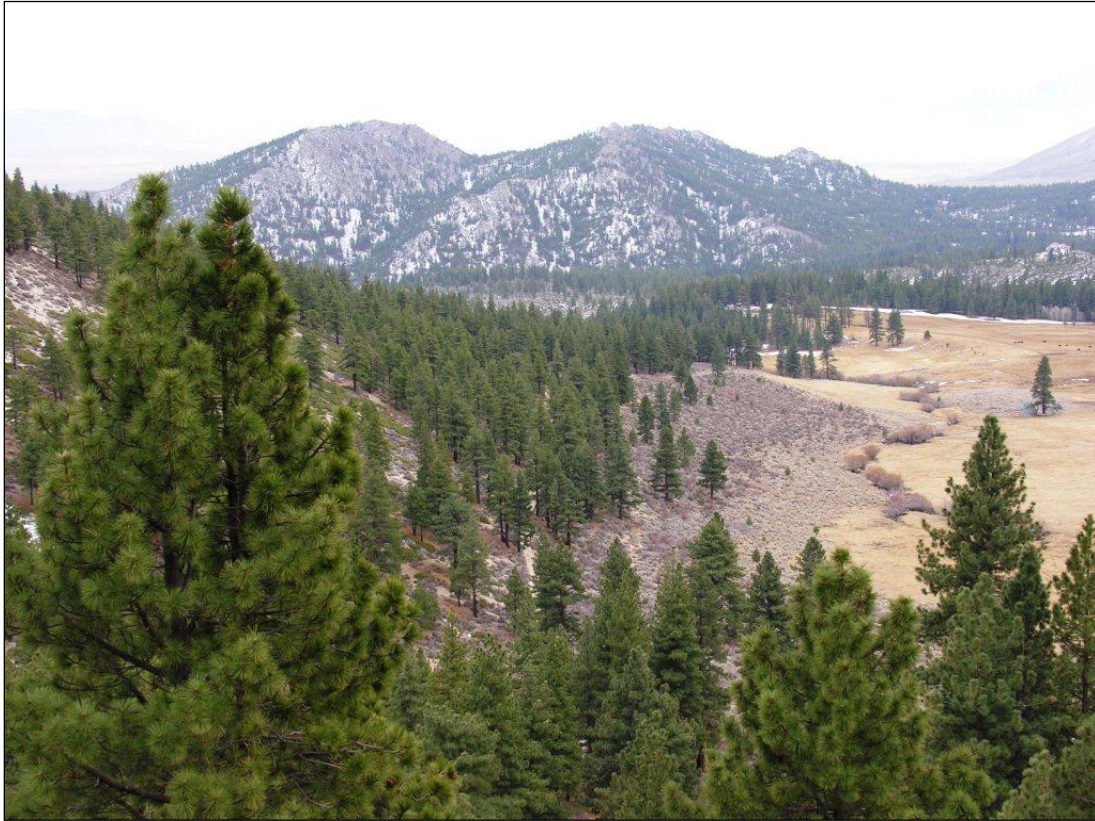
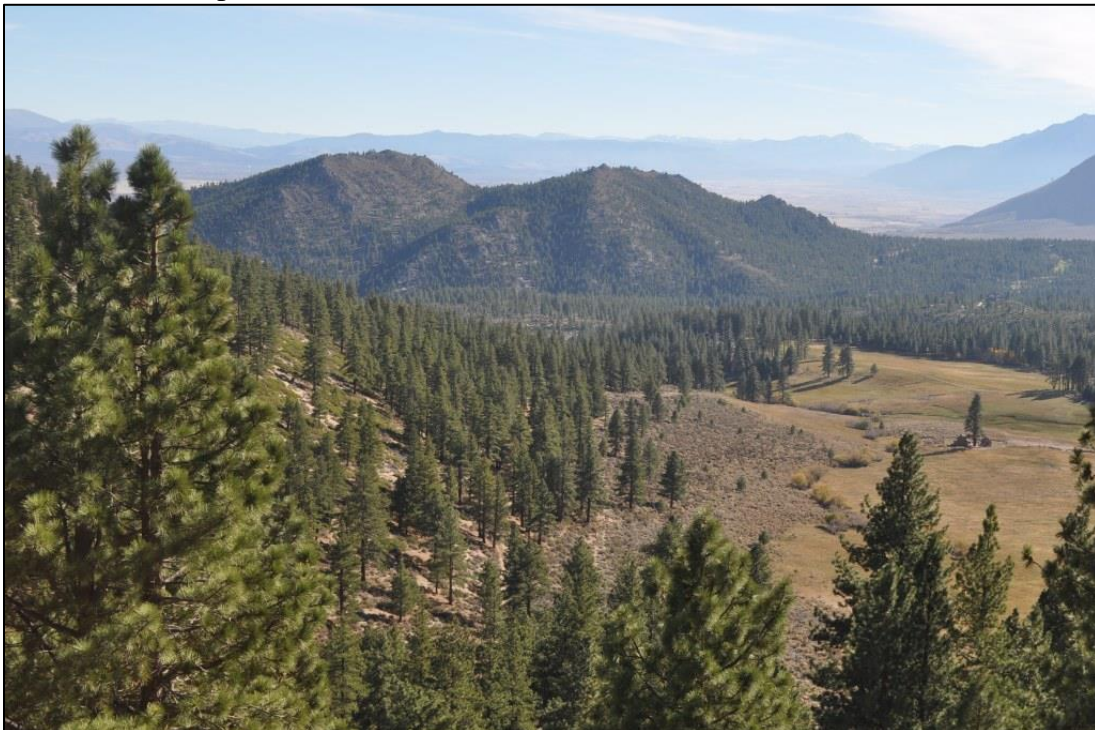
Photo Point 7A (view southeast): A photo point from Kings Canyon Road that would provide panoramic views of the ranch from a north to south perspective.

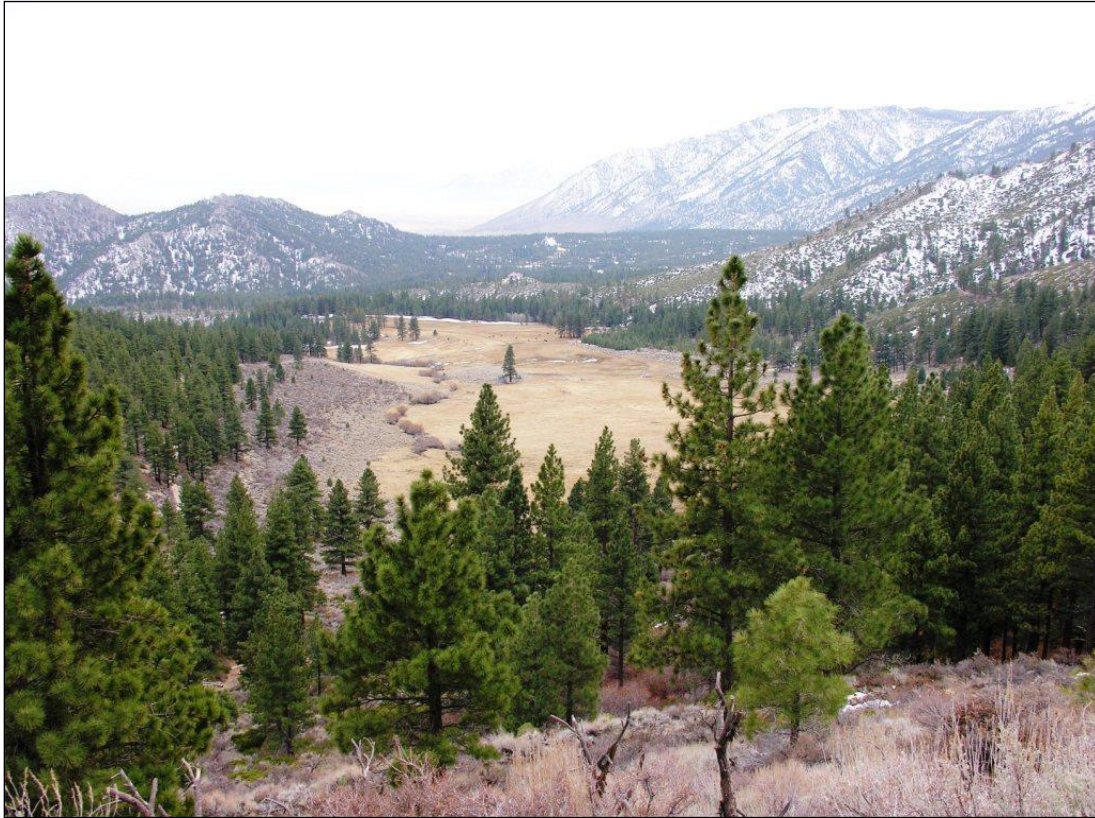
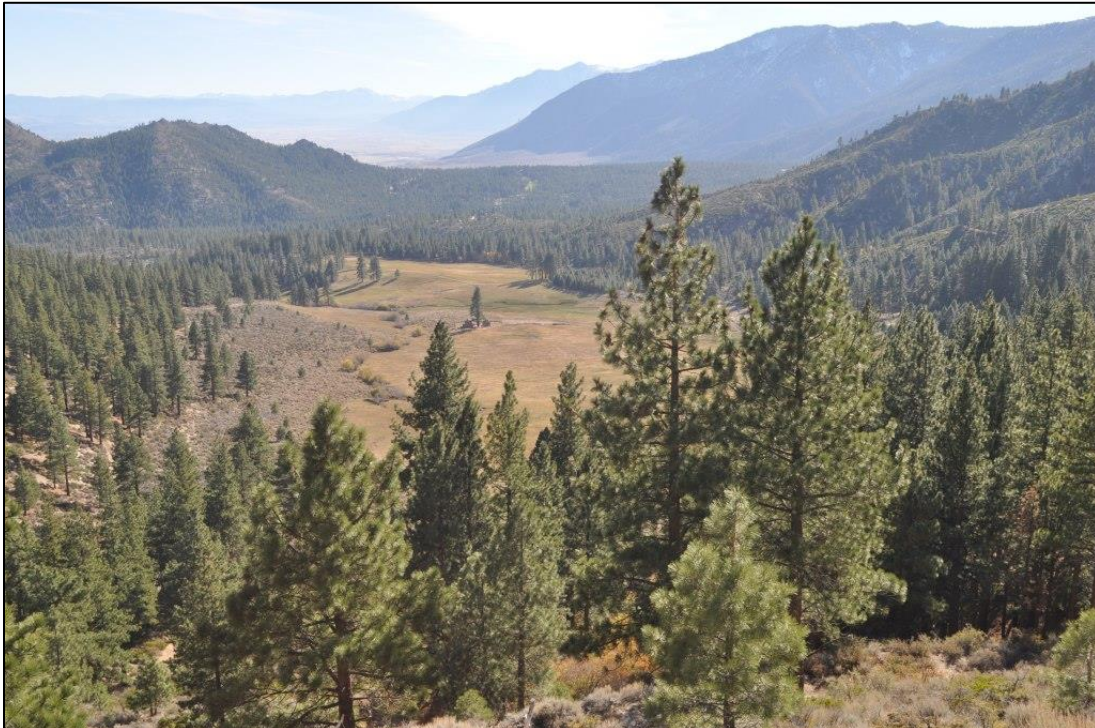
Photo Point 7B (view south): A photo point from Kings Canyon Road that would provide panoramic views of the ranch from a north to south perspective.
