**OPEN SPACE ADVISORY COMMITTEE
STAFF REPORT**

REQUEST: **For Possible Action:** To approve the monitoring report for the Horsecreek Ranch Conservation Easement for 2014.

Carson City Open Space – Conservation Easement Monitoring

Date: November 5, 2014

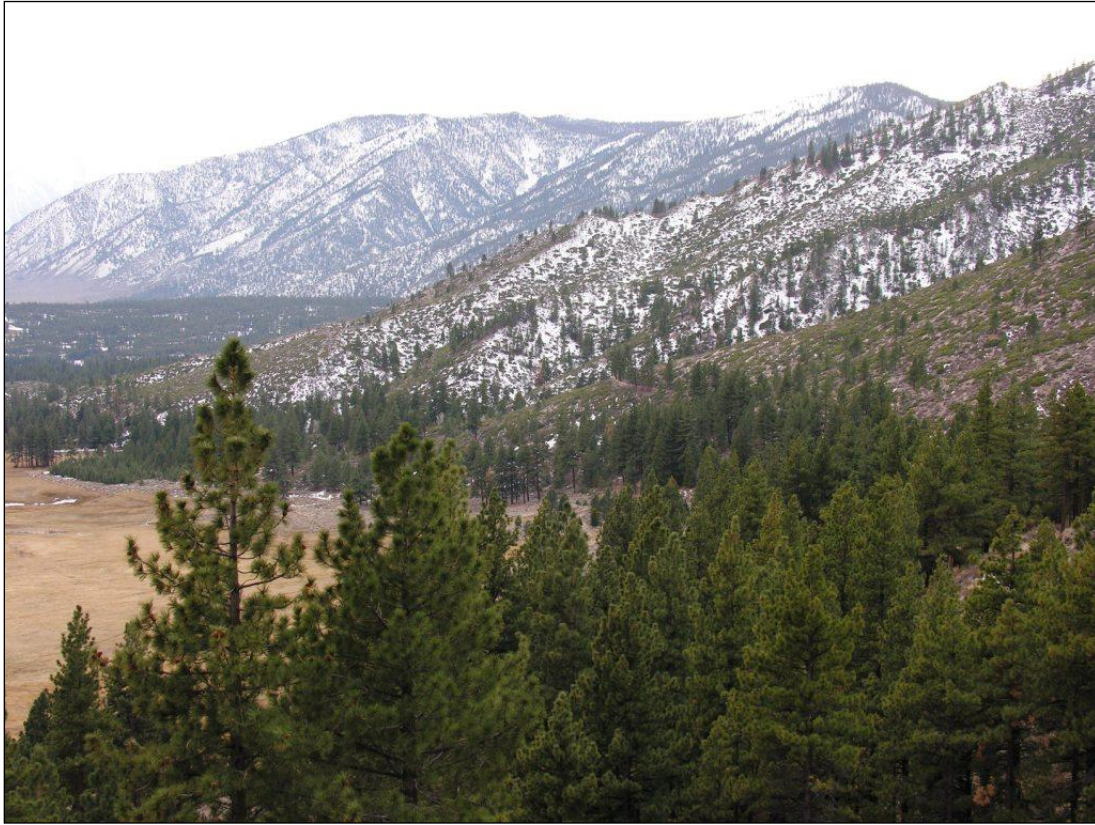
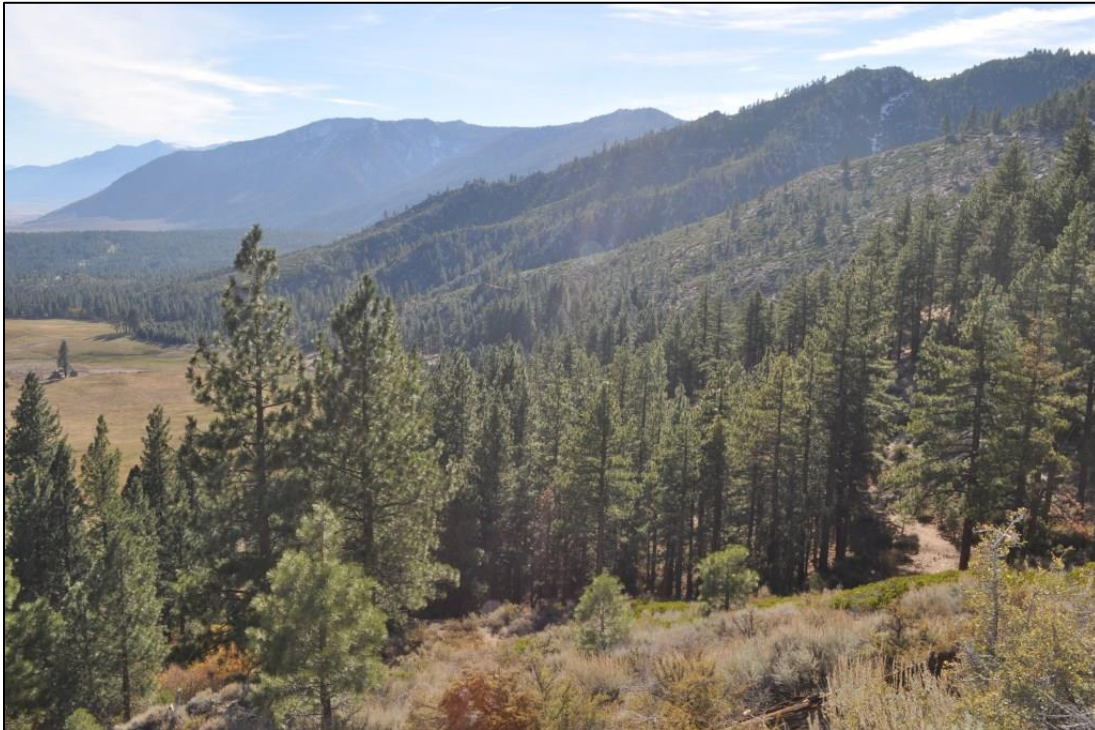
Photo Point 7C (view southwest): A photo point from Kings Canyon Road that would provide panoramic views of the ranch from a north to south perspective.

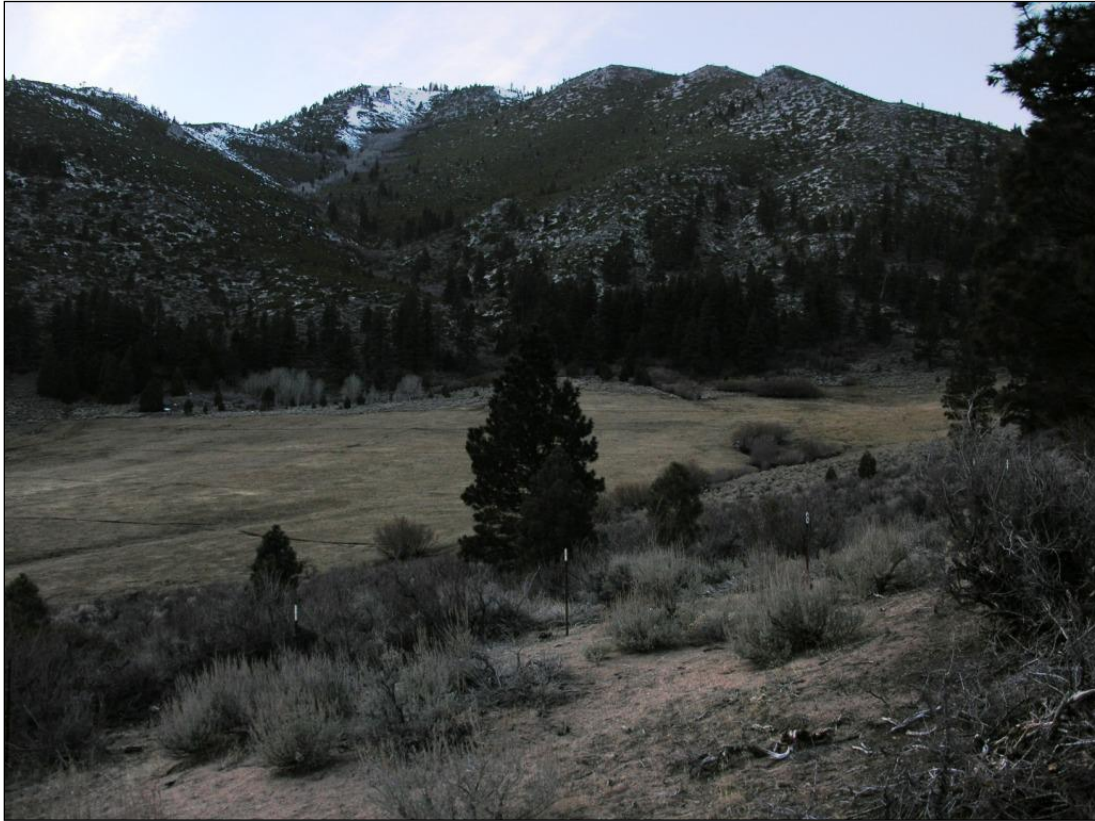
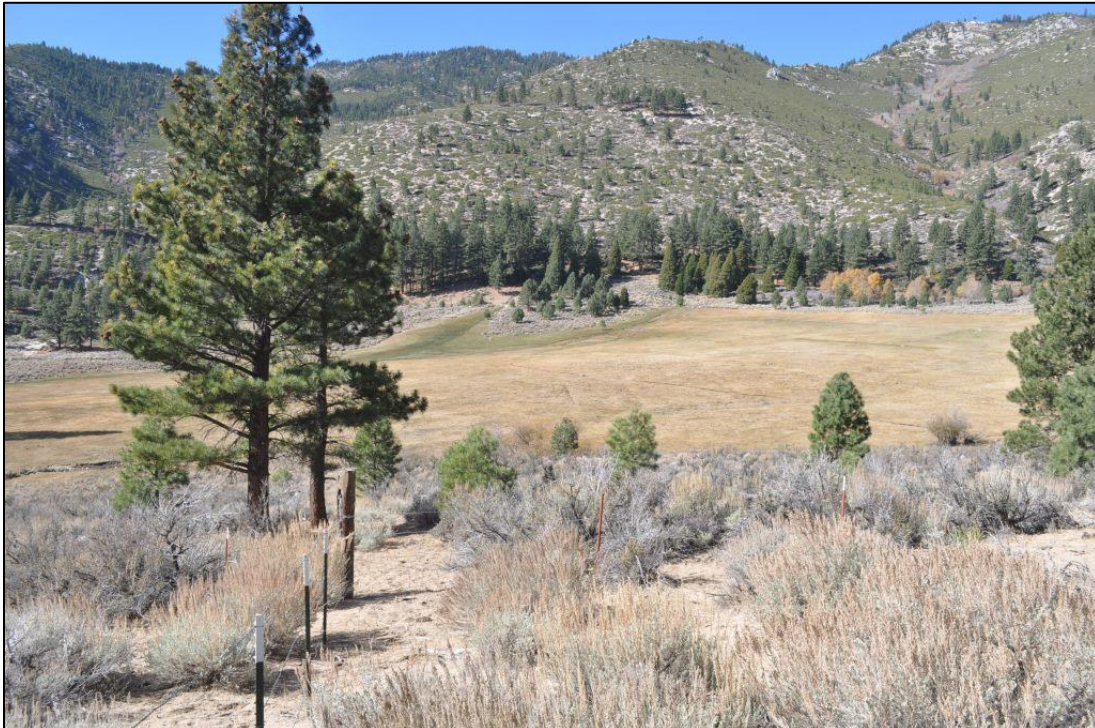
Photo Point 8A (view northwest): A photo point overlooking the meadow from the east to the west located next to the property corner along the new road.

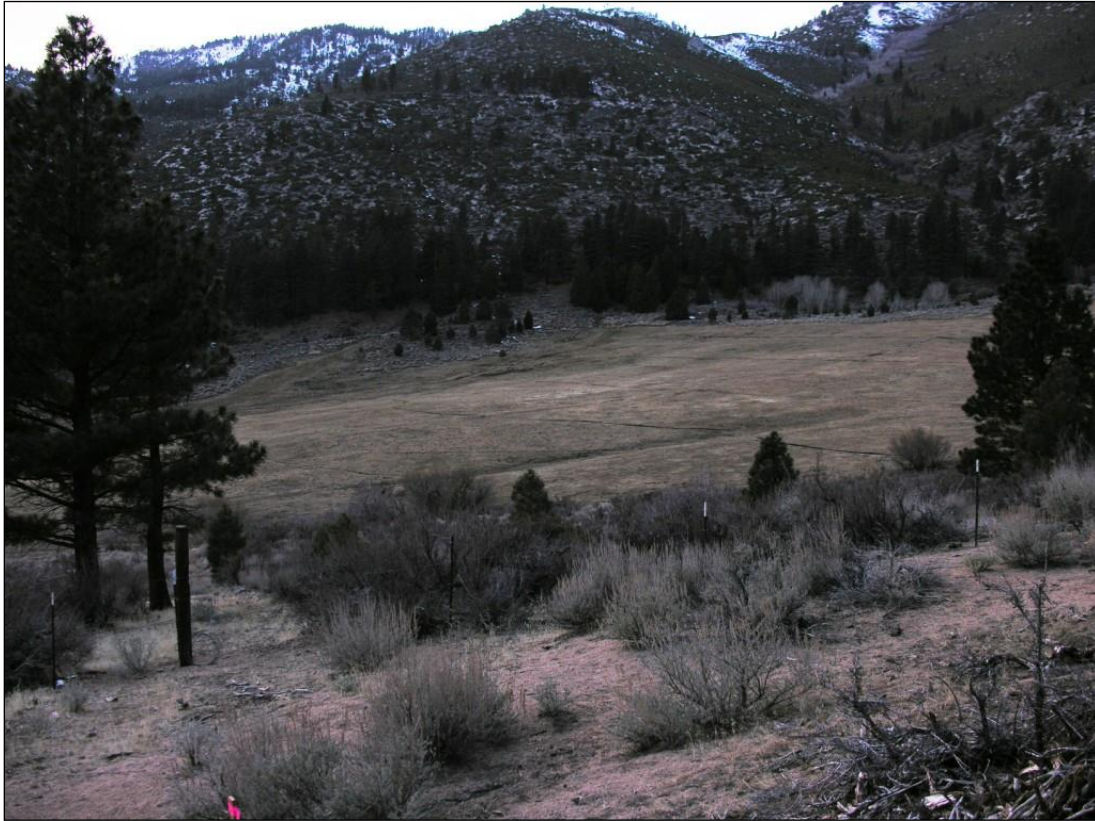
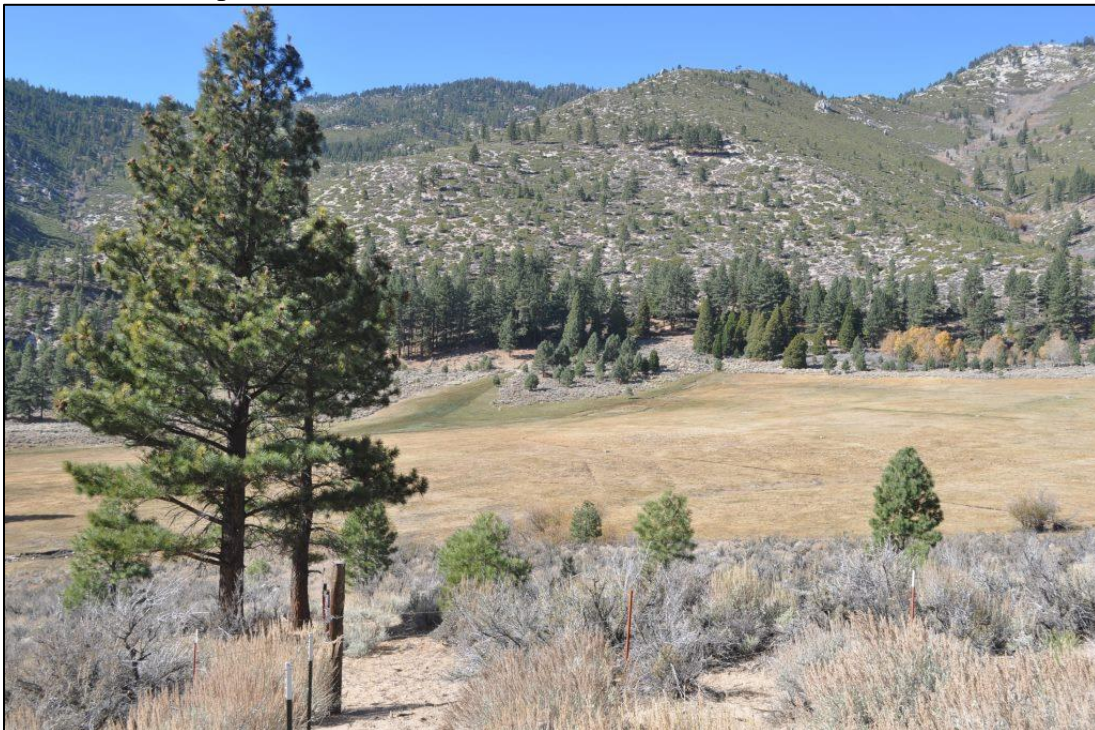
Photo Point 8B (view west): A photo point overlooking the meadow from the east to the west located next to the property corner along the new road.
