**OPEN SPACE ADVISORY COMMITTEE  
STAFF REPORT**

**REQUEST:** **For Possible Action:** To approve the monitoring report for the Horsecreek Ranch Conservation Easement for 2016.

## **Carson City Open Space – Conservation Easement Monitoring**

**Date:** June 20, 2016

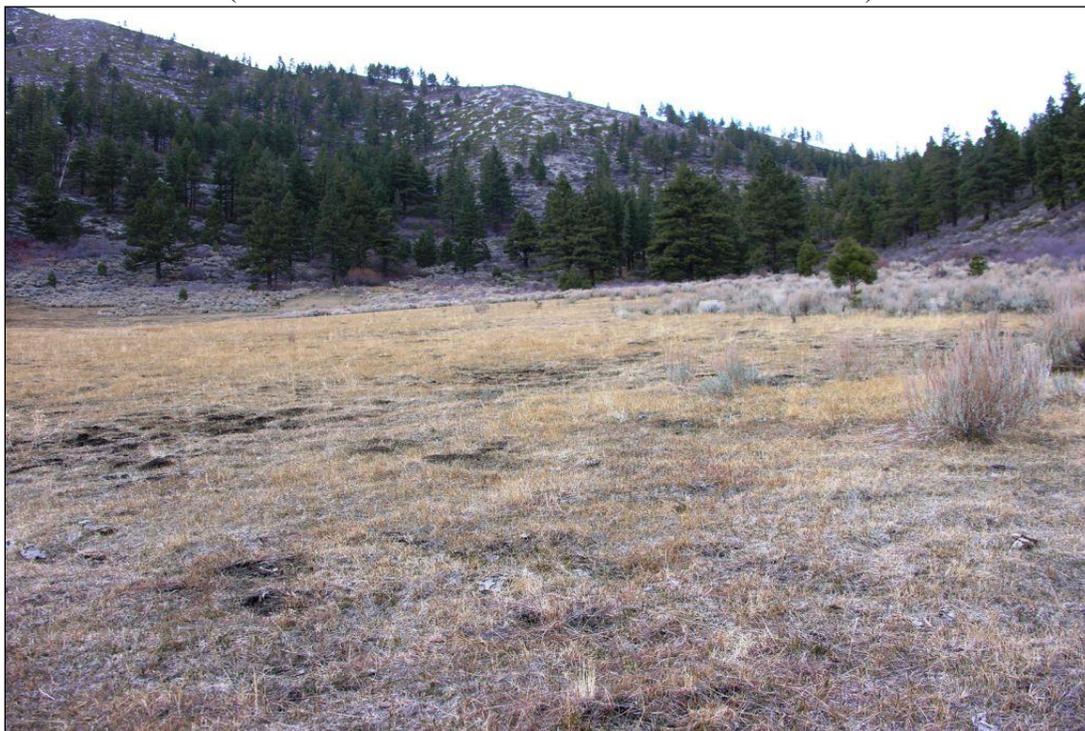
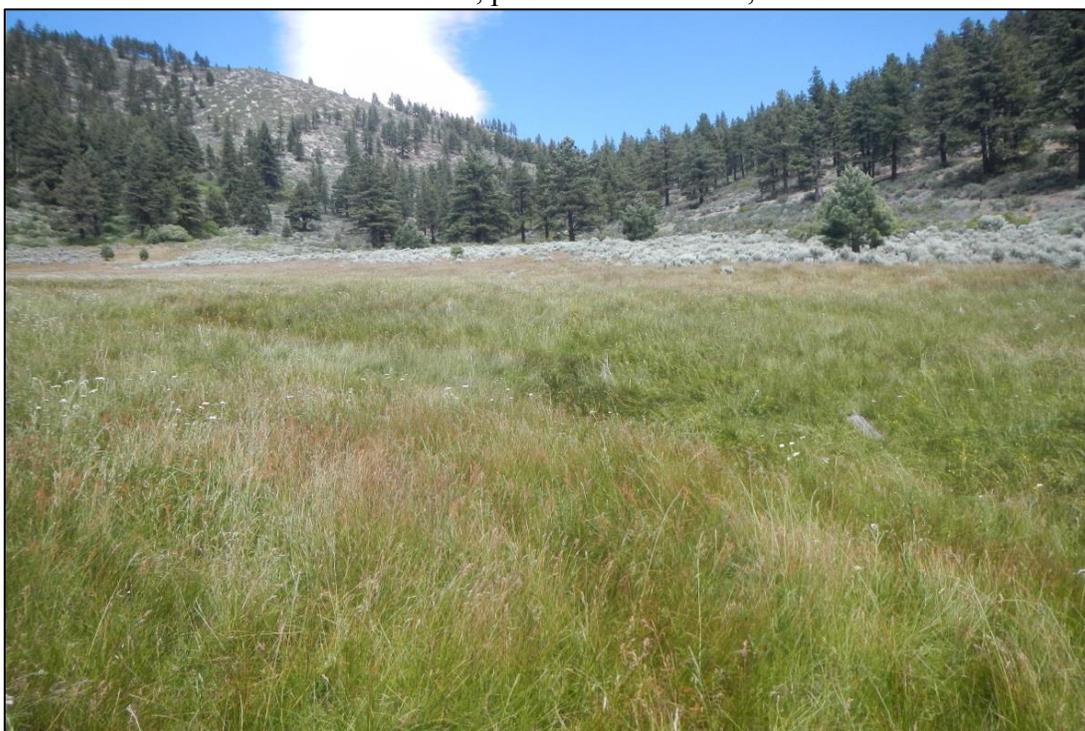
**Photo Point 1A (view northeast): A photo point located at the edge of the shrub dominated granitic fan and the irrigated meadow. This would be used to monitor shrub invasion into the meadow area indicating irrigation problems.**

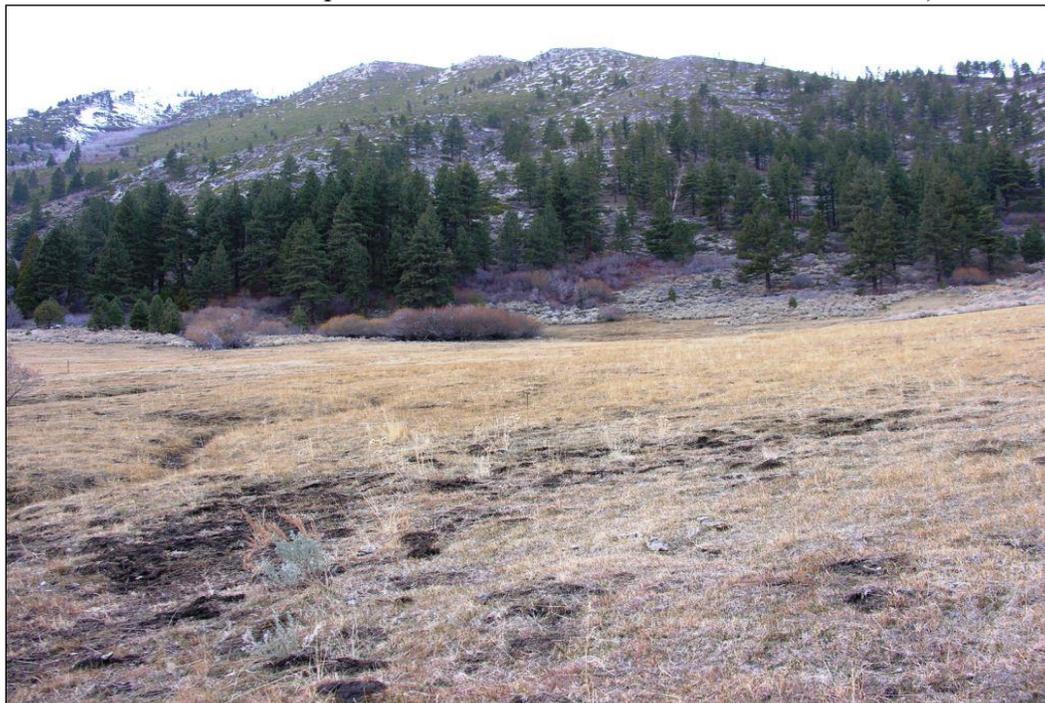
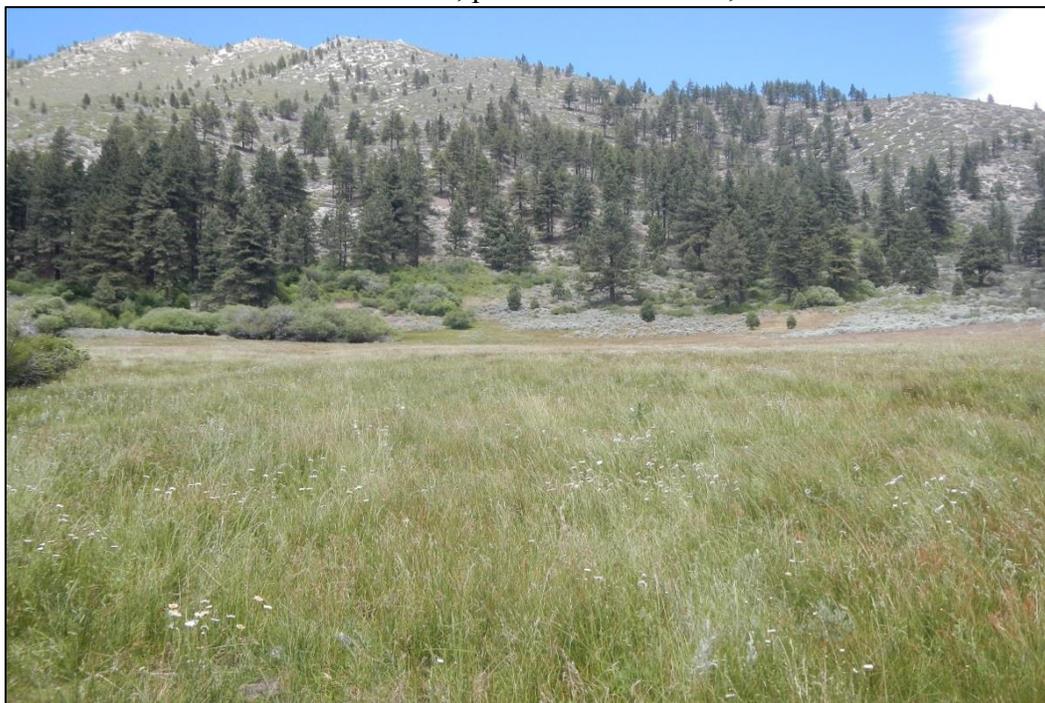
**Photo Point 1B (view northwest): A photo point located at the edge of the shrub dominated granitic fan and the irrigated meadow. This would be used to monitor shrub invasion into the meadow area indicating irrigation problems.**

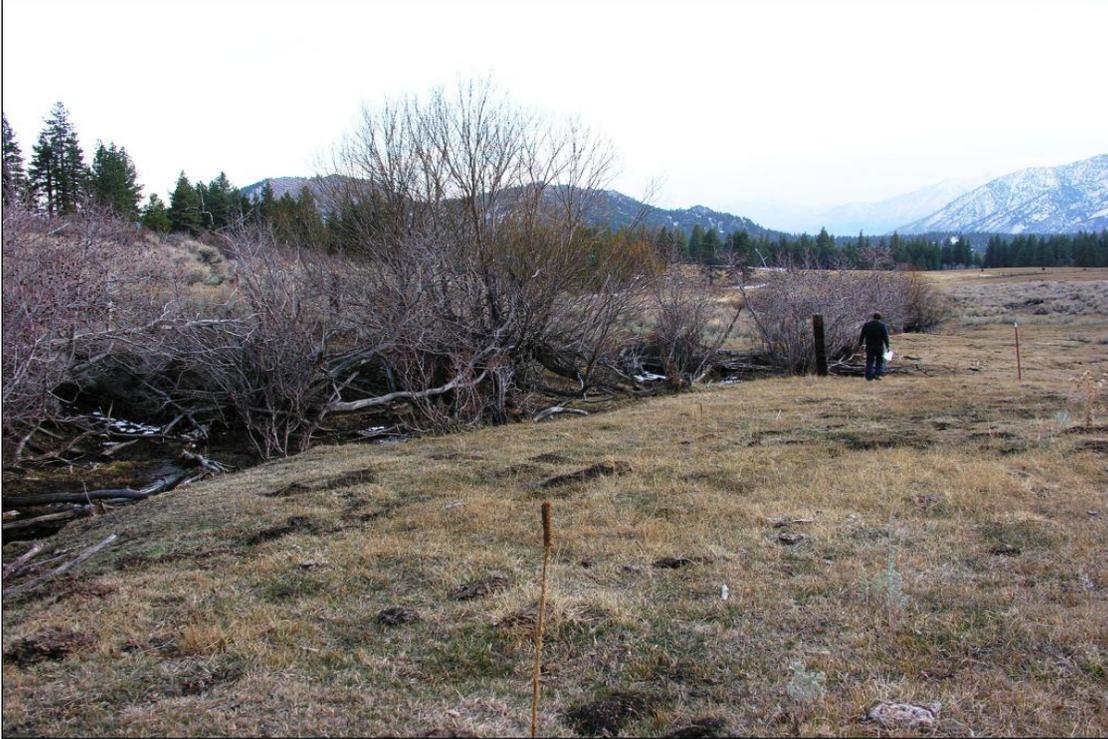
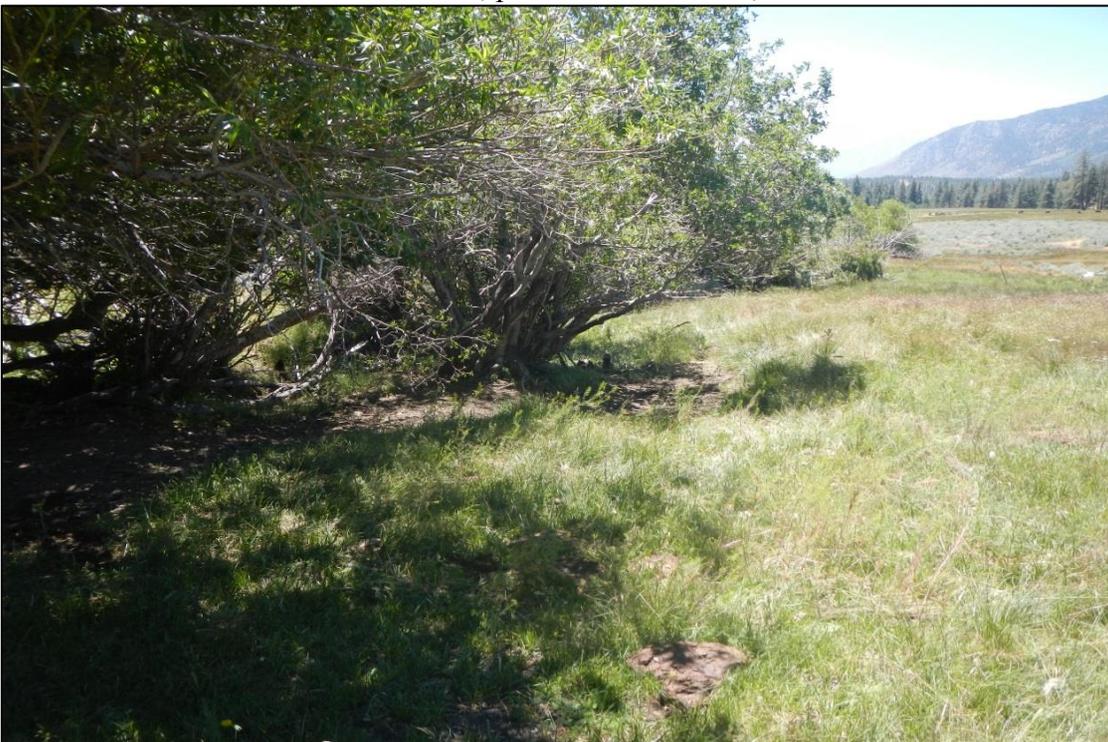
**Photo Point 2 (view south): A photo point located in bottom of the active stable drainage channel to the southeast of the house to monitor side slope stability.**

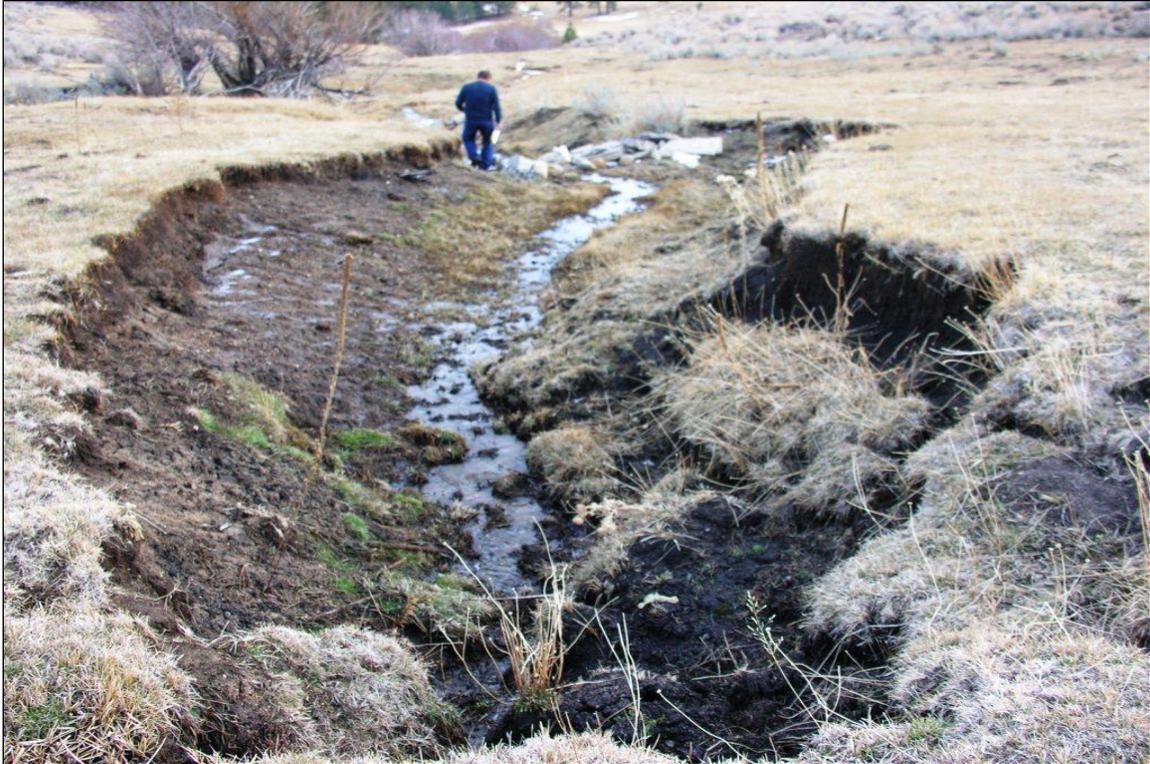
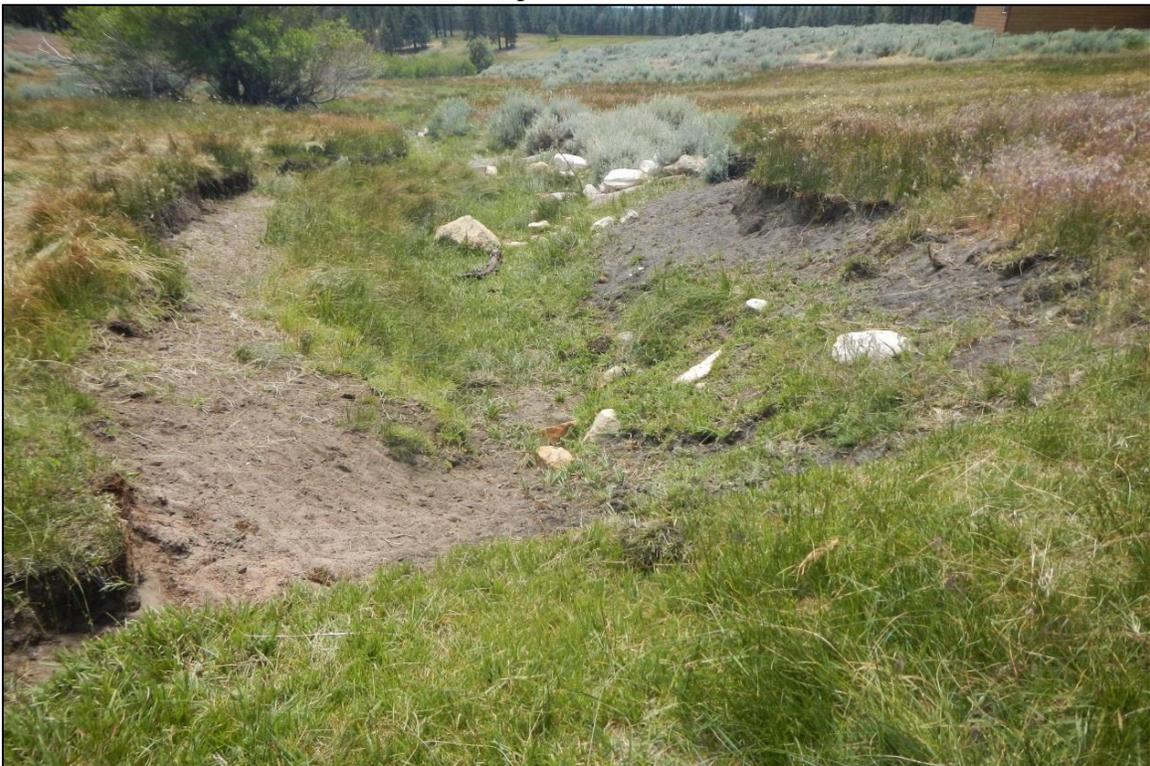
**Photo Point 3 (view south): A photo point located immediately east of the house in the active channel where rip-rap has been placed for stabilization.**

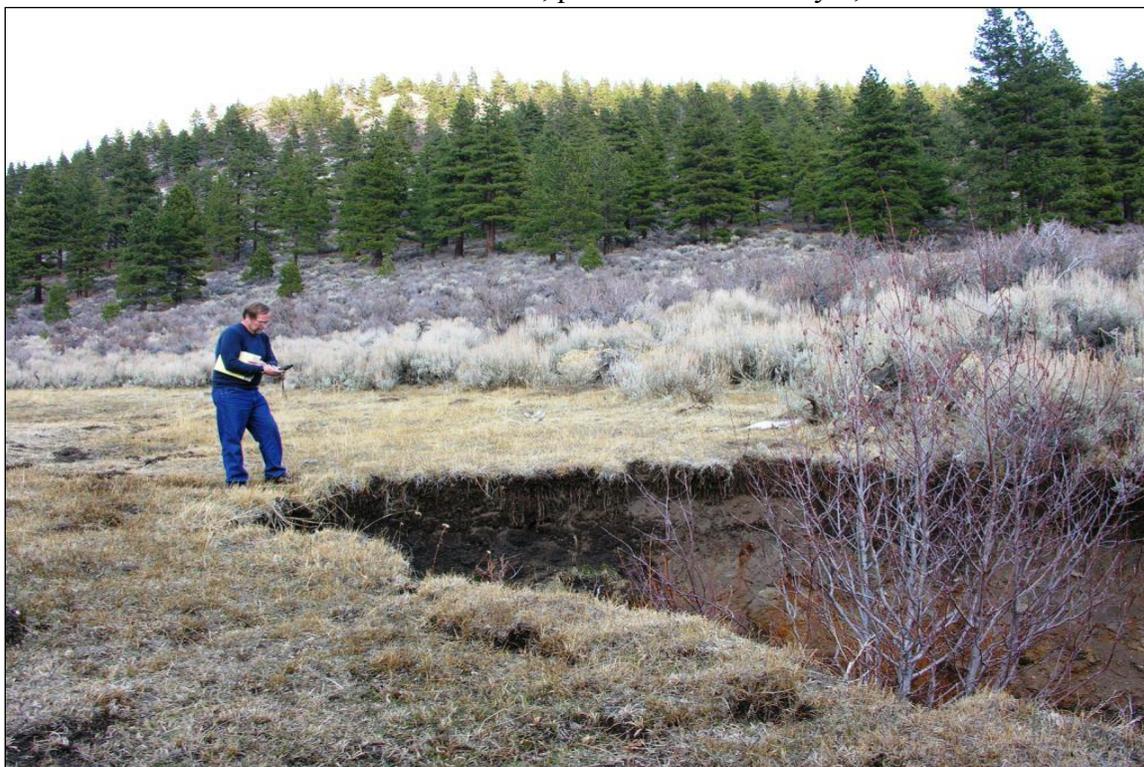
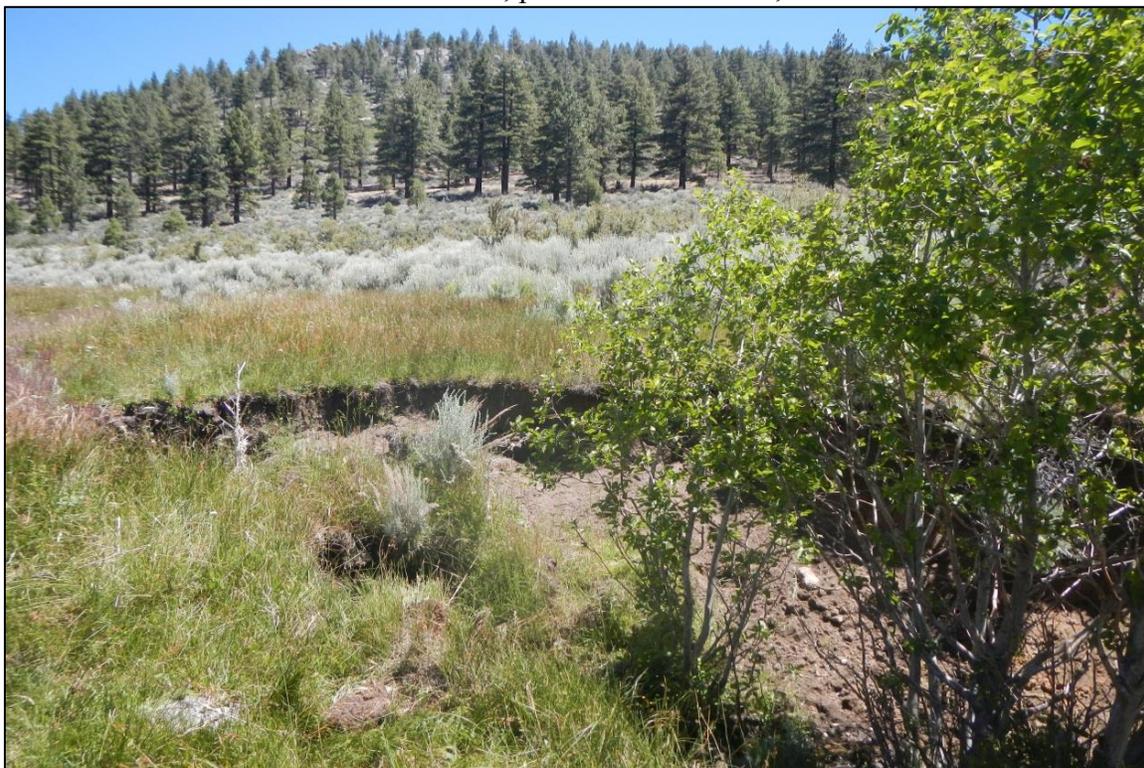
**Photo Point 4A (view north): A photo point located at the most northern active headcut after required stabilization to monitor effectiveness.**

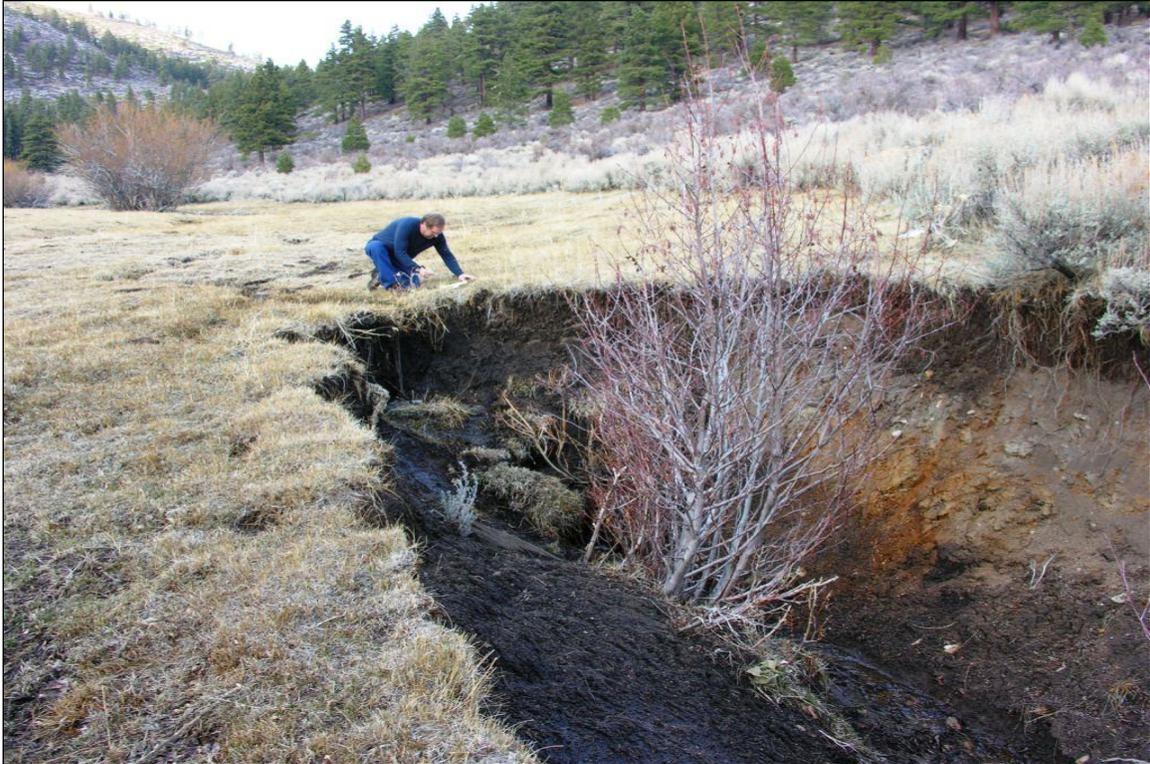
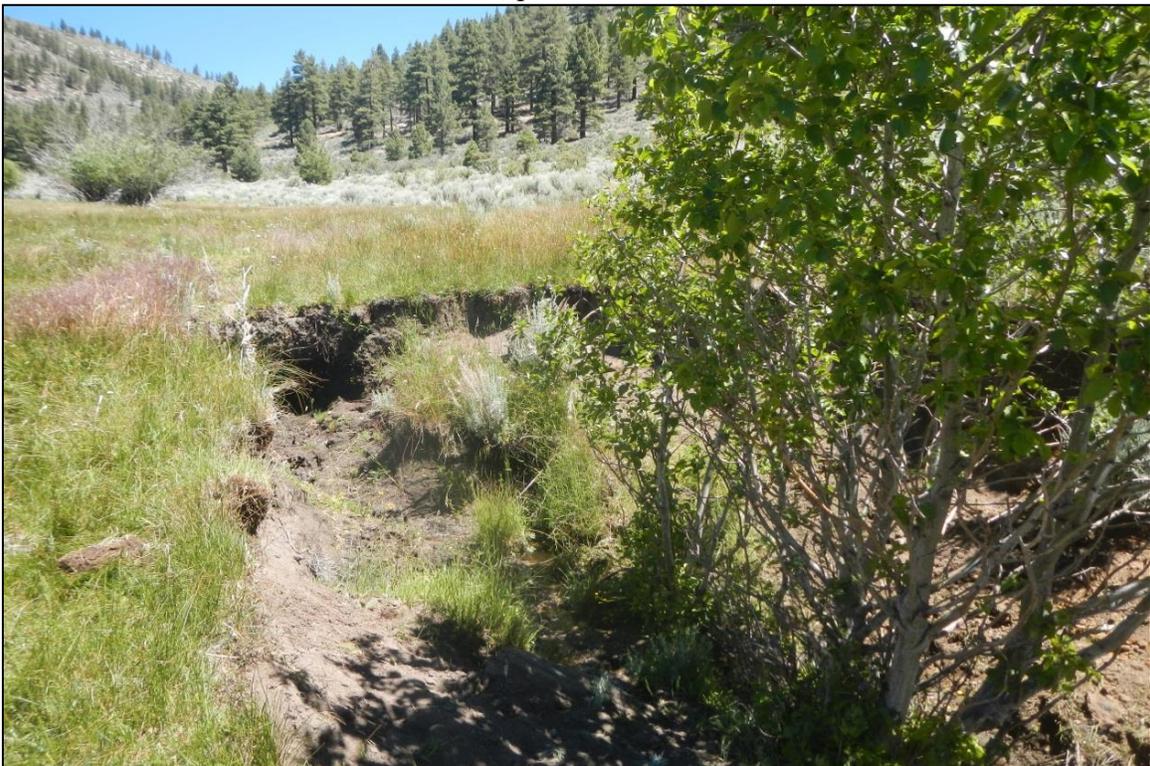
**Photo Point 4B (detail): A photo point located at the most northern active headcut after required stabilization to monitor effectiveness.**

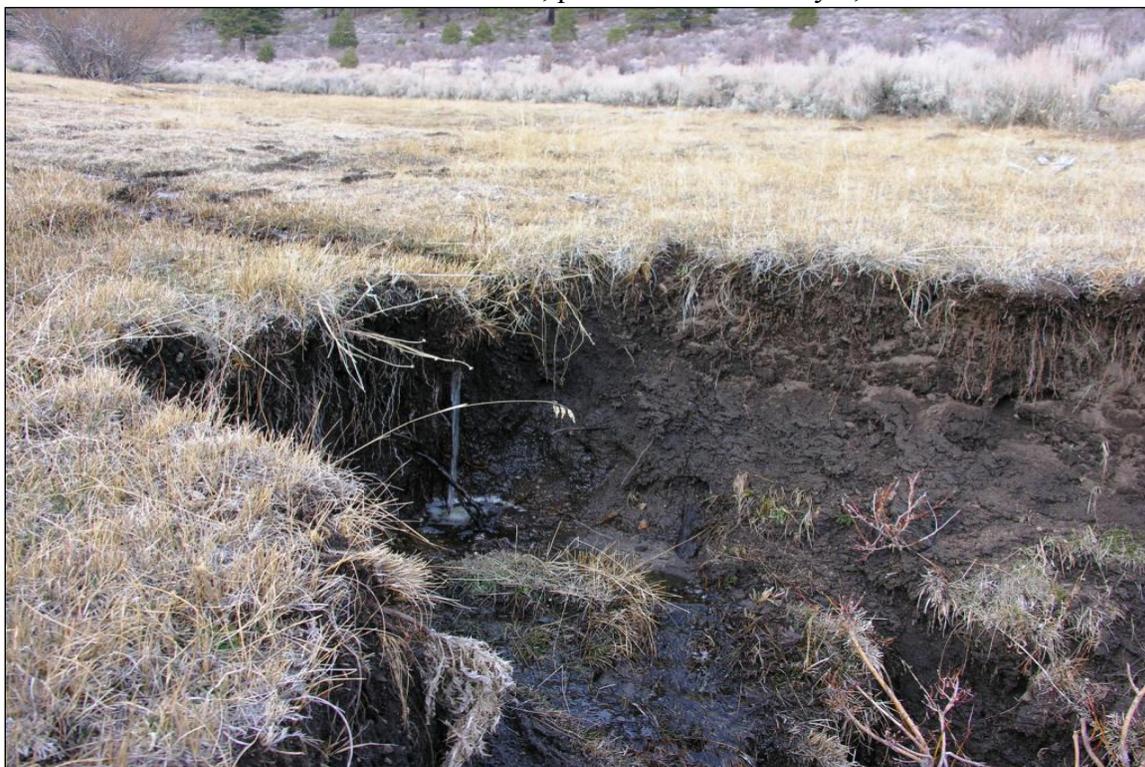
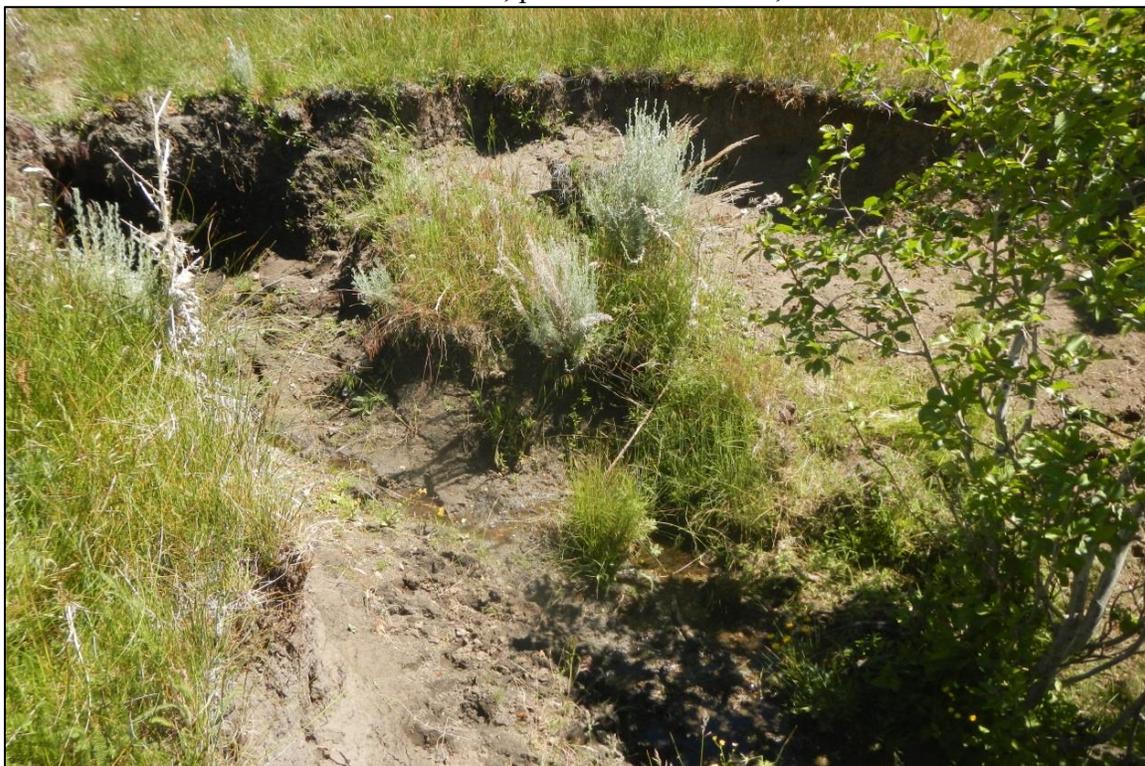
**Photo Point 4C (detail): A photo point located at the most northern active headcut after required stabilization to monitor effectiveness.**

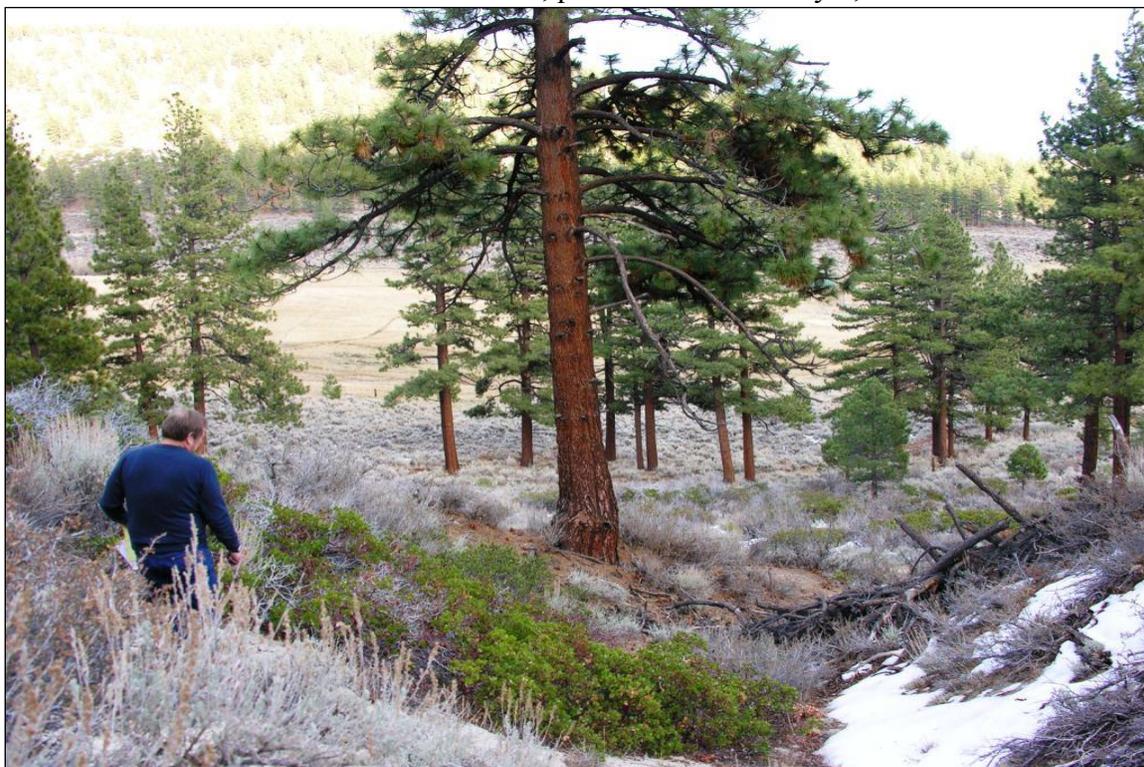
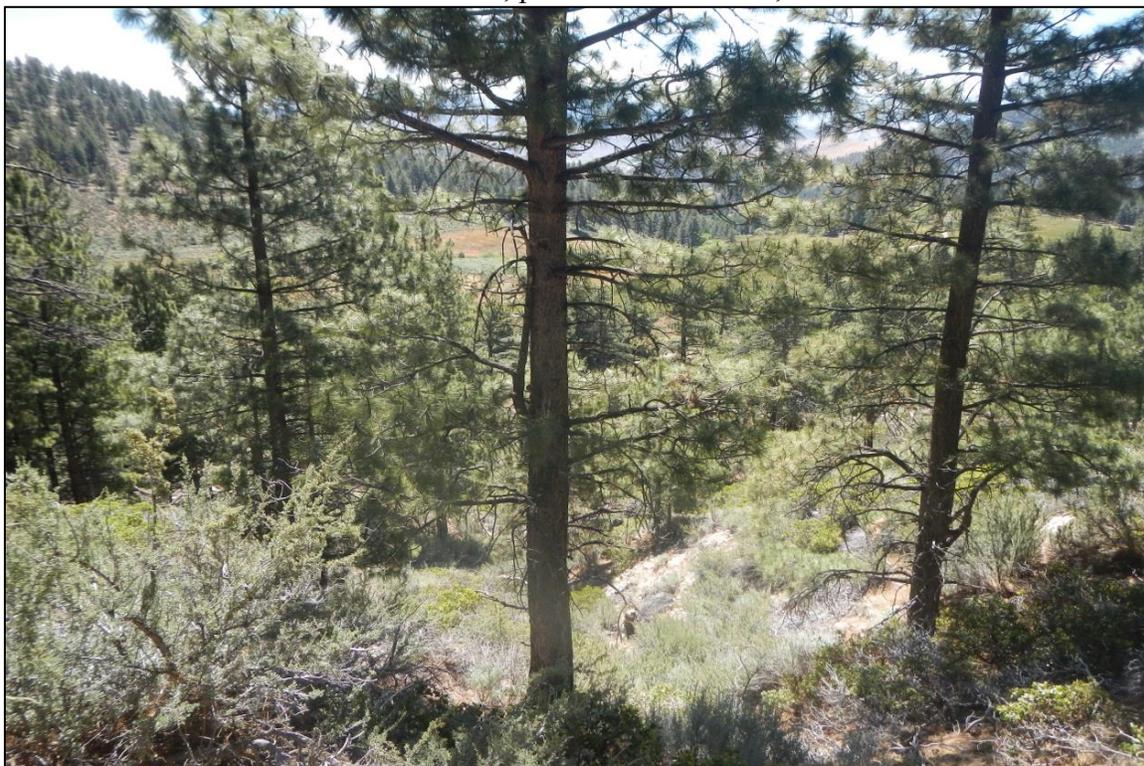
**Photo Point 5 (view east): A photo point on the hillside conveyance ditch at a location where a previous washout has occurred to monitor ditch maintenance.**

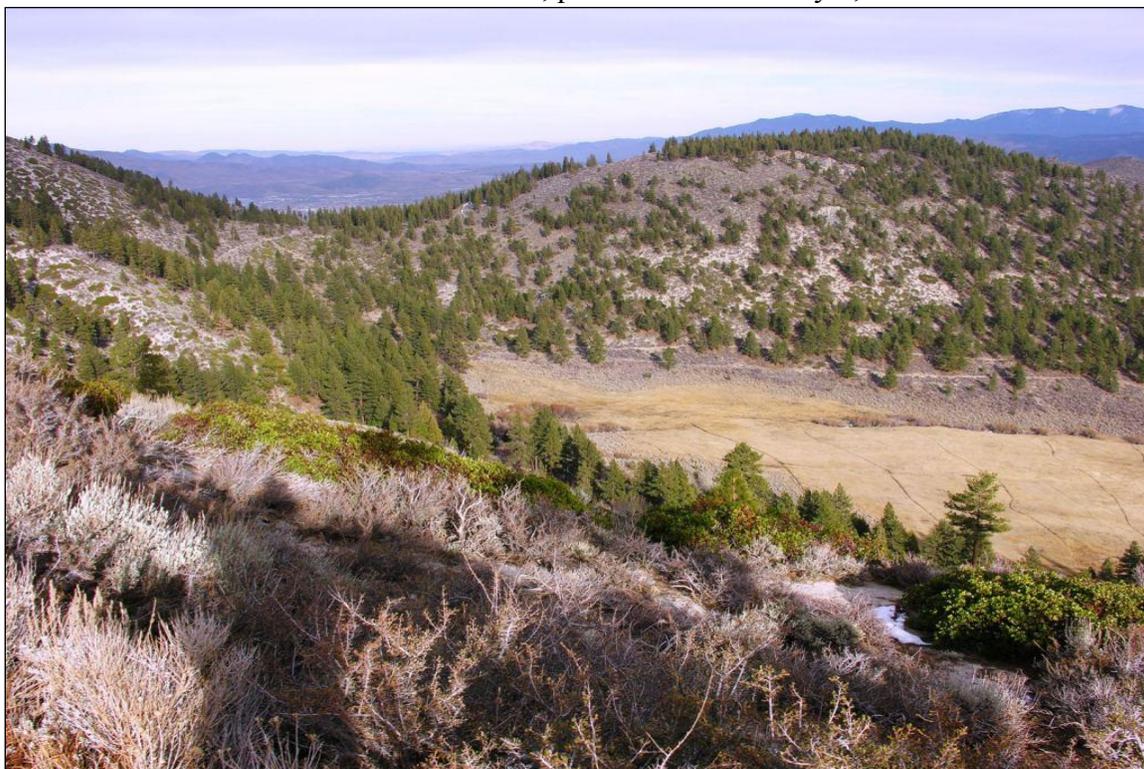
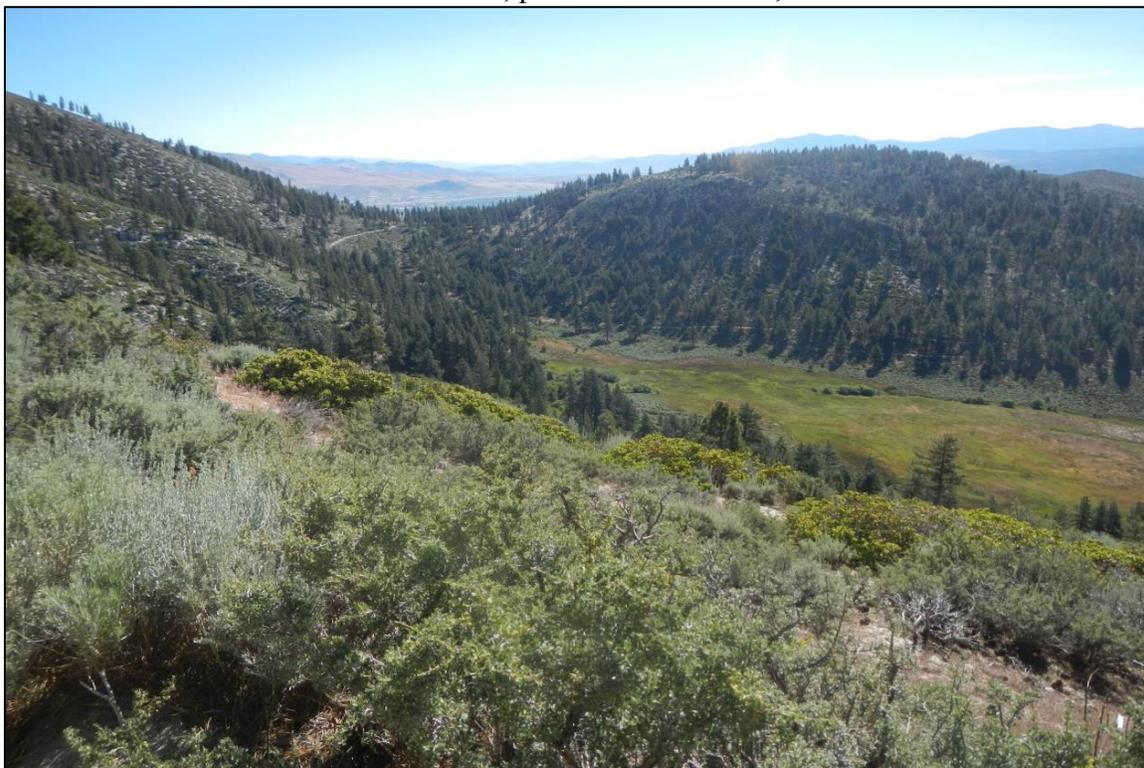
**Photo Point 6A (view north): A photo point from the Kings Canyon Road that would provide panoramic views of the ranch from a west to east perspective.**

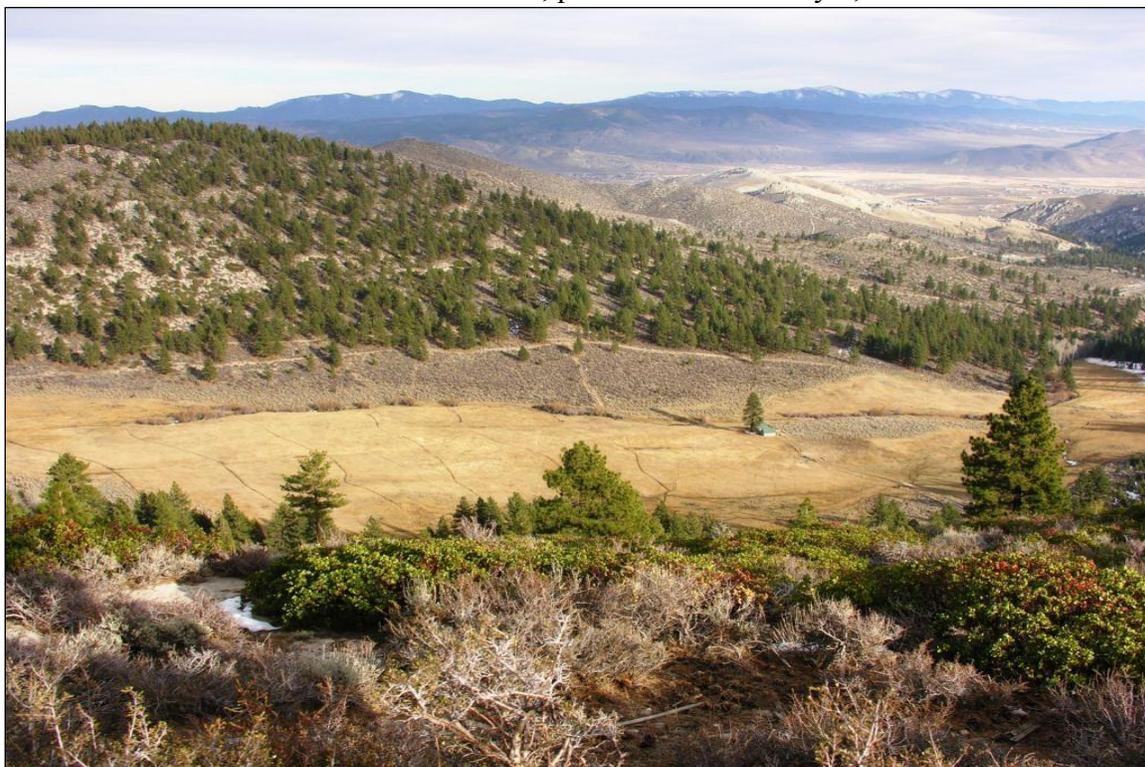
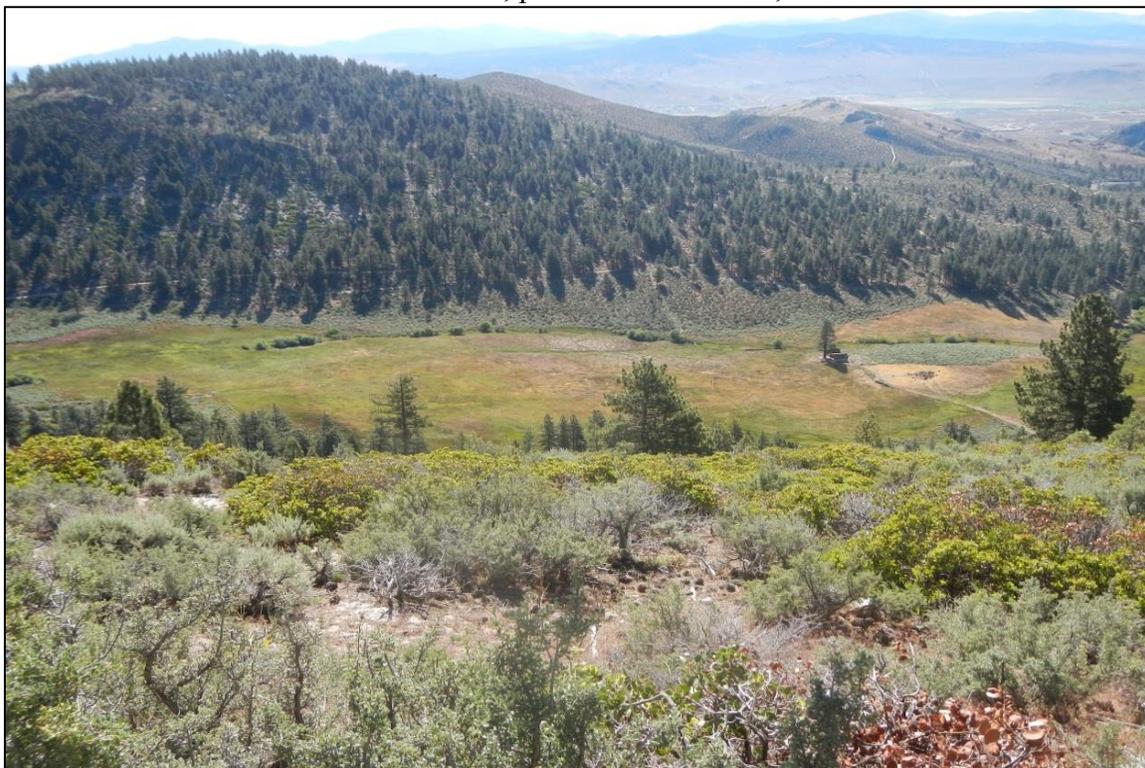
**Photo Point 6B (view center): A photo point from the Kings Canyon Road that would provide panoramic views of the ranch from a west to east perspective.**

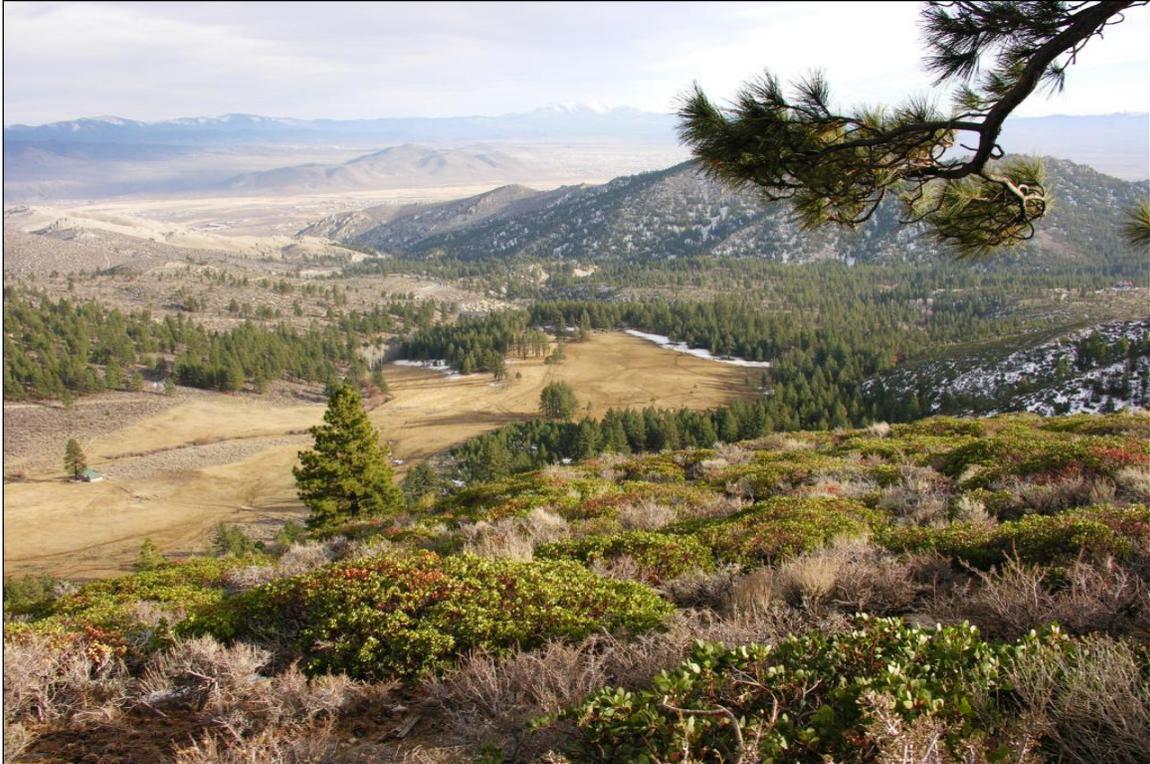
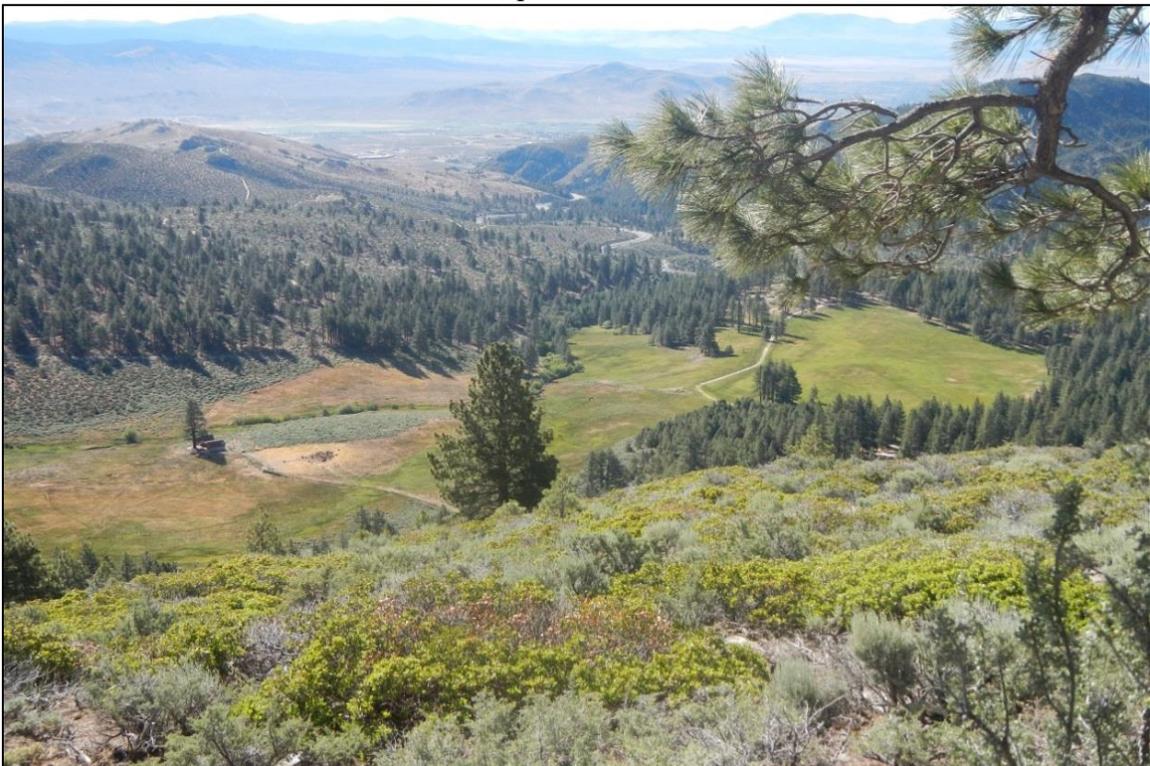
**Photo Point 6C (view south): A photo point from the Kings Canyon Road that would provide panoramic views of the ranch from a west to east perspective.**

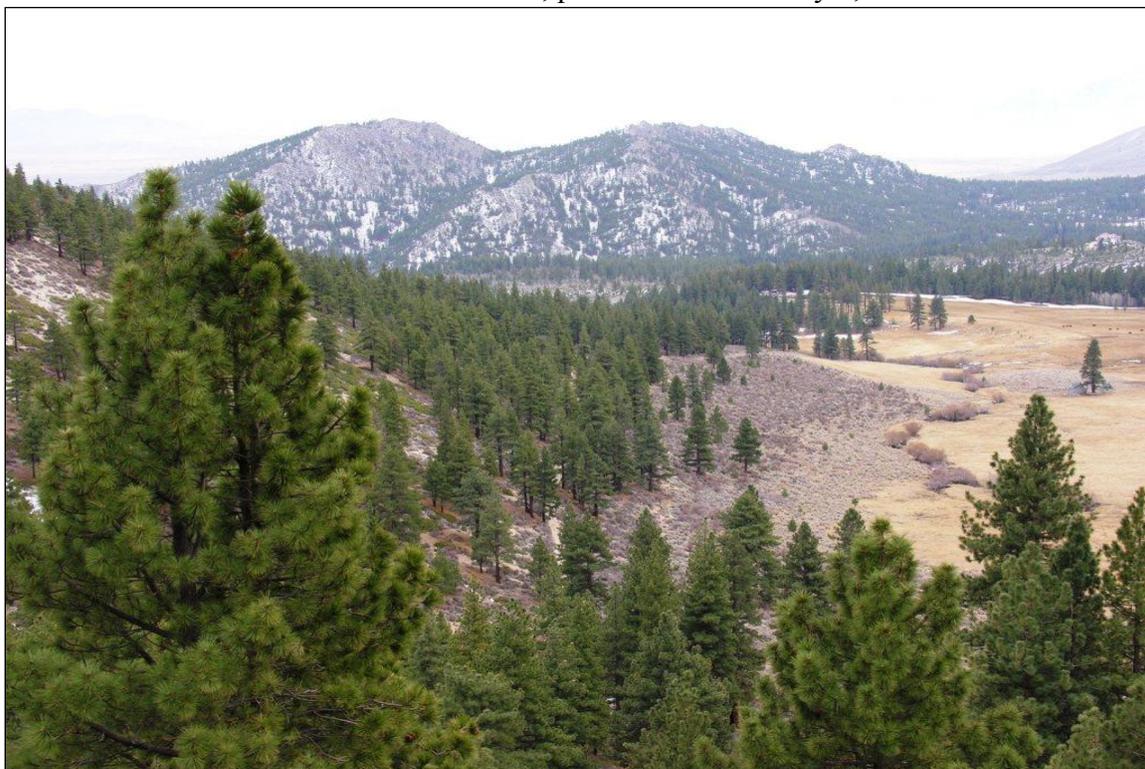
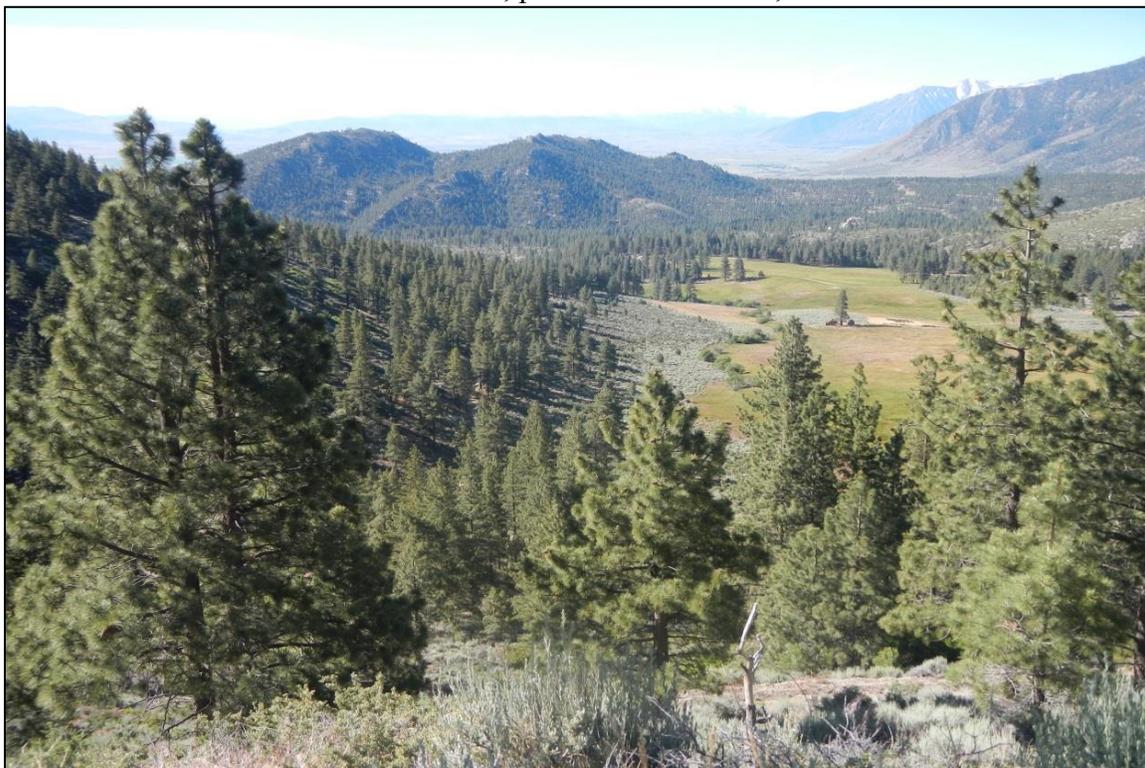
**Photo Point 7A (view southeast): A photo point from Kings Canyon Road that would provide panoramic views of the ranch from a north to south perspective.**

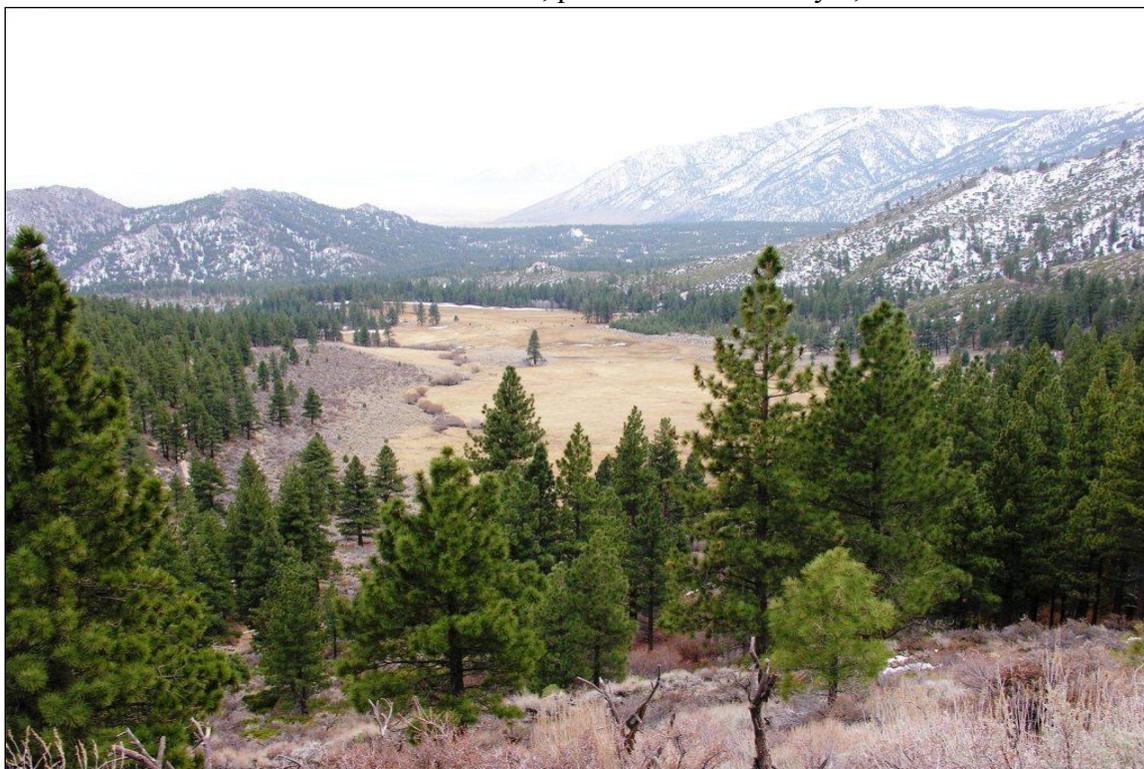
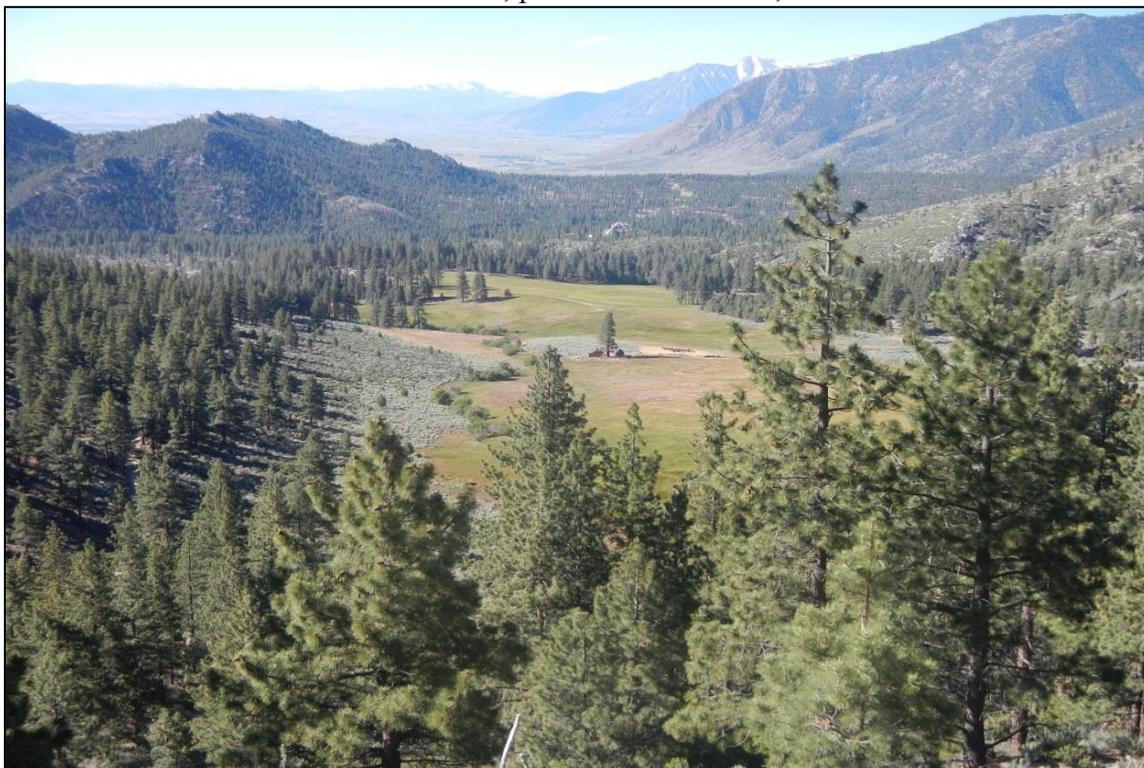
**Photo Point 7B (view south): A photo point from Kings Canyon Road that would provide panoramic views of the ranch from a north to south perspective.**
