**OPEN SPACE ADVISORY COMMITTEE  
STAFF REPORT**

**REQUEST:** **For Possible Action:** To approve the monitoring report for the Horsecreek Ranch Conservation Easement for 2016.

## **Carson City Open Space – Conservation Easement Monitoring**

**Date:** June 20, 2016

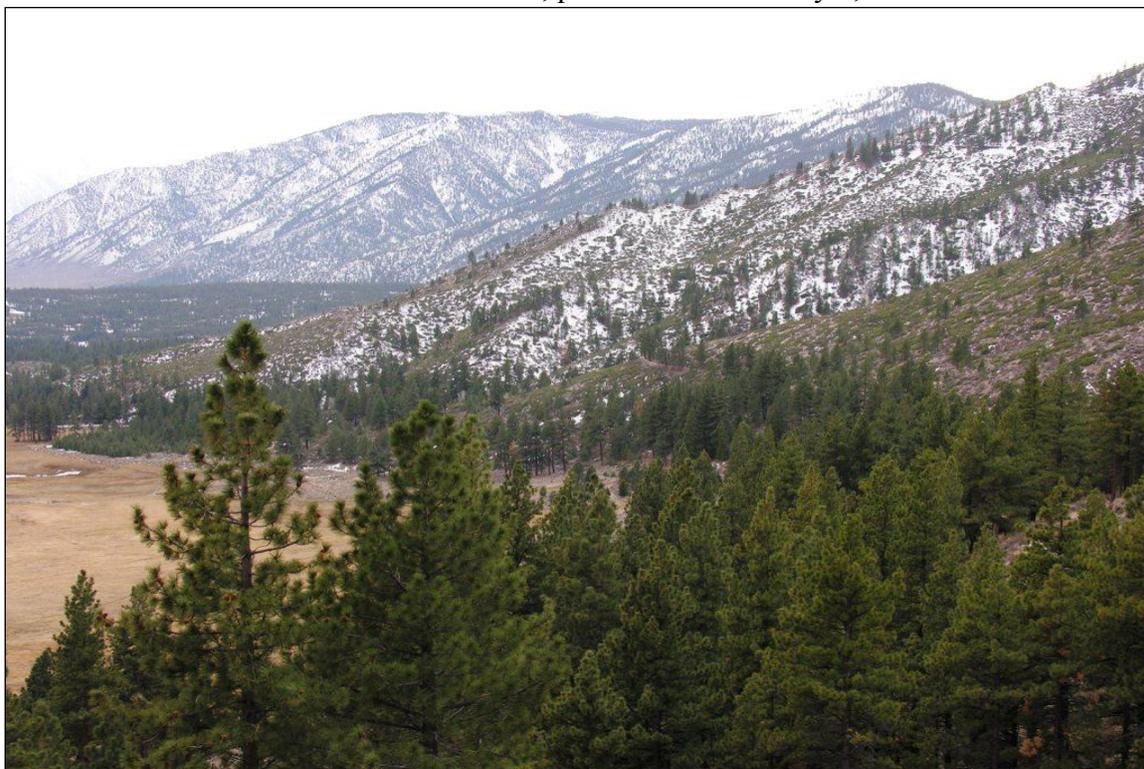
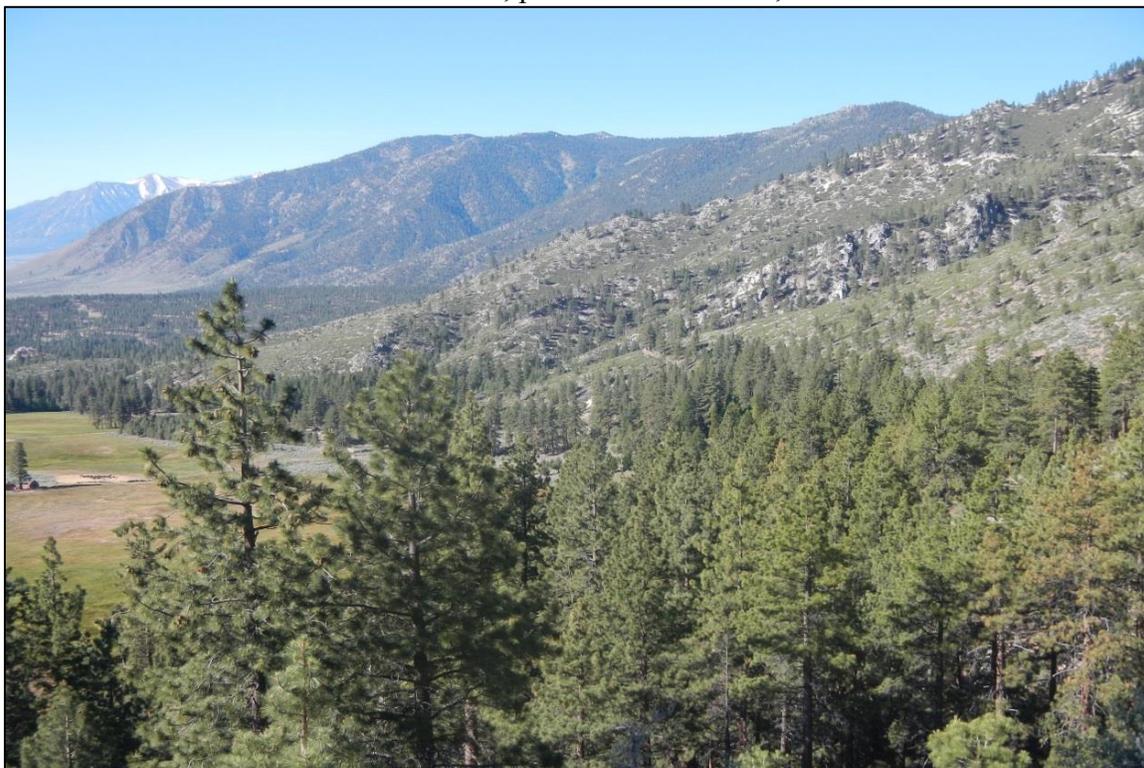
**Photo Point 7C (view southwest): A photo point from Kings Canyon Road that would provide panoramic views of the ranch from a north to south perspective.**

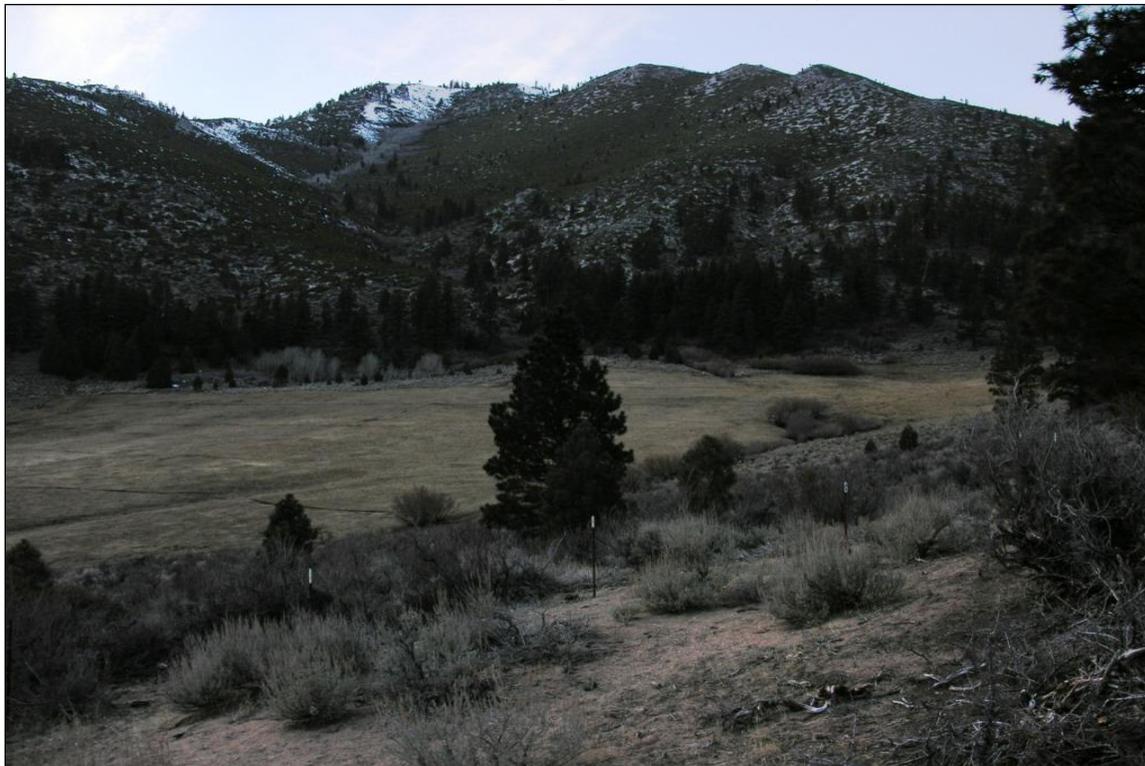
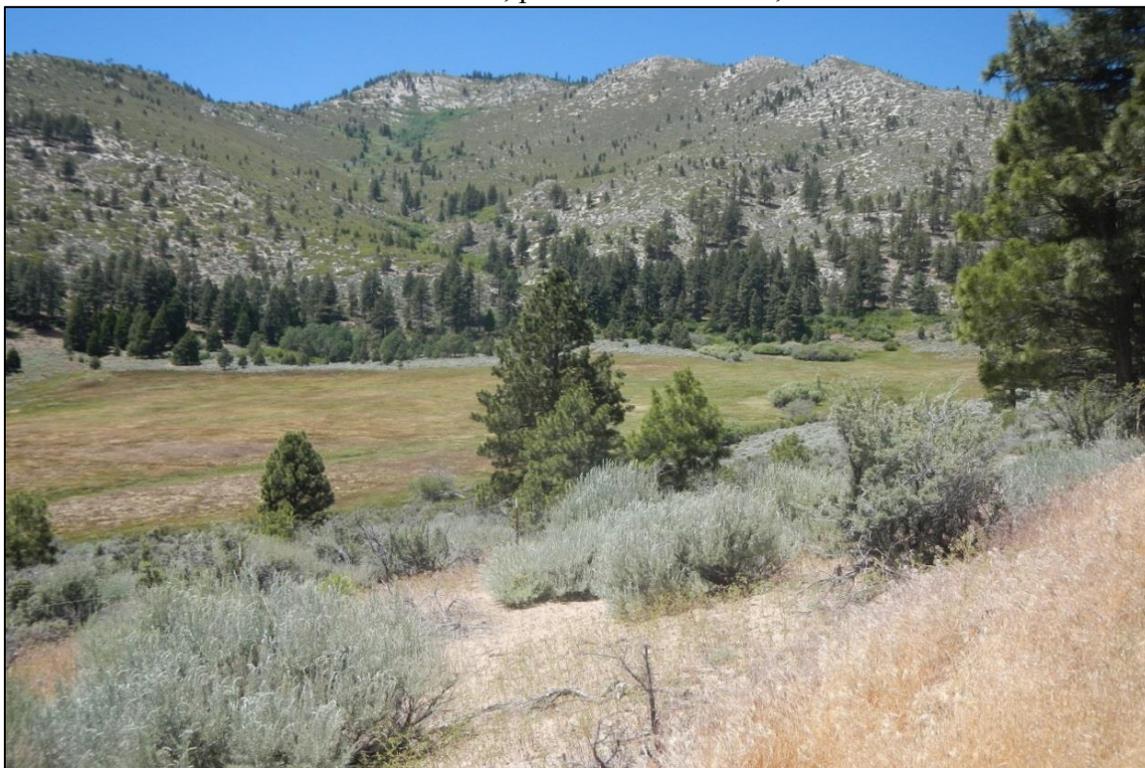
**Photo Point 8A (view northwest): A photo point overlooking the meadow from the east to the west located next to the property corner along the new road.**

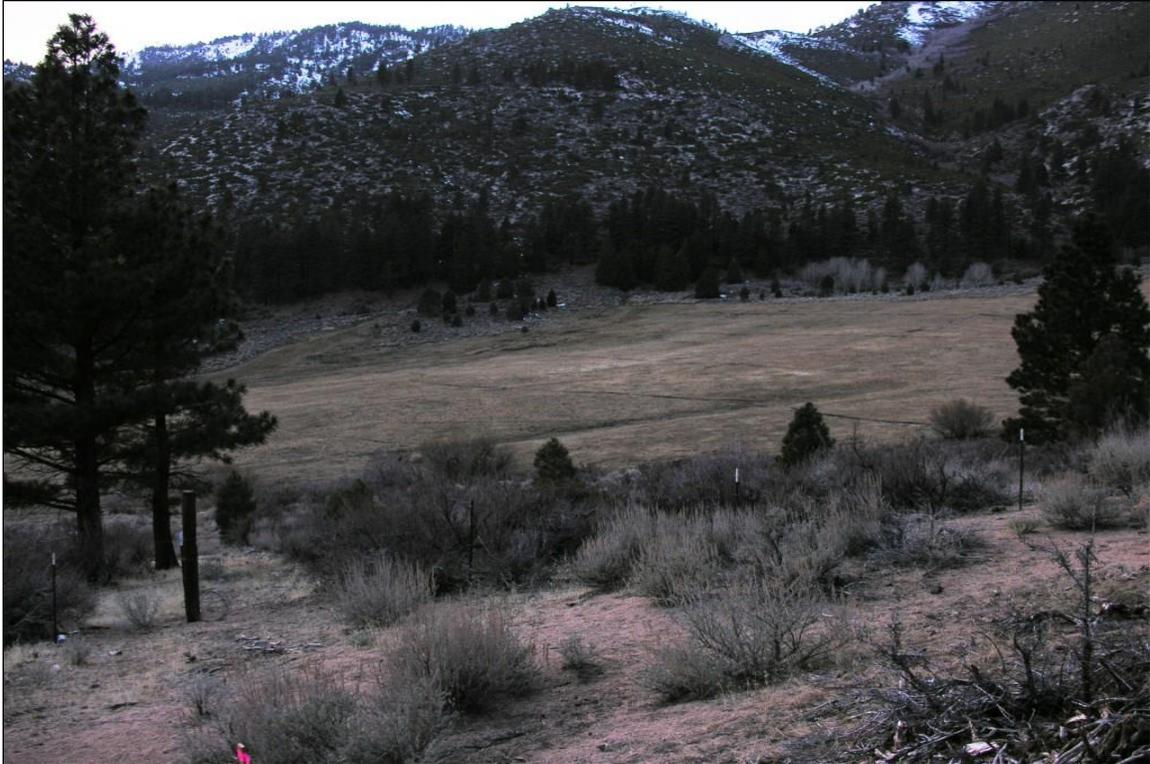
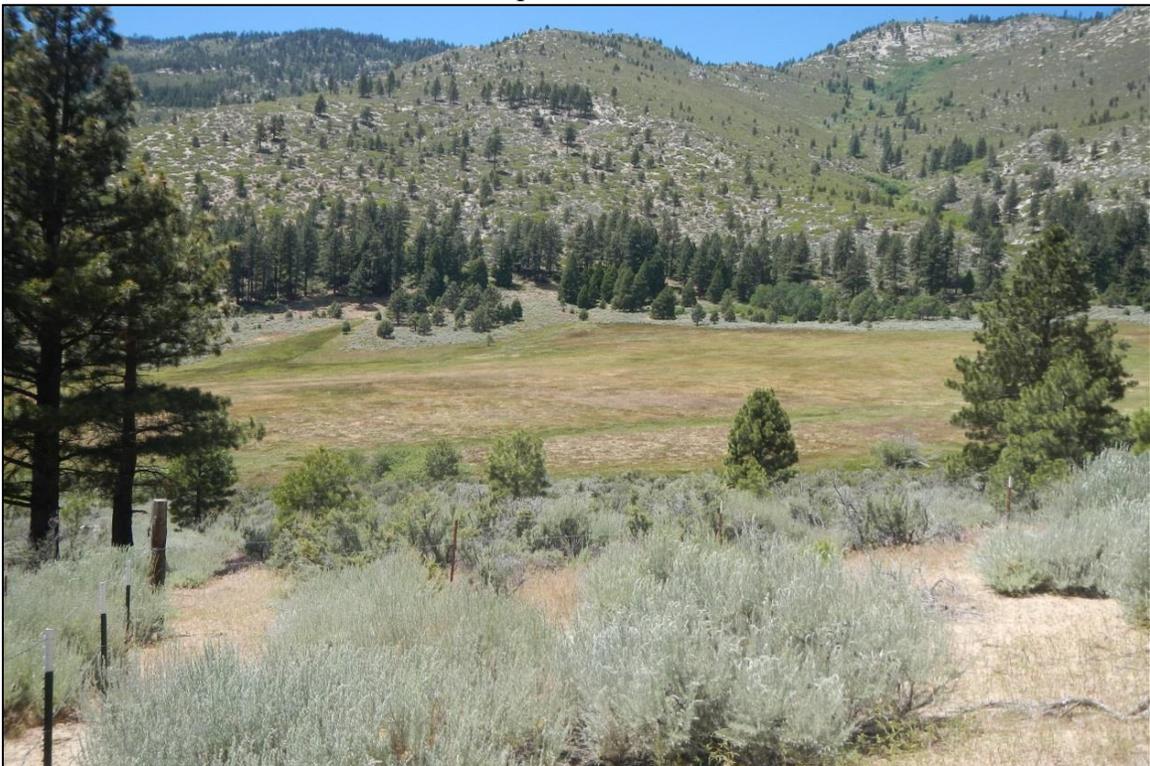
**Photo Point 8B (view west): A photo point overlooking the meadow from the east to the west located next to the property corner along the new road.**

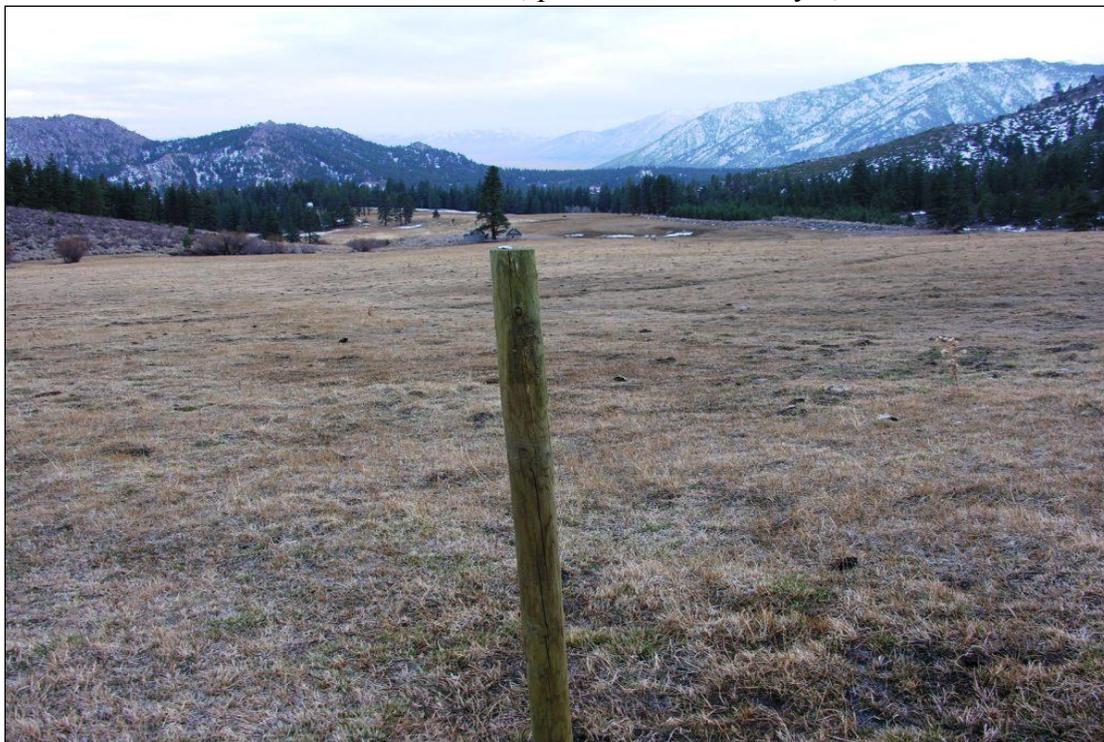
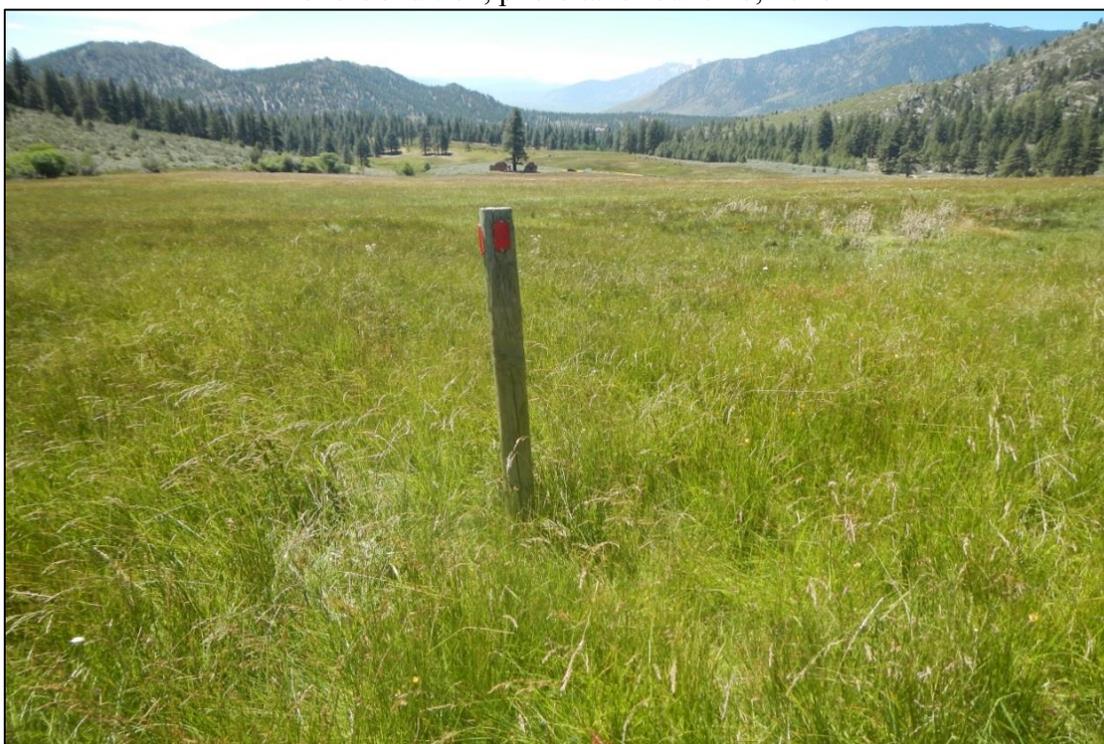
**Photo Point 9: A permanently marked 100' x 100' area to monitor pasture condition. This annual inventory will be used to monitor not only pasture condition but irrigation efficiency, vegetative response to drought and appropriate livestock utilization.**
