**OPEN SPACE ADVISORY COMMITTEE
STAFF REPORT**

REQUEST: **For Possible Action:** To approve the annual monitoring report for the Horse Creek Ranch conservation easement for 2017.

Carson City Open Space – Conservation Easement Monitoring

Date: September 26, 2017

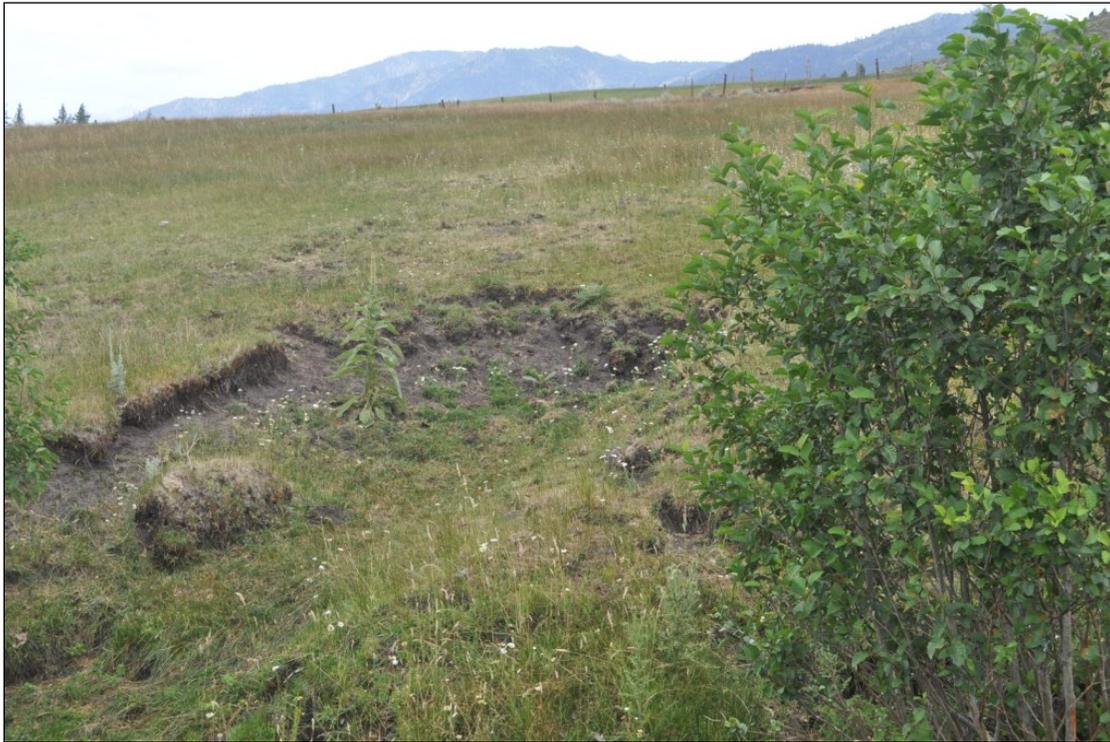
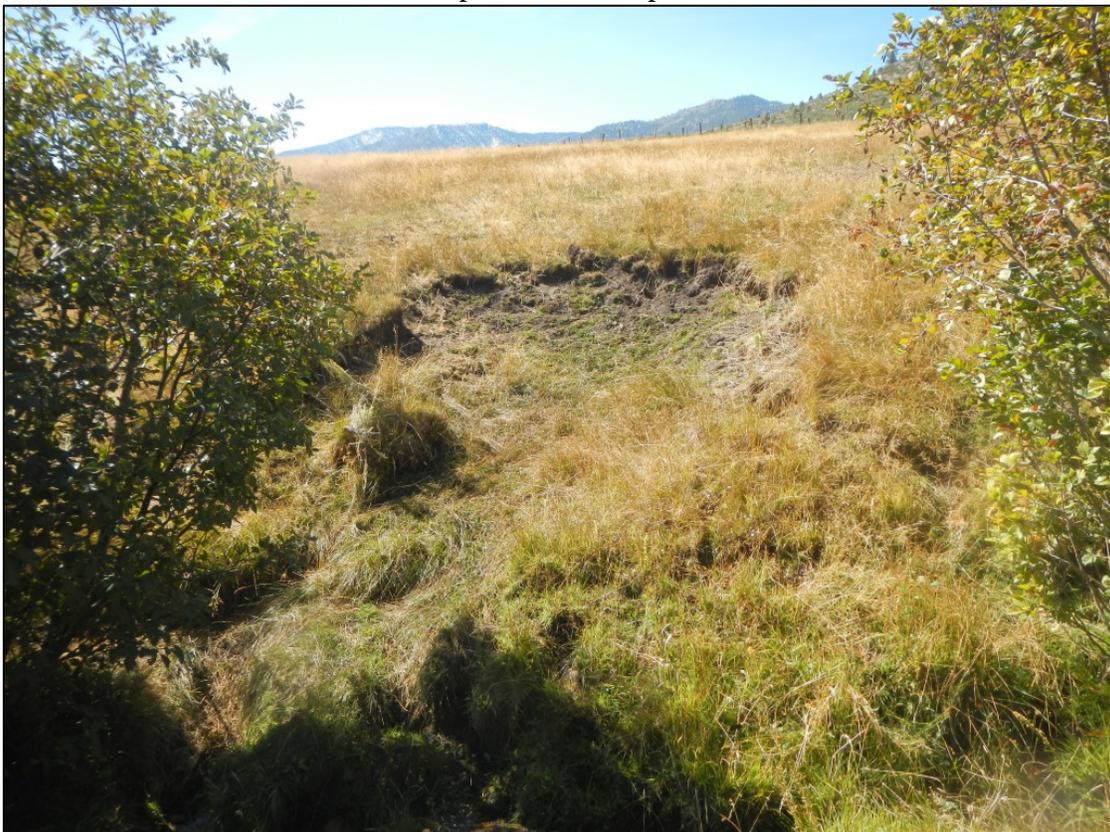
Near the southeast corner, one specific area is being monitored for landscape change. This low drainage area of the meadow appears to be vegetated and stable though a few isolated mounds or hummocks may be the result of cattle trampling. A qualitative assessment with the photo comparisons may be deceptive due to the time of year each photo was taken – either during the growing season or at the end of the season after grasses were grazed and/or senesced. Additionally, a new head cut was observed on the creek northeast of the cabins. This head cut is small in size currently (1 - 1.5 feet), but it should be monitored in future years to document change in size or location, as it could potentially migrate upstream.

2013 Condition, photo taken July 23, 2013 (initial assessment – view south)

2017 Condition, photo taken September 26, 2017

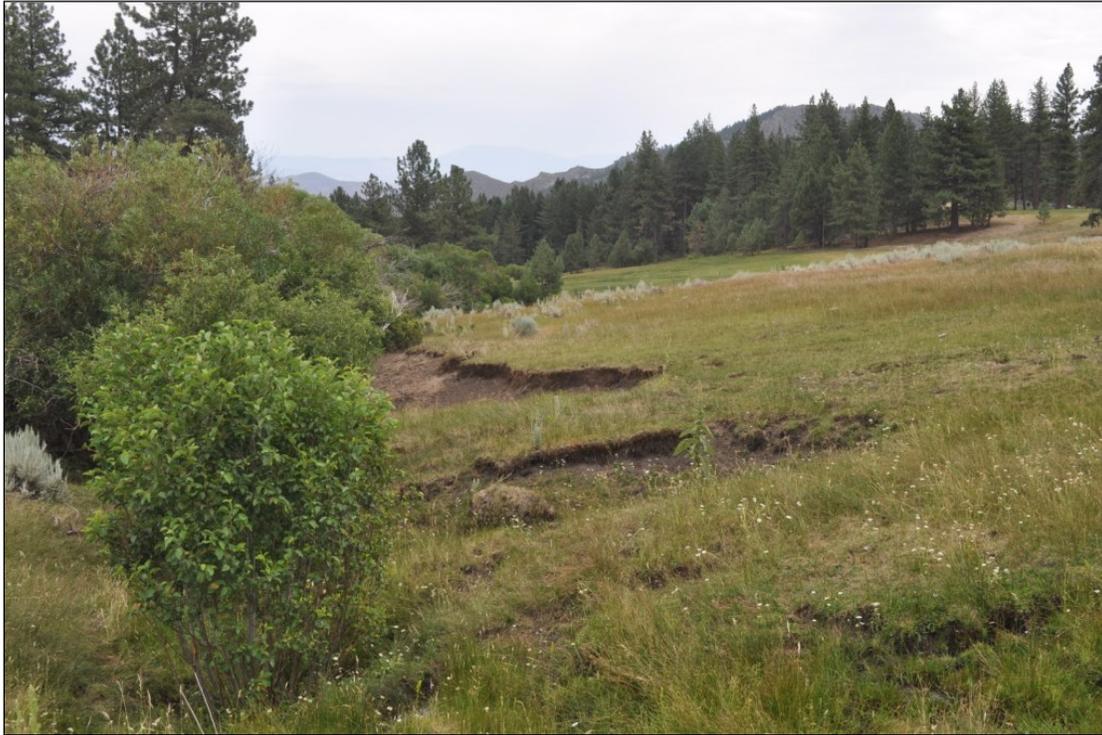
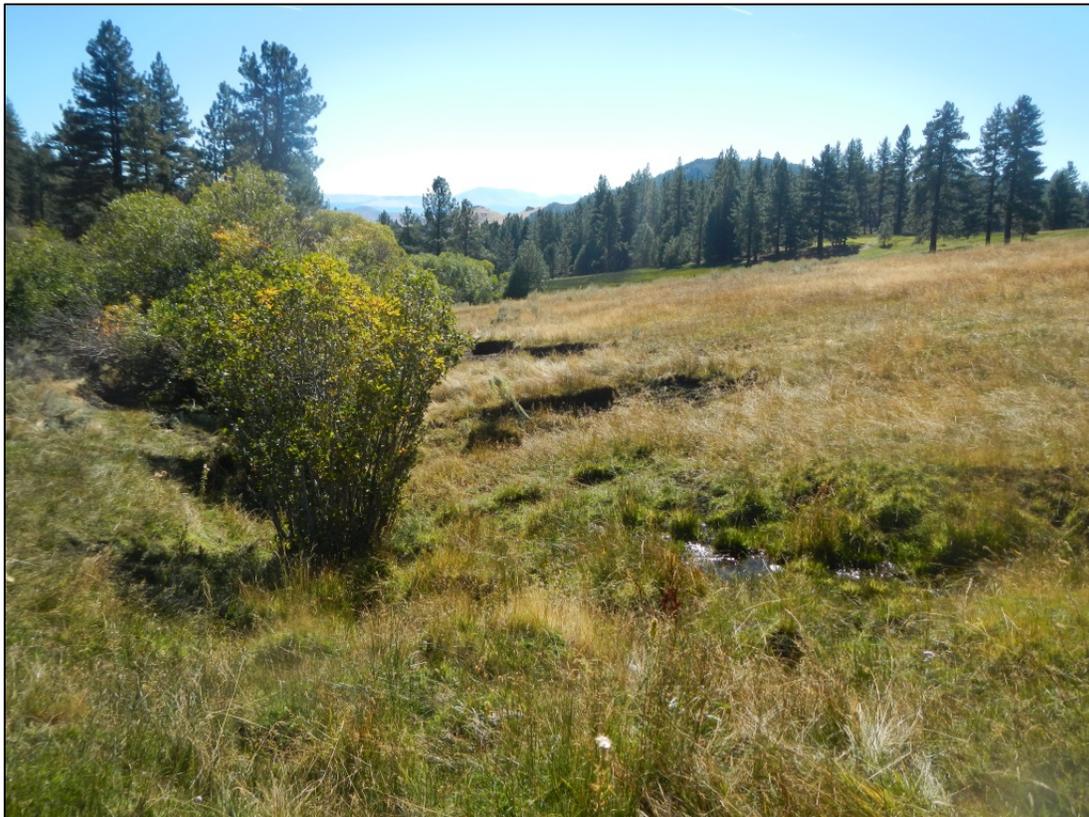
2013 Condition, photo taken July 23, 2013 (initial assessment – view south)

2017 Condition, photo taken September 26, 2017

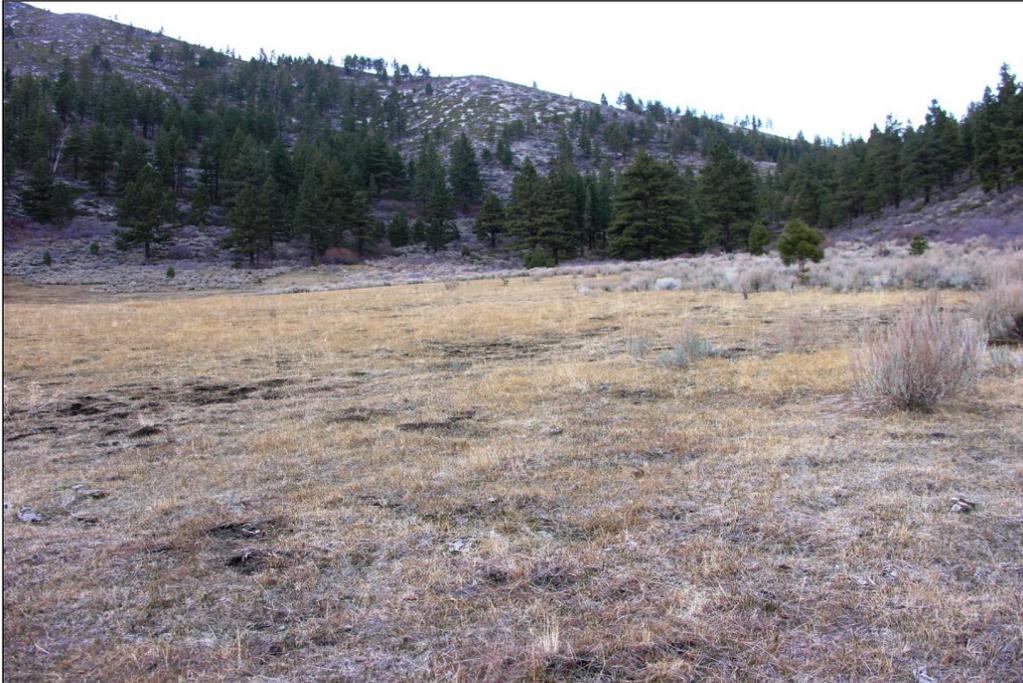
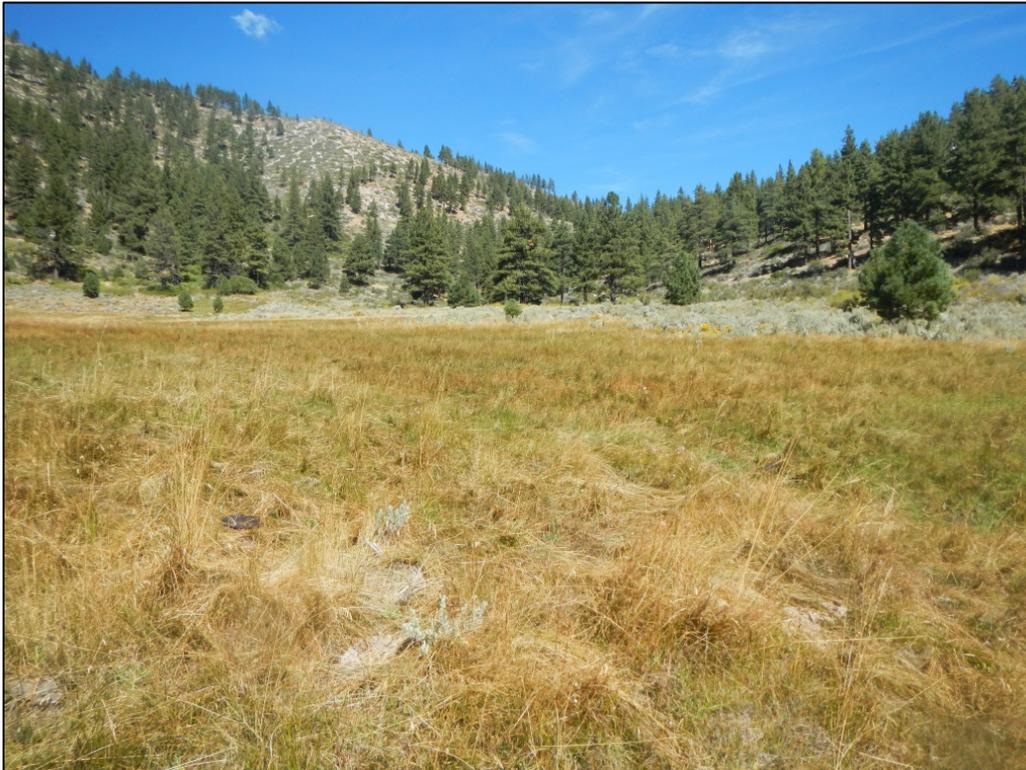
2009 Baseline Condition, photo taken February 4, 2009:
(GPS coordinate: N39° 08' 02.3" W119° 50' 11.8")

Photo Point 1A (view northeast): A photo point located at the edge of the shrub dominated granitic fan and the irrigated meadow. This would be used to monitor shrub invasion into the meadow area indicating irrigation problems.

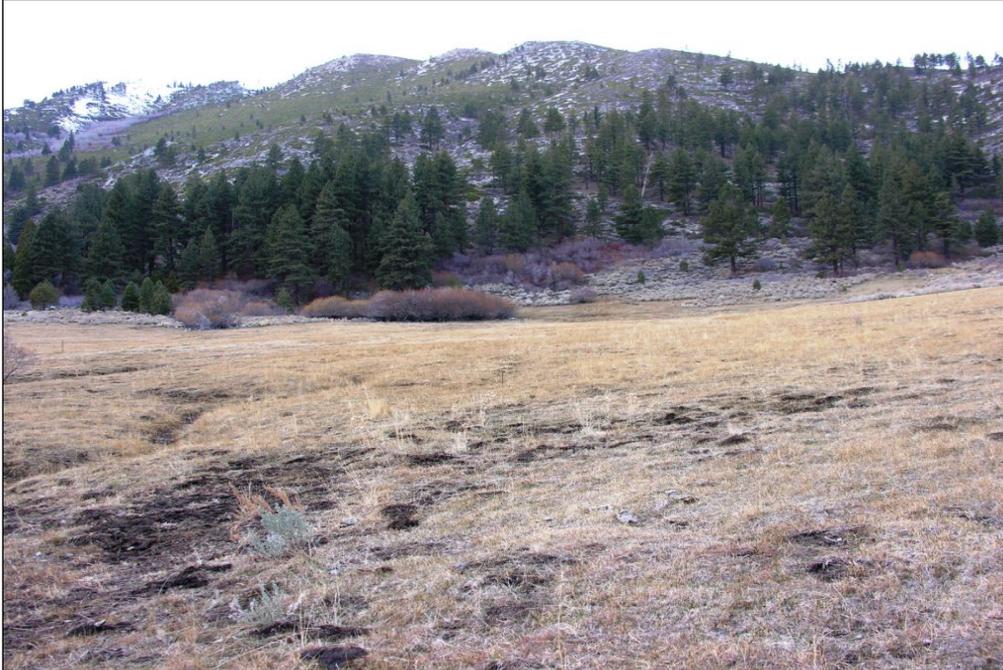
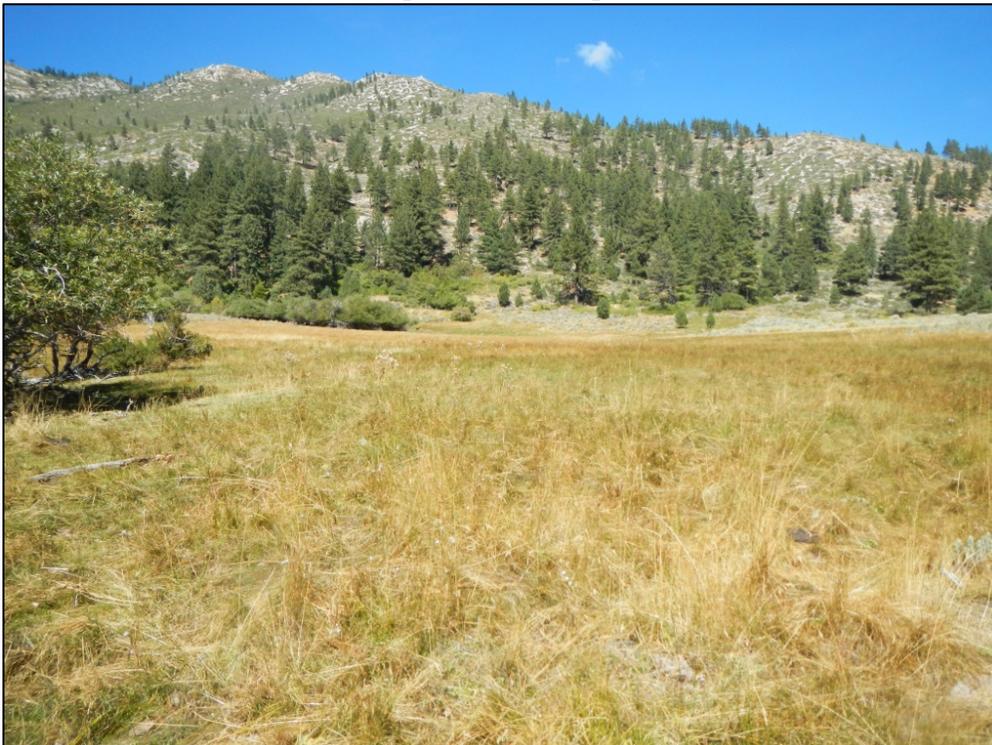
2009 Baseline Condition, photo taken February 4, 2009:
(Photo possibly taken from the upper meadow, near the new GPS coordinate for Photo Point 2 updated in 2010: N39 07' 54.9" W119 50' 11.3")

Photo Point 1B (view northwest): A photo point located at the edge of the shrub dominated granitic fan and the irrigated meadow. This would be used to monitor shrub invasion into the meadow area indicating irrigation problems.

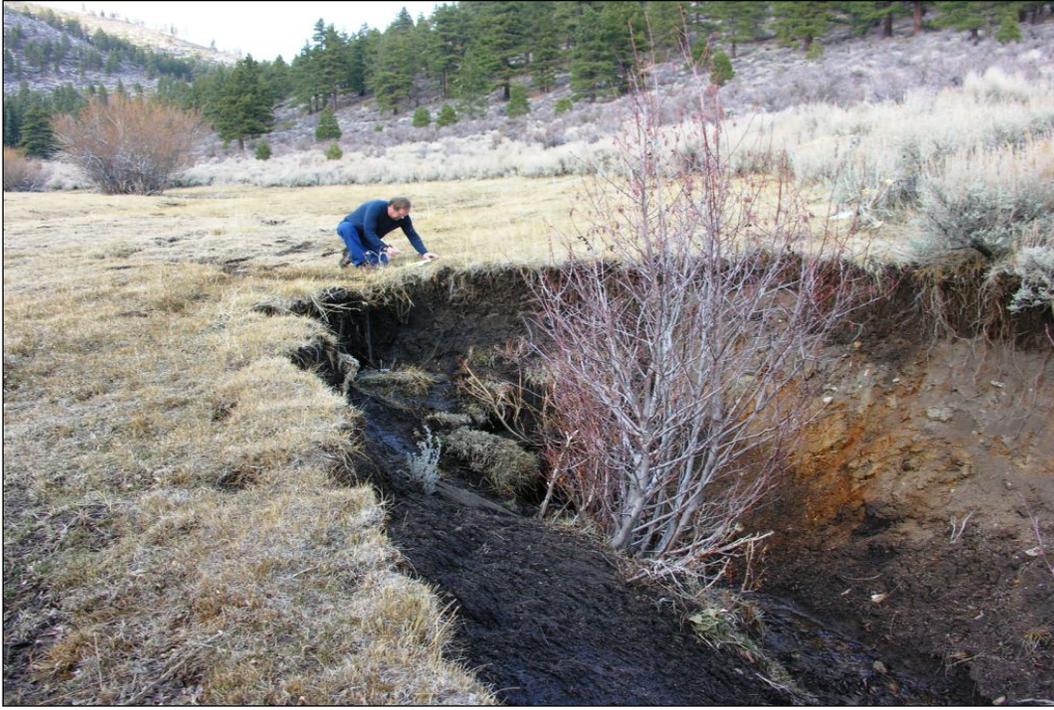
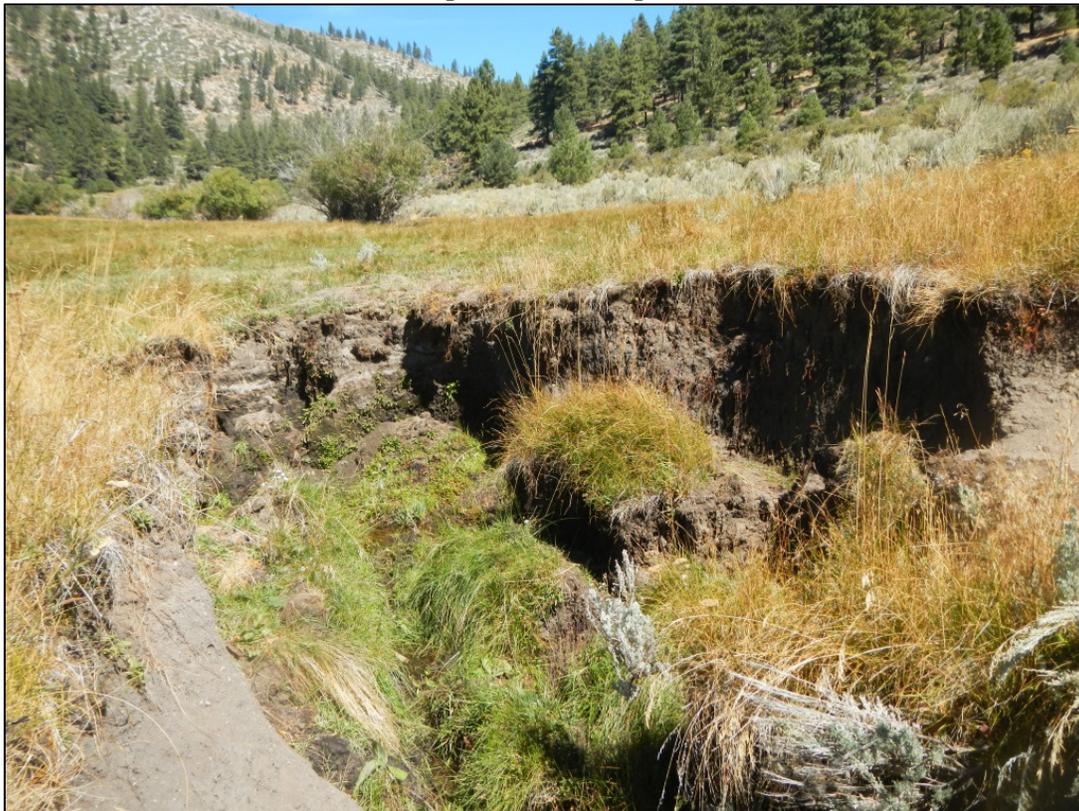
2009 Baseline Condition, photo taken February 4, 2009

Photo Point 4B (detail): A photo point located at the most northern active headcut after required stabilization to monitor effectiveness.

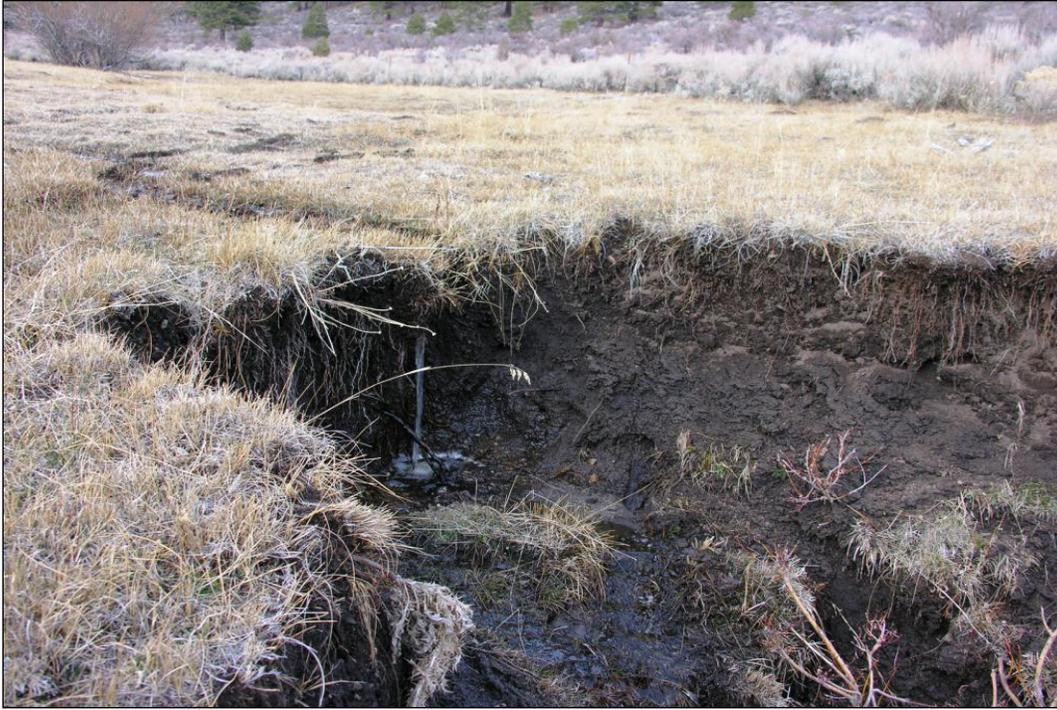
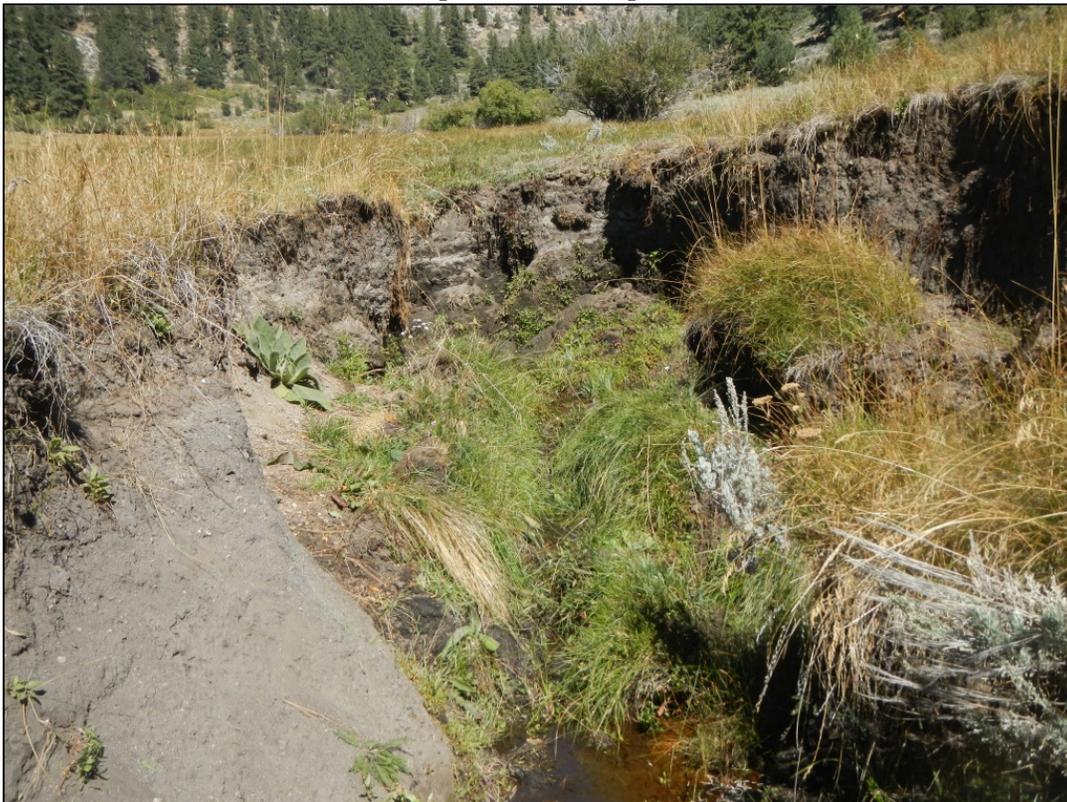
2009 Baseline Condition, photo taken February 4, 2009

Photo Point 4C (detail): A photo point located at the most northern active headcut after required stabilization to monitor effectiveness.

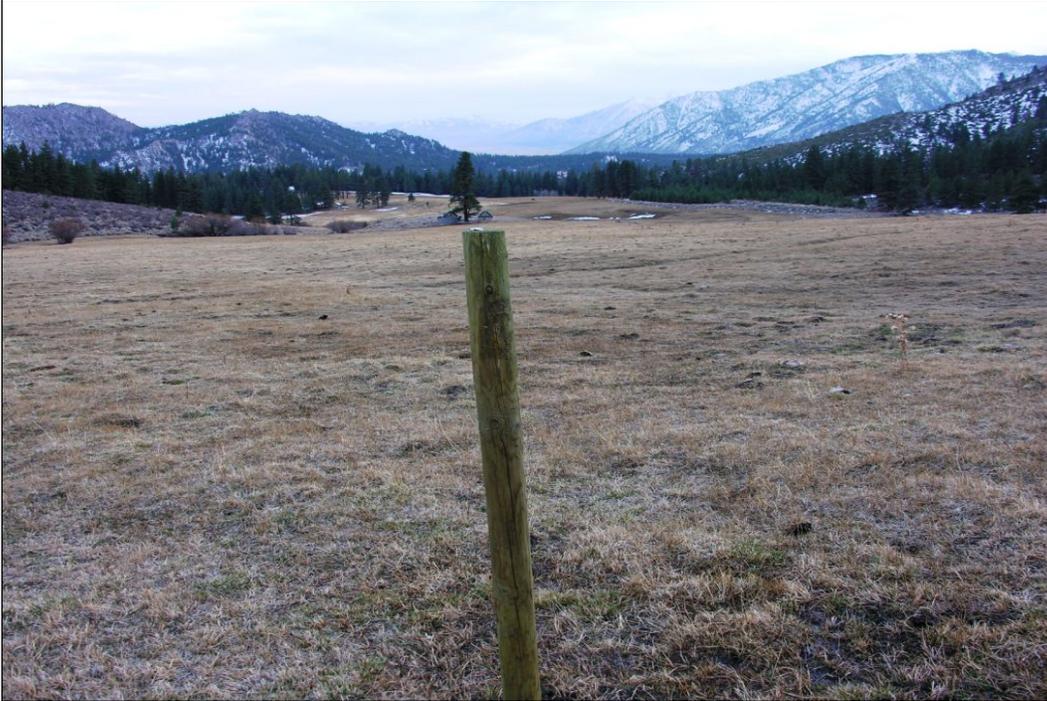
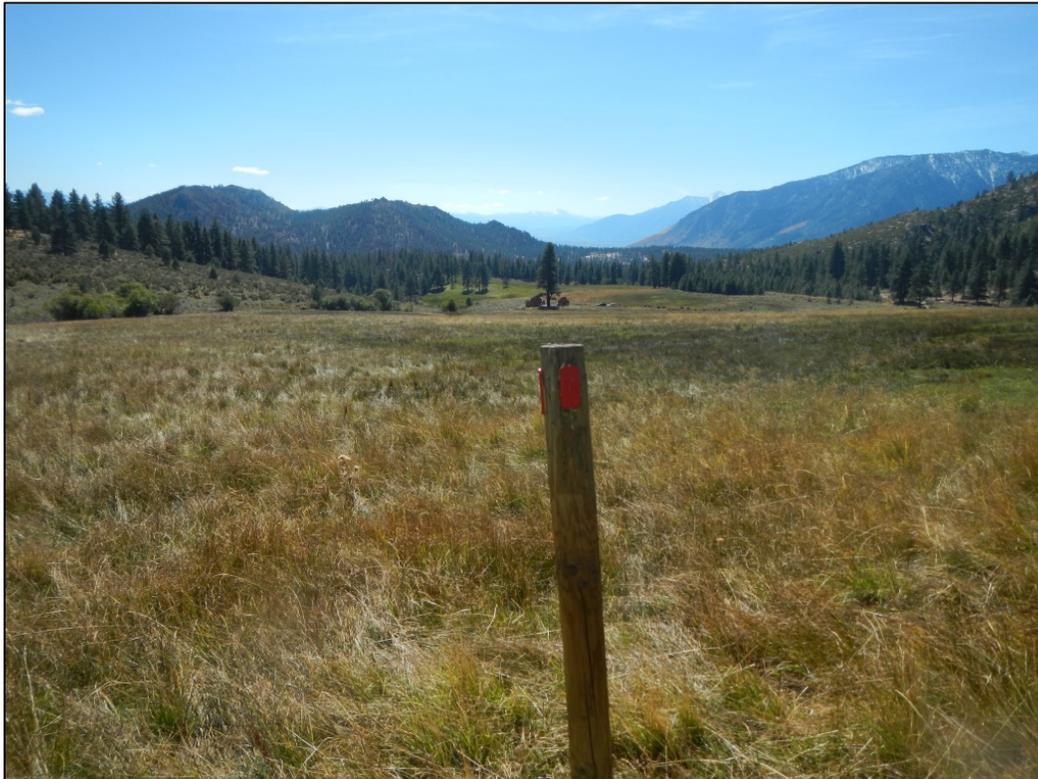
2009 Baseline Condition, photo taken February 4, 2009

- The Pasture Utilization and Condition Assessment was conducted by Ms. Bollinger and Ms. Boyer, Open Space Administrator and Senior Natural Resource Specialist, respectively. This Pasture Utilization and Condition Assessment included a visual observation of the monitoring plot as described in the Baseline Condition Report. A diversity of pasture, wetland-associated, and invasive grasses (cheatgrass) exhibited various utilization levels depending on species. Overall, grazing appeared negligible and an average stubble height of 2 – 4" was recorded.

Photo Point 9: A permanently marked 100' x 100' area to monitor pasture condition. This annual inventory will be used to monitor not only pasture condition but irrigation efficiency, vegetative response to drought and appropriate livestock utilization.
