**SUBJECT: HRC-2020-0027 For Possible Action: Discussion and possible action regarding the 2021 Historic Preservation Fund (HPF) grant.**

# RED RANCH COMPLEX PRESERVATION PLAN

## CONDITION ASSESSMENT

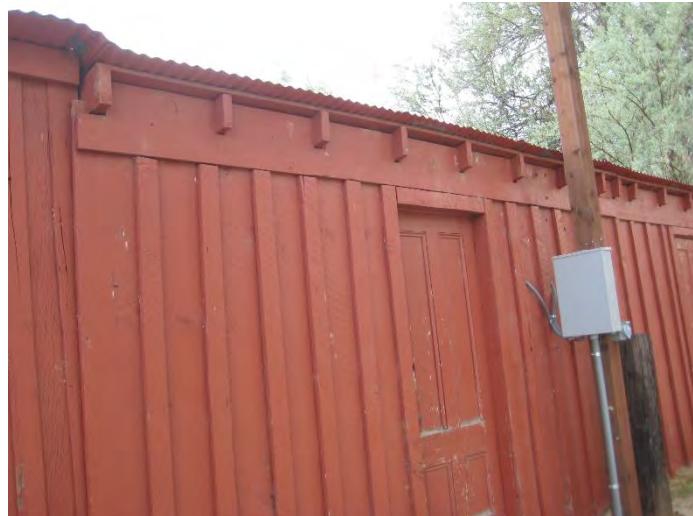
Board-and-batten siding and "barn red" color are architectural characteristics that define the complex

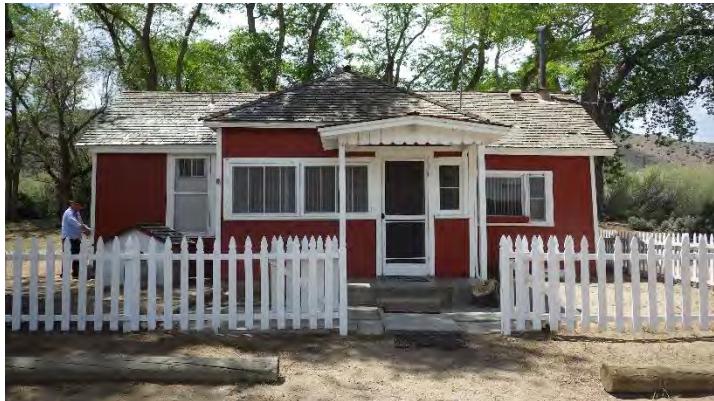
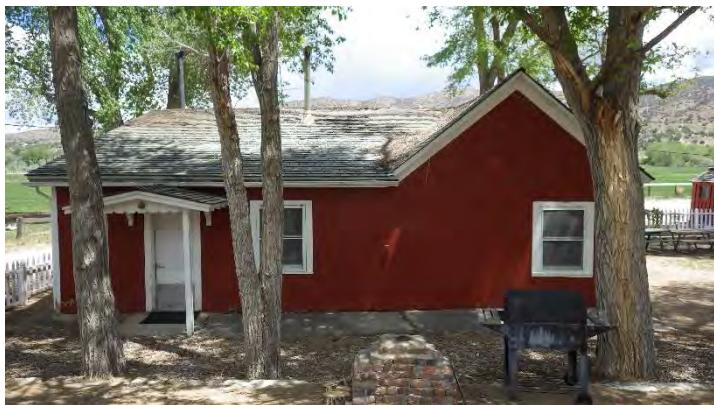
Name: Ranch House  
Building Number: 1  
Condition: Good

Top: Ranch House façade, east elevation; note hipped extension centered on façade

Bottom: Rear (west) elevation; intersection with primary gable mass gable at right; covered entrance with unusual trim visible

Inappropriate treatments and non-historic materials, added over the years, has made the Ranch House the most modified building in the complex. The overall condition of Ranch House observed and recorded during fieldwork was good. Concerns noted include bowing of north elevation wall, T1-11 siding deterioration, siding in contact with ground, rotted sill plates, ground squirrel holes, and foundation settlement. Small animal droppings were observed inside.

A baseline structural assessment of the building was suggested by the Carson City Building Inspector while discussing the condition of the North elevation wall in 2018. The baseline report will provide data to be used to monitor the overall structural condition of building. For the next episode of replacement fencing, suggest removing pickets and returning the fence to wood and wire to more accurately reflect what was standing prior to 1963.

Continue identification of spaces, features, or finishes that have been changed over time and no longer have historic significance. Less important spaces may provide areas for updating systems during rehabilitation work without having an adverse impact on the overall historic character of the building.

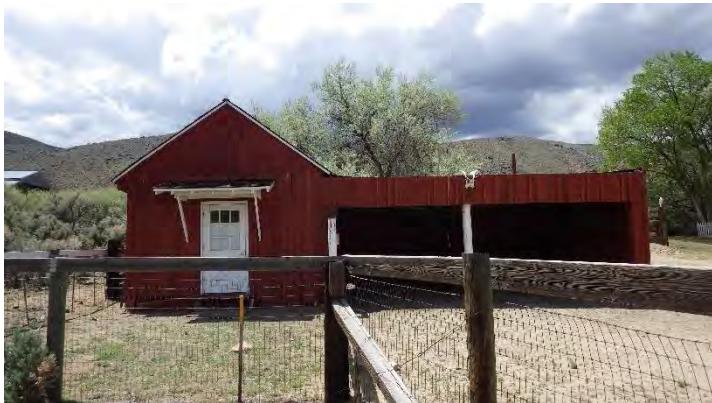
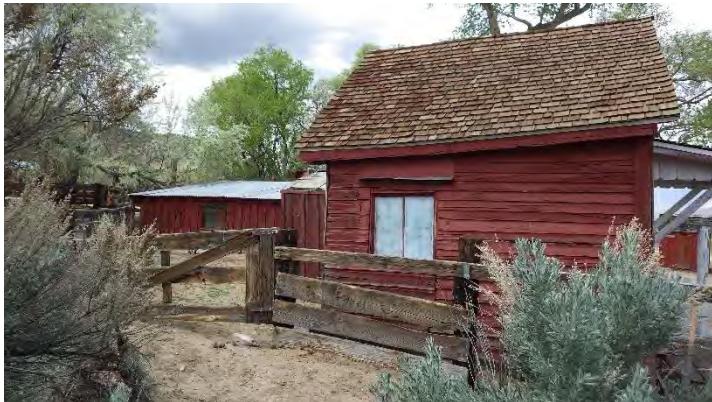
Top: **Foreman's House & Garage, view to the west**, east elevation; the front-facing gable mass was relocated circa 1946 during Herlax ownership from a site north of the Ranch House to this site

Bottom: **South wall of Foreman's House**; outhouse and shed visible at left

Jones & Stokes recommended entire building should be maintained with corrugated metal roofing, regardless of what cladding material was previously used; MSC suggest shingles if used historically.

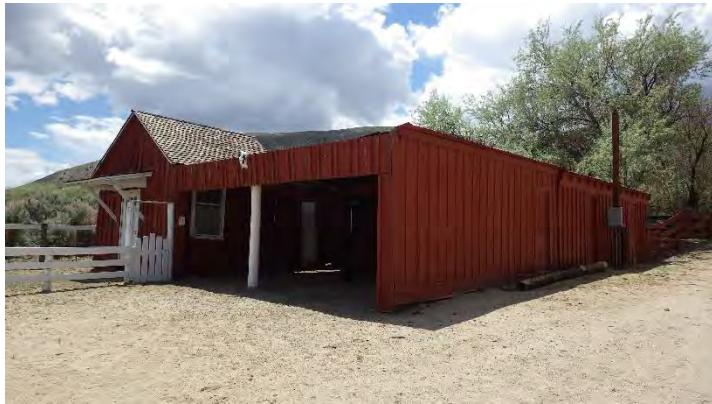
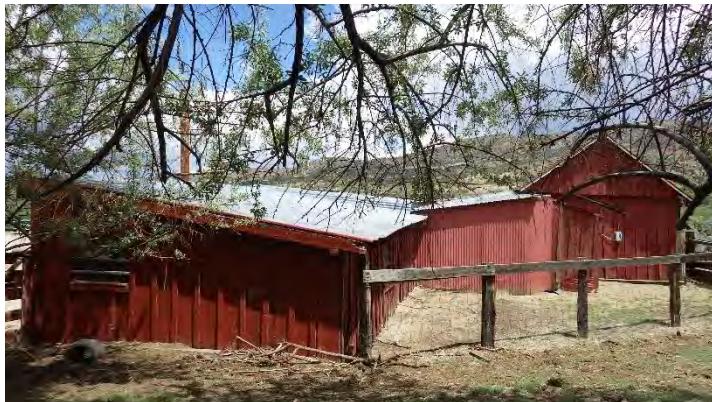
Top: **Foreman's House & Garage, view southwest**

Bottom: **Foreman's House & Garage, view to the east, rear of residence and outhouse visible and west wall of shed**

The building's smaller components are deteriorating from a somewhat haphazard construction and lack of use. While the need for major repairs is not evident from the exterior, the entire collection of vernacular forms that comprise Building #2 should be regularly maintained.

Building #2 is one of the oldest structures on the Red Ranch complex. It is recommended that repairs to this building be made with in-kind salvaged materials or with modern fabric (i.e. lumber, sheet metal) identical in appearance to the original fabrics. Because portions of this building have only an earthen foundation, wooden members and siding close to the ground should be carefully inspected and repaired or replaced in kind if rot or insect infestation is found.

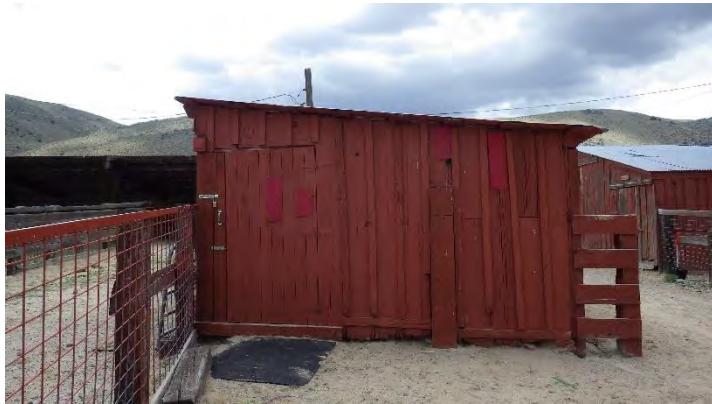
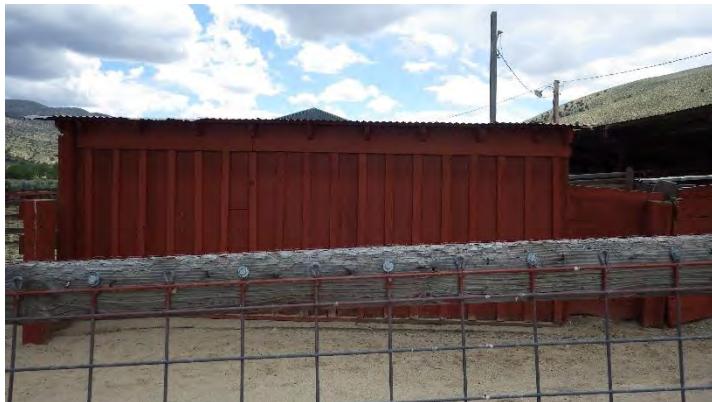
Name: Veterinary Shed  
Building Number: 5  
Condition: Fair

Top: Vet Shed, east elevation wall, view to the west

Bottom: Rear (south) elevation; view from livestock corral

The Vet Shed is in fair condition and requires routine maintenance. Any future repair or replacement of materials will be accomplished with in-kind materials in order to maintain the essential appearance of the building. Drainage to be addressed at the north elevation.

Jones & Stokes recommended that the interior of the Vet Shed be left intact to reflect the alterations made in the 1950s for the Merchants to accommodate their specific ranch operations.

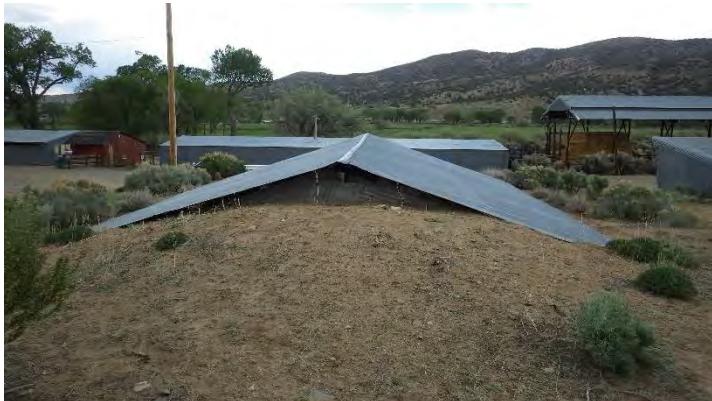
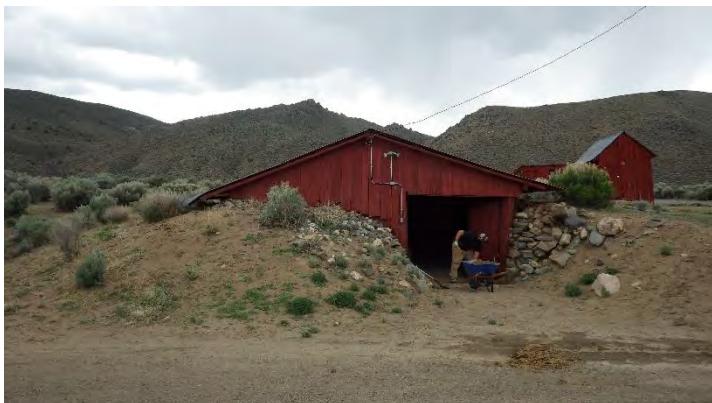
Top: Root Cellar, view to the east over the roofline; note subterranean construction and proximity of material to dirt

Bottom: Facade (east) elevation with rocks walls flanking entry door

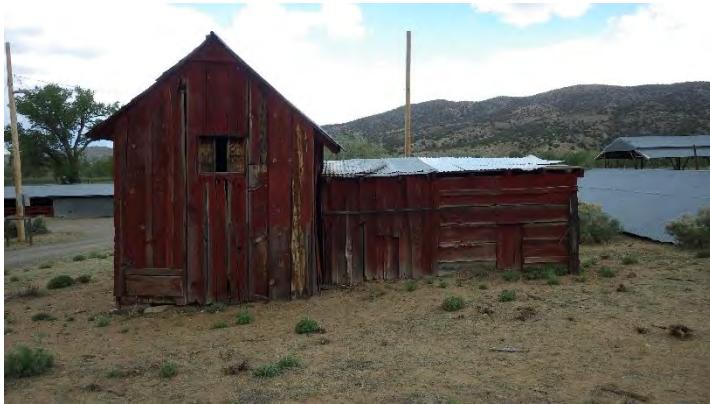
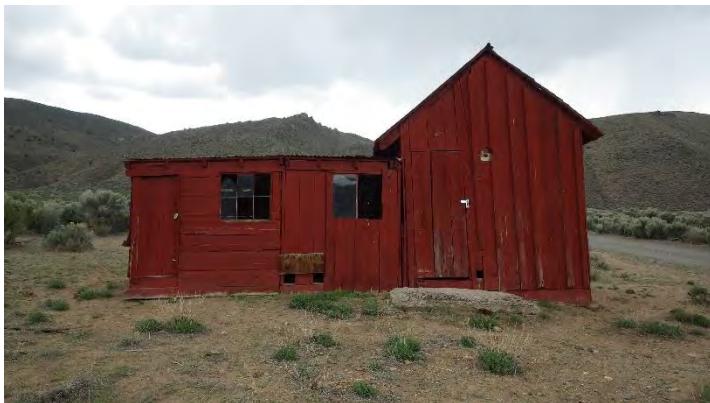
Top: Side of Chicken Coop, view to the east

Bottom: Façade (east) elevation

The chicken house is currently in poor condition. It is possible that internal stabilization of the wood frame will be necessary before further repairs can be made to the exterior. Necessary repairs include replacing the random and deteriorated siding with new board-and-batten and replacing the roof cladding with corrugated metal sheeting. Suggest determining original location and/or moving building closer to the Ranch House where it may have sat historically during Herlax occupancy for interpretive purpose.

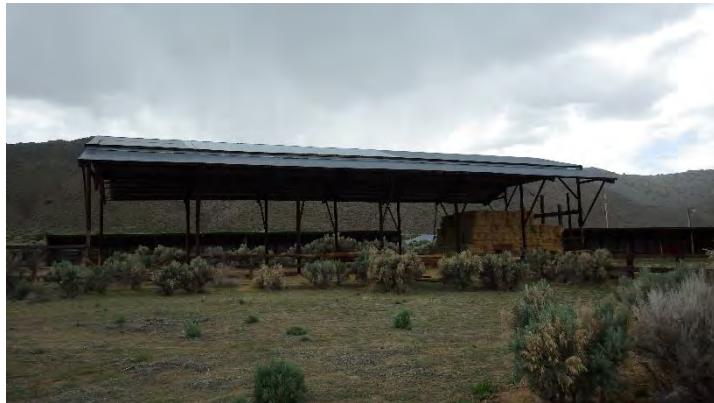
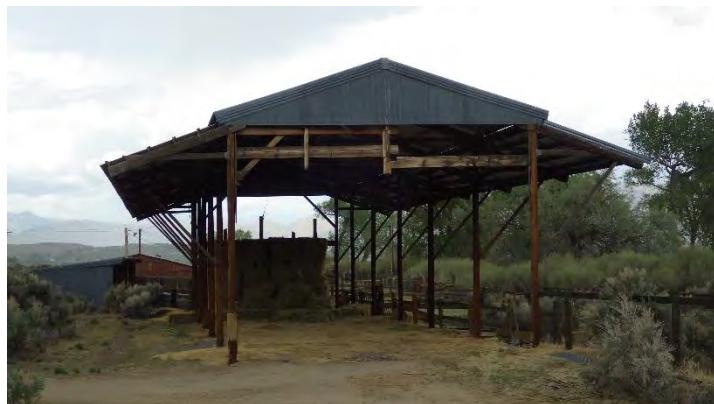
Top: Hay Shed, east elevation, view to the West

Bottom: South elevation of pole barn

In their 2005 report, Jones & Stokes recommended removal of this structure to improve the historic setting of the Red Ranch complex and the overall quality of the historic landscape at SSR:

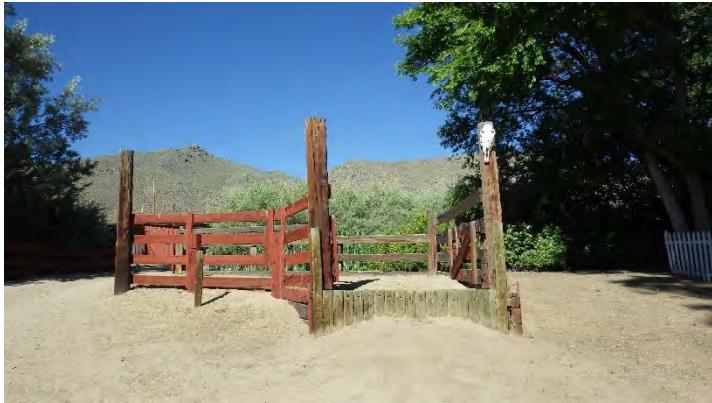
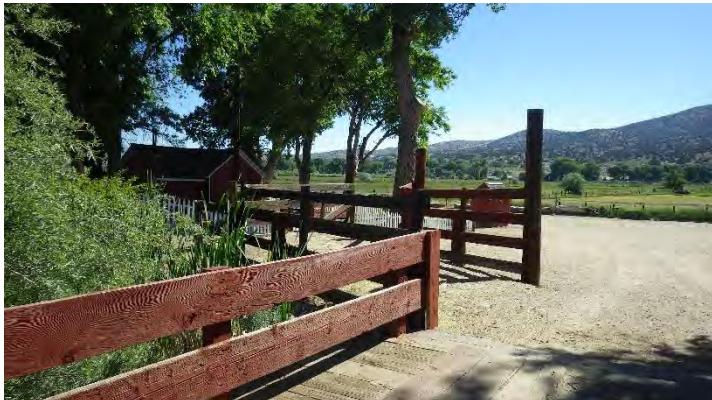
Top: Livestock Chute #14, view west

Bottom: Opening to Chute #14 near Bridge over Mexican Ditch

The oldest of the three loading/squeeze chutes, Chute #14 is located on the east side of the Mexican Ditch, across the bridge from the majority of livestock facilities and adjacent to the current entrance to the ranch house yard. This structure appears to have been used in conjunction with the adjacent bridge over the Mexican Ditch or possibly with a fence across the back yard of the ranch house that no longer exists. In either case, the loading chute was designed to use the ditch itself as an aid in funneling livestock toward it and into it. This chute may have been built by the Herlax's for loading sheep during the 1940s and abandoned during the cattle years at SSR. Chute #14 is in poor-to-fair condition due to lack of use. Though it is not likely that this chute will ever be operational again, it is considered an element of the historic landscape and should be preserved in place.

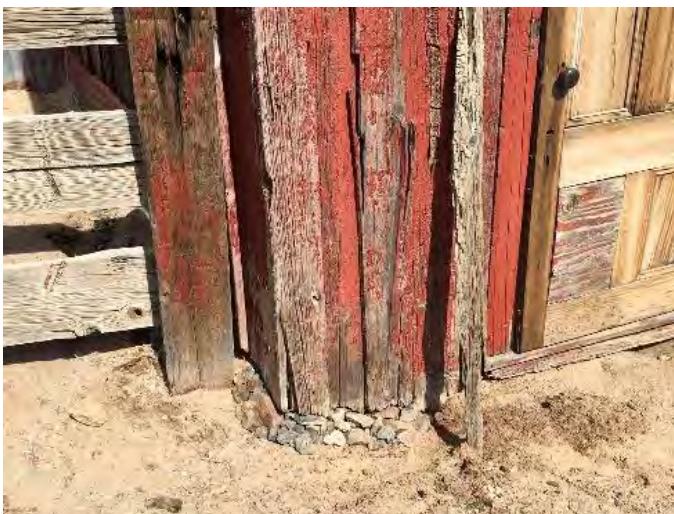
Scott pulling dirt away from wood and stacking rocks to protect and channel water away from corner of Milk Barn; problem area to be monitored.

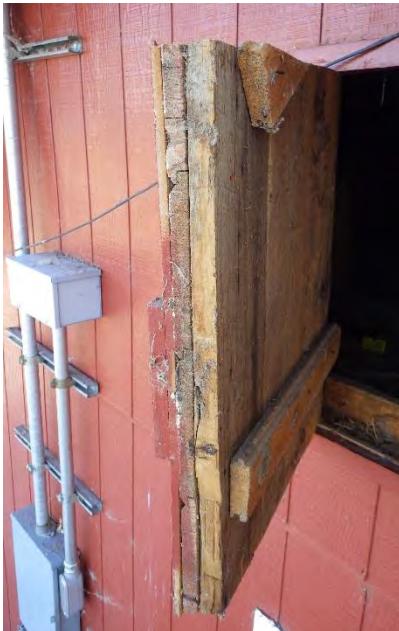
Top: Problem drainage at entry to ranch, metal in contact with earth

Rt: Entry hatch to oldest mass on the Ranch House; note wood siding under T1-11, appears to run horizontal and be V-grooved; removal of replacement siding would verify historic plus existence of asbestos siding per Gary Bowyer communication

- Investigate siding on residence – decide next steps for repair or replace; test for asbestos and make plan for abatement if needed
- Plan/budget for roof repair on residence – including replacing missing shingles on the Red House; consider a composition material that best reads like wood shingles that is also compliant with Carson City Fire Department requirements

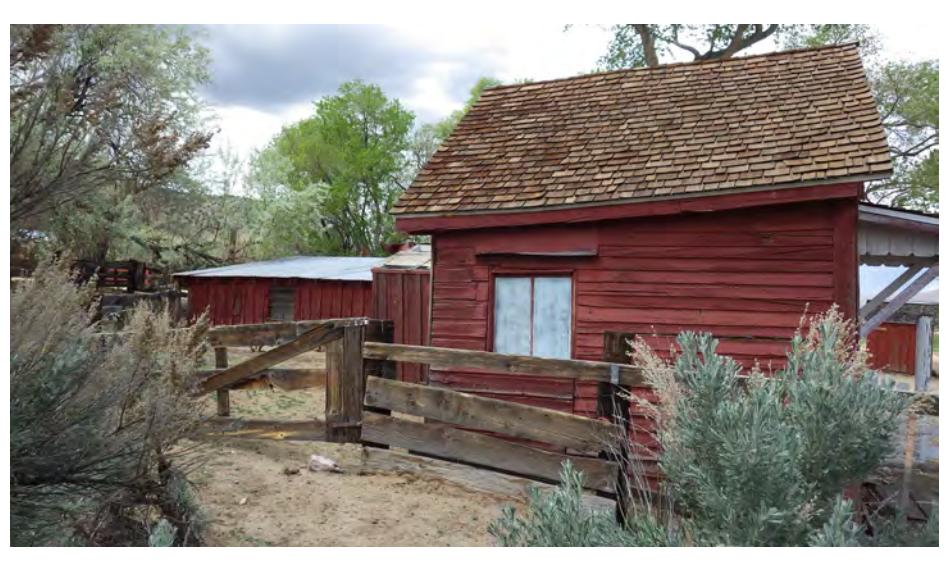
Caption: Feature 2, Foreman's house (south elevation)

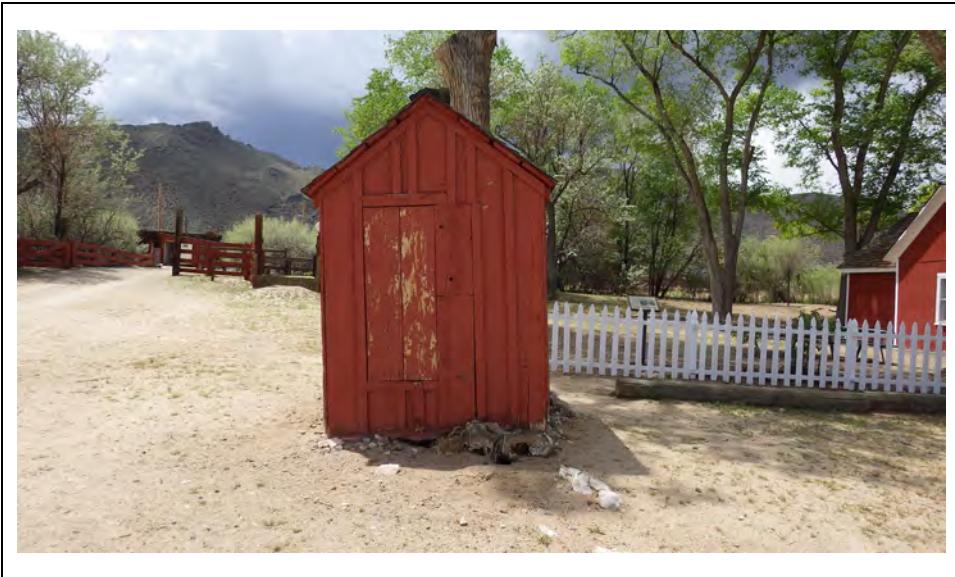
Caption: Feature 3, Tool Shed, east elevation

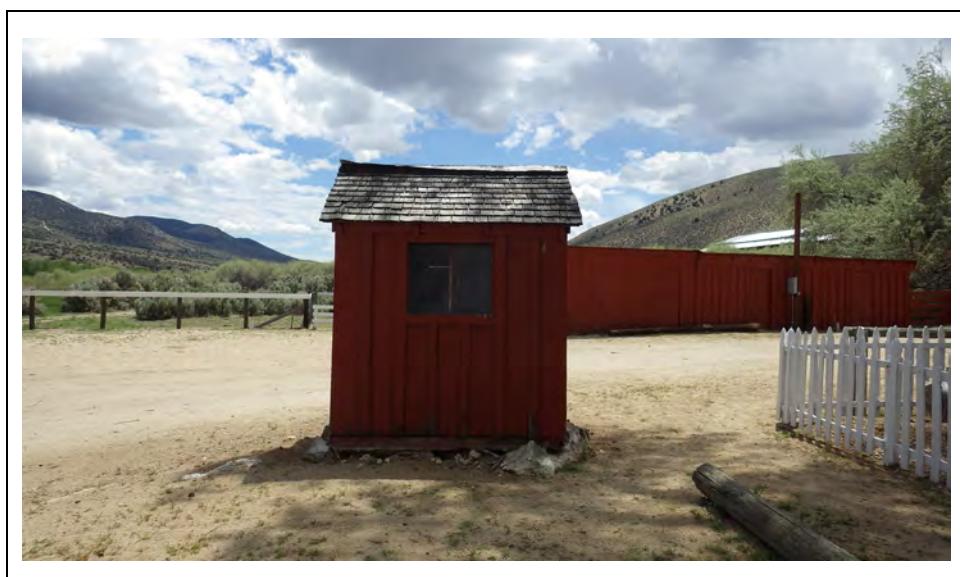
Caption: Feature 3, Tool Shed, north elevation

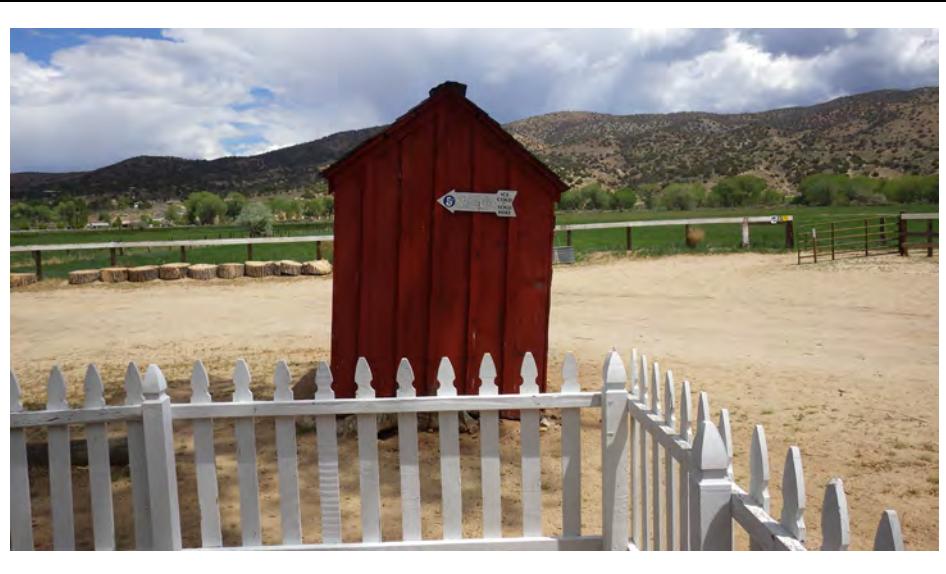
Caption: Feature 3, Tool Shed, West elevation

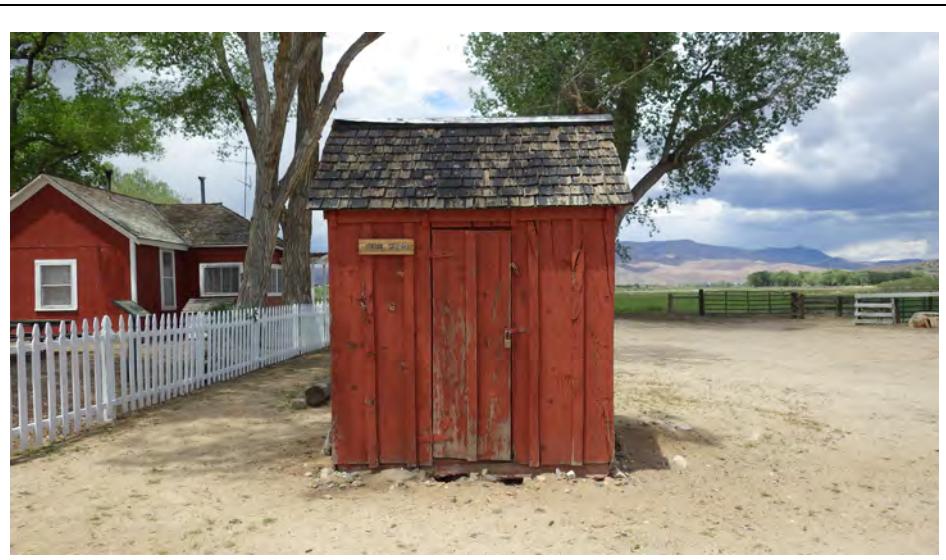
Caption: Feature 3, Tool Shed, South

Yes	No	Problem	Comment
		Walls plumb and structurally sound?	
		Door and window frames square?	
		Signs of dry-rot or water damage?	
		Signs of termite infestation?	
		Missing, loose or damaged siding?	Vertical boards are deteriorated where in contact with earth on S. side
Y		Paint peeling, blistering, powdered or chalky?	South elevation needs painting
		Other:
