Neighborhood Improvement District (NID) Board Minutes

BOB BOLDRICK THEATER

ADA ASSESSMENT

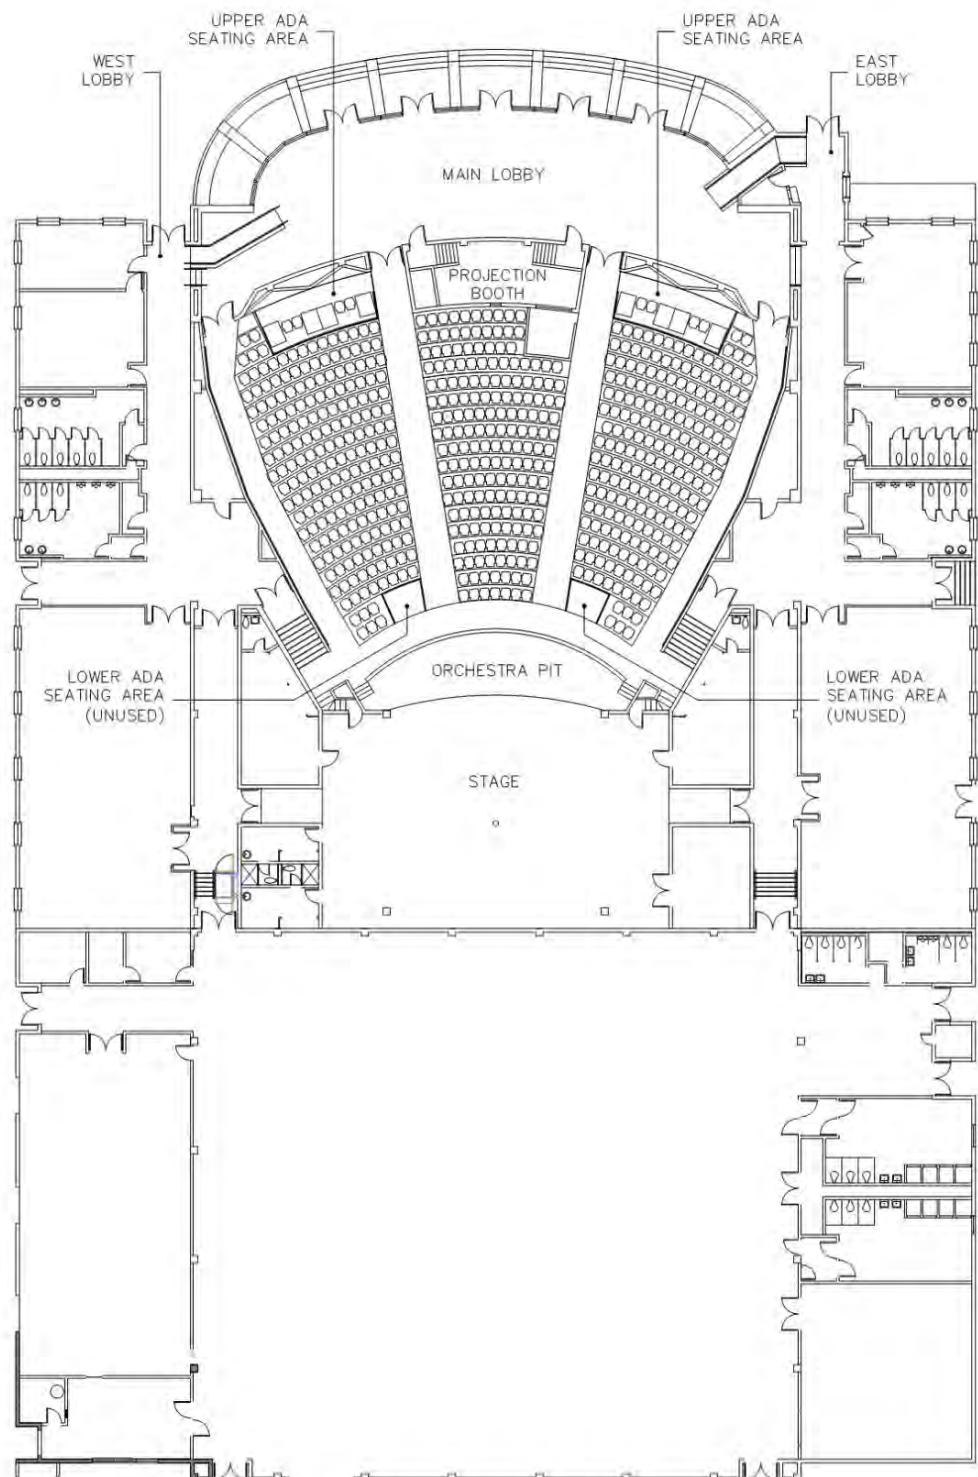
Figure 2 Overall existing floor plan

An addition to the east lobby was added at some point in the past to provide a ticket office and a new interior ramp leading from the east lobby up to the main lobby level as shown in the photo below (see also Figure 2).

Prior to the 2018-2019 renovation, there were four wheelchair space locations – one each at the east and west sides of the theater at the back wall (upper ADA seating area) and one each at the east and west sides near the stage (lower ADA seating area) – refer to Figure 2. However, without an accessible means of egress, the lower ADA seating areas are not compliant and aren't currently used for wheelchair seating.

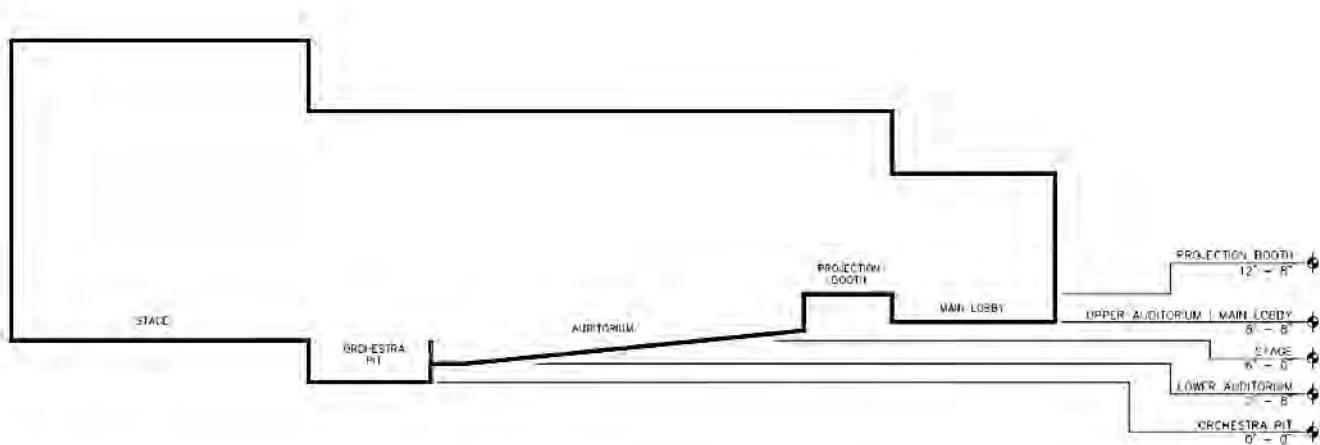
Figure 3 Theater longitudinal section

The theater floor slopes from the edge of the back wall by the main lobby down toward the stage, dropping six feet until it levels out about five feet in front of the orchestra pit as shown in Figure 3. Per ANSI A117.1, the maximum allowable slope is 8.3% and the maximum ramp rise for any leg of a ramp is 30 inches; unfortunately, the theater floor slopes in excess of 9% and lacks intermediate landings and a level landing at the top by the exit doors.
