# TRAFFIC IMPACT STUDY

# The Vintage at Kings Canyon

August 16, 2016

TRAFFIC WORKS, LLC  
5482 Longley Lane, Suite B, Reno, NV 89511  
775.322.4300  
[www.Traffic-Works.com](http://www.Traffic-Works.com)

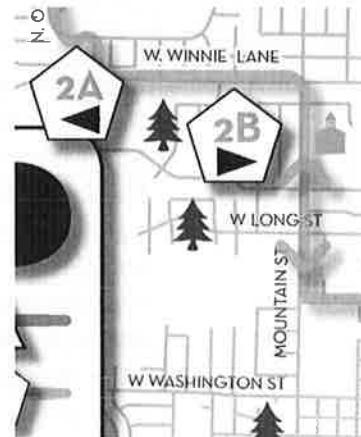
**Exhibit 1. Transit Routes**

Carson City operates public transit service on Mountain Street (Route 2A and Route 2B), adjacent to the project site, as shown in **Exhibit 1**.

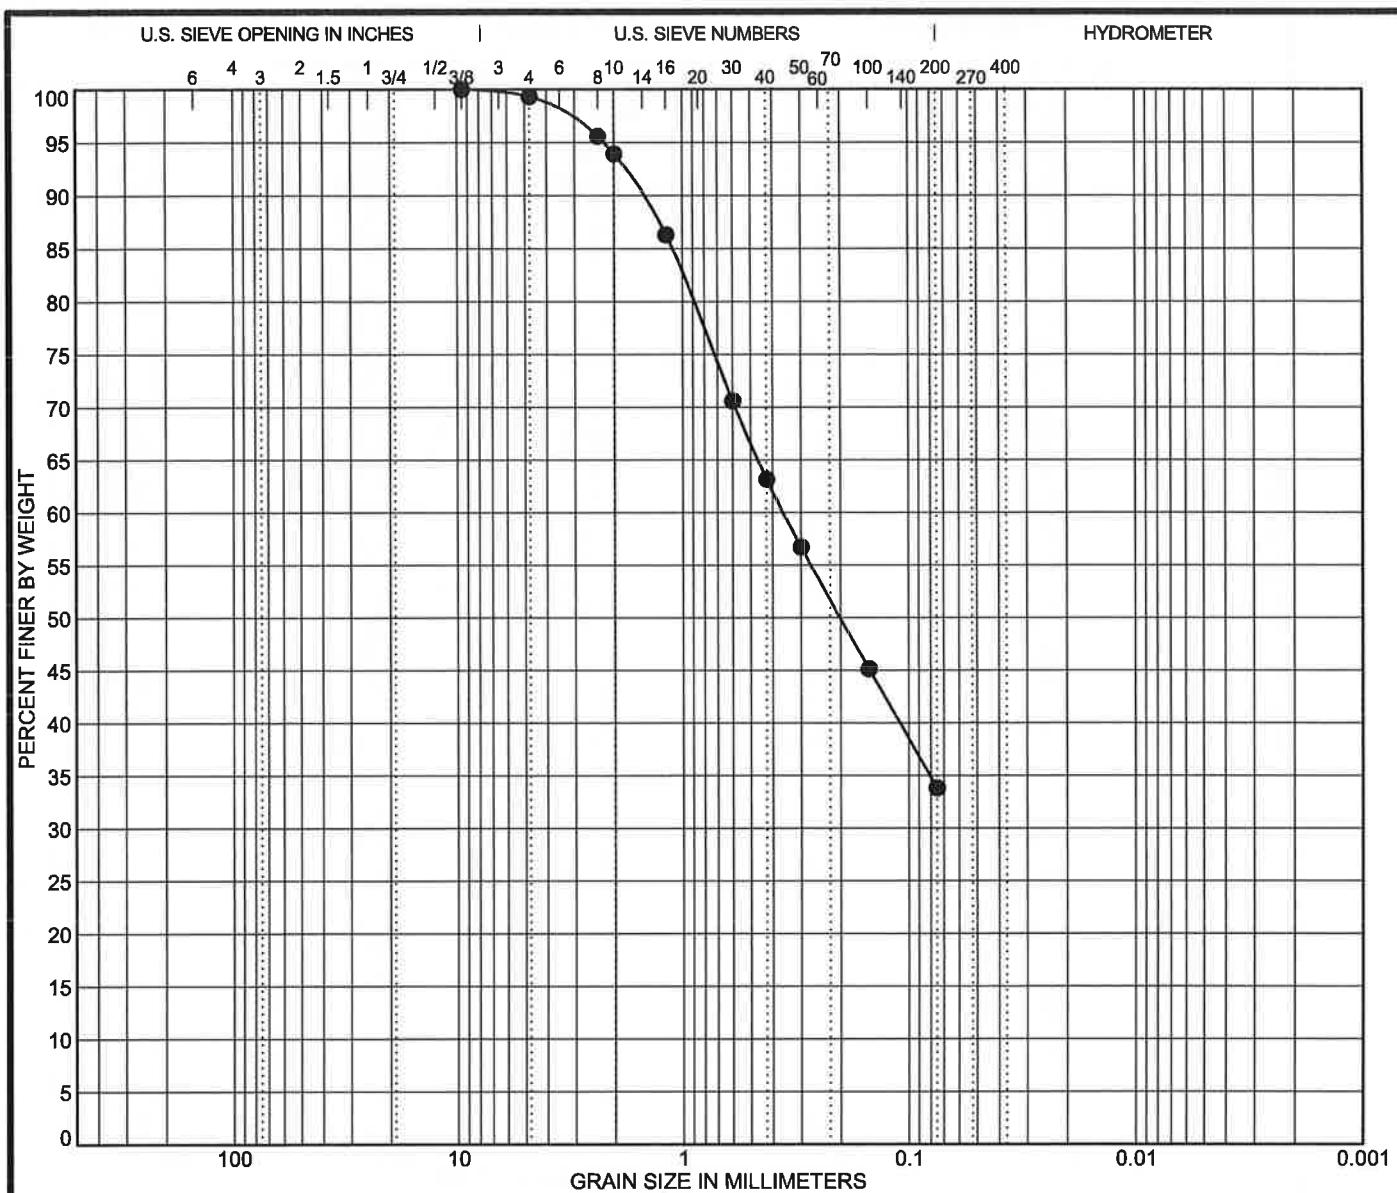
The Vintage at King's Canyon  
**GRAIN SIZE DISTRIBUTION**  
Job Number: 8947.000 Date: May 2016  
**PLATE**  
**B-1.8**

Specimen Identification		Date: 5-2-2016						
●	<b>B-05</b>			Classification		LL	PL	PI
	Depth: 3			Clayey SAND (SC)		32	21	11
	Sample Location			Boring 5 from 3' - 3.5'				
	USCS			SC				
	AASHTO							
Specimen Identification								
●	<b>B-05</b>	D100	D60	D30	D10	%Gravel	%Sand	%Silt
	Depth: 3	9.5	0.358			0.7	65.5	33.8
	Natural Moisture	11.1 %		S.E.		Absorption %		
	R-Value			Durability Index		Soundness		
	Percentage of Wear (500 rev)	%		Specific Gravity		Direct Shear

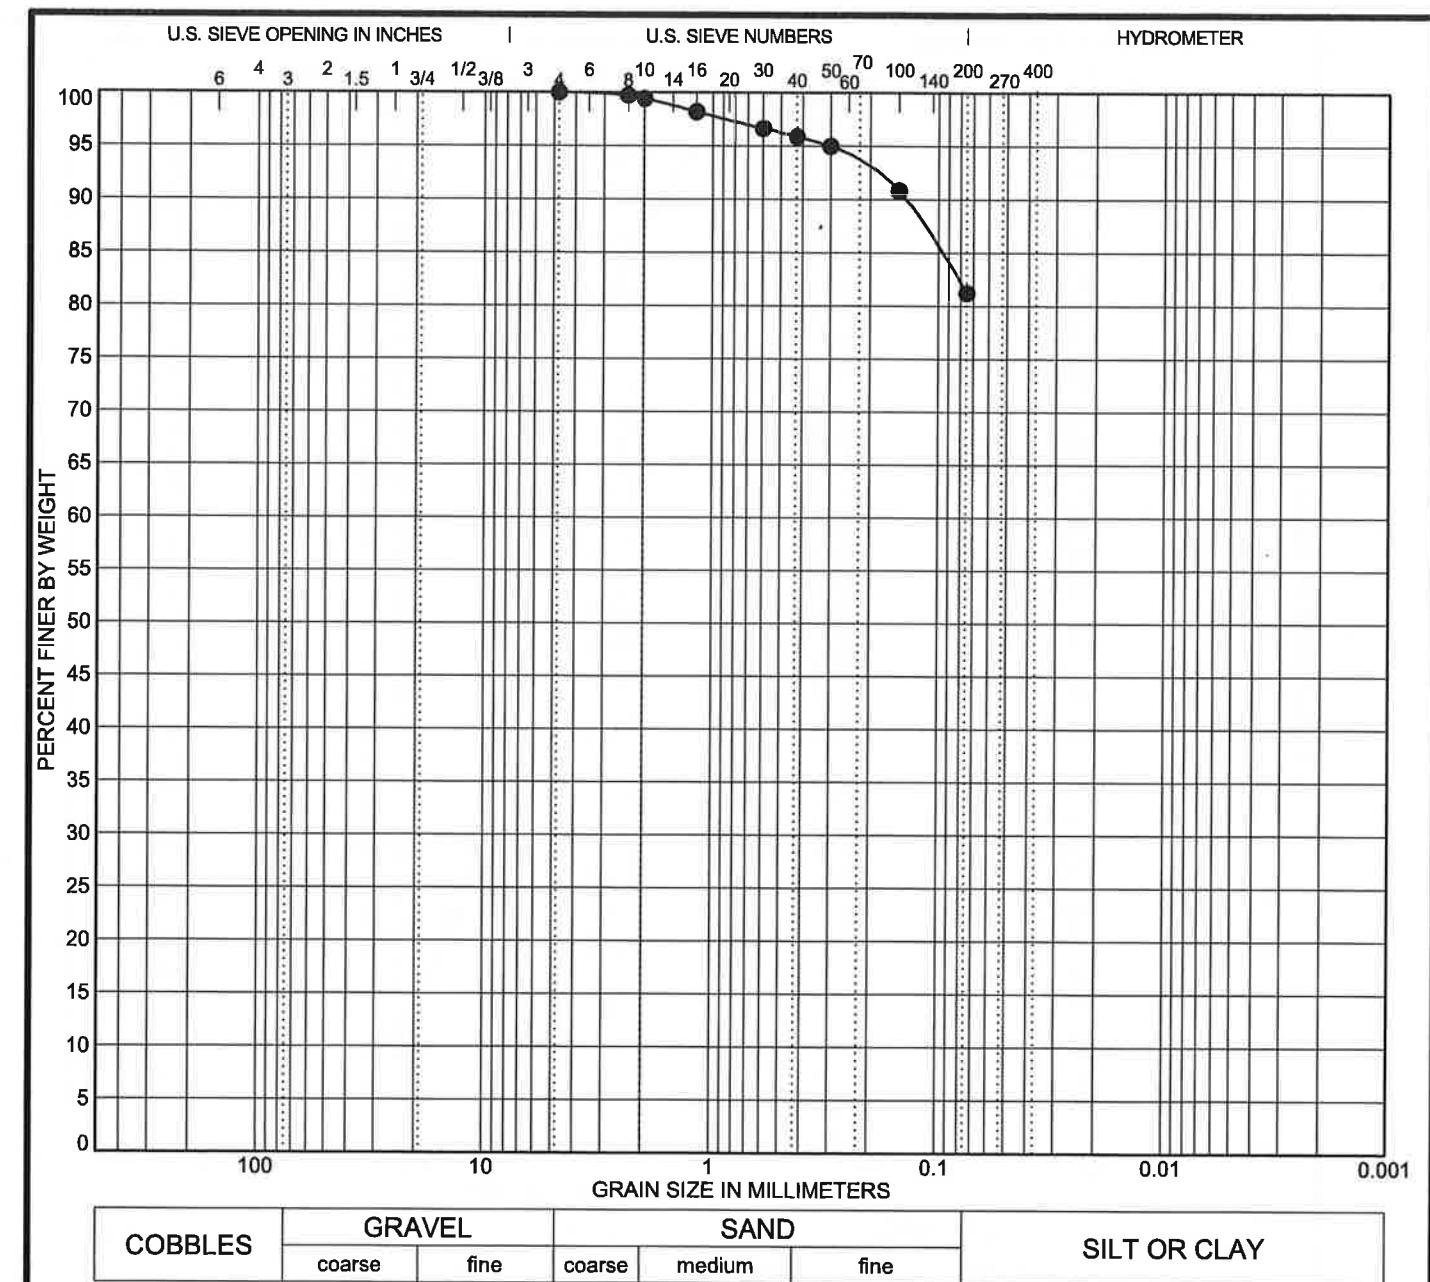
**PLATE**  
**B-1.9**

Specimen Identification		Date: 5-2-2016							
●	<b>B-06</b>	Classification				LL	PL	PI	Cc Cu
	Depth: 20	Lean CLAY with Sand (CL)				37	21	16	
	Sample Location	Boring 6 from 20' - 21'							
	USCS	CL							
	AASHTO								
Specimen Identification									
●	<b>B-06</b>	D100	D60	D30	D10	%Gravel	%Sand	%Silt	%Clay
	Depth: 20	4.75				0.0	18.8		81.2
	Natural Moisture	32.2 %		S.E.		Absorption %			
	R-Value			Durability Index		Soundness			
	Percentage of Wear (500 rev)	%		Specific Gravity		Direct Shear

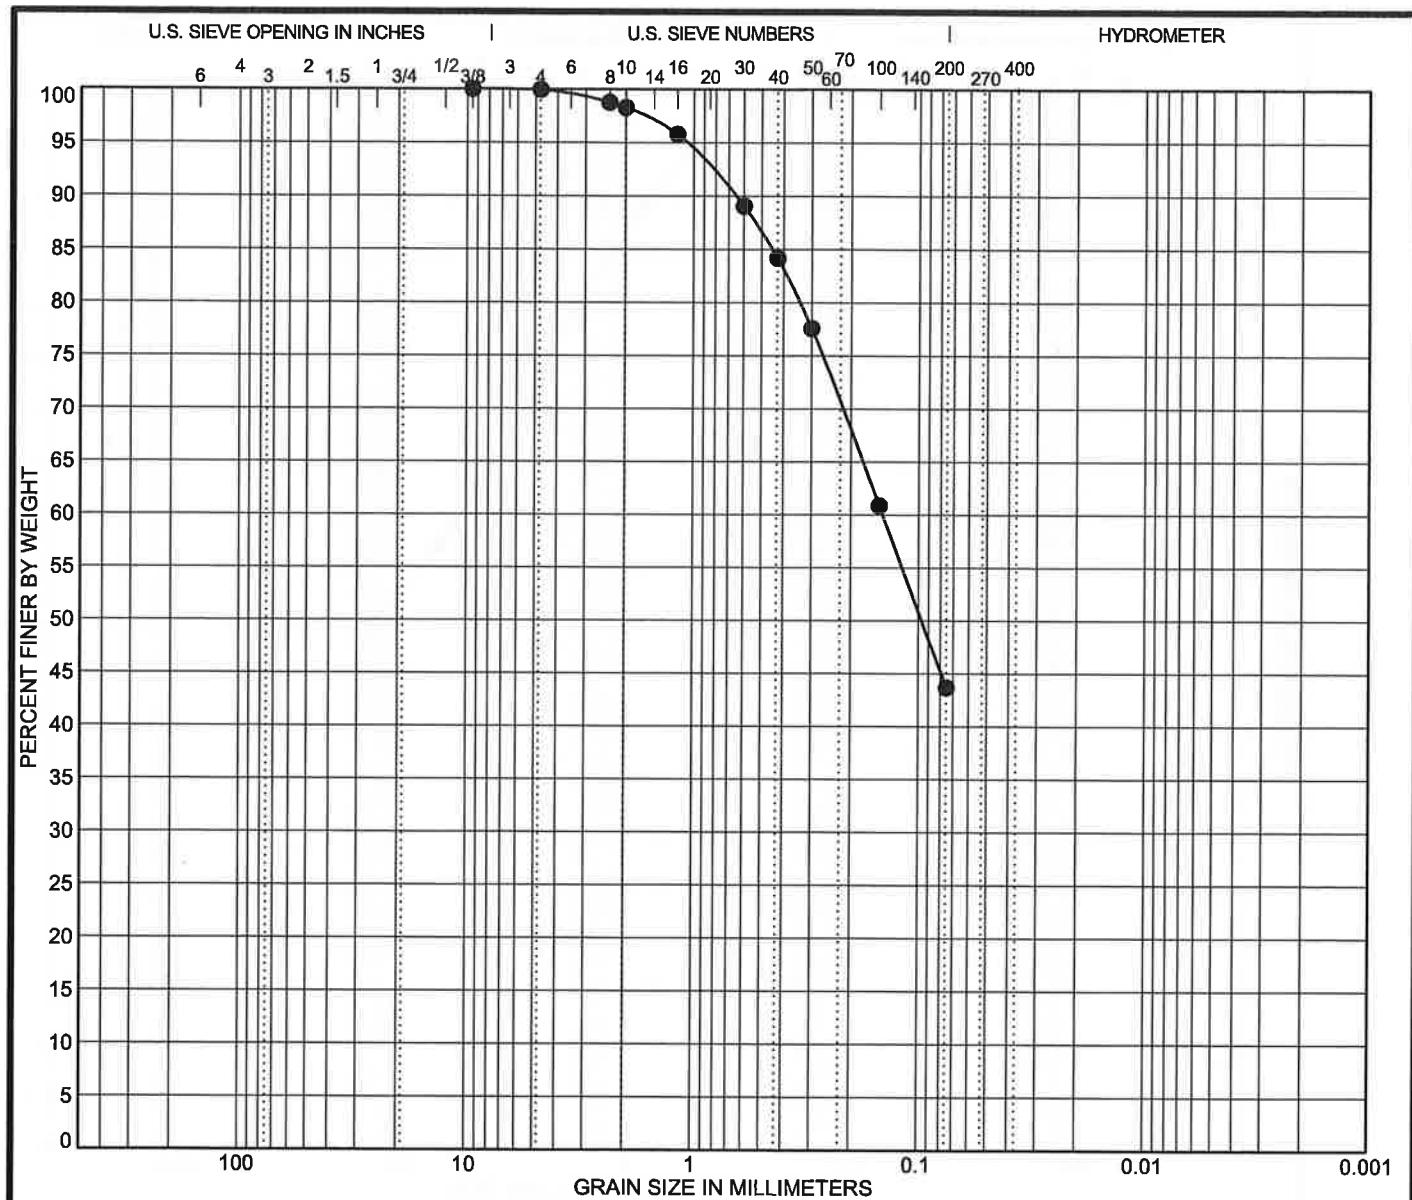
The Vintage at King's Canyon  
**GRAIN SIZE DISTRIBUTION**  
Job Number: 8947.000 Date: May 2016  
**PLATE B-1.13**  
165

Specimen Identification		Date: 5-2-2016										
●	<b>B-10</b>	Classification					LL	PL	PI	Cc	Cu	
	Depth: 8.5	Clayey SAND (SC)					26	16	10			
Sample Location		Boring 10 from 8.5' - 9'										
USCS		SC										
AASHTO												
Specimen Identification												
●	<b>B-10</b>	D100	D60	D30	D10	%Gravel	%Sand	%Silt	%Clay			
	Depth: 8.5	9.5	0.145			0.1	56.3		43.7			
Natural Moisture		7.9 %		S.E.		Absorption %						
R-Value				Durability Index		Soundness						
Percentage of Wear (500 rev)		%		Specific Gravity		Direct Shear

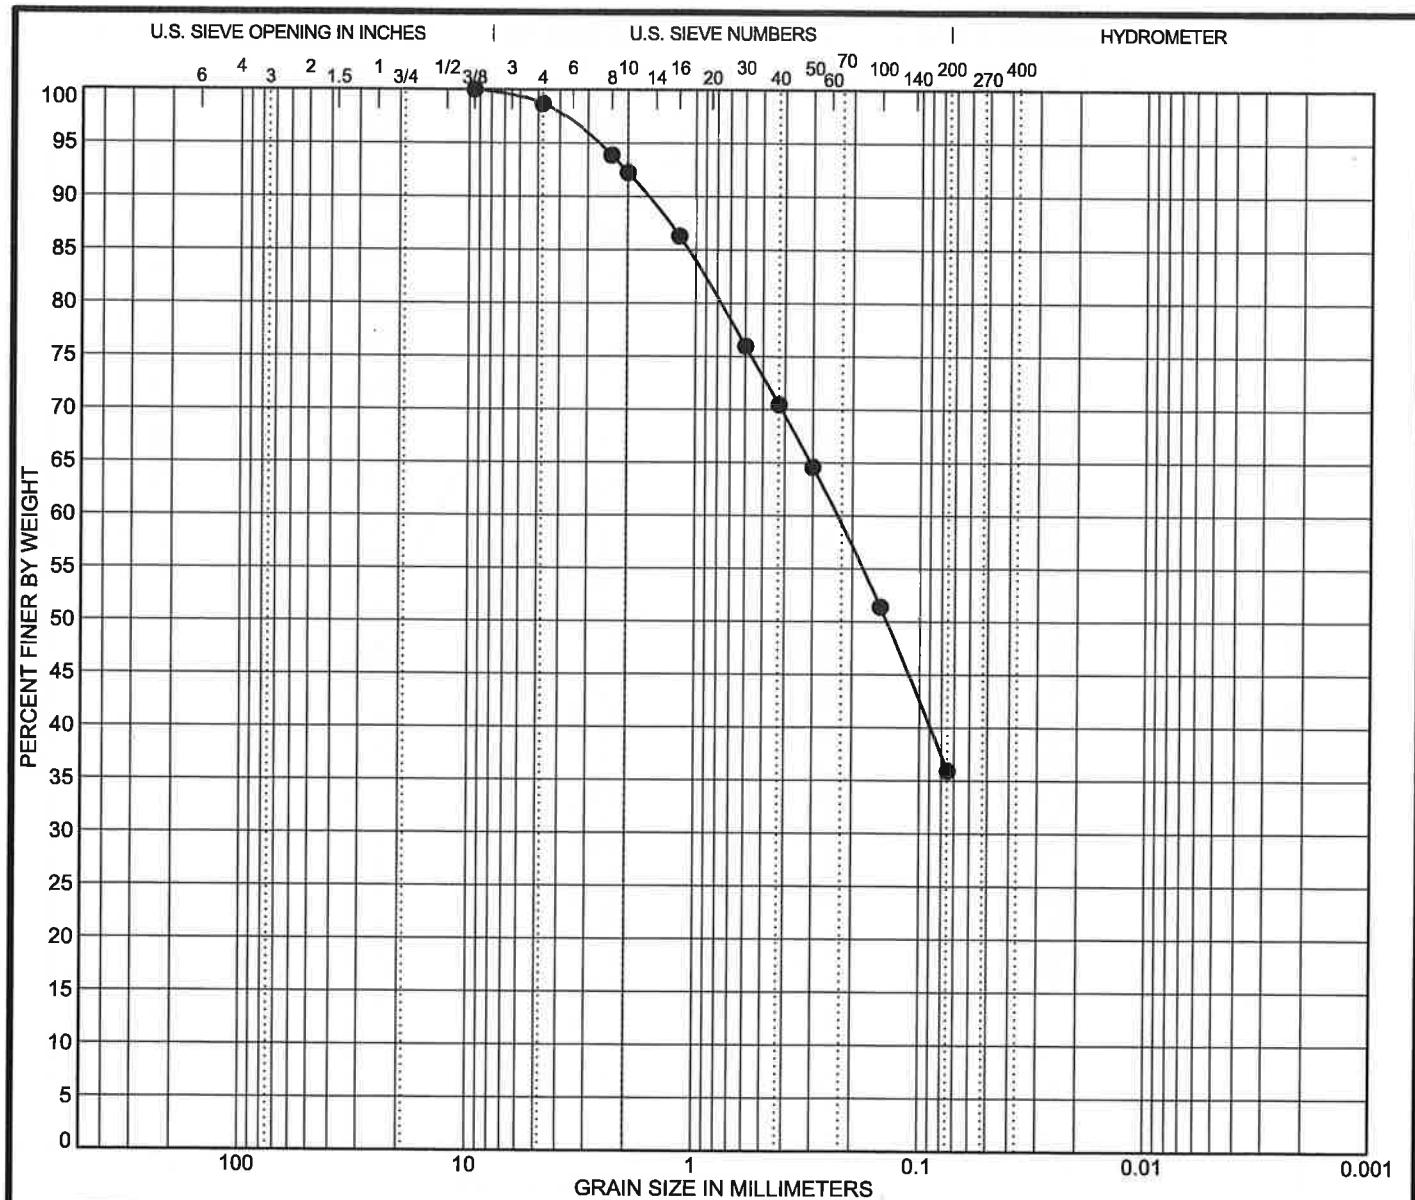
The Vintage at King's Canyon  
**GRAIN SIZE DISTRIBUTION**  
Job Number: 8947.000 PLATE B-1.19  
Date: May 2016 171

Specimen Identification		Date: 5-2-2016									
●	B-16	Classification						LL	PL	PI	Cc Cu
	Depth: 0	Silty SAND (SM)						33	26	7	
Sample Location		Comb. Samp. B-16, 19, & 22 from 0'-5'									
USCS		SM									
AASHTO											
Specimen Identification											
●	B-16	D100	D60	D30	D10	%Gravel	%Sand	%Silt	%Clay		
	Depth: 0	9.5	0.236			1.4	62.7		35.9		
Natural Moisture		6.5 %		S.E.		Absorption %					
R-Value		21		Durability Index		Soundness					
Percentage of Wear (500 rev)		%		Specific Gravity		Direct Shear	30

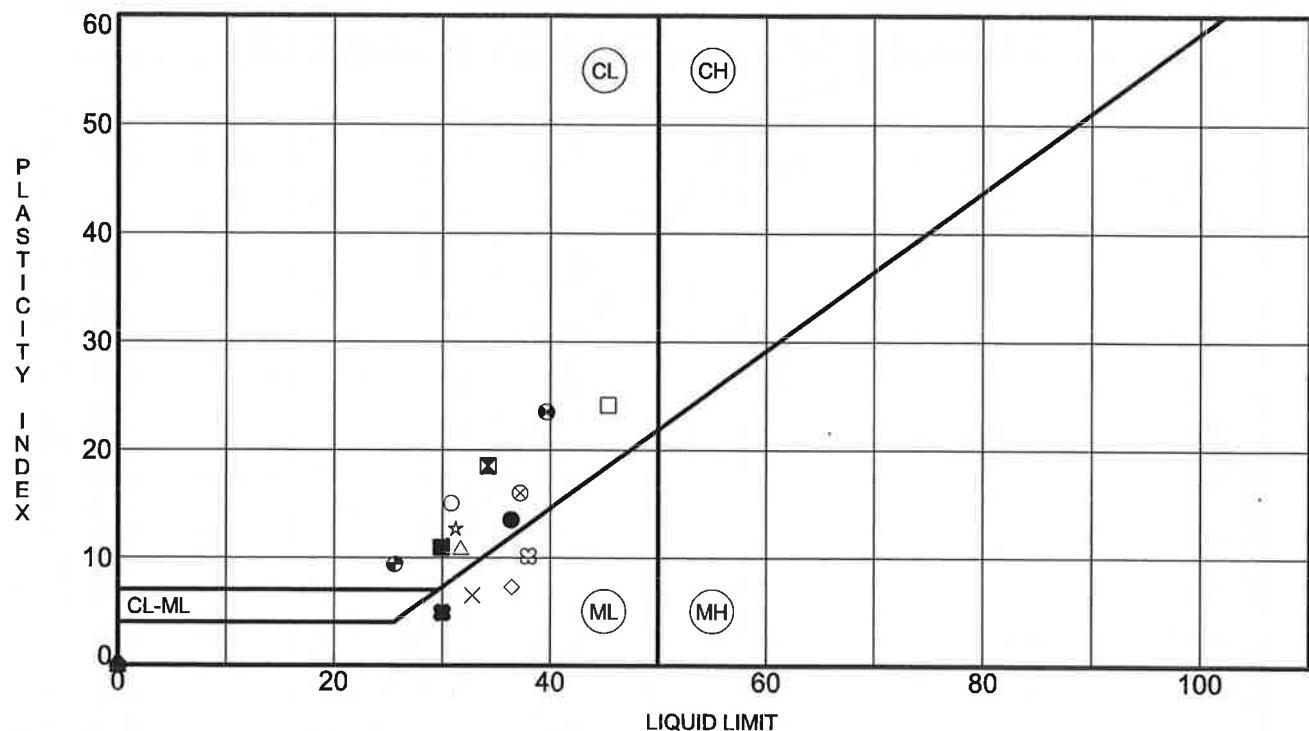
Specimen Identification	LL	PL	PI	Fines	Classification
● B-01 0.0	36	23	13	38	Clayey SAND (SC)
▣ B-01 5.0	34	16	18	29	Clayey SAND (SC)
▲ B-01 21.0	NP	NP	NP	17	Silty SAND (SM)
★ B-02 5.0	NP	NP	NP	15	Silty SAND (SM)
○ B-03 30.0	NP	NP	NP	12	Poorly Graded SAND w/Silt (SP-SM)
◆ B-04 10.0	NP	NP	NP	30	Silty SAND (SM)
○ B-04 16.0	31	16	15	46	Clayey SAND (SC)
△ B-05 3.0	32	21	11	34	Clayey SAND (SC)
⊗ B-06 20.0	37	21	16	81	Lean CLAY with Sand (CL)
⊕ B-07 11.0	NP	NP	NP	11	Poorly Graded SAND w/Silt (SP-SM)
□ B-08 5.5	45	21	24	50	Clayey SAND (SC)
⊖ B-09 0.0	40	16	24	48	Clayey SAND (SC)
● B-10 8.5	26	16	10	44	Clayey SAND (SC)
★ B-11 6.0	31	19	12	50	Clayey SAND (SC)
⊗ B-12 8.0	38	28	10	69	Sandy SILT (ML)
■ B-13 5.5	30	19	11	38	Clayey SAND (SC)
◆ B-14 30.0	NP	NP	NP	40	Silty SAND (SM)
◇ B-15 3.0	36	29	7	61	Sandy SILT (ML)
× B-16 0.0	33	26	7	36	Silty SAND (SM)
⊗ B-17 3.0	30	25	5	45	Silty SAND (SM)

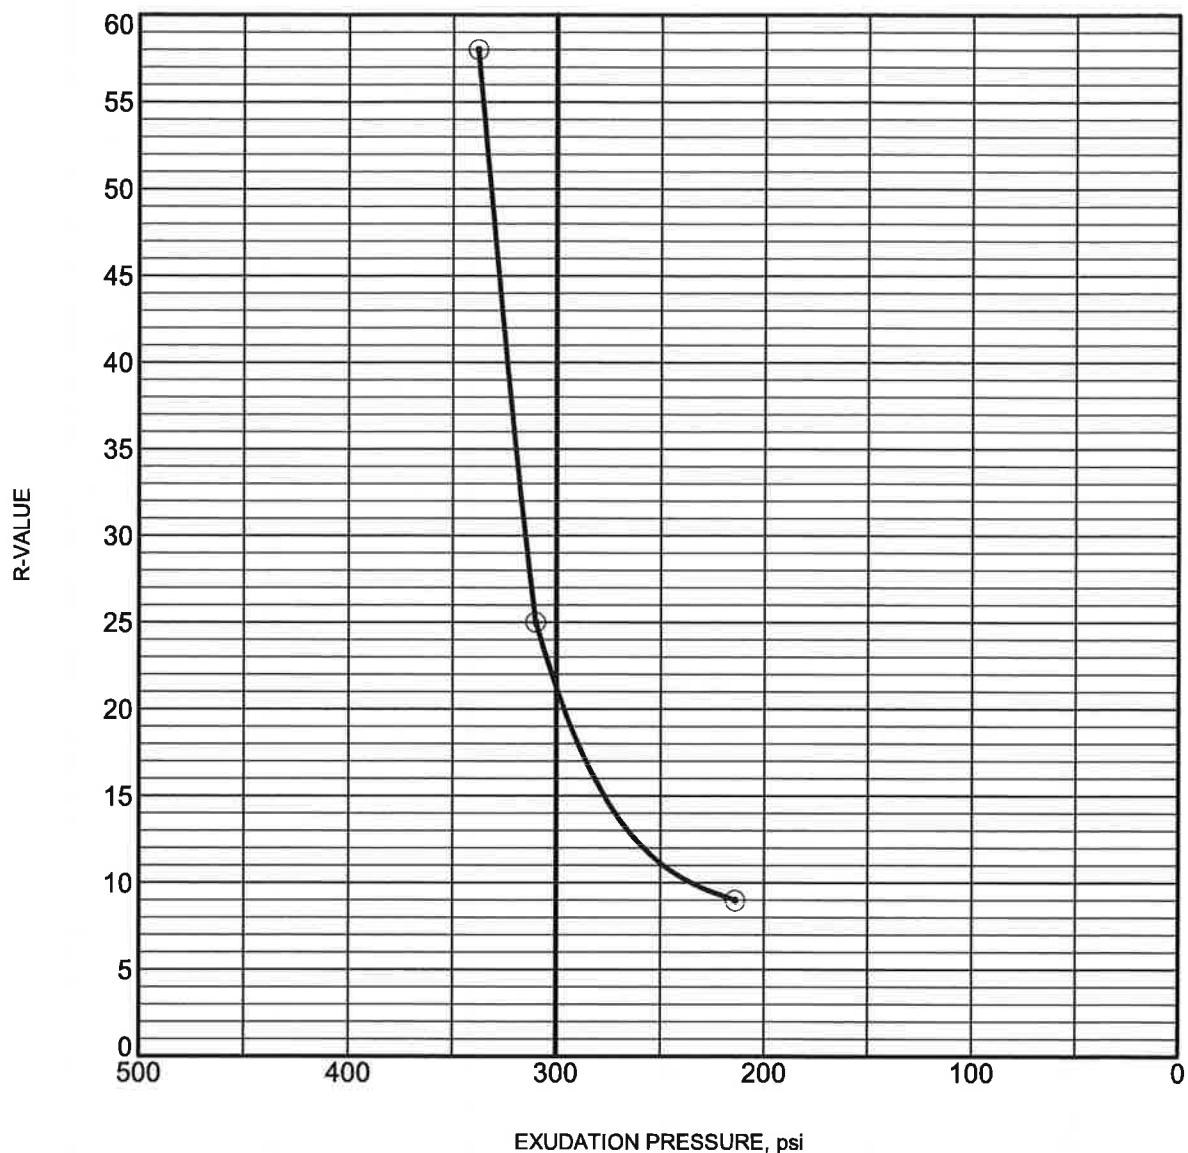
Test Data					
Specimen No.	Water Content (%)	Dry Density (pcf)	Expansion (psf)	Exudation (psi)	Test R-Value*
1	13.5	111.9	100.0	338.0	58.0
2	15.1	119.0	43.0	310.0	25.0
3	16.1	109.3	9.0	214.0	9.0

\* Reported values have been corrected for sample height, where required.

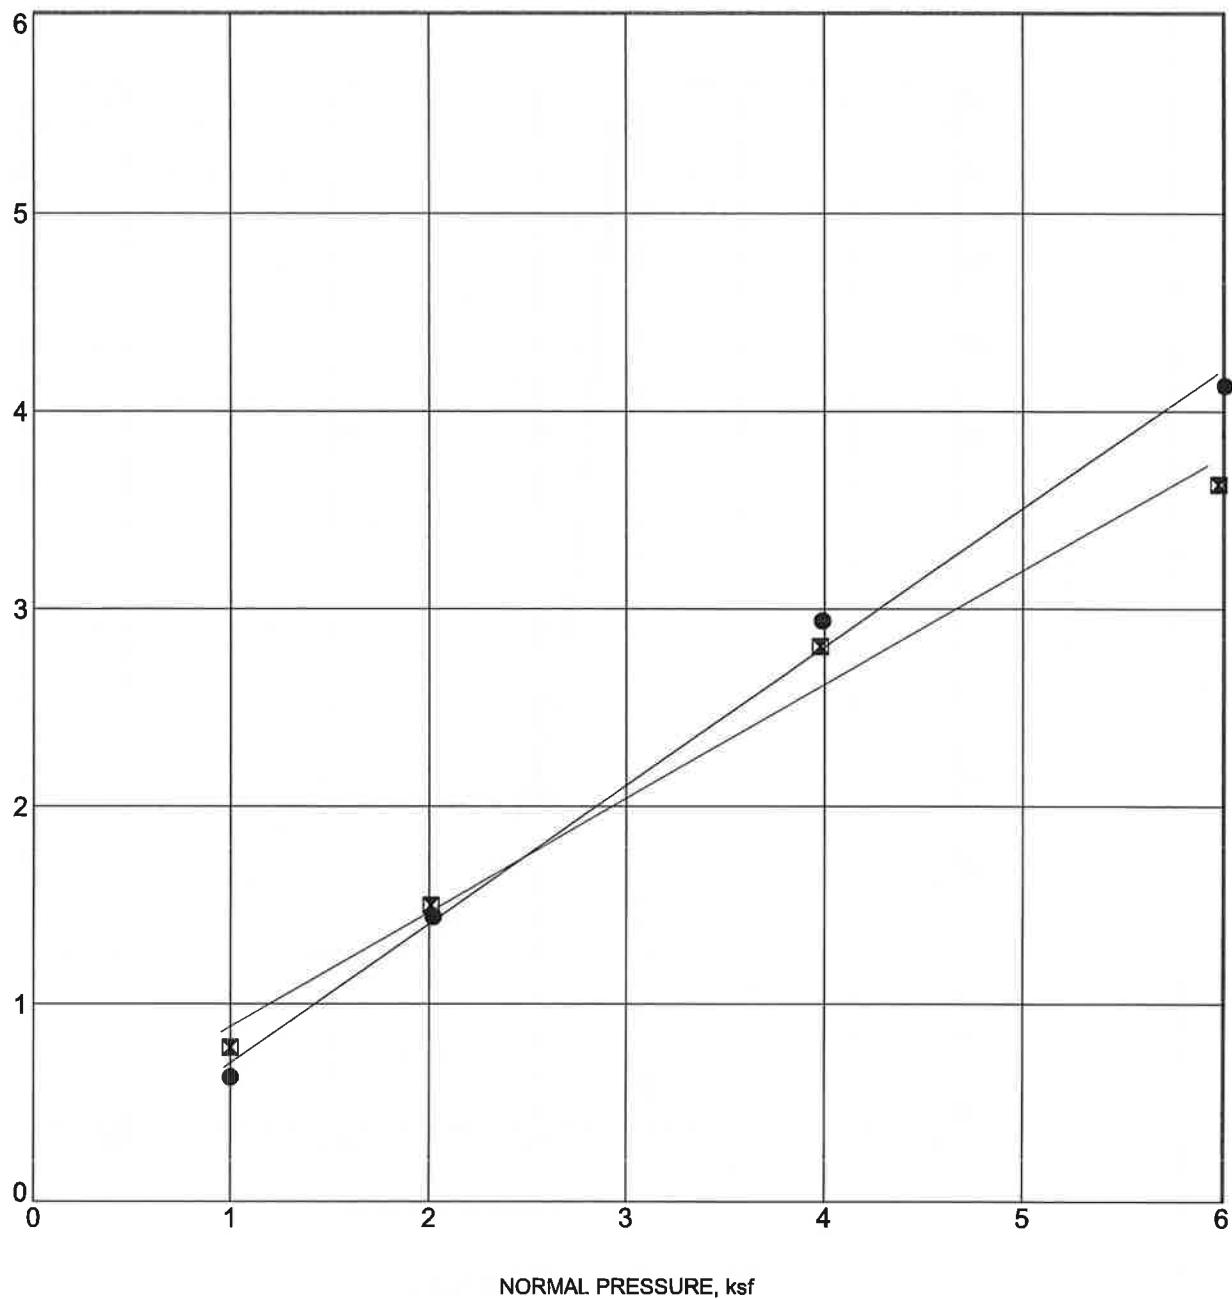
Specimen Identification	Classification	$\gamma_g$	MC%	c	$\phi$
● B-01 0.0	Clayey SAND (SC)	110	15	0.00	35.0
◻ B-16 0.0	Silty SAND (SM)	121	11	0.31	30.0

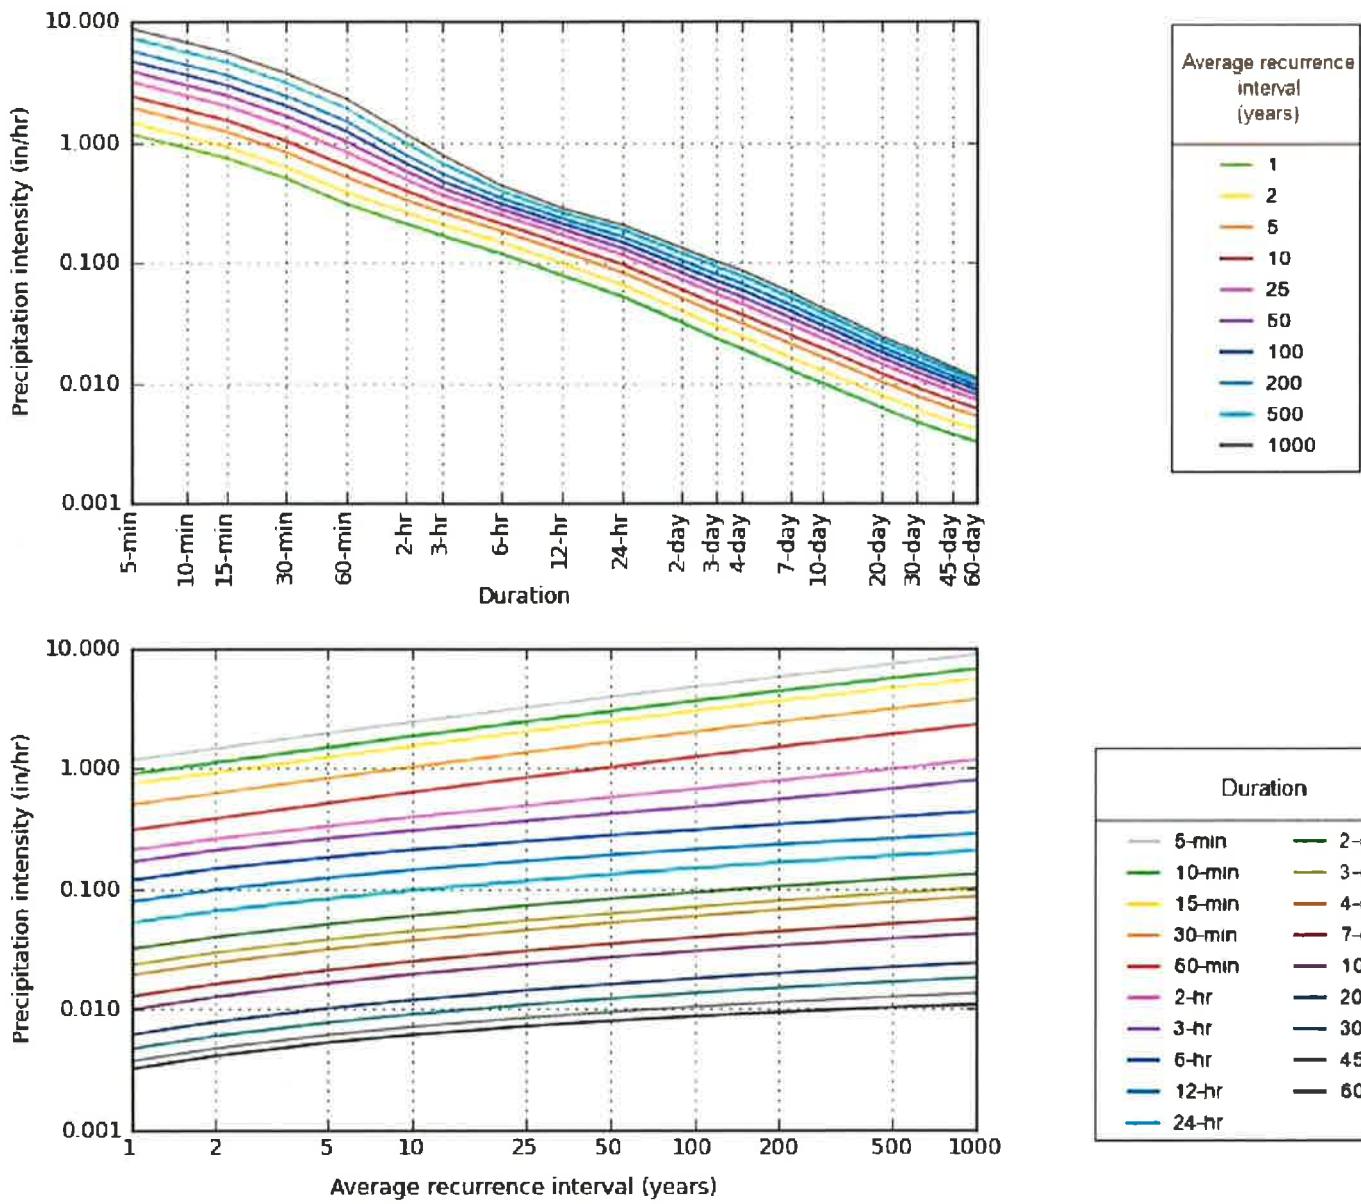
**PF graphical****PDS-based intensity-duration-frequency (IDF) curves**  
Latitude: 39.1656°, Longitude: -119.7820°

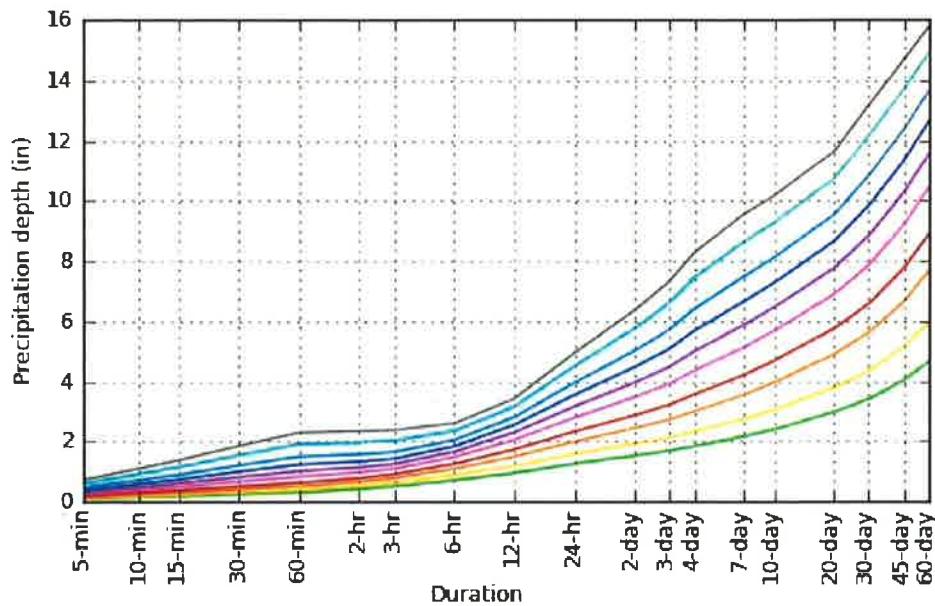
**PF graphical****PDS-based depth-duration-frequency (DDF) curves**  
Latitude: 39.1656°, Longitude: -119.7820°
