**STAFF REPORT FOR THE HISTORIC RESOURCES COMMISSION MEETING OF
SEPTEMBER 12, 2019**

FILE NO: HRC-19-092

AGENDA TITLE: For Possible Action: Discussion and possible action regarding a request for replacement of windows, repair and resurfacing of entries, repair and replacement of fencing, replacement of garage doors, and installation of pavers between the building and the sidewalk on property zoned Residential Office located at 507 North Division Street, APN 003-221-01. (Hope Sullivan, hsullivan@carson.org)

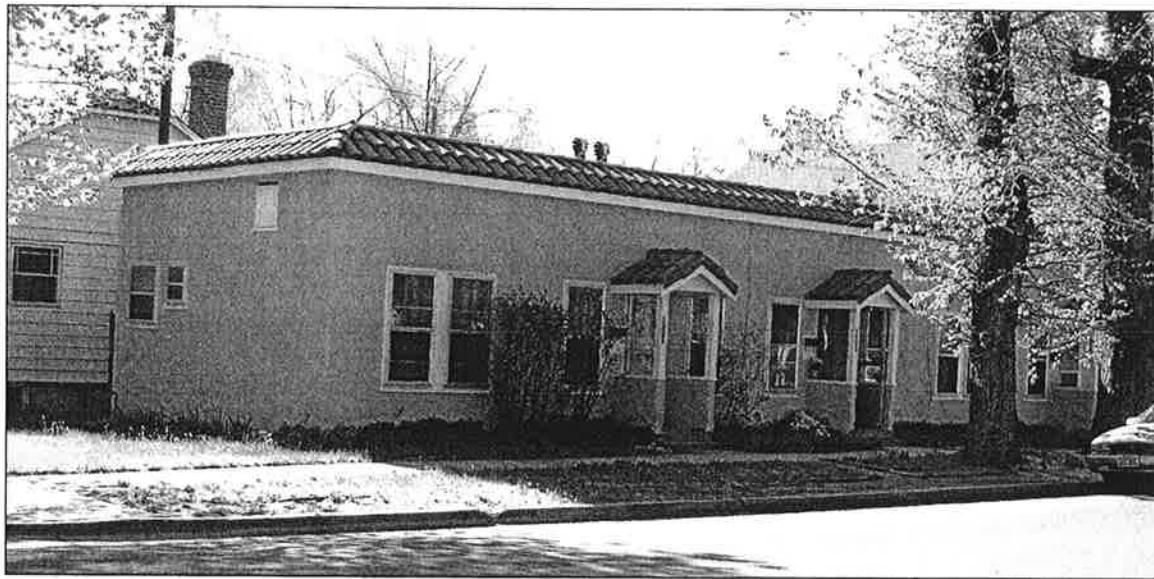
507-509-511 N Division, west facade

The triplex is a one-story building with a nearly flat roof with a parapet on the front and side facades. It is a wood frame building with a heavily-textured stucco finish, a perimeter concrete foundation, and a composition shingle roof. On the two public sides of the building the parapet is topped with clay tiles. It is a vernacular building with elements of the Spanish Colonial Revival style, constructed ca. 1941.

There are three entries to the building along Division Street. They feature a tiled, closed gable porch roof supported by two simple posts that sit on an enclosed rail finished in stucco. The porch entry is accessed via one concrete step. The doors have three panels below with a single light above. Windows throughout are paired and single double-hung windows with wood frames.

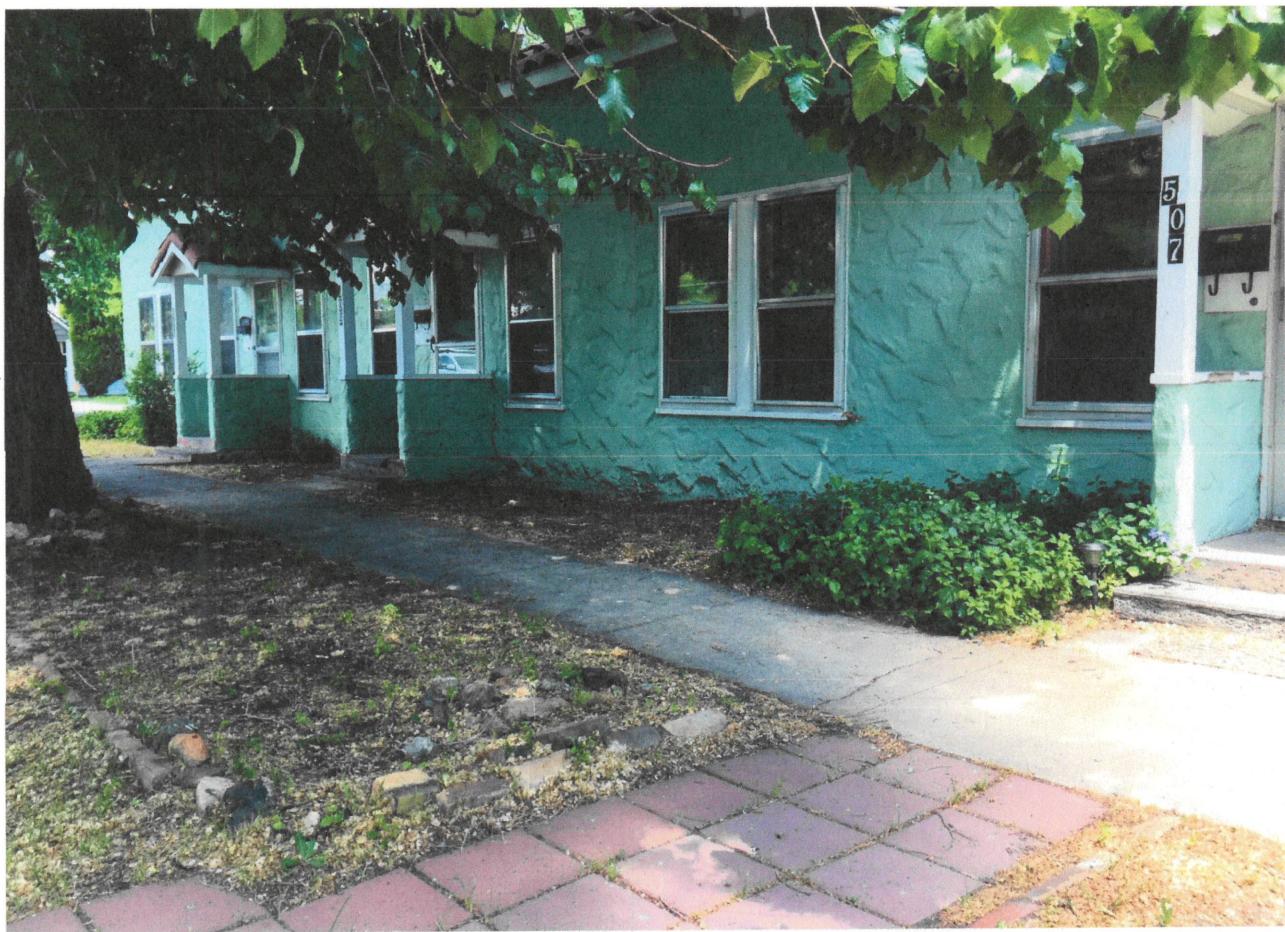
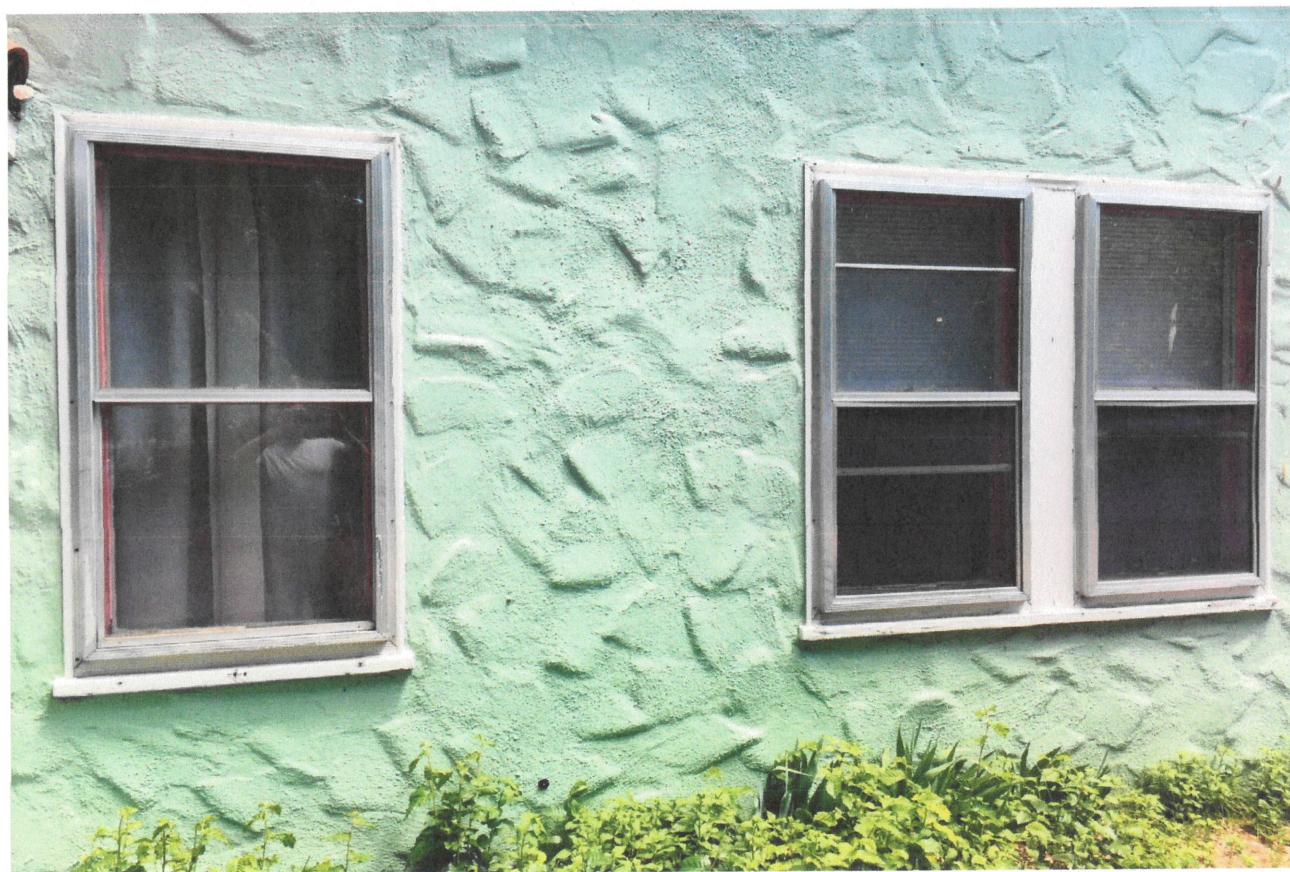
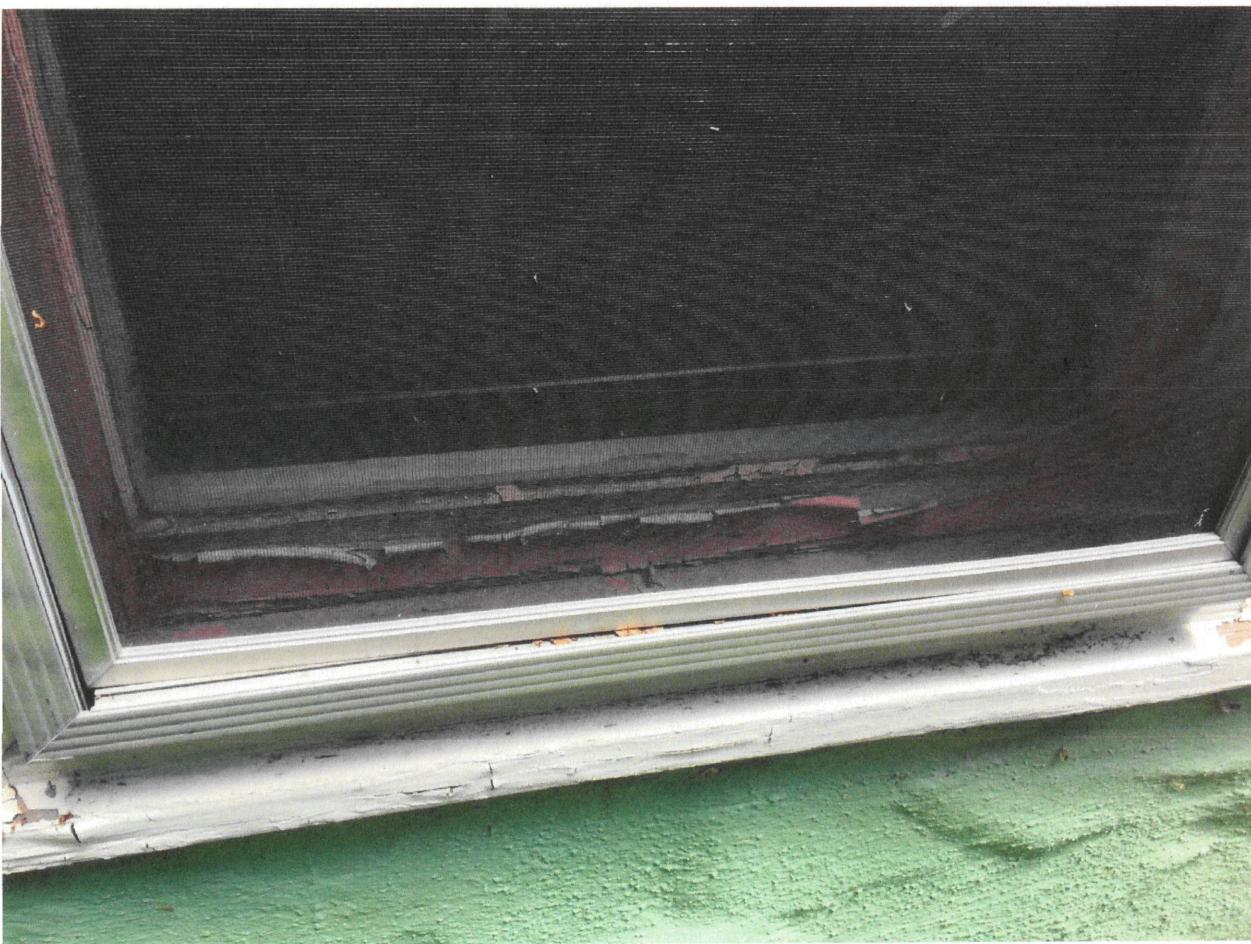
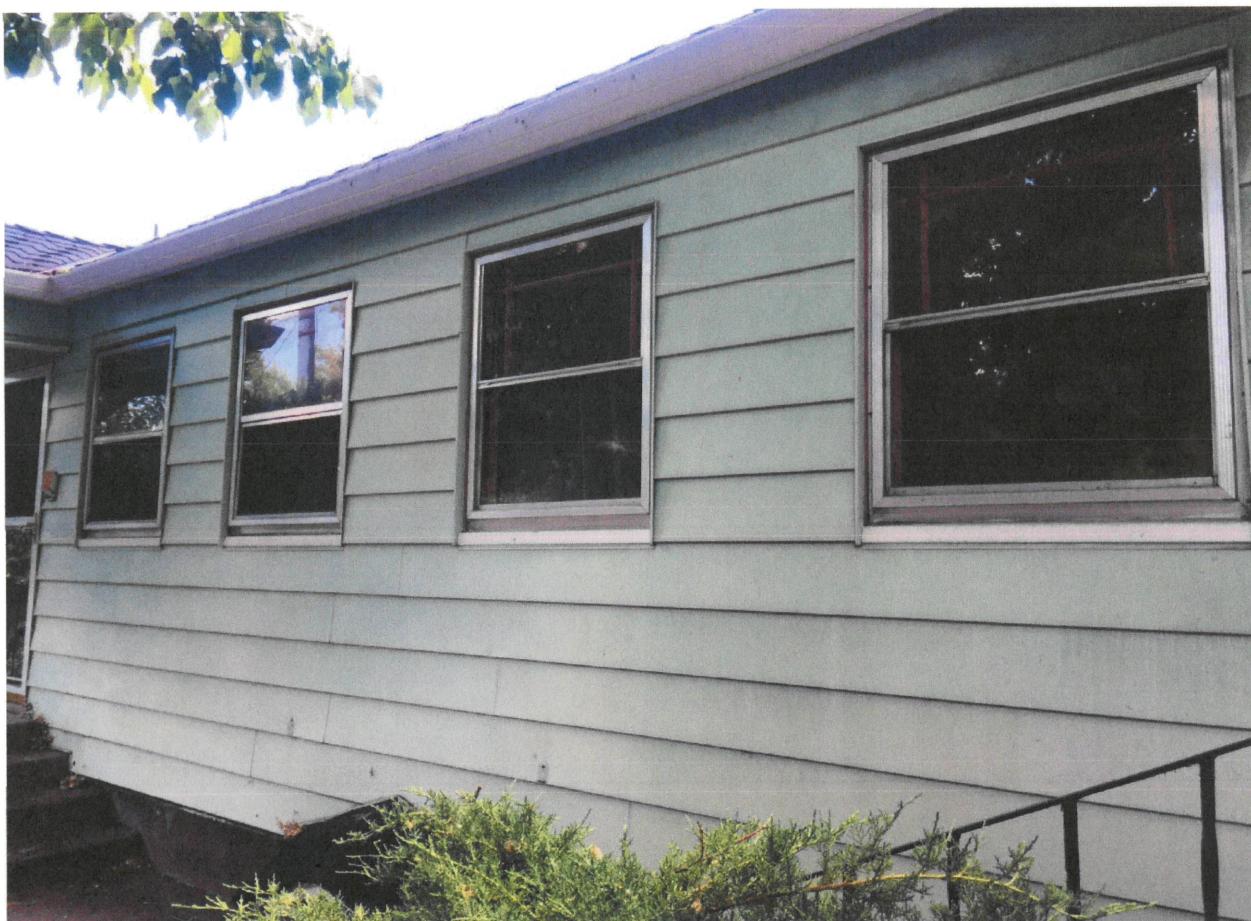
We are asking for approval to replace the current single pane, non-tempered glass, double hung and basement windows. Most of the windows do not open, show signs of wood rot or some of the panes are broken or cracked. Many of the windows have aluminum storm covers several decades newer than the property. The subject property recently experienced a small fire that raises a concern that the current configuration would make it complicated and dangerous for tenants to escape, or for the fire department to access.

Staff believes the wood windows to be original. Therefore, consistent with the guidelines, staff recommends that the windows be retained and repaired, as opposed to a complete replacement. Of note, staff viewed the windows from the exterior through the storm windows.

We propose to replace with wooden double or triple pane windows with tempered glass. This will enhance the exterior look of the property because the new windows will not require aluminum storm windows. The new windows will also be more energy efficient and increase safety for occupants. (Pages 1 - 4)
