We appreciate the opportunity to prepare this geotechnical update for the Lompa Ranch – Phase B1 & B2 project. Please contact our office should you have any related questions or comments.

APPENDIX A  
GEOTECHNICAL PLATES

**Geotechnical Investigation**  
**LOMPA RANCH - PHASES B1 & B2**  
**RYDER HOMES**  
**CARSON CITY, NV**

# Geotechnical Investigation Lompa Ranch Carson City, Nevada

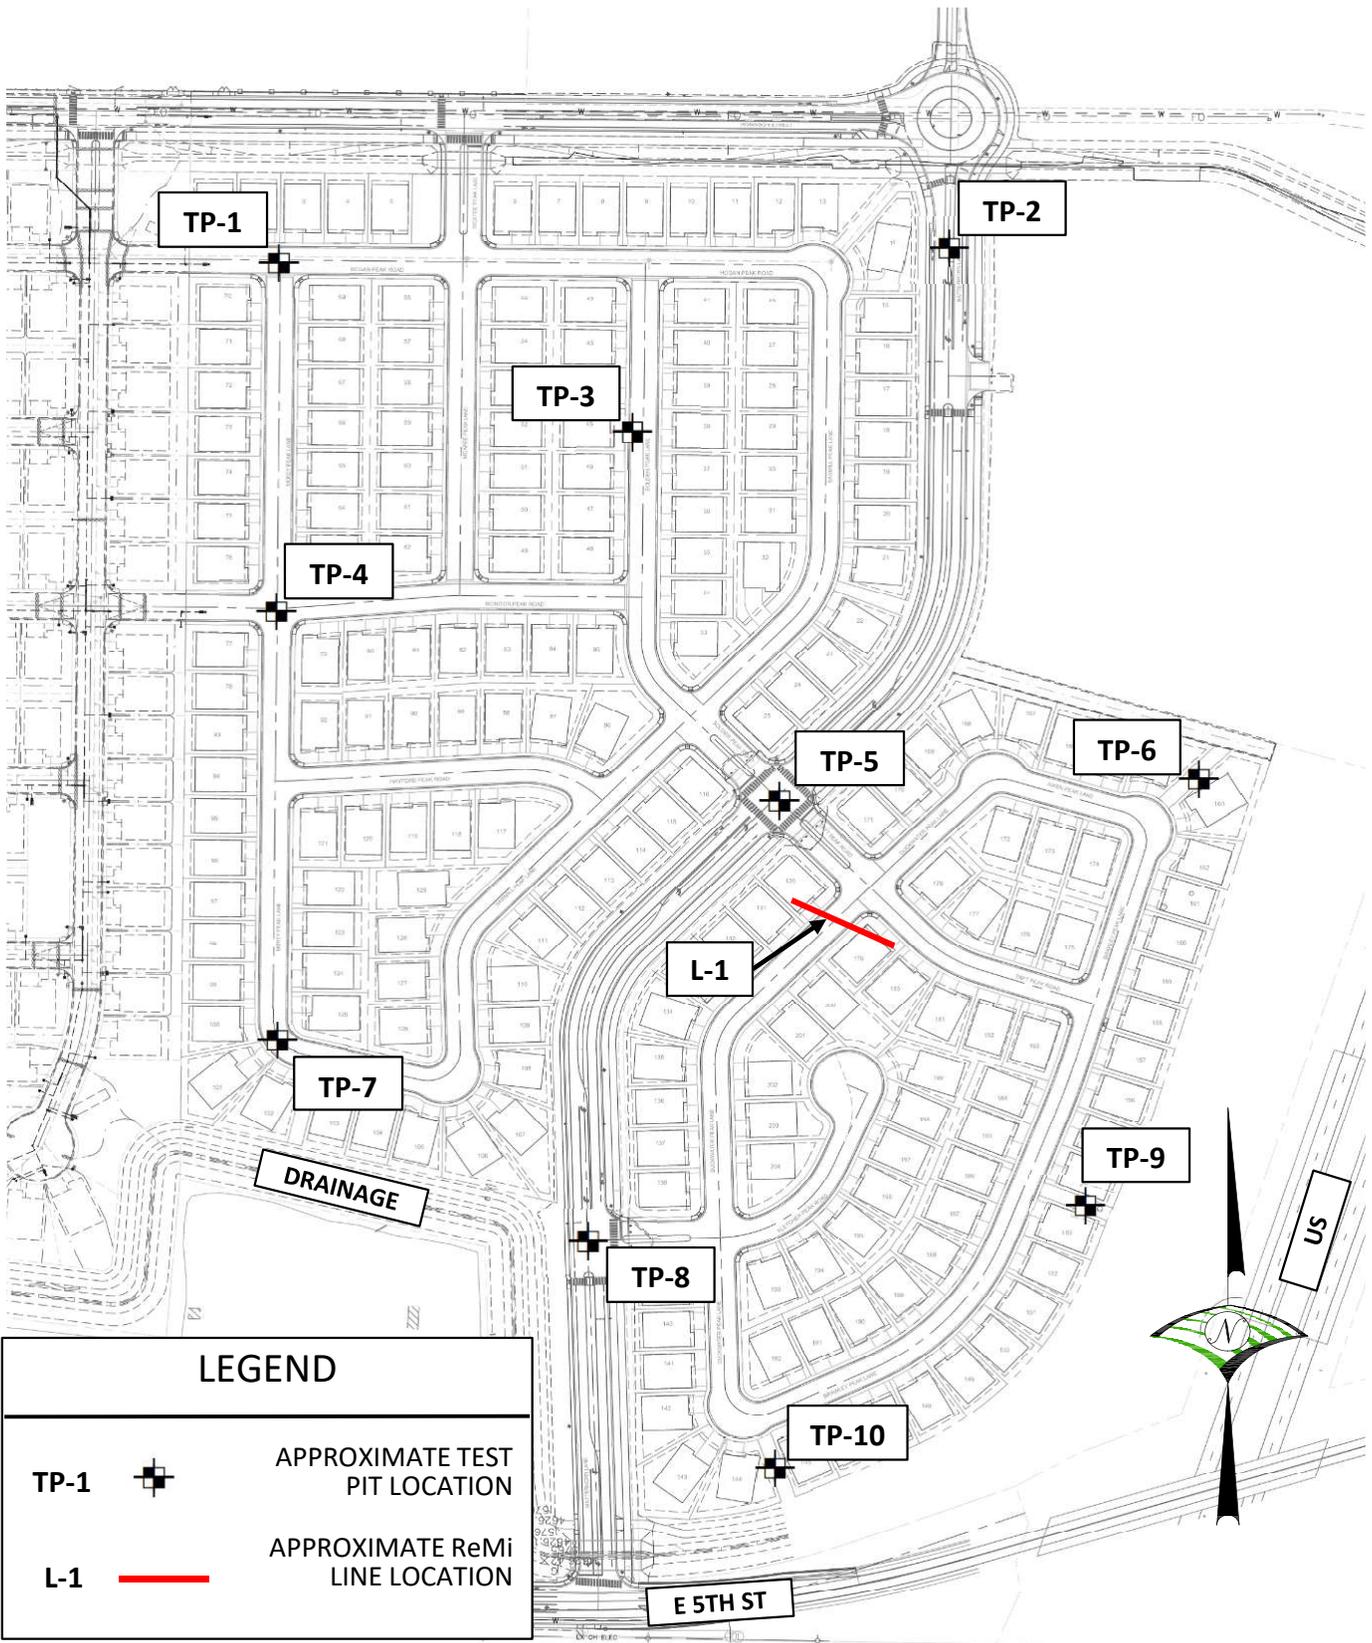
LEGEND	
TP-1

APPROXIMATE TEST PIT LOCATION
L-1

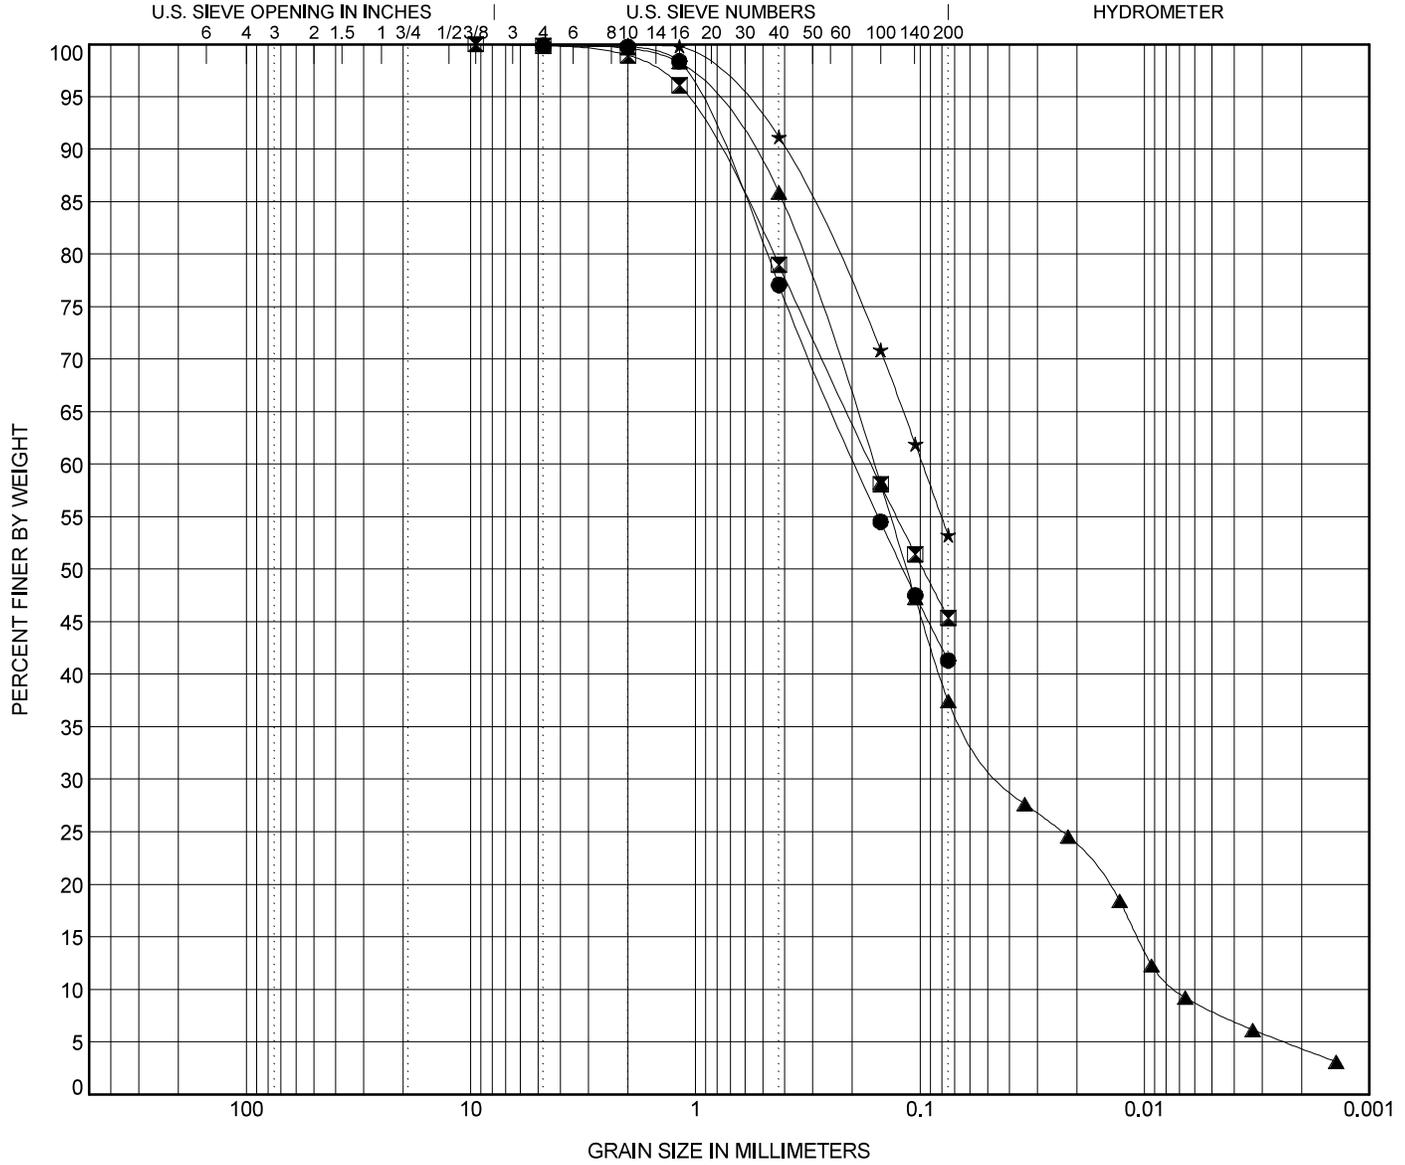
TEST PIT	MID-DEPTH	Classification	LL	PL	PI	Cc	Cu
● TP-1	0.0	CLAYEY SAND(SC)	27	14	13		
☒ TP-2,5,8	0.0	CLAYEY SAND(SC)	32	17	15		
▲ TP-6	0.0	SILTY SAND(SM)	44	28	16	1.48	22.25
★ TP-9	1.5	SANDY LEAN CLAY(CL)	32	20	12

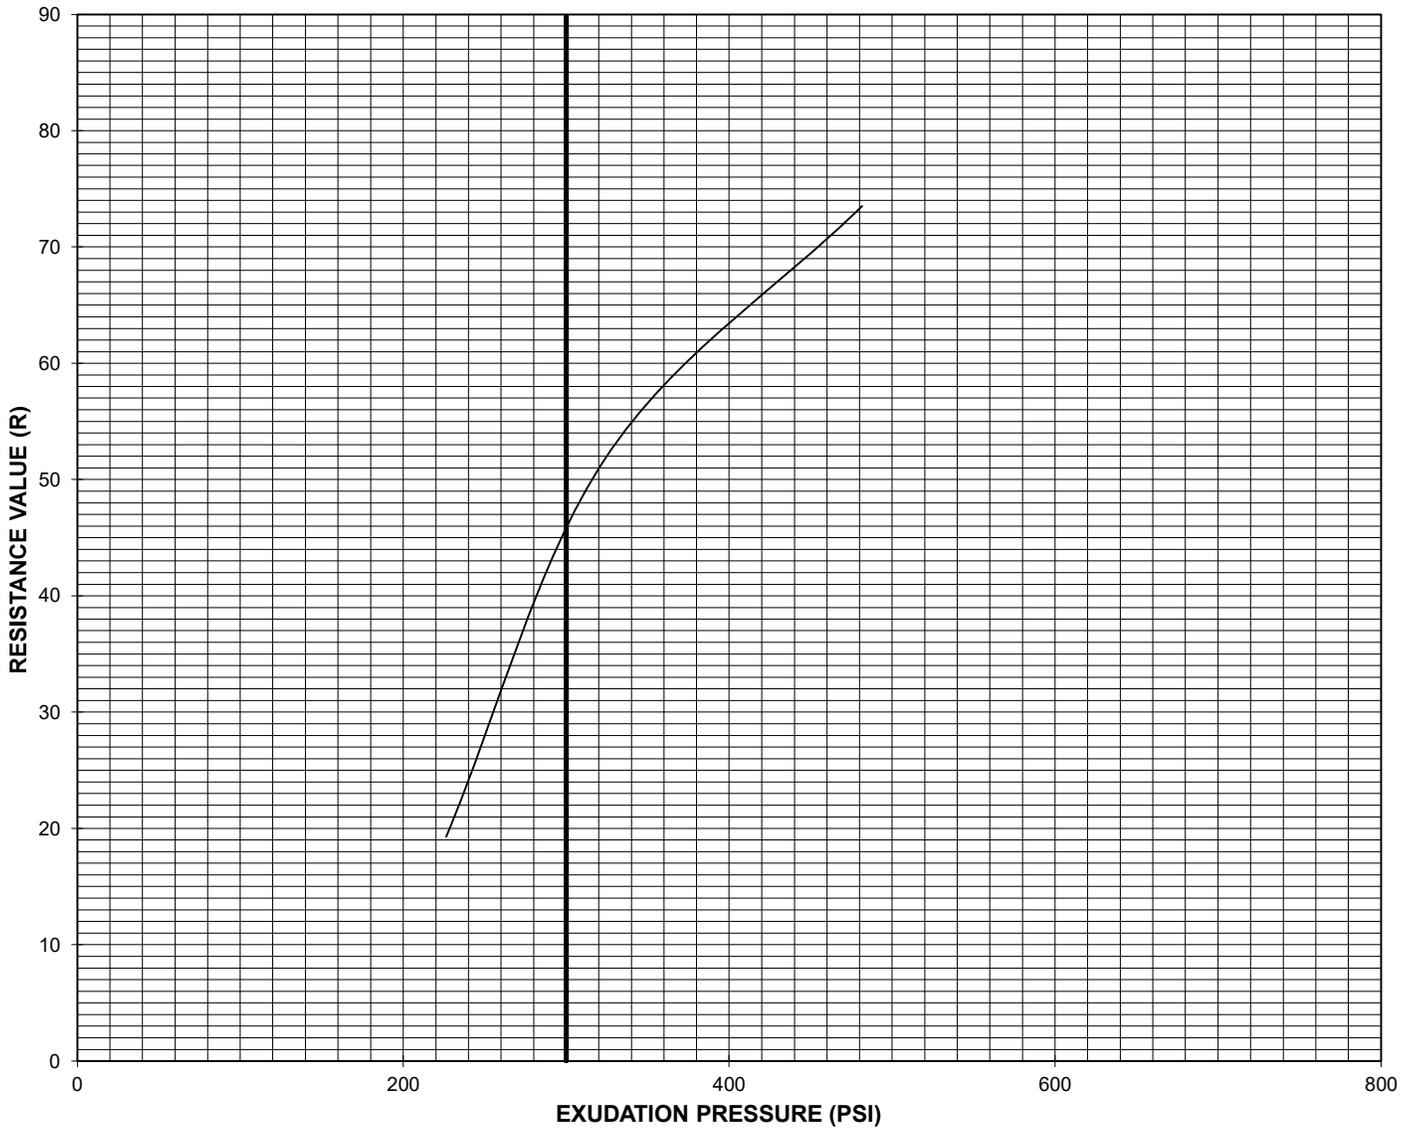
R-Value and Expansion Pressure of Compacted Soils AASHTO T190 / ASTM D2844

Lab Log #	Sample Source	Material	Expansion Pressure (psf) @ 300 (psi)	R-Value @ 300 (psi)
6144	Combined TP-2 @ 0-4.5, TP-5 @ 0-3.5, TP-8 @ 0-4	CLAYEY SAND (SC)	0	46

POINT #	WATER CONTENT (%)	DRY DENSITY (PCF)	EXUDATION PRESS. (PSI)	EXPANSION PRESS. (PSF)	RESISTANCE VALUE (R)
1	17.1	107.5	226	0	19
2	15.9	110.9	324	0	52
3	14.6	112.2	482	0	74
4					
5

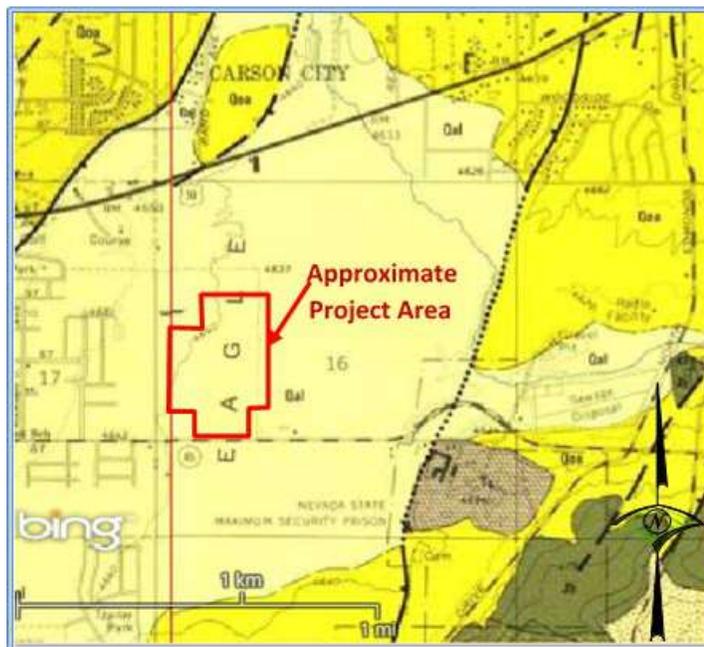
Figure 2: Geologic Map

Based on the USGS Geologic Map, presented in Figure 2, the site is mapped in an area of Quaternary Alluvium Plain Deposits (Qal), aged as middle to late Pleistocene and generally characterized as unbedded to poorly bedded, poorly to moderately sorted, yellowish brown to gray fine silty sand, sandy silt, granular muddy coarse sand, and minor sandy gravel. Natural Resources Conservation Service (NRCS) Soil Survey Maps indicates that the native material on the project site mostly consists of lean clays to a depth of 5 feet below the ground surface. Somewhat consistent to the geologic map and the NRCS soil survey map, the soils encountered in our explorations typically consisted of medium plasticity clayey sand, silty sands, and sandy lean clays.

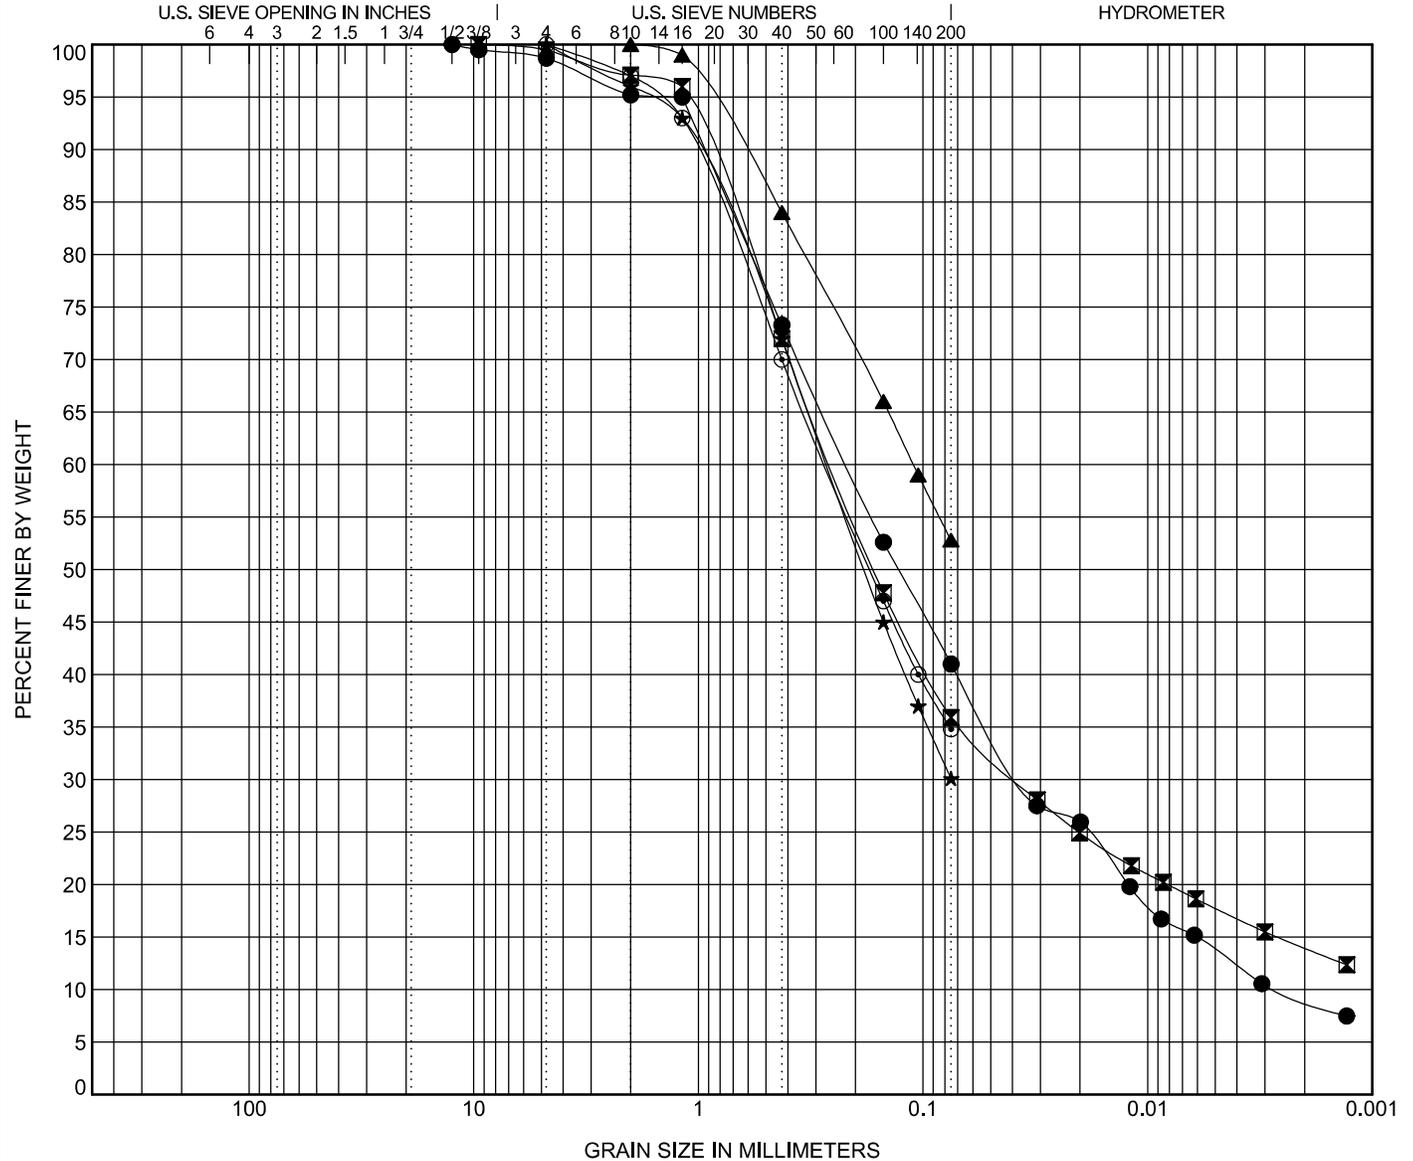
TEST PIT	DEPTH	Classification	LL	PL	PI	Cc	Cu
● TP-2	0.0	CLAYEY SAND(SC)	24	14	10	2.33	82.24
☒ TP-2	3.0	CLAYEY SAND(SC)	37	13	24		
▲ TP-6	0.0	SANDY LEAN CLAY(CL)	33	13	20		
★ TP-7	3.0	SILTY, CLAYEY SAND(SC-SM)	23	16	7		
◎ TP-10	2.0	CLAYEY SAND(SC)	28	12	16

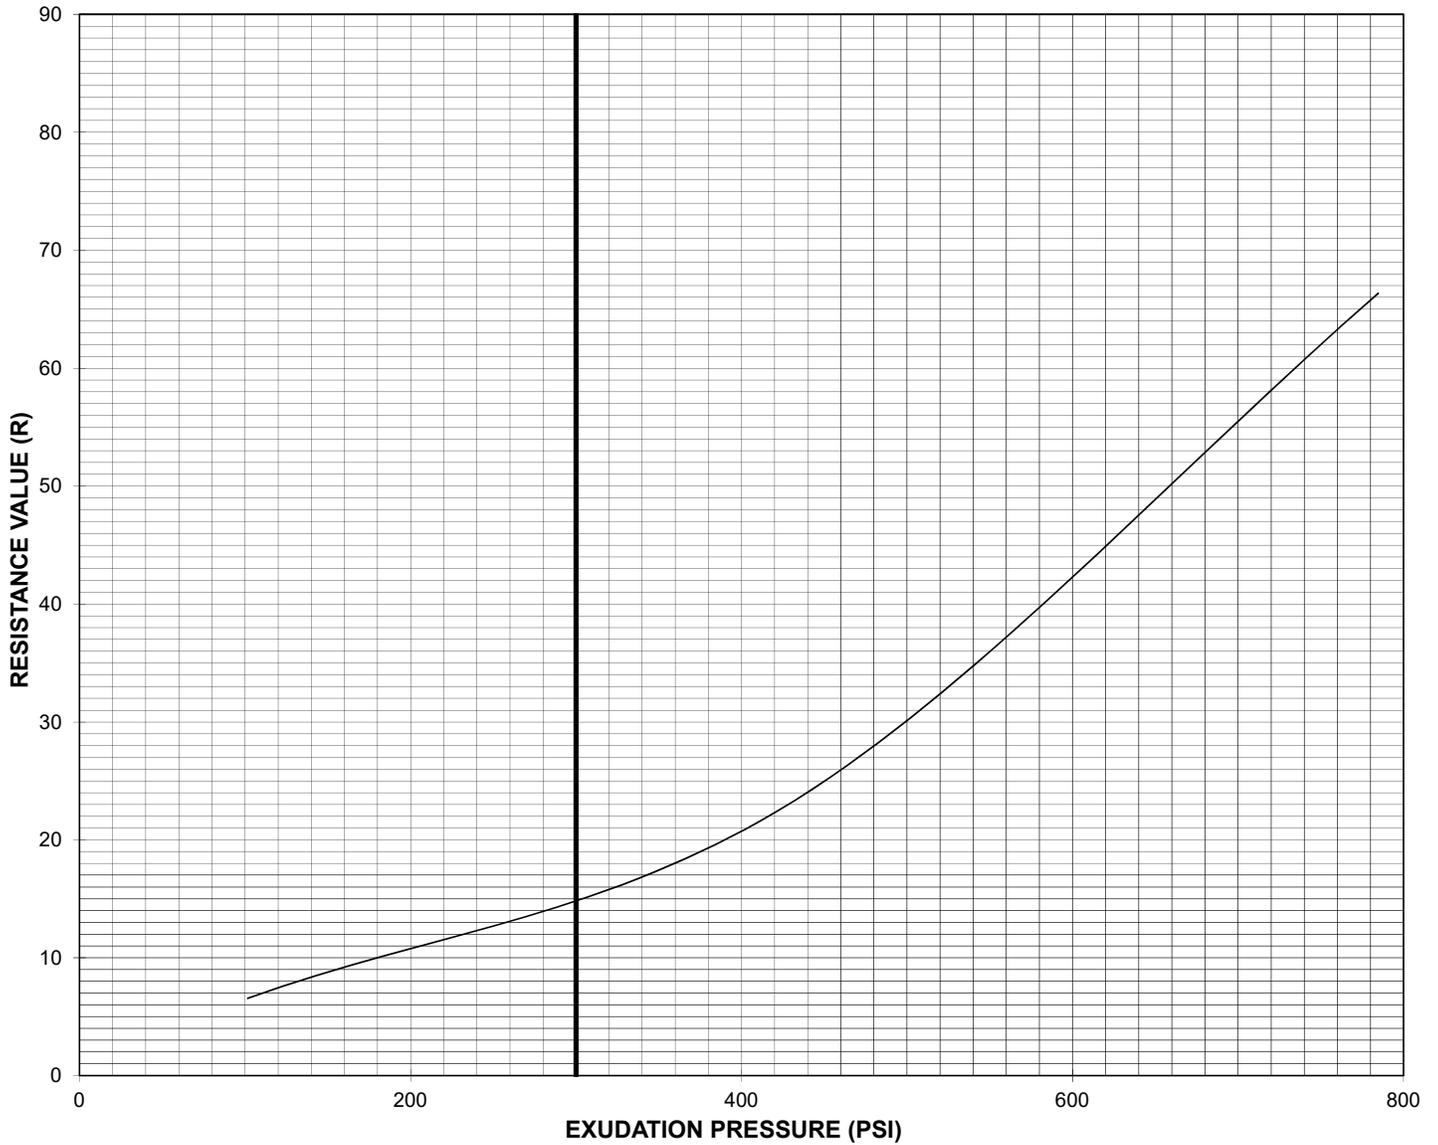
**R-Value and Expansion Pressure of Compacted Soils    AASHTO T190 / ASTM D2844**

Lab Log #	Sample Source	Material	Expansion Pressure (psf) @ 300 (psi)	R-Value @ 300 (psi)
4473	TP-1 @ 0 - 3.5'	Medium Brown Clayey Sand	0	15

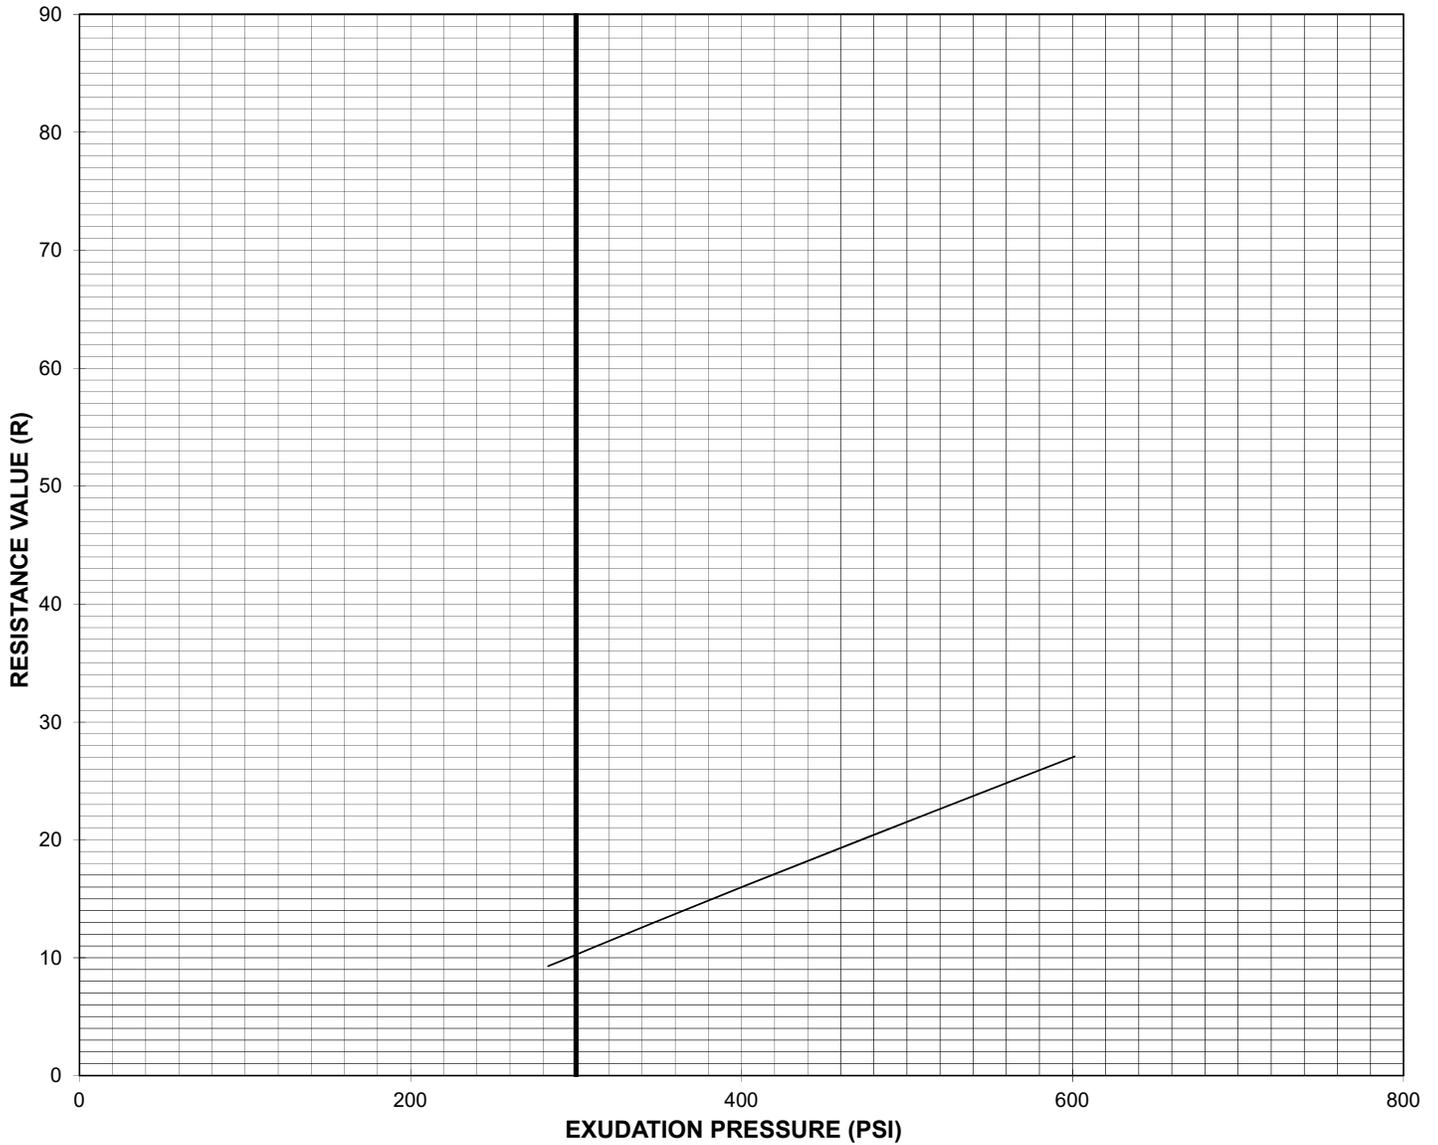
**R-Value and Expansion Pressure of Compacted Soils    AASHTO T190 / ASTM D2844**

Lab Log #	Sample Source	Material	Expansion Pressure (psf) @ 300 (psi)	R-Value @ 300 (psi)
4473	TP-3 @ 0 - 2.5'	Medium Brown Clayey Sand	0	10

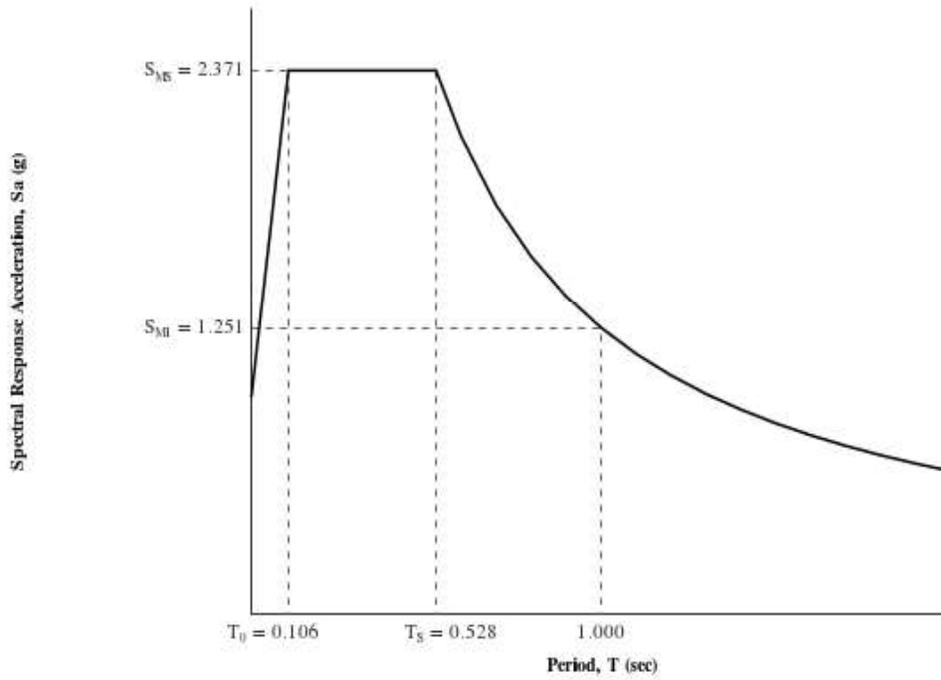
### Section 11.4.6 — Risk-Targeted Maximum Considered Earthquake (MCE<sub>R</sub>) Response Spectrum

The MCE<sub>R</sub> Response Spectrum is determined by multiplying the design response spectrum above by 1.5.

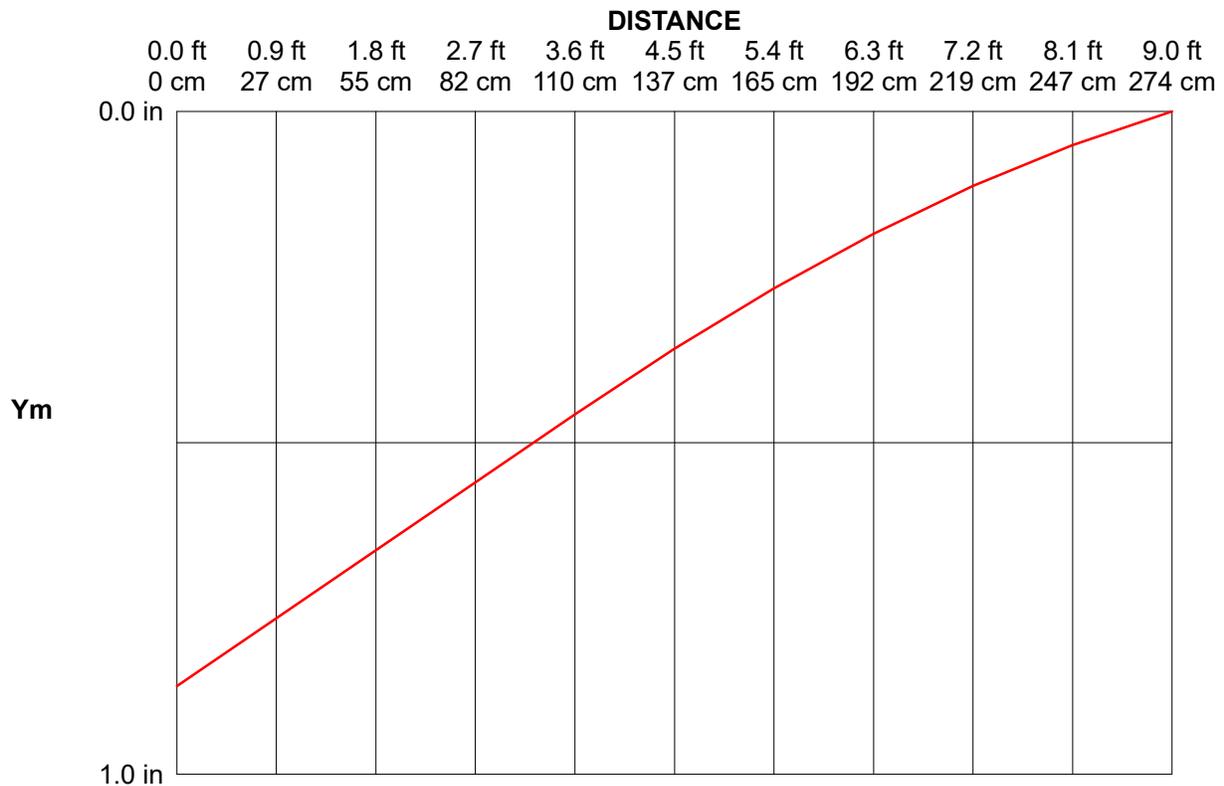
**Ym Center (Shrink) = -0.87 inches ( -2.20 centimeters )**  
**Em Center = 9.00 feet ( 274.32 centimeters )**

Shrink at Slab	Shrink at distance X from edge of slab									Shrink at
	Edge	0.9 ft	1.8 ft	2.7 ft	3.6 ft	4.5 ft	5.4 ft	6.3 ft	7.2 ft	8.1 ft	Em
	0.0 ft	27 cm	55 cm	82 cm	110 cm	137 cm	165 cm	192 cm	219 cm	247 cm	274 cm
inches	-0.87	-0.76	-0.66	-0.56	-0.46	-0.36	-0.27	-0.18	-0.11	-0.05	0.00
cm	-2.20	-1.94	-1.68	-1.42	-1.16	-0.91	-0.68	-0.47	-0.29	-0.13	0.00

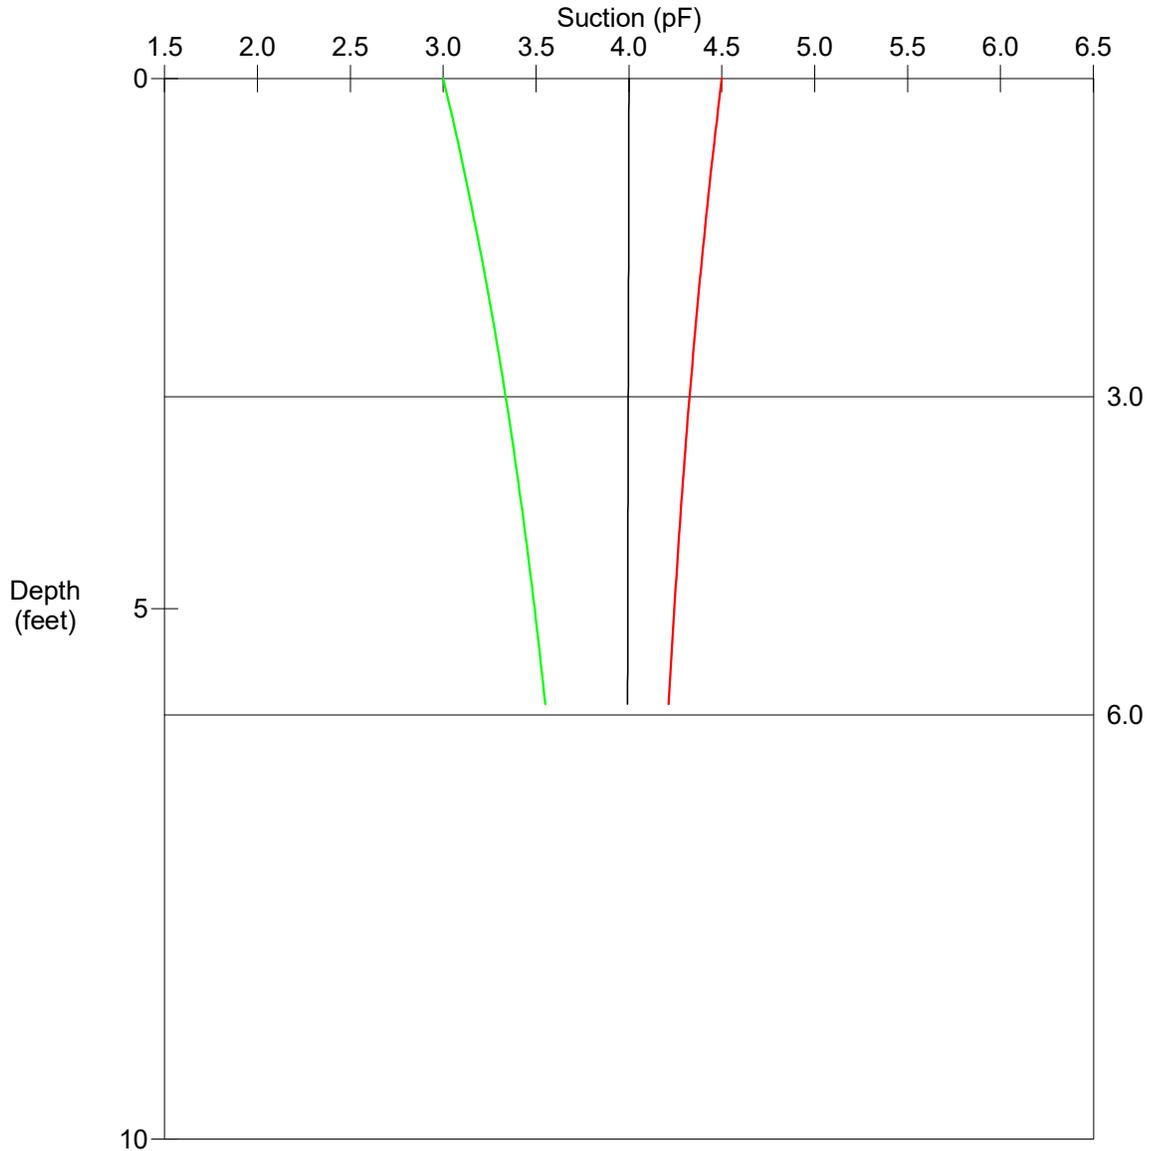
## SUCTION PROFILES

- Initial suction at edge of slab
- Final suction at edge of slab
- Constant Suction

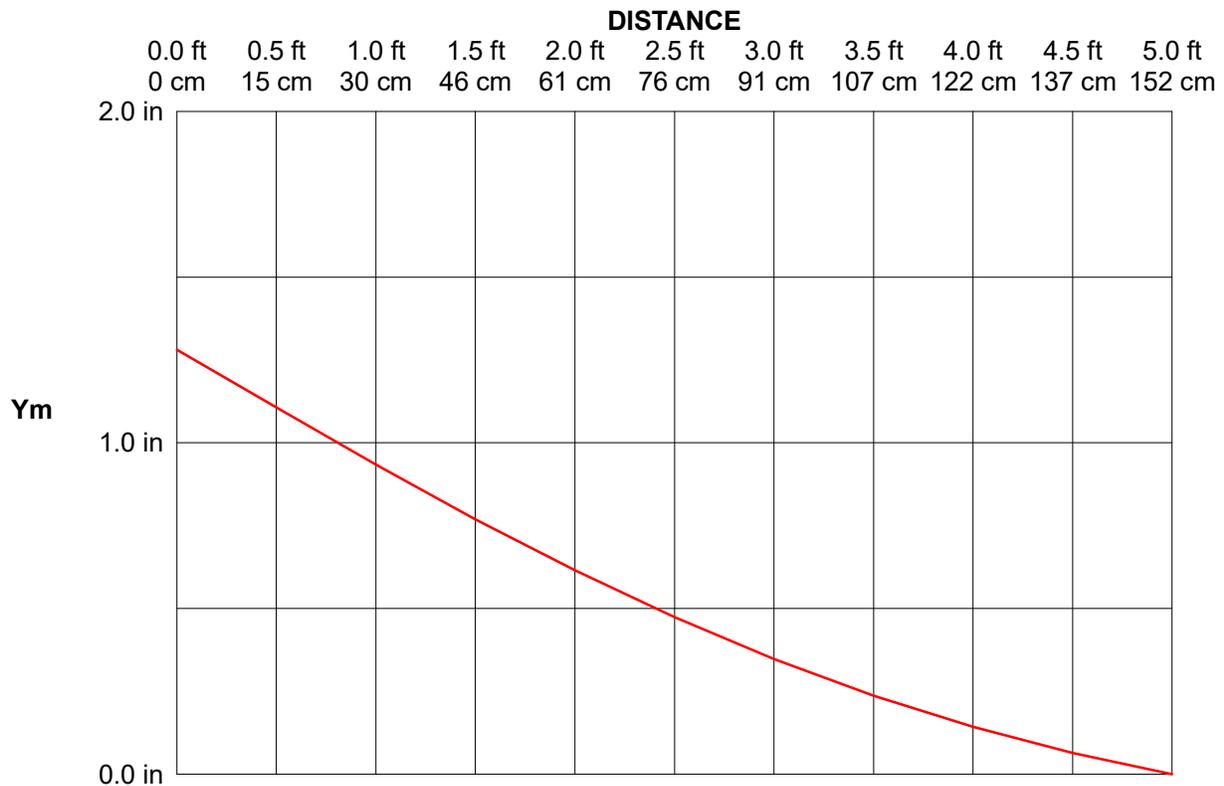
**Ym Edge (Swell) = 1.28 inches ( 3.25 centimeters )**  
**Em Edge = 5.00 feet ( 152.40 centimeters )**

Swell at distance X from edge of slab										
	Swell at Slab Edge	0.5 ft	1.0 ft	1.5 ft	2.0 ft	2.5 ft	3.0 ft	3.5 ft	4.0 ft	4.5 ft	Swell at Em
	0.0 ft	15 cm	30 cm	46 cm	61 cm	76 cm	91 cm	107 cm	122 cm	137 cm	152 cm
inches	1.28	1.11	0.93	0.77	0.62	0.47	0.35	0.24	0.14	0.06	0.00
cm	3.25	2.81	2.37	1.95	1.56	1.21	0.88	0.60	0.36	0.16	0.00

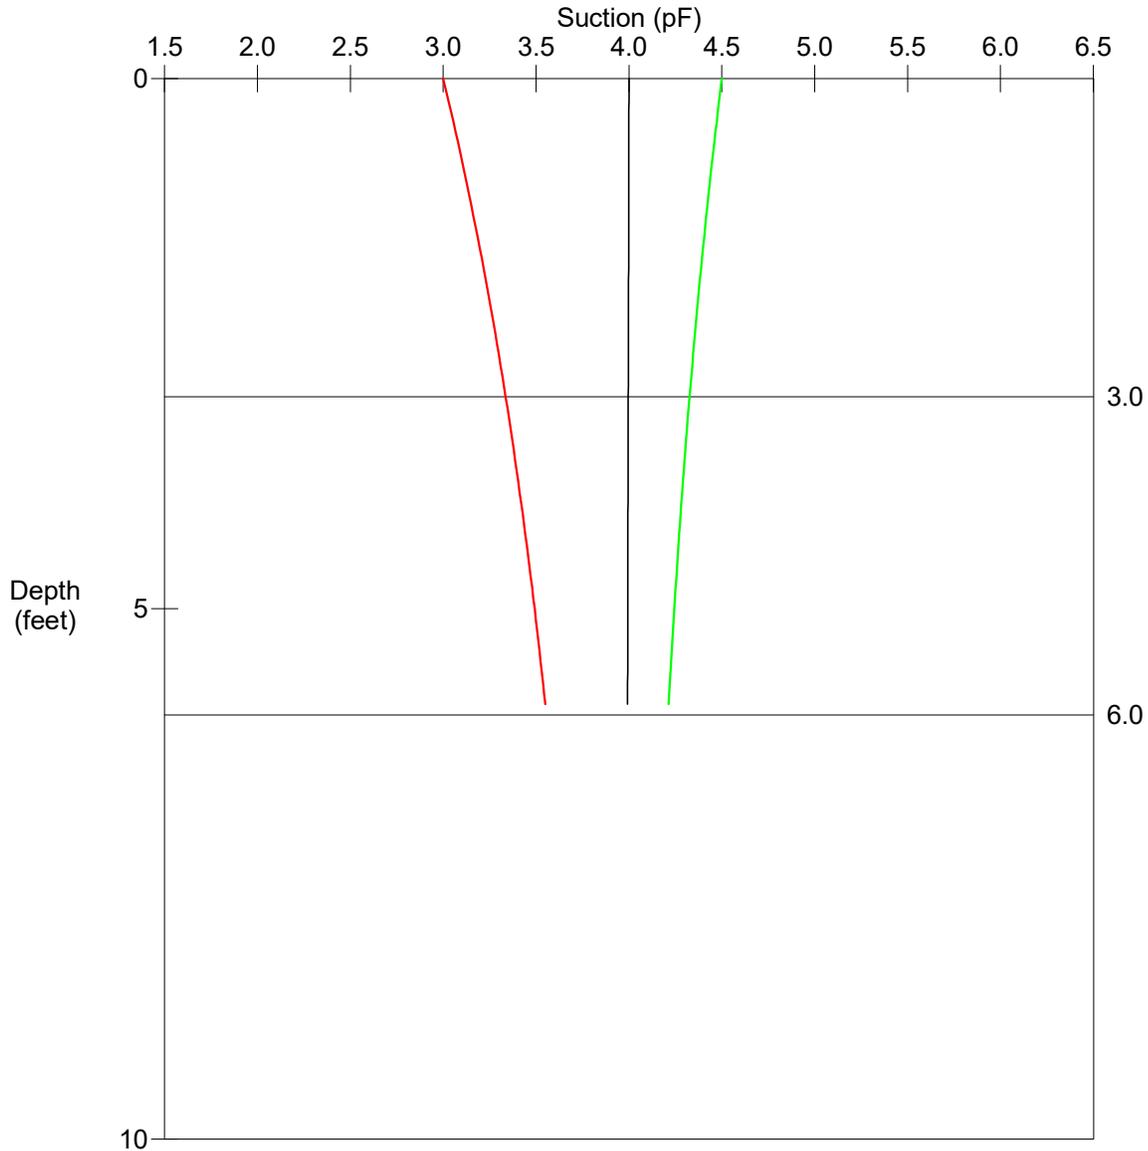
## SUCTION PROFILES

- Initial suction at edge of slab
- Final suction at edge of slab
- Constant Suction

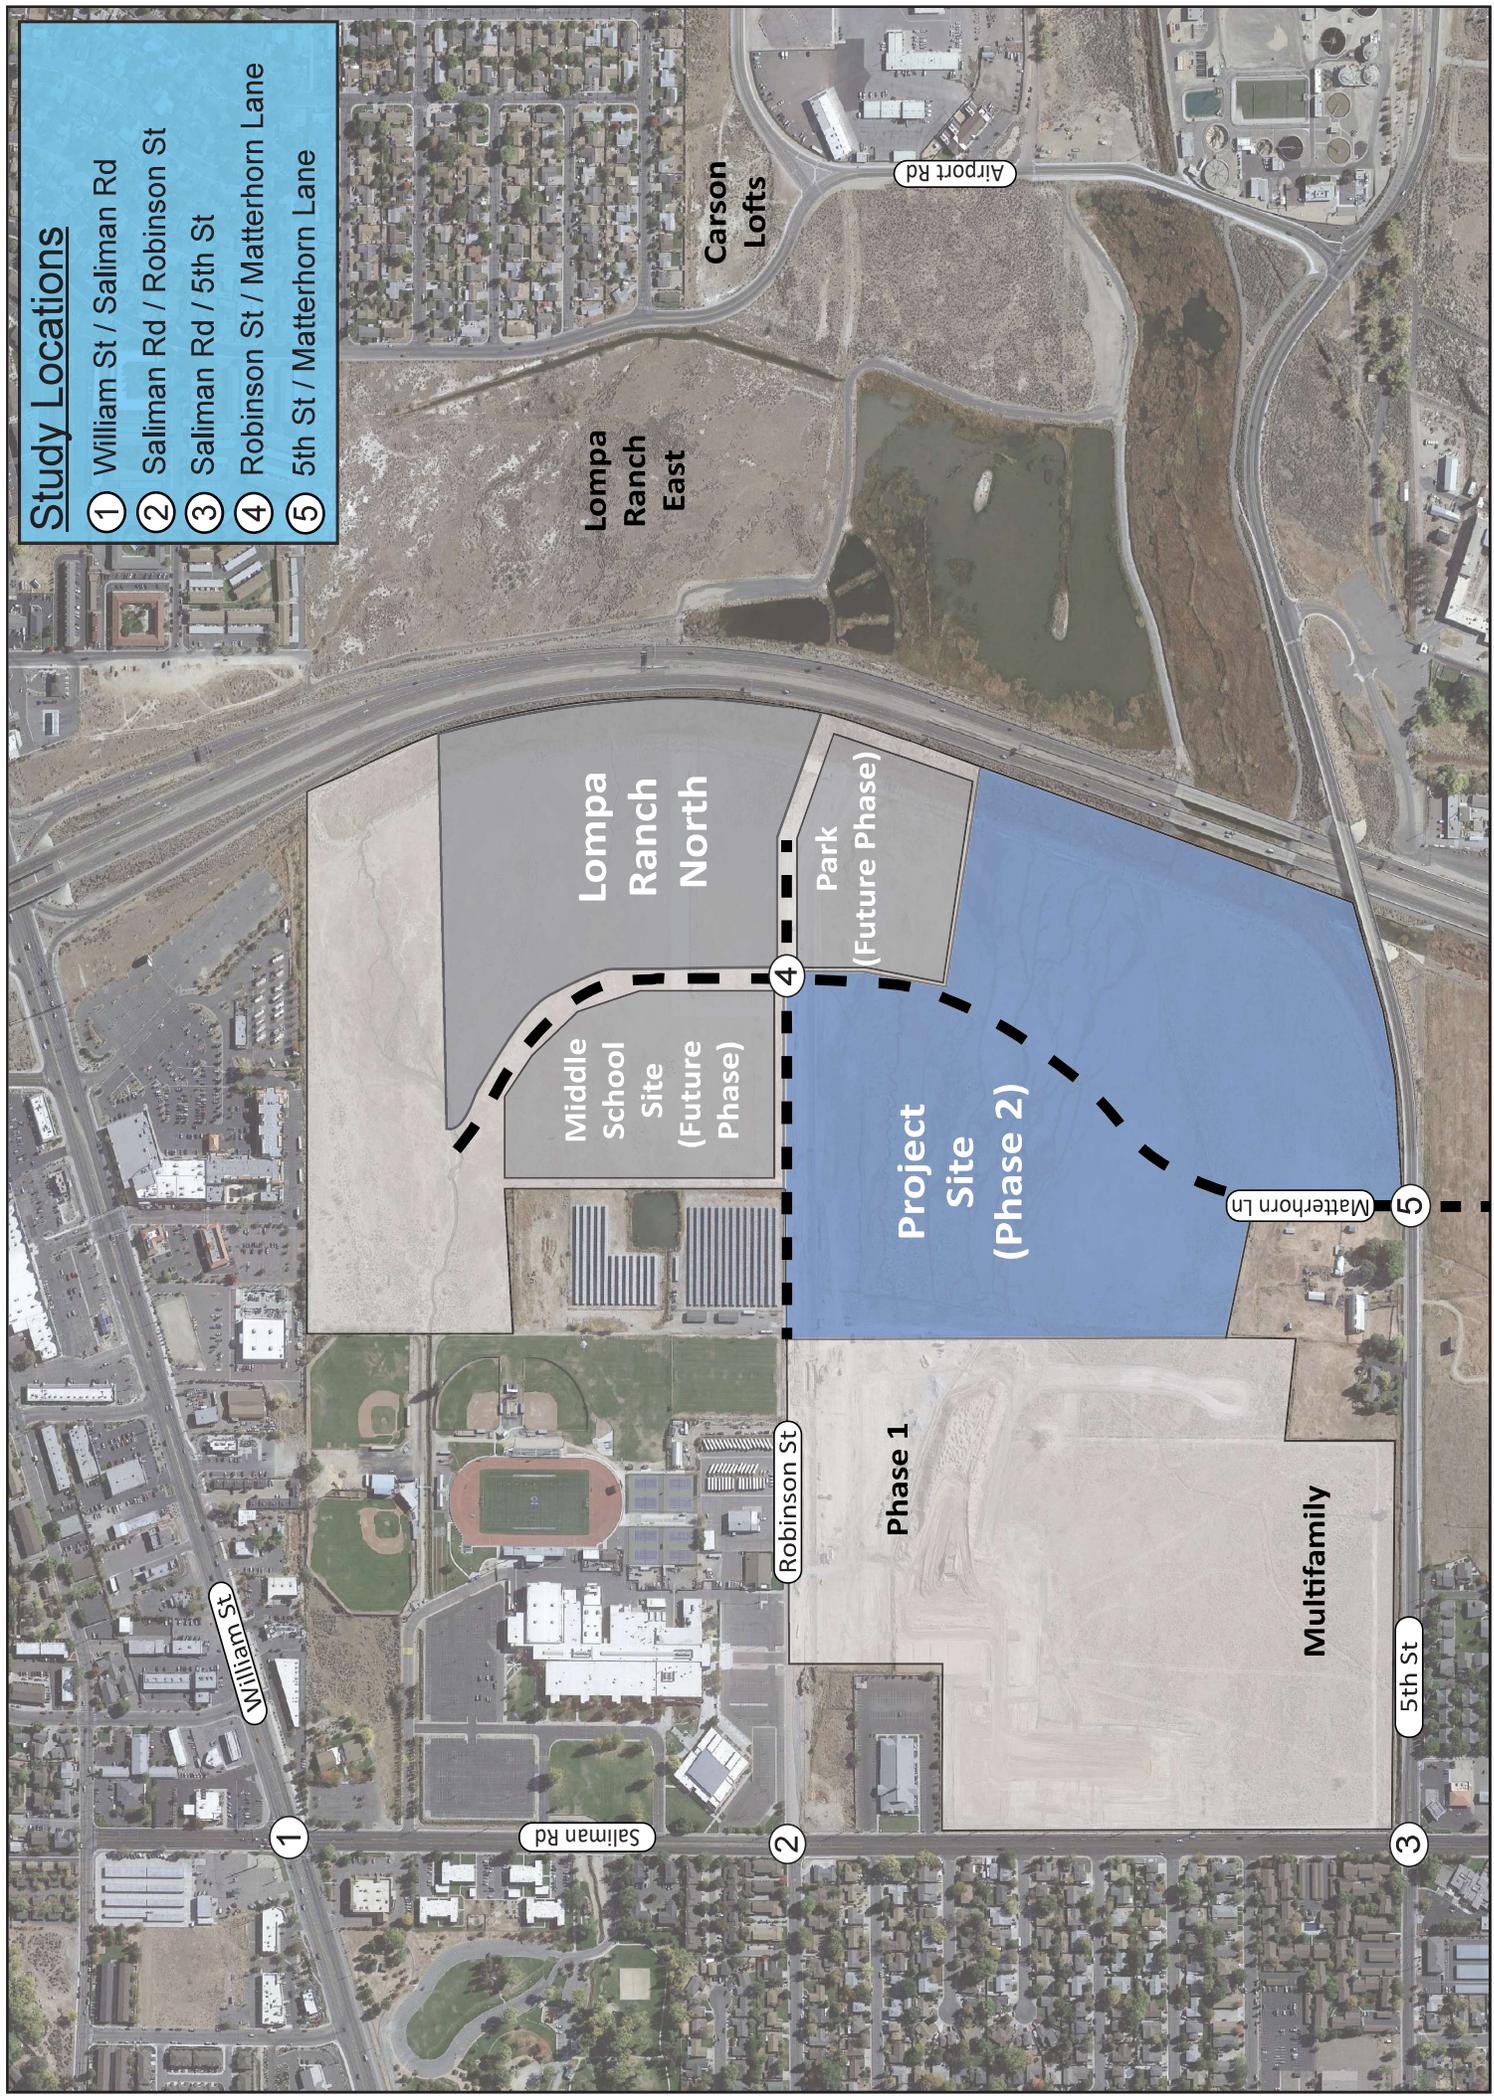
**Figure 1** Blackstone Ranch Phase 2 Traffic Impact Study Study Area

- ### Study Locations
- ① William St / Saliman Rd
  - ② Saliman Rd / Robinson St
  - ③ Saliman Rd / 5th St
  - ④ Robinson St / Matterhorn Lane
  - ⑤ 5th St / Matterhorn Lane

Legend:  
 # Study Intersection  
 Project Site  
 Future Collector Roadway

The proposed project is generally located west of I-580 between 5<sup>th</sup> Street and Robinson Street. The project site is situated on the southeast corner of the Lompa Ranch West development, as shown on **Figure 1**. The preliminary site plan is shown on **Figure 2**.
