We appreciate the opportunity to prepare this geotechnical update for the Lompa Ranch – Phase B1 & B2 project. Please contact our office should you have any related questions or comments.

APPENDIX A  
GEOTECHNICAL PLATES

**Geotechnical Investigation**  
**LOMPA RANCH - PHASES B1 & B2**  
**RYDER HOMES**  
**CARSON CITY, NV**

# Geotechnical Investigation Lompa Ranch Carson City, Nevada

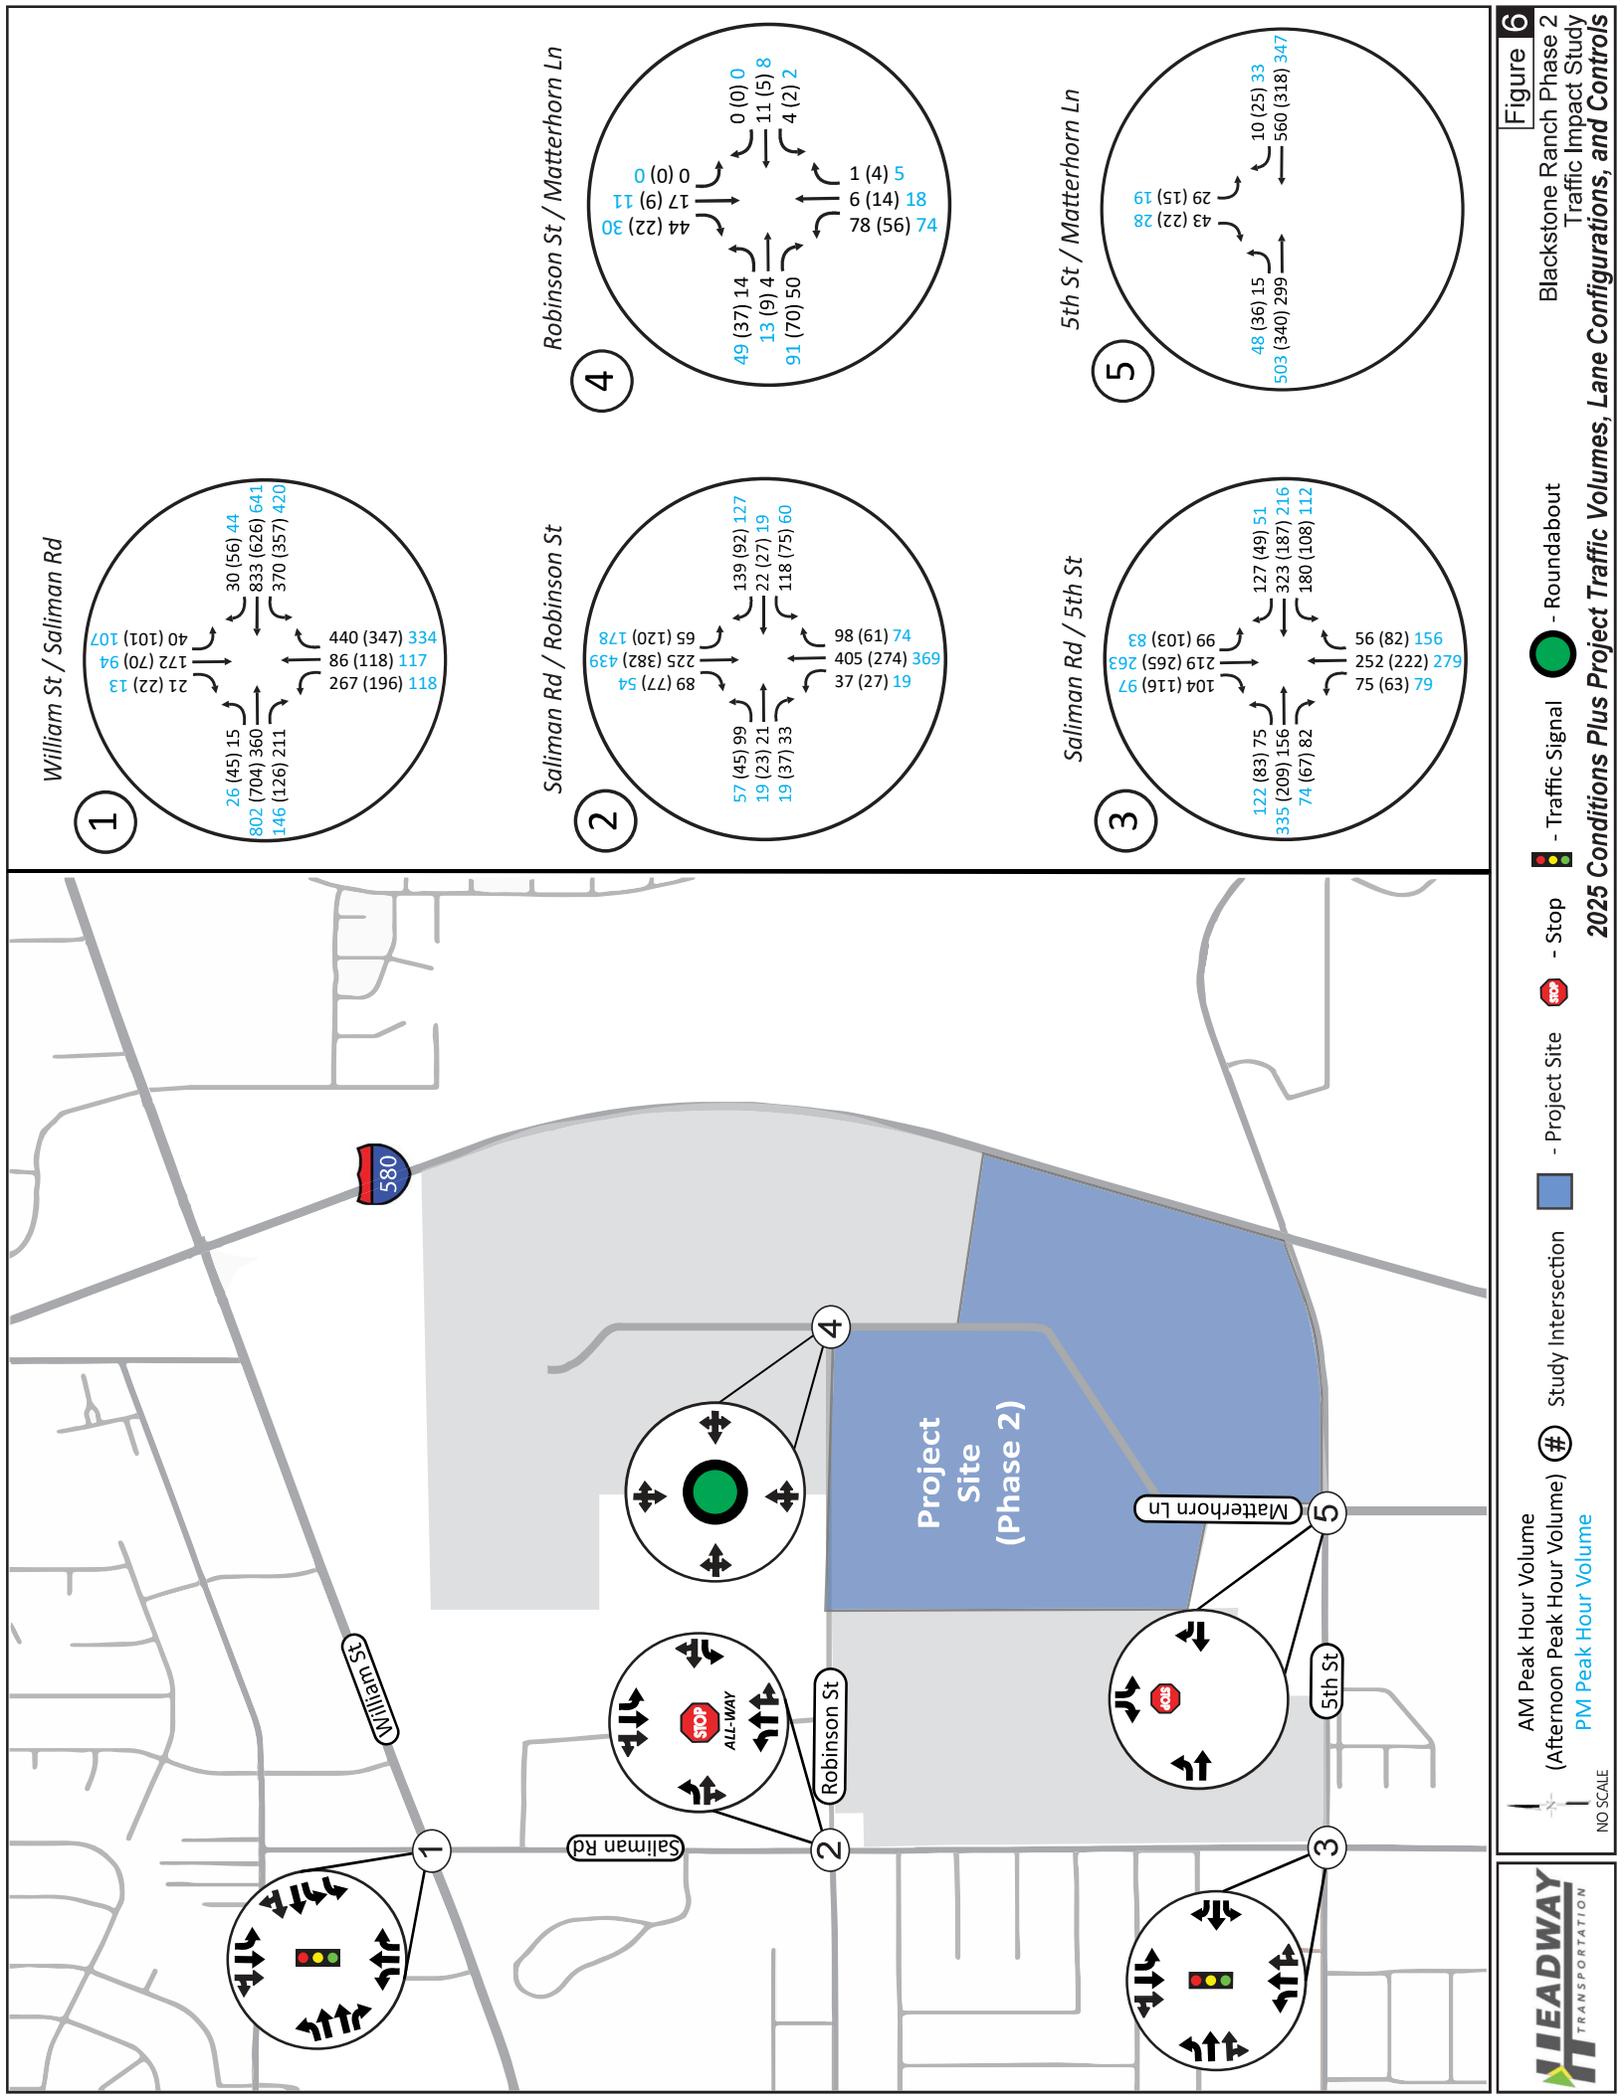
**Figure 6**  
Blackstone Ranch Phase 2  
Traffic Impact Study  
2025 Conditions Plus Project Traffic Volumes, Lane Configurations, and Controls

- AM Peak Hour Volume
- Afternoon Peak Hour Volume
- PM Peak Hour Volume
- NO SCALE
- Study Intersection
- Project Site
- Stop
- Traffic Signal
- Roundabout
